Analysis of the Coordination of Suppression and Ventilation in Single-Family Homes

John Regan
Julie Bryant
Craig Weinschenk

UL Firefighter Safety Research Institute
Columbia, MD 20145

March 19, 2020

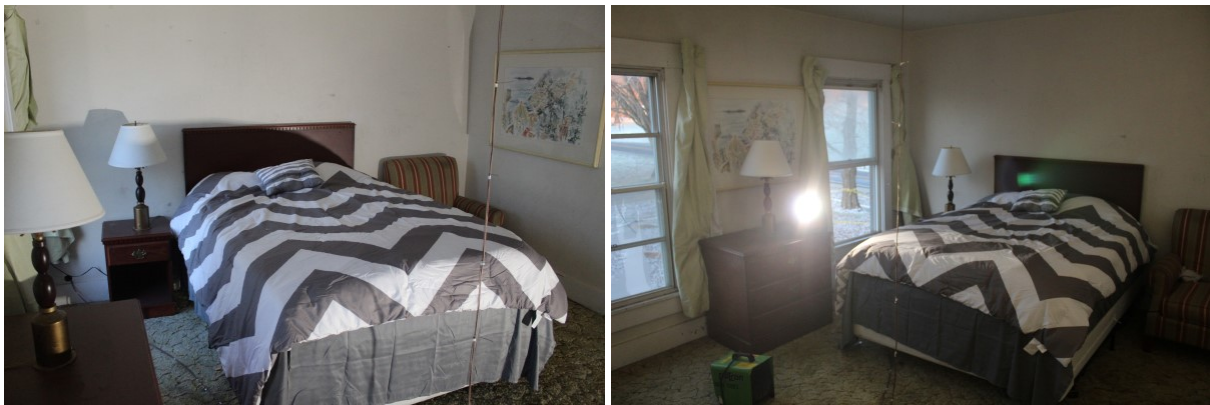
Figure 2.1: Representative bedroom fuel package containing bed frame, headboard, box spring, mattress, and associated bedding as well as a nightstand, dresser, sofa chair, lamp and shade, and pictures.

Bedroom fuel packages included a sofa chair, a steel queen size bed frame, a queen size box spring, a queen size mattress, comforter, two pillows, a head board, a night stand, lamp, dresser, and an end table. During Experiments 13 and 14 only, the fuel package also contained a sofa to prolong the burn duration. Table 2.7 provides the dimensions and weights of each item. The items were arranged in the space based on the configuration of the room. In bedrooms where no carpet was present, carpet and padding were added over the existing floors. For photographs of representative bedroom fuel packages, see Figure 2.1.

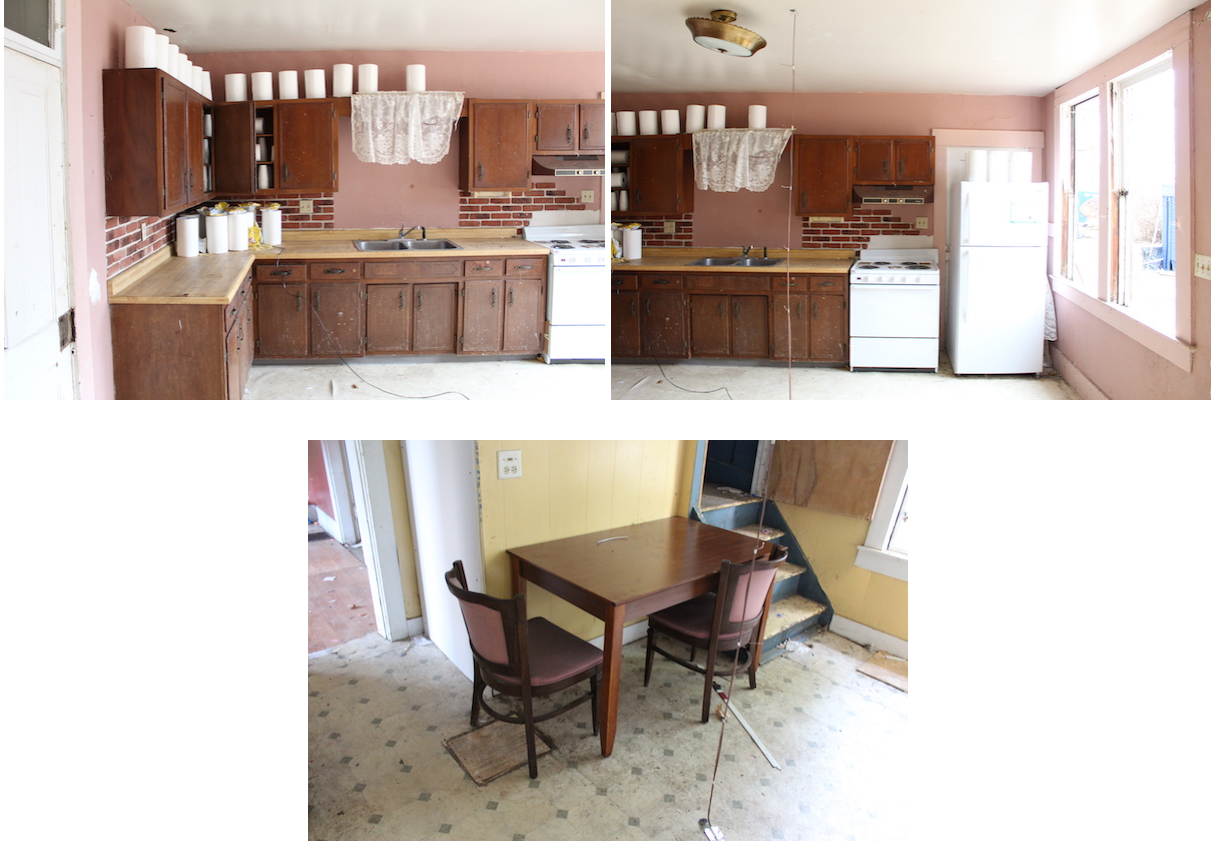
Figure 2.2: Representative kitchen fuel package containing cabinetry, a refrigerator, a range, a dining room table, two chairs, and ignition fuel package of a coffee maker, bags of potato chips, and paper towel rolls.

further increase the fuel load and provide an indication of flashover conditions. For photographs of representative kitchen fuel package, see Figures 2.2. See Table 2.8 for the dimensions and weights of each item. For cabinetry layout and dimensions as well as general fuel package configuration see each individual experiment write up in Section 3.

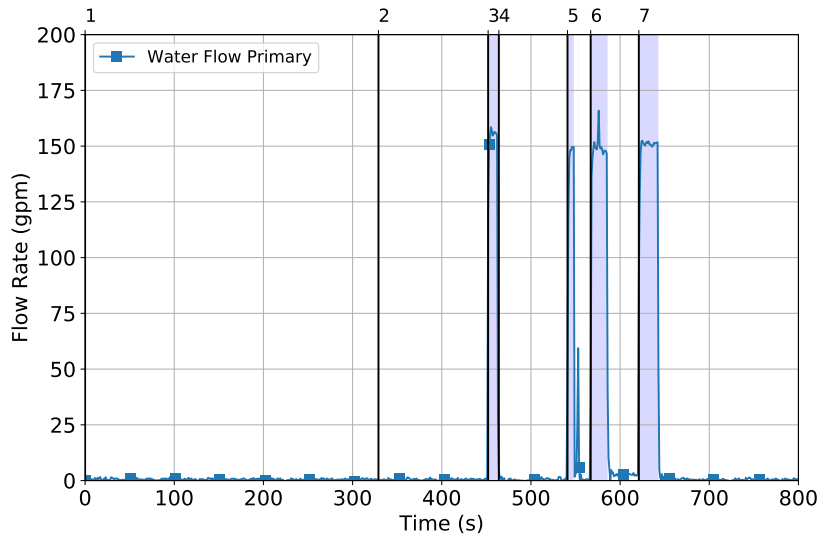
Action/Event	Time (s)
1	Ignition	0
2	Flashover	329
3	Exterior Water in Bedroom 1 Window	452
4	Front Door Open	464
5	Flow from Top of Stairs	541
6	Flow from Doorway	567
7	Suppression Crew Entered Fire Room	621

Figure 3.1: Flowmeter data obtained from Experiment 10 illustrate how data is presented on subsequent graphs.

Several fire department interventions occurred during each experiment. A list of interventions is provided for each experiment and included events such as suppression crew movement, ventilation, and water flow. Times of suppression crew movement and ventilation were recorded as they occurred and were verified from video analysis. Water flow was measured and recorded by a flow meter attached to the primary hoseline (interior suppression) or the primary and secondary hose-line (exterior followed by interior suppression). The data collected from this flow meter for each experiment has been depicted on subsequent graphs throughout this section as blue vertical bars indicating when water was flowing. Figure 3.1 provides an example of typical water flow data collected from the flow meter along with the associated fire department interventions.

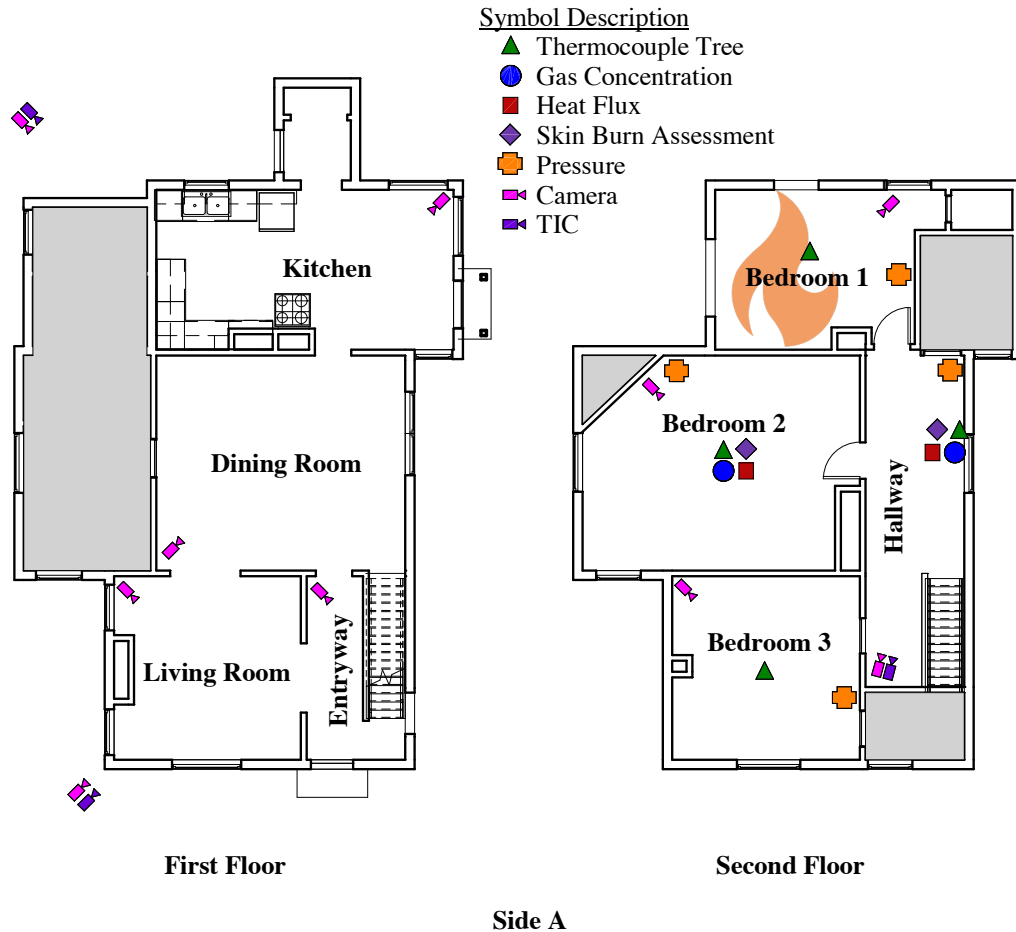
Figure 3.3: Instrumentation and floor plan for Experiment 1. The gray areas were isolated from the remainder of the structure and utilized as space for instrumentation.

to the second-floor. The second-floor had three bedrooms. These areas formed the experimental volume. The structure was instrumented for temperature, pressure, heat flux, IR, and standard video to capture the fire dynamics during experimentation. Instrumentation was also installed to characterize the potential for skin burns and occupant toxic exposure during the experiment. Figure 3.3 shows the layout of the first and second-floors with the instrumentation locations.

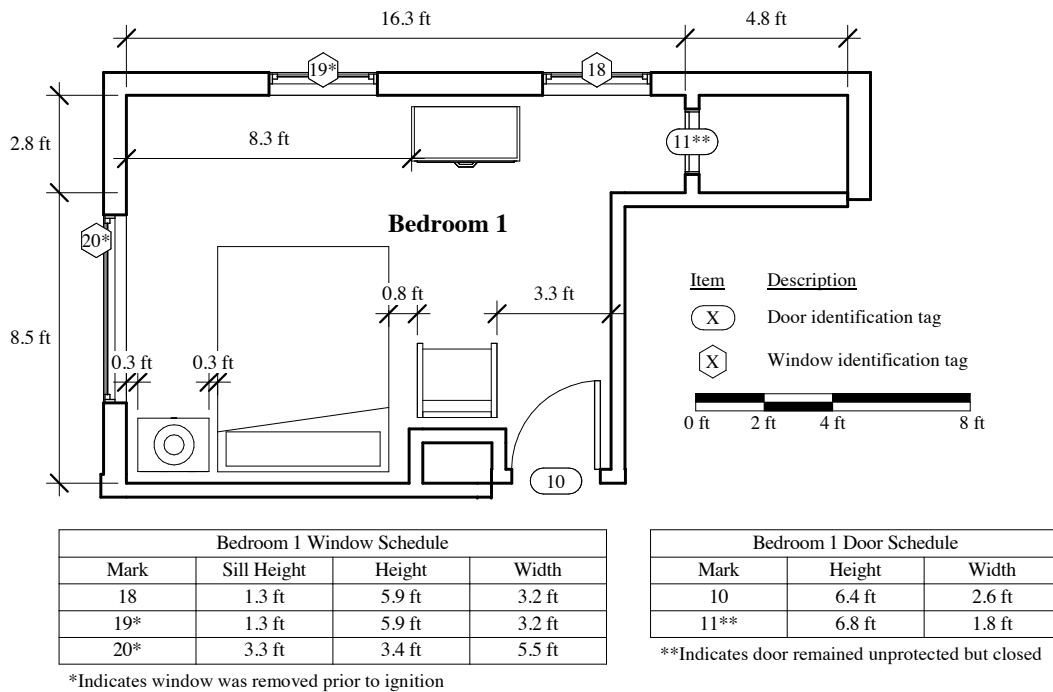
Figure 3.5: Fire room layout for Experiment 1.

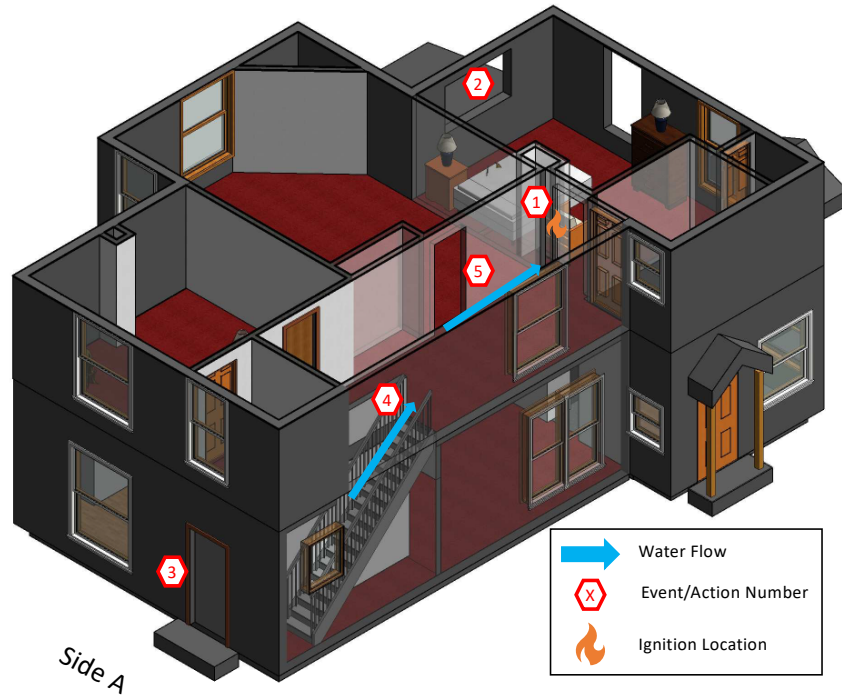
Action/Event	Time (mm:ss)	Time (s)
1 Ignition	00:00	0
2 Flashover	04:38	278
3 Front Door Open	05:59	359
4 Flow from Stairs	06:18	378
5 Flow and Move to Fire Room	06:34	394
6 Flow from Fire Room Doorway	06:59	419

Figure 3.6: Time and sequence of actions and events for Experiment 1.

Experiment 1 was conducted to examine interior suppression without additional ventilation to establish baseline conditions for the Method 1 experiments. To replicate a similar volume of space found in other experiments, bedroom 3 remained closed throughout the experiment. To ensure repeatable fire growth and a sufficient oxygen supply for flashover, the side C and side D windows (labeled 19 and 20 in Figure 3.5) were removed prior to ignition. Figure 3.6 shows the sequence of events with an isometric image of the structure.

into the fire room to complete suppression. The total tactic time from initial ventilation (front door open) to suppression was 35 s (00:35). The total water flowed for initial suppression was 136 gal, which does not include the additional water used during mop-up operations. Figure 3.6 indicates the time and sequencing of events during Experiment 1 with an isometric image of the structure.

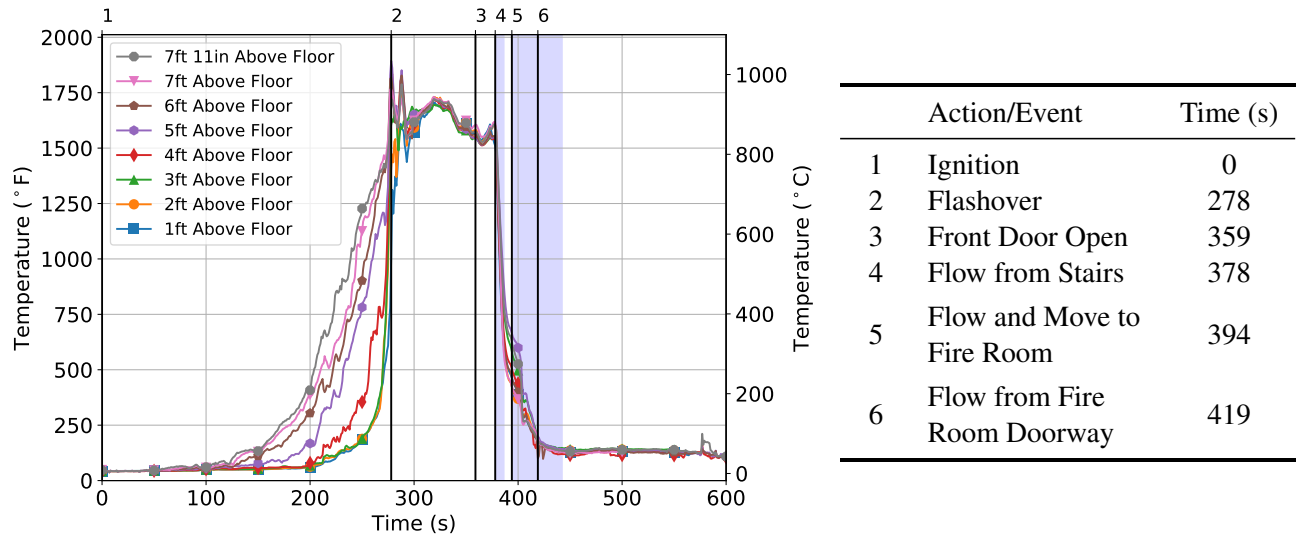
Figure 3.7: Fire room (bedroom 1) temperatures for Experiment 1. Blue vertical bars indicate time and duration of water flow.

The time history of the fire room temperature variations are presented in Figure 3.7. As smoke began leaving the side C window 100 s post ignition, temperatures nearest the ceiling (5 ft and above) increased. Temperatures at all elevations began to increase around 200 s post ignition as the chair became fully involved. At approximately 278 s post ignition, fire room temperatures increased beyond 1100 °F, indicating flashover. Temperatures remained elevated until interior suppression began at 376 s, whereafter, temperatures decreased.

The room remained in a post-flashover state throughout the first fire department intervention, which was the opening of the front door at 359 s (5:57) post ignition. The initial water application from the stairway (Action 4) was effective at reducing temperatures in the fire room (see Figure 3.7). The subsequent suppression action of flowing and moving toward the fire room further decreased the temperatures in the fire room and extinguished the fire.

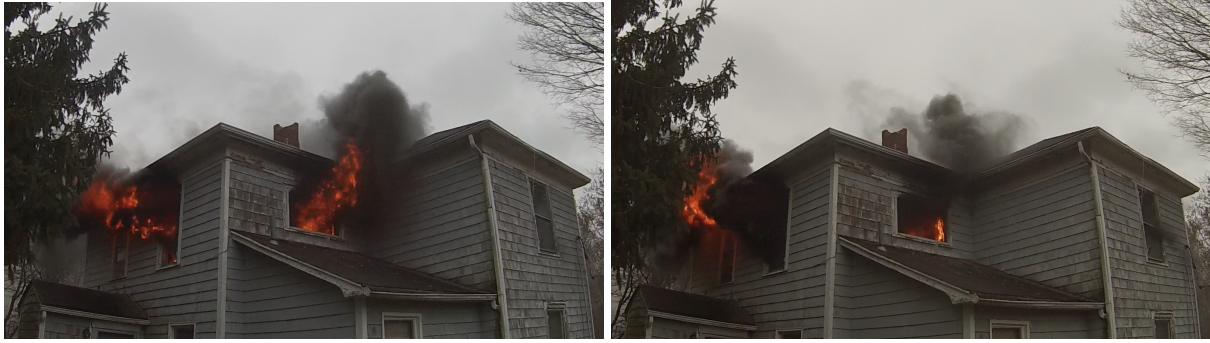
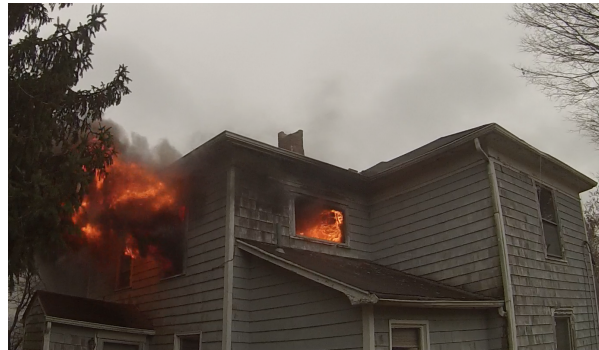
(a) Fire Room at Flashover

(b) Fire Room at 5 s Post-Flashover

(c) Fire Room at 10 s Post-Flashover

Figure 3.8: Exterior still images from the B/C corner show the impact of wind for Experiment 1.

Note: The second temperature spike in the fire room, which occurred approximately 10 s after the room transitioned to flashover. During the experiment, there was a sustained 11 mph wind in the direction of the open side B window (marked by 20 in Figure 3.5). Images presented in Figure 3.8 qualitatively show the impact of the wind on fire behavior as the room transitioned to flashover, as well as 5 s and 10 s later.

At the time of flashover, fire was visible through both open fire room windows as shown in Figure 3.8a. Five seconds after flashover as the wind speed increased, exhaust flow from the side B window was suppressed (see Figure 3.8b). The wind gusts continued for several more seconds as indicated in Figure 3.8c by the lack of exhaust out of the side B window and increased flow from the side C compared to Figure 3.8a. The blockage of the exhaust flow led to an increase in pressure and therefore transport of combustion gases through the structure.

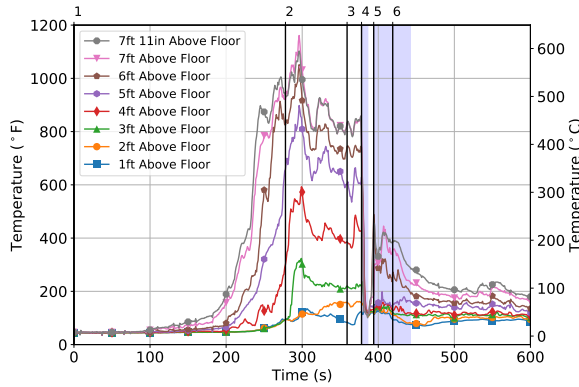
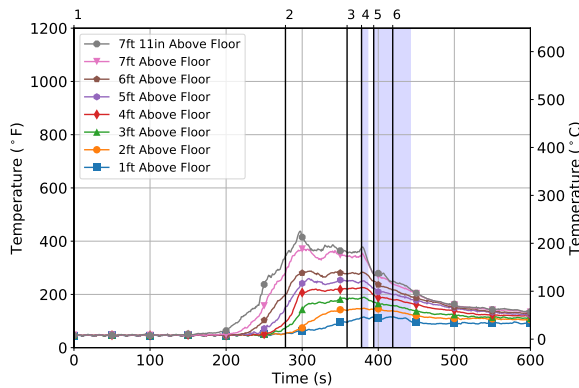
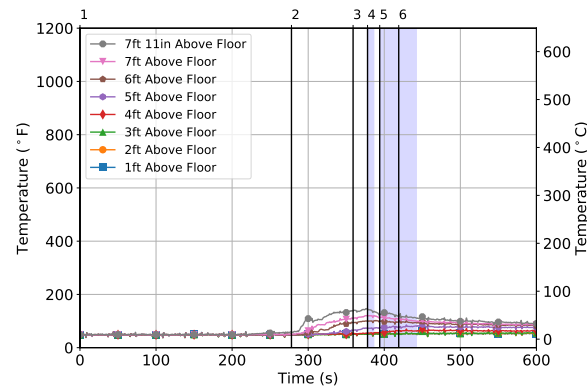
(a) Hallway Temperatures

(b) Bedroom 2 Temperatures

(c) Bedroom 3 Temperatures

Figure 3.9: Second-floor temperatures for Experiment 1. Blue vertical bars indicate time and duration of water flow.

When the fire room transitioned to flashover, temperatures in open areas of the second-floor on the structure also increased, as shown by data from the three locations in Figure 3.9. The highest temperatures observed in adjacent spaces were in the hallway. Hallway temperatures peaked approximately 20 s after the fire room transitioned to flashover as the products of combustion flowed from the fire room throughout the second-floor. The peak ceiling temperatures at this location exceeded 1100 °F, which coincided with the second peak in fire room temperatures. At the time of fire department intervention, the temperatures were stratified with the temperatures 5 ft and above in excess of 600 °F and the temperatures 3 ft and below at less than 250 °F. The initial water

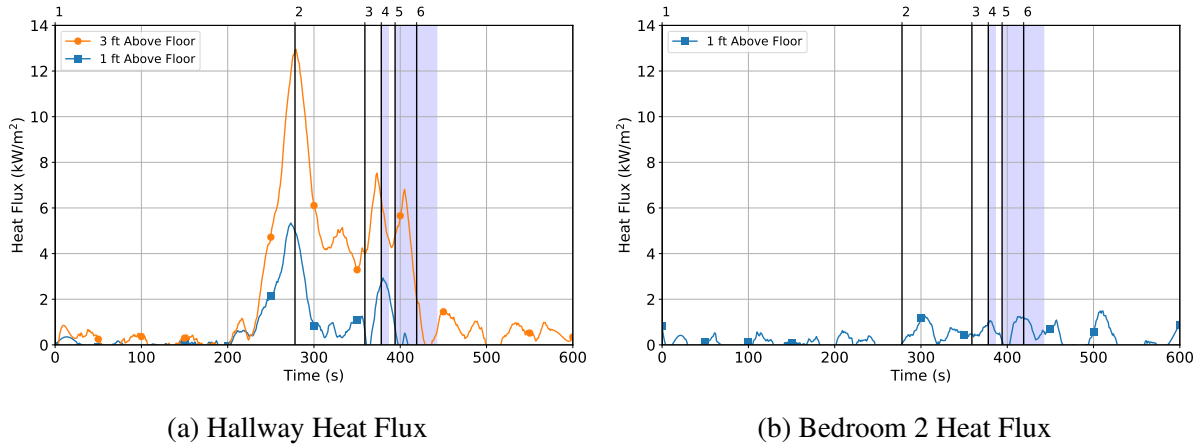
Figure 3.10: Heat flux versus time in the hallway and bedroom 2 for Experiment 1. Blue vertical bars indicate time and duration of water flow.

The heat flux at the locations in the hallway and bedroom (see Figure 3.10) showed response profiles similar to the temperatures at the respective locations. Heat flux was measured in the hallway at 1 ft and 3 ft above the floor and in bedroom 2 at 1 ft above the floor. The peak heat fluxes in the hallway both occurred prior to fire department intervention, at approximately the same time as flashover. Peak heat fluxes measured were approximately 5 kW/m² and 13 kW/m² at the

1 ft and 3 ft elevations, respectively. After this peak, the heat fluxes decreased below 2 kW/m^2 at the 1 ft level and below 7 kW/m^2 at the 3 ft level at the time the front door was opened. There was an increase in heat flux at both elevations following the front door being opened, with local peaks of 3 kW/m^2 at 1 ft and 7.5 kW/m^2 at 3 ft. Following water flow from the stairs, the heat flux dropped at both elevations, but the 3 ft elevation increased back to near pre-suppression values. Once the suppression crew reached the fire room doorway, the heat flux decreased below 2 kW/m^2 at both elevations for the remainder of the experiment. The peak heat fluxes measured in bedroom 2 were significantly less than those measured in the hallway, with a peak of 1.5 kW/m^2 .

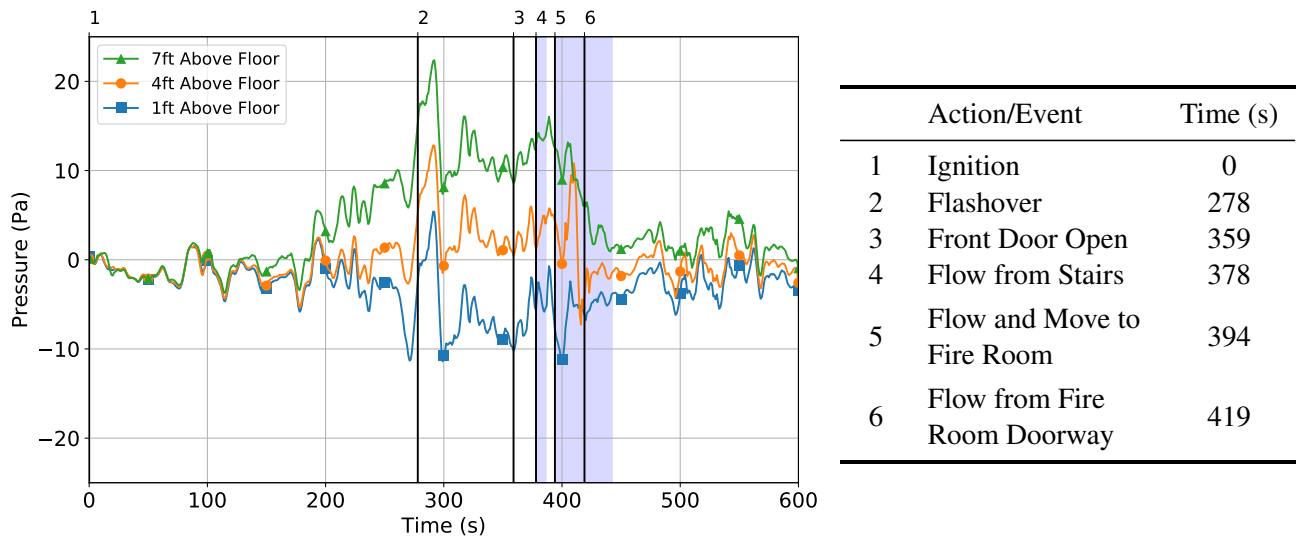
Figure 3.11: Pressures in fire room (bedroom 1) for Experiment 1. Blue vertical bars indicate time and duration of water flow.

The pressures within bedroom 1 were impacted by both the growth of the fire and the wind. As the fire grew, the 4 ft and 7 ft pressures in the fire room (see Figure 3.11) began to increase, which was consistent with products of combustion filling the top portion of the fire room. At the same time, the 1 ft pressure began to decrease as fresh air was drawn into the fire room in the lower portion. The large pressure spike at all three elevations at approximately 10 s post-flashover was a result of wind. The 7 ft pressure increased to greater than 20 Pa, while the 1 ft pressure increased from -10 Pa to 2.5 Pa. The wind sealed off the side B fire room, which prevented fire gases from exhausting and led to an increase in pressure in the fire room because the only remaining exhaust path was the open side C window. Within approximately 5 s, the second side C window failed and the wind speed decreased, leading to a drop in pressure. After the front door was opened, pressures in the fire room increased at all three elevations as the intake vent below the seat of the fire allowed the fire to grow. Following the initial suppression from the top of the stairway and

the flow-and-move toward the fire room, the 4 ft and 7 ft pressures began to decrease and the 1 ft pressure began to increase. As the fire was suppressed, the pressures converged toward ambient.

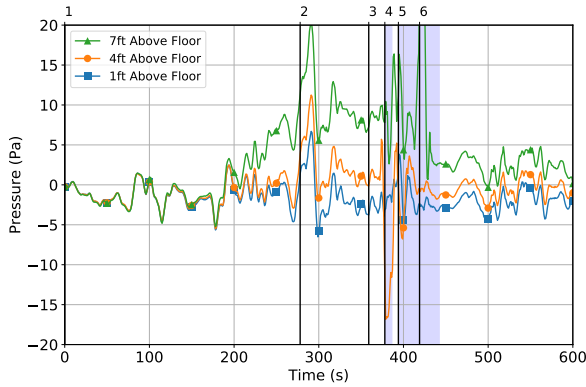
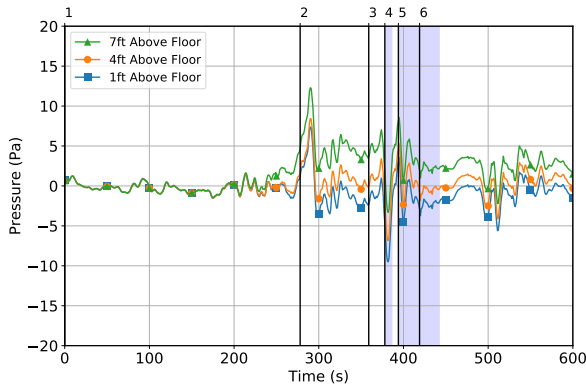
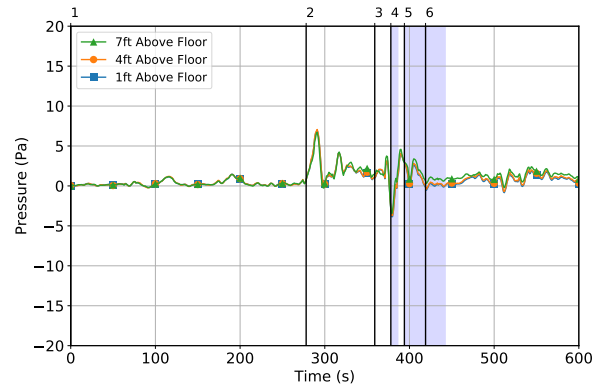
(a) Hallway Pressure

(b) Bedroom 2 Pressure

(c) Bedroom 3 Pressure

Figure 3.12: Pressure remote from fire room for Experiment 1. Blue vertical bars indicate time and duration of water flow.

The impact of wind was also evident in the pressure measurements from other locations on the second-floor as shown in Figure 3.12. At each location, there was a maximum value at all three elevations that aligned in time with the spike in the fire room pressure, just after flashover as shown in Figure 3.11. The pressure distribution at each location followed a trend similar to the fire room, with the 4 ft and 7 ft pressures that increased as the second-floor filled with products of combustion, and the 1 ft pressure that decreased as air was drawn toward the fire room from remote areas of the structure. As distance from the fire room increased, the magnitude of the 4 ft and 7 ft pressures decreased. Bedroom 3 (see Figure 3.12c) had the lowest pressure rises because it was both the furthest pressure sensor from the fire room and the bedroom door was closed.

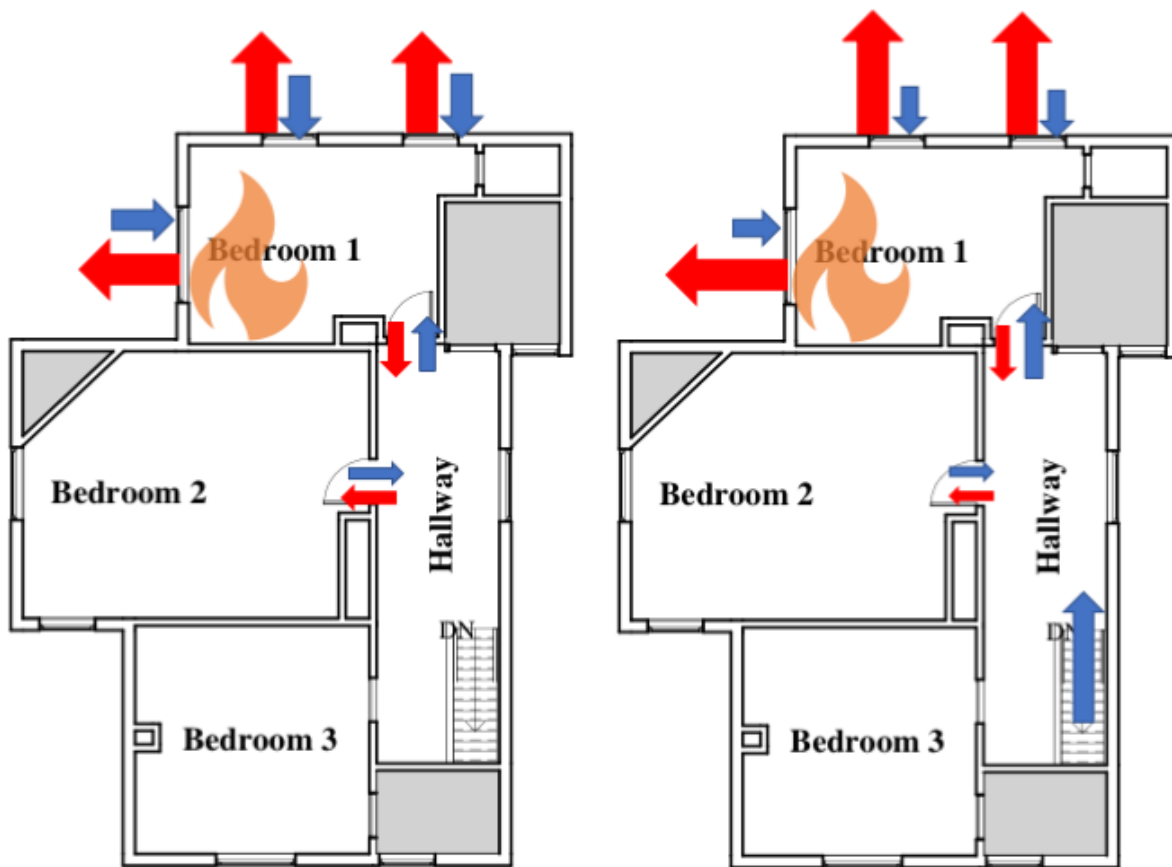
(a) Flows Prior to Front Door Being Opened

(b) Flows After Front Door was Opened

Figure 3.13: Changes in flow during Experiment 1. Red arrows indicate the flow of combustion products, blue arrows indicate the flow of fresh air, and the sizes of the arrows indicate the relative magnitude of the flow through each opening.

As the fire became ventilation limited, bi-directional flows developed in the fire room windows and fire room doorway, as shown in Figure 3.13a. Hot gases exhausted from the fire room through the top portion of these vents, while cool, fresh air was entrained into the fire room through the lower portion. These flows were maintained until the front door was opened (see Figure 3.13b) which allowed fresh air to flow through the front door, up the stairs, and to the fire room. Since suppression occurred shortly after, no significant fire growth resulted from the additional fresh air.

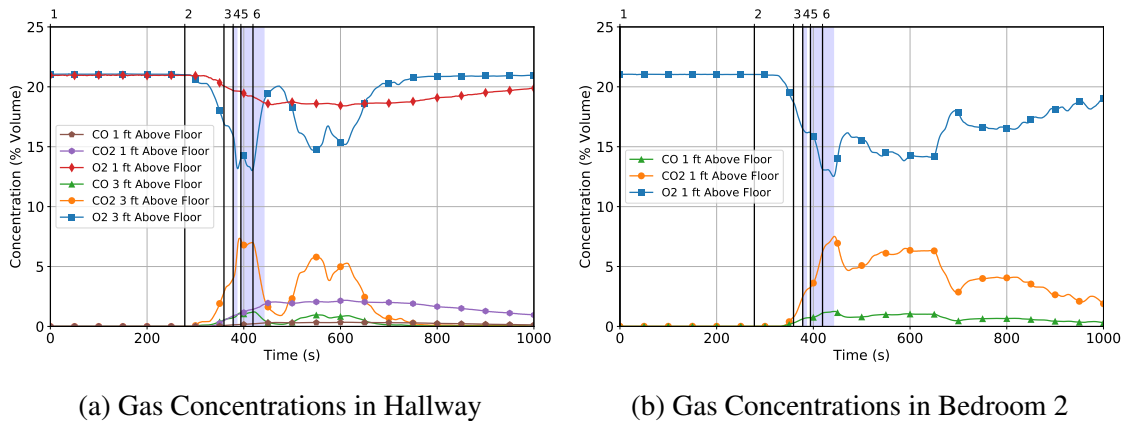
Figure 3.14: Gas concentrations for remote locations in Experiment 1. Blue vertical bars indicate time and duration of water flow.

Gas concentrations in the hallway (see Figure 3.14a) began to change due to fire growth around 275 s post ignition, approximately the same time that visibility in the hallway decreased. As the front door was opened and the suppression crew entered, the gas concentrations continued to change, reaching a peak hazard corresponding with the initial suppression action in the stairway. As the suppression crew continued flowing water and moving toward the fire room, the 3 ft gas concentrations began to return to pre-ignition concentrations, reflecting the air being entrained along the flow path by the flowing hoseline. Once the hoseline was shut off, the 3 ft O_2 concentration decreased and the 3 ft CO and CO_2 concentrations increased. Following suppression, the lack of pressure generated by the fire combined with wind limited the exiting gases. Instead, those gases flowed through the structure. The 1 ft gas concentration was not as responsive to the changes as the 3 ft gas concentration during the experiment. While the changes in concentrations reflect the increasing hazard associated with fire growth, the muted time response to the increasing and decreasing toxic hazard within the structure indicates there was likely an obstruction on the gas sample line. As a result, the 1 ft elevation concentrations should be examined from a qualitative

The gas concentrations in bedroom 2 (see Figure 3.14b) behaved similarly to the hallway location. Gas concentrations in bedroom 2 started to change approximately 300 s post ignition, after visibility was lost in the camera at this location. The peak concentrations occurred as the suppression crew had shut their line down following the hallway suppression action. Gas concentrations then remained relatively steady until there was a gradual recovery toward pre-ignition conditions roughly 650 s post ignition. The gas concentrations remained elevated (low O₂, high CO and CO₂) longer in this location than in the hallway because there was no efficient pathway for the gases to exit the room as it was offset from the flow path that existed between the open front door and open bedroom 1 windows.

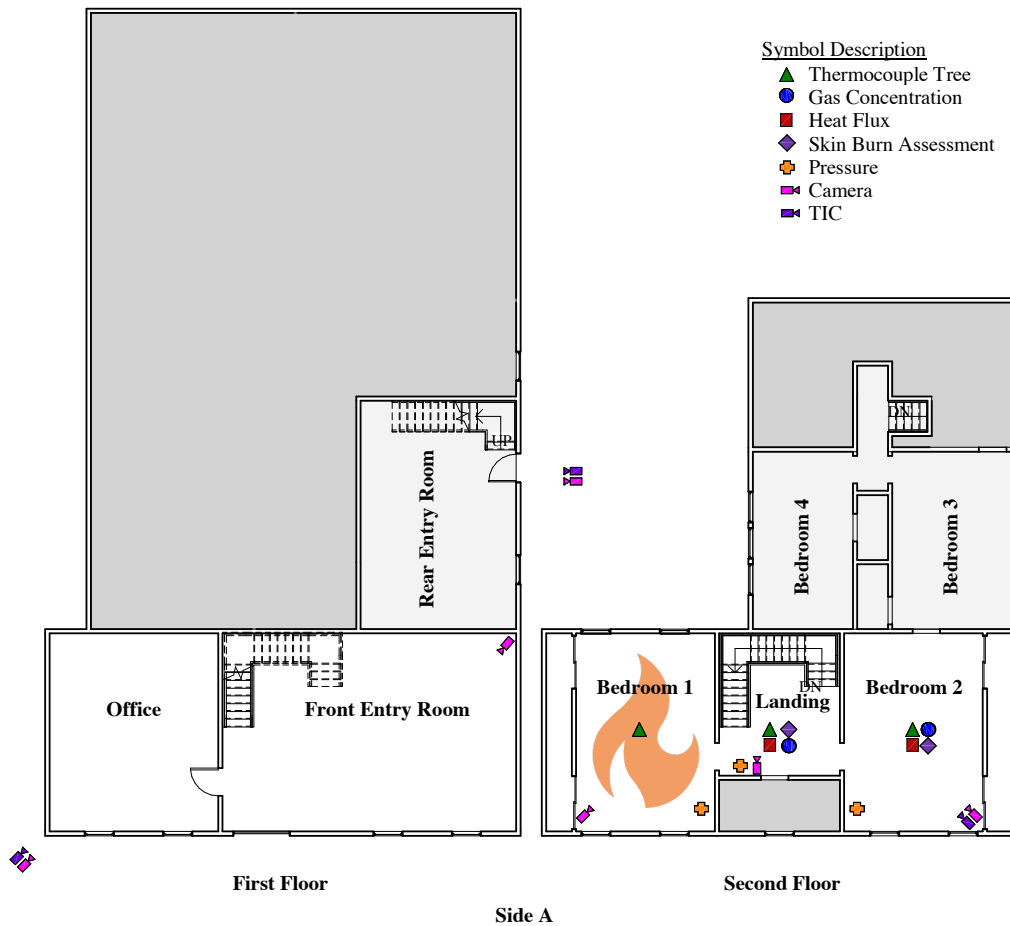
Figure 3.16: Instrumentation and floor plan for Experiment 2. The dark gray areas were isolated from the remainder of the structure and utilized as space for instrumentation. The light gray areas indicate the sub-structure not utilized for this experiment.

This structure was partitioned into two separate, independent sub-structures. The rooms located along side A of the structure (office, front entry room, and bedrooms 1 and 2) were isolated from the remaining rooms (rear entry room, bedrooms 3 and 4) within the structure. Two independent stairwells allowed this structure to be split so that the interior volume of the structure was similar to that of the other structures examined. The first-floor of the house partitioned for Experiment 2 had an office and front entry room, while the second-floor contained bedroom 1, bedroom 2, and a stairwell landing. These rooms defined the experimental volume, accounting for 1,646 sq ft of the 4,576 sq ft. The structure was instrumented for temperature, pressure, heat flux, IR, and standard video to capture the fire dynamics during experimentation. Instrumentation was also installed to characterize the potential for skin burns and occupant toxic exposure during the experiment. Figure 3.16 shows the layout of the first and second-floors with the instrumentation locations.

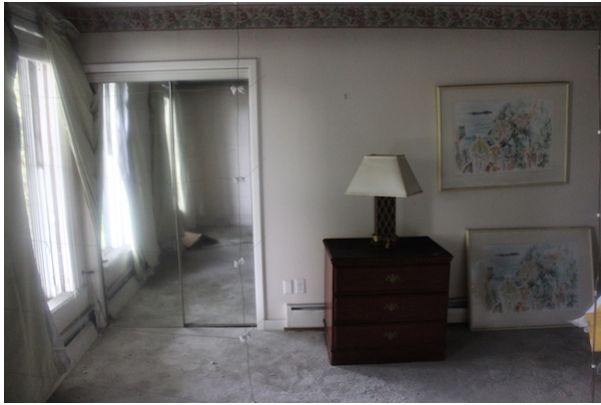
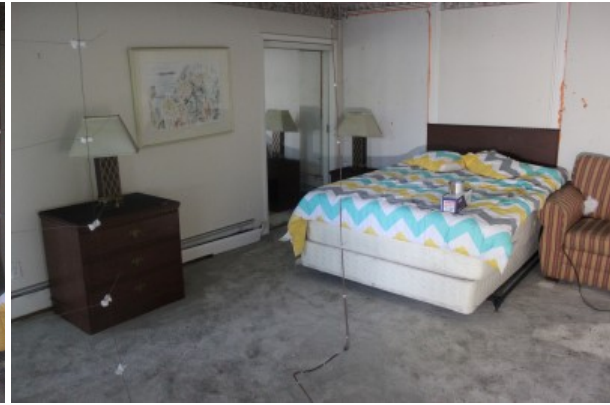
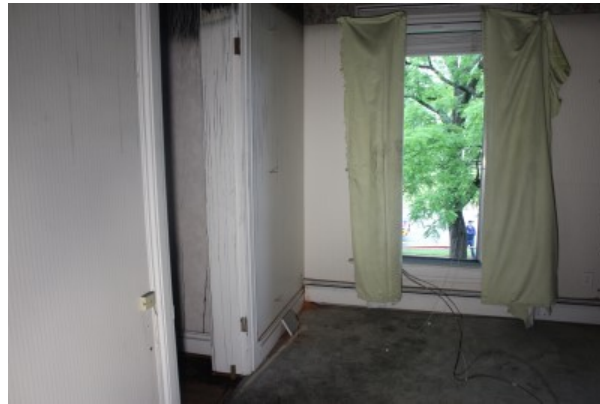
(a) A/B Corner

(b) B/C Corner

(c) A/D Corner

Figure 3.17: Interior photographs of the fire room for Experiment 2.

To ensure repeatable fire growth and a sufficient oxygen supply for fire growth, the windows labeled 8 and 9 in Figure 3.18 were removed prior to ignition. The windows labeled 6 and 7 in Figure 3.18 were covered with gypsum board for the duration of the experiment as shown in Figure 3.17b. Figure 3.19 shows the sequence of events with an isometric image of the structure.

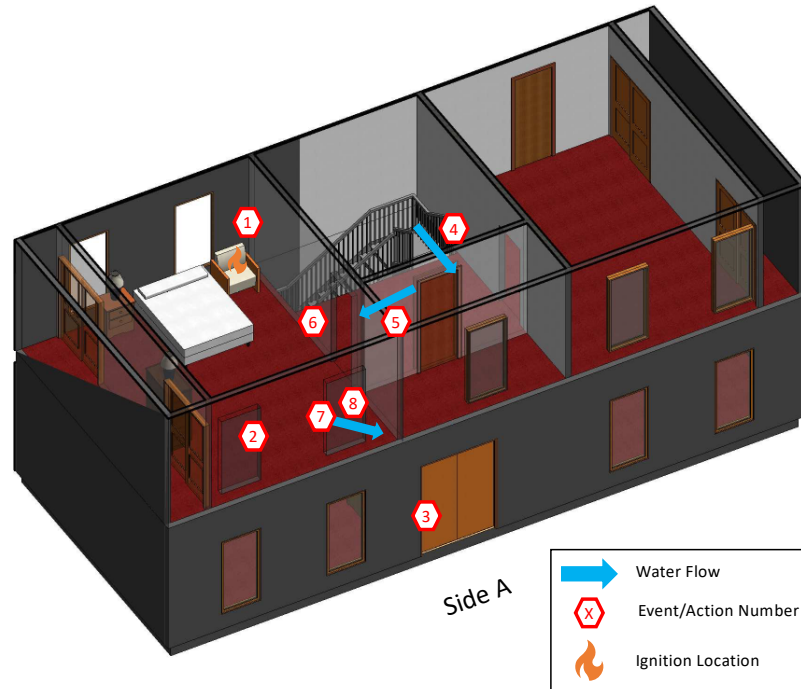
Action/Event	Time (mm:ss)	Time (s)
1 Ignition	00:00	0
2 Flashover	04:38	278
3 Front Door Open	07:01	421
4 Flow from Stairs	07:26	446
5 Flow from Landing	07:43	468
6 Suppression Crew Entered Fire Room	07:48	488
7 Begin Hydraulic Ventilation	10:10	610
8 End Hydraulic Ventilation	10:50	650

Figure 3.19: Time and sequence of actions and events for Experiment 2.

The fire in Experiment 2 was ignited in the upholstered chair next to the bed ($t = 0$ s). At 252 s (4:12) post ignition, flames were visible out of the open windows. The fire room transitioned to flashover at 278 s (4:38) post ignition. The fire continued to burn with flames extending out of the windows or approximately 3 min., until the initial water was flown by the suppression team.

The first fire department intervention in Experiment 2 was the opening of the front door 421 s (7:01) post ignition. The suppression crew entered the structure and advanced a 1.75 in. hoseline with a combination nozzle set to straight stream toward the second-floor. The first water application occurred from the stairway at 446 s (7:26) post ignition for 8 s in duration. The suppression crew continued to advance toward the fire when the second water application occurred from the landing 463 s (7:43) post ignition for 2 s in duration. The crew entered the fire room to complete suppression 468 s (7:48) post ignition. Three additional water applications occurred; lasting 21 s, 15 s, and 3 s in duration, respectively. After extinguishment, the suppression crew opened their nozzle to fog and began hydraulically ventilating the fire room from the side A window (labeled 9 in Figure 3.18) 610 s (10:10) post ignition. After 40 s, the suppression crew ended hydraulic ventilation at 650 s (10:50) post ignition.

The total tactic time from initial ventilation of the front door to initial suppression was 47 s (00:47). The tactic time from initial ventilation of the front door to the completion of hydraulic ventilation

was 3 min. 49 s (229 s). The total water flowed for initial suppression and hydraulic ventilation was 180 gal, which does not include the additional water used during mop-up operations. Figure 3.19 includes time and sequencing of events along with an isometric image of the structure.

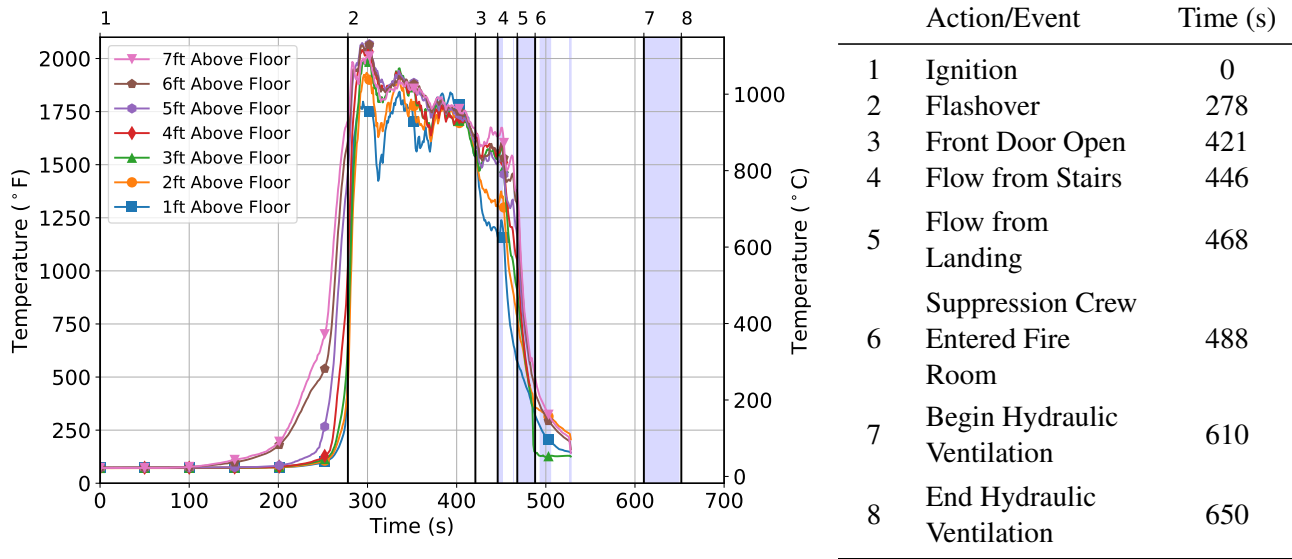
Figure 3.20: Fire room (bedroom 1) temperatures for Experiment 2. Blue vertical bars indicate time and duration of water flow.

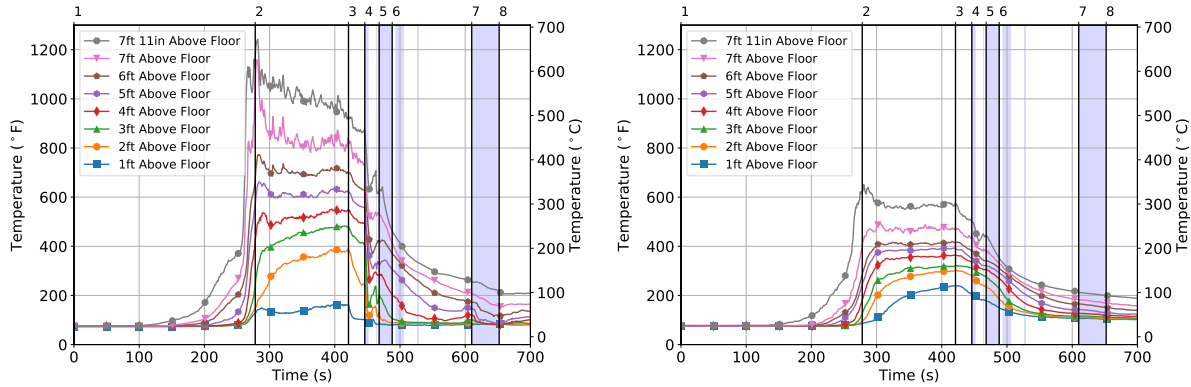
The temperatures in the stairway landing (see Figure 3.21a) first started to increase approximately 100 s post ignition (30 s after the fire room temperatures initially rose). As the fire room transitioned through flashover, these temperatures grew to steady values at the time of fire department intervention ranging from 1000 °F at the ceiling to 165 °F 1 ft above the floor. Once the front door was opened, the fresh air entrainment toward the fire room mixed with the gases exiting from the fire room, which caused the landing temperatures at all elevations to decrease. The initial suppression action from the stairway (Action 4) resulted in an immediate but temporary drop in temperatures in the landing. After the water flow from the stairs was stopped, combustion gases flowing from the fire room led to a small increase in landing thermocouple temperatures. The suppression actions in the landing and fire room doorway led to a continued decrease in temperatures. At the time that hydraulic ventilation was initiated, 610 s (10:10) post ignition, the temperatures at all elevations in the landing were less than 250 °F. Hydraulic ventilation had the most profound impact on the 1 ft to 5 ft temperatures, reducing them to near pre-ignition conditions.

Figure 3.21: Stairway landing and bedroom 2 temperatures for Experiment 2. Blue vertical bars indicate time and duration of water flow.

As bedroom 2 was farther from the fire room than the stairwell landing, the measured temperatures in bedroom 2 were less (see Figure 3.21b). Bedroom 2 temperatures followed a similar trend to those at the landing. At the time of fire department intervention, most of the temperatures in bedroom 2 had reached a steady state, ranging from approximately 550 °F at the ceiling to 250 °F 1 ft above the floor. Once the front door was opened, the temperature at all elevations decreased. The temperatures in bedroom 2 were not as responsive to the actions of the suppression crew. The temperatures began to decrease more quickly as suppression actions progressed into the fire compartment. The temperatures at all elevations in bedroom 2 had decreased below 215 °F at the time that hydraulic ventilation was initiated. Hydraulic ventilation did not have any noticeable impact on the temperatures in bedroom 2 as bedroom 2 was not in the flow path.

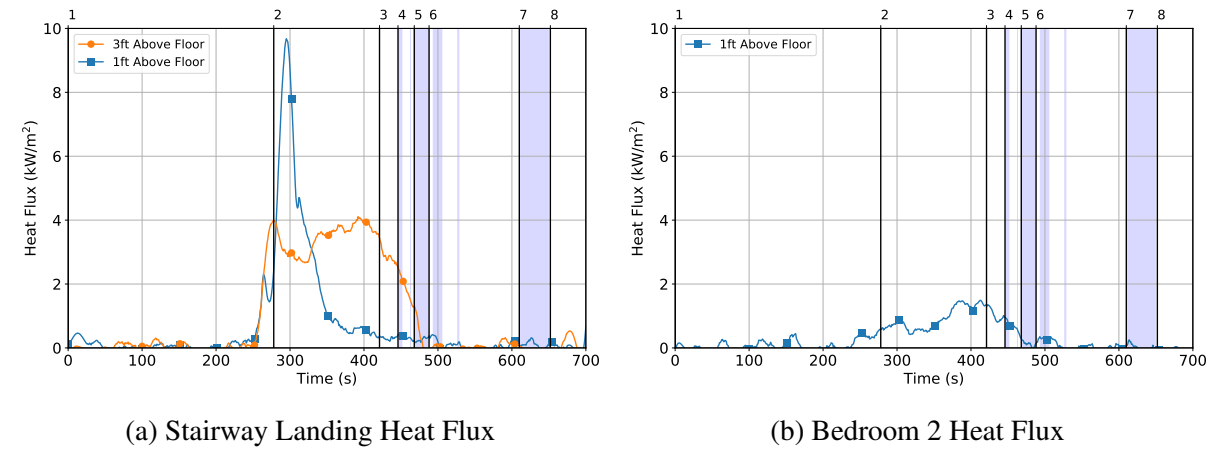
The heat flux time histories (see Figure 3.22) at 1 ft and 3 ft above the floor in the stairway landing and 1 ft above the floor in bedroom 2 followed a trend similar to the temperature profiles at these locations. The heat flux at both elevations in the stairway landing began to increase approximately 250 s post ignition, as the smoke layer began to descend to the floor. At approximately the time of flashover, the 3 ft heat flux reached a local peak of approximately 4 kW/m² and maintained this heat flux until the front door was opened. The 1 ft heat flux reached a greater peak heat flux of 10 kW/m² shortly after flashover, before decreasing below 1 kW/m² at the time the front door was opened. The greater heat flux at the 1 ft level following flashover was likely due to the 3 ft

gauge being completely covered by the smoke layer. The 1 ft gauge, however, remained below the smoke layer and had a line of sight to the flames at the doorway of the fire room. The heat flux at the 1 ft level decreased as the smoke layer continued to descend and there was less combustion at the fire room doorway. Most of the burning in the fire room was located near the window vents. After the front door was opened, the 3 ft landing heat flux began to decrease and the 1 ft landing heat flux remained steady. Suppression in the landing (Action 5) further decreased the landing heat flux, and as suppression continued in the fire room doorway (Action 6), the heat fluxes decreased to approximately pre-ignition conditions. The heat flux 1 ft above the floor in bedroom 2 was considerably less than the stairway landing, remaining below 2 kW/m^2 for the duration of the experiment.

Figure 3.22: Heat flux at remote locations for Experiment 2. Blue vertical bars indicate time and duration of water flow.

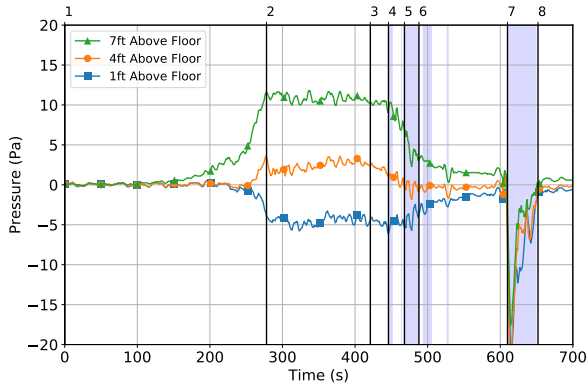
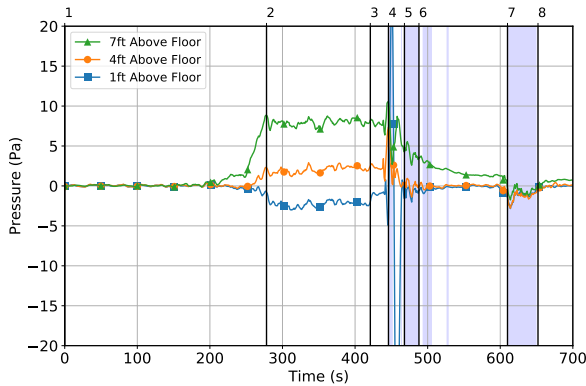
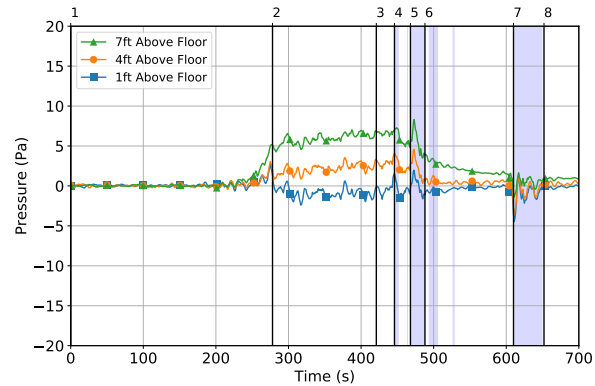
The pressures in the fire room, stairway landing, and bedroom 2 can be used to understand the growth of the fire and the subsequent flow of hot gases throughout the second-floor. Figure 3.23 shows the pressure time histories for these three locations on the second-floor. The pressure 7 ft above the floor in the fire room (see Figure 3.23a) first started to increase approximately 125 s post ignition, indicating hot gases were starting to accumulate close to the ceiling in the fire room. As the smoke layer continued to descend, 250 s post ignition, the 4 ft pressure began to increase and the 1 ft pressure began to decrease. The decrease at the lowest pressure sensor indicated the fire entrained air and therefore created a local area of low-pressure. Shortly afterward, the room

Figure 3.23: Second-floor pressure for Experiment 2. Blue vertical bars indicate time and duration of water flow.

The pressures in the stairway landing (see Figure 3.23b) and bedroom 2 (see Figure 3.23c) followed a similar trend in the period prior to the front door opening, although the magnitudes of the pressures were less than in the fire room. This indicates hot gases were flowing from the fire room to remote areas of the second-floor while at the same time fresh air was being entrained into the fire room from these remote rooms. Following the front door opening, the 1 ft pressure in the stairway landing increased in magnitude, indicating more air was being drawn into the fire room from the exterior of the structure because this pressure was in the flow path between the front door intake and fire room exhaust. Additionally, water flow from the stairs (Action 4) led to a drop in pressure at the 1 ft level before recovering as firefighters entered the fire room (Action 5). Similar to the

When hydraulic ventilation was initiated 610 s (10:10) post ignition, the pressure decreased by 15 Pa in the fire room. Note: That at its peak, the fire generated approximately 10 Pa of overpressure in the fire room. By the time the nozzle was closed 40 s after it was opened, the pressures in the fire room had returned to approximately ambient. Similar drops in pressure were observed in the stairwell landing and bedroom 2, but these pressure decreases were significantly smaller. In the landing, the pressure decreased by 2.5 Pa at all three elevations, and fluctuated between positive and negative pressures for the duration of the hydraulic ventilation. In bedroom 2, the pressure also decreased but fluctuated for the duration of the tactic.
