Analysis of the Coordination of Suppression and Ventilation in Single-Family Homes

John Regan
Julie Bryant
Craig Weinschenk

UL Firefighter Safety Research Institute
Columbia, MD 20145

March 19, 2020

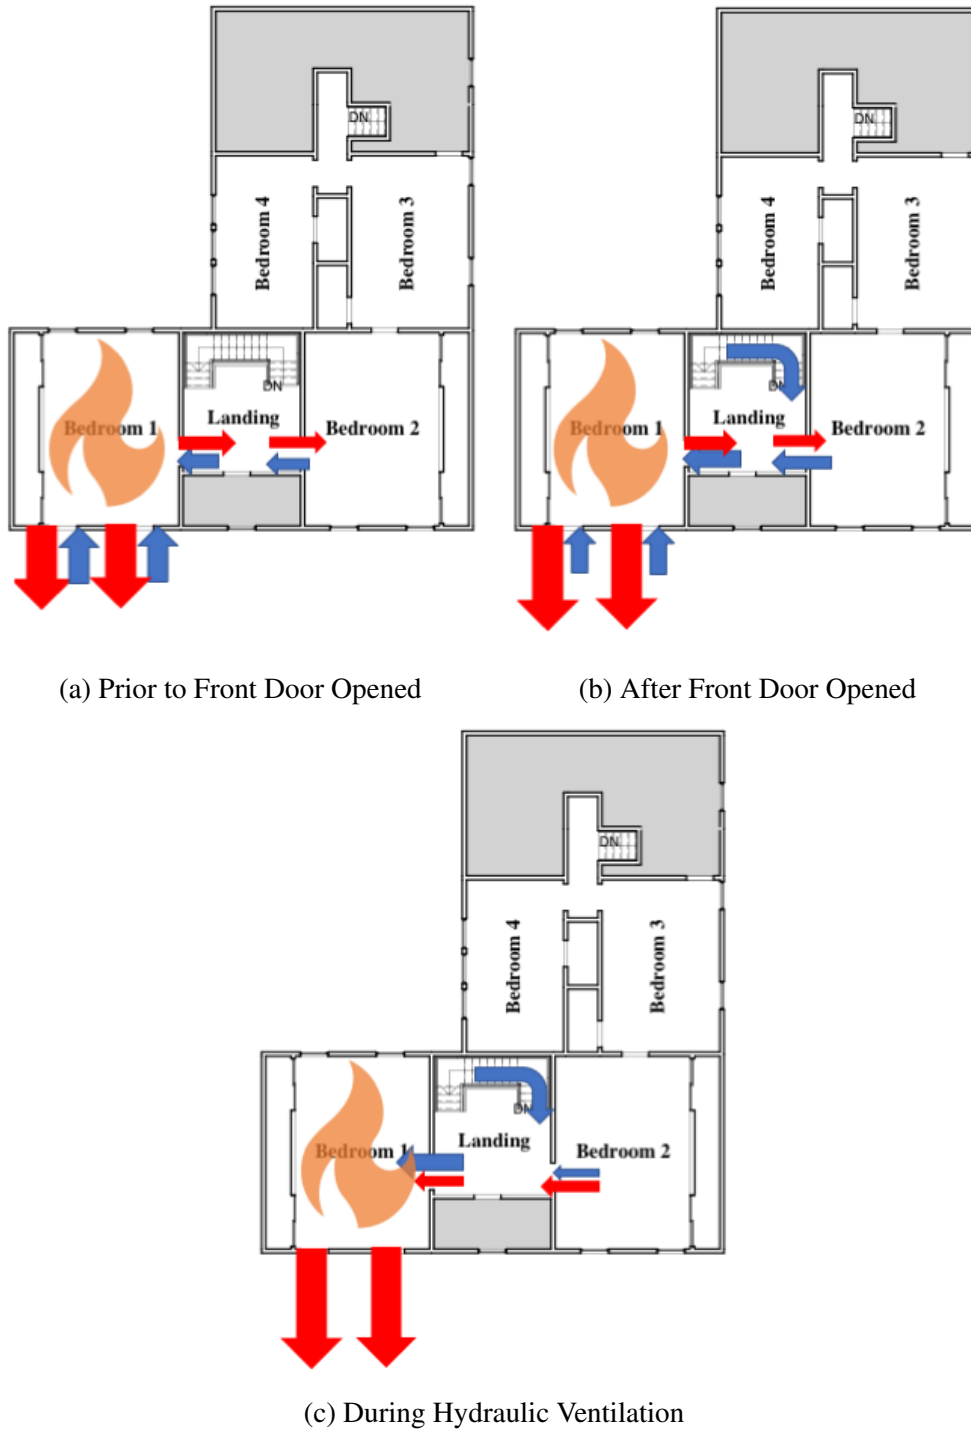
Figure 3.24: Changes in flow during Experiment 2. Red arrows indicate the flow of combustion products, blue arrows indicate the flow of fresh air, and the sizes of the arrows indicate the relative magnitude of the flow through each opening.

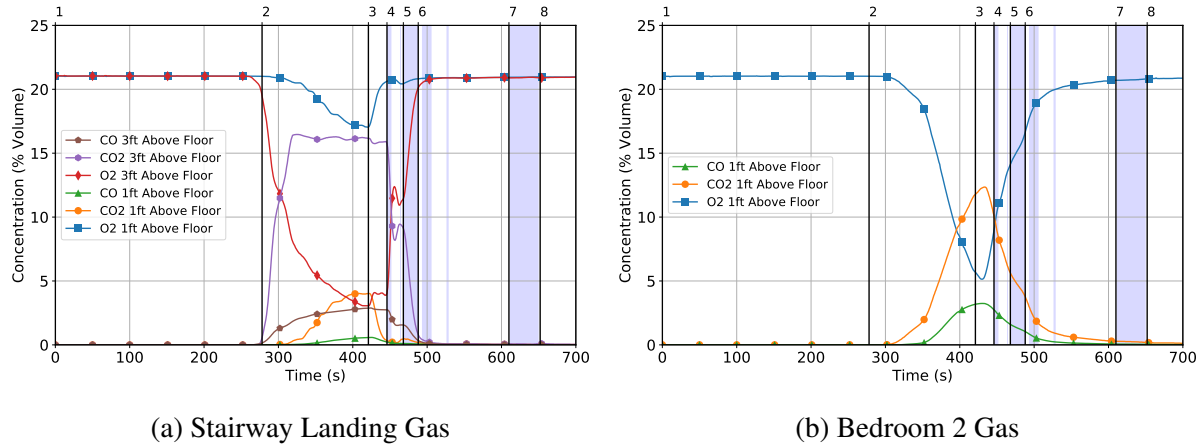
The changes in pressure provided the driving force for the variations in gas concentrations at the 1 ft and 3 ft elevation in the stairway landing and 1 ft elevation in bedroom 2 as shown in Figure 3.25.

In the stairway, the O₂ concentrations began to decrease and the CO and CO₂ concentrations began to increase at both elevations shortly before flashover. At the 3 ft elevation (see Figure 3.25a) on the landing when the front door was opened, the O₂, CO₂, and CO concentrations were 3.0%, 16.0%, and 3.0%, respectively. The opening of the front door resulted in a minimal increase in O₂ and decrease in CO, but the gas concentrations did not begin to significantly change until after the initial water application from the stairway. After water flow was stopped, there was a fluctuation in gas concentrations before the suppression action from the stairway landing, when the gas concentrations permanently began to return to pre-ignition conditions.

Figure 3.25: Gas concentrations at 1 ft and 3 ft in stairway landing and in bedroom 2 for Experiment 2. Blue vertical bars indicate time and duration of water flow.

The gas concentrations at the 1 ft level in the stairway (see Figure 3.25a) were typically less hazardous than the corresponding 3 ft gas concentrations. The 1 ft gas concentrations in the stairway landing first began to increase as the fire room transitioned through flashover. The peak gas concentrations were measured immediately before the front door was opened, and were 17.0%, 4.0%, and 1.0% for O₂, CO₂, and CO respectively. The fresh air entrained by the opening of the front door immediately resulted in an increase in O₂ and decrease in CO₂ and CO. A change in concentration was observed after the initial suppression action (Action 4) from the stairway that was caused by either pressure-driven flow from the nozzle or from mixing and cooling of the upper gas layer. The gas concentrations at the 1 ft level had returned approximately to pre-ignition conditions by the time that the suppression crew entered the fire room (Action 6). The CO concentration decreased

below 0.1% 55 s after the front door was opened. It should be noted that the gas concentrations at both locations in the stairway landing returned to pre-ignition conditions rather quickly after the onset of suppression actions and therefore were largely unaffected by the subsequent hydraulic ventilation.

The gas concentrations in bedroom 2 (see Figure 3.25b) first started to increase approximately 300 s post ignition. At the time the front door was opened, the O₂ was approximately 5.0% and the CO and CO₂ were 4.0% and 13%, respectively. The gas concentrations reached a peak approximately 5 s after the front door was opened and subsequently began to return to pre-ignition conditions. The gas concentrations in bedroom 2 took longer to recover than the corresponding location in the stairway because this location was impacted by being at the dead end of the structure—there was little to no inlet flow that could bring fresh air through the compartment and assist in moving combustion gasses out.

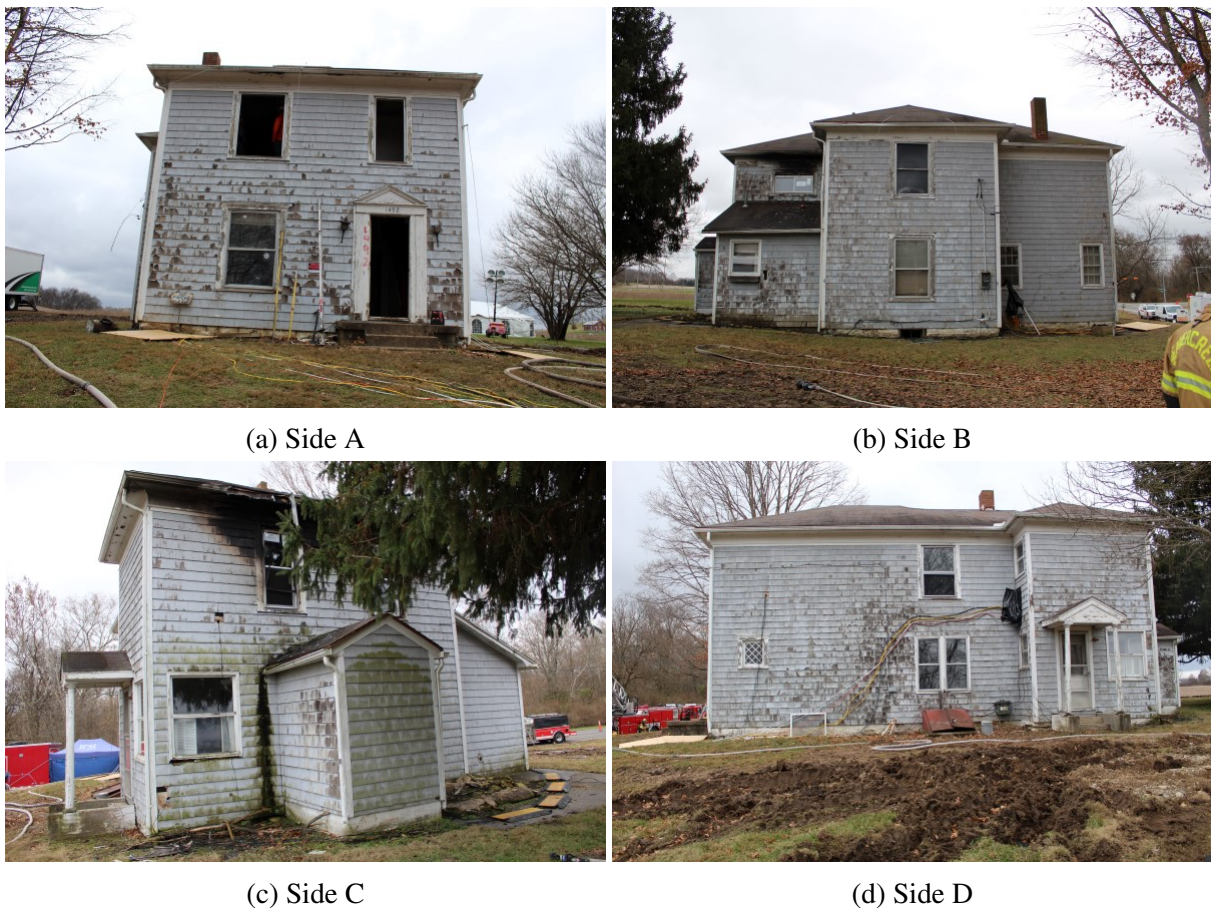
Figure 3.26: Exterior photographs of the structure for Experiment 3.

Experiment 3 was conducted to examine coordinated interior suppression and vertical ventilation. At 1492 Dayton Xenia Road in Xenia, Ohio, a two-story, 2,100 sq ft, wood frame structure was instrumented to conduct this second-floor bedroom fire experiment. The four exterior sides of the structure appear in Figure 3.26. The structure was stick-built with rough cut lumber framing with wood-slat siding. The foundation was a mix of concrete block and stone. The hip-style roof was constructed using 1 in.-by-6 in. sheathing covered with asphalt shingles. Detailed dimensioned drawings for the first and second story appear in Appendix Figures B.14 and B.15, respectively.

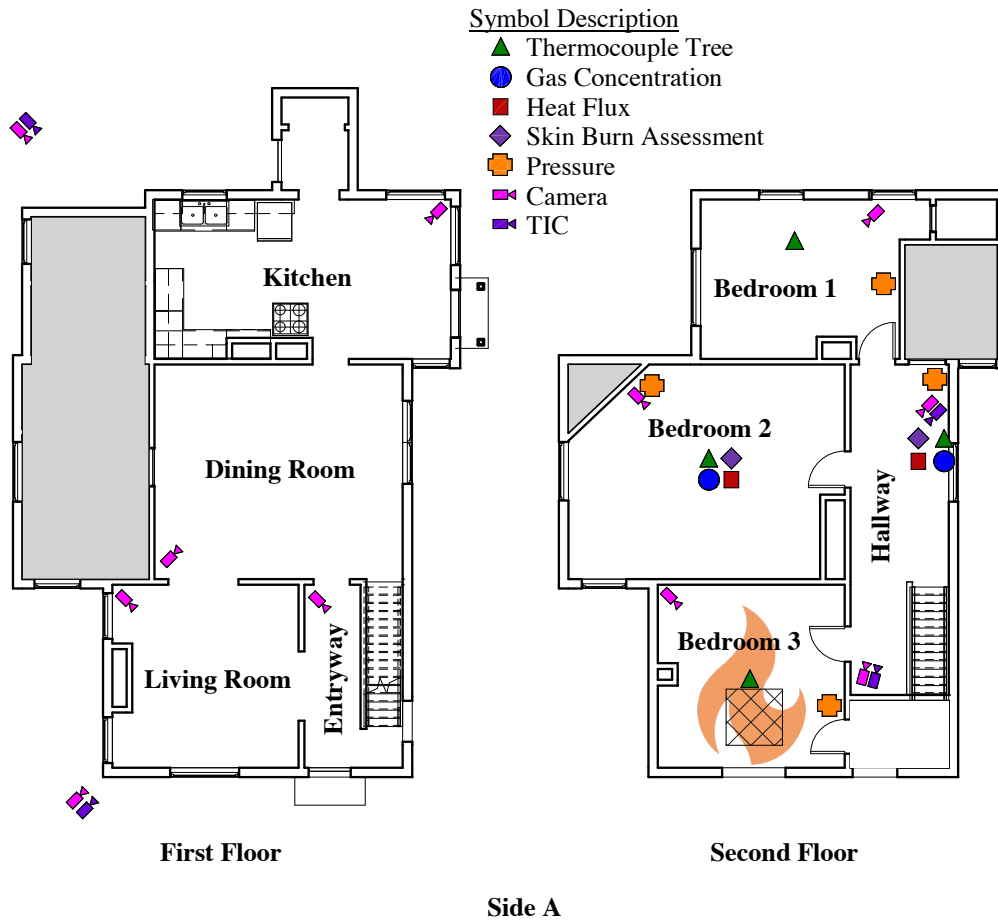
Figure 3.27: Instrumentation and floor plan for Experiment 3. The gray areas were isolated from the remainder of the structure and utilized as space for instrumentation. The cross-hatched box indicates the size and location of the vertical vent.

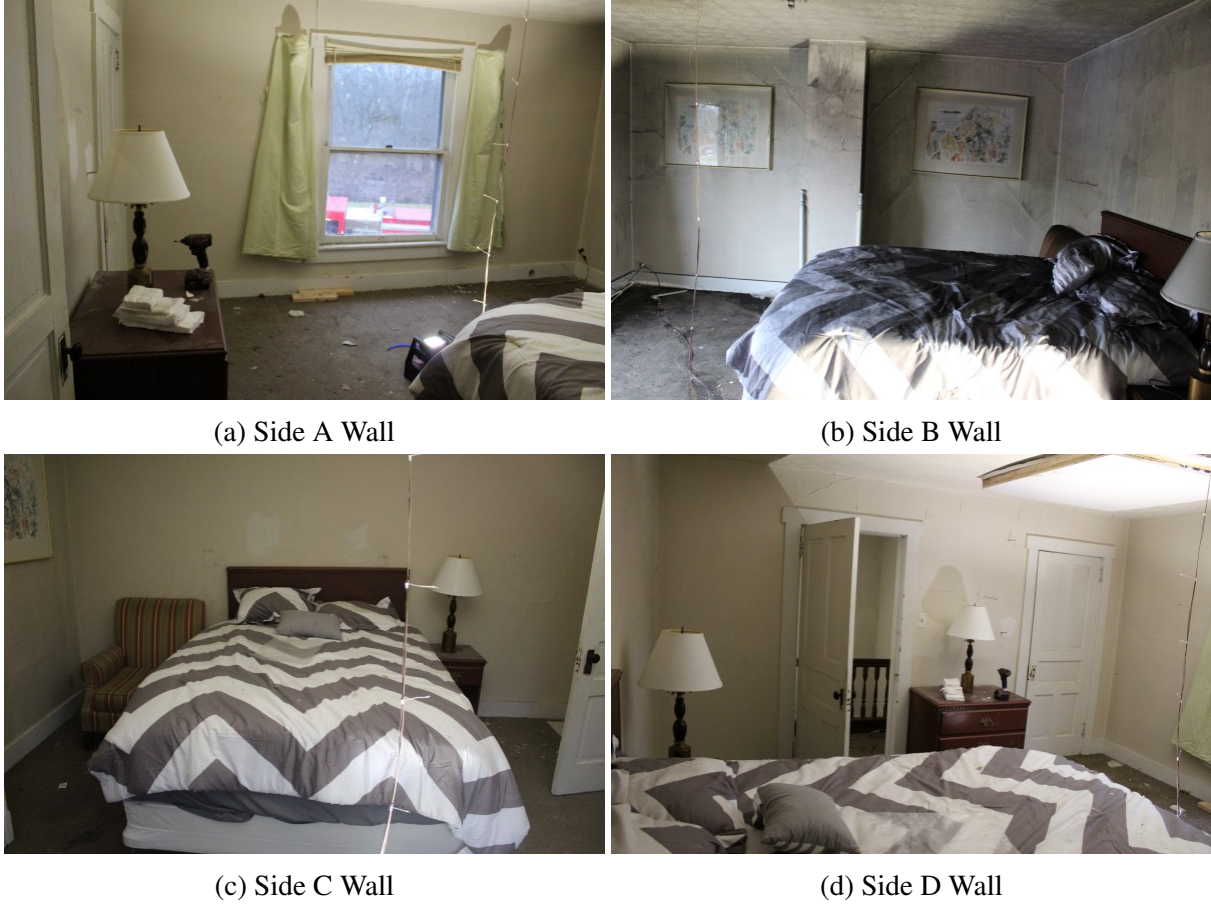
Figure 3.28: Interior photographs of fire room for Experiment 3.

Bedroom 3, the fire room, was furnished with the bedroom fuel package described in Section 2.4.1. Photographs of bedroom 3 prior to ignition are presented in Figure 3.28. A dimensioned layout of the fire room is included in Figure 3.29.

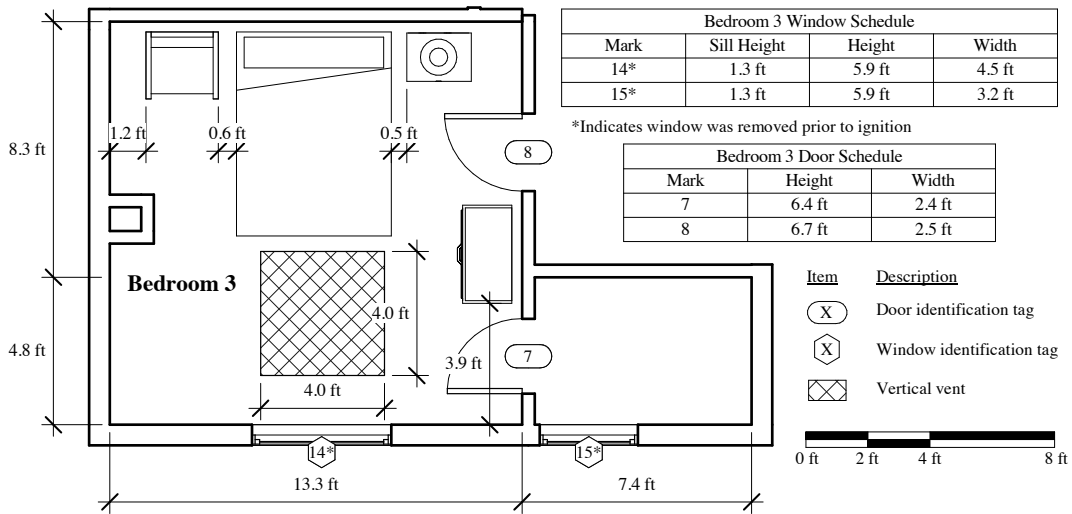
Figure 3.29: Fire room layout for Experiment 2. The cross-hatched box indicates the size and location of the vertical vent.

To ensure repeatable fire growth and a sufficient oxygen supply for flashover, the windows labeled 14 and 15 in Figure 3.29 were removed prior to ignition.

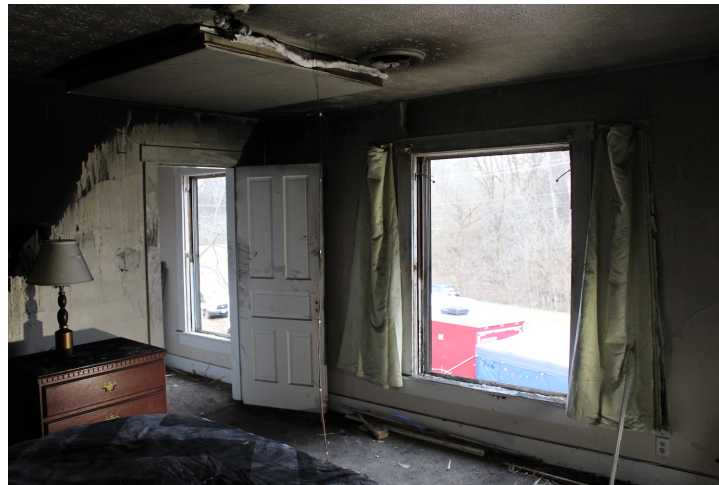
Experiment 3 examined a coordinated interior suppression with vertical ventilation post knock-down. Prior to ignition, a 4 ft-by-4 ft roof hole and ceiling hole located over bedroom 3 were cut. The roof hole was covered by plywood and sealed to prevent leakage. The ceiling hole was covered with half-inch gypsum board. Ventilation occurred by first removing the plywood to expose the precut roof hole, replicating a crew cutting a ventilation hole. Immediately following, the interior gypsum was released to expose the precut ceiling hole, replicating a crew removing the compartment ceiling materials. Figure 3.30 shows the interior hinged ceiling.

Figure 3.30: Interior vertical ventilation opening for Experiment 3.

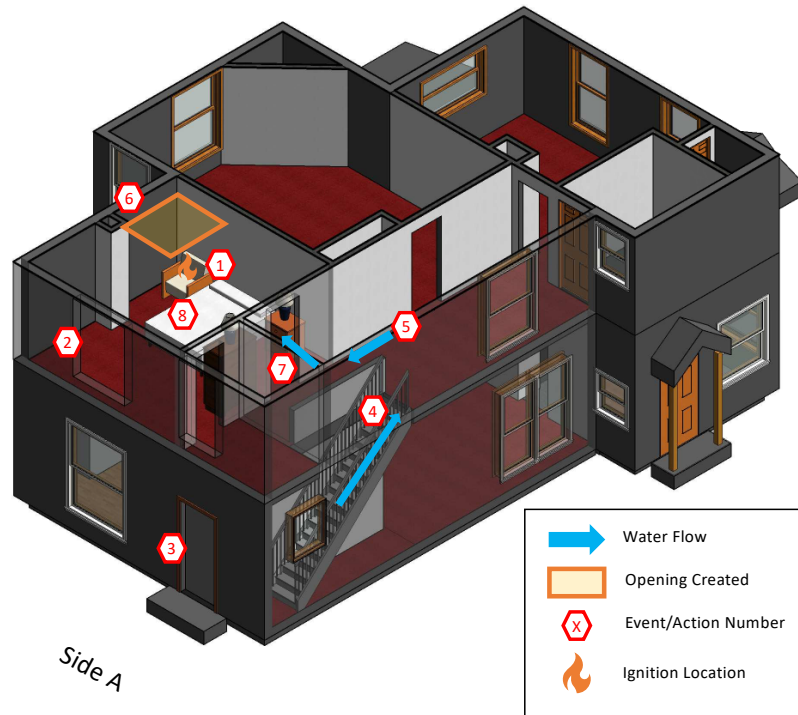
Action/Event	Time (mm:ss)	Time (s)
1 Ignition	00:00	0
2 Flashover	04:17	257
3 Front Door Open	05:30	330
4 Flow from Stairs	05:51	351
5 Flow from Landing	06:17	376
6 Vertical Ventilation Completed	06:51	411
7 Flow from Fire Room Doorway	07:02	422
8 Suppression Crew Entered Fire Room	07:12	432

Figure 3.31: Time and sequence of actions and events for Experiment 3.

The fire was ignited in the upholstered chair next to the bed set ($t = 0$ s). Flames were first visible from the side A windows at 240 s (4:00) post ignition. Flames continuously vented from the side A windows at 249 s (4:09) post ignition. The fire grew and reached flashover at 257 s (4:17) post ignition. The fire transitioned to a post-flashover state before the first fire department intervention.

The sequence of fire department interventions started with the opening of the front door at 330 s (5:30) post ignition. The suppression crew entered 10 s (5:40) later and advanced halfway up the stairwell. Using a 1.75 in. hoseline with a combination nozzle set to straight stream, the crew applied water in the direction of the fire room at 351 s (5:51) post ignition for 7 s. They then advanced to the top of the stairs and continued suppression from the fire room doorway landing 376 s (6:16) post ignition for 10 s. The suppression crew paused in the hallway while the vertical ventilation hole was opened and the ceiling was pushed in, completing the vertical vent at 411 s (6:51). The suppression crew then began to flow water from the fire room doorway at 422 s (7:02) post ignition for 6 s. The crew entered the fire room 432 s (7:12) post ignition before flowing water for an additional 14 s. The total time from the initial action of opening the front door to occupying the fire room was 81 s (1:21). The total water used for initial suppression was 88 gal, which does not include the additional water used during mop-up operations. Figure 3.31 shows the sequence of events with an isometric image of the structure.

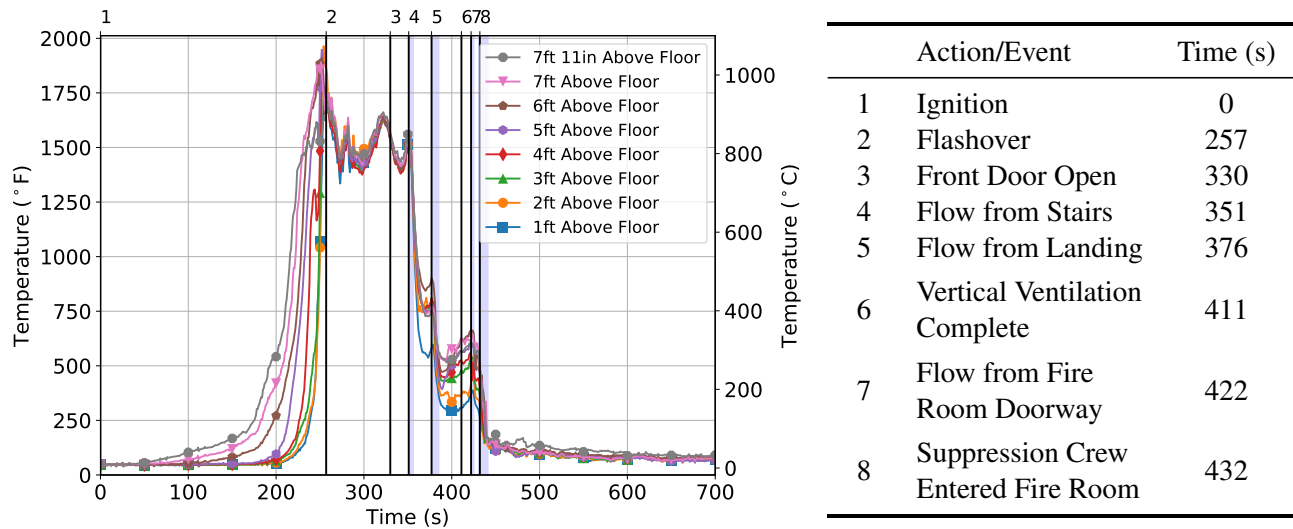
Figure 3.32: Fire room (bedroom 3) temperatures for Experiment 3. Blue vertical bars indicate time and duration of water flow.

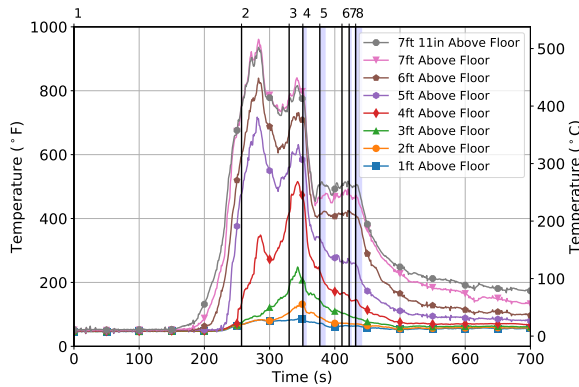
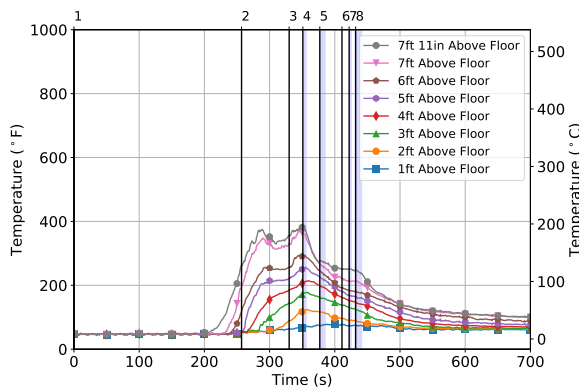
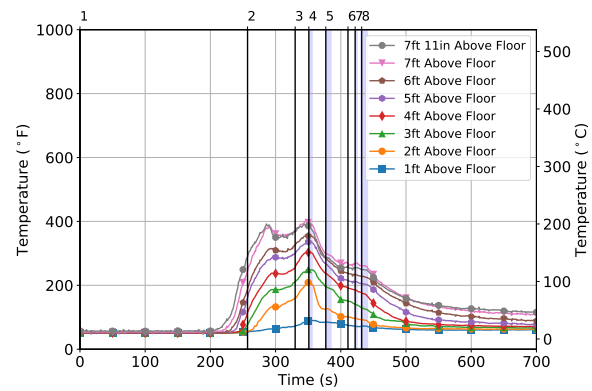
The highest temperatures measured in remote areas of the second-floor were in the hallway, the space adjacent to the fire room. Temperatures close to the ceiling in the hallway first began to increase approximately 150 s post ignition, and began to increase more rapidly as the fire room transitioned through flashover, as shown in Figure 3.33a. A local peak was observed at the 4 ft through 7 ft 11 in. heights approximately 245 s post ignition, which appeared to correspond with a gust of wind. At the time the front door was opened, the temperatures 5 ft and above in the hallway were approximately steady, while those closer to the floor were increasing. The initial suppression action in the stairway (Action 4) decreased the temperatures close to the ceiling by 450 °F. After the initial suppression from the stairway, the temperatures 4 ft and below never exceeded 300 °F for the remainder of the experiment. The temperatures between 6 ft above the floor and the ceiling remained steady above 400 °F in the period between the stairway and landing area suppression actions (Actions 4 and 5). There was no significant increase in temperature in the hallway following the completion of the vertical vent. As the suppression crew continued final suppression from the fire room doorway and inside the fire room itself, temperatures at all elevations in the hallway decreased permanently. 600 s post ignition (270 s after front door open), the ceiling temperature dropped below 200 °F.

Figure 3.33: Second-floor temperatures for Experiment 3. Blue vertical bars indicate time and duration of water flow.

The temperatures in the remote bedrooms (bedrooms 1 and 2) were less than those observed in the hallway. In both of the remote rooms, temperatures began to increase approximately 200 s post ignition. The peak temperatures close to the ceiling were approximately 400 °F. The temperatures in each of the remote rooms were still increasing at the time the front door was opened. The initial suppression from the stairway caused temperatures to decrease at all elevations in both bedrooms. Similar to the temperatures in the hallway, the temperatures in the remote bedrooms remained approximately steady in the period between the landing suppression action (Action 5) and the completion of the vertical vent (Action 6). Temperatures in the remote rooms continued to decrease after the final suppression actions following vertical ventilation.

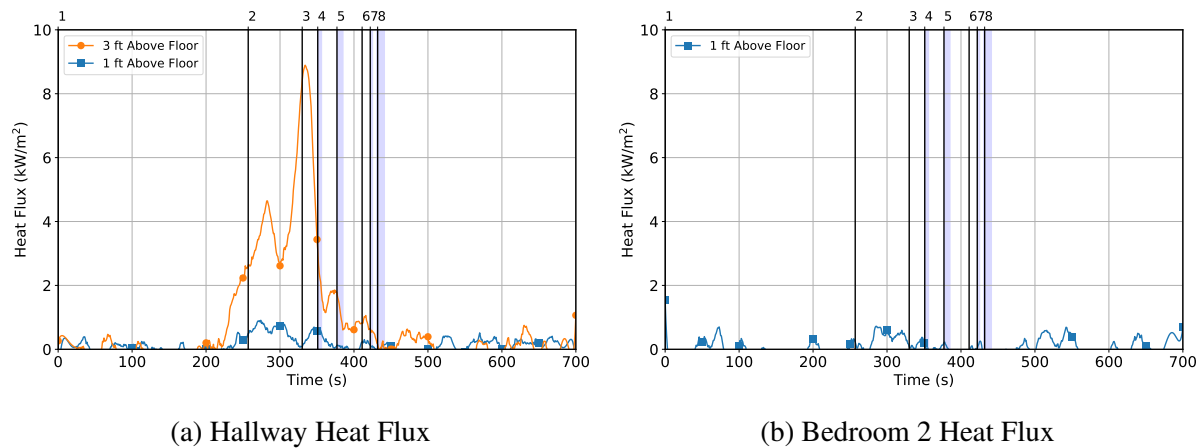
Heat flux as shown in Figure 3.34 was measured 1 ft and 3 ft above the floor in the hallway and 1 ft above the floor in bedroom 2. The heat flux at both 1 ft locations was less than 1 kW/m² for the duration of the experiment. The 3 ft heat flux recorded notably greater peaks, and first started to increase approximately 200 s post ignition. A local peak in heat flux was observed at approximately 285 s post ignition, at a similar time that local temperature peaks were observed. The maximum heat flux observed during the experiments was 9 kW/m², and was measured at the time the front door was opened. The heat flux decreased significantly with the opening of the front door and the initial suppression action from the stairway (Action 2). After this initial suppression, the heat flux remained below 2 kW/m² for the remainder of the experiment.

Figure 3.34: Heat flux at remote locations for Experiment 3. Blue vertical bars indicate time and duration of water flow.

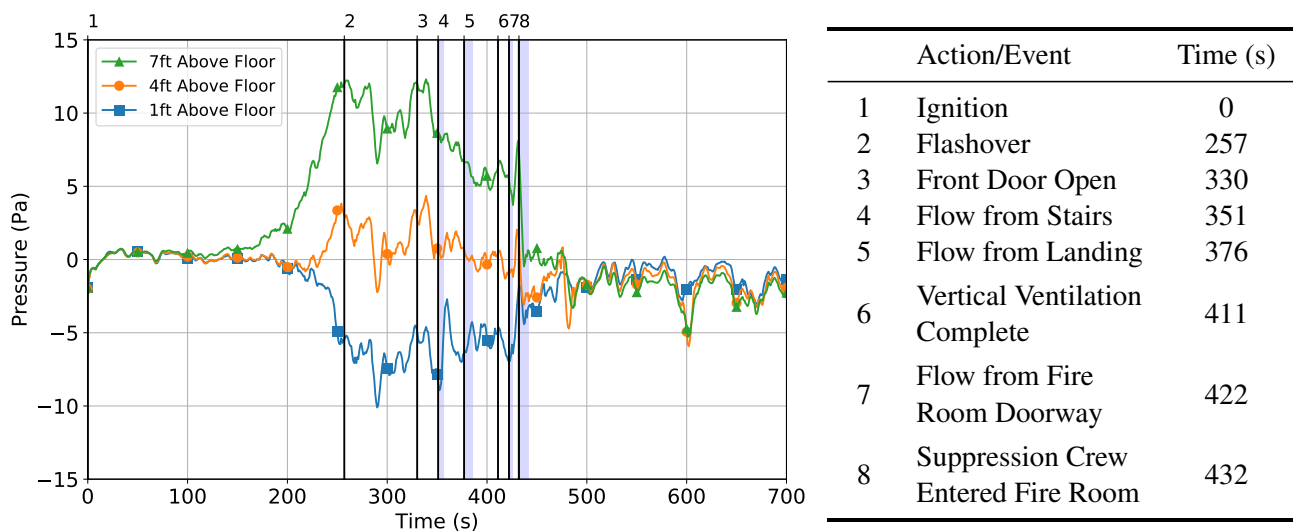
Figure 3.35: Pressures in fire room (bedroom 3) for Experiment 3. Blue vertical bars indicate time and duration of water flow.

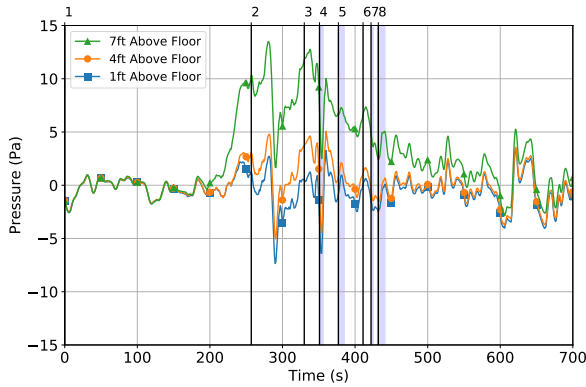
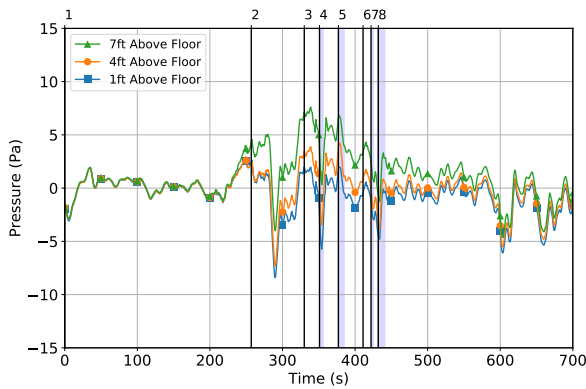
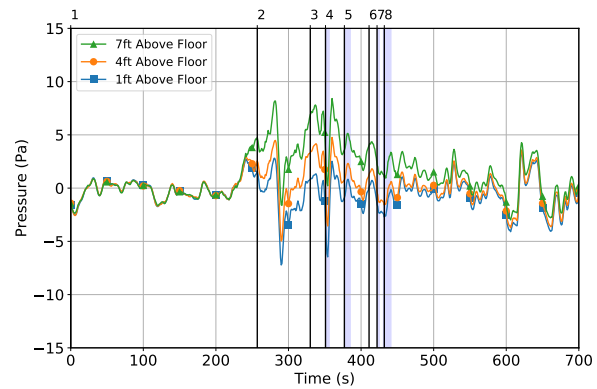
The pressure changes as a result of fire growth and wind were also reflected in the pressures in remote areas of the structure, which are displayed in Figure 3.36. The pressures in the hallway and bedrooms 1 and 2 first began to change between 200 s and 225 s post ignition. At the time the front door was opened, the pressures at all three elevations in the three locations were positive, with the highest pressures measured closest to the ceiling. This indicates that at the time of fire department intervention, air was being entrained into the fire room from remote areas of the second-floor. Both the opening of the front door and the completion of the vertical vent hole resulted in a decrease in pressures throughout the second-floor.

Figure 3.36: Pressure remote from fire room for Experiment 3. Blue vertical bars indicate time and duration of water flow.

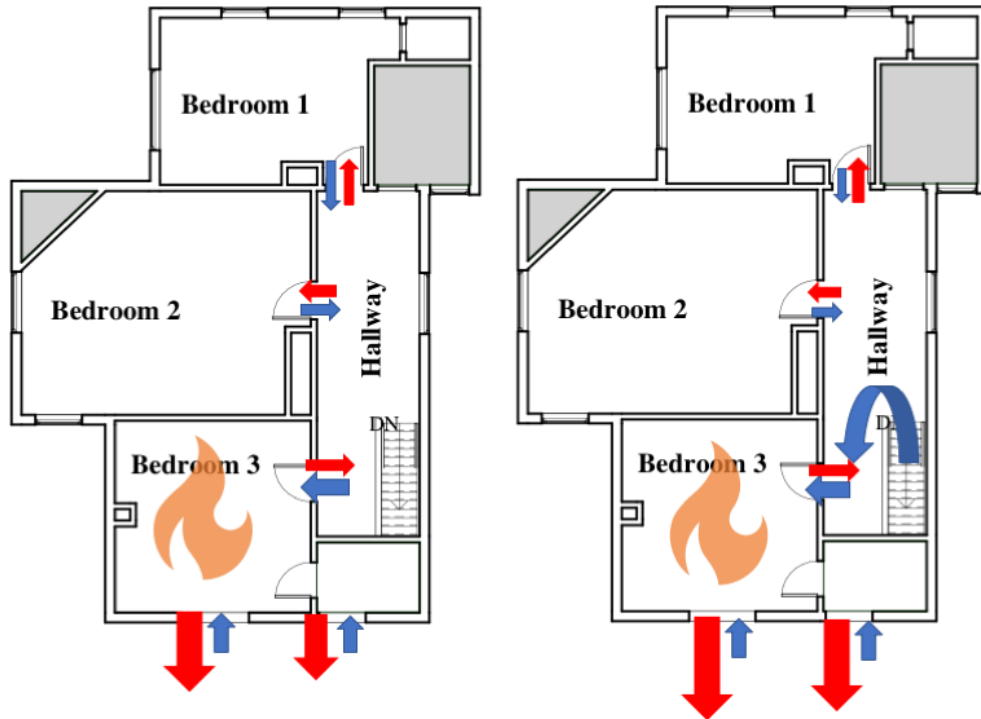
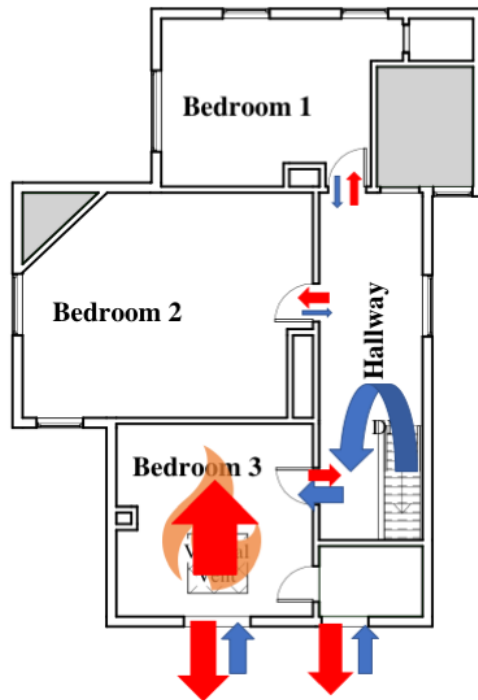
The changes in flow during the experiment are illustrated in Figure 3.37. As the fire grew to a point where it became ventilation limited, bi-directional flows were created at the fire room windows, entraining fresh air into the fire room and exhausting hot gases out of the fire room. Bi-directional flow also existed at the fire room doorway—fresh air drawn into the fire room from remote parts of the structure was replaced with products of combustion (see Figure 3.37a). The opening of the front door created a more efficient flow path, allowing fresh air to flow into the structure through the front door and travel up the stairs and into the fire room, while hot gases exhausted from the upper portion of the fire room windows and doorway, as shown in Figure 3.37b. When the vertical vent over the fire room was completed following initial water flow, there was not a significant growth in the fire. The vertical vent increased the area available for ventilation. As shown in Figure 3.37c, additional hot gases were exhausted from the uni-directional exhaust through the ceiling. The fire room windows continued to act as bi-directional vents, with hot gases exhausting from the upper portion and fresh air replacing them through the lower portion.

Figure 3.37: Changes in flow during Experiment 3. Red arrows indicate the flow of combustion products, blue arrows indicate the flow of fresh air, and the sizes of the arrows indicate the relative magnitude of the flow.

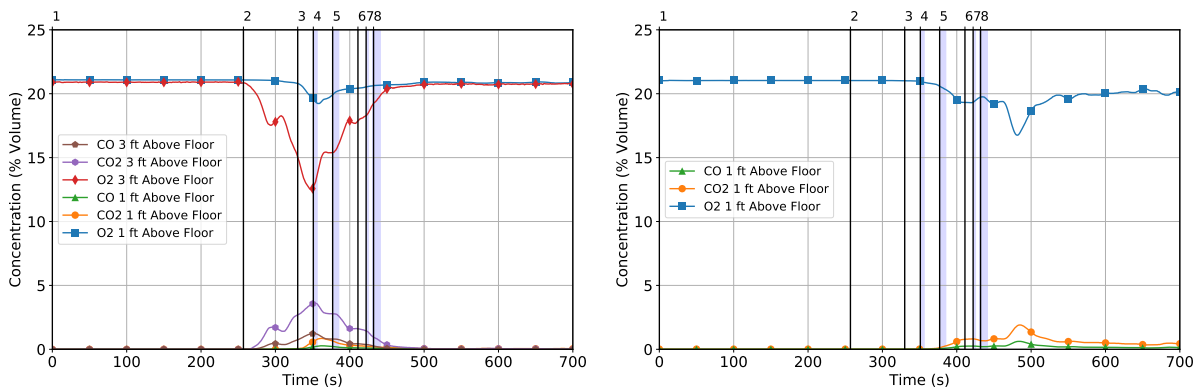
Gas concentrations were measured at the same locations as heat fluxes—1 ft and 3 ft above the floor in the hallway, and 1 ft above the floor in bedroom 2. The O₂ concentrations first began to decrease and the CO and CO₂ concentrations first started to decrease in the hallway as the fire room transitioned through flashover and oxygen was drawn from other spaces of the second-floor and replaced with products of combustion. At the time the front door was opened, the gas concentrations at both the 1 ft and 3 ft elevations in the hallway were still increasing. Both elevations reached a peak at the time of the stairway suppression action, after which they began to decrease toward pre-ignition conditions. The peak gas concentrations at 3 ft in the hallway were 12.5%, 4.0%, and 2.0% for O₂, CO₂, and CO, respectively. The peak 1 ft hallway gas concentrations were approximately 19.0%, 1.0%, and 1.0% for O₂, CO₂, and CO, respectively. The gas concentrations at both elevations steadily returned to pre-ignition values as vertical ventilation was completed and suppression continued. The CO concentrations at the 1 ft and 3 ft elevations in the hallway decreased below 0.1% 135 s and 97 s, respectively, after the front door was opened.

(a) Gas Concentrations in the Hallway

(b) Gas Concentrations in Bedroom 2

Gas concentrations in bedroom 2 took longer to change than in the hallway. CO₂ and CO first began to increase around the time of the stairway suppression action (Action 4). The O₂ continued to decrease and the CO₂ and CO continued to increase until the completion of the vertical vent, which stabilized gas concentrations. Gas concentrations in the hallway reached a peak 475 s post ignition, concurrently when the fire room gas concentrations had returned to pre-ignition conditions.

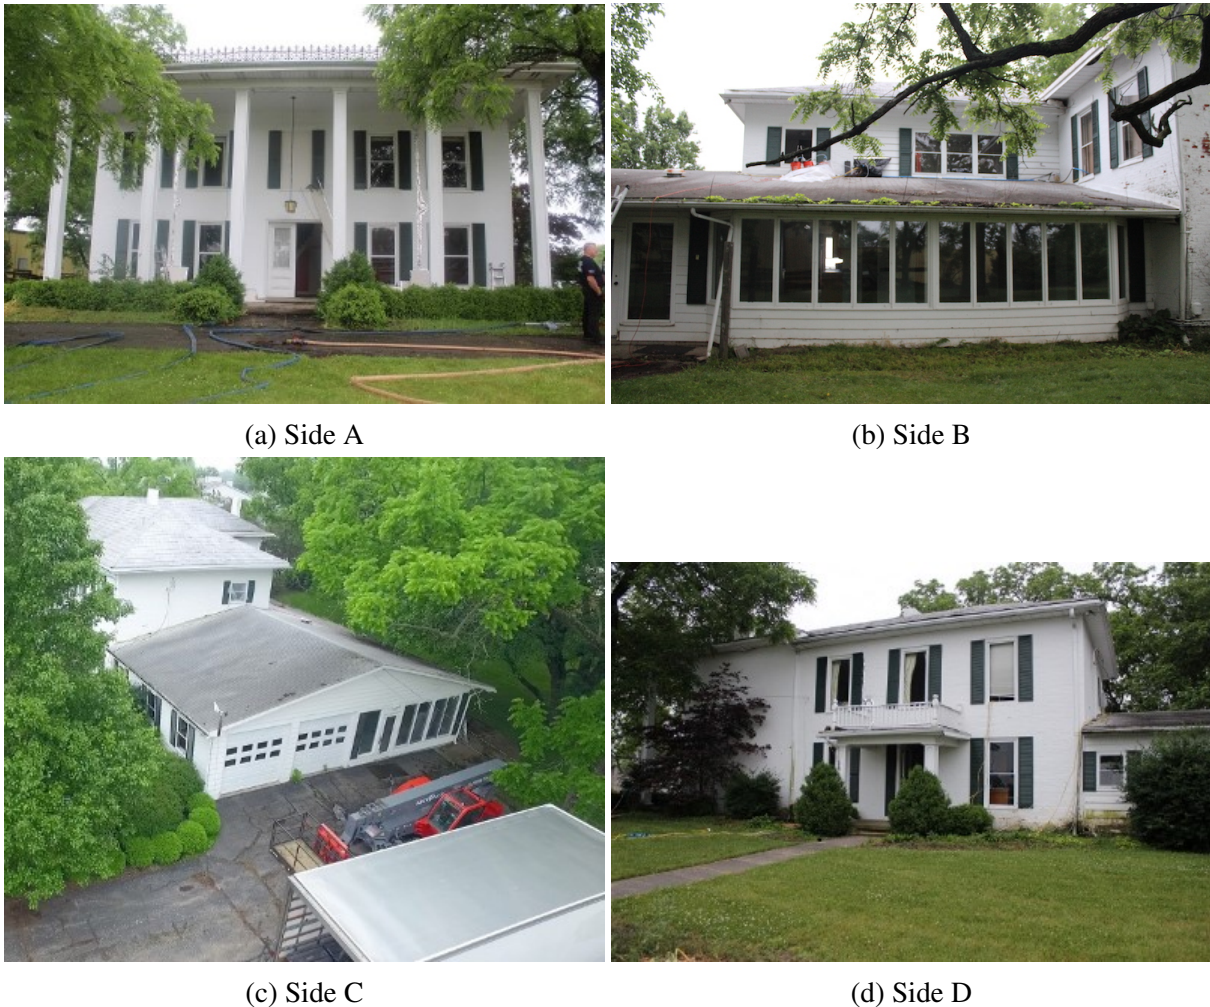
Figure 3.39: Exterior photographs of the structure for Experiment 4.

Experiment 4 examined coordinated interior suppression with additional horizontal ventilation post knockdown. At 2401 Wapakoneta Avenue in Sidney, Ohio, a two-story, 4,576 sq ft, wood frame structure was instrumented to conduct this second-floor bedroom fire experiment. The four exterior sides of the structure appear in Figure 3.39. The structure was concrete block and brick with some stick-built additions using dimensional lumber framing with a combination of brick and vinyl siding. The foundation was a mix of poured concrete, concrete block and stone. The roof was a combination of a hip-style roof and a peaked roof using 1 in.-by-6 in. sheathing and plywood sheathing covered with asphalt shingles. Detailed dimensioned drawings for the first and second story appear in Appendix Figures B.7 and B.8, respectively.

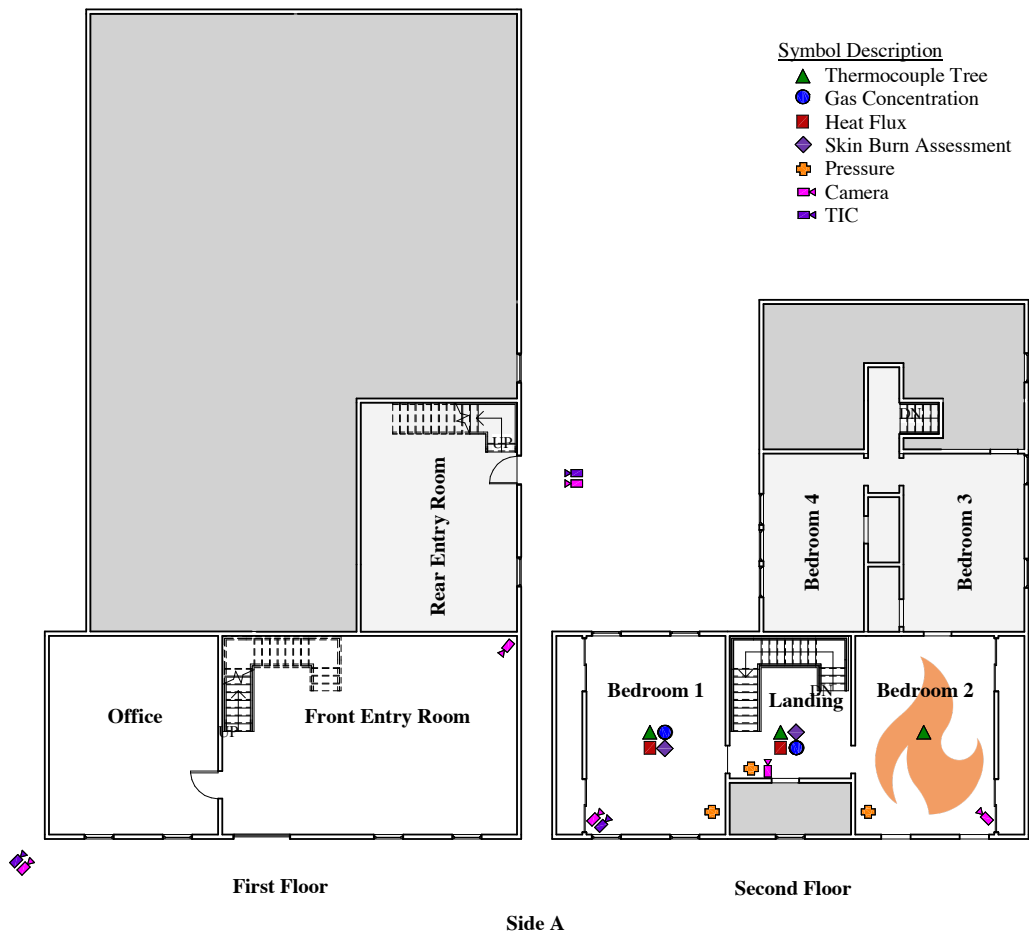
Figure 3.40: Instrumentation and floor plan for Experiment 4. The dark gray areas were isolated from the remainder of the structure and utilized as space for instrumentation. The light gray areas indicate the sub-structure not utilized for this experiment.

along side A (office, front entry room, and bedrooms 1 and 2) were isolated from the remaining rooms (rear entry room, bedrooms 3 and 4) within the structure. Two independent stairwells allowed this structure to be split so that the interior volume of the structure was similar to that of the other structures examined. The first-floor of the house partitioned for Experiment 2 had an office and front entry room while the second-floor contained bedroom 1, bedroom 2, and a stairwell landing. These rooms defined the experimental volume, accounting for 1,646 sq ft of the 4,576 sq ft. The structure was instrumented for temperature, pressure, heat flux, IR, and standard video to capture the fire dynamics during experimentation. Instrumentation was also installed to characterize the potential for skin burns and occupant toxic exposure during the experiment. Figure 3.40 shows the layout of the first and second-floors with the instrumentation locations.

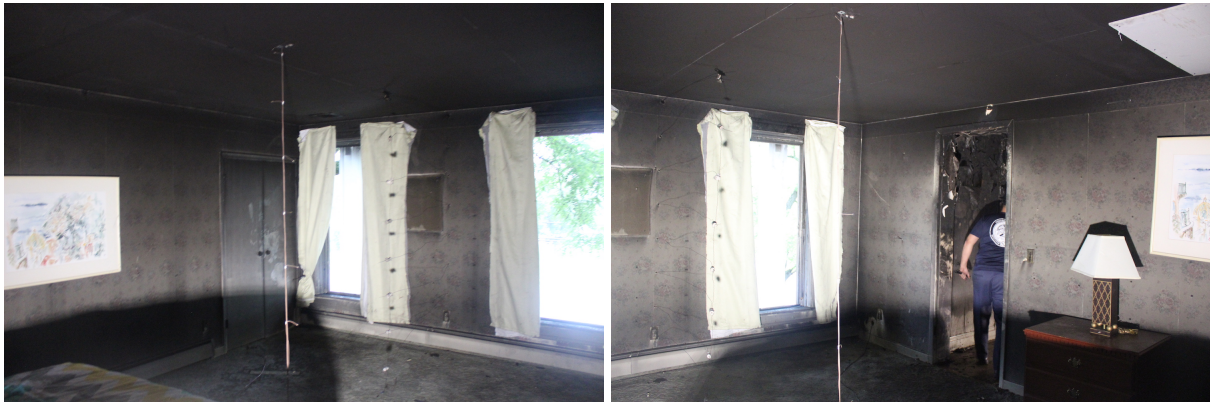
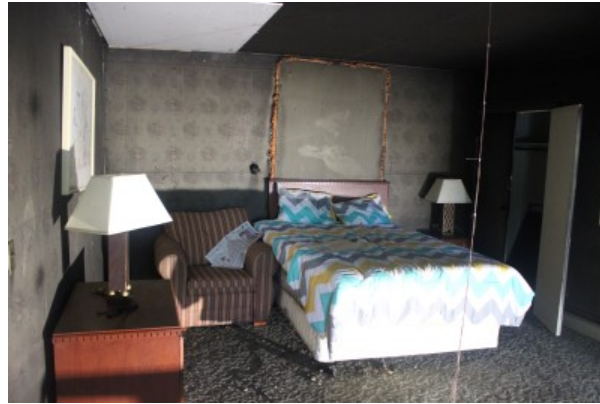
(a) A/D Corner

(b) A/B Corner

(c) Side C Wall

Figure 3.41: Interior photographs of fire room for Experiment 4.

Bedroom 2, the fire room, was furnished with the bedroom fuel package described in Section 2.4.1. Photographs of the fire room prior to ignition are presented in Figure 3.41. A dimensioned layout

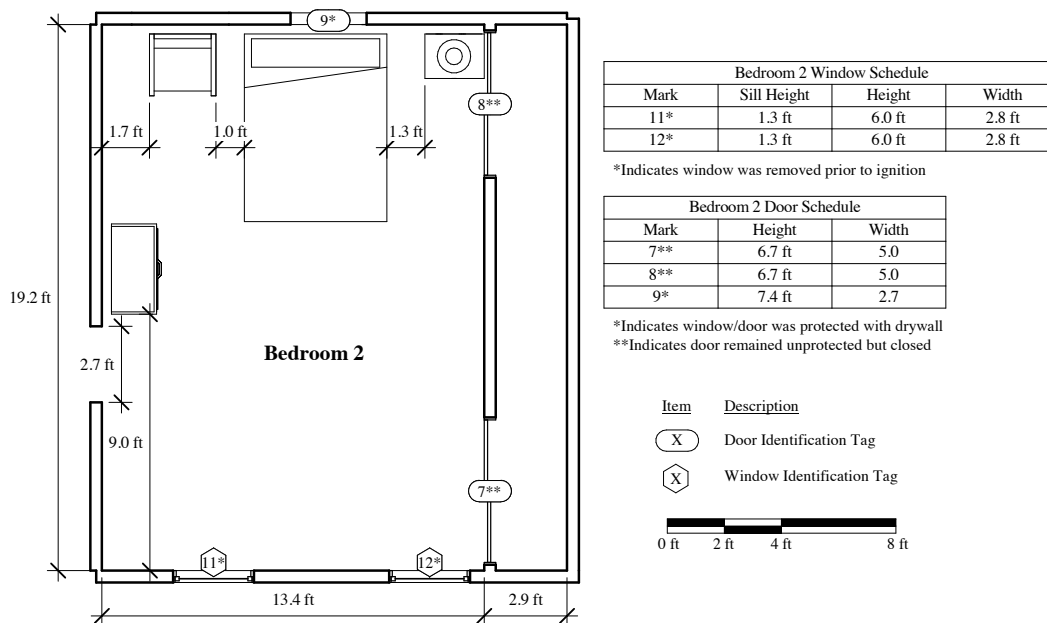
Figure 3.42: Fire room layout for Experiment 4.

Experiment 4 examined coordinated interior suppression with additional horizontal ventilation post knockdown. To replicate a similar volume of space found in other experiments, the rear entry was isolated from the front half of the first-floor, and bedroom 3, bedroom 4, and the hallway were isolated from the front half of the second-floor. These areas did not play a role in this experiment. To ensure repeatable fire growth and a sufficient oxygen supply for flashover, the windows labeled 15 and 16 in Figure 3.42 were removed prior to ignition.

The fire was ignited in the upholstered chair next to the mattress in bedroom 2 ($t = 0$ s). The fire was observed from the side A windows (labeled 15 and 16 in Figure 3.42) shortly afterward, 209 s (3:29) post ignition. The room transitioned through flashover 231 s (3:51) post ignition (Event 2) and remained in a post-flashover state until the door was opened.

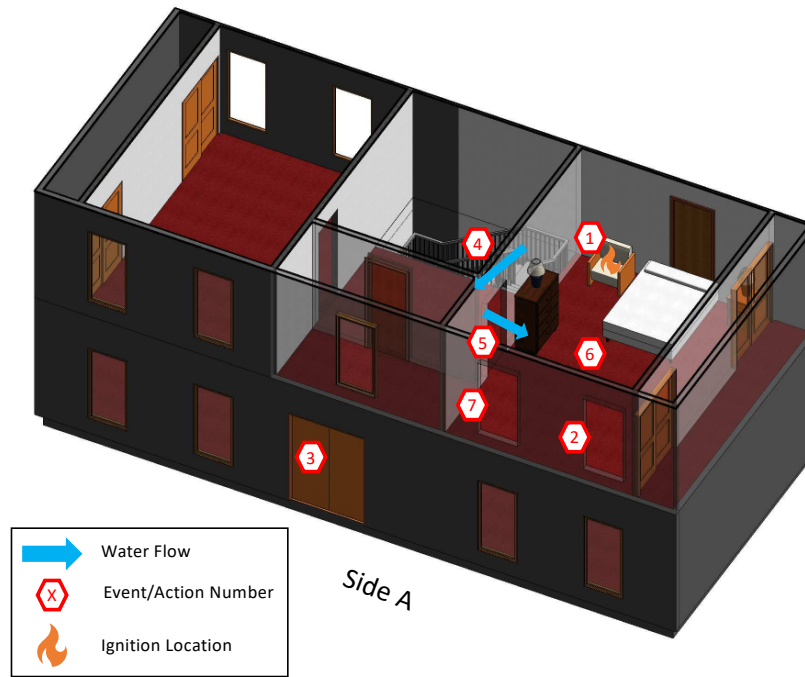
Action/Event	Time (mm:ss)	Time (s)
1 Ignition	00:00	0
2 Flashover	03:51	231
3 Front Door Open	07:00	420
4 Flow from Stairs	07:21	441
5 Flow from Fire Room Doorway	07:39	459
6 Bedroom 1 Windows Opened	07:49	469
7 Suppression Crew Entered Fire Room	08:19	499

Figure 3.43: Time and sequence of actions and events for Experiment 4.

The total tactic time from initial ventilation (front door open) to initial suppression was 47 s (00:47). The total water used for initial suppression was 102 gal, which does not include water flowed during mop-up operations. The suppression and ventilation sequence, complete with the

locations of each action, is shown in Figure 3.43.

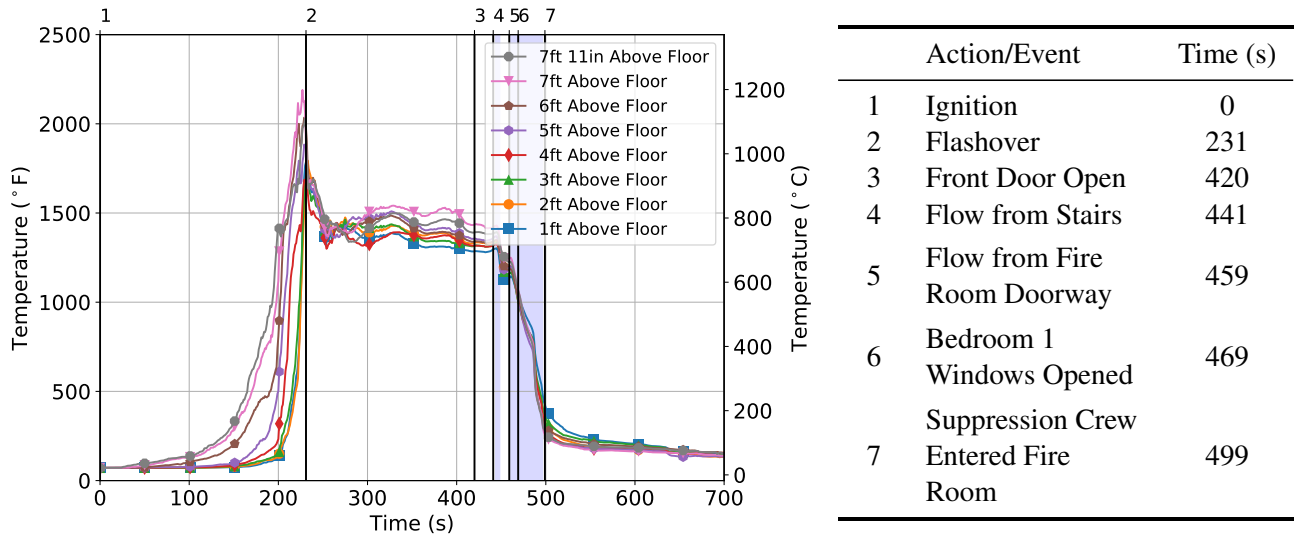
Figure 3.44: Fire room (bedroom 2) temperatures for Experiment 4. Blue vertical bars indicate time and duration of water flow.

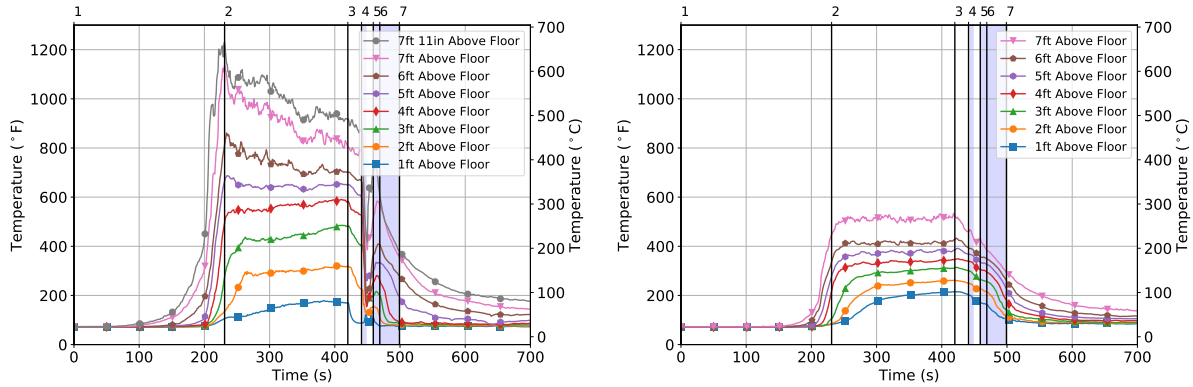
(a) Temperature on the Stairway Landing

(b) Temperature in Bedroom 1

Figure 3.45: Remote temperatures for Experiment 4. Blue vertical bars indicate time and duration of water flow.

Figure 3.45 shows the temperatures in the stairway landing and bedroom 1. Temperatures in the stairway landing began to increase rapidly at approximately the time fire began to exhaust from the fire room into the stairway landing. The peak temperatures close to the ceiling were measured at the time of flashover. Temperatures closer to the floor were considerably less, indicating air was entrained from remote areas of the structure. The landing temperatures at the time the front door was opened were steady, ranging from 915 °F at the ceiling to 170 °F 1 ft above the floor. Temperatures close to the floor gradually decreased as a flow path was established from the front door to the fire room and fresh air was entrained into the fire room. The initial suppression action in the stairway (Action 4) decreased temperatures at all elevations throughout the stairway landing, although they regrew before the suppression crew began to apply water in the doorway. Once the suppression crew continued suppression in the fire room doorway, temperatures decreased again.

The temperatures in bedroom 1 followed a similar trend to those in the stairway landing. Temperatures initially increased approximately 175 s post ignition, reached a steady state prior to fire department intervention, and then began to decrease after the front door was opened. While the effects of suppression were not as immediate as in the stairway landing, as suppression continued, the temperatures began to decrease more rapidly.
