Analysis of the Coordination of Suppression and Ventilation in Single-Family Homes

John Regan
Julie Bryant
Craig Weinschenk

UL Firefighter Safety Research Institute
Columbia, MD 20145

March 19, 2020

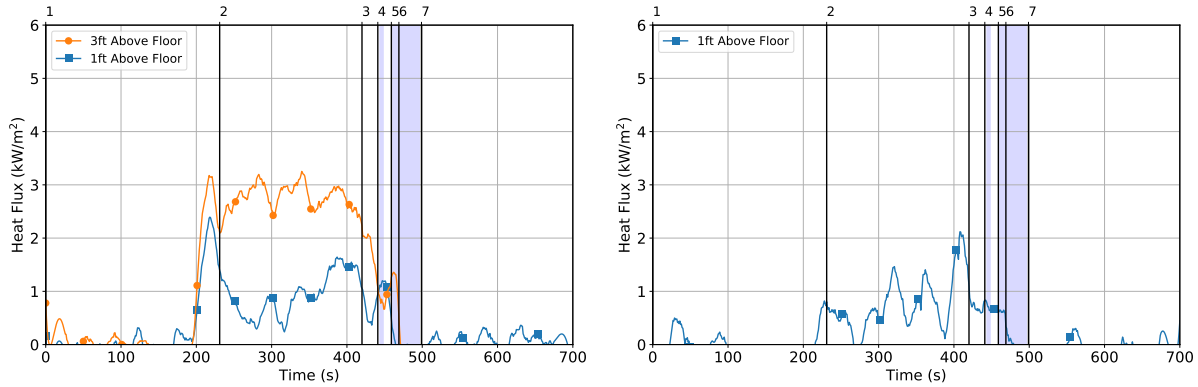
(a) Heat Flux on the Stairway Landing

(b) Heat Flux in Bedroom 1

Heat flux was measured at three locations—1 ft and 3 ft above the floor in the hallway landing and 1 ft above the floor in bedroom 1. The hallway landing heat fluxes first started to increase shortly before flashover, reaching peaks of 2.3 kW/m² and 3.1 kW/m² at 1 ft and 3 ft, respectively. The heat flux remained approximately steady through the time the front door was opened. The stairway heat flux decreased at both elevations following the opening of the front door, as fresh air was entrained into the fire room through the stairwell. The heat flux continued to decrease as the suppression crew advanced into the fire room itself.

The heat flux in bedroom 1 also began to increase around the time of flashover, and continued to increase to a 2 kW/m^2 peak corresponding with the front door opening. The opening of the front door decreased the 1 ft bedroom 1 heat flux below 1 kW/m^2 . Suppression from the doorway decreased heat fluxes to background levels.

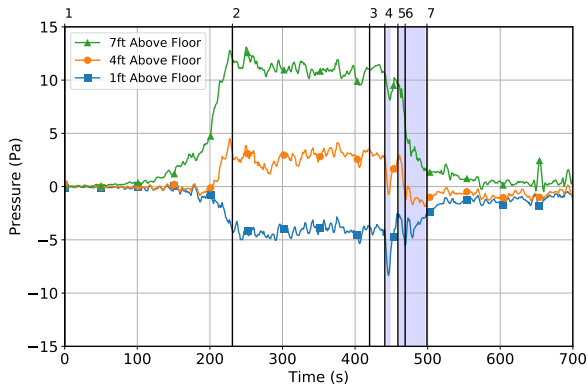
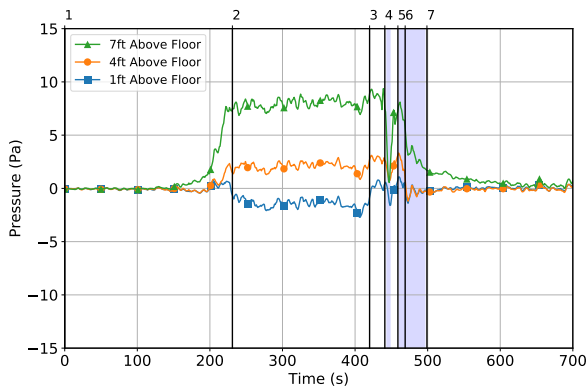
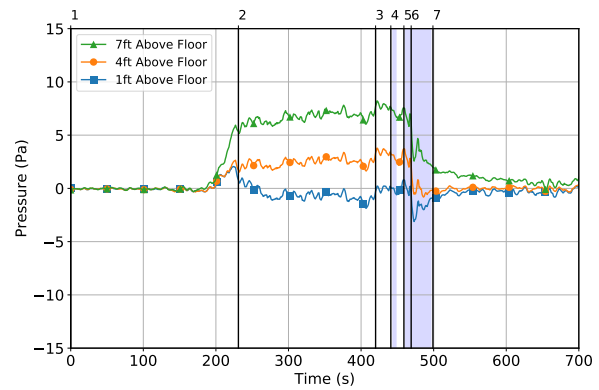
(a) Bedroom 2 Pressure

(b) Stairway Landing Pressure

(c) Bedroom 1 Pressure

Figure 3.47: Second-floor pressure for Experiment 4. Blue vertical bars indicate time and duration of water flow.

Like the fire room temperatures, the fire room pressure (see Figure 3.47a) began to increase shortly after ignition, as the smoke layer began to develop close to the ceiling. As the fire continued to grow, 4 ft pressure began to increase and the 1 ft pressure began to decrease, as a bi-directional flow path was established through both fire room windows and the fire room doorway. The pressures then adopted a steady profile at 12 Pa, 4 Pa, and -4 Pa at 7 ft, 4 ft, and 1 ft, respectively. The opening of the front door decreased the 1 ft pressure in the fire room as additional air was entrained via the new flow path. The stairway suppression action resulted in a decrease in the pressure magnitude at all three locations. Pressures continued to converge to background levels as suppression was continued from the fire room doorway.

Remote from the fire room, the pressures in the stairway landing (see Figure 3.47b) and bedroom 1 (see Figure 3.47c) followed a similar trend to the fire room pressures, although the magnitude of the pressures in these areas were less than the fire room. This indicates that as the fire grew, hot gases were exhausted to remote areas of the structure while fresh air was entrained to the fire room from these remote areas. After the front door was opened, the 1 ft pressure in both the stairway landing and bedroom 2 increased above 0 Pa, reflecting the entrainment of air via the open front door. Once the bedroom 1 windows were opened (Event 6), the pressure at all three elevations in bedroom 1 decreased, with the 1 ft and 4 ft pressures decreasing below 0 Pa as smoke was exhausted and fresh air was entrained.

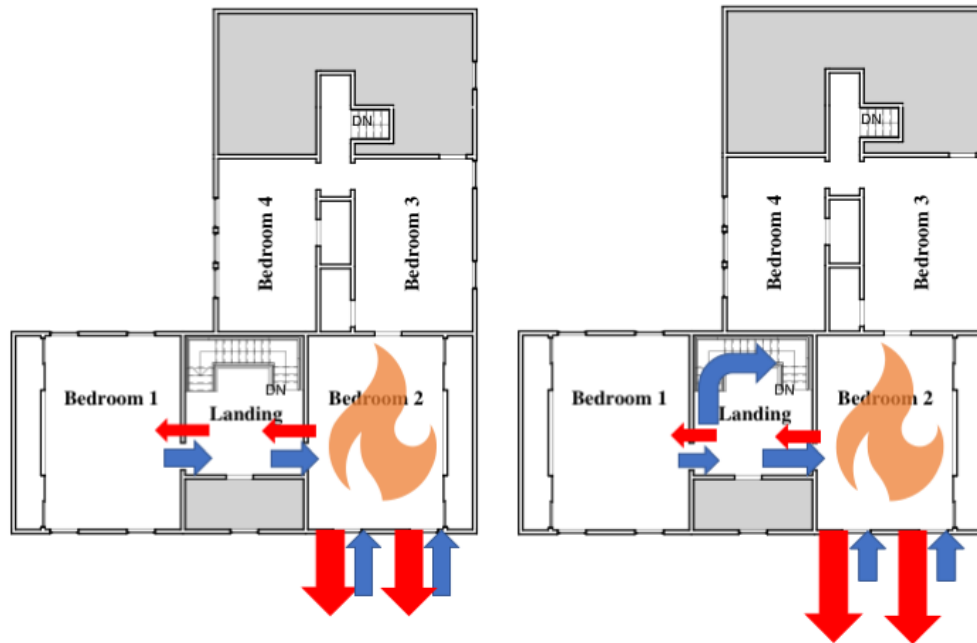
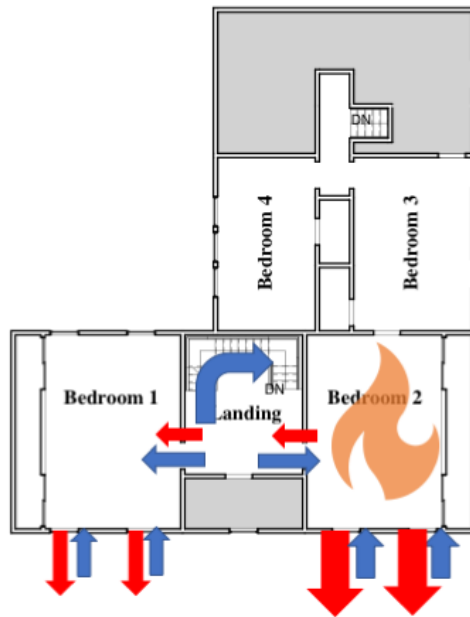
(a) Prior to Front Door Opened

(b) After Front Door Opened

(c) After Horizontal Ventilation

Figure 3.48: Changes in flow during Experiment 4. Red arrows indicate the flow of combustion products, blue arrows indicate the flow of fresh air, and the sizes of the arrows indicate the relative magnitude of the flow.

The pressure data shows that as the fire grew and became ventilation limited, bi-directional flow paths were established through the fire room windows and fire room doorway (see Figure 3.48a). Once the front door was opened, an additional flow path was created through the front door. Fresh air flowed along this flow path, as it was entrained to the fire through the front door, up the stairs, and into the fire room. The windows were bi-directional vents (see Figure 3.48b). As suppression occurred, the fire transitioned from ventilation limited to fuel limited, meaning that the additional ventilation in bedroom 1 (Action 7) did not result in additional fire growth. Rather, it created additional flow paths through the bedroom 1 windows (see Figure 3.48c), products of combustion were exhausted and replaced with fresh air.

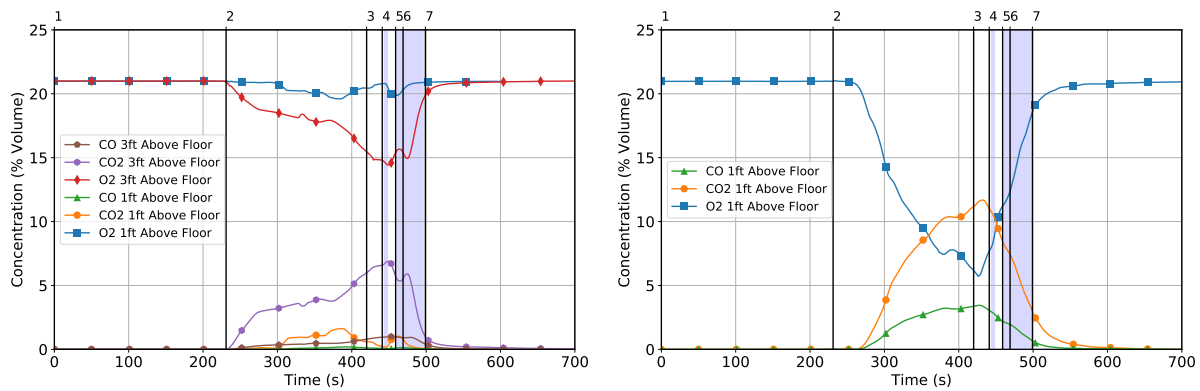
(a) Gas Concentration on the Stairway Landing

(b) Gas Concentration in Bedroom 1

Figure 3.49: Gas concentrations at 1 ft and 3 ft in stairway landing (see Figure 3.49a) and in the remote bedroom (see Figure 3.49b) for Experiment 4. Blue vertical bars indicate time and duration of water flow.

These changes in flow path were reflected in the gas concentrations (see Figure 3.49), which were measured 1 ft and 3 ft above the floor in the stairway and 1 ft above the floor in bedroom 1. The

gas concentrations in the stairway began to increase as the fire room transitioned through flashover. Because the fresh air was entrained through the front door and up the stairs to the fire room, the stairway gas concentrations were less than those measured in bedroom 2. The 3 ft stairway gas concentrations peaked after the opening of the front door, reaching an O₂ minimum and CO₂, and CO maximums of 15.0%, 7.0%, and 1.0%, respectively. The stairway suppression action caused the gas concentrations to begin to decrease, and as suppression continued from the fire room doorway, the gas concentrations continued to decrease.

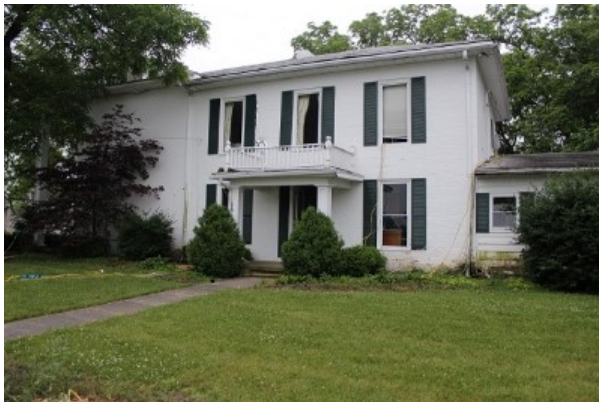
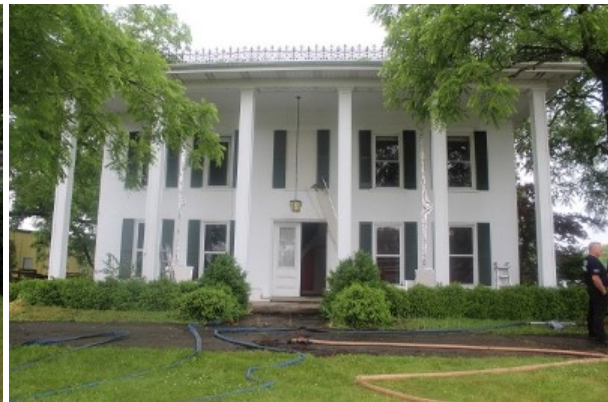
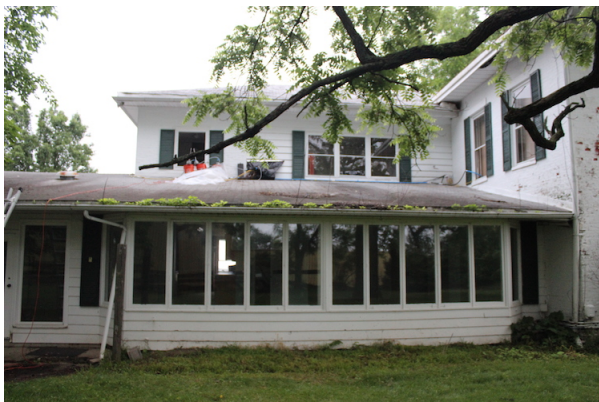
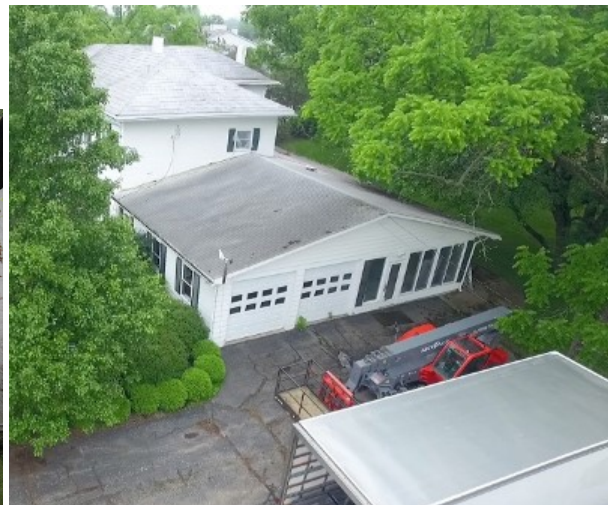
(a) Side A

(b) Side B

(c) Side C

(d) Side D

Figure 3.50: Exterior photographs of the structure for Experiment 5.

Experiment 5 examined coordinated interior suppression with positive pressure ventilation post knockdown. At 2401 Wapakoneta Avenue in Sidney, Ohio, a two-story, 4,576 sq ft, wood frame structure was instrumented to conduct this second-floor bedroom fire experiment. The four exterior sides of the structure appear in Figure 3.50. Note: That in contrast to Experiments 2 and 4, side A was designated for the secondary structure entrance in this experiment. The structure was concrete block and brick with some stick-built additions using dimensional lumber framing with a combination of brick and vinyl siding. The foundation was a mix of poured concrete, concrete block and stone. The roof was a combination of a hip-style roof and a peaked roof using 1 in.-by-6 in. sheathing and plywood sheathing covered with asphalt shingles. Detailed dimensioned drawings for the first and second story appear in Appendix Figures B.7 and B.8, respectively.

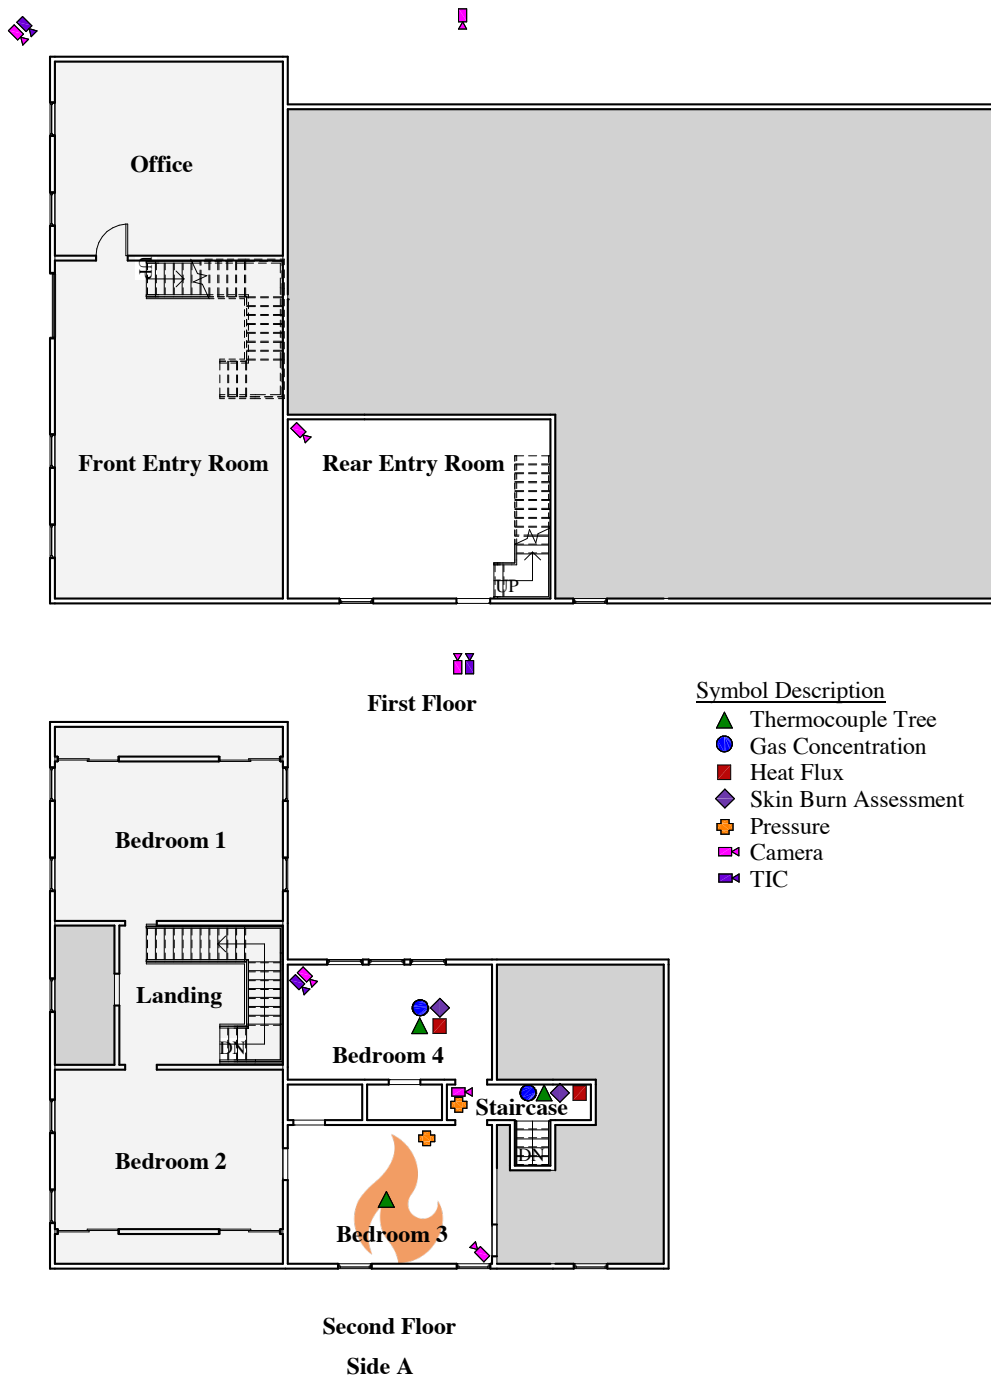
Figure 3.51: Instrumentation and floor plan for Experiment 5. The dark gray areas were isolated from the remainder of the structure and utilized as space for instrumentation. The light gray areas indicate the sub-structure not utilized for this experiment.

This structure contained two stairwells, allowing the structure to be partitioned into two separate, independent sub-structures. The interior volume of each sub-structure was similar. The first-floor of the house partitioned for Experiment 5 had a rear entry room while the second-floor contained bedroom 3 and bedroom 4. The rear stairwell connected these two floors, and together they formed the experimental volume of the structure, accounting for 837 sq ft of the 4,576 sq ft. The structure was instrumented for temperature, pressure, heat flux, IR, and standard video to capture the fire dynamics during experimentation. Instrumentation was also installed to characterize the potential for skin burns and occupant toxic exposure during the experiment. Figure 3.51 shows the layout of the first and second-floors with the instrumentation locations.

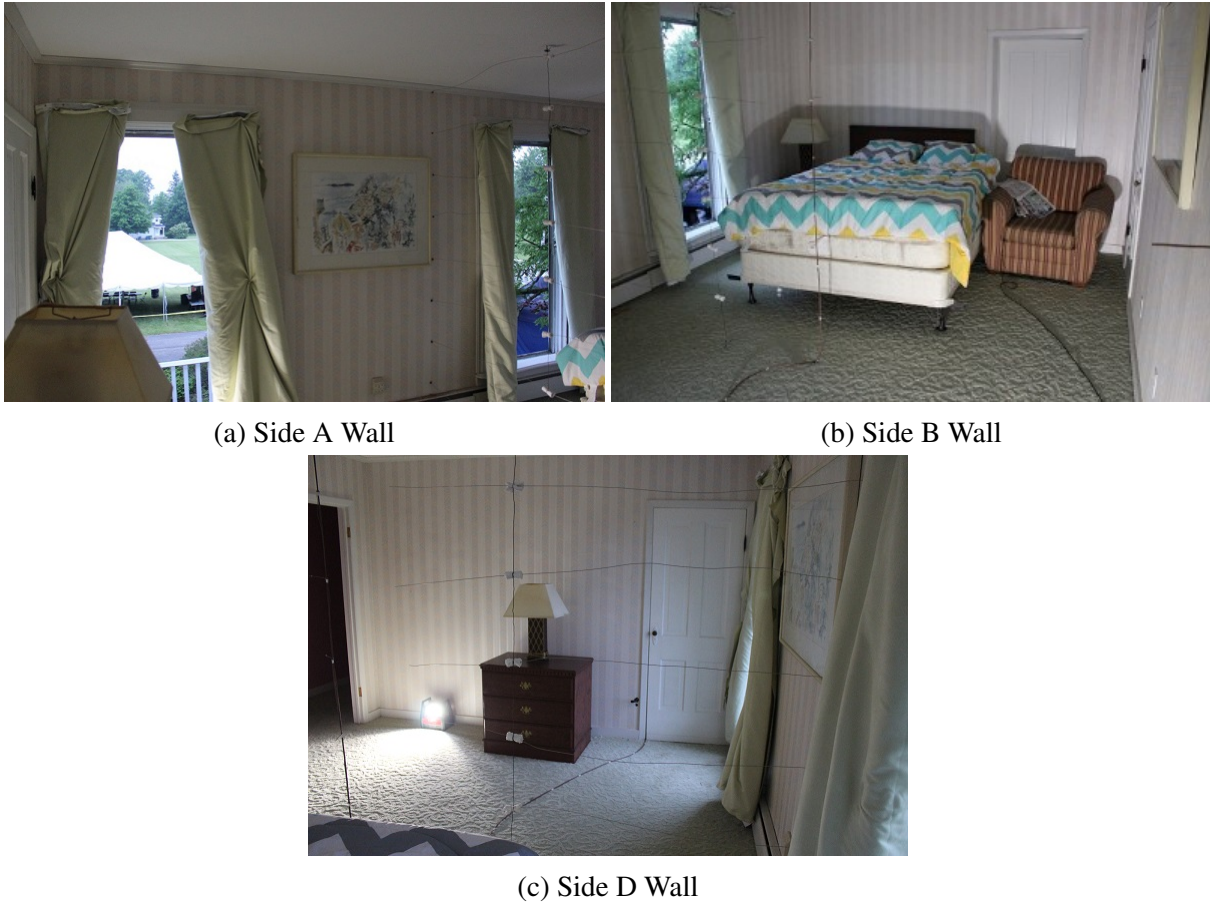
(a) Side A Wall

(b) Side B Wall

(c) Side D Wall

Figure 3.52: Interior photographs of fire room for Experiment 5.

Photographs of the fire room, bedroom 3, prior to ignition are presented in Figure 3.52. A dimensioned layout of the fire room is included in Figure 3.53.

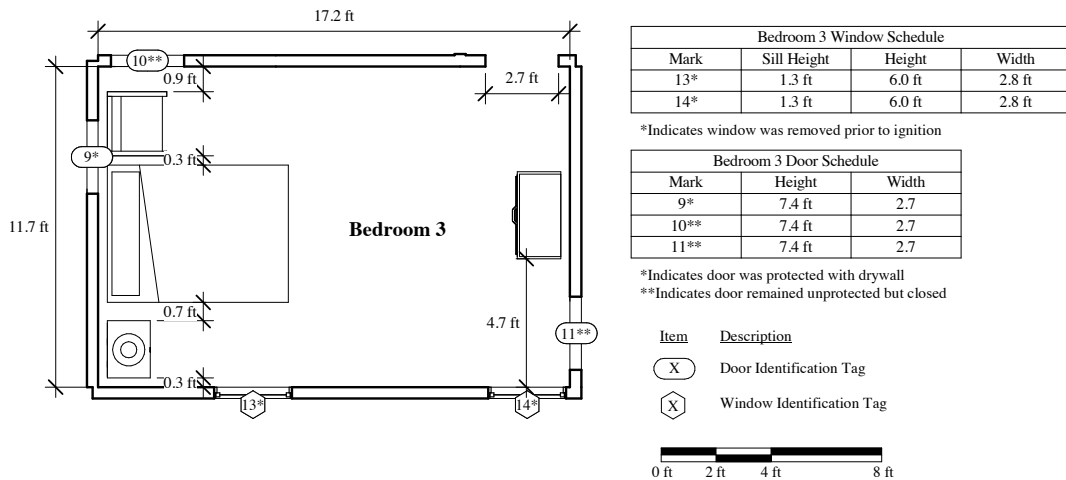
Figure 3.53: Fire room layout for Experiment 5.

Experiment 5 examined coordinated interior suppression with positive pressure ventilation post knockdown. To replicate a similar volume of space found in other experiments, the front entry and office were isolated from the right side of the first-floor, and bedroom 1, bedroom 2, landing were isolated from the right side of the second-floor. These areas did not play a role in this experiment. To ensure repeatable fire growth and a sufficient oxygen supply for flashover, the windows labeled 13 and 14, shown in Figure 3.53, were removed prior to ignition.

The fire was ignited in the upholstered chair ($t = 0$ s) in bedroom 3. The fire grew, producing smoke visible from the side A windows at 161 s (2:41). Visible flames from the leftmost side A window (labeled 13 in Figure 3.53) were apparent at 220 s (3:40) post ignition. Continuously venting flames were apparent from both side A windows at 246 s (4:06) post ignition. Flashover occurred just after at 253 s (4:13) post ignition. The fire transitioned through flashover to a steady state before any fire department intervention.

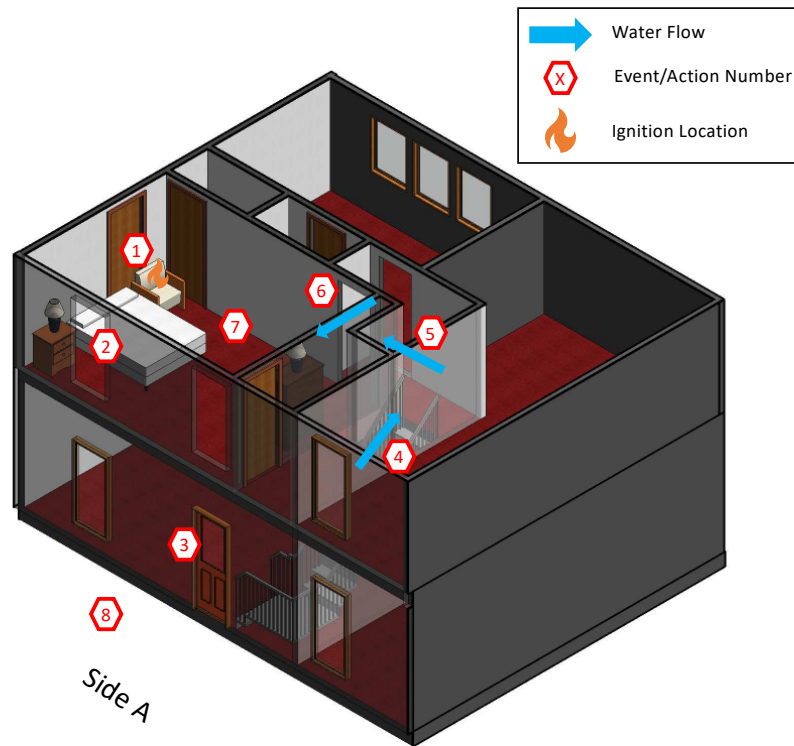
Action/Event	Time (mm:ss)	Time (s)
1 Ignition	00:00	0
2 Flashover	04:13	253
3 Front Door Open	07:01	421
4 Flow from Stairs	07:20	440
5 Flow from Landing	07:34	454
6 Flow from Fire Room Doorway	07:46	466
7 Suppression Crew Entered Fire Room	07:51	471
8 PPV Fan Turned In	07:59	479

Figure 3.54: Time and sequence of actions and events for Experiment 5.

A single 1.75 in. hoseline with a combination nozzle set to straight stream was utilized for interior suppression. The fan was started and placed into position at the front door after the suppression crew entered the structure and made their way to the fire room. The fan was placed approximately 5 ft from the door at an angle of 95° with the ground. The total tactic time from initial ventilation of the front door to suppression was 50 s (00:50). The total water flowed for initial suppression was 166 gal, which does not include water used for mop-up operations. Figure 3.54 lists these events and actions, along with their relative locations, on an isometric view of the structure.

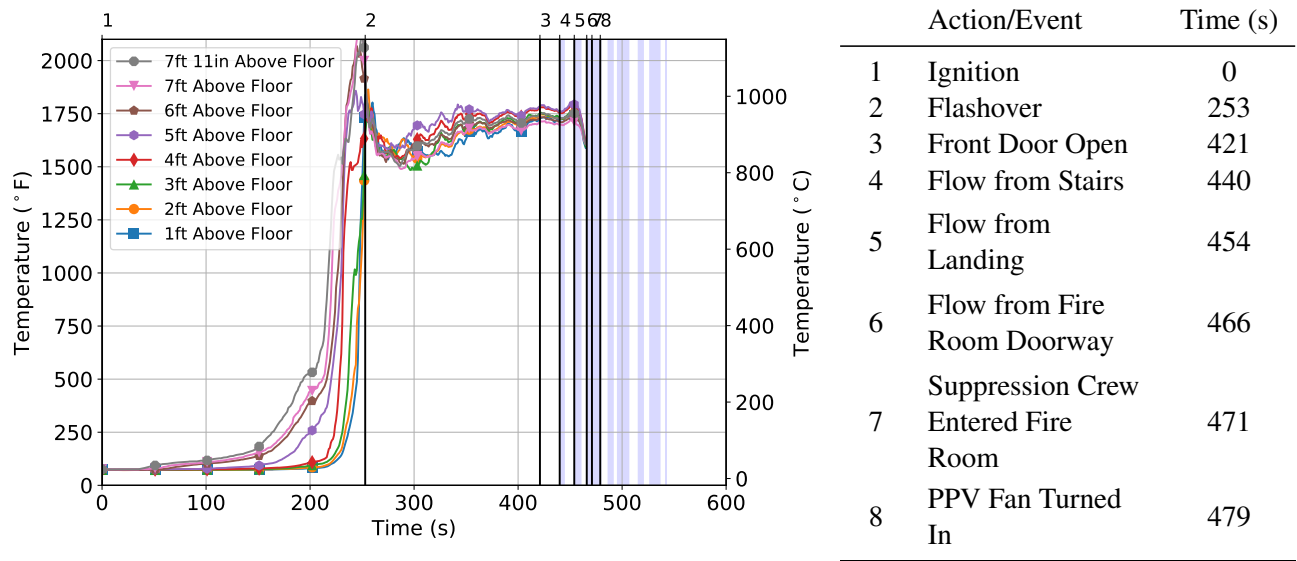
Figure 3.55: Fire room (bedroom 3) temperatures for Experiment 5. Blue vertical bars indicate time and duration of water flow. Water flow from the fire room doorway compromised the thermocouple array, and data beyond this action has not been included.

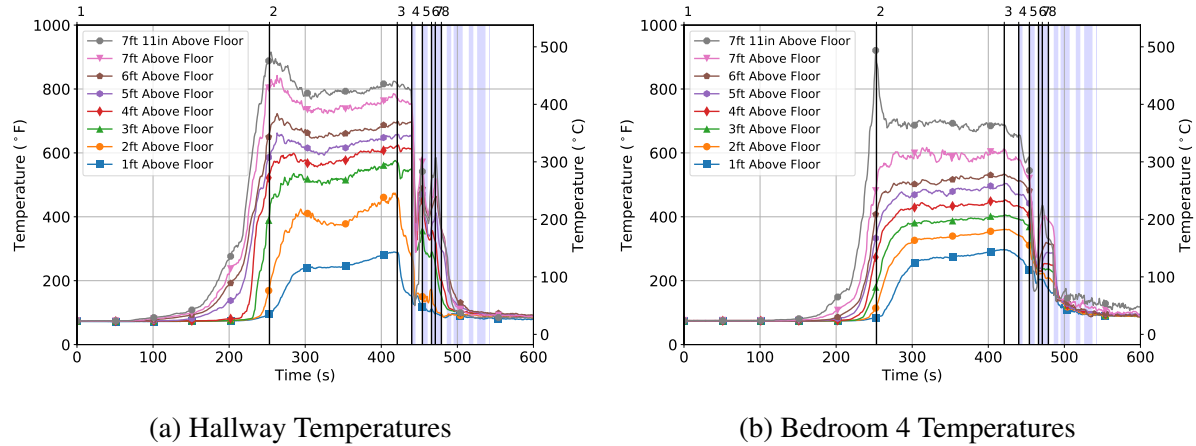
Figure 3.56: Remote temperatures for Experiment 5. Blue vertical bars indicate time and duration of water flow.

Temperatures in the hallway, shown in Figure 3.56a, first began to increase approximately 60 s post ignition as smoke from the fire room first began to spread throughout the structure. The temperatures began to increase more rapidly as flames began to roll into the stairway landing, reaching a peak at the time bedroom 3 reached flashover. The temperatures in the hallway remained relatively steady through the post-flashover period, ranging from 820 °F close to the ceiling to 294 °F 1 ft above the floor. The opening of the front door resulted in a decrease in the 1 ft and 2 ft temperatures, which was the intake portion of a flow path established from the front door to the fire room. The initial suppression action in the stairway cooled temperatures 3 ft above the floor from 544 °F to 294 °F. This allowed the suppression crew to advance to the top of the stairway to continue suppression from that location and the fire room doorway, which were both effective at cooling temperatures not only in the stairway landing, but also in the fire room and bedroom 4. While the hallway temperatures rebounded after both the stairway suppression and the landing suppression actions, temperatures decreased permanently after suppression within the fire room.

The temperatures in bedroom 4 (see Figure 3.56) began to increase later in the experiment than in the stairway landing, approximately 150 s post ignition. The temperatures began to increase more rapidly as bedroom 3 transitioned through flashover, with the 7 ft 11 in. temperature reaching a peak during flashover. The bedroom 4 temperatures were steady at the time the front door was opened, ranging from 690 °F close to the ceiling to 300 °F 1 ft above the floor. After the front door was opened, temperatures began to gradually decrease. The suppression action from the stairway landing (Action 5) reduced temperatures in bedroom 4, although they rebounded during the water application in the fire room doorway. Just before entering the fire room to complete extinguishment, the suppression crew applied a brief, 7 s burst of water into bedroom 4. This action, combined with the activation of the fan for PPV, reduced temperatures below 150 °F for the duration of the test.

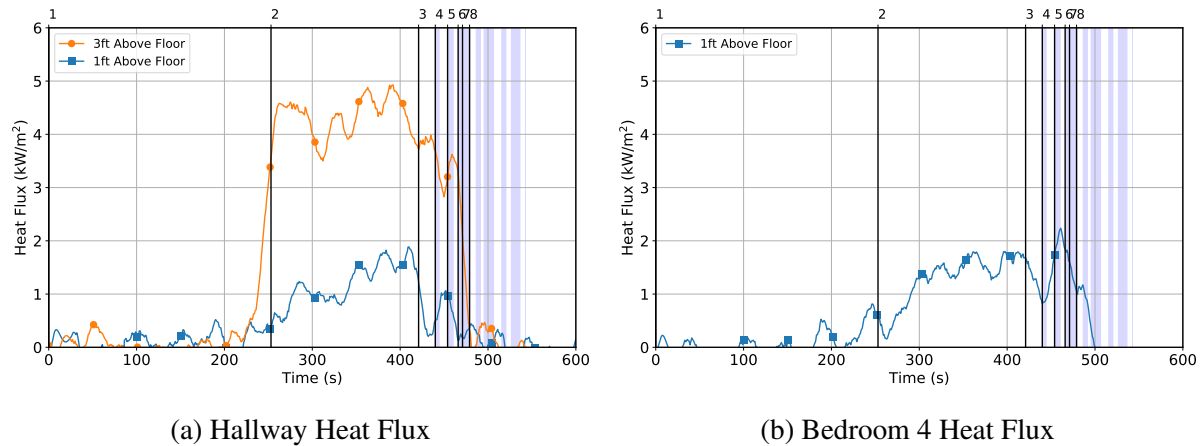
Figure 3.57: Heat flux in hallway and bedroom 4 for Experiment 5. Blue vertical bars indicate time and duration of water flow.

Heat flux was measured 1 ft and 3 ft above the floor in the hallway and 1 ft above the floor in the center of bedroom 4. The heat fluxes at the three locations are shown in Figure 3.57. In the hallway, the heat flux at 1 ft and 3 ft elevations began to increase shortly before flashover, as flames extended out of the bedroom door. The 1 ft heat flux gradually increased during this period to a peak of 1.9 kW/m² at the time the front door was opened, while the 3 ft heat flux remained relatively steady between 3.5 kW/m² and 5 kW/m². The fresh air entrained from the front door opening decreased the heat flux at both elevations, although the decrease was greater at the 1 ft

elevation. The 3 ft heat flux briefly decreased with the initial suppression action from the stairway, although it quickly rebounded. The subsequent suppression actions from the stairway landing and fire room doorway permanently decreased the 3 ft heat flux from 3.5 kW/m² to 0 kW/m². Similarly, after the decrease from the front door opening, the 1 ft heat flux recovered before the stairway landing suppression action permanently decreased the 1 ft hallway heat flux.

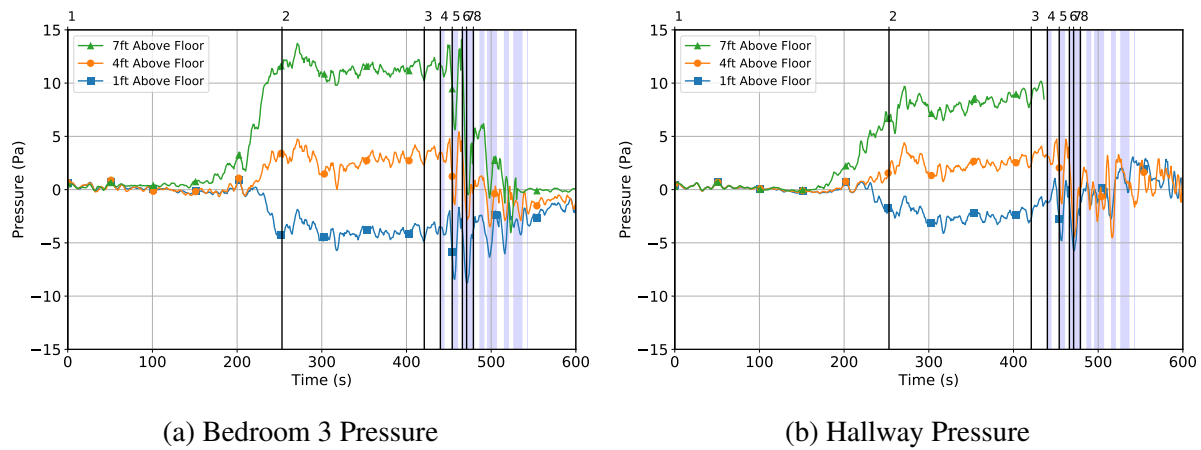
Figure 3.58: Second-floor pressures for Experiment 5. Blue vertical bars indicate time and duration of water flow.

The fire room pressures in Experiment 5 began to increase as the fire grew and the hot gas layer started to develop and gases expanded. The 7 ft pressure and 4 ft pressure first started to increase 125 s and 210 s post ignition, respectively. At the same time the 4 ft pressure started to increase, the 1 ft pressure decreased below 0 Pa, which indicates a bi-directional flow through the fire room vents. This pressure profile was maintained until the front door was opened, with pressures of 13.0 Pa, 4.0 Pa, and -4.0 Pa at 7 ft, 4 ft, and 1 ft above the floor, respectively. The fire growth after

the front door was opened is reflected by an increase in pressure prior to the initial suppression action. Although the stairway suppression action did not significantly decrease fire room temperatures, it did result in a decrease in pressure at all three elevations in the fire room. As suppression continued, the 7 ft, 4 ft, and 1 ft continued to decrease. The decrease in 1 ft pressure can likely be attributed to gas contraction. The combination of the fan used for PPV and suppression actions reduced pressures below 0 Pa for the duration of the test. The pressure in the hallway increased during this period, indicating air was flowing from the stairway into the fire room.

The pressures in the hallway followed a similar trend to those in the fire room, although the magnitude of the pressures was less. This indicates that as the fire grew, hot gases were exhausted from the fire room into the hallway and fresh air was entrained into the fire room from remote parts of the structure. Once the front door was opened, the 1 ft pressure started to increase. The 7 ft pressure sensor was damaged 436 s post ignition, when water clogged the sample port. The pressure at both the 1 ft and 4 ft elevations decreased significantly during each suppression action, reflecting the contraction of hot gases and the entrainment of fresh air behind the hoseline. Approximately 15 s after the PPV fan was turned in, the 1 ft and 4 ft pressures increased above 0 Pa, and remained relatively steady for the rest of the experiment.

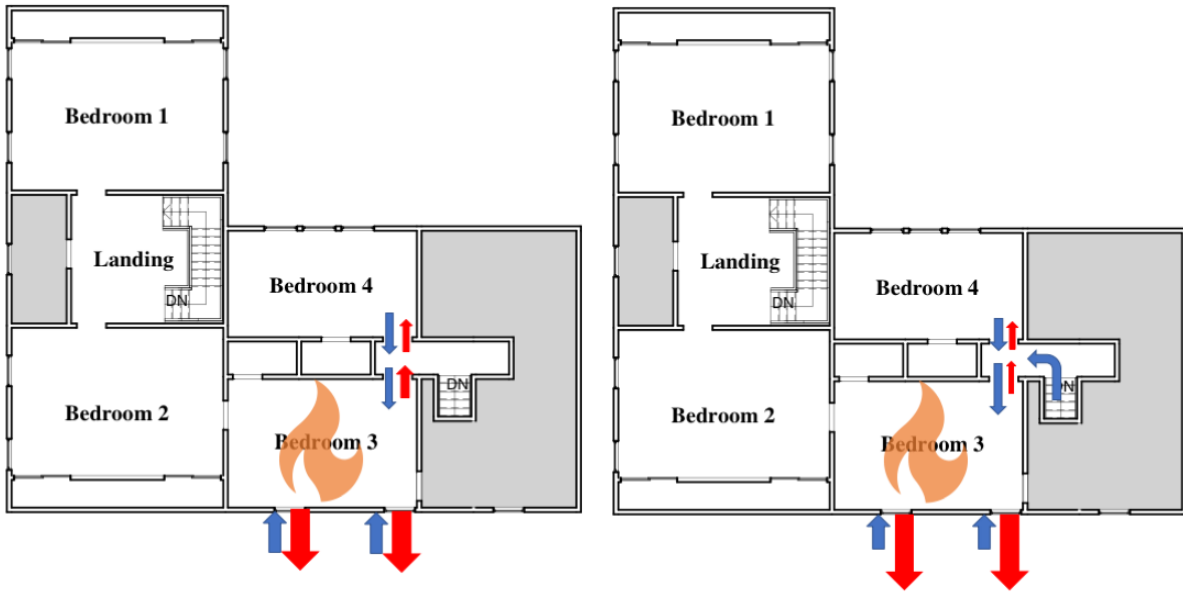
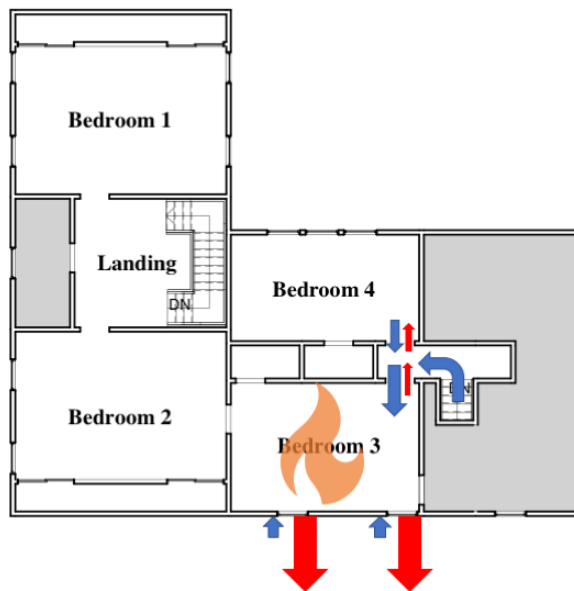
Figure 3.59: Changes in flow during Experiment 5. Red arrows indicate the flow of combustion products, blue arrows indicate the flow of fresh air, and the sizes of the arrows indicate the relative magnitude of the flow.

The changes in flow during the experiment are illustrated in Figure 3.59. As the fire grew to

ventilation limited state, there was bi-directional flow at the fire room windows; fresh air entrained into the fire room and hot gases exhausted out of the fire room. There was also bi-direction flow at the fire room doorway, drawing fresh air from remote parts of the structure to the fire room and replacing it with products of combustion, as shown in Figure 3.59a. The opening of the front door allowed fresh air to flow into the structure and travel up the stairs and into the fire room. Hot gases exhausted from the upper portion of the fire room windows and doorway, as shown in Figure 3.59b. After the suppression crew began flowing water from the stairway, doorway, and inside of the fire room, a fan was activated for PPV. The fan increased the flow rate of fresh air through the front door and the exhaust through the fire room windows, as seen in Figure 3.59c.

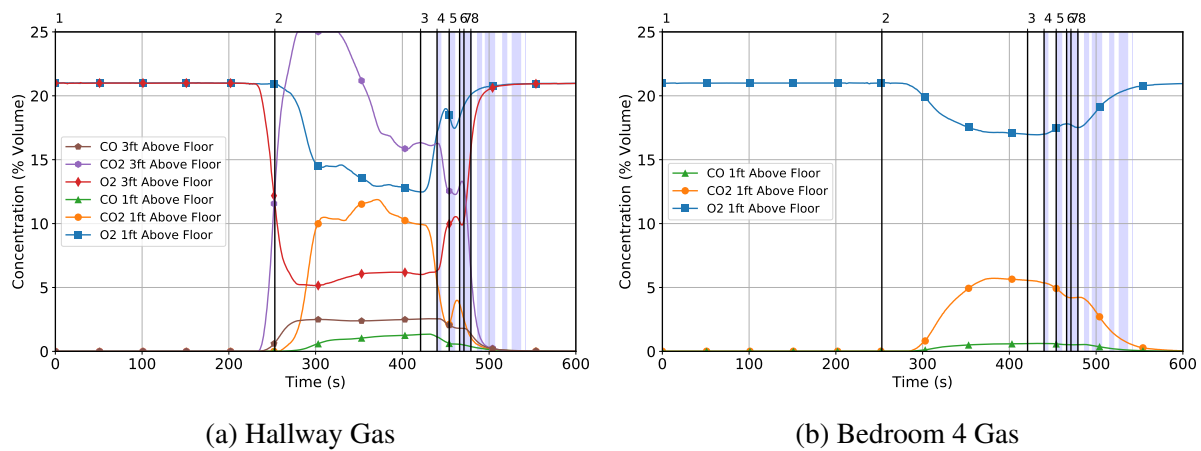
Figure 3.60: Gas concentrations in the hallway and bedroom 4 for Experiment 5. Blue vertical bars indicate time and duration of water flow.

Gas concentrations were measured at the same locations and elevations as heat flux, as shown in Figure 3.60. The gas concentrations at 1 ft and 3 ft in the landing (see Figure 3.60a) first began to change before flashover in the fire room, when visibility conditions in the hallway began to deteriorate. As the second-floor was filled with products of combustion, the O_2 concentration

rapidly decreased and the CO₂ and CO concentrations rapidly increased. The O₂ concentration at the 3 ft level fell to 5.0%, corresponding to the loss of visibility in the hallway camera 285 s into the experiment. The O₂ concentrations at this elevation remained steady through the opening of the front door. The O₂ concentration at the 1 ft level dropped after flashover and continued to gradually decrease and reached a minimum value of 12.4% at the time the front door was opened. The CO₂ concentration at the 3 ft level exceeded the upper limit of the analyzer (measurement limit was 25%), while the concentration at the 1 ft elevation reached a peak of 11.8%. The CO concentrations prior to fire department intervention were steady at 2.6 and 1.3% at the 3 ft and 1 ft elevations, respectively. A reason for the comparatively low O₂ concentrations and high CO₂ and CO concentrations in this experiment was because of the relatively small landing, offset stairs, and direct alignment of bedroom 4 to the fire room, which resulted in rapid filling with products of combustion.

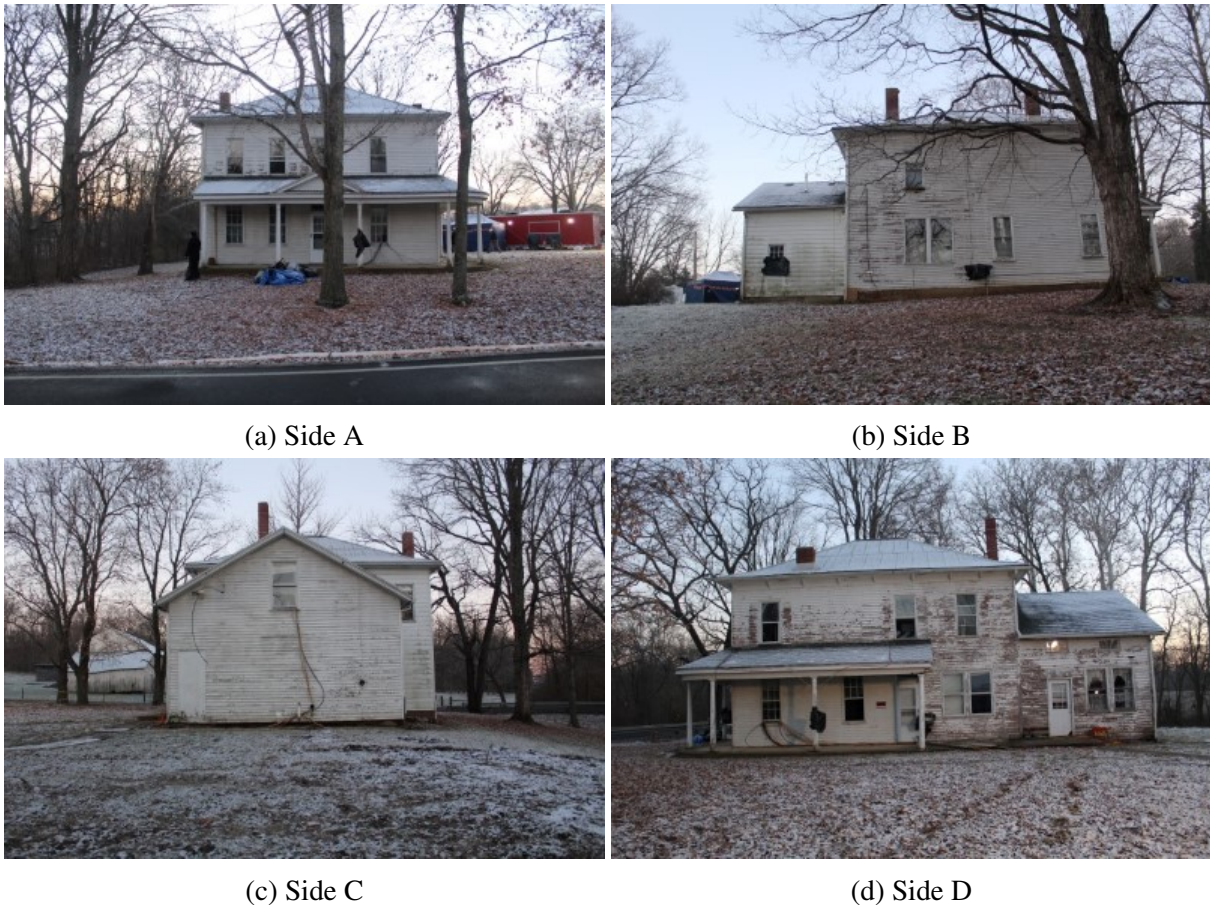
Figure 3.61: Exterior photographs of the structure for Experiment 6.

Experiment 6 examined interior suppression coordinated with door control on the front door. At 1030 Hilltop Road in Xenia, Ohio, a two-story, 2,200 sq ft wood frame structure was instrumented to conduct this second-floor bedroom fire experiment. The four exterior sides of the structure appear in Figure 3.61. The structure was stick-built with rough cut lumber framing with wood-slat siding. The foundation was a combination of block and stone. The original house had a hip-style tin roof supported by wood members and the rear addition had a peaked roof constructed using 1 in.-by-6 in. sheathing covered with asphalt shingles. Detailed dimensioned drawings for the first and second story appear in Appendix Figures B.12 and B.13, respectively.

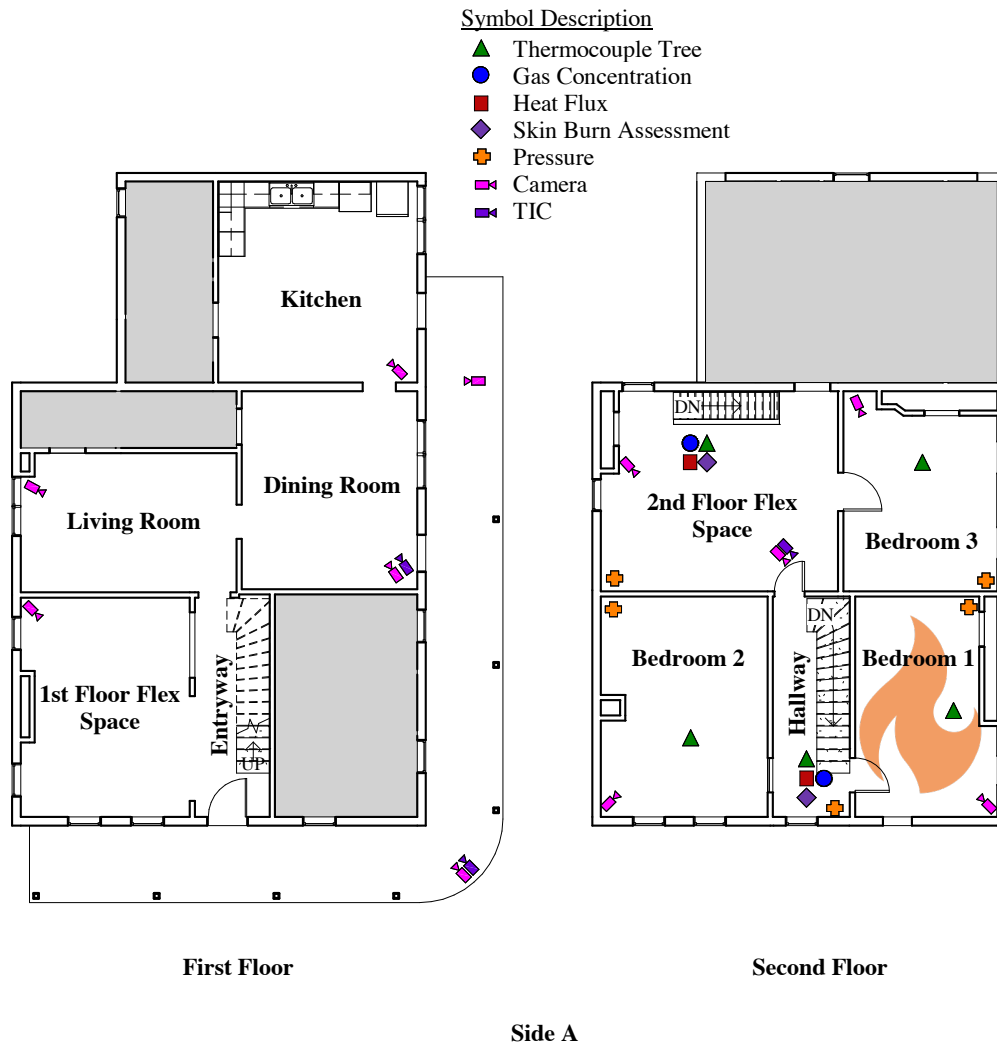
Figure 3.62: Instrumentation and floor plan for Experiment 6. The gray areas were isolated from the remainder of the structure and utilized as space for instrumentation.

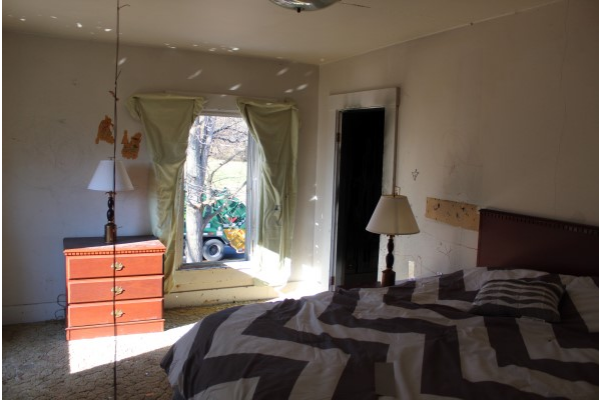
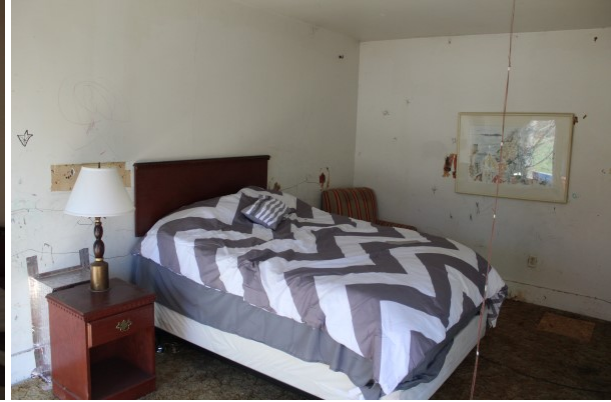
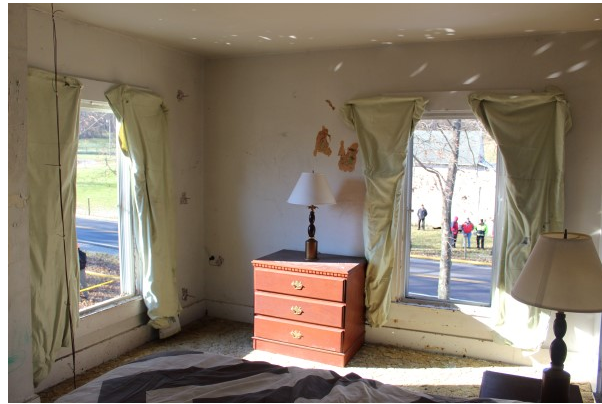
Figure 3.63: Interior photographs of fire room for Experiment 6.

Bedroom 1, the fire room, was furnished with the bedroom fuel package described in section 2.4.1. Photographs of the fire room prior to ignition are presented in Figure 3.63. A dimensioned layout of the fire room is included in Figure 3.64. To replicate a similar volume of space found in other experiments, bedroom 2 and bedroom 3 remained closed throughout the experiment. To allow for repeatable fire growth, the windows labeled 18 and 19 in Figure 3.64 were removed prior to ignition.

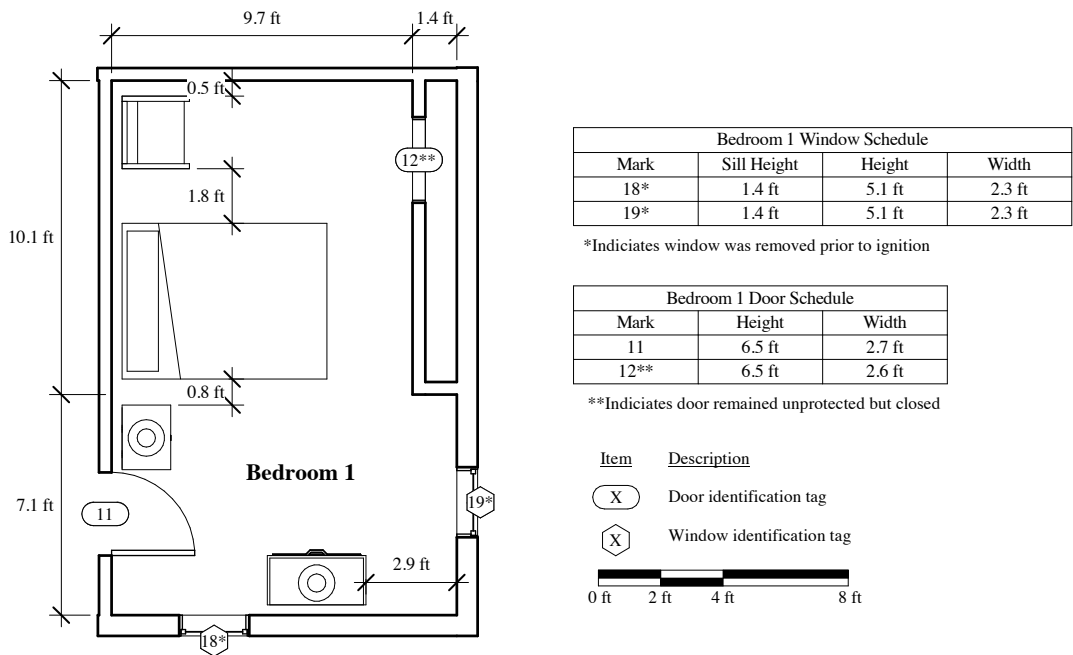
Figure 3.64: Fire room layout for Experiment 6.

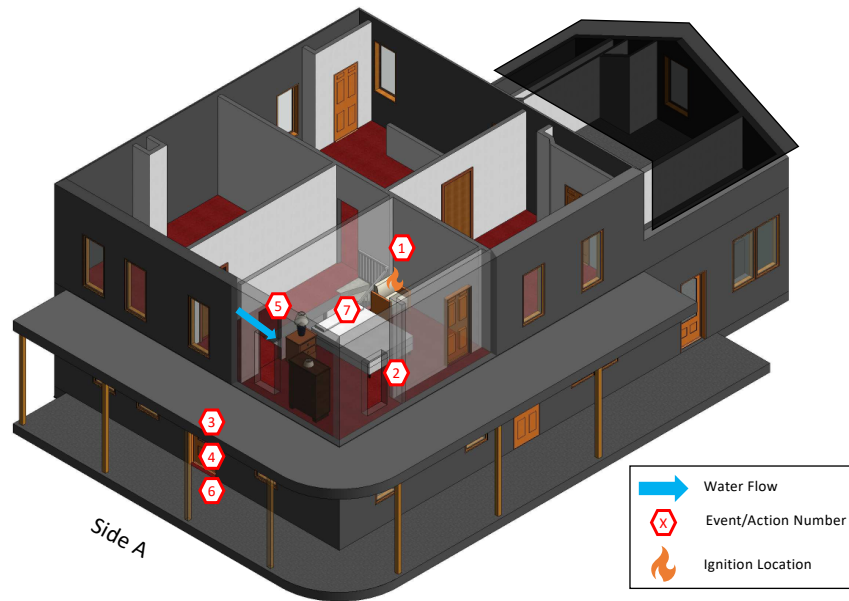
Action/Event	Time (mm:ss)	Time (s)
1 Ignition	00:00	0
2 Flashover	05:29	329
3 Front Door Open	08:31	511
4 Suppression Crew Entered, Door Controlled	08:41	521
5 Flow from Fire Room Doorway	09:09	549
6 Front Door Chocked Open	09:35	575
7 Suppression Crew Entered Fire Room	09:40	580

Figure 3.65: Time and sequence of actions and events for Experiment 6.

The total tactic time from front door open to suppression was 69 s (1:09). The total water used for initial suppression was 97 gal, which does not include the water flowed during mop-up operations. The events and actions for Experiment 6 are listed in Figure 3.65, along with their locations imposed on an isometric view of the structure.

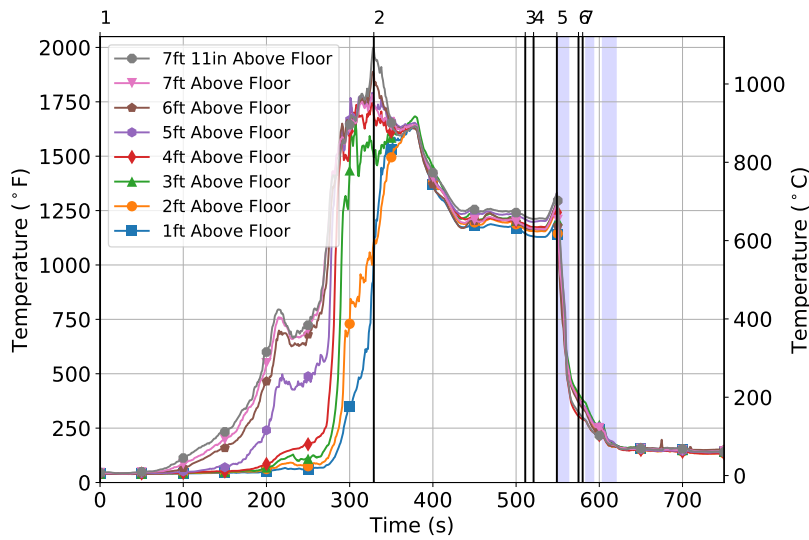
Figure 3.66: Fire room (bedroom 1) temperatures for Experiment 6. Blue vertical bars indicate time and duration of water flow.

Temperatures closest to the ceiling (6 ft and above) in the fire room began to increase approximately 50 s post ignition. All elevations experienced an increase in temperature by 250 s post ignition. At approximately 329 s post ignition, the fire room reached flashover as all fire room temperatures increased beyond 1100 °F. Temperatures post-flashover decreased and remained steady. Approximately 40 s after the front door was opened and controlled, a brief increase in fire room temperatures was observed, prior to the initial suppression action from the fire room doorway (Action 5). This initial suppression effectively reduced temperatures in the fire room, and subsequent suppression actions in the fire room itself further reduced temperatures.

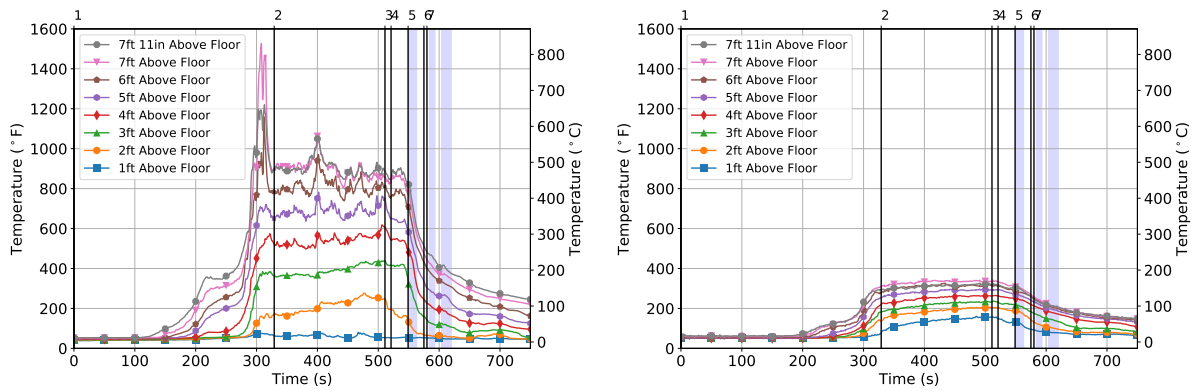
Figure 3.67: Second-floor temperatures for Experiment 6. Blue vertical bars indicate time and duration of water flow.

The hallway temperatures followed a similar trend in the pre-intervention period to the fire room temperatures, as shown in Figure 3.67a, with a brief pause in the fire growth approximately 220 s post ignition. Peak ceiling temperatures were observed shortly before the fire room transitioned through flashover. Temperatures then decreased to a steady value which was maintained until the time of fire department intervention. The temperatures at the time of fire department intervention ranged from 935 °F close to the ceiling to 60 °F 1 ft above the floor. Temperatures at the 1 ft elevation are indicative of the air temperatures in remote locations throughout the structure, suggesting air was entrained into the fire room at this elevation. After the front door was opened, the hallway temperatures above 1 ft slightly decreased at all levels, before a more rapid decrease occurred. The rapid decrease corresponded with the initial suppression action from the fire room doorway. As suppression continued, temperatures continued to decrease, dropping below 300 °F 160 s after the front door was opened.
