Analysis of the Coordination of Suppression and Ventilation in Single-Family Homes

John Regan
Julie Bryant
Craig Weinschenk

UL Firefighter Safety Research Institute
Columbia, MD 20145

March 19, 2020

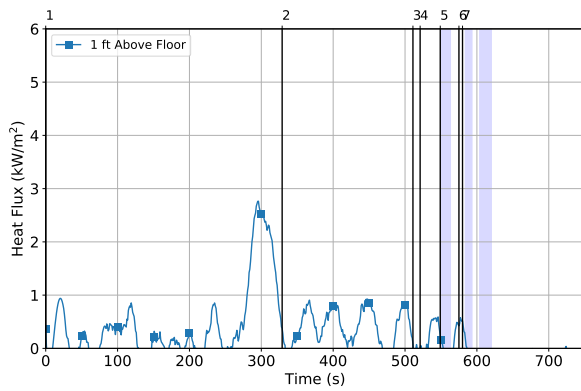
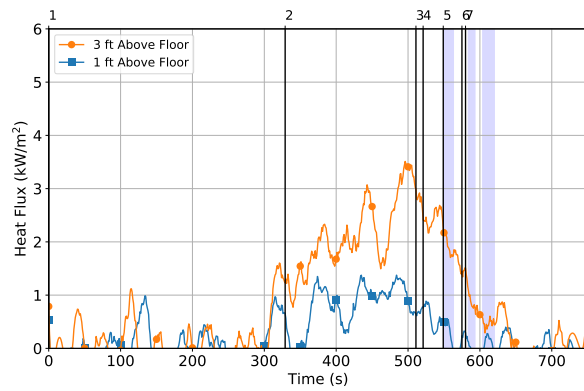
Figure 3.68: Heat flux for Experiment 6. Blue vertical bars indicate time and duration of water flow.

The low temperatures measured 1 ft above the floor in the hallway were mirrored by the heat flux at that location (see Figure 3.68b). The heat flux was negligible during the initial growth period, reaching a brief peak of 2.8 kW/m², 300 s post ignition, shortly before the time of flashover. The heat flux then decreased to below 1 kW/m² for the remainder of the experiment. One reason this low heat flux occurred directly outside the fire room doorway is that the gauge was located directly in the path of fresh air being entrained into the fire room. Because the seat of the fire was located in the corner of bedroom 1, away from the doorway, there were no flames rolling out of the fire room doorway over the heat flux gauge, as was observed in other experiments.

The heat flux values 1 ft and 3 ft above the floor in the flex space began to increase at the same time as the heat flux in the hallway—shortly before flashover in the fire room. Because these gauges were not exposed to a constant flow of cool air, they increased during the post-flashover period to values of 3.5 kW/m² and 1.4 kW/m² at 3 ft and 1 ft, respectively. Like the flex space temperatures, the flex space heat fluxes began to decrease after the front door was opened, and continued to decrease as suppression was conducted. The heat flux at both elevations in the flex space decreased to background levels approximately 650 s post ignition.

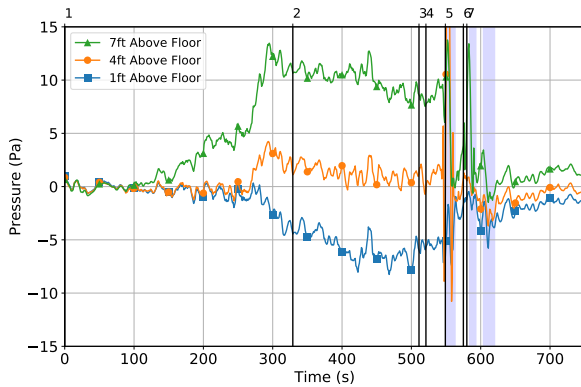
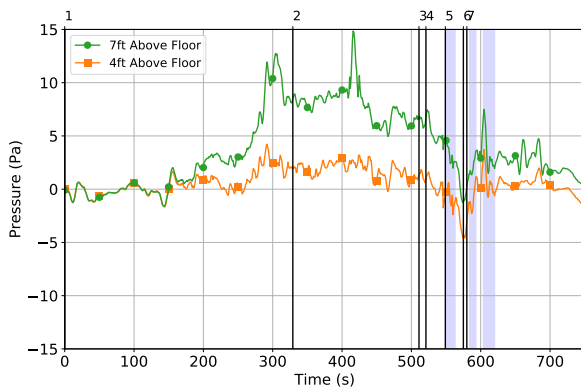
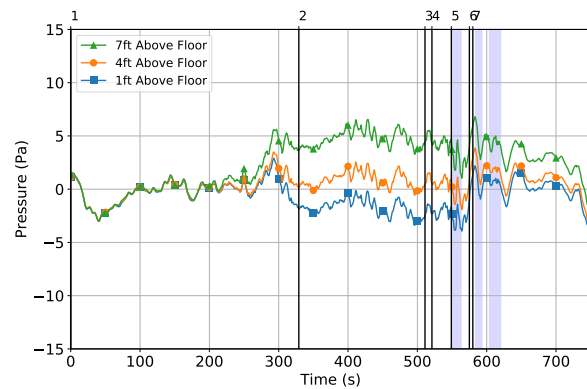
Figure 3.69: Second-floor pressure for Experiment 6. Blue vertical bars indicate time and duration of water flow.

The growth trend observed in the fire room temperatures was mirrored in the behavior of the fire room pressures (shown in Figure 3.69a). The 7 ft pressure in the fire room first started to increase approximately 100 s post ignition, as the smoke layer in the fire room started to develop. The pressure increased until 210 s post ignition, briefly stabilized, and continued to increase, reaching a peak 13.0 Pa. As the smoke layer continued to bank down in the fire room, the 4 ft pressure increased and the 1 ft pressure decreased below 0 Pa, indicating a bi-directional flow was established through the fire room vents. This pressure profile was maintained through the time of fire department intervention. The pressures were not drastically affected by the opening of the front door, but started to converge to 0 Pa as suppression began. In particular, the 7 ft pressure in the fire room decreased significantly during water application from the fire room doorway (Action 5).

Note: The 1 ft pressure in the hallway was damaged prior to the start of the experiment. The 4 ft and 7 ft pressures at this location followed a similar trend to the fire room, although the magnitude of the pressures were less. After the front door was opened, the 4 ft and 7 ft pressures both began to decrease, and continued to decrease through the initial suppression action (Action 5) to 0 Pa and -3.0 Pa at 7 ft and 4 ft, respectively. This may be a result of gas contraction from suppression.

The pressures in the flex space had the lowest magnitude of the open spaces on the second-floor and did not start to change until approximately 20 s post ignition. As the fire reached flashover in bedroom 1, all three pressures were increasing. The 1 ft pressure decreased below 0 Pa 300 s post ignition, at approximately the same time visibility in the flex space was reduced. This pressure profile was maintained through the front door opening, only beginning to decrease once the suppression crew began flowing water from the fire room doorway. This decrease in pressure at all three elevations mirrored the decrease in the flex space.

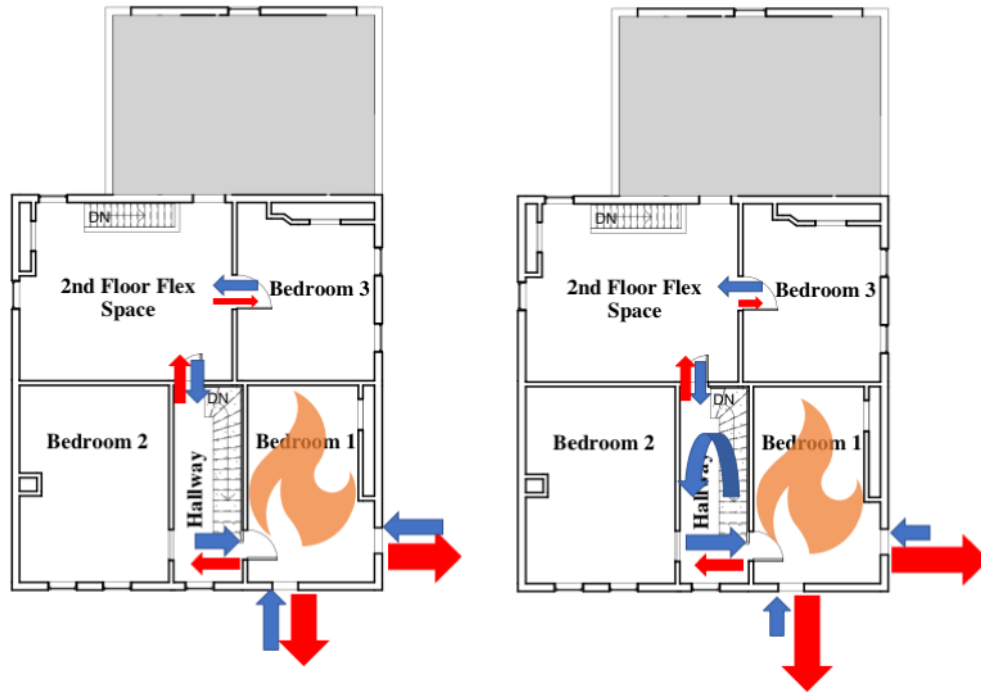
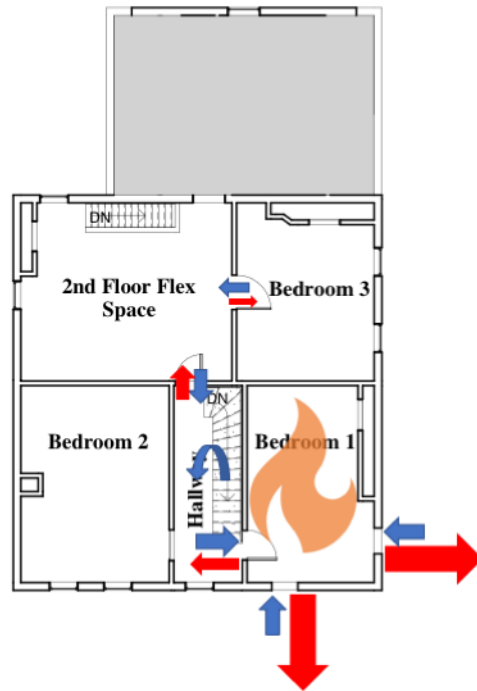
Figure 3.70: Changes in flow during Experiment 6. Red arrows indicate the flow of combustion products, blue arrows indicate the flow of fresh air, and the sizes of the arrows indicate the relative magnitude of the flow.

The changes in flow during the experiment are illustrated in Figure 3.70. As the fire grew to a point where it became ventilation limited, bi-directional flow paths were created in the fire room windows, entraining fresh air into the fire room and exhausting hot gases out of the fire room and the fire room doorway, drawing fresh air from remote parts of the structure to the fire room and replacing it with products of combustion, as shown in Figure 3.70a. The opening of the front door created a more efficient flow path, allowing fresh air to flow into the structure through the front door and travel up the stairs and into the fire room, while hot gases still exhausted from the upper portion of the fire room windows and doorway, as shown in Figure 3.70b. After the suppression crew entered, the front door was closed, reducing the amount of air entrained into the fire room (indicated by the smaller blue arrow in Figure 3.70c). Although the door was closed, the entrained air did result in an increase in fire room temperature and pressure, indicating the fire grew despite the door control action, although the suppression actions in the fire room doorway and fire room interior prevented this fire growth from increasing temperatures or gas concentrations elsewhere in the structure.

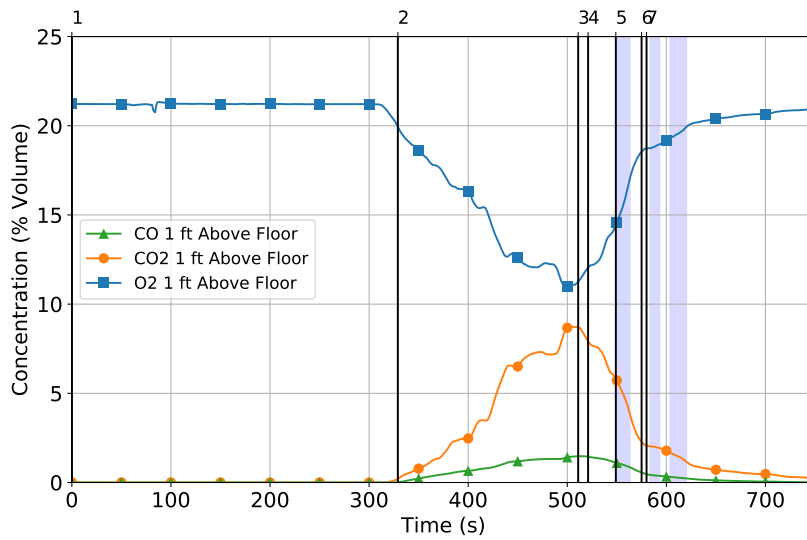
Figure 3.71: Flex space gas concentrations for Experiment 6. Blue vertical bars indicate time and duration of water flow.

In the flex space, there was an error with the 3 ft gas analyzer, so only the 1 ft data is displayed in Figure 3.71. All gases first started to decrease shortly before the fire room transitioned through flashover, shortly after visibility was lost at this location 290 s post ignition. All gases continued to decrease until the front door was opened, reaching values of 11.0%, 9.0%, and 1.5% for O₂, CO₂, and CO, respectively. The opening of the front door caused 1 ft gas concentrations to decrease, although the door was closed to the width of the hoseline, the entrained air had a positive impact on gas concentrations close to the floor in the flex space.

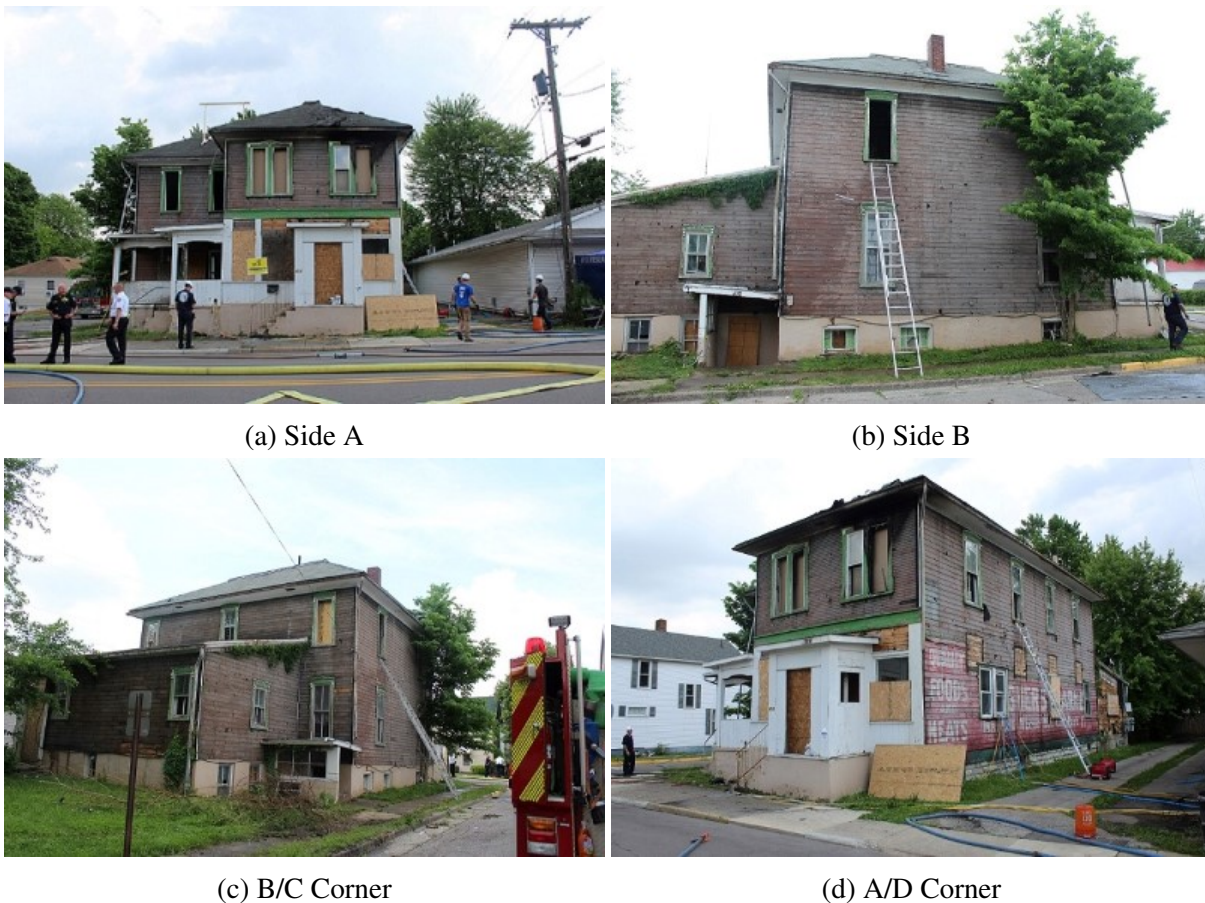
Figure 3.72: Exterior photographs of the structure for Experiment 7.

Experiment 7 was designed to evaluate vertical ventilation prior to suppression with the ventilation location over the fire room. At 201/203 Water Street in Sidney, Ohio, a two-story, 3,074 sq ft wood frame structure was instrumented to conduct this second-floor bedroom fire experiment. The four exterior sides of the structure appear in Figure 3.72. The structure was built with rough cut lumber framing with wood-slat siding. The foundation was a mix of poured concrete and concrete block. The hip-style roof was constructed using 1 in.-by-6 in. sheathing covered with asphalt shingles. Interior walls were finished with plaster and lath while interior floors included carpet in both bedrooms and wood on the steps and landing. Detailed dimensioned drawings for the first and second story appear in Appendix Figures B.1 and B.2, respectively.

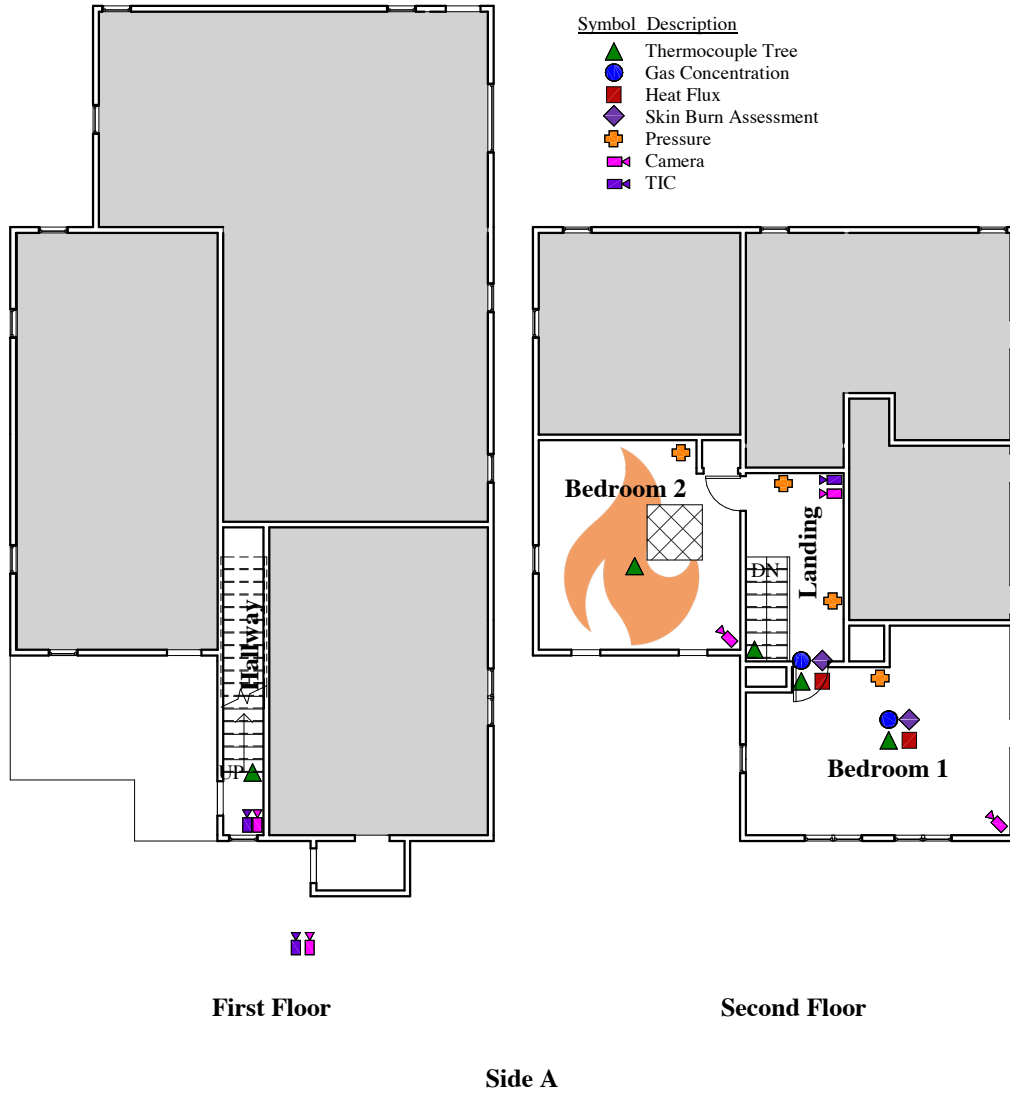
Figure 3.73: Instrumentation and floor plan for Experiment 7. The gray areas were isolated from the remainder of the structure and utilized as space for instrumentation. The cross-hatched area indicates the size and location of the vertical vent. Not shown on this plan was an additional thermocouple array located in the attic.

Originally a single-family home, the building was last used as multiple tenant spaces with two apartments on the first-floor and two on the second-floor. The second-floor apartments were re-configured for the experiment as two bedrooms with a common access stairway. These areas, accounting for 584 sq ft, defined the experimental volume of the structure; all other areas within the structure were isolated and used to protect instrumentation from products of combustion. The structure was instrumented for temperature, pressure, heat flux, IR, and standard video to capture the fire dynamics during experimentation. Instrumentation was also installed to characterize the potential for skin burns and occupant toxic exposure during the experiment. Figure 3.73 shows the layout of the first and second-floors with the instrumentation locations.

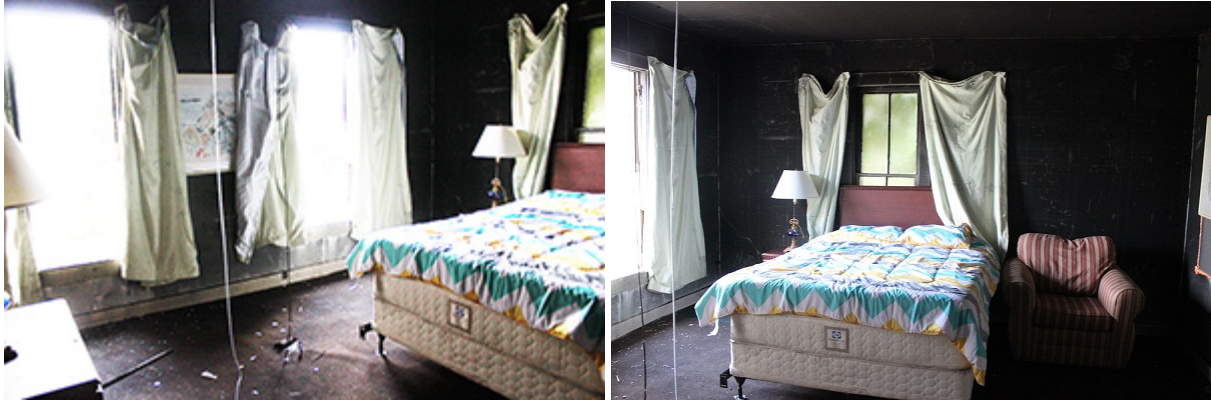
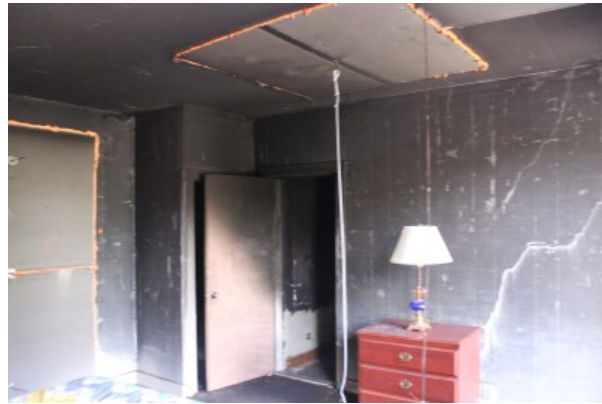
Figure 3.74: Interior photographs of fire room for Experiment 7.

Bedroom 2 was furnished with the bedroom fuel package described in Section 2.4.1. Photographs of the fire room prior to ignition are presented in Figure 3.74. A dimensioned layout of the fire room is included in Figure 3.75.

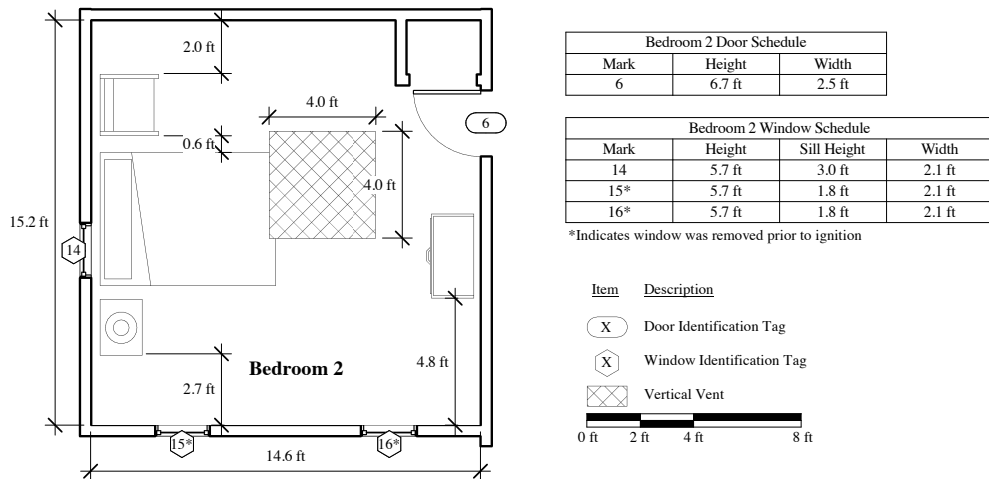
Figure 3.75: Fire room layout for Experiment 7. The cross-hatched box indicates the size and location of the vertical vent.

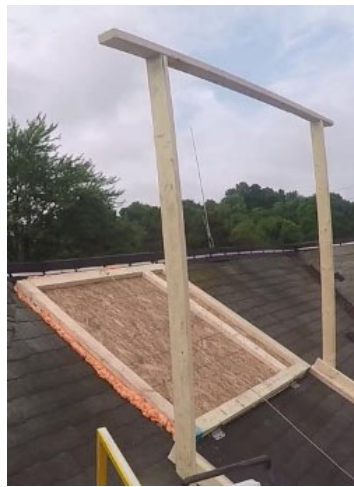
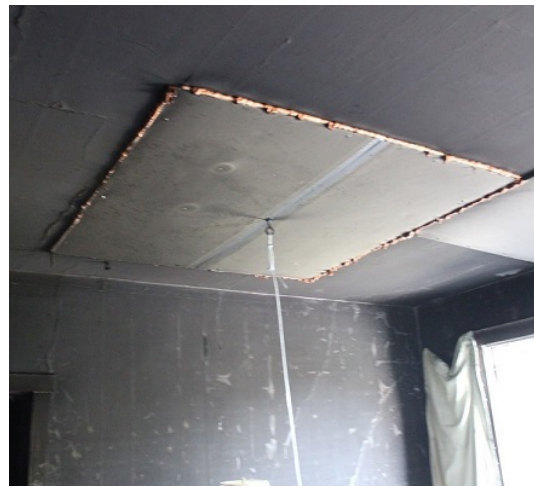
A 4 ft-by-4 ft ventilation opening was located over bedroom 2. A roof hole and a ceiling hole located directly below the roof hole were cut prior to ignition. The roof hole was covered by plywood and sealed to prevent leakage. The ceiling hole was covered with half-inch gypsum board. Vertical ventilation was completed by first removing the plywood to expose the precut roof hole, replicating a crew cutting a ventilation hole. Immediately following, the interior gypsum was released, exposing the precut ceiling hole and replicating a crew removing the compartment ceiling. Figure 3.76 shows the covered precut roof opening and the interior hinged ceiling.

Figure 3.76: Vertical ventilation openings for Experiment 7.

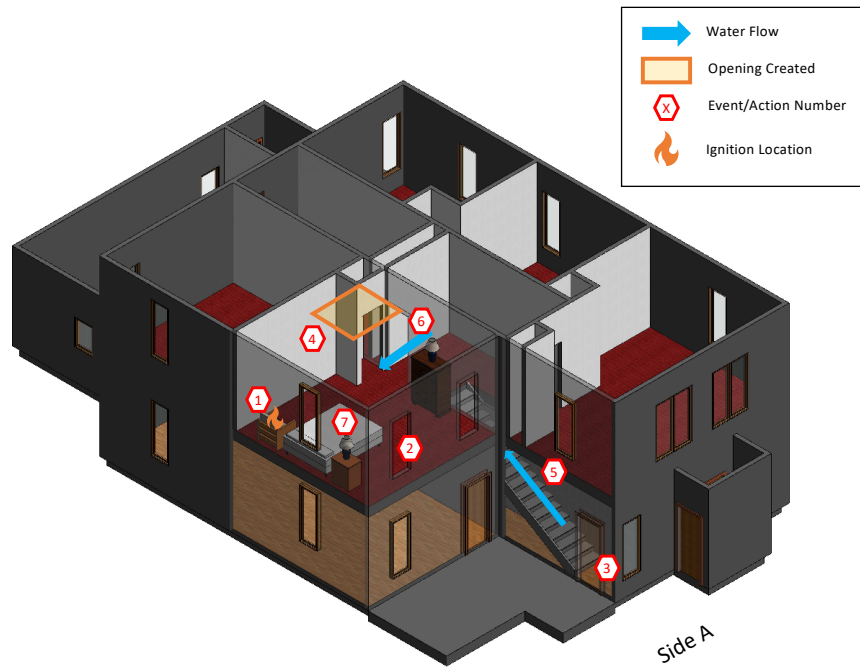
Action/Event	Time (mm:ss)	Time (s)
1 Ignition	00:00	0
2 Flashover	04:56	296
3 Front Door Open	07:10	430
4 Vertical Vent Completed	07:22	442
5 Flow from Stairs	07:36	456
6 Flow from Fire Room Doorway	07:52	472
7 Suppression Crew Entered Fire Room	08:30	510

Figure 3.77: Time and sequence of actions and events for Experiment 7.

The entire tactic from front door open to occupying the fire room was 80 s (1:20). The total water flowed for initial suppression was approximately 133 gal. This does not include the water flowed during mop-up operations. Figure 3.77 shows the sequence of events with an isometric image of the structure.

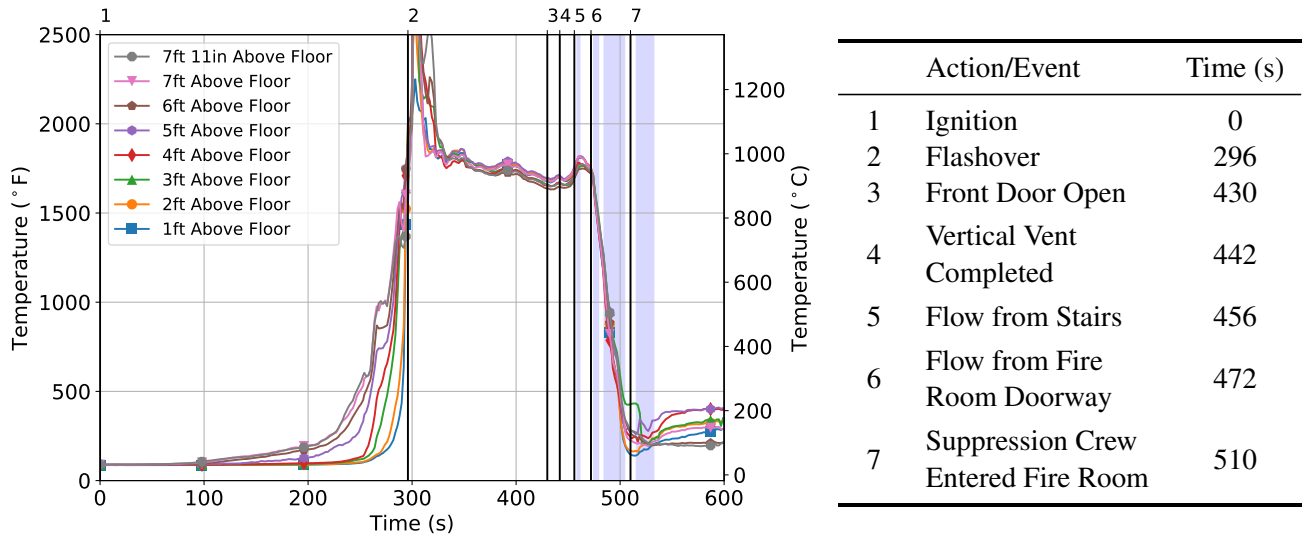
Figure 3.78 shows the time history of the measured temperature variations in the fire room. Thermocouples first measured a temperature increase at approximately 80 s post ignition. As the fire room transitioned through flashover, temperatures in the fire room exceeded the listed calibration of the thermocouple wire used for these experiments. This introduced an increased uncertainty (above the typical $\pm 15\%$) in the accuracy of the measurements for the duration of the experiment. The fire room remained in a post-flashover state until firefighters initiated suppression. Following the front door opening and the vertical ventilation sequence, temperatures increased in the fire room. The open front door allowed fresh air to be entrained into the structure while the open roof hole allowed hot gases to exhaust from the structure, increasing fire growth. Temperatures began to drop following hallway suppression, but the most significant impact occurred when the nozzle firefighter began suppression from the fire room doorway.

Figure 3.78: Temperatures in fire room (bedroom 2) for Experiment 7. Blue vertical bars indicate time and duration of water flow.

The fire behavior in the structure was also reflected by changes in pressure. As the bedroom fire in Experiment 7 grew, bi-directional flows were established at the fire room windows and doorway. The fire room pressure (see Figure 3.81) started to change approximately 200 s post ignition. The 4 ft and 7 ft pressure increased as hot, combustion gases filled the fire room. The 1 ft pressure decreased below ambient pressure, which drew gases toward the fire room. This pressure profile was steady until the front door and vertical vent were opened. These vents resulted in a drop in pressure in the fire room at all three elevations—7.0 Pa, 7.4 Pa, and 8.3 Pa at the 7 ft, 4 ft, and 1 ft levels, respectively. The pressure drop associated with the change in ventilation was temporary as all three elevations showed a pressure rise due to the resulting fire growth. The pressure increase coincided with the temperature rise shown in Figure 3.78, prior to the suppression crew flowing water from the fire room doorway.

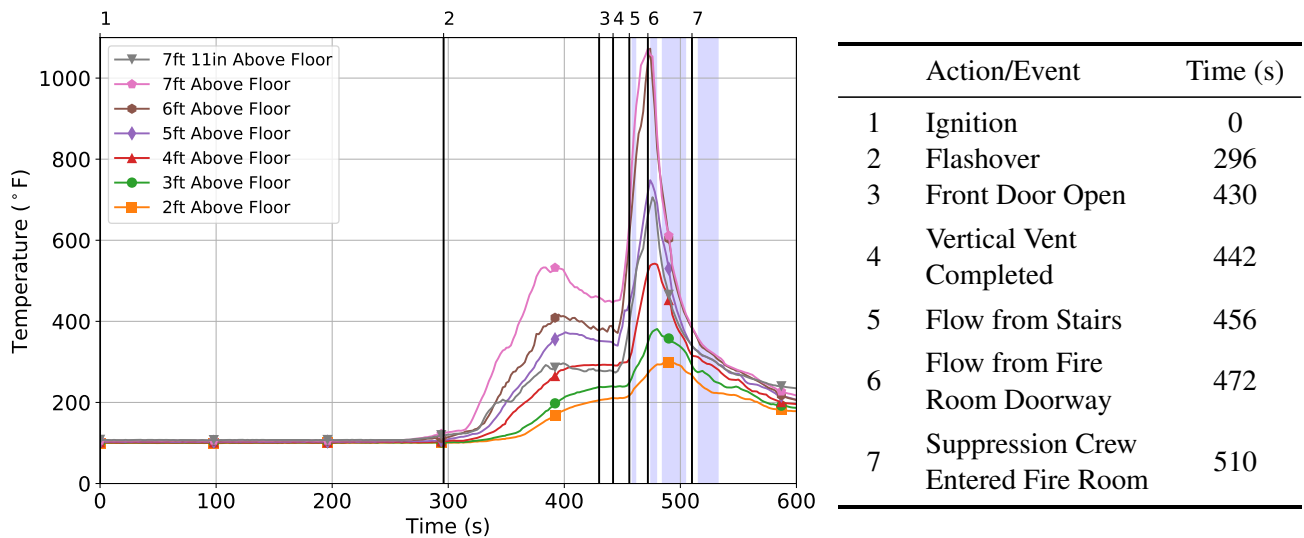
Figure 3.79 shows the temperatures measured by the thermocouple array located in the center of the attic space of the structure. Attic temperatures first started to increase as the fire room transitioned through flashover. Flames and combustion gases venting from the bedroom 2 windows impinged on the soffit, traveling through the soffit vents into the attic space. The measured peak attic temperature prior to fire department intervention was 535 °F at 7 ft above the floor. After vertical ventilation was completed, hot gases from the post-flashover fire were able to exhaust into the attic space. The peak temperature exceeded 1000 °F. Temperatures significantly decreased once the suppression crew began flowing water from the fire room doorway.

Figure 3.79: Temperatures in attic for Experiment 7. Blue vertical bars indicate time and duration of water flow.

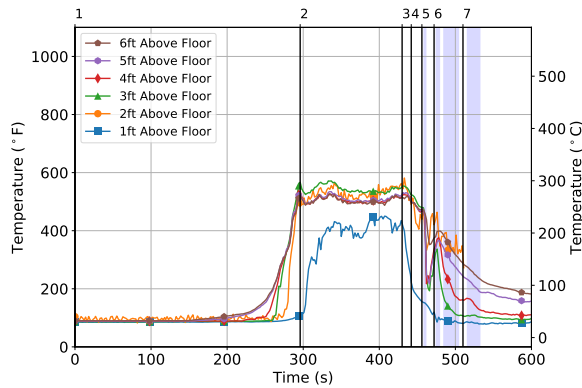
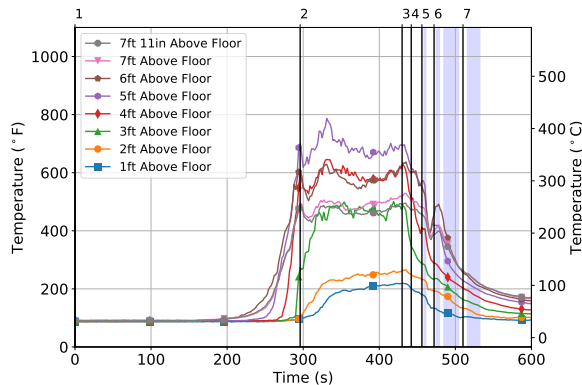
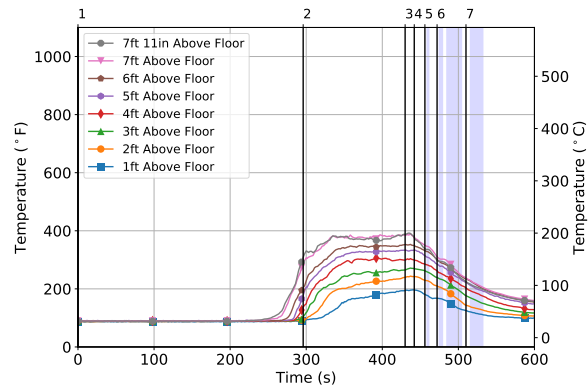
While the combination of the open front door and vertical vent led to an increase in fire room and attic temperatures, temperatures generally decreased in the open spaces throughout the second-floor over the 2 min. following initial firefighter intervention (see Figure 3.80). Landing temperatures were steady prior to the front door opened, as shown in Figure 3.80a. Above the 2 ft elevation, the temperatures were between 500 °F and 565 °F. After ventilation was complete, temperatures began to decrease. The initial suppression from the stairway reduced temperatures. At 3 ft and above, temperatures increased after water flow stopped as a result of the gases that continued to flow from the fire room until suppression from the fire room doorway.

(a) Landing Temperatures

(b) Bedroom 1 Doorway Temperatures

(c) Bedroom 1 Temperatures

Figure 3.80: Temperatures remote from the fire room for Experiment 7. Blue vertical bars indicate time and duration of water flow.

Bedroom 1 doorway temperatures were also steady prior to fire department interventions. The temperature profile at the doorway (seen Figure 3.80b) indicated the hot gas layer was between 2 ft and 3 ft at the time the front door was opened. Following the ventilation sequence, the 1 ft temperature decreased from 220 °F to 180 °F, the 3 ft temperature decreased from 480 °F to 285 °F, and the 5 ft temperature decreased from 700 °F to 575 °F. Stairway suppression reduced temperatures at the 4 ft level and above, but they began to rise again until suppression from the fire room doorway.

Bedroom 1 temperatures at the time of front door opening were steady, ranging between 380 °F near the ceiling and 195 °F 1 ft above the floor (see Figure 3.80c). Following ventilation, temperatures at all elevations of the space began to decrease. The decrease in temperatures was more rapid close to the ceiling. Unlike the landing and remote room doorway temperatures, there were not immediate changes in temperature that corresponded to suppression actions.

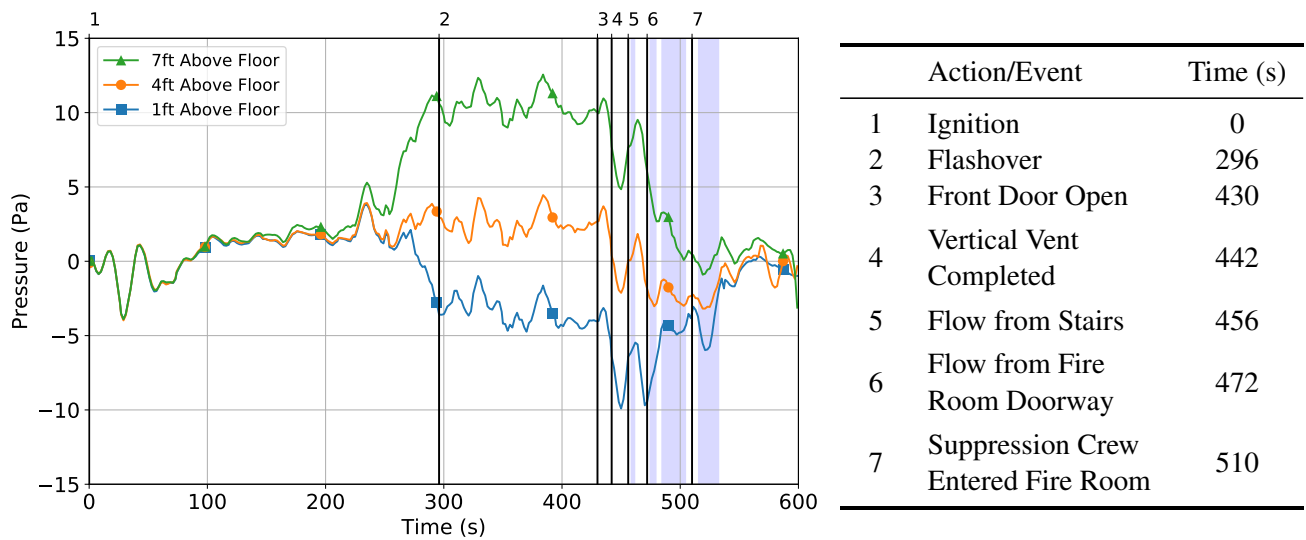
Figure 3.81: Pressures in fire room (bedroom 2) for Experiment 7. Blue vertical bars indicate time and duration of water flow.

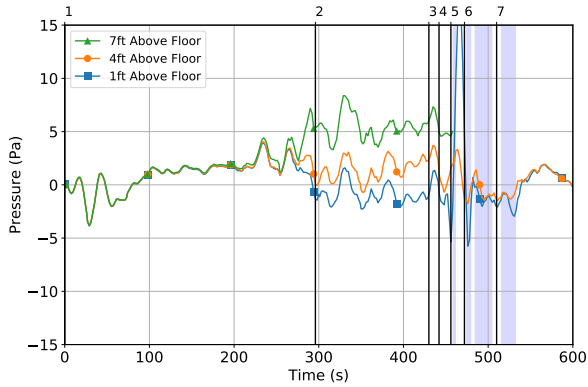
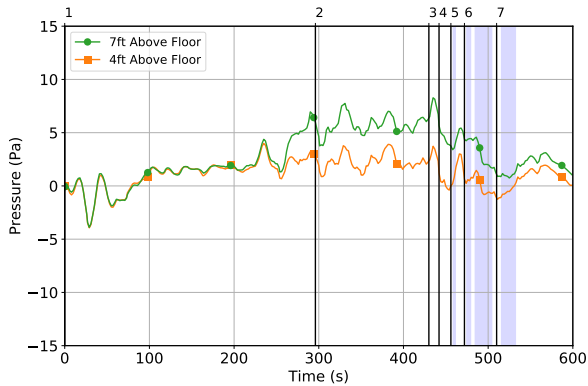
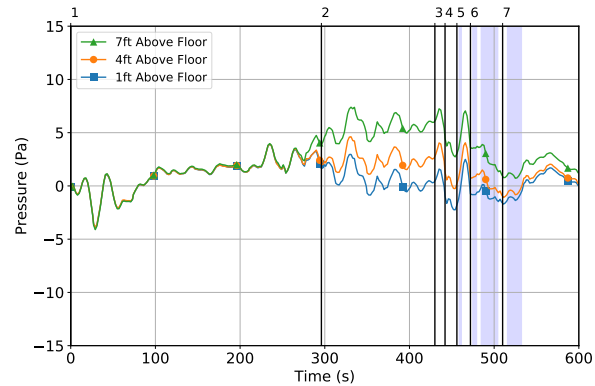
Figure 3.82 shows the pressure in the hallway outside the fire room (see Figure 3.82a), in the hallway outside bedroom 1 (see Figure 3.82b), and in bedroom 1 (see Figure 3.82c) for Experiment 7. At each of these locations, the pressures were least close to the floor and greatest at the ceiling. Large pressures indicated hot gases were filling the area near the ceiling. Small pressures indicated fresh air was being entrained out of remote rooms toward the fire room. Because the fire was the source of the pressure increase within the structure, the magnitude of pressure increase decreased with distance from the fire room.

(a) Hallway Pressure

(b) Hallway Pressure Outside Bedroom 1

(c) Bedroom 1 Pressure

Figure 3.82: Pressures remote from fire room for Experiment 7. Blue vertical bars indicate time and duration of water flow.

when the vertical vent hole was completed and the initial suppression. The increase in flow into the fire room was indicated by the lower fire room pressure compared to the hallway at the 1 ft and 4 ft levels and the decreased gradient at the 7 ft level (see Figure 3.82b). Note: That the short duration spike in pressure at the 1 ft level following the water flow from the stairs is likely from the hose stream hitting the pressure measurement probe.

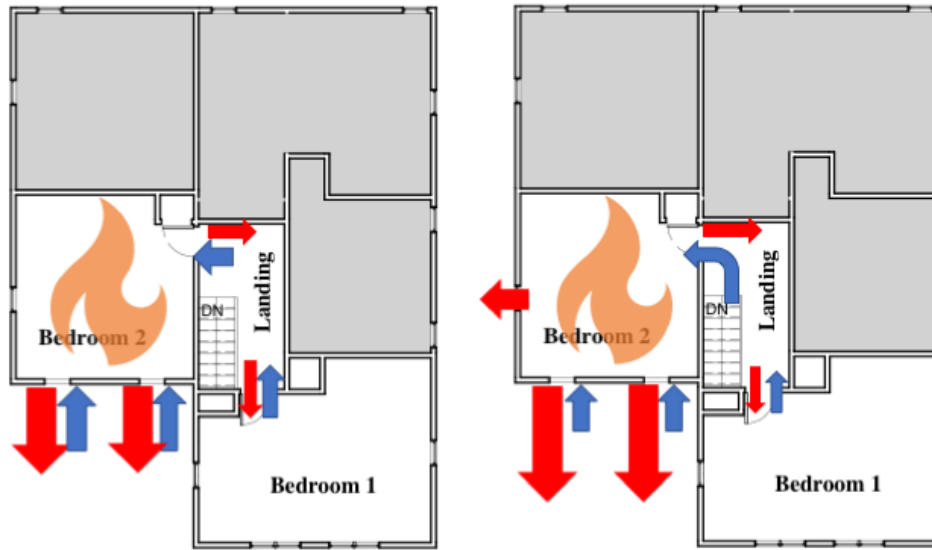
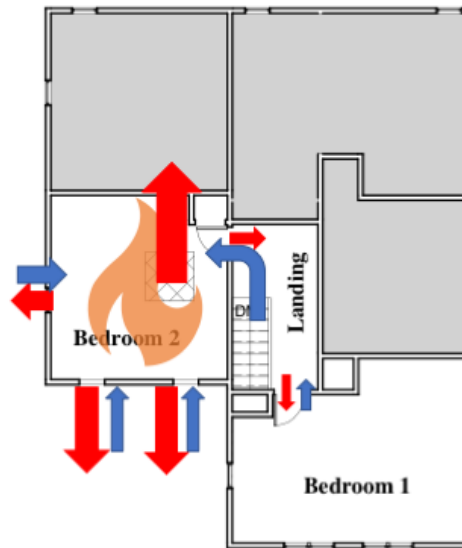
The pressure differences between the fire room and the hallway are useful for describing the changes in gas flow over the course of Experiment 7. Prior to fire department intervention, the 1 ft fire room pressure was less than the 1 ft pressure in the hallway. Similarly, the 7 ft pressure in the fire room was greater than the 7 ft pressure in the hallway outside the fire room. These pressure gradients reflect an exchange of cool air into the fire room through the bottom of the doorway and hot gases out of the fire room through the top of the doorway. The flows prior to fire department intervention are illustrated in Figure 3.83a.

(a) Prior to Front Door Opened

(b) After Front Door Opened

(c) After Vertical Ventilation

Figure 3.83: Changes in flows for Experiment 7 as function of firefighter ventilation. Red arrows indicate the flow of combustion products, blue arrows indicate the flow of fresh air, and the sizes of the arrows indicate the relative magnitude of the flow.

The opening of the front door at 430 s post ignition allowed for additional entrainment of fresh air into the fire room as depicted in Figure 3.83b. When the vertical vent was completed, there was more surface area available for exhaust in the fire room. This provided an additional low-pressure exhaust pathway as shown in Figure 3.83c. Hot gases were able to exhaust from the vertical vent hole and the fire room doorway and windows.

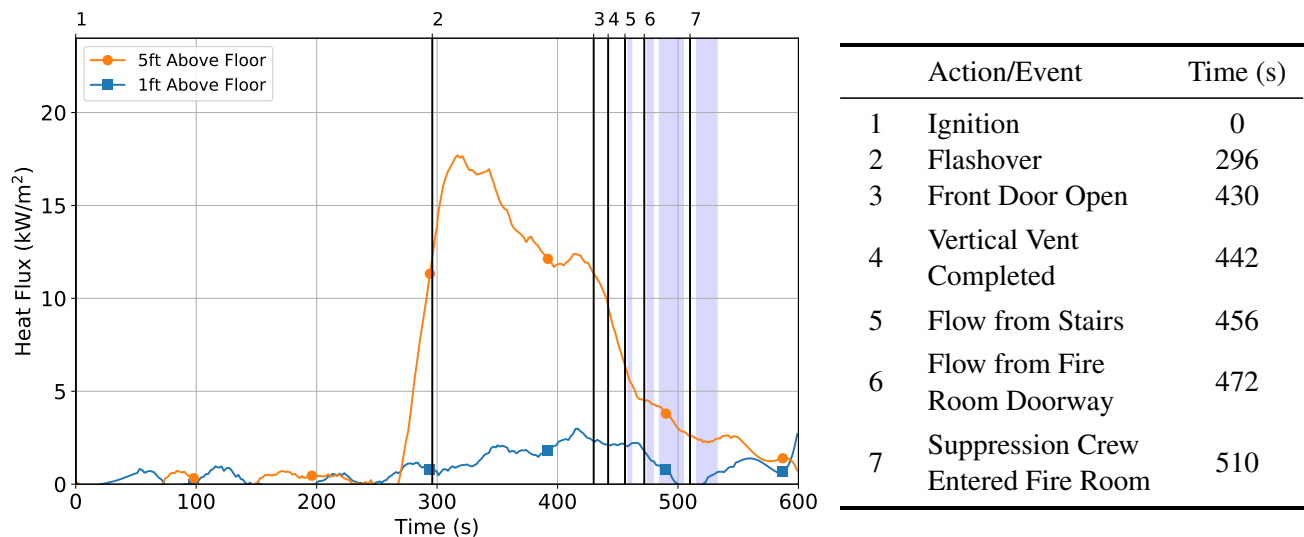
Heat flux was measured at 1 ft and 5 ft above the floor in the bedroom 1 doorway and 1 ft over the floor in bedroom 1. Figure 3.84 shows the heat flux in the doorway of bedroom 1. The ventilation sequence resulted in a decrease in heat flux at the 1 ft elevation in the doorway from 3.5 kW/m² to 1.0 kW/m². The initial suppression in the stairway further decreased the heat flux from 1.0 kW/m² to 0.5 kW/m² at the 1 ft level. Similarly, at the 5 ft level in the doorway, the heat flux decreased from 12 kW/m² to 6 kW/m². Water application further decreased the heat flux from 6 kW/m² to 3 kW/m². Note: Heat flux in the remote bedroom remained negligible during the experiment.

Figure 3.84: Heat flux in the doorway of bedroom 1 for Experiment 7. Blue vertical bars indicate time and duration of water flow.

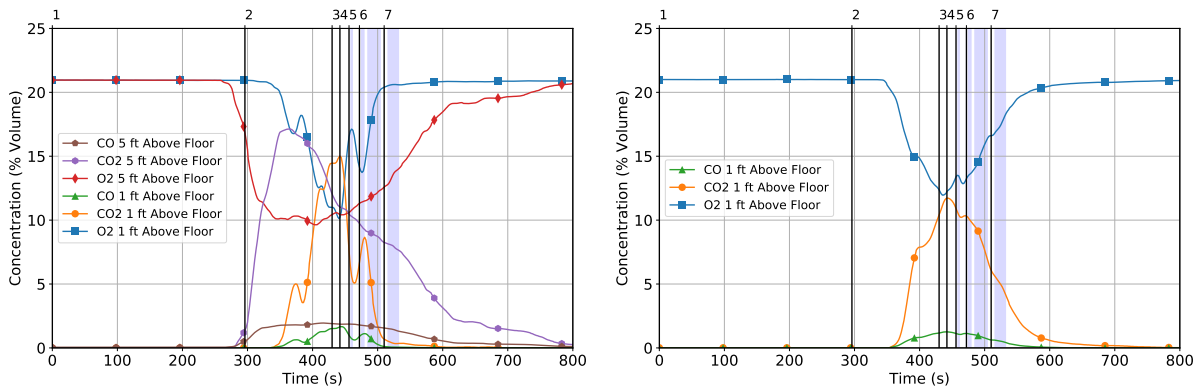
Figure 3.85 shows the gas concentrations (CO, CO₂, and O₂) measured at 1 ft and 5 ft above the floor in the doorway to bedroom 1 and 1 ft above the floor in bedroom 1. The highest CO and CO₂ concentrations and lowest O₂ concentration of the three locations were measured at the 5 ft location in the doorway (see Figure 3.85a). O₂ concentrations first decreased and CO and CO₂ concentrations correspondingly increased approximately 260 s post ignition. By the time the front door was opened, the O₂ concentration was 10.5%, the CO₂ concentration was 11%, and the CO concentration was 1.9%. The peak CO₂ concentration (17%) and CO concentration (2.0%) both occurred prior to firefighter intervention. The ventilation and suppression actions did not have an immediate effect on the gas concentrations, although the gases began to trend to ambient after the front door was opened. Gas concentrations at the 5 ft level returned to approximately pre-ignition conditions within 450 s of the front door opening.

The gas concentrations at the 1 ft location in the doorway first began to change approximately 300 s post ignition, as the fire room transitioned through flashover. At the time the front door was opened, the gas concentrations were 11% for O₂, 14.5% for CO₂, and 1.5% for CO. The O₂ concentration continued to decrease and CO and CO₂ concentrations continued to increase following the front door being opened and reached their peak hazard levels—minimum O₂ and peak CO and CO₂. As the vertical vent was completed, O₂ began to increase while CO₂ and CO decreased. This trend continued through suppression from the stairs, but when water flow from the stairs stopped, the trend in gas concentrations changed. The O₂ began to drop and CO and CO₂ increased as combustion gases flowed from the fire room. After suppression began at the fire room doorway, the gas concentrations returned to pre-ignition conditions.

(a) Bedroom 1 Doorway Gas Concentrations

(b) Bedroom 1 Gas Concentrations

Figure 3.85: Gas concentrations for remote locations in Experiment 7. Blue vertical bars indicate time and duration of water flow.

The 1 ft gas concentrations in the center of the remote room followed a similar trend to the 1 ft gas concentrations in the doorway of that room (see Figure 3.85b). Gas concentrations at the 1 ft level in the remote room first begin to change 300 s post ignition, and, similar to the gas concentrations at 1 ft in the doorway, the hazard decreased shortly after fire department intervention when the O₂ concentration was 12%, the CO₂ concentration was 11.6%, and the CO concentration was 1.2%. Though not as significant, there was a slight increase in hazard following water flow from the stairwell and prior to flow from the doorway. After flow from the doorway, conditions returned to pre-ignition conditions.

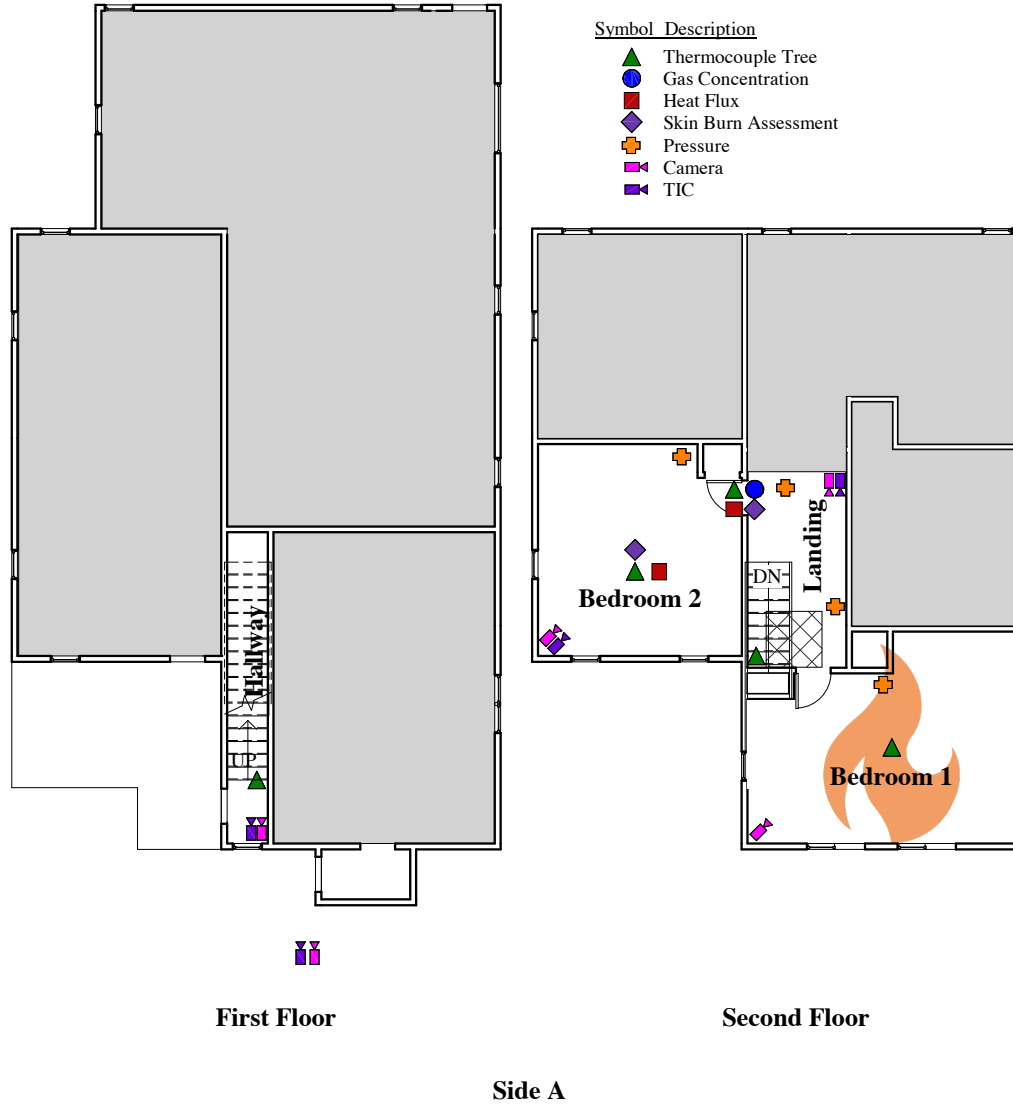
accounting for 584 sq ft, define the experimental volume of the structure. All other spaces within the structure were isolated from the experimental volume and used to protect instrumentation. The experimental volume was instrumented for temperature, pressure, heat flux, gas concentrations, IR, and standard video to document the fire dynamics and occupant exposure during the experiment. Figure 3.87 shows the layout of the second-floor with the instrumentation locations.

Figure 3.87: Instrumentation and floor plan for Experiment 8. The gray areas were isolated from the remainder of the structure and utilized as space for instrumentation. The cross-hatched area indicates the size and location of the vertical vent. Not shown on this plan was an additional thermocouple array located in the attic.

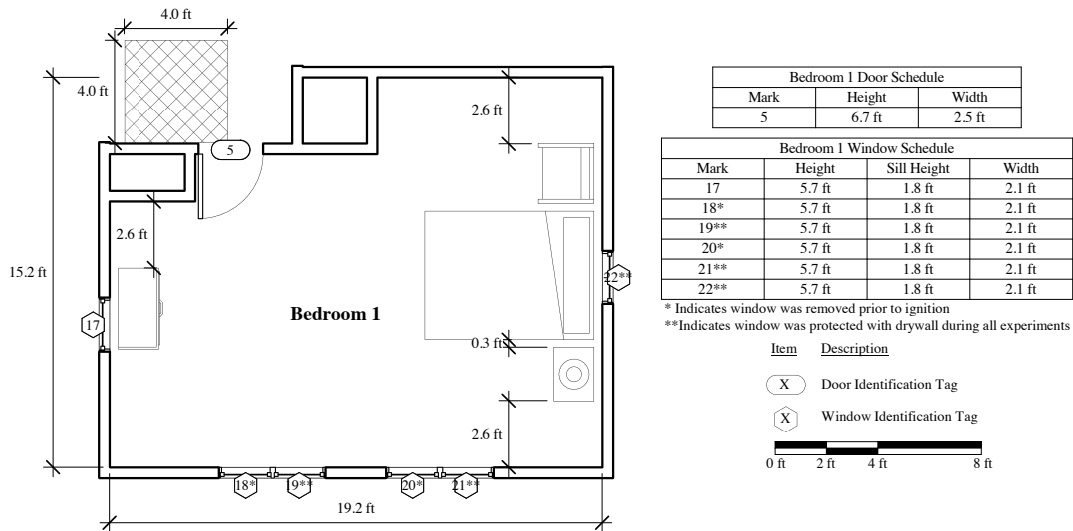
Figure 3.89: Fire room layout for Experiment 8. The cross-hatched area indicates the size and location of the vertical vent.

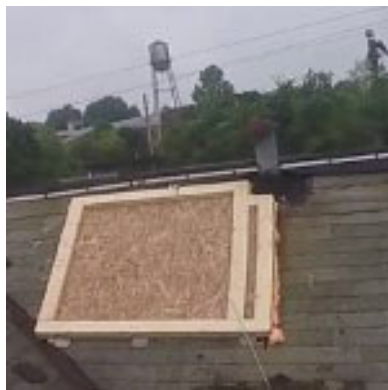
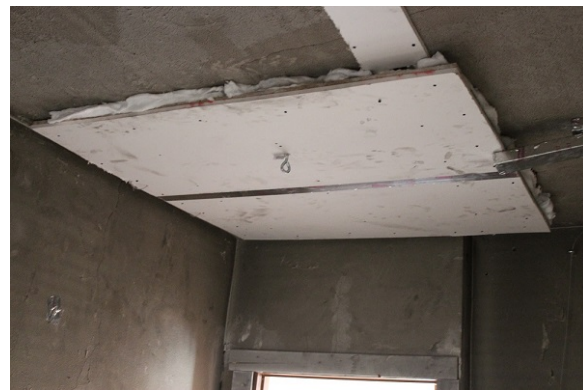
A 4 ft-by-4 ft roof hole and ceiling hole located over the hallway were cut prior to ignition. The roof hole was covered by plywood and sealed to prevent leakage. The ceiling hole was covered with half-inch gypsum board. Ventilation occurred by first removing the plywood to expose the precut roof hole, simulating a crew cutting a ventilation hole. Immediately following, the interior gypsum was released to expose the precut ceiling hole, simulating a crew removing the compartment ceiling materials. Figure 3.90 shows the covered precut roof opening and the hinged ceiling below.

(a) Roof Vent

(b) Interior Ceiling

Figure 3.90: Vertical ventilation openings for Experiment 8.

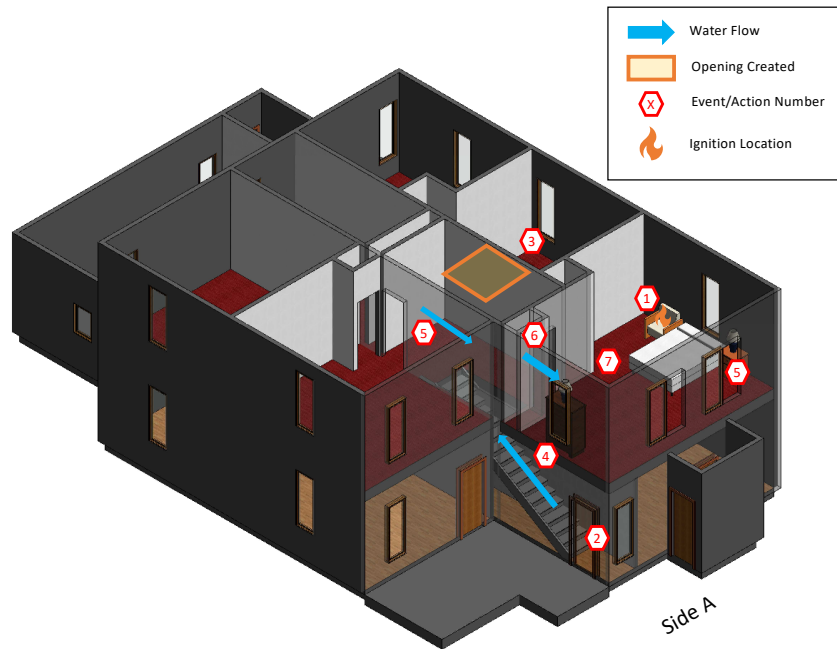
The total time from the fire department opening the front door open to the fire room entrance was 84 s (1:24). The total water used for initial suppression was 120 gal. This does not include the water flowed during mop-up operations. Figure 3.91 shows the sequence of events with an isometric image of the structure.

Action/Event	Time (mm:ss)	Time (s)
1 Ignition	00:00	0
2 Front Door Open	07:30	450
3 Vertical Vent Completed	07:42	462
4 Flow from Stairs	07:54	474
5 Flashover & Flow from Landing	08:11	491
6 Flow from Doorway	08:30	510
7 Suppression Crew Entered Fire Room	08:56	526

Figure 3.91: Time and sequence of actions and events for Experiment 8. Note: That there are two icons for Event 5. Event 5 at the top of stairs indicates the flow from the landing while Event 5 at the window indicates flashover.
