Analysis of the Coordination of Suppression and Ventilation in Single-Family Homes

John Regan
Julie Bryant
Craig Weinschenk

UL Firefighter Safety Research Institute
Columbia, MD 20145

March 19, 2020

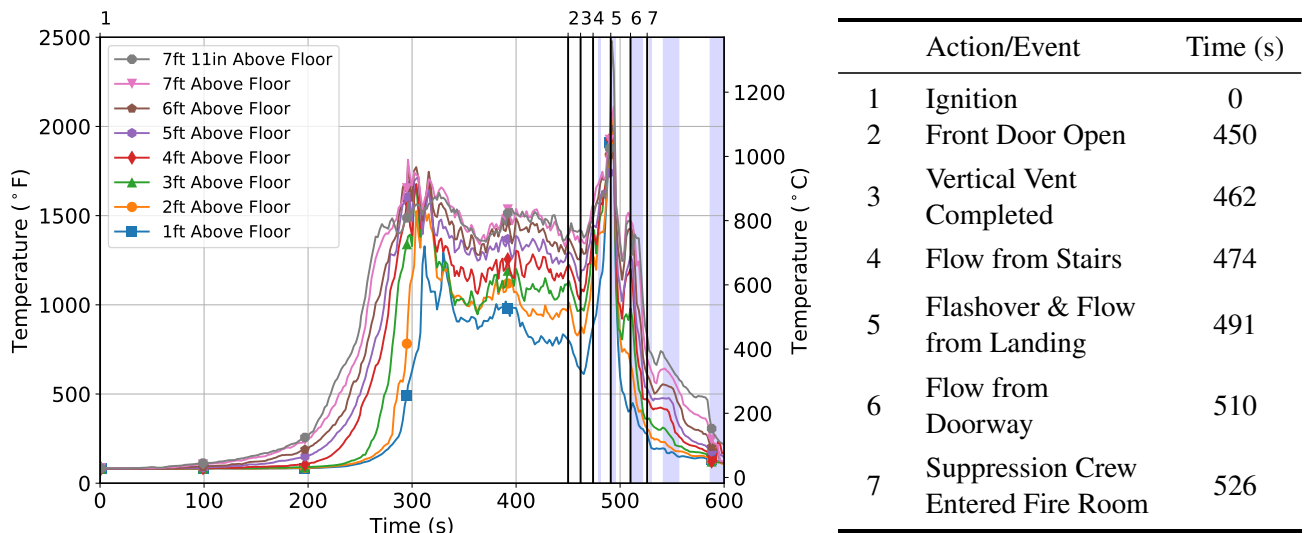
Figure 3.92 shows the time history of the temperature variations in the fire room. Prior to firefighter intervention, temperatures exceeded 1100 °F at approximately 310 s post ignition. Temperature remained stratified through the start of firefighter actions. The front door was opened 450 s post ignition and the landing vertical vent was completed 12 s later. The change in ventilation led to an increase in fire room temperatures that peaked as the fire room transitioned to flashover at 492 s, 40 s after the front door was opened and 30 s after the vertical vent was completed. Water application from the stairway (Event 4) did not have a major impact on the temperatures in the fire room because the water application was directed to flames above the crew. Water application from the top of the landing, which was applied as the room transitioned to flashover (Events 5), led to an initial decrease in fire room temperatures, but without direct suppression the fire began to regrow after the flow stopped. Suppression from the fire room doorway (Event 6) and within the fire room

itself resulted in a permanent decrease in temperatures.

Figure 3.92: Fire room (bedroom 1) temperatures for Experiment 8. Blue vertical bars indicate time and duration of water flow.

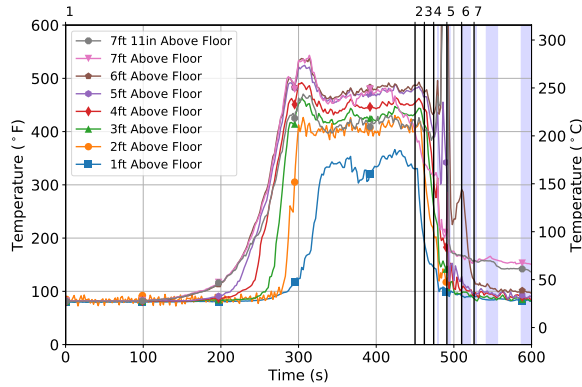
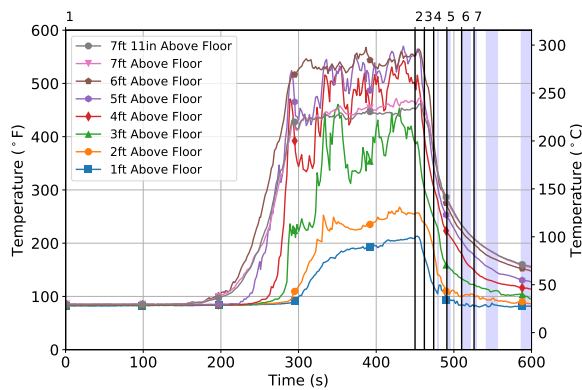
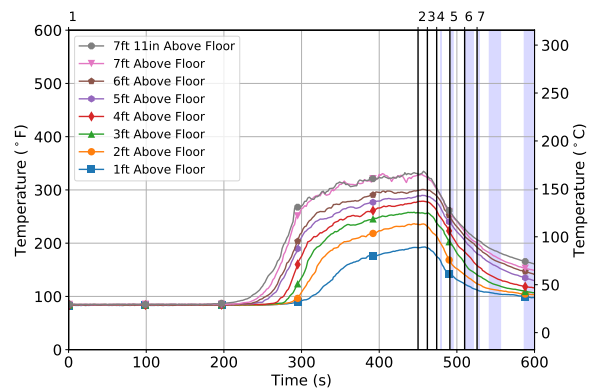
After the hallway vent was completed, fire was visible on the landing as hot gases exiting the fire room were able to mix with fresh air that entered from the open front door and ignite. This resulted in an increase in landing thermocouple temperatures close to the ceiling, as shown in Figure 3.93a. The 6 ft and 8 ft temperatures in the landing increased from approximately 450 °F to 640 °F and 830 °F, respectively. Note: That the 7 ft thermocouple began to drop around 425 s while the remainder of the thermocouples measurements did not decrease. It is believed that the 7 ft thermocouple bead made contact with the stairwell wall and no longer measured gas temperature. The landing suppression action, which occurred 36 s after the front door was opened, was effective at reducing the temperatures close to the ceiling.

(a) Landing Temperatures

(b) Bedroom 2 Doorway Temperatures

(c) Bedroom 2 Temperatures

Figure 3.93: Temperatures remote from the fire room for Experiment 8. Blue vertical bars indicate time and duration of water flow.

At the bedroom 2 doorway (see Figure 3.93b) and at the center of bedroom 2 (see Figure 3.93c), temperatures began to decline at all elevations after the front door and the vertical vent were opened. The vertical vent was positioned between the fire room and bedroom 1. The distance of bedroom 1 from the fire room and the coordinated suppression that occurred as fire began to extend to the hallway prevented a rise in temperature at the remote locations despite the rise in fire room temperatures.

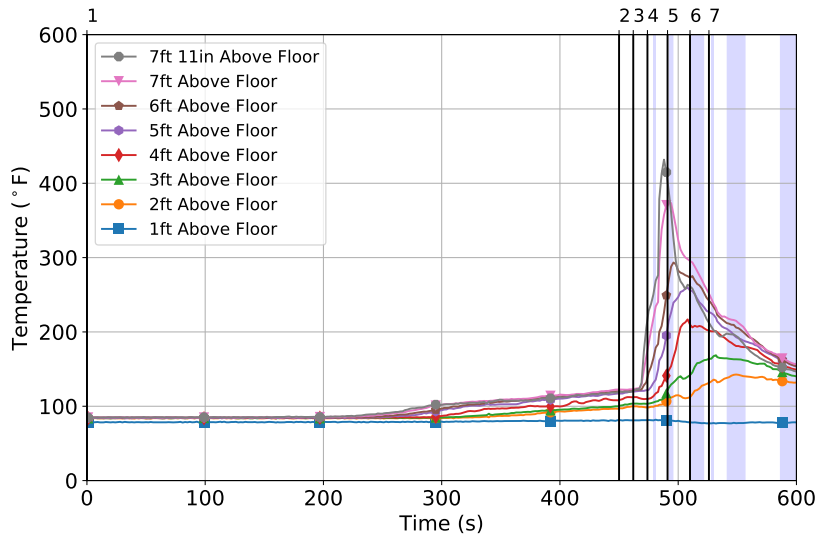
A thermocouple array was also installed in the attic space to quantify the impact of the vertical ventilation. Temperatures increased following the completion of the vent opening (see Figure 3.94) and peaked to approximately 430 °F. Attic temperatures began to decrease after the suppression crew flowed water from the landing, and continued to decrease as they advanced to the fire room doorway and continued suppression.

Figure 3.94: Attic temperatures for Experiment 8. Blue vertical bars indicate time and duration of water flow.

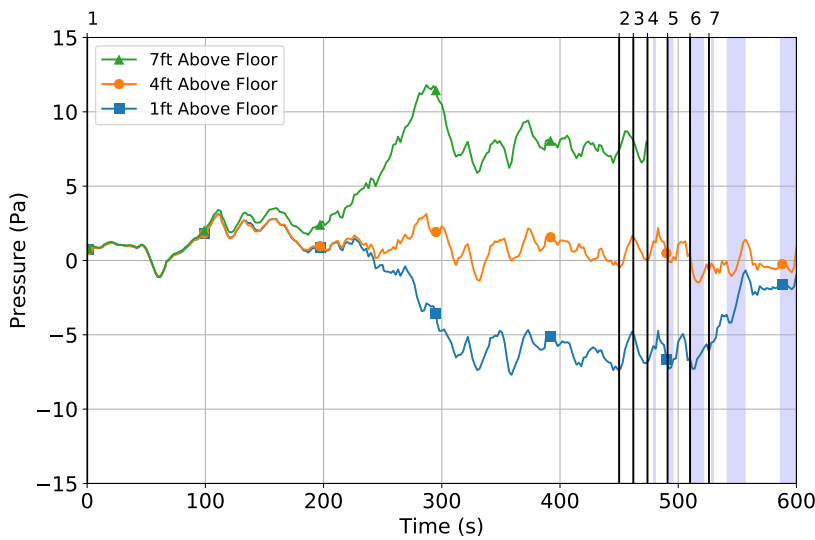
Figure 3.95 shows the pressure in the fire room during Experiment 8. In the period prior to the front door being opened, when the fire room temperatures had reached steady state, the 7 ft pressure measured 8 Pa above ambient. This is an indication gases at that elevation were exhausting from the fire room. At 4 ft above the floor, the pressure fluctuated around 0 Pa, an indication of neutral or no flow. The pressure at the 1 ft elevation was negative, an indication of an intake for fresh air low into the fire room. The vertical ventilation remote from the fire compartment did not impact the local pressure. Pressures did not return to ambient until the fire was suppressed.

Figure 3.95: Changes in pressure in fire room (bedroom 1) for Experiment 8. Blue vertical bars indicate time and duration of water flow.

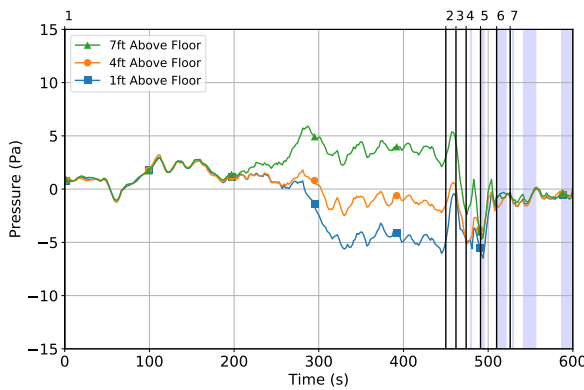
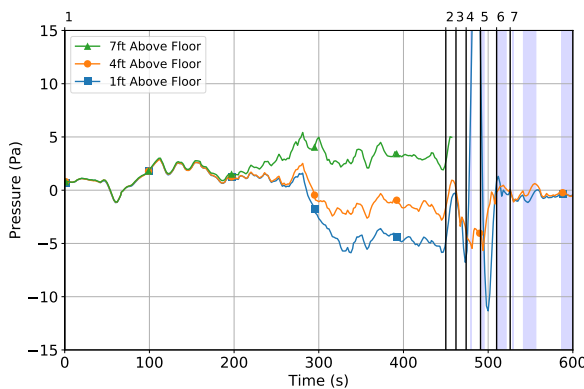
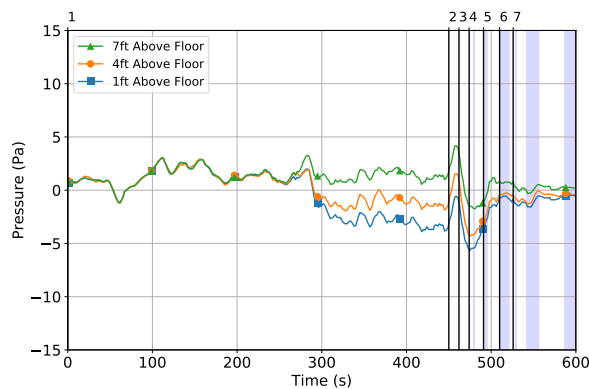
Prior to ventilation, the hallway and bedroom 2 pressures were similar to the fire room. During the growth phase of the fire (approximately the first 200 s), the pressure did not vary as a function of elevation as all three elevations increased above ambient. At 200 s post ignition, when temperature rises were noticeable in the remote space, the 7 ft elevations continued to increase as the hot gases filled the second-floor. Pressure at the 4 ft and 1 ft elevations began to decrease—in all three locations the pressure dropped below ambient—as air was drawn toward the fire. After the front door was opened, all pressures remote from the fire room rose as a low-pressure inlet was created. At 462 s post ignition, when the vertical vent was created, all pressures in Figure 3.95 decreased. The vertical vent provided an exhaust path for the high-temperature, high-pressure fire gases to exhaust the structure. Following suppression from the fire room doorway, all pressures returned to ambient.

Figure 3.96: Pressures in hallway outside fire room (see Figure 3.96a), in hallway outside bedroom 1 (see Figure 3.96b), and in bedroom 1 (see Figure 3.96c) for Experiment 8, with vertical ventilation above the hallway. Blue vertical bars indicate time and duration of water flow.

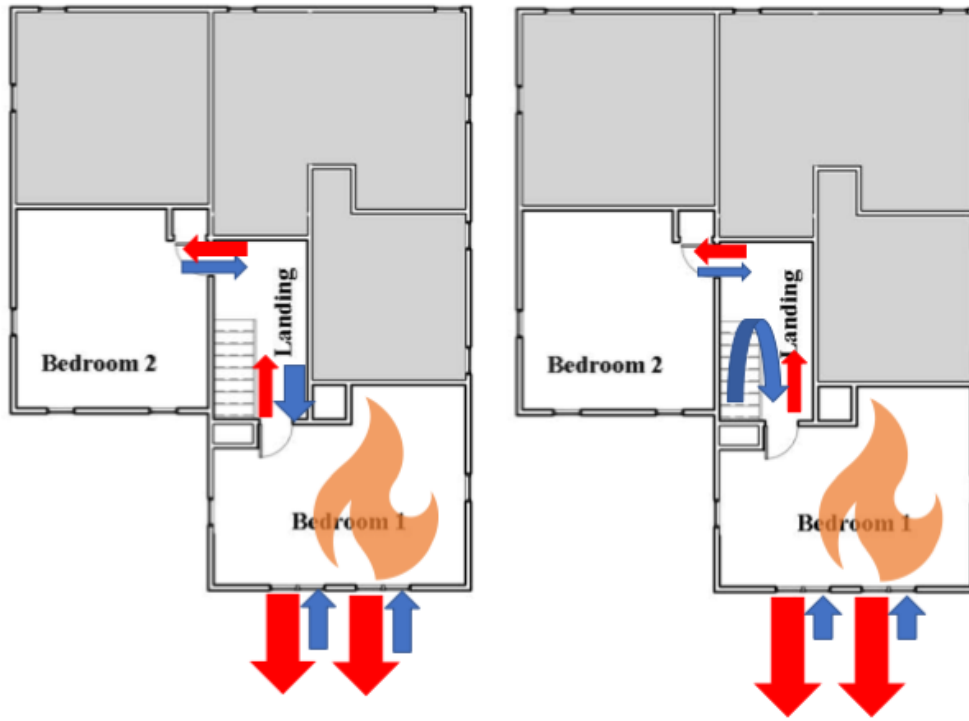
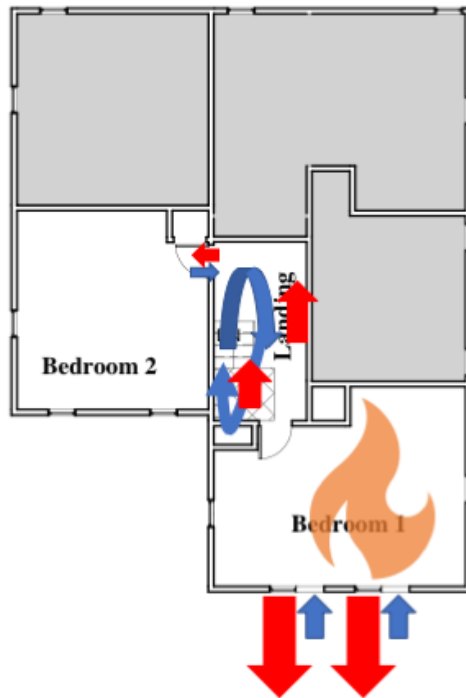
Bi-directional flows were initially established through open fire room windows and at the fire room doorway. Prior to the front door being opened (see Figure 3.97a), the fire room doorway flow became less efficient as the structure filled with smoke and the fresh air became depleted. The open front door at 450 s post ignition allowed for the entrainment for more fresh air into the fire

room than was possible with the door closed. This changed the flow; a flow path was established between the open front door and fire room. This change is shown in Figure 3.97b. The open front door allowed for more air to flow through the fire room door, therefore the fire room windows became a more efficient exhaust.

Figure 3.97: Changes in flows for Experiment 8 as function of firefighter ventilation. Red arrows indicate the flow of combustion products, blue arrows indicate the flow of fresh air, and the sizes of the arrows indicate the relative magnitude of the flow.

When the vertical vent was opened (see Figure 3.97c), products of combustion were exhausted from the fire room through both the windows and the top half of the fire room doorway. The intake and exhaust openings that had the potential to be the most efficient vents were offset from the fire room, and therefore less efficient. The fire room doorway became the restriction point for the amount of flow able to enter and leave the fire room.

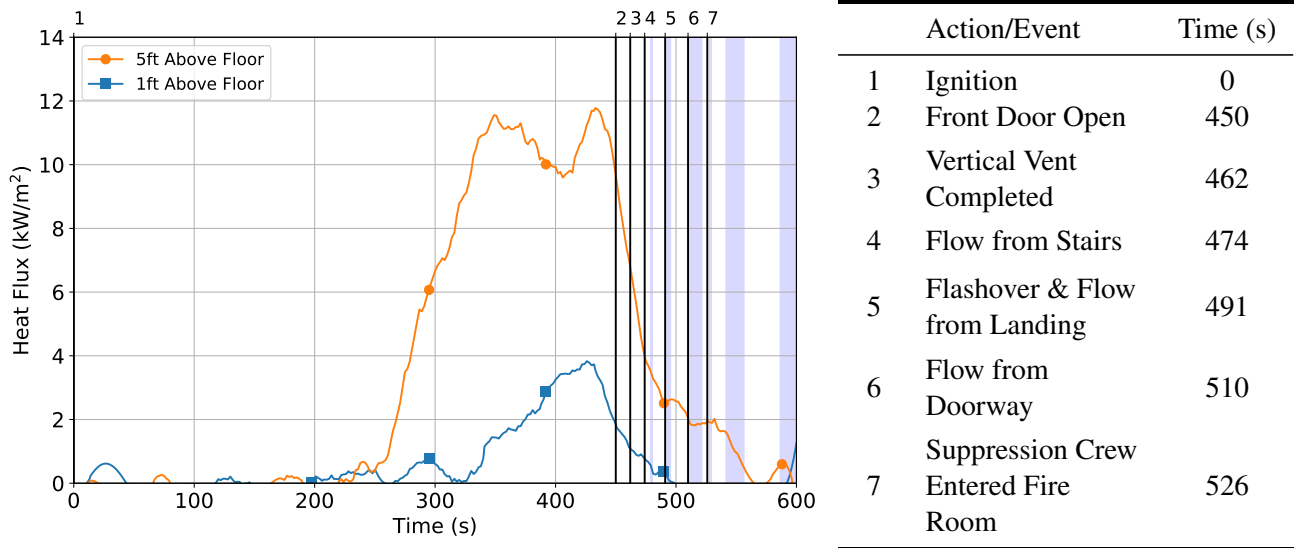
Heat flux locations for Experiment 8 were located 1 ft above the floor and 5 ft above the floor in the doorway of bedroom 2 and 1 ft above the floor in the center of bedroom 2. The heat flux measurements for the doorway location followed a similar trend to the temperatures at that location. Prior to the front door opening, the peak heat flux at each elevation was 12.0 kW/m² and 4.0 kW/m², respectively. The removal of combustion products from the fire floor following ventilation led the heat flux at both elevations to decline to 4.0 kW/m² and 1.1 kW/m² at the 5 ft and 1 ft. Suppression further reduced the heat flux to less than 1 kW/m² at both elevations within approximately 100 s of firefighter intervention. Note: The heat flux gauge in bedroom 2 remained negligible for the duration of experiment.

Figure 3.98: Changes in heat flux in bedroom 2 for Experiment 8. Blue vertical bars indicate time and duration of water flow.

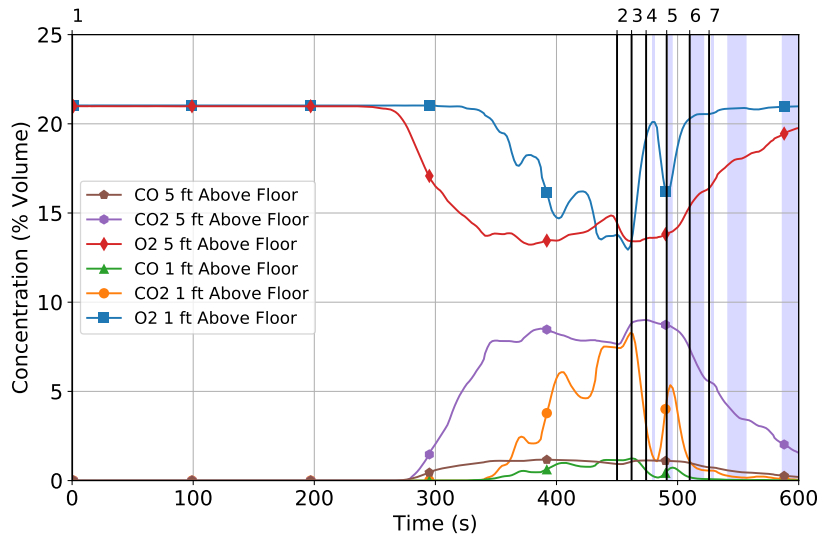
The 5 ft gas location at the bedroom 2 doorway first showed signs of CO and CO₂ concentration increase and O₂ concentration depletion 240 s post ignition. The O₂ concentration dropped to 13%, below the 15% level where combustion could be supported. The 1 ft elevation lagged in response, dropping at approximately 300 s post ignition, because it took longer for the smoke layer to descend. Post vertical ventilation and water flow from the stairs, the the 1 ft elevation recovered back to 20% O₂ concentration. Following the initial water flow, the O₂ concentration dropped along with a corresponding rise in CO and CO₂ concentration as the fire room transitioned to flashover and combustion gases flowed from the fire room. Following suppression from the fire doorway, gases at both elevations began to recover to pre-ignition conditions.

Figure 3.99: Gas concentrations for bedroom 2 doorway location for Experiment 8. Blue vertical bars indicate time and duration of water flow.

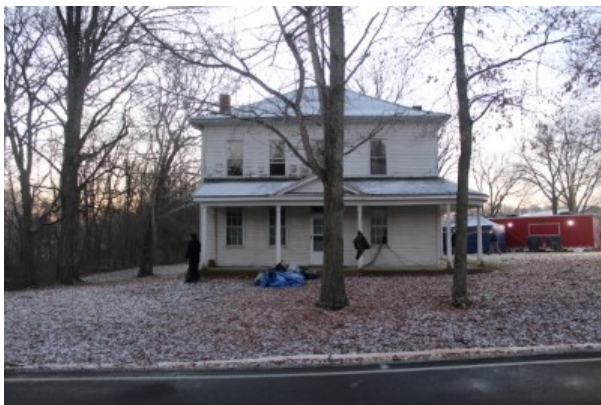
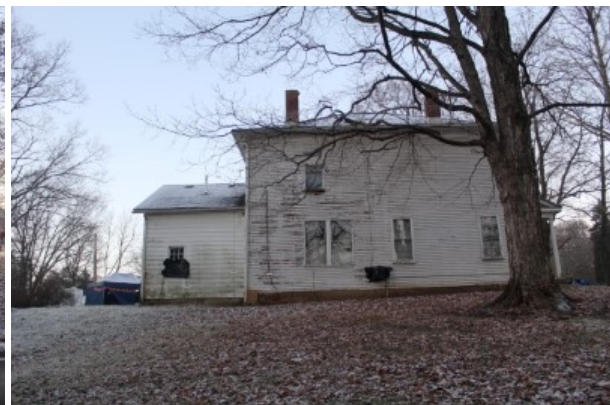
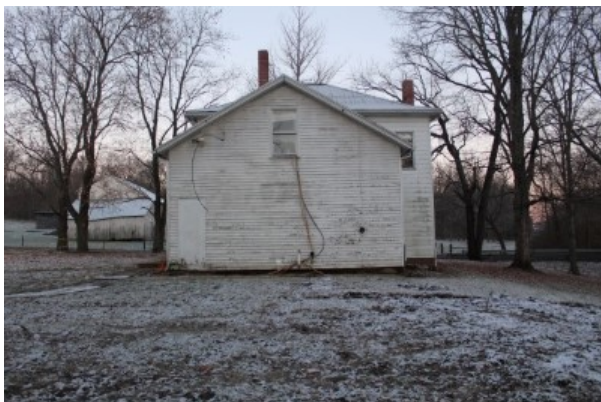
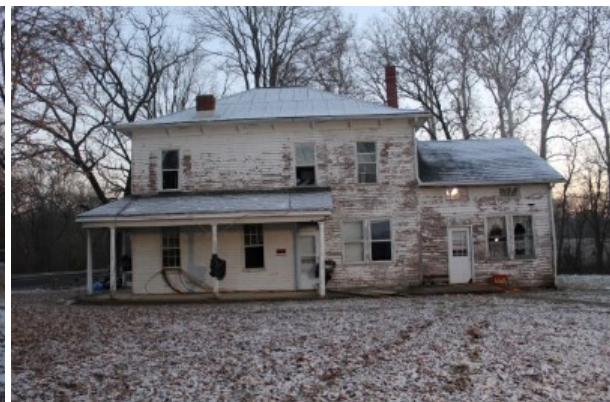
Figure 3.100: Exterior photographs of the structure for Experiment 9.

Experiment 9 was designed to evaluate the effect of positive pressure ventilation and interior suppression when coordinated simultaneously. Positive pressure ventilation occurred on side A at the front door. At 1030 Hilltop Road in Xenia, Ohio, a two-story, 2,200 sq ft wood frame structure was instrumented to conduct this second-floor bedroom fire experiment. The four exterior sides of the structure appear in Figure 3.100. The structure was stick-built with rough cut lumber framing with wood-slat siding. The foundation was a combination of block and stone. The original house had a hip-style tin roof supported by wood members and the rear addition had a peaked roof constructed using 1 in.-by-6 in. sheathing covered with asphalt shingles. Interior walls in the original house were finished with plaster and lath while the addition was finished with gypsum board. Interior floor coverings included vinyl tile in the kitchen, wood in the dining room, and carpet in all other areas. Detailed dimensioned drawings for the first and second story appear in Appendix Figures B.12 and B.13, respectively.

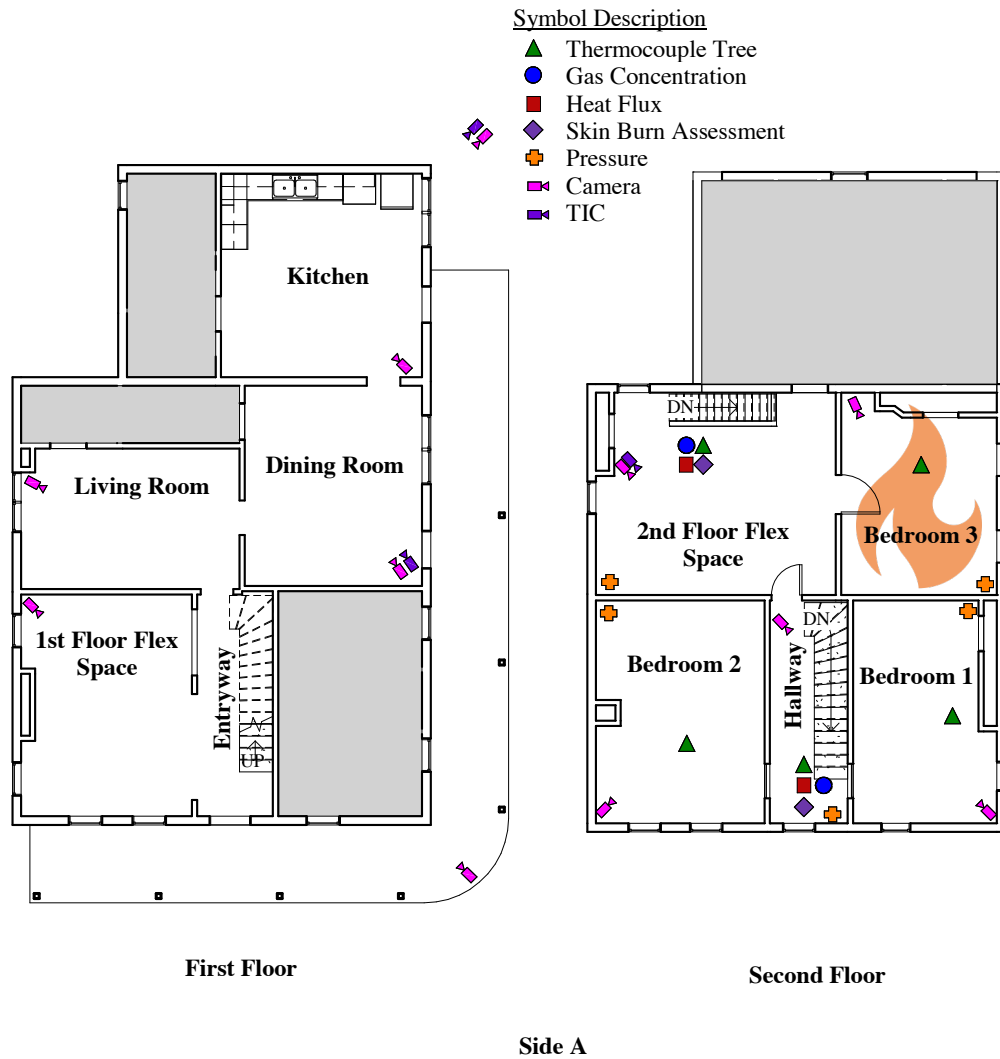
The first-floor had a kitchen, dining room, family room, and flex space. The second-floor had three bedrooms and a flex space. A stairwell located on side A connected the two floors. These areas defined the experimental volume of the structure. The spaces located on the first-floor in the A/D corner and on the second-floor along side D were isolated from the experimental volume and utilized as instrumentation space. The structure was instrumented for temperature, pressure, heat flux, IR, and standard video to capture the fire dynamics during experimentation. Instrumentation was also installed to characterize the potential for skin burns and occupant toxic exposure during the experiment. Figure 3.101 shows the layout of the second-floor with the instrumentation locations.

Figure 3.101: Instrumentation and floor plan for Experiment 9. The gray areas were isolated from the remainder of the structure and utilized as space for instrumentation.

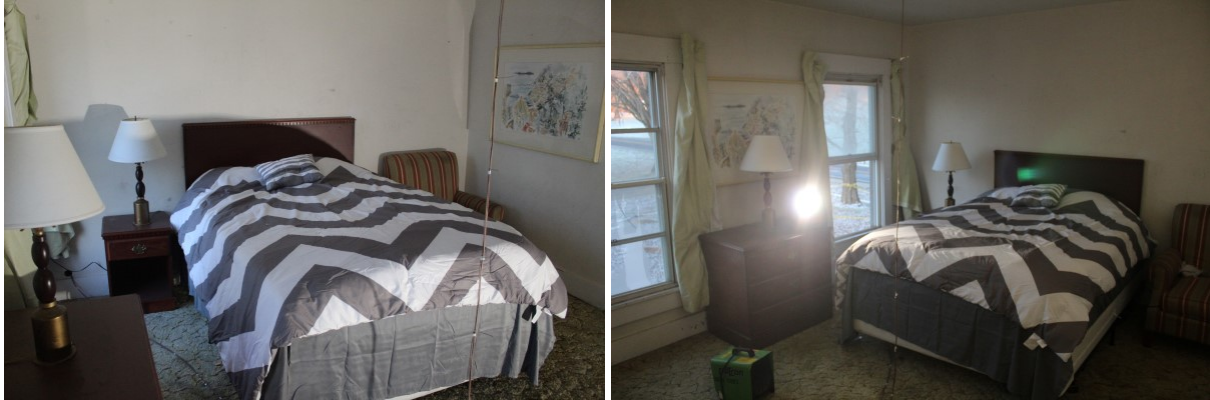
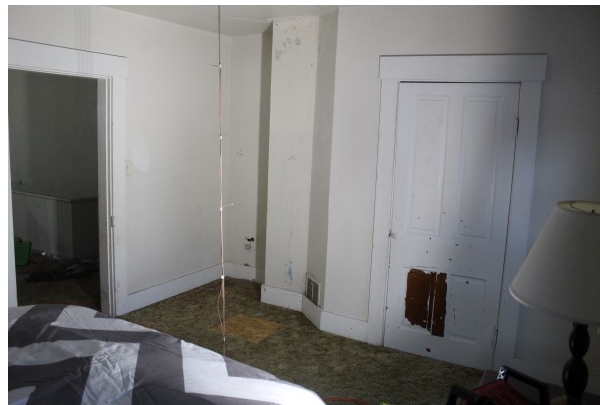
Figure 3.102: Interior photographs of the fire room for Experiment 9.

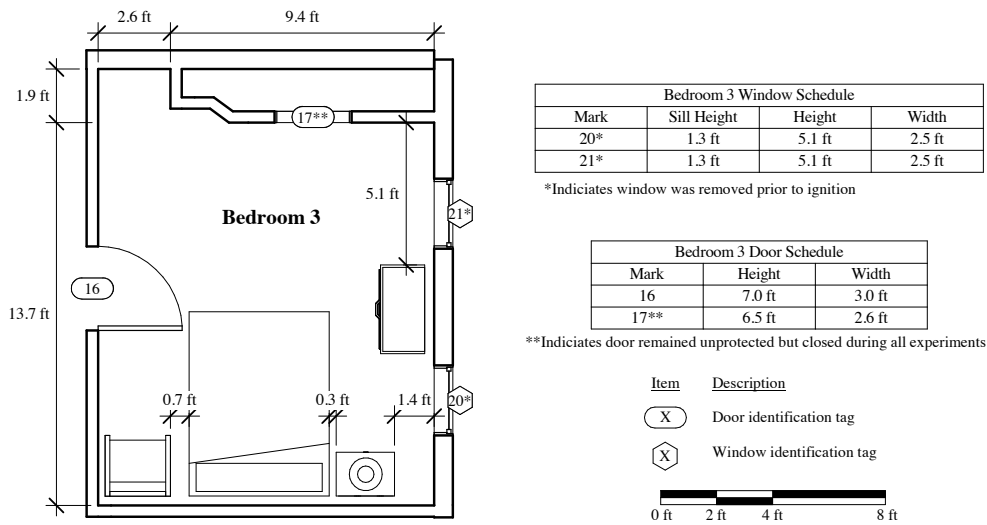
of the fire room is included in Figure 3.102. To replicate a similar volume of space found in other experiments, bedroom 1 and bedroom 2 remained closed throughout the experiment. To allow for repeatable fire growth, the windows labeled 20 and 21 in Figure 3.103 were removed prior to ignition.

Figure 3.103: Fire room layout for Experiment 9.

The fire was ignited in the upholstered chair. Flames were first visible from window 20 (in Figure 3.103) 212 s (3:32) post ignition. Flames were visible in both windows (labeled 20 and 21 in Figure 3.103) 225 s (3:45) post ignition. Bedroom 3 reached flashover at 240 s (4:00) post ignition. The fire transitioned to a post-flashover state with fire venting from both open windows before fire department interventions occurred.

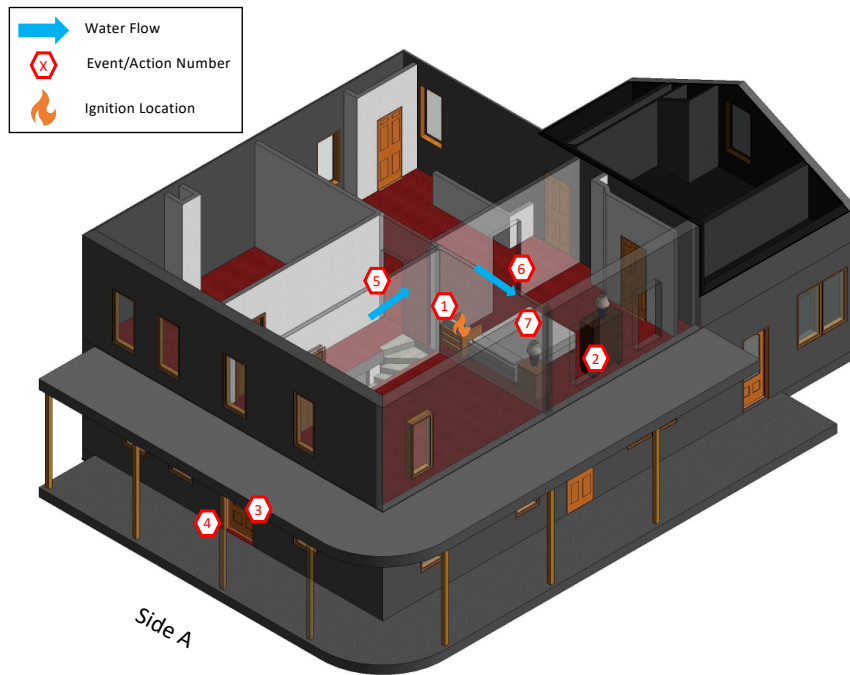
The front door was opened at 390 s (6:30) post ignition. The fan was started prior to the door opening and turned into position approximately 10 s after the door was opened². After a flow path through the structure was established approximately 405 s (6:45) post ignition, the suppression crew entered through the front door. The suppression crew advanced a 1.75 in. hoseline with a combination nozzle set to straight stream up the stairs. The suppression crew reached the top of the stairs and flowed water toward the fire room at 435 s (7:15) post ignition for a duration of 6 s. This initial water application was directed across the flex space, toward the instrumentation room. The crew advanced to the fire room doorway with the bale cracked, flowing water for 9 s. The crew reached the fire room doorway 450 s (7:30) post ignition and fully opened the nozzle to flow water a second time at 455 s (7:35) post ignition for 15 s. Once the nozzle firefighter determined the fire room was cooled sufficiently to enter, the suppression crew entered for final suppression 527 s (8:47) post ignition. The crew applied water to the fire two additional times for 13 s and 15 s in duration, respectively. The entire tactic from front door open to occupying the fire room was 133 s (2:13). The total amount of water flowed for initial suppression was 109 gal, which does not include water flowed during mop-up operations. Figure 3.104 shows the sequence of events with an isometric image of the structure.

Action/Event	Time (mm:ss)	Time (s)
1 Ignition	00:00	0
2 Flashover	04:00	240
3 Front Door Open	06:30	390
4 PPV Fan Turned In	06:41	401
5 Flow from Top of Stairs	07:15	435
6 Flow from Doorway	07:35	455
7 Suppression Crew Entered Fire Room	08:47	527

Figure 3.104: Time and sequence of actions and events for Experiment 9.

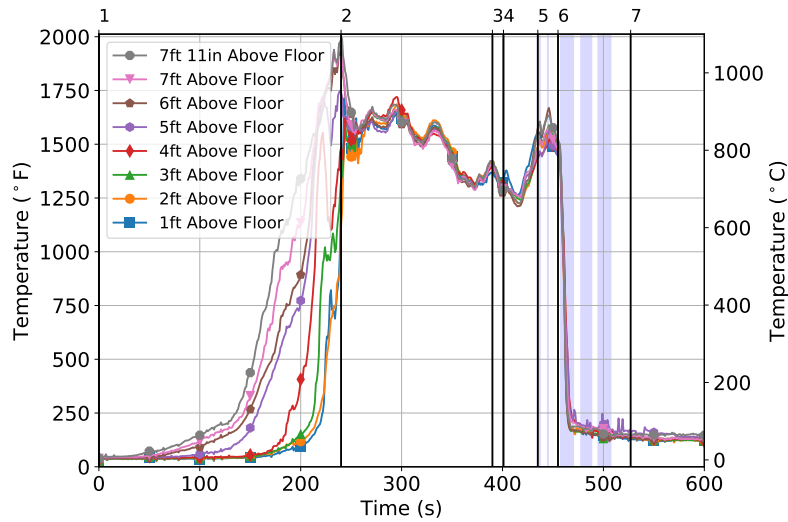
The fire room temperatures are shown in Figure 3.105. The room transitioned to flashover approximately 240 s post ignition, when the temperature close to the floor exceeded 1100 °F. After the front door was opened and the positive pressure fan was turned in, temperatures within the fire room increased for 30 s, prior to final suppression in the fire room.

Figure 3.105: Fire room (bedroom 3) temperatures for Experiment 9. Blue vertical bars indicate time and duration of water flow.

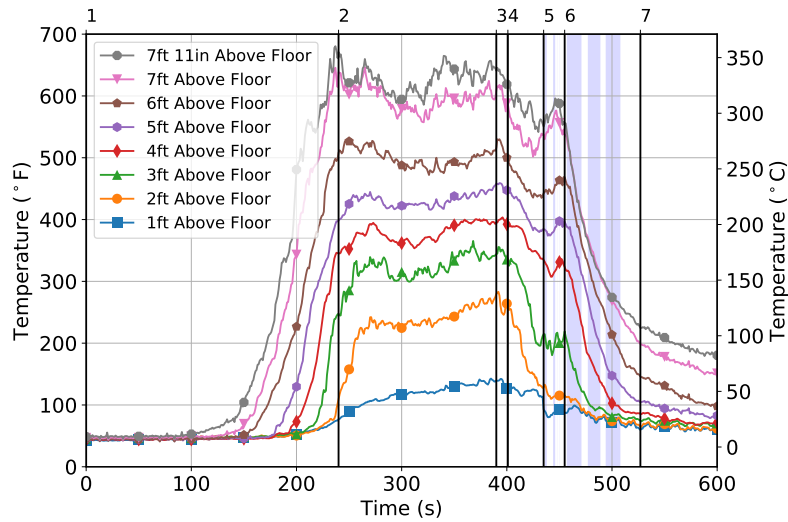
At the time the front door was opened, the temperatures in the flex space were steady or gradually increasing, and were stratified as shown in Figure 3.106. When the front door was opened, the temperatures close to the ceiling ranged between 600 °F and 650 °F, the 2 ft temperature was 275 °F, and the 1 ft temperature was 140 °F. Once the front door was opened and the positive pressure fan was introduced, temperatures in the flex space began to decrease at all elevations, although the most notable changes occurred at the 1 ft through 3 ft elevations. The largest temperature decrease across all elevations occurred at approximately 455 s (7:35) post ignition, which was the time at which the nozzle firefighter began suppression with the bale fully opened in the doorway of the fire room. Flex space temperatures continued to decrease as suppression occurred in the fire room.

Figure 3.106: Flex space temperatures for Experiment 9. Blue vertical bars indicate time and duration of water flow.

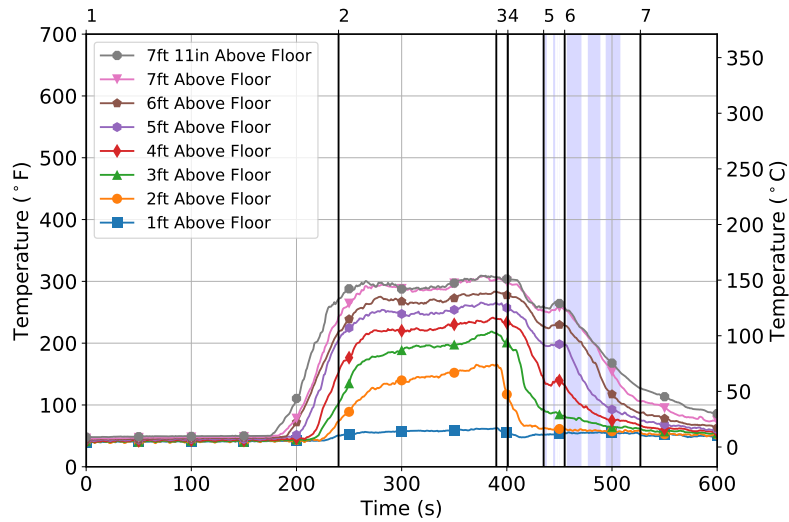
Figure 3.107 shows the temperatures in the hallway, which followed a similar trend to those in the flex space. The temperatures in the hallway began to reach steady values following flashover in the fire room. At the time the front door was opened, the temperatures close to the ceiling were steady, while those closer to the floor were gradually increasing. When the front door was opened, the smoke layer was between 1 ft and 2 ft in the hallway, as indicated by both the camera view in the hallway and the 102 °F difference between the 1 ft and 2 ft temperatures at this time. There was a significant decrease in the hallway temperatures following the opening of the front door and the introduction of the fan. In the time between front door open and initial water application, the 2 ft temperatures decreased from 165 °F to 60 °F and the 3 ft temperatures decreased from 215 °F to 90 °F. The temperature drop at elevations close to the ceiling was also greater than was observed in the flex space. Similar to the flex space temperatures, the hallway temperatures at all levels dropped substantially when the nozzle firefighter reached the fire room and began to flow water 455 s post ignition.

Figure 3.107: Hallway temperatures for Experiment 9. Blue vertical bars indicate time and duration of water flow.

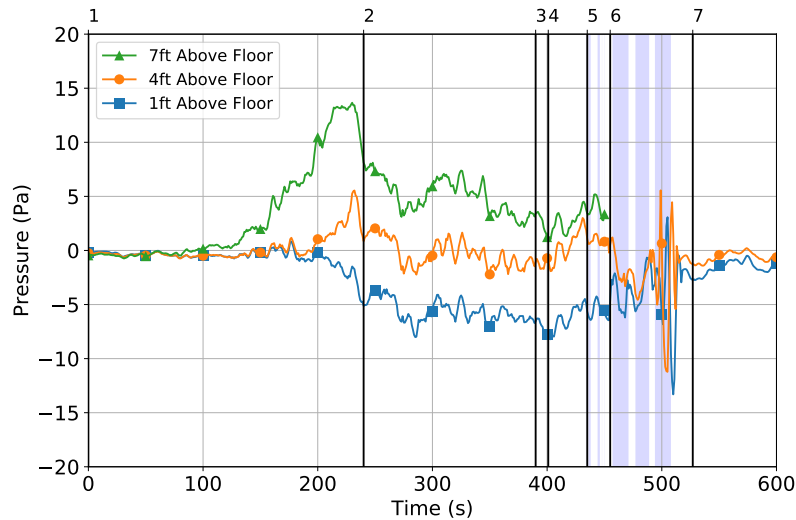
The growth of the bedroom fire was accompanied by an increase in pressure at the 7 ft elevation, as shown in Figure 3.108. The 4 ft pressure began to increase and the 1 ft pressure began to decrease approximately 200 s post ignition. The 1 ft temperature remained negative until the sensor malfunctioned following suppression, whereas the 4 ft sensor fluctuated between positive and negative pressure during this period. The sustained negative pressure at the 1 ft level reflected the entrainment of air through the front door. After the positive pressure fan was turned into the door, the pressures at the 4 ft and 7 ft elevations increased while the 1 ft pressure remained negative.

Figure 3.108: Fire room pressure data for Experiment 9. Data is presented until fire room suppression, when the sensors were damaged. Blue vertical bars indicate time and duration of water flow.

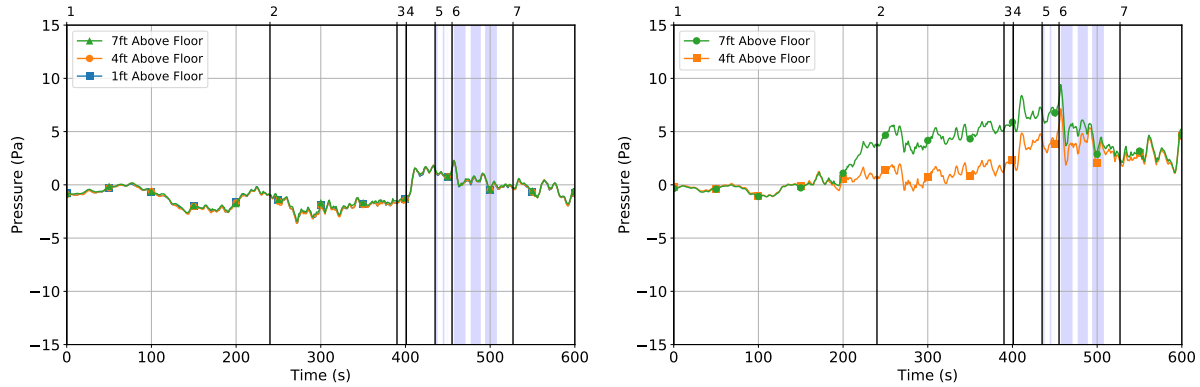
Figure 3.109 shows the pressures for the flex space and the second-floor hallway for Experiment 9. In both locations, as the fire grew, the 7 ft pressure increased to a positive value, reflecting the development of a hot gas layer in these areas. Although the 1 ft pressure sensor at the hallway location malfunctioned, the 1 ft pressure in the flex space decreased below zero around the time of flashover. The 4 ft pressures at both locations fluctuated between positive and negative values in the period prior to the front door being opened. The magnitudes of the pressures at each location remote from the fire room were less than the pressure in the fire room at the corresponding height. Once the positive pressure fan was turned into the doorway, there was an increase in pressure throughout the open spaces remote from the fire room on the second-floor. The pressure increase at the 1 ft and 4 ft elevations in the flex space were sufficient that they were greater than the corresponding pressures in the fire rooms, indicating the flow was into the fire room at these heights. The pressure increase at the 7 ft level was not enough to be greater than the 7 ft pressure in the fire room, although it did decrease the difference between the two values. The changes in pressure following the introduction of the positive pressure fan suggest the positive pressure fan was successful in reducing the flow from the fire room to adjacent spaces of the structure.

Figure 3.109: Flex space (see Figure 3.109a) and hallway (see Figure 3.109b) pressure for Experiment 9. Blue vertical bars indicate time and duration of water flow.

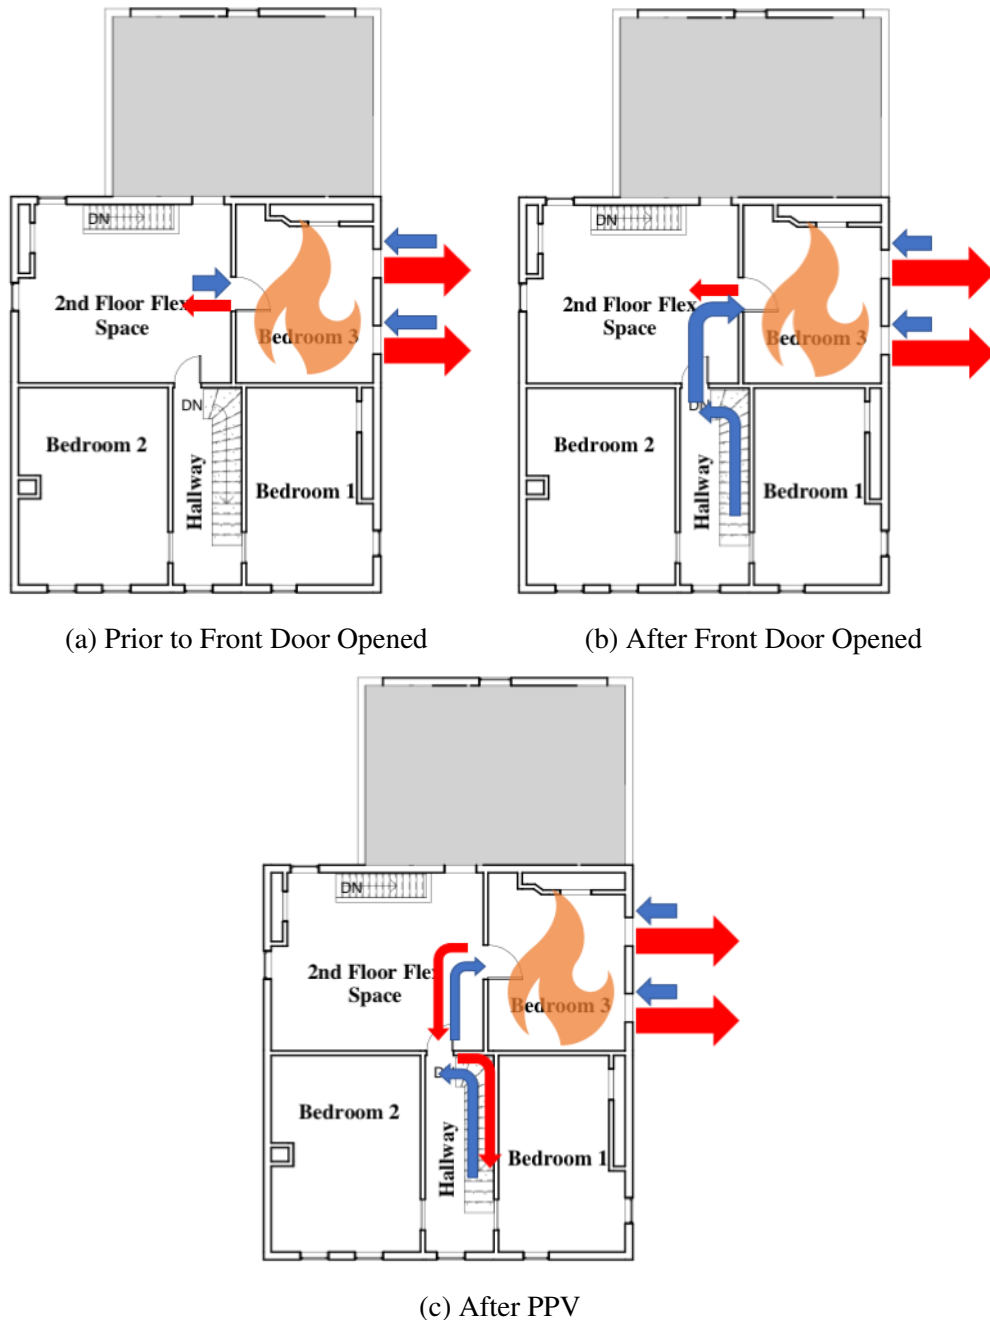
Figure 3.110: Changes in flow during Experiment 9 as a function of firefighter ventilation. Red arrows indicate the flow of combustion products, blue arrows indicate the flow of fresh air, and the sizes of the arrows indicate the relative magnitude of the flow.

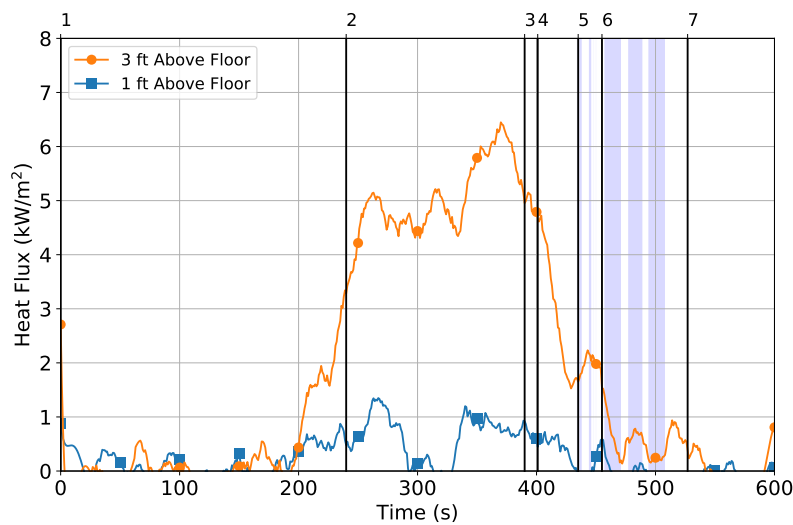
The heat flux location for Experiment 9 was located in the center of the flex space adjacent to the fire room at the 1 ft and 3 ft elevations. The heat flux at this location mirrored the behavior observed from the temperature sensors at these elevations. Figure 3.111 shows the heat flux at this location. The peak heat flux at the 3 ft elevation was 6.5 kW/m^2 , and was observed prior to the front door opening. The heat flux in the period prior to fire department intervention was relatively

steady. Once the front door was opened and the fan was turned in, the heat flux dropped to 1.4 kW/m². The heat flux then briefly increased back to 2.2 kW/m² before a final decrease, which corresponded to the nozzle firefighter reaching the fire room and opening the line. The heat flux at the 1 ft elevation was significantly less than the 3 ft elevation. The peak heat flux measured was 1.5 kW/m², occurring prior to the front door opening but remained below 1 kW/m² for the majority of the experiment.

Figure 3.111: Heat flux for the flex space for Experiment 9. Blue vertical bars indicate time and duration of water flow.

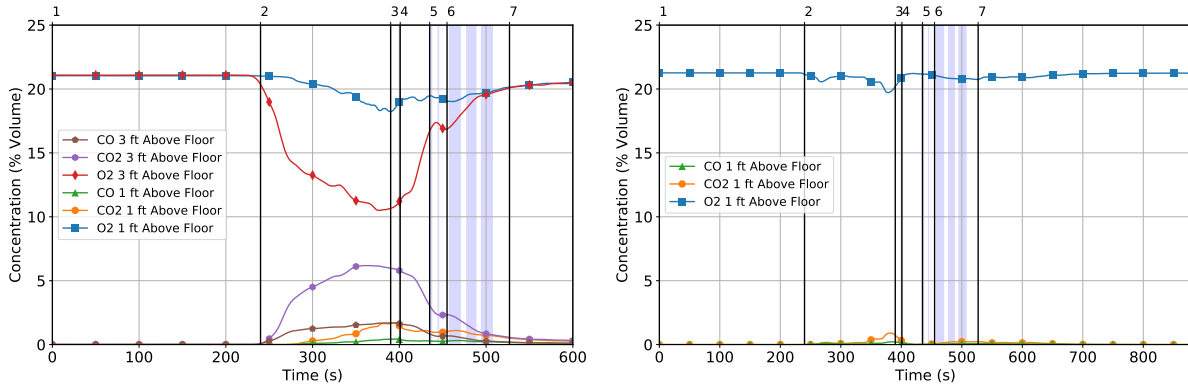
The gas concentrations at the 3 ft elevation were greater than those observed at the 1 ft elevation in the same location. Figure 3.112 shows the gas concentrations in the flex space and hallway for Experiment 9. At the 3 ft elevation in the flex space (see Figure 3.112a), the O₂ concentration started to decrease and CO and CO₂ concentrations started to increase approximately 225 s post ignition. At the time the front door was opened, the gas concentrations were approximately steady at 10.7% for O₂, 6.0% for CO₂, and 1.8% for CO. When the front door was opened and the positive pressure fan introduced, the gas concentrations began to decrease. As the nozzle firefighter applied water from the top of the stairway, CO and CO₂ concentrations began to increase and the O₂ concentration began to decrease. The gas concentrations continued to increase for approximately 10 s, before the flow from the fire room doorway caused the gas concentrations to permanently trend toward ambient.

Figure 3.112: O₂, CO₂, and CO concentrations for the 1 ft and 3 ft inside flow path locations in the flex space, and for the 1 ft level in the hallway for Experiment 9. Blue vertical bars indicate time and duration of water flow.

The gas concentrations at the 1 ft level in the flex space (see Figure 3.112a) also began to increase around the time of flashover, and were gradually increasing at the time the front door was opened. When the front door was opened, the O₂ concentration was 18.3%, the CO₂ concentration was 3.7%, and the CO concentration was 0.4%. The peak 1 ft gas concentrations were observed when the front door was opened, and the O₂ gradually increased and CO and CO₂ gradually decreased while the fan was activated and suppression began.

The gas concentrations in the hallway (see Figure 3.112b) were less than both the 1 ft and 3 ft elevations in the flex space. The peak gas concentrations were observed after the front door was opened. The lowest O₂ concentration was 19.7% and the peak CO₂ and CO concentrations were 0.9% and 0.3%, respectively. A reason the gas concentrations in this location were less than other location in the structure is likely due to the layer height in the hallway being above the 1 ft sample point. Additionally, the location was directly above the stairway and may have been impacted by the fresh air entrained onto the second-floor through the staircase.

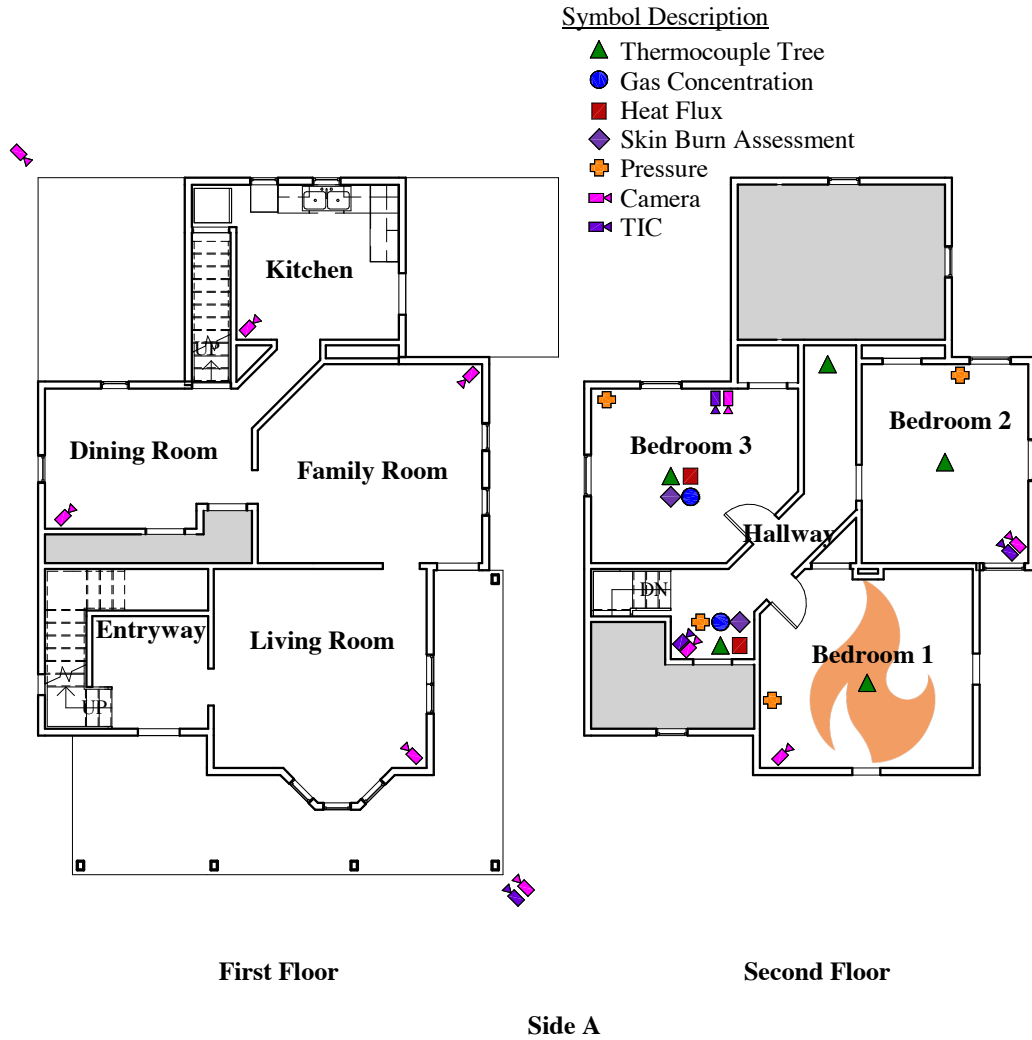
Figure 3.114: Instrumentation and floor plan for Experiment 10. The gray areas were isolated from the remainder of the structure and utilized as space for instrumentation.

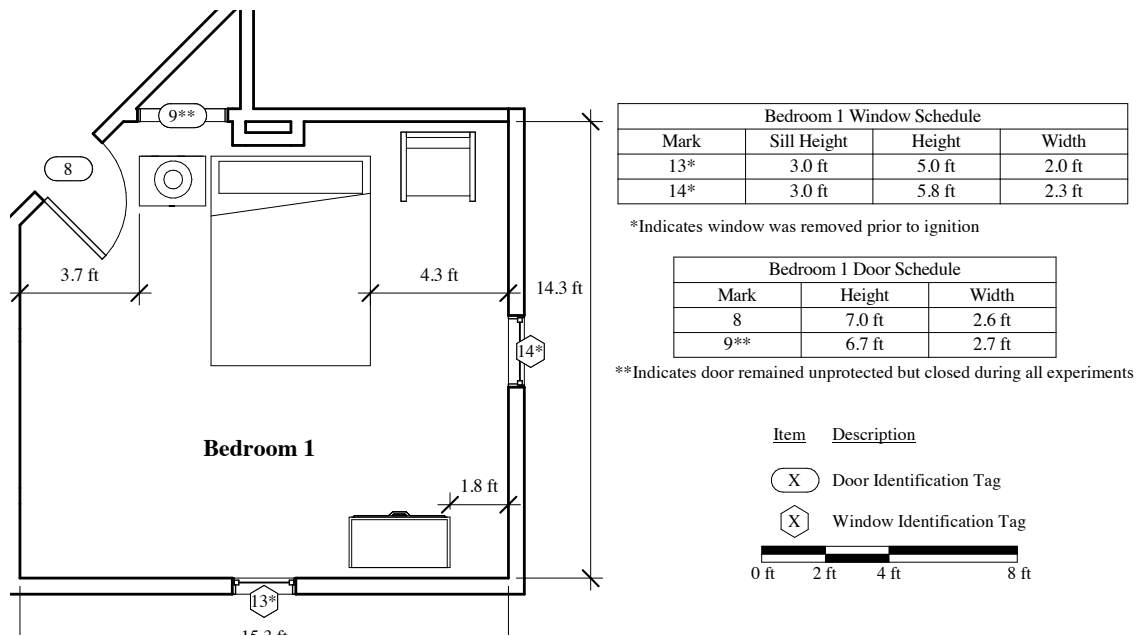
Figure 3.116: Fire room layout for Experiment 10.

The fire room (bedroom 1) was furnished with the bedroom fuel package described in section 2.4.1. Photographs of the fire room (bedroom 1) prior to ignition are presented in Figure 3.115. A dimensioned layout of the fire room is included in Figure 3.116. To replicate a similar volume of

space found in other experiments, bedroom 2 remained closed throughout the experiment. To allow for repeatable fire growth, the windows located on side A and side D (labeled 13 and 14 in Figure 3.116) were removed prior to ignition.
