Analysis of the Coordination of Suppression and Ventilation in Single-Family Homes

John Regan
Julie Bryant
Craig Weinschenk

UL Firefighter Safety Research Institute
Columbia, MD 20145

March 19, 2020

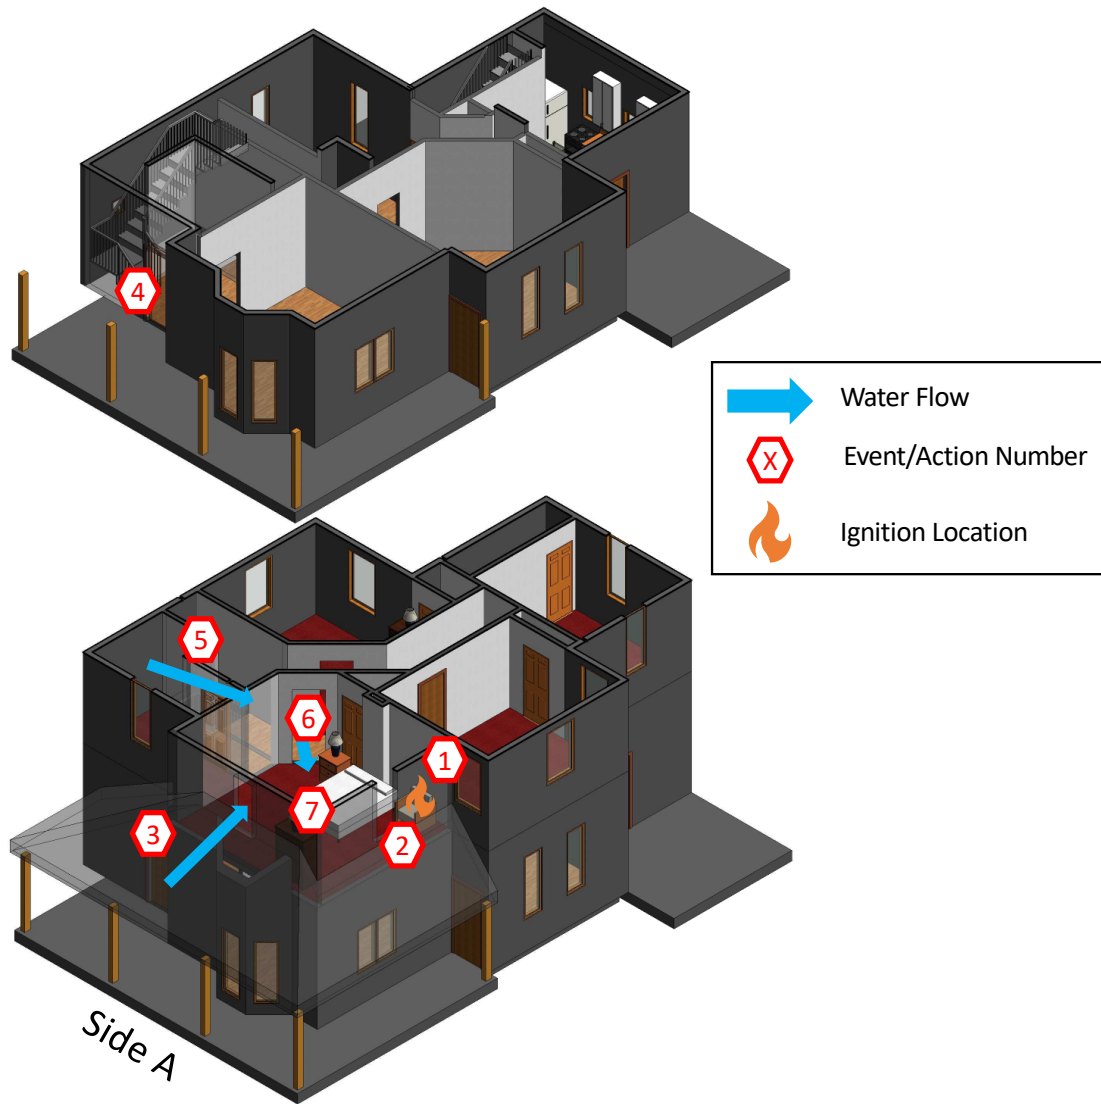
Figure 3.117: Time and sequence of actions and events for Experiment 10.

A single 1.75 in. hoseline with a combination nozzle set to straight stream was used for both interior and exterior suppression. No additional ventilation beyond the front door was established. The times and locations at which events and actions occurred in Experiment 10 are illustrated in Figure 3.117.

Action/Event	Time (mm:ss)	Time (s)
1 Ignition	00:00	0
2 Flashover	05:29	329
3 Exterior Water, Bedroom 1 Window	07:32	452
4 Front Door Open	07:44	464
5 Flow from Top of Stairs	09:01	541
6 Flow from Doorway	09:27	567
7 Suppression Crew Entered Fire Room	10:21	621

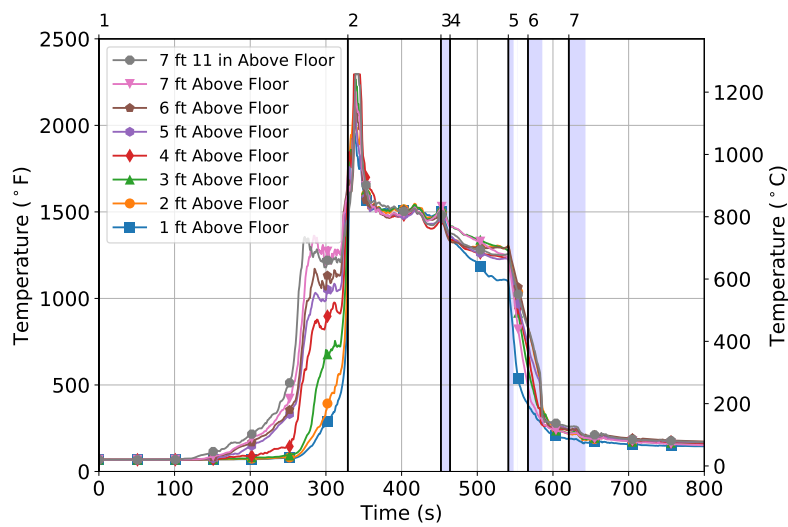
Figure 3.118: Fire room (bedroom 1) temperature data for Experiment 10. Blue vertical bars indicate time and duration of water flow.

The fire room (bedroom 1) temperatures, shown in Figure 3.118, began to increase approximately 100 s post ignition as the fire began to spread beyond the upholstered chair where it was ignited.

As fire growth continued, fire began to extend out of the fire room windows 267 s post ignition and out the fire room doorway 274 s post ignition. The thermocouple data indicated the fire room transitioned through flashover 329 s post ignition. After this time, the temperatures within the fire room exceeded the listed calibration of the thermocouple wire, introducing a greater amount of uncertainty into the temperature measurements. The exterior suppression action (Action 3) reduced temperatures from post-flashover values. After exterior water application, the fire room temperatures gradually decreased until the initial interior suppression action, indicating the exterior suppression action did not completely extinguish the fire. Fire room temperatures began to decrease more rapidly after the stairway suppression action (Action 5). As suppression continued, fire room temperatures continued to decrease.

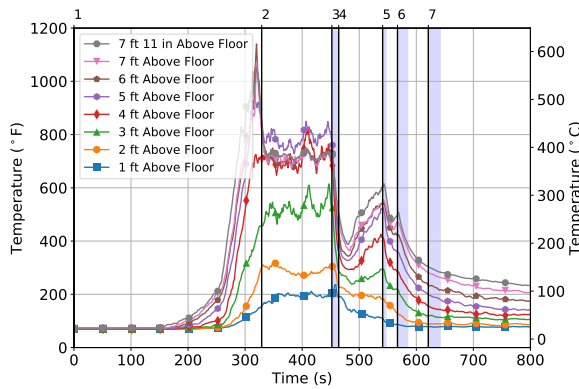
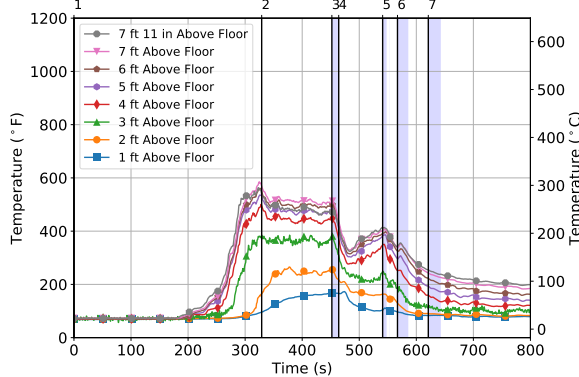
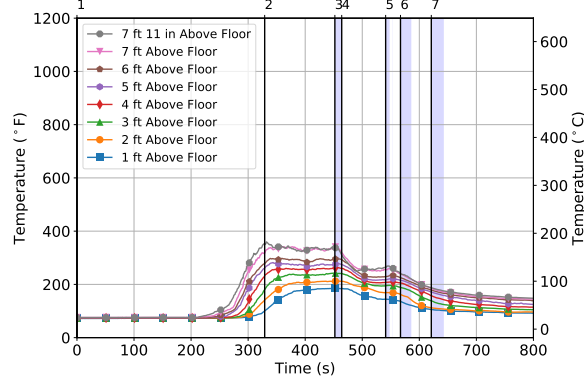
Figure 3.119: Temperatures in open areas of second-floor of structure for Experiment 10. Blue vertical bars indicate time and duration of water flow.

The temperatures in the areas of the second-floor remote from the fire room (bedroom 1), shown in Figure 3.119, followed a similar trend to the fire room temperatures. The temperatures measured in the hallway directly outside the fire room (see Figure 3.119a), began to increase as smoke and fire began to extend into the hallway approximately 200 s post ignition. These temperatures reached a peak corresponding to flashover in the fire room. Temperatures remained steady until the time of fire department intervention, ranging from 210 °F 1 ft above the floor to 810 °F close to the ceiling. The exterior water application dropped the 7 ft 11 in. temperature to 390 °F. After reaching a local minimum value after exterior suppression, the 3 ft through 7 ft temperatures began to increase, while the 1 ft and 2 ft temperatures continued a gradual decrease. These trends reflect the fresh air being entrained into the fire room via the open front door and the subsequent growth of the fire prior to final, interior suppression. The 7 ft 11 in. temperature rebounded to 600 °F, but then the suppression action at the top of the stairway (Action 5) began to decrease temperatures. After the suppression crew began to flow water into the fire room from the doorway (Action 6), temperatures

permanently decreased.

As distance from the fire room increased, the magnitude of the temperatures decreased, and response to suppression actions were not as immediate. The temperatures farther down the hallway (see Figure 3.119b) and in bedroom 3 (see Figure 3.119c) both reflect the initial increase in temperatures following growth and subsequent decrease in temperatures prior to initial suppression. Because the door to bedroom 2 was closed throughout the experiment, the temperatures did not significantly increase during the experiment and are therefore not presented.

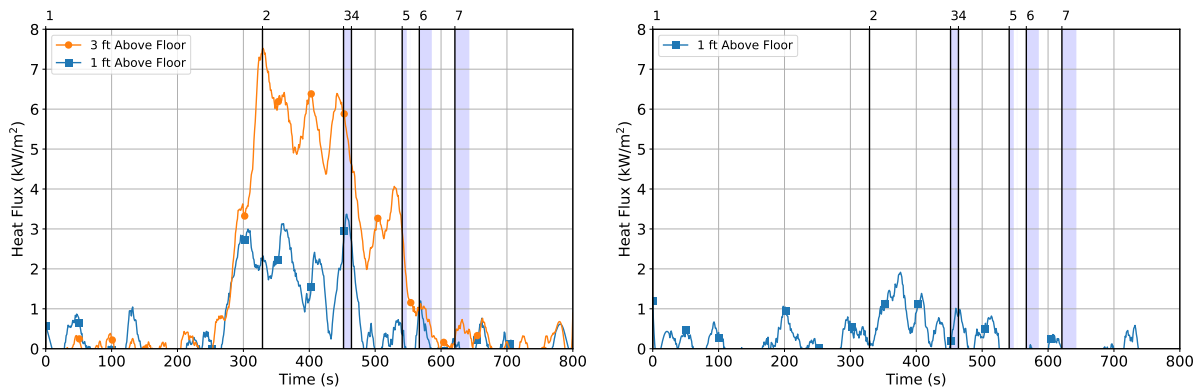
Figure 3.120: Heat flux at remote locations for Experiment 10. Blue vertical bars indicate time and duration of water flow.

Similar to the temperatures in the open areas of the second-floor, the hallway heat flux, measured at 1 ft and 3 ft elevations (see Figure 3.120a), and bedroom 3 heat flux, measured at a 1 ft elevation (see Figure 3.120b), began to increase as the fire room transitioned through flashover. The bedroom 3 heat flux was substantially less than the hallway heat flux, remaining under 2 kW/m^2 for the duration of the experiment. The peak heat fluxes in the hallway were measured prior to fire department intervention after the fire room had flashed over, and were 7.6 kW/m^2 and 3.2 kW/m^2 at 3 ft and 1 ft, respectively. The hallway heat fluxes initially decreased after exterior suppression to 2 kW/m^2 and 0 kW/m^2 at 3 ft and 1 ft, respectively. As the fire began to regrow, the heat fluxes

again increased to 4.0 kW/m^2 and 0.7 kW/m^2 before final suppression decreased the heat flux to negligible values approximately 600 s post ignition.

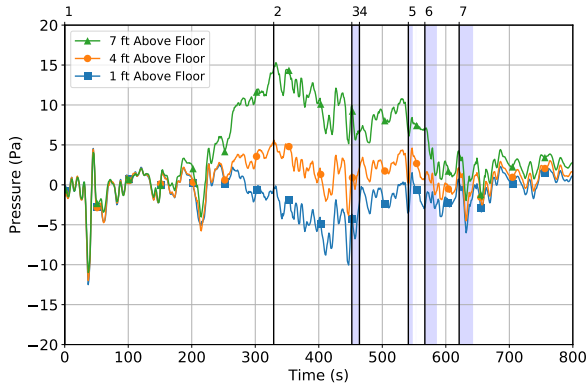
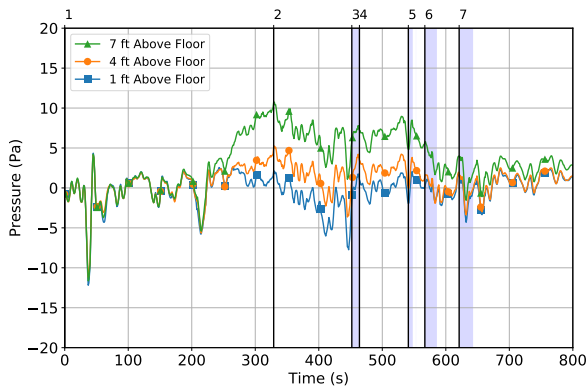
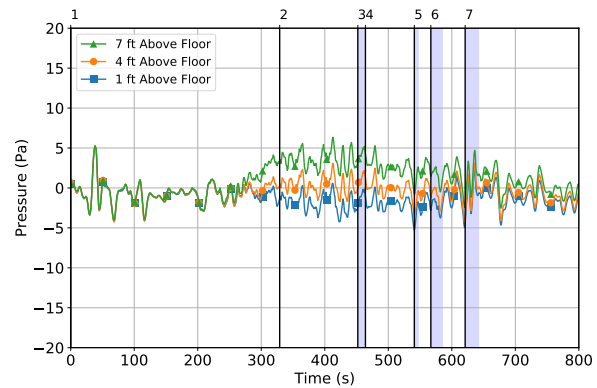
Figure 3.121: Pressures in second-floor of structure for Experiment 10. Blue vertical bars indicate time and duration of water flow.

The pressure measurements taken in the fire room (bedroom 1) and adjacent areas of the second-floor (shown in Figure 3.121) provide insight into fire growth and flow changes during the experiment. The 7 ft pressure in the fire room increased first as the smoke layer in the fire room began to develop. The 4 ft pressure began to increase and the 1 ft pressure began to decrease below 0 Pa approximately 250 s post ignition, as bi-directional flow was established through the fire room windows and doorway. The pressure at the 7 ft and 4 ft elevations peaked at the time of flashover at 14 Pa and 5 Pa, respectively. These pressures were steadily decreasing prior to fire department intervention. The exterior water flow (Action 3) resulted in an increase in the 1 ft and 4 ft pressure. Following the exterior flow, the pressures at all three elevations steadily increased, indicating re-growth of the fire during this period. As the suppression crew advanced up the stairs and continued suppression from the stairway and fire room doorway, the pressures in the fire room converged to 0 Pa.

The pressures in the hallway (see Figure 3.121b) and bedroom 3 (see Figure 3.121c) followed a similar trend to the fire room (bedroom 1) pressures, although the magnitude of the pressures in these locations were less than in the fire room. As the fire grew, a bi-directional flow was established through the fire room doorway (see Figure 3.122a). Hot gases flowed out of the fire room into open spaces on the second-floor, and fresh air was entrained into the fire room.

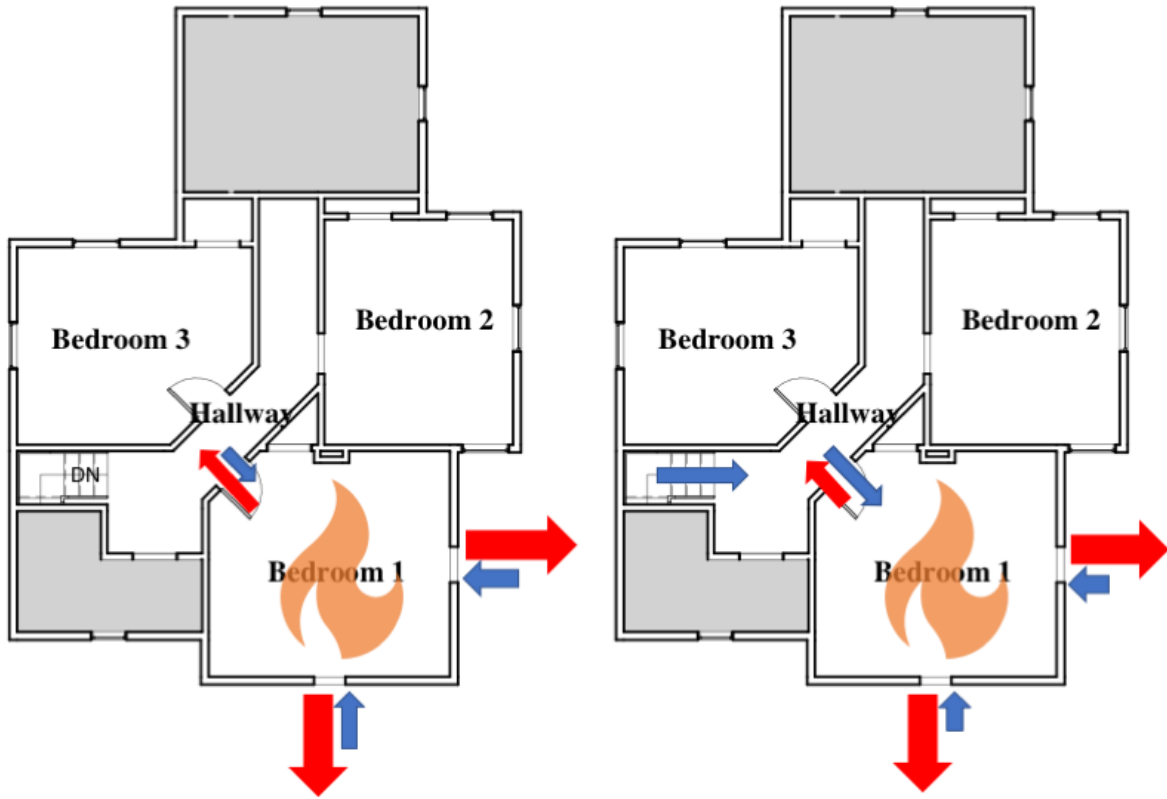
Figure 3.122: Changes in flow during Experiment 10 as a function of firefighter ventilation. Red arrows indicate flow out of the compartment, blue arrows indicate entrainment into the compartment, and the sizes of the arrows indicate the relative magnitude of the flow through each opening.

As the fire consumed the available oxygen within the structure, the primary source of oxygen for combustion came from the fire room windows. After exterior water flow and front door ventilation, a new flow path was established (see Figure 3.122b). Fresh air was entrained through the front door, up the stairs, and into the fire room. This further decreased temperatures close to the floor at the top of the stairs while contributing to the regrowth of the fire.

(a) Flows Prior to Front Door being Opened

(b) Flows After Front Door was Opened

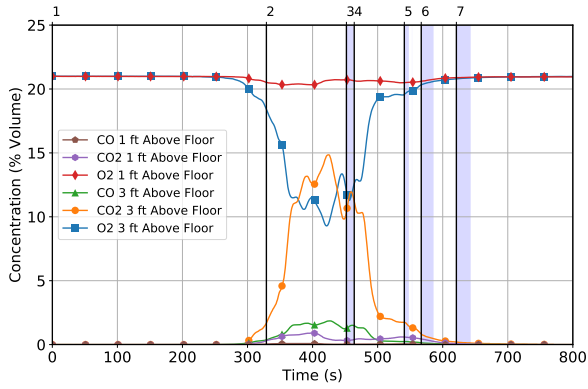
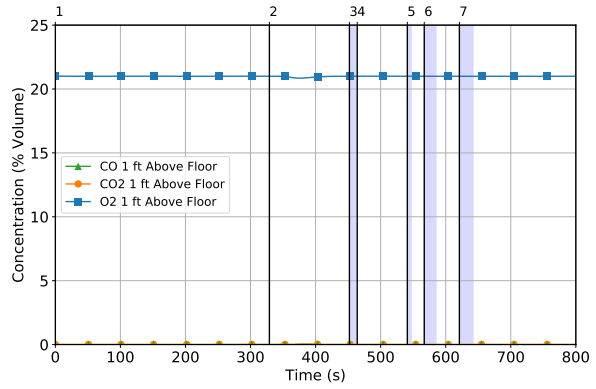
Figure 3.123: Gas concentrations in the hallway and in bedroom 3 for Experiment 10.

Gas concentrations were measured in the same locations as heat flux: 1 ft and 3 ft elevations in the hallway, and 1 ft above the floor in bedroom 3 (see Figure 3.123). Visibility in the hallway and bedroom 3 cameras decreased approximately 260 s post ignition. Shortly after, O_2 decreased and CO and CO_2 increased at the hallway location as shown in Figure 3.123a. The O_2 concentration 1 ft above the floor remained close to pre-ignition conditions, which is indicative of the fresh air entrained into the fire room. The concentration of CO and CO_2 were similarly near ambient. The 3 ft elevation concentrations were greater, reaching peaks of 11.3% for both O_2 and CO_2 , and 1.9% for CO at the time of fire department intervention. The combination of the exterior suppression and front door ventilation caused the O_2 concentration to increase and the CO_2 and CO concentrations to decrease as fresh air from the newly created flow path traveled past the hallway location. In the remote location, bedroom 3, there was negligible change in gas concentration as shown in Figure 3.123b.

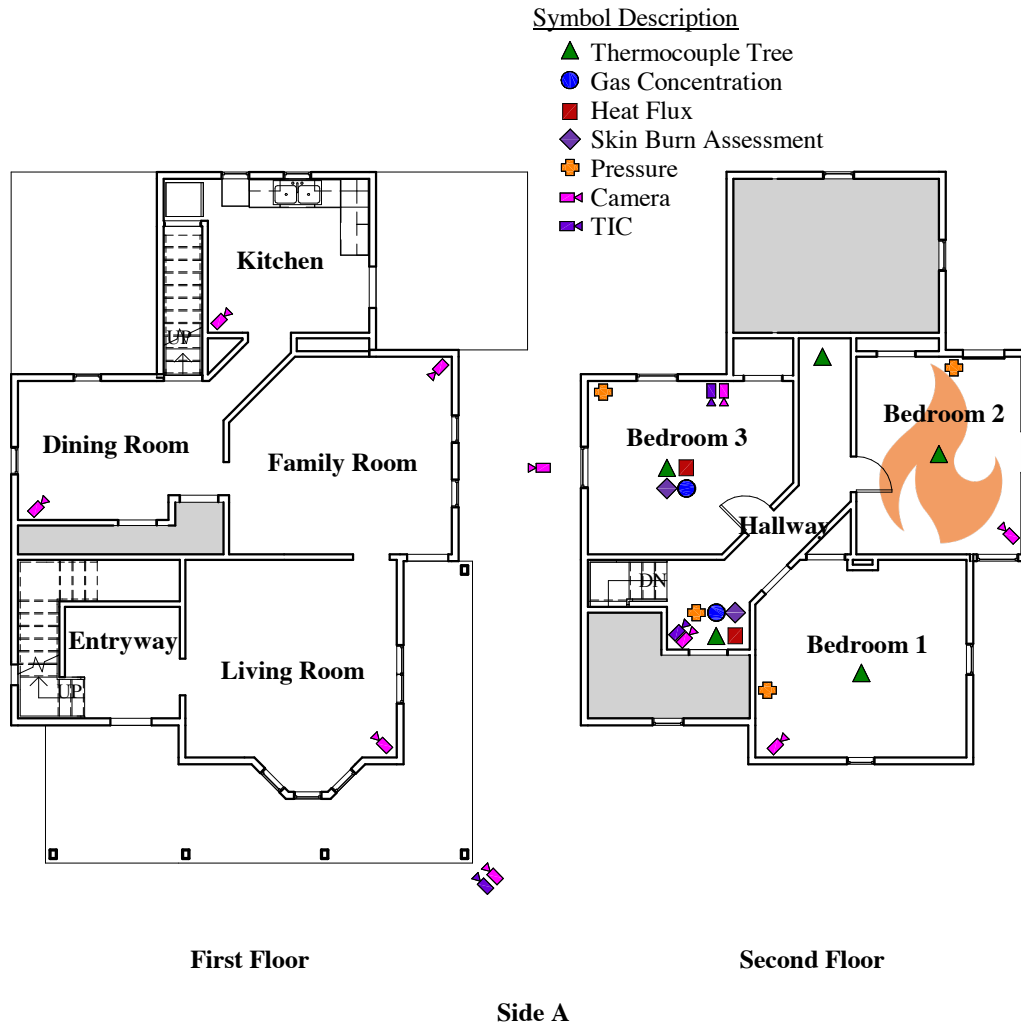
Figure 3.125: Instrumentation and floor plan for Experiment 11. The gray areas were isolated from the remainder of the structure and utilized as space for instrumentation.

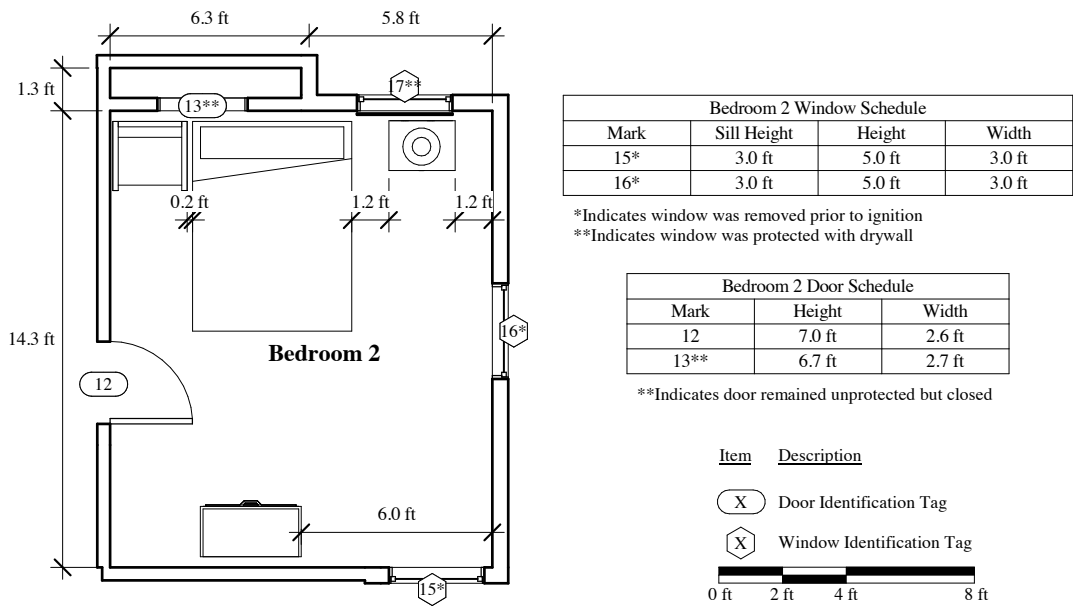
Figure 3.127: Fire room layout for Experiment 11.

The fire room (bedroom 2) was furnished with the bedroom fuel package described in Section 2.4.1. Photographs of the fire room prior to ignition are presented in Figure 3.126. A dimensioned layout of the fire room is included in Figure 3.127.

To replicate a similar volume of space found in other experiments, bedroom 1 remained closed throughout the experiment. To allow for repeatable fire growth, the windows located on side A and

side D (labeled 15 and 16 in Figure 3.127) were removed prior to ignition.

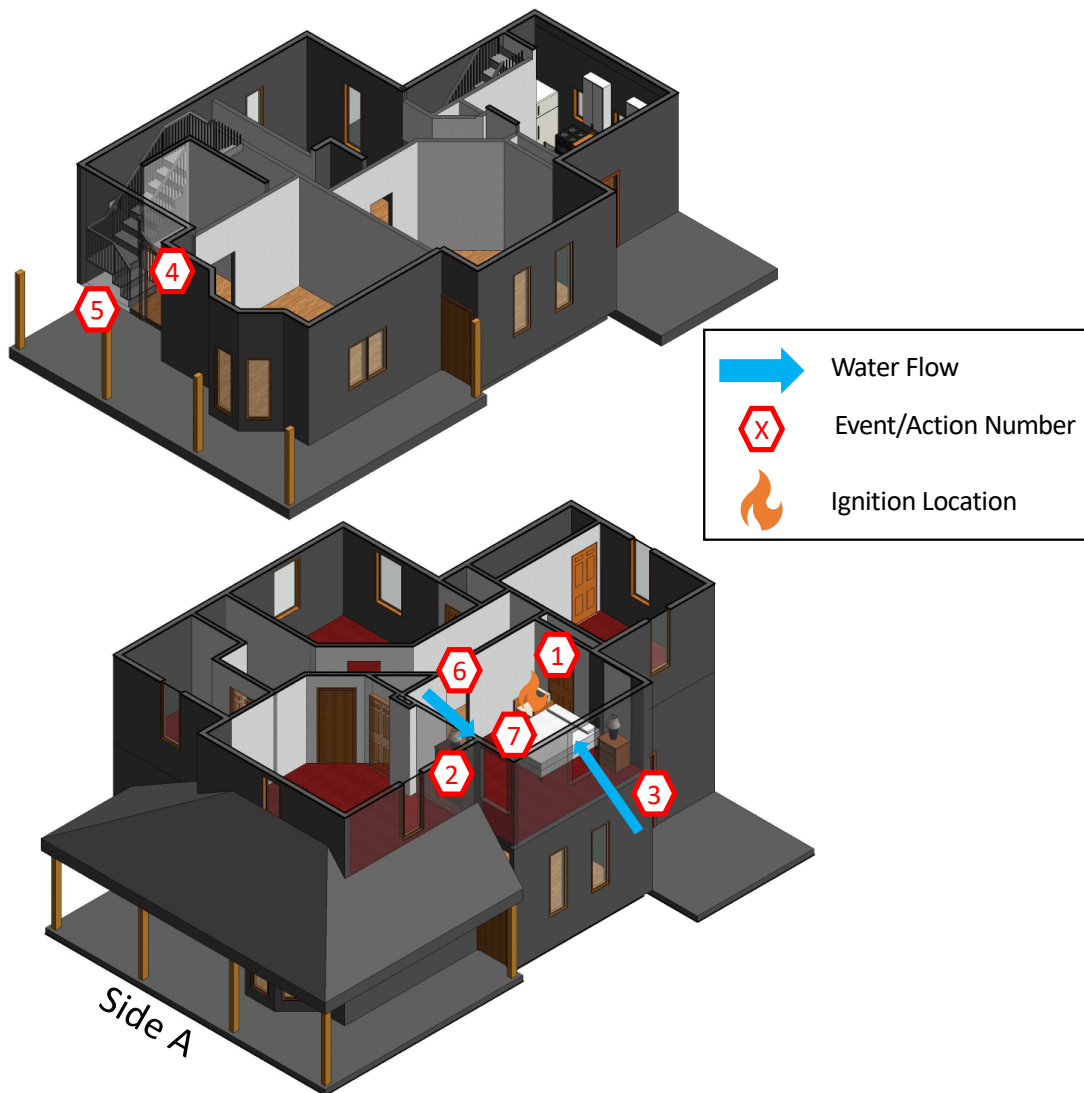
Figure 3.128: Time and sequence of actions and events for Experiment 11.

the house for interior suppression. The secondary hoseline was placed on side D and used for exterior suppression. A gas-powered fan³ was used to for positive pressure ventilation. The times and locations of the actions and events conducted during Experiment 11 are shown on the isometric diagram presented in Figure 3.128.

Action/Event	Time (mm:ss)	Time (s)
1 Ignition	00:00	0
2 Flashover	05:21	321
3 Exterior Water, Bedroom 2 Window	07:31	451
4 Front Door Open	07:49	469
5 PPV Fan Turned In	07:56	476
6 Flow from Doorway	09:09	549
7 Suppression Crew Entered Fire Room	09:37	577

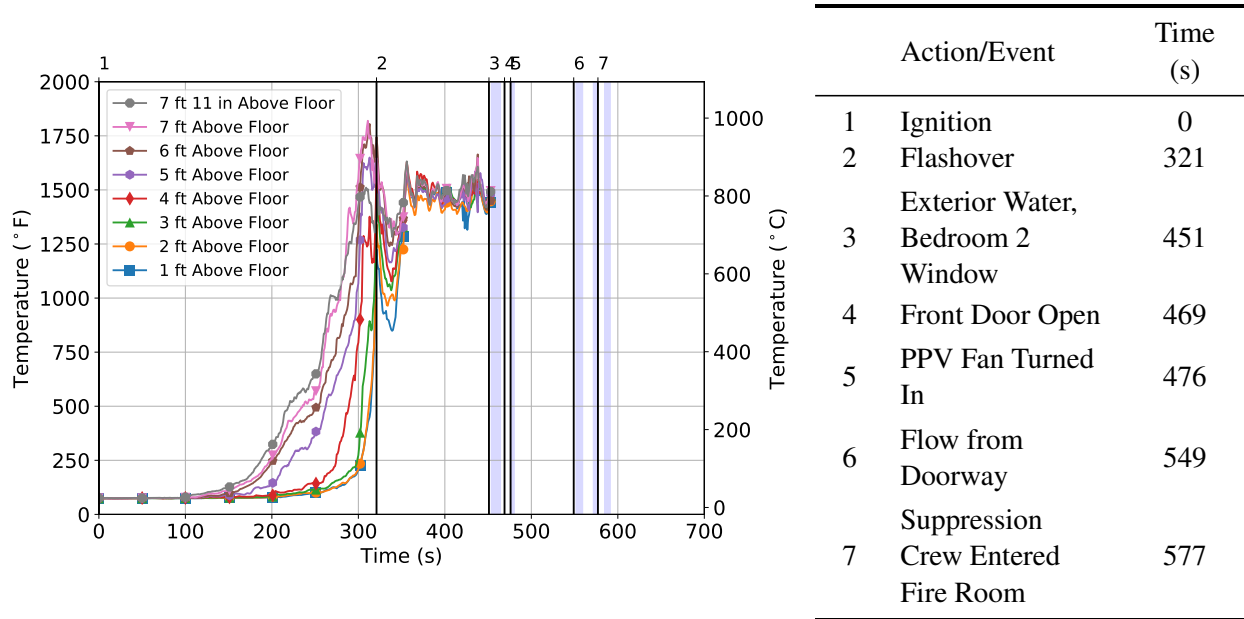
Figure 3.129: Fire room (bedroom 2) temperature data for Experiment 11. Blue vertical bars indicate time and duration of water flow.

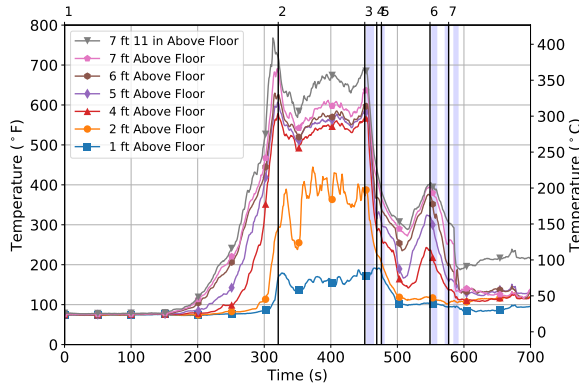
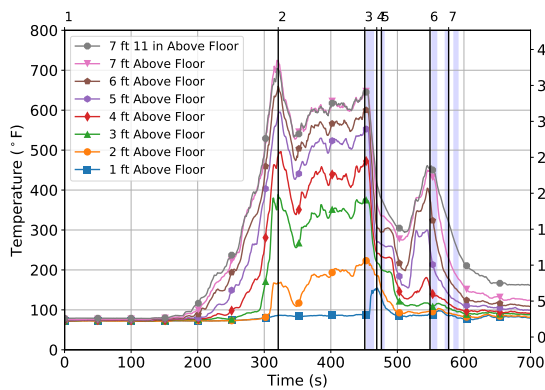
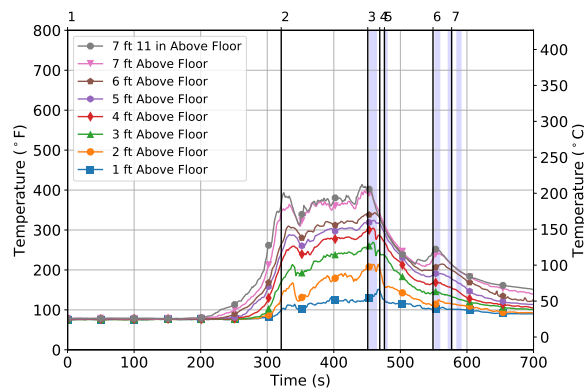
Figure 3.130: Temperatures in open areas of second-floor of structure for Experiment 11. Blue vertical bars indicate time and duration of water flow.

Temperatures outside the fire room (see Figure 3.130) first began to increase approximately 150 s post ignition as the smoke layer in the fire room descended causing products of combustion to spill into the hallway. The hallway temperatures located outside the fire room (see Figure 3.130a) reached a peak corresponding with flashover in the fire room. Temperatures in the hallway remained relatively steady in the period leading up to fire department intervention. The exterior suppression action caused the temperatures to drop from between 375 °F to 685 °F, to below 285 °F. Meanwhile, the 1 ft temperature briefly increased from 165 °F to 190 °F then decreased below 90 °F. After the initial temperature decrease from exterior suppression, temperatures in the hallway began to increase again approximately 515 s post ignition, and continued to increase until suppression occurred from the fire room doorway (Action 6) 549 s post ignition. Temperatures decreased as suppression continued in the fire room, with another significant drop occurring 589 s post ignition as suppression was occurring in the fire room.

The temperature locations more remote from the fire room (bedroom 2), the hallway temperatures outside bedroom 1 (see Figure 3.130b), and the bedroom 3 temperatures (see Figure 3.130c) followed a similar trend to the hallway temperatures outside the fire room, reaching a peak close to the time of flashover. The exterior suppression action (Action 3) decreased the 2 ft through 7 ft 11 in. temperatures at both measurement locations, while the 1 ft temperatures at both locations increased. In bedroom 3, this increase was fairly insignificant, with the 1 ft temperature increasing from 132 °F to 151 °F, but in the remote hallway location the temperature increased from 89 °F to 154 °F. The regrowth in temperatures observed approximately 515 s post ignition was also observed in bedroom 3 and the remote hallway thermocouple locations. The 7 ft 11 in. temperatures increased to local peaks of 465 °F and 250 °F for the remote hallway and bedroom 3, respectively. As the suppression crew began flowing water from the fire room doorway, the temperatures at each of these locations began to decrease permanently.

When exterior suppression was initiated, a burst of gases was observed rolling down the hallway from the fire room to the top of the stairs. Figure 3.134 shows this phenomenon, which lasts for approximately 15 s and corresponds with the rise in 1 ft temperatures in Figures 3.130b and 3.130c and the hallway gas concentrations discussed in the following paragraph. It is unclear what caused this movement of gases, although it is possibly a result of steam production in the fire room (bedroom 2) as the exterior stream cooled the hot plaster ceiling. The opening of the front door and

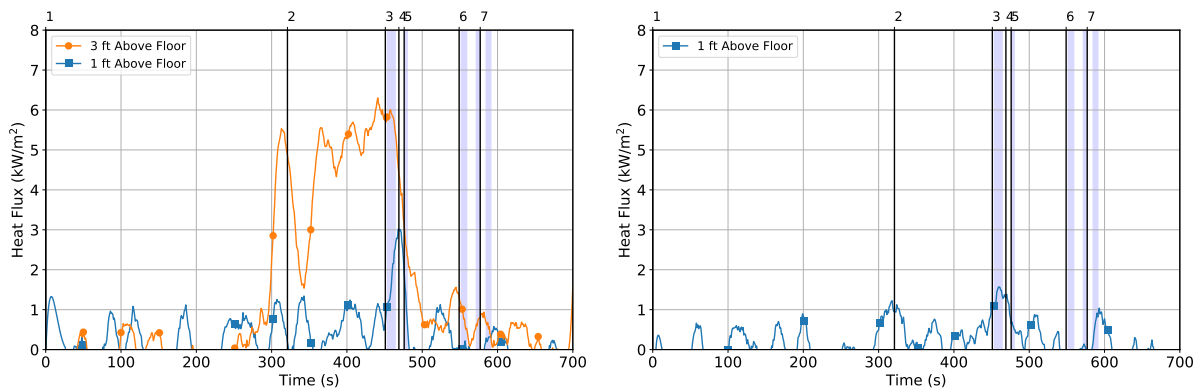
the duration of the experiment. The 3 ft heat flux first started to increase shortly before flashover. It peaked to 6 kW/m² at the time of exterior suppression, after which the heat flux decreased below 2 kW/m². The heat flux increased at the same time that temperatures throughout the second-floor started to increase, before fire room doorway suppression permanently reduced the 3 ft heat flux.

The 1 ft heat flux in the hallway remained under 2 kW/m² for the majority of the experiment, with the exception of a peak of 3 kW/m², which occurred simultaneous with the exterior water application and mirrored the temperature increase at 1 ft at this location. The 1 ft heat flux in bedroom 3 remained under 2 kW/m² for the duration of the experiment. A spike in heat flux coincident with suppression was not observed.

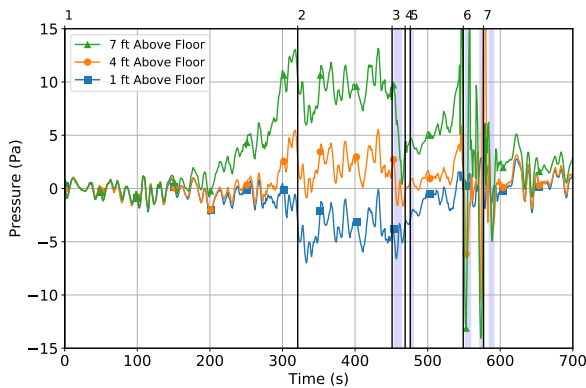
Figure 3.132: Pressures in second-floor of structure for Experiment 11. Blue vertical bars indicate time and duration of water flow.

As the fire grew and a smoke layer began to develop, the 7 ft pressure in the fire room began to increase approximately 150 s post ignition, as shown in Figure 3.132a. As the fire continued to spread to other objects in the fire room (bedroom 2) and become ventilation limited, the 4 ft pressure also began to increase, while the 1 ft pressure began to decrease. This indicates a bi-directional flow was established in the fire room windows and doorway. This pressure profile was maintained until exterior suppression (Action 3), which caused all pressures to approach ambient conditions. The activation of the PPV fan 7 s after the front door was opened caused the pressure at all three elevations in the fire room to increase above zero. The fire room pressures began to increase more quickly as the fire began to regrow before suppression in the fire room caused the

pressure to converge.

Although the pressures in bedroom 3 followed a similar trend to the hallway location, these pressures did not fluctuate as much as those in the hallway. The increase in pressure, observed after the PPV fan was activated, was not as significant since this location was remote from the flow path. Data presented in Figure 3.132 shows the magnitude of the pressures decreased as the distance from the fire room increased. This indicates fresh air flowed from these remote locations toward the fire room at the 1 ft elevation, while hot gases were exhausted from the fire room to these remote locations at the 4 ft and 7 ft elevations.

The pressures presented in Figure 3.132 lend insight into the changes in flow over the course of

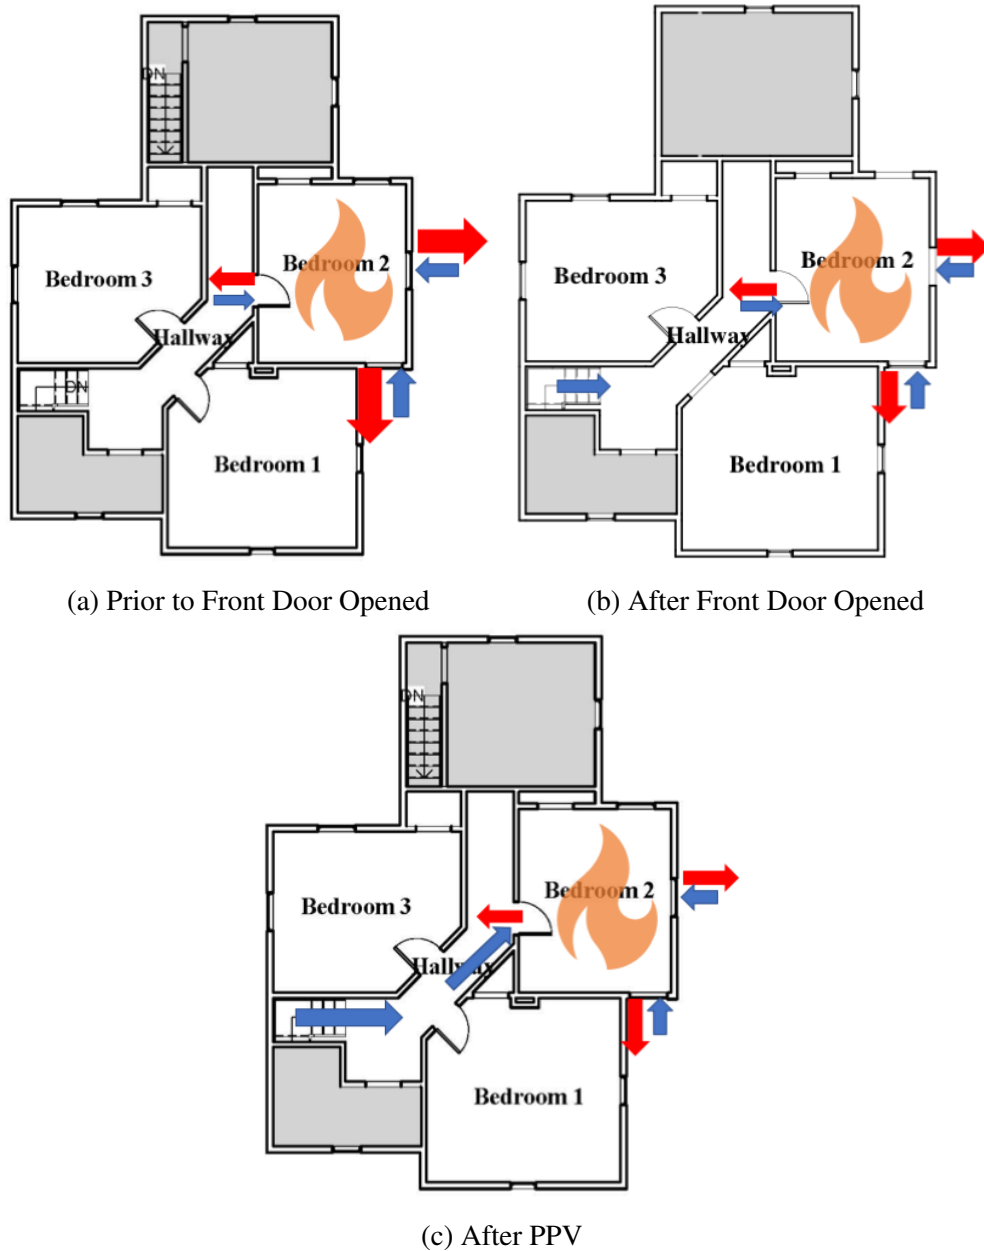
Figure 3.133: Changes in flow during Experiment 11. Red arrows indicate flow out of the compartment, blue arrows indicate entrainment into the compartment, and the sizes of the arrows indicate the relative magnitude of the flow through each opening.

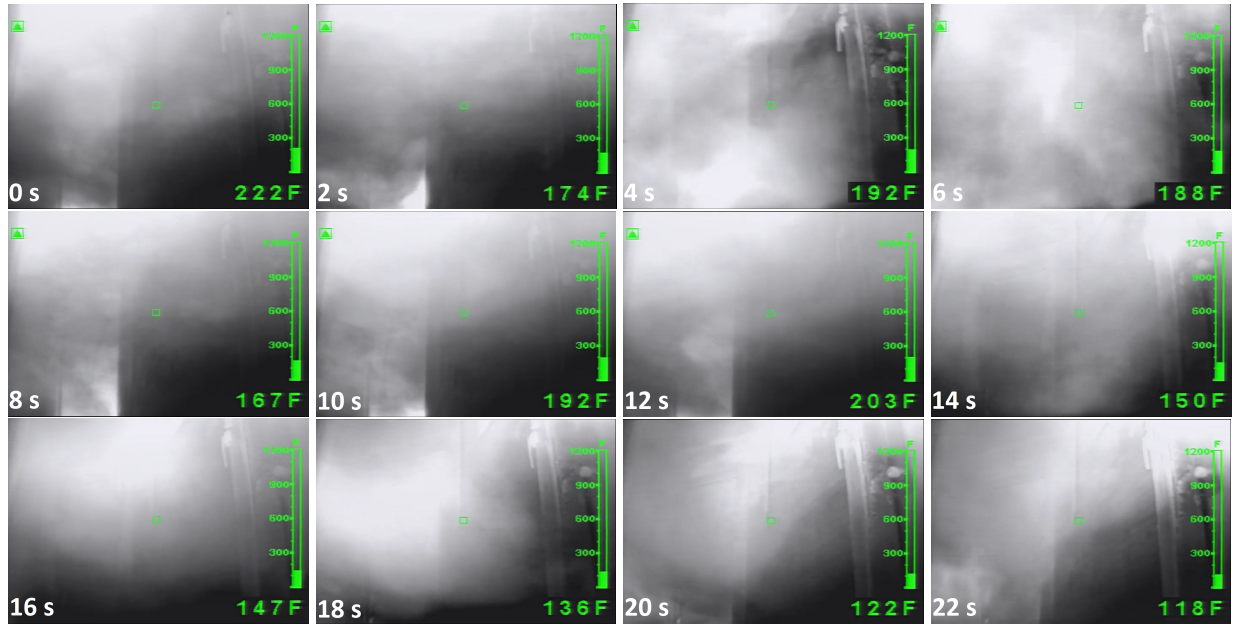
Figure 3.134: Time lapse of thermal camera in remote hallway location for Experiment 11. Shows movement of products of combustion down the hallway from the fire room to the top of the stairs. Still images are shown every 2 s from the start of the smoke movement.

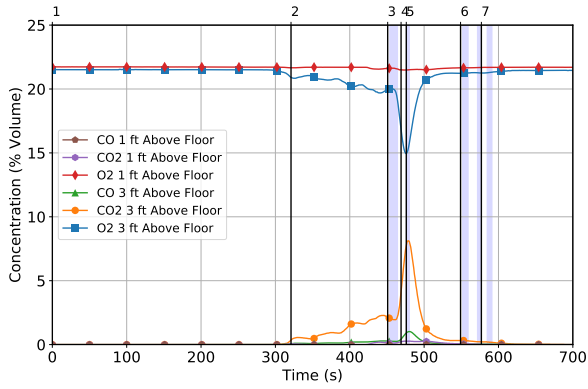
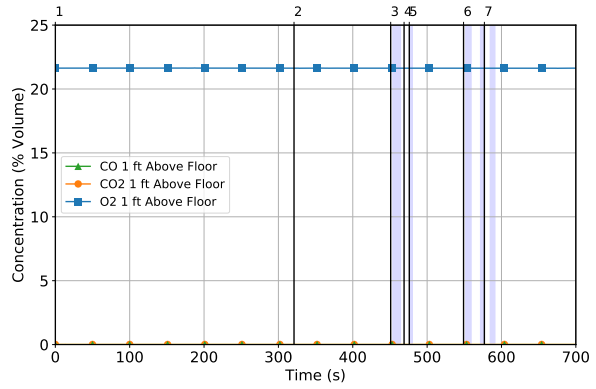
Gas concentrations were measured at the same locations as heat flux: 1 ft and 3 ft above the floor in the hallway, and 1 ft above the floor in bedroom 3 (see Figure 3.135). The 1 ft gas concentrations at both of these locations remained approximately ambient for the duration of the experiment, although visibility was lost at both locations approximately 315 s post ignition. At approximately the time of visibility loss, the 3 ft O₂ began to decrease and the CO₂ and CO began to increase. During the exterior suppression action, the O₂, CO₂, and CO concentrations were 20%, 2%, and 1%, respectively. The movement of products of combustion down the hallway caused the 3 ft gas concentrations to peak, decreasing the O₂ concentration to 15% and increasing the CO₂ and CO to 8% and 1%, respectively. The opening of the front door and the activation of the PPV fan caused these concentrations to sharply return to pre-ignition conditions, and they trended toward ambient for the remainder of the experiment.

Figure 3.135: Gas concentrations at remote locations for Experiment 11. Blue vertical bars indicate time and duration of water flow.

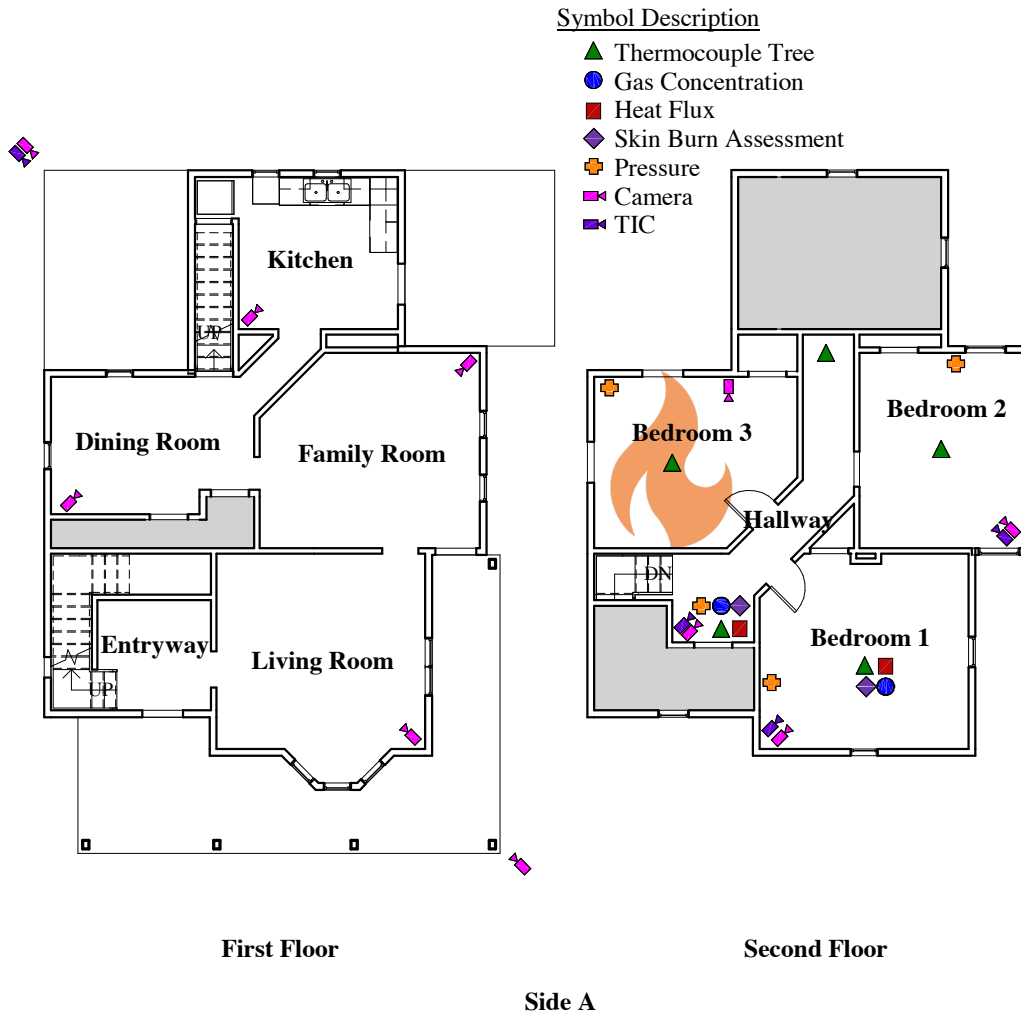
Figure 3.137: Instrumentation and floor plan for Experiment 12. The gray areas were isolated from the remainder of the structure and utilized as space for instrumentation.

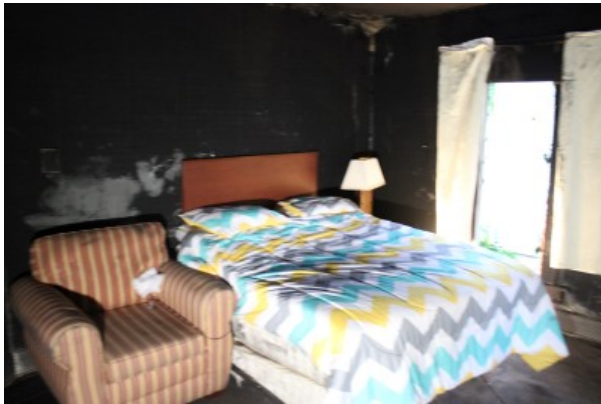
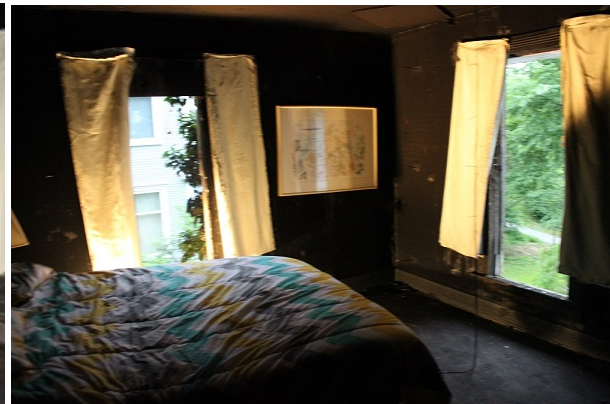
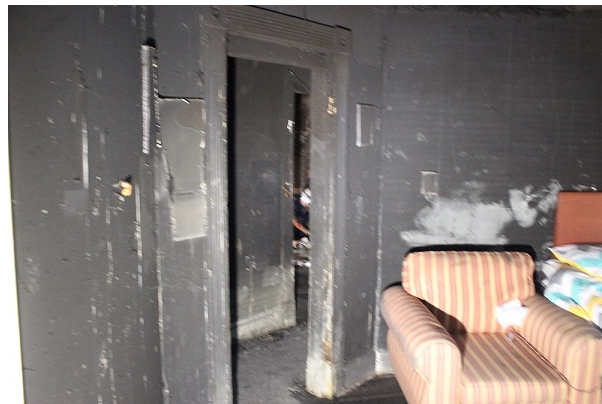
Figure 3.138: Interior photographs of fire room for Experiment 12.

The fire room (bedroom 3) was furnished with the bedroom fuel package described in Section 2.4.1. Photographs of the fire room prior to ignition are presented in Figure 3.138. A dimensioned layout of the fire room is included in Figure 3.139.

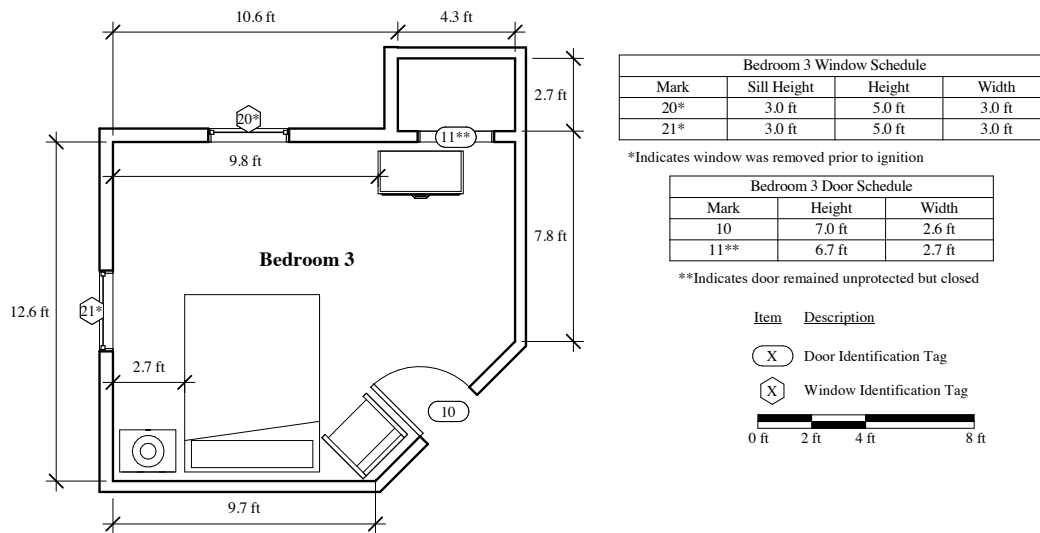
Figure 3.139: Fire room layout for Experiment 12.

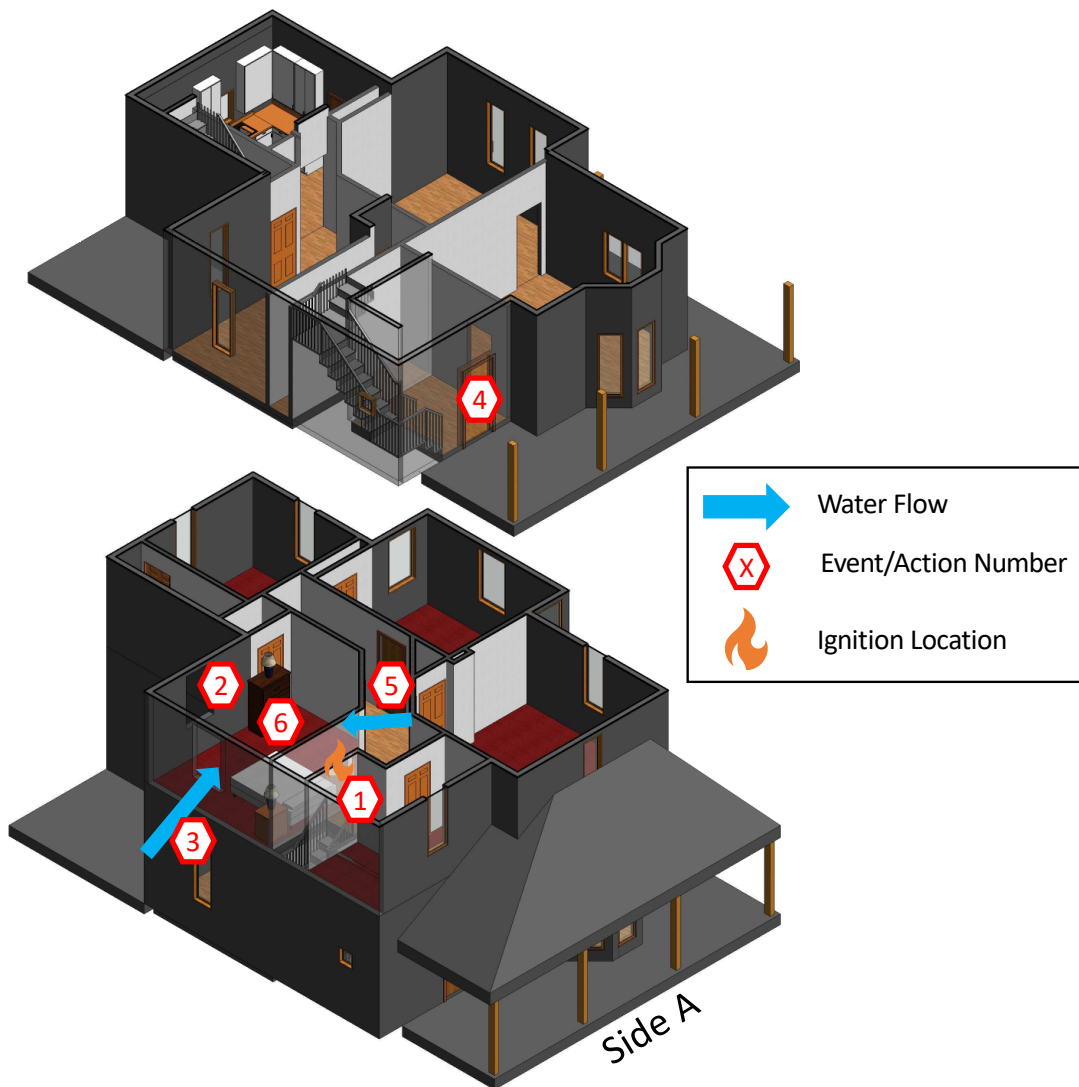
Action/Event	Time (mm:ss)	Time (s)
1 Ignition	00:00	0
2 Flashover	04:35	275
3 Exterior Water, Bedroom 3 Window	07:01	421
4 Front Door Open, Second-Floor Windows Vented	07:15	435
5 Flow from Fire Room Doorway	08:36	516
6 Suppression Crew Entered Fire Room	08:53	533

Figure 3.140: Time and sequence of actions and events for Experiment 12.

Two 1.75 in. hoselines with combination nozzles set to straight stream, were used for interior and exterior suppression. The primary hoseline was placed on side A and advanced into the structure for interior suppression. The secondary hoseline was placed on side B and used for exterior suppression. Additional ventilation was provided by opening all windows on the second-floor. The times and locations of the actions and events conducted during Experiment 12 are shown on the

isometric diagram in Figure 3.140.

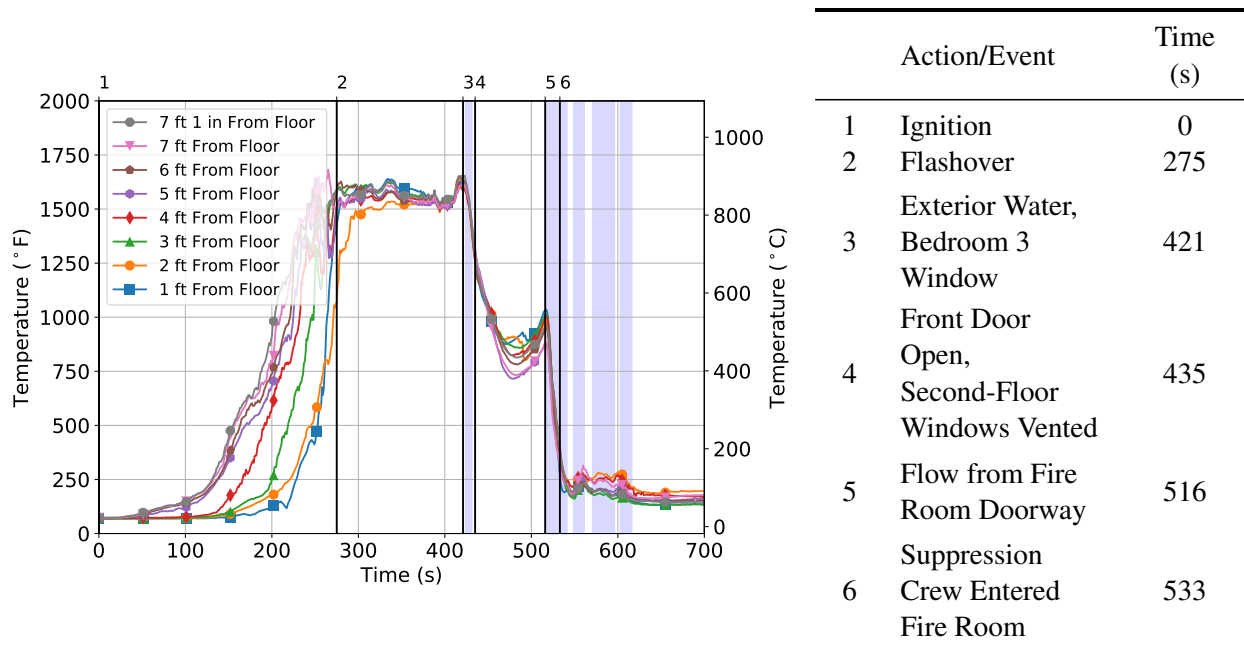
30 s post ignition. The temperatures began to increase more rapidly as the fire spread from the chair to the mattress. Interior and exterior camera views indicated the fire began to vent from the fire room into the hallway at 187 s and was first seen venting out the window at 210 s. Shortly afterward, the fire room transitioned through flashover 275 s post ignition. After flashover, the temperatures in the fire room (bedroom 3) exceeded the listed calibration of the thermocouple wire used, introducing a greater amount of uncertainty to the temperature measurements taken after this time. The fire remained in a post-flashover state until the initial fire department action. The exterior suppression action caused temperatures in the fire room to decrease.

Approximately 470 s post ignition (48 s after exterior suppression was started), temperatures began to increase, starting with those closest to the ceiling and followed by the temperatures closer to the floor. Interior suppression from the fire room doorway permanently decreased the temperatures in the fire room.

Figure 3.141: Fire room (bedroom 3) temperature data for Experiment 12. Blue vertical bars indicate time and duration of water flow.
