Analysis of the Coordination of Suppression and Ventilation in Single-Family Homes

John Regan
Julie Bryant
Craig Weinschenk

UL Firefighter Safety Research Institute
Columbia, MD 20145

March 19, 2020

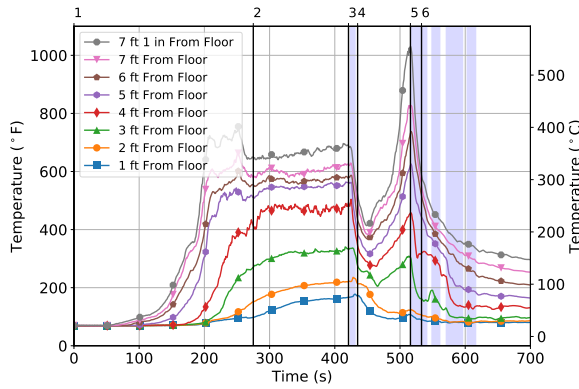
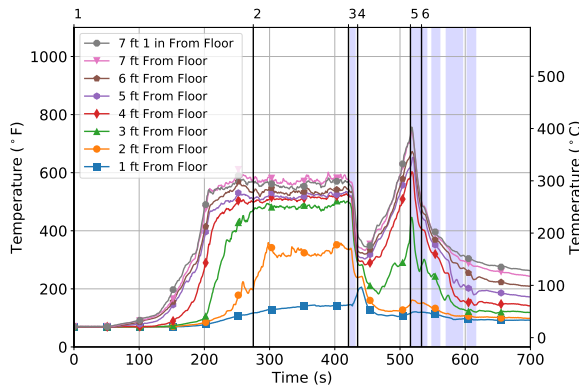
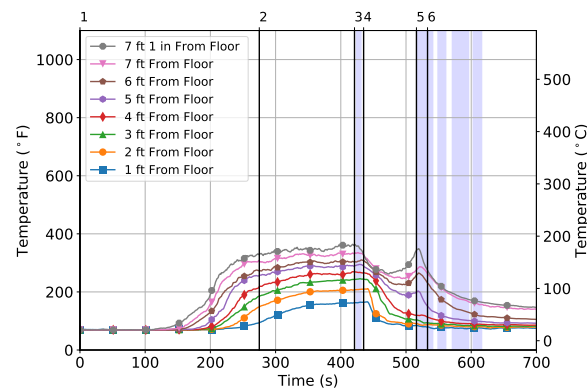
Temperatures in both hallway locations began to increase as smoke began to spill from the fire room (bedroom 3) into the hallway. These temperatures increased more rapidly as fire vented into the hallway approximately 187 s post ignition. Both measurement locations reached a peak corresponding with flashover and maintained steady values in the time leading up to fire department intervention. The temperatures in the hallway locations outside bedroom 1 (see Figure 3.142a) were greater than those between bedrooms 2 and 3. Temperatures at this location ranged between 165 °F, 1 ft above the floor, and 685 °F, 7 ft 11 in. above the floor, at the time of intervention. Exterior suppression reduced temperatures in the hallway to 95 °F 1 ft above the floor and to 420 °F 7 ft 11 in. above the floor. The decrease in temperatures was temporary, as the 3 ft through 7 ft 11 in. temperatures increased approximately 450 s post ignition (29 s after exterior suppression began).

The temperatures higher than 3 ft continued their increase until the suppression crew reached the fire room doorway and began interior suppression, reaching peaks ranging from 300 °F at 3 ft to 1025 °F at 7 ft 11 in. The temperatures 3 ft and above permanently decreased as suppression continued. Meanwhile, the 1 ft and 2 ft temperatures continued to decrease as fresh air from the open front door flowed up the stairs, through the hallway, and into the fire room.

Figure 3.142: Temperatures in open areas of second-floor of structure for Experiment 12. Blue vertical bars indicate time and duration of water flow.

The temperatures in the hallway outside bedroom 2 (see Figure 3.142b) were less than outside bedroom 1, ranging from 140 °F at 1 ft to 594 °F, at 7 ft 11 in., at the time of intervention. Exterior suppression dropped the temperatures from the 2 ft through 7 ft 11 in. temperatures, while the 1 ft temperature at this location increased slightly from 145 °F to 205 °F. Like the temperatures at the other hallway location, the temperatures 3 ft and above increased at 450 s as the fire regrew, while the 1 ft and 2 ft temperatures decreased because of the fresh air being entrained into the fire room. The hallway temperatures peaked between 445 °F at 3 ft and 755 °F at 7 ft 11 in. The peak temperatures at both hallway measurement locations corresponded to fire venting from the fire room into the hallway as the suppression crew began interior suppression shown in Figure 3.143.

Bedroom 1 temperatures followed a similar trend to temperatures in the hallway and fire room (bedroom 3), although the magnitude of the temperatures were lower because of the proximity to the fire room. Exterior suppression decreased the temperature at all elevations, but the effect was not as pronounced as in the hallway. When temperatures began to increase due to fire regrowth, only the temperatures 5 ft and above began to increase. This is likely because of both the distance from the fire room and the additional horizontal ventilation that occurred at 435 s after ignition (Event 4). All temperatures decreased toward pre-ignition conditions when interior suppression was initiated.

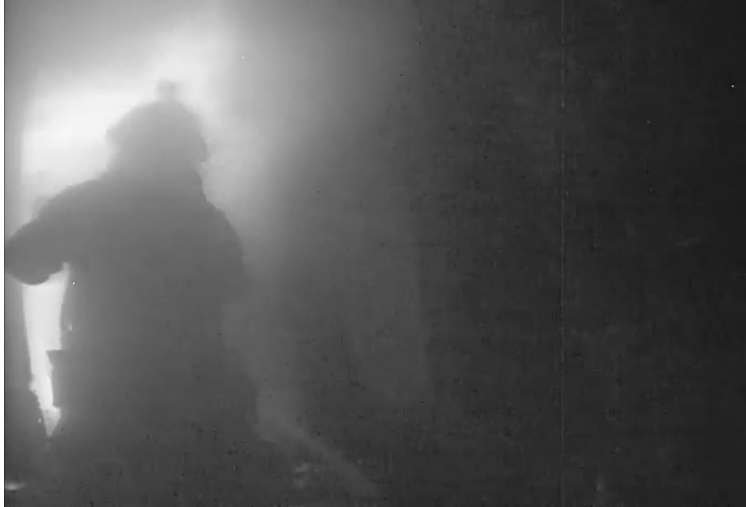
Figure 3.143: Fire conditions meeting suppression crew in hallway outside bedroom 3.

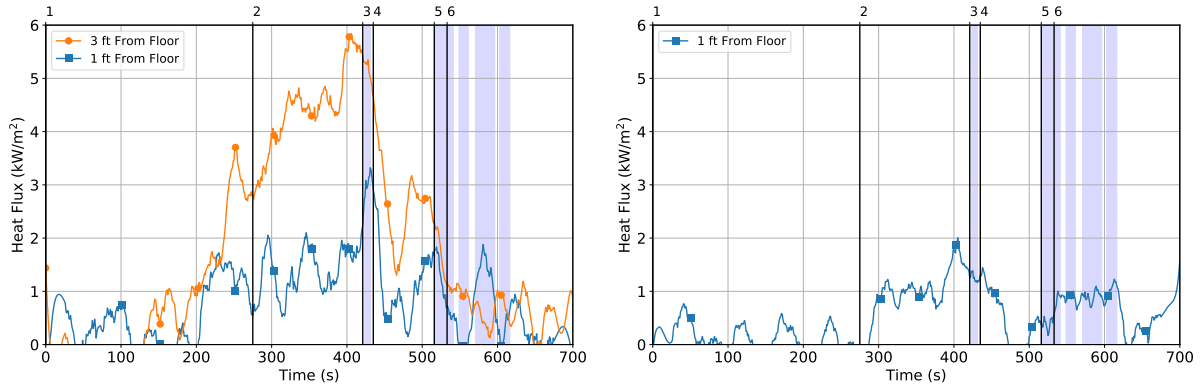
The heat flux, measured 1 ft and 3 ft above the floor in the hallway and 1 ft above the floor in bedroom 1, followed a similar trend to the temperatures at those locations. Heat flux at both locations in the hallway (see Figure 3.144a) increased shortly before flashover as fire was observed venting into the hallway. Heat flux increased until fire department intervention, peaking at 3 kW/m^2 and 6 kW/m^2 at 1 ft and 3 ft, respectively. Suppression reduced the 1 ft and 3 ft heat fluxes to 1 kW/m^2 and 2 kW/m^2 , respectively. Fire regrowth 450 s post ignition increased heat flux to final peaks of 2 kW/m^2 and 3 kW/m^2 , respectively. Final suppression reduced the heat flux at both elevations to negligible values. The heat flux in bedroom 1, shown in Figure 3.144b, was significantly less than the corresponding height in the hallway, reaching a peak of 2 kW/m^2 shortly before fire department intervention. Suppression decreased the heat flux below 1 kW/m^2 for the remainder of the experiment.

Figure 3.144: Heat flux at remote locations for Experiment 12. Blue vertical bars indicate time and duration of water flow.

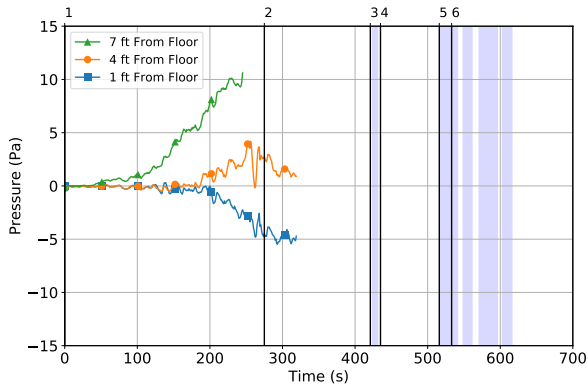
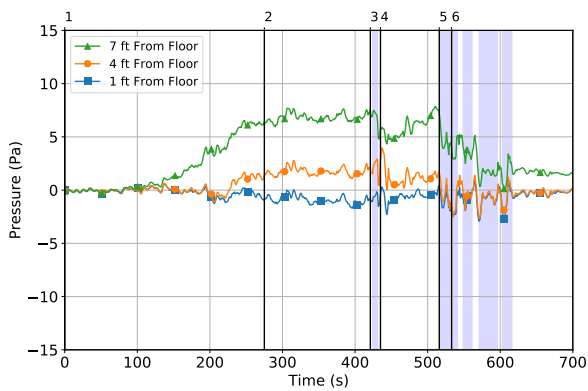
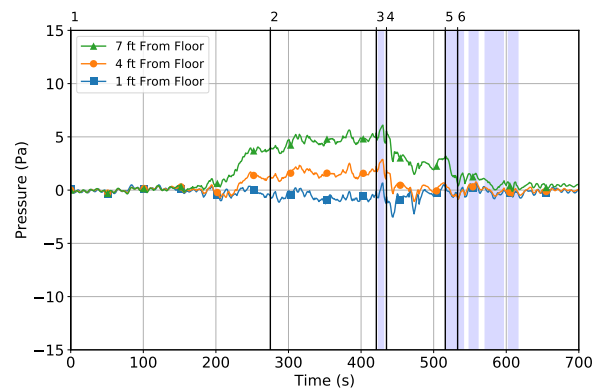
The increase in fire room (bedroom 3) pressure mirrored the increase in temperatures described previously (see Figure 3.145a). The 7 ft pressure in the fire room increased approximately 30 s post ignition as a smoke layer developed in the fire room. As the fire continued to grow, the 4 ft pressure increased and the 1 ft pressure decreased, indicating bi-directional flows were created in the fire room windows and doorway. Fresh air was entrained through the lower portion and hot gases were exhausted through the top portion of these ventilation openings. The 7 ft, 4 ft, and 1 ft pressures experienced errors at 245 s, 328 s, and 319 s, respectively. Therefore, this data is not shown.

Figure 3.145: Second-floor pressures during Experiment 12. Blue vertical bars indicate time and duration of water flow.

Bedroom 1 pressures also followed a similar trend, although the magnitude of the pressures were lower. Fresh air entrained through the windows caused both the 1 ft and 4 ft pressures to decrease below 0 Pa.

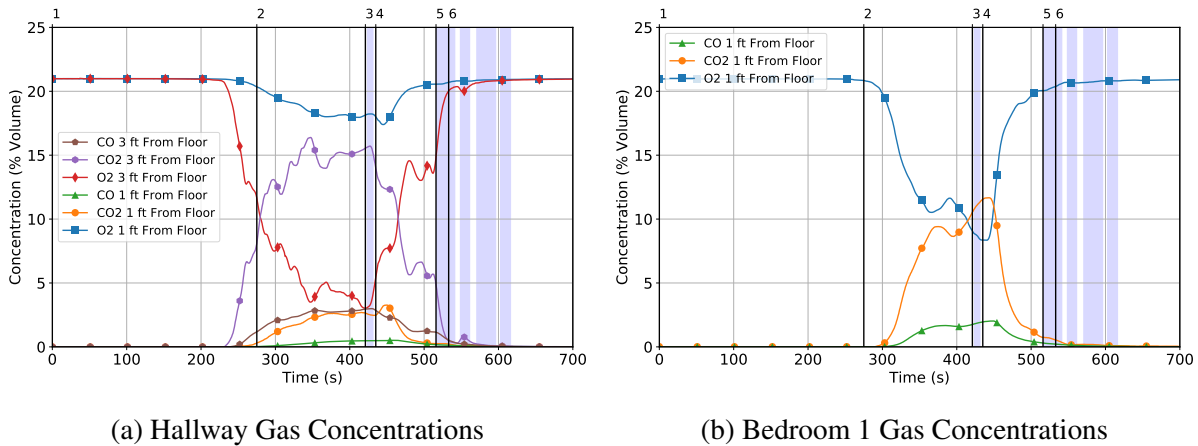
ventilation on potential trapped occupants. As the fire grew and smoke filled the hallway, the O₂ concentrations decreased, while CO₂ and CO concentrations increased. The 3 ft gas concentrations increased approximately 225 s post ignition and continued to increase through the post-flashover period, reaching steady values of 4%, 16%, and 3% for O₂, CO₂, and CO, respectively. The exterior suppression action and ventilation sequence caused the 3 ft O₂ to increase and the 3 ft CO₂ and CO to decrease. The improvement in conditions was halted approximately 480 s post ignition as the fire regrew. Interior suppression from the fire room doorway caused the 3 ft gas concentrations to rapidly trend to ambient.

Figure 3.146: Gas concentrations at remote locations for Experiment 12. Blue vertical bars indicate time and duration of water flow.

Since the 1 ft gas concentration measurement port in bedroom 1 was not located in the fresh air portion of the flow path, gas concentrations reached notably lower peak O₂ volume percent and greater CO₂ and CO volume percent than the corresponding elevation in the hallway. The gas concentrations first started to increase approximately 290 s post ignition, at around the same time the camera in this room lost visibility. At the time of fire department intervention, the O₂ was still decreasing and CO₂ and CO were still increasing, and had values of 9%, 11%, and 3%, respectively. The gas concentrations continued to decrease and increase through exterior suppression. After the bedroom 1 windows were horizontally ventilated and the front door was opened, the gas concentrations reached a peak and began to trend to ambient with 10 s.

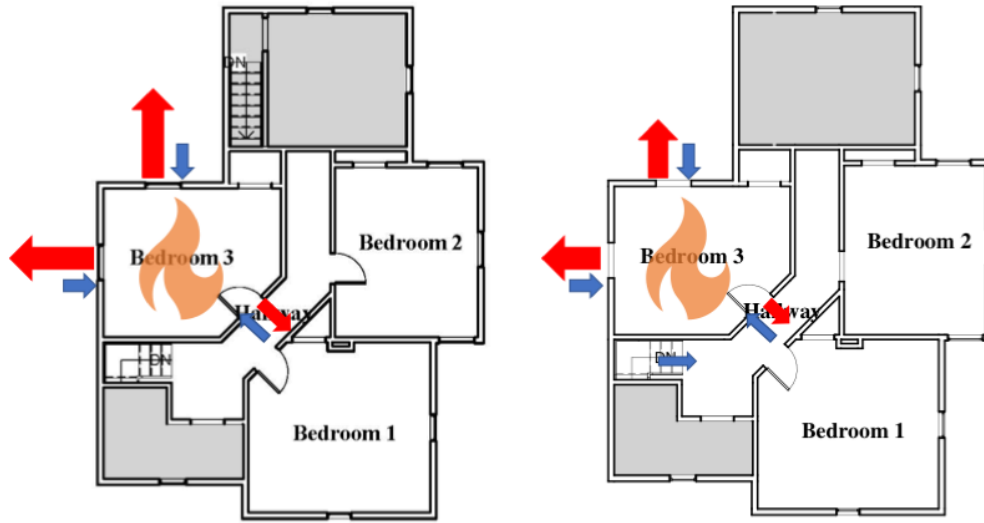
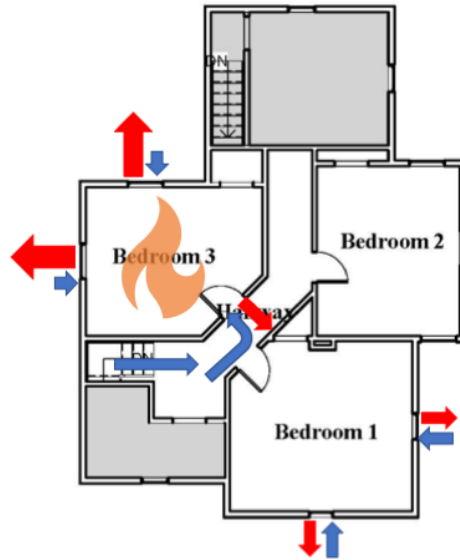
The increase and decrease in temperatures and toxic gas concentrations highlights the changes in gas flow over the course of the experiment, shown in Figure 3.147. As the fire became ventilation-limited, bi-directional flows were established through the fire room windows and doorway (see Figure 3.147a). Fresh air from the exterior of the structure was entrained into the windows, while hot gases were exhausted to the exterior. Similarly, fresh air was entrained from remote areas of the first and second-floors through the fire room doorway and were replaced with smoke. When the front door was opened, a flow path was created from the front door to the fire room (see Figure 3.147b), along which fresh air was entrained, keeping temperatures and gas concentrations low. Additionally, flow paths were created through the bedroom 1 windows, which allowed smoke trapped in this room to exhaust and be replaced with fresh air (see Figure 3.147c). Eventually, temperatures increased again as the effect of suppression subsided and the additional air provided by the ventilation action allowed the fire to regrow before final suppression resulted in a permanent decrease in temperatures.

Figure 3.147: Changes in flow during Experiment 12. Red arrows indicate flow out of the compartment, blue arrows indicate entrainment into the compartment, and the sizes of the arrows indicate the relative magnitude of the flow through each opening.

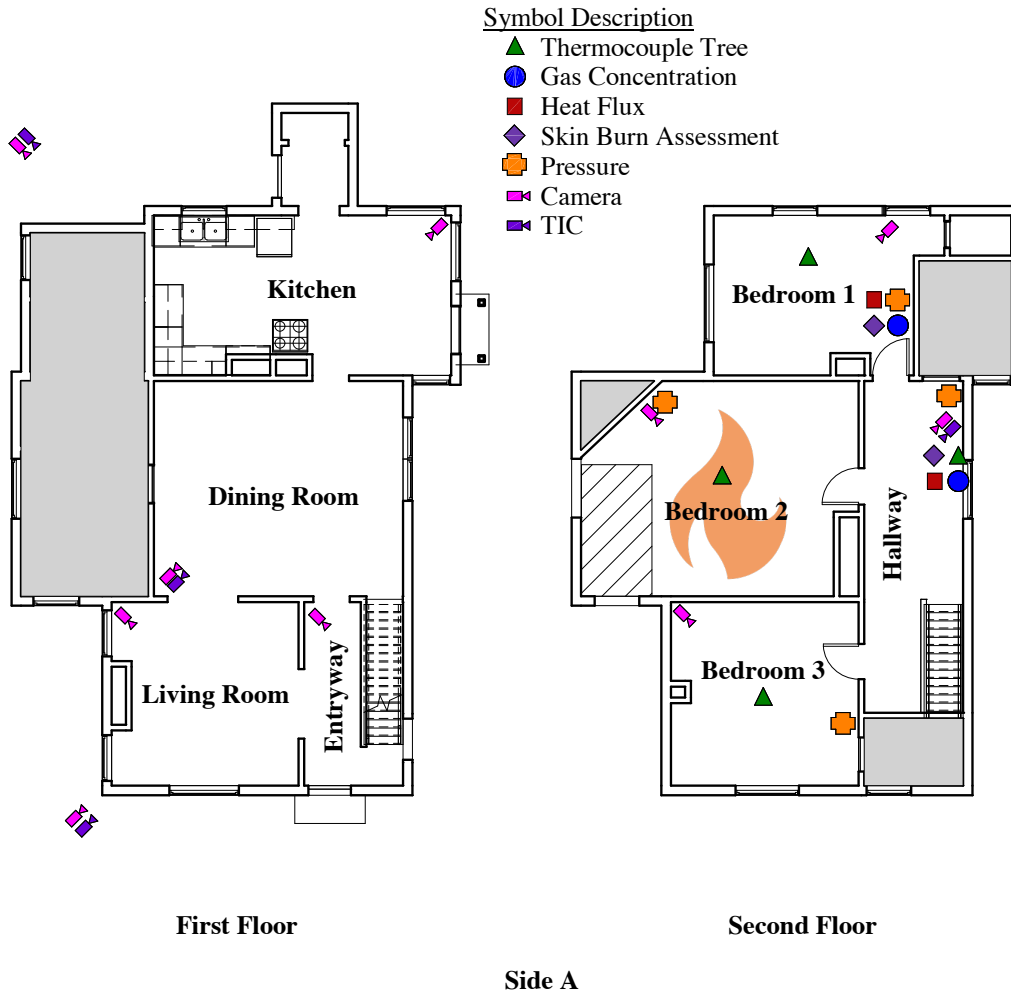
Figure 3.149: Instrumentation and floor plan for Experiment 13. The gray areas were isolated from the remainder of the structure and utilized as space for instrumentation. The diagonal hatched box indicates the size and location of the failed ceiling.

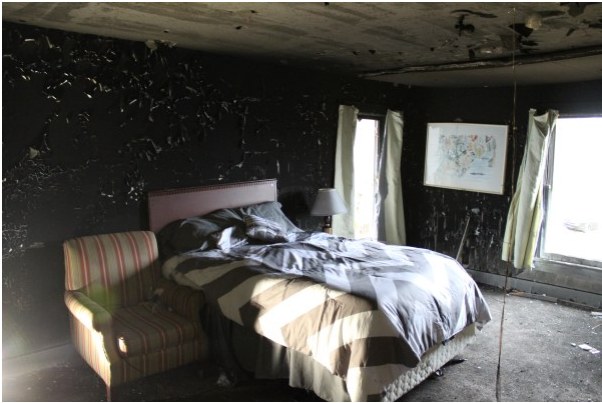
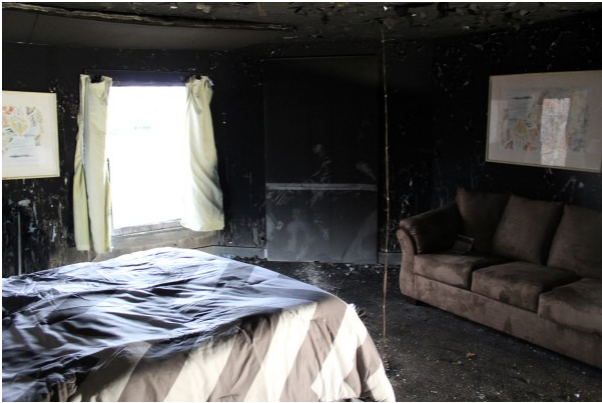
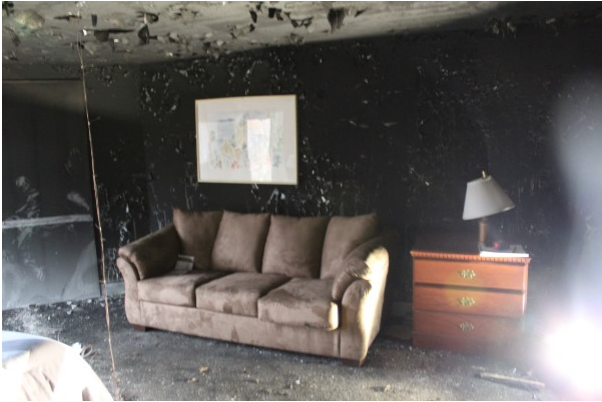
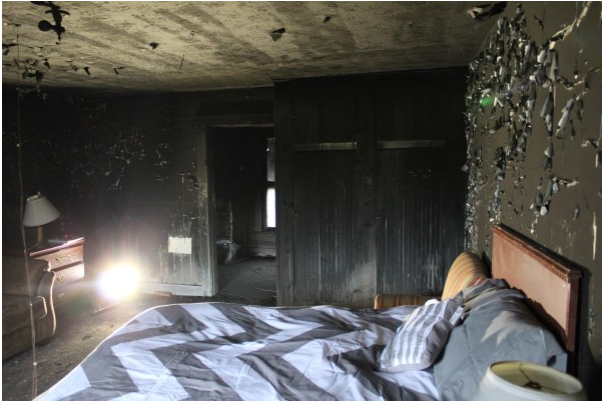
Figure 3.150: Interior photographs of fire room for Experiment 13.

The fire room (bedroom 2) was furnished with the standard bedroom fuel package described in Section 2.4.1. The fuel package was increased to also contain a sofa, described in Section 2.4.1. Photographs of the fire room prior to ignition are presented in Figure 3.150. A dimensioned layout

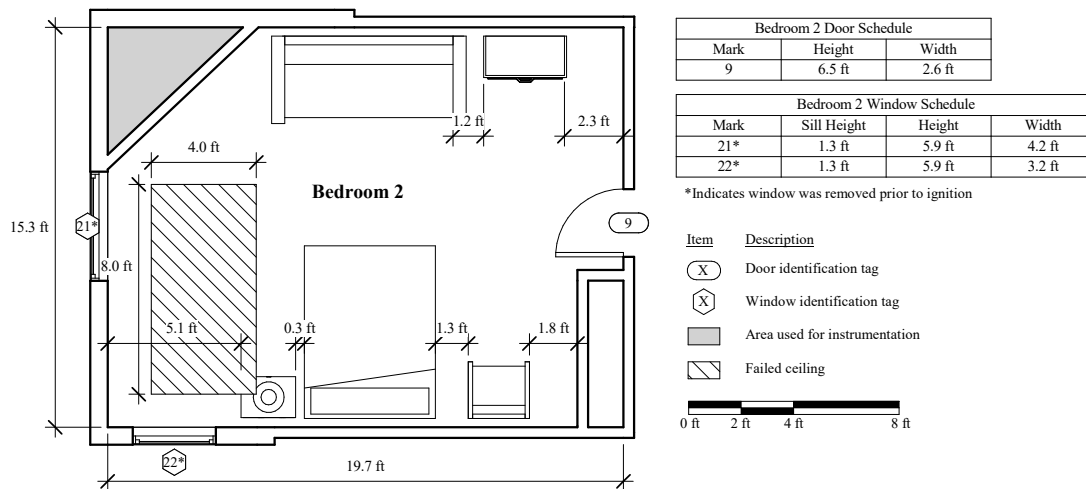
Figure 3.151: Fire room layout for Experiment 13. The diagonal hatched box indicates the size and location of the failed ceiling.

of the fire room is included in Figure 3.151. The windows located on the side A and side B of the structure were left open (numbered 21 and 22 in Figure 3.151) to ensure repeatable fire growth.

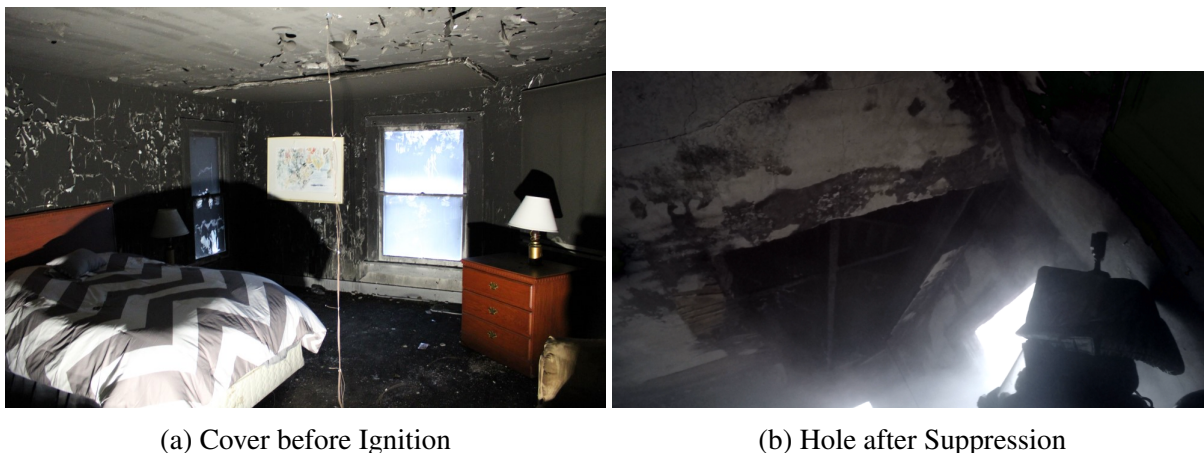
Figure 3.152: Interior photographs of the failed ceiling prior to ignition (see Figure 3.152a) and after suppression (see Figure 3.152b) for Experiment 13.

Experiment 13 examined the effectiveness of two different exterior water flow techniques during a failed ceiling scenario followed by interior water flow to extinguish the fire. The first exterior water flow technique utilized a straight stream directed into the fire room's failed ceiling, resulting in a steep angle between the stream and the ceiling. The second exterior water flow technique utilized a straight stream directed onto the side B window lintel (window header), at steep angle between the stream and the lintel. A 8 ft by 4 ft ceiling hole was cut and removed in the fire room (bedroom 2). A 9 ft by 5 ft drywall-plywood cover was placed over the hole and sealed within insulation to prevent air leakage. The cover was constructed to be removed remotely by the ventilation crew located outside the structure. The cover was removed after ignition but before any fire department intervention, replicating a failed ceiling. The cover before ignition and hole after suppression are presented in Figure 3.152.

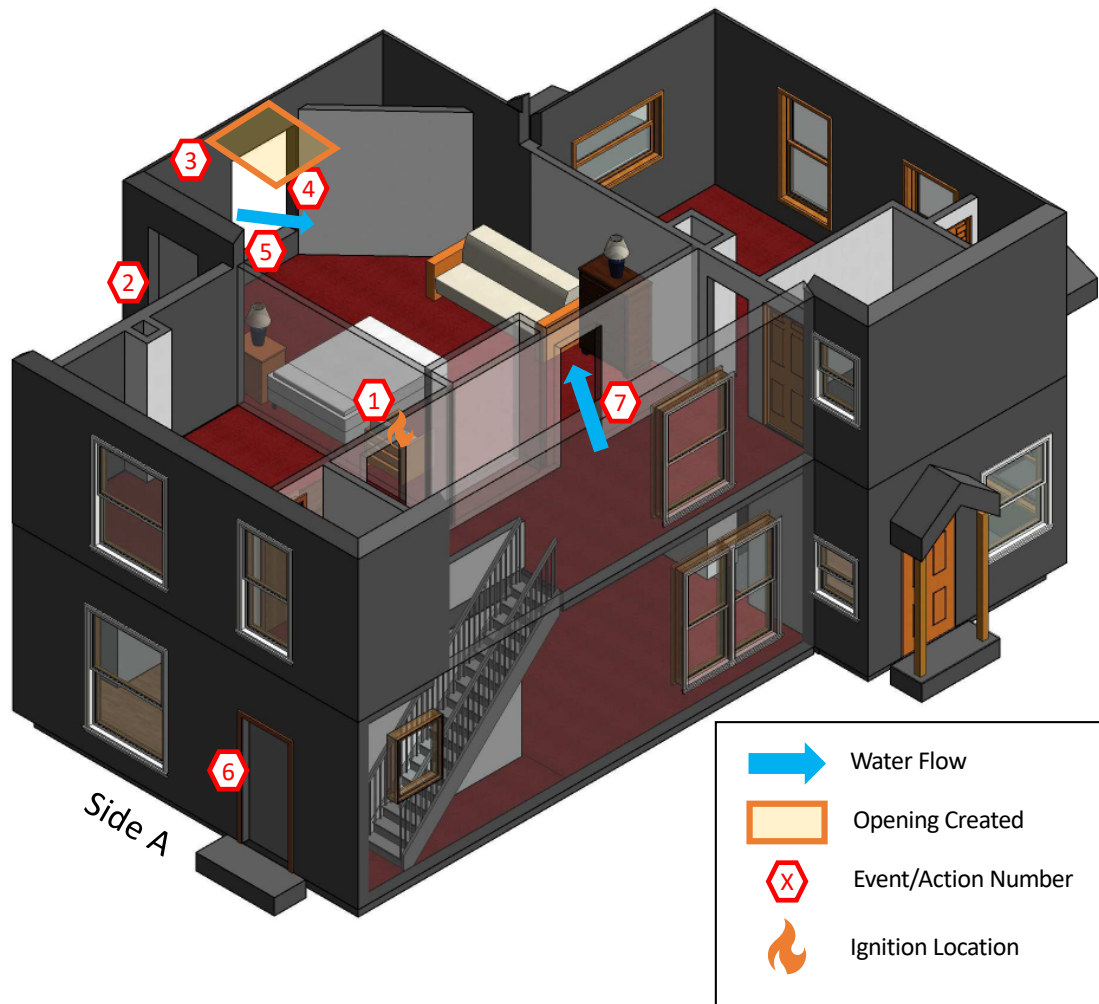
Action/Event	Time (mm:ss)	Time (s)
1 Ignition	00:00	0
2 Flashover	04:47	287
3 Ceiling Failure	06:00	360
4 Exterior Flow - Ceiling	07:00	420
5 Exterior Flow - Lintel	12:00	720
6 Front Door Open	12:31	751
7 Interior Flow	13:45	825

Figure 3.153: Time and sequence of actions and events for Experiment 13.

Two 1.75 in. hoselines both with a combination nozzle set to straight stream were used during this experiment. The primary hoseline was placed on side B of the structure and used to apply water to the fire from the exterior and extinguish exterior surface flames. The secondary hoseline was placed on side A of the structure and advanced inside to apply water from the interior. Figure 3.153 indicates the time and sequence of fire department interventions along with an isometric drawing of the structure.

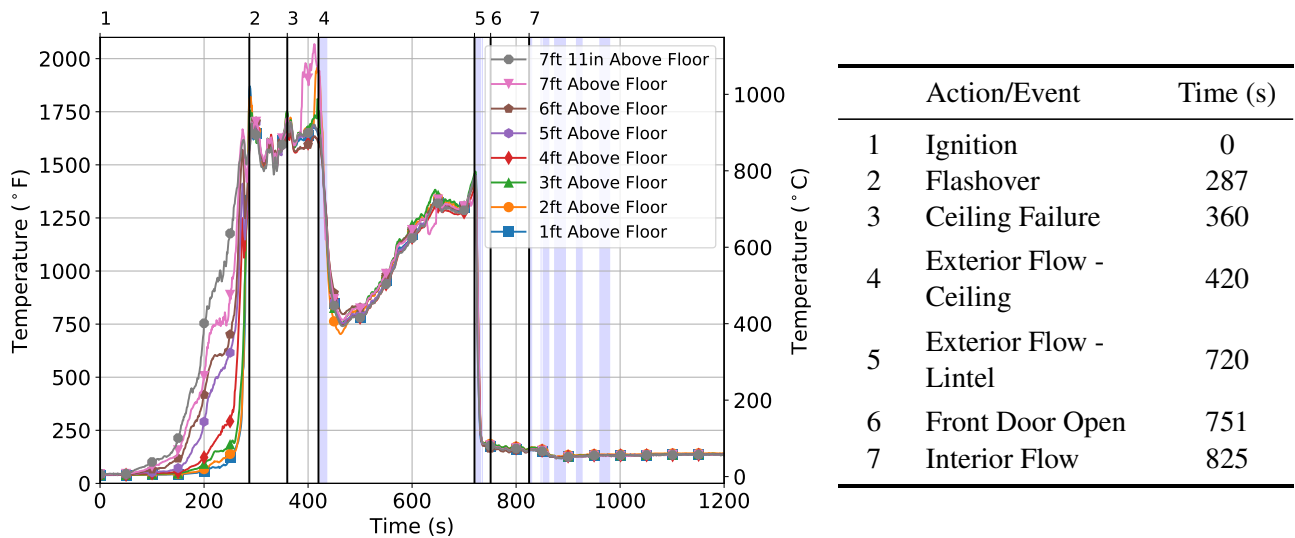
Figure 3.154: Fire room (bedroom 2) temperatures for Experiment 13. Blue vertical bars indicate time and duration of water flow.

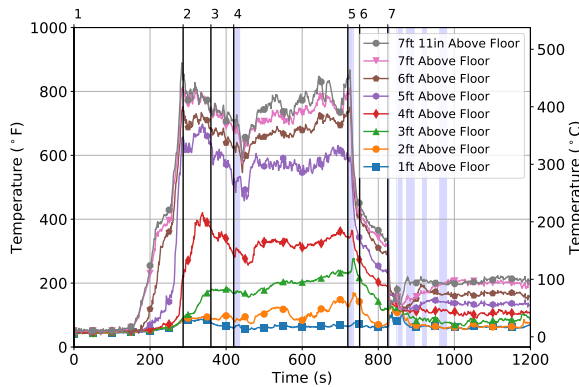
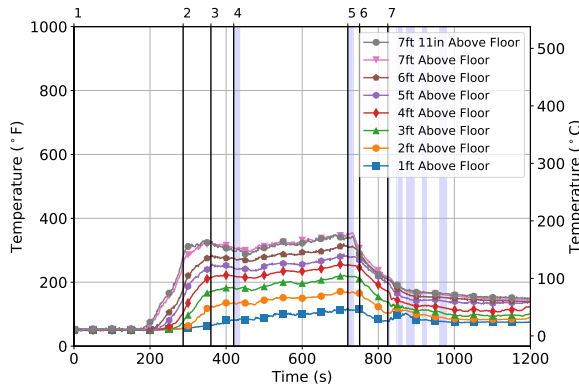
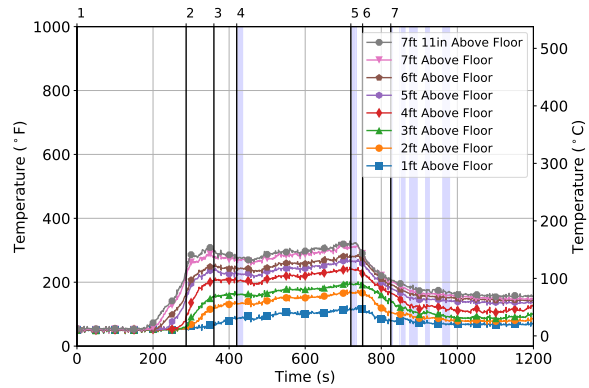
Temperature data for locations on the second-floor are presented in Figure 3.155. Hallway temperatures were greater than bedroom temperatures. Hallway temperatures 5 ft and above began to increase approximately 180 s post ignition. This corresponded to the smoke layer exhausting into the hallway. All temperatures increased just prior to flashover in the fire room at 287 s. Temperatures 4 ft and below continued to increase after flashover, while temperatures above 4 ft became steady. Temperatures remained steady until the second exterior water application. Bedroom 1 and bedroom 3 temperatures behaved similarly. Temperatures increased in both locations approximately 200 s post ignition. Following flashover in the fire room at 287 s post ignition, temperatures within the structure became steady. A decrease in remote temperatures did not occur until after the second exterior water flow occurred at 720 s post ignition. Temperatures returned to pre-ignition conditions after interior water flow at 825 s post ignition.

Figure 3.155: Second-floor temperatures (hallway, bedroom 1 and bedroom 3) for Experiment 13. Blue vertical bars indicate time and duration of water flow.

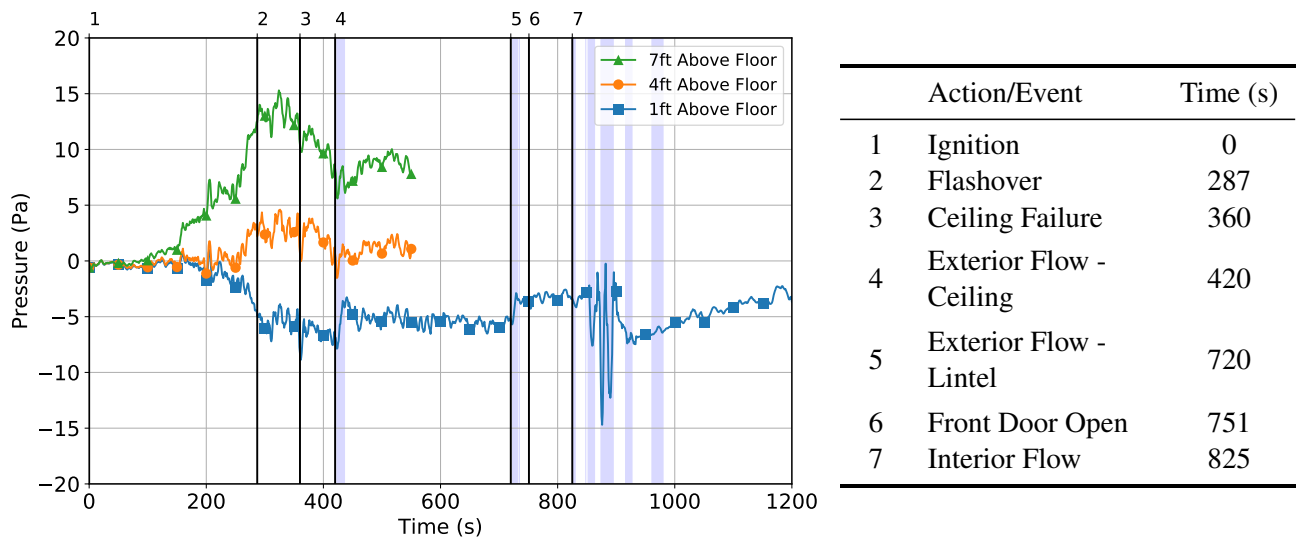
Figure 3.156: Pressures in the fire room (bedroom 2) for Experiment 13. Blue vertical bars indicate time and duration of water flow.

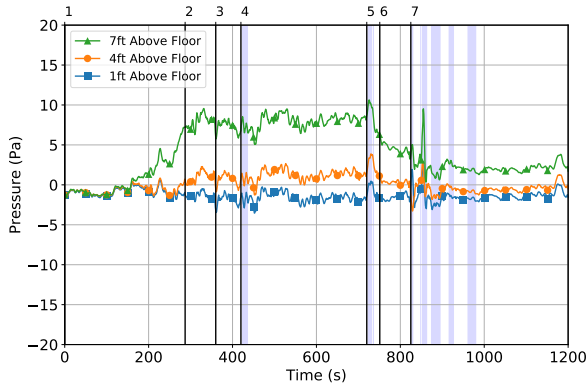
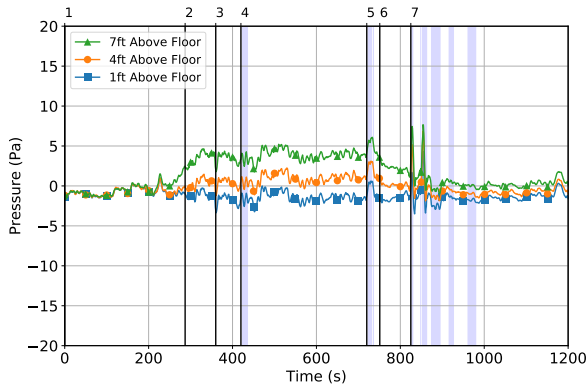
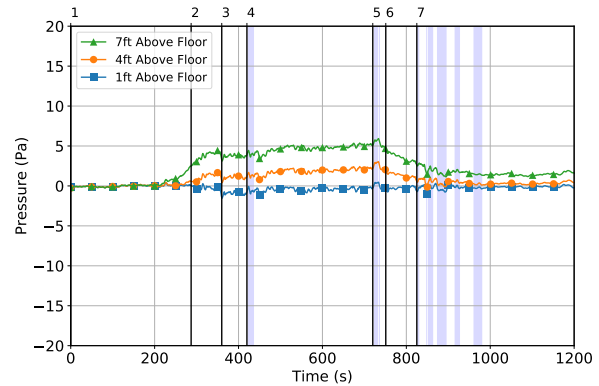
Pressures remote from the fire room (hallway, bedroom 1, and bedroom 3) indicate a bi-directional flow of gases throughout the structure. Pressure at all three remote locations began to change approximately 200 s post ignition as the smoke traveled throughout the structure. The 7 ft elevation was highest in the hallway as it was closest to the fire room. The positive pressure at the 7 ft elevation indicates gas expansion at the ceiling. Pressure at the 4 ft elevation remained at atmospheric until flashover, when it increased with the smoke layer descent. Pressure at the 1 ft elevation was lowest in the hallway because it was closest to the fire room. Pressure at the 1 ft elevation became negative, indicating air entrainment throughout the structure toward the fire room (bedroom 2). After flashover, pressures within the structure became stable. After the second exterior water application, pressures at all locations and elevations began to return to atmospheric pressure.

Figure 3.157: Pressure remote from the fire room for Experiment 13. Blue vertical bars indicate time and duration of water flow.

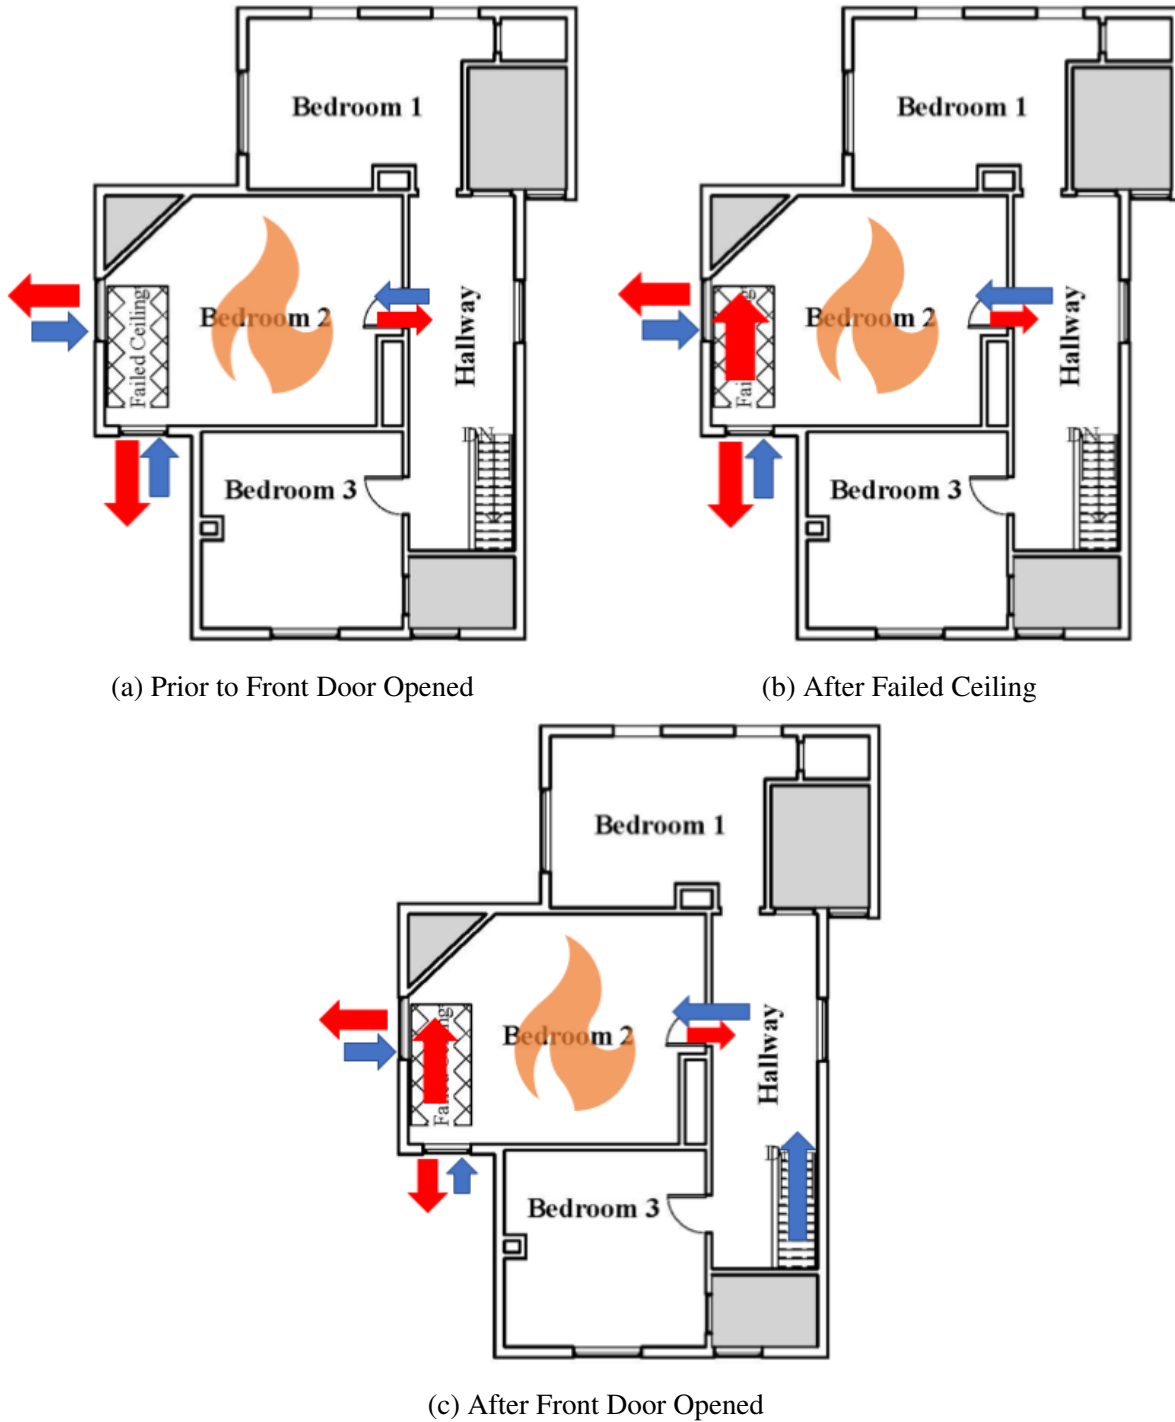
Figure 3.158: Changes in flow path for Experiment 13. The red arrows indicate flow out of the compartment, the blue arrows indicate entrainment into the compartment, and the sizes of the arrows indicate the relative magnitude of the flow through each opening.

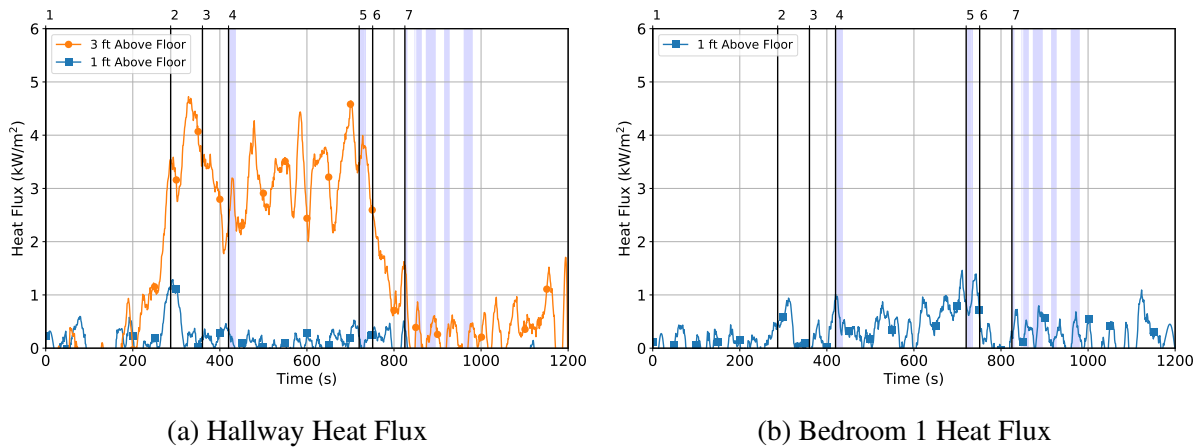
in Figure 3.159. The hallway heat flux was measured at 1 ft and 3 ft elevations above the floor. Heat flux first began to increase approximately 200 s post ignition. Heat flux at both elevations increased just prior to flashover at 287 s. The 3 ft elevation was greater than the 1 ft elevation because this elevation was closer to the smoke layer. After flashover, the 1 ft elevation decreased back to atmospheric conditions and remained constant throughout the remainder of the experiment. The 3 ft elevation increased until the simulated ceiling failure. After which, the 3 ft heat flux decreased and remained steady until the second exterior water flow application. The 3 ft elevation began returning to atmospheric conditions before interior water flow.

The bedroom 1 heat flux was measured at the 1 ft elevation above the floor. Heat flux remained below 1 kW/m² for the majority of the experiment as the measurement location was more remote from the fire room than the hallway. There was a peak around 1.5 kW/m² prior the second exterior water flow application and dropped following the front door being opened.

Figure 3.159: Heat flux versus time in the hallway and bedroom 1 for Experiment 13. Blue vertical bars indicate time and duration of water flow.

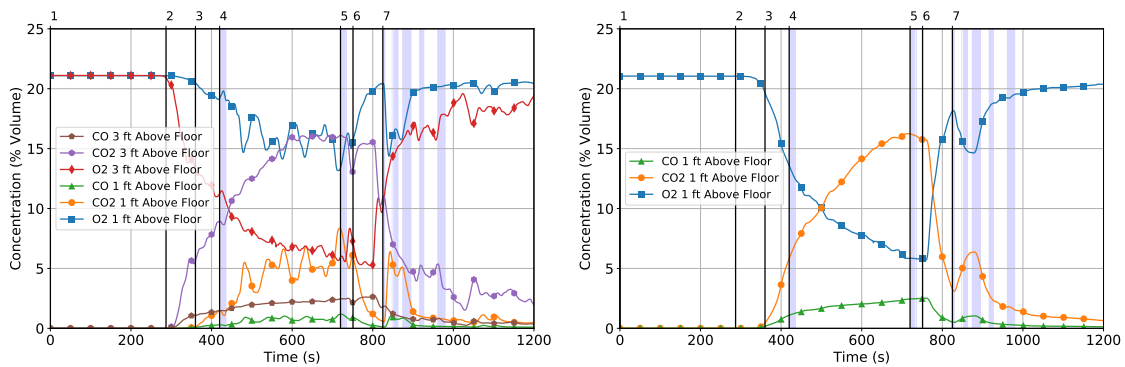
Bedroom 1 gas concentrations did not begin to change until the ceiling failure in the fire room. The ceiling failure led to increased mixing of gases which brought smoke to the 1 ft elevation. Gas concentrations did not improve at either measurement location following the first exterior water application though conditions did improve after the second exterior water application and the front door was opened. After the first interior water flow at 825 s post ignition mixing led to gas concentrations to worsen, but conditions began returning to pre-ignition conditions after the second interior water flow at 842 s after interior suppression.

(a) Hallway Gas Concentrations

(b) Bedroom 1 Gas Concentrations

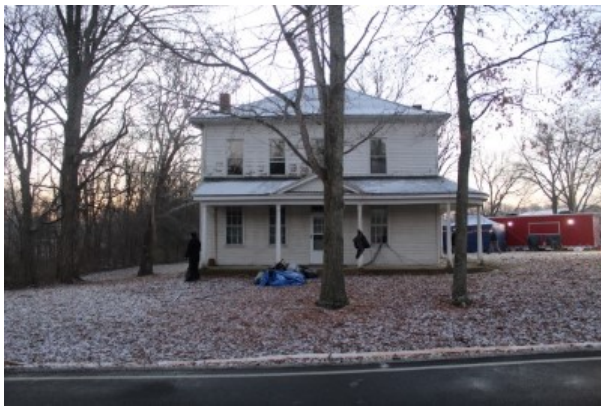
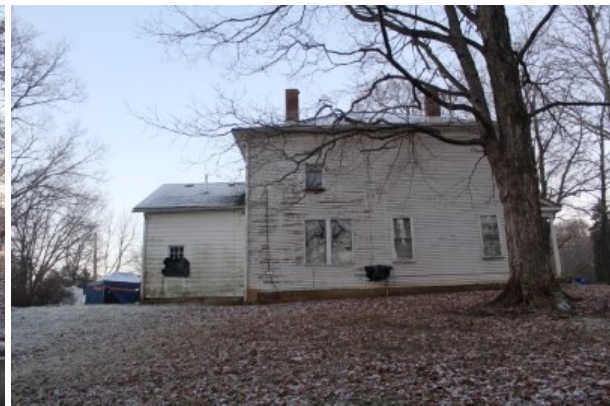
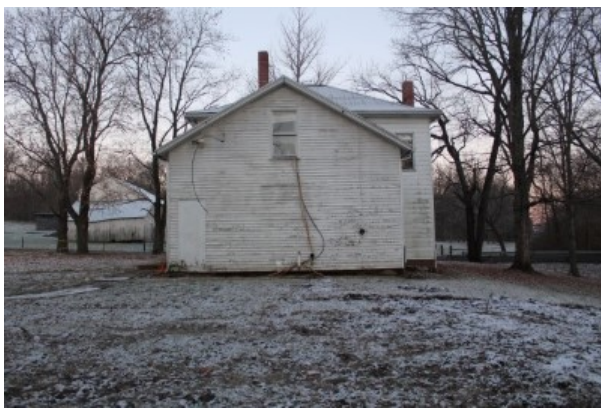
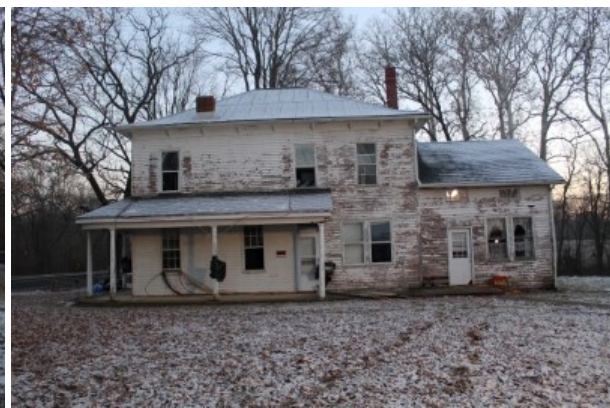
Experiment 14 was conducted to evaluate exterior suppression with a failed fire room ceiling followed by a transition to interior suppression; this experiment used Coordination Method 4. At 1030 Hilltop Road in Xenia, Ohio, a two-story, 2,200 sq ft wood frame structure was instrumented to conduct this second-floor bedroom fire experiment. The four exterior sides of the structure appear in Figure 3.161. The structure was stick-built with rough cut lumber framing with wood-slat siding. The foundation was a combination of block and stone. The original house had a hip-style tin roof supported by wood members and the rear addition had a peaked roof constructed using 1 in.-by-6 in. sheathing covered with asphalt shingles. Detailed dimensioned drawings for the first and second story appear in Appendix Figures B.12 and B.13, respectively.

Figure 3.161: Exterior photographs of the structure for Experiment 14.

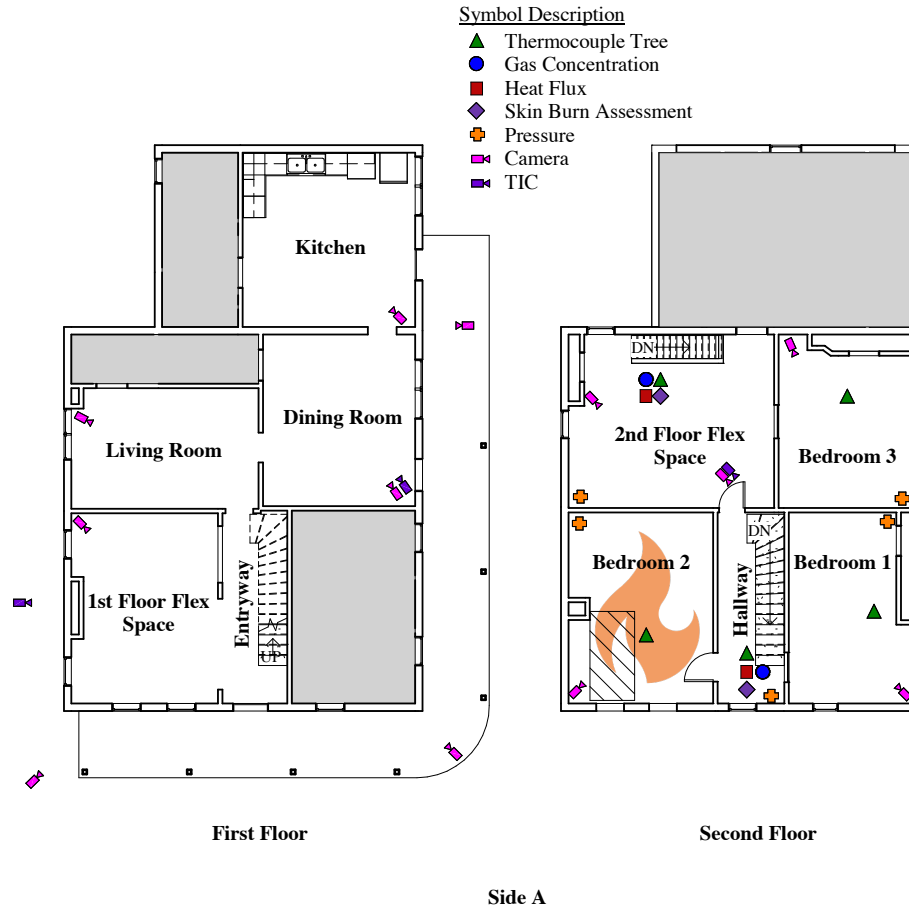
Figure 3.162: Instrumentation and floor plan for Experiment 14. The gray areas were isolated from the remainder of the structure and utilized as space for instrumentation. The diagonal hatched box indicates the size and location of the failed ceiling.

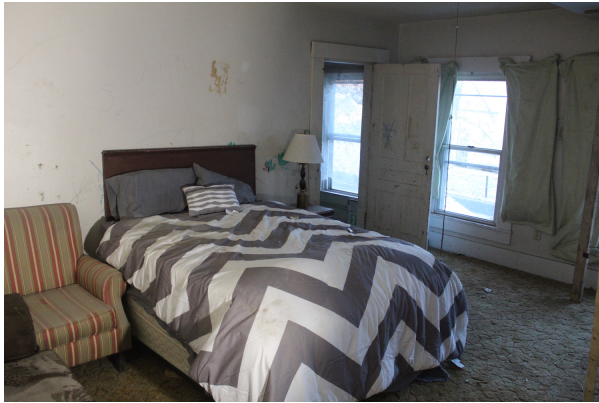
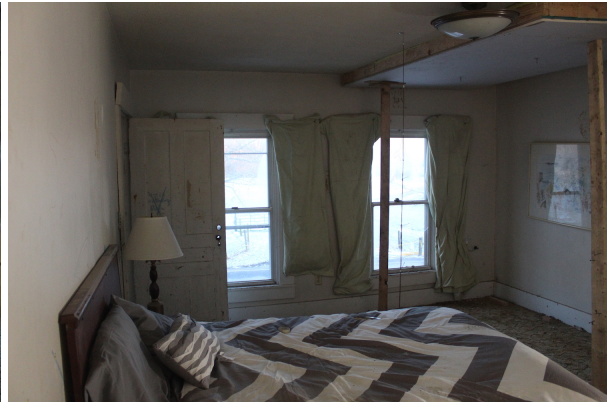
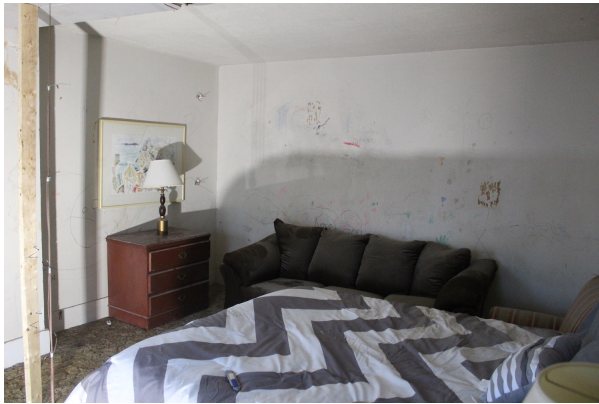
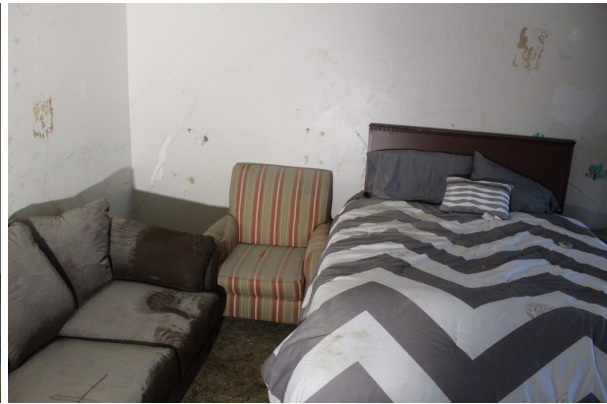
Figure 3.163: Interior photographs of fire room for Experiment 14.

The fire room (bedroom 2) was furnished with the standard bedroom fuel package described in Section 2.4.1. The fuel package was increased to also contain a sofa, described in Section 2.4.1. This fuel package included a mattress with associated frame, headboard, and furnishings, a nightstand, a dresser, an upholstered chair, an upholstered sofa, and two lamps. Photographs of the fire room prior to ignition are presented in Figure 3.163. A dimensioned layout of the fire room is included in Figure 3.164. To replicate a similar total structure volume found in other experiments, the doors to bedroom 1 and bedroom 3 remained closed throughout the experiment. To allow for

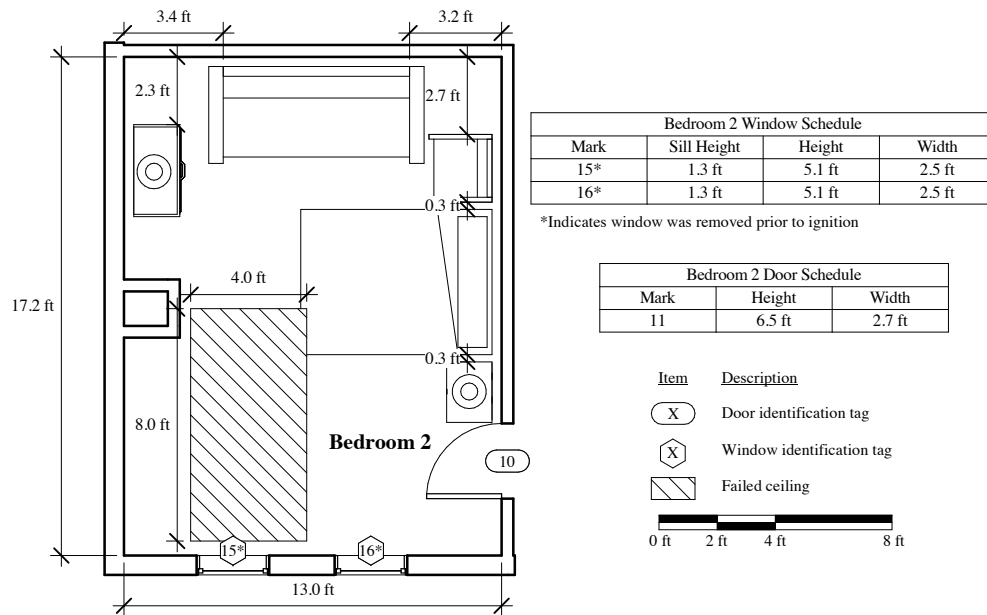
Figure 3.164: Fire room layout for Experiment 14. The diagonal hatched box indicates the size and location of the failed ceiling.

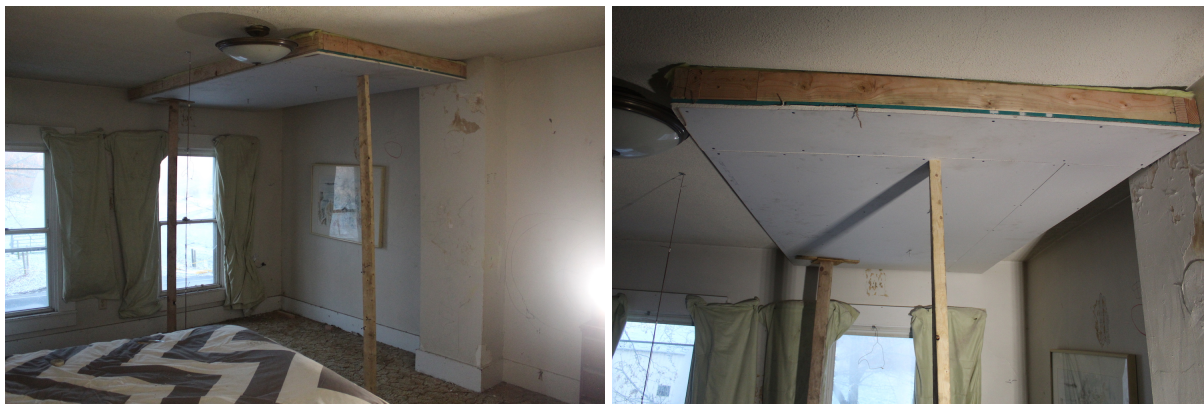
A 8 ft by 4 ft ceiling hole was cut and removed prior to ignition. A 9 ft by 5 ft drywall-plywood cover was placed over the hole and sealed within insulation to prevent air leakage. The cover was constructed to be removed from the exterior of the structure, replicating a failed ceiling. Figure 3.165 indicates the ceiling cover prior to ignition.

Figure 3.165: Interior photographs of the failed ceiling prior to ignition for Experiment 14.
