Analysis of the Coordination of Suppression and Ventilation in Single-Family Homes

John Regan
Julie Bryant
Craig Weinschenk

UL Firefighter Safety Research Institute
Columbia, MD 20145

March 19, 2020

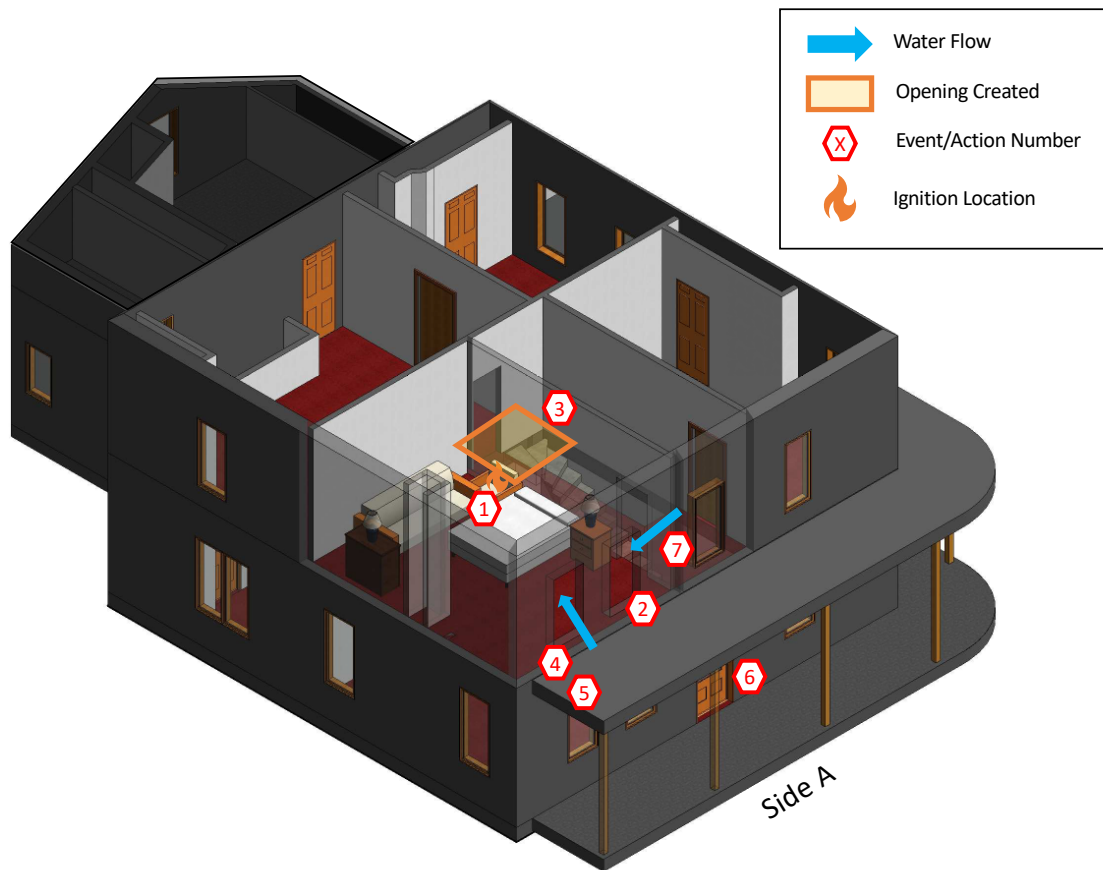
A single 1.75 in. hoseline with a combination nozzle set to straight stream was used to flow water from both the exterior and interior of the structure. The line was initially placed on side A for exterior suppression and moved inside the structure for interior suppression. Figure 3.166 shows the sequence of events with an isometric image of the structure.

Action/Event	Time (mm:ss)	Time (s)
1 Ignition	00:00	0
2 Flashover	04:21	261
3 Ceiling Failure	06:01	361
4 Exterior Flow - Ceiling	07:01	421
5 Exterior Flow - Lintel	09:02	542
6 Front Door Open	09:42	582
7 Interior Flow	10:36	636

Figure 3.166: Time and sequence of actions and events for Experiment 14.

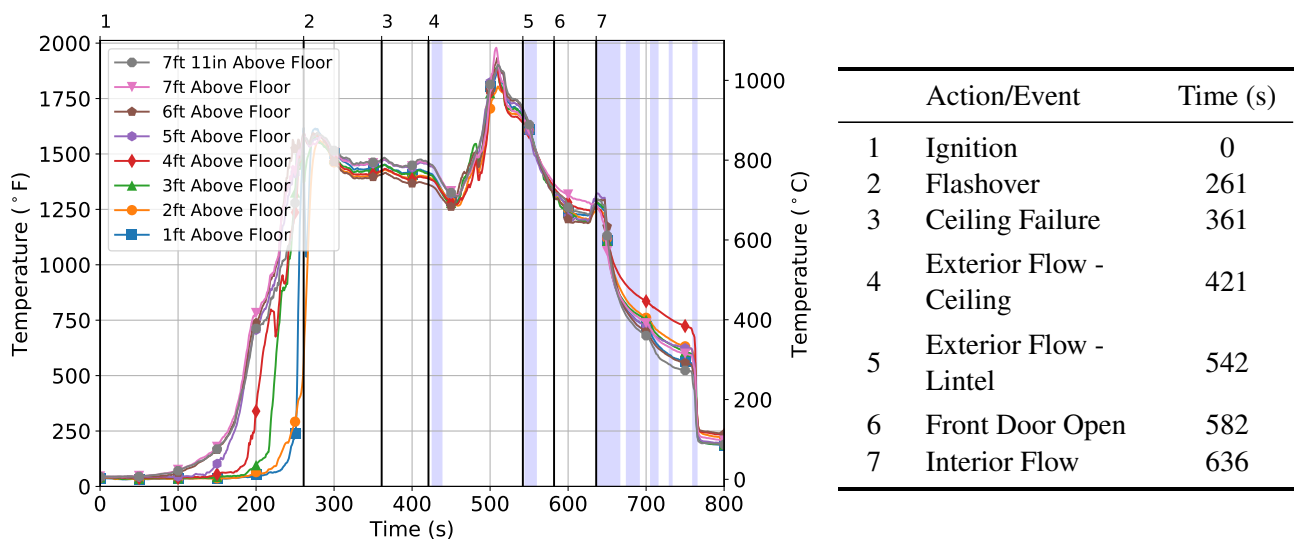
Figure 3.167: Fire room (bedroom 2) temperatures for Experiment 14. Blue vertical bars indicate time and duration of water flow.

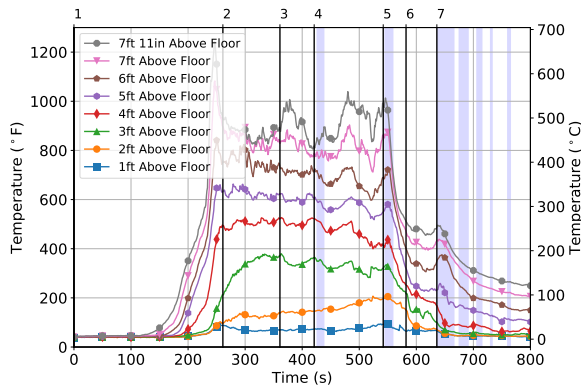
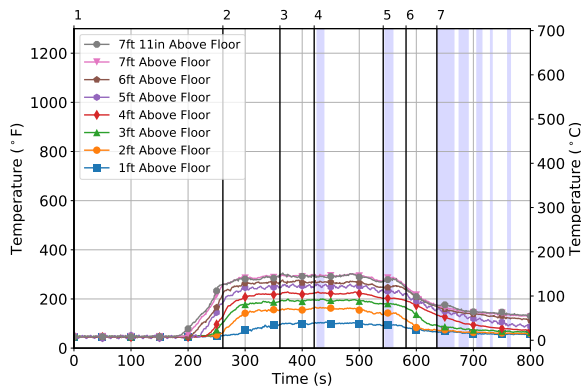
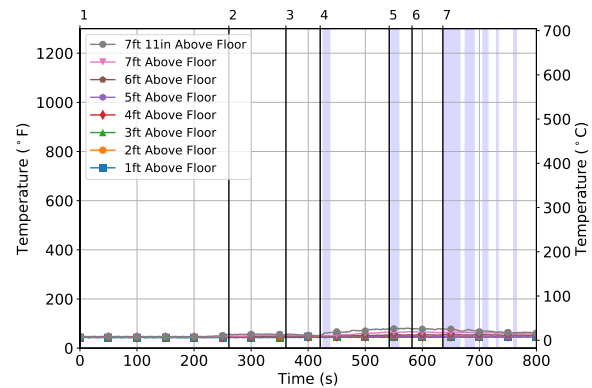
Temperatures throughout the structure began to increase as the fire grew. Figure 3.168 presents temperature data collected in remote locations of the structure. Hallway temperatures were greater than the flex space and bedroom 1 temperatures. Hallway Temperatures higher than 3 ft peaked during flashover, but temperatures below continued to increase after the fire room reached flashover. Exterior water directed off the lintel (window header) dropped temperatures through the hallway, with 5 ft and above having the largest decreases. Temperatures in the second-floor flex space also increased just prior to flashover within the fire room. These temperatures did not increase to hallway temperature magnitudes as the flex space was further from the fire room. The door to bedroom 1 remained closed, resulting in lower temperatures during experimentation.

Figure 3.168: Second-floor (hallway, flex space, and bedroom 1) temperatures for Experiment 14. Blue vertical bars indicate time and duration of water flow.

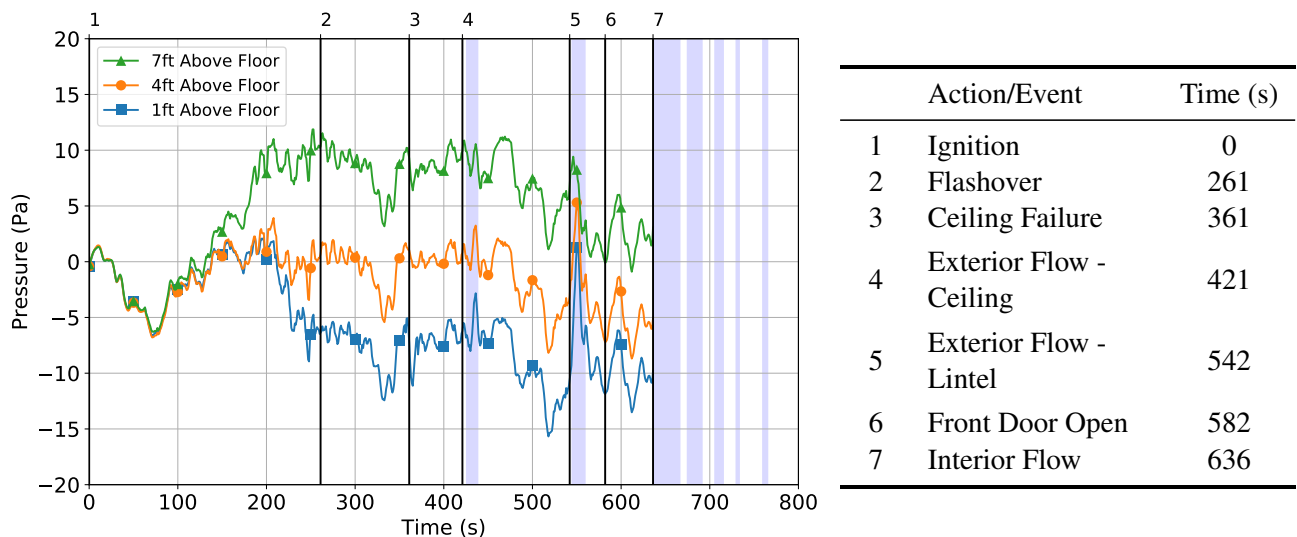
Figure 3.169: Pressures in fire room (bedroom 2) for Experiment 14. Interior suppression caused sensor error. Blue vertical bars indicate time and duration of water flow.

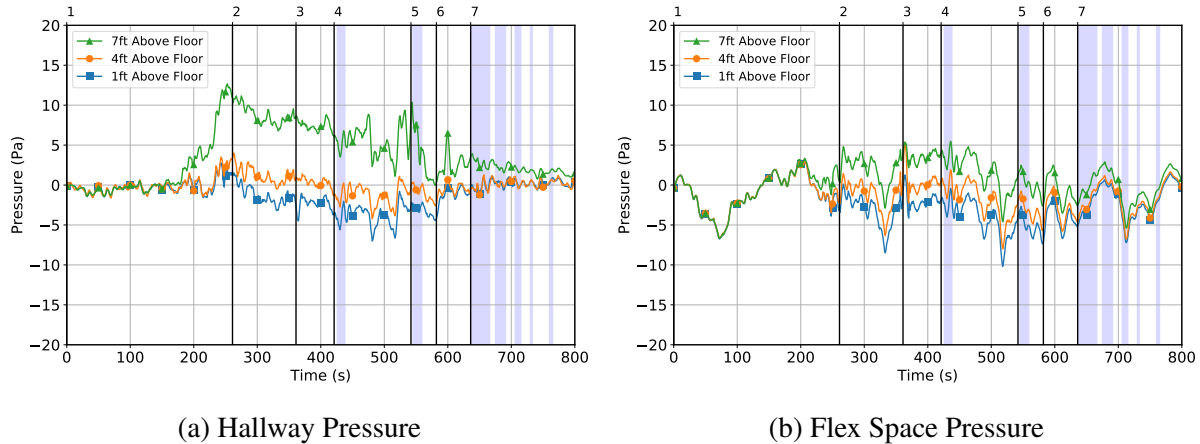
Pressures in the hallway and flex space were also monitored and are presented in Figure 3.170. The pressure in the hallway remained at atmospheric pressure at all three elevations until 190 s post ignition. The pressure at the 7 ft elevation increased as the smoke layer began to descend from the ceiling in the hallway. Pressure at the 4 ft and 1 ft elevations increased just prior to flashover, indicating exhaust of smoke. Post-flashover conditions created a bi-directional flow in the hallway. Pressure at the 7 ft elevation indicated the exhaust of smoke, while the pressure at the 1 ft elevation indicated entrainment of air. The pressure at the 4 ft elevation remained at atmospheric pressure, which indicated the presence of neutral plane. Pressures remained steady until the front door was opened. That ventilation caused the pressure at all three elevations to return toward atmospheric pressure.

All pressures in the flex space began to increase approximately 190 s post ignition. Just prior to flashover, the pressure at the 4 ft and 1 ft elevations decreased, while the 7 ft elevation continued to increase. Pressures remained constant throughout the experiment until the front door was opened at 582 s post ignition. After which, all pressures began returning to near atmospheric pressure.

Figure 3.170: Pressure remote from fire room for Experiment 14. Blue vertical bars indicate time and duration of water flow.

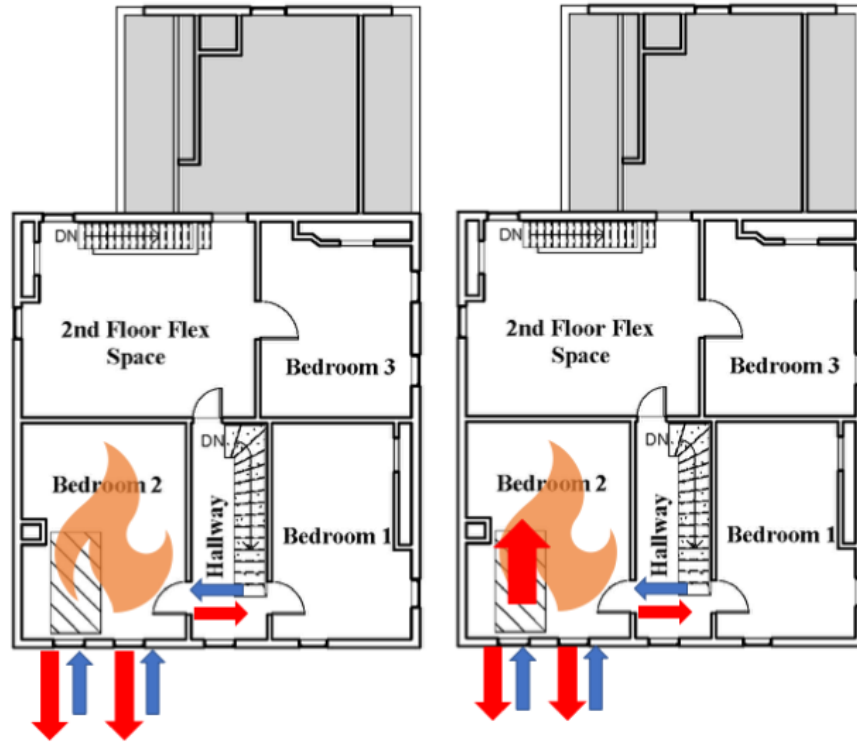
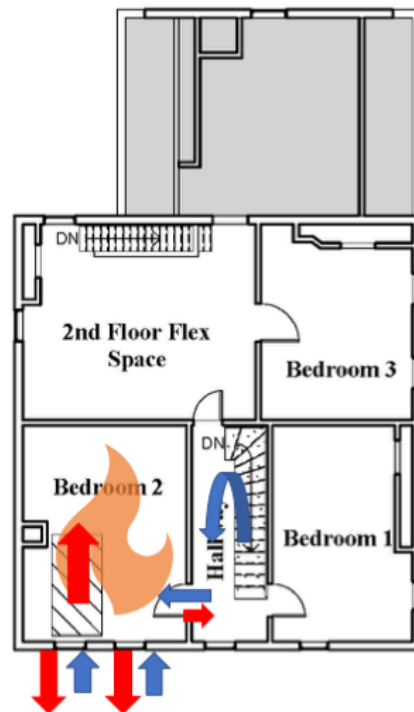
The pressure differentials between remote locations within the structure led to the production of flow paths. Figure 3.171 indicates the flows within the structure before the front door was opening, after the ceiling failed, and after fire department ventilation of the front door. Prior to fire department intervention, the pressure at the 7 ft elevation in the fire room was greater than the pressure at the 7 ft elevation in the hallway or flex space. Similarly, the pressure at the 1 ft elevation in the fire room was less than the pressure at the 1 ft elevation in the hallway or flex space. These pressure gradients reflect an exchange of cool air into the fire room through the bottom of the doorway in bedroom 2 and hot gases out of the fire room through the top of the doorway. The flow path prior to fire department intervention is illustrated in Figure 3.171a. Initially the only ventilation openings were the fire room windows and doorway. Fresh air was entrained and hot gases were expelled through these openings. After the ceiling failed, a new exhaust vent was established (see Figure 3.171b). After the vertical exhaust vent was established, less gases were exhausted through the fire room windows and doorway, allowing more fresh air to be entrained. The front door was opened, establishing a new inlet vent (see Figure 3.171c). Fresh air was entrained at the front door, which was a more efficient inlet, leading to less flow through the fire room windows.

Figure 3.171: Changes in flow path for Experiment 14. Red arrows indicate flow out of the compartment, blue arrows indicate entrainment into the compartment, and the sizes of the arrows indicate the relative magnitude of the flow through each opening.

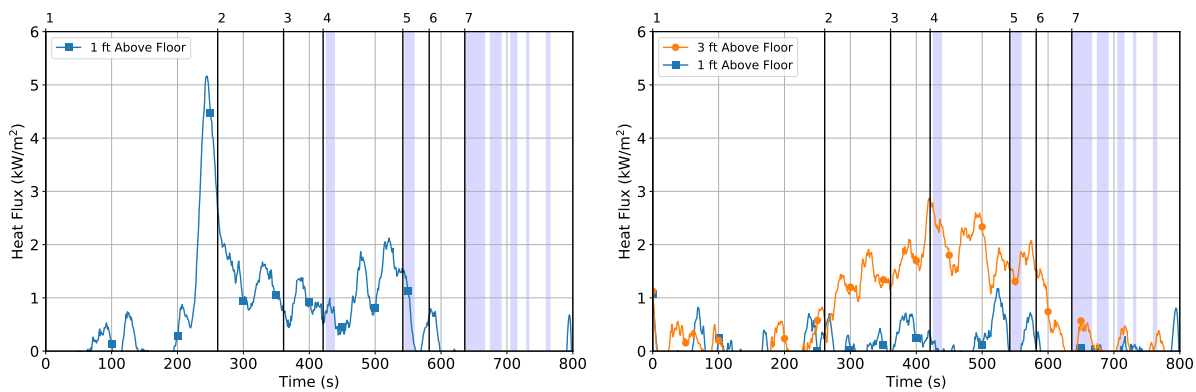
Heat flux was monitored at the hallway and in the second-floor flex spaces; the data collected is presented in Figure 3.172. The location in the hallway measured heat flux 1 ft above the floor. Heat flux first began to rise approximately 200 s post ignition. The smoke layer in the fire room was approximately at the height of the bed. Just prior to flashover at 261 s post ignition, heat flux at 1 ft peaked and began to decrease. Post-flashover conditions produced a steady heat flux to the location in the hallway. After the exterior water stream directed at the lintel occurred, heat flux decreased to pre-ignition conditions.

The location in the flex space monitored heat flux at two elevations, 1 ft and 3 ft above the floor. Heat flux at both locations remained low until flashover occurred in the fire room at 261 s. The 3 ft elevation gradually increased, peaking just prior to the first exterior water flow directed at the failed ceiling. The 3 ft elevation heat flux steadily decreased until the front door was opened. After which, heat flux at the 3 ft elevation returned to pre-ignition conditions. The 1 ft elevation remained close to 0 kW/m² but increased several times to 1.25 kW/m².

Figure 3.172: Heat flux versus time in the hallway and flex space for Experiment 14. Blue vertical bars indicate time and duration of water flow.

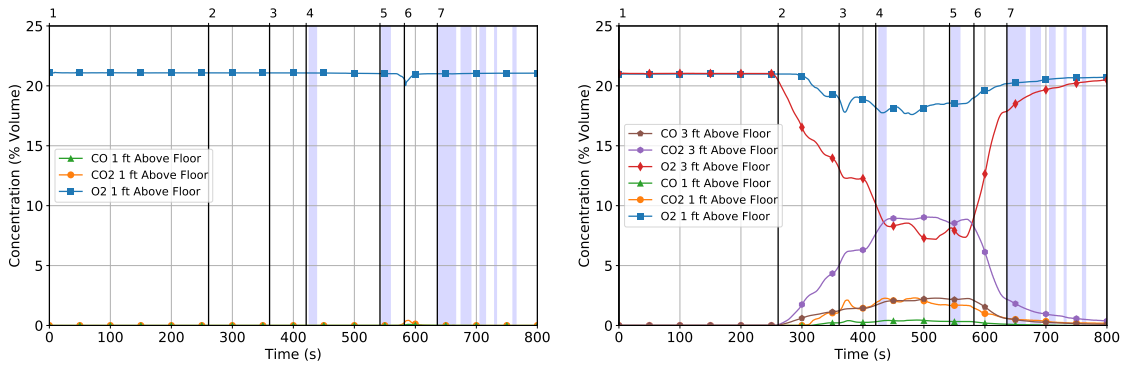
The aforementioned locations also monitored gas concentrations for CO, CO₂, and O₂ at the respective heights. The gas concentrations in the hallway peaked just after the front door was opened. CO₂ increased to 0.5% and O₂ decreased to 20%, while CO remained unchanged. The gas concentrations in the flex space began to change as flashover occurred in the fire room 261 s post ignition. CO and CO₂ concentrations were greater at the 3 ft elevation than at the 1 ft elevation.

A peak increase of CO₂ and CO occurred simultaneously as O₂ was at its lowest concentration. This occurred between the two exterior water applications. Gas concentrations trended toward pre-ignition conditions after the front door was opened at 582 s post ignition.

(a) Gas Concentrations in Hallway

(b) Gas Concentrations in Flex Space

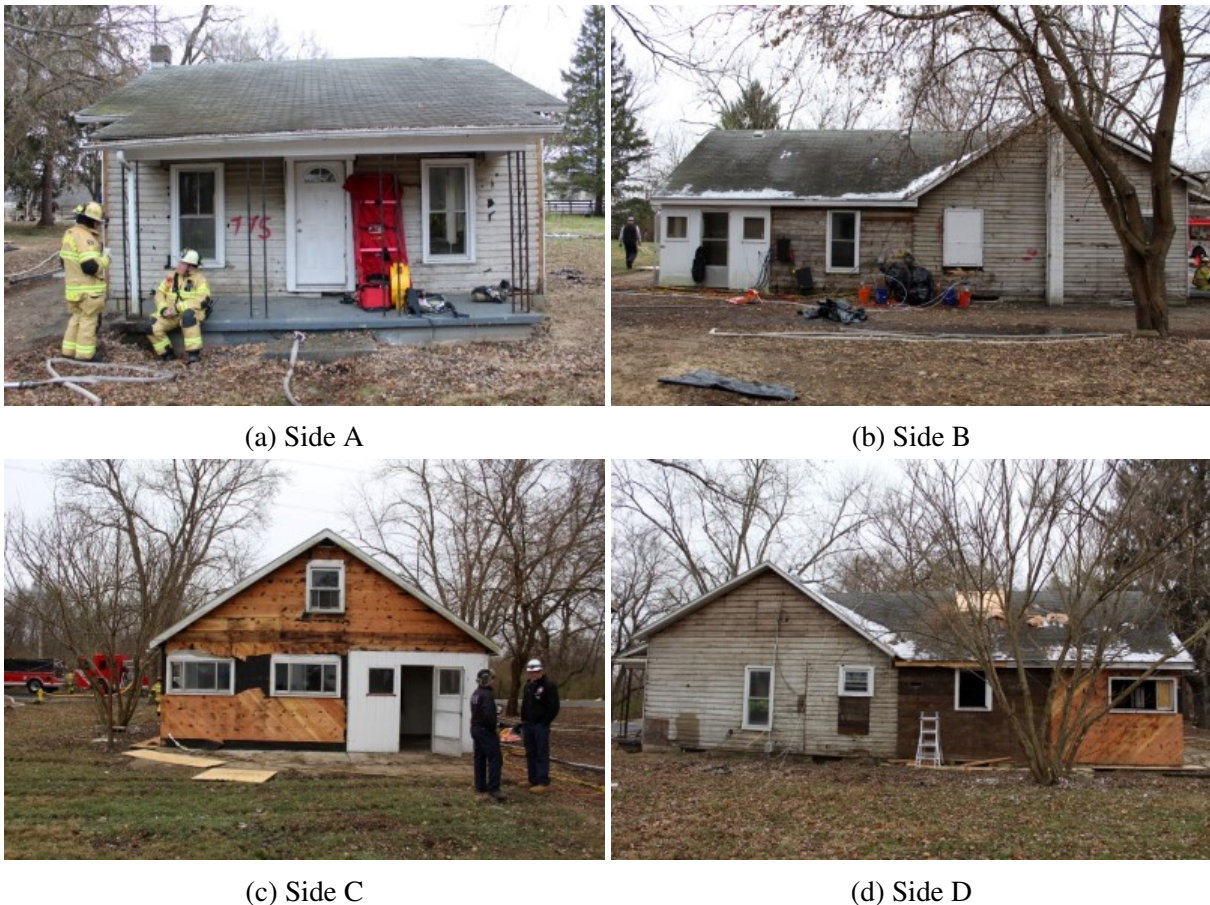
Experiment 15 was conducted to examine interior suppression without additional ventilation. This was the control experiment for Coordination Method 5. A one-and-a-half-story, single-family home located at 775 Hilltop Road in Xenia, Ohio, was instrumented to conduct this first-floor kitchen fire experiment. Each exterior side of this 1,004 sq ft, wood-framed structure appears in Figure 3.174. The structure was built with rough cut lumber framing with a combination of various wood sidings. The foundation was a mix of poured concrete and concrete block. The peaked roof was constructed using 1 in.-by-6 in. sheathing covered with asphalt shingles. Interior wall finishes included a combination of plaster and lath, plasterboard (kitchen), gypsum wallboard, and wood paneling (flex space), while interior floor finishes were a combination of tile (kitchen) and carpet (flex space, etc.). Detailed dimensioned drawings for the first and second floor appear in Appendix Figures B.10 and B.11, respectively.

Figure 3.174: Exterior photographs of the structure for Experiment 15.

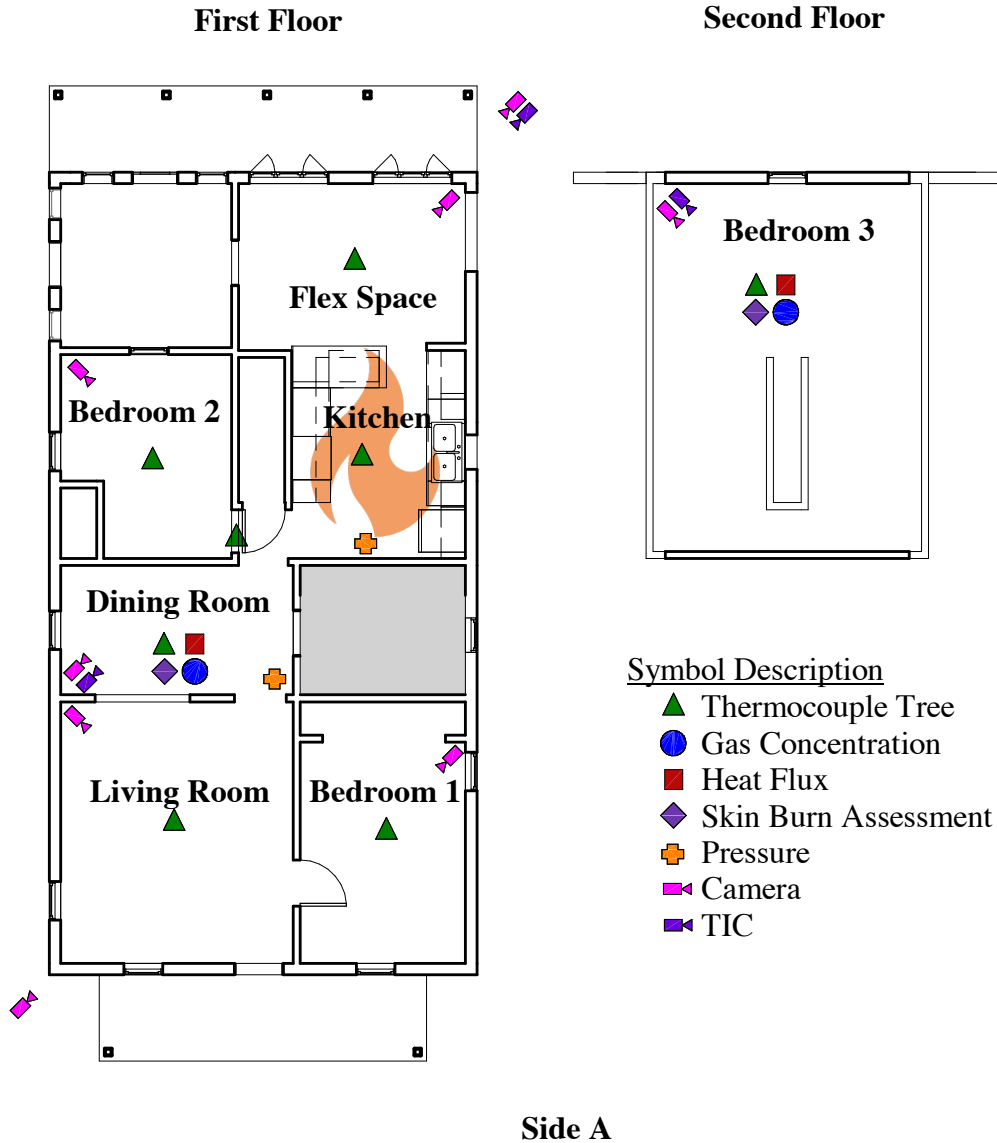
Figure 3.175: Instrumentation and floor plan for Experiment 15. The gray area was isolated from the remainder of the structure and utilized as space for instrumentation.

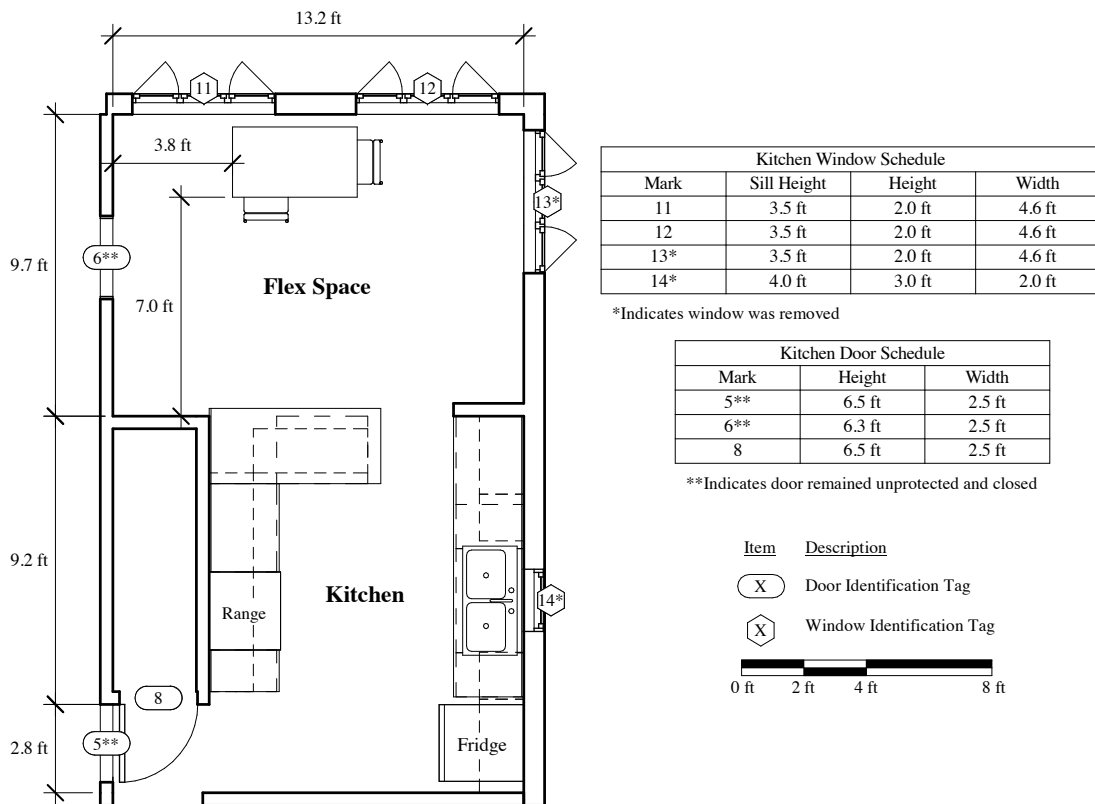
To have consistent pre-ignition ventilation compared to the other experiments and to provide sufficient oxygen needed for flashover, two windows were removed prior to ignition. The first window was located along side D of the fire room (labeled 14 in Figure 3.176), and the second window was located along side D of the flex space (labeled 13 in Figure 3.176). A dimensioned layout of the kitchen and flex space are included in Figure 3.176.

Figure 3.176: Fire room and flex space layout for Experiment 15.

The fire room (kitchen) was located along side D of the home. The fire room was open to the vestibule connecting the stairwell, bedroom 2, the dining room, and the flex space located in the C/D corner. The flex space contained a table and two chairs.

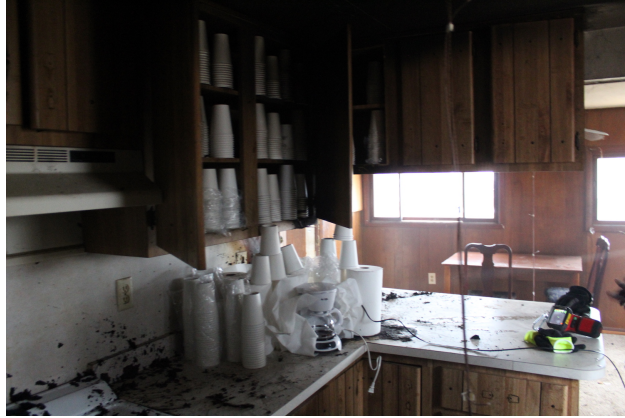
Figure 3.177: Photograph of the fuel package for Experiment 15.

The kitchen was furnished with the fuel package described in Section 2.4.2 and contained a range and a refrigerator. The ignition location was surrounded by 1250 paper cups, a coffee maker, and six paper towel rolls. The paper cups were distributed between the counter top and the open wall cabinets above the ignition location. Four additional paper towel rolls were located on top of the refrigerator. Figure 3.177 presents the fuel package.

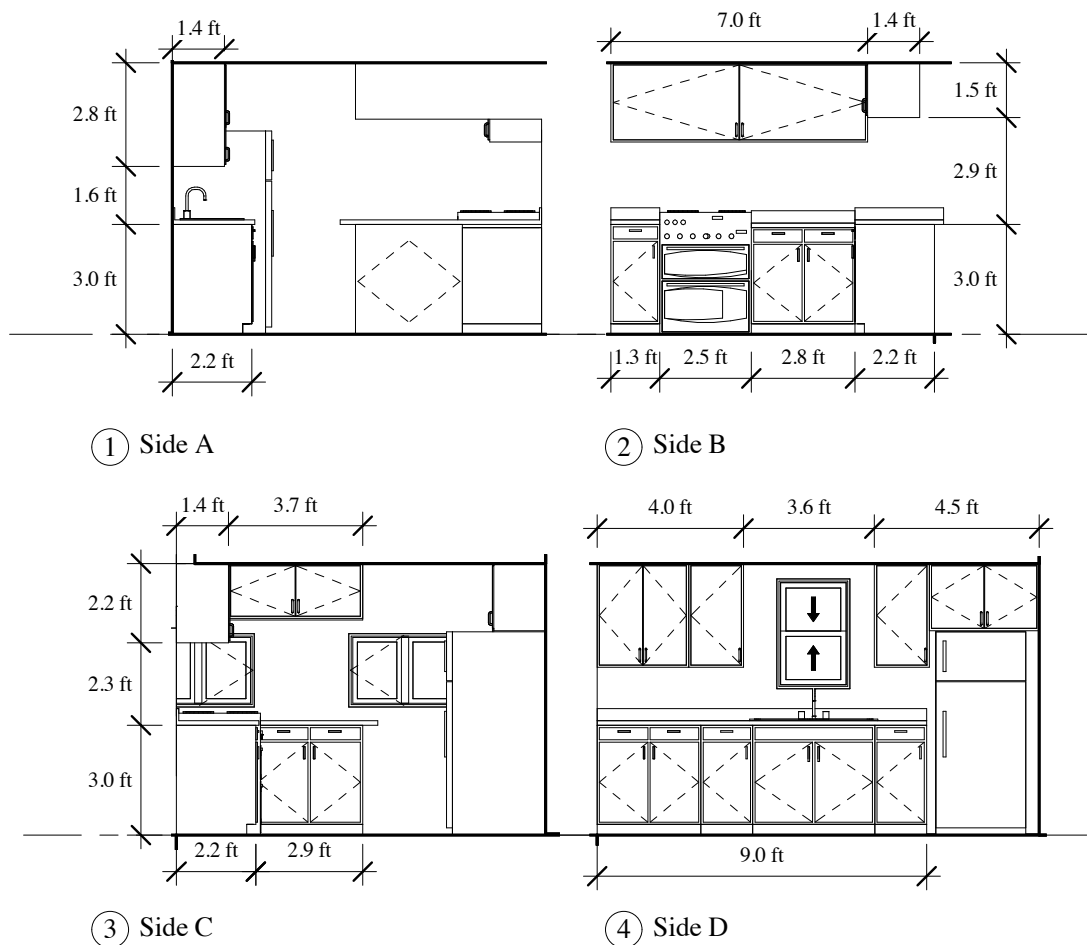
Figure 3.178: Wall and base cabinet locations, dimensions, and elevations within the kitchen for Experiment 15.

The furnishings in the kitchen included pre-existing wood cabinetry. Wall and base cabinets were located against the perimeter of the kitchen on sides B, C, and D. Wall cabinets were 26 in. high by 17 in. deep, and the base cabinets were 36 in. high by 26 in. deep. A detailed drawing of these cabinets are included in Figure 3.178.

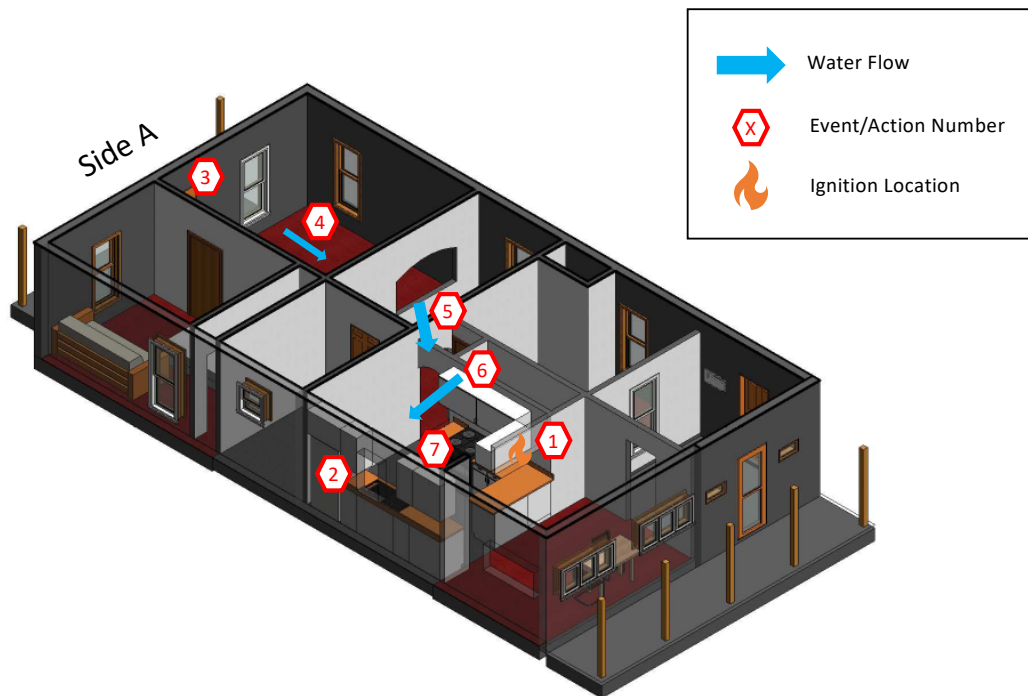
Action/Event	Time (mm:ss)	Time (s)
1 Ignition	00:00	0
2 Flashover	04:54	294
3 Front Door Open	06:00	360
4 Flow from Living Room	06:18	378
5 Flow from Dining Room	06:29	389
6 Flow from Kitchen Doorway	06:50	410
7 Suppression Crew Entered Fire Room	07:16	435

Figure 3.179: Time and sequence of actions and events for Experiment 15.

The fire was ignited in the cluster of cups and paper towels located on the kitchen counter ($t = 0$ s). Once the fire was ignited and flashed over (294 s (4:54) post ignition), fire department interventions began. The ventilation crew opened the front door 360 s (6:00) post ignition. The suppression crew entered the structure 8 s later and advanced a 1.75 in. hoseline with a combination nozzle set to straight stream into the living room. The nozzle operator flowed water for 2 s, 378 s (6:18) post ignition. The suppression crew advanced into the dining room and flowed water for 12 s, 389 s (6:29) post ignition. The crew advanced to the kitchen doorway and flowed water for 14 s, 410 s (6:50) post ignition. Final suppression began 436 s (7:16) post ignition as the suppression crew made entry into the kitchen.

From front door open to fire room entry, the total tactic duration was 75 s (1:15). The total water flowed for initial suppression was 99 gal, which does not include the additional water used during mop-up operations. The location and sequence of events are presented in Figure 3.179.

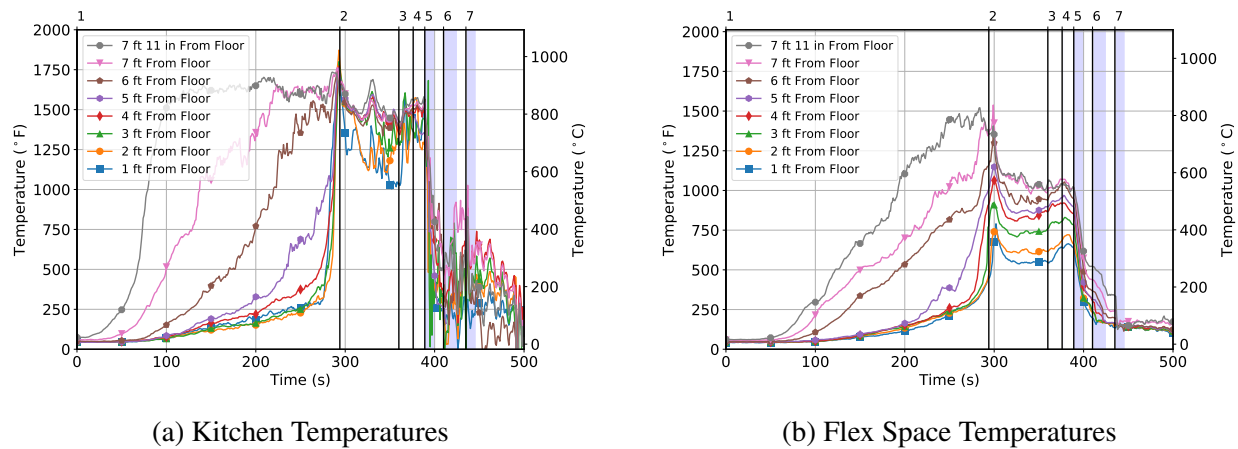
Figure 3.180: Temperatures in fire room (kitchen) for Experiment 15. Temperature measurements post suppression were compromised by the water flow of the interior hoseline. The flow from the hoseline dislodged the thermocouple array from its anchor point at approximately 400 s. Blue vertical bars indicate time and duration of water flow.

Figure 3.180 shows the time history of the temperature variations within the fire room and attached flex space. Kitchen temperatures (see Figure 3.180a) nearest the ceiling began to increase 25 s post ignition as products of combustion began to accumulate. Temperatures 5 ft and below began to increase approximately 70 s post ignition, as flames reached the ceiling in the kitchen. The fire grew to flashover 294 s post ignition, indicated by floor temperatures exceeding 1100 °F. Post-flashover, ceiling temperatures decreased to 1475 °F and floor temperatures decreased to 1150 °F. The opening of the front door provided additional ventilation to the structure. Fresh air entrainment through this opening caused the heat release rate of the fire to increase. Temperatures continued to steadily increase until water flow from the living room was initiated. Flow from the living room at 376 s post ignition results in a drop in temperature to below 500 °F.

as kitchen temperatures increased. Flex space ceiling temperatures (see Figure 3.180b) increased 50 s post ignition, as smoke accumulated at the kitchen ceiling spilled into the flex space. Temperatures nearest the floor increased 100 s post ignition. Similar to kitchen temperatures, temperatures at all elevations had a sharp rise during the 30 s prior to flashover of the kitchen. Unlike conditions within the kitchen, the flex space did not achieve flashover, as temperatures nearest the floor peaked to 790 °F, 302 s post ignition. After the kitchen reached flashover, temperatures within the flex space decreased to a steady state. Temperatures within this space increased with additional ventilation from the front door being opened. Temperatures at the floor reached 660 °F and temperatures at the ceiling reached 1075 °F. Suppression from the living room decreased temperatures below 600 °F (Action 6). Extinguishment of the kitchen fire caused temperatures to permanently decrease (Action 7).

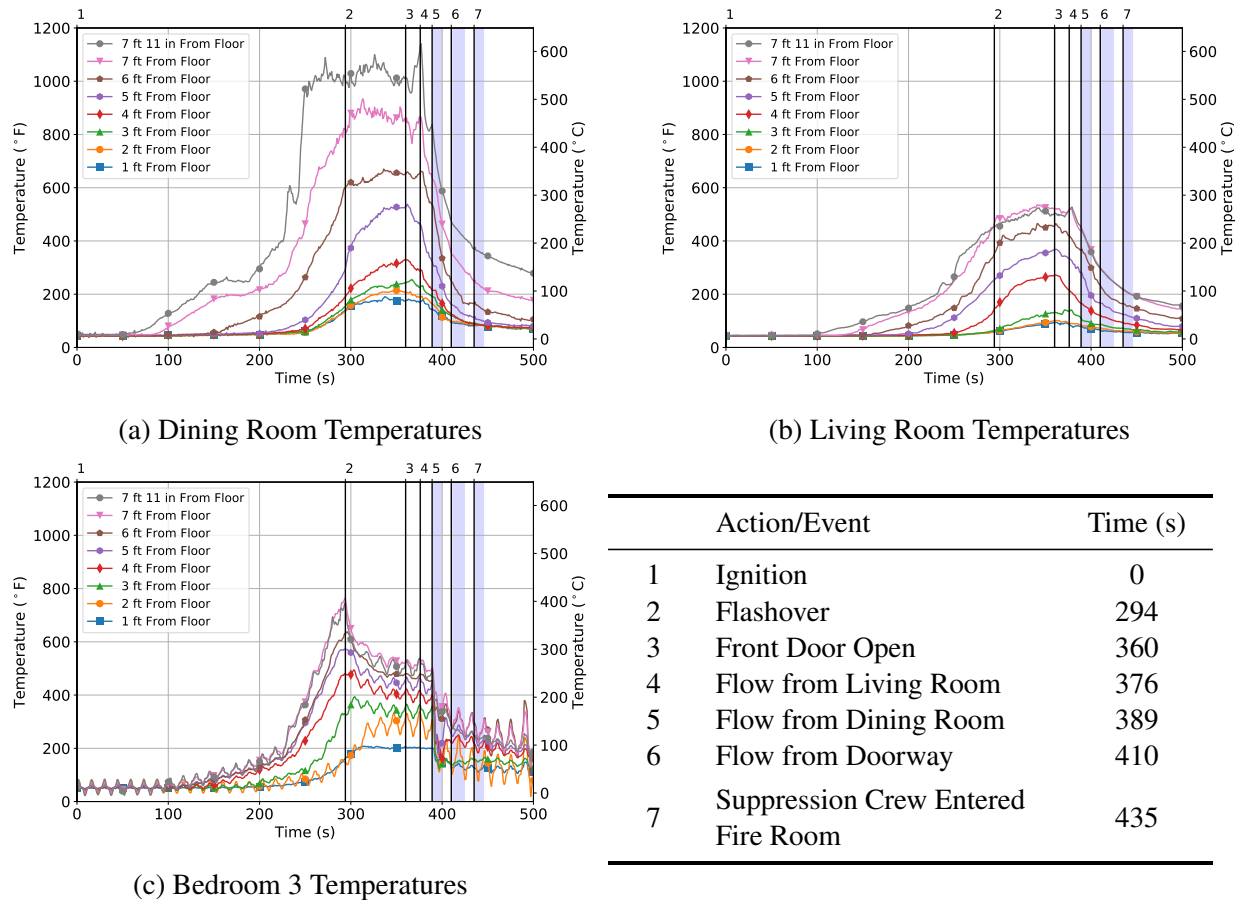
Figure 3.181: Temperatures remote from the fire room (kitchen). Blue vertical bars indicate time and duration of water flow.

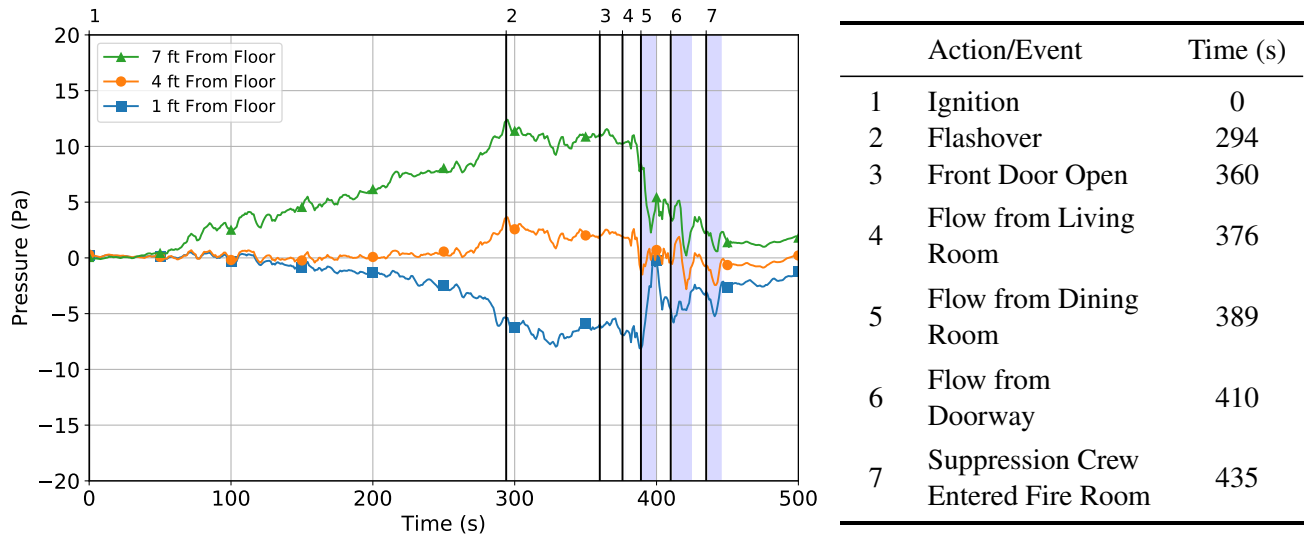
Figure 3.182: Pressures in the fire room (kitchen) for Experiment 15. Blue vertical bars indicate time and duration of water flow.

The kitchen pressures, displayed in Figure 3.182, began to deviate from ambient at approximately 50 s post ignition. The pressure 7 ft above the floor increased due to gas expansion of the combustion products that began to fill the kitchen. The pressure 1 ft above the floor began to decrease approximately 100 s post ignition as cool air was entrained into the fire room. As the fire approached flashover, the pressure at the 4 ft elevation started to increase as the hot gas layer descended from the ceiling. During flashover, the 7 ft and 4 ft pressures peaked to 12.4 Pa and 3.6 Pa, respectively. After flashover, all kitchen pressures remained relatively constant at approximately 10.0 Pa, 2.0 Pa, and -7.0 Pa, respectively, until suppression.

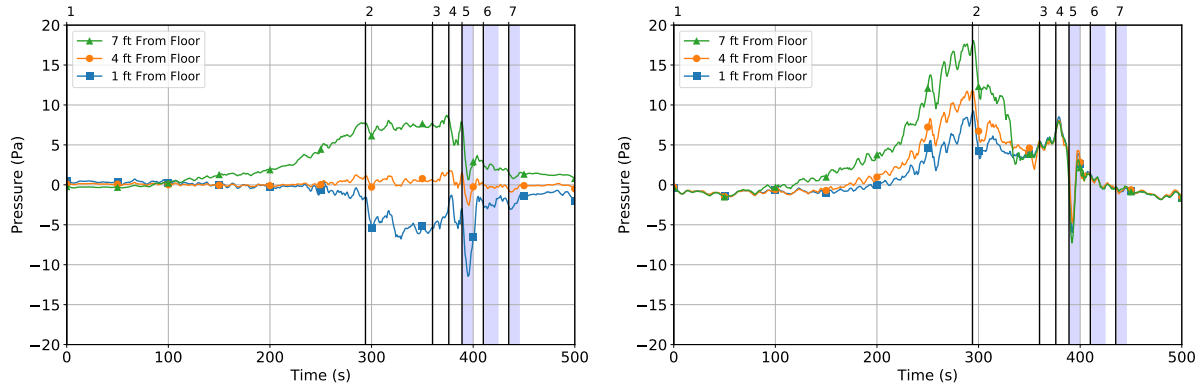
Figure 3.183: Pressures remote from the fire room (kitchen) for Experiment 15. Blue vertical bars indicate time and duration of water flow.

Pressure data measured in remote locations in the structure is presented in Figure 3.183. Pressures in the dining room began to change approximately 100 s post ignition (see Figure 3.183a). The pressure at the 7 ft elevation began to increase as the hot gases began to flow into the dining from the kitchen. The pressure at the 1 ft elevation began to decrease approximately 250 s, post ignition, as air was entrained to the fire room. The pressure at the 4 ft elevation remained relatively constant over the duration of the experiment, indicating there was a neutral plane approximately 4 ft above the floor. Post-flashover conditions created steady pressures at approximately 7.0 Pa, 1.0 Pa, and -5.0 Pa, respectively. Interior suppression returned pressures to near ambient conditions.

An increase in pressure in bedroom 3 (see Figure 3.183b) also occurred approximately 100 s post ignition. However, unlike the kitchen and dining room, the pressure at all three elevations in bedroom 3 increased. Pressures peaked during flashover to 18.0 Pa, 12.0 Pa, and 9.0 Pa, respectively. All three elevations showed an increase in pressure from the front door ventilation, peaking to 8.5 Pa. The buoyant, hot gases rose and naturally pressurized the second-floor.

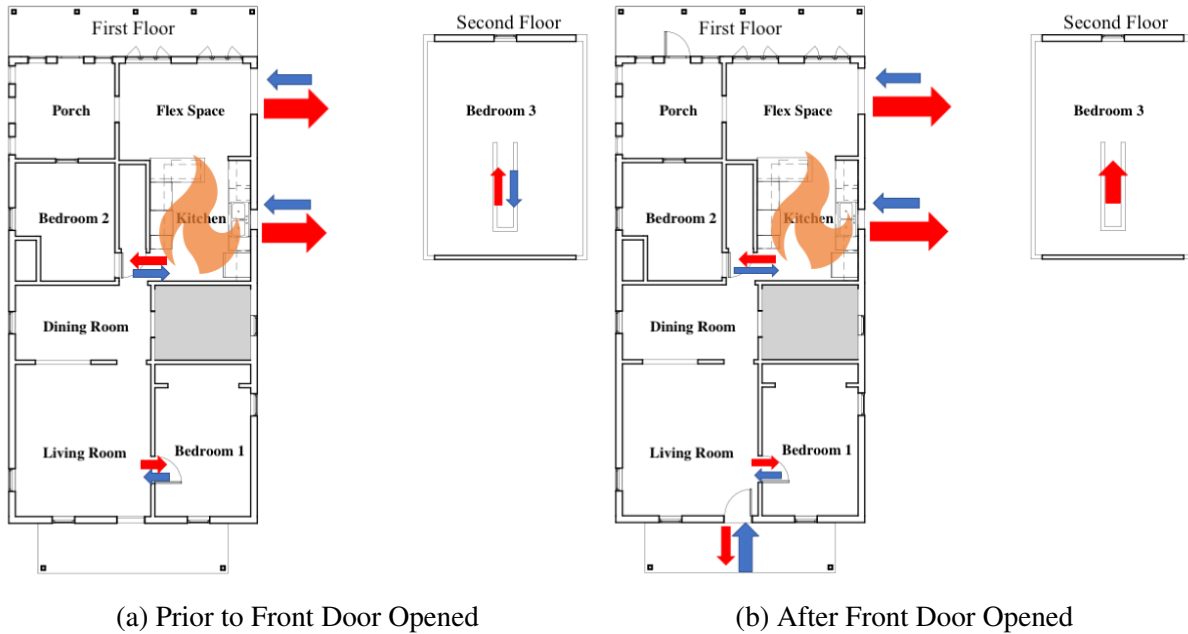
Figure 3.184: Changes in flow during Experiment 15. Red arrows indicate the flow of combustion products, the blue arrows indicate the flow of fresh air, and the sizes of the arrows indicate the relative magnitude of the flow.

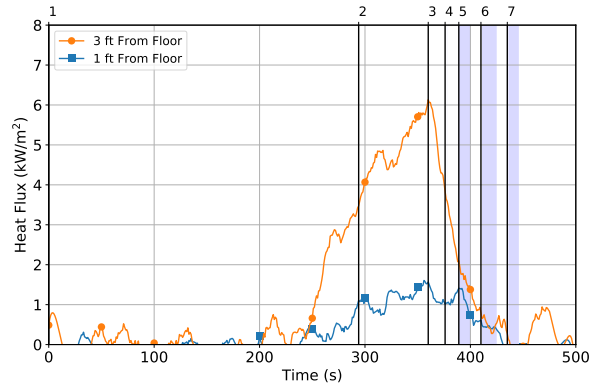
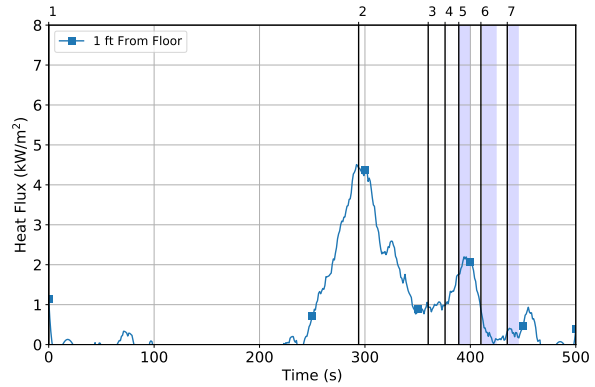
Figure 3.185: Heat flux in remote locations for Experiment 15. Blue vertical bars indicate time and duration of water flow.

Heat flux data recorded in remote locations within the structure are presented in Figure 3.185. Dining room heat flux (see Figure 3.185a) began to increase in the minute before flashover. Heat flux steadily increased, peaking at the time the front door was opened to 1.6 kW/m^2 and 6.0 kW/m^2 at the 1 ft and 3 ft elevations, respectively. Once the door was opened, the hot gas layer exhausted out of the structure, decreasing the heat flux at the measured locations. Heat flux returned to pre-ignition conditions after interior water flow.

Bedroom 3 heat flux (see Figure 3.185b) began to increase 250 s post ignition. The heat flux peaked during flashover to 4.5 kW/m^2 . Post-flashover heat flux at this elevation decreased to a steady 1.0 kW/m^2 prior to front door ventilation. As interior water flow occurred, heat flux in bedroom 3 briefly increased to approximately 2.2 kW/m^2 , then decreased to near pre-ignition values.

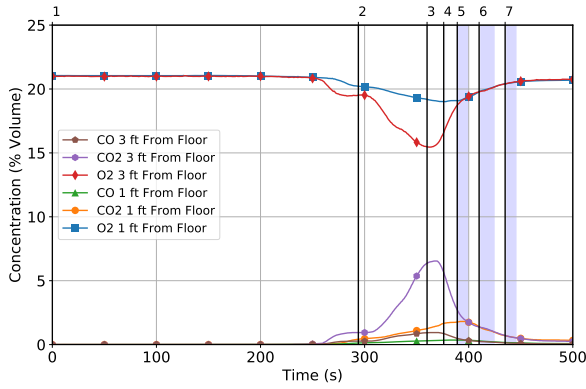
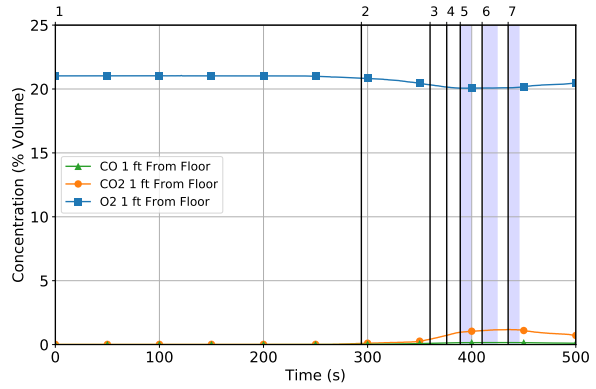
Figure 3.186: Gas concentrations in remote locations in Experiment 15. Figure 3.186b ends at 500 s to show that gas concentrations returned to pre-ignition values in bedroom 3. Blue vertical bars indicate time and duration of water flow.

Gas concentration data for remote locations within the structure are presented in Figure 3.186. Dining room gas concentrations (see Figure 3.186a) began to change approximately 30 s before flashover occurred. The greatest concentration of CO and CO₂ and least concentration of O₂ were measured at the 3 ft elevation in the dining room and occurred approximately 8 s after the front door was opened: 6.6% CO, 1.8% CO₂, and 15.5% O₂. Opening the front door affected gas concentrations at the 3 ft elevation but not at the 1 ft elevation. Suppression decreased gas concentrations of CO and CO₂ and increased O₂ concentration at both elevations in the dining room.

Gas concentrations within bedroom 3 (see Figure 3.186b) did not begin to change until after the front door was opened and suppression efforts were initiated. Gas concentrations peaked at 0.2% CO, 1.2% CO₂, and 20.0% O₂ before returning to pre-ignition conditions after interior water flow was completed.

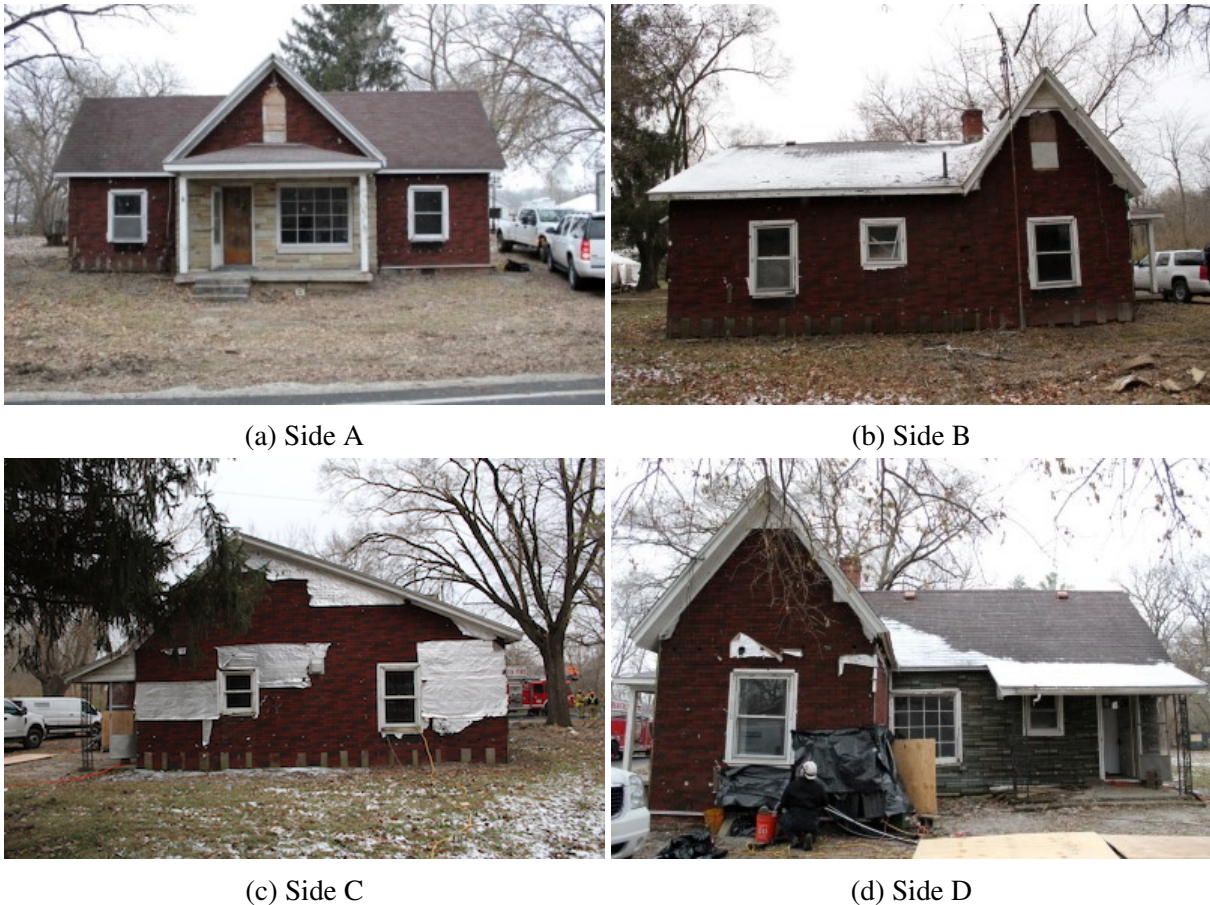
Figure 3.187: Exterior photographs of the structure for Experiment 16.

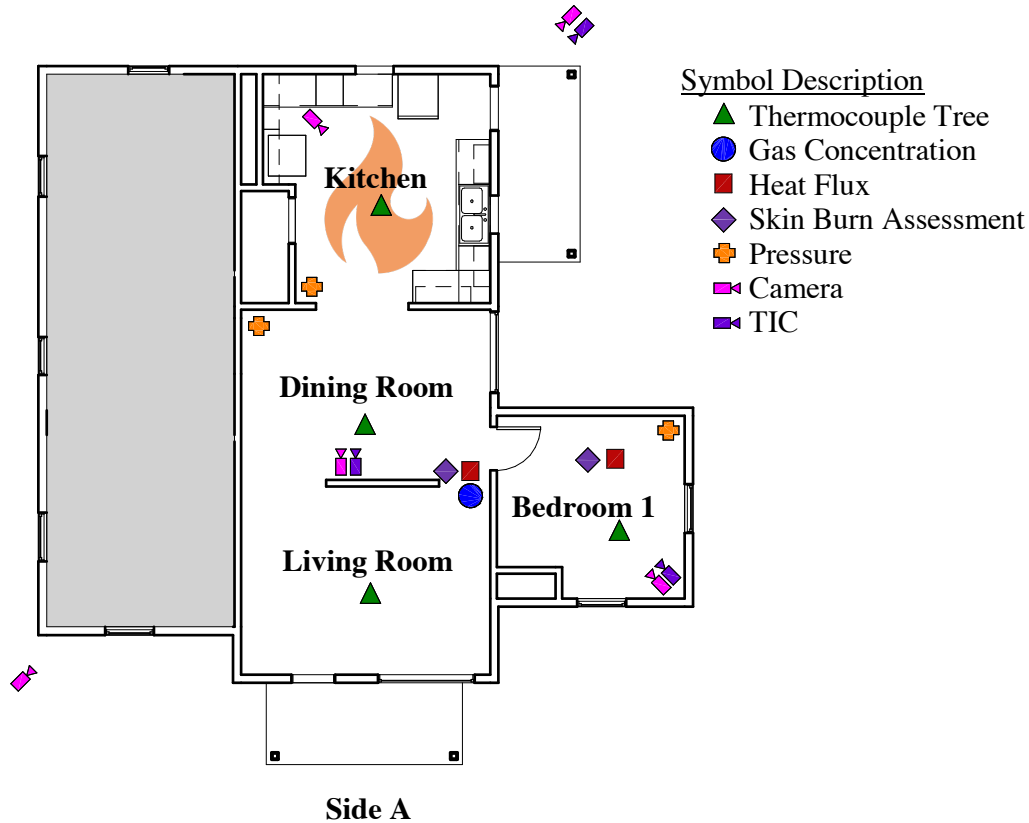
Figure 3.188: Instrumentation and floor plan for Experiment 16. The gray area was isolated from the remainder of the structure and utilized as space for instrumentation.
