Analysis of the Coordination of Suppression and Ventilation in Single-Family Homes

John Regan
Julie Bryant
Craig Weinschenk

UL Firefighter Safety Research Institute
Columbia, MD 20145

March 19, 2020

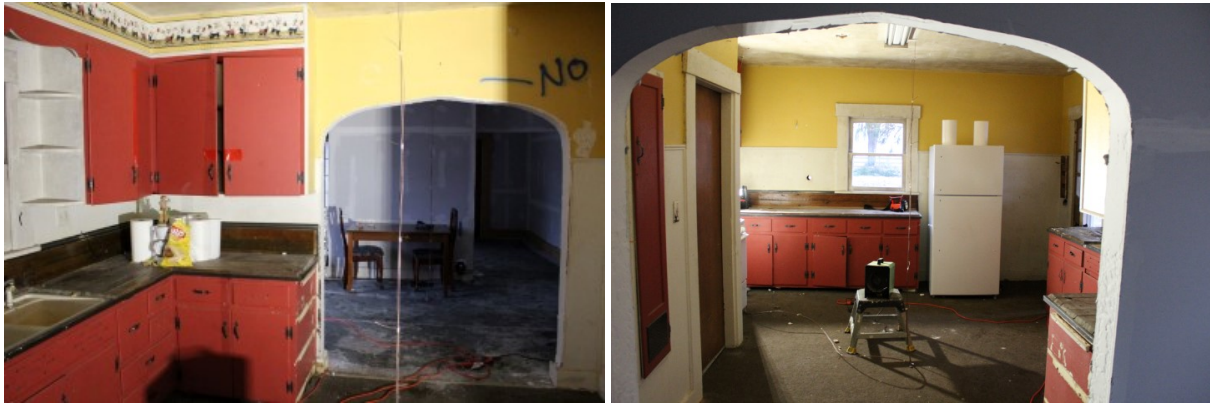
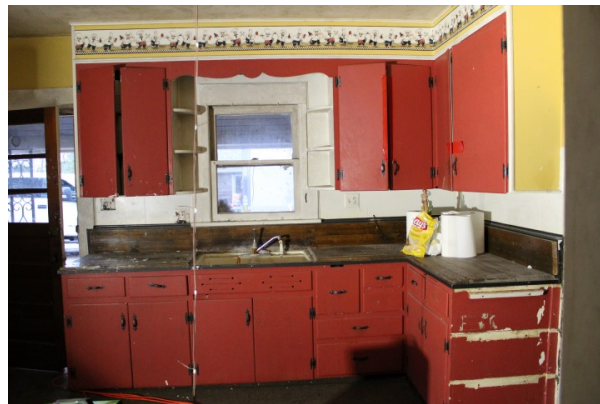
Figure 3.189: Interior photographs of the fire room for Experiment 16.

rolls were located on top of the refrigerator. Photographs of the fire room containing the fuel package prior to ignition are presented in Figure 3.189. A dimensioned layout of the kitchen is included in Figure 3.190.

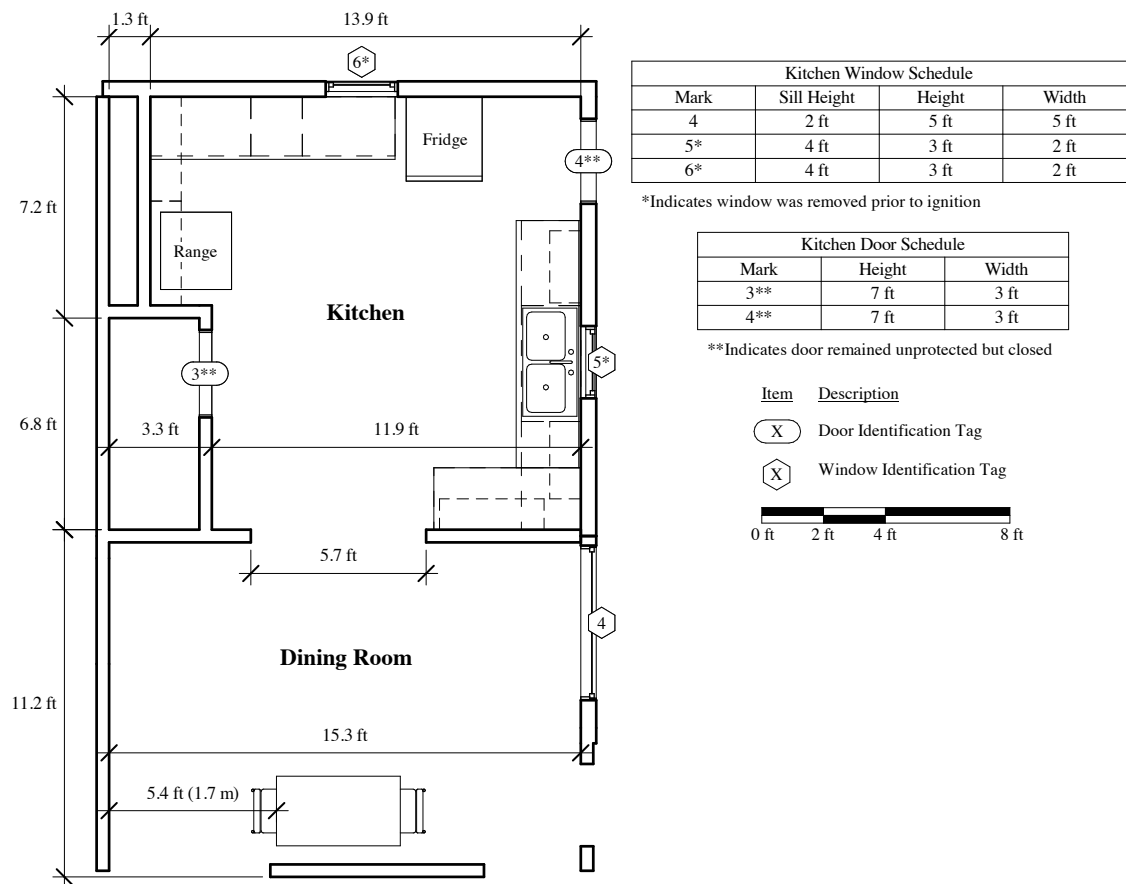
Figure 3.190: Fire room layout for Experiment 16.

The ignition package located on the counter in the A/D corner of the kitchen was ignited to begin the experiment ($t = 0$ s). Flames were first visible from the side D window (labeled 5 in Figure 3.190) 120 s (2:00) post ignition. However, flames did not pass the threshold of the side D window until 470 s (7:50) post ignition. Flames surpassed the side C window (labeled 6 in Figure 3.190) approximately 525 s (8:45) post ignition. The fire room reached flashover 532 s (8:52) post ignition.

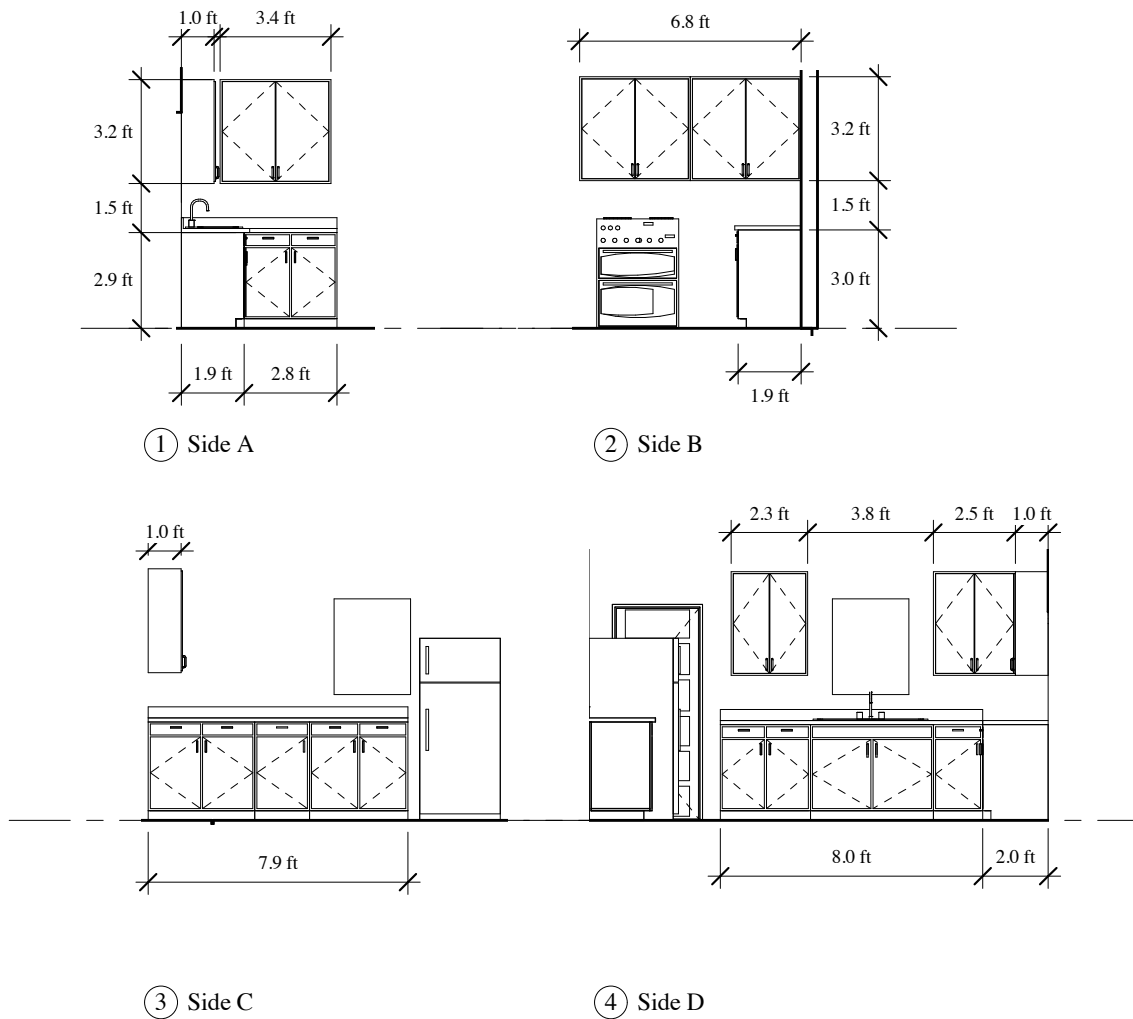
Figure 3.191: Wall and base cabinet locations, dimensions, and elevations within the kitchen for Experiment 16.

The kitchen was furnished with wood cabinets. Wall and base cabinets were located against the perimeter of the kitchen along the side C and side D walls. Wall cabinets were located on the side B wall over the range and were 38 in. high and 12 in. deep. The base cabinets were 35 in. high and 23 in. deep. The cabinets directly above the ignition location were left partially open. A detailed drawing of the kitchen cabinets is included in Figure 3.191.

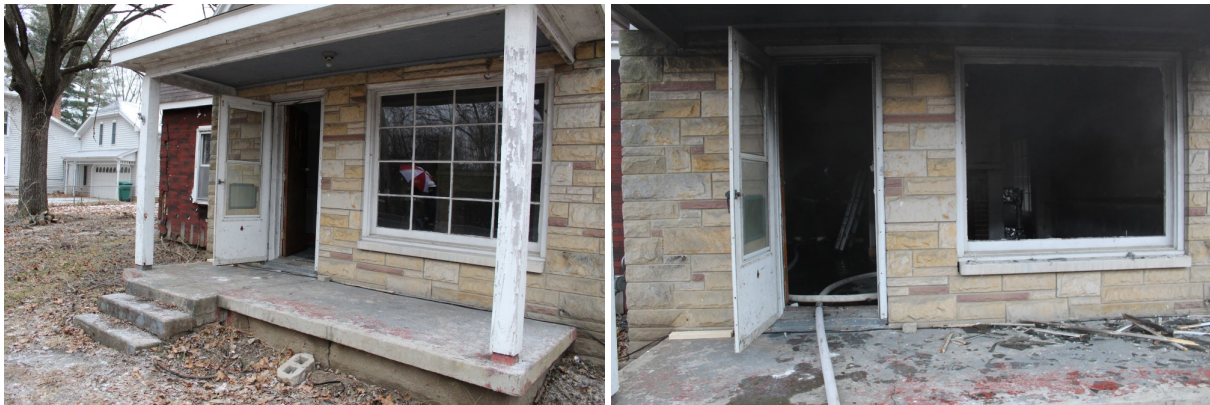
Figure 3.192: Photographs of the additional horizontal ventilation for Experiment 16.

Horizontal ventilation was provided by breaking a 71 in. by 61 in. window located on side A of the structure. The remote window location was 22.5 ft from the kitchen. Photographs of the side A window before and after ventilation are presented in Figure 3.192.

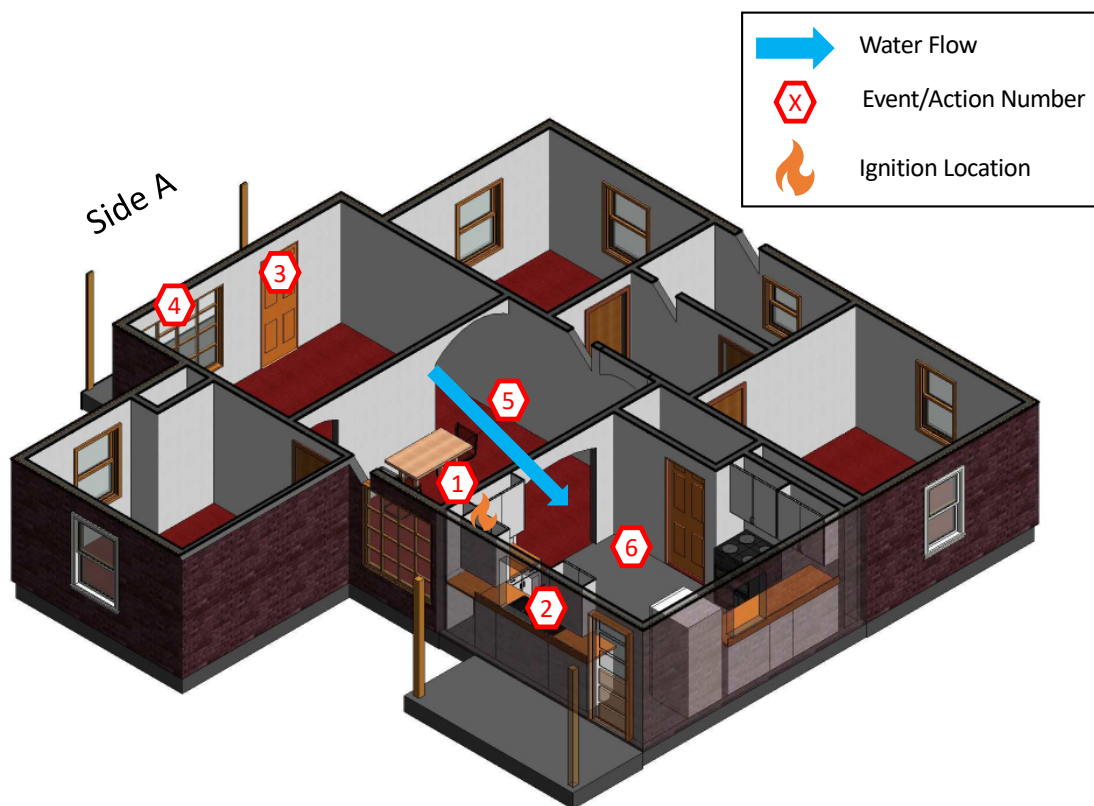
Action/Event	Time (mm:ss)	Time (s)
1 Ignition	00:00	0
2 Flashover	08:52	532
3 Front Door Open	10:00	600
4 Horizontal Ventilation	10:11	611
5 Flow throughout Structure	10:26	626
6 Suppression Crew Entered Fire Room	12:08	728

Figure 3.193: Time and sequence of actions and events for Experiment 16.

The ventilation crew opened the front door 600 s (10:00) post ignition and began horizontal ventilation on side A 611 s (10:11) post ignition. The suppression crew entered the structure through the front door and began flowing water 626 s (10:26) post ignition. A combination nozzle set to straight stream attached to a 1.75 in. hoseline was utilized for interior suppression. The nozzle operator opened the bale completely and flowed water for approximately 3 s. The nozzle operator then closed the bale approximately halfway while flowing water for an additional 32 s. During this time, the suppression crew made their way to the doorway of the kitchen, and then the bale was opened completely and water was flown for an additional 44 s. The total flow time for the first water application was 79 s. The crew then entered the fire room and the second water application occurred 742 s (12:22) post ignition and lasted 19 s. The total tactic time from front door ventilation to fire room entrance was 128 s (2:08). The total water flowed for initial suppression was 217 gal. This value does not include additional water used for mop-up operations. The sequence of events with an isometric image of the structure are presented in Figure 3.193.

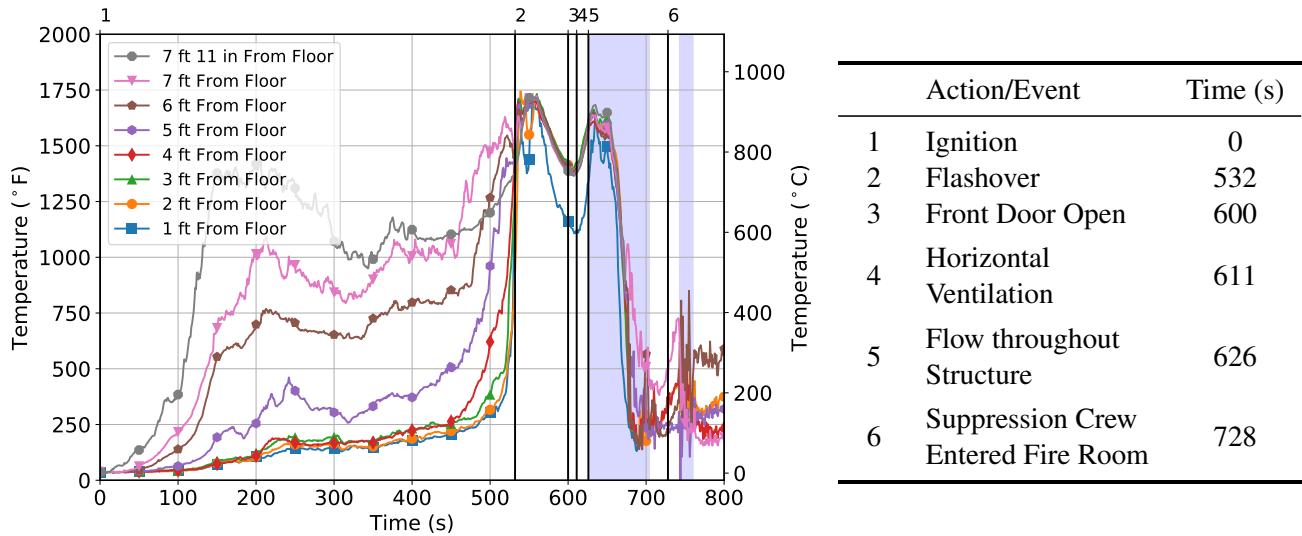
Figure 3.194: Temperatures in fire room (kitchen) for Experiment 16. Blue vertical bars indicate time and duration of water flow.

Figure 3.194 shows the time history of the temperature variations in the fire room (kitchen). Temperatures nearest the ceiling began to increase approximately 25 s post ignition as products of combustion began to collect near the ceiling. Temperatures below 5 ft began to increase around 100 s post ignition as the smoke layer filled the kitchen. Temperatures at all elevations increased steadily until 30 s prior to flashover. At such time, temperatures increased at a greater rate. Shortly after flames crossed the threshold of both kitchen windows, the fire room transitioned to flashover 532 s post ignition. Flashover is defined here as the point in which temperatures 1 ft above the kitchen floor surpassed 1100 °F. After flashover, temperatures in the kitchen decreased to 1200 °F at the floor and 1400 °F at the ceiling. The conditions within the structure began to change after the ventilation crew opened the front door and completed horizontal ventilation (opened side A win-

dow) approximately 615 s post ignition. Fresh air was entrained through these openings, resulting in increased fire growth; ceiling temperatures were approximately 1700 °F, and floor temperatures were approximately 1600 °F. Water flow decreased temperatures approximately 635 s post ignition.

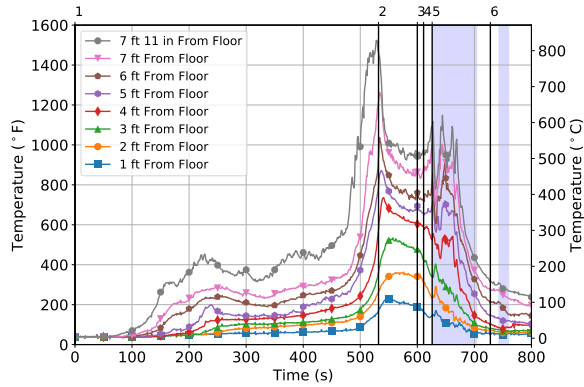
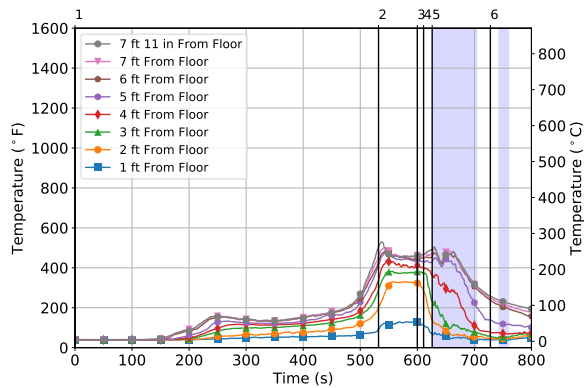
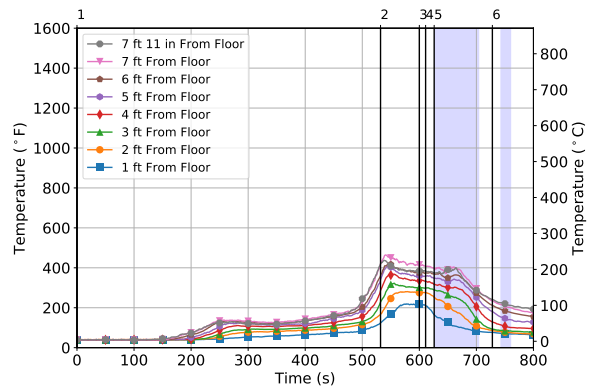
Figure 3.195: Temperatures remote from the fire room for Experiment 16. Blue vertical bars indicate time and duration of water flow.

Temperatures in the remaining open areas of the structure are presented in Figure 3.195. As the fire began to exhaust hot products of combustion into adjacent areas of the structure, temperatures in these areas began to increase relative to their proximity to the kitchen fire. Dining room temperatures increased before living room and bedroom 1 temperatures approximately 100 s, 150 s, and 150 s post ignition, respectively. Temperatures in the structure remote from the fire room increased to local peaks as the upper kitchen cabinets became fully involved in flames 225 s post ignition. Temperatures within all three spaces increased steadily for approximately 400 s as the kitchen fire grew. Approximately 30 s prior to kitchen flashover, temperatures within all three spaces increased at a greater rate. Flashover was not achieved in any of these locations as temperatures at the floor reached 250 °F (dining room), 125 °F, (living room) and 225 °F (bedroom). After kitchen flashover, temperatures in all areas remained stable: The dining room temperatures ranged from 200 °F to 1000 °F, living room temperatures ranged from 150 °F to 450 °F, and bedroom 1 temperatures ranged from 200 °F to 400 °F. Ventilation increased air entrainment to the structure resulting in increased fire growth. Temperatures 4 ft and below in the dining and living rooms decreased after ventilation while temperatures 5 ft and above in the dining and living rooms increased, suggesting air was entrained near the floor and gases were exhausted near the ceiling. Suppression caused a greater reduction in dining room temperatures than in other rooms as the stream from the nozzle was directed into this space.

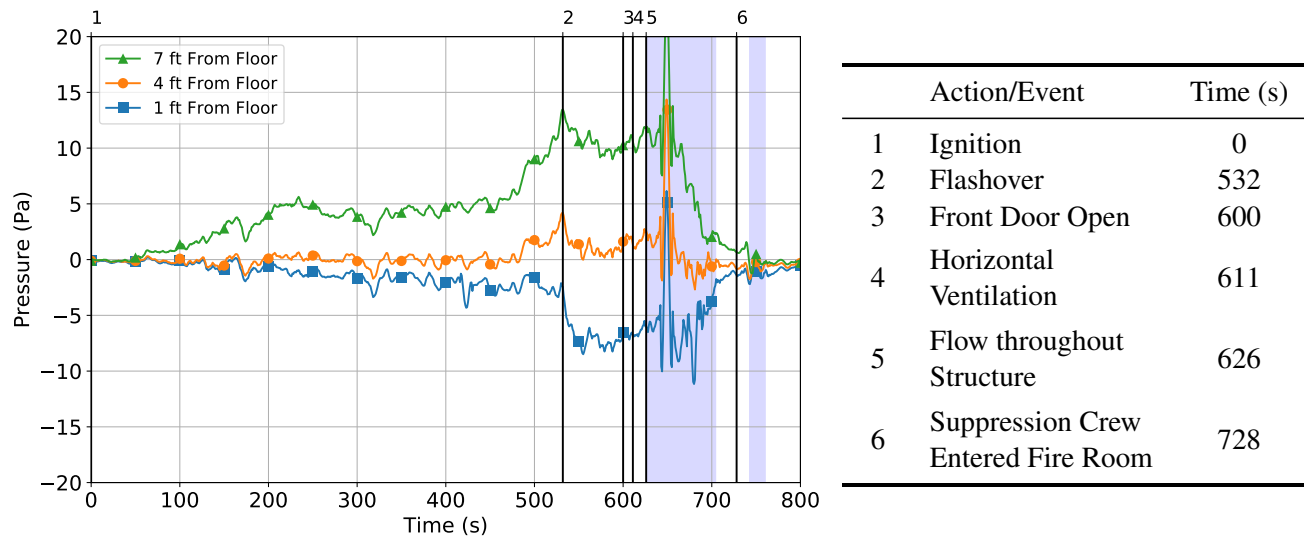
Figure 3.196: Pressures in the fire room (kitchen) for Experiment 16. Blue vertical bars indicate time and duration of water flow.

Pressure data collected from the kitchen are presented in Figure 3.196. Kitchen pressure at the 7 ft elevation was effected by the kitchen fire 40 s post ignition. The pressure increased due to expansion of the the hot gases that began to fill the kitchen. Pressure at the 4 ft elevation remained near ambient. Pressure at the 1 ft elevation began to decrease 120 s post ignition. The pressure decreased as the fire grew and entrained air from surrounding areas. Pressures changed at a faster rate during the minute prior to kitchen flashover. Post flashover, the pressure at the 7 ft and 4 ft elevations peaked to 12.6 Pa and 3.1 Pa, respectively. Pressure at all three elevations remained steady during the time between flashover and the front door being opened. The 7 ft elevation was 10.0 Pa, the 4 ft elevation was 1.0 Pa, and the 1 ft elevation was -7.5 Pa. Pressures increased after horizontal ventilation and increased as the water from the hose stream entered the kitchen. Pressures returned to ambient post suppression.

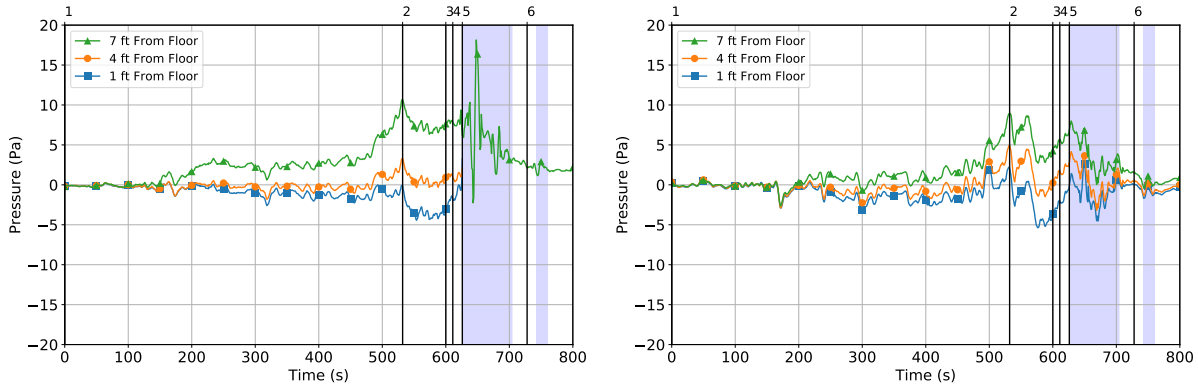
Figure 3.197: Pressures remote from fire room for Experiment 16. Flow from the hoseline compromised the pressure at the 1 ft and 4 ft elevations in the dining room. Blue vertical bars indicate time and duration of water flow.

Pressure data collected in remote areas of the structure are presented in Figure 3.197. Dining room pressures were effected by the kitchen fire before bedroom 1 pressures; the dining room was closer in proximity and more open to the fire room than bedroom 1. The dining room pressure at the 7 ft elevation began to increase around 140 s post ignition. The pressure increased as hot gases exhausted from the kitchen into the dining room. The pressure at the 4 ft elevation remained near ambient. The 1 ft elevation decreased 200 s post ignition. The pressure decreased as air was entrained to the fire room. The pressure differences between elevations suggests the establishment of a bi-directional flow within the space with the neutral plane near the 4 ft elevation. Pressure at all three elevations peaked just prior to or at flashover to 9.7 Pa, 2.3 Pa, and -1.0 Pa, respectively. Pressures became stable until horizontal ventilation caused all pressures to increase. Water flow from the hoseline damaged the 4 ft and 1 ft pressure sensors. The 7 ft elevation returned to ambient conditions post suppression.

Bedroom 1 pressures decreased approximately 160 s post ignition, suggesting air from bedroom 1 was beginning to be entrained to the fire. After the initial negative pressurization of the space, a bi-directional flow was established through the doorway of the bedroom. The pressure at the 7 ft elevation increased 200 s post ignition as higher temperature gases filled the space. The pressure at the 1 ft and 4 ft elevations decreased 225 s post ignition as air within bedroom 1 was entrained to the fire room. All pressures increased during the minute prior to flashover and peaked to 7.8 Pa, 3.8 Pa, and 1.4 Pa, respectively. Pressures increased post-flashover in response to the increased ventilation before decreasing in response to suppression. All pressures returned to ambient conditions post suppression.

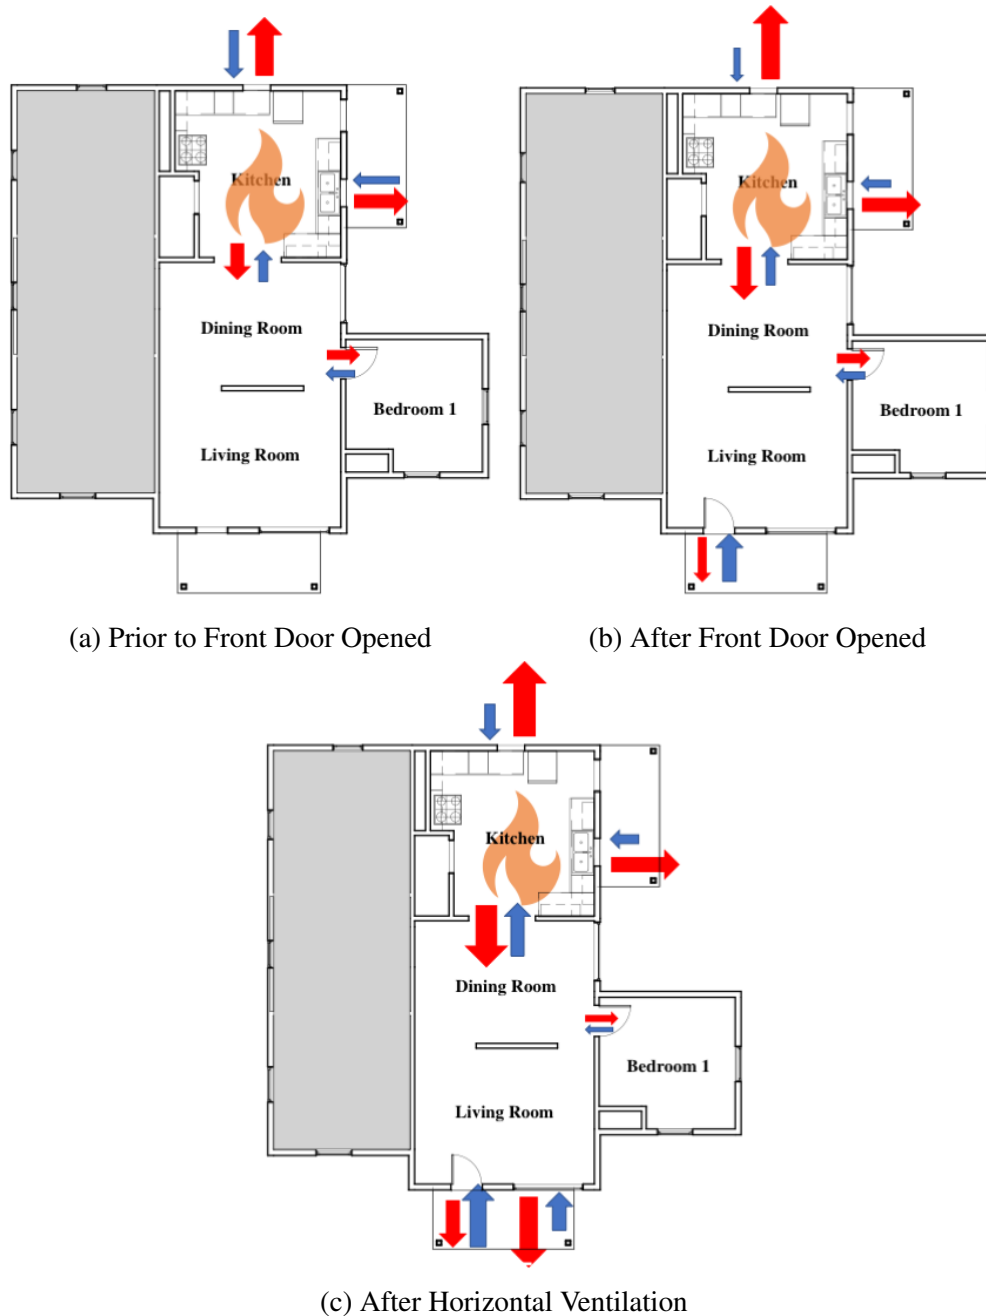
Figure 3.198: Changes in flow path for Experiment 16. Red arrows indicate flow out of the compartment, blue arrows indicate entrainment into the compartment, and the sizes of the arrows indicate the relative magnitude of the flow through each opening.

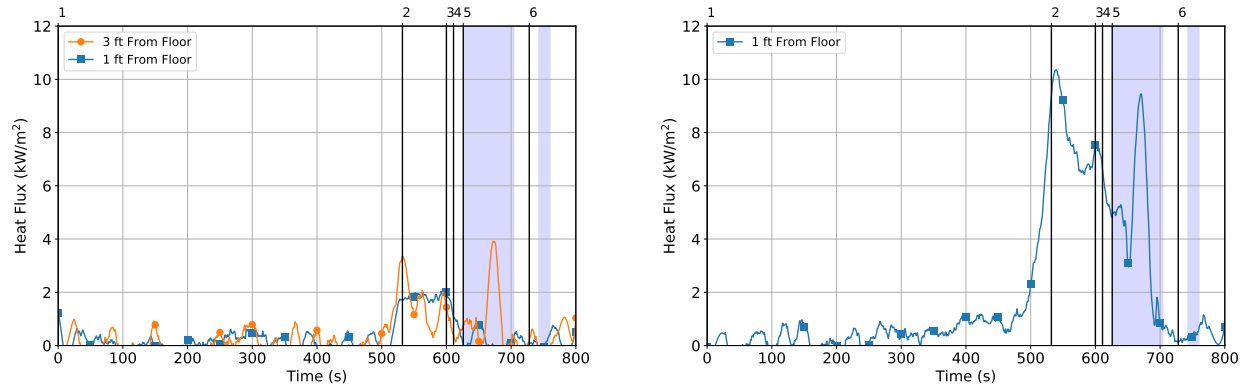
(a) Dining Room Heat Fluxes

(b) Bedroom 1 Heat Flux

Figure 3.199: Heat flux in the remote rooms for Experiment 16. Blue vertical bars indicate time and duration of water flow.

Heat flux data measured from two locations are presented in Figure 3.199. Dining room heat fluxes measured at 1 ft and 3 ft elevations remained near pre-ignition levels until 30 s prior to flashover when both increased. During flashover, the heat flux at the 3 ft elevation peaked to 3.5 kW/m^2 , while the heat flux at the 1 ft elevation peaked to approximately 2.0 kW/m^2 . Post-flashover conditions caused the heat flux at the 3 ft elevation to decrease and the heat flux at the

1 ft elevation to remain steady. Ventilation of the front door and window increased air entrainment into the structure, resulting in decreased heat flux at both elevations.

Bedroom 1 heat flux measured 1 ft above the floor remained near pre-ignition levels until 30 s prior to flashover, when heat flux increased. Approximately 10 s post flashover, the dining room heat flux peaked to approximately 10.5 kW/m². Post-flashover conditions reduced the heat flux below 7.0 kW/m². Ventilation of the front door and window further decreased the heat flux to approximately 5.0 kW/m². Heat fluxes, post suppression, returned to ambient conditions.

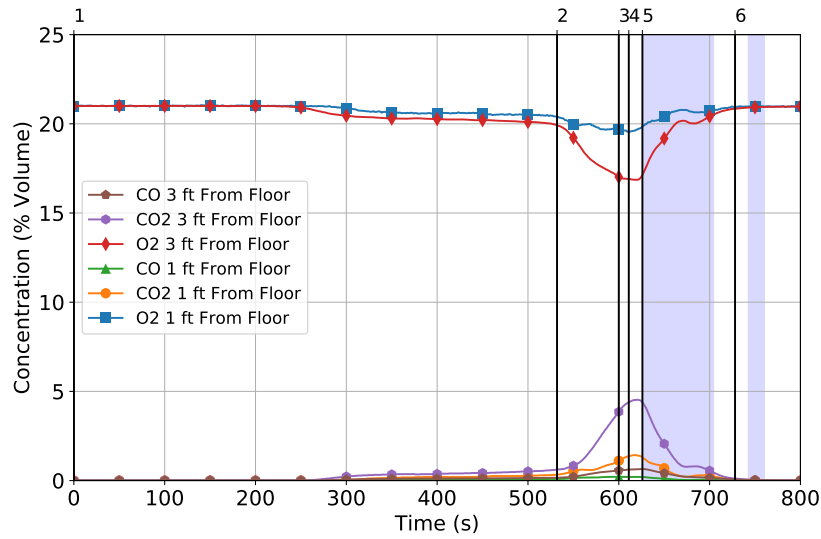
Figure 3.200: Dining room gas concentrations in Experiment 16. Blue vertical bars indicate time and duration of water flow.

CO, CO₂, and O₂ concentrations were measured at two elevations in the dining room; the data collected is presented in Figure 3.200. Gas concentrations at the 3 ft elevation gradually began to change 250 s post ignition, while the 1 ft elevation gradually began to change 280 s post ignition. A simultaneous decrease in O₂ concentration occurred as CO and CO₂ concentrations increased for both elevations. Gas concentrations increased more rapidly during post-flashover conditions. Gas concentrations at the 3 ft elevation peaked after ventilation was complete: CO was 0.7%, CO₂ was 4.6%, and O₂ was 16.8%. Gas concentrations at the 1 ft elevation increased gradually after ventilation occurred. Gas concentrations at both elevations returned to pre-ignition conditions after suppression.

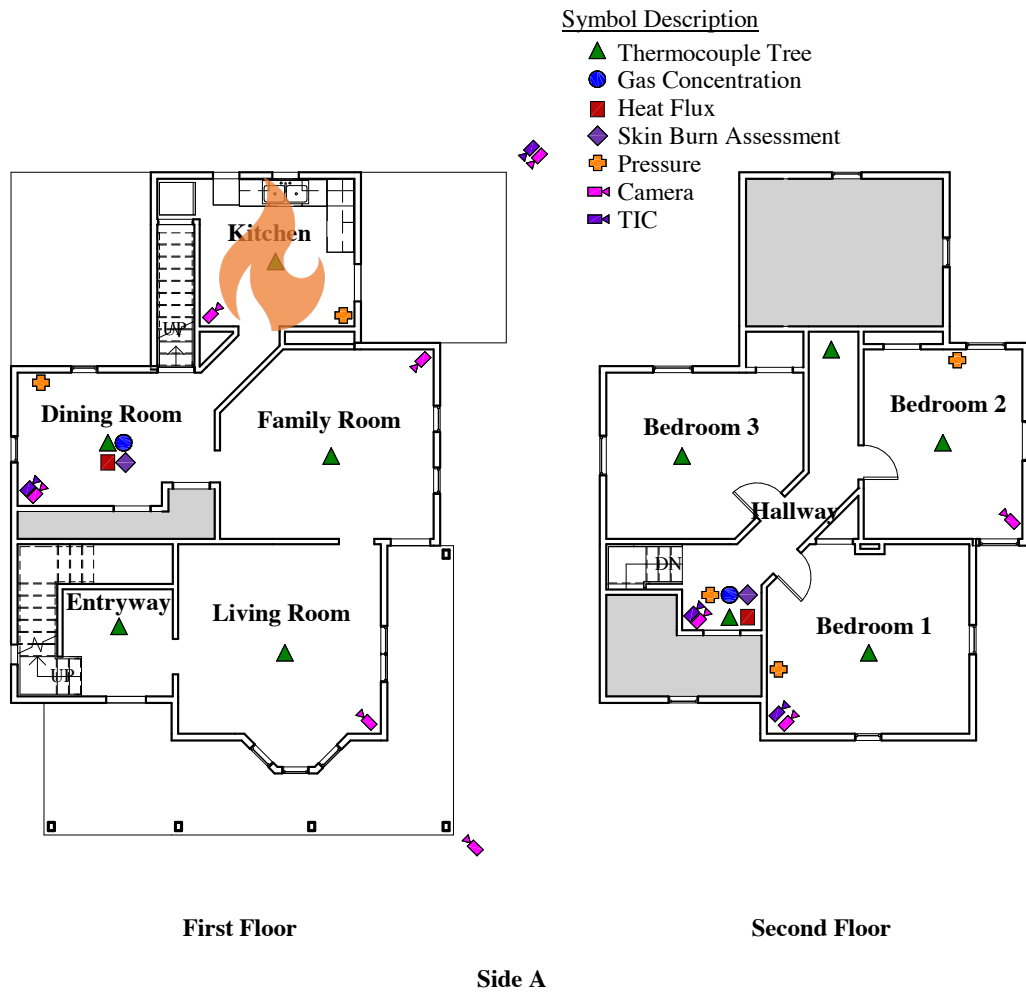
Figure 3.202: Instrumentation and floor plan for Experiment 17. Gray areas were isolated from the remainder of the structure and utilized as instrumentation space.

This structure had two levels and a partial basement. The first-floor had a living room, family room, dining room, and kitchen. The second-floor contained three bedrooms. The A/B corner stairwell connected the two floors. These areas defined the experimental volume of the structure. A second-floor bedroom, bathroom, and rear stairwell were separated from the experimental volume to protect sensitive instrumentation. This experiment utilized the first-floor kitchen as the fire room. The structure was instrumented for temperature, pressure, heat flux, IR, and standard video to capture the fire dynamics during experimentation. Instrumentation was also installed to characterize the potential for skin burns and occupant toxic exposure during the experiment. Figure 3.202 shows the layout of the structure with the instrumentation locations.

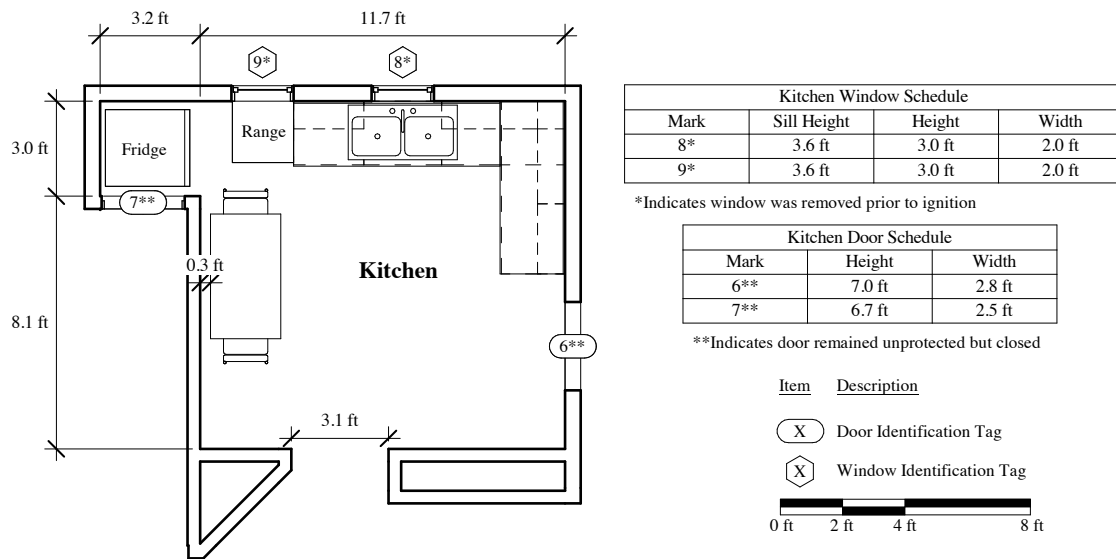
Figure 3.204: Fire room layout for Experiment 17.

The ignition package located on top of the C/D corner counter was ignited ($t = 0$ s). Flames were visible from the kitchen window (labeled 8 in Figure 3.204) 436 s (7:16) post ignition. Flashover occurred at 650 s (10:50) post ignition. The fire transitioned to a post flashover state with fire continuously venting from window 8 before any fire department intervention occurred.

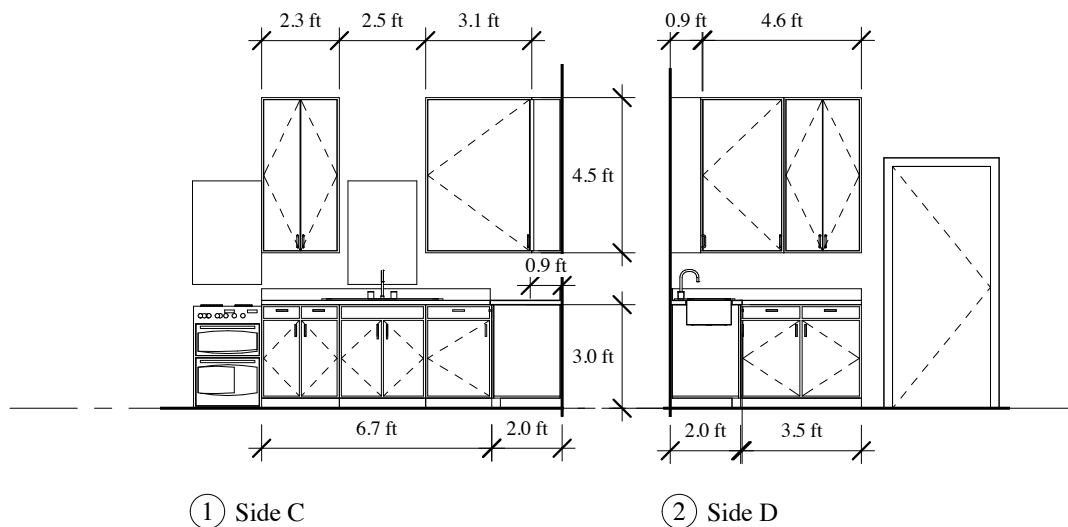
Figure 3.205: Wall and base cabinet locations, dimensions, and elevations within the kitchen for Experiment 17.

The cabinets directly above the ignition location were filled with approximately 1250 paper cups and the doors were left partially open. The kitchen pantry located along side A contained 17 paper towel rolls, while five paper towel rolls were located on top of the refrigerator. The kitchen windows located on side C were removed to provide comparable ventilation to other experiments that was sufficient to support flashover. The kitchen door on side D remained closed for the duration of the experiment. Photographs of the fire room prior to ignition are presented in Figure 3.203. A dimensioned layout of the kitchen is included in Figure 3.204. A detailed drawing of the kitchen cabinets is included in Figure 3.205.

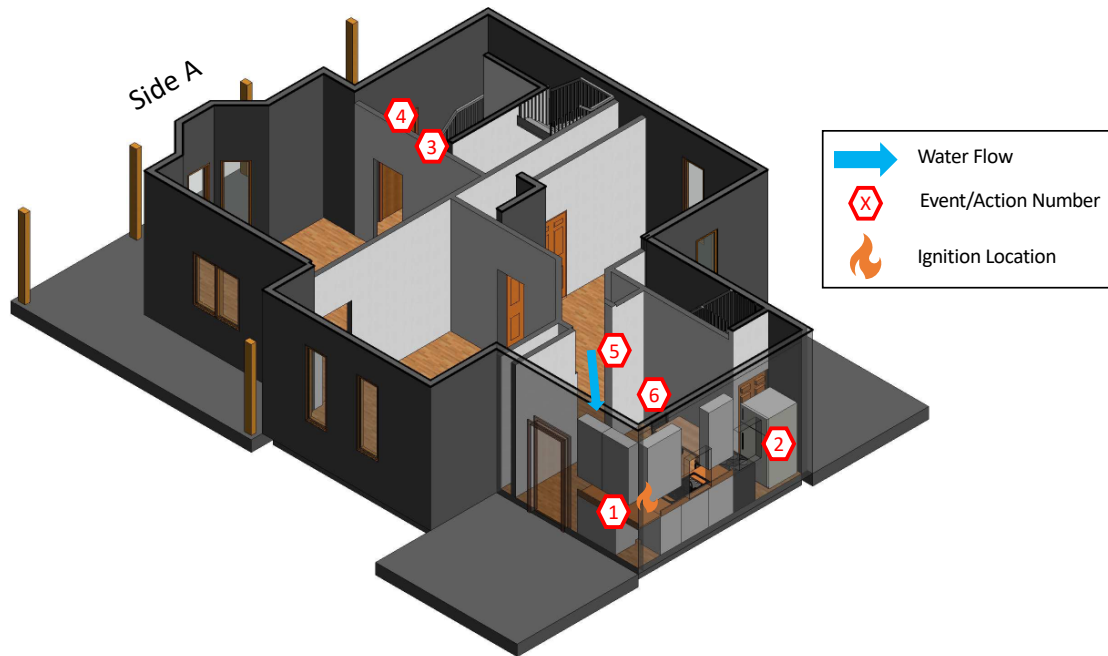
Action/Event	Time (mm:ss)	Time (s)
1 Ignition	00:00	0
2 Flashover	10:50	650
3 Front Door Open	13:01	781
4 PPV Fan Turned In	13:11	791
5 Flow from Dining Room	14:11	851
6 Suppression Crew Entered Fire Room	14:29	869

Figure 3.206: Time and sequence of actions and events for Experiment 17.

The front door was opened 781 s (13:01) post ignition. The PPV fan⁴ was turned on prior to the front door opening and was positioned to face the front door 791 s (13:11) post ignition. The suppression crew entered the structure through the front door advancing a 1.75 in. hoseline with a combination nozzle set to straight stream. The crew advanced to the dining room, where they stopped to flow water into the kitchen 851 s (14:11) post ignition for 9 s. The stream was directed toward the side B wall of the hallway leading into the kitchen. The suppression crew then moved closer to the kitchen, entering the fire room, before flowing water 869 s (14:29) post ignition for 10 s. While within the fire room, the suppression crew opened the hoseline three additional times at 889 s (14:49), 901 s (15:01), and 918 s (15:18) post ignition. The duration of each water flow was 7 s, 10 s, and 4 s respectively. After the fifth water application, the suppression crew stopped flowing water. The total tactic time, from front door open to entrance to the fire room, lasted 88 s (1:28). The total water flowed for initial suppression was 99 gal, which did not include the water flowed during mop-up operations. Figure 3.206 shows the sequence of events with an isometric image of the structure.

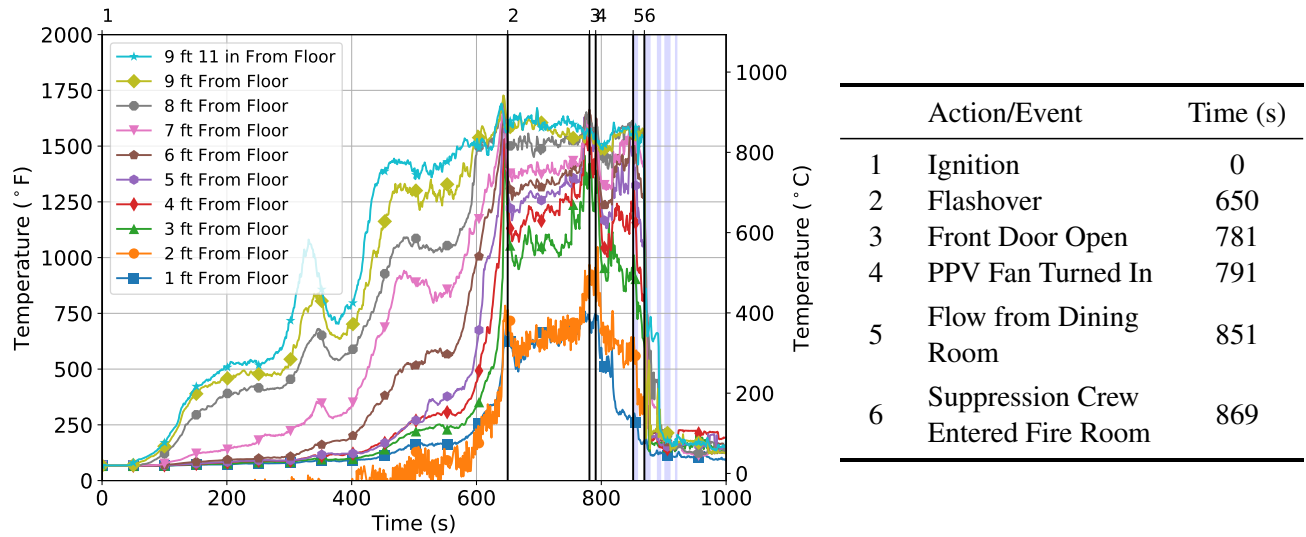
Figure 3.207: Temperatures in fire room (kitchen) for Experiment 17. The thermocouple 2 ft in elevation was compromised by from the water stream. Blue vertical bars indicate time and duration of water flow.

The time history of temperatures recorded in the fire room are shown in Figure 3.207. Temperatures 8 ft above the floor and higher began to increase approximately 50 s post ignition. These temperatures peaked between 675 °F and 1100 °F 340 s post ignition, corresponding to the cabinet door falling into the floor near the thermocouple array. Temperatures at all elevations began increasing more rapidly within the minute prior to flashover, during which the paper towel roll located on the kitchen table became engulfed in flames 588 s post ignition. Flashover occurred when floor temperatures exceeded 1100 °F 650 s post ignition. Temperatures during post-flashover conditions remained stable between 1600 °F at the ceiling and 600 °F at the floor until the front door was opened 781 s post ignition (Action 3). After which, temperatures briefly decreased before increasing back to their post-flashover state. Upon application of water 851 s post ignition, temperatures within the kitchen decreased to pre-combustion conditions.

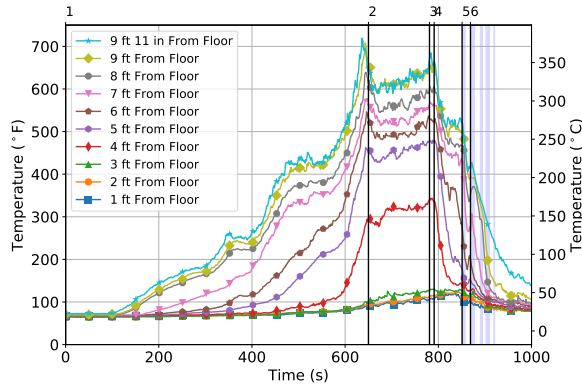
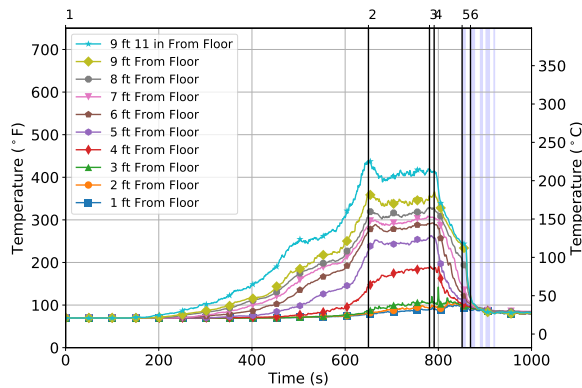
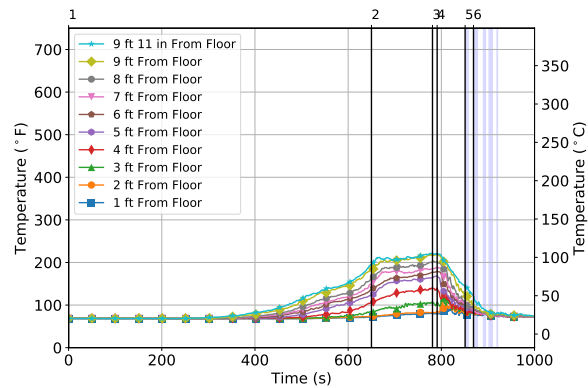
Figure 3.208: Temperatures remote from the fire room located on the first-floor for Experiment 17. Blue vertical bars indicate time and duration of water flow.

Temperatures recorded at first-floor locations remote from the kitchen are presented in Figure 3.208. Temperatures increased based on their relative proximity to the fire room as products of combustion spread throughout the structure. Dining room temperatures (see Figure 3.208a) increased around 100 s post ignition. Temperatures in the family room (see Figure 3.208b) began to increase around 250 s post ignition. Living room temperatures (see Figure 3.208c) began to increase around 400 s post ignition. Temperatures 4 ft above the floor and higher throughout the remote areas of the first floor peaked during kitchen flashover 650 s post ignition with peak dining room temperatures of 720 °F, family room temperatures of 440 °F, and living room temperatures of 220 °F. Before 3 ft, temperatures remained below 125 °F. This stratification of temperatures indicates the smoke layer did not descend past 3 ft. Post-flashover conditions produced steady temperatures for the smoke layer between 130°F and 620 °F throughout the structure. Temperatures began to decrease after the PPV fan was turned to face the doorway. Temperatures returned to pre-ignition conditions after suppression was complete.

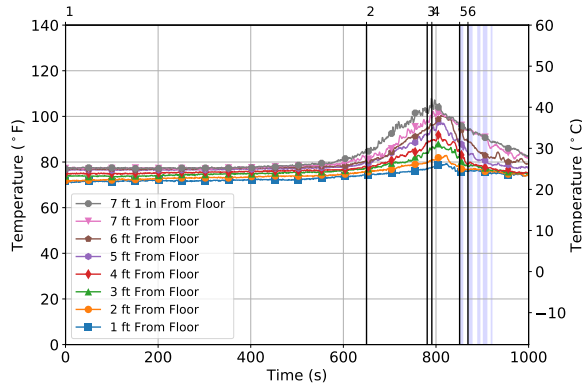
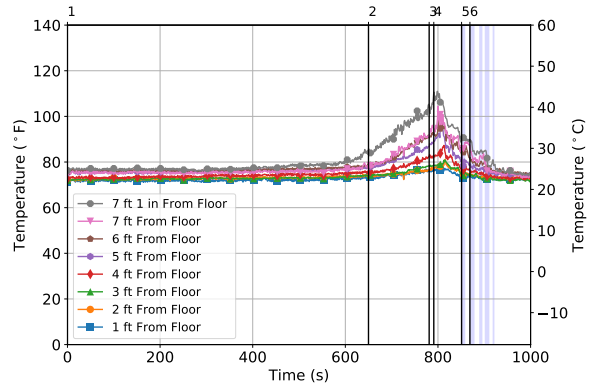
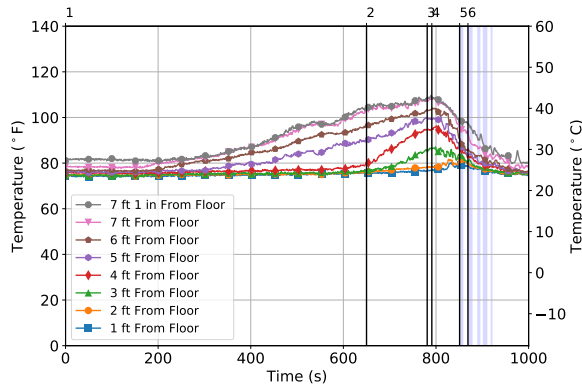
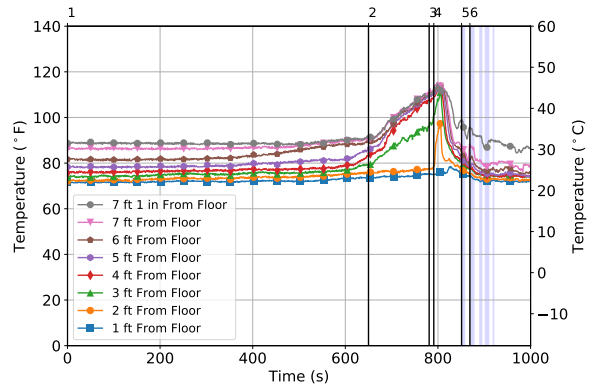
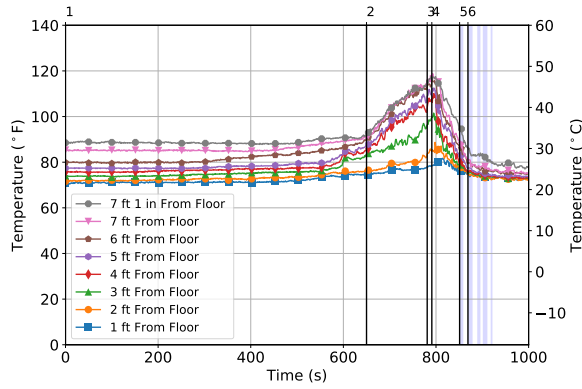
Figure 3.209: Temperatures remote from the fire room located on the second-floor for Experiment 17. Blue vertical bars indicate time and duration of water flow.

Temperatures recorded on the second-floor are presented in Figure 3.209. Bedroom 1 (see Figure 3.209a) and bedroom 2 (see Figure 3.209b) temperature behaved similarly, increasing just prior to flashover (approximately 650 s post ignition) and reaching a local maximum just after positive pressure ventilation was established. Bedroom 3 (see Figure 3.209c) ceiling temperatures began increasing earlier than the other bedrooms, at approximately 170 s post ignition. Temperatures similarly reached a local maximum just after positive pressure ventilation. Temperatures in all three bedrooms reached a peak of approximately 110 °F. Temperatures steadily decreased after positive pressure ventilation began and continued through suppression, after which temperatures returned to near pre-ignition conditions. Hallway temperatures began increasing most significantly within the minute prior to flashover. Temperatures in the hallway between bedrooms 1 and 3 (see Figure 3.209e) began increasing before temperatures in the hallway between bedrooms 2 and 3 due to the closer proximity to the stairwell. Temperatures within the hallway peaked just after positive pressure ventilation was established reaching peaks of approximately 115 °F. Temperatures decreased after PPV and continued to pre-ignition conditions with suppression of the kitchen fire.

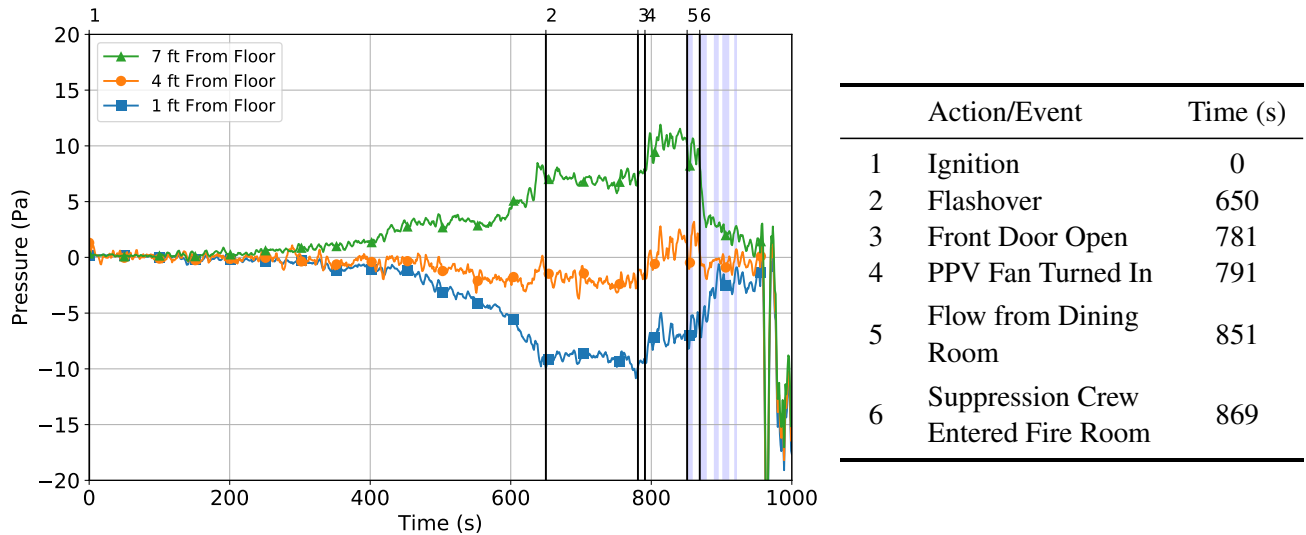
Figure 3.210: Pressures in the fire room (kitchen) for Experiment 17. Blue vertical bars indicate time and duration of water flow.

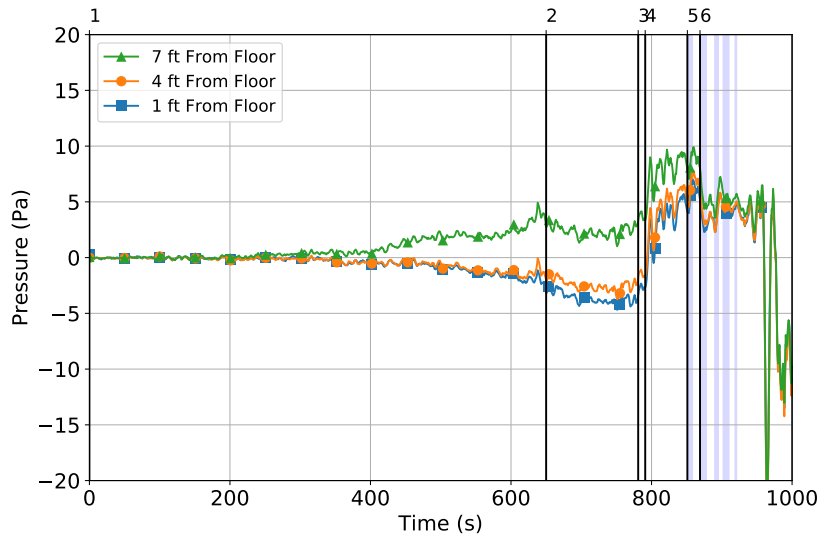
Figure 3.211: Dining room pressures for Experiment 17. Blue vertical bars indicate time and duration of water flow.

Dining room pressures (see Figure 3.211) responded to the bi-directional flow created by the kitchen fire 250 s post ignition. Pressure at the 7 ft elevation increased to approximately 5.0 Pa while the 4 ft and 1 ft elevations to decreased to approximately -3.0 and -4.0 Pa, respectively. These pressures remained stable until the PPV fan was turned to face the doorway 791 s post ignition. Pressures increased between 6.0 Pa and 8.0 Pa, and remained at an elevated state until the fan was turned off.

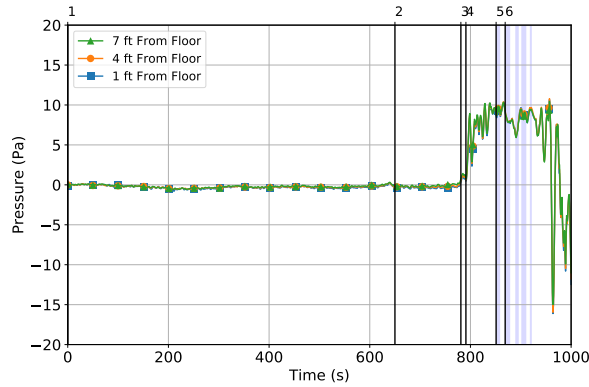
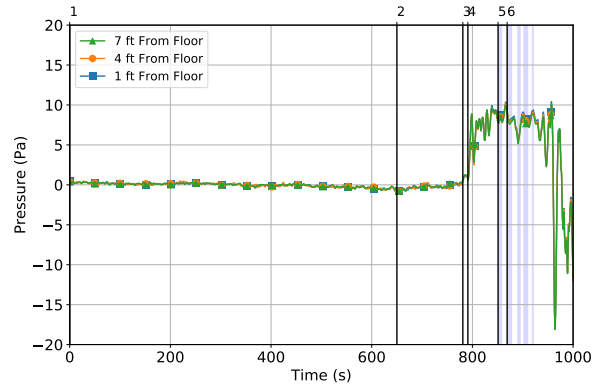
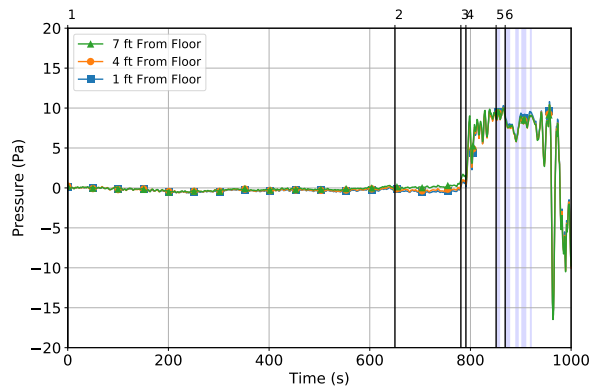
Figure 3.212: Pressures remote on the second-floor for Experiment 17. Blue vertical bars indicate time and duration of water flow.

Pressure on the second-floor (i.e., pressures within bedroom 1 (see Figure 3.212a), bedroom 2 (see Figure 3.212b), and the hallway (see Figure 3.211)) were not impacted by the fire growth of the first-floor kitchen fire. Pressures at all elevations remained at pre-ignition values until the front door was opened upon which pressure increased by approximately 1.0 Pa. Following the start of PPV, pressures increased by approximately 8.0 Pa. Pressures remained at an elevated state until the fan was turned off. Bedroom 3 pressure did not record during Experiment 17, as the sensor was damaged in Experiment 12.
