Analysis of the Coordination of Suppression and Ventilation in Single-Family Homes

John Regan
Julie Bryant
Craig Weinschenk

UL Firefighter Safety Research Institute
Columbia, MD 20145

March 19, 2020

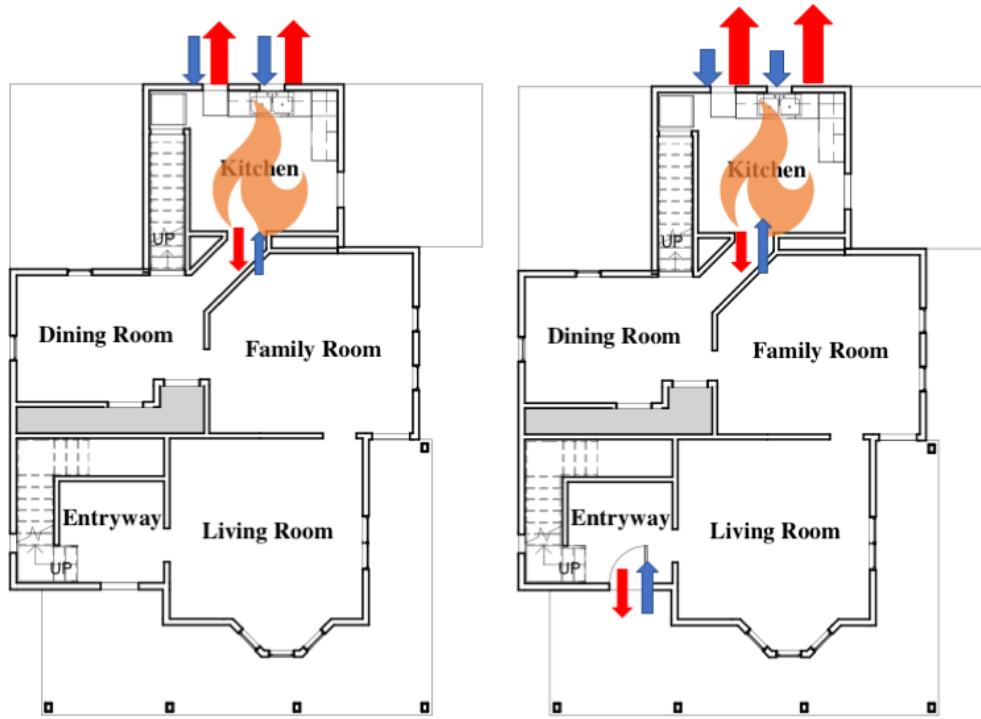
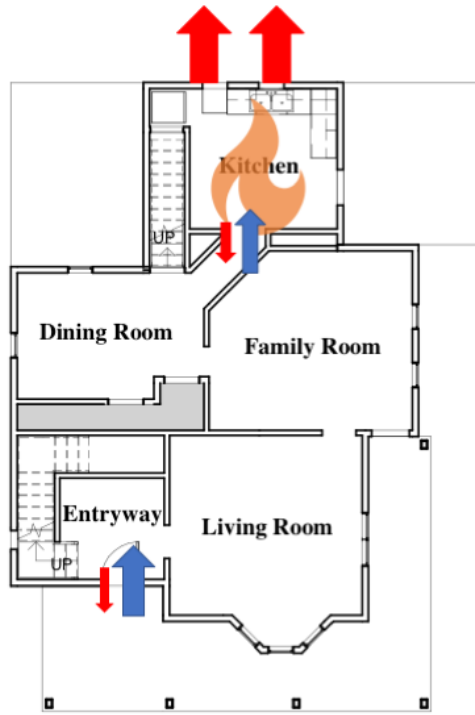
Figure 3.213: Changes in flow path for Experiment 17. Red arrows indicate flow out of the compartment, blue arrows indicate entrainment into the compartment, and the sizes of the arrows indicate the relative magnitude of the flow through each opening.

The fire growth in the kitchen created bi-directional flows throughout openings within the structure. Differences in pressure between the fire room and remote locations illustrate the changes in flow before and post fire department interventions. Prior to fire department interventions the only exterior ventilation openings were the two kitchen windows on side C. Pressure at the 7 ft elevation in the fire room was greater than the pressure at the same height in the dining room or on the second-floor. Similarly, pressure at the 1 ft elevation in the fire room was less than the pressure at the same elevation elsewhere in the structure. The gradient in pressure confirms the entrainment of air into the fire room near the floor and the exhaust of hot gases out of the fire room near the ceiling. The flows prior to fire department intervention is illustrated in Figure 3.213a.

The front door was opened 781 s post ignition, establishing a third ventilation hole. As fresh air was entrained through the bottom of the front door, less air was entrained through the kitchen windows. As less air was entrained through the bottom of the windows, more gases were exhausted through the top of the windows as well as through the top of the front door. Figure 3.213b represents the flow paths within the structure after the front door was opened.

By positively pressurizing the structure from the front door, the doorway became an inlet for fresh air. The kitchen windows became the exhaust for hot gases. Figure 3.213c represents the flow path within the structure after the PPV fan was turned into the front door.

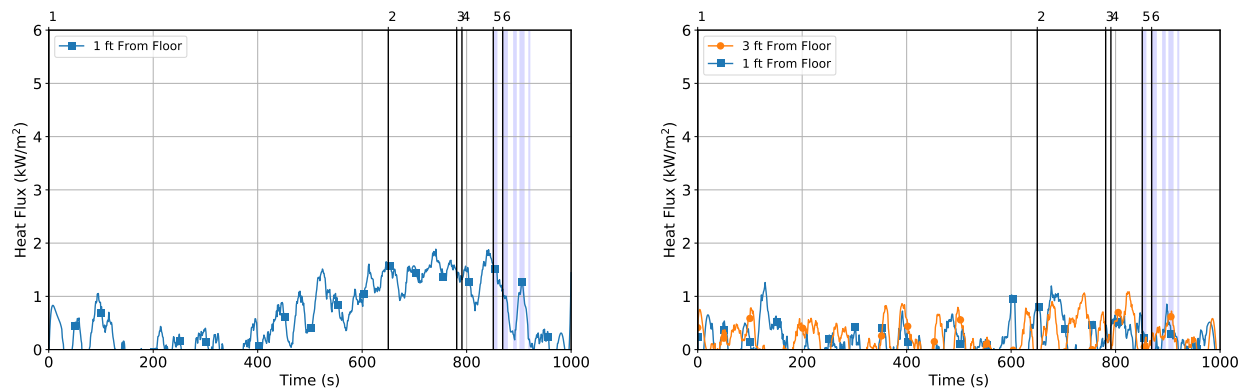
Figure 3.214: Heat flux in remote locations for Experiment 17. Blue vertical bars indicate time and duration of water flow.

Heat flux data recorded in the dining room and hallway are presented in Figure 3.214. Dining room heat flux at the 1 ft elevation began to increase approximately 400 s post ignition. Heat flux peaked around the time of flashover to 1.7 kW/m^2 . Post-flashover conditions produced a steady heat flux that remained around 2.0 kW/m^2 . Following positively pressurizing the structure, the heat flux decreased to 0.7 kW/m^2 as cool air was entrained through the dining room into the kitchen. The heat flux increased just before suppression efforts began to 1.8 kW/m^2 , but returned to pre-ignition conditions after suppression was complete.

Hallway heat flux at both the 1 ft and 3 ft elevations did not increase above 1.3 kW/m^2 for the duration of the experiment.

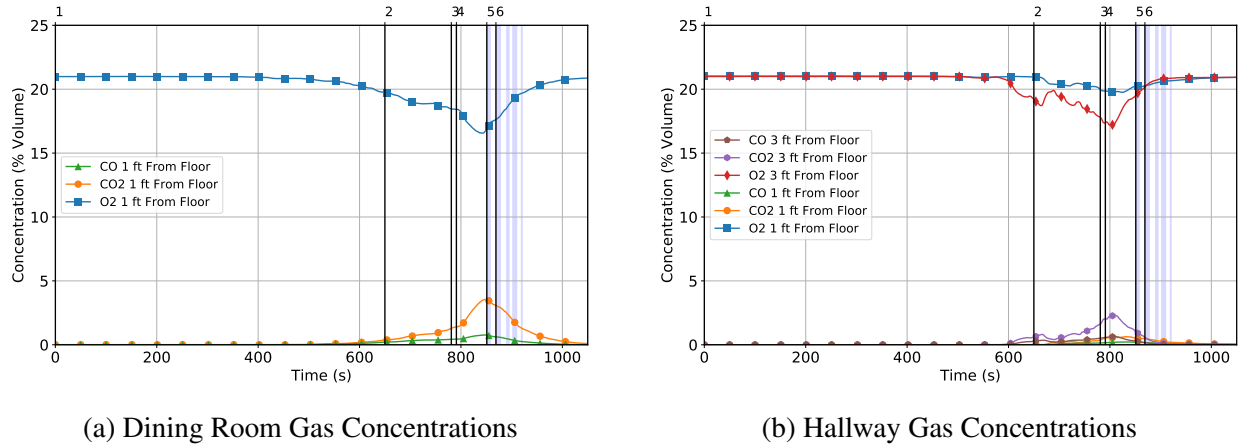
Figure 3.215: Gas concentrations at remote locations in Experiment 17. Blue vertical bars indicate time and duration of water flow.

The aforementioned locations also measured gas concentrations, and the CO , CO_2 , and O_2 data recorded is presented in Figure 3.215. Dining room gas concentrations (see Figure 3.215a) began to change around 500 s post ignition. O_2 concentration during flashover was 19.8%. O_2 concentration continued to decrease throughout the experiment until it reached a minimum 845 s post ignition of 16.5%. CO and CO_2 concentrations during flashover were 0.2% and 0.4%, respectively. Similarly, concentrations increased until reaching a maximum of 0.7% and 3.6% approximately 1 min. after the PPV fan was turned into position.

Hallway gas concentrations (see Figure 3.215b) at the 3 ft elevation began to change around 600 s post ignition, while the 1 ft elevation began to change around 660 s post ignition. Conditions at

the 3 ft elevation were worse than at the 1 ft elevation for the entirety of the experiment. Hallway gas concentrations reached peak concentrations of O₂ at 17.2%, CO at 0.7%, and CO₂ at 2.3%, approximately 10 s after the PPV fan was turned into position. Mechanical ventilation of the structure combined with suppression returned the hallway gas concentration to ambient levels.

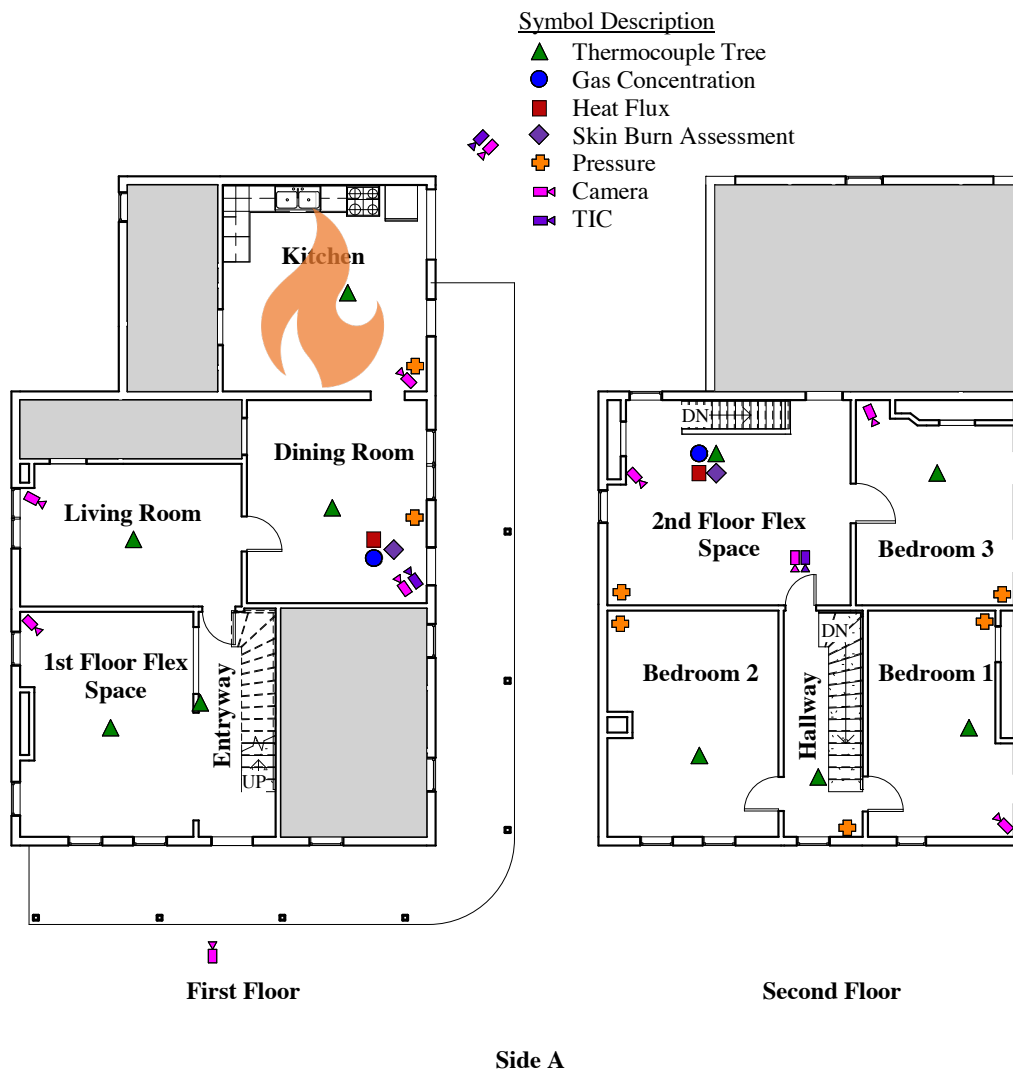
Figure 3.217: Instrumentation and floor plan for Experiment 18. The gray areas were isolated from the remainder of the structure and utilized as space for instrumentation.

The structure had two floors and a partial basement. A one-and-a-half-story addition was built, increasing the total area of the structure to 2,912 sq ft. The first-floor had a flex space, living room, dining room, and kitchen. The second-floor had three bedrooms and a second flex space. The side A stairwell connected the two floors. These areas defined the experimental volume of the structure. Various spaces on the first and second-floors were separated from this volume and used as instrumentation space. This experiment utilized the first-floor kitchen as the fire room. The structure was instrumented for temperature, pressure, heat flux, IR, and standard video to capture the fire dynamics during experimentation. Instrumentation was also installed to characterize the potential for skin burns and occupant toxic exposure during the experiment. Figure 3.217 shows the layout of the structure with the instrumentation locations.

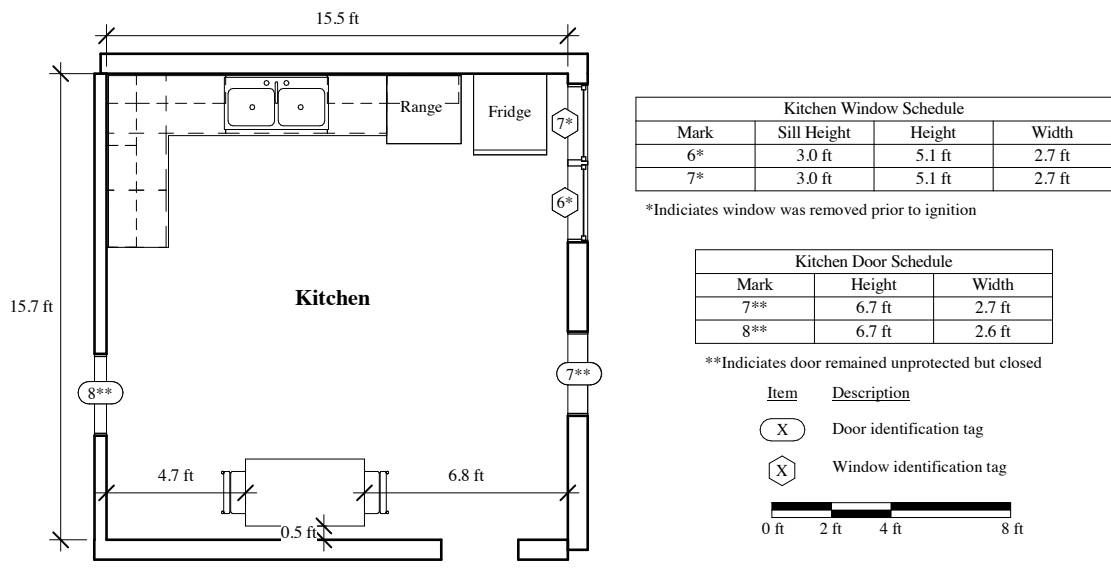
Figure 3.219: Fire room layout for Experiment 18.

The fire room (kitchen) was furnished with the kitchen fuel package described in Section 2.4.2 and contained a range, refrigerator, table, and two chairs. The ignition location was immediately surrounded by nine small bags of potato chips and eight paper towel rolls. The wall cabinets directly above the ignition location were left open, exposing approximately 1250 paper cups and two paper towel rolls. Fourteen paper towel rolls were placed on top of the wall cabinets in the B/C corner while six paper towel rolls were located on top of the refrigerator. The kitchen windows on side D were removed prior to ignition to ensure repeatable fire growth and a sufficient oxygen supply for flashover. The side D door remained closed for the duration of the experiment. Photographs of the fire room prior to ignition are presented in Figure 3.218. A dimensioned layout of the kitchen is included in Figure 3.219. A detailed drawing of the kitchen cabinets is included in Figure 3.220.

Exterior water flow through the side D window (labeled 6 in Figure 3.219) began 720 s (12:00)

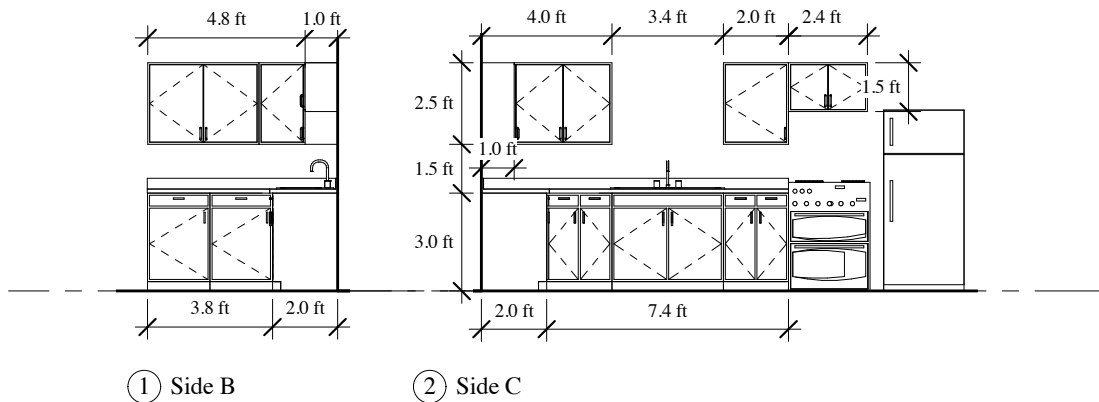
Figure 3.220: Wall and base cabinet locations, dimensions, and elevations within the kitchen for Experiment 18.

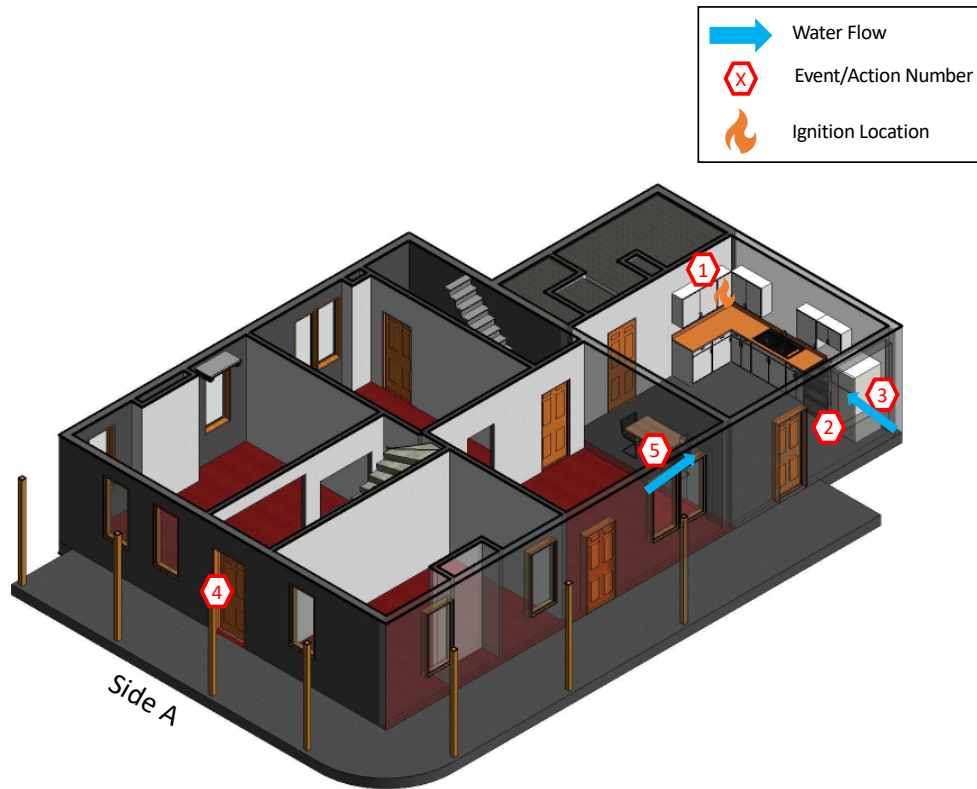
Action/Event	Time (mm:ss)	Time (s)
1 Ignition	00:00	0
2 Flashover	10:20	620
3 Exterior Flow	12:00	720
4 Front Door Open	12:21	741
5 Interior Flow	13:48	828

Figure 3.221: Time and sequence of actions and events for Experiment 18.

Two 1.75 in. hoselines with combination nozzles set to straight stream were used for suppression. The primary hoseline was placed on side D and utilized for exterior water application and the secondary hoseline was placed on side A and brought into the structure for interior water application. No additional ventilation beyond the front door was provided. Figure 3.221 shows the sequence of events with an isometric image of the structure.

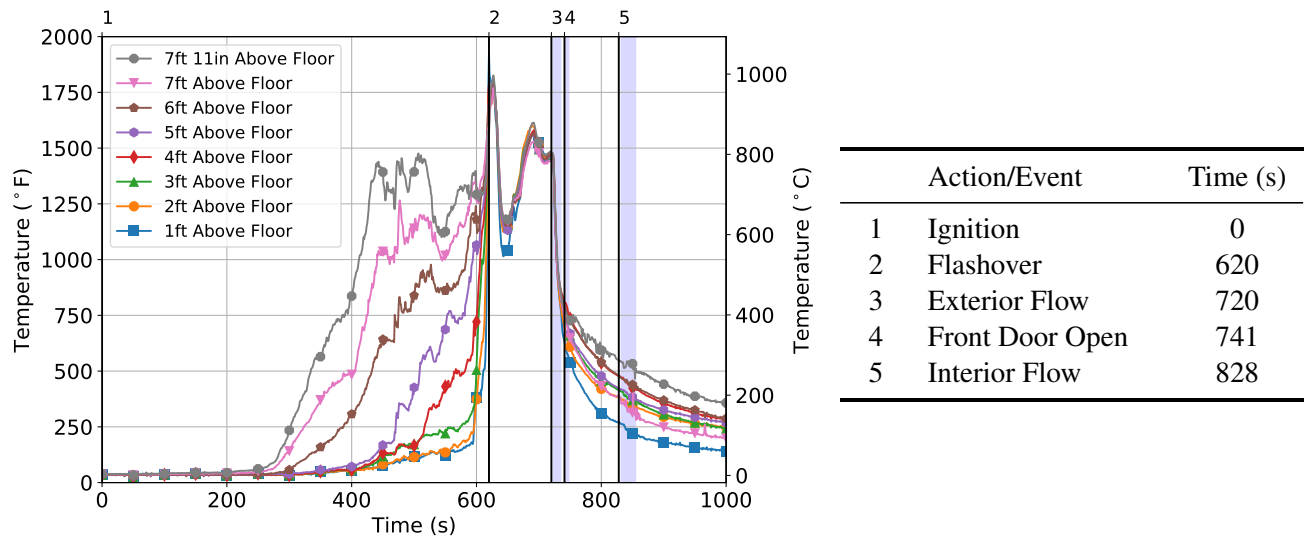
Figure 3.222: Temperatures in fire room (kitchen) for Experiment 18. Blue vertical bars indicate time and duration of water flow.

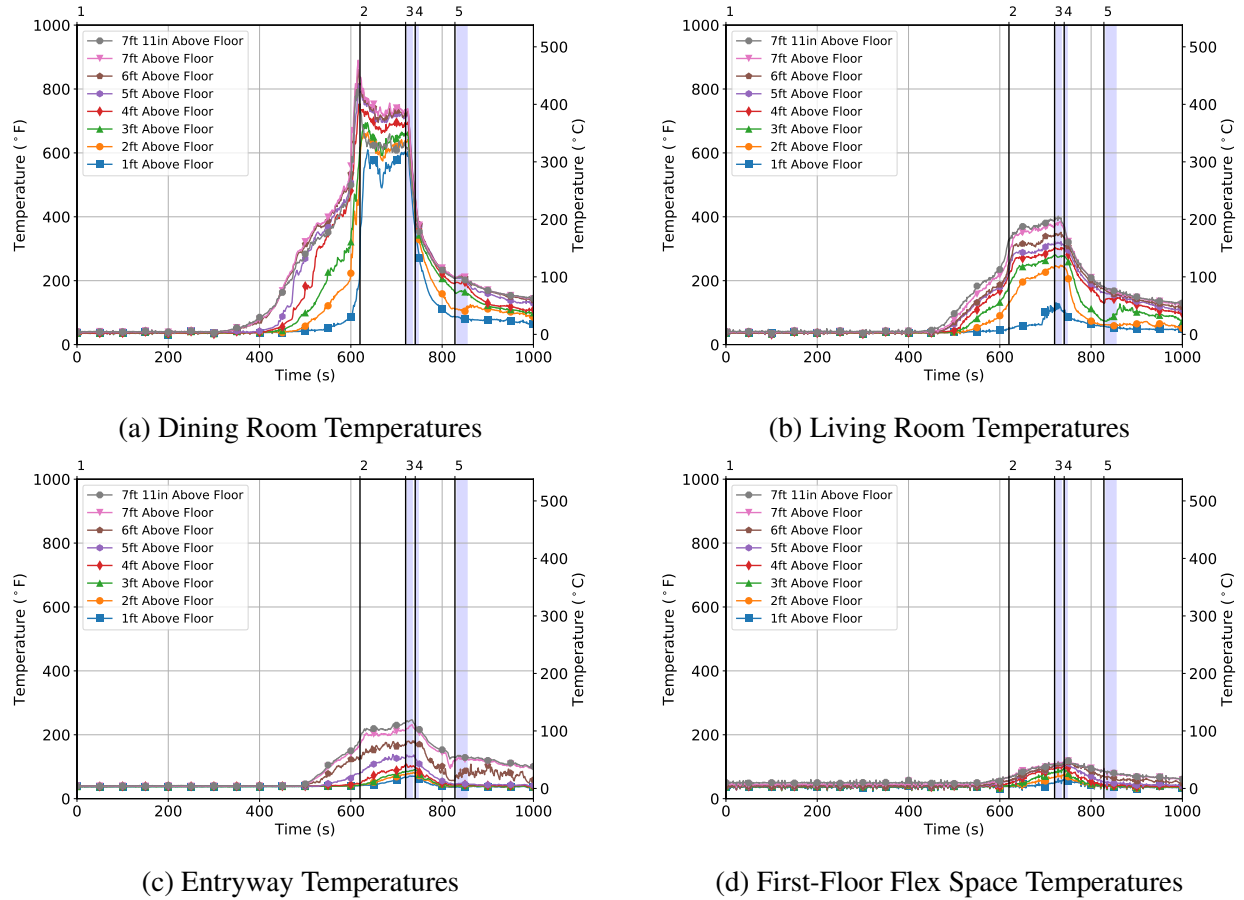
First-floor remote temperatures are presented in Figure 3.223. Temperatures remote from the kitchen responded relative to their proximity to the fire room. Dining room temperatures (see Figure 3.223a) began to increase around 350 s post ignition. At flashover, temperatures ceiling temperatures peaked at approximately 900 °F, while floor temperatures peaked at approximately 600 °F. Post flashover, temperatures became steady between 550°F and 750 °F. Exterior suppression 720 s post ignition decreased temperatures within the dining room (Action 3). Temperatures returned to pre-ignition conditions after interior suppression (Action 5).

Temperatures within the living room (see Figure 3.223b) began to increase around 450 s post ignition. Temperatures did not peak during flashover, but rather increased steadily until reaching a plateau ranging from 200°F to 400 °F above 2 ft. Temperatures remained elevated until suppression 720 s post ignition, after which temperatures decreased back to pre-ignition conditions.

Entryway temperatures (see Figure 3.223c) did not increase until approximately 500 s post ignition. Temperatures gradually increased until after flashover when temperatures reached an elevated plateau ranging from 50°F to 230 °F. Temperatures began to decrease after exterior suppression at 720 s post ignition and returned to near pre-ignition conditions before interior suppression at 828 s.

First-floor flex space temperatures (see Figure 3.223d) began to increase approximately 500 s post ignition. Temperatures increased gradually reaching a peak of approximately 120 °F. Exterior water flow caused temperatures to decrease toward pre-ignition conditions.

Figure 3.223: Temperatures remote from the fire room on the fire floor for Experiment 18. Blue vertical bars indicate time and duration of water flow.

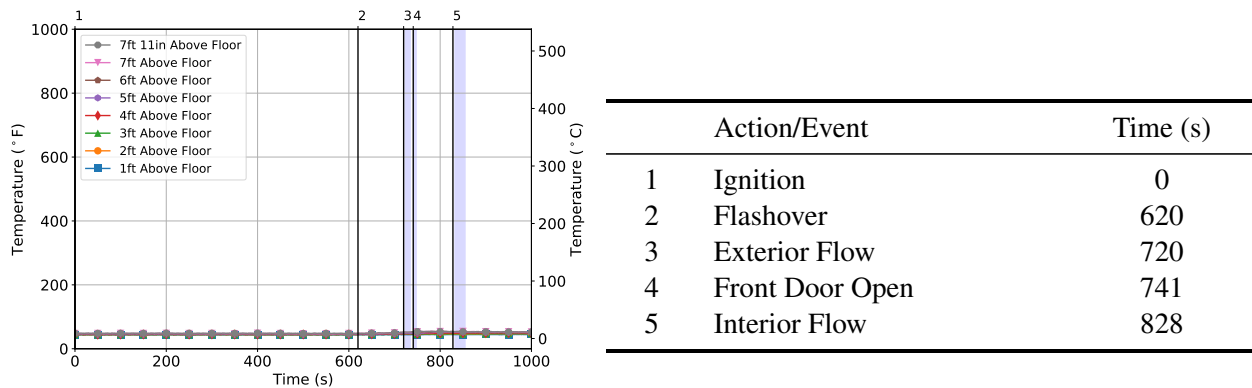
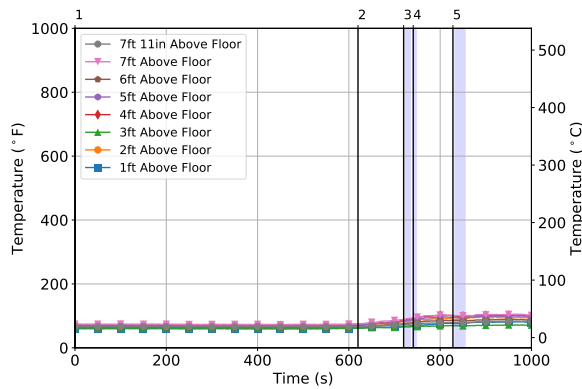
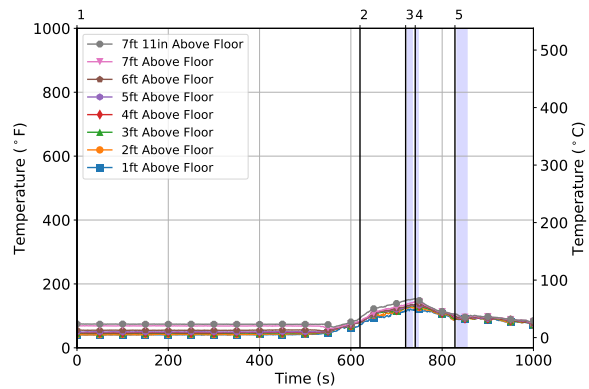
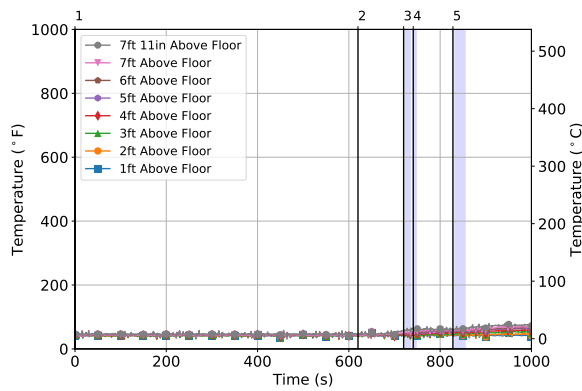
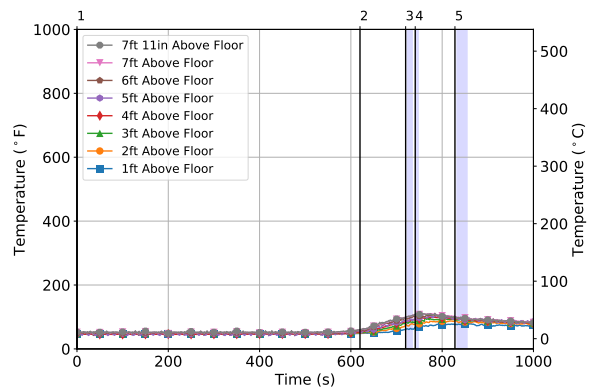
Second-floor temperatures are presented in Figure 3.224. Temperatures on the floor above the fire did not increase above 160 °F throughout the duration of the experiment. Hallway temperatures first increased approximately 550 s post ignition. Temperatures steadily increased as smoke traveled up to the second-floor, reaching a peak of approximately 150 °F during exterior water flow. Flex space temperatures began increasing approximately 560 s post ignition and peaked to 110 °F after exterior water flow (Action 3). Temperatures in both spaces decreased after exterior water flow (Action 5).

Temperatures within bedroom 1 (see Figure 3.224a), bedroom 2 (see Figure 3.224b), and bedroom 3 (see Figure 3.224d) behaved similarly, as all bedroom doors were open to the volume of

the second-floor. Temperatures in these spaces began gradually increasing after flashover. Temperatures increased during the duration of the experiment but remained below approximately 105 °F.

Figure 3.224: Remote temperatures on the floor above the fire room for Experiment 18. Blue vertical bars indicate time and duration of water flow.

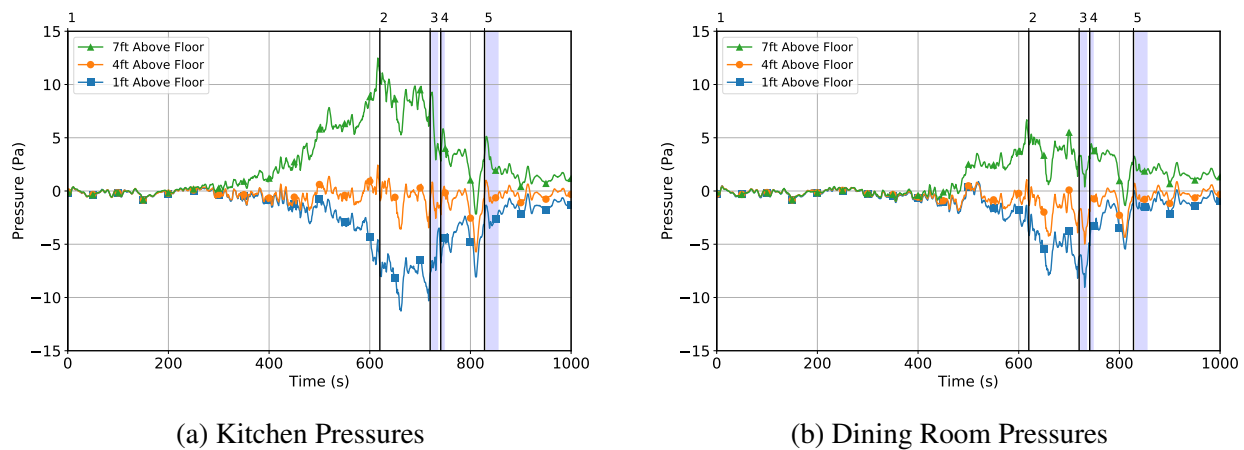
Pressures recorded on the fire floor are presented in Figure 3.225. Kitchen pressures are presented in Figure 3.225a where the 7 ft elevation increased approximately 300 s post ignition due to gas

expansion. Pressure continued to increase, peaking during flashover to 12.6 Pa. Post-flashover the pressure at the 7 ft elevation remained steady around 8.0 Pa. Pressure at the 4 ft elevation remained steady near ambient conditions throughout the experiment, indicating its elevation was between the entrainment and exhaust flows. Pressure at the 1 ft elevation also began to decrease approximately 300 s post ignition as the fire entrained fresh air from remote areas within the structure. Pressure reached its minimum of -11.3 Pa approximately 40 s after flashover. Following exterior water flow 720 s post ignition, all pressures began to return toward ambient conditions. Pressures returned to ambient conditions after interior suppression.

Pressure within the dining room (see Figure 3.225b) began to change around 400 s post ignition. Pressure at the 7 ft elevation increased as hot gases gathered at the ceiling and peaked during flashover at 6.8 kW/m². Pressure at the 4 ft elevation remained near ambient throughout the experiment. Pressure at the 1 ft elevation decreased as air was entrained to the fire room. Pressure at all three elevations decreased as fire room temperatures decreased during post-flashover conditions, ranging from 0.6 Pa to 7.8 Pa. Pressures steadily trended toward ambient for the remainder of the experiment.

Figure 3.225: Pressures on the fire floor for Experiment 18. Blue vertical bars indicate time and duration of water flow.

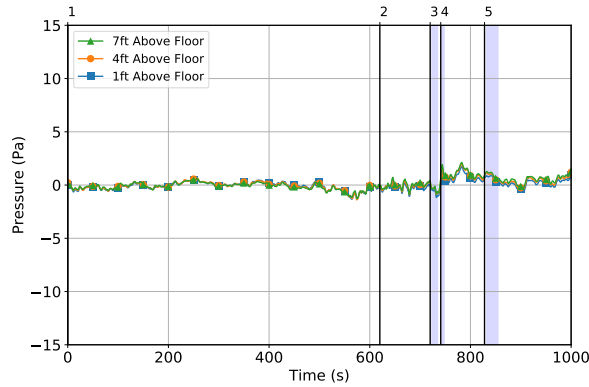
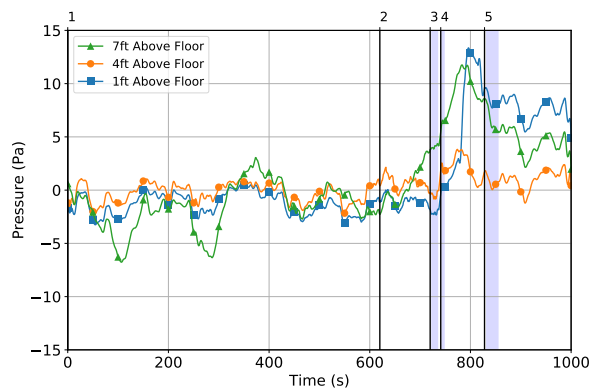
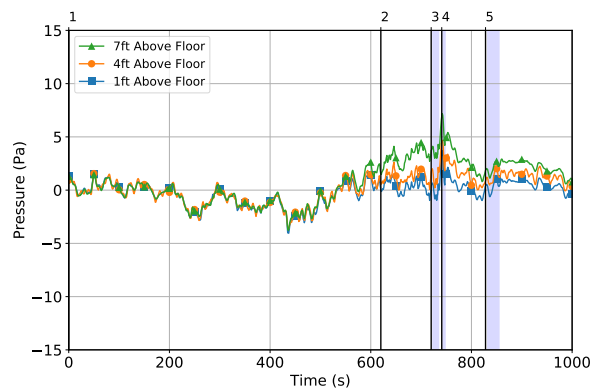
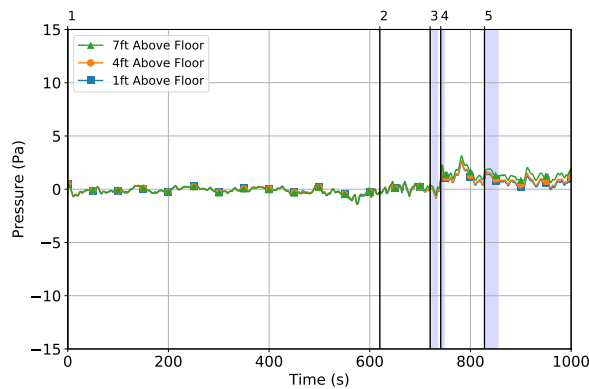
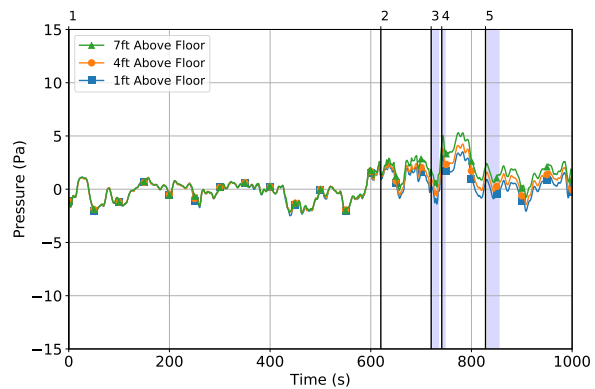
Pressures recorded on the floor above the fire room are presented in Figure 3.226. Pressure within the hallway (see Figure 3.226c) decreased around 200 s post ignition; an indication entrainment of air from the second-floor. Prior to flashover, approximately 550 s post ignition, pressure at all three elevations in both the hallway and flex space increased. The second-floor became positively pressurized as hot gases traveled upward. Pressures peaked after the front door was opened ranging

from 3.6 Pa at the floor to 5.4 Pa at the ceiling and then subsequently returned toward ambient for the duration of the experiment. Pressures within bedroom 1, bedroom 2, and bedroom 3 were similar to one another. Pressures remained near atmospheric pressure until the front door was opened, when pressure increased at all three elevations.

Figure 3.226: Second-floor pressures remote from fire room for Experiment 18. Blue vertical bars indicate time and duration of water flow.

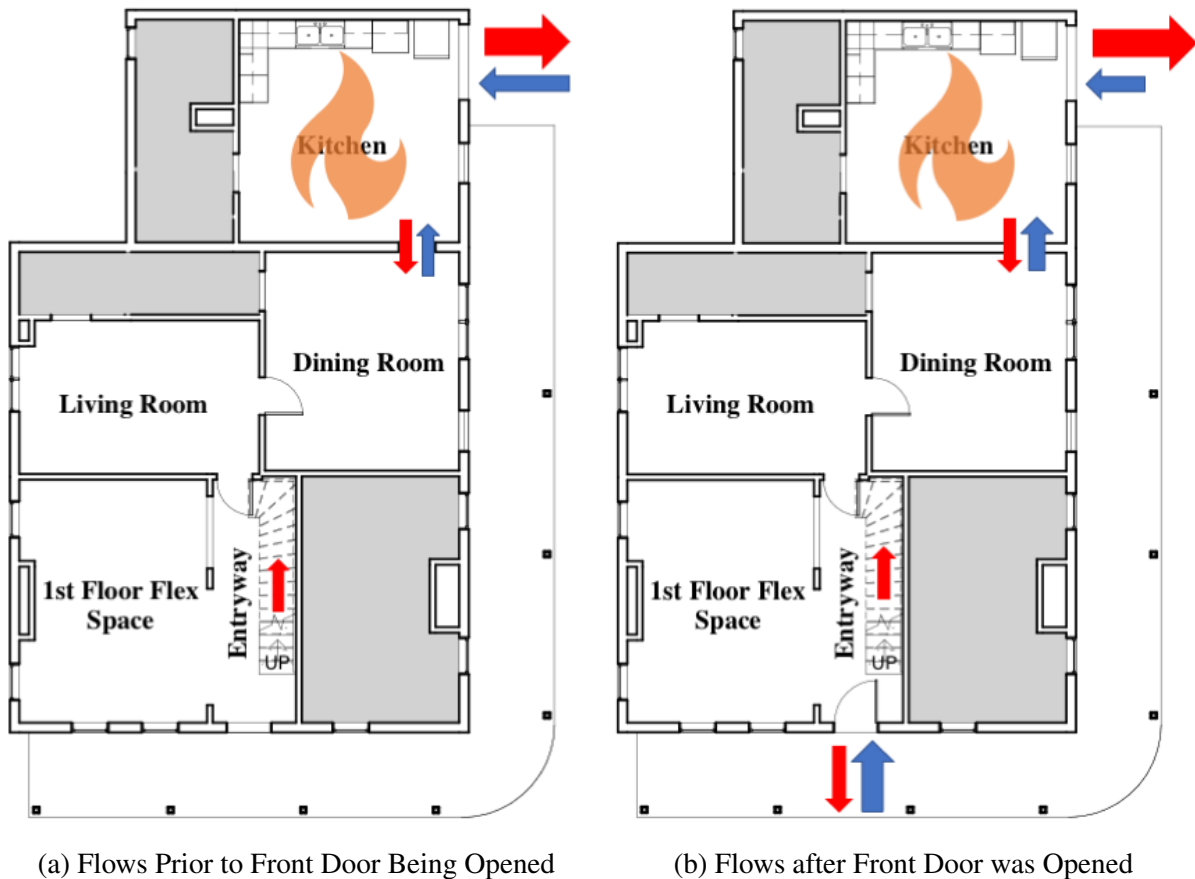
Figure 3.227 illustrates the flow of hot and cool gases throughout the structure. The kitchen fire initially created bi-directional flows through the open kitchen windows and doorway to the dining room (see Figure 3.227a). Pressure at the 7 ft elevation in the fire room was greater than the pressure at the same elevation in the dining room. Similarly, the pressure at the 1 ft elevation in the fire room was less than the pressure at the same elevation in the dining room. The gradient in pressure between the fire room and dining room confirms the exhaust of hot gases out of the fire room and entrainment of cool air into the fire room. The direction of flow did not change when the front door was opened (see Figure 3.227b), but the magnitude in each direction changed. Entrainment of air through the front door decreased the entrainment of air through the windows. As a result, exhaust through the windows increased and exhaust was established through the front door.

Figure 3.227: Changes in flow path for Experiment 18. Red arrows indicate flow out of the compartment, blue arrows indicate entrainment into the compartment, and the sizes of the arrows indicate the relative magnitude of the flow through each opening.

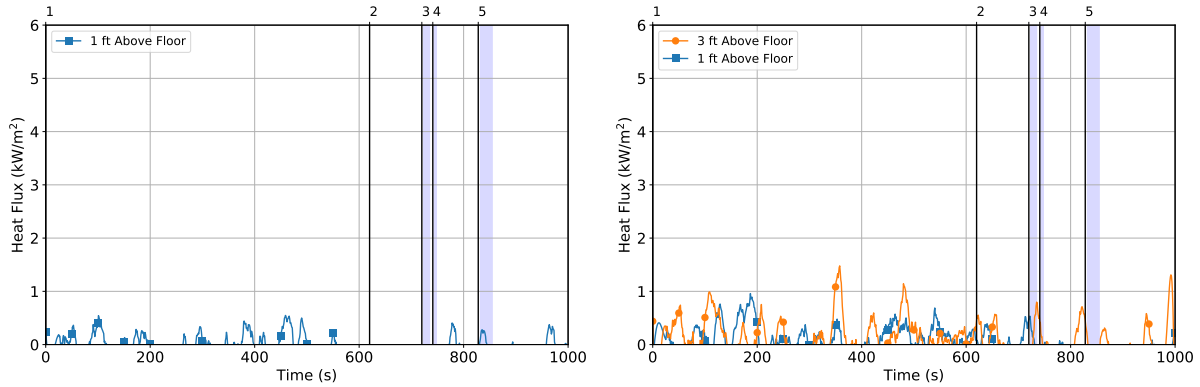
Dining room and flex space heat flux data are presented in Figure 3.228. Dining room heat flux was recorded at the 1 ft elevation. Flex space heat flux was recorded at both the 1 ft and 3 ft elevations. Neither location recorded a notable increase in heat flux throughout the experiment.

Figure 3.228: Heat flux at remote locations for Experiment 18. Blue vertical bars indicate time and duration of water flow.

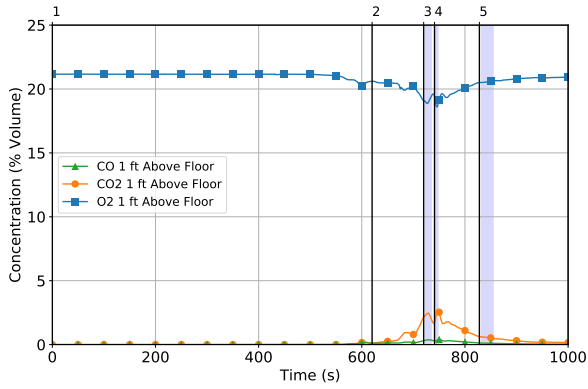
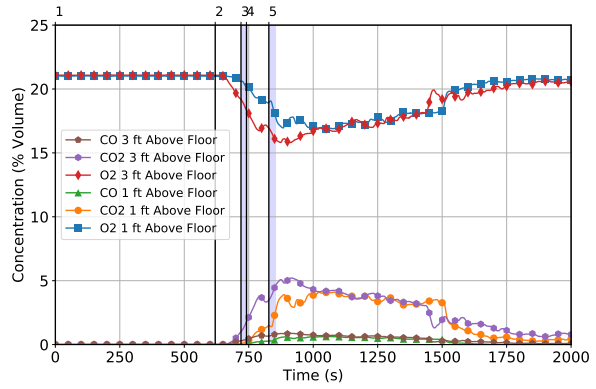
The aforementioned locations were also monitored for gas concentrations, of CO, CO₂, and O₂. Gas concentration data is presented in Figure 3.229. Dining room O₂ concentration began to decrease while CO and CO₂ concentrations began to increase approximately 560 s post ignition (see Figure 3.229a). Gas concentrations steadily trended away from ambient, coming to a local peak during the first exterior water flow of 18.8% O₂, 2.4% CO₂, and 0.3% CO. The first exterior water flow decreased gas concentrations. During the 9 s of no flow between the first and second exterior water flows, the gas concentrations began to worsen, peaking during the second exterior water flow to 18.6% O₂, 2.8% CO₂, and 0.4% CO. After the second exterior water flow, gas concentrations began trending back toward ambient.

Flex space gas concentrations (see Figure 3.229b) began to change approximately 640 s post ignition for both elevations. Gas concentrations increased without impact from exterior or interior water flow to peak at both elevations approximately 910 s post ignition. Conditions at the 3 ft elevation were worse than at the 1 ft elevation for the entire experiment. Peak concentrations were 15.8% O₂, 5.2% CO₂, and 0.9% CO approximately 910 s post ignition.

Figure 3.229: Gas concentrations at remote locations for Experiment 18. Figure 3.229b ends at 2000 s post ignition to indicate that gas concentrations returns to ambient. Blue vertical bars indicate time and duration of water flow.

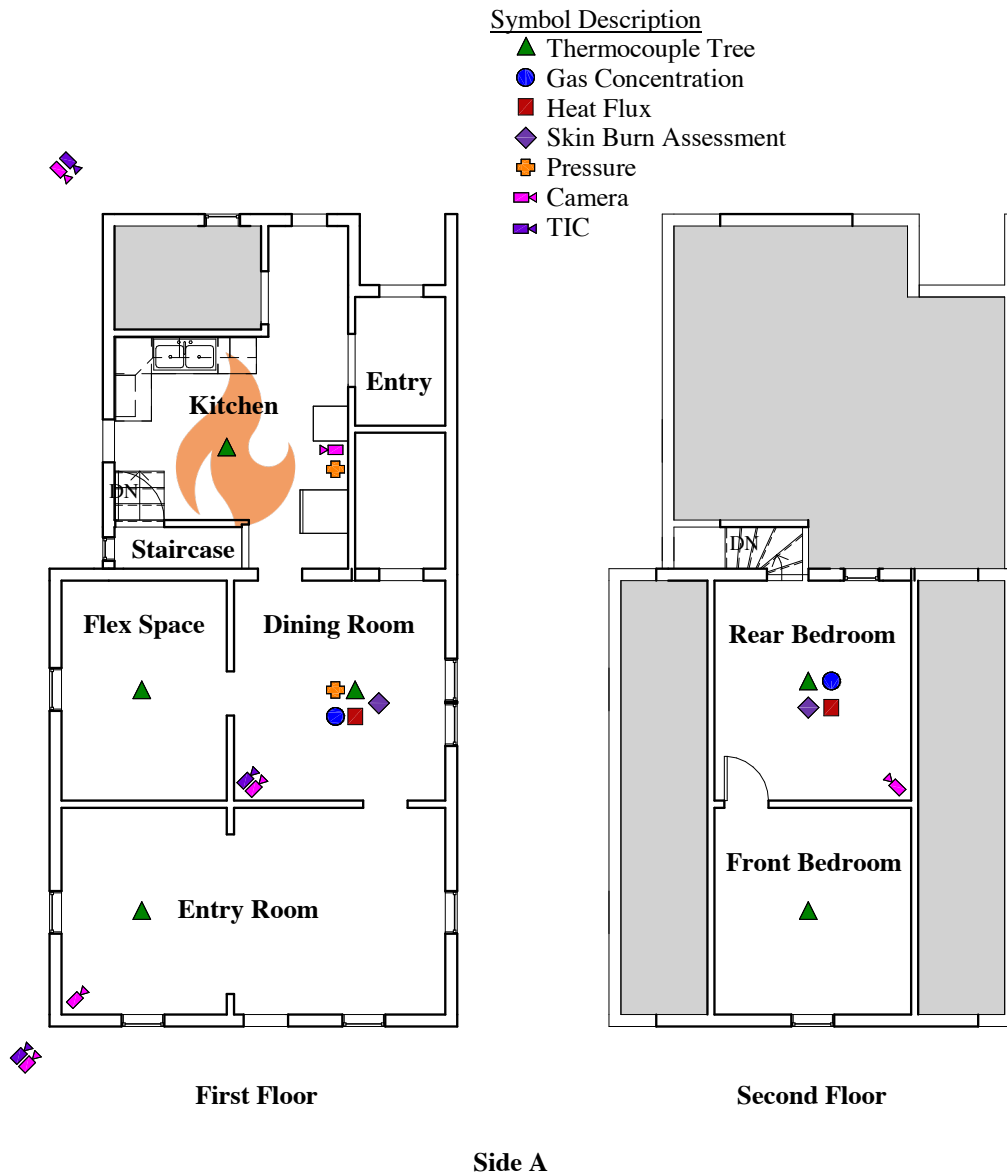
The first-floor had an entry-room, dining room, flex space, kitchen, and rear entry. The second-floor had two bedrooms. A stairwell located off the kitchen connected the two floors. These areas defined the experimental volume of the structure. The B/C corner bathroom was separated from this volume and used as instrumentation space. The fire was ignited in the first-floor kitchen. The structure was instrumented for temperature, pressure, heat flux, IR, and standard video to capture the fire dynamics during experimentation. Instrumentation was also installed to characterize the potential for skin burns and occupant toxic exposure during the experiment. Figure 3.231 shows the layout of the structure with the instrumentation locations.

Figure 3.231: Instrumentation and floor plan for Experiment 19. The gray areas were isolated from the remainder of the structure and utilized as space for instrumentation.

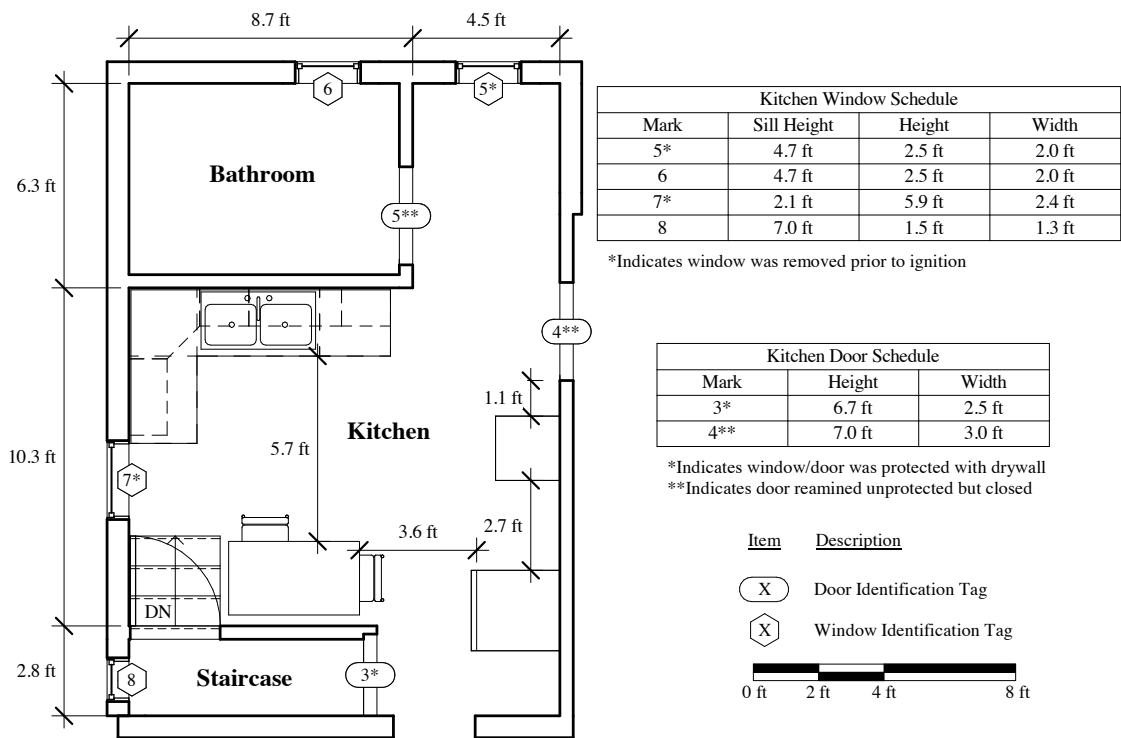
Figure 3.233: Fire room layout for Experiment 19.

The fire room was furnished with the kitchen fuel package described in Section 2.4.2 and contained a range, refrigerator, table, and two chairs. The ignition location was immediately surrounded by a large bag of potato chips, three paper towel rolls, and a coffee maker. The wall cabinets contained approximately 1250 paper cups. Five paper towel rolls were placed on top of the range hood and eight paper towel rolls were placed on top of the refrigerator. The kitchen windows located on sides B and C were removed prior to ignition to ensure repeatable fire growth and a sufficient oxygen supply for flashover. Photographs of the fire room prior to ignition are presented in Figure 3.232. A dimensioned layout of the kitchen is included in Figure 3.233. A detailed drawing of the kitchen cabinets is included in Figure 3.234.

Exterior water flow began 660 s (11:00) post ignition through the side B window (labeled 7 in Figure 3.233) for approximately 10 s. Approximately 675 s (11:15) post ignition, two fire department interventions occurred simultaneously: a secondary exterior water flow (7 s in duration), and opening the front door. The ventilation crew broke windows on sides A, B, and D 682 s (11:22) post ignition. The suppression crew transitioned into the structure for interior water flow. The first interior water flow application was initiated 753 s (12:33) post ignition and lasted 16 s. A secondary interior water flow application occurred 799 s (13:19) post ignition for 15 s. The total tactic time, from exterior water flow to interior water flow, was 93 s (1:33). Total water flowed during initial suppression was 108 gal, which did not include water flowed during mop-up operations.

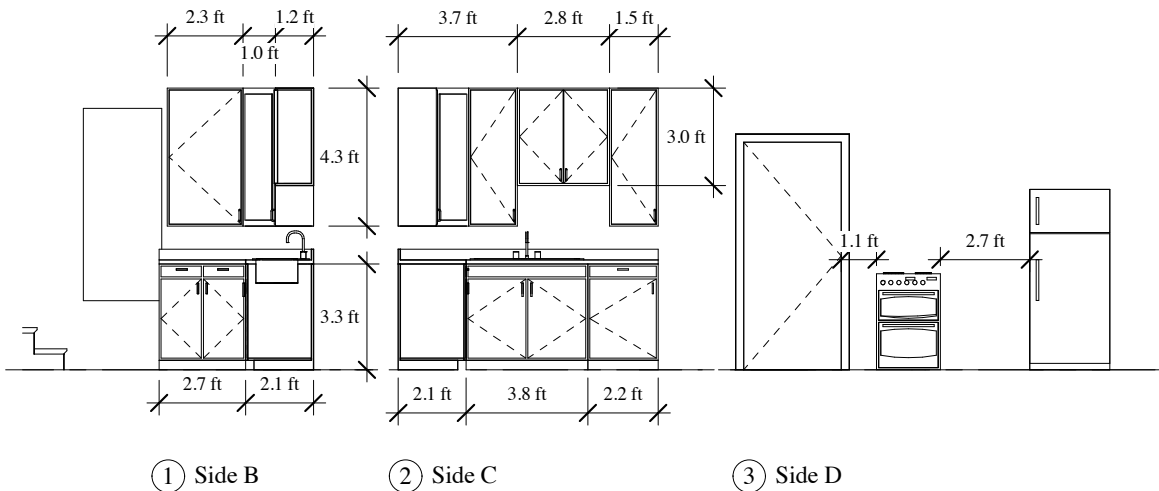
Figure 3.234: Wall and base cabinet locations, dimensions, and elevations within the kitchen for Experiment 19.

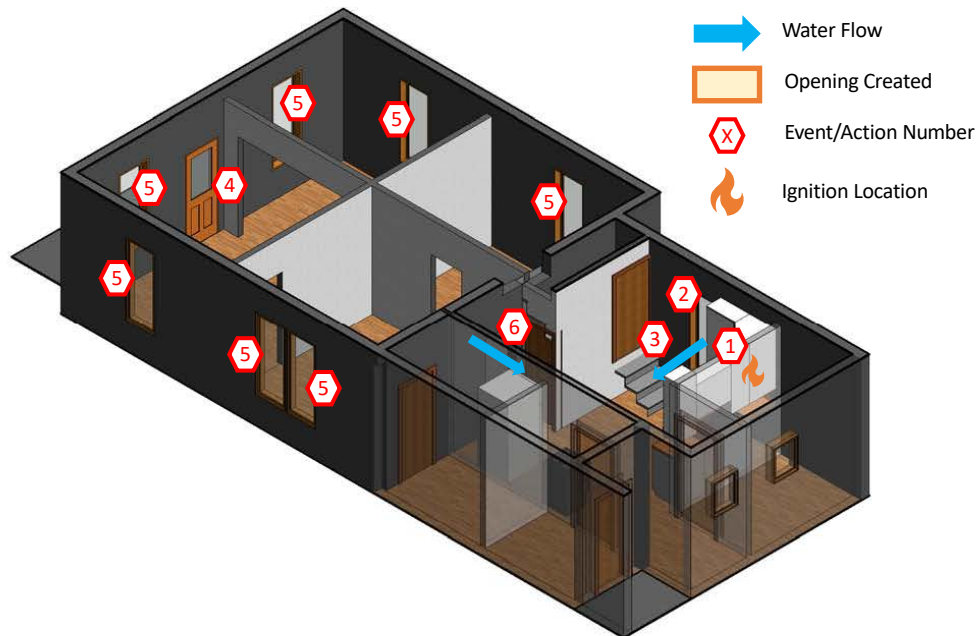
Action/Event	Time (mm:ss)	Time (s)
1 Ignition	00:00	0
2 Flashover	08:41	521
3 Exterior Flow	11:00	660
4 Front Door Open	11:15	675
5 Window Ventilation	11:22	682
6 Interior Flow	12:33	753

Figure 3.235: Time and sequence of actions and events for Experiment 19.

One 1.75 in. hoseline with a combination nozzle set to straight stream was used for both exterior and interior water flow. The line was initially placed on side B of the structure for exterior flow. It was moved to side A and brought into the structure for interior suppression. Figure 3.235 shows the sequence of events with an isometric image of the structure.

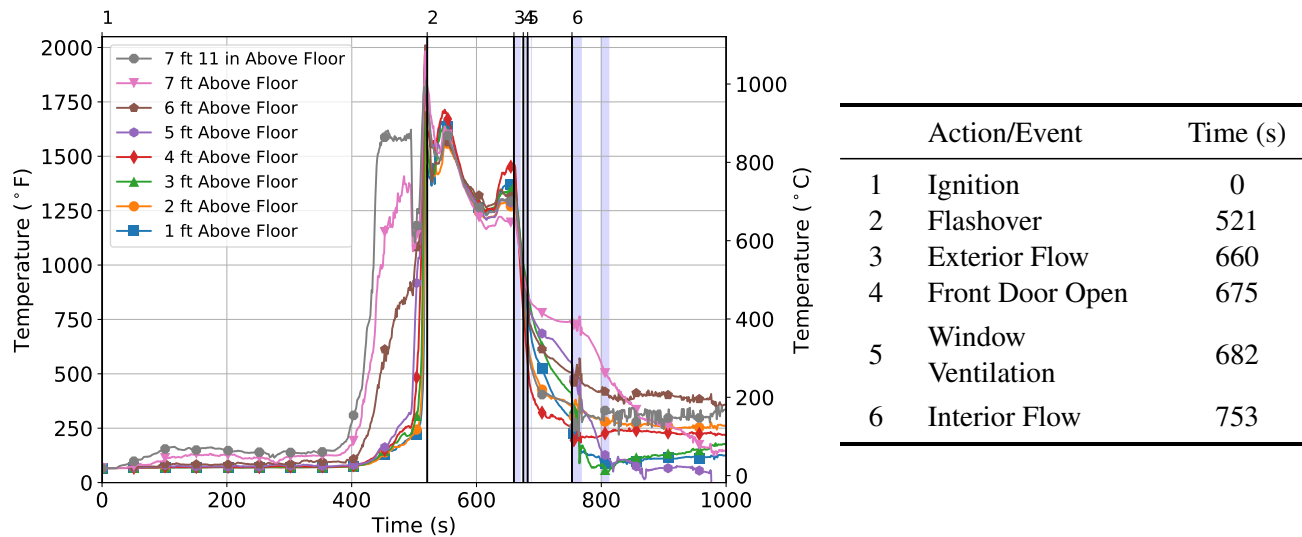
Temperatures recorded in the fire room are shown in Figure 3.236. Temperatures near the ceiling began to increase approximately 20 s post ignition. Temperatures at the ceiling reached a plateau of approximately 1600 °F 450 s post ignition. Temperatures at all other elevations began to increase around 425 s post ignition, increasing rapidly within the 30 s prior to flashover. Flashover occurred 521 s post ignition when temperatures at the floor exceeded 1100 °F, peaking to 1500 °F. Post-flashover temperatures decreased for approximately 30 s before increasing to a local peak of approximately 1700 °F. After which, temperatures decreased until just prior to exterior water flow, when they increased slightly. Exterior water flow reduced fire room temperatures. Interior water flow decreased fire room temperatures further.

Figure 3.236: Temperatures in fire room (kitchen) for Experiment 19. Blue vertical bars indicate time and duration of water flow.

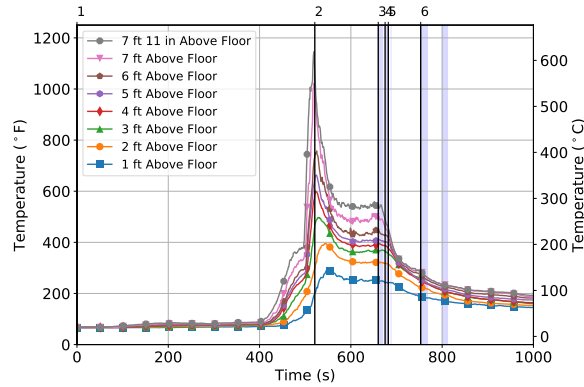
(a) Rear Bedroom Temperatures

Temperature data recorded from remote areas within the structure are presented in Figure 3.237. Temperatures on the second-floor in the rear bedroom (see Figure 3.237a) began to increase around 400 s post ignition. Temperatures peaked during flashover 521 s post ignition, ranging from 1200 °F at the ceiling to 300 °F at the floor. Post-flashover temperatures decreased initially but became steady between 250°F to 550 °F 575 s post ignition. Temperatures began to decrease during exterior water flow and decreased permanently after interior water flow.

Figure 3.237: Temperatures remote from the fire room for Experiment 19. Blue vertical bars indicate time and duration of water flow.
