Analysis of the Coordination of Suppression and Ventilation in Single-Family Homes

John Regan
Julie Bryant
Craig Weinschenk

UL Firefighter Safety Research Institute
Columbia, MD 20145

March 19, 2020

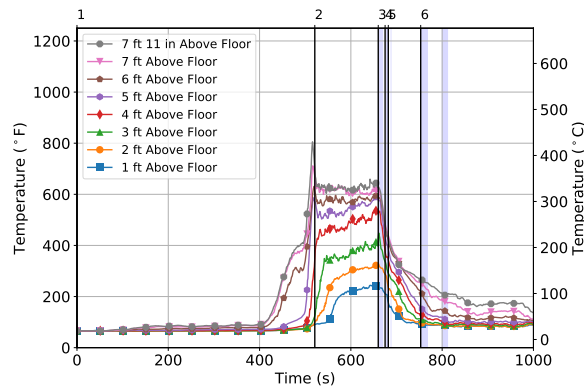
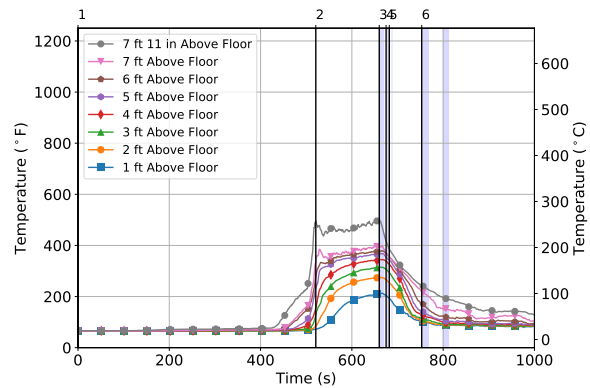
(a) Rear Bedroom Temperatures

(b) Dining Room Temperatures

Figure 3.237: Temperatures remote from the fire room for Experiment 19. Blue vertical bars indicate time and duration of water flow.

Temperature data recorded from remote areas within the structure are presented in Figure 3.237. Temperatures on the second-floor in the rear bedroom (see Figure 3.237a) began to increase around 400 s post ignition. Temperatures peaked during flashover 521 s post ignition, ranging from 1200 °F at the ceiling to 300 °F at the floor. Post-flashover temperatures decreased initially but became steady between 250°F to 550 °F 575 s post ignition. Temperatures began to decrease during exterior water flow and decreased permanently after interior water flow.

Dining room temperatures nearest the ceiling (see Figure 3.237b) increased around 400 s post ignition, followed by temperatures near the floor just prior to flashover. At flashover, temperatures 5 ft and above peaked between 460°F and 800 °F. Post-flashover temperatures within the dining room were steady between 230°F and 630 °F until exterior water flow. Upon which, temperatures decreased steadily until the fire was extinguished with the interior flow.

Flex space temperatures (see Figure 3.237c) began to increase around 450 s post ignition. All temperatures above 1 ft in elevation increased just prior to flashover 521 s post ignition. Post-flashover temperatures within this space were steady between 200 °F and 450 °F until exterior suppression began. Exterior water flow 660 s post ignition caused temperatures to decrease to ambient conditions.

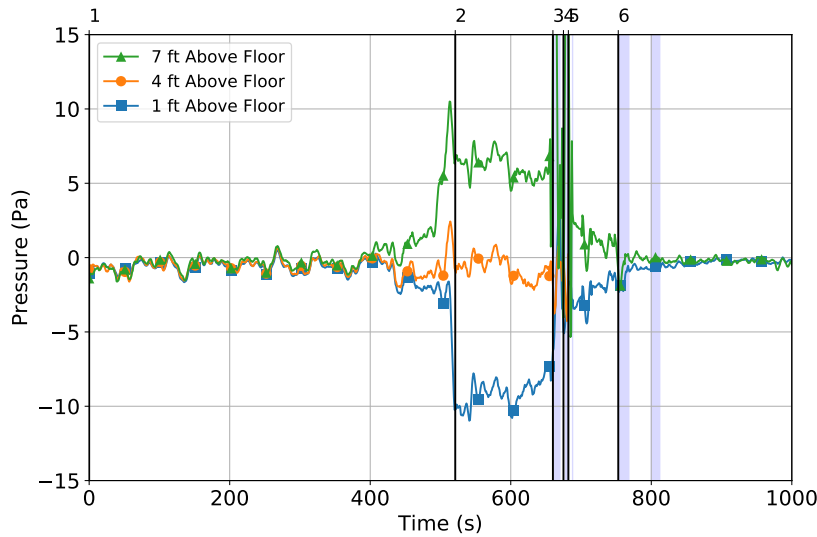
Figure 3.238: Pressures in the fire room (kitchen) for Experiment 19. The pressure at the 4 ft elevation was compromised from the water stream. Blue vertical bars indicate time and duration of water flow.

Kitchen pressures were constant until approximately 400 s post ignition. Pressure near the ceiling increased as the production of hot gases accumulated at the ceiling and peaked to 10.6 Pa during flashover. Pressure at the 4 ft elevation remained near ambient until flashover, when it peaked to 2.5 Pa. Pressure at the 1 ft elevation decreased as the fire entrained air to sustain combustion. It reached a minimum at flashover of approximately -10.0 Pa. Pressures became stable after flashover 521 s post ignition with the 7 ft elevation near 7.0 Pa, the 4 ft elevation near ambient, and the 1 ft elevation near -9.0 Pa. Exterior suppression caused the 7 ft and 1 ft pressures elevations to decrease back to atmospheric pressure. Note this action led to a failure at the 4 ft elevation, likely due to the probe filling with water.

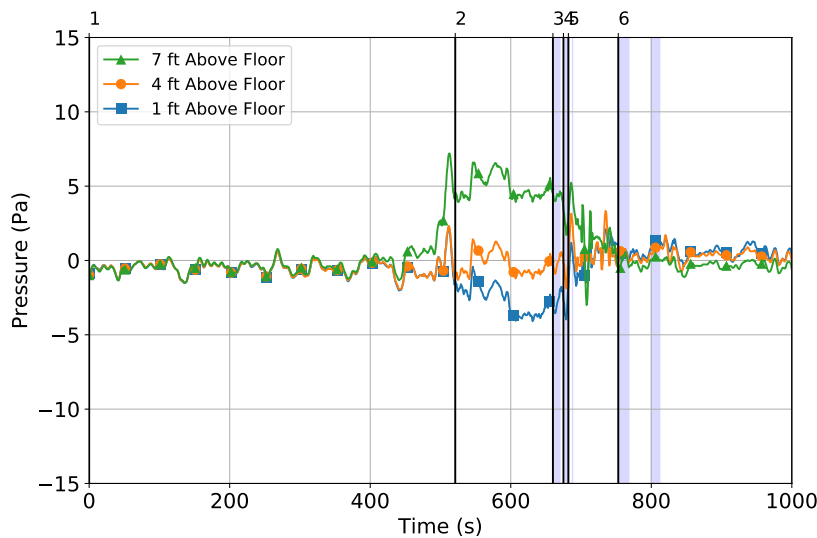
Figure 3.239: Pressure remote from fire room for Experiment 19. Blue vertical bars indicate time and duration of water flow.

Pressure remote from the fire room is presented in Figure 3.239. Dining room pressures did not begin to change until approximately 400 s post ignition. Pressure at the 7 ft elevation increased as hot gases gathered at the ceiling, peaking during flashover to 7.3 Pa. Pressure at the 4 ft elevation remained near ambient. Pressure at the 1 ft elevation decreased as the fire entrained cool air, coming to a steady peak near -4.0 Pa during post-flashover conditions. Exterior suppression caused pressures to return to atmospheric pressure.

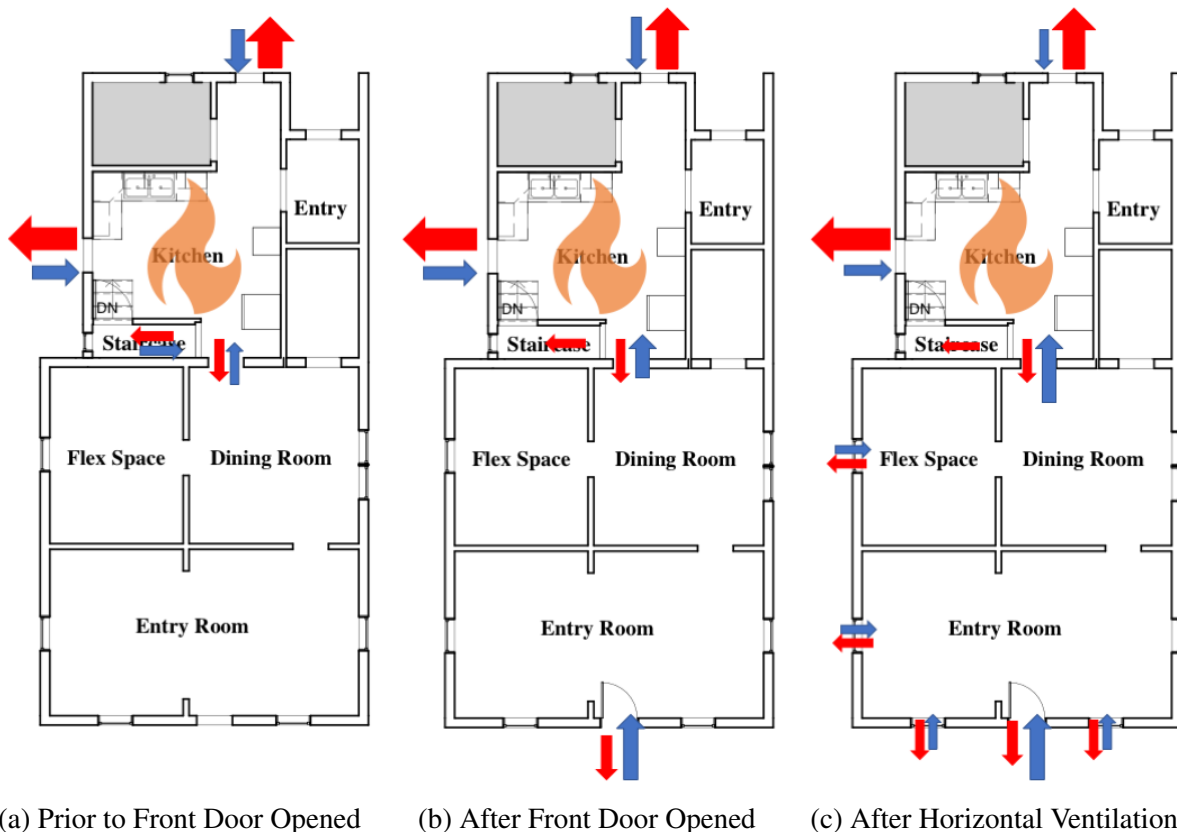
Figure 3.240: Changes in flow path for Experiment 19. Red arrows indicate flow out of the compartment, blue arrows indicate entrainment into the compartment, and the sizes of the arrows indicate the relative magnitude of the flow through each opening.

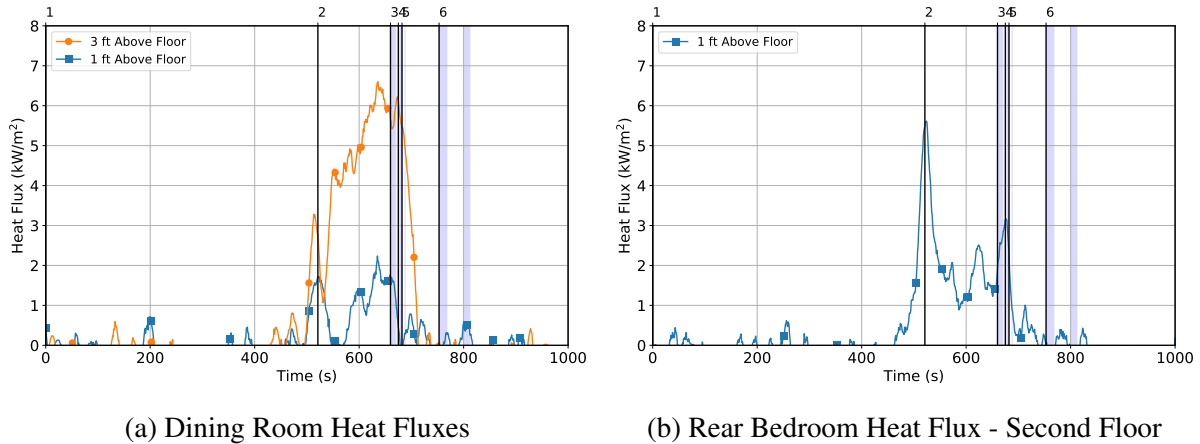
Figure 3.241: Heat flux at remote locations for Experiment 19. Blue vertical bars indicate time and duration of water flow.

Dining room and rear bedroom heat flux data are presented in Figure 3.241. Dining room heat flux began to increase 30 s prior to flashover. Conditions at the 3 ft elevation were generally worse than at the 1 ft elevation. Heat flux at both elevations locally peaked at flashover to 3.3 kW/m^2 and 1.7 kW/m^2 , respectively. Post-flashover the heat flux at both elevations to decrease for approx-

imately 20 s before increasing again to peak values of 6.6 kW/m² and 2.2 kW/m², respectively. Exterior suppression caused the heat flux at both elevations decreased to ambient conditions. Rear bedroom heat flux (see Figure 3.241b) began to increase 60 s prior to flashover. Heat flux peaked at flashover to 5.6 kW/m². Post-flashover the heat flux decreased to approximately 2.0 kW/m². Exterior suppression caused the heat flux to decrease to ambient conditions.

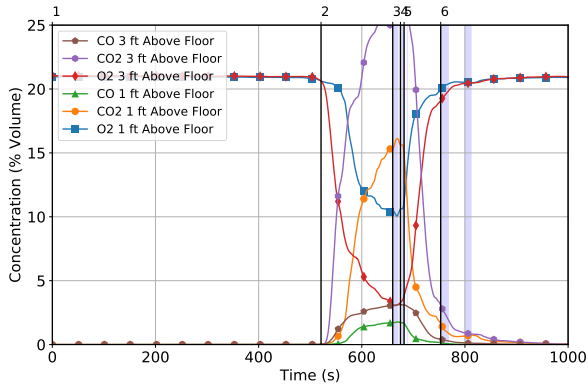
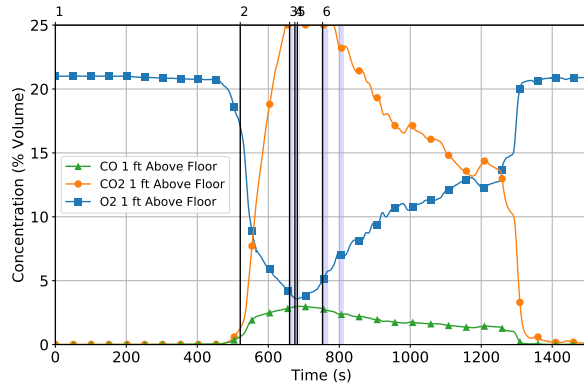
(a) Dining Room Gas Concentrations

(b) Rear Bedroom Gas Concentrations

Figure 3.242: Gas concentrations at remote locations for Experiment 19. Figure 3.242b ends 1500 s post ignition to show that gas concentration within the rear bedroom returned to ambient. At approximately 1320 s the second floor windows were opened. Blue vertical bars indicate time and duration of water flow.

Gas concentration (CO, CO₂, and O₂) data for remote locations within the structure is presented in Figure 3.242. Dining room gas concentrations did not begin to change until after flashover, approximately 575 s post ignition. As O₂ concentration decreased, CO and CO₂ concentrations increased. Conditions at the 3 ft elevation were worse than at the 1 ft elevation. Gas concentrations peaked during exterior water flow approximately 660 s post ignition. The 3 ft elevation gas concentrations were 3.0% O₂, 25% CO₂, and 3.1% CO, while the 1 ft elevation gas concentrations were 10.1% O₂, 16.1% CO₂, and 1.7% CO. Exterior suppression caused gas concentrations to decrease, while interior suppression caused gas concentrations to return to ambient conditions.

Rear bedroom gas concentrations began to change prior to flashover 475 s post ignition. Gas concentrations peaked during exterior water flow at approximately 680 s to 3.5% O₂, 25% CO₂, and 3.0% CO. Gas concentrations began trending toward ambient after exterior suppression concluded.

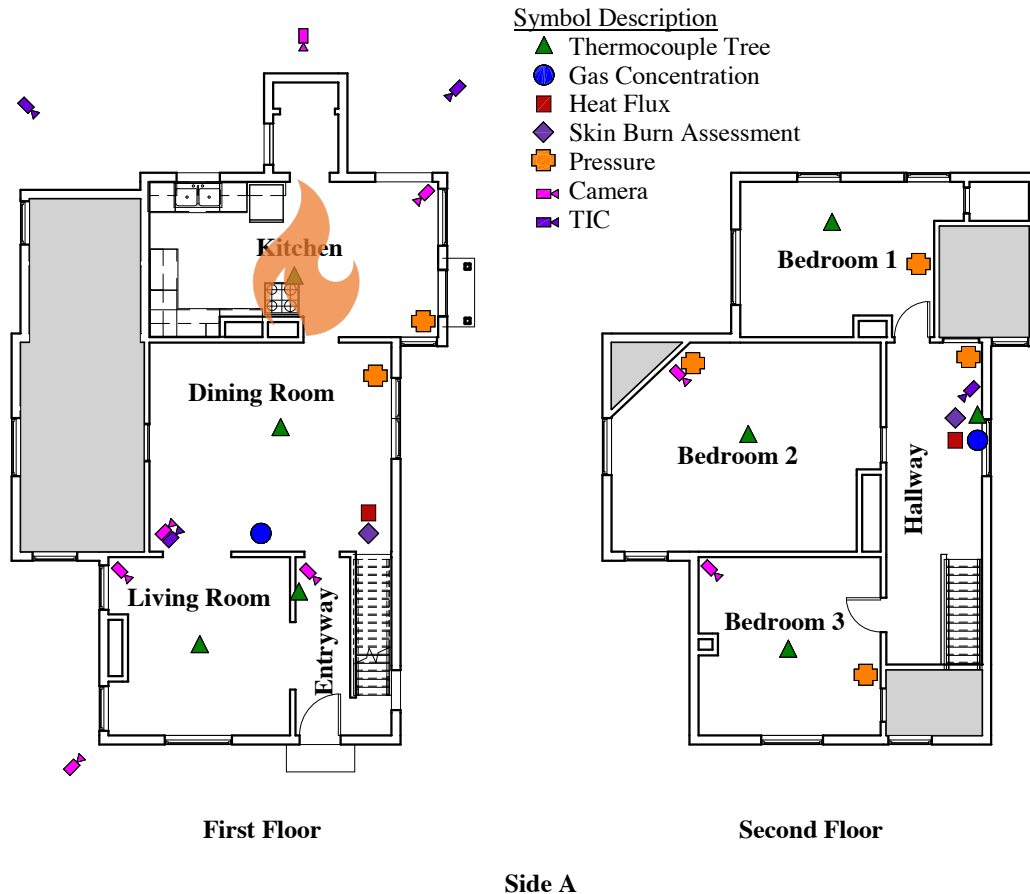
Figure 3.244: Instrumentation and floor plan for Experiment 20. The gray areas were isolated from the remainder of the structure and utilized as space for instrumentation.

This experiment utilized the kitchen as the fire room. The first-floor included a living room, dining room, and a kitchen. The second-floor included three bedrooms. The stairwell located in the A/D corner connected the two floors. These areas defined the experimental volume of the structure. Various areas of the structure were protected and utilized for instrumentation. Figure 3.244 shows the layout of the structure with the instrumentation locations.

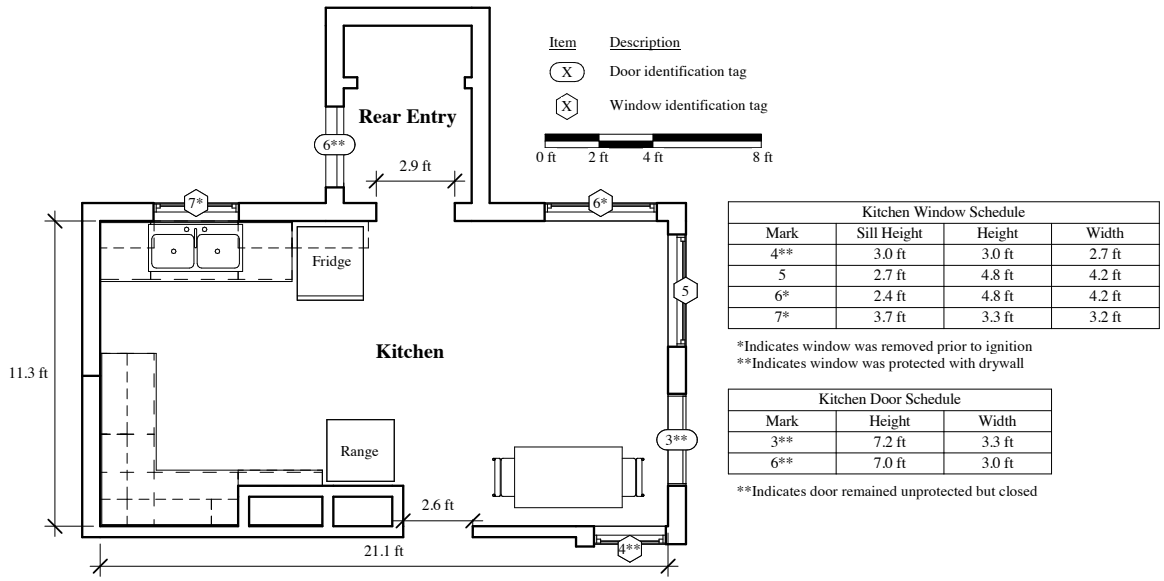
Figure 3.246: Fire room layout for Experiment 20.

The fire room was furnished with the kitchen fuel package described in Section 2.4.2 and contained a range, refrigerator, table, and two chairs. The ignition location was immediately surrounded by one large bag of potato chips, 16 paper towel rolls, and a coffee maker. Wall cabinets above the ignition location contained approximately 1250 paper cups. The two cabinets bordering the A/B corner (above the ignition location) were left open, exposing the fuel located inside. Two paper towel rolls were located on the side C counter. Five paper towel rolls were placed on top of the stove and six paper towel rolls were placed on top of the refrigerator. Both kitchen windows located on side C were removed prior to ignition to ensure repeatable fire growth and a sufficient oxygen supply for flashover. Photographs of the fire room prior to ignition are presented in Figure 3.245. A dimensioned layout of the kitchen is included in Figure 3.246. A detailed drawing of the kitchen

The fire was ignited in the A/B corner of the kitchen to begin the experiment ($t = 0$ s). Approximately 102 s (1:42) post ignition, flames were visible from the side C window (labeled 7 in Figure 3.246). Flames rolled along the ceiling at approximately 228 s (3:48) post ignition. The paper towel rolls located on top of the refrigerator ignited approximately 279 s (4:39) post ignition. Flames extended out window 7 337 s (5:37) post ignition, becoming continuous 385 s (6:25) post ignition. Flashover of the kitchen occurred 459 s (7:39) post ignition. The fire transitioned to post-flashover conditions before any fire department intervention.

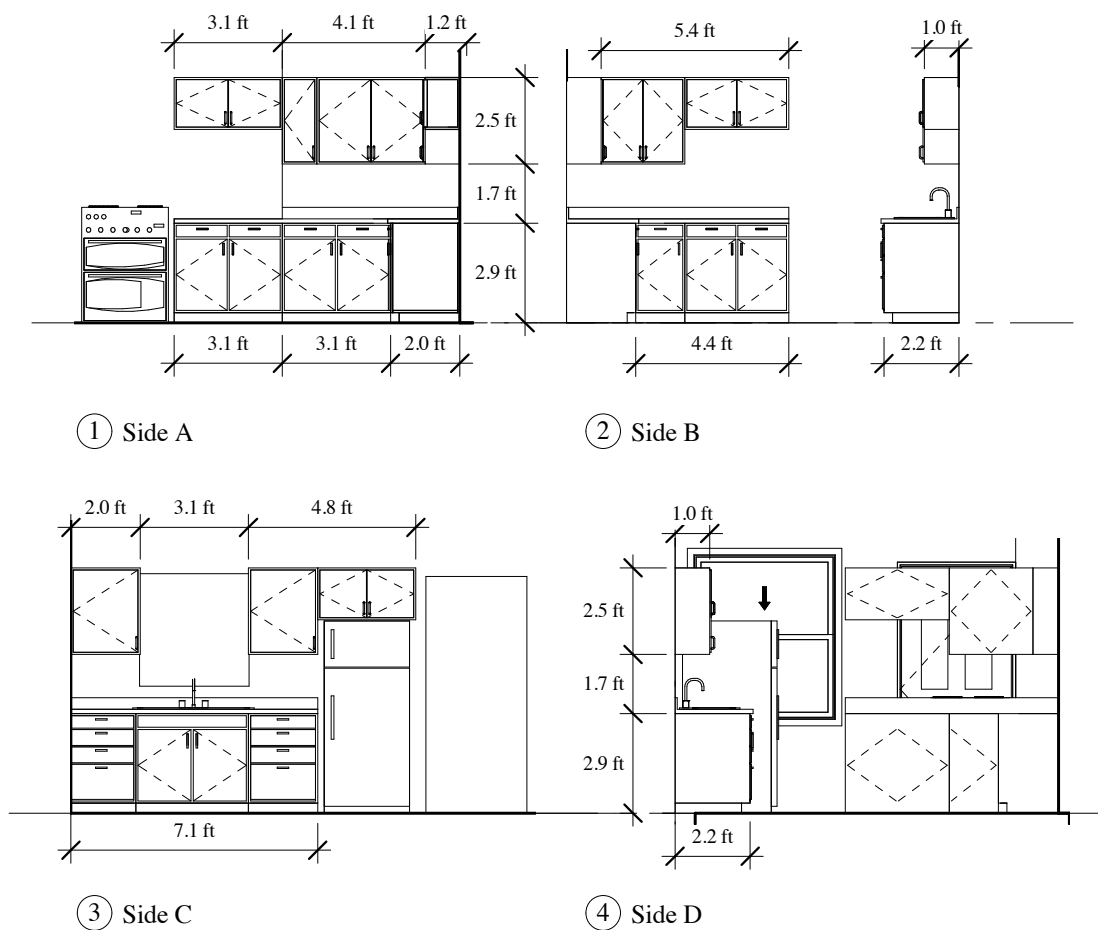
Figure 3.247: Wall and base cabinet locations, dimensions, and elevations within the kitchen for Experiment 20.

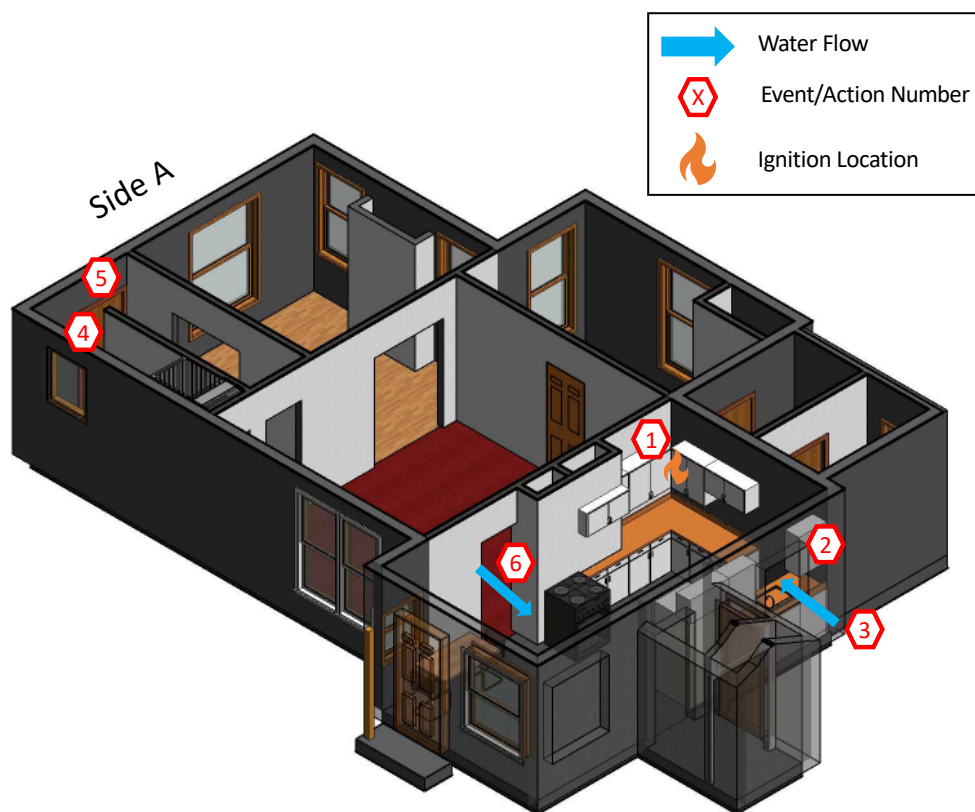
Action/Event	Time (mm:ss)	Time (s)
1	Ignition	00:00	0
2	Flashover	07:39	459
3	Exterior Flow	10:03	603
4	Front Door Open	10:20	620
5	PPV Fan Turned In	10:33	633
6	Interior Flow	11:55	715

Figure 3.248: Time and sequence of actions and events for Experiment 20.

Two hoselines were used to conduct the exterior and interior suppression. Both lines were 1.75 in. with a combination nozzle set to straight stream. The primary line was placed on side A and moved inside the structure for interior flow. The secondary line was placed on side C of the structure and used for exterior flow. Ventilation was aided with a positive pressure fan⁵. The fan was placed approximately 5 ft from the front door at an angle of roughly 95°. Firefighters ensured flow through the top of the doorway and that the fan was on full throttle. Figure 3.248 shows the sequence of events, including fire department interventions, with an isometric image of the structure.

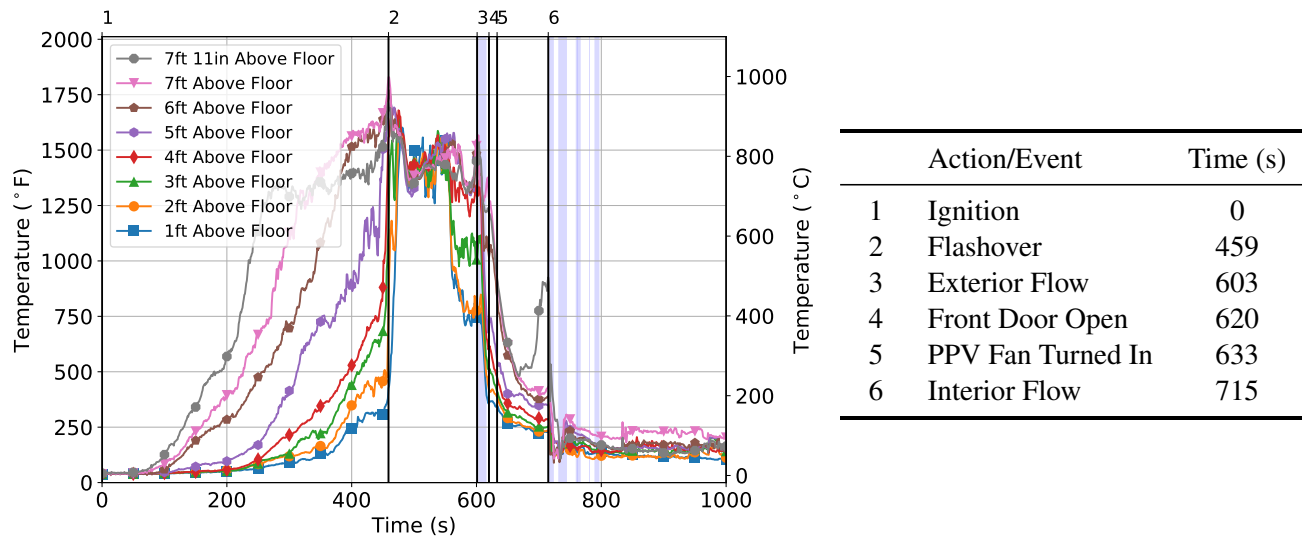
Figure 3.249: Temperatures in fire room (kitchen) for Experiment 20. Blue vertical bars indicate time and duration of water flow.

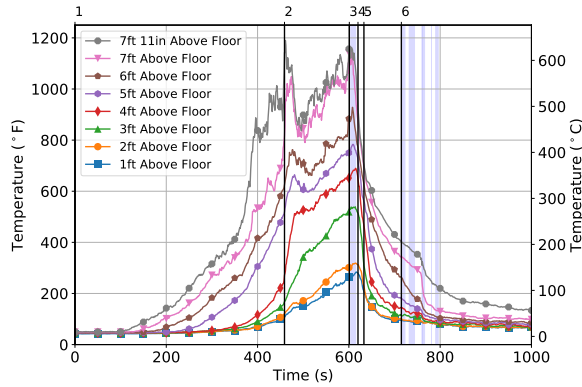
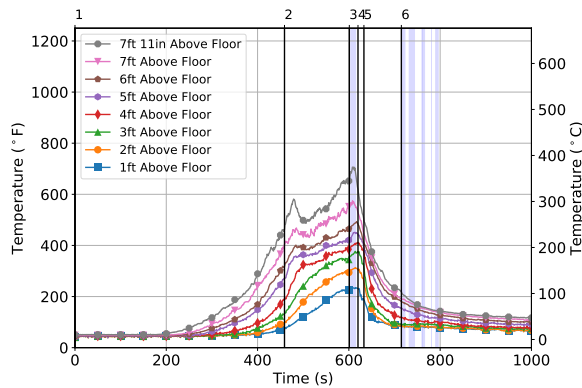
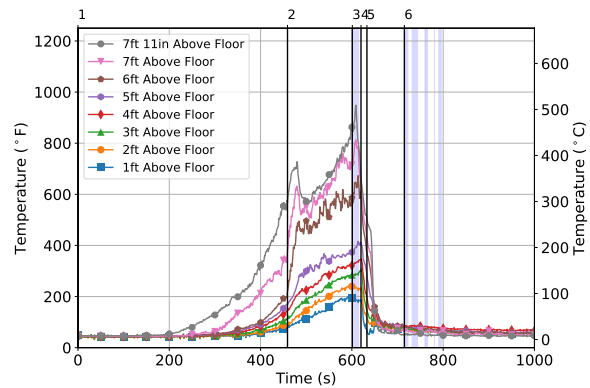
(a) Dining Room Temperatures

(b) Living Room Temperatures

(c) Entryway Temperatures

Figure 3.250: Temperatures remote from the fire room on the fire floor for Experiment 20. Blue vertical bars indicate time and duration of water flow.

Temperatures on the fire floor, remote from the kitchen, are presented in Figure 3.250. Temperatures in the dining room began to increase at the ceiling approximately 100 s post ignition. Once flames began to enter the dining room at 363 s post ignition, temperatures 4 ft and below began to increase. Temperatures 3 ft and above increased just after flashover occurred at 469 s post ignition. Temperatures steadily increased post-flashover but decreased after exterior water flow 603 s post ignition. Temperatures returned to ambient conditions post interior water flow at 715 s post ignition.

Temperatures within the living room and entryway began to increase just after 200 s post ignition, corresponding to the flames in the kitchen reaching the ceiling. Temperatures in both locations peaked just after flashover approximately at 490 s post ignition then decreased for 20 s. Temperatures steadily increased until exterior suppression began at 603 s post ignition. Temperatures within the entryway returned to ambient before interior water flow was conducted because it was closer in proximity to the open doorway. Temperatures within the living room decreased to ambient after interior suppression at 715 s post ignition.

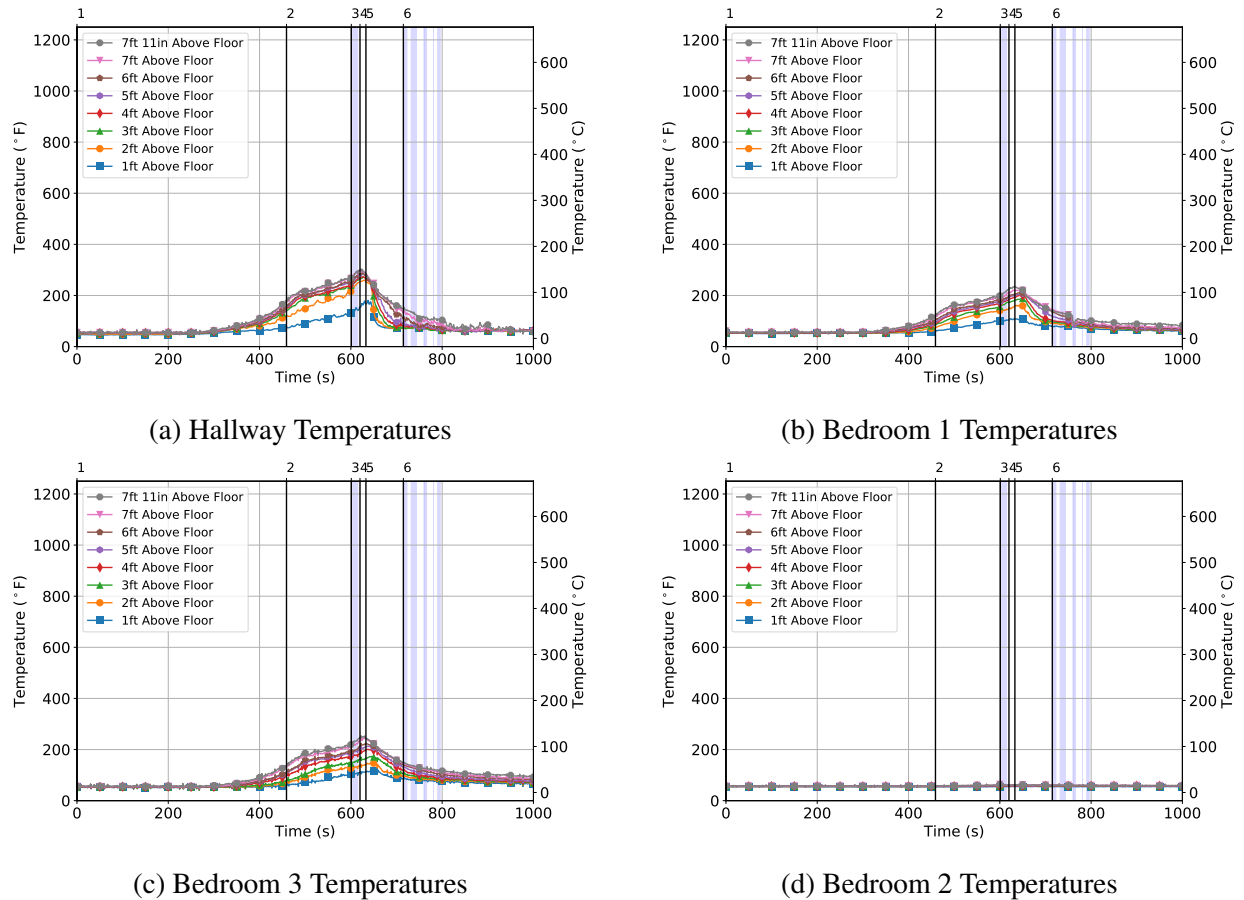
Figure 3.251: Remote temperatures above the fire floor for Experiment 20. Blue vertical bars indicate time and duration of water flow.

Remote temperatures on the floor above the fire room are presented in Figure 3.251. Hallway temperatures began increasing approximately 250 s post ignition, as hot gases rose to the second-floor. Temperatures peaked just after exterior water flow, reaching approximately 305 °F. Exterior water flow cooled fire room temperatures, causing a reduction in temperatures in the hallway. Temperatures returned to near ambient conditions after interior water flow.

Temperatures within bedrooms 1 and 3 (see Figures 3.251b and 3.251c, respectively) behaved similarly, as both bedroom doors were open. Temperatures began increasing prior to flashover, approximately 300 s post ignition. Temperatures reached a peak between 230 °F and 235 °F after exterior suppression. Temperatures then decreased. Bedroom 2 temperatures behaved differently than bedrooms 1 and 3, as the door to bedroom 2 was closed to the experimental volume. Temperature within this closed bedroom remained near ambient, reaching a maximum of approximately 65 °F.

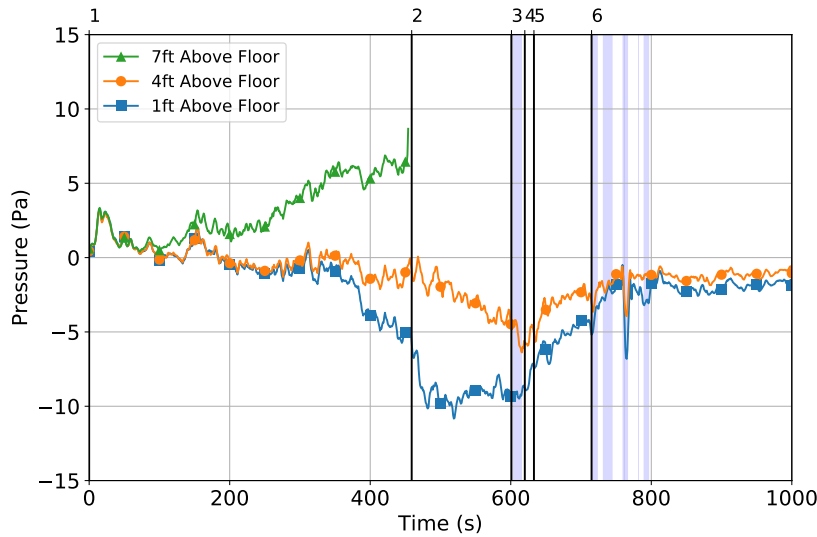
Figure 3.252: Pressures in the fire room (kitchen) for Experiment 20. The pressure at the 7 ft elevation sensor failed after flashover. Blue vertical bars indicate time and duration of water flow.

Prior to fire department intervention, the only openings into and out of the kitchen were the two windows on side C and the doorway leading to the dining room. The growth of the fire in the kitchen created changes in pressure, resulting in bi-directional flows throughout these openings. The pressure data from the fire room is presented in Figure 3.252. Kitchen pressures began to change approximately 100 s post ignition. Pressure at the 7 ft elevation increased as hot gases accumulated at the ceiling of the kitchen. Pressures at the 4 ft and 1 ft elevations decreased as the fire entrained cool air to sustain combustion. Flashover occurred 459 s post ignition, causing the pressure at the 1 ft elevation to remain constant and the pressure at the 4 ft elevation to decrease steadily. After interior water flow, pressures return to ambient levels.

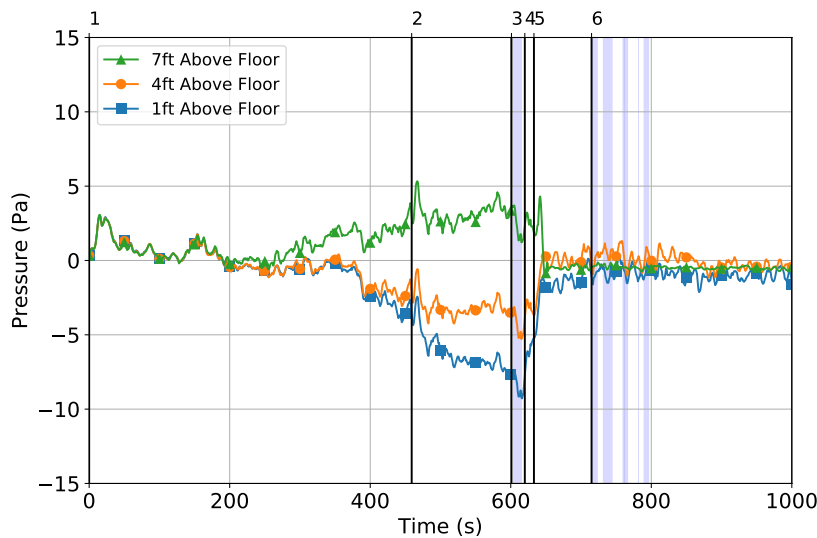
Figure 3.253: Dining room pressures during Experiment 20. Blue vertical bars indicate time and duration of water flow.

Pressures remote from the fire room on the fire floor were monitored in the dining room; that data is presented in Figure 3.253. Dining room pressures began to change around 200 s post ignition, corresponding to the initial temperature increase within this space. Pressure at the 7 ft elevation increased from ambient pressure as hot gases accumulated near the ceiling. Pressures at the 4 ft and 1 ft elevations decreased from ambient pressure as the fire entrained air to sustain combustion. Pressure at all three elevations returned to ambient pressure after the PPV fan was turned into position.

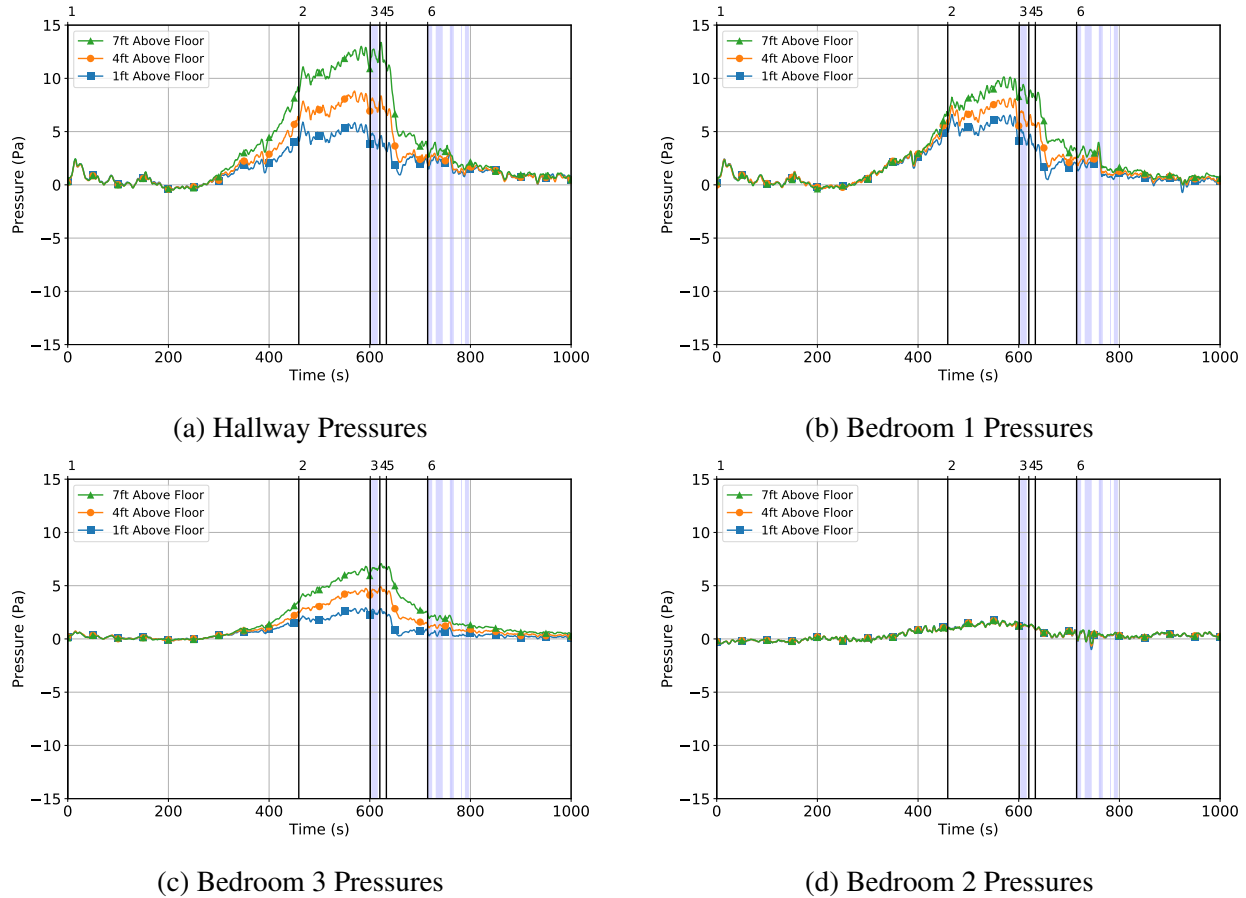
Figure 3.254: Remote pressures on the second floor for Experiment 20. Blue vertical bars indicate time and duration of water flow.

Second-floor remote pressures are presented in Figure 3.254. Pressures within spaces open to the experimental volume of the structure, hallway (see Figure 3.254a), bedroom 1 (see Figure 3.254b), and bedroom 3 (see Figure 3.254c), behaved similarly. Positive pressure was indicated at all three elevations throughout the duration of the test. The pressure began to increase around 250 s post ignition. Pressure remained constant until after exterior water flow.

Although the pressure within these spaces all began to increase approximately 300 s post ignition, the magnitudes of the increase were different due to the distance from the fire and the pathway to the pressure measurement location. The hallway pressure reached a peak of 13.4 Pa, while bedroom 1 and bedroom 3 reached peaks of 10.1 and 7.2 Pa, respectively. The spaces on the second-floor became positively pressurized as hot gases accumulated at the highest elevation of the house. Bedroom 2 also became positively pressurized, but only reached a magnitude of 1.8 Pa, as that room was isolated from the flow path because of a closed door.

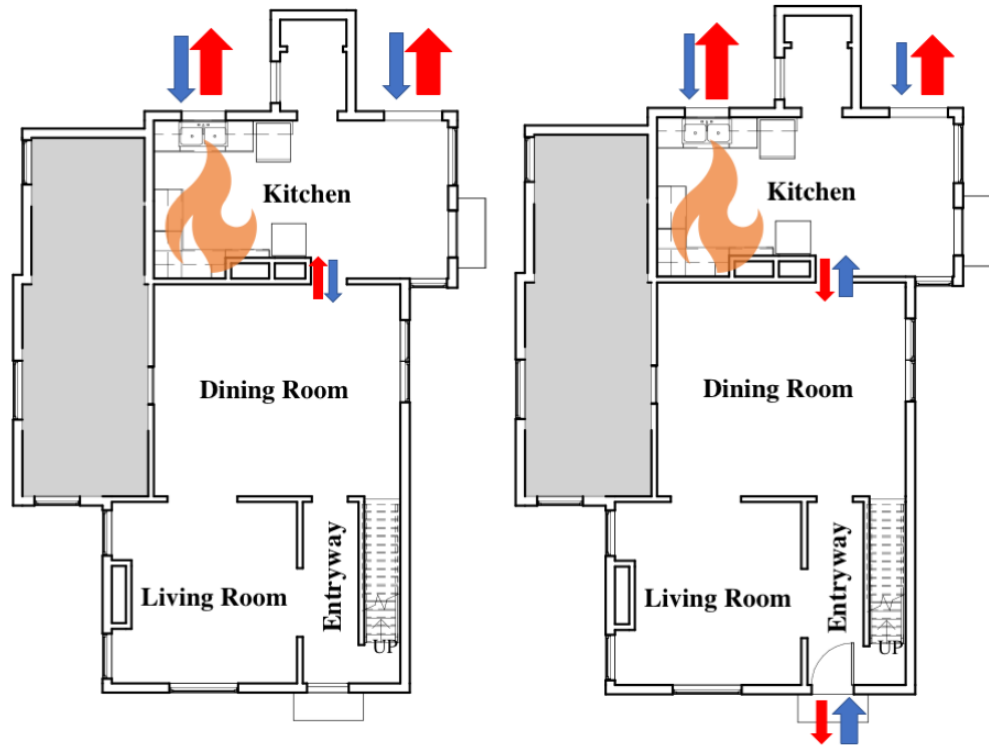
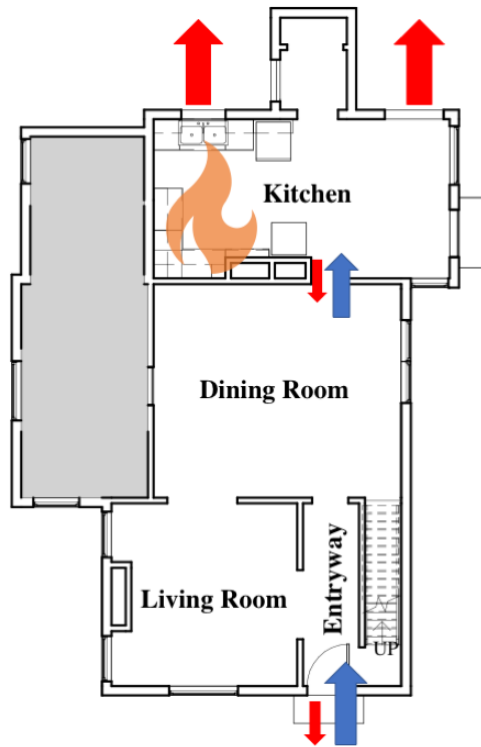
(a) Prior to Front Door Opened

(b) After Front Door Opened

(c) After PPV

Figure 3.255: Changes in flow path for Experiment 20. Red arrows indicate flow out of the compartment, blue arrows indicate entrainment into the compartment, and the sizes of the arrows indicate the relative magnitude of the flow through each opening.

The differences in pressure throughout the structure established a bi-directional flow throughout openings. The changes in flow before and after fire department intervention are presented in Figure 3.255. Prior to fire department intervention the only openings in the kitchen were the doorway into the dining room and the windows located on side C and side D. Pressure at the 7 ft elevation in the fire room was greater than the pressure at the 7 ft elevation in the dining room. Pressure at the 1 ft elevation in the fire room was less than the pressure at the 1 ft elevation in the dining room. The gradient in pressure between the fire room and dining room promoted the exhaust of hot gases and entrainment of cool air out of and into the fire room, respectively (see Figure 3.255a). Entrainment of air was increased from the front door and exhaust of gases was increased through the windows

(see Figure 3.255b). After the fan was turned into place, air was forced into the structure, blocking most exhaust from exiting through the front door (see Figure 3.255c). This caused more exhaust to exit the structure through the fire room windows.

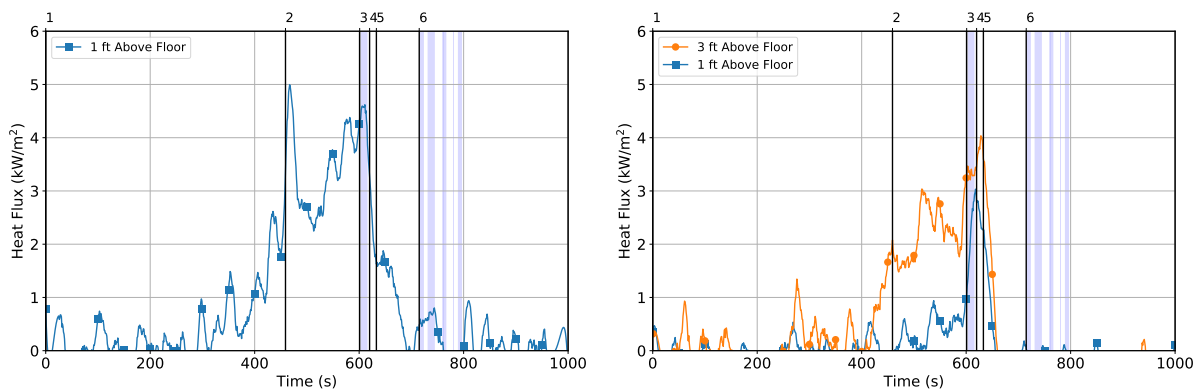
Heat flux was recorded at two locations, the dining room and hallway for Experiment 20. The dining room location monitored heat flux at a 1 ft elevation and the second floor hallway location monitored heat flux at the 1 ft and 3 ft elevations. The data recorded for both locations are presented in Figure 3.256. The dining room location on the first-floor experienced an increase in heat flux approximately 300 s post ignition. This corresponded to the ignition of the paper towel rolls on top of the fridge. At flashover 469 s post ignition, heat flux at this location peaked. Immediately after flashover, the heat flux decreased but it increased again approximately 500 s post ignition. This corresponded to constant flames from the side C window nearest side D. The heat flux at the dining room location returned to ambient after exterior water flow.

The hallway location on the second-floor experienced an increase in heat flux just prior to flashover at the 3 ft elevation. Post-flashover heat flux for the 3 ft elevation remained constant while the 1 ft elevation increased, peaking when the front door was opened. Both elevations returned to ambient just after the PPV fan was turned into position.

(a) Dining Room Heat Flux

(b) Second Floor Hallway Heat Fluxes

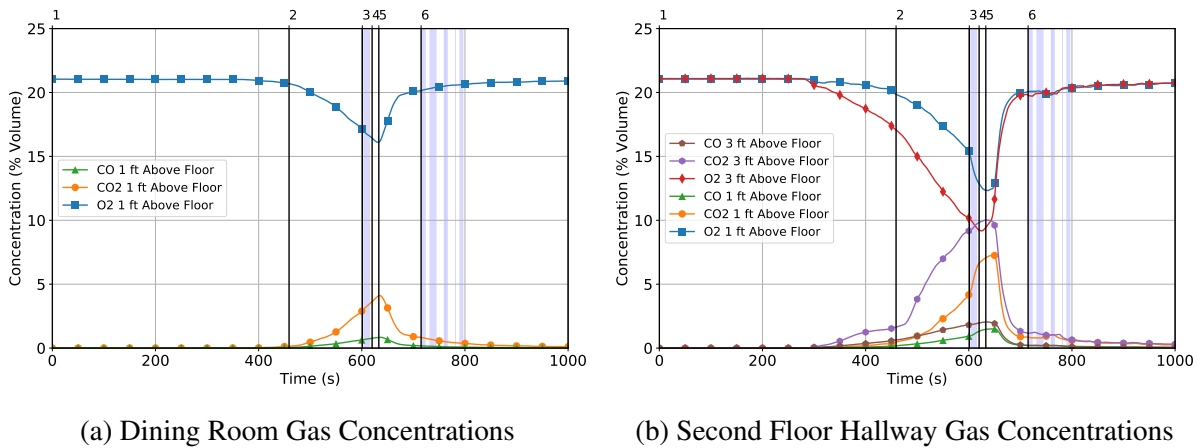
The aforementioned locations also monitored gas concentrations of CO, CO₂, and O₂. The dining room location monitored gas concentrations at 1 ft above the floor, while the second floor hallway location monitored gas concentrations at 1 ft and 3 ft above the floor. Gas concentration data is presented in Figure 3.257. The dining room location did not witness a change in gas concentration until after flashover occurred, approximately 500 s post ignition. As O₂ concentration decreased, CO and CO₂ concentrations increased. The peak gas concentration occurred 660 s post ignition,

The location on the second level of the structure decreased in O_2 as an increase in CO and CO_2 was recorded approximately 300 s post ignition. Prior to the first fire department intervention of exterior water flow, the O_2 concentration at 3 ft was 9%, the CO concentration was 3%, and the CO_2 was 10%. The 1 ft elevation gas concentrations were 13%, 2%, and 7%, respectively. O_2 , CO, and CO_2 conditions in the second floor hallway began to improve just after exterior suppression and ventilation occurred, approximately 650 s post ignition.

Action/Event	Time (s)
1	Ignition	0
2	Flashover	459
3	Exterior Flow	601
4	Front Door Open	620
5	PPV Fan Turned In	633
6	Interior Flow	715

Figure 3.257: Gas concentrations at remote locations for Experiment 20. Blue vertical bars indicate time and duration of water flow.

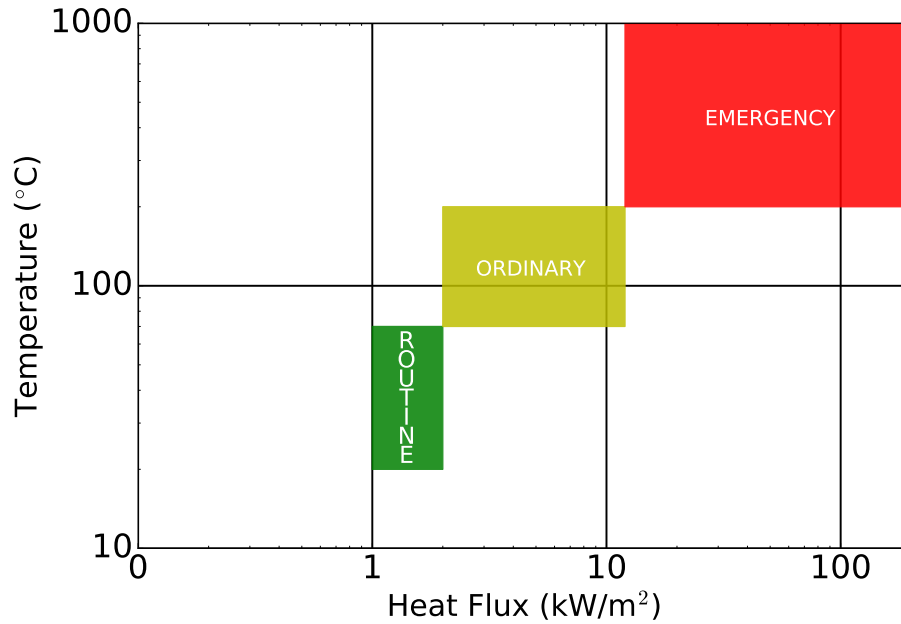
In 1973, Utech suggested a combination of the local air temperature and the incident heat flux to estimate the components of radiative and convective heat transfer, respectively, to a firefighter. He used these two quantities to define three ranges of firefighters' operational thermal conditions: routine, ordinary, and emergency [19]. According to Utech, routine conditions are those with a surrounding temperature between 70 °F (20 °C) and 162 °F (72 °C) and an incident heat flux between 1 kW/m² and 2 kW/m². Utech maintained that these conditions translate approximately to ambient environments such as those experienced outside a typical structure fire to those that may be present during the overhaul phase of a fire. The thermal environment crosses into the ordinary operating range when temperatures were between 162 °F (72 °C) and 392 °F (200 °C) and heat fluxes between 2 kW/m² and 12 kW/m². Ordinary operating conditions include thermal environments that might be encountered next to a post-flashover room. According to Utech, firefighters are likely able to function under ordinary operating conditions from 10 min. to 20 min. at a time, or for the approximate working duration of an SCBA cylinder. Utech suggested that ordinary operating conditions were those typical of a house fire. Emergency operating conditions are present when heat flux exceeds 12 kW/m² and temperature is in excess of 392 °F (200 °C). These conditions resulted in increased risk for injury to a firefighter even when operating in PPE. Utech describes the emergency zone as one in which a firefighter's PPE is only be able to withstand an exposure on the order of a few seconds. The thresholds for the thermal operating classes are illustrated in Figure 4.1.

Figure 4.1: Thermal Operating Classes

the battery of performance standards for firefighter PPE [20, 21]. Research conducted on SCBA facepieces, which have been identified as one of the weak points of the firefighter PPE ensemble, has quantified the heat flux thresholds at which various forms of damage can manifest [22–24]. These thresholds are illustrated in Figure 4.2. The figure shows that while the most severe damage in a short period of time can be expected for heat flux exposures in the emergency operating class, hole formation, bubbling, and microcracking were observed for heat fluxes consistent with the ordinary operating class. Further, the 90th percentile of firefighter heat flux exposures for this series of experiments, measured by the heat flux helmets for the nozzle and officer positions and detailed in Sections 4.2 - 4.7, fall at different points in ordinary operating class. Because of the relatively large range of the ordinary operating class, which includes thresholds at which PPE damage can occur, this analysis considers the ordinary operating class in two sections—a lower portion from 2 kW/m² to 7 kW/m² and an upper portion from 7 kW/m² to 12 kW/m².

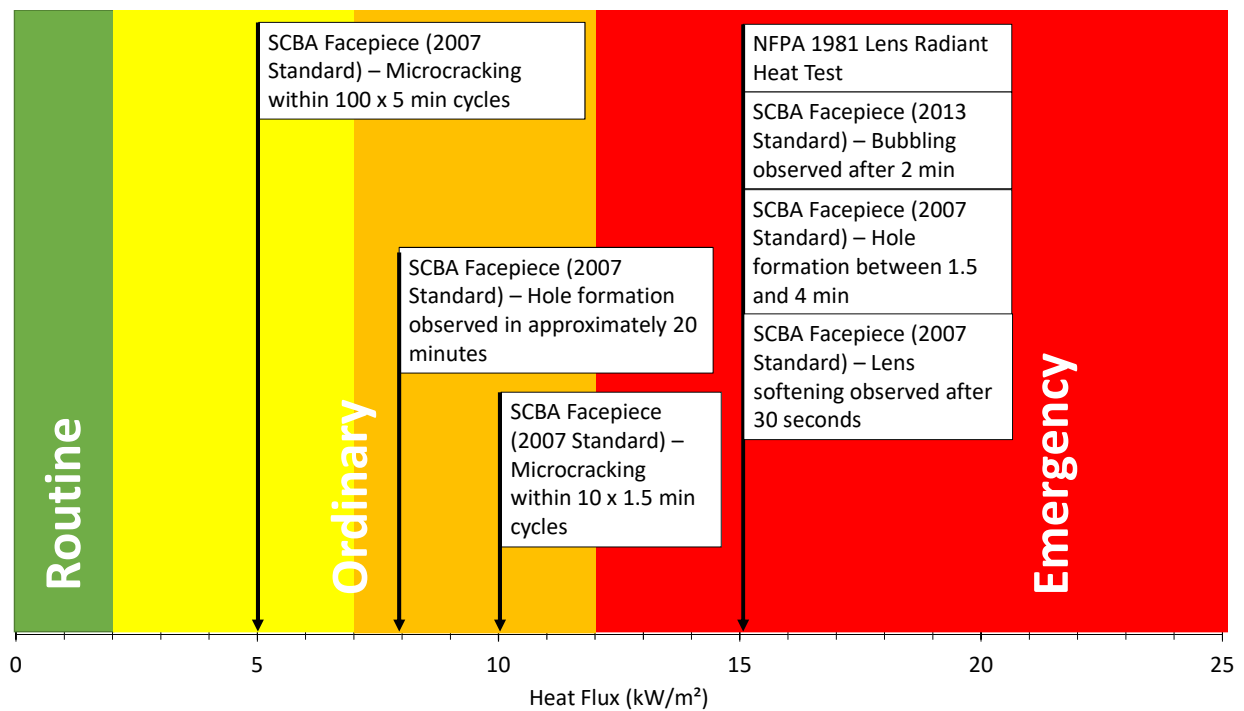
Figure 4.2: Comparison of Utech thermal operating classes with modern PPE performance limits from [21–24].

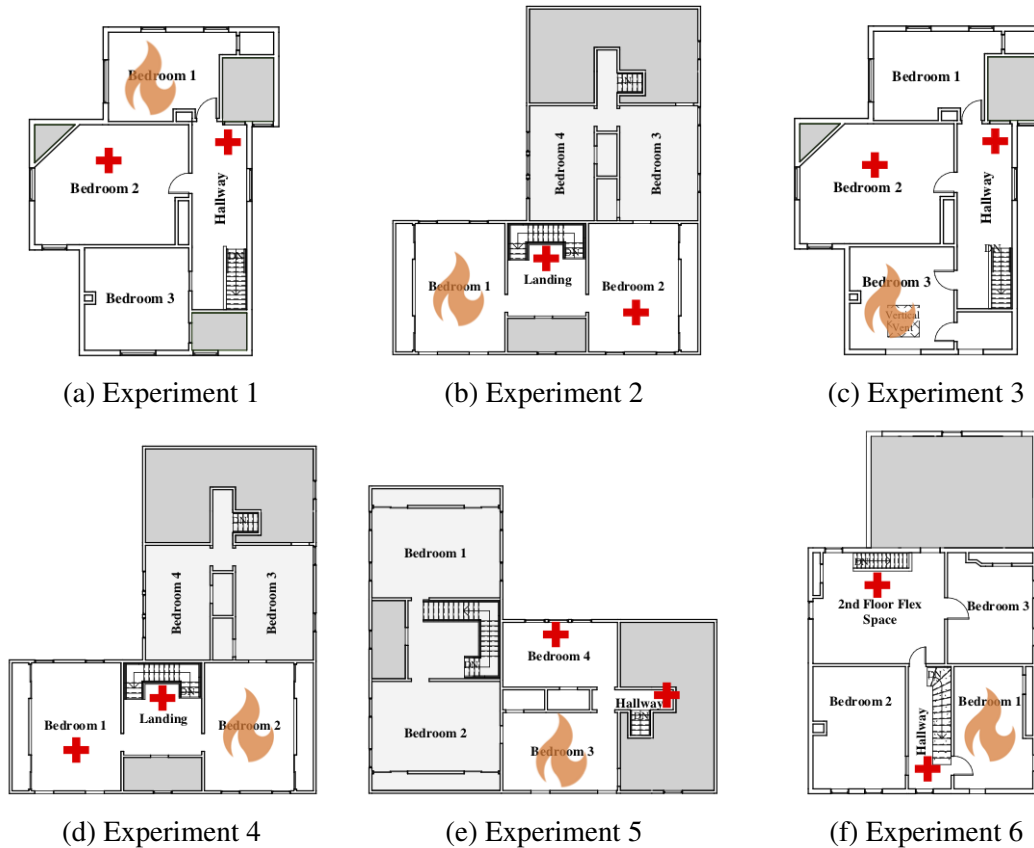
The average distance from the fire room to the remote occupant package was 23 ft \pm 8 ft (mean plus/minus standard deviation). For the occupant package inside the flow path, the average distance was shorter, at 10 ft \pm 5 ft. The standard deviation of one-third to one-half of the mean for the remote and inside locations, respectively, highlight the relative variability between each experiment. It is therefore important to recognize that exposures are a function of the tactics studied and the relative location in each experiment. Figure 4.3 summarizes the fire floor layouts for each experiment in Method 1.

Figure 4.3: Fire floor layouts for acquired structures used in Method 1 experiments. The red crosses represent the approximate locations of the occupant assessment packages. The gray areas were isolated from the remainder of the structure and utilized as space for instrumentation.
