Analysis of the Coordination of Suppression and Ventilation in Single-Family Homes

John Regan
Julie Bryant
Craig Weinschenk

UL Firefighter Safety Research Institute
Columbia, MD 20145

March 19, 2020

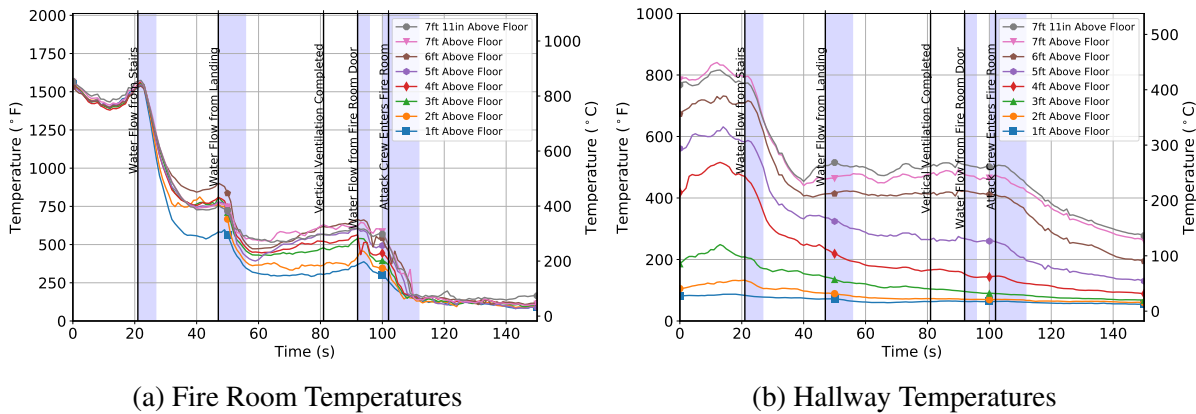
To compare to impact of structure layout and the resulting effectiveness of suppression actions, consider Experiment 3 and Experiment 5. The transient nature of the remote suppression action can be seen in the example provided in Figure 4.4, from Experiment 3, where the suppression crew’s initial action occurred from the stairway, toward the fire room in bedroom 3. The 7 s stairway suppression action reduced temperatures in the fire room from above 1500 °F to between 850 °F and 550 °F. In the 19 s pause between stairway suppression and landing suppression actions, temperatures began to recover in upper region of the fire room while the remainder leveled off. The landing suppression further decreased fire room temperatures but cooling was limited by the inability to apply water to all of the burning items in the room. Temperatures remained steady as the vertical vent was completed. Temperatures within the fire room returned to pre-ignition conditions once the suppression crew entered the fire room. Simultaneous with the temperature decrease in the fire room, temperatures in the hallway decreased. Note: In Figure 4.4b the lack of impact on hallway temperature from the vertical ventilation.

Figure 4.4: Effect of hallway, landing, doorway, and fire room suppression actions on fire room and hallway temperatures in Experiment 3. Time = 0 corresponds to the front door being opened and data is included for 150 s after fire department intervention.

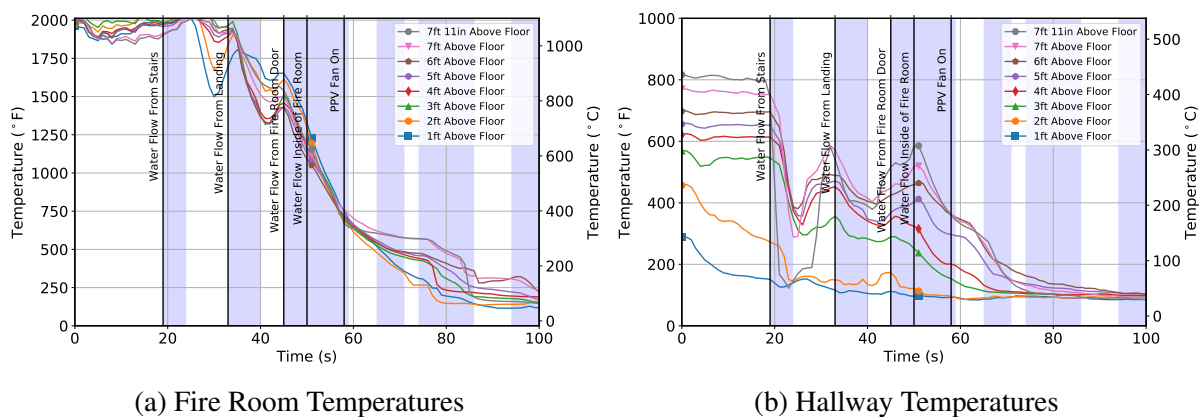
In Experiment 5, the initial suppression action from the stairway was not effective at reducing the fire room temperatures, although it did provide local cooling in the hallway as the suppression crew advanced to the stairway landing (see Figure 4.5). Although this initial suppression action

reduced temperatures in the hallway, temperatures began to increase after water flow stopped as hot combustion gases flowed out of the fire room. Further suppression actions from the landing and fire room doorway also reduced temperatures, but they did not return to pre-ignition conditions until suppression crew advanced into the fire room to completely wet all surfaces. The effectiveness of suppression actions in Experiments 3 and 5 illustrate the importance of water application into the fire room. “Shut-down-and-move” suppression techniques with no ability to apply water into the fire room provided brief benefit in the local area of the suppression crew, but temperatures in both the fire room and remote areas rebounded or remained steady until the suppression crew began to effectively apply water within the fire room.

Figure 4.5: Effect of hallway, landing, doorway, and fire room suppression actions on fire room and hallway temperatures in Experiment 5. Time = 0 corresponds to the front door being opened and data is included for 150 s after fire department intervention.

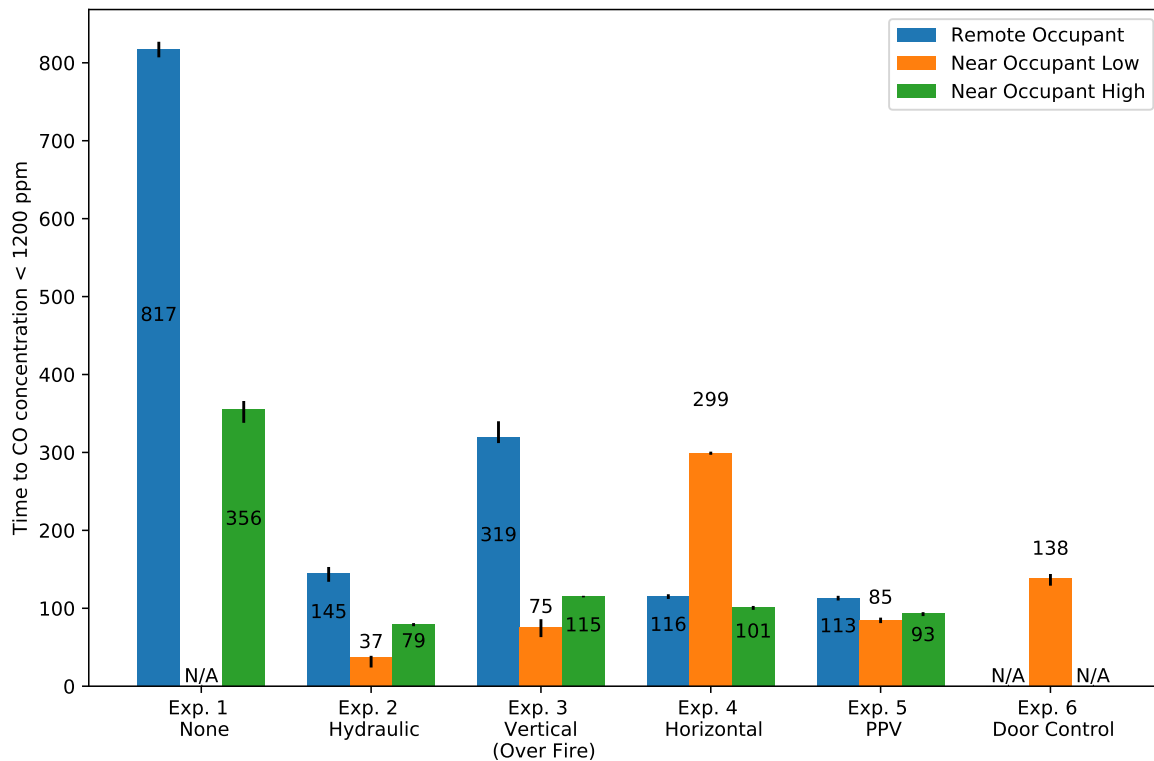
Figure 4.6: Time elapsed from the opening of the front door to the time at which the CO concentration at occupant locations dropped below 1200 ppm. Note: “N/A” indicates a sensor error or experiment in which the peak CO concentration was below the measurement error.

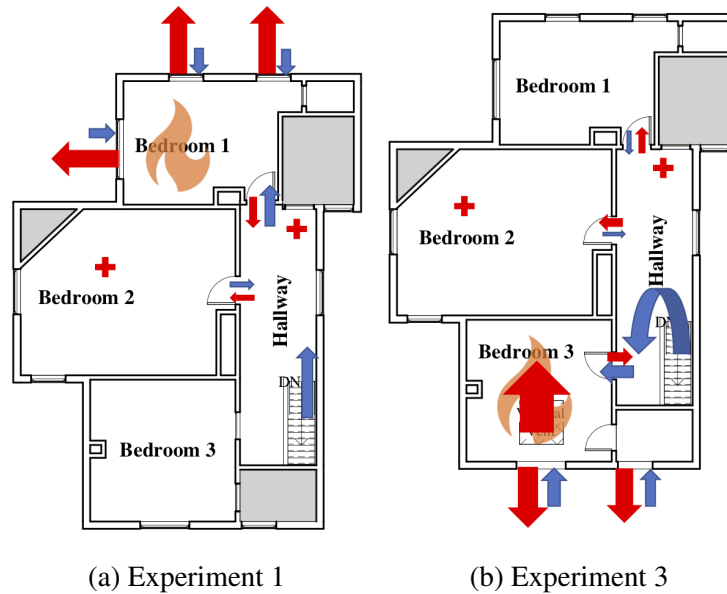
impact on gas flow on the second-floor outside the fire room. This is because the occupant location in bedroom 2 was remote from the flow path, which is similar to the lack of flow in Experiment 1. Figure 4.7 shows the flow paths in Experiments 1 and 3 after the completion of ventilation. Although there is exchange of fresh air and products of combustion between bedroom 2 and the hallway (see Figure 4.7b), the majority of flow is directed toward the fire room.

Figure 4.7: Comparison of post-ventilation flow paths at the comparable location in Experiments 1 and 3.

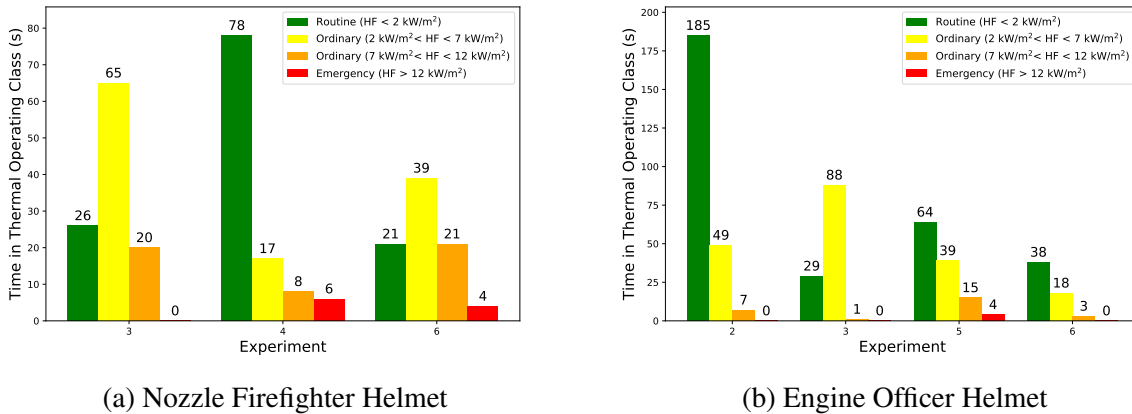
Figure 4.8 shows the total time, in seconds, that the maximum (maximum between horizontal and vertical) heat flux exposure of nozzle and officer firefighter positions fell into each of the thermal operating classes [19]. While the maximum exposures were remarkably high, such as the nozzle firefighter in Experiment 4 with a peak heat flux of 27 kW/m² (see Table 4.6), these peak exposures were short in duration. Typically, these exposures occurred immediately prior to the doorway suppression action, after which heat fluxes decreased substantially.

Figure 4.8: Time spent in each thermal operating class according to heat flux criteria for Method 1 Experiments where helmet data was recorded. Green indicates routine operating class ($HF < 2 \text{ kW/m}^2$). Yellow indicates lower half of ordinary operating class ($2 \text{ kW/m}^2 < HF < 7 \text{ kW/m}^2$). Orange indicates upper half of ordinary operating class ($7 \text{ kW/m}^2 < HF < 12 \text{ kW/m}^2$). Red indicates emergency operating class ($HF > 12 \text{ kW/m}^2$).

The officer position tended to spend more time during the suppression actions in the routine operating class or lower half of the ordinary operating class. Experiment 5 was the only experiment where data was recorded in which the officer firefighter was exposed to conditions consistent with the emergency operating class. In this experiment, the initial suppression actions from the stairway were ineffective at reducing temperatures in the fire room. Effective suppression in the fire room was only accomplished once the suppression crew reached the landing, where they were exposed to heat from the fire room doorway at close proximity, leading to a more severe exposure.

Figure 4.8 also demonstrates that considering only the peak exposure to the suppression crew is important, but only one piece of necessary information. The nozzle firefighter in Experiment 4 experienced a peak heat flux of 27 kW/m^2 , which was the highest of any of the Method 1 experiments. This peak was rather brief, however, and the majority of the nozzle firefighter's exposure in Experiment 4 fell into the routine operating class. Compared to Experiments 3 and 6, the nozzle firefighter in Experiment 4 spent a shorter period of time exposed to heat fluxes above 7 kW/m^2 and had a lower total energy exposure (see Table 4.6). Thus, it is important to consider not only the peak exposure, but cumulative exposure to the firefighters and their PPE.

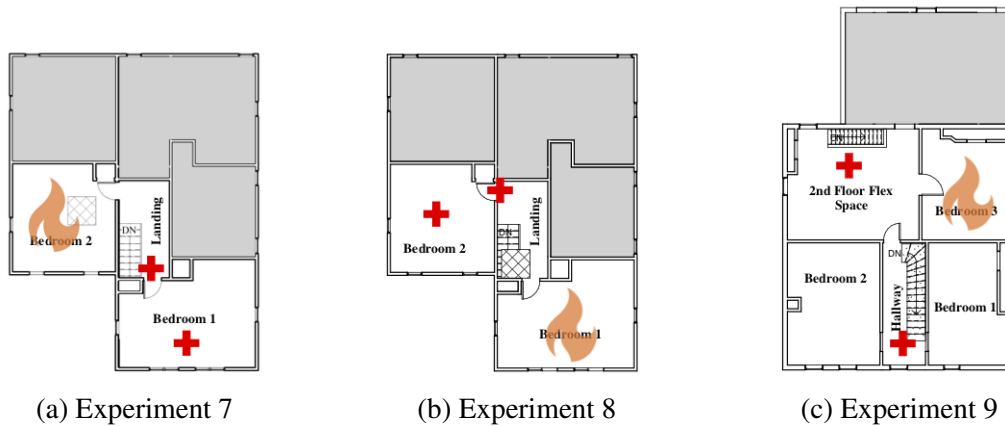
Table 4.8 shows the impact of structure geometry on occupant package location. The average distance away from the fire room for the remote occupant package was 27 ft with a standard deviation of 1 ft. For the occupant package inside the flow path, the average distance was shorter, at 17 ft, with a standard deviation of 2 ft. The small standard deviations relative to the mean values indicate that the occupant packages were similarly spaced relative to the fire room during the three experiments.

Figure 4.9: Fire floor layouts for acquired structures used in Method 2 experiments. The red crosses represent the approximate locations of the occupant assessment packages. The gray areas were isolated from the remainder of the structure and utilized as space for instrumentation.

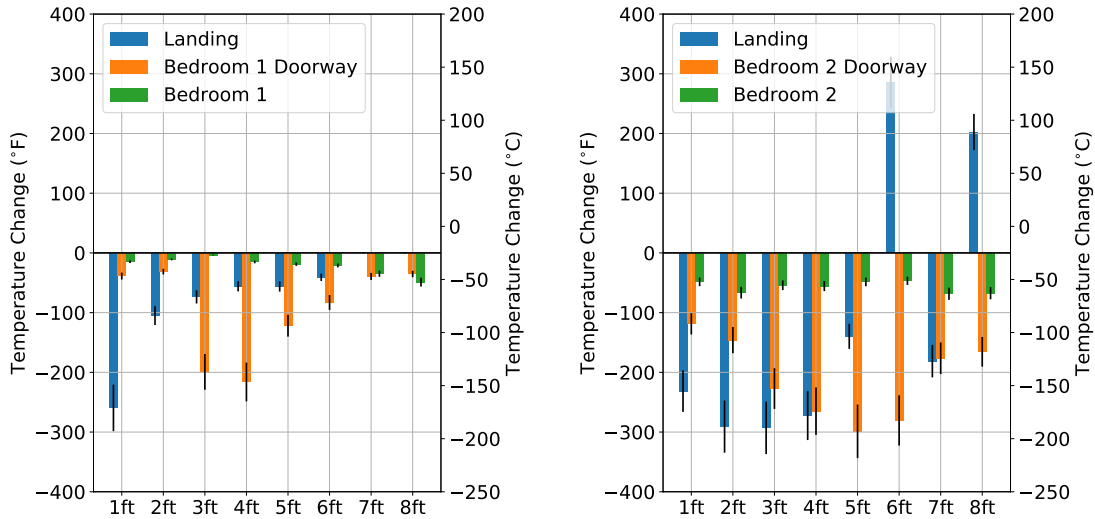
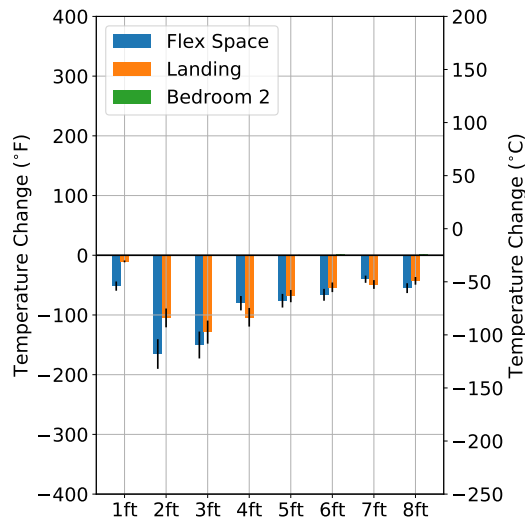
Despite the increase in temperatures within the fire room after secondary ventilation actions, temperatures generally decreased in spaces remote from the fire room for each of the experiments in Method 2. Figure 4.10 shows the temperature change from the time the front door was opened until the second prior to initial suppression at locations remote from the fire room. The charts show that elevations closer to the floor and locations close to the flow path showed the greatest temperature decrease. This is because of the ambient air being entrained into the fire room along the inlet of the flow path. In Experiment 7 (vertical vent over fire) and Experiment 9 (positive pressure), the temperatures at elevations closer to the ceiling also decreased, although not as much as at lower elevations. In Experiment 8, the vertical vent over the hallway provided a low-pressure exhaust outside the fire room, allowing hot gases to vent through the top portion of the fire room doorway, into the hallway, and out the vent hole. This resulted in a temperature increase in the 6 ft and 7 ft 11 in. elevations in the stairway landing, as shown in Figure 4.10.

(a) Experiment 7

(b) Experiment 8

(c) Experiment 9

Figure 4.10: Change in temperature from the time the front door was opened until the second before initial water flow for the suppression crew. Negative values indicate a temperature decrease, while positive values indicate a temperature increase.

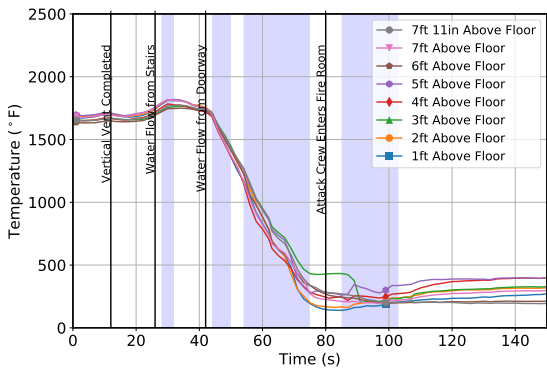
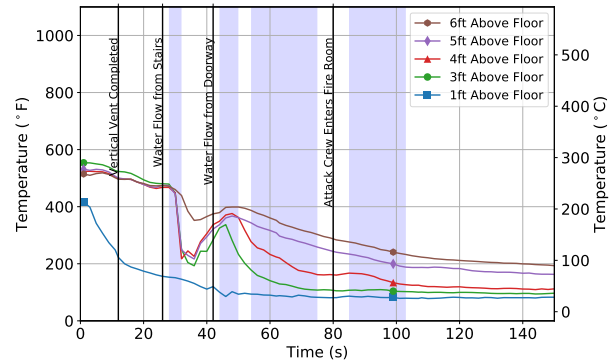
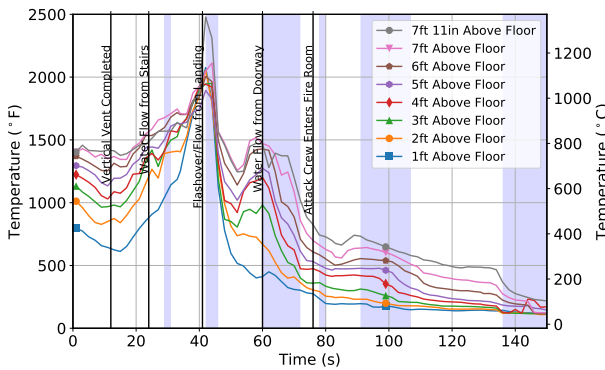
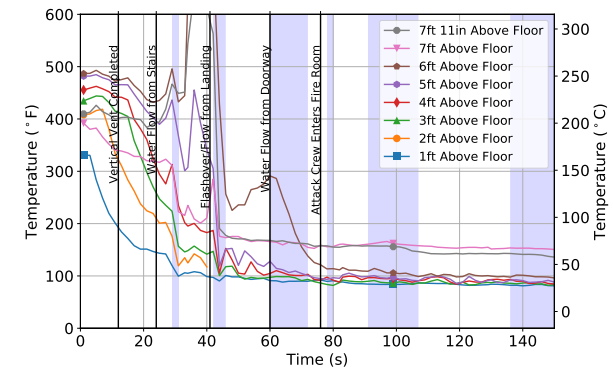
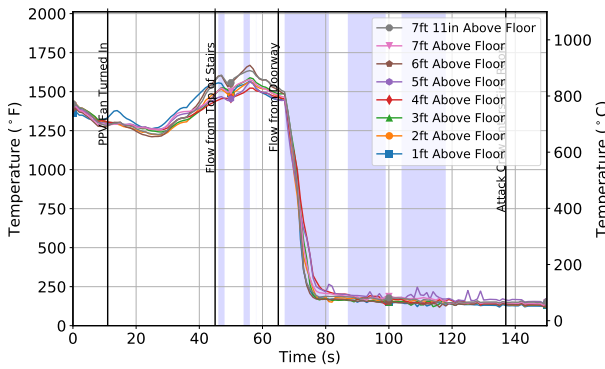
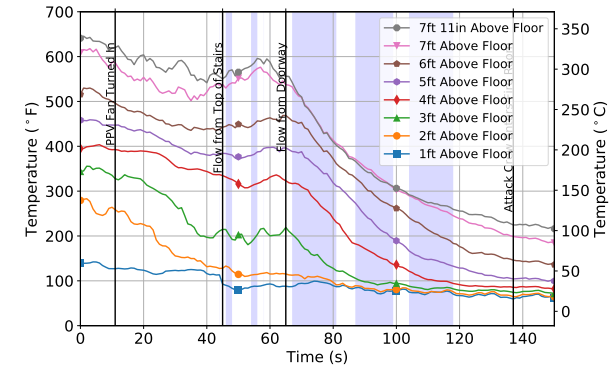
(a) Experiment 7 Fire Room

(b) Experiment 7 Landing

(c) Experiment 8 Fire Room

(d) Experiment 8 Landing

(e) Experiment 9 Fire Room

(f) Experiment 9 Flex Space

Figure 4.11: Suppression effects on fire room and landing temperatures for Experiments 7, 8, and 9. Time = 0 corresponds to the front door being opened and data is included for 150 s after fire department intervention.

after water flow stopped. The 14 s doorway suppression further reduced temperatures to between 275 °F and 900 °F, after which they continued to decrease as the suppression crew commenced final suppression. The remote suppression actions in Experiments 7 and 8 show that although remote suppression actions may not have a significant impact on fire room temperatures, water flow remote from the fire room can be effective at local cooling. While water flow outside the fire room temporarily cooled the immediate area, the temperatures quickly recovered once water flow stopped. In Experiment 9, the fire room was not in a direct sight line from the stairwell as it required travel through the flex space (recall from Figure 3.101). As a result, the most effective temperature reductions occurred from fire room doorway suppression.

During each experiment in Method 2, the nozzle firefighter employed a “shutdown and move” method of hoseline advancement, where the crew would stop their advancement toward the fire room, apply water for a period of time, and then resume their advancement after shutting down. In each case, the nozzle firefighter applied water at least once before reaching the fire room doorway. Figure 4.11 compares the impact of suppression actions prior to reaching the fire room doorway on fire room temperatures and landing temperatures for the 150 s following the opening of the front door in Experiments 7, 8, and 9. While water application prior to reaching the fire room doorway had mixed results among the three experiments, the doorway suppression action had the most significant cooling within the fire room for each of the three experiments. In Experiment 7, the 26 s doorway suppression action reduced temperatures from above 1700 °F at the beginning of the flow to between 425 °F and 160 °F at the end of the flow. The 14 s initial doorway suppression in Experiment 8, reduced temperatures that were over 1200 °F at 4 ft above the floor in the fire room, to approximately 475 °F. Similarly, in Experiment 9, the 21 s doorway suppression action reduced the fire room temperatures from 1400 °F at the start of water flow to less than 250 °F at the end of water flow at all elevations. The reason that the doorway flow was the most effective at reducing fire room temperatures is because from this location, the nozzle firefighter can apply water to any burning surface in the fire room that is not shielded by obstructions, allowing for efficient surface cooling and fuel wetting.

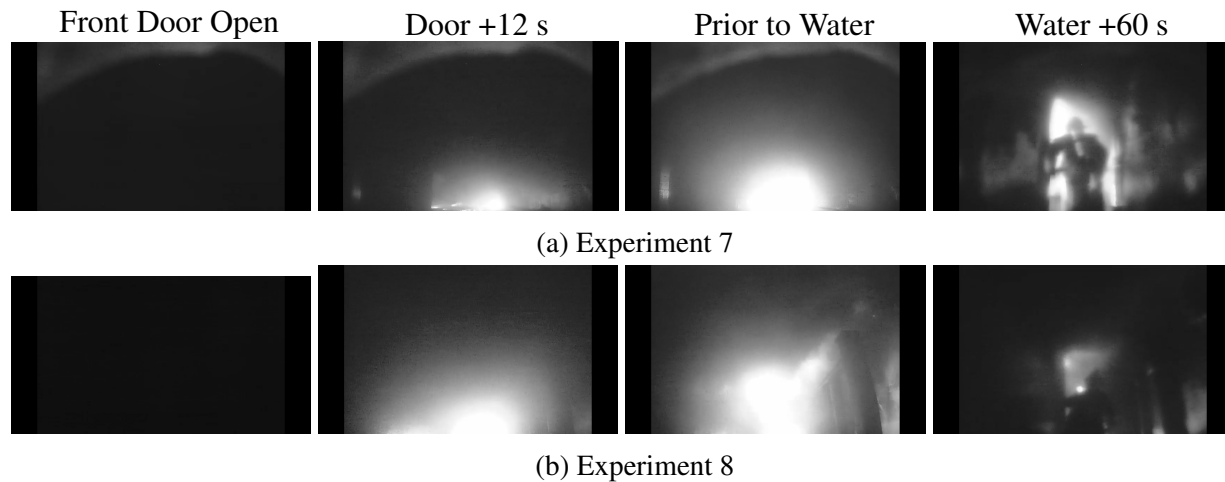
Figure 4.12: Change in visibility in the 60 s. following front door opening for Experiments 7 and 8. Images show the visibility in the hallway camera at the the time of front door open (left), 12 s after the front door opening, which corresponds to the completion of the vertical vent for Experiments 7 and 8 (middle left), immediately prior to initial water application in the stairway (middle right), and 60 s. following initial suppression (far right).

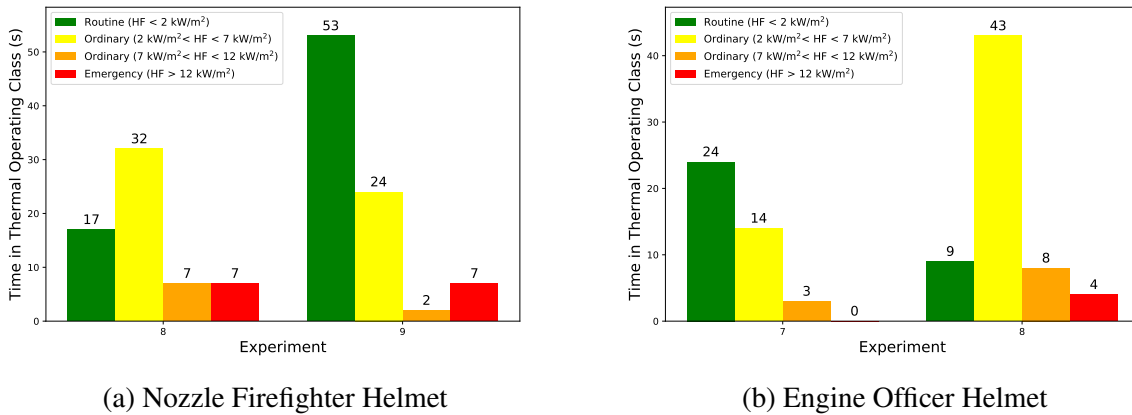
pared to design thresholds for firefighter turnout gear and previous research. Figure 4.13 shows the amount of time, in seconds, from the entry of the suppression team to the completion of suppression in the fire room that each suppression position spent in each of the thermal operating classes based on heat flux criteria.

Figure 4.13: Time spent in each thermal operating class according to heat flux criteria for Method 2 Experiments where helmet data was recorded. Green indicates routine operating class ($HF < 2 \text{ kW/m}^2$). Yellow indicates lower half of ordinary operating class ($2 \text{ kW/m}^2 < HF < 7 \text{ kW/m}^2$). Orange indicates upper half of ordinary operating class ($7 \text{ kW/m}^2 < HF < 12 \text{ kW/m}^2$). Red indicates emergency operating class ($HF > 12 \text{ kW/m}^2$).

The nozzle firefighter in Experiment 8 sustained the highest peak temperature and heat flux exposures out in the Method 2 experiments at $427 \text{ }^\circ\text{F}$ and 23.1 kW/m^2 . The data captured for the officer position for this experiment had a lower peak temperature and heat flux ($210 \text{ }^\circ\text{F}$) and 15.8 kW/m^2 , respectively). Despite the lower peak heat flux, the officer position sustained a total energy exposure comparable to the nozzle position. This is reflected in Figure 4.13, which shows that the officer position spent a comparable, but slightly greater amount of time than the nozzle firefighter in the ordinary and emergency operating classes (55 s compared to 46 s). Further, the officer and nozzle positions spent a slightly greater proportion of the operation exposed to heat fluxes above 7 kW/m^2 (12 s and 14 s, respectively). The reason for the higher exposure in this experiments is the proximity of the hallway vent to the fire room doorway. The low-pressure in the hallway following the vent allowed flaming combustion in the landing, through which the suppression team had to advance to reach the fire room and complete suppression.

The exposures to the nozzle and officer positions in Experiments 7 and 9 were lower than the corresponding position in Experiment 8. The officer position in Experiment 7 was exposed to a lower peak heat flux and temperature than the officer position in Experiment 8. The peak heat flux and temperature in Experiment 7 were $116 \text{ }^\circ\text{F}$ and 10.6 kW/m^2 . The lower total energy exposures listed in Table 4.12 is illustrated in Figure 4.13b, which shows that the engine officer spent most of the suppression portion of the experiment in the lower half of the ordinary operating class and the routine operating class. In a similar fashion, the nozzle firefighter in Experiment 9 experienced a peak temperature and heat flux of $168 \text{ }^\circ\text{F}$ and 20.5 kW/m^2 , respectively. The total energy exposure

was lower than in Experiment 8, which is further illustrated in Figure 4.13a. The chart shows that the nozzle firefighter in Experiment 9 spent less time in the ordinary and emergency operating classes than the nozzle firefighter in Experiment 8.

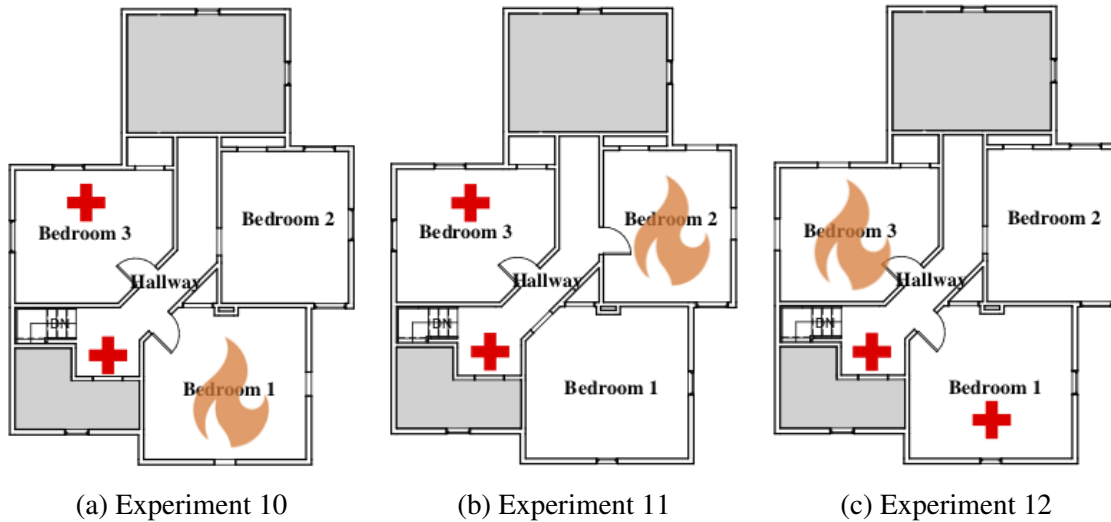
Figure 4.14: Fire floor layouts for acquired structures used in Method 3 experiments. The red crosses represent the approximate locations of the occupant assessment packages. The gray areas were isolated from the remainder of the structure and utilized as space for instrumentation.

Table 4.14 shows the impact of structure geometry on occupant package location. The average distance away from the fire room for the remote occupant package was 15 ft with a standard deviation of 1 ft. For the occupant package inside the flow path, the average distance was shorter, at 12 ft, with a standard deviation of 4.5 ft. The small standard deviation relative to the mean value for the remote package indicates similarly spaced instrumentation packages for these experiments. For the flow path occupant packages, the larger standard deviation indicates, independent of tactics examined, the distance from fire room may play a role in occupant data variability. Figure 4.14 summarizes the fire floor layouts for each experiment in Method 3.

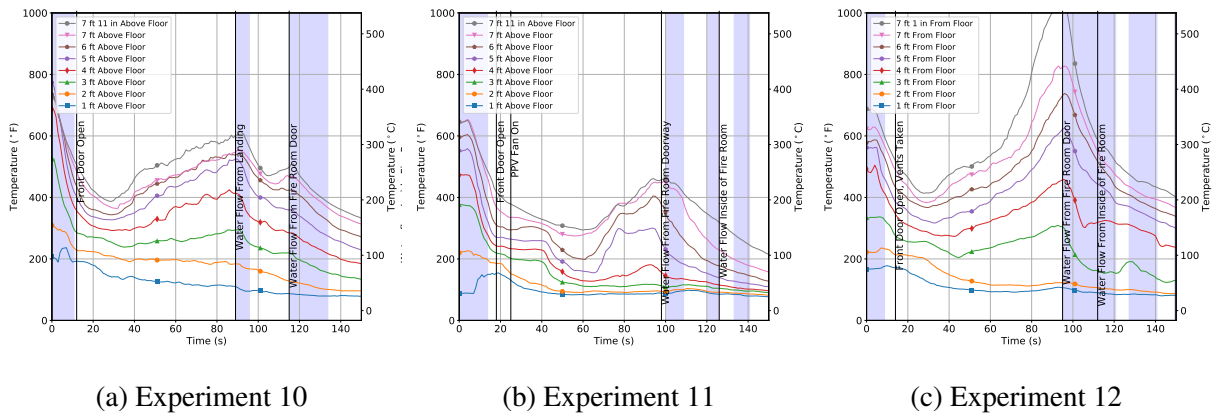
Figure 4.15: Temperature regrowth in the hallway following exterior suppression for Method 3 experiments. Time = 0 corresponds to the beginning of the exterior suppression action and data is included for 150 s after fire department intervention.

In all three experiments, the exterior suppression action reduced temperatures and pressures within the fire room. Fire growth following the exterior suppression action was observed in each of the three Method 3 experiments. The regrowth is best reflected in the hallway temperatures outside the fire rooms as these thermocouples were not damaged by water flow. Figure 4.15 shows the temperatures in the hallway outside the fire room in the period following the exterior suppression action.

Table 4.15 summarizes the data presented in the charts in Figure 4.15. The table highlights the temperatures prior to exterior (ext.) suppression, the time elapsed from the exterior suppression until temperature regrowth began in the hallway (i.e. the time to reach minimum temperatures), the minimum hallway temperature following the exterior suppression, the regrowth temperature (or temperature prior to interior suppression, and the time from the initial fire department intervention until the suppression crew entered the fire room.

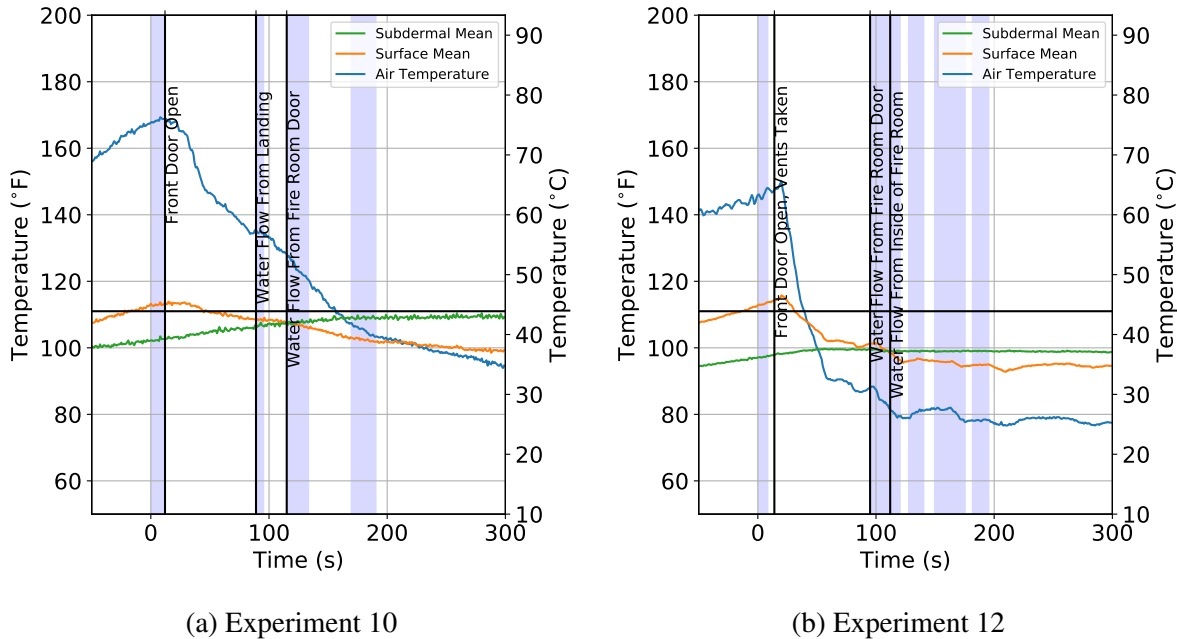
Figure 4.16: Comparison of occupant package temperatures 1 ft from the floor of the remote bedroom. In Experiment 12, the bedroom window was ventilated and in Experiment 10 it was not. Data is presented for the 50 s preceding and 300 s following exterior suppression, with time = 0 corresponding to the start of exterior suppression.

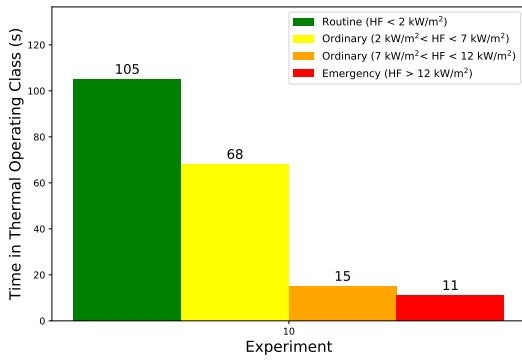
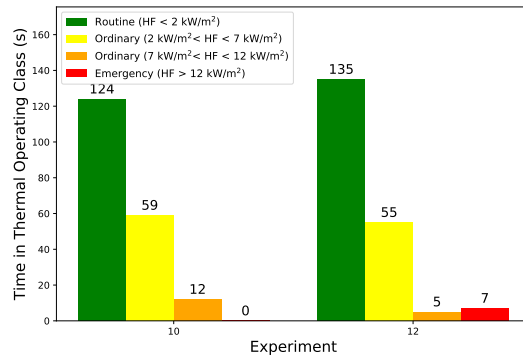
(a) Nozzle Firefighter Helmet

(b) Engine Officer Helmet

Figure 4.17: Time spent in each thermal operating class according to heat flux criteria for Method 3 Experiments where helmet data was recorded. Green indicates routine operating class ($HF < 2 \text{ kW/m}^2$). Yellow indicates lower half of ordinary operating class ($2 \text{ kW/m}^2 < HF < 7 \text{ kW/m}^2$). Orange indicates upper half of ordinary operating class ($7 \text{ kW/m}^2 < HF < 12 \text{ kW/m}^2$). Red indicates emergency operating class ($HF > 12 \text{ kW/m}^2$).

The peak heat fluxes that the Experiment 10 nozzle firefighter and Experiment 12 officer were exposed to were consistent with emergency operating conditions, while the peak heat flux exposure for the Experiment 10 officer was consistent with ordinary operating conditions. Figure 4.17 shows the amount of time spent in each exposure threshold during the fire suppression period (from the beginning of exterior water to the suppression crew’s entry into the fire room). The figure shows that the nozzle and officer positions in both experiments spend minimal amounts of time, comparatively, in the upper half of the ordinary and the emergency operating classes. Although the time lapse between initial exterior and final interior suppression allowed regrowth of the fire to the point where flames were visible in the fire room and out the windows, the interior suppression actions quickly reduced the thermal insult to the suppression crew.

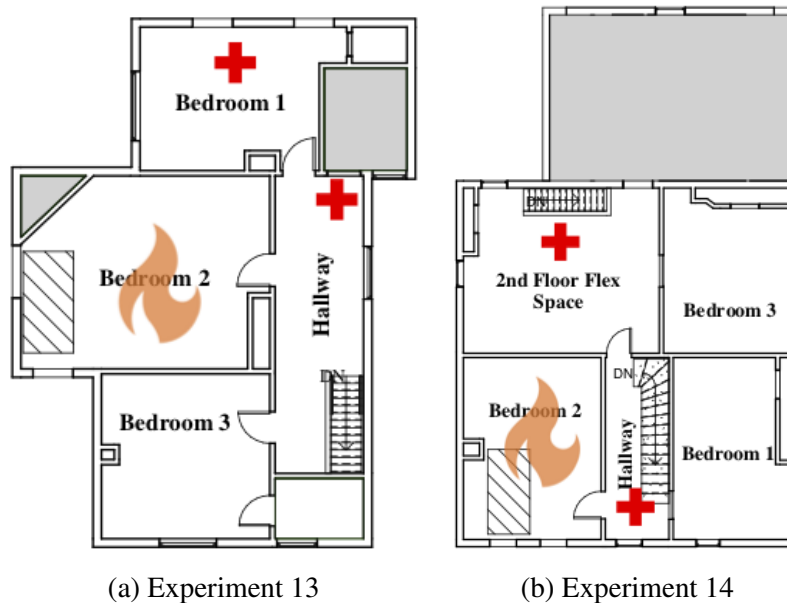
Figure 4.18: Fire floor layouts for acquired structures used in Method 4 experiments. The red crosses represent the approximate locations of the occupant assessment packages. The gray areas were isolated from the remainder of the structure and utilized as space for instrumentation.

cupant packages were located in the hallway, immediately outside the fire room, and in the flex space. Skin burn assessment packages and gas sample points were located 1 ft above the floor in each of these locations. Additionally, gas concentrations were measured 3 ft above the floor in the hallway in Experiment 13 and in the flex space in Experiment 14. Table 4.20 lists these occupant locations, their location with respect to the flow path established after the front door was opened, and their distance from the fire room doorway. Note: The occupant package closest to the fire room (hallway in Experiments 13 and 14) were a comparable distance away from the fire room, while the remote occupant in Experiment 14 (flex space) was considerably farther than its counterpart in Experiment 13 (bedroom 1). Figure 4.18 summarizes the fire floor layouts for each experiment in Method 4.

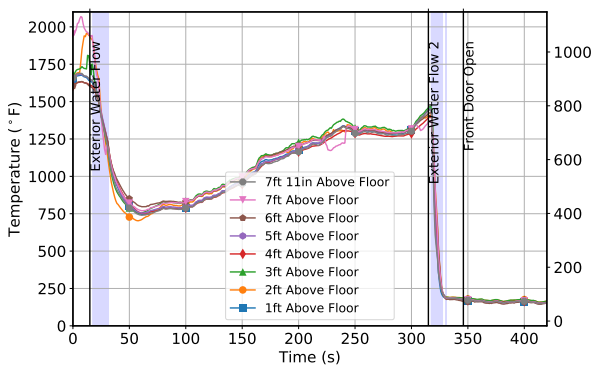
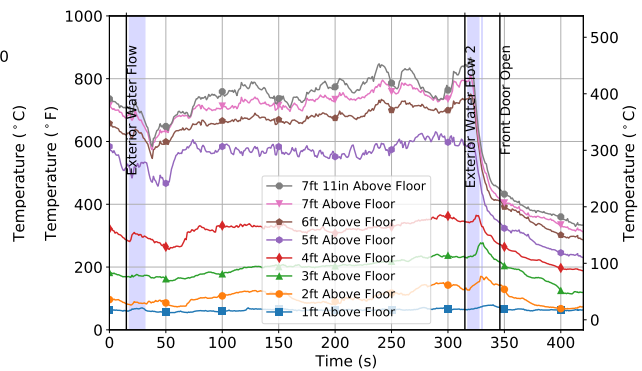
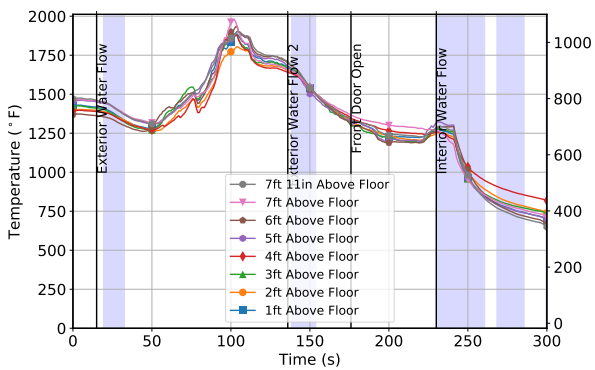
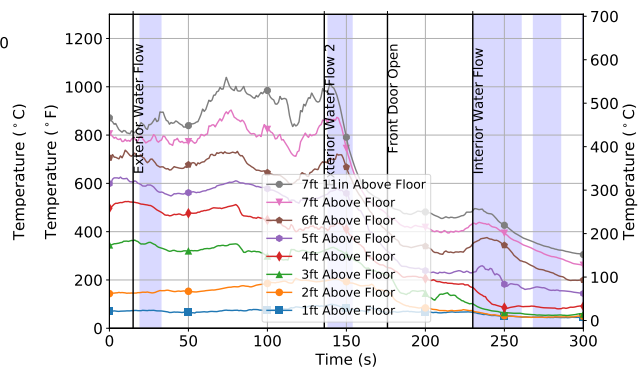
(a) Experiment 13 Fire Room

(b) Experiment 13 Hallway

(c) Experiment 14 Fire Room

(d) Experiment 14 Hallway

Figure 4.19: Effect of suppression actions on fire room temperatures and hallway temperatures in Method 4 experiments. Time = 0 corresponds to the beginning of the straight stream suppression action and data is included through the opening of the front door and the initial interior suppression actions.

The fire room temperature and pressure data presented in Sections 3.13 and 3.14 indicated the initial, straight stream suppression action was more effective at reducing fire room temperatures in Experiment 13 than in Experiment 14. Figure 4.19 shows the temperatures in the fire room and the space immediately adjacent (hallway in Experiments 13 and 14) from the time of the initial exterior straight stream suppression through final fire room suppression. In Experiment 13, the straight stream application reduced fire room temperatures from between 1950 °F and 1600 °F to between 800 °F and 700 °F over a period of approximately 45 s. In this case, the straight stream interacted with the rafters running through the failed ceiling, leading to a partially broken stream.

Approximately 30 s after the end of the initial exterior suppression action, temperatures in the fire room subsequently increased until the lintel hit was initiated, which dropped temperatures from 1450 °F to about 180 °F. Although temperatures dropped in the fire room, there was not a noticeable change in the hallway as a result of the initial application, as shown in Figure 4.19b. In Experiment 14, temperatures dropped slightly after the straight stream through the failed ceiling, but began to increase approximately 20 s after the nozzle was shut down, rebounding to peak temperatures uniformly in excess of 1750 °F prior to the start of the lintel hit. The lintel hit dropped temperatures from over 1650 °F to 1350 °F by the time the front door was opened. Similar to Experiment 13, the temperatures in the hallway outside the fire room doorway remained steady in the period between the two suppression actions.

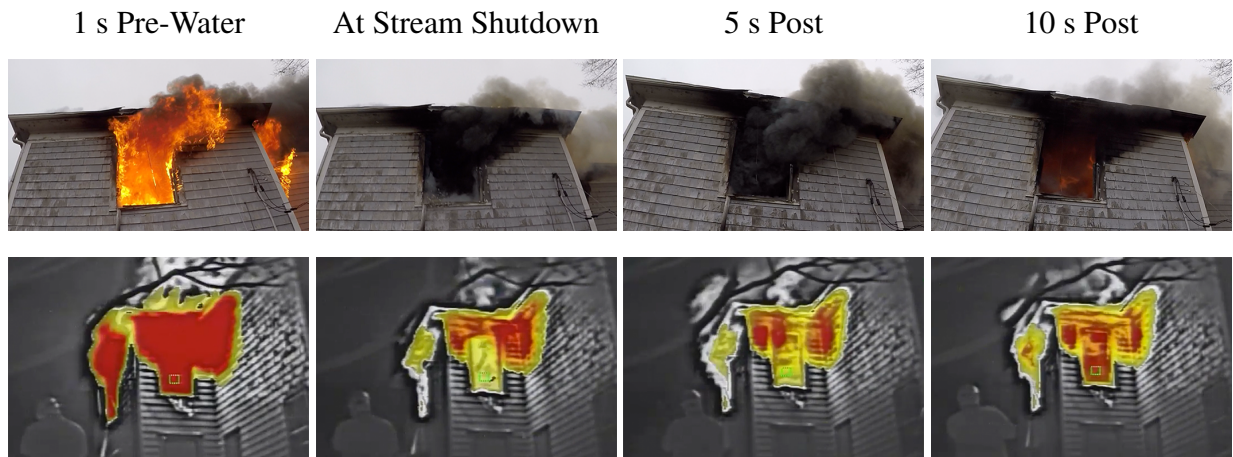
Figure 4.20: Visual representation of the effect of the initial water application on the fire room where the ceiling has failed for Experiment 13. Standard video from firefighters helmet on the B side (top), and infrared video from the A/B corner (bottom). The columns are 1 s prior to water application (left) at the point the stream was shut down (left middle), 5 s post water application (right middle), and 10 s post water application (right).

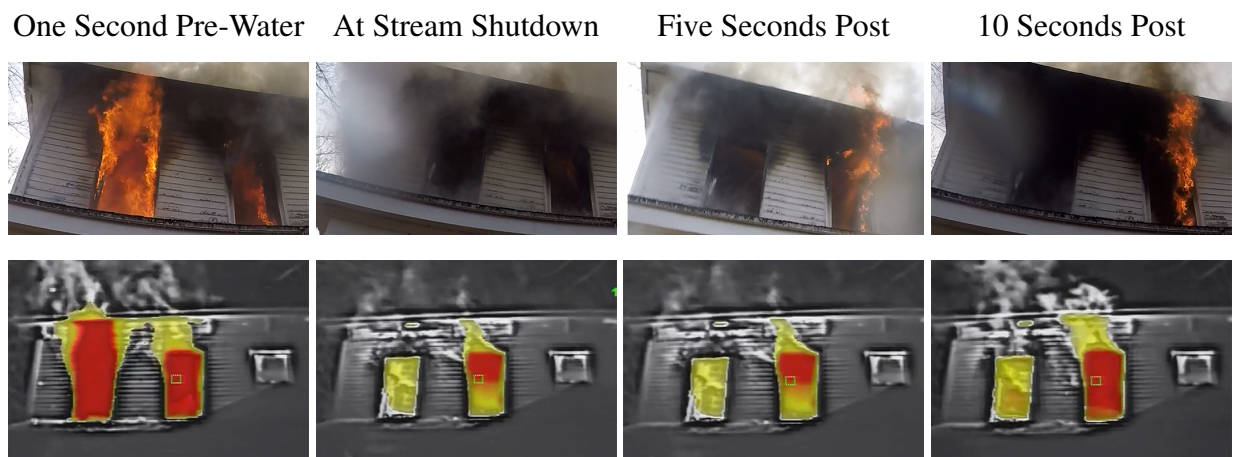
Figure 4.21: Visual representation of the effect of the initial water application on the fire room where the ceiling has failed for Experiment 14. Standard video from firefighters helmet from the A side (top), and infrared video from the A side (bottom). The columns are 1 s prior to water application (left) at the point the stream was shut down (left middle), 5 s post water application (Right Middle), and 10 s post water application (right).

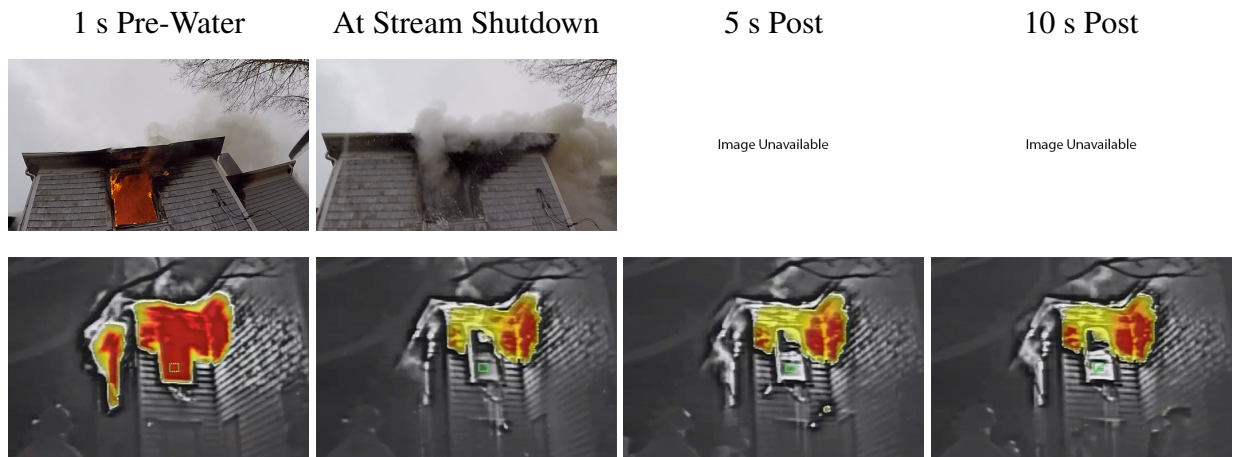
Figure 4.22: Visual representation of the effect of water application using a lintel suppression for Experiment 13. Standard video from firefighters helmet (top), and infrared video from A/B corner (bottom). The columns are 1 s prior to water application (left) at the point the stream was shut down (left middle), 5 s post water application (right middle), and 10 s post water application (Right).

In a similar fashion to the straight stream steep angle suppression, the lintel hit resulted in the complete reduction of visible fire in both windows. The change in the infrared camera view, however, was different than after the straight stream, steep angle suppression. Figure 4.22 and 4.23 show the standard and infrared camera views for Experiments 13 and 14, respectively. The nozzle firefighter began to transition to the compartment immediately after application which resulted in a lack of standard camera footage at that position for the five and ten seconds post water application. The infrared camera was stationary and shows that in the window adjacent to where water was applied there was a more pronounced change between pre- and post-water application than the initial steep angle application, where little to no change in the heat signature was observed.

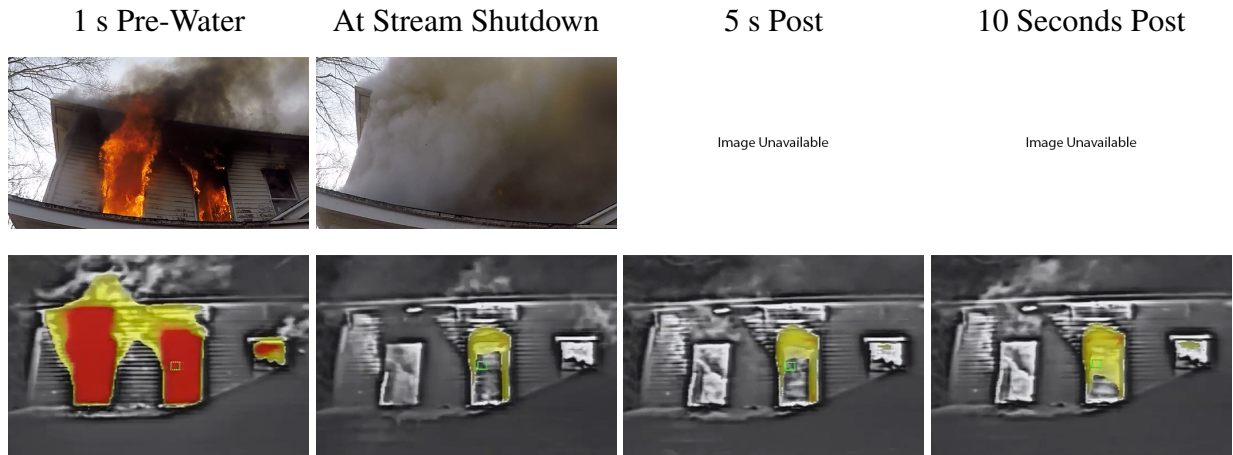
Figure 4.23: Visual representation of the effect of water application using a lintel suppression for Experiment 14. Standard video from firefighters helmet (Top), and infrared video from A/B corner (Bottom). The columns are 1 s prior to water application (left) at the point the stream was shut down (left middle), 5 s post water application (right middle), and 10 s post water application (right).

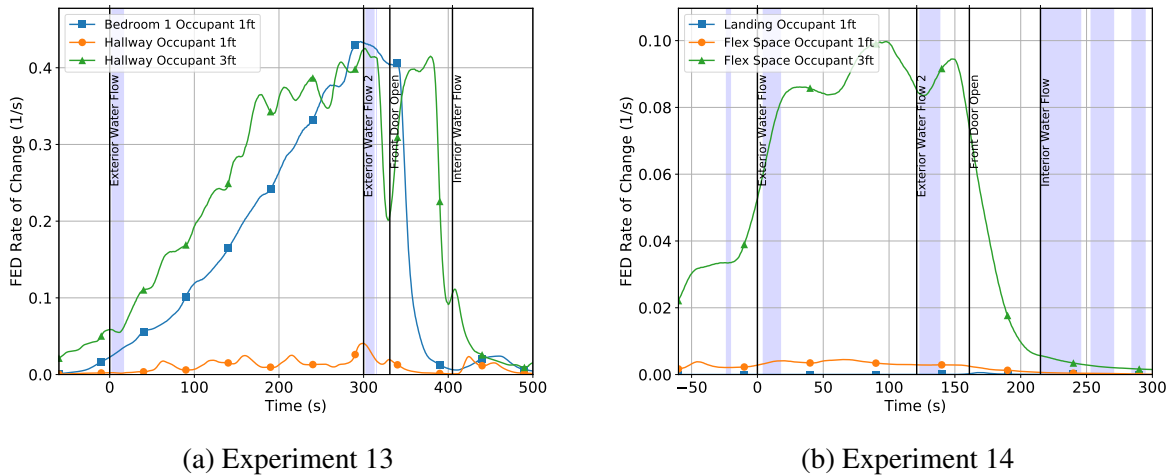
Figure 4.24: Fractional Effective Rate (FER) for Method 4 Experiments. Time = 0 corresponds to exterior suppression.

into the failed ceiling had an effect on the fire, this was not reflected in the gas concentration data. The FER for Experiments 13 and 14, shown in Figure 4.24, was not noticeably affected by initial suppression, and continued to increase during the period between the first exterior suppression (straight stream) and second exterior suppression (lintel hit) in both Experiments 13 and 14. The lintel hit, on the other hand, was more effective at decreasing FER. Following the lintel hit and subsequent front door open, the FER decreased to negligible values.

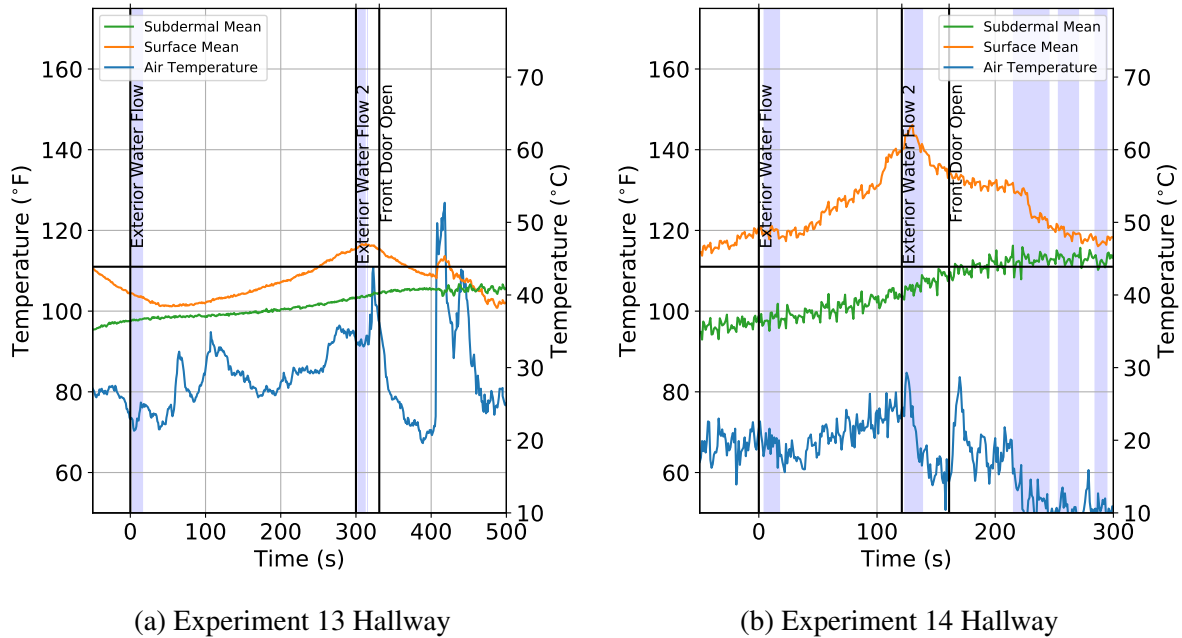
Figure 4.25: Effect of exterior suppression actions on skin burn assessment measurements in Experiments 13 and 14. Time = 0 corresponds to the start of the initial exterior suppression action.

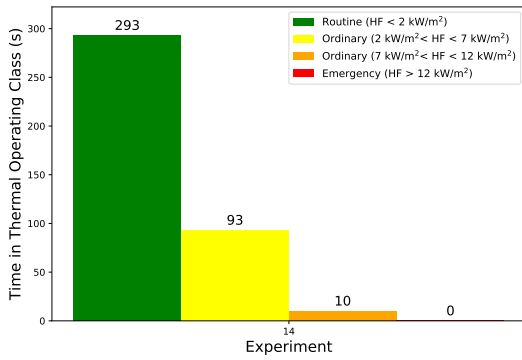
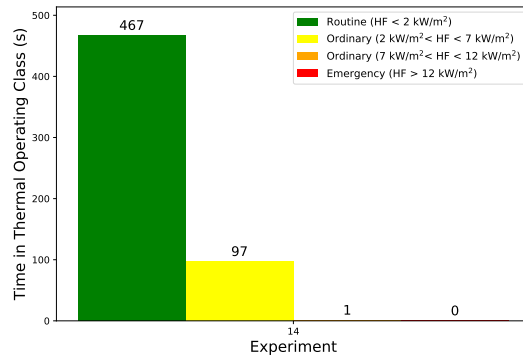
(a) Nozzle Firefighter Helmet

(b) Engine Officer Helmet

Figure 4.26: Time spent in each thermal operating class according to heat flux criteria for Method 4 Experiments where helmet data was recorded. Green indicates routine operating class ($HF < 2 \text{ kW/m}^2$). Yellow indicates lower half of ordinary operating class ($2 \text{ kW/m}^2 < HF < 7 \text{ kW/m}^2$). Orange indicates upper half of ordinary operating class ($7 \text{ kW/m}^2 < HF < 12 \text{ kW/m}^2$). Red indicates emergency operating class ($HF > 12 \text{ kW/m}^2$).

The nozzle firefighter experienced a peak horizontal heat flux of 10.2 kW/m², which is higher than the peak heat flux experienced by the officer position, which was 7.3 kW/m². These peak exposures were experienced as the suppression crew reached the fire room doorway and began interior suppression. After the peak, heat flux quickly decreased as suppression continued. The peak exposures in Experiment 14 are consistent with ordinary thermal operating conditions, as shown in Figure 4.26.

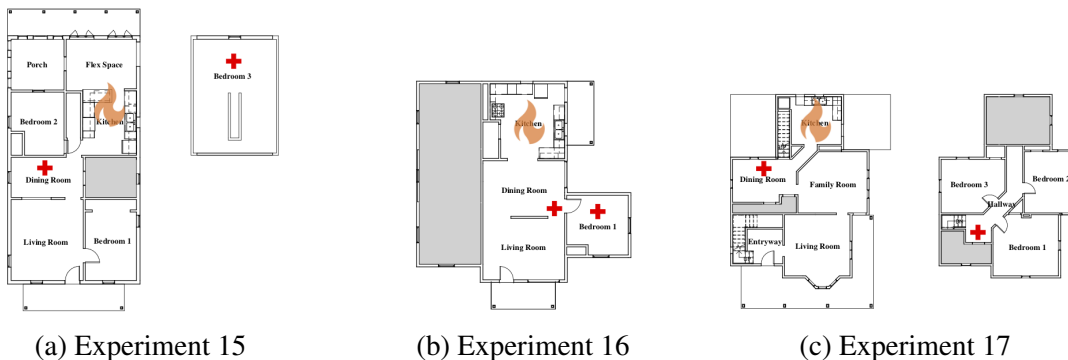
Figure 4.27: Fire floor layouts for acquired structures used in Method 5 experiments. The red crosses represent the approximate locations of the occupant assessment packages. The gray areas were isolated from the remainder of the structure and utilized as space for instrumentation.

the stairs, located close to the front door. In Experiment 16, the remote occupant package was located in a bedroom, adjacent to the flow path between the front door and the kitchen. At each of these occupant locations, skin burn assessment packages were located 1 ft above the floor, which recorded surface, subdermal, and local air temperatures. Additionally, gas concentrations were monitored 1 ft and 3 ft above the floor in the dining room in Experiments 15 and 16 and in the hallway in Experiment 17 and 1 ft above the floor in the remote bedroom in Experiments 15 and 16 and in the dining room in Experiment 17. Figure 4.27 summarizes the fire floor layouts for each experiment in Method 5.

Table 4.25 shows the impact of structure geometry on occupant package location. The average distance away from the fire room for the remote occupant package was 44 ft with a standard deviation of 29 ft. For the occupant package inside the flow path, the average distance was shorter, at 15 ft, with a standard deviation of 1 ft. The small standard deviation relative to the mean value for the flow path occupant package indicates similarly spaced instrumentation packages for these experiments. For the remote occupant packages, the larger standard deviation indicates, independent of tactics examined, the distance from fire room may play a role in occupant data variability.
