Analysis of the Coordination of Suppression and Ventilation in Single-Family Homes

John Regan
Julie Bryant
Craig Weinschenk

UL Firefighter Safety Research Institute
Columbia, MD 20145

March 19, 2020

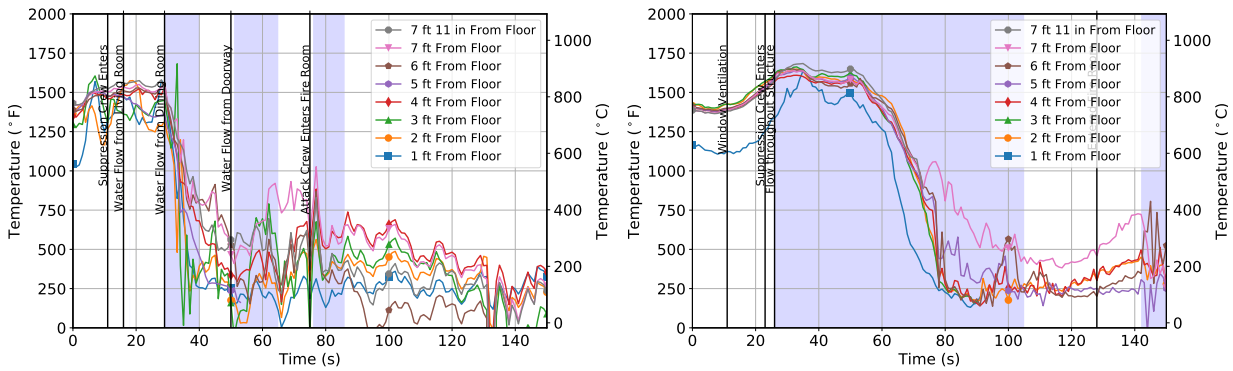
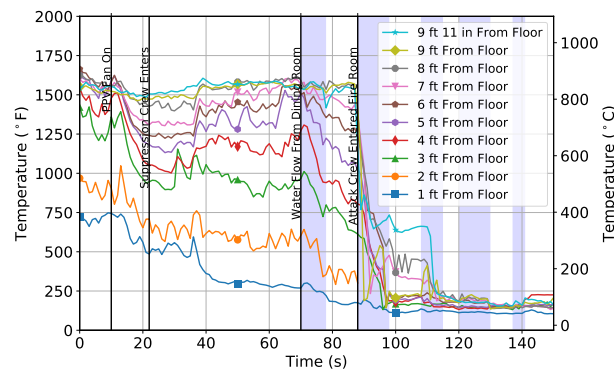
(a) Experiment 15 Fire Room Temperatures

(b) Experiment 16 Fire Room Temperatures

(c) Experiment 17 Fire Room Temperatures

Figure 4.28: Suppression/Ventilation effects on fire room temperatures for Method 5 experiments. Time = 0 corresponds to the front door being opened and data is included for 150 s after the initial fire department intervention.

Fire room temperatures within each experiment began increasing between 7 s and 10 s post front door ventilation before any additional ventilation was provided. Figure 4.28 documents the kitchen temperature variations post front door ventilation for each experiment in Method 5. In Experiment 16, kitchen temperatures initially dropped following the front door open ($t = 0$ s in Figure 4.28b) and began to increase in the 5 s prior to horizontal ventilation. The opening of the windows resulted in an approximate 150 °F temperature rise in the fire room before suppression began. Experiment 17 kitchen temperatures (see Figure 4.28c) indicated positive pressure ventilation initially improved conditions within the fire room, as temperatures decreased for approximately 27 s. Subsequently, temperatures at 3 ft and 4 ft above the floor began to increase and above 4 ft the temperatures recovered to pre-ventilation magnitudes prior to the start of suppression.

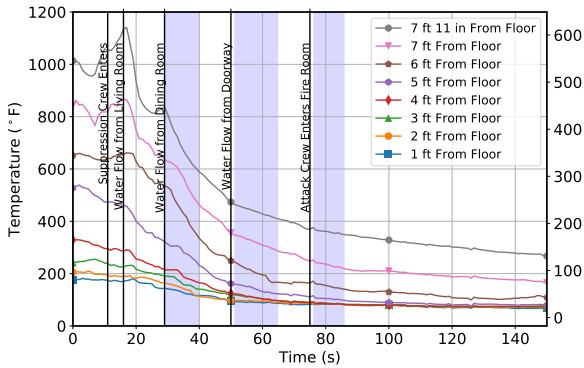
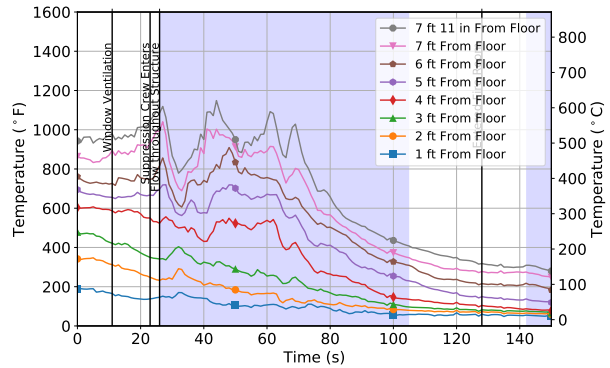
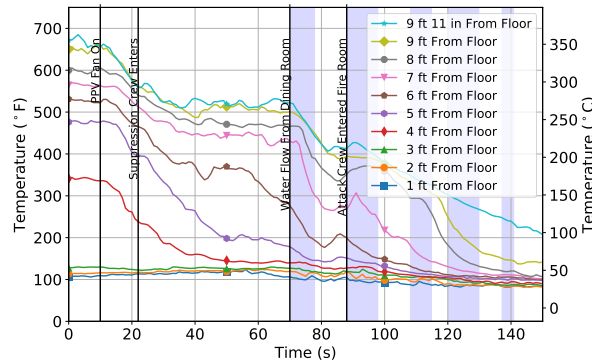
(a) Experiment 15 Dining Room Temperatures

(b) Experiment 16 Dining Room Temperatures

(c) Experiment 17 Dining Room Temperatures

Figure 4.29: Suppression effects on remote room temperatures for Method 5 experiments. Time = 0 corresponds to the front door being opened and data is included for 150 s after fire department intervention.

Temperature data from the dining room, which was on the inlet side of the flow path established after the front door was opened, is presented in Figure 4.29. In each of the experiments, temperatures close to the floor (approximately 4 ft and below) began to decrease as fresh air was entrained

along the flow path from the front door to the kitchen. This decrease was most pronounced in Experiment 17, after the activation of the PPV fan, at which point temperatures at all elevations began to decrease in the dining room in the period leading up to suppression. On the contrary, in Experiments 15 and 16, temperatures closer to the ceiling were not notably affected by front door ventilation.

Suppression efforts were effective at reducing temperatures at all elevations in the adjacent space to the fire room. During Experiment 15 (see Figure 4.29a), the suppression from the living room and the approximately 30 gal flow from the dining room reduced temperatures toward pre-ignition conditions. In Experiment 16, the flow and move tactic did not efficiently reduce temperatures in the dining room until the stream was directed into the fire room approximately 26 s after the start of the flow. This is partially because the initial suppression efforts were ineffective at applying water into the kitchen, and partially because the dining room and kitchen were essentially one open space, meaning that once suppression was effective in the kitchen, temperatures also dropped in the dining room. Similarly, in Experiment 17 the dining room suppression action resulted in minimal temperature change, since the stream was directed at the wall between the kitchen and

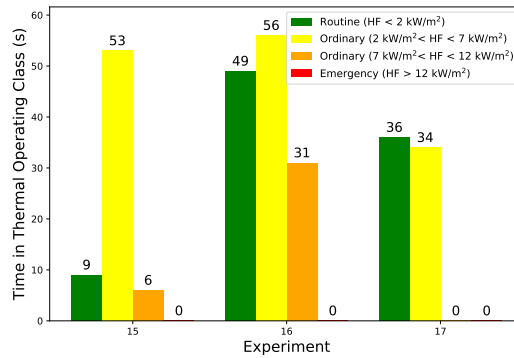
Figure 4.30: Time spent in each thermal operating class according to heat flux criteria for Method 5 Experiments where helmet data was recorded. Green indicates routine operating class ($HF < 2 \text{ kW/m}^2$). Yellow indicates lower half of ordinary operating class ($2 \text{ kW/m}^2 < HF < 7 \text{ kW/m}^2$). Orange indicates upper half of ordinary operating class ($7 \text{ kW/m}^2 < HF < 12 \text{ kW/m}^2$). Red indicates emergency operating class ($HF > 12 \text{ kW/m}^2$).

Initial suppression efforts were effective in Experiment 15, lowering the thermal exposure within the structure, while water directed into the kitchen was delayed in Experiment 16, increasing the total energy exposure compared to Experiment 15. This delay in suppression resulted in a greater amount of time that the officer in Experiment 16 spent in the upper portion of the ordinary operating class, as shown in Figure 4.30. The ceiling height of the kitchen and remote areas in Experiment 17 was 10 ft while only 8 ft in Experiment 16. The additional height of the space delayed the descent of the smoke layer, resulting in cooler temperatures and lower heat fluxes to the suppression crew, such that conditions didn't reach the higher ordinary thermal operating class during Experiment 17.

The routine operating class accounted for approximately 13%, 36%, and 51% of the total tactic time for the officer firefighter in Experiments 15, 16 and 17, respectively. During Experiment 15, the lower half of the ordinary operating class accounted for 78% of the tactic time while it was approximately 41% and 49% during Experiments 16 and 17, respectively. However, the upper half of the ordinary operating class accounted for approximately 9% of the total tactic time for Experiment 15 while Experiments 16 and 17 were 23% and 0%, respectively. Time spent in the upper ordinary operating class may have been affected by the type of ventilation, the effectiveness of suppression techniques, and the ceiling height, as the flow and move method employed during Experiment 16 was not effective in suppressing the fire until the suppression crew reached the fire room doorway threshold.

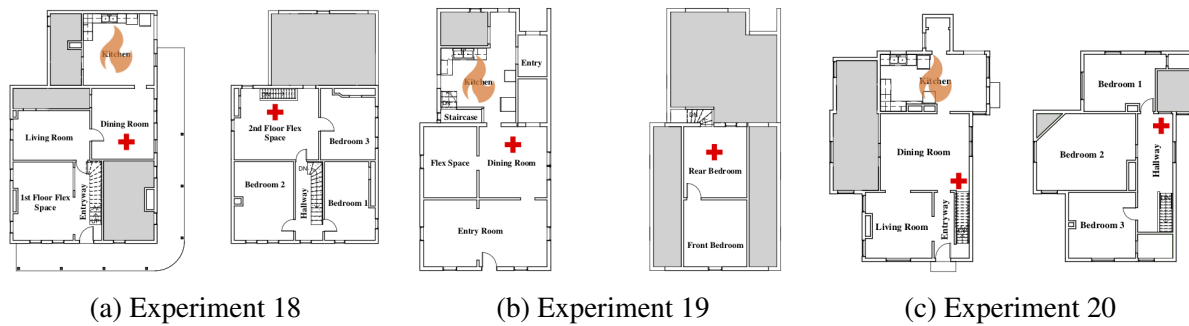
Figure 4.31: Fire floor layouts for acquired structures used in Method 6 experiments. The red crosses represent the approximate locations of the occupant assessment packages. The gray areas were isolated from the remainder of the structure and utilized as space for instrumentation.

The average distance from the fire room to the remote occupant package was $55 \text{ ft} \pm 35 \text{ ft}$ (mean plus/minus standard deviation). For the occupant package inside the flow path, the average distance was shorter, at $11 \text{ ft} \pm 2 \text{ ft}$. The standard deviation distance of greater than one-half of the mean values for the remote package, highlights the spatial variability between each experiment. It is therefore important to recognize that exposures are a function of the tactics studied and the relative location in each experiment. For the occupant package, the small standard deviation relative to the mean indicates spatial variations likely have a smaller impact. Figure 4.31 summarizes the fire floor layouts for each experiment in Method 6.

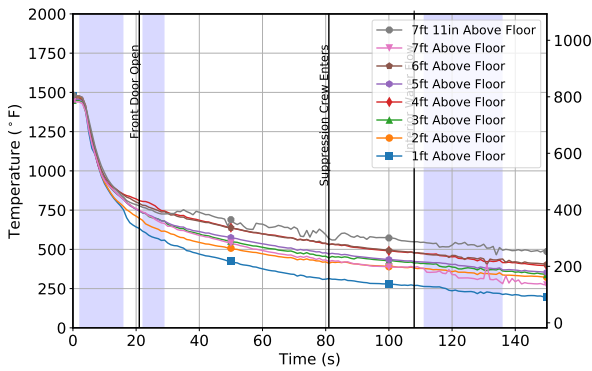
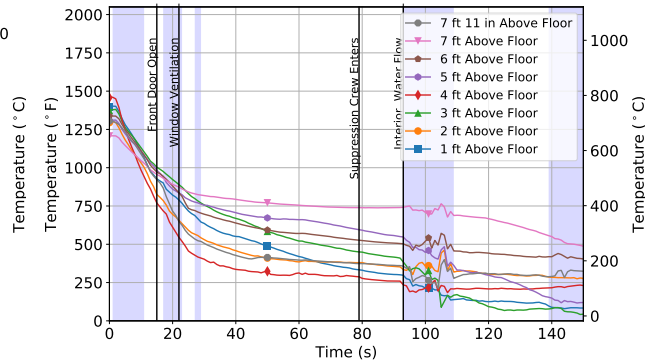
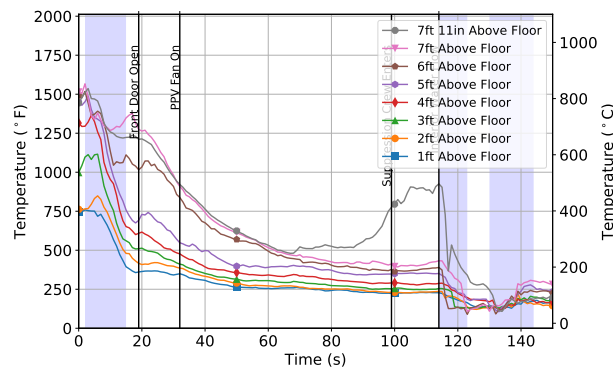
(a) Experiment 18 Fire Room Temperatures

(b) Experiment 19 Fire Room Temperatures

(c) Experiment 20 Fire Room Temperatures

Figure 4.32: Suppression/Ventilation effects on fire room temperatures for Method 6 experiments. Time = 0 corresponds to exterior suppression.

Prior to exterior water flow, fire room temperatures across all three experiments were approximately 1500 °F. The initial straight stream suppression reduced temperatures by approximately 200 °F to 700 °F in the fire room, as shown by the fire room temperature histories in Figure 4.32. The secondary, fuel-wetting suppression action in Experiments 18 and 19 did not have a substantial impact on temperatures in the fire room, which continued to decrease through the remainder of the experiment.

Fire room temperatures indicate that regrowth was not observed in Experiments 18 or 19, despite the additional horizontal ventilation in Experiment 19. In Experiment 20, the temperature close to the ceiling began to increase approximately 60 s after fire department intervention, although the remainder of fire room temperatures remained steady through final, interior suppression. The suppression crew was delayed 60 s from making entry into after the front door was opened in order to evaluate the potential for regrowth and to simulate any difficulty in relocating the hose line from the location of exterior water flow to the front door and the time duration between exterior water flow and interior water flow was 88, 93, and 112 s, respectively. The lack of any meaningful regrowth in the three experiments indicates the exterior suppression was effective at controlling the fire. The temperature rise close to the ceiling that was observed in Experiment 20 did not translate to an increase in temperatures elsewhere in the fire room.

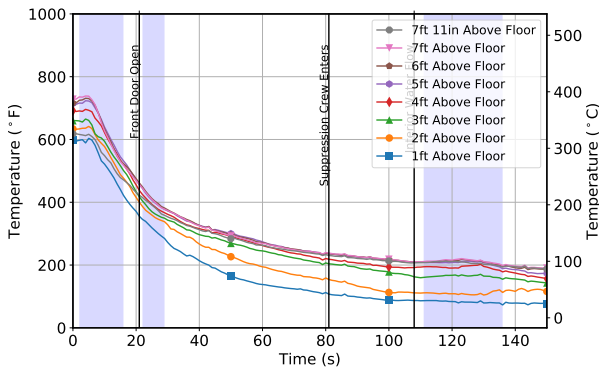
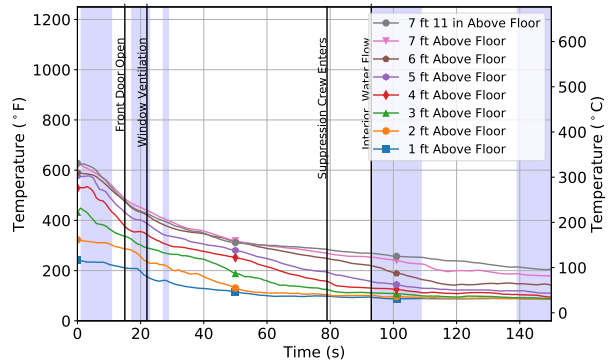
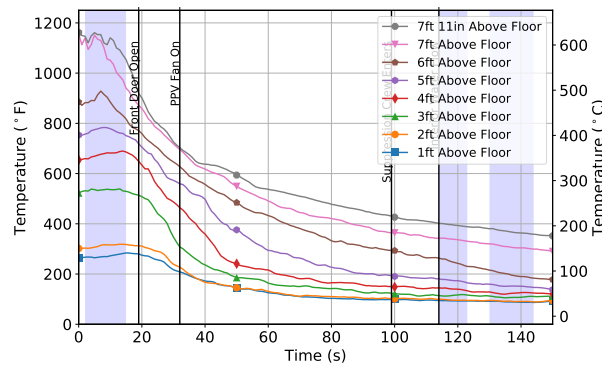
(a) Experiment 18 Dining Room Temperatures

(b) Experiment 19 Dining Room Temperatures

(c) Experiment 20 Dining Room Temperatures

Figure 4.33: Suppression effects on remote room temperatures for Method 6 experiments. Time = 0 corresponds to exterior suppression.

In each experiment, the dining room was adjacent to the kitchen on the inlet side of the flow path established after the opening of the front door (Figure 4.33). In Experiments 19 and 20, dining room temperatures were stratified prior to suppression with temperatures at the ceiling between 500 °F and 1000 °F higher than temperatures at the floor. In Experiment 18, on the other hand, dining room temperatures were approximately 750 °F from floor to ceiling. Dining room temperatures began to continuously decrease after exterior suppression in each of the three experiments. In Experiments 18 and 19, the combined suppression action of gas cooling and fuel wetting dropped temperatures at all elevations below 500 °F by the end of the suppression action, and below 250 °F within 80 s. In Experiment 20, temperatures were higher than the other two experiments at the time of intervention, but similarly decreased following exterior suppression and continued to decrease for the remainder of the experiment.

Remote temperatures within the structure further illustrate the absence of fire regrowth during the time between exterior and interior water flows. Although fire room temperatures became steady between this time, heat did not spread to remote areas along the inlet flow path. Dining room temperatures decreased after exterior suppression without fire regrowth due to additional ventilation.

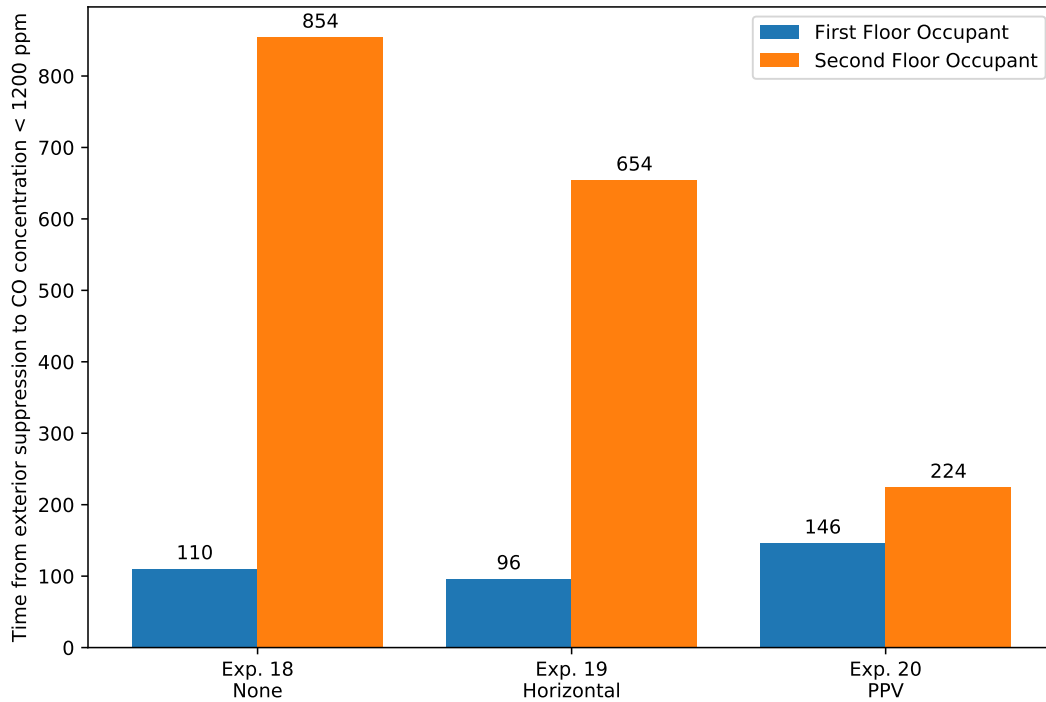
Figure 4.34: Time elapsed from the opening of the front door to the time at which the CO concentration at occupant locations dropped below 1200 ppm.

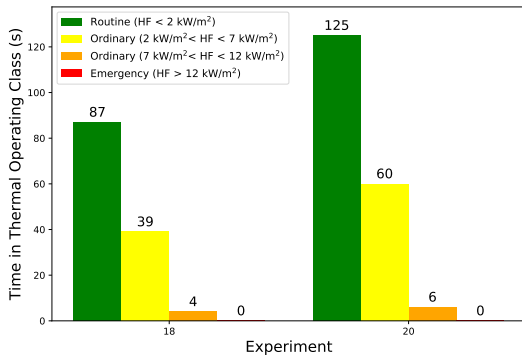
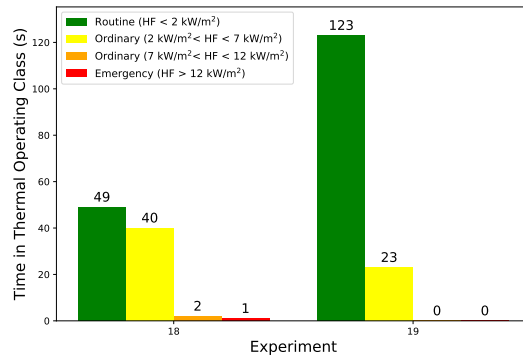
(a) Nozzle Firefighter Helmet

(b) Engine Officer Helmet

Figure 4.35: Time spent in each thermal operating class according to heat flux criteria for Method 6 Experiments where helmet data was recorded. Green indicates routine operating class ($HF < 2 \text{ kW/m}^2$). Yellow indicates lower half of ordinary operating class ($2 \text{ kW/m}^2 < HF < 7 \text{ kW/m}^2$). Orange indicates upper half of ordinary operating class ($7 \text{ kW/m}^2 < HF < 12 \text{ kW/m}^2$). Red indicates emergency operating class ($HF > 12 \text{ kW/m}^2$).

Figure 4.35 provides the breakdown of the time each firefighter spent in each thermal operating class as defined by Utech. For the experiments where data was recorded, the nozzle firefighter spent approximately the same amount of time in each thermal operating class; approximately 65% to 67% routine, 30% to 31% lower ordinary, and < 1% upper ordinary. The officer firefighter during Experiment 18 spent 53% of the total tactic time in the routine class compared to 84% during Experiment 19 while time spent in the lower ordinary class was 43% and 16%, respectively. The relatively small amount of time that the officer and nozzle firefighter spent exposed to heat fluxes above 7 kW/m² reflects both the effectiveness of the initial exterior suppression and the post-suppression ventilation at reducing the thermal insult to the suppression crew.

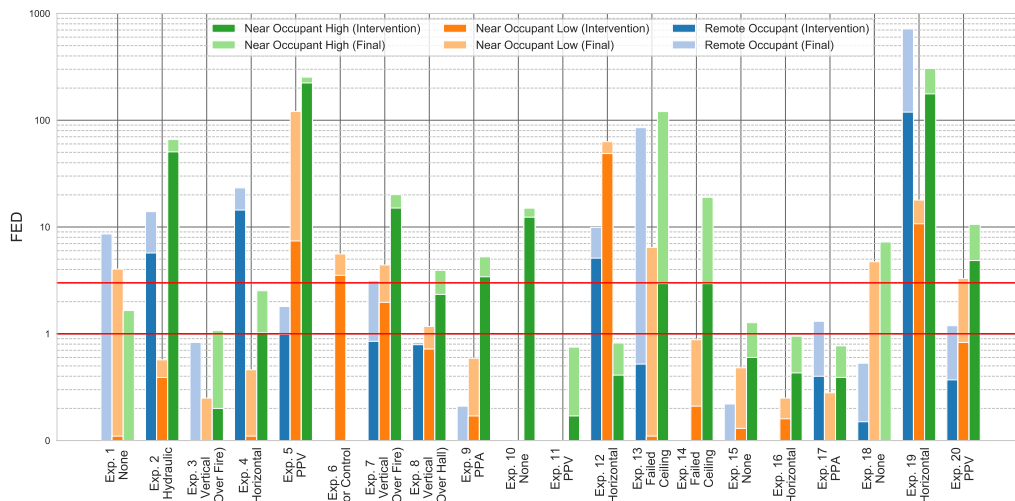
Figure 4.36: FED values at time of intervention (dark shaded) and at end of experiment (light shaded)

Figure 4.36 shows the toxic FED at the time of intervention (dark shaded) and at the end of the experiment (light shaded) at the occupant locations for each of the 20 experiments. At the time of fire department intervention, which ranged from 330 s to 781 s, the FED had not yet reached the threshold for incapacitation for 50% of the population for 77%, 74%, and 42% for the 1 ft remote, 1 ft inside flow path, and 3 ft inside flow path locations, respectively.

The FED continued to increase as suppression and ventilation actions were conducted. The magnitude of the FED increase following intervention was dependent on the magnitude of the gas concentrations in the structure and the effectiveness of ventilation tactics at reducing gas concentrations in the area of the occupant location. While suppression actions generally caused the FER to decrease, the rate at which the FER decreased varied by building construction and ventilation tactic. The experiments in which the FED increase was highest percent change from intervention to the end of the experiment were those in which no ventilation actions were conducted other than the opening of the front door (Experiments 1 and 18). By the end of the experiments, the percentage of occupants that had not reached the threshold for toxic incapacitation had dropped to 55%, 52%, and 16% for the 1 ft remote, 1 ft inside flow path, and 3 ft inside flow path locations, respectively.

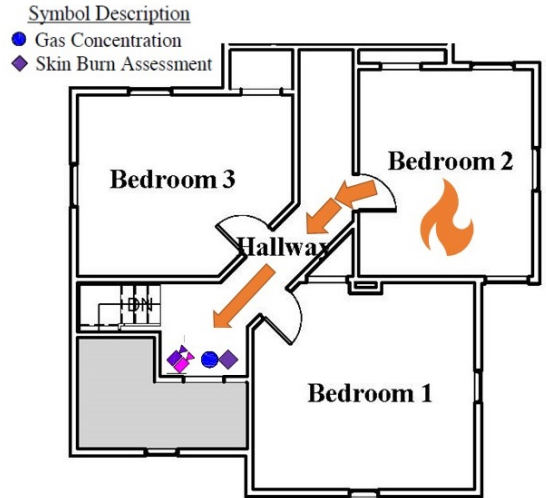
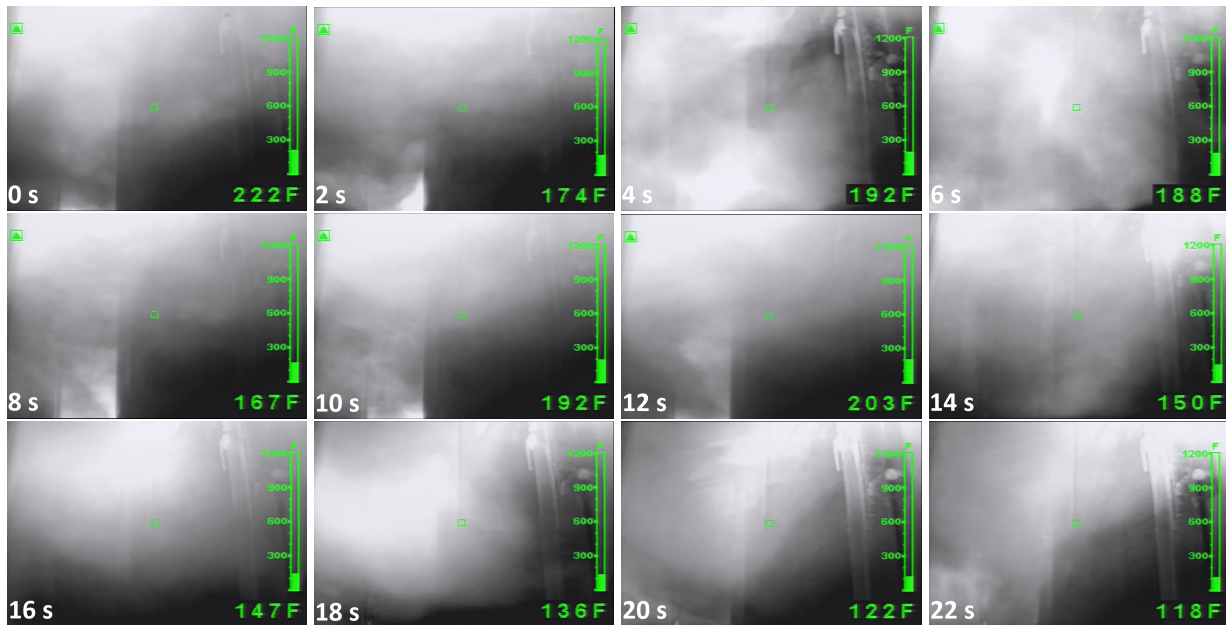
(a) Path of smoke movement in Experiment 11

(b) Time lapse of thermal imaging camera view in Experiment 11. Still images are shown every 2 s from the start of the smoke movement.

Figure 4.37: Gas movement following suppression in Experiment 11

During the straight stream, steep angle exterior water application in Experiment 11, a flow of products of combustion was observed in the thermal imaging camera in the hallway. The flow of gases followed the path indicated in Figure 4.37a. A time lapse of still images starting immediately prior to the gas movement is shown in Figure 4.37b. This movement of hot gases corresponded to an increase in FER and gas temperature at the hallway occupant location, shown in Figures 4.38a and 4.38b. The 1 ft gas temperature increased from 89 °F to 167 °F. The increase in thermal conditions resulted in a smaller increase in the pig skin surface temperature, increasing from 104 °F to 113 °F. While 1 ft CO and CO₂ concentrations, and the resultant FER, at 1 ft in the hallway remained low during the gas movement. At the 3 ft level, however, the gas movement resulted in a spike in the FER, increasing the FED from 0.2 to 0.7 over the course of the event. Approximately 25 s after the start of the event, the FER, gas temperature, and pig skin surface temperature decreased to pre-suppression values and continued to decrease for the remainder of the experiment.

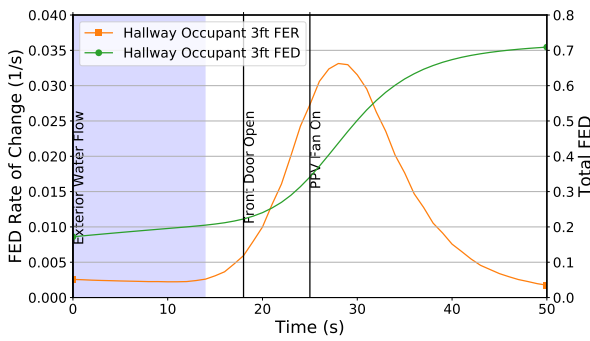
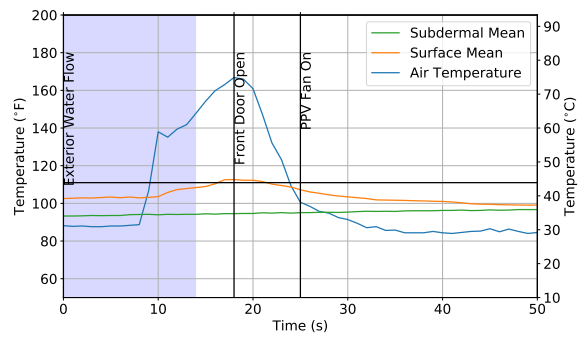
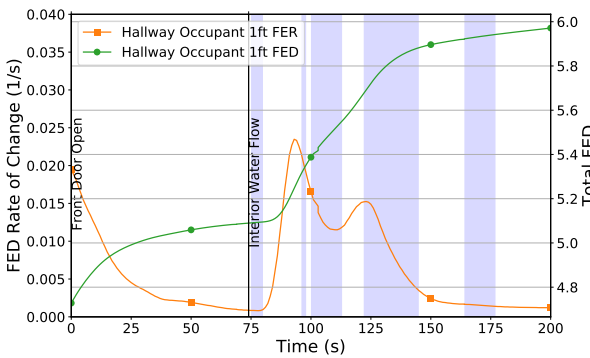
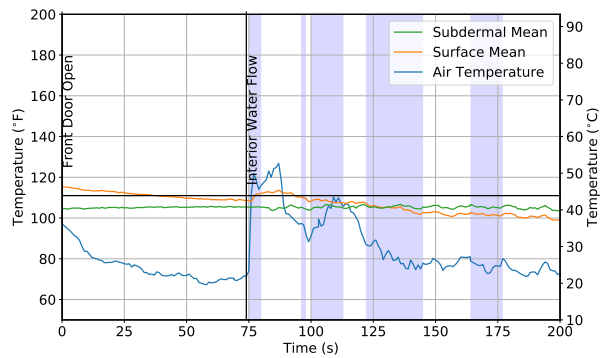
(a) Experiment 11 – Hallway 3 ft FED

(b) Experiment 11 – Hallway 1 ft Pig Skin Temp.

(c) Experiment 13 – Hallway 1 ft FED

(d) Experiment 13 – Hallway 1 ft Pig Skin Temp.

Figure 4.38: Increase in FED/FER and pig skin/gas temperature following suppression actions in Experiments 11 and 13. Time = 0 corresponds to the start of exterior suppression in Experiment 11 and the opening of the front door in Experiment 13.

A similar phenomenon was observed in Experiment 13 during the initial interior suppression action. The change in conditions following the suppression action can best be seen at the 1 ft elevation in the hallway occupant package shown in Figures 4.38c and 4.38d. At the time that the front door was opened ($t = 0$) both the gas temperature and the FER at the 1 ft hallway occupant location were decreasing. Simultaneous with the initial interior suppression action, however, the FER and ambient temperature both increased, reaching a peak between 75 and 100 s after the door opening. A second increase, smaller in magnitude than the first, occurred simultaneous with the second interior suppression action 100 s after the opening of the door. The ambient temperature increased from 73 °F to 126 °F after the initial interior suppression action, and from 88 °F to 110 °F after the second interior suppression action. The pig skin surface temperature increased from 108 °F to a brief peak of 113 °F after the initial suppression action before decreasing for the remainder of the experiment. The increase in pig skin surface temperature was accompanied by an increase in FED from 5.2 to 5.4 between the first and second interior suppression actions, and an increase from 5.4 to 5.9 between the second suppression action and the end of the final decrease in FER.

periment 13. In both experiments, the increase in gas temperature close to the floor increased the pig skin surface temperature, although the brief duration of the exposure and subsequent suppression efforts caused the pig skin surface temperature to quickly decrease. The toxic exposure was similarly brief, but the FED increased from 0.2 to 0.7 in Experiment 11 (250% increase) and from 5.2 to 5.9 in Experiment 13 (28% increase). While it is unclear what exactly caused the movement of gases in these two experiments, both of the structures were constructed using plaster and lathe as an interior finish. It is possible that the hose stream caused sections of the ceiling to drop, causing mixing between fresh air close to the floor and hot gases which were previously close to the ceiling.

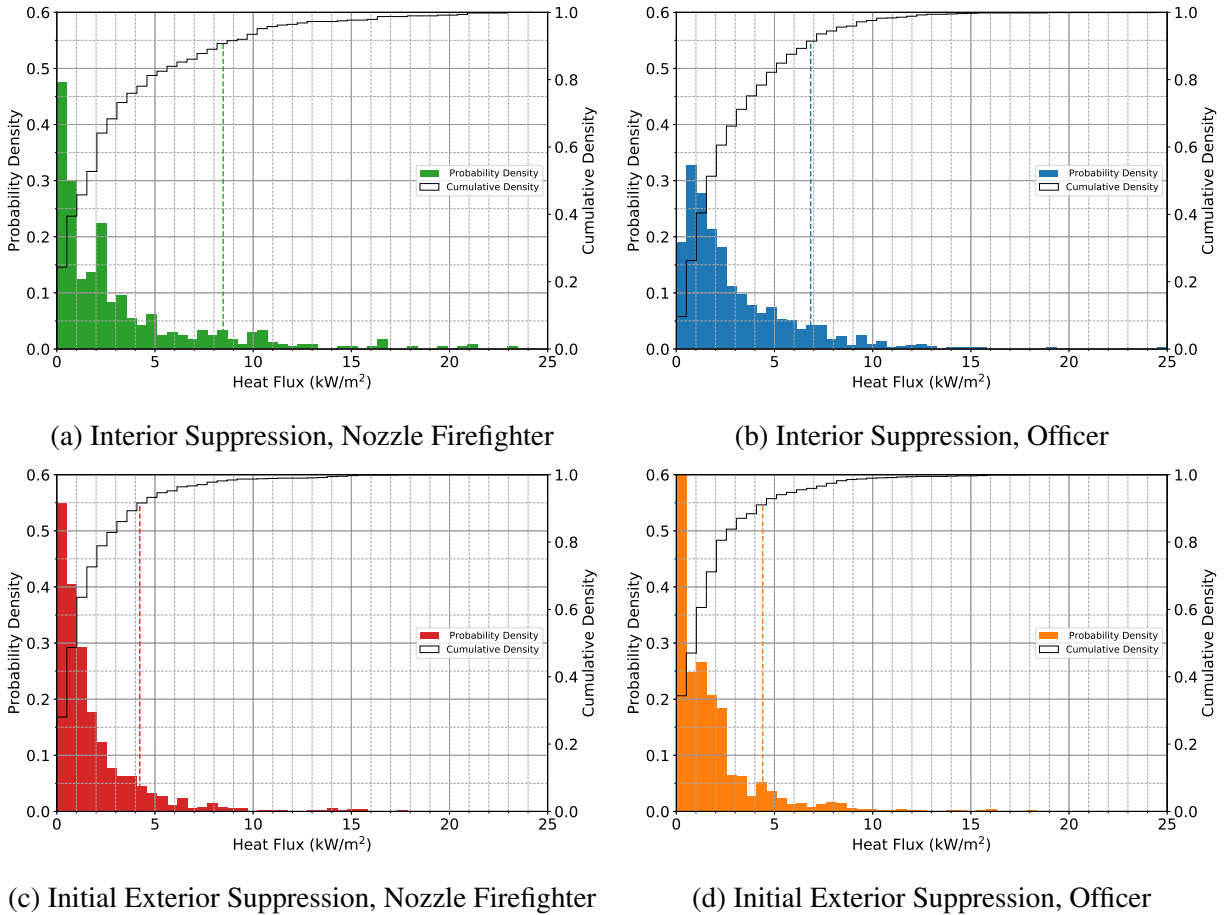
Figure 4.39: Probability density and cumulative density of heat flux exposures for firefighter, displayed by firefighter position and type of suppression. 90th percentile exposures are indicated by the dashed vertical line in each chart.

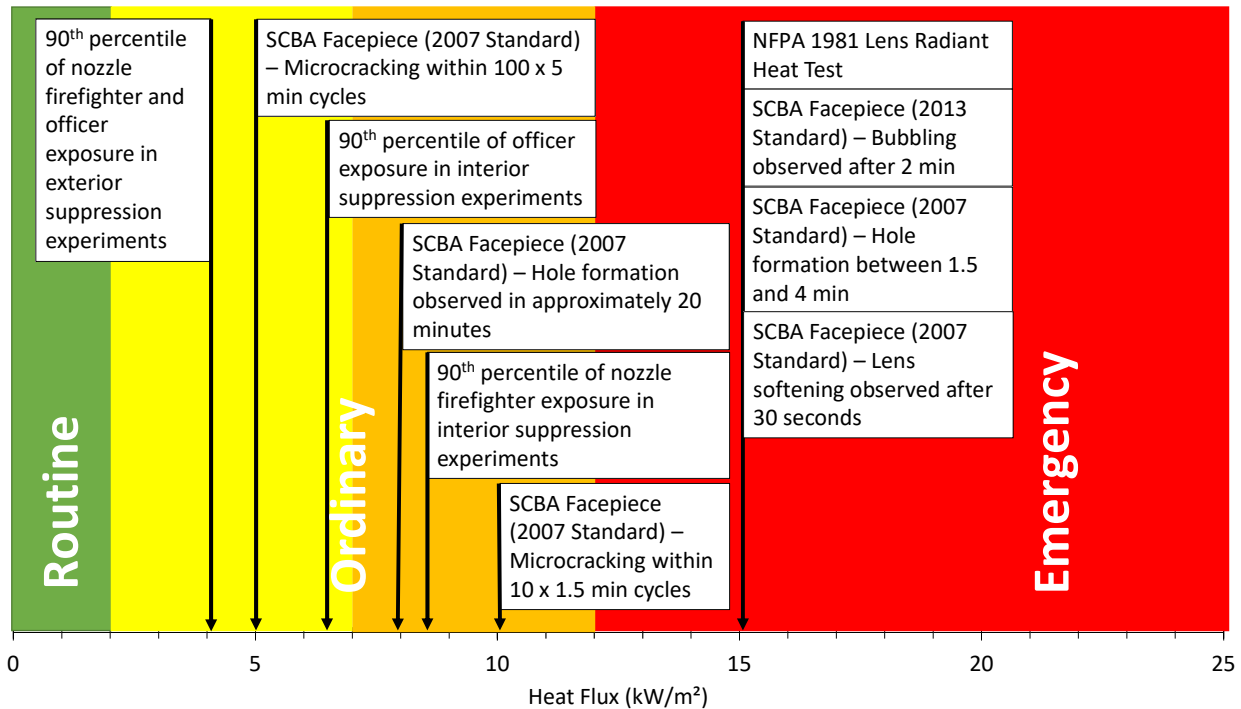
Figure 4.40: Comparison of Utech thermal operating classes with modern PPE performance limits from [21–24].

While the peak heat flux values would indicate a severe exposure, it is important to note that duration of these peaks were brief, as demonstrated by the 90th percentile values in Table 4.35. These values reflect that for the majority of the suppression period, heat flux values were considerably lower. The nozzle firefighter and officer sustained a higher 90th percentile heat flux exposure (8.5 kW/m² and 6.8 kW/m², respectively) during interior suppression actions compared to the same positions during initial exterior suppression actions (4.2 kW/m² and 4.4 kW/m², respectively). The 90th percentile exposure for the nozzle firefighter during the interior suppression fell into the upper portion of the ordinary operating class and the others fell within the lower portion of the ordinary operating class. Figure 4.40 shows the 90th percentile values interposed on Figure 4.2 from Section 4.1, which shows that these 90th percentile values also fall within the design criteria for modern PPE.

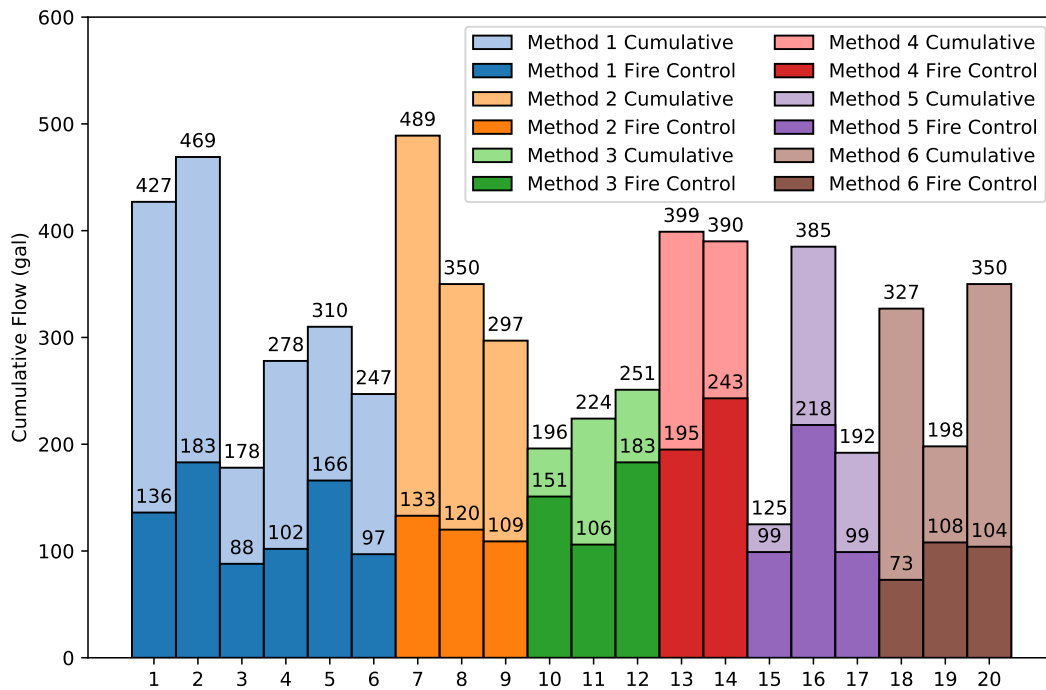
Figure 5.1: Water usage per experiment, colored by coordination method. Dark shaded bars represent water usage prior to fire control and light shaded bars represent total water usage for the experiment, including overhaul.

ous experiments, with a combination nozzle flowing 150-165 gpm. The experiments conducted as part of this project had comparable total water flows to similar experiments conducted in the laboratory. Figure 5.1 shows the water use for initial suppression (dark shaded bars) and total water usage (light shaded bars) for the 20 acquired structure experiments. Just as in the laboratory experiments, all experiments used less than 250 gal of water for fire control. Further, total water usage, including water used for overhaul and extension, was less than 500 gal. The average water usage by suppression method is listed in Table 5.2. The experiments which used the greatest amount of water for suppression were the two failed-ceiling exterior suppressions in Method 4, which is consistent with expectations, since these experiments involved two exterior water applications, followed by interior extinguishment. The experiments which used the least amount of water were those in Method 6.

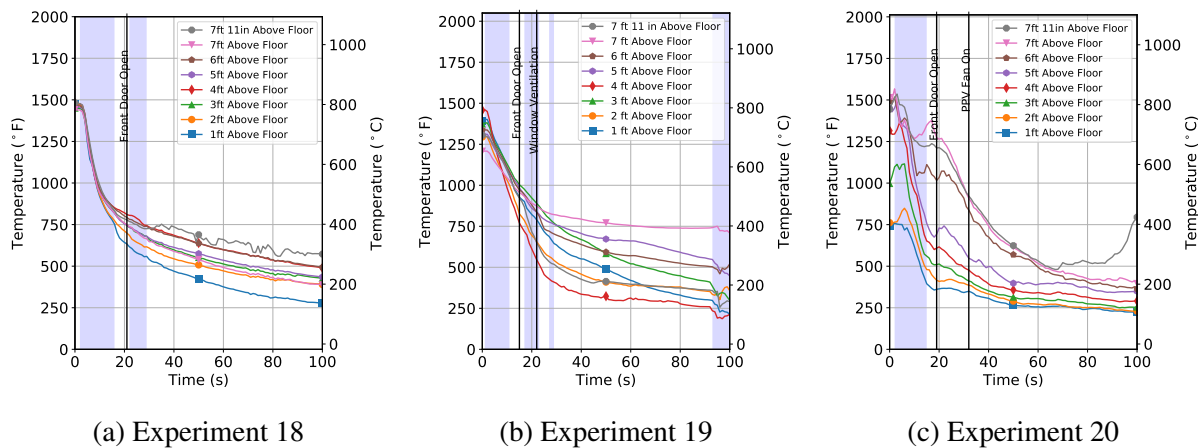
Figure 5.2: Kitchen temperature change in 100 s after exterior suppression. Time = 0 corresponds to the start of exterior suppression.

The additional fuel wetting that was conducted in the first-floor kitchen experiments had a notable impact on the regrowth potential of the kitchen fires. Following exterior suppression, temperatures in the kitchen in Experiments 18, 19, and 20 decreased until the time of interior suppression, as shown in Figure 5.2, which shows the temperature profiles in the 100 seconds after the start of exterior suppression. Only in Experiment 20 did the 7 ft 11 in. temperature begin to increase prior to suppression.

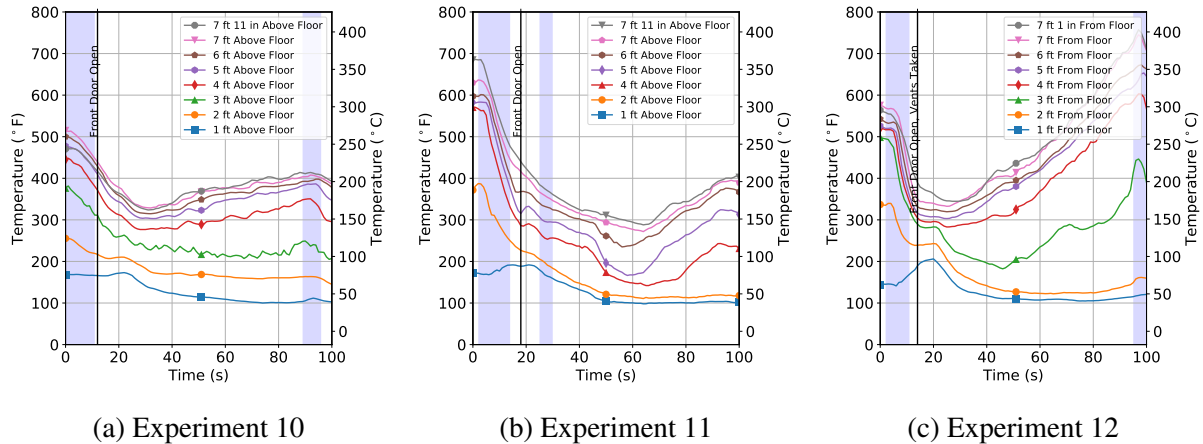
Figure 5.3: Hallway temperature change for the 100 s following start of exterior suppression. Time = 0 corresponds to the start of exterior suppression.

While regrowth was not seen after exterior suppression in the first-floor kitchen experiments, it was observed in each of the second-floor bedroom exterior suppression experiments in Method 3. Because of sensor errors in the fire room thermocouples, this regrowth is best demonstrated by the hallway temperatures, shown in Figure 5.3 which were measured in the hallway outside each fire room. The figure shows that temperatures close to the ceiling in the hallway begin to increase 16 s, 50 s, and 20 s in Experiment 10, 11, and 12, respectively. In Experiment 12, this regrowth was sufficient to increase temperatures in excess of 600 °F from 4 ft to the ceiling in the hallway, with the suppression crew being met with flames by the time that they reached the fire room doorway.

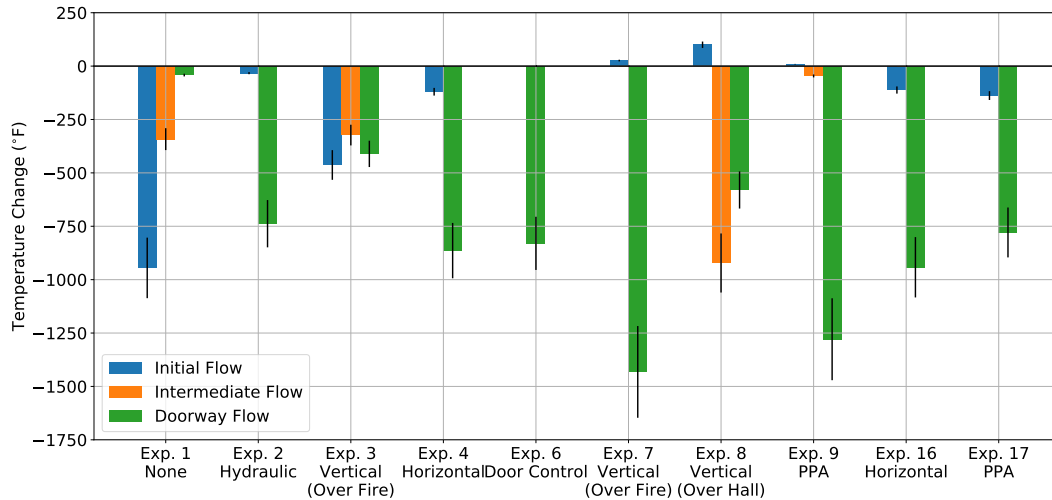
Figure 5.4: Change in average floor-to-ceiling fire room temperature as a result of suppression actions up to and including fire room doorway. Values reflect the change from the start of suppression to the end of suppression action. Positive values indicate that the average fire room temperature increased and negative values indicated the average fire room temperature decreased.

The discussion in Sections 4.2 - 4.7 described that the effectiveness of suppression outside the fire room had mixed results on decreasing fire room temperatures. Figure 5.4 shows the effect of each interior water application at reducing average floor-to-ceiling fire room temperatures for experiments where the fire room thermocouples were undamaged through the suppression period. Prior to suppression, the average fire room temperature in each experiment was in excess of 1200 °F. For seven out of the ten experiments, the suppression action which resulted in the greatest reduction in fire room temperatures was the doorway suppression action. In these seven experiments, initial suppression actions from outside the fire room had a limited impact on fire room temperatures,

Although water application remote from the fire room did not always reduce fire room temperatures, it often substantially reduced temperatures in the path to the fire room. Figure 5.7 is similar to Figure 5.4, but shows the effect of various suppression actions on the temperatures in the room immediately outside the fire room, which was either a hallway, stairway landing, or dining room. The figure shows that the initial suppression actions often resulted in the greatest temperature reduction in the area of the suppression crew. The notable exception to this trend is in Experiment 16, where the nozzle firefighter flowed into the dining room wall for 26 s prior to flowing into the fire room. Although the flow into the dining room had a minor cooling effect in the dining room, cooling was more effective when the stream was directed into the fire room, since the two rooms were a single connected space. The resulting change in thermal imaging views is shown in Figure 5.8.

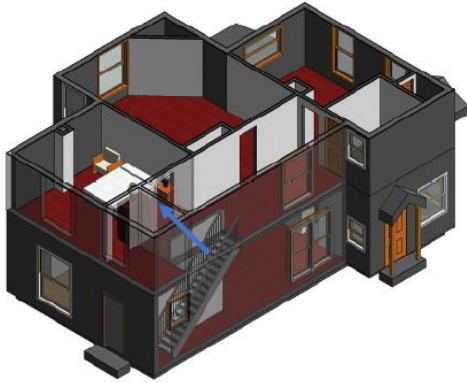
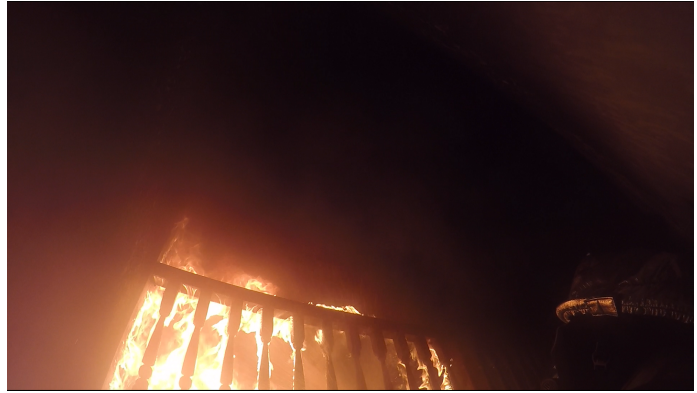
Figure 5.5: Initial suppression from stairway. From a position on the stairway (shown in isometric view, left), the nozzle firefighter applied water through the banister (right), dropping fire room temperatures.

In the remaining three experiments (Experiments 1, 3, and 8), remote suppression actions were able to orient hose streams such that it was possible to apply water directly into the fire room, decreasing temperatures within it. These temperature decreases were not permanent, however, and extinguishment was not observed until the suppression crew advanced into the fire room. Consider Experiment 3 (vertical ventilation over the fire room, post-suppression) as an example. In Experiment 3, from a position on the stairway, the nozzle firefighter was able to direct their stream through the banisters directly into the fire room, as shown in Figure 5.5. The second suppression position from the top of the stairs also allowed for direct water into the fire room. Although each of these suppression actions decreased the average fire room temperatures by more than 250 °F, the temperatures in the fire room leveled off in the 35 s period between the end of the landing suppression and the fire room doorway suppression action. Immediately prior to the landing suppression action, fire could be observed in the hallway as shown in Figure 5.6. These three experiments show that remote water application can be effective, but suppression in the fire room is essential to ensure extinguishment.

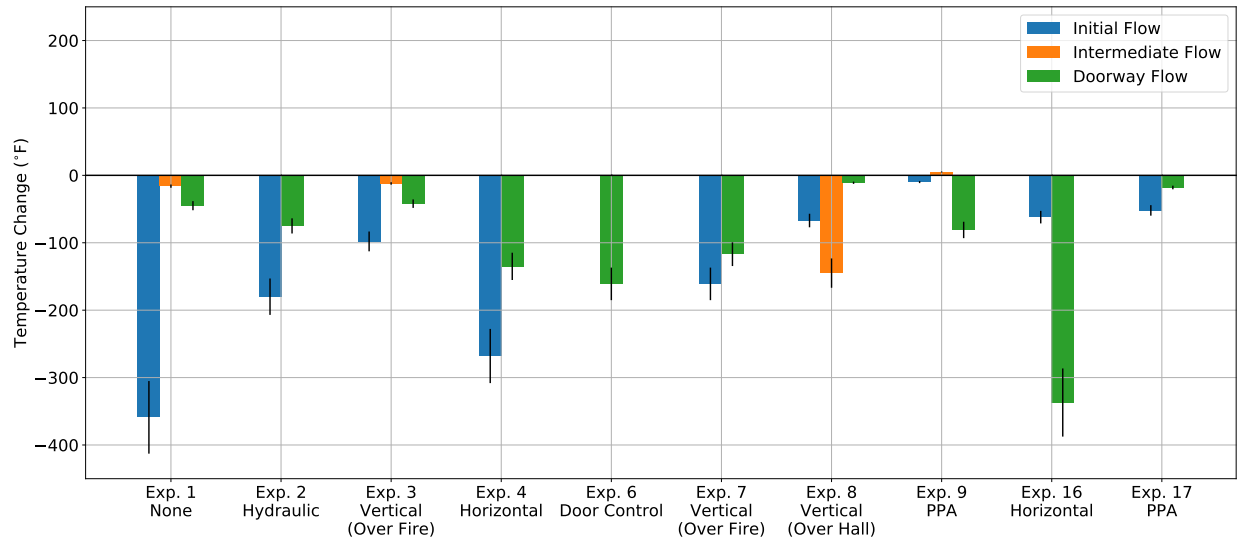
Figure 5.7: Change in average floor-to-ceiling temperature in room immediately outside the fire room as a result of suppression actions up to and including fire room doorway. Values reflect the change from the start of suppression to the end of suppression action. Positive values indicate that the average temperature increased and negative values indicated the average temperature decreased.

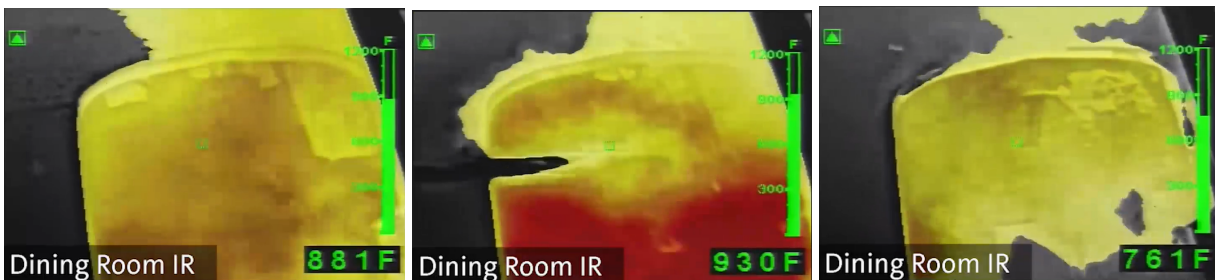
Figure 5.8: Thermal imaging views of ineffective water application in Experiment 16. Camera is in the dining room, directed toward the kitchen. Images show start of flow into dining room wall (left), start of flow into fire room (middle), and 40 s after start of water flow (right).

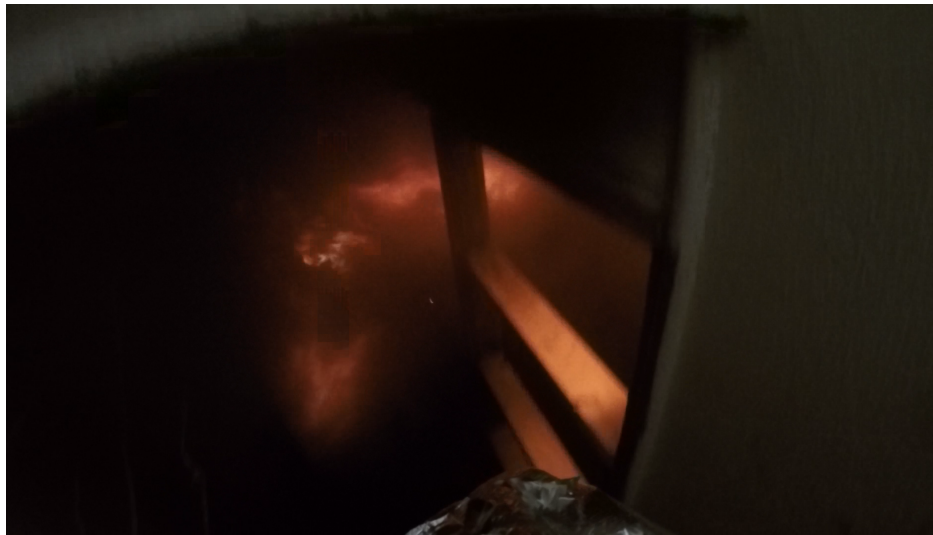
Figure 5.9: Nozzle firefighter’s view from staircase of fire extending from fire room doorway into vertical vent hole outside the doorway in Experiment 8.

Experiment 8, which was a second-floor bedroom fire with a vertical vent opening in the hallway immediately outside the fire room doorway, illustrated an important caveat to this consideration. Because the vertical vent hole was adjacent to the doorway, fire was able to extend out of the fire room doorway and into the low-pressure vent in the hallway, as shown in Figure 5.9. Water flow in the stairway was initiated 12 seconds after the vertical vent hole was completed, therefore, the fire extension into the hallway did not result in a deterioration in conditions remote from the fire room. Thus, while vertical ventilation caused fire growth in both of the pre-suppression vertical ventilation experiments (Experiments 7 and 8), the prompt water application by the suppression crew quickly controlled and extinguished the fire. This emphasizes the importance of communication between suppression crews and crews performing vertical ventilation to avoid unwanted or unexpected fire growth.

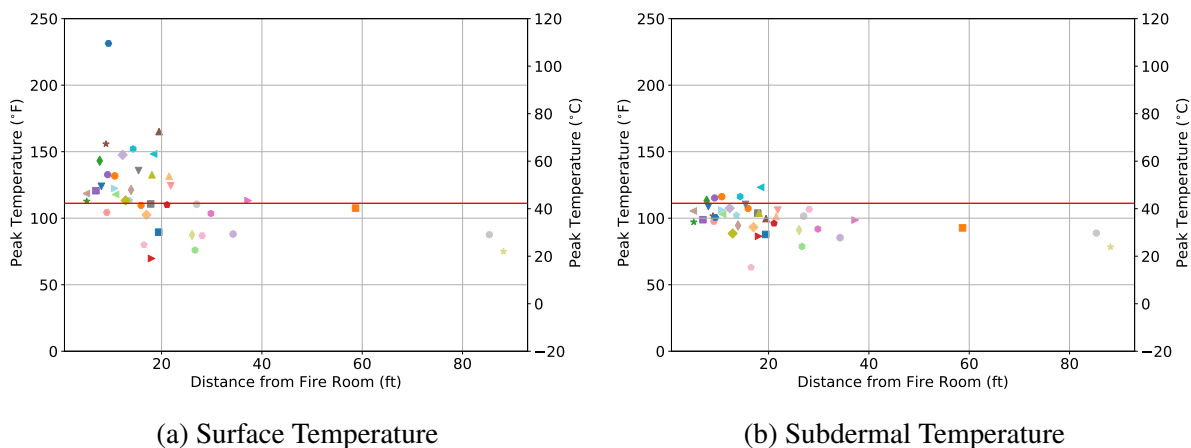
Figure 5.10: Comparison of peak pig skin surface temperature on pig skin burn assessment packages and distance of occupant package from fire room doorway at the time of initial fire department intervention (front door opening or exterior suppression). The solid red line denotes 111 °F (44 °C).

These experiments supported the same general trend as was observed in previous research. Occupant locations closest to the fire room typically exhibited the highest peak pig skin surface and subdermal temperatures, as demonstrated in Figure 5.10. Figure 5.10 shows the pig skin surface and subdermal temperatures for all occupant packages in the 20 experiments at the time of initial fire department intervention. The solid red line denotes 111 °F (44 °C), which is the minimum pig skin surface temperature required for thermal injury. The chart shows that the occupant packages which were closest to the fire room experienced the highest pig skin surface temperatures. In particular, many of the occupant packages which were 20 ft or closer to the fire room doorway had pig skin surface temperatures which exceeded 111 °F (44 °C), suggesting the possibility of thermal injury. A smaller proportion of the occupant packages 20 ft or closer to the fire room doorway had subdermal temperatures which exceeded 111 °F (44 °C). This suggests the possibility of deeper thermal injury. The peak pig skin surface temperature that was observed in the experiments quickly decreased as distance from the fire room increased. While skin burn assessment packages were not placed at different elevations, as was the case in the Fire Attack study, the data from this series of experiments supported the trend that occupants which were located closest to the fire room experienced the highest thermal insult, and the severity of thermal exposure was lower for occupants located farther away from the fire room.

Figures 5.10, 5.11 and 5.12 show that while the highest thermal and toxic exposures were measured in the occupant packages closest to the fire room, high toxic exposures could be found even in remote locations. The discussion in Sections 4.2–4.7 emphasized that the FED at these locations continues to increase even after the onset of suppression. This reinforces the importance of effective suppression and ventilation actions to reduce the rate of toxic exposure to potentially trapped occupants. Further, the variation in the toxic FEDs at the time of intervention demonstrate how numerous factors, including structure geometry, furnishings, and environmental conditions, can cause gas concentrations to vary considerably, even among fires with similar thermal conditions.
