Analysis of the Coordination of Suppression and Ventilation in Single-Family Homes

John Regan
Julie Bryant
Craig Weinschenk

UL Firefighter Safety Research Institute
Columbia, MD 20145

March 19, 2020

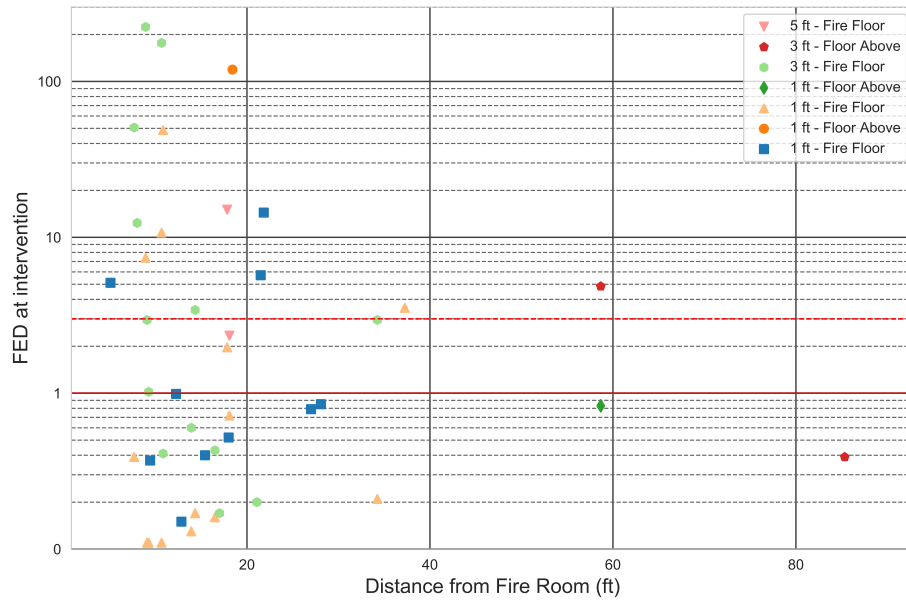
Figure 5.11: Comparison of toxic gas exposure FED at time of initial fire department intervention (front door opening or exterior suppression) and distance of occupant package from fire room doorway (top). Values are shown on a logarithmic scale to show detail at lower FED values. The solid and dashed red lines denote FED = 1.0 and FED = 3.0, which are the thresholds for incapacitation for 50% and 89% of the population, respectively.

While the peak pig skin surface and subdermal temperatures at the time of initial intervention were generally related to the distance from the fire room, there was increased variability in gas concentrations and resultant FED values. This can be seen in Figure 5.11, which shows the FED at

the time of initial intervention across all experiments for each occupant package plotted against the distance from the fire room doorway to the occupant package. The figure shows that while there were occupant locations which experienced the highest toxic insults close to the fire room, there were also several occupant locations close to the fire room which did not exceed the criteria for incapacitation. Similarly, several occupant locations 20 ft or farther from the fire room doorway had sustained high FEDs by the time of fire department intervention. Figure 5.11 shows that, while occupants trapped closest to the fire may be more likely to sustain a higher dose than occupants trapped further away from the fire, there was no direct relationship between distance from the fire room and toxic exposure.

Figures 5.10, 5.11 and 5.12 show that while the highest thermal and toxic exposures were measured in the occupant packages closest to the fire room, high toxic exposures could be found even in remote locations. The discussion in Sections 4.2–4.7 emphasized that the FED at these locations continues to increase even after the onset of suppression. This reinforces the importance of effective suppression and ventilation actions to reduce the rate of toxic exposure to potentially trapped occupants. Further, the variation in the toxic FEDs at the time of intervention demonstrate how numerous factors, including structure geometry, furnishings, and environmental conditions, can cause gas concentrations to vary considerably, even among fires with similar thermal conditions.

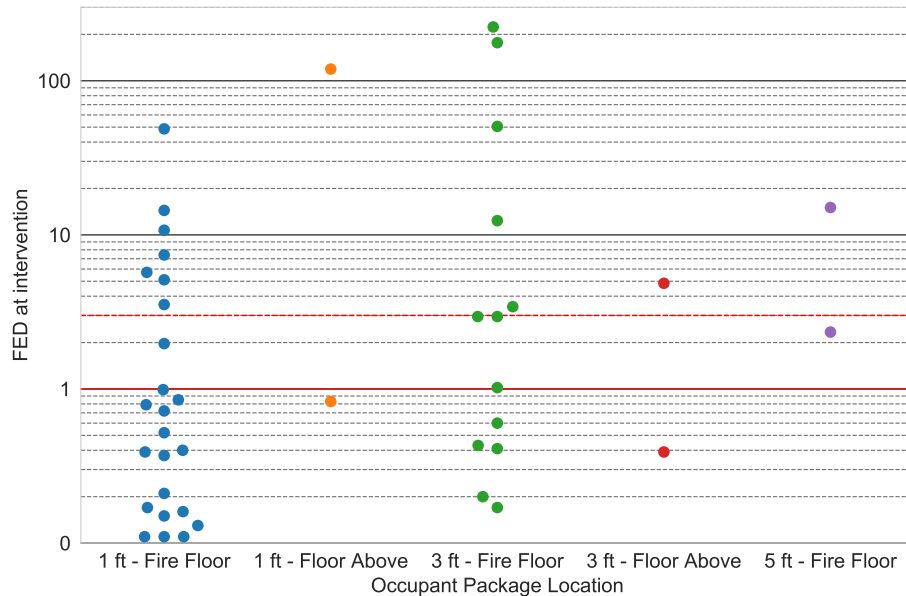
Figure 5.12: Variation of FED at time of initial fire department intervention (front door opening or exterior suppression) among occupant package locations, grouped by elevation above floor and locations with respect to the fire room. Values are shown on a logarithmic scale to show detail at lower FED values. The solid and dashed red lines denote FED = 1.0 and FED = 3.0, which are the thresholds for incapacitation for 50% and 89% of the population, respectively.

Another way to consider the variation in toxic exposure is to group the FED value at the time of first intervention by the location of the occupant package with respect to the fire room as shown in Figure 5.12.

The horizontal solid and dashed red lines in Figure 5.12 represent FED = 1.0 (incapacitation for 50% of population) and FED = 3.0 (incapacitation for 89% of population), respectively. While in some experiments, the FED at the time of intervention was quite high, in many others, the FED at the time of intervention was negligible. For fire floor occupant locations 1 ft above the floor, 77% and 80% of the FED values were less than 1.0 and 3.0, respectively. Similarly, 3 ft above the floor, 67% of the FED values were less than both 1.0 and 3.0. This demonstrates that even with a post-flashover bedroom or kitchen fire, there is survivable space.

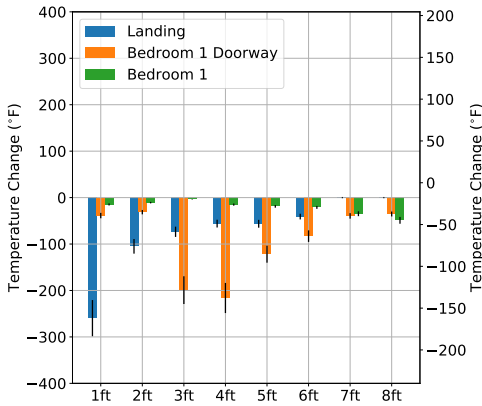
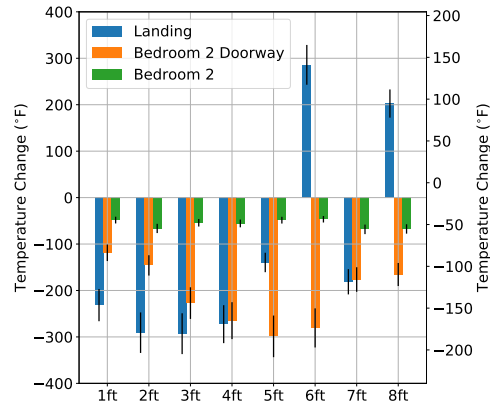
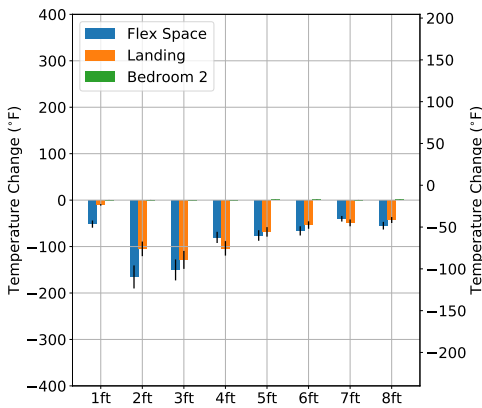
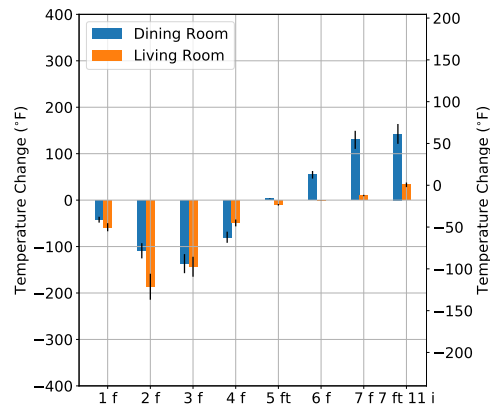
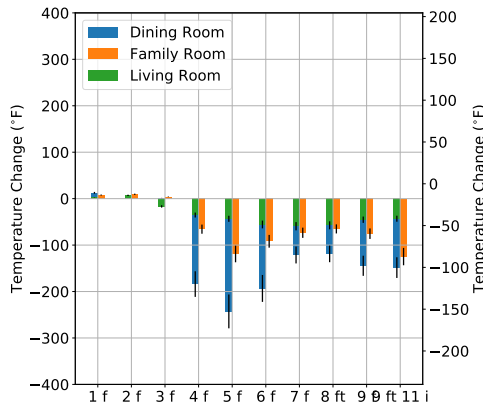
Figure 5.13: Change in average compartment temperature outside of the fire room from initial ventilation to suppression for experiments where ventilation actions were taken prior to initial suppression. Bars indicate the temperature change from the time the front door was opened until the initial water flow into the fire room for each elevation in areas of structure remote from the fire room. Negative values indicate that the temperature at location has decreased, while positive values indicate that the temperature has increased.

Figure 5.13 shows the change in average temperature from the time the front door was opened to the second before initial water flow at each elevation in areas of the fire floor outside the fire room for experiments with ventilation occurring prior to suppression. The charts show that for Experiments 7 (vertical vent over fire room), 9 (PPA), and 17 (PPA), temperatures did not increase by more than a few degrees, and generally decreased in the period following the opening of the front door, particularly close to the floor. This is at least in part due to the entrained air from the open front door and other ventilation actions in the period between ventilation and suppression. In Experiment 8 (vertical vent over hall), temperatures increased at elevations close to the ceiling as a result of fire venting into the hallway after completion of the low-pressure roof vent. Although temperatures close to the ceiling increased, which may increase radiative heat transfer to advancing firefighters, temperatures 5 ft and below decreased due to entrained air, potentially providing

cooling for the suppression crew. In Experiment 16, the temperature increases close to the ceiling were a result of a lack of compartmentation between the kitchen, bedroom, and dining room. Temperatures close to the floor again decreased from the entrained air.

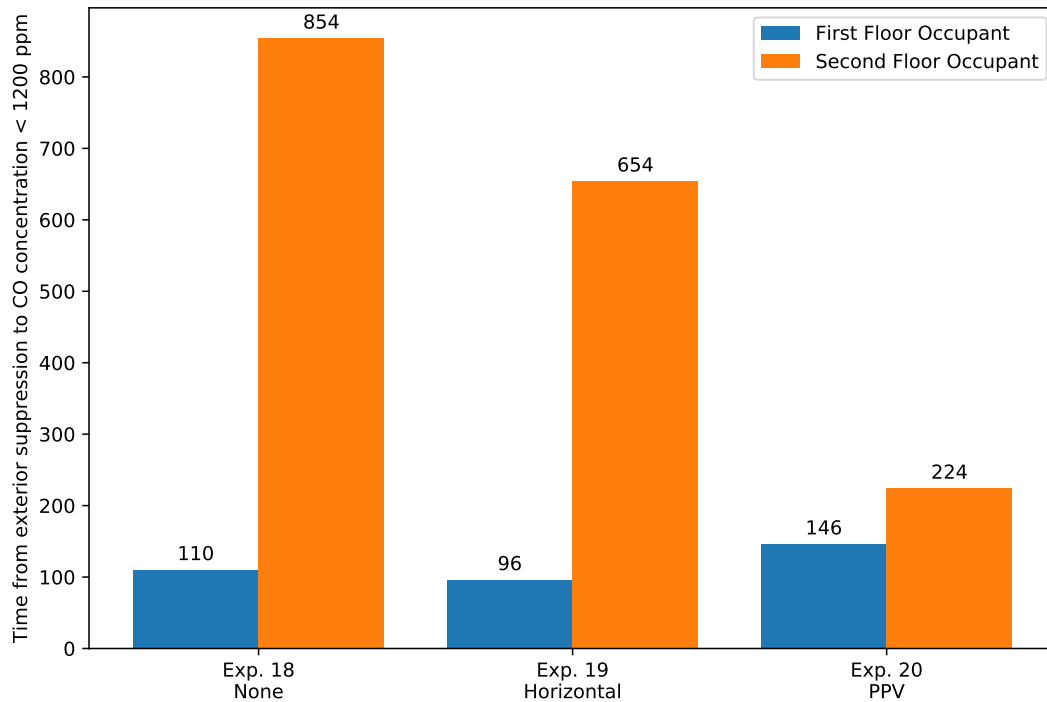
Figure 5.14: CO recovery times for experiments where lack of ventilation resulted in long recovery times.

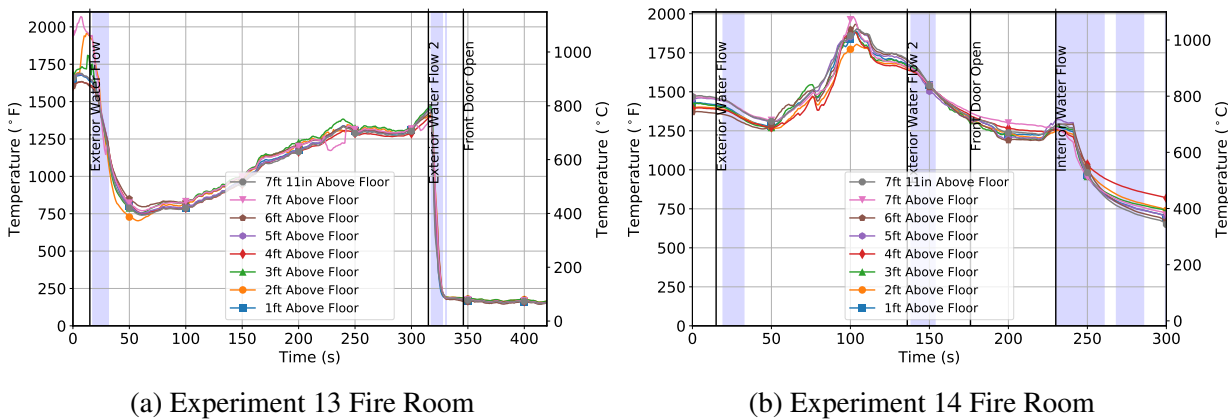
Figure 5.15: Effect of suppression actions on fire room temperatures in Method 4 experiments. Time = 0 corresponds to the beginning of the straight stream suppression action and data is included for 300 s after fire department intervention.

The two experiments in Method 4 (Experiments 13 and 14) were designed to examine straight stream exterior suppression in a compartment with a ceiling failure. The fire room temperature data, shown in Figure 5.15, indicates that although temperatures in the fire room decreased following the straight stream suppression, they began to increase again approximately 40 s after the end of suppression. In each case, the lintel hit was more effective than the straight stream at reducing fire room temperatures, although experiments were not conducted with the lintel hit as the first exterior water flow.

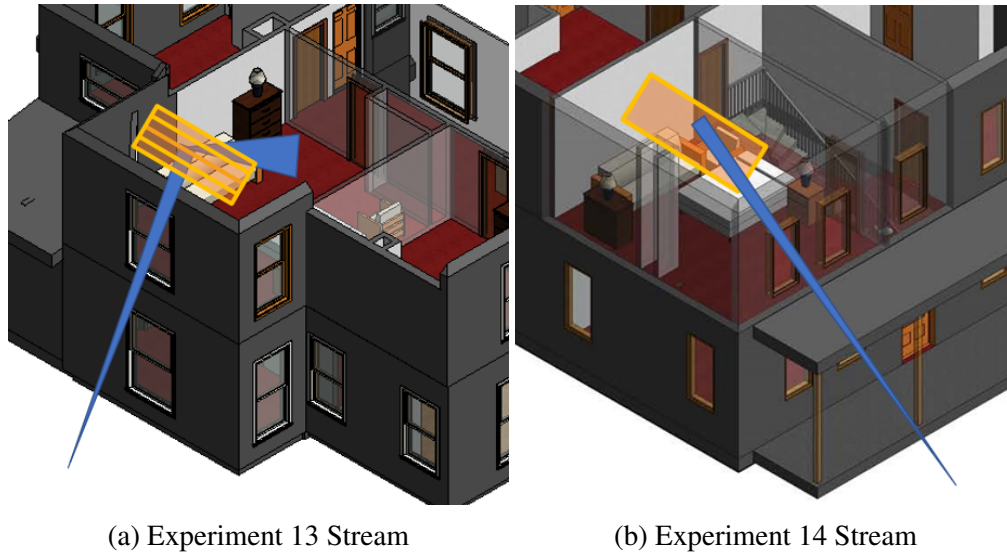
Figure 5.16: Comparison of initial straight stream, steep angle exterior water application and resulting distribution. In Experiment 13, the stream hit the rafters, breaking the stream apart while in Experiment 14, the rafters were removed, allowing the stream to pass through the missing ceiling unbroken.

A slight difference between experiments that impacted the effectiveness of the straight stream suppression was the presence of ceiling rafters. In Experiment 13, the ceiling rafters were left intact, whereas in Experiment 14, they were removed. These rafters ran perpendicular to the direction of the hose stream, and were difficult to identify from the ground due to the fire venting from the window at the time of initial suppression. Their impact on the hose stream is illustrated in Figures 5.16a and 5.16b—the rafters provide an additional obstacle to break apart the hose stream, deflecting water onto burning surfaces and providing more cooling, as shown by the difference in temperature recovery between the two experiments in Figures 5.15a and 5.15b. In Experiment 13, fire room temperatures take several minutes to recover after the initial decrease due to suppression, while in Experiment 14, the fire room recovers to post-flashover temperatures within 50 s.

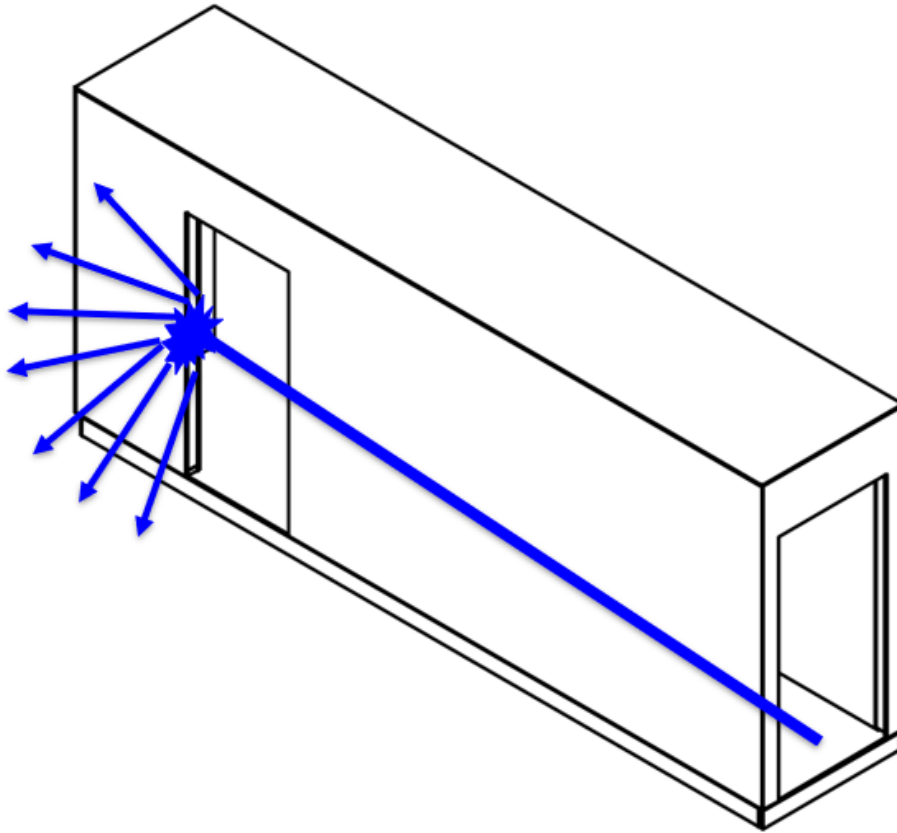
Figure 5.18: Interior dispersion with water application to the king stud (or door frame) of the fire compartment doorway.

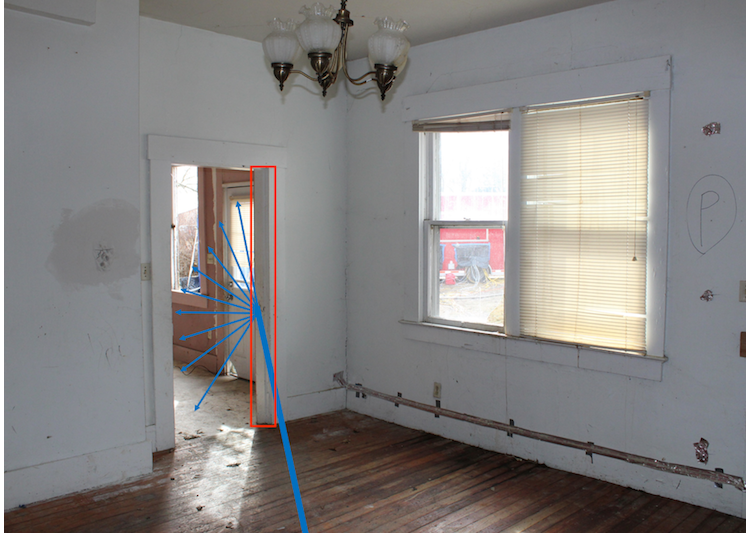
Figure 5.19: Interior view along the entry path looking toward the fire compartment (a kitchen). Note: The doorway king stud highlighted in red.

As a hose team advances toward the fire compartment flowing water, they can use audible clues of a change in sound for water deflection in combination with any visual to determine the doorway to the fire room. (See Figure 5.19)

If the nozzle operator is able to determine the location of the door frame, water can be deflected into the fire compartment by manipulating the nozzle up and down along the frame. This will cause the stream to break apart, sending some component of the water into the fire compartment and cooling surfaces long before the hose team has even reached the room for entry.

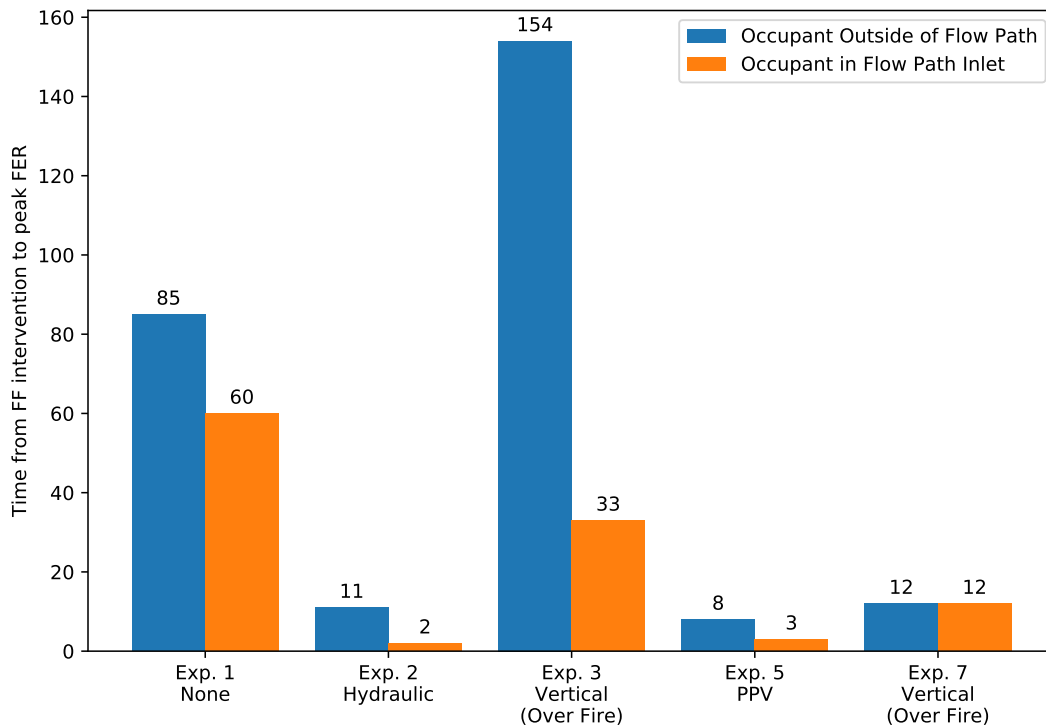
Figure 5.20: Comparison of time elapsed from opening of front door to peak FER for occupants located in the inlet portion of the flow path vs. occupants remote from flow path. Experiments where one of the sensor locations experienced a sensor error are not included.

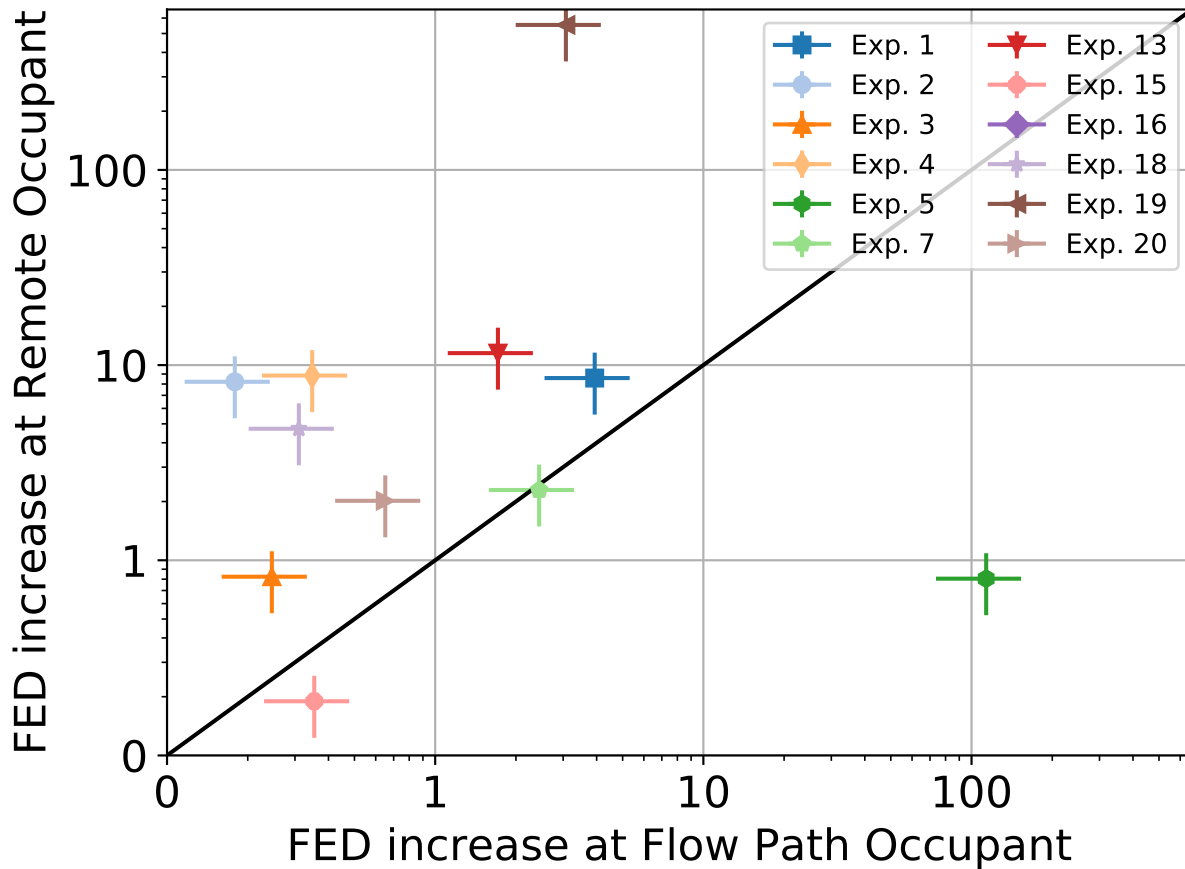
Figure 5.21: Increase in FED from opening of front door until end of experiment. Y-axis shows increase in FED for the remote occupant while x-axis shows increase in FED for occupant located within flow path. Values are shown on a log-log scale to account for differing FED magnitudes between structures. Experiments where 1 ft gas concentrations were negligible or experienced a sensor error were omitted (Experiments 6, 8, 9, 10, 11, 12, 14, and 17).

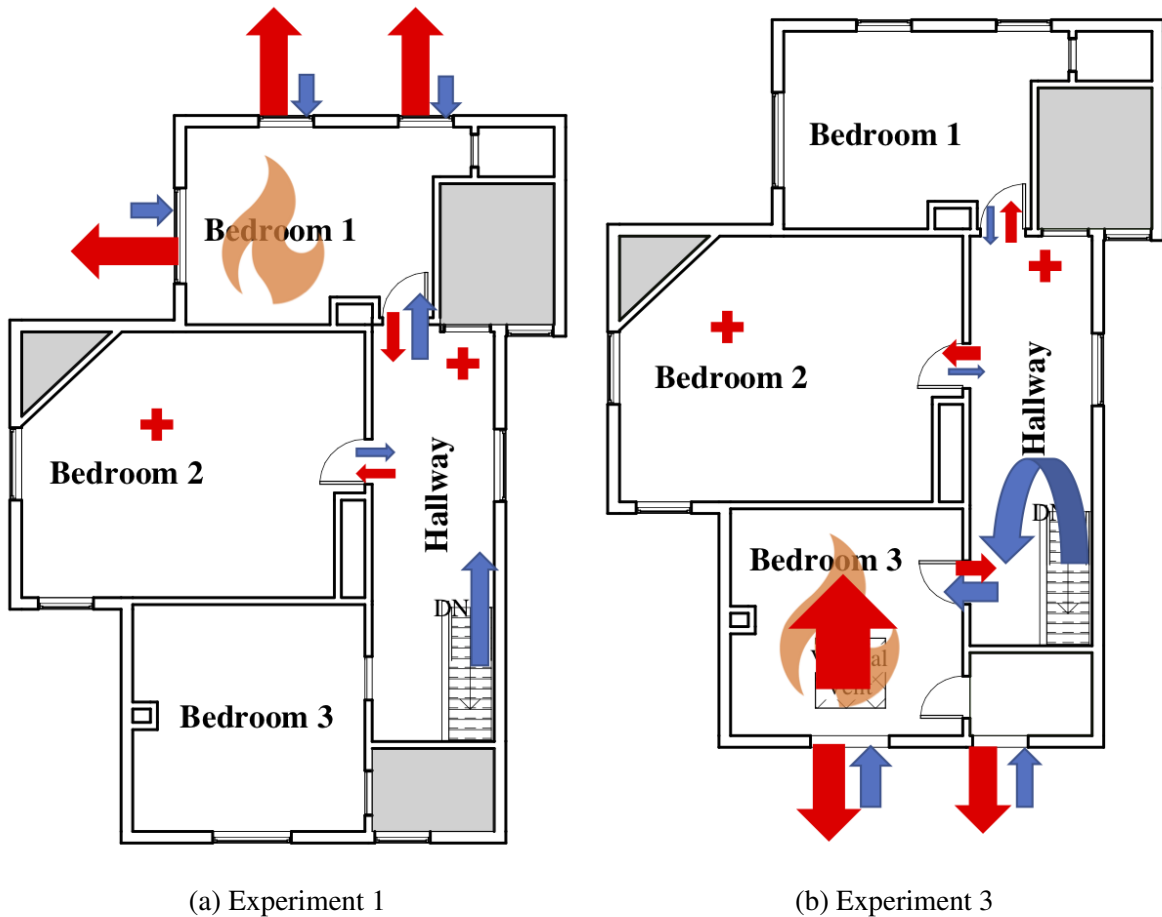
Figure 5.22: Comparison of flow path after opening of front door in Experiment 1 with flow path after vertical ventilation in Experiment 3.

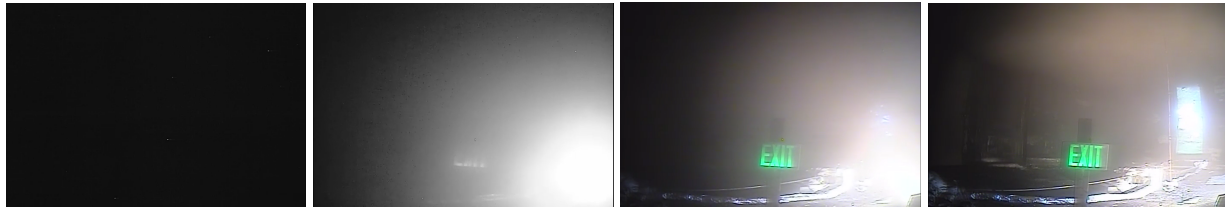
Figure 5.23: Change in visibility at the remote bedroom occupant location in Experiments 10 and 12. Images show visibility at the time of intervention (left), 1 min. following exterior suppression (middle left) 2 min. following exterior suppression (middle right) and 4 min. following exterior suppression (right)

In the experiments in which horizontal ventilation was performed at any available opening, gas concentrations, visibility, and skin burn assessment package temperatures dropped at a more rapid rate than in experiments where no local ventilation was performed. This effect is most dramatically demonstrated by the improvement in visibility in the remote bedroom in Experiment 12 (initial exterior suppression with additional horizontal ventilation) compared to Experiment 10 (initial exterior suppression with no additional ventilation). These two experiments were conducted on the second-floor of the same structure. Figure 5.23 shows the view from the remote bedroom camera at the start of exterior suppression, 60 s after suppression, 120 s after exterior suppression, and 240 s after suppression for Experiments 10 and 12. The images show that visibility at the floor level begins to improve within the first minute of local horizontal ventilation and continues to improve through the interior suppression actions. In the case without ventilation, on the other hand, visibility does not begin to return until nearly 4 min. after the exterior suppression action. By horizontally ventilating bedroom windows, fresh air is entrained in the same manner as when the front door is opened, reducing the gas concentrations close to the floor and improving visibility for search crews that may be operating.

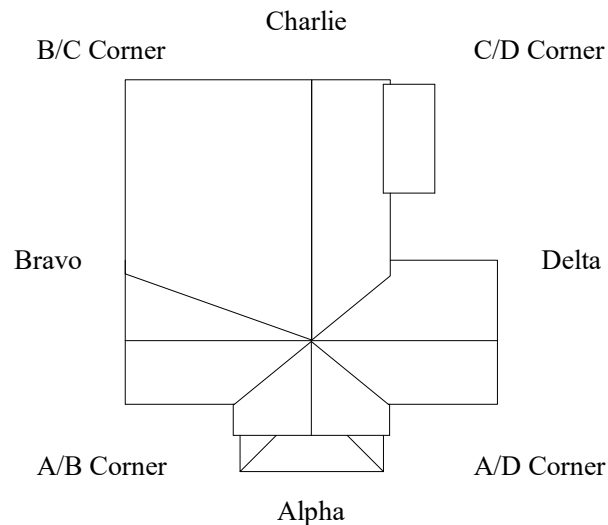
Figure 7.1: Building Side Terminology

Building Sides: See Figure 7.1 for an image depicting the Alpha(A), Bravo(B), Charlie(C), and Delta(D) sides a structure.

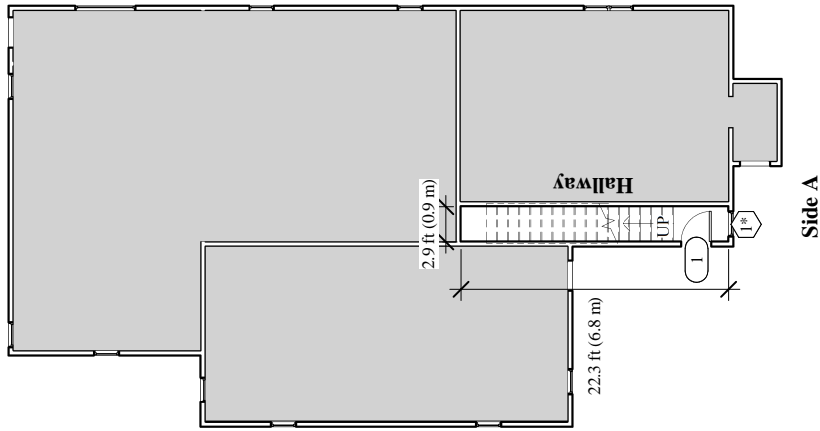
Figure B.1: 201/203 Water Street, Sidney, OH: 1st Floor Architectural Layout

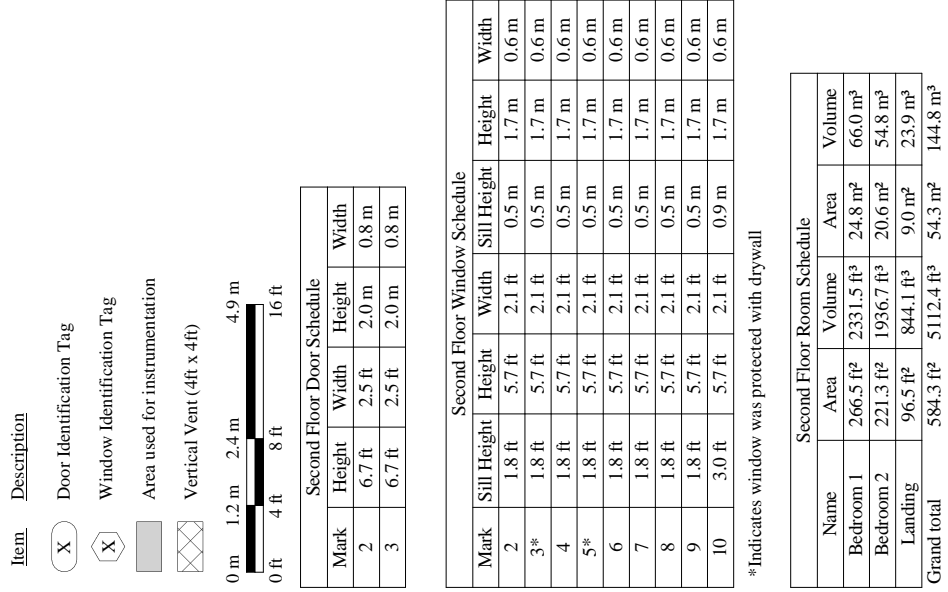
Figure B.2: 201/203 Water Street, Sidney, OH: 2nd Floor Architectural Layout

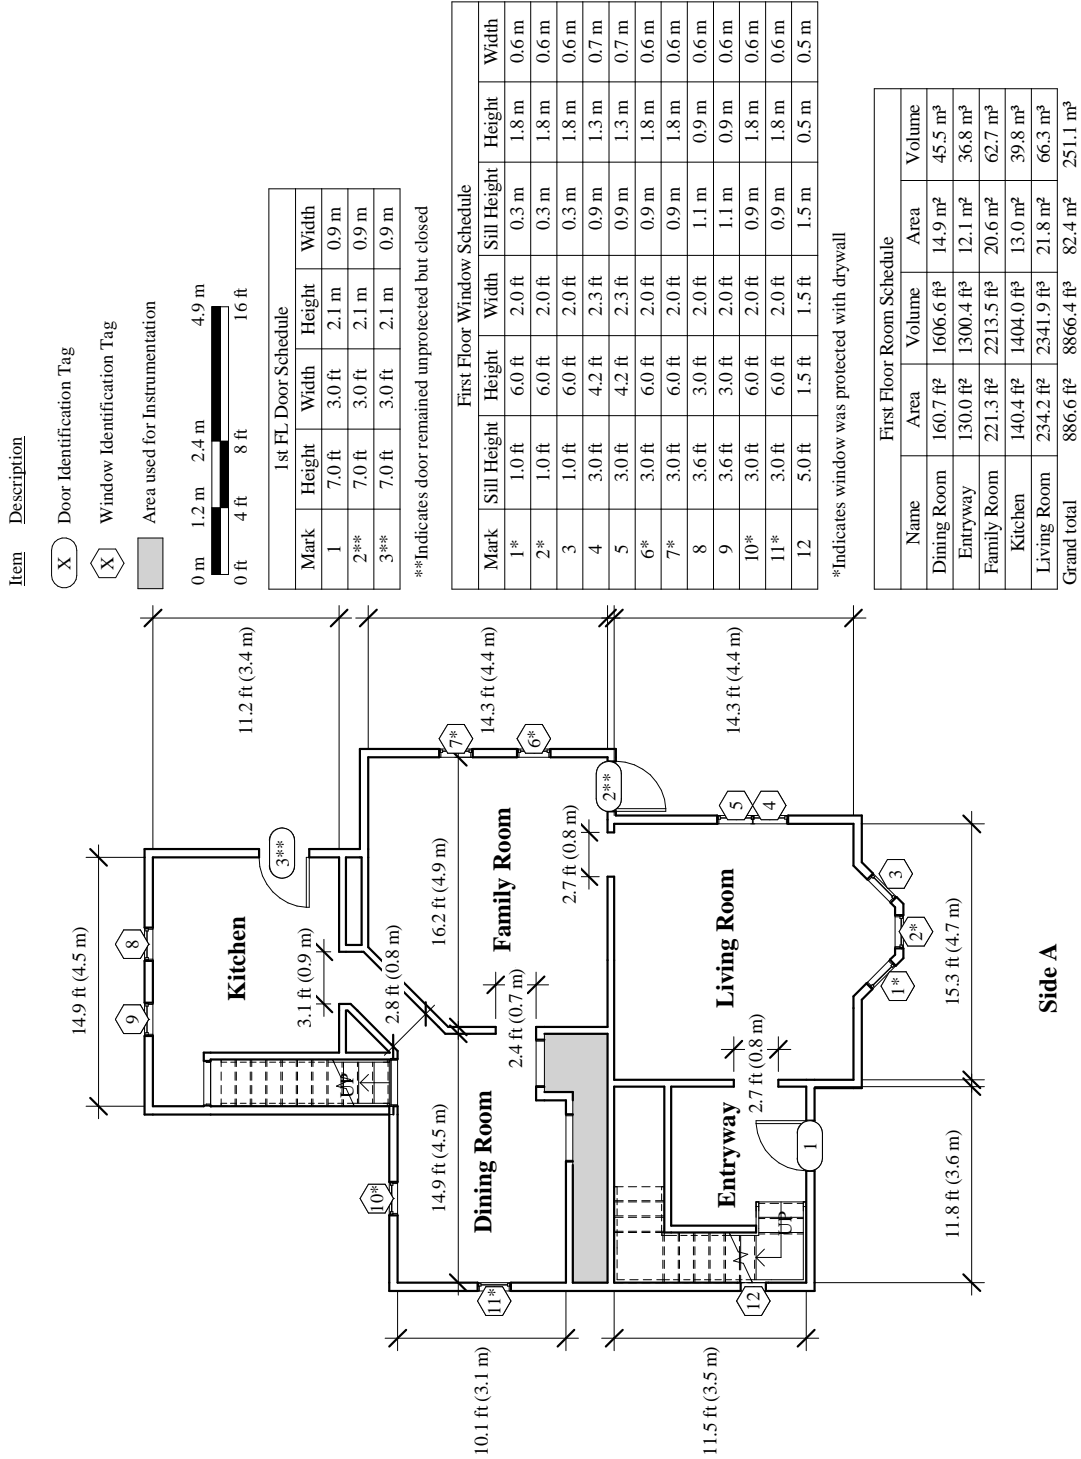
Figure B.3: 230 North, Walnut Street, Sidney, OH: 1st Floor Architectural Layout

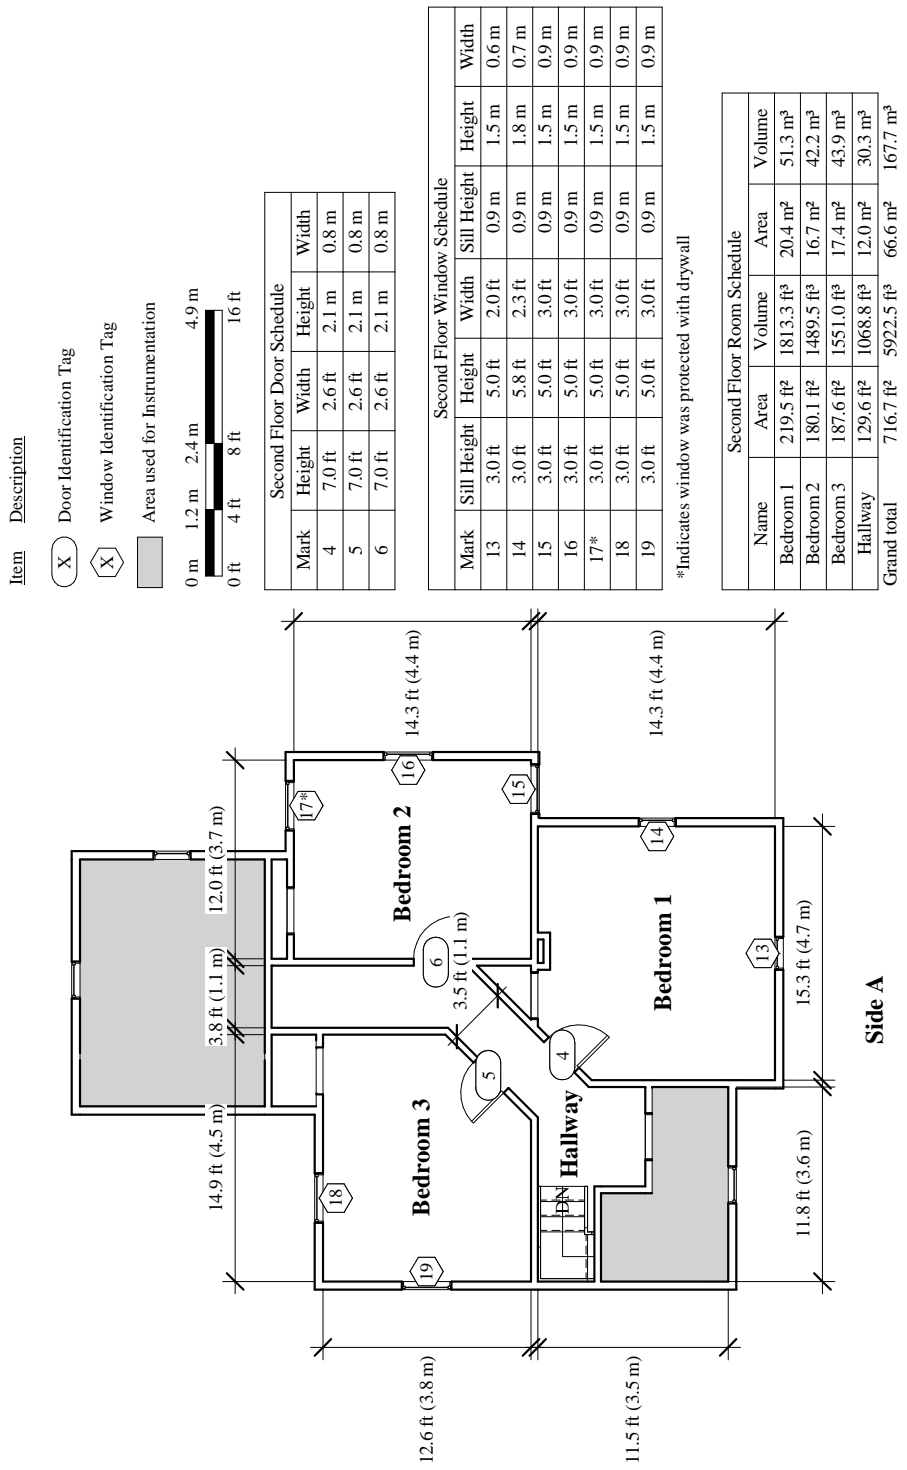
Figure B.4: 230 North Walnut Street, Sidney, OH: 2nd Floor Architectural Layout

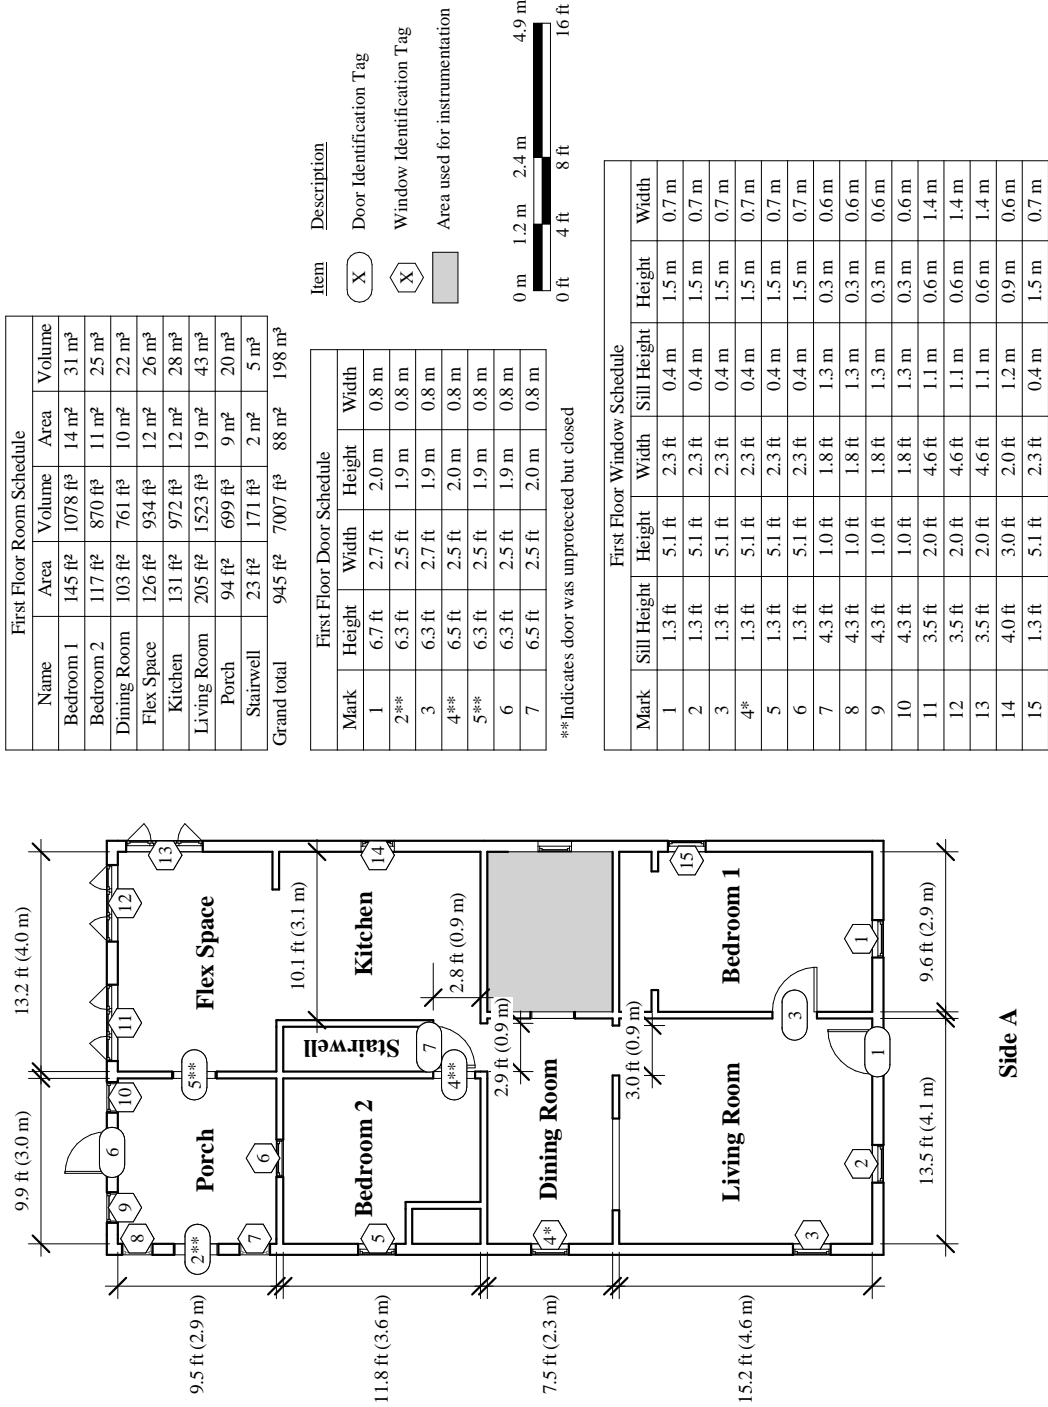
Figure B.10: 775 Hilltop Rd., Xenia, OH: 1st Floor Architectural Floor Plan

**Indicates door was unprotected but closed

*Indicates window was protected with plywood
