Study of Residential Attic Fire Mitigation Tactics and Exterior Fire Spread Hazards on Fire Fighter Safety

UL Firefighter Safety Research Institute

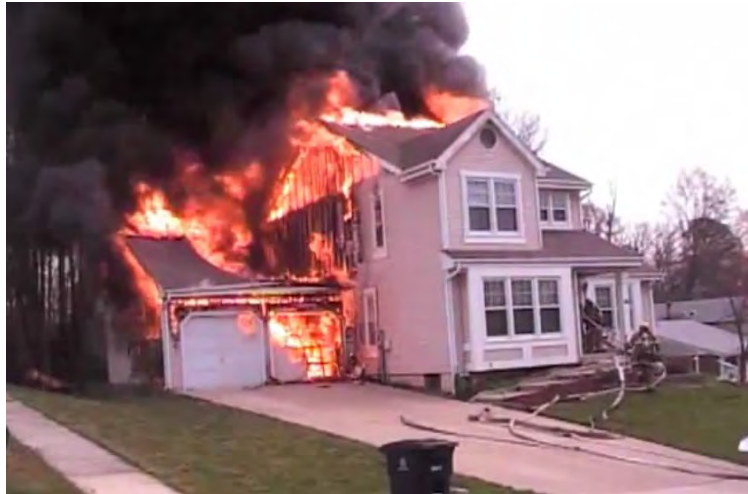
Figure 1. 1: A fire that started in the garage spread up the exterior of the home and into the attic.

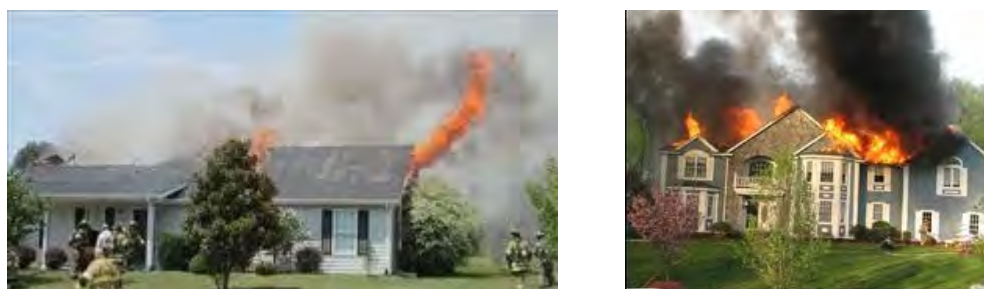
Figure 1. 3: Attic fires with older (left) and newer (right) attic construction

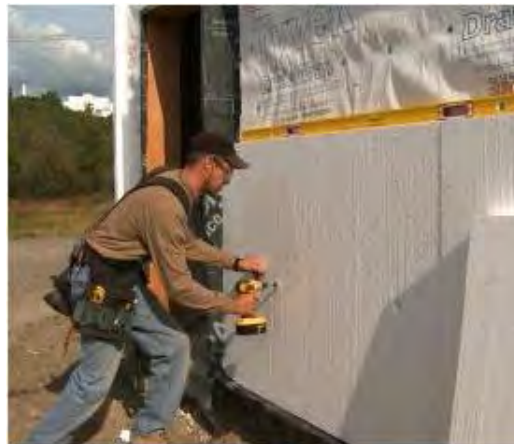
Figure 1. 4: Rigid foam insulation applied to an exterior wall

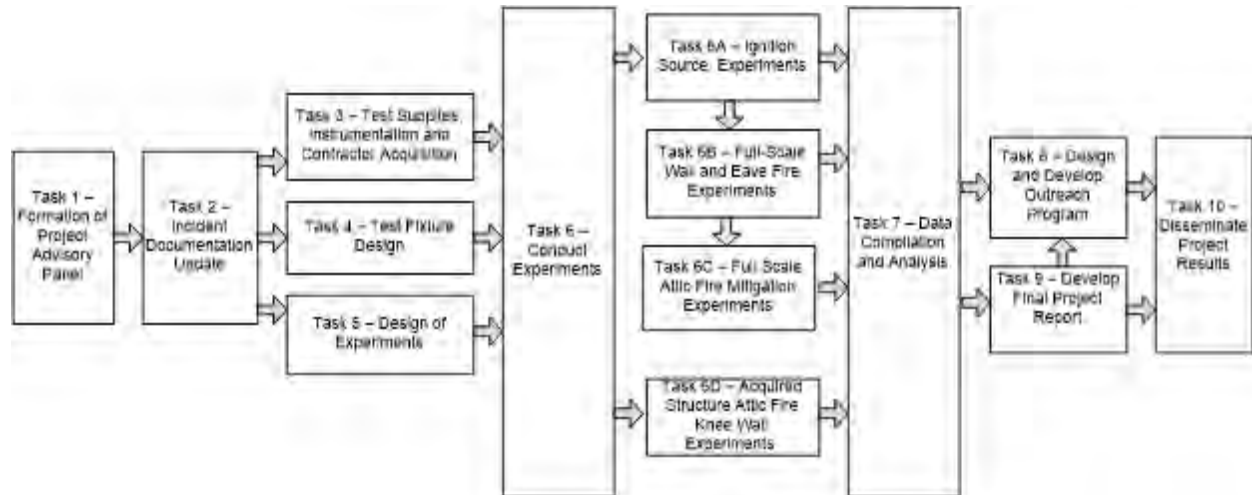
Figure 2. 1: Project Technical Plan

This studies technical plan is detailed in Figure 2. 1, with ten separate tasks.

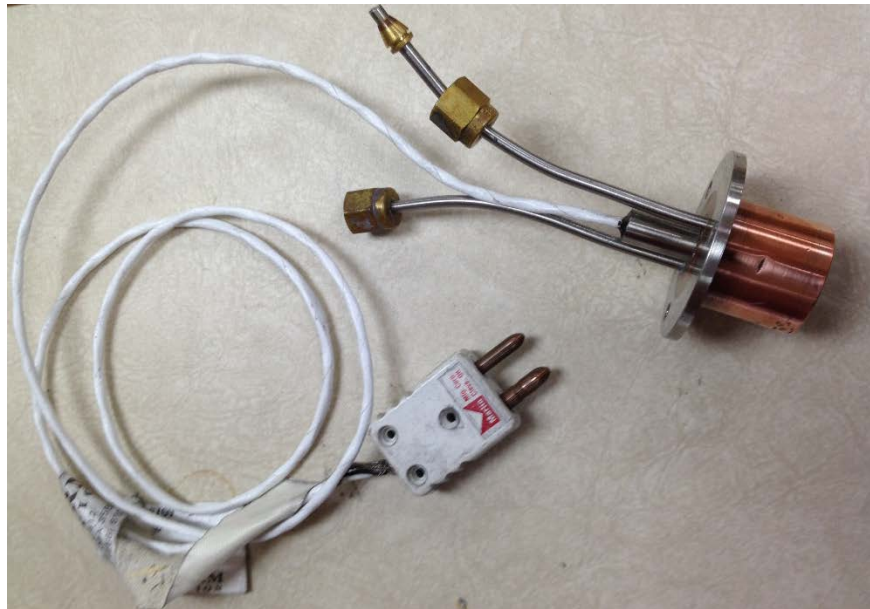
Heat flux measurements were made using a 2.54 cm nominal diameter water-cooled Schmidt-Boelter heat flux gauge (Figure 5. 1). The gauges measured the combined radiative and convective heat flux. For these experiments, the dominant form of heat flux is radiative due to the distance of the heat flux gauges from the flames. It should be noted that the convective contribution to the heat flux is dependent upon the surface temperature of the heat flux gauge. The manufacturer gives an uncertainty of $\pm 3\%$ and results from a study on heat flux calibration found the typical expanded uncertainty to be $\pm 8\%$.⁴¹

Figure 5. 1: Water Cooled Schmidt-Boelter Heat Flux Gauge

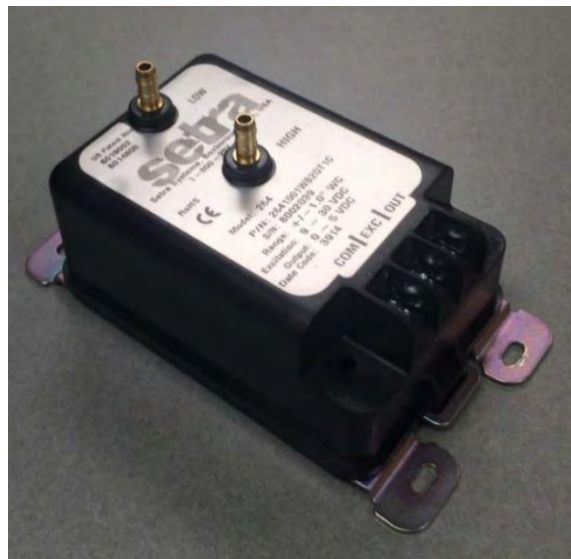
Pressure was recorded through the use of a Setra Model 264 differential pressure transducer with a range of $\pm 0.5''$ Wc (± 124.5 Pa) (Figure 5. 3). The transducer was used to evaluate the pressure difference from ambient. The uncertainty given by the manufacture is $\pm 1\%$ or ± 1.2 Pa.⁴³

Figure 5. 3: Setra Model 264 Differential Pressure Transducer.

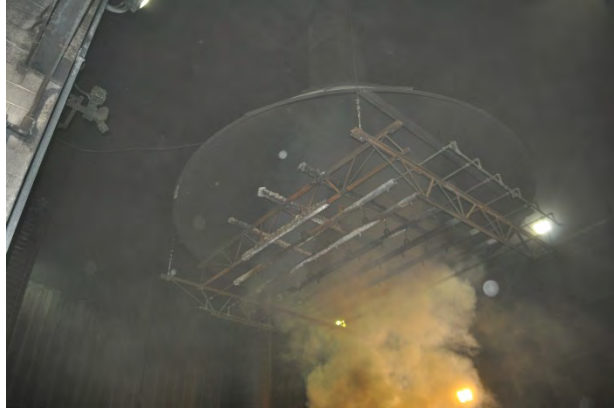
The heat release rate is measured through the use of oxygen consumption techniques. The oxygen consumption calorimeter is capable of accurately measuring the heat release rate up to 10 MW. Above 10 MW, larger inaccuracies are expected due to the combustion products overflowing the collection hood. Figure 5. 5 shows the collection hood utilized for the calorimetry data.

Figure 5. 5: Calorimetry Hood

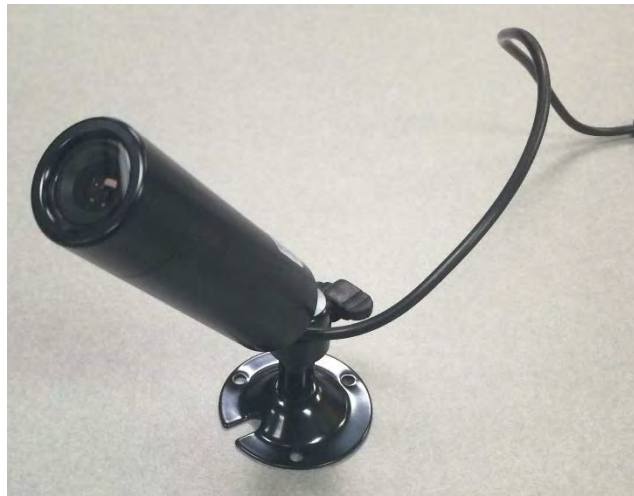
Stand video was obtained through the use of Marshall Electronics V-1255-B-BNC and Bosch VTC-206F03-4 video cameras (Figure 5. 6). Thermal imaging of the front and rear of the structure was taken using ISG Infrasy Elite XR (Figure 5. 7). The thermal imaging camera has a fixed emissivity value of 0.9 and was utilized for visual representation of relative conditions, no temperature measurements or analysis were derived using the camera. All cameras were recorded using a TriCaster 8200 video acquisition system.

Figure 5. 6: Bosh VTC-206F03-4 B&C Video Camera

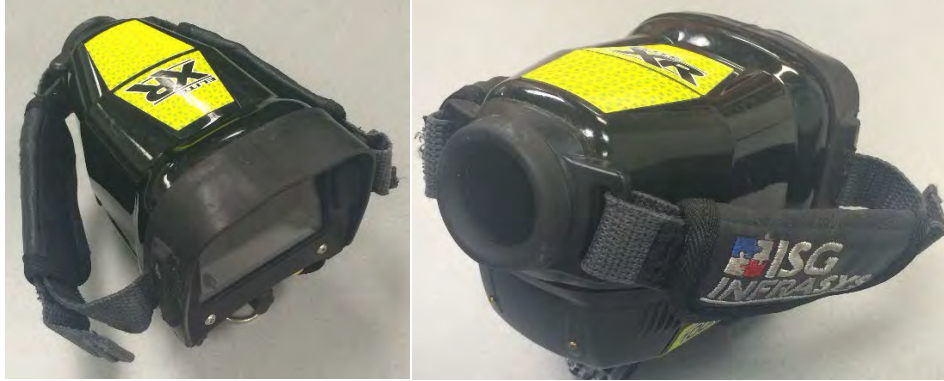
Figure 5. 7: ISG Elite XR Fire Service Thermal Imaging Camera

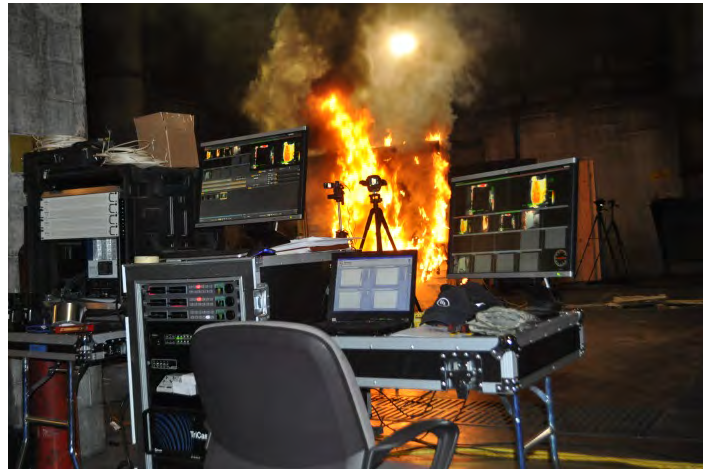
All data was logged through the use of a national instruments data acquisition system incorporating a SCXI-1001 chassis with 8 SCXI-1102C 32-Channel modules (Figure 5. 8). The system is configured for a total of 256 channels capable of reading values between 0-10 volts DC. Values are recorded once a second and translated to quantities of interest through the use of LabVIEW software specifically programmed for use with the system.

Figure 5. 8. Data acquisition and video systems

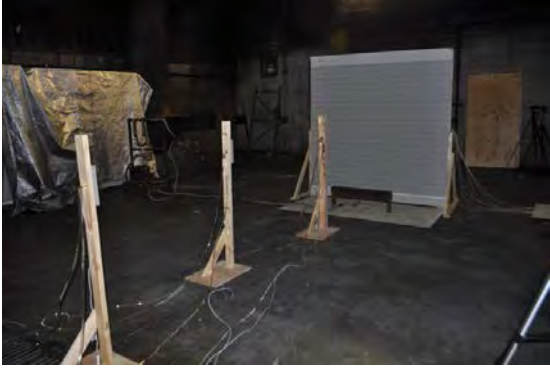
Figure 6. 1: Exposed Side of Wall

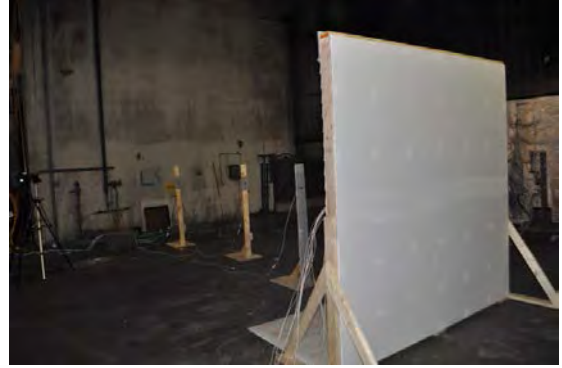
Figure 6. 2. Unexposed side of wall

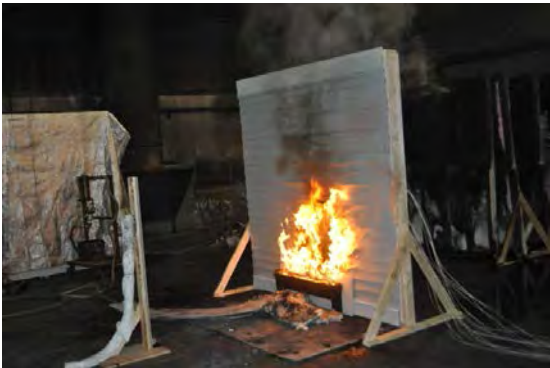
Figure 6. 3. 100 kW fire from 36 in. line burner

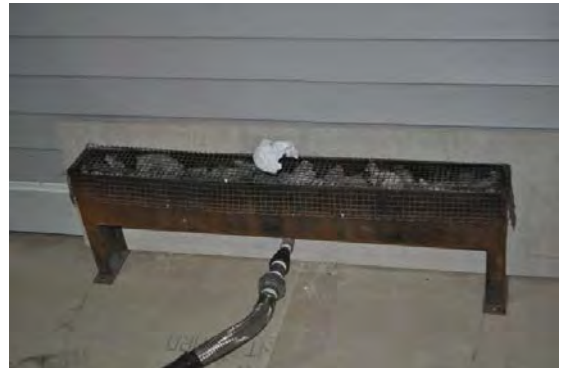
Figure 6. 4. Line burner

For most of the experiments, the heat source was a line burner with dimensions 39 in. wide, 4 in. thick, and 16 in. high. A picture of the natural gas flow controller and burner can be seen in Figure 4.12 and Figure 4.13, respectively. The burner operated at 50 kW, 100 kW, 150 kW, 200 kW, and 300 kW. The actual heat release rate of the burner fell within $\pm 10\%$ of the targeted heat release rate. This was determined by examining the actual data in the early stages of the experiment before the wall became involved. For Experiments 15 and 16, a Nexgrill 720-0783C propane gas grill was located 1 in. off the wall and used as the heat source. For Experiments 23 and 24, a 1 ft. by 1 ft. sand burner operated at a heat release rate of 25 kW, with the fuel flow rate to the burner controlled by the natural gas flow controller. The uncertainty of the sand burner heat release rate was determined by examining the heat release rate in the early stages of the experiment before the wall became involved and was determined to be $\pm 20\%$ of the targeted heat release rate.

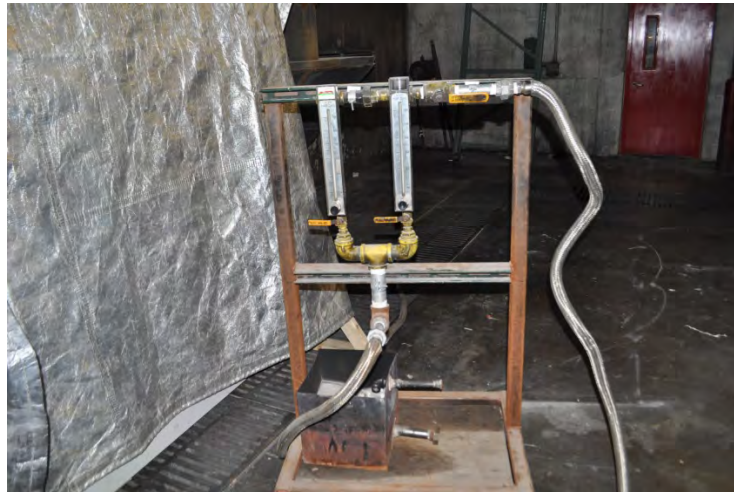
Figure 6. 5: Picture of Natural Gas Flow Controller

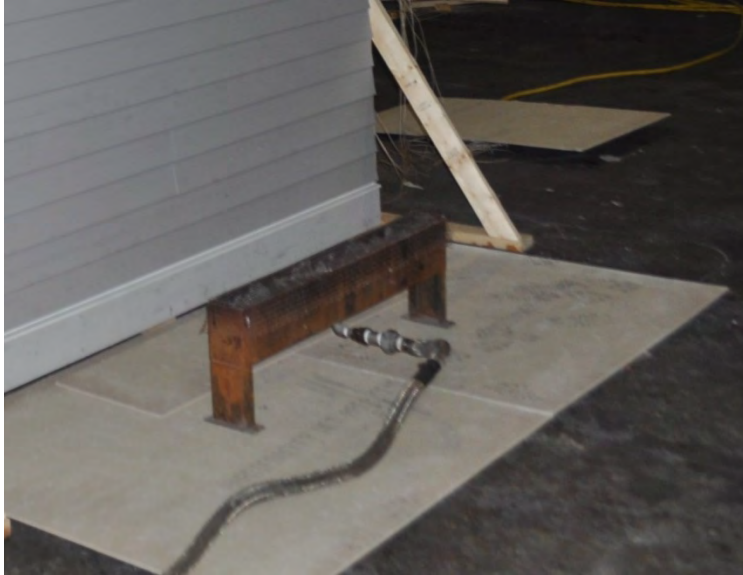
Figure 6. 6: Picture of Line Burner

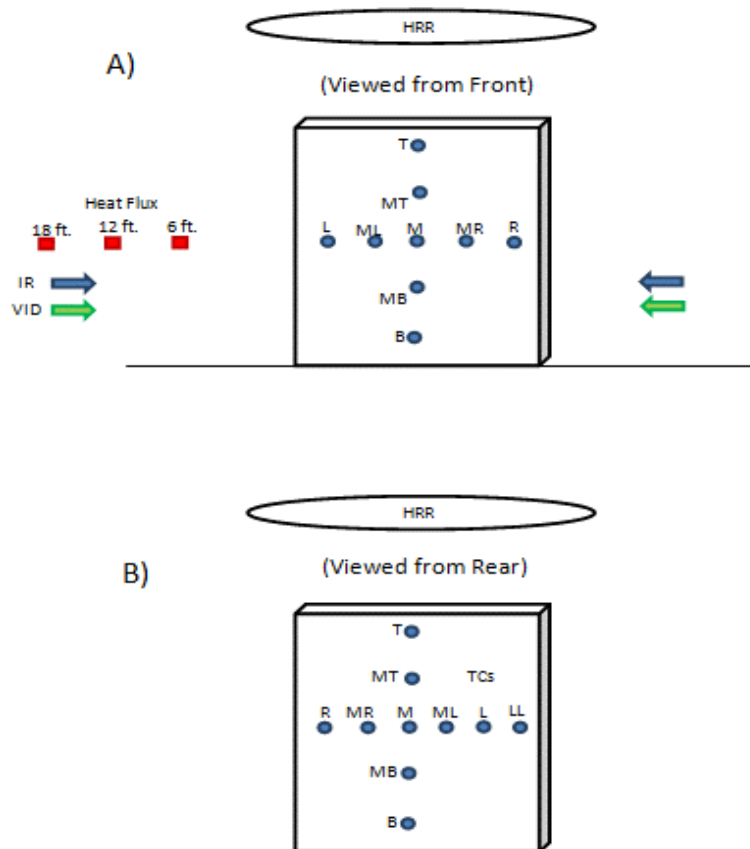
Figure 6. 7: Instrumentation for Wall Burn Experiments, (A) Thermocouple Locations under siding, (B) Thermocouple Locations in the wall cavity (viewed from back of the wall)

The experiments were performed in a 50 by 50 ft. test cell with a 25 ft. hood to measure the heat release rate. In the test cell four inlet ducts provide air to the room and are located 5 ft. above the floor to minimize induced drafts within the room. Heat flux measurements were made 6 ft., 12 ft., and 18 ft. from the front surface of the wall at a height of 4 ft. above the ground. Temperatures were recorded under the siding and halfway in the depth of the wall cavity.

Video of the front surface and rear surface of the wall was recorded during the experiments, along with thermal imaging of the front and rear of the structure. The IR imaging of the surfaces is largely meant for qualitative observations. The layout for the instrumentation utilized in the experiments is shown in Figure 6. 7.

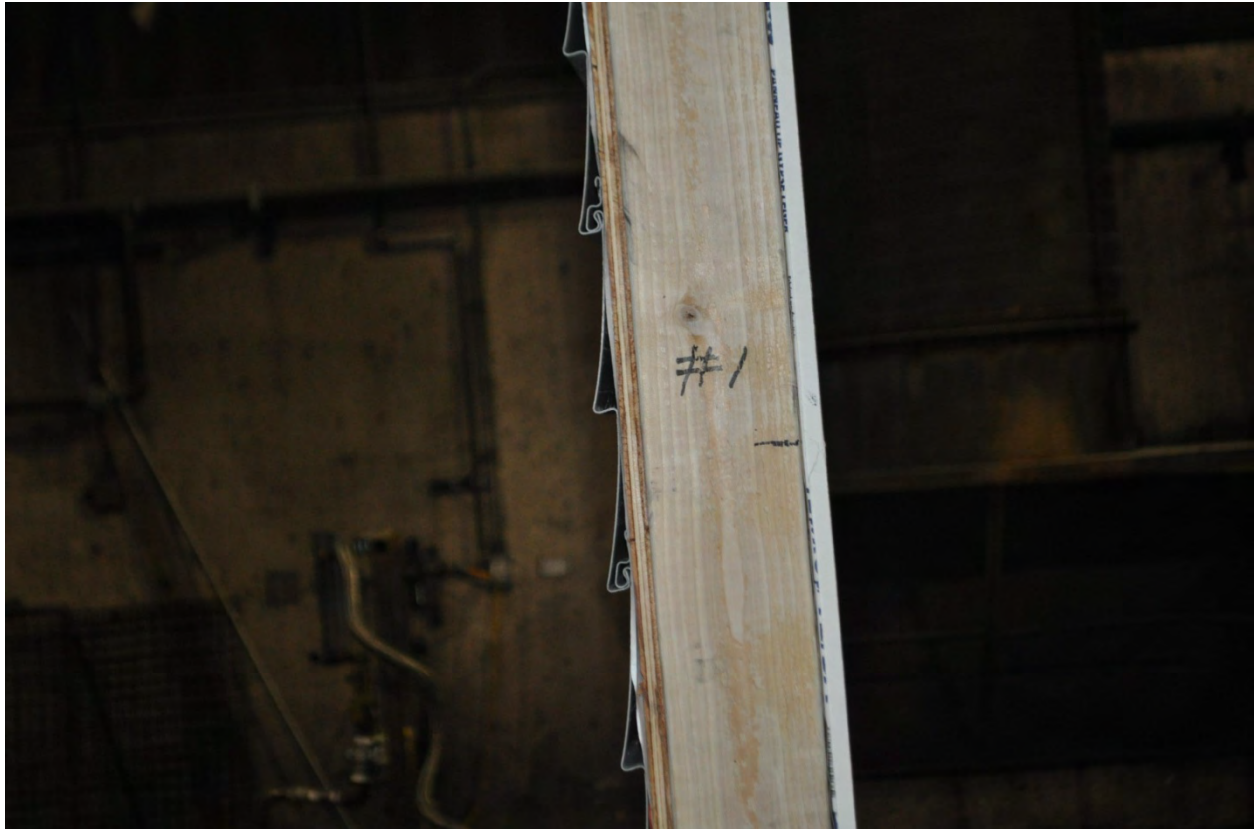
Wall Type	Siding	Additional Material	Sheathing	Insulation	Back Wall
Wall 1	Double 4" Vinyl Siding	Weather-Resistant Barrier	1/2" Plywood Sheathing	2x4, R-13 KFI w/ IVB*	1/2" Gypsum Board

Figure 6. 8: Wall Type 1 Side View

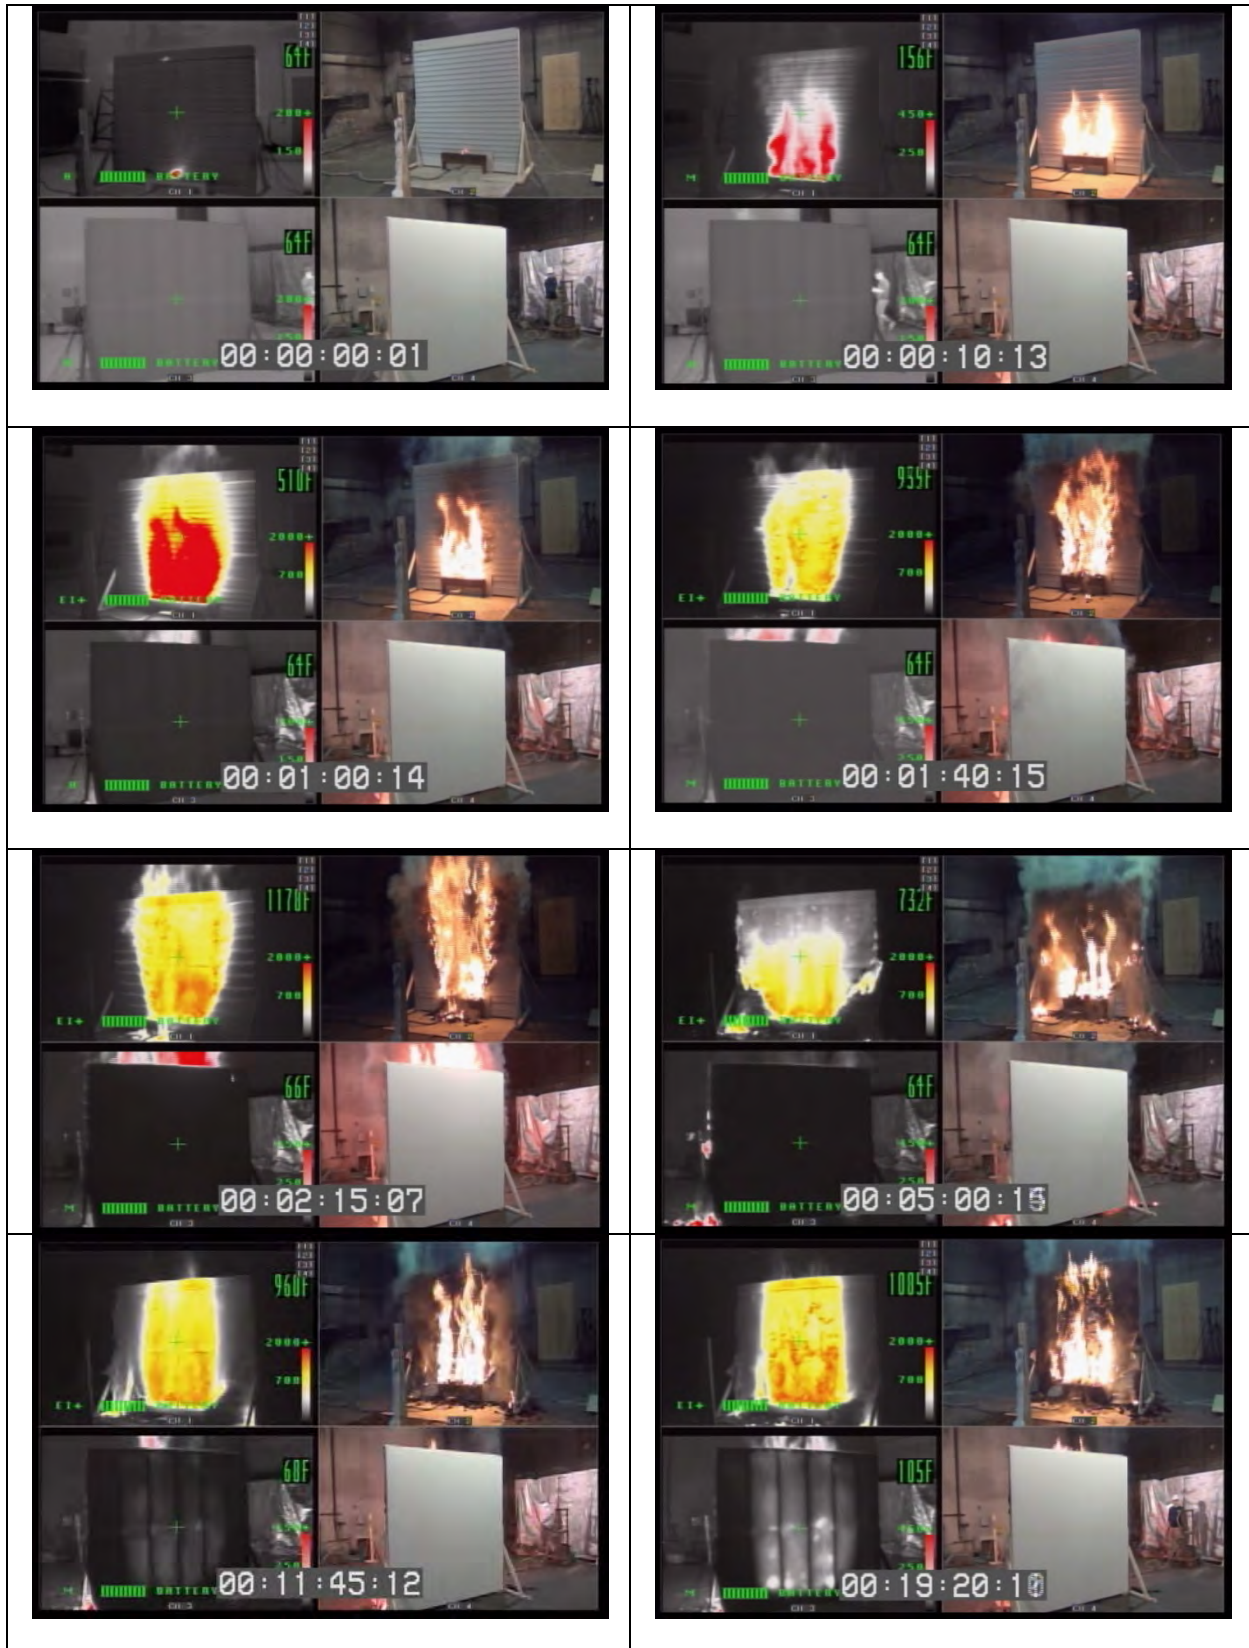
Table 6. 3: Experiment 1 Pictures (Timeline starts at ignition [hr:min:sec:frames])

Time (mm:ss)	Description
00:00	Experiment begins
00:10	Burner reaches 150 kW
01:00	Vinyl Siding is melting and burning, flames are beginning to spread up the wall
01:40	Flames have reached the top of the wall
02:15	Flames have extended above the wall, the fire is beginning to spread horizontally along the wall
05:00	Most the vinyl siding has burned or fallen off the wall, smaller pieces of still burning vinyl siding can be seen on the ground in front of the wall
11:45	Insulation and the studs get involved in the fire
19:20	Shows the fire just before the burner is turned off
19:35	The burner is turned off, there is still a small amount of fire near the bottom of the wall by the burner and near the top of the wall
31:10	Most of the fire has self-extinguished, end of experiment

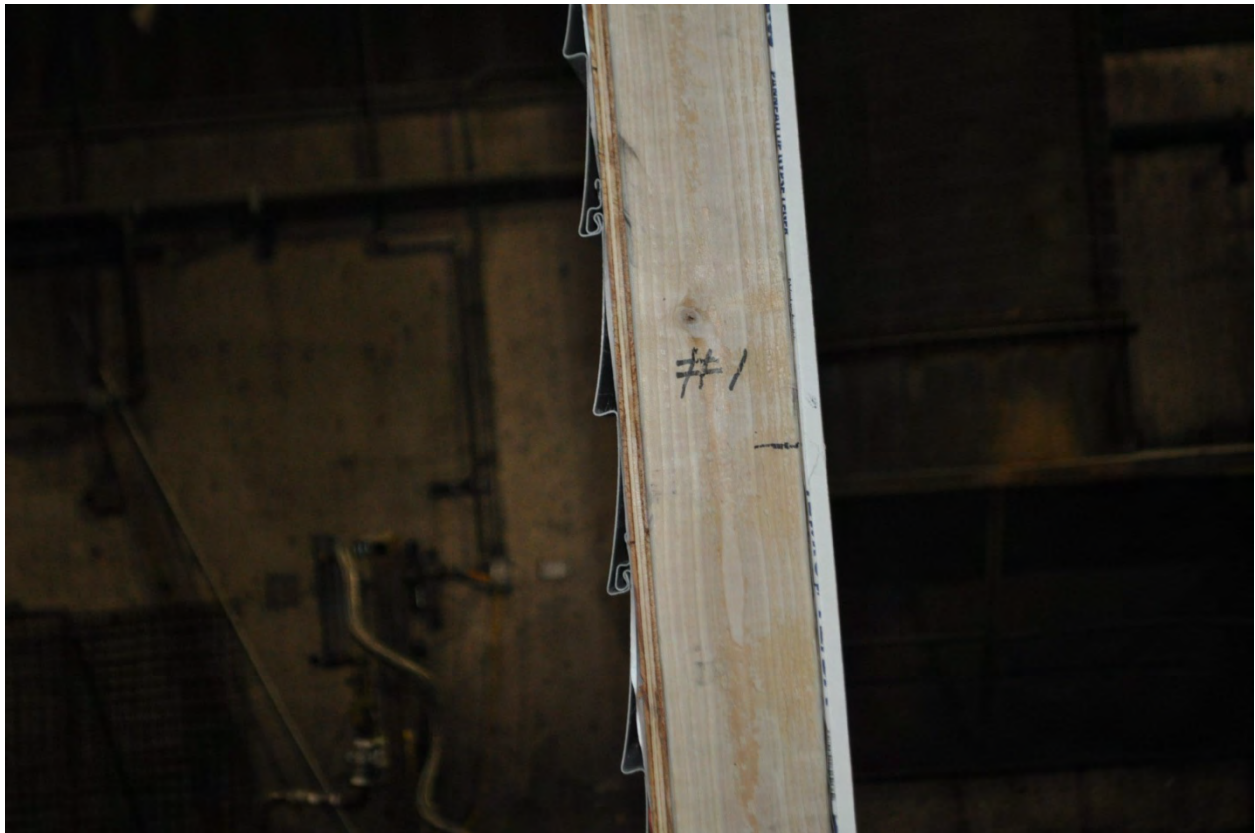
Wall Type	Siding	Additional Material	Sheathing	Insulation	Back Wall
Wall 1	Double 4" Vinyl Siding	Weather-Resistant Barrier	1/2" Plywood Sheathing	2x4, R-13 KFI w/ IVB	1/2" Gypsum Board

Figure 6. 9: Wall Type 1 Side View

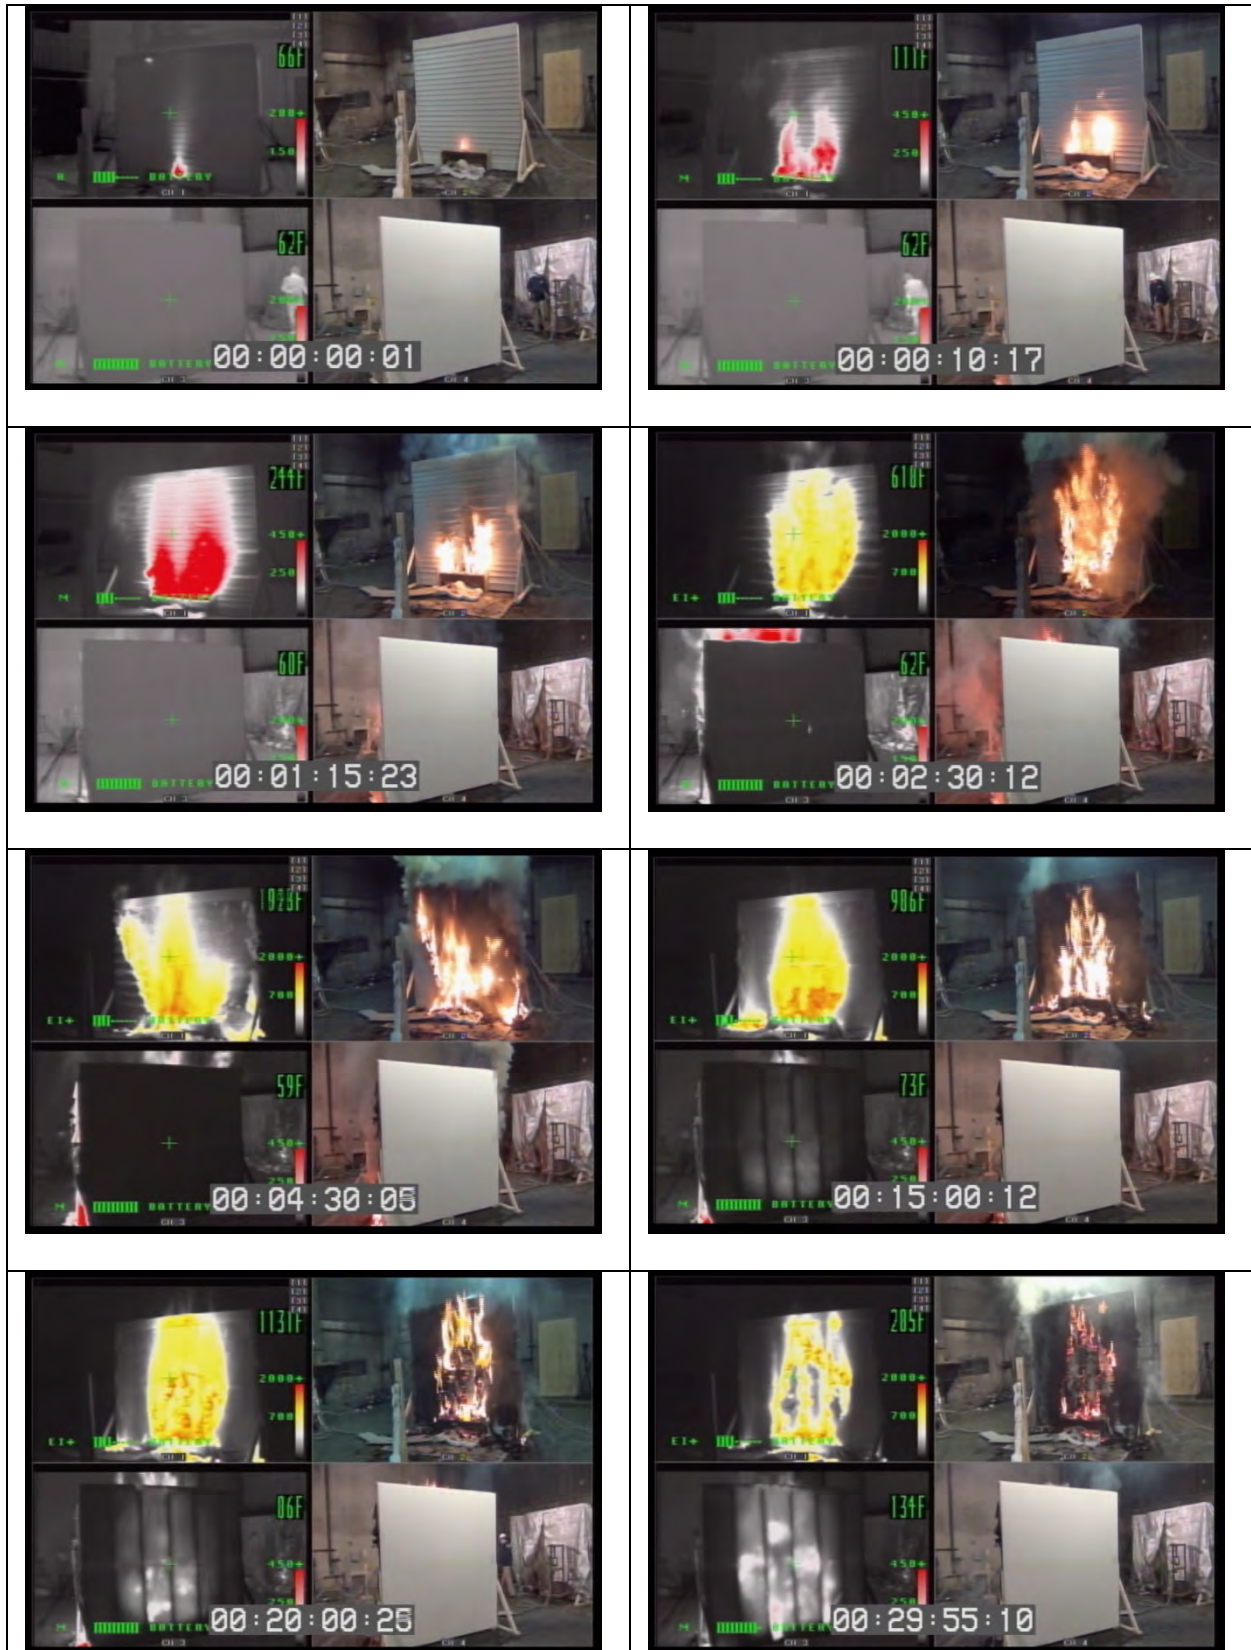
Table 6. 9: Experiment 3 Pictures

Time (mm:ss)	Description
00:00	Experiment pre-ignition
00:10	Burner is on and reaching desired 100 kW heat release rate
01:15	Vinyl siding begins to melt and burn, flames are spreading up the wall
02:30	Flames have reached the top of the wall
04:30	Most of the vinyl siding has fallen off or burned
15:00	Insulation and wall studs are involved and fire has again reached the top of the wall
20:00	The burner is turned off, fire is still present near top of the wall
29:55	Most of the fire has self-extinguished, the experiment is over

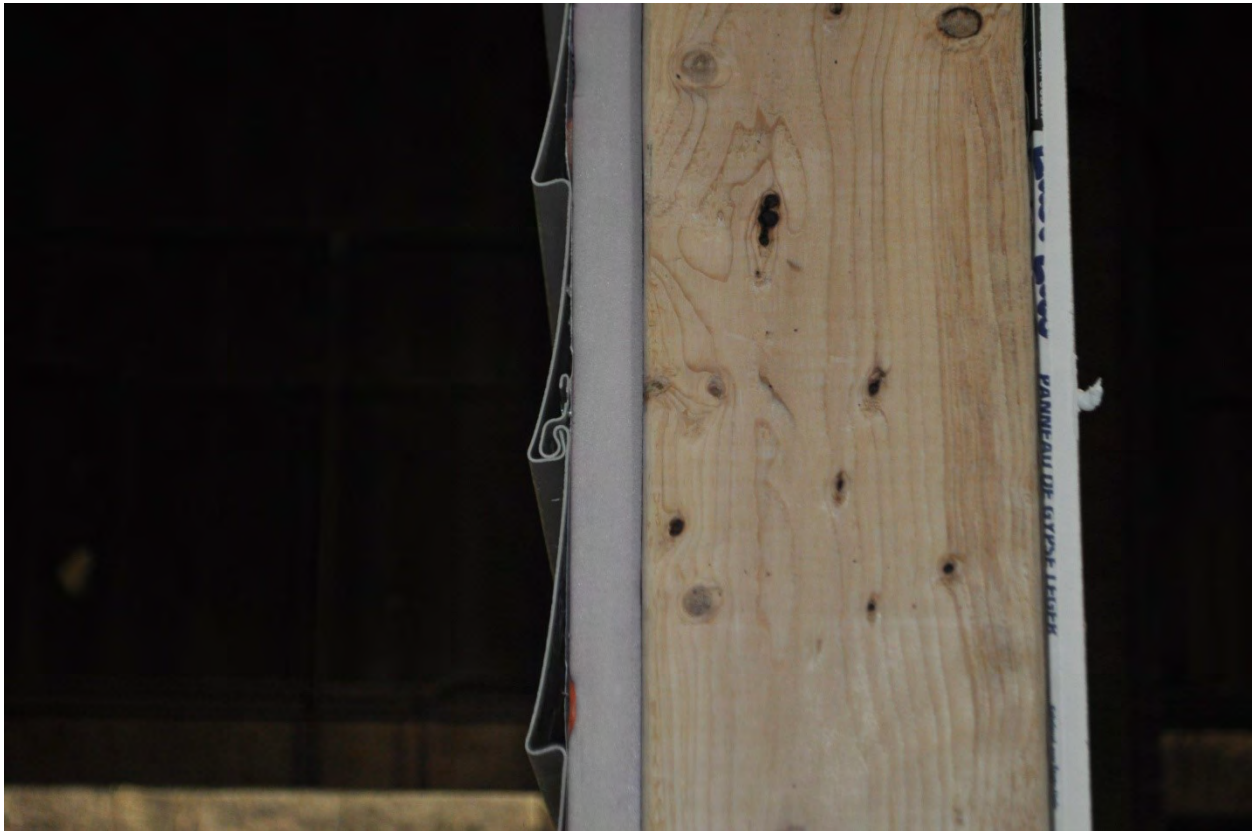
Wall Type	Siding	Additional Material	Sheathing	Insulation	Back Wall
Wall 8	Double 4" Vinyl Siding	Weather-Resistant Barrier	1" R-5 EPS Insulation Board	2x6, R-19 KFI w/ IVB	1/2" Gypsum Board

Figure 6. 11: Wall Type 8 Side View

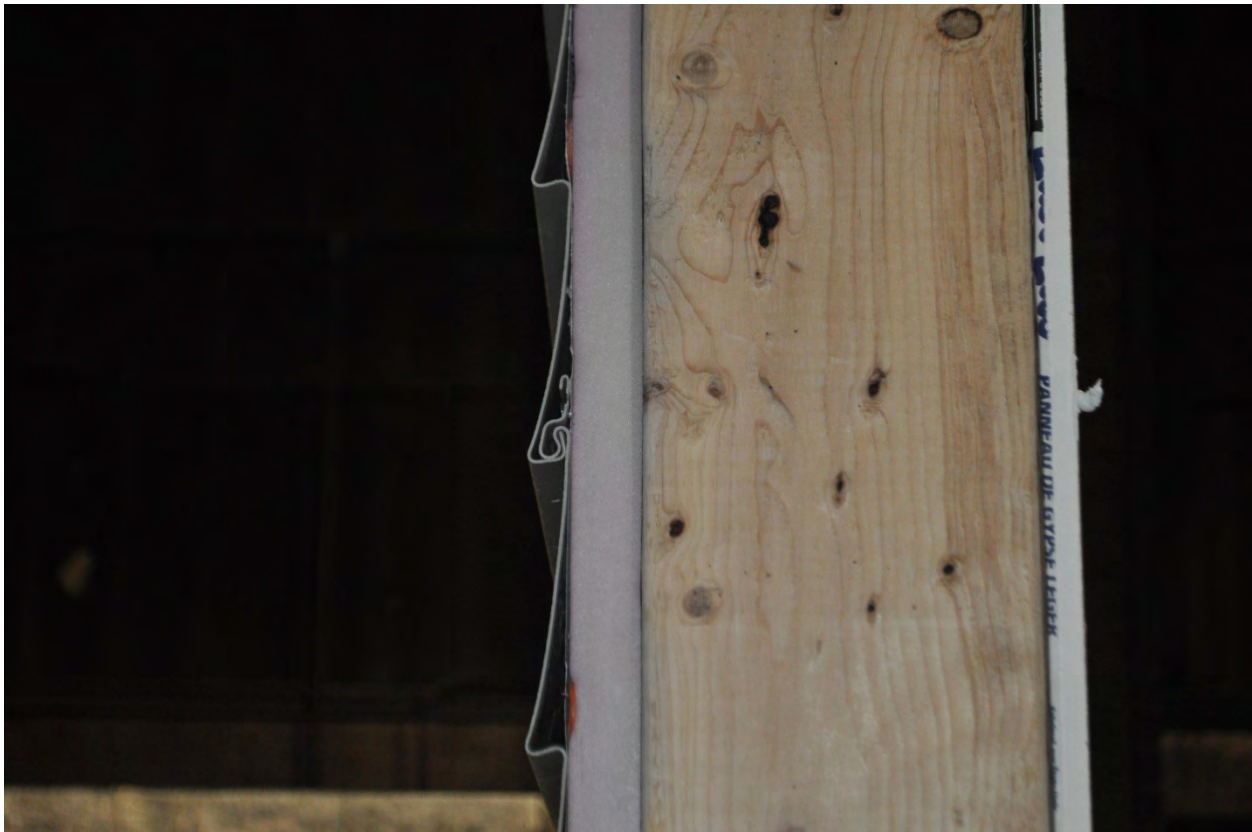
Figure 6. 12: Wall Type 8 Side View

Table 6. 14: Wall Type and Material for Experiment 5 (100 kW)

Wall Type	Siding	Additional Material	Sheathing	Insulation	Back Wall
Wall 8	Double 4" Vinyl Siding	Weather-Resistant Barrier	1" R-5 EPS Insulation Board	2x6, R-19 KFI w/ IVB	1/2" Gypsum Board

The layout of the wall and materials used for each layer of the wall are specified in Table 6. 14. A side view of the wall is shown in Figure 6. 12. The burner heat release rate (HRR) was 100 kW for Experiment 5 while the burner was on. Photos from Experiment 5 are displayed in Table 6. 15. A timeline of the events within Experiment 5, matching with the photos in Table 6. 15, is shown in Table 6. 16. Heat release rate data, heat flux data, and temperature data from Experiment 5 are shown in appendix G, figures G.25-G.30.

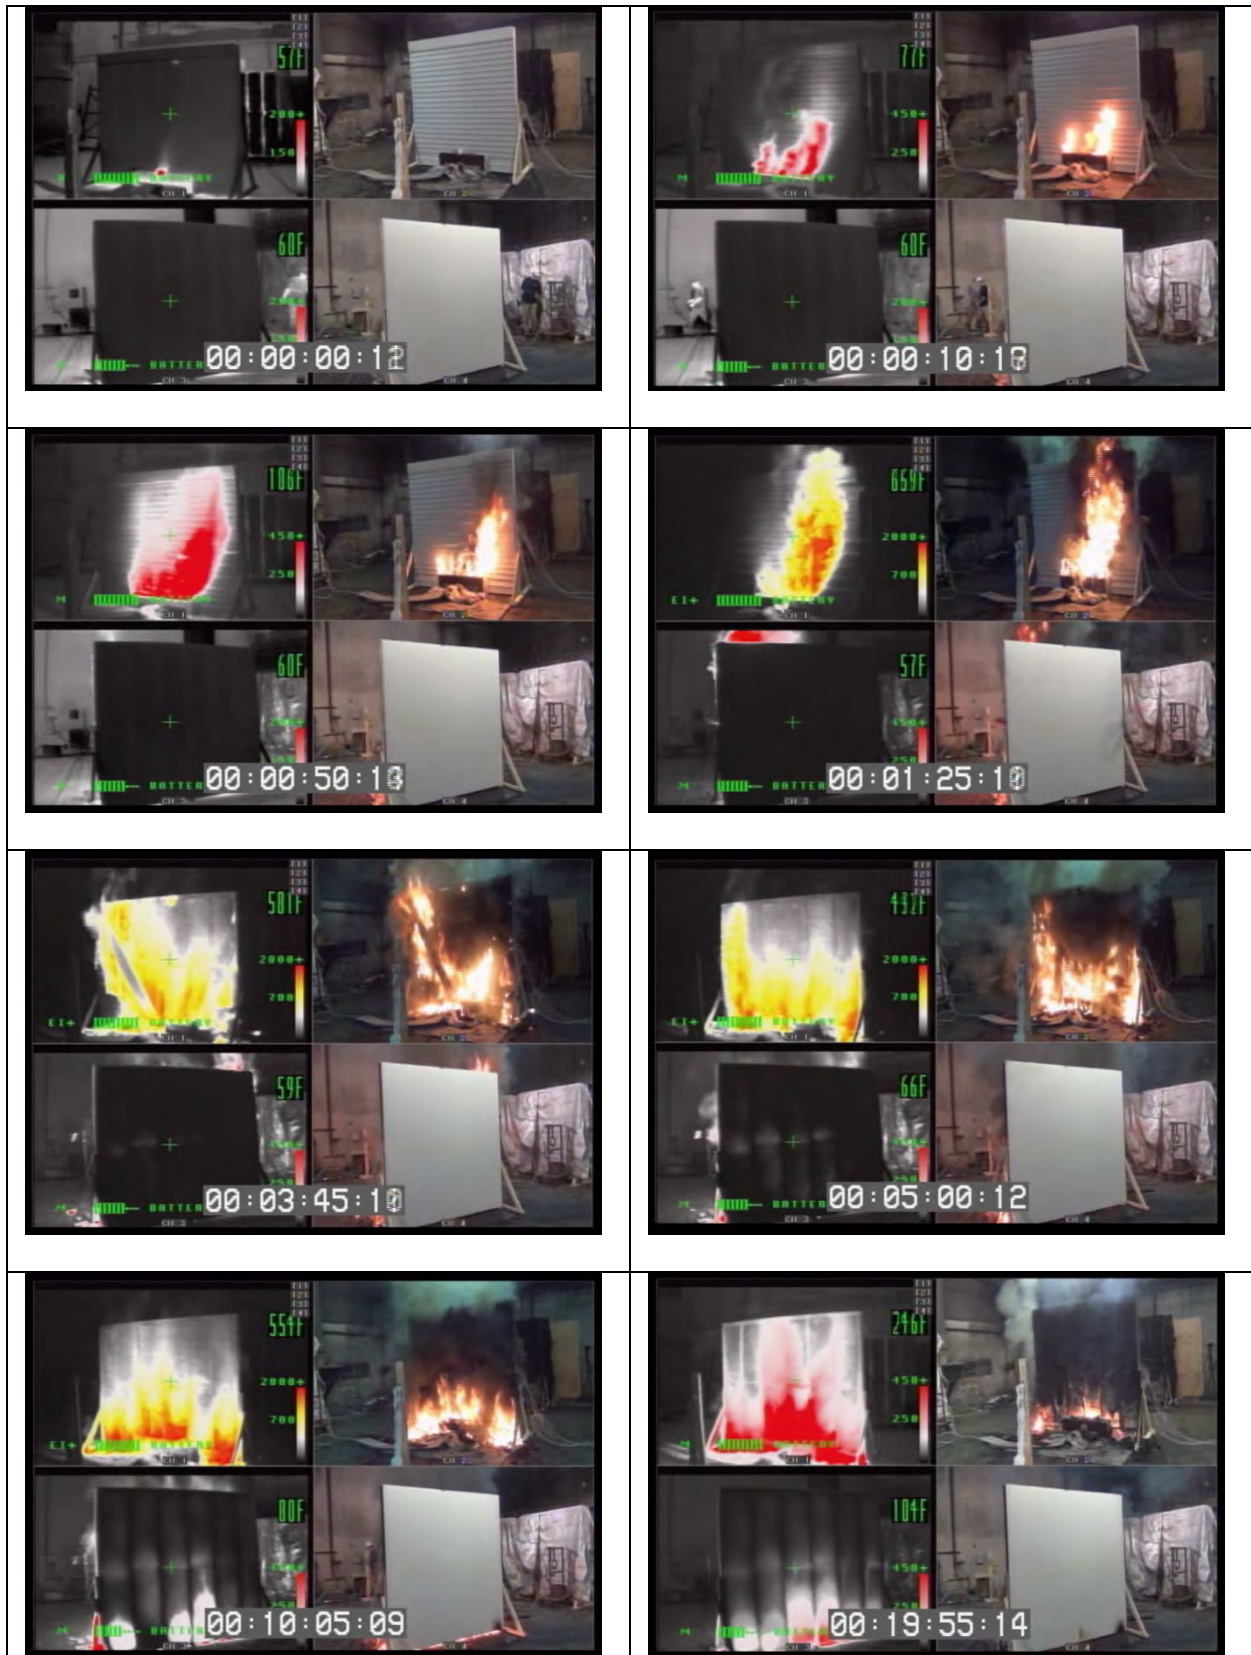
Table 6. 15: Experiment 5 Pictures

Time (mm:ss)	Description
00:00	Experiment begins
00:10	Burner is on and reaching desired 100 kW heat release rate
00:50	Vinyl siding begins to burn and melt, flames begin extending up the wall
01:25	Flames reach top of the wall and extend above the wall
03:45	The vinyl siding has burned off
05:00	Pieces of vinyl siding are burning on the ground in front of the wall, not much of the wall is burning
10:05	Burner is turned off, small amount of flame is still above the burner, pieces of vinyl siding are still burning on the ground
19:55	Most of the fire has self-extinguished, the experiment is over

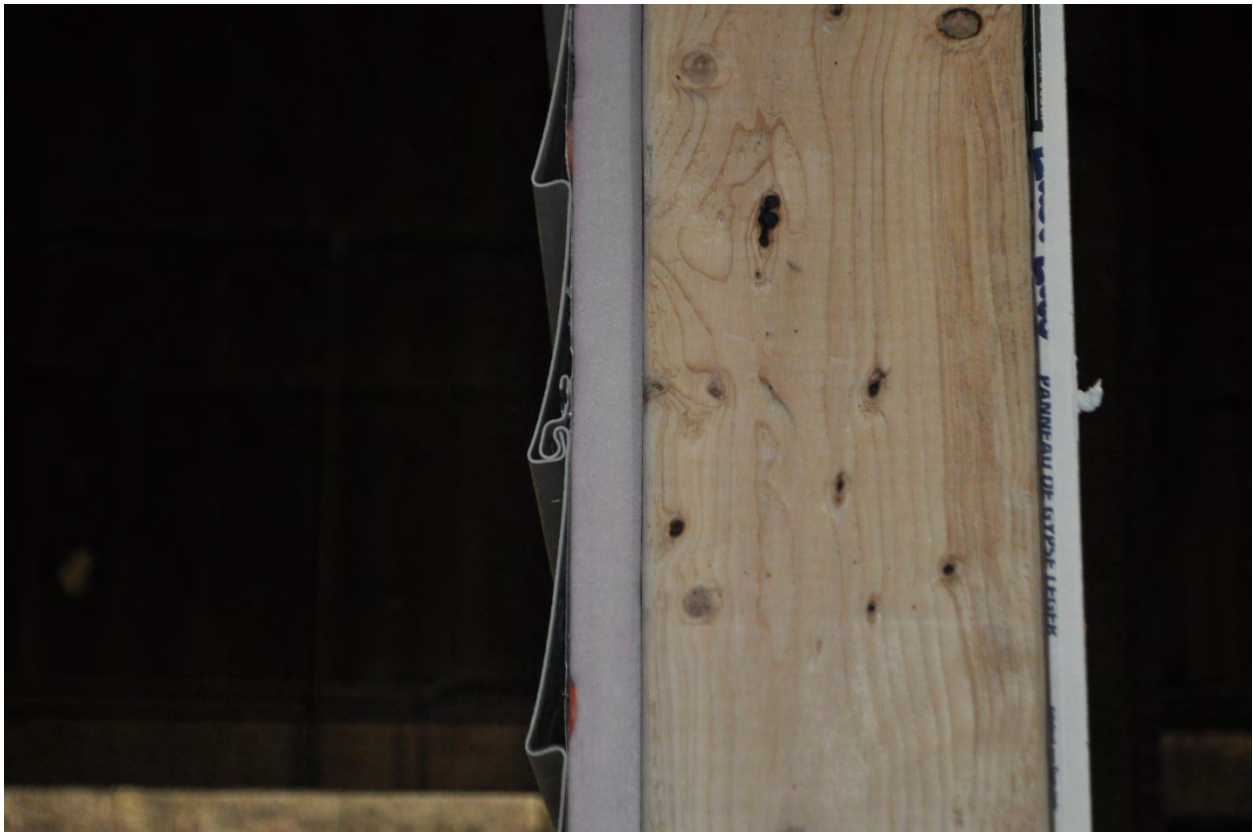
Figure 6. 13: Wall Type 8 Side View

Table 6. 17: Wall Type and Material for Experiment 6 (50 kW)

Wall Type	Siding	Additional Material	Sheathing	Insulation	Back Wall
Wall 8	Double 4" Vinyl Siding	Weather-Resistant Barrier	1" R-5 EPS Insulation Board	2x6, R-19 KFI w/ IVB	1/2" Gypsum Board

The layout of the wall and materials used for each layer of the wall are specified in Table 6. 17. A side view of the wall is shown in Figure 6. 13. The burner heat release rate (HRR) was 50 kW for Experiment 6 while the burner was on. Photos from Experiment 6 are displayed in Table 6. 18. A timeline of the events within Experiment 6, matching with the photos in Table 6. 18, is shown in Table 6. 19. Heat release rate data, heat flux data, and temperature data from Experiment 6 are shown in appendix G, figures G.31-G.36.

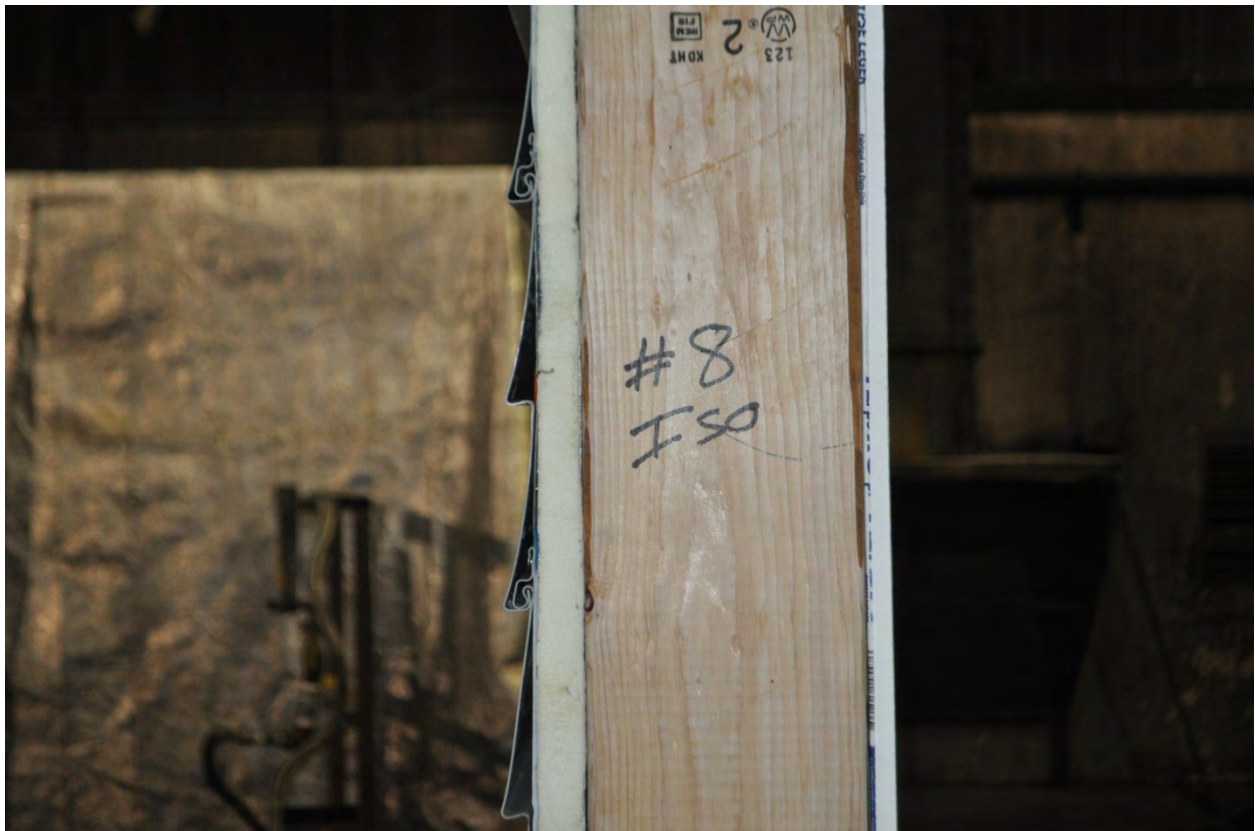
Figure 6. 14: Wall Type 8-I Side View

Table 6. 20: Wall Type and Material for Experiment 7 (100 kW)

Wall Type	Siding	Additional Material	Sheathing	Insulation	Back Wall
Wall 8-I	Double 4" Vinyl Siding	Weather-Resistant Barrier	1" Polyisocyanurate Insulation Board	2x6, R-19 KFI w/ IVB	1/2" Gypsum Board

The layout of the wall and materials used for each layer of the wall are specified in Table 6. 20. A side view of the wall is shown in Figure 6. 14. The burner heat release rate (HRR) was 100 kW for Experiment 7 while the burner was on. Photos from Experiment 7 are displayed in Table 6. 21. A timeline of the events within Experiment 7, matching with the photos in Table 6. 21, is shown in Table 6. 22. Heat release rate data, heat flux data, and temperature data from Experiment 7 are shown in appendix G, figures G.37-G.42.

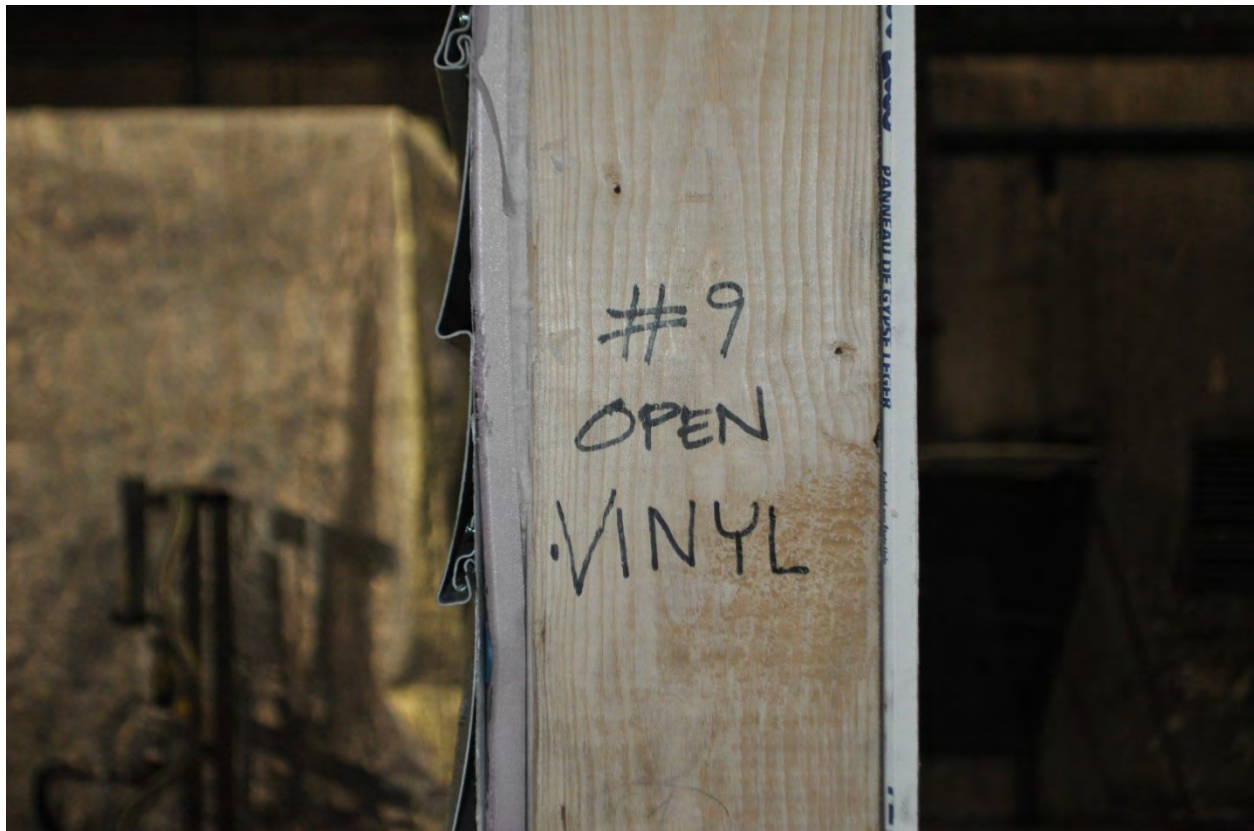
Figure 6. 15: Wall Type 9-O Side View

Table 6. 23: Wall Type and Material for Experiment 8 (100 kW)

Wall Type	Siding	Additional Material	Sheathing	Insulation	Back Wall
Wall 9-O	Double 4" Vinyl Siding	Weather-Resistant Barrier	1" R-5 EPS Insulation Board	2x6, Open Cell Foam	1/2" Gypsum Board

The layout of the wall and materials used for each layer of the wall are specified in Table 6. 23. A side view of the wall is shown in Figure 6. 15. The burner heat release rate (HRR) was 100 kW for Experiment 8 while the burner was on. Photos from Experiment 8 are displayed in Table 6. 24. A timeline of the events within Experiment 8, matching with the photos in Table 6. 24, is shown in Table 6. 25. Heat release rate data, heat flux data, and temperature data from Experiment 8 are shown in appendix G, figures G.43 through G-48.
