Study of Residential Attic Fire Mitigation Tactics and Exterior Fire Spread Hazards on Fire Fighter Safety

UL Firefighter Safety Research Institute

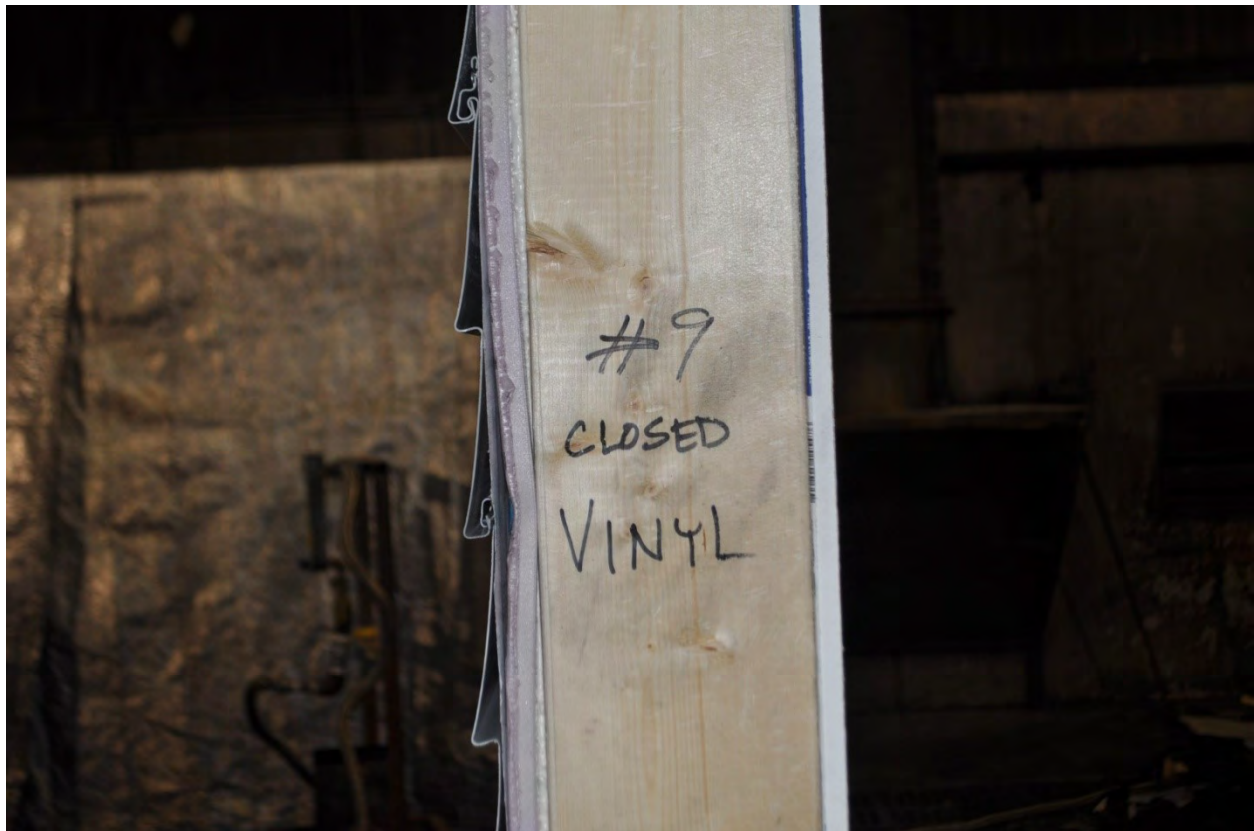
Figure 6. 16: Wall Type 9-C Side View

Table 6. 26: Wall Type and Material for Experiment 9 (100 kW)

Wall Type	Siding	Additional Material	Sheathing	Insulation	Back Wall
Wall 9-C	Double 4" Vinyl Siding	Weather-Resistant Barrier	1" R-5 EPS Insulation Board	2x6, Closed Cell Foam	1/2" Gypsum Board

The layout of the wall and materials used for each layer of the wall are specified in Table 6. 26. A side view of the wall is shown in Figure 6. 16. The burner heat release rate (HRR) was 100 kW for Experiment 9 while the burner was on. Photos from Experiment 9 are displayed in Table 6. 27. A timeline of the events within Experiment 9, matching with the photos in Table 6. 27, is shown in Table 6.28. Heat release rate data, heat flux data, and temperature data from Experiment 9 are shown in appendix G, figures G.49-G.54.

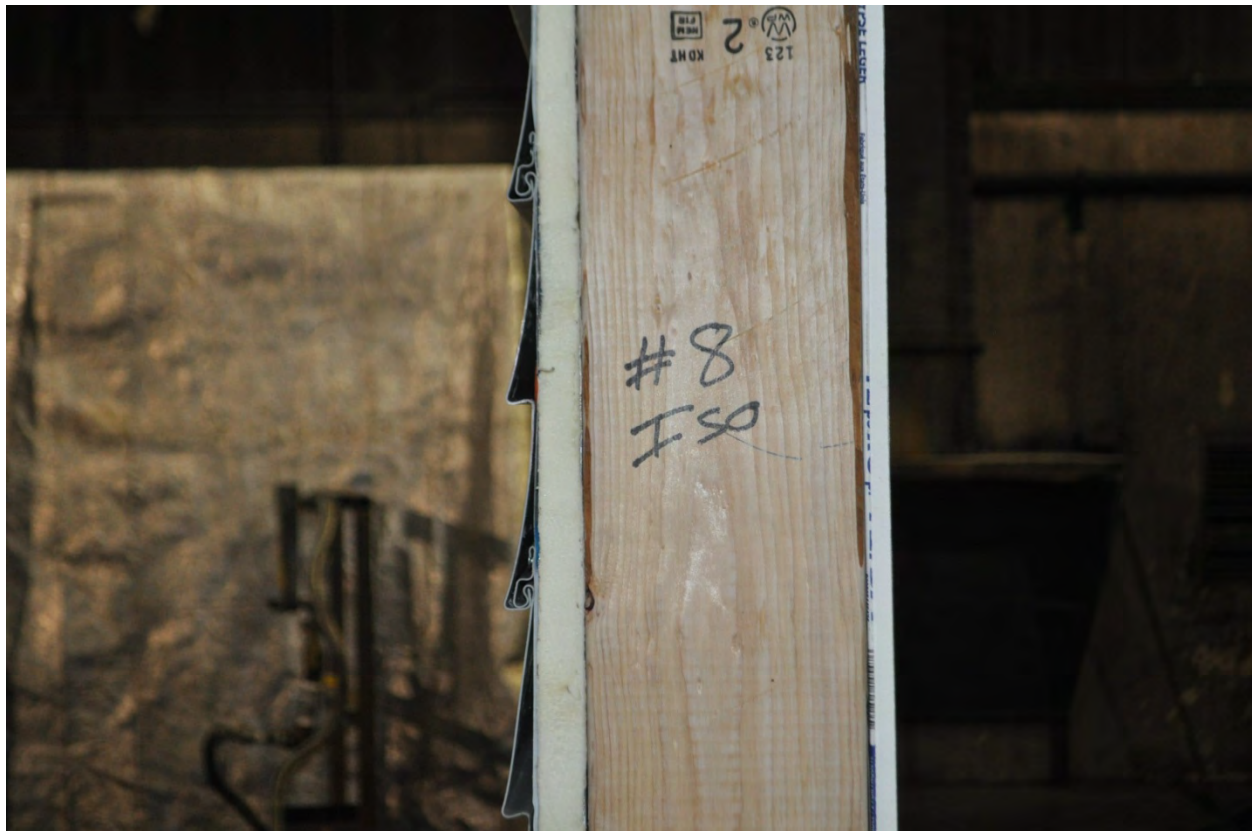
Figure 6. 17: Wall Type 9-I Side View (Side View of 8-I same as Side View of 9-I)

Table 6. 29: Wall Type and Material for Experiment 10 (100 kW)

Wall Type	Siding	Additional Material	Sheathing	Insulation	Back Wall
Wall 9-I	Double 4" Vinyl Siding	Weather-Resistant Barrier	1/2" Polyisocyanurate Insulation Board	2x6, R-19 KFI w/ IVB	1/2" Gypsum Board

The layout of the wall and materials used for each layer of the wall are specified in Table 6. 29. A side view of the wall is shown in Figure 6. 17. The burner heat release rate (HRR) was 100 kW for Experiment 10 while the burner was on. Photos from Experiment 10 are displayed in Table 6. 30. A timeline of the events within Experiment 10, matching with the photos in Table 6. 30, is shown in Table 6. 31. Heat release rate data, heat flux data, and temperature data from Experiment 10 are shown in appendix G, figures G.55-G.60.

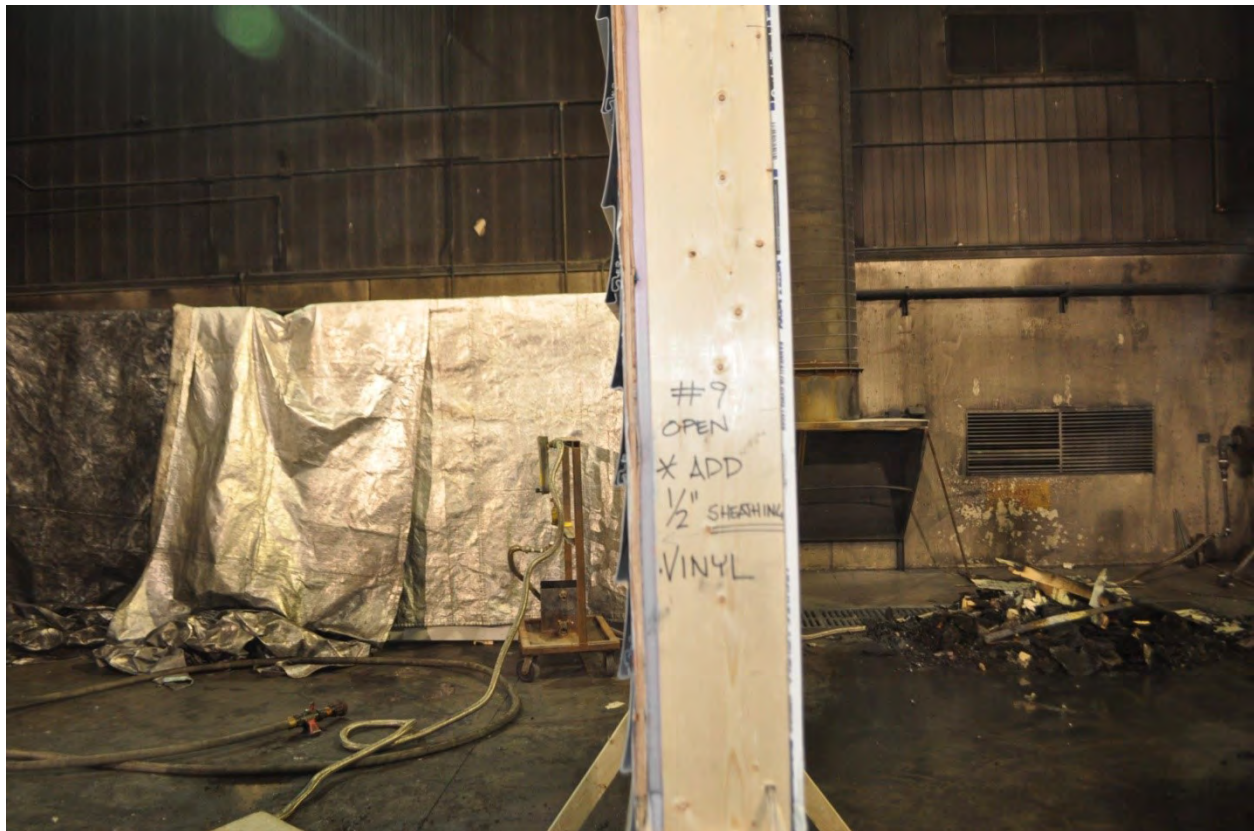
Figure 6. 18: Wall Type 9-S Side View

Table 6. 32: Wall Type and Material for Experiment 11 (100 kW)

Wall Type	Siding	Additional Material	Sheathing	Insulation	Back Wall
Wall 9-S	Double 4" Vinyl Siding	Weather-Resistant Barrier	1/2" Plywood followed by 1" R-5 EPS Insulation Board	2x6, Spray Polyurethane Foam	1/2" Gypsum Board

The layout of the wall and materials used for each layer of the wall are specified in Table 6. 32. A side view of the wall is shown in Figure 6. 18. The burner heat release rate (HRR) was 100 kW for Experiment 11 while the burner was on. Photos from Experiment 11 are displayed in Table 6. 33. A timeline of the events within Experiment 11, matching with the photos in Table 6. 33, is shown in Table 6. 34. Heat release rate data, heat flux data, and temperature data from Experiment 11 are shown in appendix G, figures G.61-G.66.

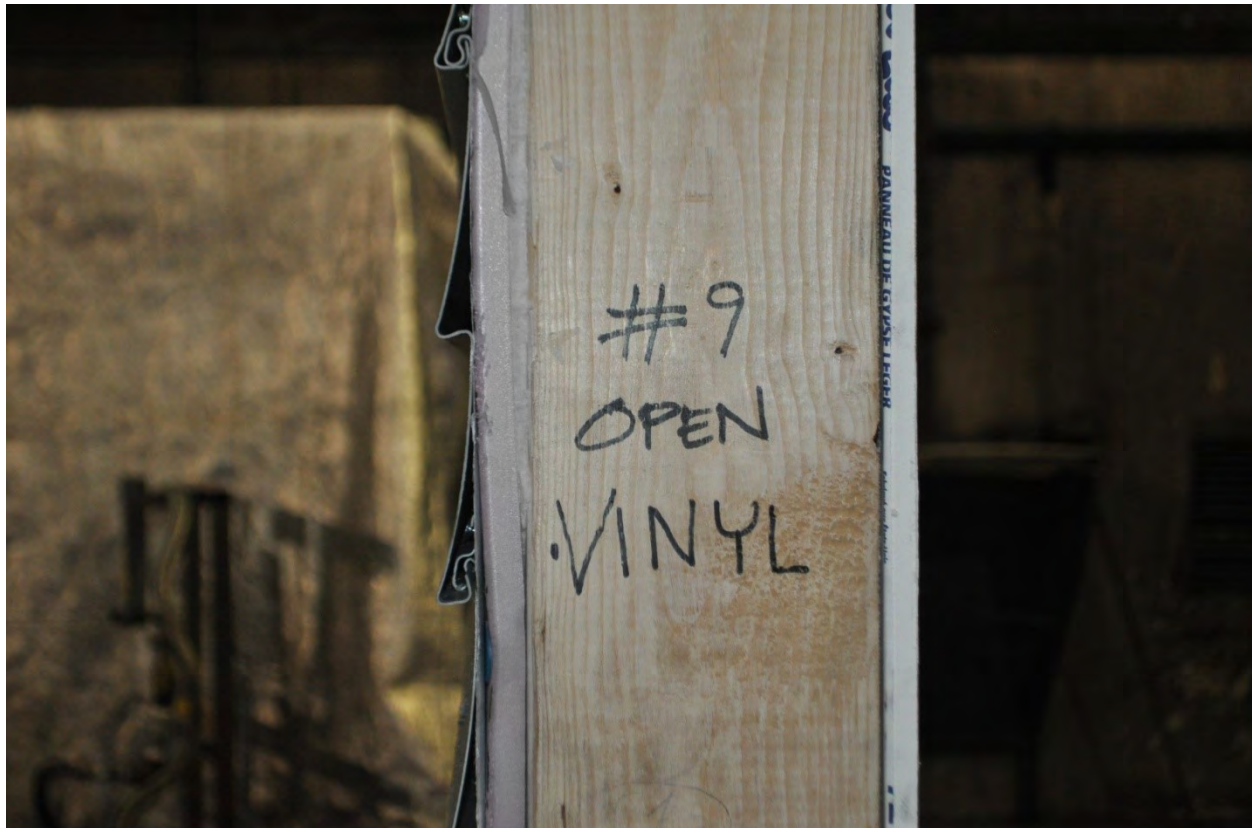
Figure 6. 19: Wall Type 9-R Side View

Table 6. 35: Wall Type and Material for Experiment 12 (100 kW)

Wall Type	Siding	Additional Material	Sheathing	Insulation	Back Wall
Wall 9-R	Double 4" Vinyl Siding	Weather-Resistant Barrier	1" R-5 EPS Insulation Board	2x6, Spray Polyurethane Foam	1/2" Gypsum Board

The layout of the wall and materials used for each layer of the wall are specified in Table 6. 35. A side view of the wall is shown in Figure 6. 19. This wall also had receptacles, which were outlets placed on the back of the wall. The burner heat release rate (HRR) was 100 kW for Experiment 12 while the burner was on. Photos from Experiment 12 are displayed in Table 6. 36. A timeline of the events within Experiment 12, matching with the photos in Table 6. 36, is shown in Table 6. 37. Heat release rate data, heat flux data, and temperature data from Experiment 12 are shown in appendix G, figure G.67-G.72.

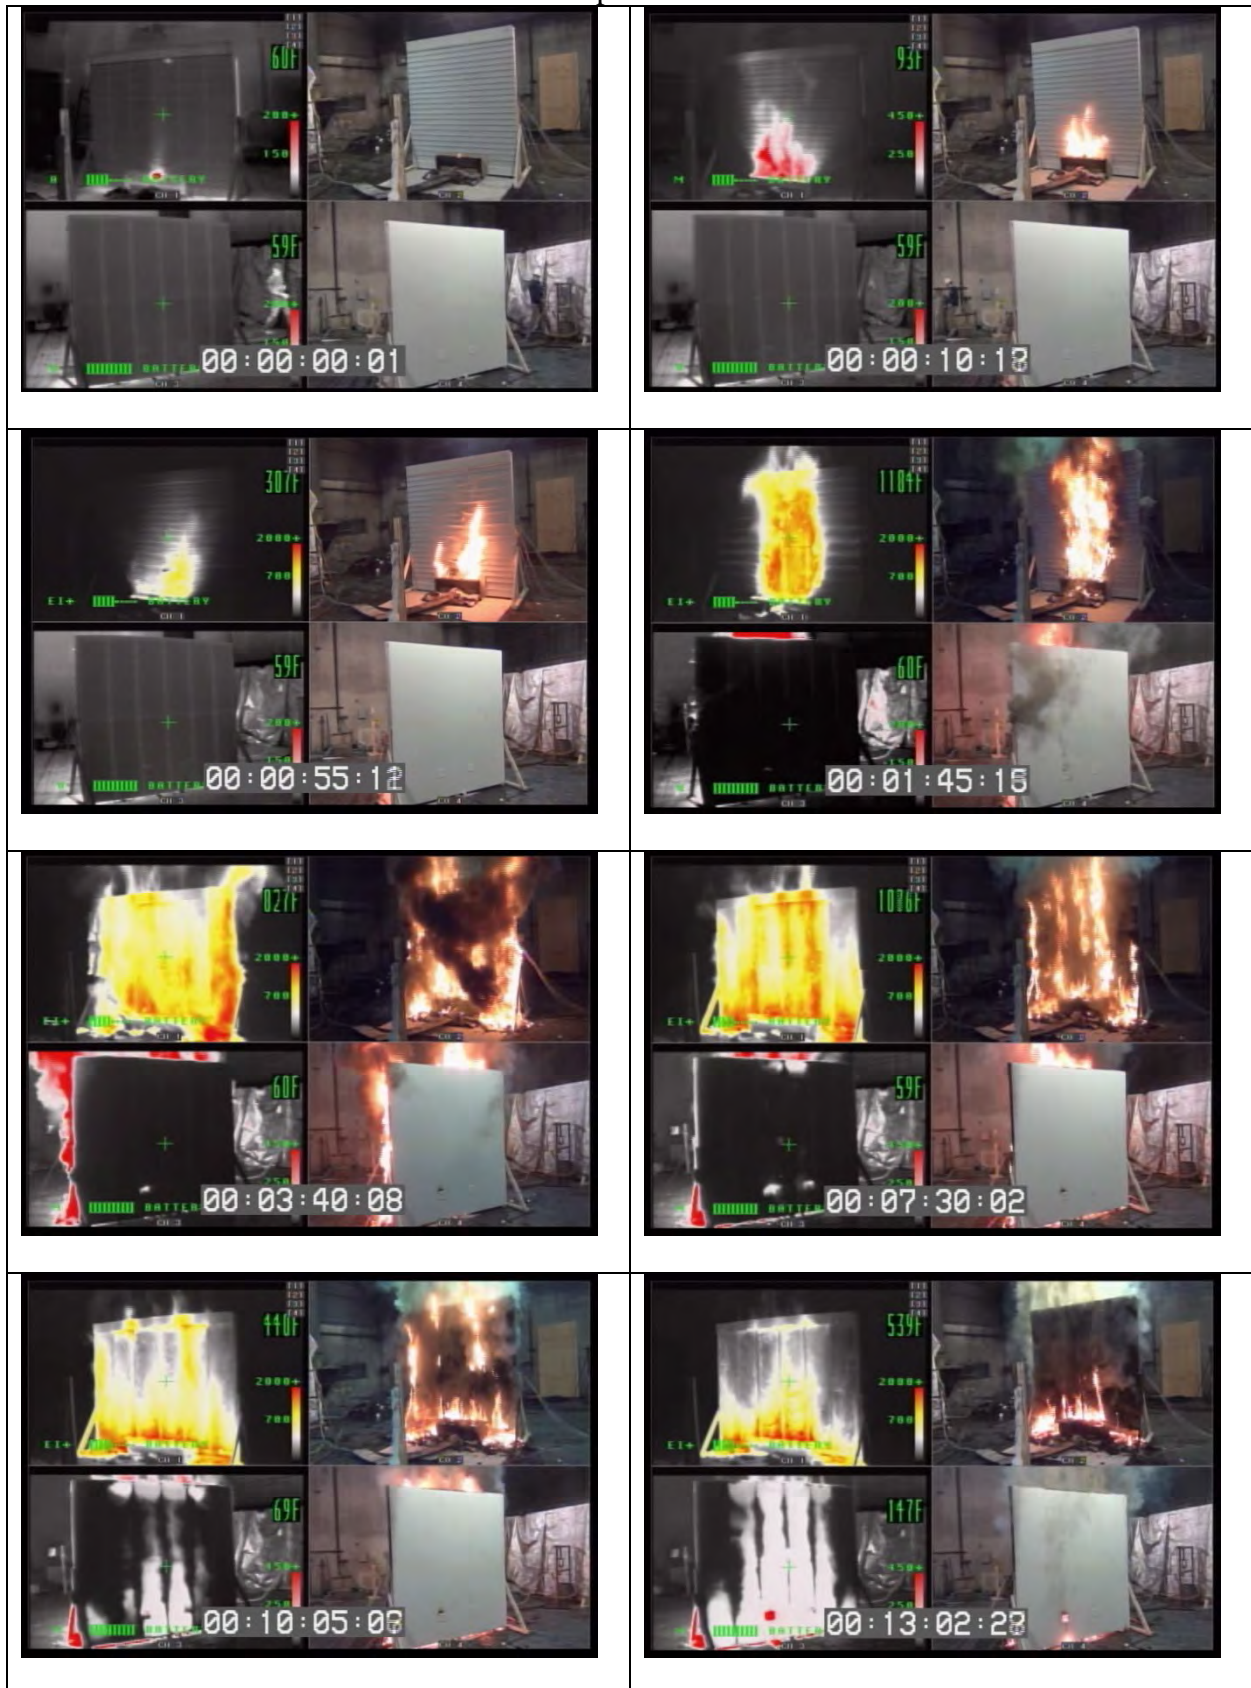
Table 6. 36: Experiment 12 Pictures

Time (mm:ss)	Description
00:00	Experiment begins
00:10	Burner is on and reaching desired 100 kW heat release rate
00:55	Vinyl siding begins to melt and burn, flames spread up the wall

01:45	Flames reach top of the wall and extend above the wall
03:40	Large amounts of smoke and flame extending from the wall, also large amount of burning occurring on the ground

07:30	Flames still present in the studs and insulation, burning still occurring on the ground
10:05	Burner turned off, flames still near the top of the wall, above the burner, and on the ground

13:02	Much of the flame has reduced, only remaining above the burner and on the ground, back of the wall has been burned through at the receptacle, smoke rising out of the hole in the back of the wall

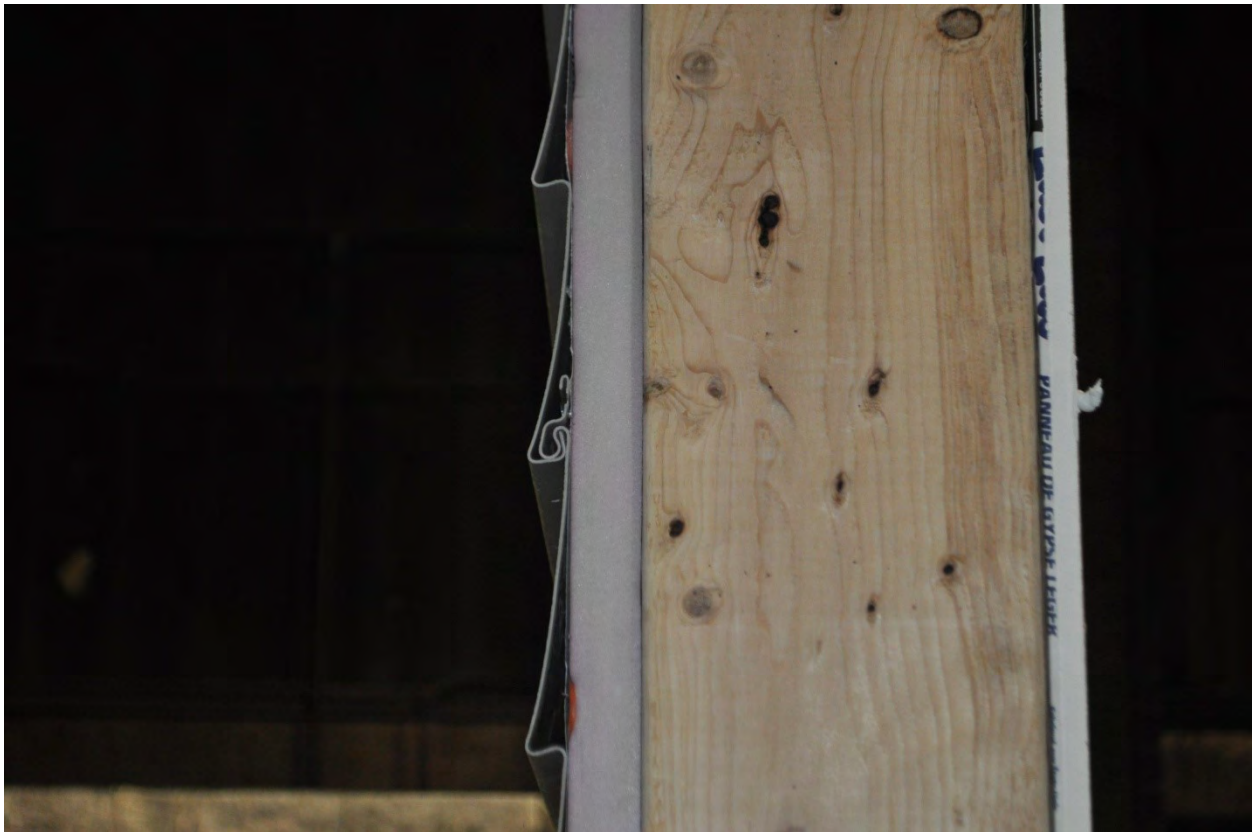
Figure 6. 20: Wall Type 8-R Side View

Table 6. 38: Wall Type and Material for Experiment 13 (100 kW)

Wall Type	Siding	Additional Material	Sheathing	Insulation	Back Wall
Wall 8-R	Double 4" Vinyl Siding	Weather-Resistant Barrier	1" R-5 EPS Insulation Board	2x6, R-19 KFI w/ IVB	1/2" Gypsum Board

The layout of the wall and materials used for each layer of the wall are specified in Table 6. 38. A side view of the wall is shown in Figure 6. 20. This wall also had receptacles on the back wall. The burner heat release rate (HRR) was 100 kW for Experiment 13 while the burner was on. Photos from Experiment 13 are displayed in Table 6. 39. A timeline of the events within Experiment 13, matching with the photos in Table 6. 39, is shown in Table 6. 40. Heat release rate data, heat flux data, and temperature data from Experiment 13 are shown in appendix G, figures G.73-G.78.

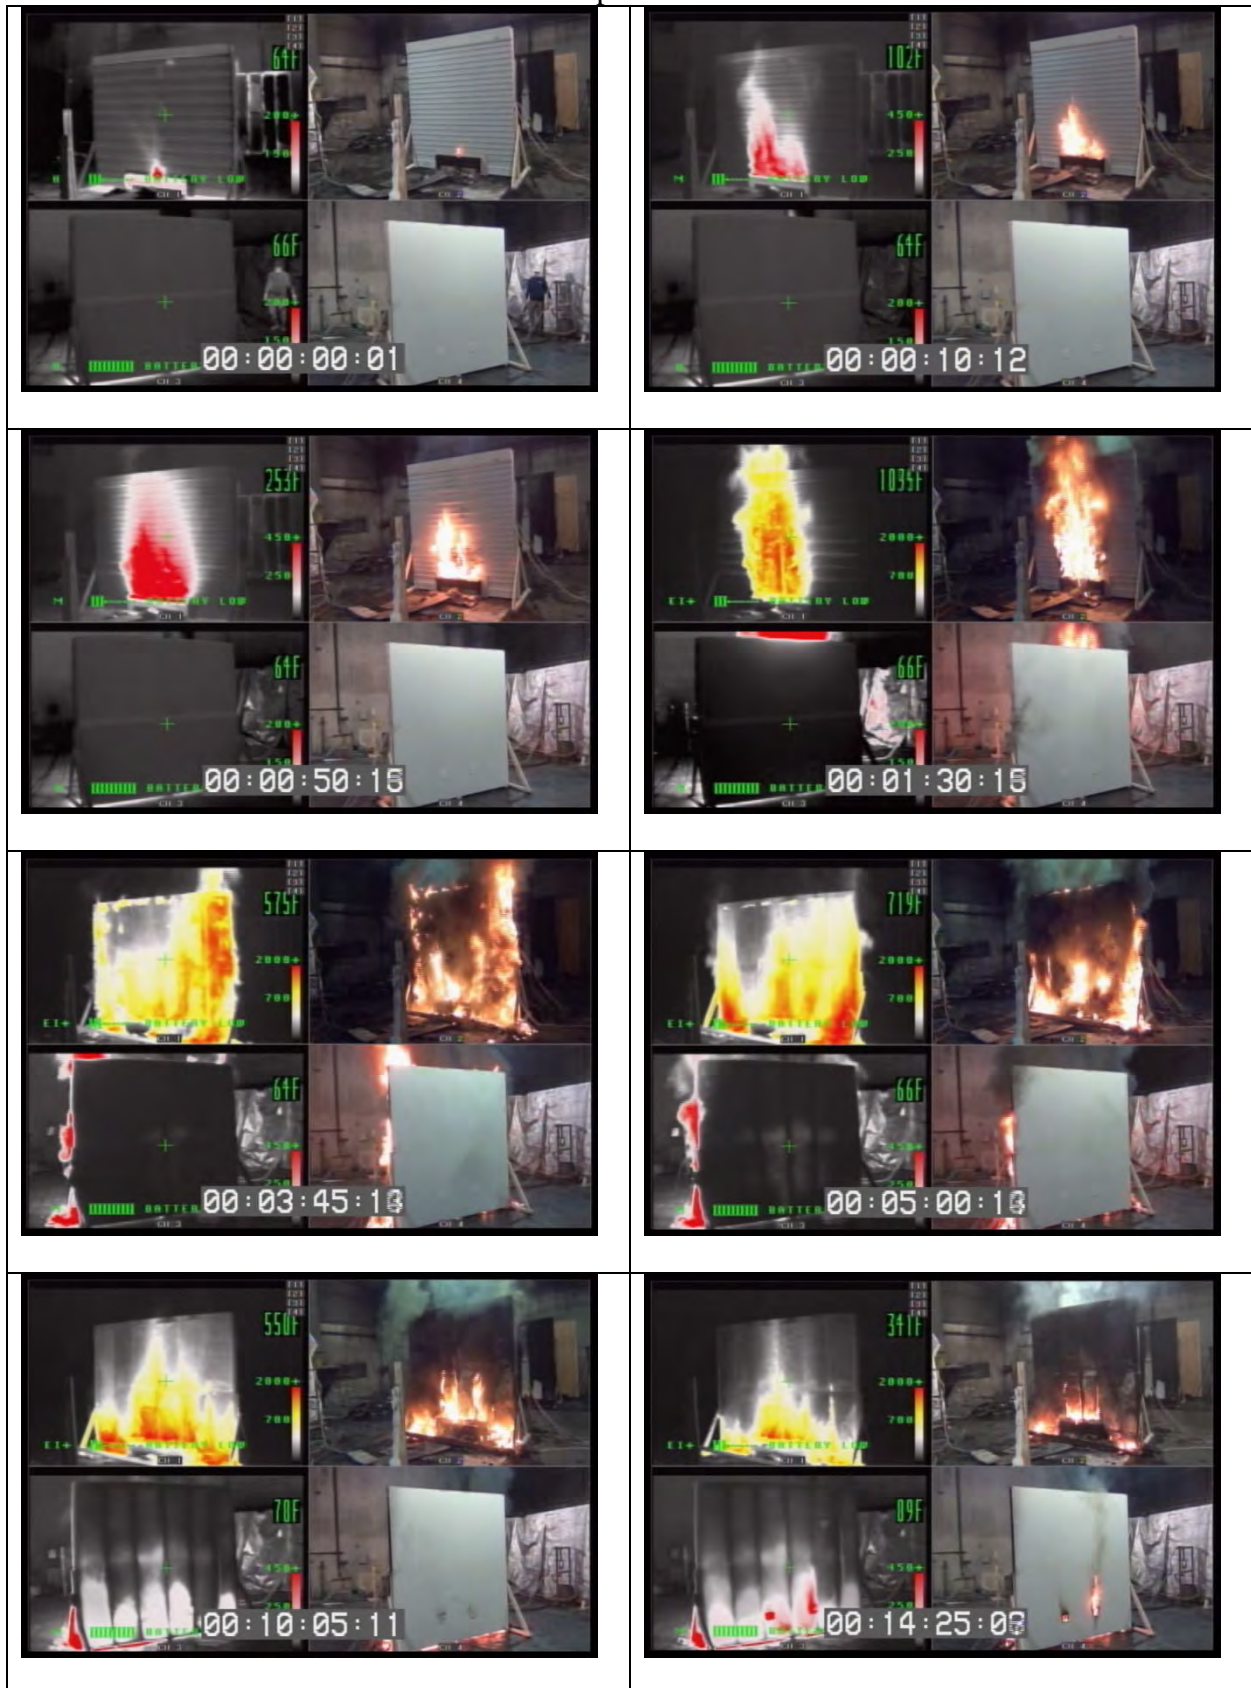
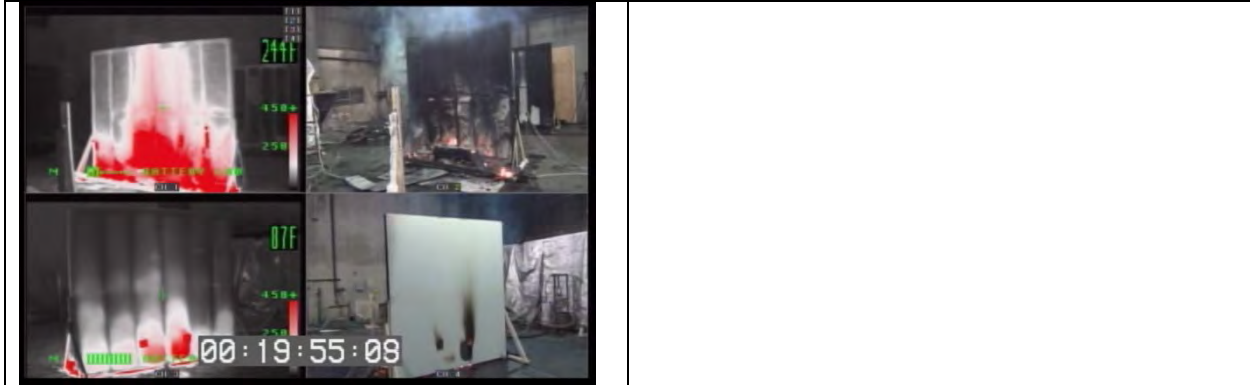
Table 6. 39: Experiment 13 Pictures

Time (mm:ss)	Description
00:00	Experiment begins
00:10	Burner is on and reaching desired 100 kW heat release rate
00:50	Vinyl siding begins to melt and burn, flames spread up the wall
01:30	Flames reach top of the wall and extend above the wall
03:45	Most of the vinyl siding has burned off, still large amounts flame originating on the ground and right side of the wall
05:00	Burning still occurring on the ground in front of the wall
10:05	Burner turned off, flames still on the ground and above the burner, discoloration seen on back of the wall
14:25	Two holes on back of the wall, flames coming from one of the receptacle holes
19:55	The fire has self-extinguished, large amount of charring on the back wall, experiment is over

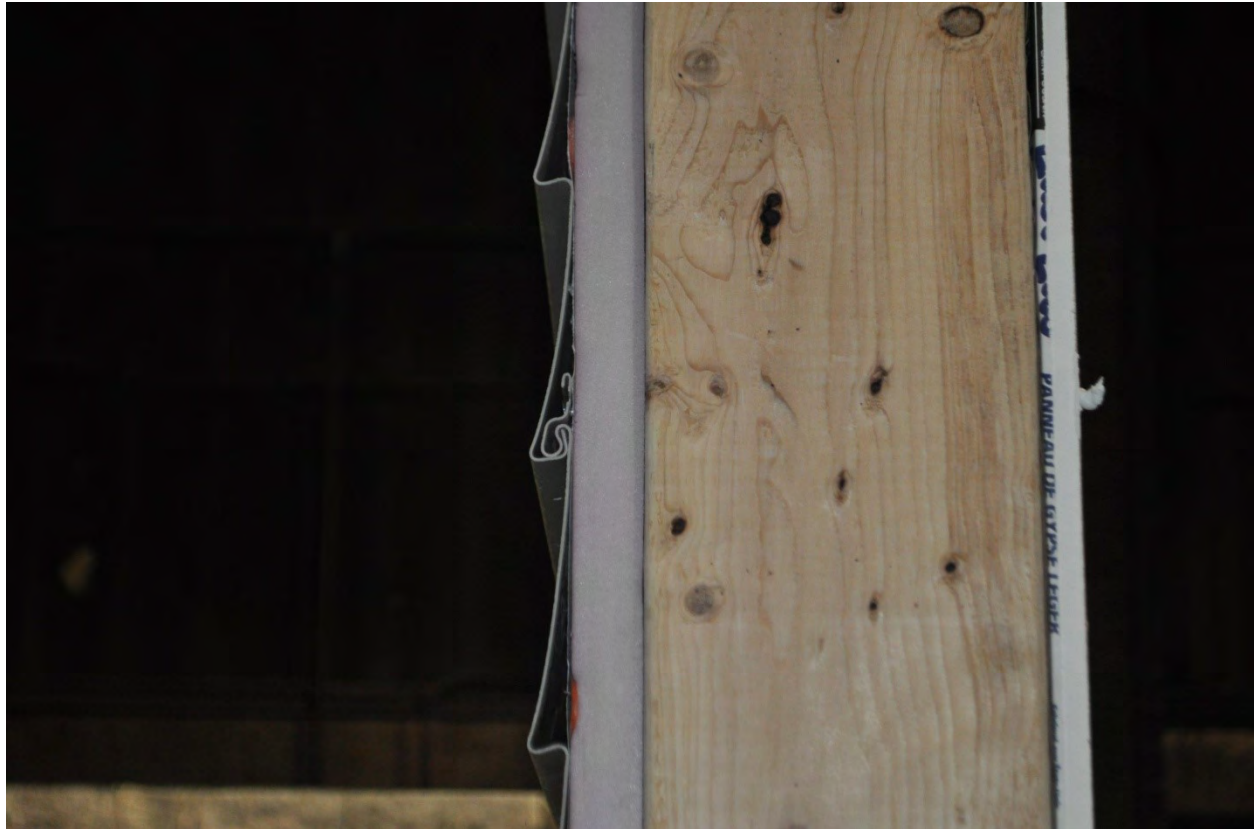
Figure 6. 22: Wall Type 8 Side View

Table 6. 44: Wall Type and Material for Experiment 15 (Grill)

Wall Type	Siding	Additional Material	Sheathing	Insulation	Back Wall
Wall 8	Double 4" Vinyl Siding	Weather-Resistant Barrier	1" R-5 EPS Insulation Board	2x6, R-19 KFI w/ IVB	1/2" Gypsum Board

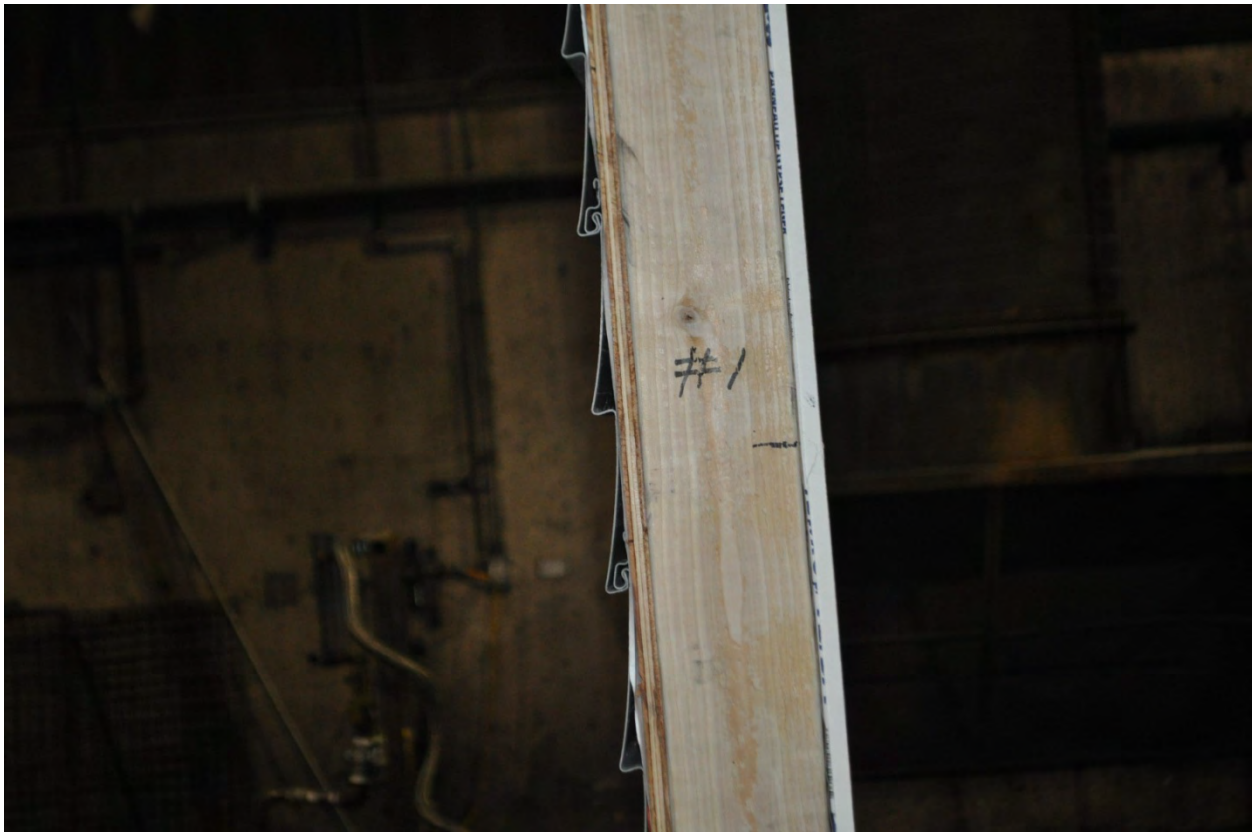
Figure 6. 23: Wall Type 8 Side View

Table 6. 47: Wall Type and Material for Experiment 16 (Grill)

Wall Type	Siding	Additional Material	Sheathing	Insulation	Back Wall
Wall 1	Double 4" Vinyl Siding	Weather-Resistant Barrier	1/2" Plywood Sheathing	2x6, R-19 KFI w/ IVB	1/2" Gypsum Board

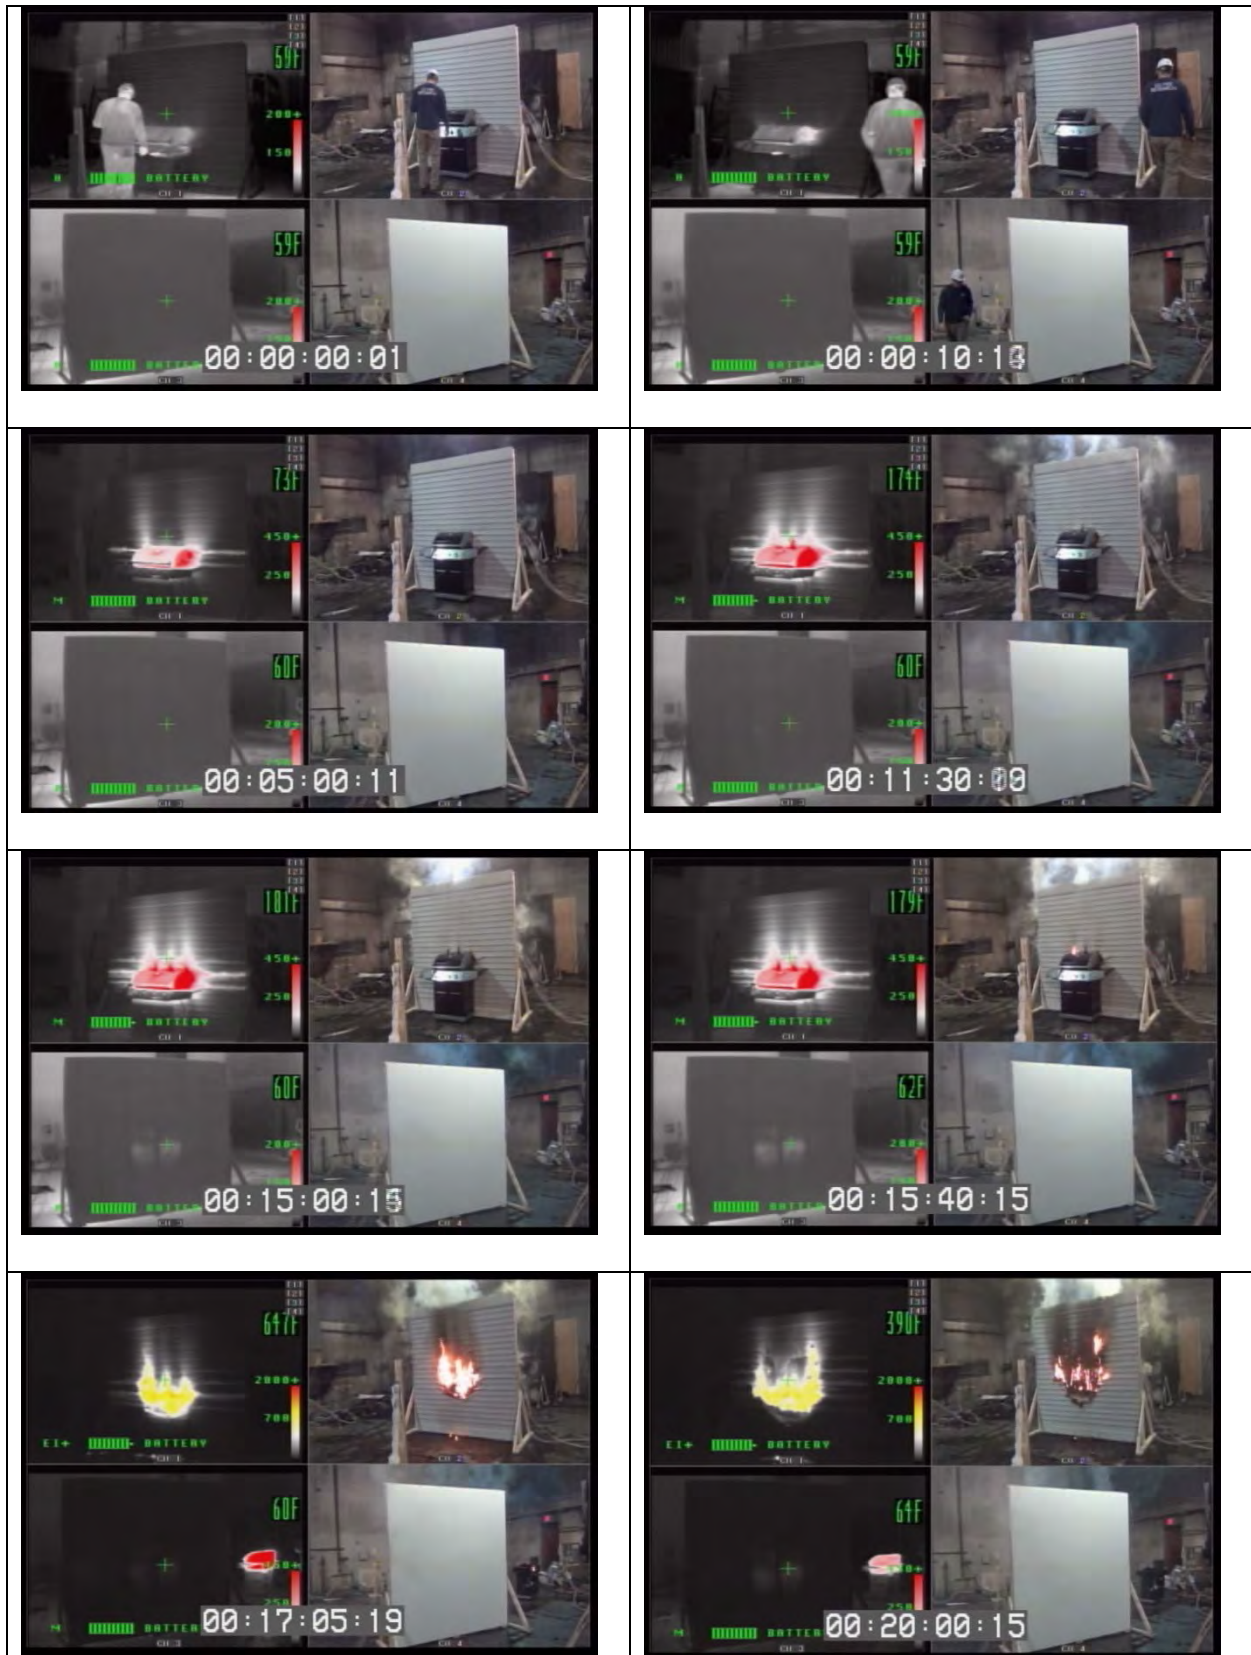
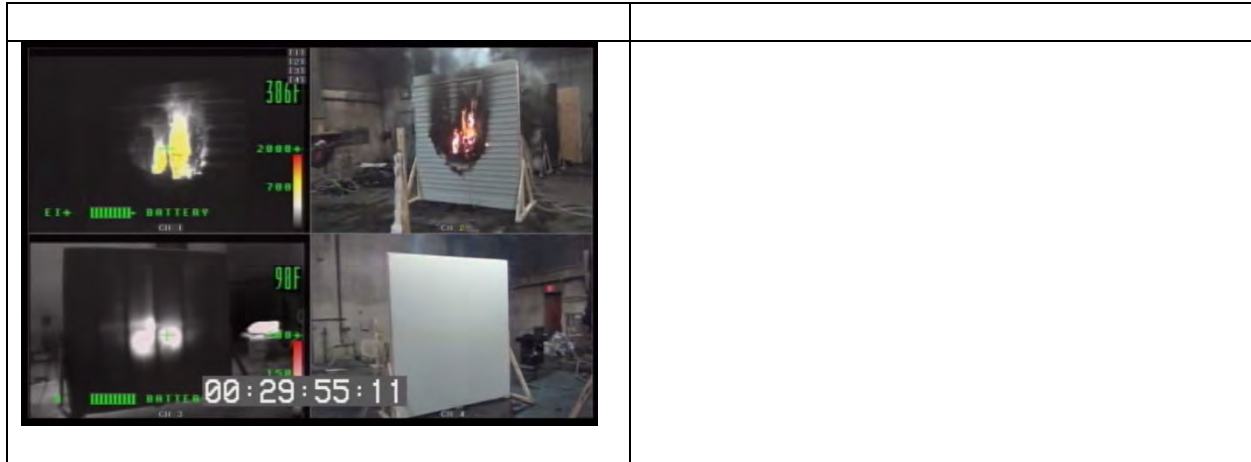
Table 6. 48: Experiment 16 Pictures

Time (mm:ss)	Description
00:00	Experiment begins
00:10	Grill is on and heating up
05:00	Only a very small amount of melting of the vinyl siding
11:30	First separating of vinyl siding is seen just above the grill
15:00	Another separation point of the vinyl siding is seen above the grill
15:40	Flames are seen for first time
17:05	Fire begins to grow, grill is removed
20:00	Fire begins to die down, does not reach top of the wall
29:55	Some fire still remains but it has not grown, soot and charring is seen on some of the wall, experiment is over

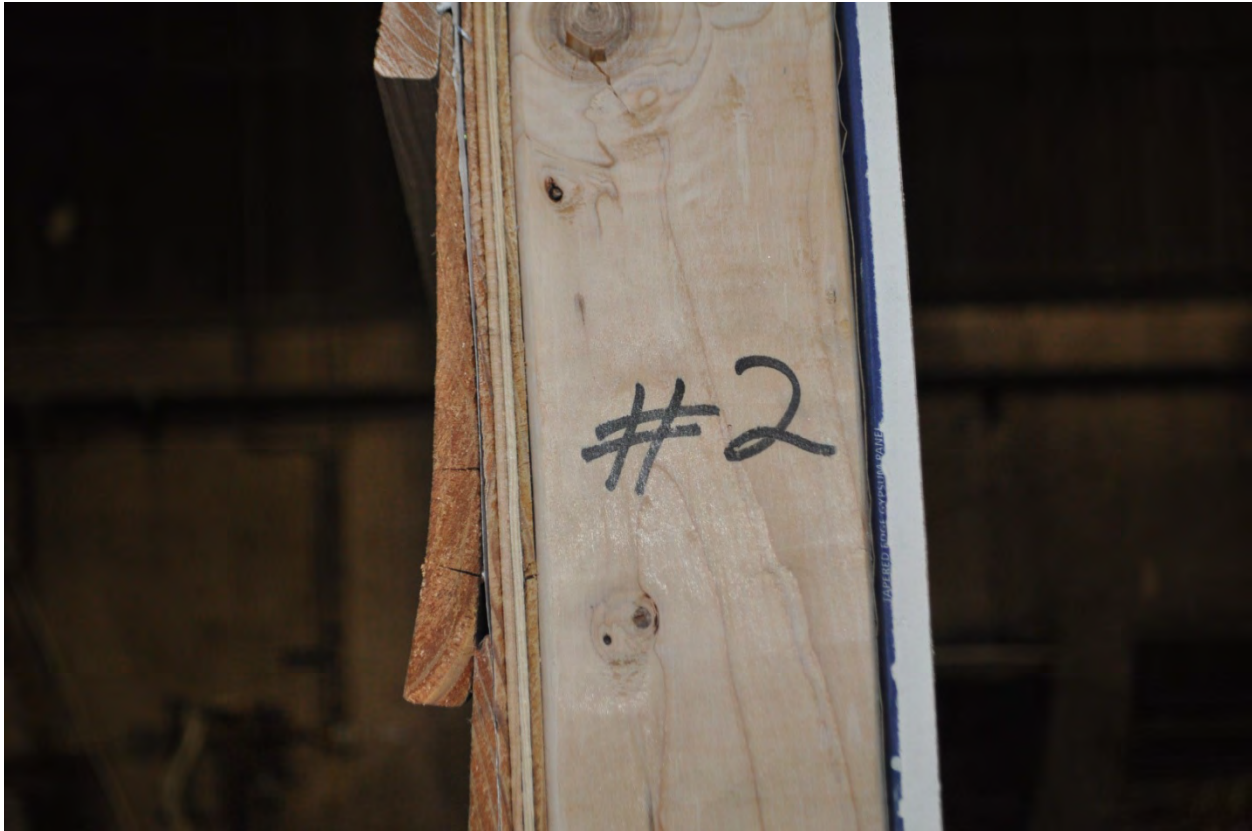
Figure 6. 24: Wall Type 2 Side View

Table 6. 50: Wall Type and Material for Experiment 17 (100 kW)

Wall Type	Siding	Additional Material	Sheathing	Insulation	Back Wall
Wall 2	8" Wood Lap Siding	Weather-Resistant Barrier	1/2" Plywood Sheathing	2x4, R-13 KFI w/ IVB	1/2" Gypsum Board

The layout of the wall and materials used for each layer of the wall are specified in Table 6. 50. A side view of the wall is shown in Figure 6. 24. The burner heat release rate (HRR) was 100 kW for Experiment 17 while the burner was on. Photos from Experiment 17 are displayed in Table 6. 51. A timeline of the events within Experiment 17, matching with the photos in Table 6. 51, is shown in Table 6. 52. Heat release rate data, heat flux data, and temperature data from Experiment 17 are shown in appendix G, figures G.97-G.102.

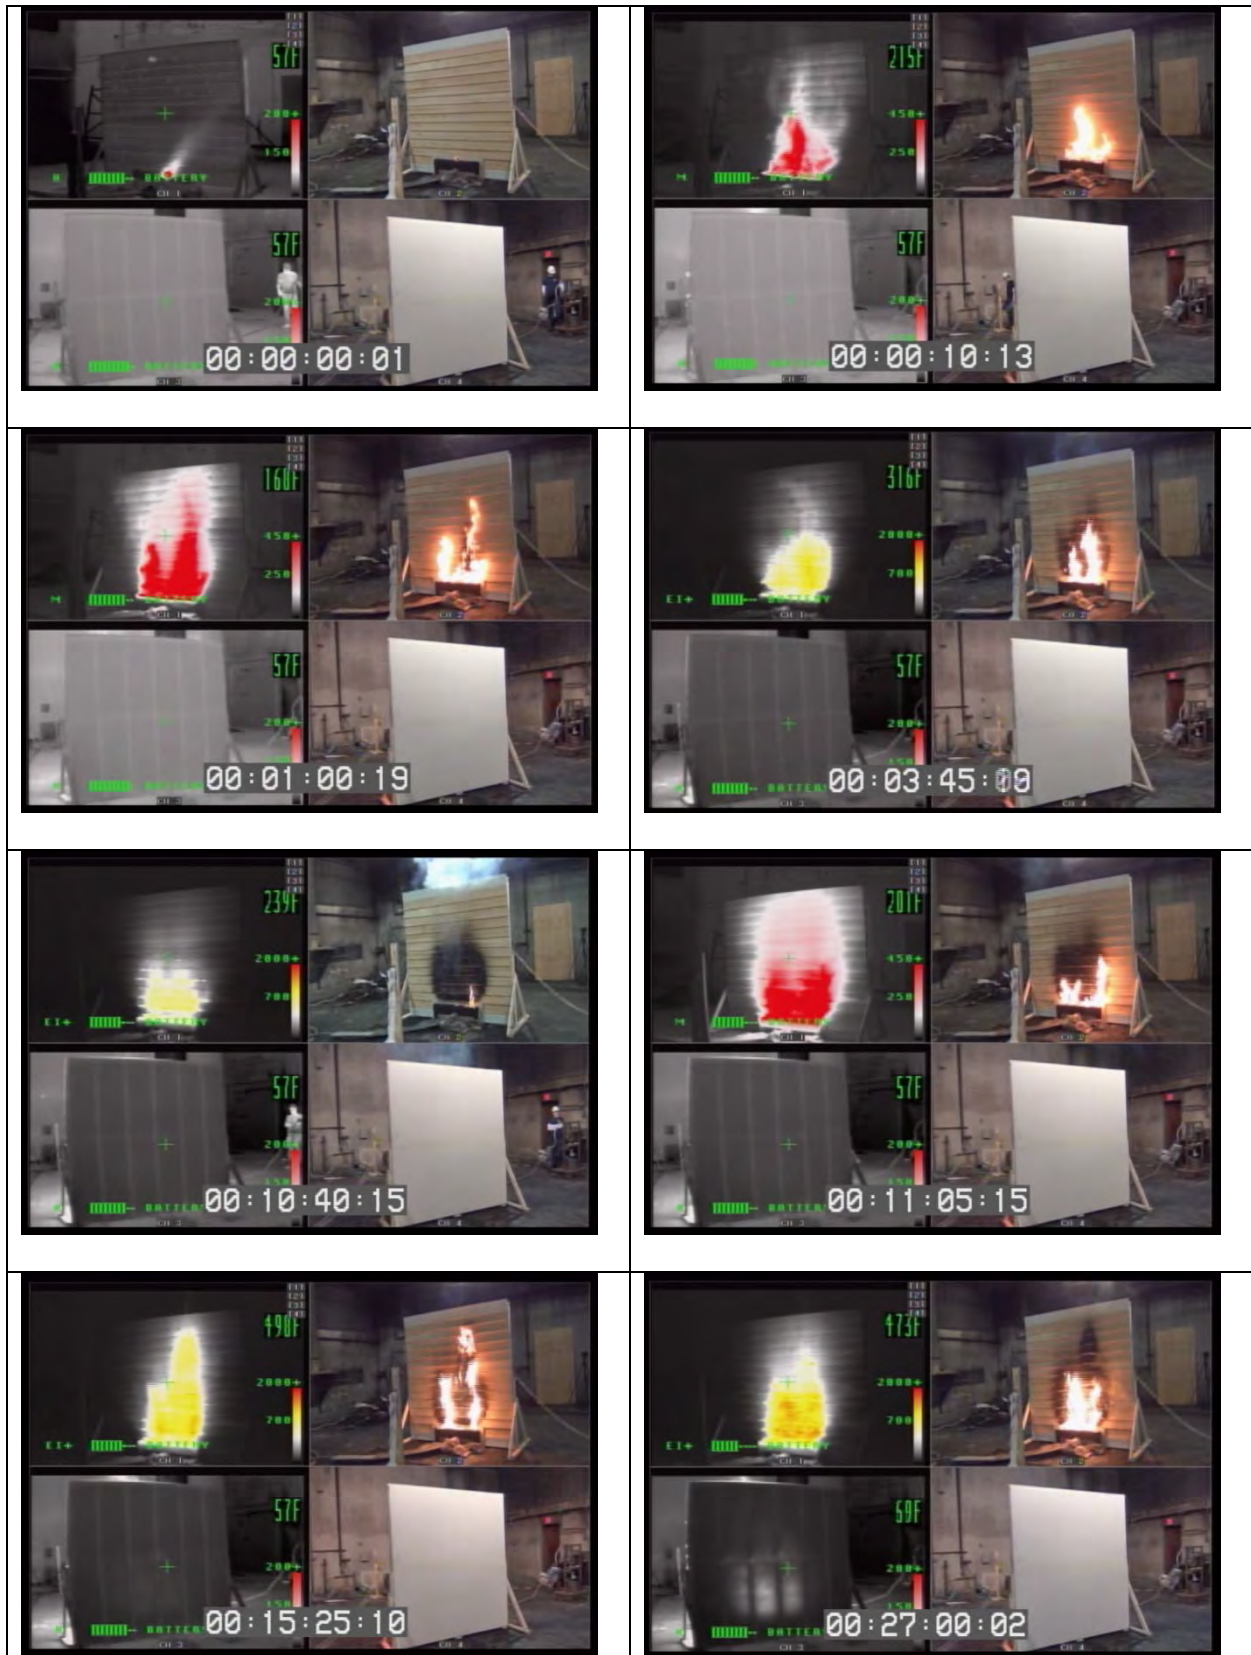
Table 6. 51: Experiment 17 Pictures

Time (mm:ss)	Description
00:00	Experiment begins
00:10	Burner is on and reaching desired 100 kW heat release rate
01:00	Charring is visible but most the flame is from the burner
03:45	Charring has increased along the surface of the siding but still most of the flame is from the burner
10:40	Burner is turned off, no flame remains on the wall
11:05	Burner is turned back on
15:25	Charring increases up along the wall, reaching the top
27:00	Flame is again reduced to mostly just the burner
29:25	Flame spread up the wall, again reaching the top
30:05	Burner is turned off, some flame remains just above the burner in the center of the wall
34:50	Some fire still remains on the lower center part of the wall, experiment is over

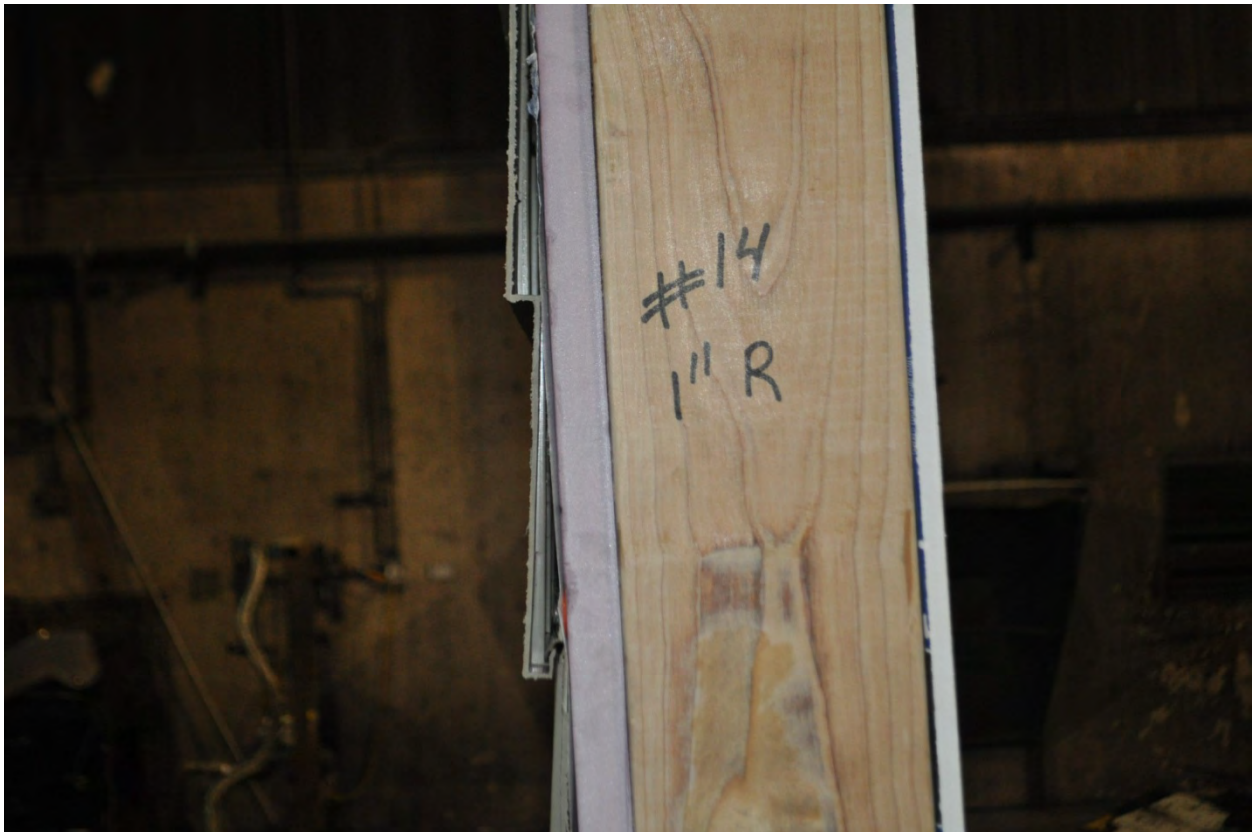
Figure 6. 25: Wall Type 14 Side View

Table 6. 53: Wall Type and Material for Experiment 18 (100 kW)

Wall Type	Siding	Additional Material	Sheathing	Insulation	Back Wall
Wall 14	Double 7" Polypropylene Shingle Siding	Weather-Resistant Barrier	1" R-5 EPS Insulation Board	2x6, R-19 KFI w/ IVB	1/2" Gypsum Board

The layout of the wall and materials used for each layer of the wall are specified in Table 6. 53. A side view of the wall is shown in Figure 6. 25. The burner heat release rate (HRR) was 100 kW for Experiment 18 while the burner was on. Photos from Experiment 18 are displayed in Table 6. 54. A timeline of the events within Experiment 18, matching with the photos in Table 6. 54, is shown in Table 6. 55. Heat release rate data, heat flux data, and temperature data from Experiment 18 are shown in appendix G, figures G.103-G.108.

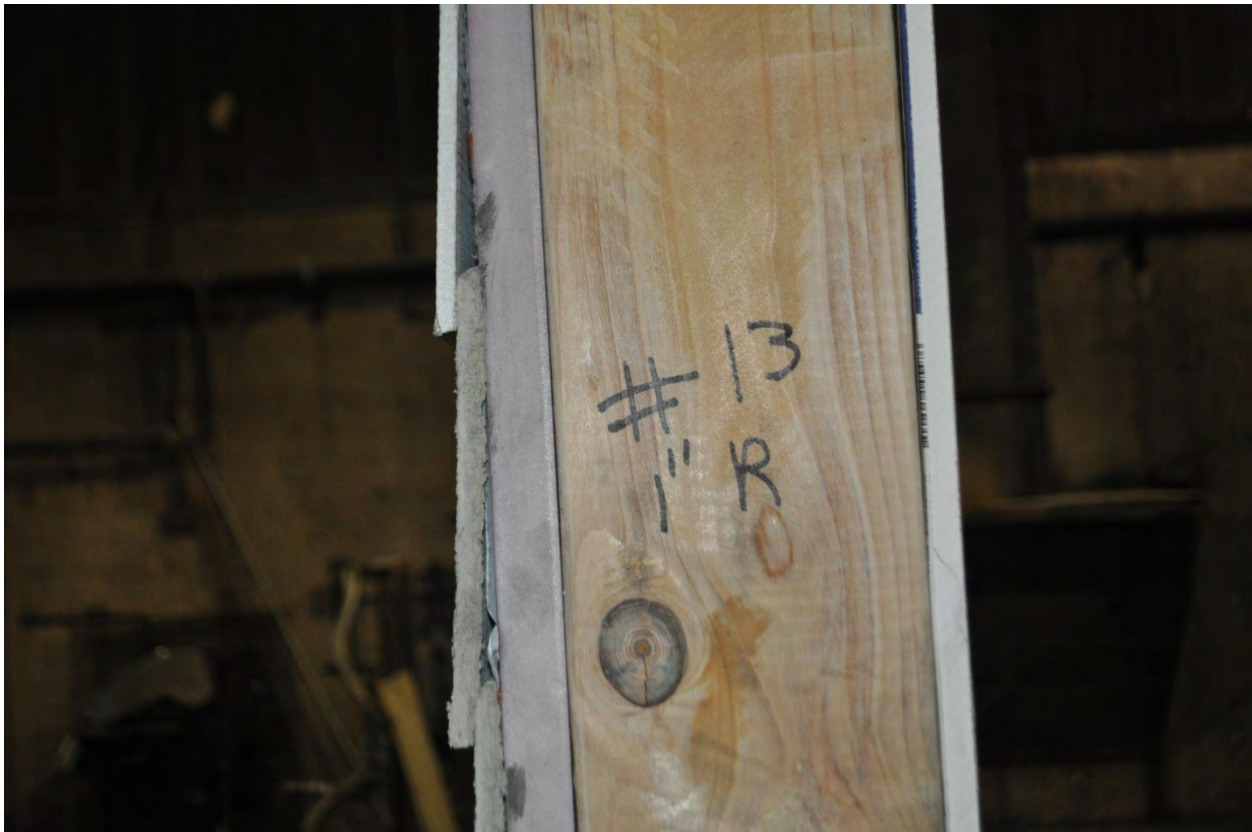
Figure 6. 26: Wall Type 13 Side View

Table 6. 56: Wall Type and Material for Experiment 19 (100 kW)

Wall Type	Siding	Additional Material	Sheathing	Insulation	Back Wall
Wall 13	8" Fiber Cement Siding	Weather-Resistant Barrier	1" R-5 EPS Insulation Board	2x6, R-19 KFI w/ IVB	1/2" Gypsum Board

The layout of the wall and materials used for each layer of the wall are specified in Table 6. 56. A side view of the wall is shown in Figure 6. 26. The burner heat release rate (HRR) was 100 kW for Experiment 19 while the burner was on. Photos from Experiment 19 are displayed in Table 6. 57. A timeline of the events within Experiment 19, matching with the photos in Table 6. 57, is shown in Table 6. 58. Heat release rate data, heat flux data, and temperature data from Experiment 19 are shown in appendix G, figures G.109-G.114.
