Study of Residential Attic Fire Mitigation Tactics and Exterior Fire Spread Hazards on Fire Fighter Safety

UL Firefighter Safety Research Institute

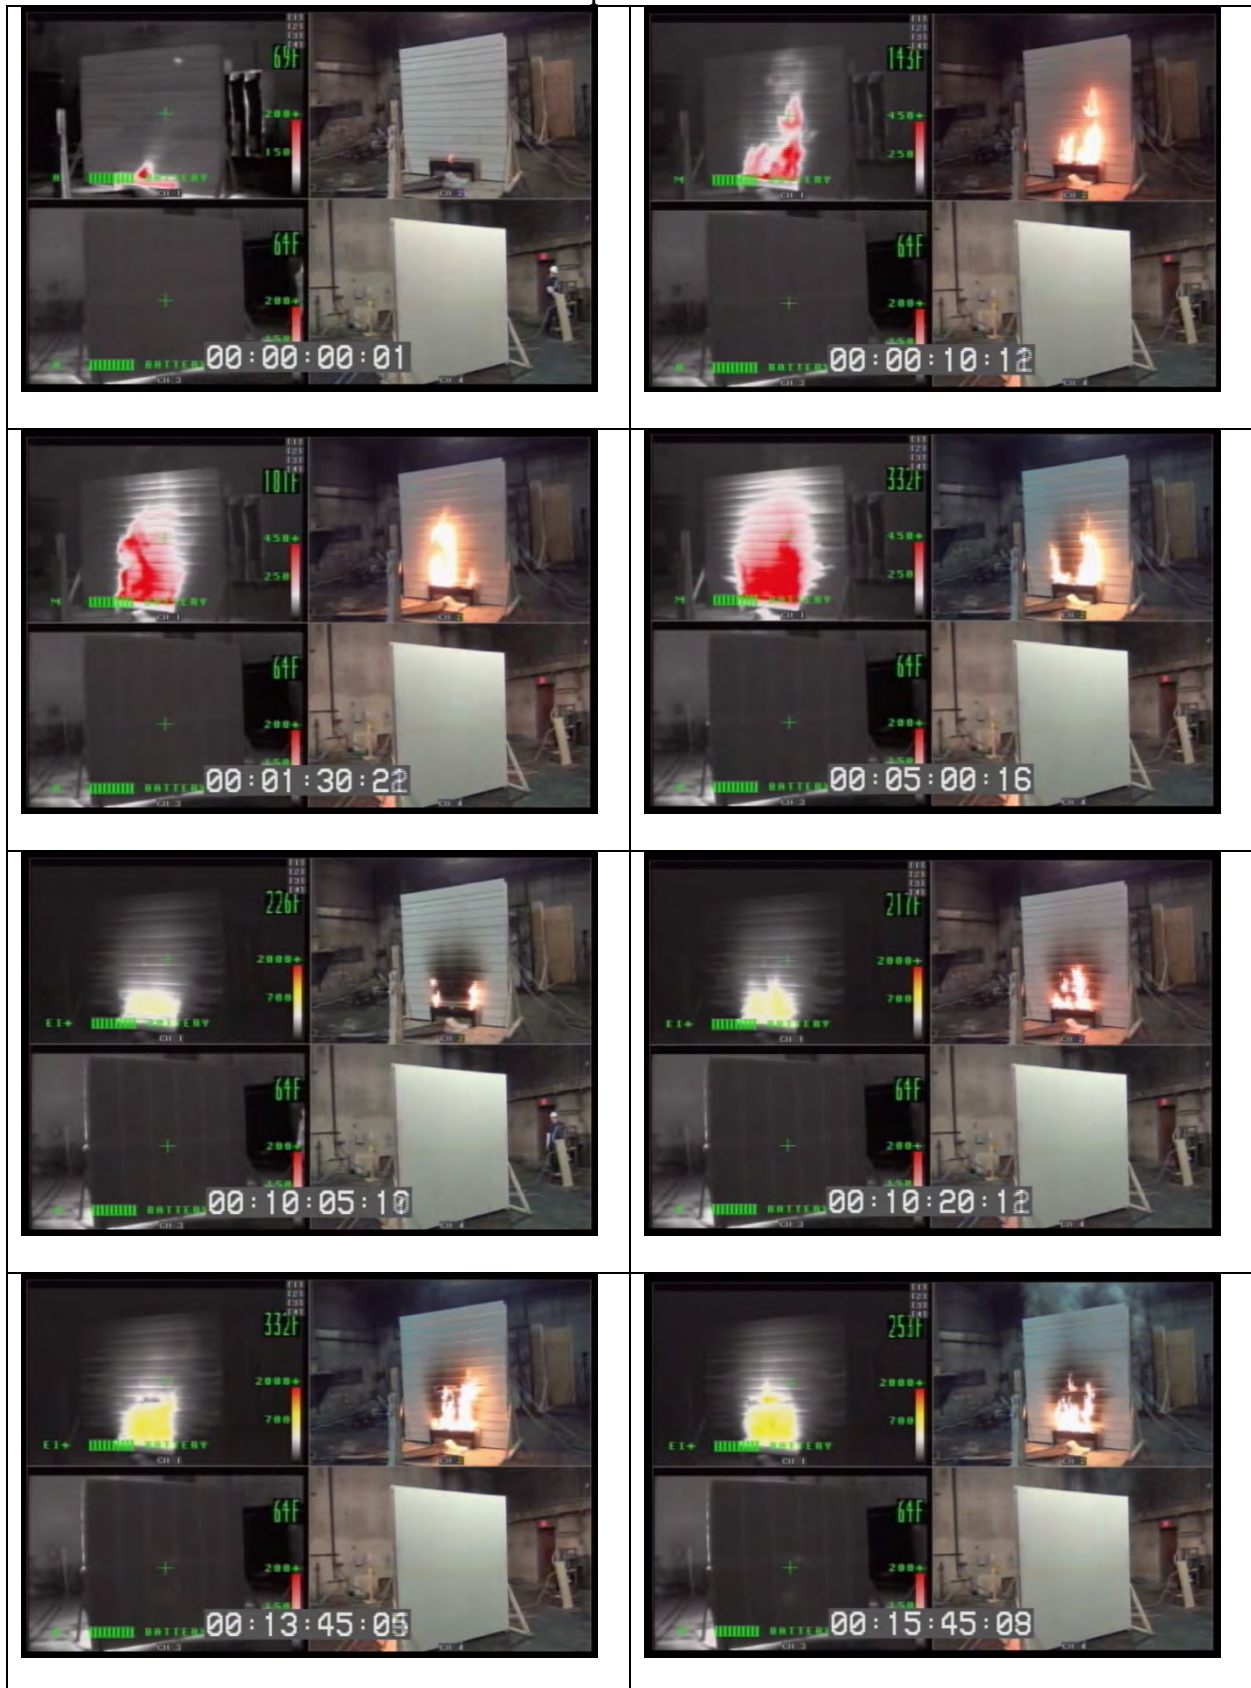
Table 6. 57: Experiment 19 Timeline

Time (mm:ss)	Description
00:00	Experiment begins
00:10	Burner is on and reaching desired 100 kW heat release rate
01:30	Small amount of charring on the siding

05:00	More charring seen on the siding, it is still not involved in the fire
10:05	Burner is turned off, charring of siding can be seen but no flame on the wall

10:20	Burner is turned back on
13:45	Some holes form in the siding exposing the sheathing underneath
15:45	Flame can be seen coming from the hole in the siding as the sheathing gets involved, smoke can be seen coming from the sides and top of the wall from under the siding

20:05	Burner is turned off, flames are now coming from the burning of the material under the siding
24:00	Large portions of the siding are falling off, flames can be seen underneath

27:55	Most of the flames are gone, only some burning in the upper right corner
29:55	Most of the fire has self-extinguished, experiment is over

The layout of the wall and materials used for each layer of the wall are specified in Table 6. 56. A side view of the wall is shown in Figure 6. 26. The burner heat release rate (HRR) was 100 kW for Experiment 19 while the burner was on. Photos from Experiment 19 are displayed in Table 6. 57. A timeline of the events within Experiment 19, matching with the photos in Table 6. 57, is shown in Table 6. 58. Heat release rate data, heat flux data, and temperature data from Experiment 19 are shown in appendix G, figures G.109-G.114.

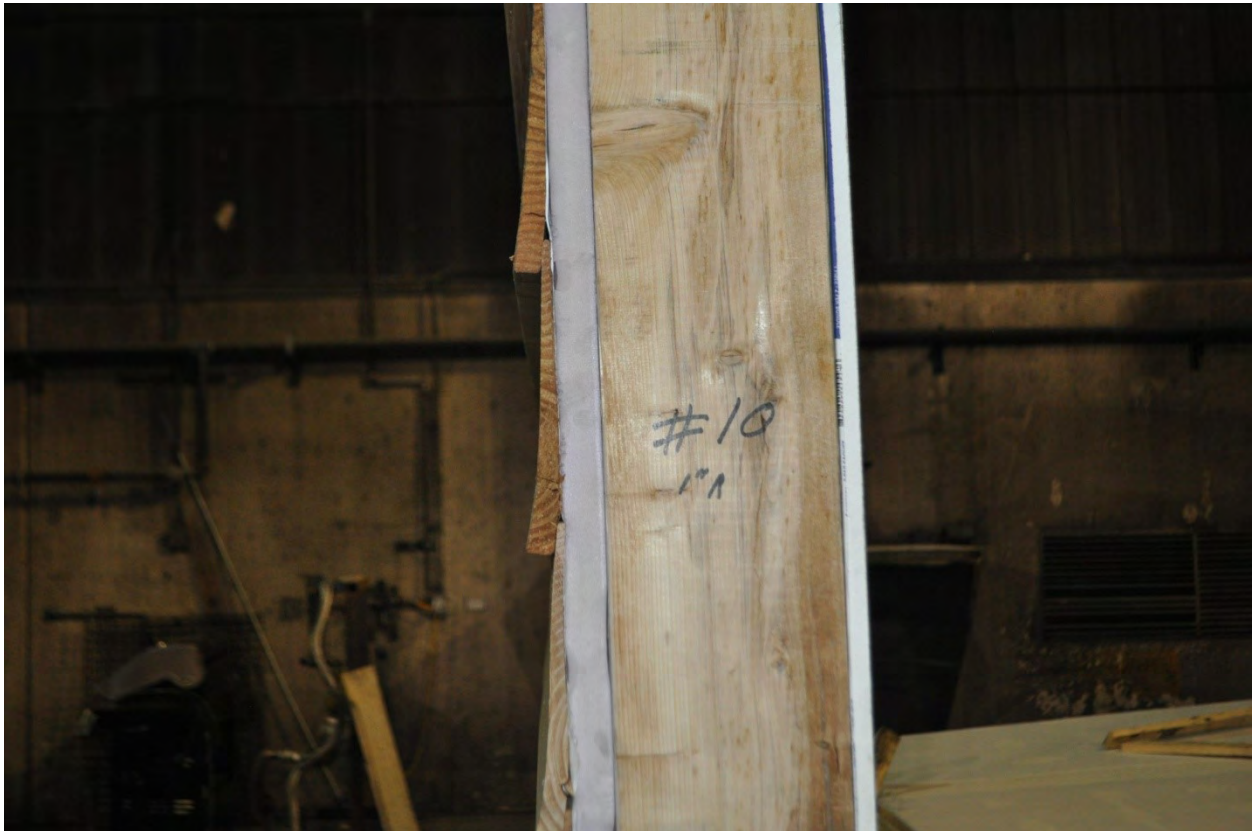
Figure 6. 28: Wall Type 10 Side View

Wall Type	Siding	Additional Material	Sheathing	Insulation	Back Wall
Wall 10	8" Wood Lap Siding	Weather-Resistant Barrier	1" R-5 EPS Insulation Board	2x6, R-19 KFI w/ IVB	1/2" Gypsum Board

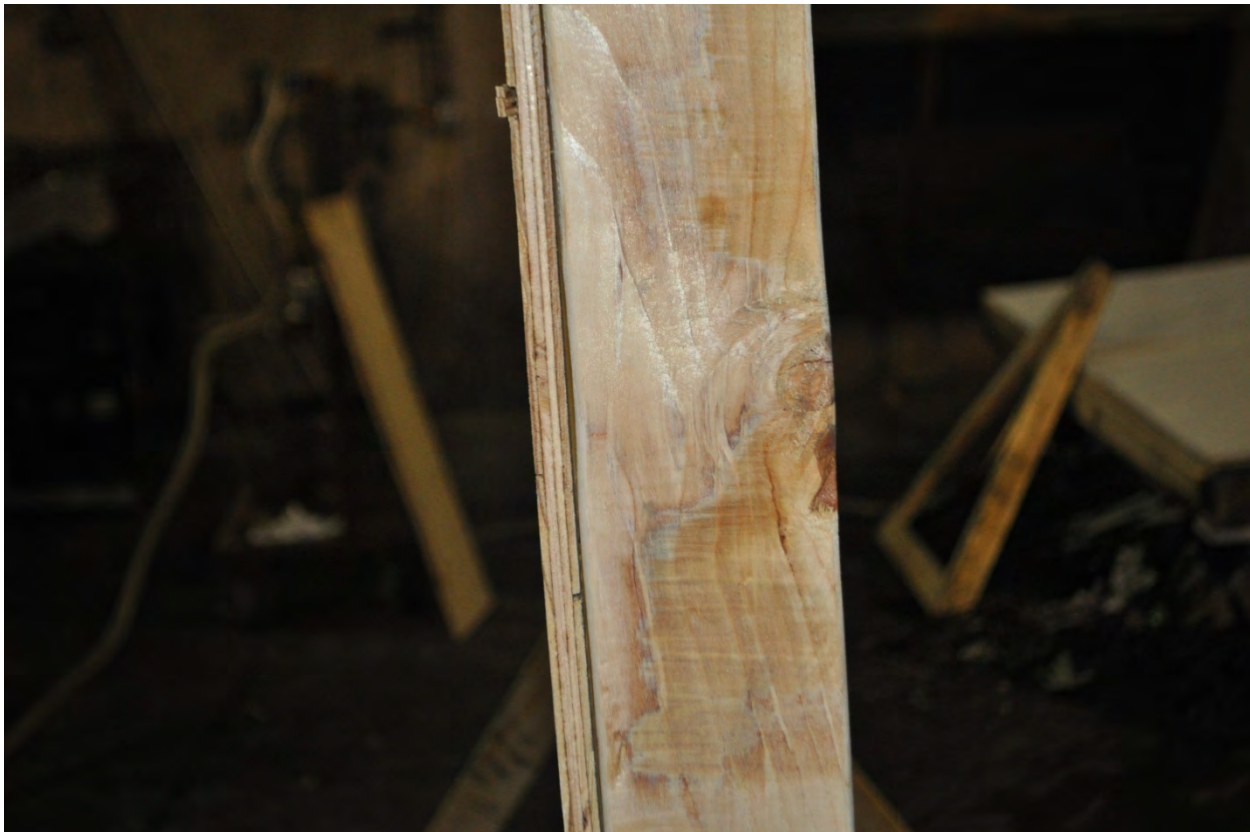
Figure 6. 29: Experiment 22 Side View

The layout of the wall and materials used for each layer of the wall are specified in Table 6. 65. A side view of the wall is shown in Figure 6. 29. The burner heat release rate (HRR) was 100 kW for Experiment 22 while the burner was on. Photos from Experiment 22 are displayed in Table 6. 66. A timeline of the events within Experiment 22, matching with the photos in Table 6. 66, is shown in Table 6. 67. Heat release rate data from Experiment 22 is shown in appendix G, figure G.123.

Wall Type	Siding	Additional Material	Sheathing	Insulation	Back Wall
N/A	None	None	1/2" Plywood	2x4 Studs w/ Open Space	None

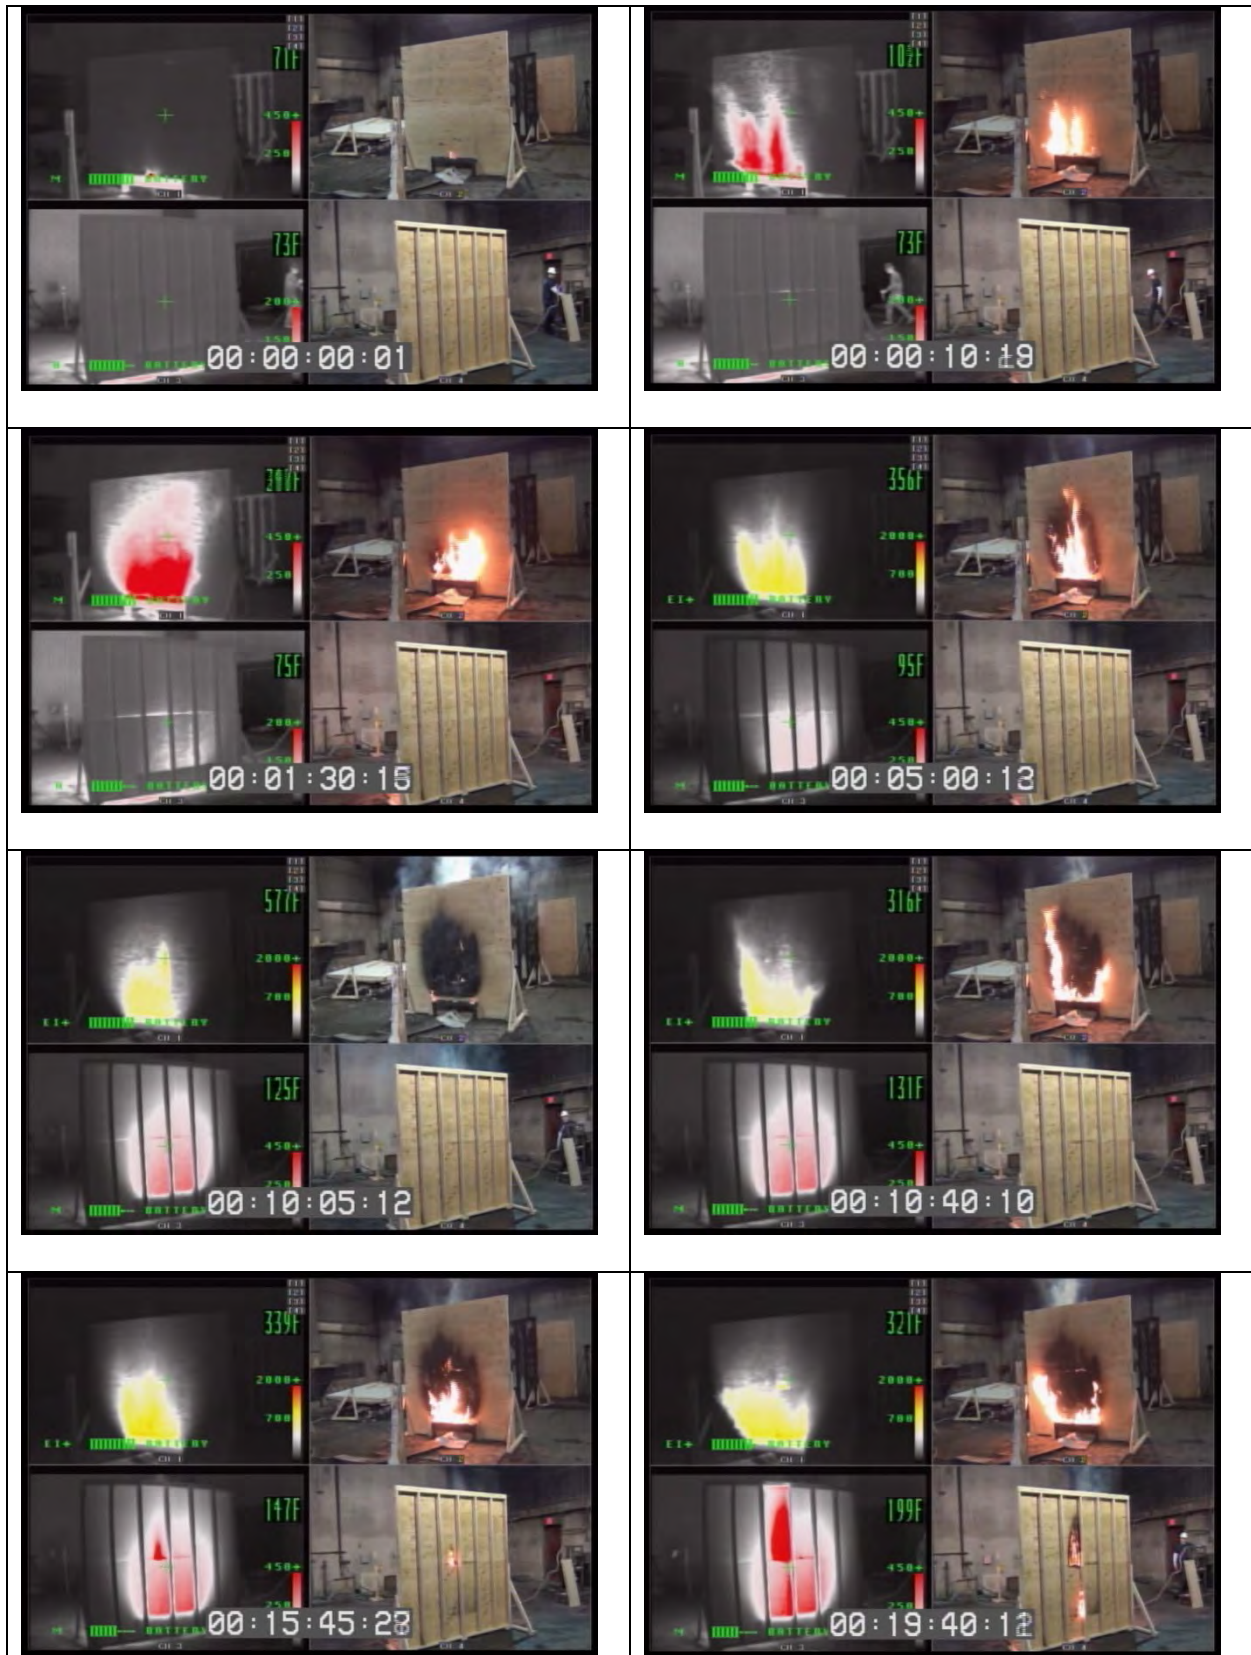
Table 6. 66: Experiment 22 Pictures

Time (mm:ss)	Description
00:00	Experiment begins
00:10	Burner is on and reaching desired 100 kW heat release rate
01:30	Some initial charring of the plywood
05:00	Charred area on the surface increases
10:05	Burner is turned off, no flame remains
10:40	Burner is turned back on
15:45	Flame breaks through plywood and burns out the other side
19:40	Flame breaks through plywood in an additional location
20:05	Burner is turned off, still some flame remains mostly on the back side of the plywood
25:00	Flame has grown on the back side and spread on both sides of the plywood, extending above the wall, experiment is over

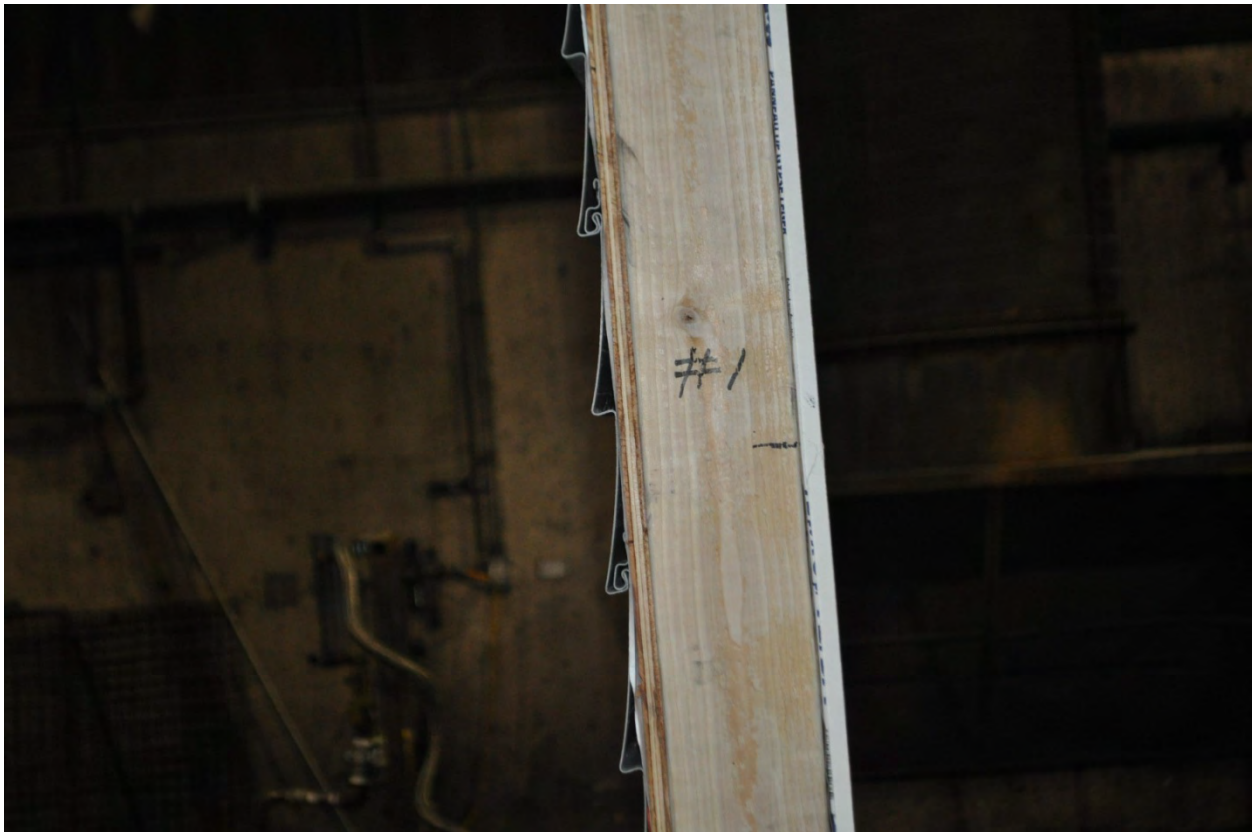
Figure 6. 30: Wall Type 1 Side View

The layout of the wall and materials used for each layer of the wall are specified in Table 6. 68. A side view of the wall is shown in Figure 6. 30. The burner heat release rate (HRR) was 25 kW for Experiment 23 while the burner was on. Photos from Experiment 23 are displayed in Table 6. 69. A timeline of the events within Experiment 23, matching with the photos in Table 6. 69, is shown in Table 6. 70. Heat release rate data, heat flux data, and temperature data from Experiment 23 are shown in appendix G, figure G.124-G.129.

Wall Type	Siding	Additional Material	Sheathing	Insulation	Back Wall
Wall 1	Double 4" Vinyl Siding	Weather-Resistant Barrier	1/2" Plywood Sheathing	2x4, R-13 KFI w/ IVB	1/2" Gypsum Board

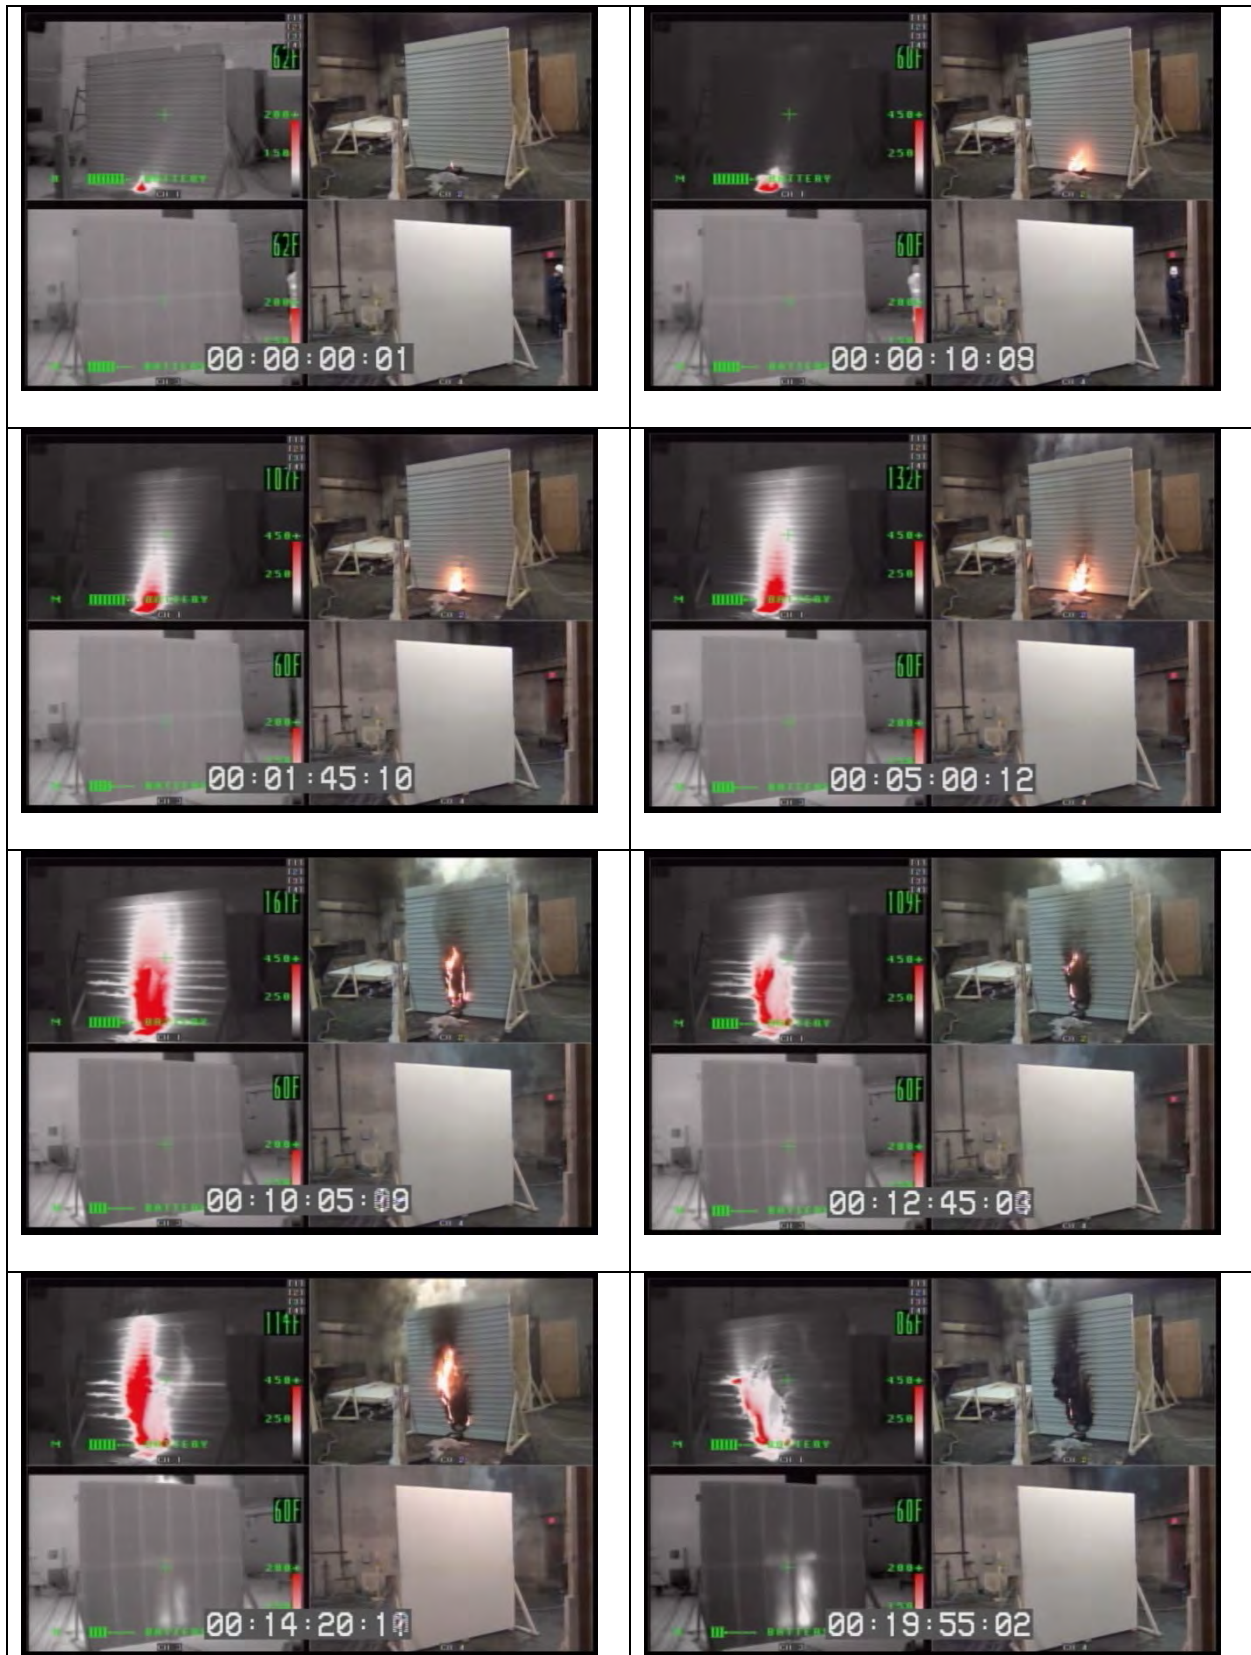
Table 6. 69: Experiment 23 Pictures

Time (mm:ss)	Description
00:00	Experiment begins
00:10	Burner is on and reaching desired 25 kW heat release rate
01:45	Some charring on the siding
05:00	Fire begins to grow, rising slightly up the wall
10:05	Burner is turned off, only the outer edge of the burnt region is flaming
12:45	Flame is dying out, has not gotten any higher
14:20	Left side of burnt region continues to burn
19:55	Fire has self-extinguished, never reached the top of the wall, experiment is complete

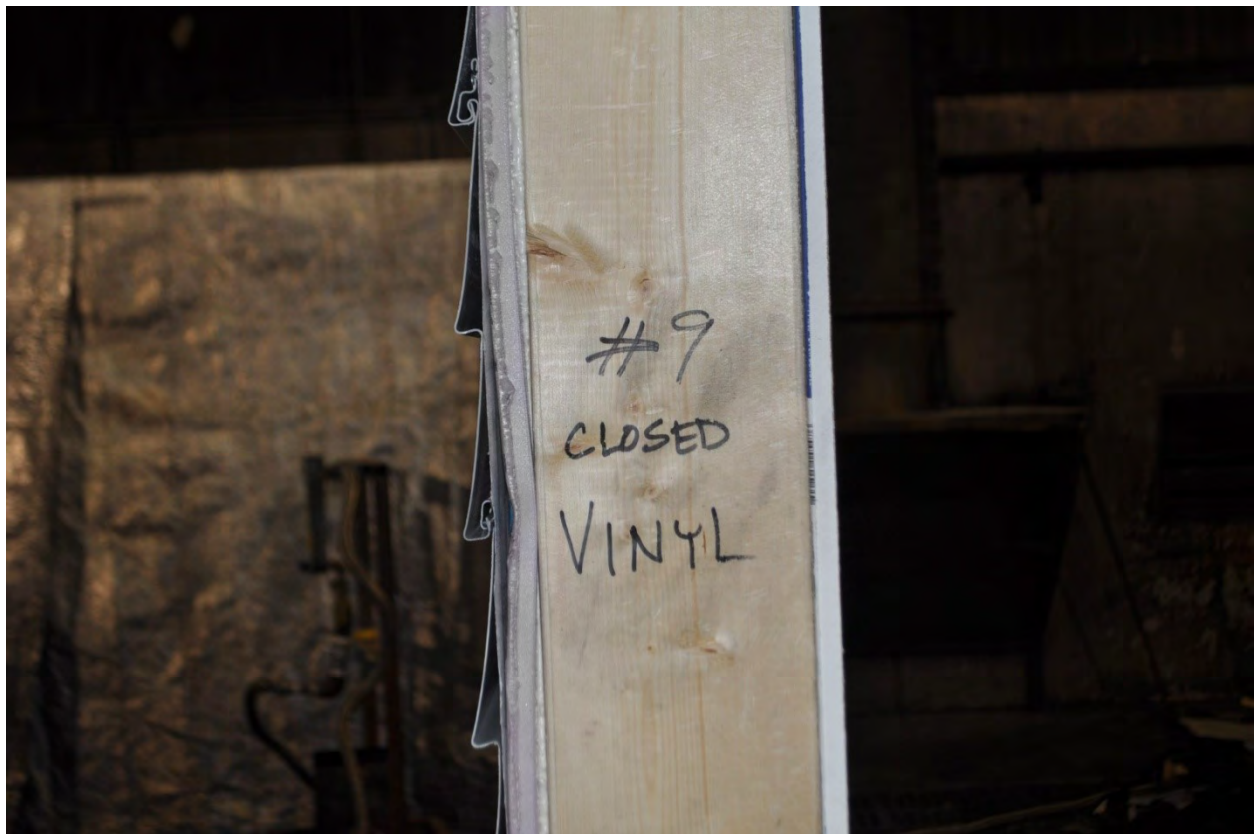
Figure 6. 31: Wall Type 9-C Side View

The layout of the wall and materials used for each layer of the wall are specified in Table 6. 71. A side view of the wall is shown in Figure 6. 31. The burner heat release rate (HRR) was 25 kW for Experiment 24 while the burner was on. Photos from Experiment 24 are displayed in Table 6. 72. A timeline of the events within Experiment 24, matching with the photos in Table 6. 72, is shown in Table 6. 73. Heat release rate data, heat flux data, and temperature data from Experiment 24 are shown in appendix G, figures G.130-G.135.

Wall Type	Siding	Additional Material	Sheathing	Insulation	Back Wall
Wall 9-C	Double 4" Vinyl Siding	Weather-Resistant Barrier	1" R-5 EPS Insulation Board	2x6, Closed Cell Foam	1/2" Gypsum Board

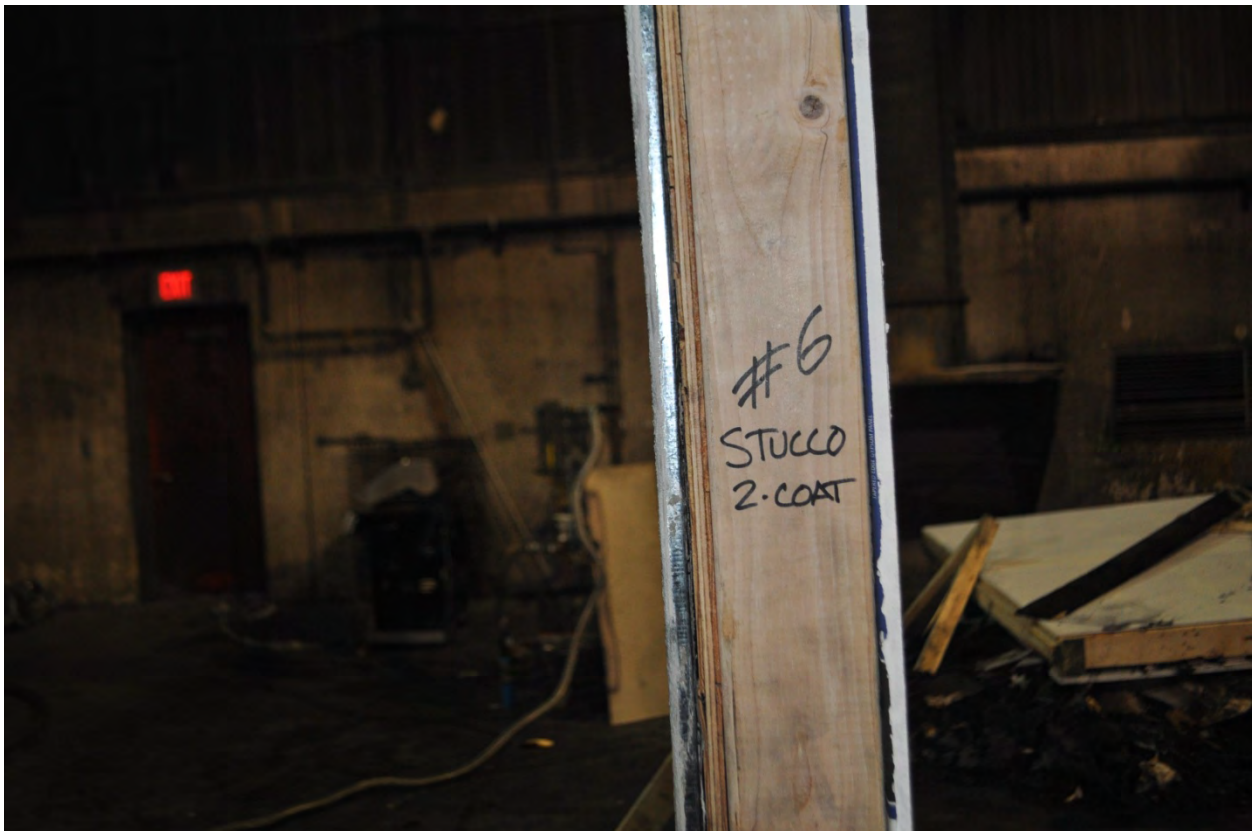
Figure 6. 32: Wall Type 6 Side View

The layout of the wall and materials used for each layer of the wall are specified in Table 6. 74. A side view of the wall is shown in Figure 6. 32. The burner heat release rate (HRR) was initially 100 kW for Experiment 25 and then raised to 200 kW after 20 minutes passed. Photos from Experiment 25 are displayed in Table 6. 75. A timeline of the events within Experiment 25, matching with the photos in Table 6. 75, is shown in Table 6. 76. Heat release rate data, heat flux data, and temperature data from Experiment 25 are shown in appendix G, figures G.136-G.141.

Wall Type	Siding	Additional Material	Sheathing	Insulation	Back Wall
Wall 6	3/8" Elastomeric Base Coat (Stucco)	Weather resistant barrier	1/2" Plywood Sheathing	2x4, R-13 KFI w/ IVB	1/2" Gypsum Board

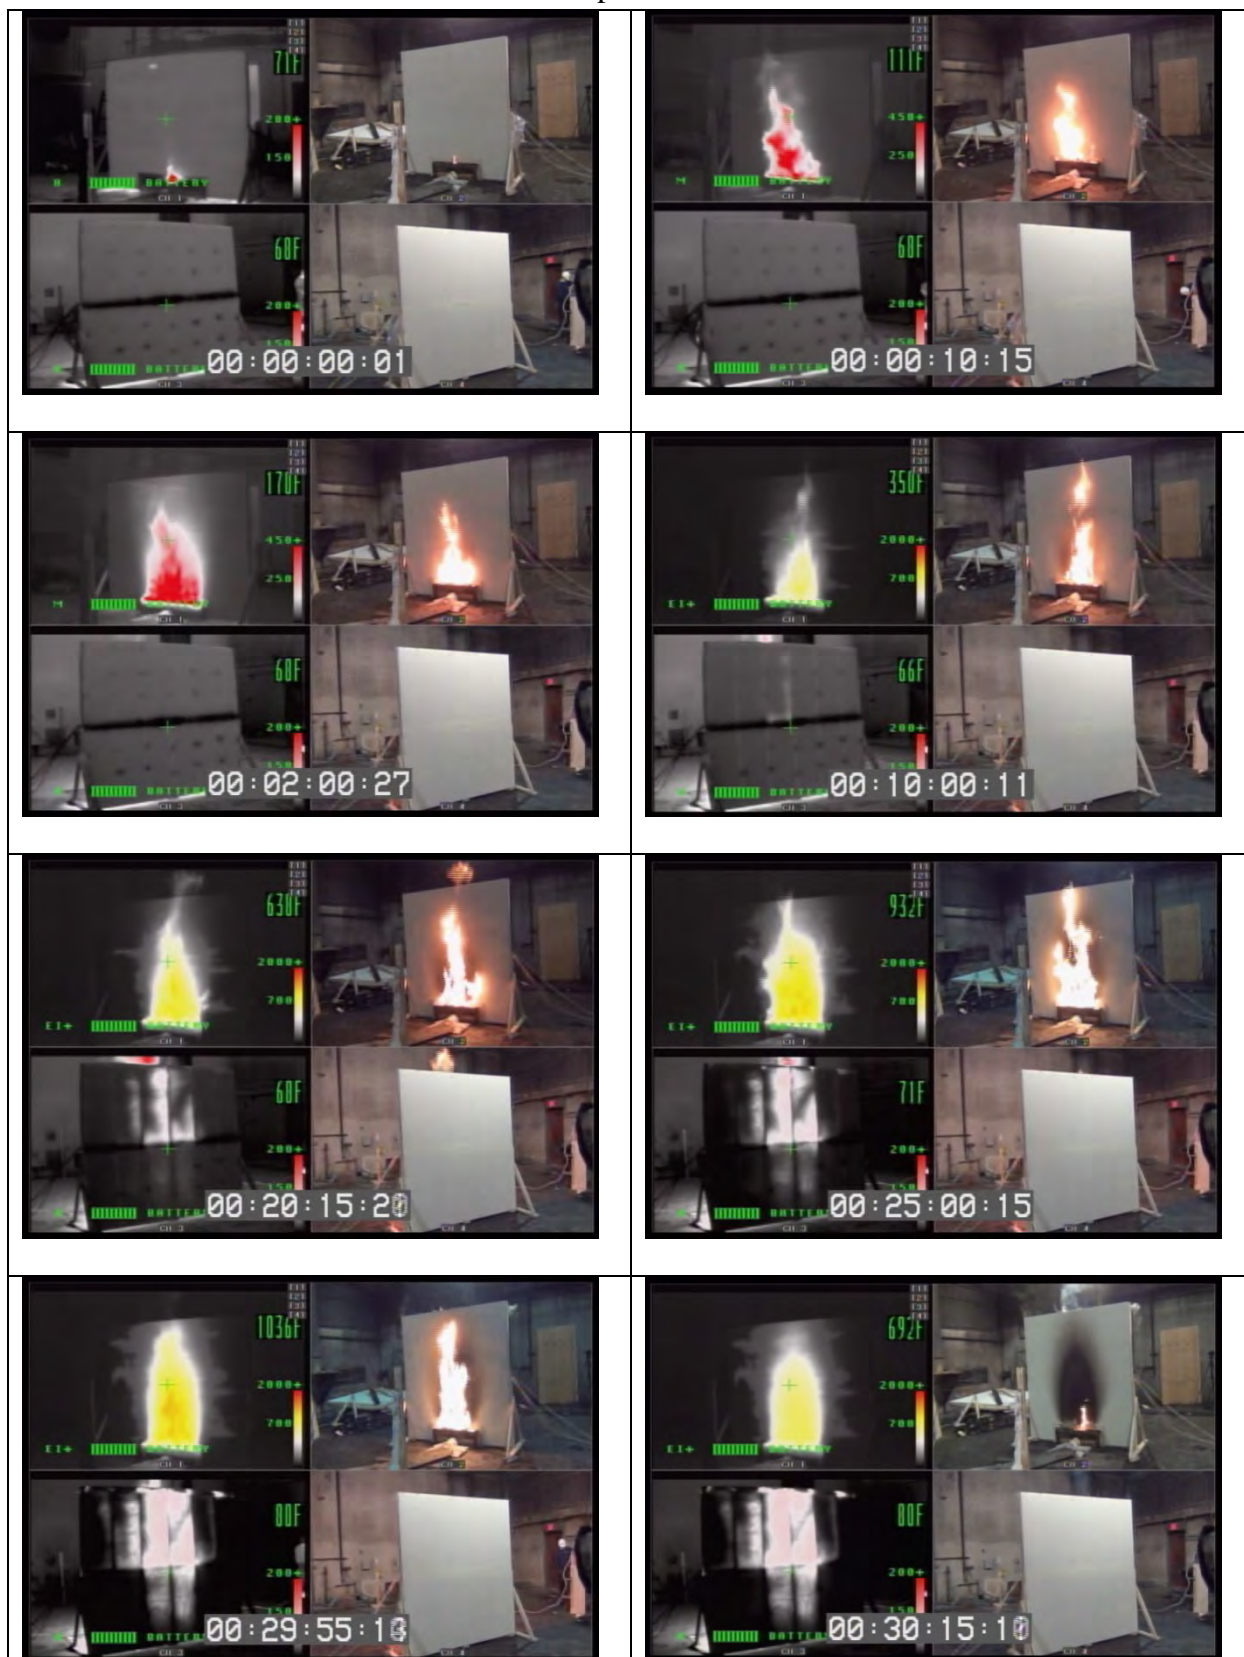
Table 6. 75: Experiment 25 Pictures

Time (mm:ss)	Description
00:00	Experiment begins
00:10	Burner is on and reaching desired 100 kW heat release rate
02:00	Some initial charring on the siding
10:00	The charred area on the siding is now larger but the siding is still not involved in the fire
20:15	The siding is still not involved the burner HRR is increased
25:00	The siding is still not involved, some smoke is exiting out of the top of the wall
29:55	Siding still not involved or degrading
30:15	The burner is turned off, no flame remains, experiment is over

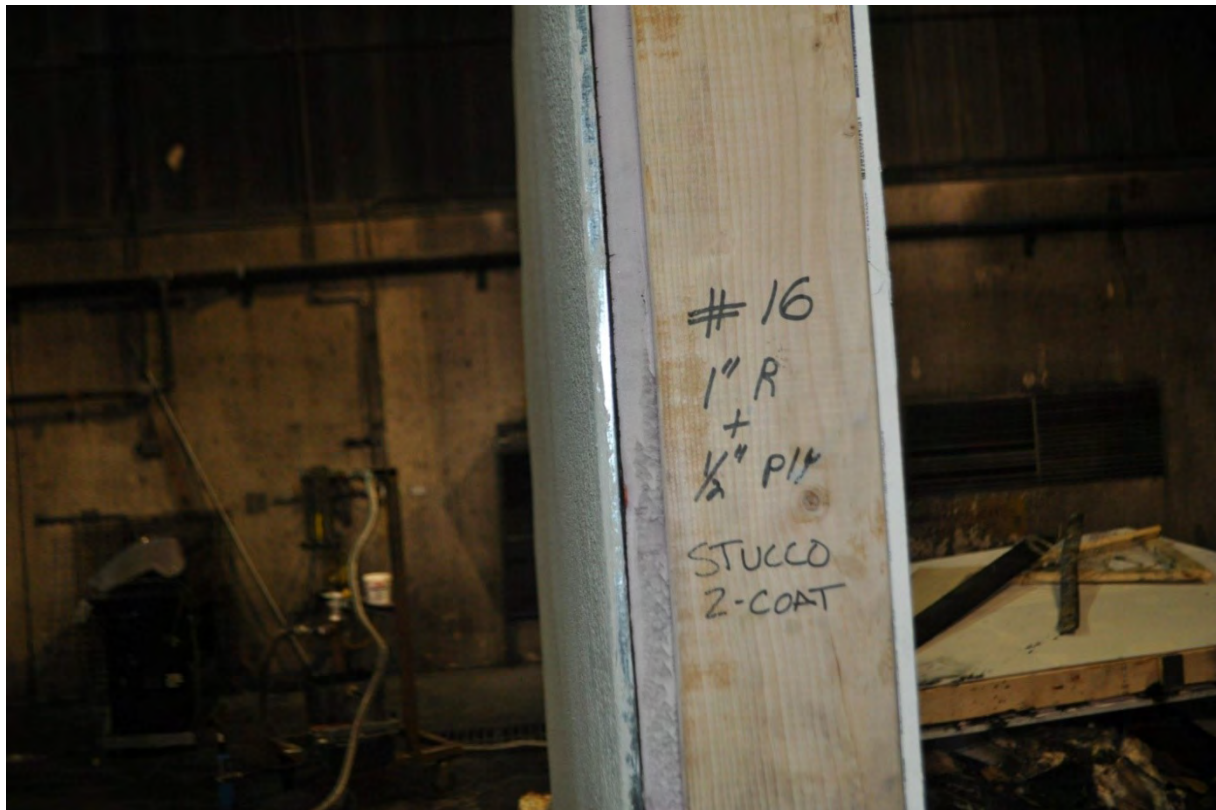
Figure 6. 33: Wall Type 16 Side View

The layout of the wall and materials used for each layer of the wall are specified in Table 6. 77. A side view of the wall is shown in Figure 6. 33. The burner heat release rate (HRR) was initially 100 kW for Experiment 26 and then raised to 200 kW after 20 minutes passed. Photos from Experiment 26 are displayed in Table 6. 78. A timeline of the events within Experiment 26, matching with the photos in Table 6. 78, is shown in Table 6. 79. Heat release rate data, heat flux data, and temperature data from Experiment 26 are shown in appendix G, figures G.142-G.147.

Wall Type	Siding	Additional Material	Sheathing	Insulation	Back Wall
Wall 16	3/8" Elastomeric Base Coat (Stucco)	Layer of W.R.B.	1" R-5 EPS followed by 1/2" Plywood Sheathing	2x6, R-19 KFI w/ IVB	1/2" Gypsum Board

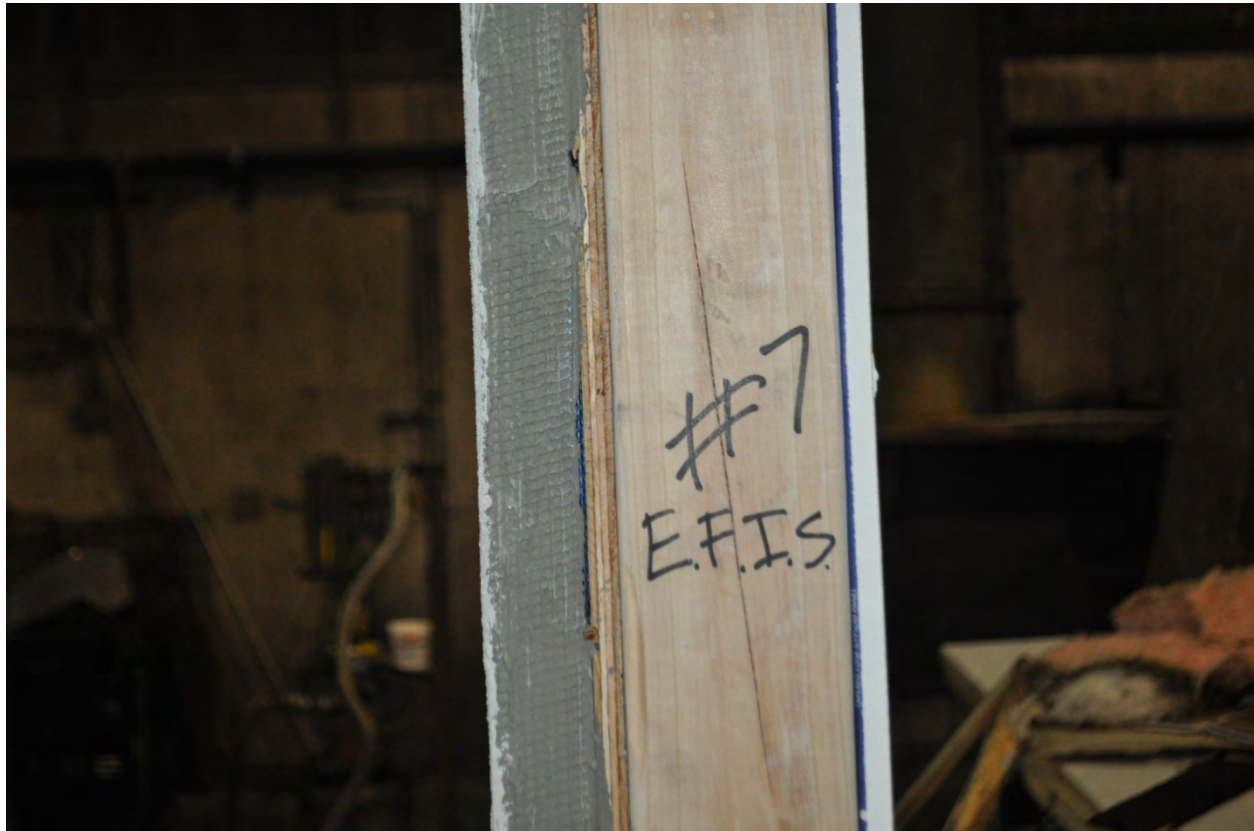
Figure 6. 34: Wall Type 7 Side View

The layout of the wall and materials used for each layer of the wall are specified in Table 6. 80. A side view of the wall is shown in Figure 6. 34. The burner heat release rate (HRR) was initially 100 kW for Experiment 27 and then raised to 200 kW after 20 minutes passed. Photos from Experiment 27 are displayed in Table 6. 81. A timeline of the events within Experiment 27, matching with the photos in Table 6. 81, is shown in Table 6. 82. Heat release rate data, heat flux data, and temperature data from Experiment 27 are shown in appendix G, figures G.148-G.153.

Wall Type	Siding	Additional Material	Sheathing	Insulation	Back Wall
Wall 7	3/16" Base Coat on fiberglass mesh w/ Acrylic Finish (E.I.F.S.)	Weather-Resistant Barrier	1.5" EPS followed by 1/2" Plywood Sheathing	2x4, R-13 KFI w/ IVB	1/2" Gypsum Board

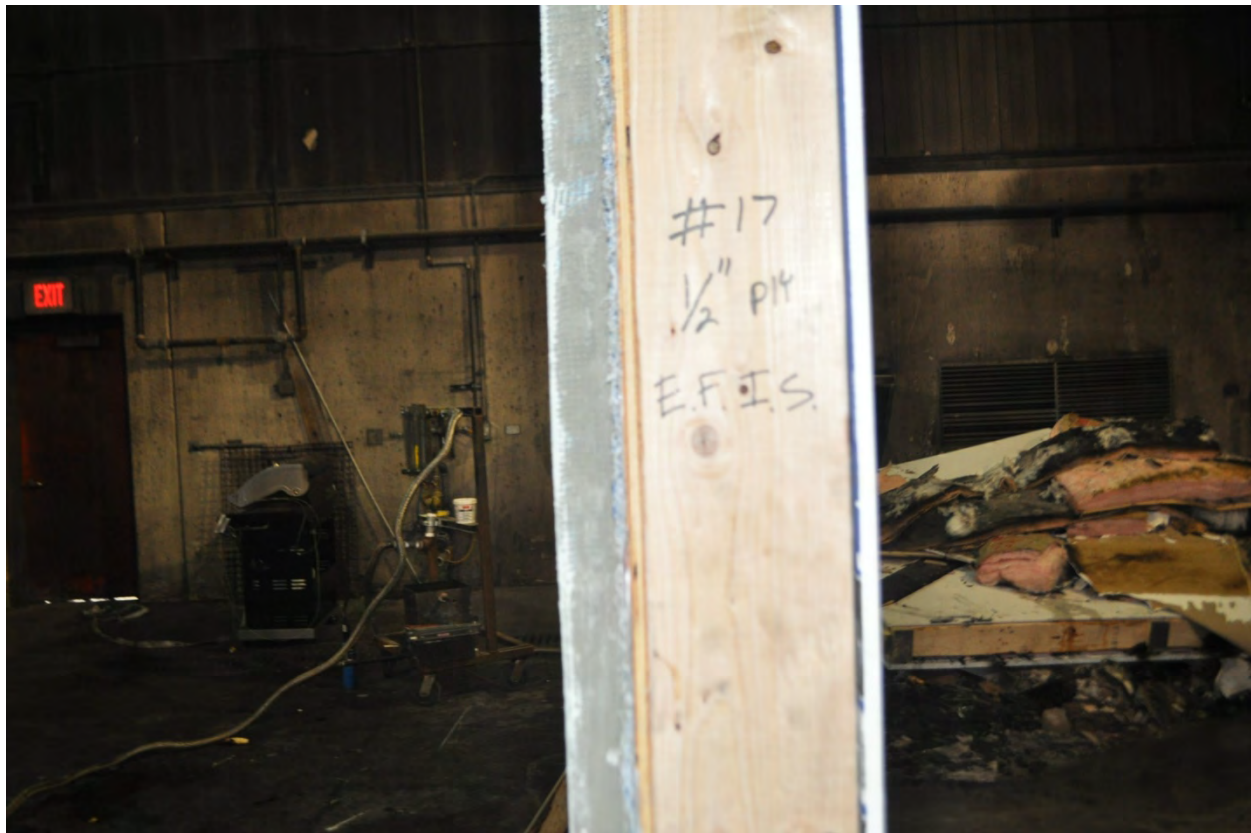
Figure 6. 35: Wall Type 17 Side View

The layout of the wall and materials used for each layer of the wall are specified in Table 6. 83. A side view of the wall is shown in Figure 6. 35. The burner heat release rate (HRR) was initially 100 kW for Experiment 28 and then raised to 300 kW after 10 minutes passed. Photos from Experiment 28 are displayed in Table 6. 84. A timeline of the events within Experiment 28, matching with the photos in Table 6. 84, is shown in Table 6. 85. Heat release rate data, heat flux data, and temperature data from Experiment 28 are shown in Appendix G, figures G.154-G.159.

Wall Type	Siding	Additional Material	Sheathing	Insulation	Back Wall
Wall 17	3/16" Base Coat on fiberglass mesh w/ Acrylic Finish (E.I.F.S.)	Weather-Resistant Barrier	1.5" EPS followed by 1/2" Sheathing	2x6, R-19 KFI w/ IVB	1/2" Gypsum Board

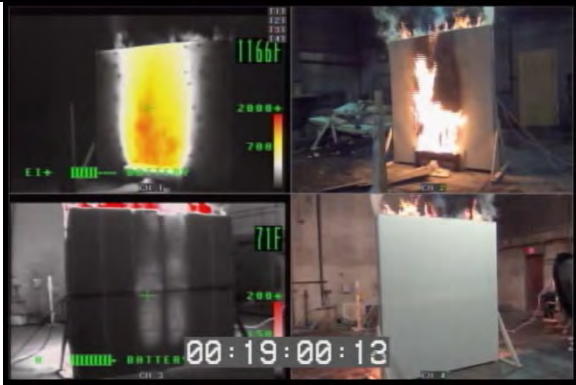
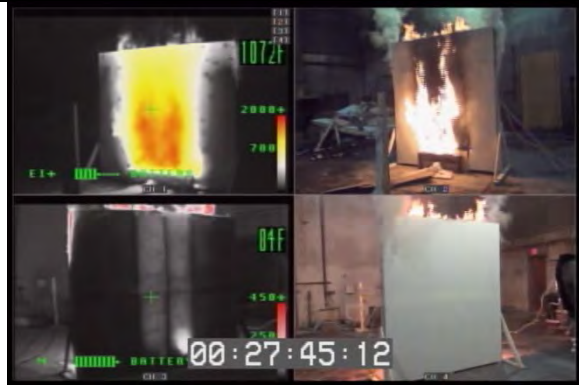
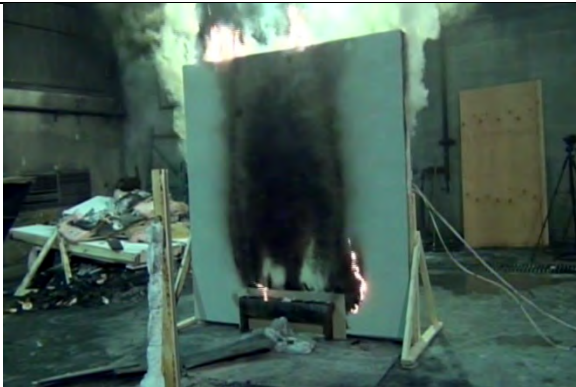
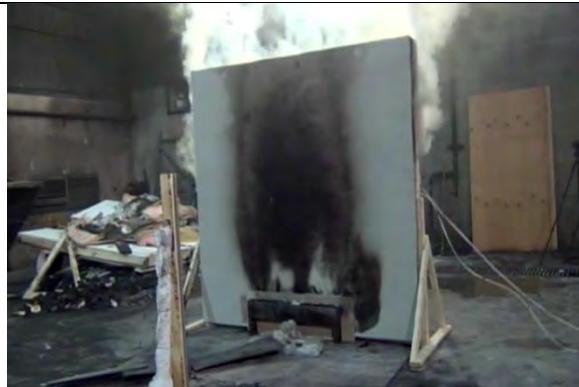
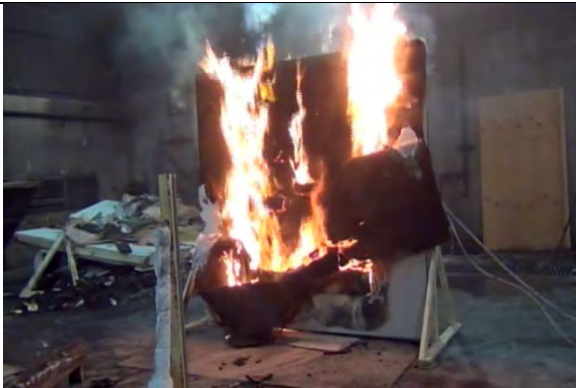
Table 6. 84: Experiment 28 Pictures

Front View at 30:05

Front View at 34:50

Front View at 36:05

Back View at 39:05

Front View at 40:00

Front View at 45:00

Time (mm:ss)	Description
00:00	Experiment begins
00:10	Burner is on and reaching desired 100 kW heat release rate
02:00	Some initial charring of the siding

06:00	The charred area on the wall has increased, siding is still not involved, smoke is exiting out the top of the wall
10:15	Burner HRR is increased
12:45	Charring has reached the top of the wall, some flame is exiting out the top of the wall

19:00	Flame is exiting out the entire width of the top wall, siding is still not involved
27:45	Conditions mostly unchanged from 19:00, video ends
30:05	Burner is turned off, flames still exiting out the top of the wall, siding is no longer burning except for a small portion near the bottom right of the wall

39:05	Initial charring on the back of the wall
40:00	Materials under siding still involved, heaviest burning is on the outside of the wall where the supports of the wall have gotten involved in the fire

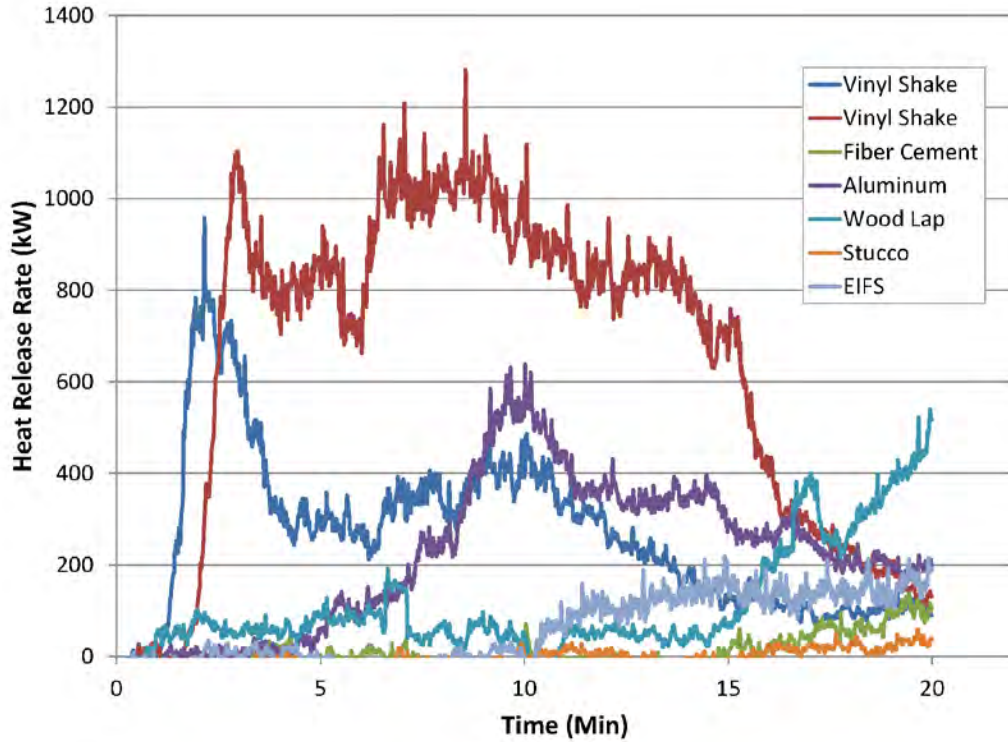
Figure 6. 36: Heat Release Rate (w/o burner) for Walls with Different Sidings

Table 6. 88 compares the ignition time, time to top 7ft on the wall, peak heat release rate and exposure time for the wall types listed in Table 6. 87. As listed the shortest ignition time was in the combustible materials such as vinyl, Polypropylene Shingle and wood lap. The Aluminum siding delayed ignition significantly until it melted away after 04:52 minutes of exposure. The Fiber Cement delayed ignition until it broke apart at 16:00 minutes. The cementitious materials did not ignite at the 100kW burner and did not permit penetration into the sheathing and insulation limiting the fire hazard.

After the initial growth of the fire, the heat release for wall type 8, the double 4 in. vinyl siding begins to decrease as the fuel is consumed, with the polypropylene shingle siding maintaining a high heat release rate due to the larger mass of fuel. The differences observed in the performance of the polypropylene shingle and the vinyl siding is likely due to the thickness differences of the sidings. The thickness of vinyl siding can be as low as 0.035 in., while the thickness of polypropylene shingle siding is usually in the range of 0.08 in. to 0.09 in [43]. From the total

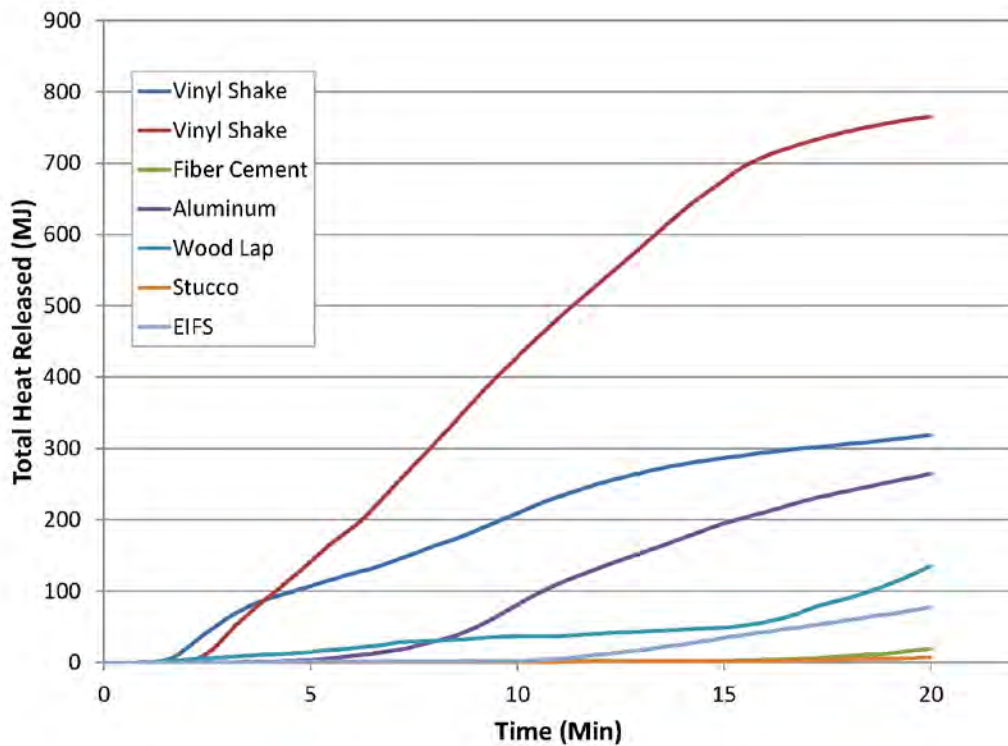
Figure 6. 37: Total Heat Released (w/o burner) for Walls with Different Sidings

The total heat released show in Figure 6. 37 indicates the fire resistive materials delayed the penetration into the sheathing in siding materials resulting in lower heat release rates and over all energy release whereas synthetic materials that melted or burned away showed larger heat release rates due to the additional fuel in the sheathing and insulation materials.
