Study of Residential Attic Fire Mitigation Tactics and Exterior Fire Spread Hazards on Fire Fighter Safety

UL Firefighter Safety Research Institute

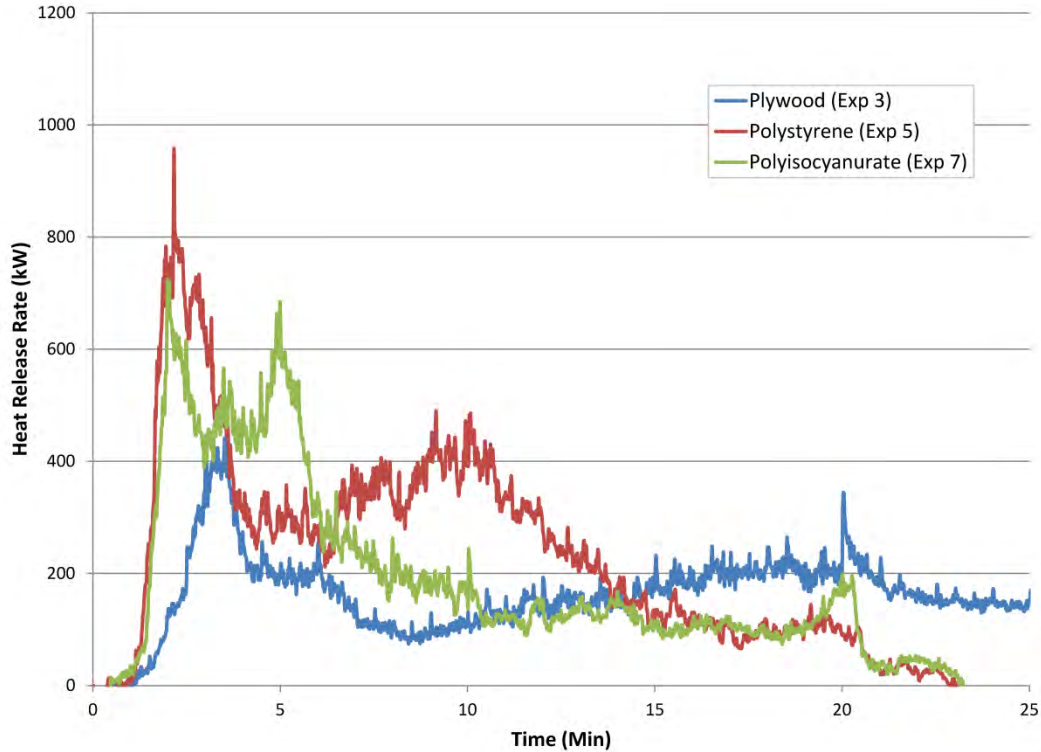
Figure 6. 38: Sheathing Comparison with Vinyl Siding – Heat Release Rate

Flame spread up the wall surface varies considerably over the three types of sheathing with slowest rate being plywood taking 01:17 to reach the top of the wall and the fastest being the Polyisocyanurate in 0:29 as shown in Table 6. 90. This difference can be attributed to the tendency of the vinyl siding to melt away exposing the sheathing surface and making flame spread very dependent on the type of sheathing material underneath. Figure 6. 38 shows the Polystyrene and Polyisocyanurate fire growth track similar through the first 02:00 of the test at which the Polyisocyanurate peaks and the Polystyrene continues to grow. The plywood grows at a much slower rate and peaks at half the value of the others.

The exposure shown in Table 6. 90 varies greatly with different sheathing materials. The Polyisocyanurate provided the highest exposure at 04:18 which can be seen additionally in Figure 6. 38 as the heat release rate peaks and maintains a value in excess of 400 kW for almost 07:00. The Polystyrene has less of an exposure time however as seen in Figure 6. 39 the energy release over the first 20 minutes of the experiment was over 50 MJ greater for the Polystyrene than the Polyisocyanurate with the Plywood releasing the least amount of energy.

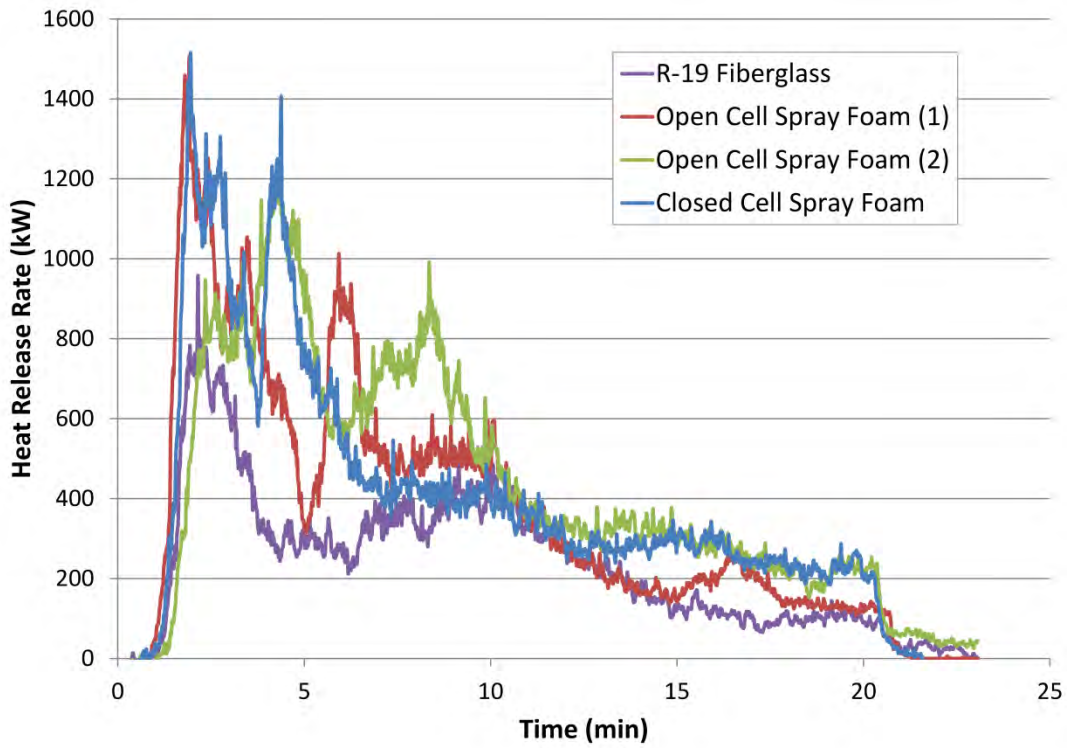
Figure 6. 40: Insulation Comparison Vinyl Siding – Heat Release Rate

The peak heat release rate varies with the highest in the Open Cell Spray Foam (1) and Closed Cell Spray Foam both over 1500kW and the lowest being the Fiberglass at 958kW from Table 6. 92. The Fiberglass, Open Cell Spray Foam (1) and Closed Cell Spray Foam all peak approximately 01:00 after ignition where the Open Cell Spray Foam (2) Peaks 04:18 into the test, 03:34 after ignition shown in Figure 6. 40. This occurs as the vinyl siding did not fall away as effectively as it did with the Open Cell Spray Foam (1) case limiting the exposed insulation material and limiting the fire size. Overall the insulation material of Fiberglass vs Spray Foam indicates Spray Foam has a much larger potential fire size as confirmed by a graph of the total heat released in the first 20:00 of the experiment shown in Figure 6. 41.

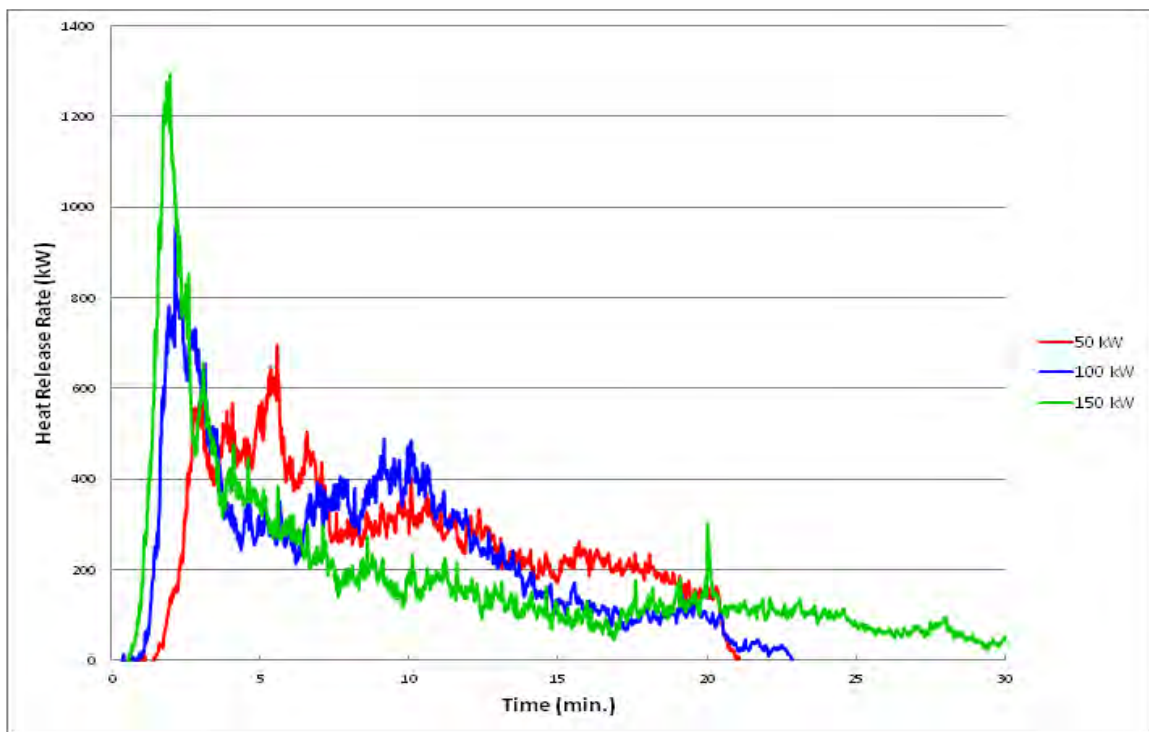
Figure 6. 43: Heat Release Rates (w/o burner) for Wall Type 8 with Different Burner Heat Release Rates

The exposure time has the inverse correlation due to the burning rate of the foam insulation. The 50kW burner caused a rapid vertical spread but the horizontal spread was slower resulting in a larger exposure time than both the 100kW and 150kW burners. The increased energy at ignition caused a rapid vertical and horizontal spread resulting in more material burning at the same time (peak heat release rate) however the more material burning at once the faster the fuel is consumed and the fire size decreases.

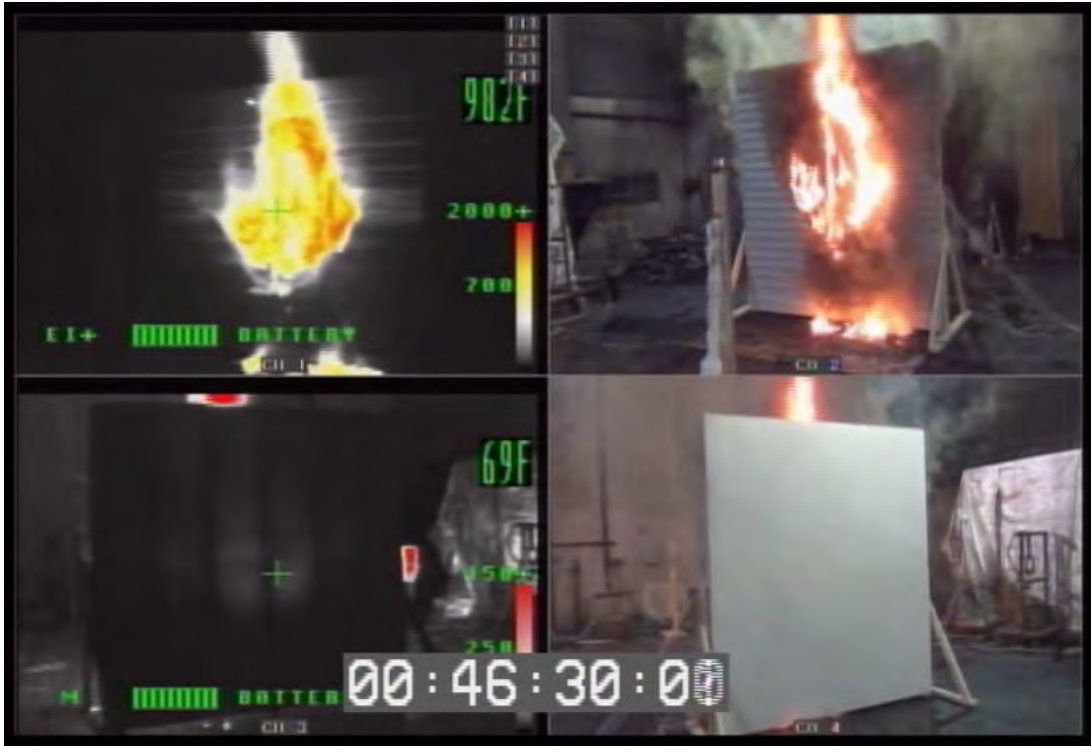
Figure 6. 44: Picture of Peak Heat Release Rate for Wall Type 8 Grill Fire

The grill source was a low hazard with wall type 1 as ignition took on the order of tens of minutes the fire self-extinguished when the grill was removed. It was only able to generate a small area of flame as seen in Figure 6. 45 For wall type 8 with the polystyrene sheathing the fire spread up the wall surface and would have exposed a potential eave line indicating the grill source would have a been a hazard for that wall type for this configuration see Figure 6. 44.

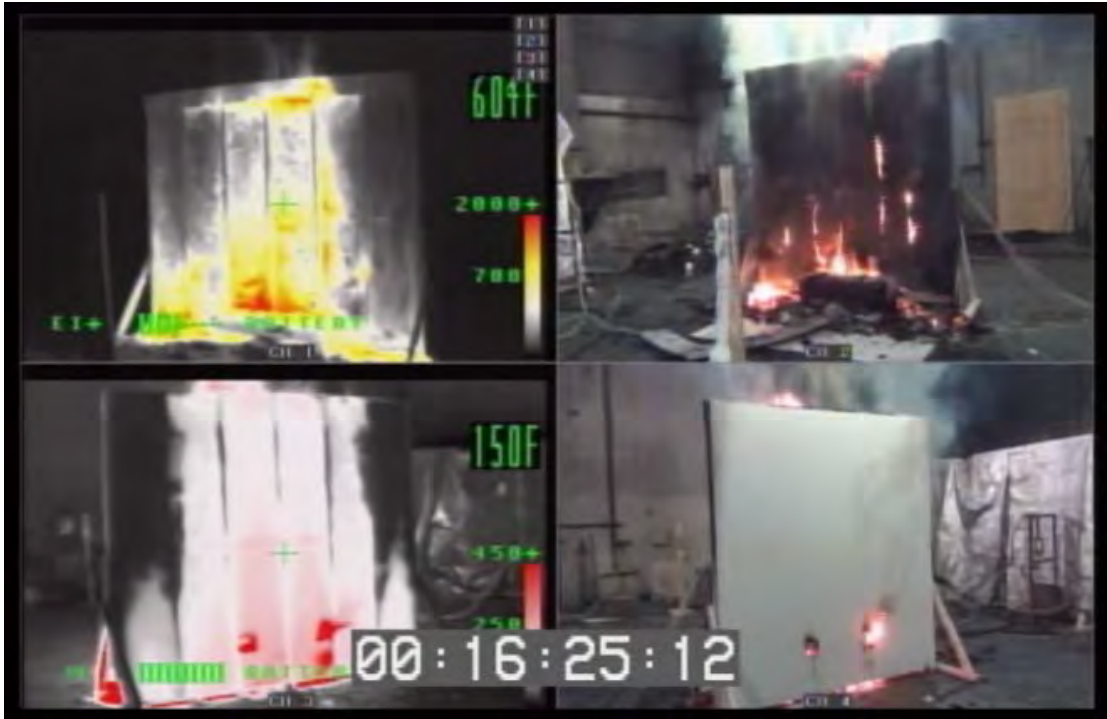
Figure 6. 46: Image of Fire out of Back Wall of Experiment 12

To evaluate the effect of electrical receptacles experiment 12 and experiment 13 had receptacles, i.e. outlets, on the back wall. In Figure 6. 46 and Figure 6.47 fire can be seen exiting out of the back wall through the receptacles. This suggests that the receptacles can contribute to the penetration of an exterior fire to the interior. These two experiments were the only two experiments with significant flaming exiting out of the back wall. There were other experiments with large areas of discoloration indicating heat damage, but the flame did not penetrate through, since there was no hole in the wall for the flame to exit. The gypsum board provides an effective fire barrier when not compromised by penetrations for purposes such as electrical or plumbing. Therefore the walls themselves are unlikely to be the method of penetration from the exterior. Instead, other parts of the wall that make the wall more vulnerable to penetration, such as receptacles or possibly windows, are likely to be the cause of exterior to interior fire spread.

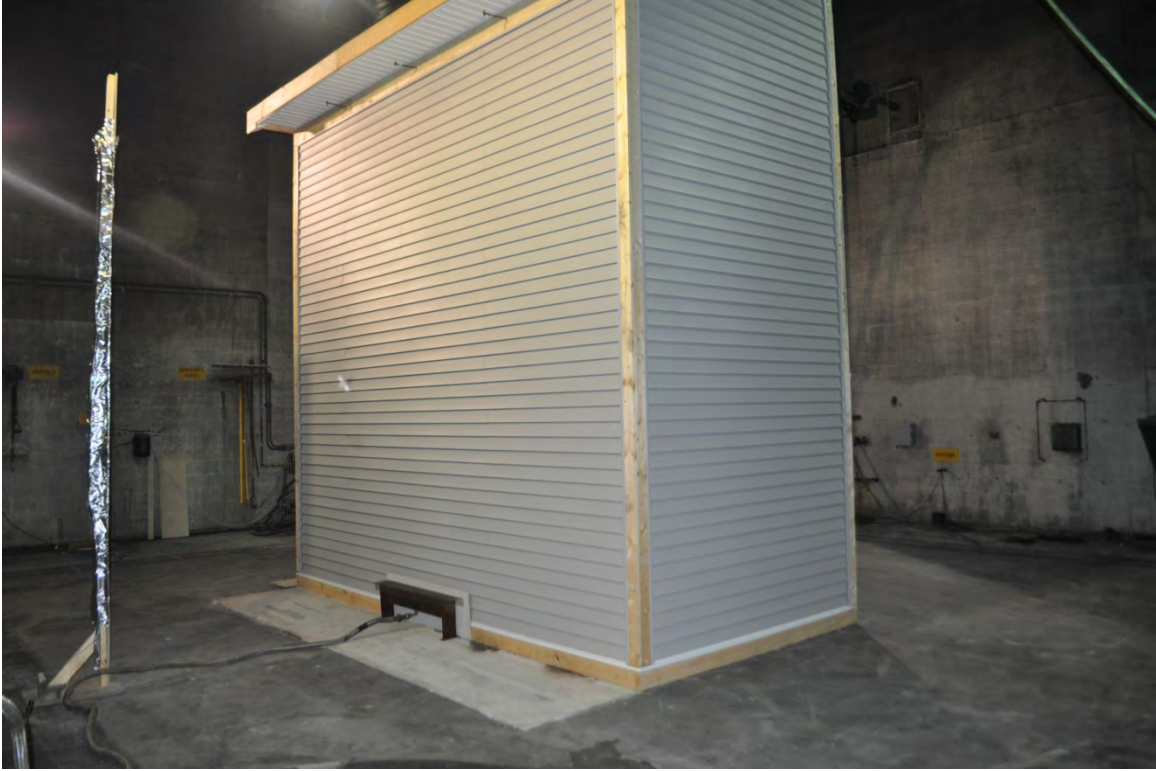
Figure 7. 2: Front View of Eave Structure for Experiment 1

The layout of the wall and materials used for each layer of the exterior wall are specified in Table 7. 1. The attic insulation is the same as the wall insulation and lies on the ceiling in the attic. A front view and rear view of the wall and attic structure is shown in Figure 7. 2 and Figure 7. 3. The burner heat release rate (HRR) was 100 kW for Experiment 1 while the burner was on. Photos from Experiment 1 are displayed in Table 7. 2. A timeline of the events within Experiment 1, matching with the photos in Table 7. 2, is shown in Table 7. 3. Heat release rate data, heat flux data, temperature, and flow velocity data from Experiment 1 are shown in appendix H figures H.1-H.13.

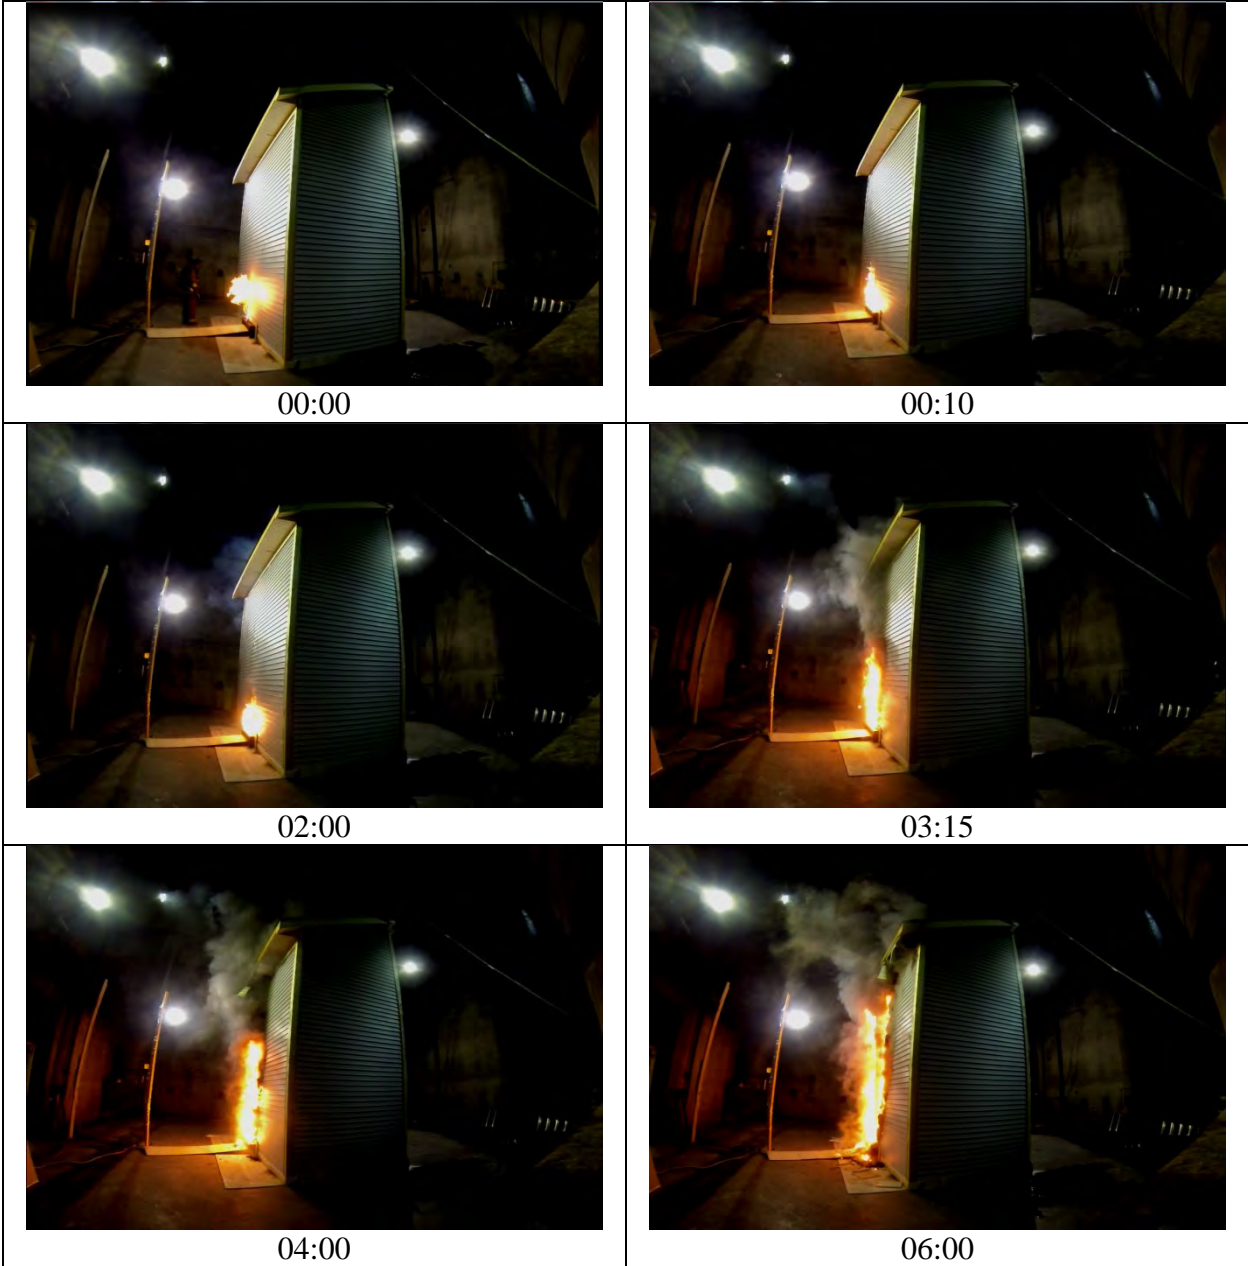
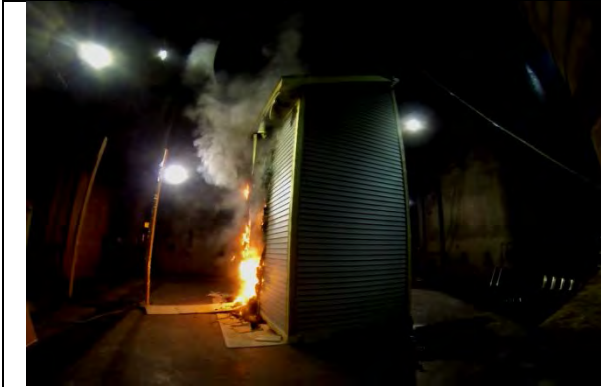
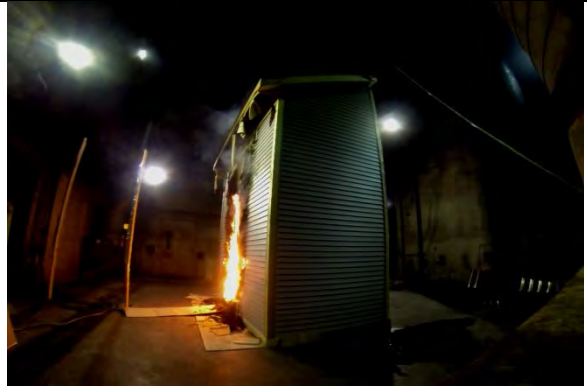
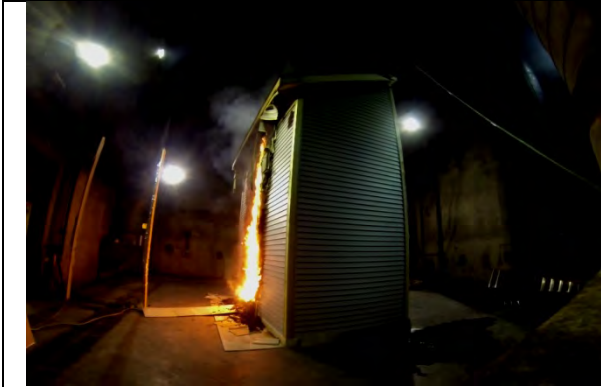
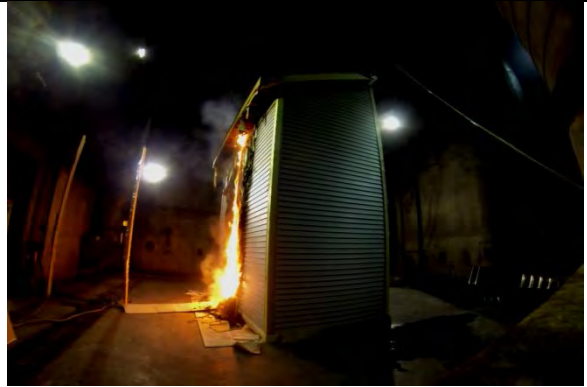
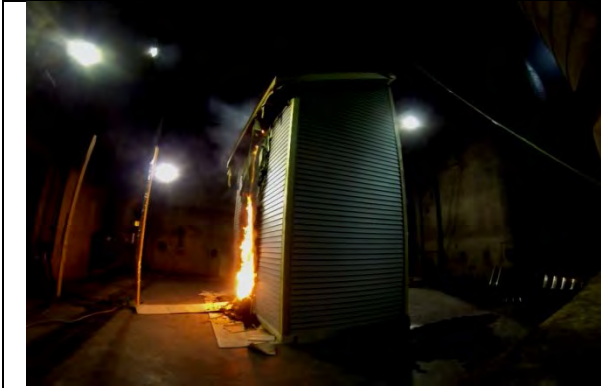
Table 7. 2: Eave Experiment 1 Pictures

Time (mm:ss)	Description
00:00	Start of the Experiment
00:10	Burner is turned on and heat release rate reaches 100 kW
02:00	Smoke is visible and the vinyl siding is involved in the fire

07:00	Fire recedes back down, only the outer parts of the vinyl siding are burning
15:00	Fire starts to grow again vertically along the plywood sheathing

19:00	Fire dies back down again, burning in the eave is almost completely diminished
24:40	Flames visible in attic space
26:00	Fire again spreads to the top of the wall from the plywood sheathing

Eave experiment 1 took over 24 minutes to transition from the bases of the test set up to the flames in the attic space. The flame spread rate up the wall surface was the driving factor as initially the flames spread up the vinyl siding but as that melted and fell away the flames returned to the burner. The higher ignition temperature of the plywood along with the development of a char layer slowed the growth up the wall surface. Once the flames reached the eave line the vinyl eaves (Figure 7. 10) melted away along with the plastic baffles (Figure 7. 11) and provided a direct path for flames to spread into the attic space. See Table 7. 2 for visuals of the flame spread.

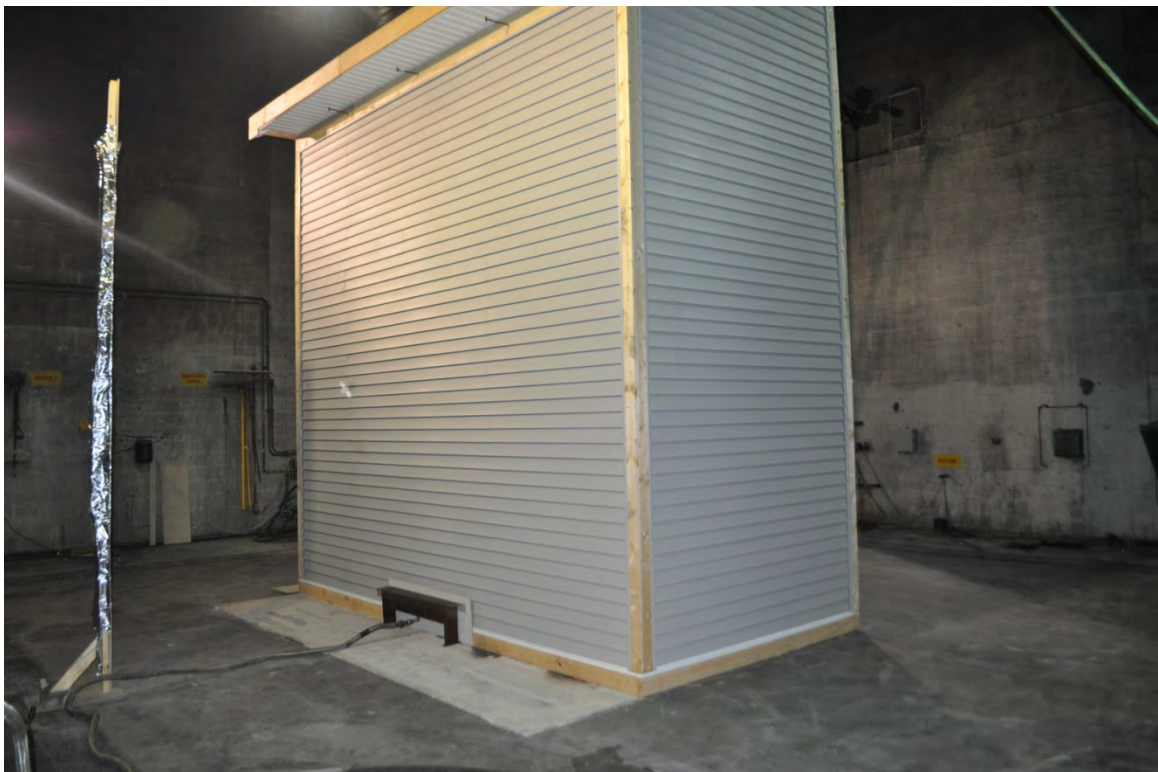
Figure 7. 4: Front View of Eave Structure for Experiment 2

The layout of the wall and materials used for each layer of the exterior wall are specified in Table 7. 4. The attic insulation is the same as the wall insulation and lies on the ceiling in the attic. A front view and rear view of the wall and attic structure is shown in Figure 7. 4 and Figure 7. 5. The burner heat release rate (HRR) was 100 kW for Experiment 2 while the burner was on. Photos from Experiment 2 are displayed in Table 7. 4. A timeline of the events within Experiment 2, matching with the photos in Table 7. 4, is shown in Table 7. 6. Heat release rate data, heat flux data, temperature, and flow velocity data from Eave Experiment 2 are shown in appendix H figures H.14-H26.

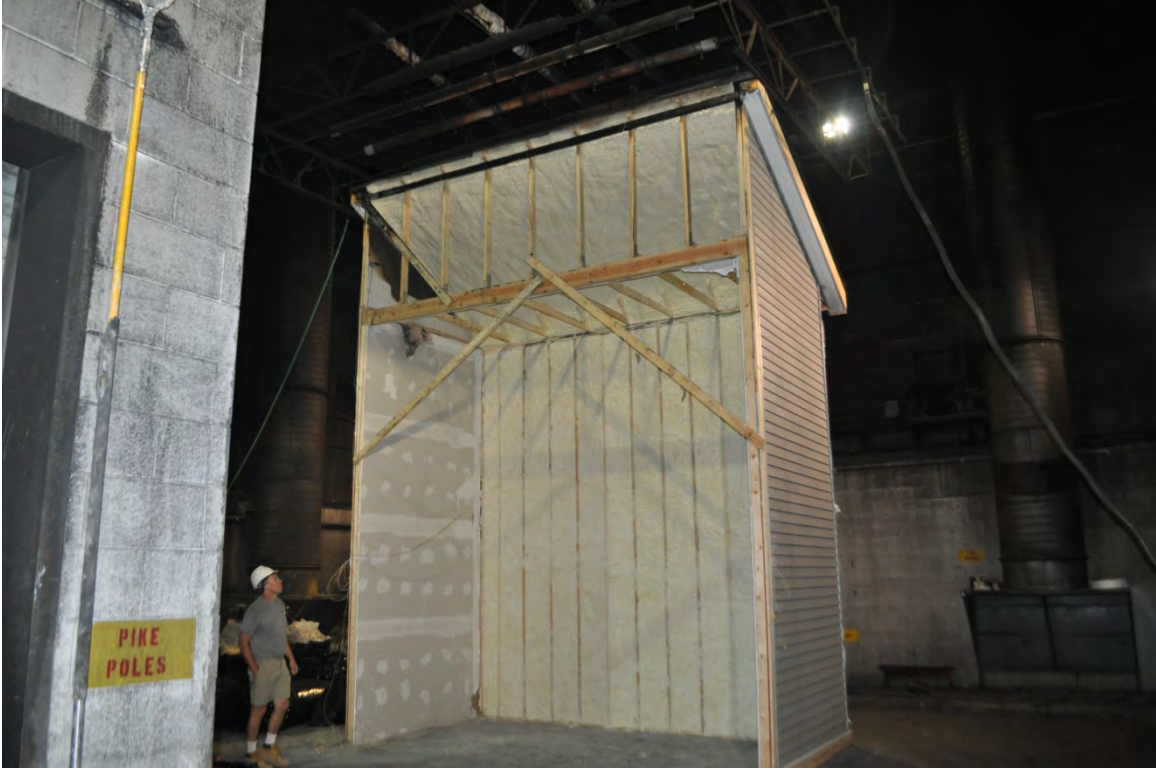
Figure 7. 7: Rear View of Eave Structure for Experiment 3 before drywall application

The layout of the wall and materials used for each layer of the exterior wall are specified in Table 7. 7. The attic insulation is the same as the wall insulation, and, in this case, is applied to the underside of the roof. A front view and rear view of the wall and attic structure is shown in Figure 7.6 and Figure 7. 7. The burner heat release rate (HRR) was 100 kW for Experiment 3 while the burner was on. Photos from Experiment 3 are displayed in Table 7. 8. A timeline of the events within Experiment 3, matching with the photos in Table 7. 8, is shown in Table 7. 9. Heat release rate data, heat flux data, temperature, and flow velocity data from Eave Experiment 3 are shown in appendix H, figures H.27-H.39.

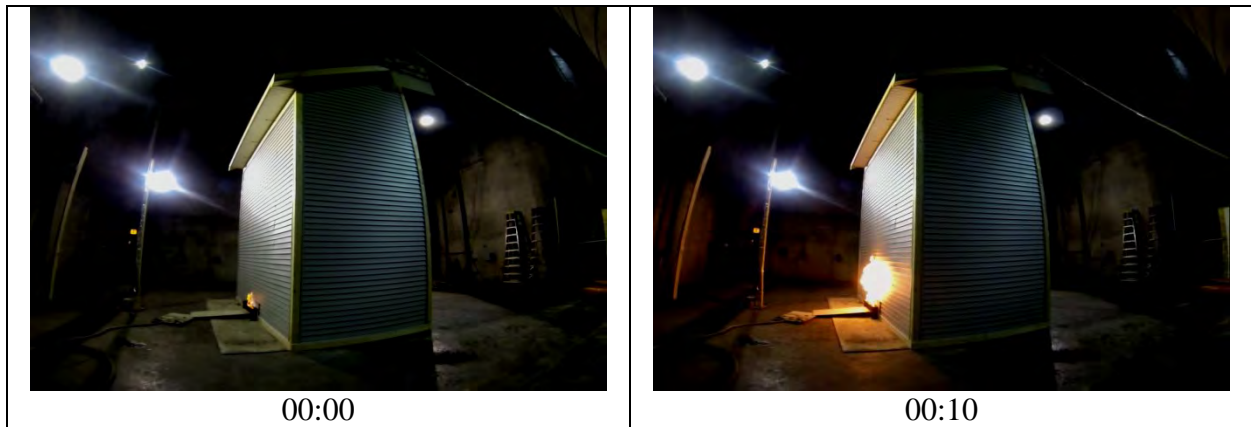
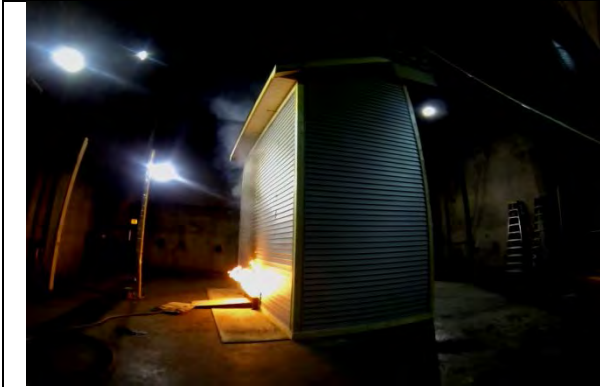
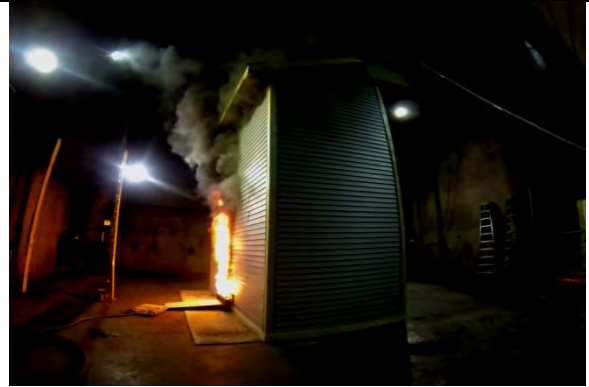
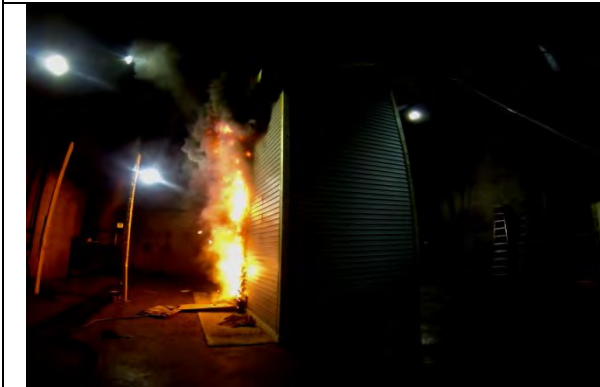
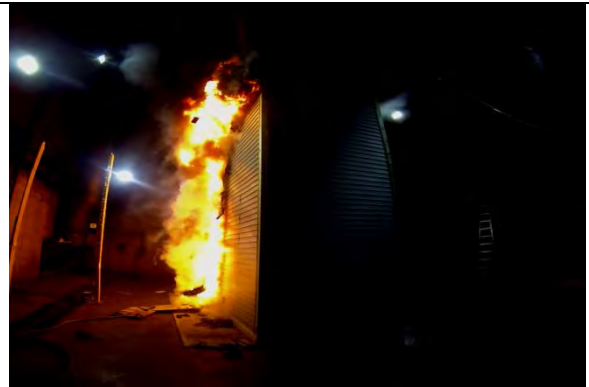
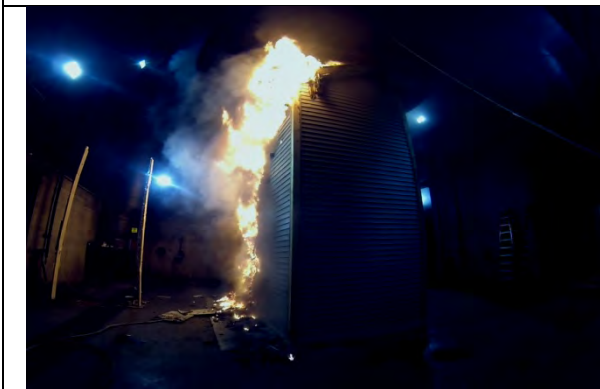
Table 7. 8: Eave Experiment 3 Pictures

Time (mm:ss)	Description
00:00	Start of the Experiment
00:10	Burner is turned on and set to a heat release rate of 100 kW
01:00	Smoke is visible, vinyl siding begins to burn

06:00	Eaves are still fully involved, parts of the wall in the center have burned up, the fire on the wall is spreading horizontally outwards from the center

08:00	Eaves still fully involved, flames have spread farther out and are nearing the edge of the wall, flame from the wall has diminished
10:00	Eaves still fully involved, clear damage to vinyl siding at the top of the side of the structure

10:24	Flames visible in the eave space
12:00	Attic still fully involved though producing less flame and more smoke
14:00	Attic fire still well involved but has died down in severity, and flames have reached the edge of the wall on the wall's front surface. Almost all of the vinyl siding of the front wall has burned off

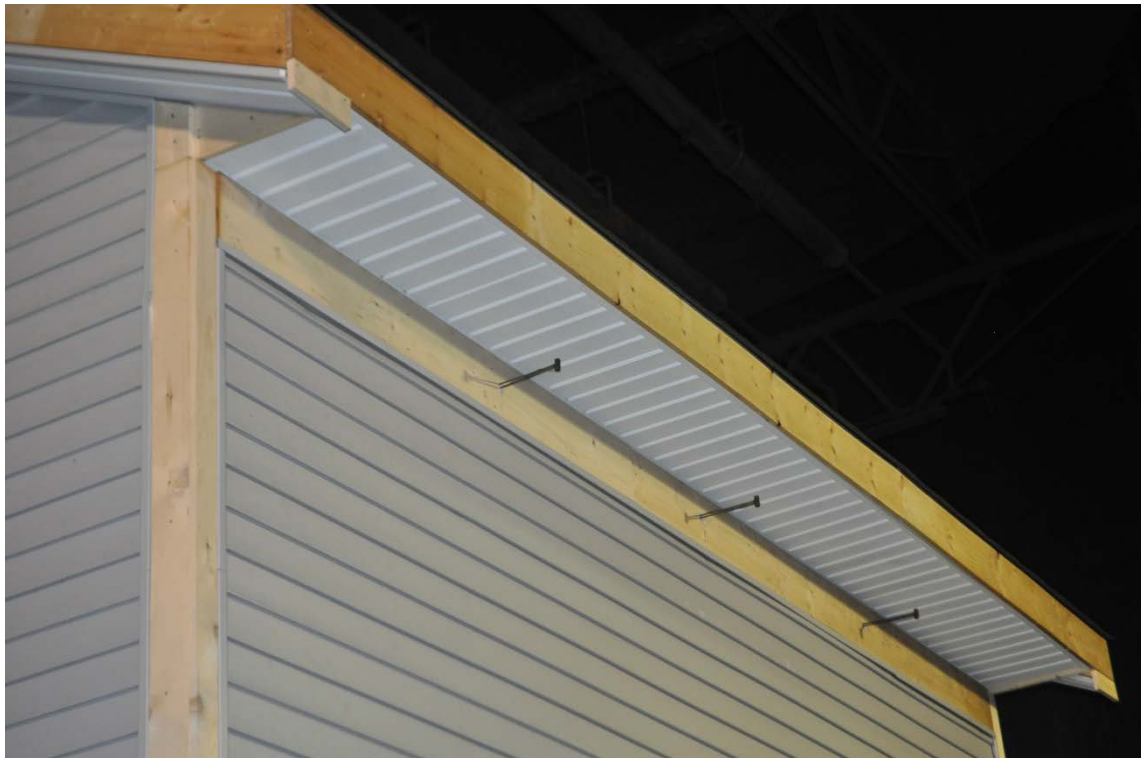
Figure 7. 10: Vinyl Eave Vents

The attic space of the structure became involved as the flames spread up the surface vertically and through the eaves in all three experiments. Due to the different materials and construction the transition from an exterior fire to a structure fire occurred on very different time scales.

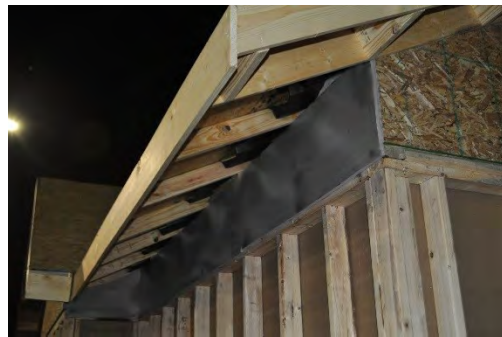
Figure 8. 4: Eave construction detail (before soffit was added)

The four full scale attics test structures incorporated a light weight truss roof system with an 8 ft. space below simulating the living space in a home. The structures measured 30 ft. by 36 ft. with 6-12 pitched roofs constructed with wood plywood sheathing, ridge vent, gable vents and eave vents (Figure 8. 1 through Figure 8. 8). Shingles were provided on the ridge vent and 4 ft. down each side of the peak for all fixtures with the exception of the test fixture used in experiment 1. The attic was separated from the space below with a layer of ½ in. gypsum wall board and two layers of 6” fiberglass bat insulation. Attic access hatches measuring 2 ft. by 4 ft. were used to gain access to the attic space for instrumentation however were closed off with a ½ in. sheet of gypsum wall board and no insulation during tests. The space below was finished with ½ in. gypsum wall board to provide an enclosure finished with tape and plaster. A single door provided access for suppression tactics and instrumentation. Each structured was used to evaluate the effectiveness of one or more fire suppression tactics for a total of 7 experiments. Construction drawings for the test fixtures can be found in Appendix C, Figures C.1-C.4.

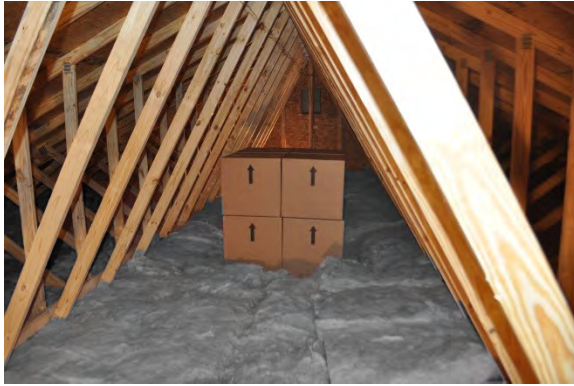
Figure 8. 9: Attic Experiment 1 Fuel Load

This experiment was intended to evaluate the fire dynamics and suppression effectiveness of an attic fire where interior operations were conducted. The suppression tactic evaluated involved breaching the attic ceiling just enough to provide access to the space with a nozzle. Eight (8) type IV commodity boxes (cardboard boxes with plastic cups) were placed on a 4 ft. x 4 ft. cement board located centered in the attic space. This experiment was the only experiment conducted without shingles over the ridge vent and 4 ft. down the roof slope. Ignition was provided by an electric match located at the center of the boxes covered with shredded paper to ensure fire spread to the commodity boxes. Figure 8. 9 and Figure 8. 10 below show the fuel load in the attic and a sample of the electric match used for ignition.

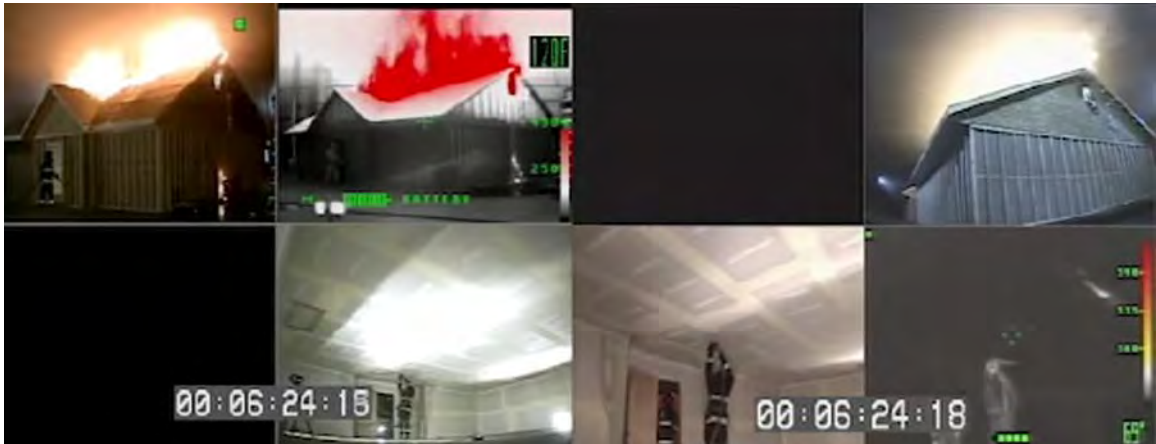
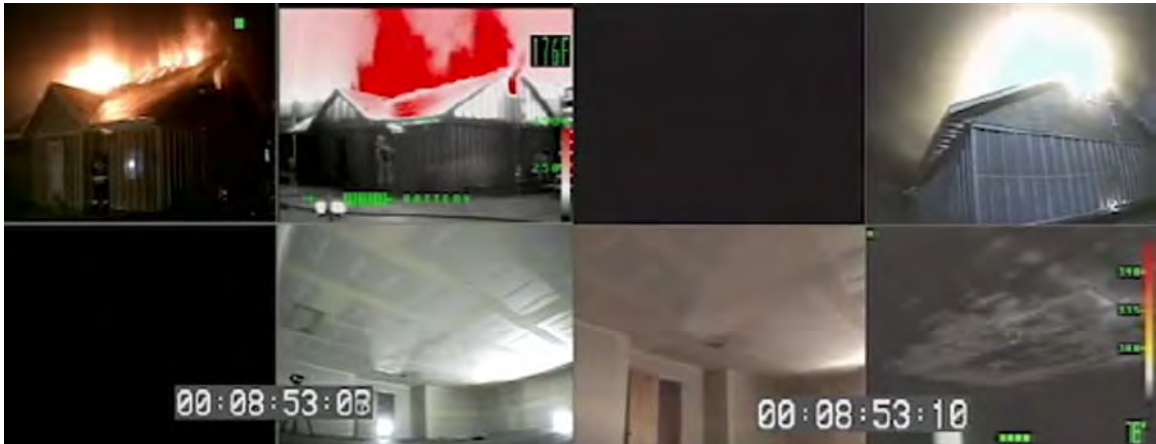
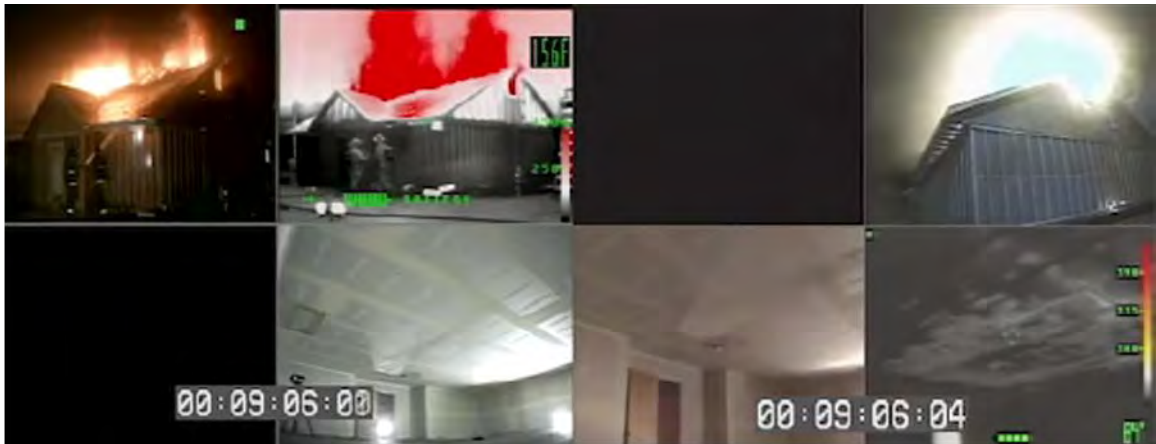
Table 8. 2: Experiment 1 - Chronological Images

<u>Event</u>	<u>Time</u>
Ignition	00:00
Fog Stream through Small Hole Below - On	05:46
Fog Stream through Small Hole Below - Off	06:24
1 Minute Following Water Application	07:24
Straight Stream East Gable	08:06
Eaves Pulled	08:53
Water Applied through Eaves – Side A East	09:06
Water Applied through Eaves – Side A West	09:33
Water Applied through Eaves – Side C	11:31
Ceiling Collapse	11:47

The front door to the test set up was closed and ignition takes place at 00:00. After the fire grows to a relatively steady state a simulated engine crew opens the front door and uses a pike pole to punch a small hole is put in ceiling just inside the door just large enough for an automatic nozzle to fit through. An automatic nozzle set to a wide fog and supplied with 100psi flowing approximately 150gpm is placed in the hole created and turned on at 05:46. Water flows for 38 seconds or a total of approximately 95 gallons and the nozzle is removed at 06:24. The crew backs out and leaves the front door open. The crew repositions to the east gable and at 08:06 uses a straight stream for 24 seconds through the east gable with the same flow rate. At 08:53 the front eaves are pulled starting on the west side of the door and working toward the east side. Water is applied through the eaves at 09:06 starting in the same location and working west using a straight stream at 100psi flowing 150gpm. While water is flowing through the front east eaves the west eaves are removed at 09:15. At 09:33 the line is repositioned to the west eaves and water is applied using the straight stream pattern at the same flow rate. Water is applied though the rear eaves at 11:31 using a safety line for which pressure/flow were not monitored. The ceiling collapses at 11:47. After 12:00 the majority of the flames have been extinguished, video and data continue until 12:45. Table 8. 2 shows images of the experiment at each of the events steps described in Table 8. 1. All data gathered during the experiment can be found in Appendix I, Figures I.1-I.11.

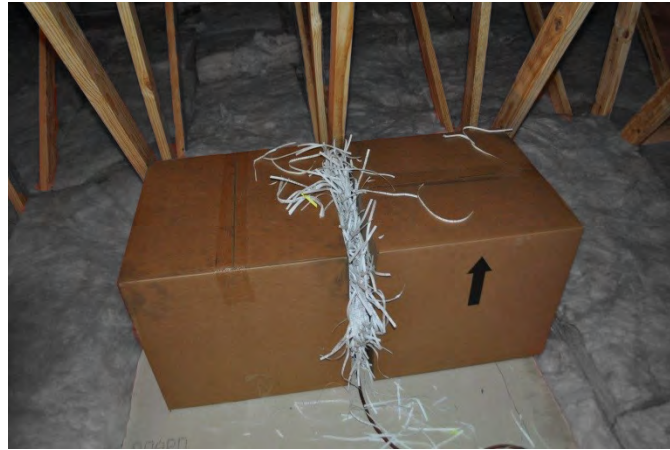
Figure 8. 11: Attic Experiment Two Box Fuel Load

This experiment was intended to study the fire dynamics and suppression effectiveness when a large is created below the fire to apply water while the attic is intact. Two (2) type IV commodity boxes were placed on a 4 ft. x 4 ft. cement board located centered in the attic space. Ignition was provided by an electric match located at the center of the boxes covered with shredded paper to ensure fire spread to the commodity boxes. Figure 8. 11 shows the fuel load for this experiment.
