Study of Residential Attic Fire Mitigation Tactics and Exterior Fire Spread Hazards on Fire Fighter Safety

UL Firefighter Safety Research Institute

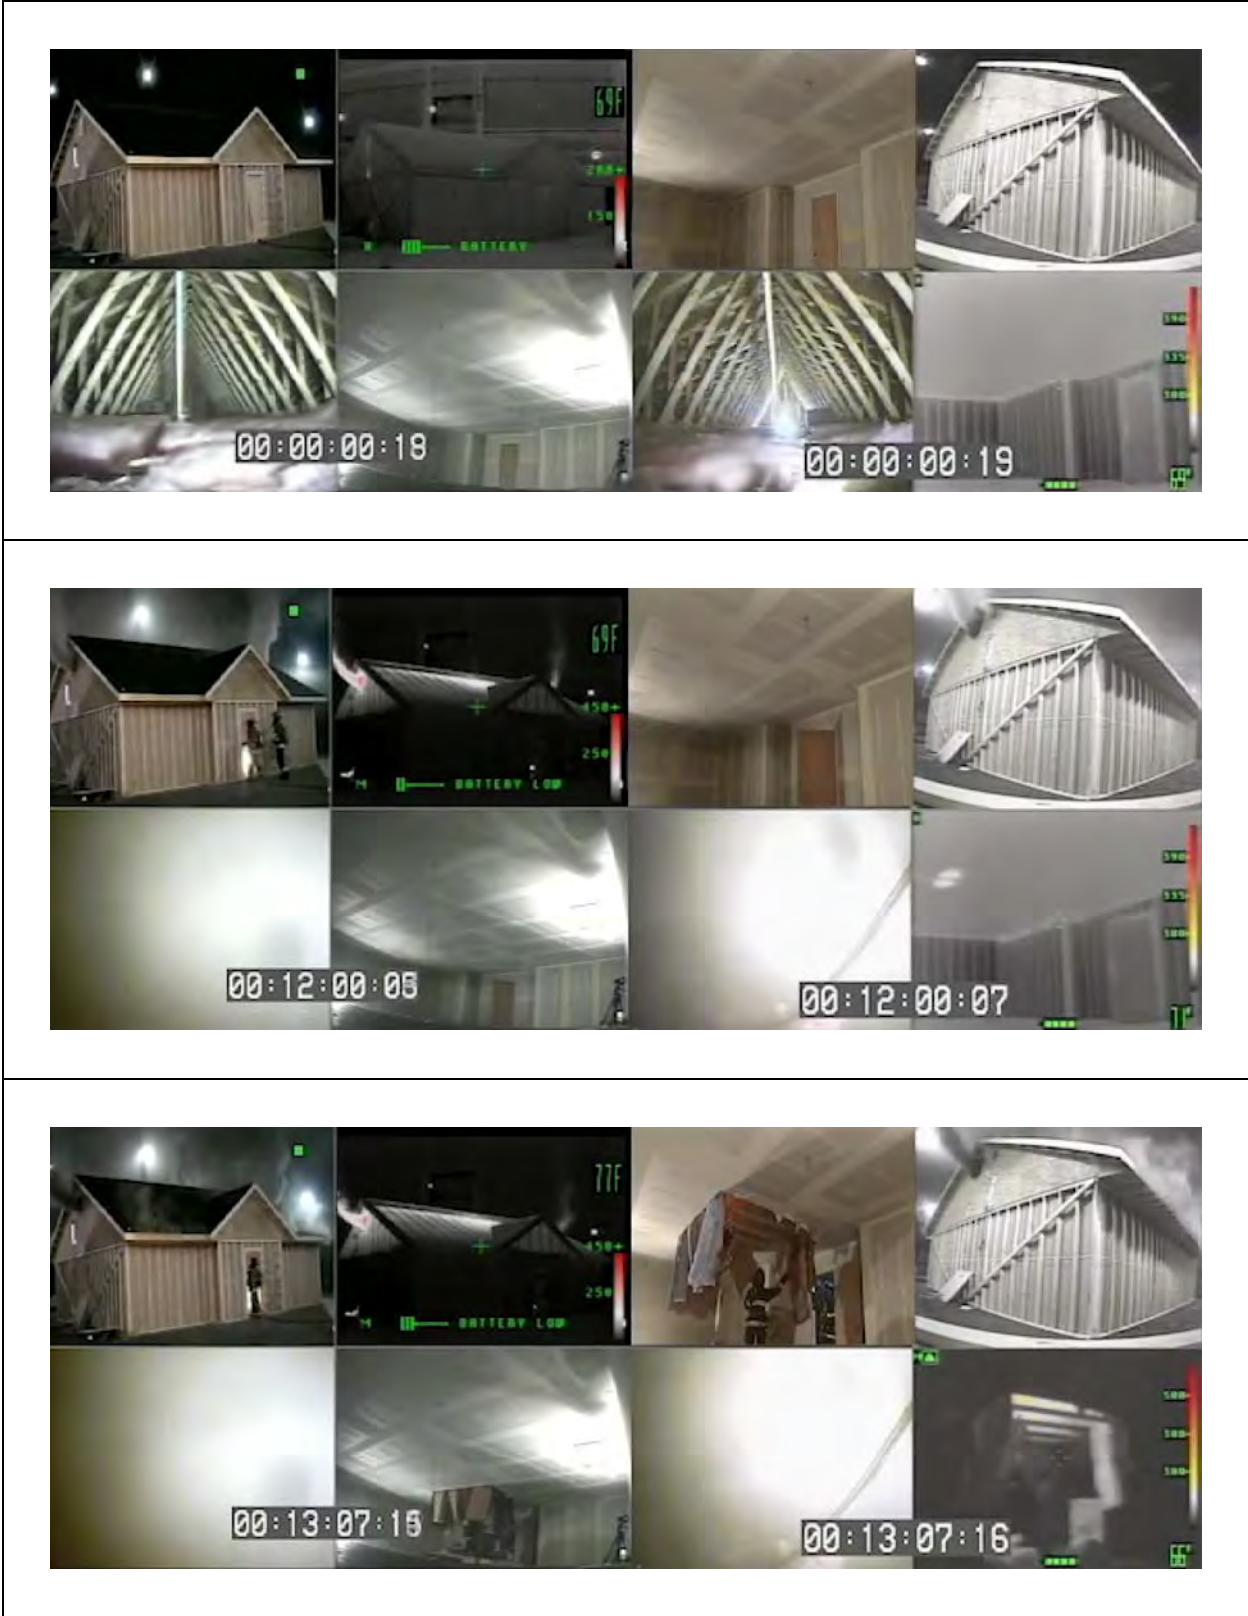
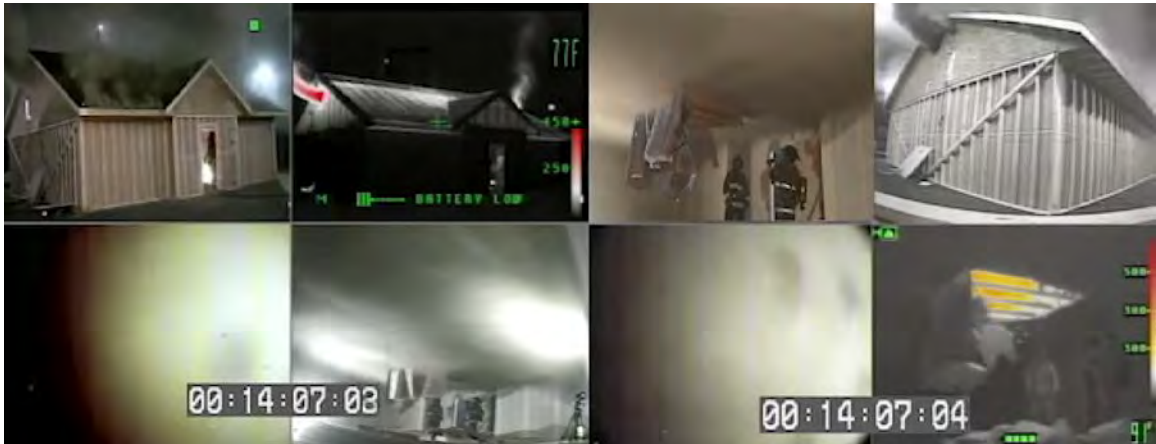
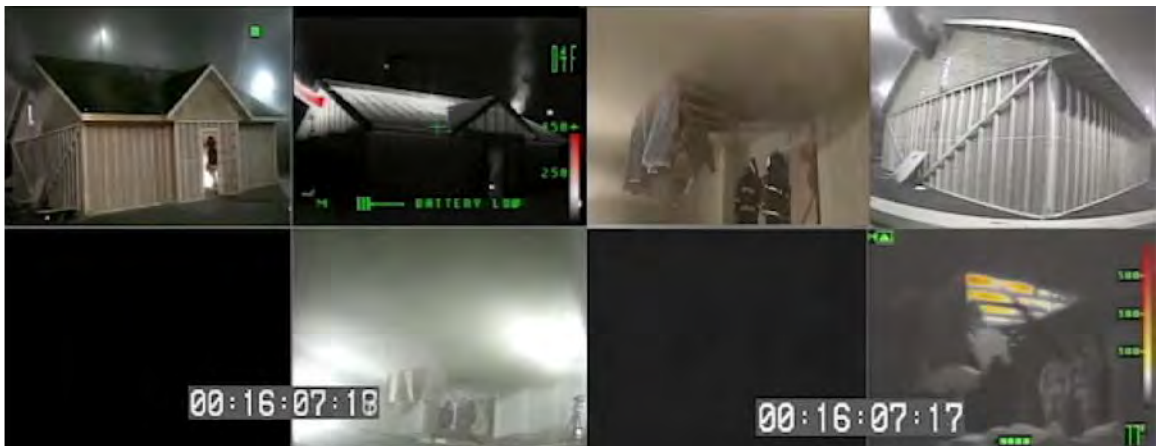
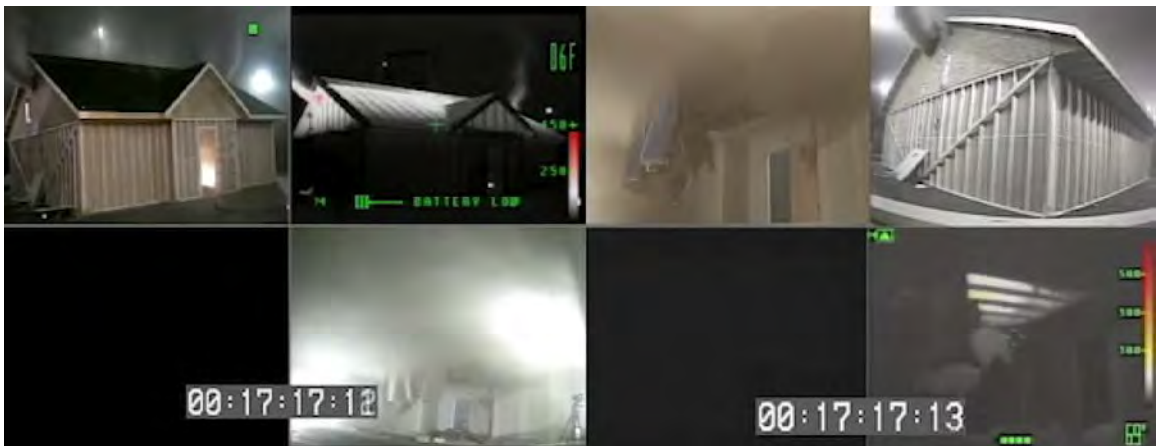
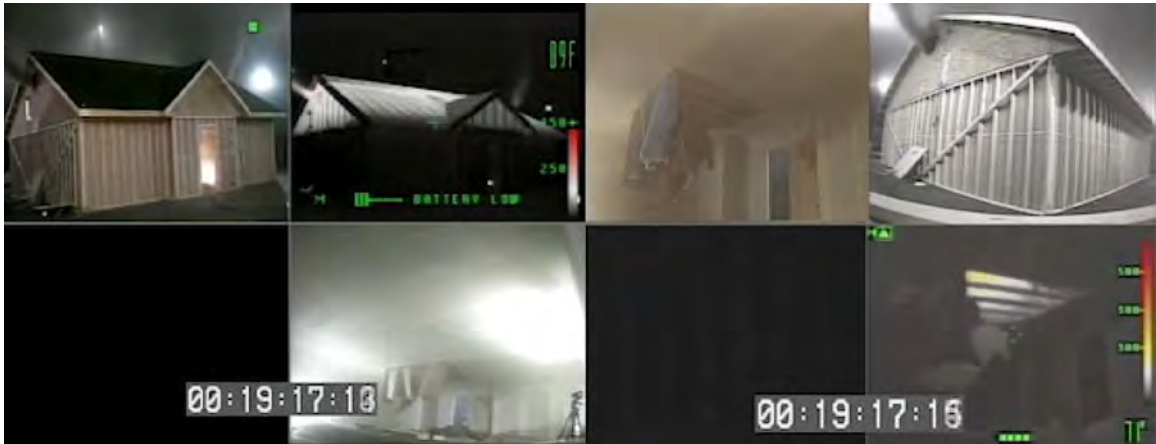
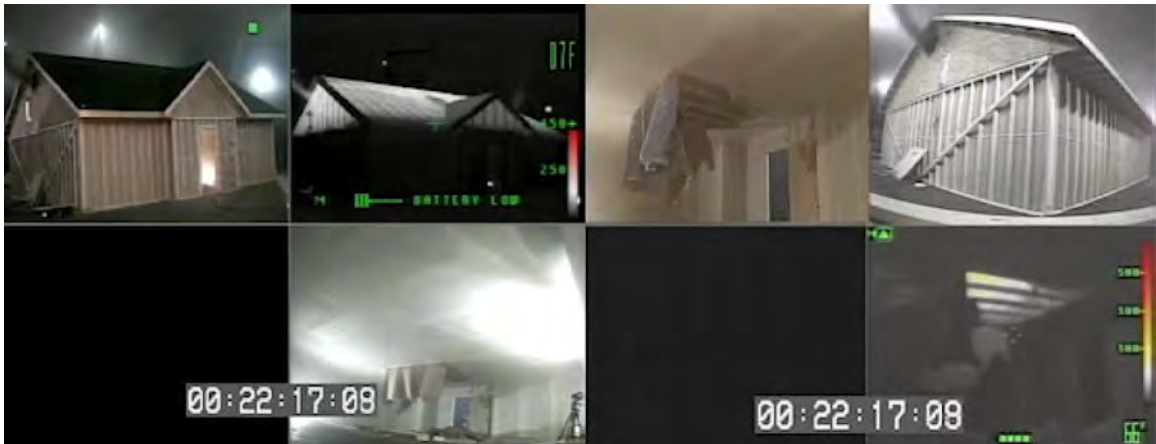
Table 8. 4: Experiment 2A Chronological Images

<u>Event</u>	<u>Time</u>
Ignition	00:00
Door Opened & 8ft. x 8ft. Attic Access Hole	12:00
1 Minute after access hole	13:07
2 Minutes after access hole	14:07
10 Seconds water from below (Straight Stream & Fog)	16:07
1 Minute after water application	17:17
2 Minutes after water application	19:17
5 Minutes after water application	22:17
9 Minutes after water application	26:17

At 00:00 ignition occurred. The fire was permitted to grow to a ventilation-limited state. At 12:00 a simulated engine crew opened the front door and made an approximately 8 ft. x 8 ft. attic access hole just inside the door to the structure. The conditions were monitored for two minutes. Water was applied at 15:07 for 20 seconds using a straight stream followed by a fog stream. The nozzle was supplied with 100psi flowing approximately 150gpm. After the application of water conditions were monitored and after 30 minutes the temperatures were steadily decreasing and the experiment ended. Table 8. 4 shows images of the experiment at each of the events described in Table 8. 3. All data gathered during this experiment can be found in Appendix I, Figures I.12-I.26.

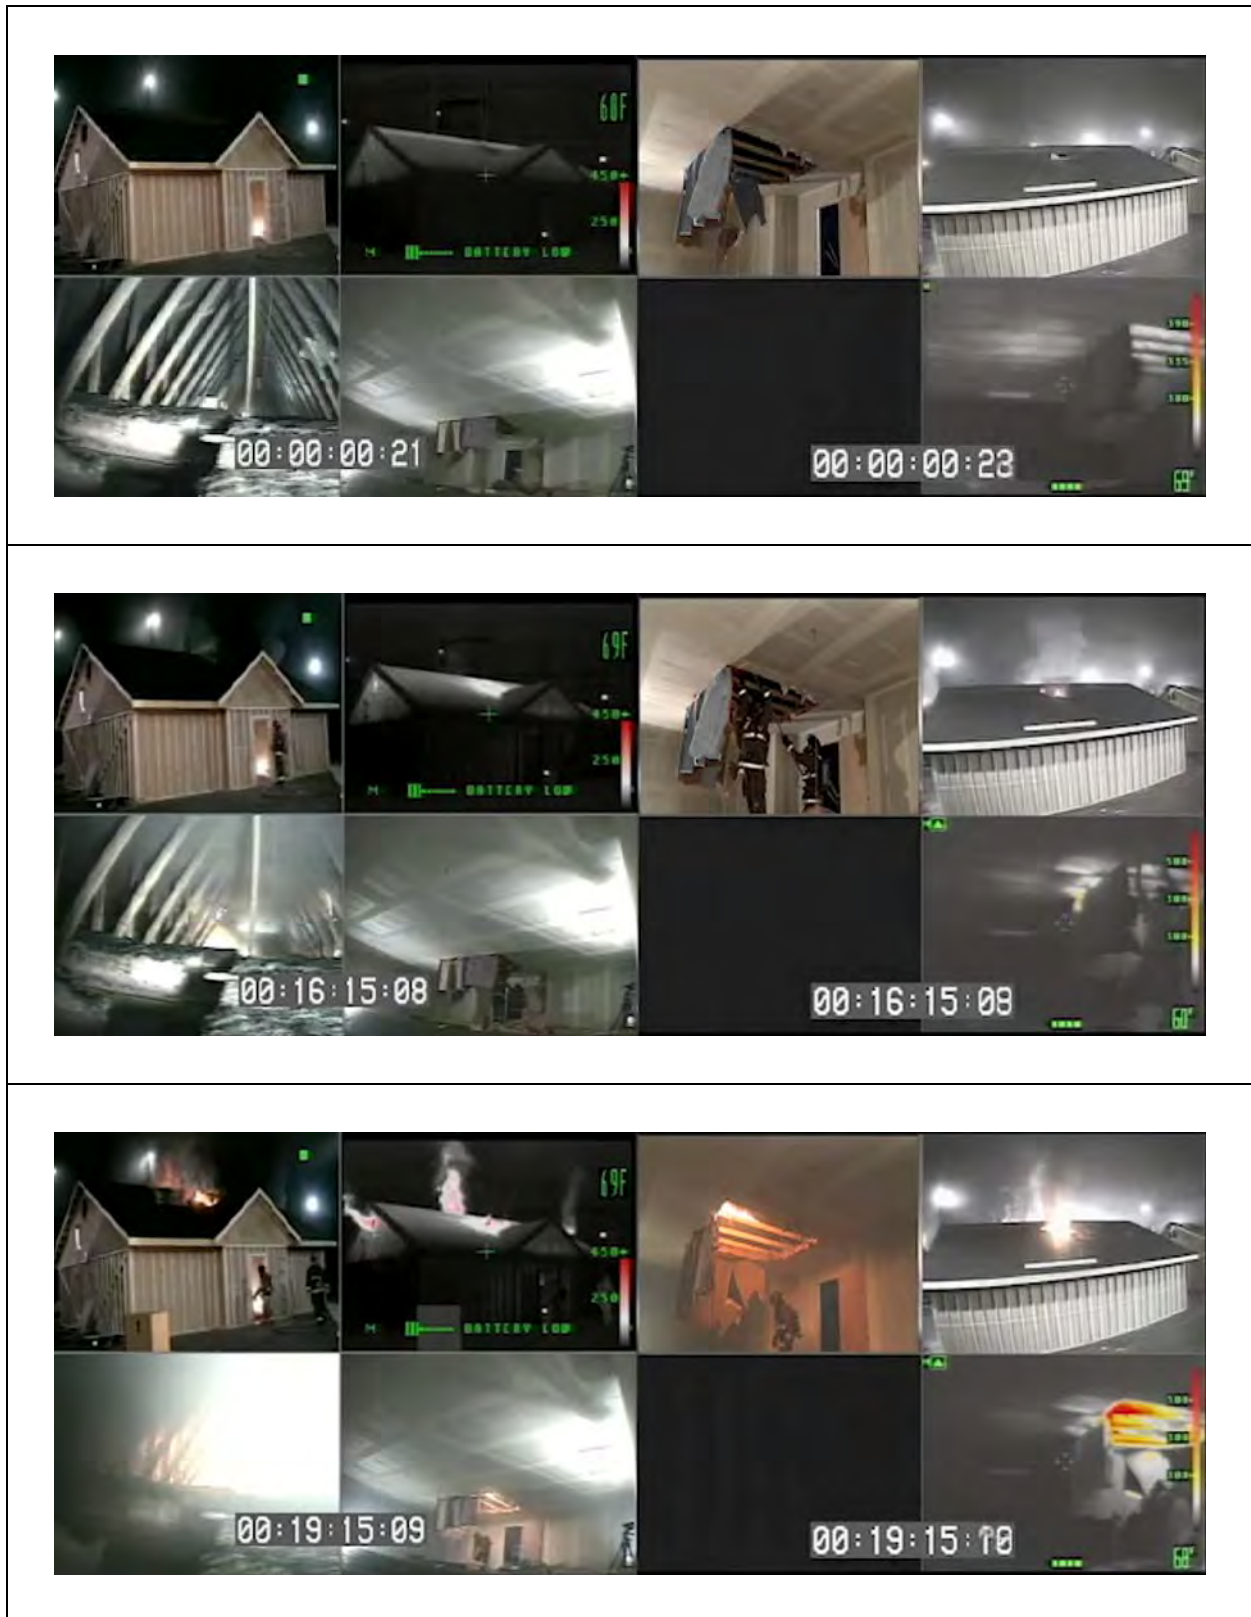
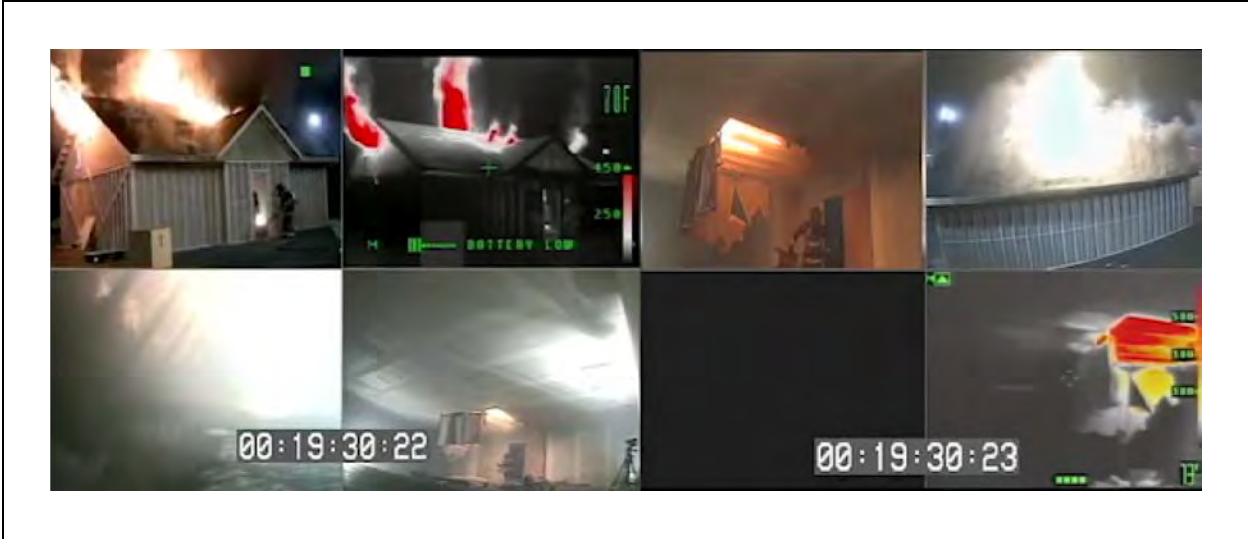
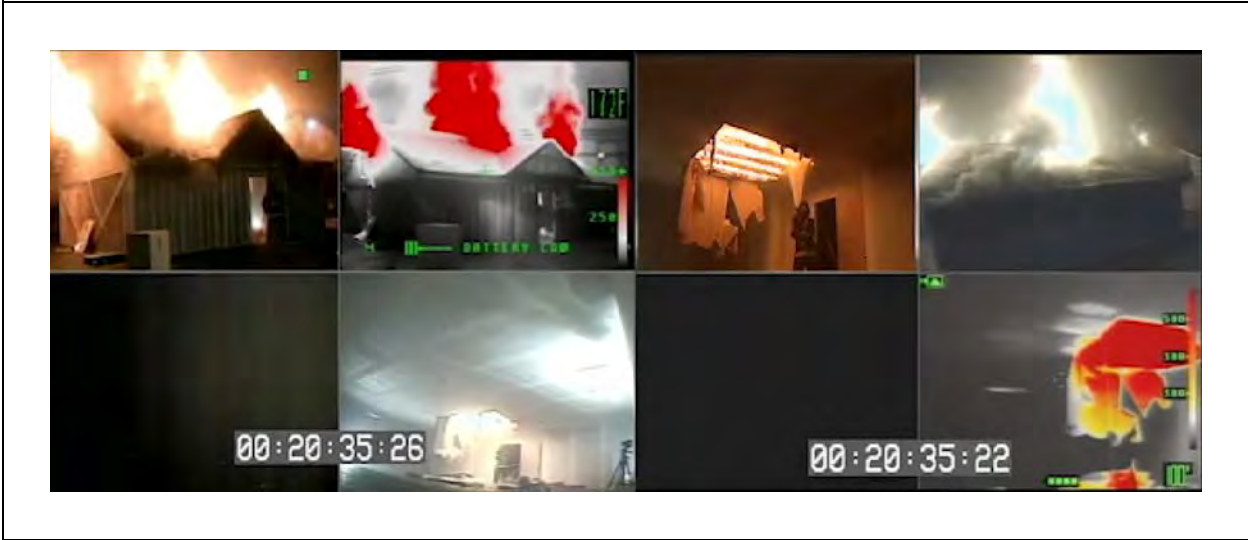
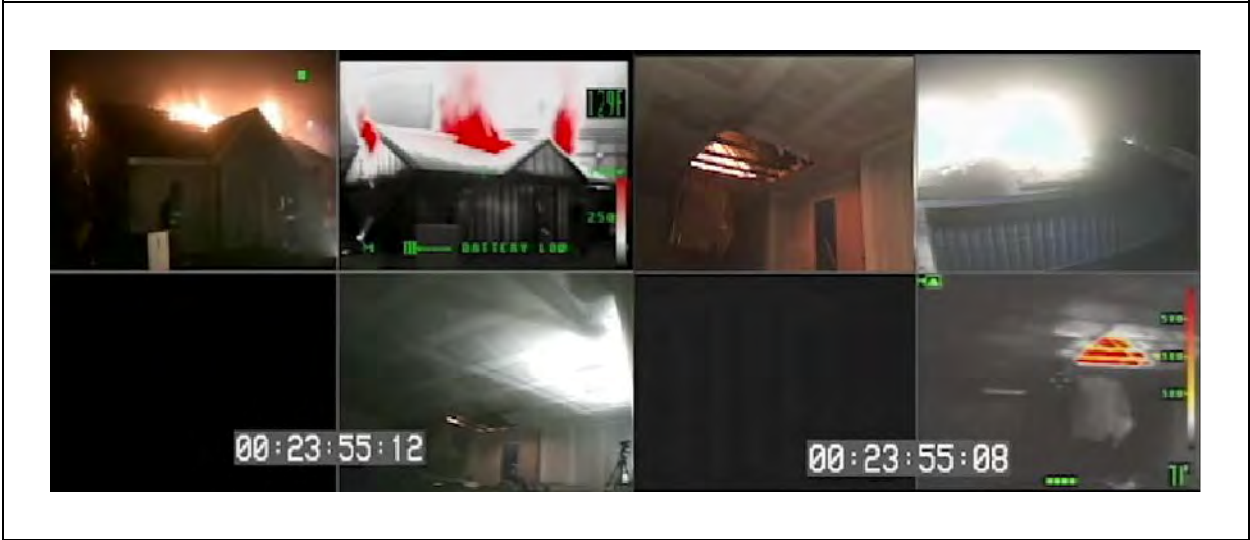
Table 8. 6: Attic Experiment 2B Chronological Images

<u>Event</u>	<u>Time</u>
Ignition	00:00
2 Commodity Boxes Added	16:15
3 Minutes After Boxes Added	19:15
Attic space approaches Flashover	19:30
15 Seconds of Fog	20:35
1 Minute after water application	21:50
23 Seconds of Straight Stream	22:32
1 Minute after water application	23:55
Water through Front Soffits (Extinguishment)	25:10

A continuation of experiment 2A this experiment was intended to evaluate the fire dynamics and suppression effectiveness of interior operations where a large hole is made below and water applied into a vented or burned through attic. Two (2) type IV commodity boxes placed just inside the 8ft. x 8ft. attic access hole and an approximate 4ft. x 4ft. ventilation hole was opened centerline on the side ‘C’ roof to simulate a ventilated or burned through attic. Ignition was provided with an electronic match shown in Figure 8. 11 placed between the commodity boxes and covered with shredded paper. Ignition occurred at 00:00 and the fire was permitted to grow. Due to the moisture from the earlier water application two (2) additional commodity boxes were added at 16:15 to provide the required fuel load to dry out the wood surfaces and permit flashover of the attic space. The attic approached flashover at 19:30. Water was applied with a fog nozzle supplied with 100 psi flowing 150gpm for 15 seconds at 20:35. The effect was evaluated and followed up with 23 seconds of straight stream supplied with 100psi at 150gpm at 22:32. Extinguishment was initiated at 25:10 via the eaves. Table 8. 6 shows the experiment images at each of the events described in Table 8. 5. All data for this experiment is shown in Appendix I.

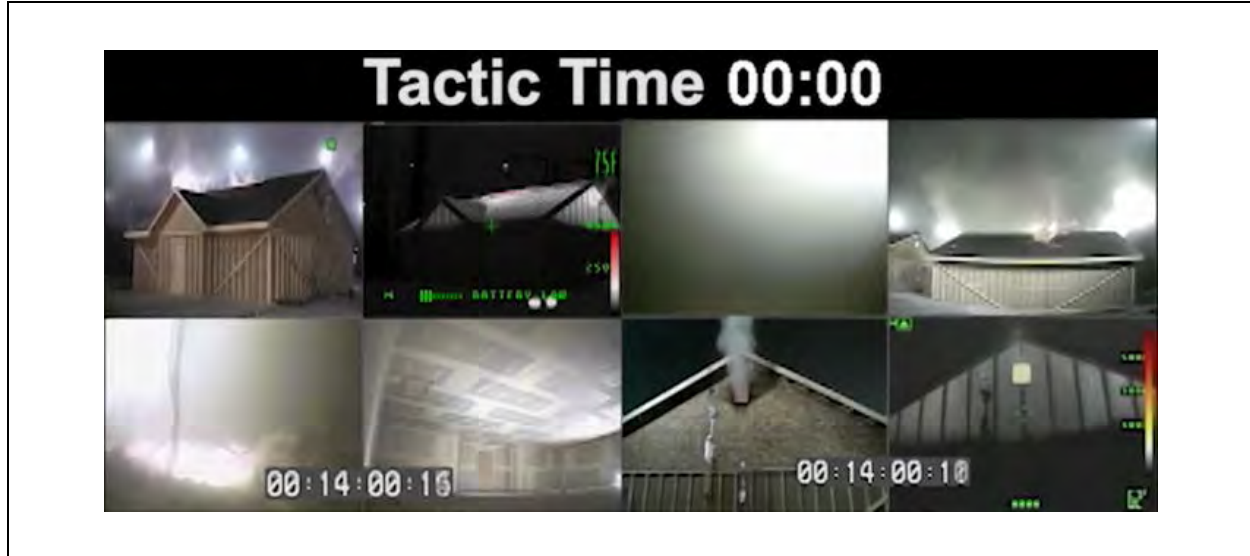
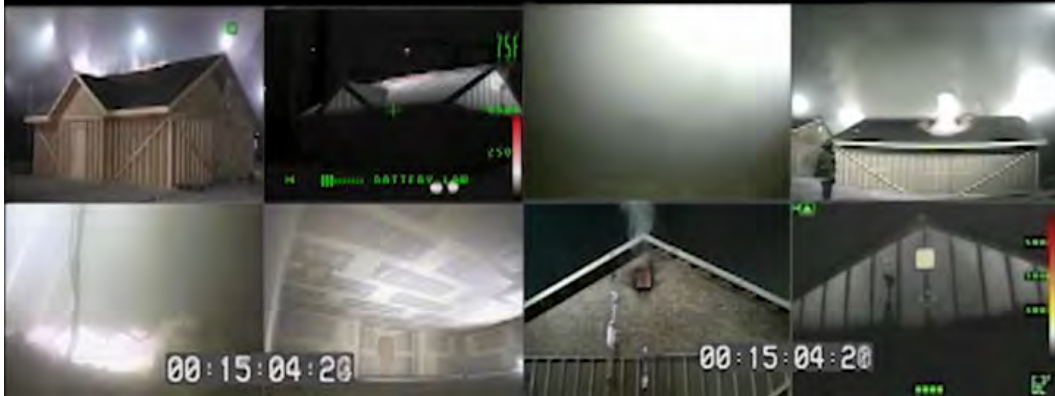
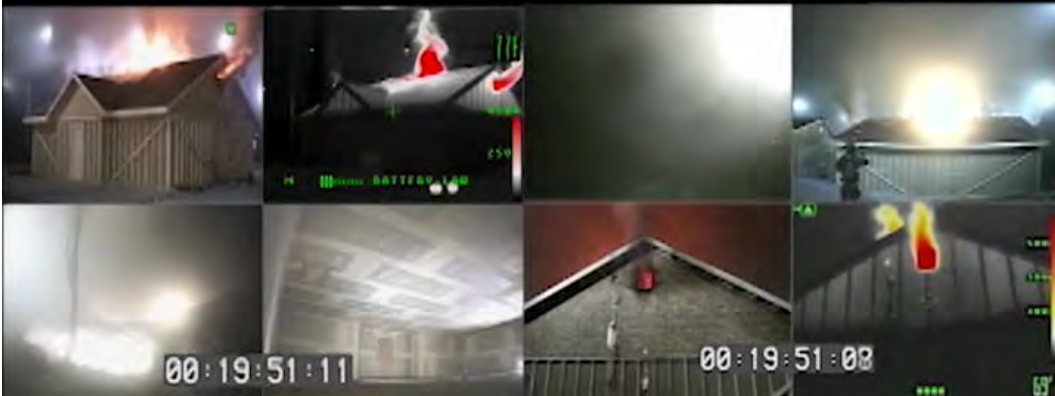
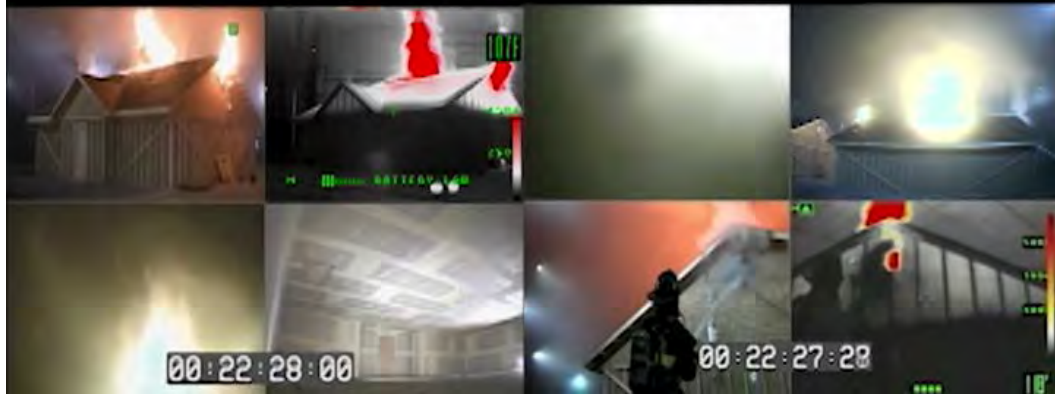
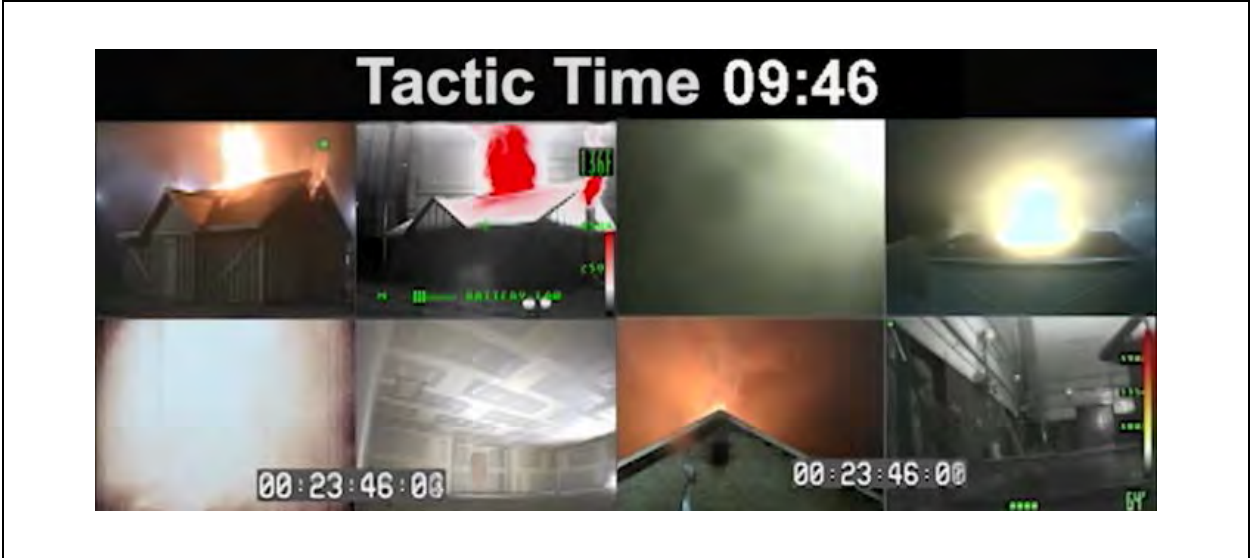
Table 8. 10: Attic Experiment 3B Chronological Images

Experiment 3B is a continuation of experiment 3A, intended to evaluate the fire dynamics and suppression effectiveness of water application through the gable vent of a ventilated or burned through attic space. The experiment begins at 00:00 after the conclusion of experiment 3A. A 4 ft. x 4 ft. roof vent is opened on the ‘C’ side at 1:03. At 5:51 flames are visible from the side ‘C’ roof ventilation hole and side ‘D’ gable. Water is applied from the side ‘B’ gable using the same combination nozzle and pressure/flow from before for 20 seconds at 8:27. The water application effect is monitored for a little over 1 minute. At 9:46 the experiment is concluded. Table 8. 10 shows the experiment images at each of the events described in Table 8. 9. All data for this experiment is shown in Appendix I, Figures I.58-I.71.

<u>Event</u>	<u>Time</u>
Experiment Begins from Experiment 3A (14:00)	0:00
4 ft. x 4 ft. Attic Vent Open	1:04
Flames from Vent & East Gable	5:51
20 Seconds of Water West Gable	8:27
Experiment Concluded	9:46

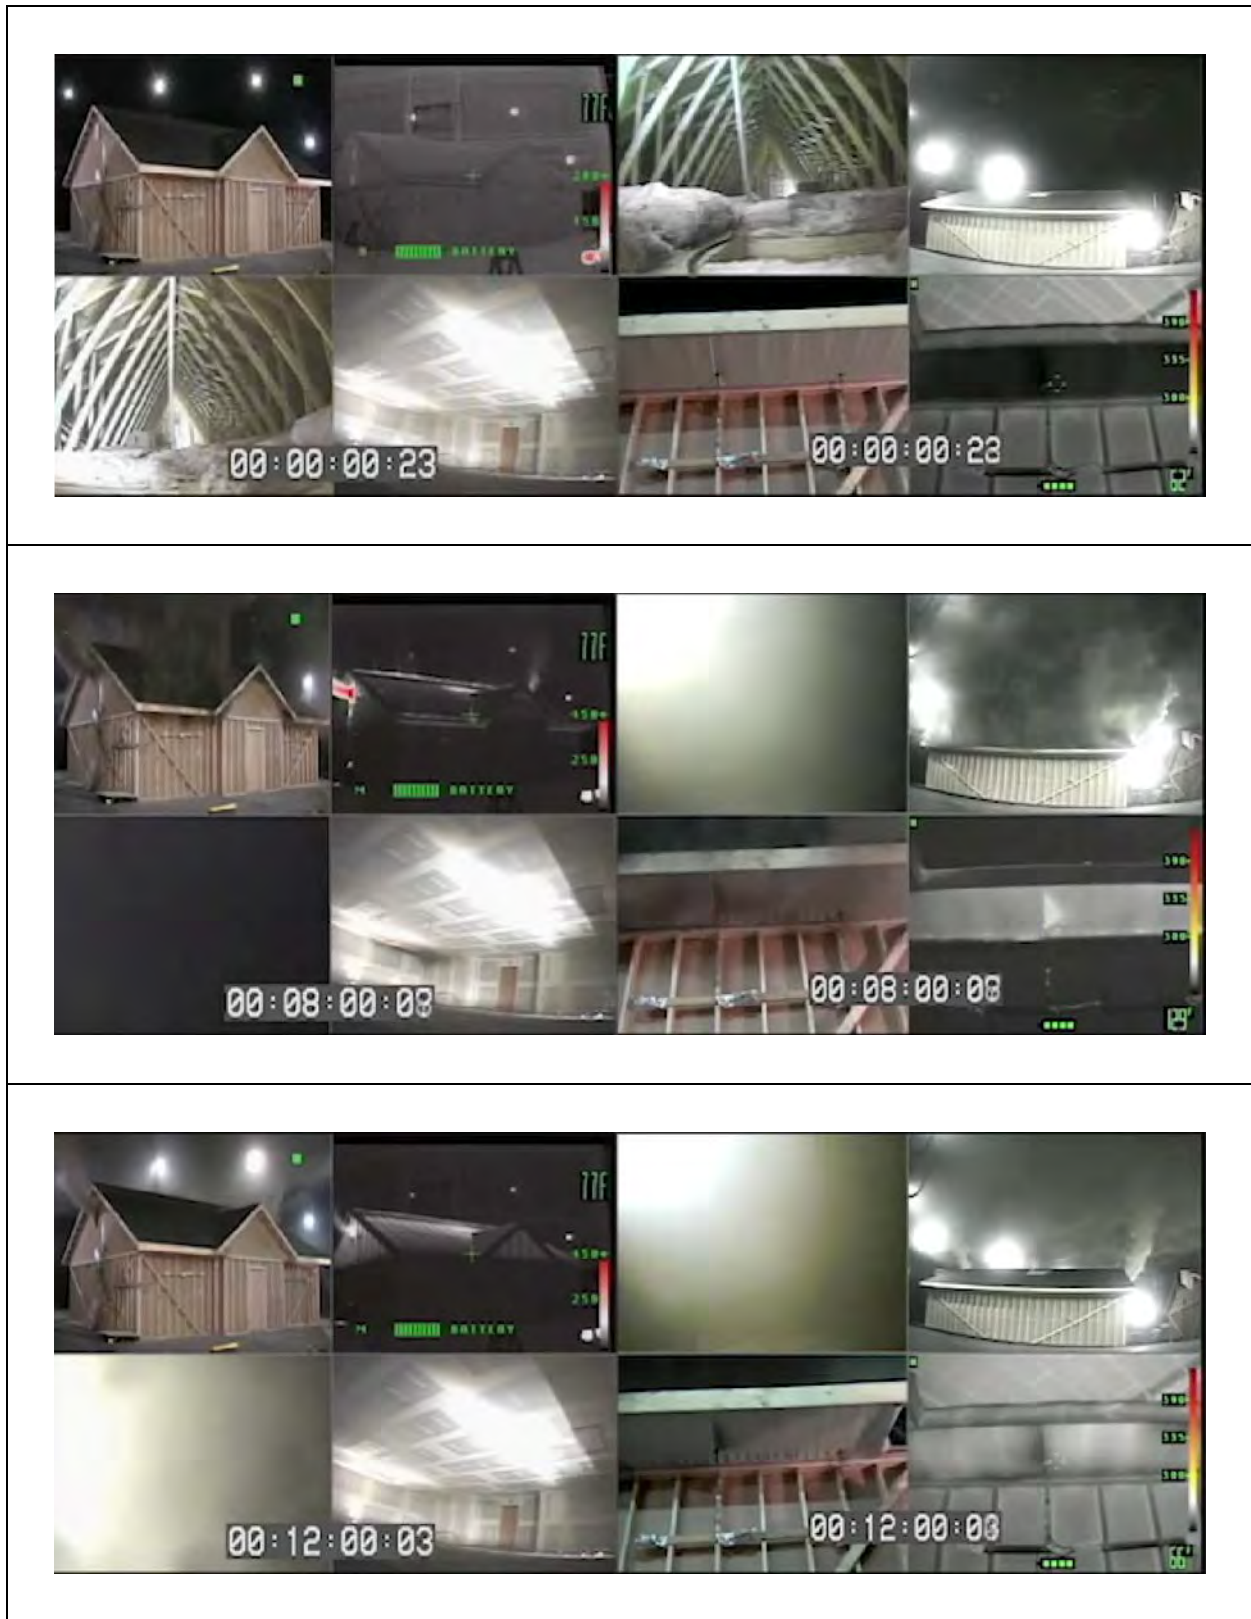
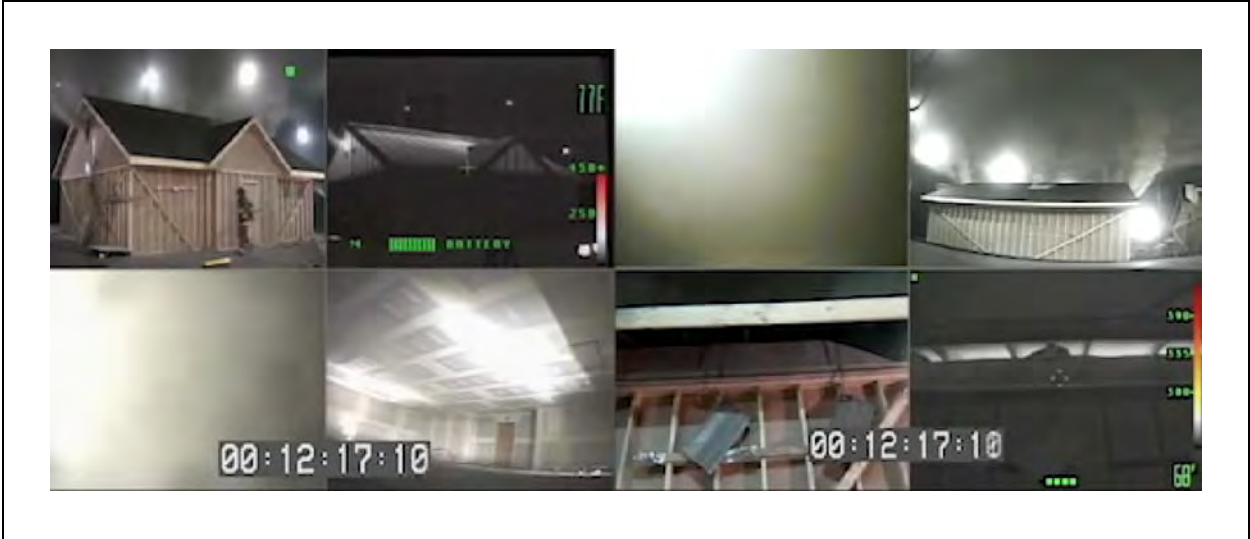
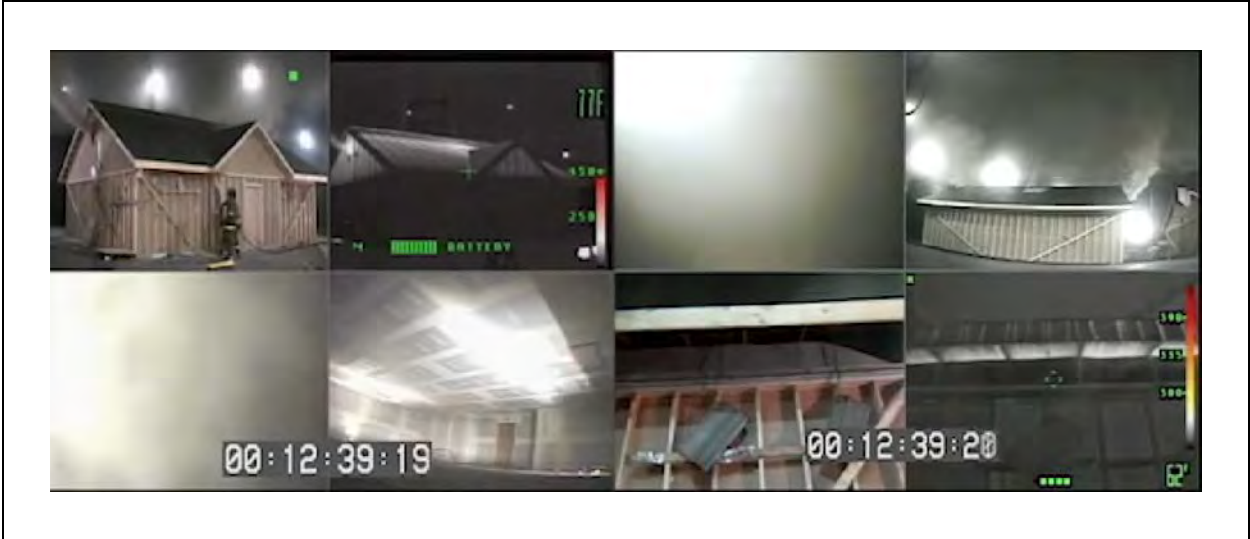
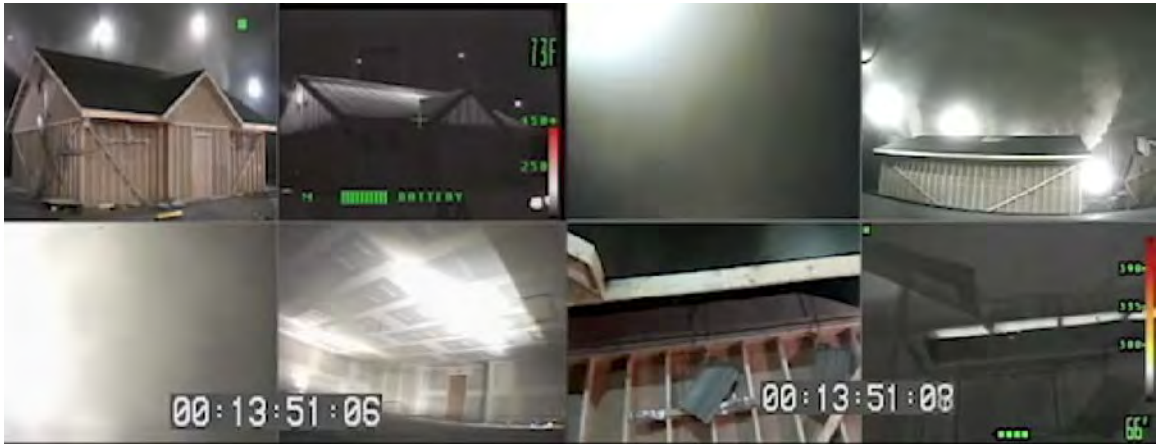
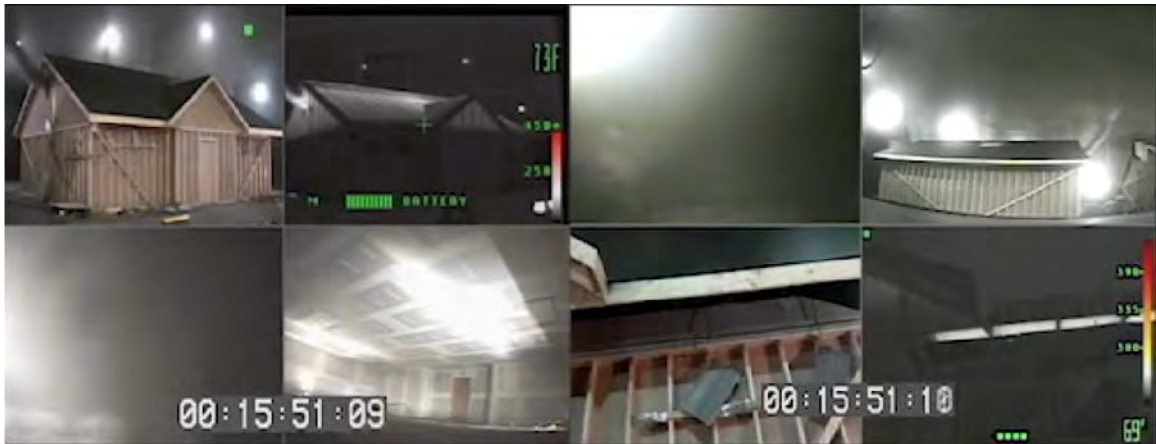
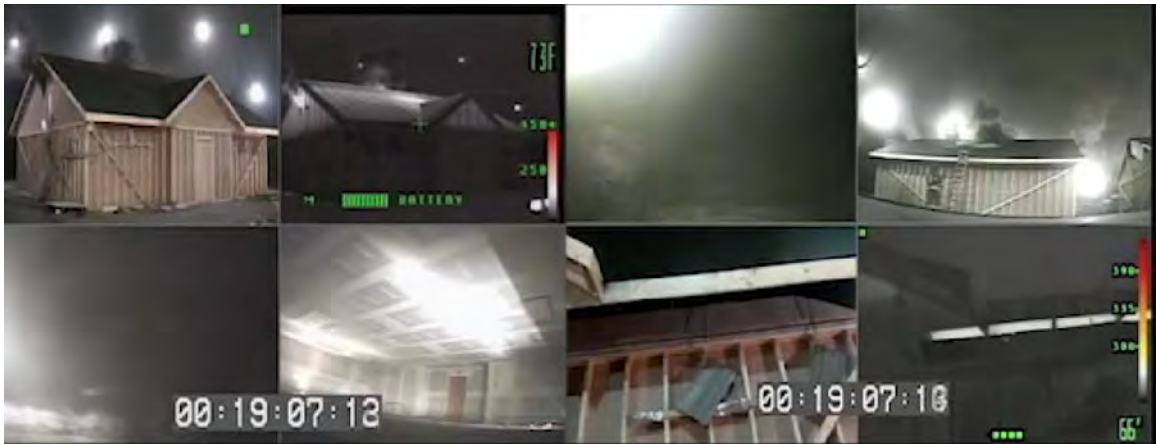
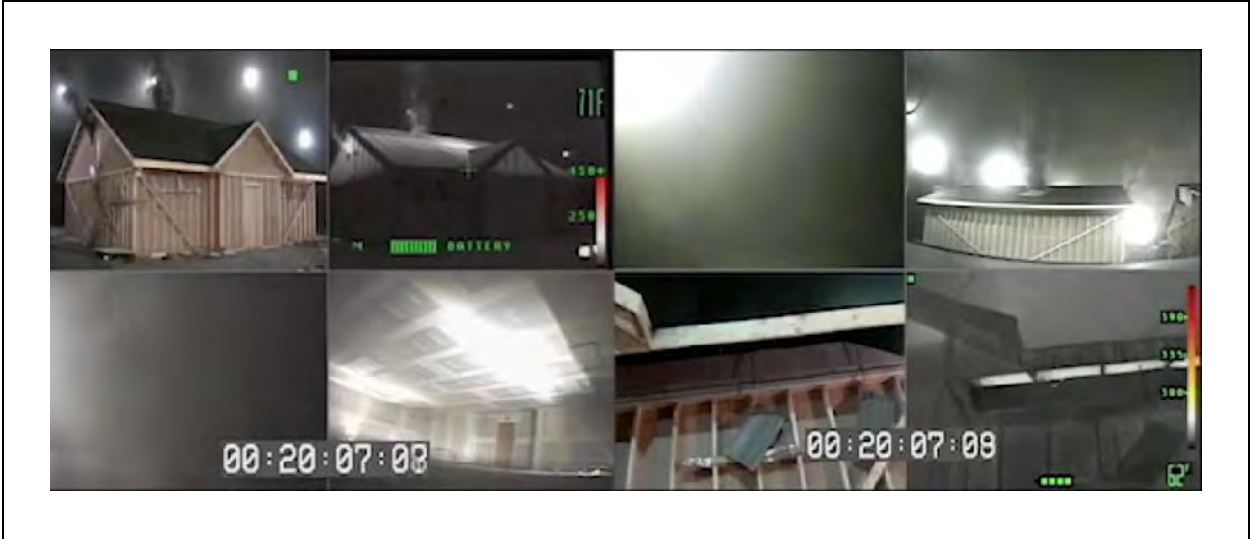
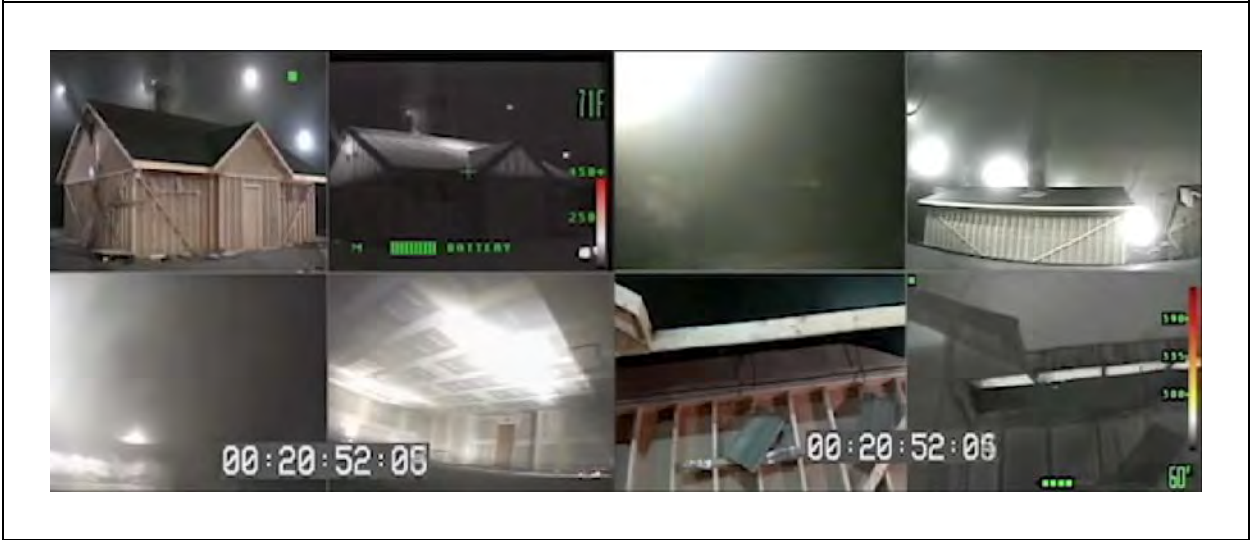
Table 8. 12: Attic Experiment 4A Chronological Images

This experiment was intended to investigate the fire dynamics and suppression effectiveness of water application through the eaves into an intact attic fire. Two (2) type IV commodity boxes were placed on a 4 ft. x 4 ft. cement board located centered in the attic space. Ignition was provided by an electric match located at the center of the boxes covered with shredded paper to ensure fire spread to the commodity boxes. Figure 8. 11 shows the fuel load for this experiment. Ignition occurred at 00:00 and the fire was permitted to grow. At approximately 08:00 the fire becomes ventilation-limited. The side ‘A’ East eaves are removed at 12:00, followed by water application through them at 12:17 with a combination nozzle set to straight stream supplied with 100psi flowing 150gpm. The side ‘A’ West eaves are removed at 12:20 followed by water application through them at 12:39 using the same nozzle, pressure and flow. The effects of the water application are evaluated for approximately 7 minutes and 45 seconds at which time a 4 ft. x 4 ft. roof vent is opened on the ‘C’ side at 19:07. Conditions were evaluated for the next two minutes with further decrease in interior temperature. The experiment was stopped 1:45 after the vent hole was opened.

<u>Event</u>	<u>Time</u>
Ignition	00:00
Temperature Decrease in Attic Space – Ventilation-limited	08:00
Side ‘A’ East Eaves Pulled	12:00
Water East Eaves Straight Stream – 12 Seconds	12:17
Side ‘A’ West Eaves Pulled	12:20
Water West Eaves Straight Stream – 12 Seconds	12:39
1 Minute After Water Application	13:51
3 Minutes After Water Application	15:51
4ft. x 4ft. Side ‘C’ Roof Vent Open	19:07
1 Minute After Open Vent	20:07
1:45 After Open Vent (End Experiment)	20:52
