Study of Residential Attic Fire Mitigation Tactics and Exterior Fire Spread Hazards on Fire Fighter Safety

UL Firefighter Safety Research Institute

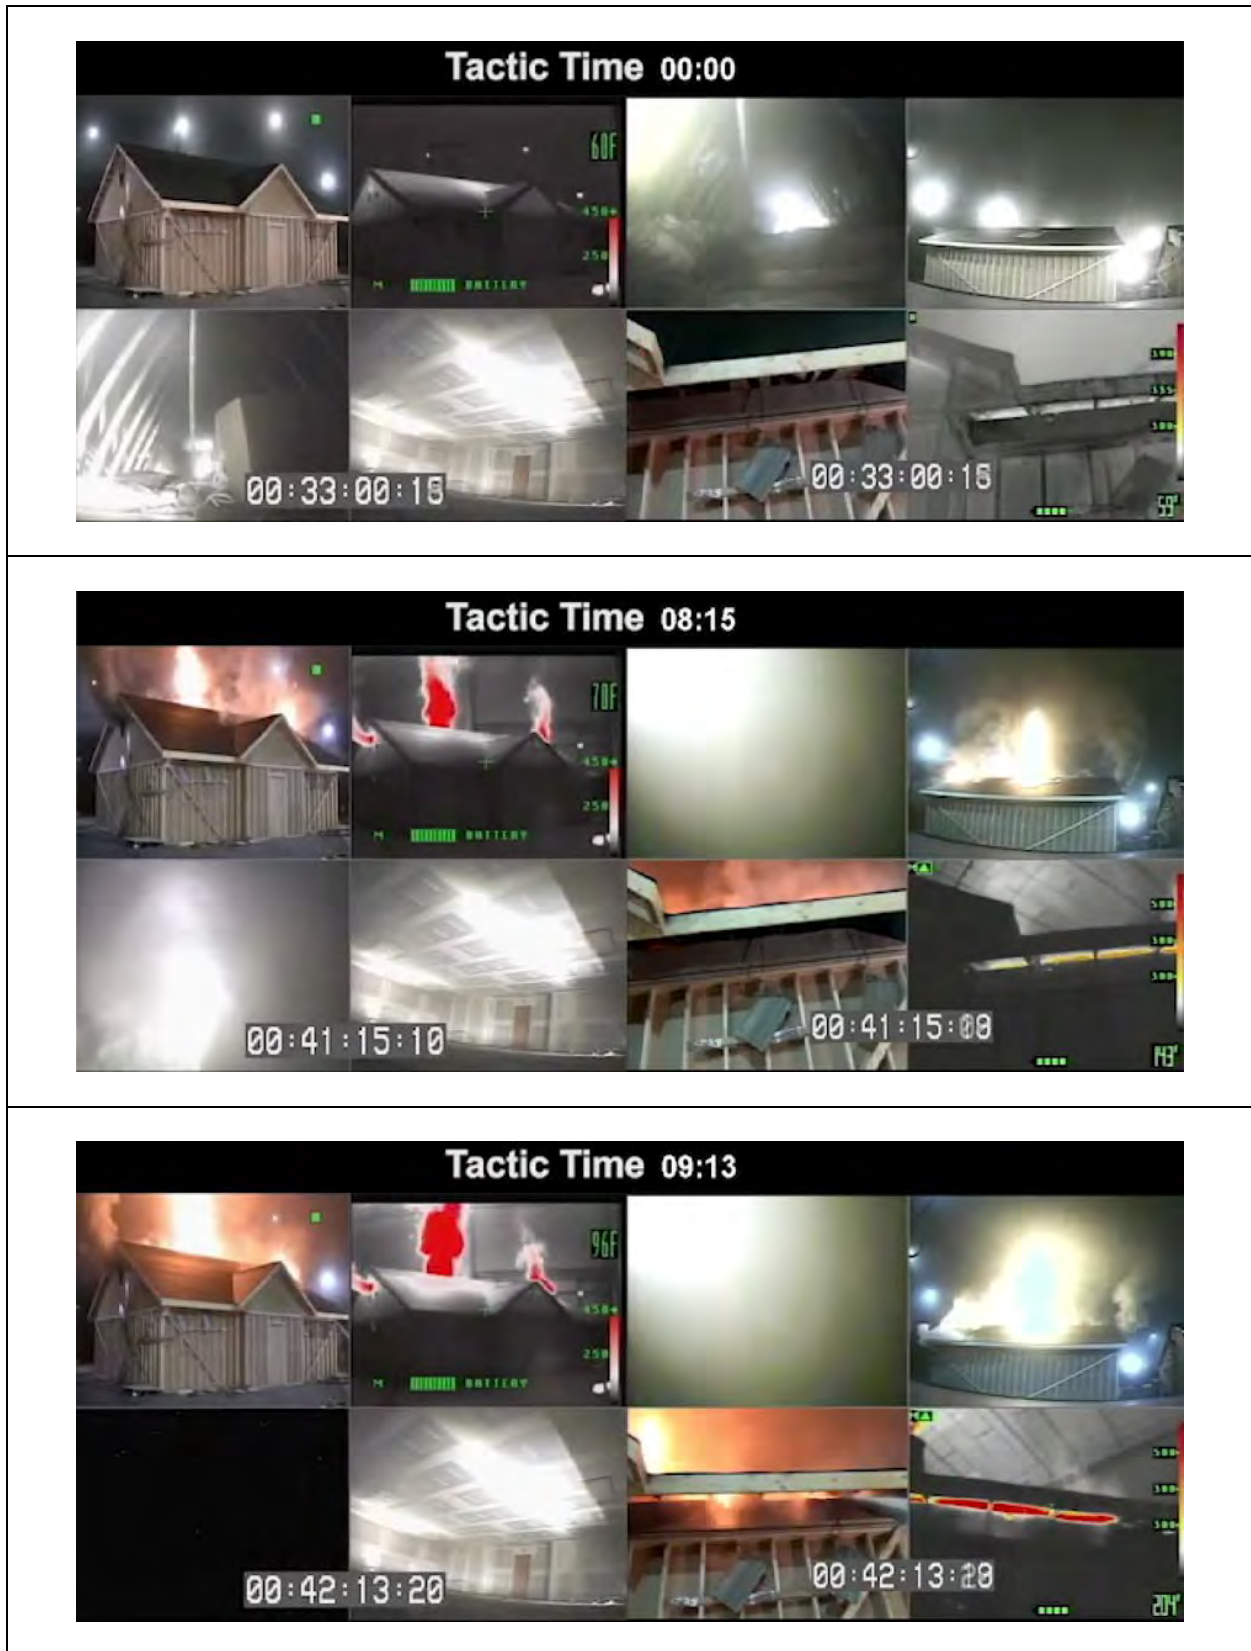
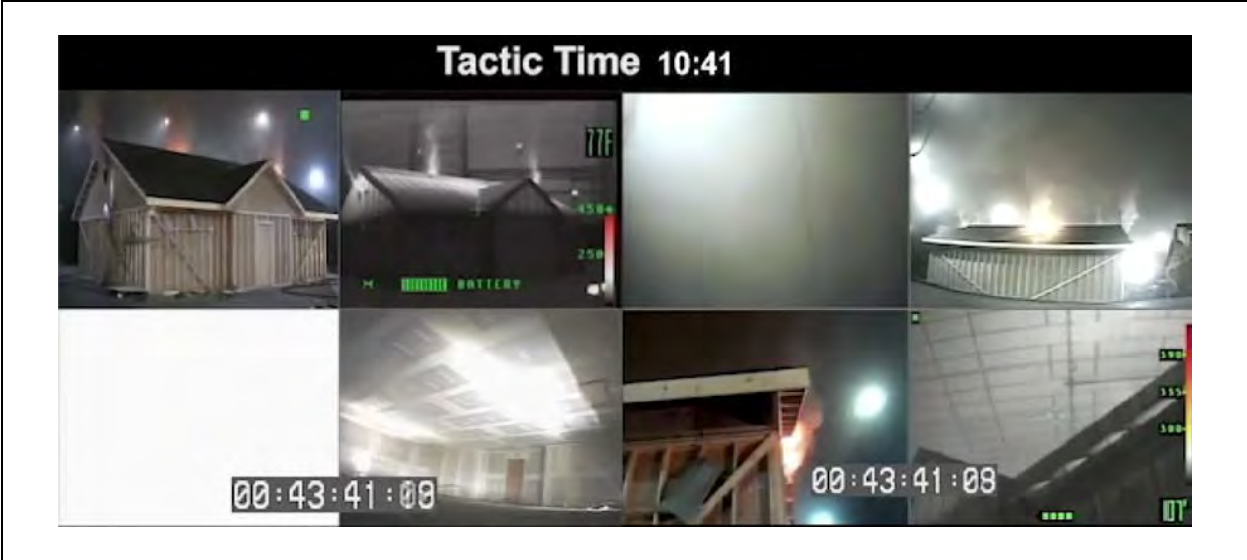
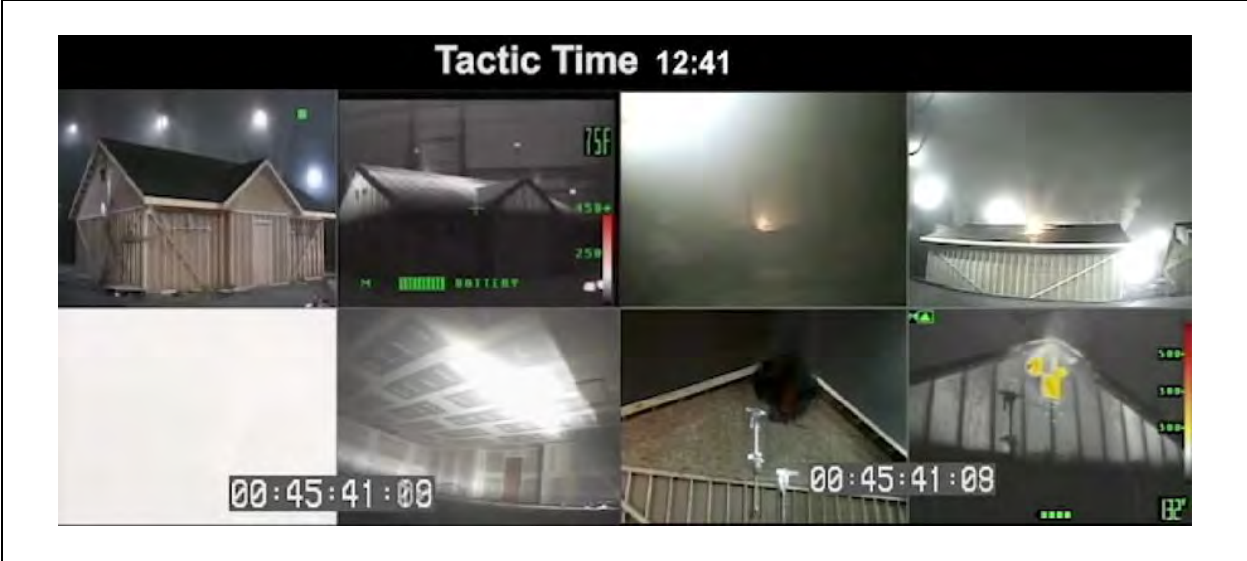
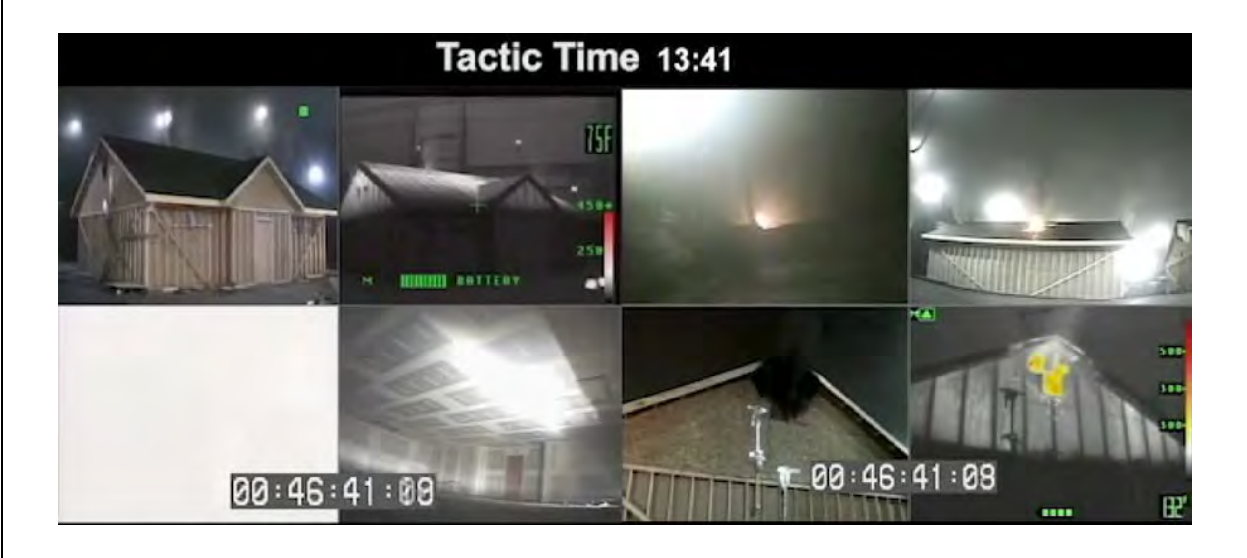
Table 8. 14: Attic Experiment 4B Chronological Images

This experiment was intended to evaluate the fire dynamics and suppression effectiveness of water application through the eaves on a ventilated or burned through attic. It was a continuation of experiment 4A, where the majority of the initial fuel load had been consumed and the remaining fuel could not heat adjacent surfaces enough to propagate flame spread. At the beginning of the experiment temperatures at the peak of the attic were below 150°F. Two (2) type IV commodity boxes were placed inside the East access hatch as additional fuel. Ignition was provided by an electric match located at the center of the boxes covered with shredded paper to ensure fire spread to the commodity boxes. Figure 8. 11 shows an example of the fuel load for this experiment. Ignition occurred at 00:00 and the fire was permitted to grow in the attic vented attic space. At approximately 08:15 the temperatures stabilize in the attic space representing roughly a steady state. Water is applied through the side ‘A’ eaves at 09:13 using a combination nozzle set to straight stream supplied with 100psi flowing 150gpm. The effects of the water application are evaluated for approximately 4 minutes where further decrease in interior temperature occurred. The test is concluded 4 minutes after water is applied. Table 8. 14 shows the experiment images at each of the events described in Table 8. 13. All data for this experiment is shown in Appendix I, Figures I.88-I.102.

<u>Event</u>	<u>Time</u>
Ignition	00:00
Relatively Steady State Temperatures in Attic	08:15
Water Through Side ‘A’ Eaves – 12 Seconds Each Side	09:13
1 Minute after water application	10:41
3 Minutes after water application	12:41
4 Minutes after water application	13:41

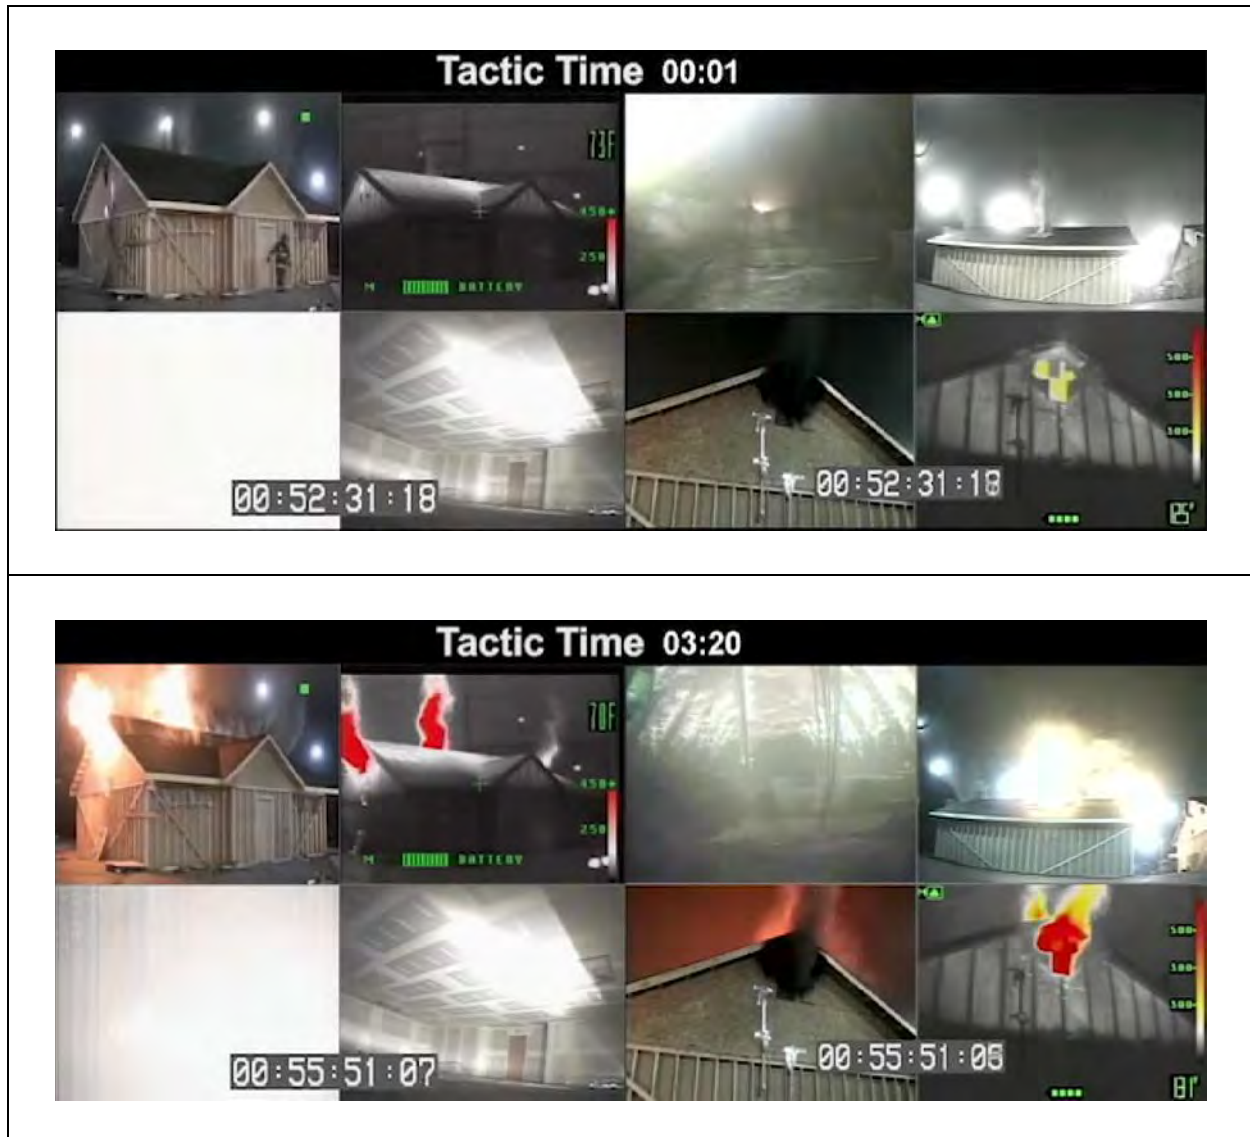
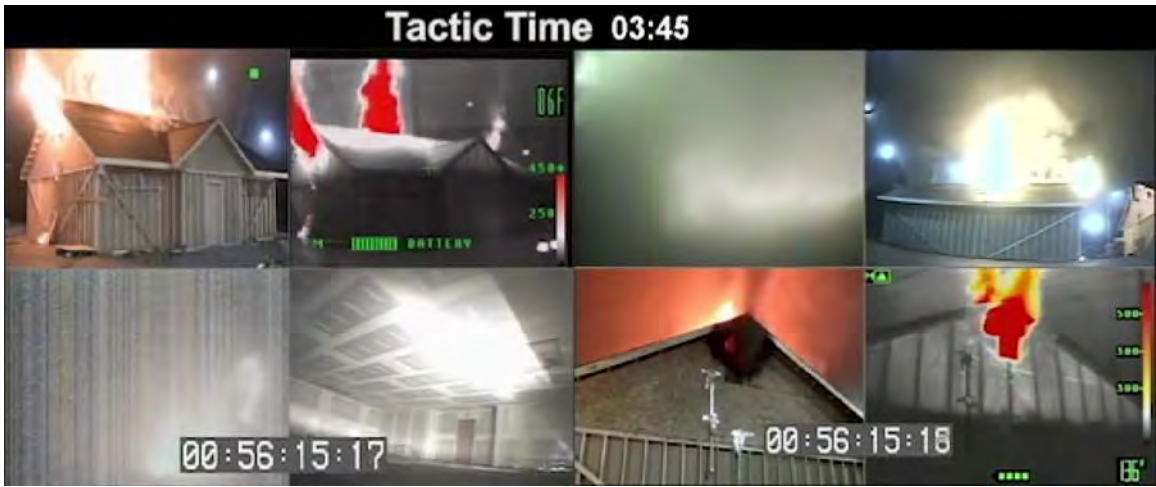
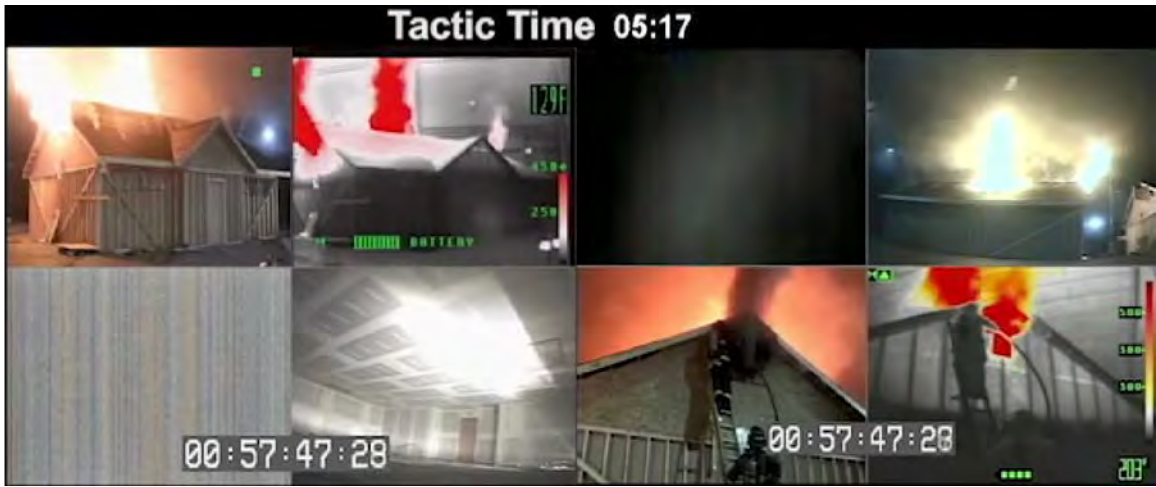
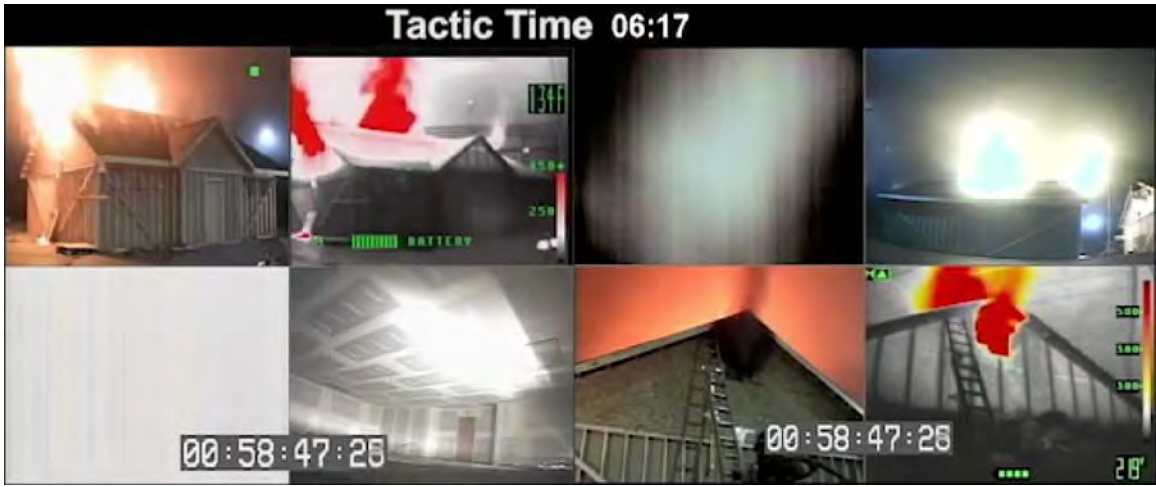
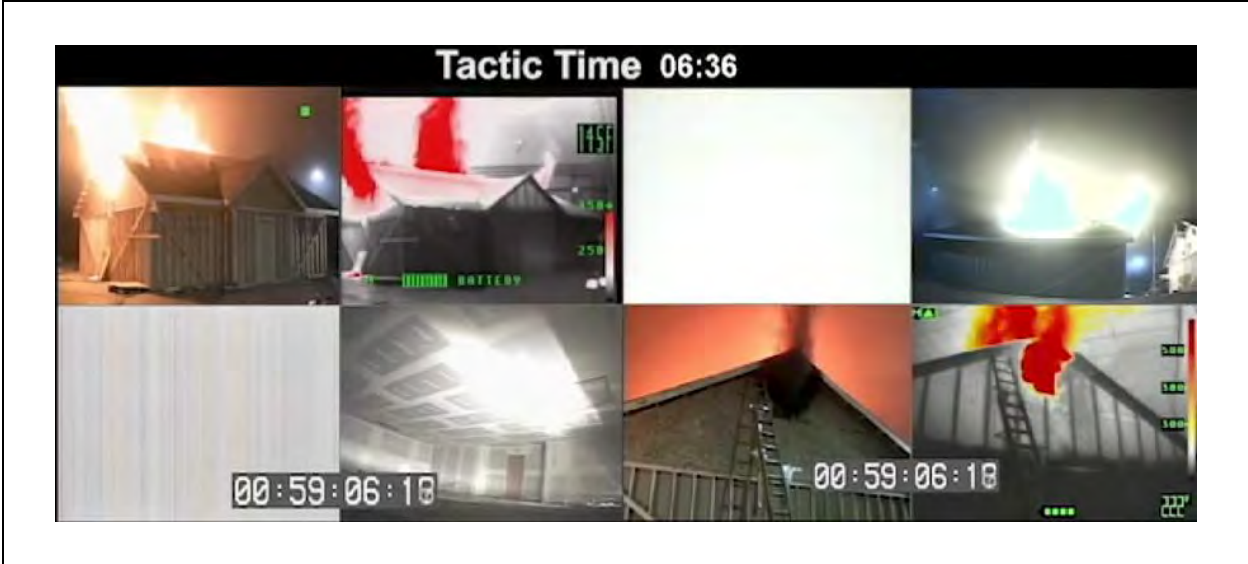
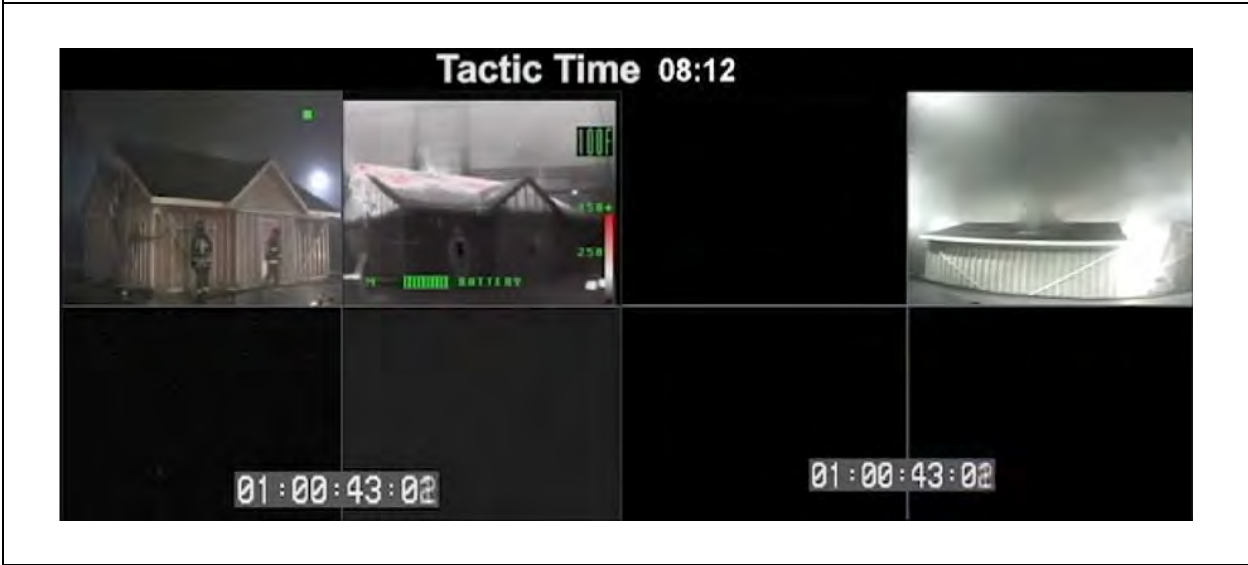
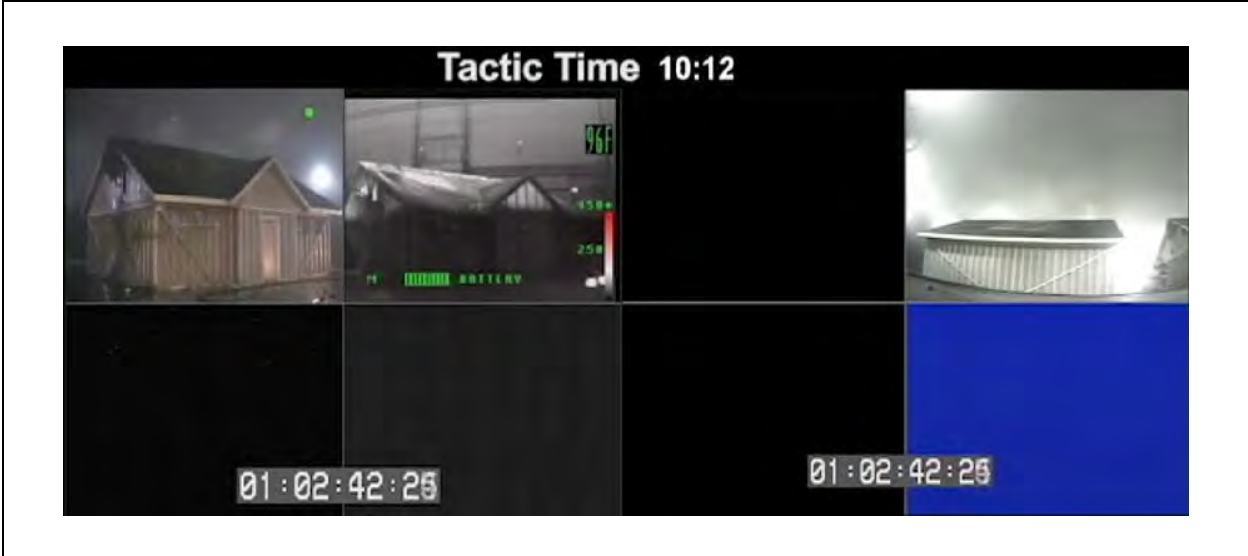
Table 8. 16: Attic Experiment 4C – Chronological Images

This experiment is intended to revisit suppression by gable attack and eave attack on a ventilated or burned through attic. At the conclusion of experiment 4B the majority of the initial fuel load had been consumed and the remaining fuel could not heat adjacent surfaces enough to propagate flame spread. The temperatures at the peak of the attic were below 150°F. Two (2) type IV commodity boxes were placed inside the West access hatch as additional fuel. Ignition was provided by an electric match located at the center of the boxes covered with shredded paper to ensure fire spread to the commodity boxes. Figure 8. 11 shows an example of the fuel load for this experiment. Ignition occurred at 00:00 and the fire was permitted to grow in the attic vented attic space. As the fire progresses roll over on at the peak of the attic space can be seen in the attic camera at 03:20. At approximately 03:45 the temperatures stabilize in the attic space. The rapid increase in the fire is most likely attributed to the pre-heated fuel which due to the flashover in the earlier experiment permitted heat to transfer into the material. Water is applied through the side ‘D’ gable vent at 05:17 for 50 seconds using a combination nozzle set to straight stream provided with 100psi flowing 150gpm. The effects of the water application are evaluated and 10 seconds after application and temperatures in the attic space are climbing rapidly at 06:17. Water is applied through the eaves 12 seconds on the East side and 15 seconds on the west side at 06:36 using the same nozzle, pressure and flow. Temperature are monitored for an additional 3 minutes after water application and the experiment is concluded at 10:12. Table 8. 16 shows the experiment images from at each of the events described in Table 8. 15. All data for this experiment is shown in Appendix I.

<u>Event</u>	<u>Time</u>
Ignition	00:01
Roll Over Seen in Attic Camera	03:20
Relatively Steady State Temperatures in Attic	03:45
Water Through Side ‘D’ Gable – 50 Seconds	05:17
10 Seconds After Water Application	06:17
Water Through Side ‘A’ Eaves – 12 Seconds East, 15 Seconds West	06:36
1 Minutes After Water Application	08:12
3 Minutes After Water Application (End Experiment)	10:12

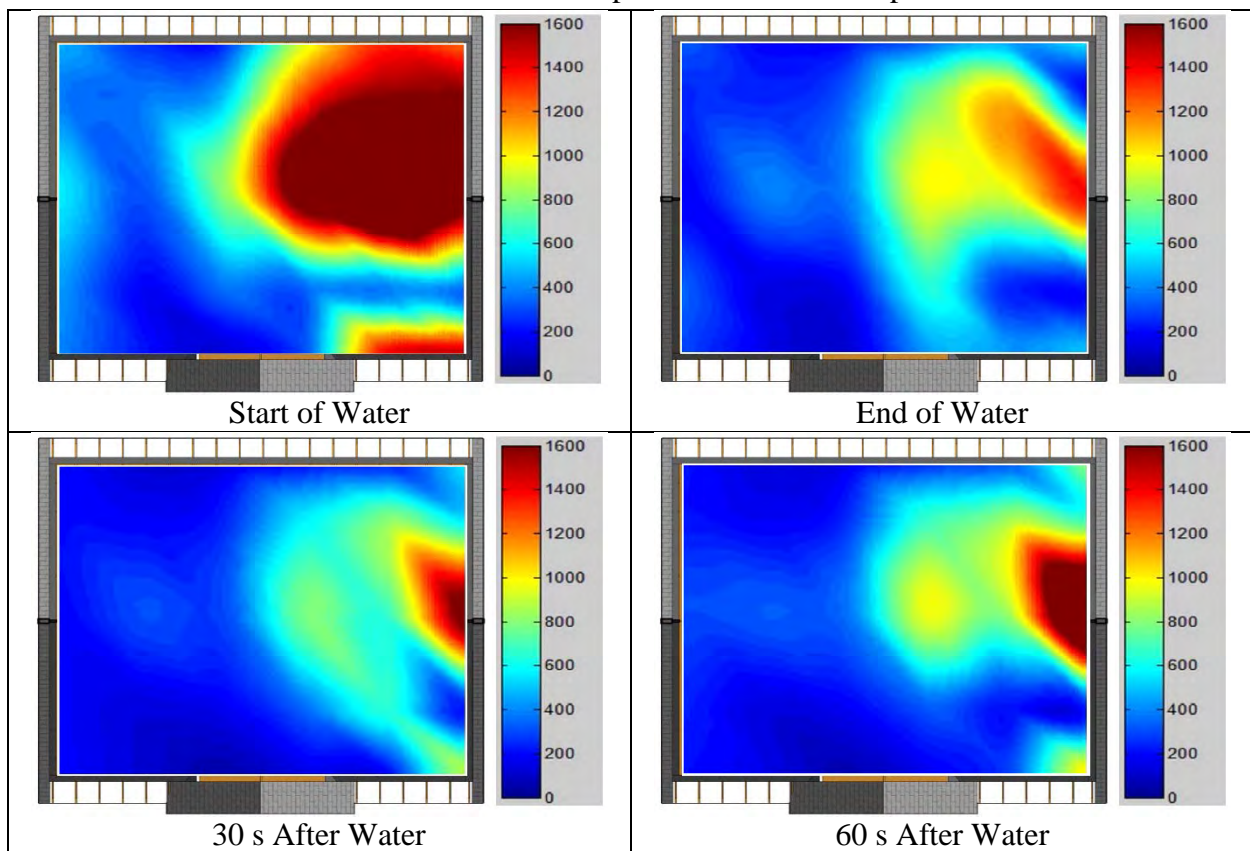
Table 8. 20: Attic Experiment 2B Heat Maps

In experiment 2B, 22:32 after ignition, water was supplied to the attic space through a large hole in the ceiling with a straight stream with 100 psi flowing 150 gpm. The water application lasted for 23 s. Table 8. 20 shows the heat maps of the attic space before water application, at the end of water application, 30 s after water application, and 60 s after water application. From the heat maps, it is evident that prior to water application, the attic space was not fully involved and the fire seemed to be confined in the back right quadrant of the attic space. At the end of water application, the temperatures in the back right quadrant have significantly cooled, though temperatures above 1200°F are still observed. The fire does not recover much at 30 s and 60 s after water application, however recovers well after two minutes. Similar to the fog stream minimal surface cooling/wetting occurred as the trusses in the attic obstructed the spray and small pockets of burning remained. Regrowth occurred in 2 minutes after water application (see Appendix I, Figures I.27-I.32).

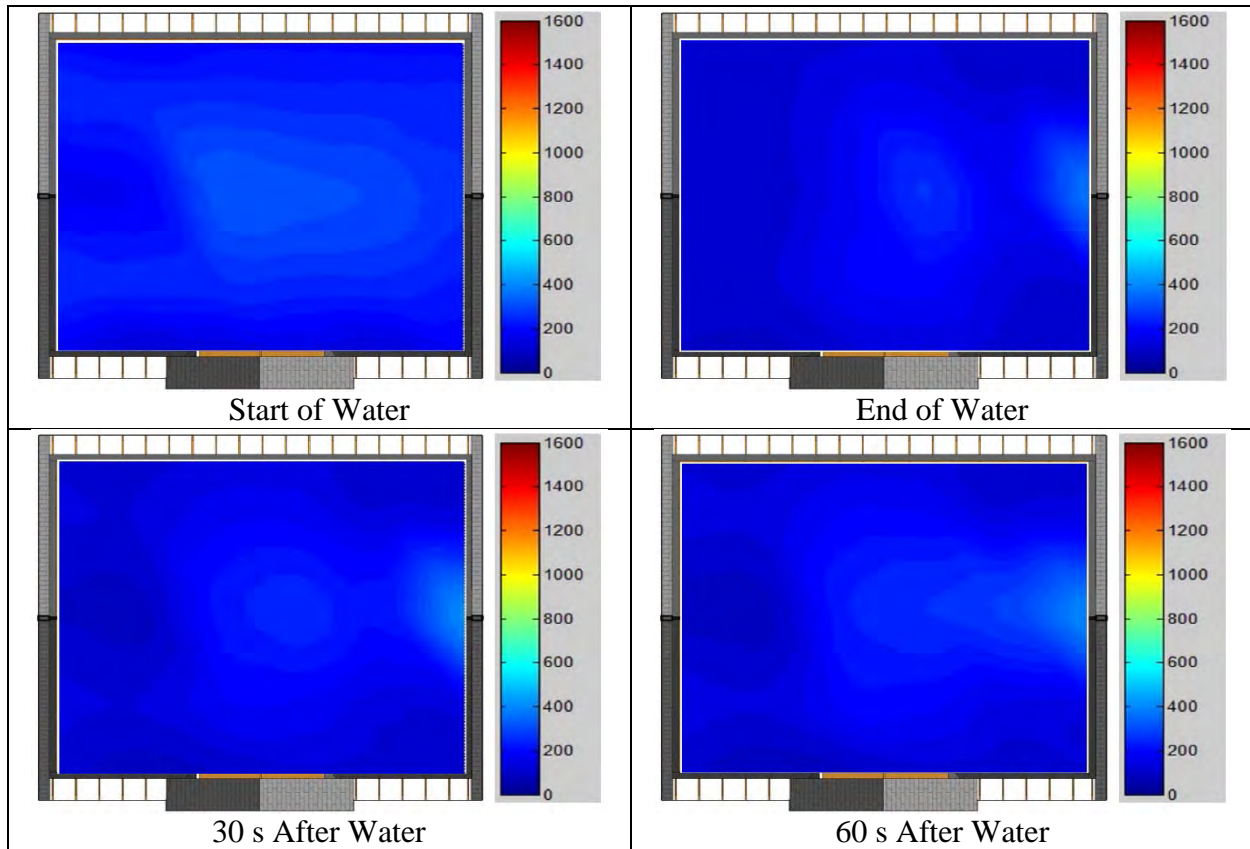
Table 8. 23: Attic Experiment 4A Heat Maps

In experiment 4A, 12:17 after ignition, water was supplied to the attic space through the eave line with a straight stream with 100 psi flowing 150 gpm. The water application lasted for 24 s. Table 8. 23 shows the heat maps of the attic space before water application, at the end of water application, 30 s after water application, and 60 s after water application. From the heat maps, it is evident that prior to water application, the temperatures in the attic space are uniformly under 400°F. At the end of water application, the temperatures in the structure decrease to being uniformly under 250°F, except near the right gable vent where the temperature is near 400°F. The conditions remain similar 30 s and 60 s after water application with only small temperature

increases near the right gable vent. The temperatures rebound some due to the trapped heat in the unvented attic however remain under 400°F for over 5 minutes. When ventilation is provided on the rear of the attic temperature further decrease to below 250 °F. The eave line attack was effective at controlling the fire and improving the conditions in the attic space. The effectiveness can be attributed to the water reaching the surface of the burning material cooling and extinguishing fuel. See Appendix I, Figures I.72-I.77 for the temperature throughout the experiment.

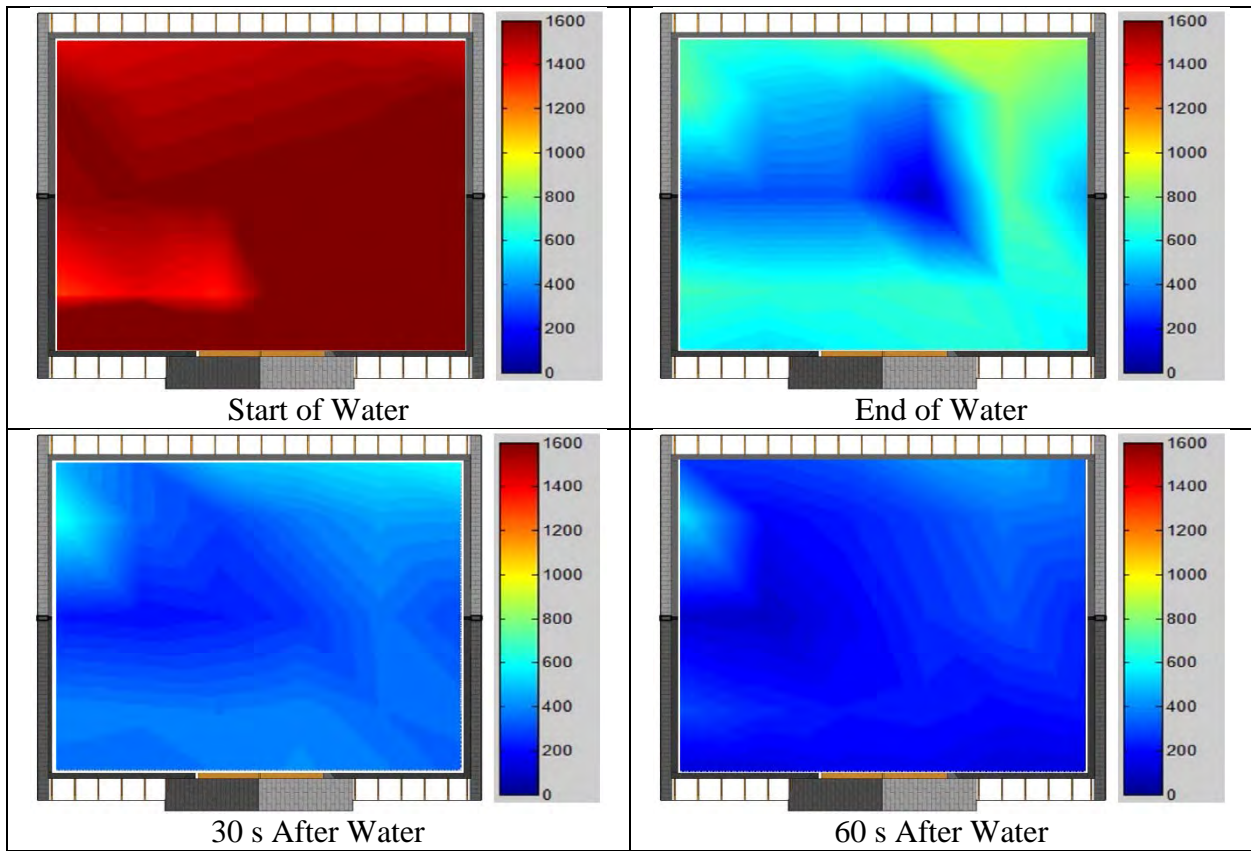
Table 8. 25: Attic Experiment 4C Heat Maps

In experiment 4C, 06:36 after ignition, water was supplied to the attic space through the eave line with a straight stream with 100 psi flowing 150 gpm. The water application lasted for 27 s.

Table 8. 25 shows the heat maps of the attic space before water application, at the end of water application, 30 s after water application, and 60 s after water application. From the heat maps, it is evident that prior to water application, the attic space is well involved with the temperatures above 1400°F. At the end of water application, the temperatures have cooled in the attic space, though there is still a large amount of area above 500°F. The attic space continues to cool down 30 s and 60 s after water application, with most of the attic space under 400°F at 60 s after water application. The fire never recovers. The water reached the surface of the sheathing cooling and extinguishing the majority fuel in the attic.

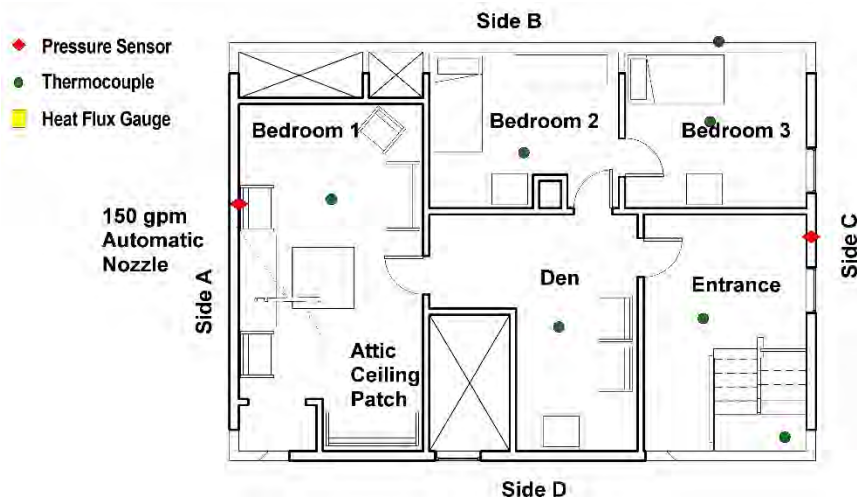
Figure 9. 10: 25th St. Attic Instrumentation

Two pressure measurements were made in the attic space and two measurements were made in the peak of the attic. Pressures were measured on each end of the peak of the attic 1 ft. above the floor, and in the entrance area and bedroom 1 of the attic space 1 ft. above the floor.

High definition cameras recorded video in bedroom 1, bedroom 2, bedroom 3, and the den of the attic space. Thermal imaging was recorded in bedroom 1 of the attic space. High definition video and thermal imaging video of the exterior of the structure was recorded at the BC corner. Additionally, a high definition video camera recorded the exterior of the structure at the AB corner of the structure.

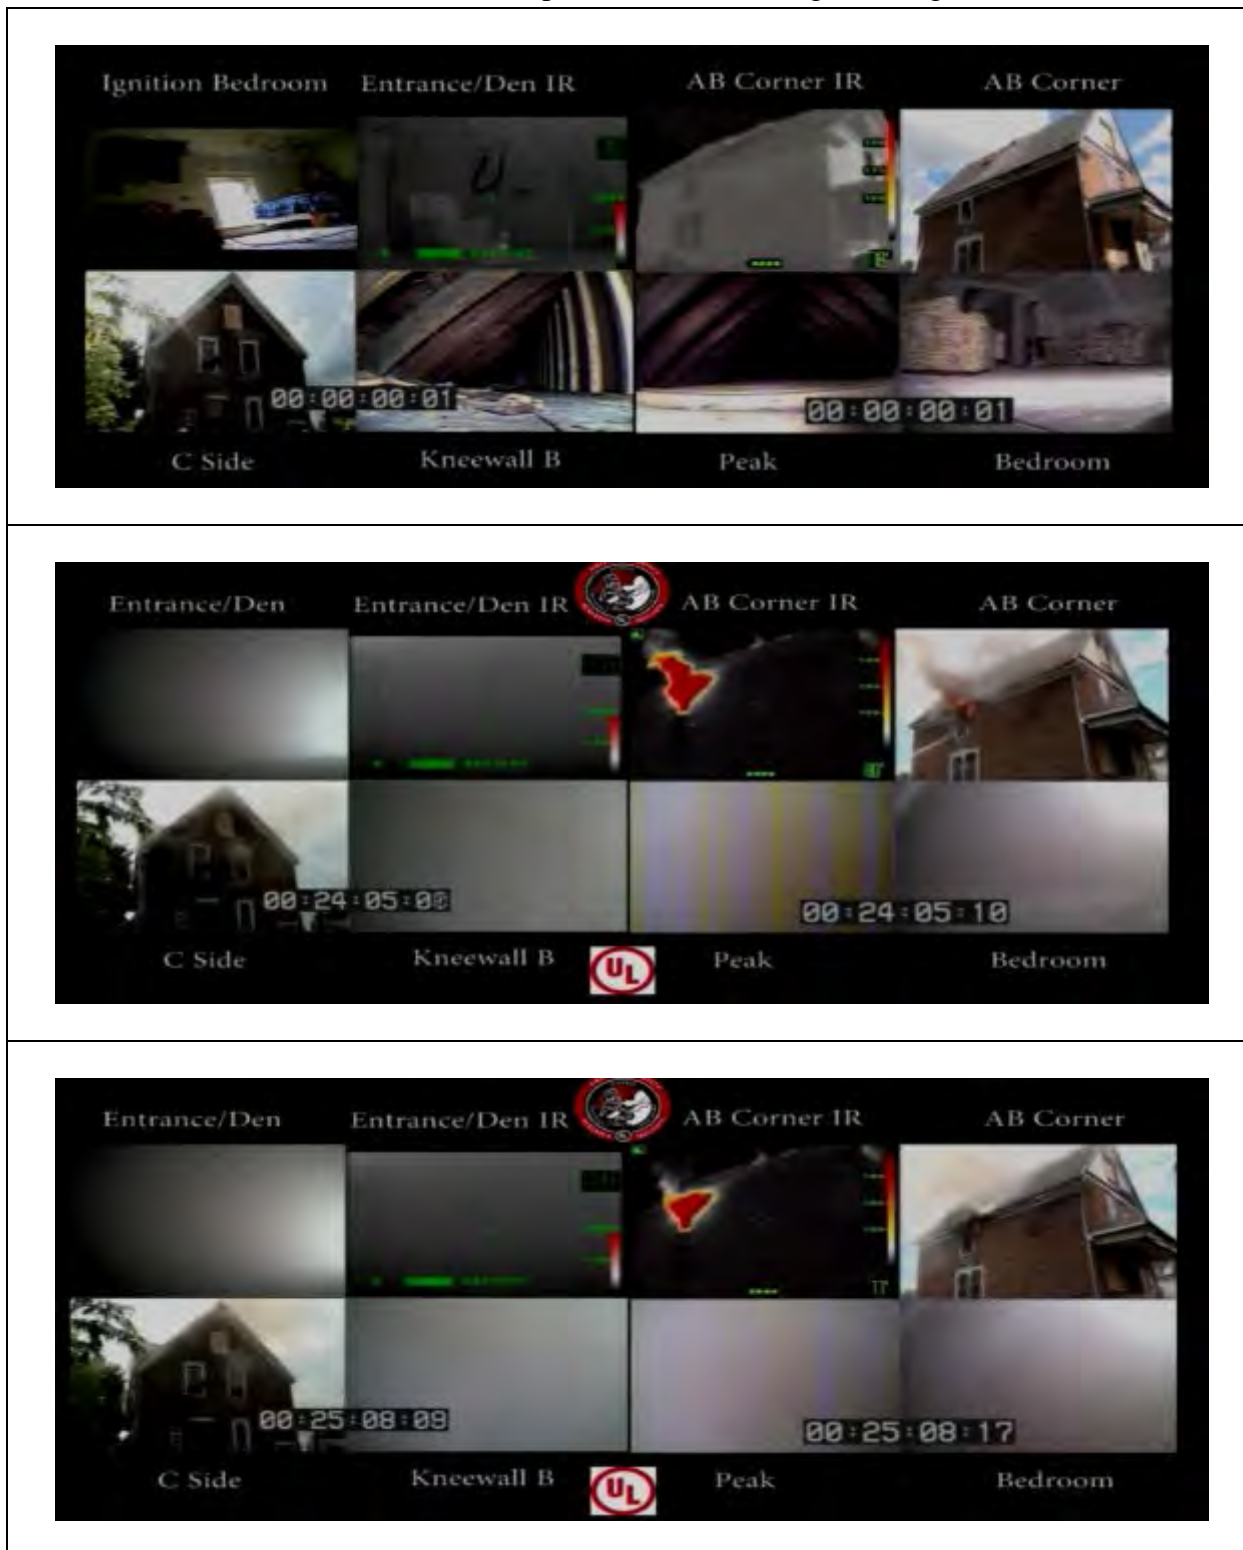
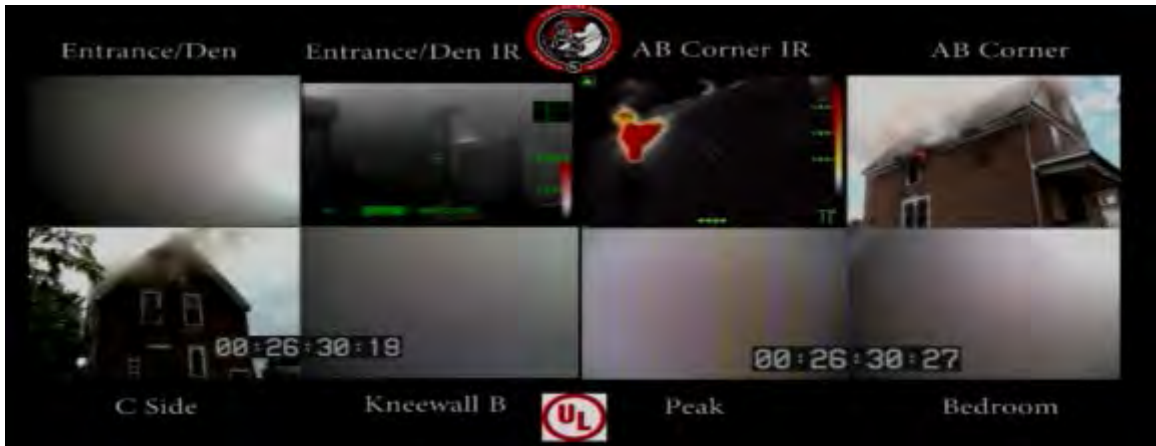
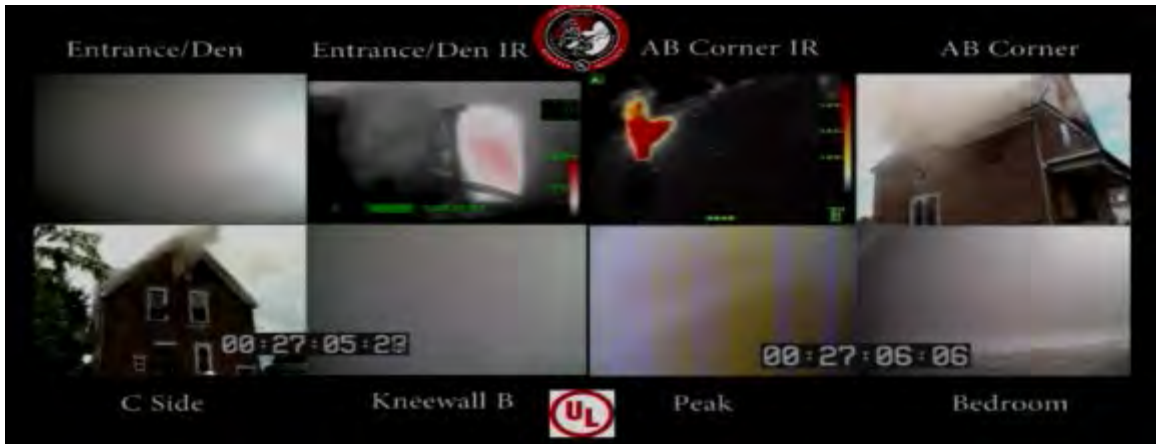
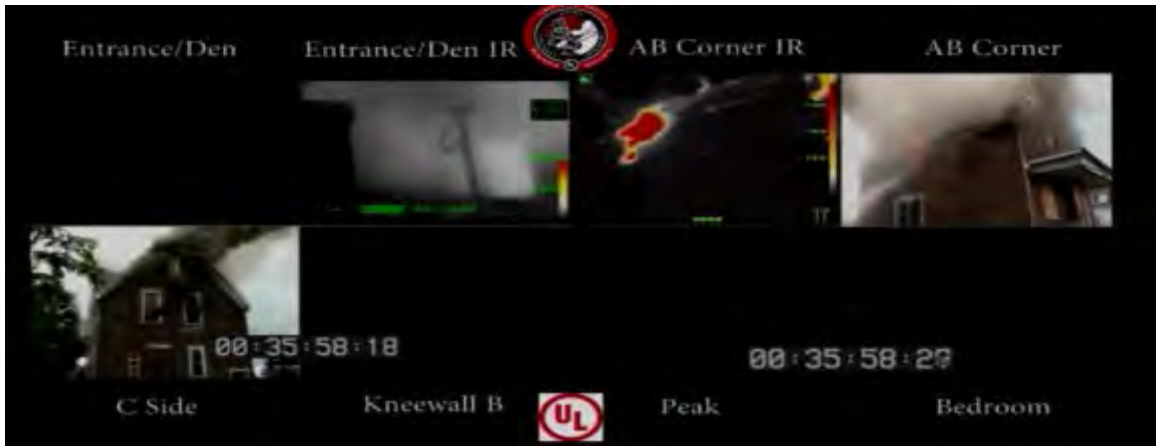
Table 9. 1: Field Experiment 1 Chronological Images

Ignition occurs at time 00:00 (mm:ss). The fire was allowed to grow and reach steady state and at 24:05, 8s of water was supplied into the ignition room from an exterior ground attack. At 25:08, the door of the attic space was opened, and then at 25:41 and 26:30, the ‘C’ side and ‘A’ side windows were opened, respectively. The knee wall patch was opened at 27:05. Conditions were monitored for two minutes followed by 7 s of exterior water applied to the fire room at 29:00. Conditions were monitored further with exterior water applied to the fire room for 10 s at 35:58. At 39:10, the nozzle mounted in the stairwell to simulate an interior attack was turned on for 10s. At 42:36 water was applied for 30 s to all the area where there was visible fire, i.e. the exterior siding, the roof, the fire room, etc. At 51:40, the deck gun was applied to side A of the structure. Conditions were monitored while the deck gun suppressed the side ‘A’ fire. At 52:36 the Side B visible fire was suppressed using the exterior line at which time the experiment was turned over to Milwaukee Fire Department for complete suppression. Table 9. 2 below lists all actions and at what time they occurred, Table 9. 1 provides the images of all 8 camera views at the times listed.

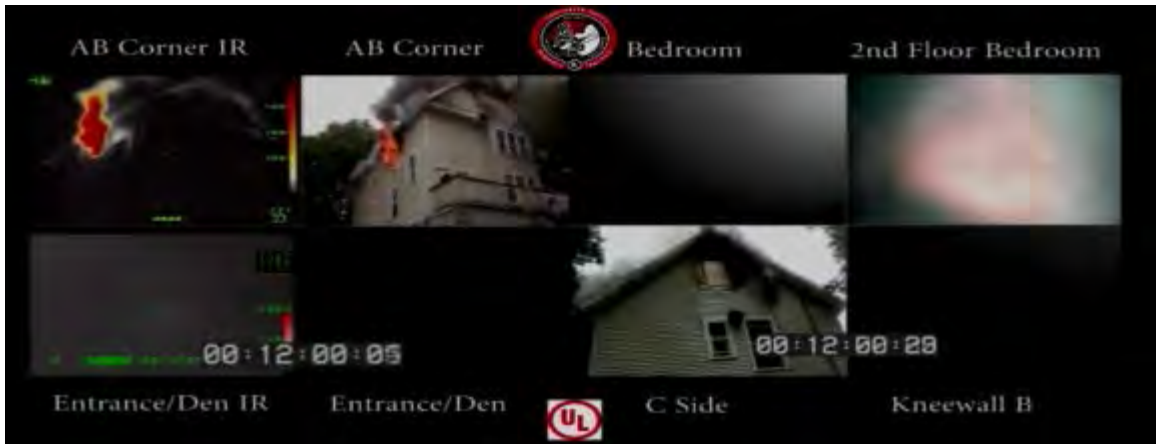
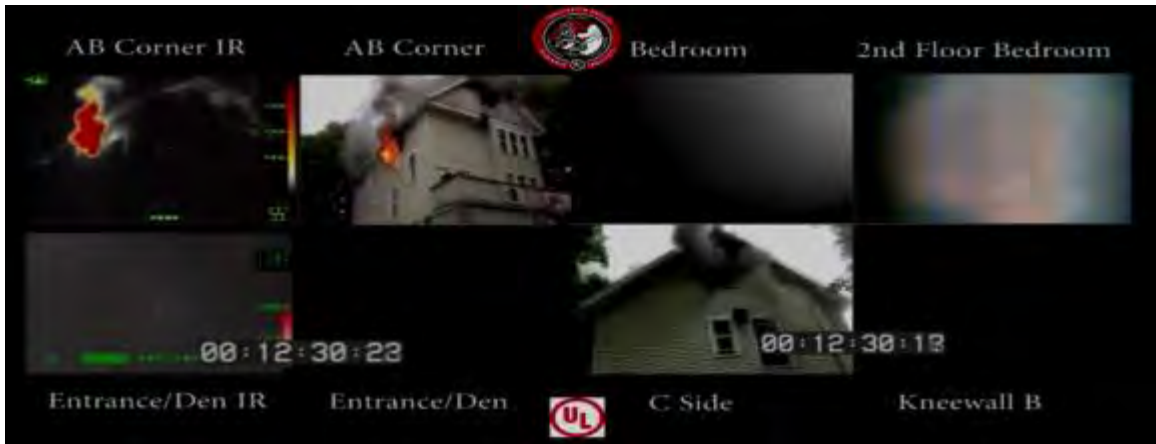
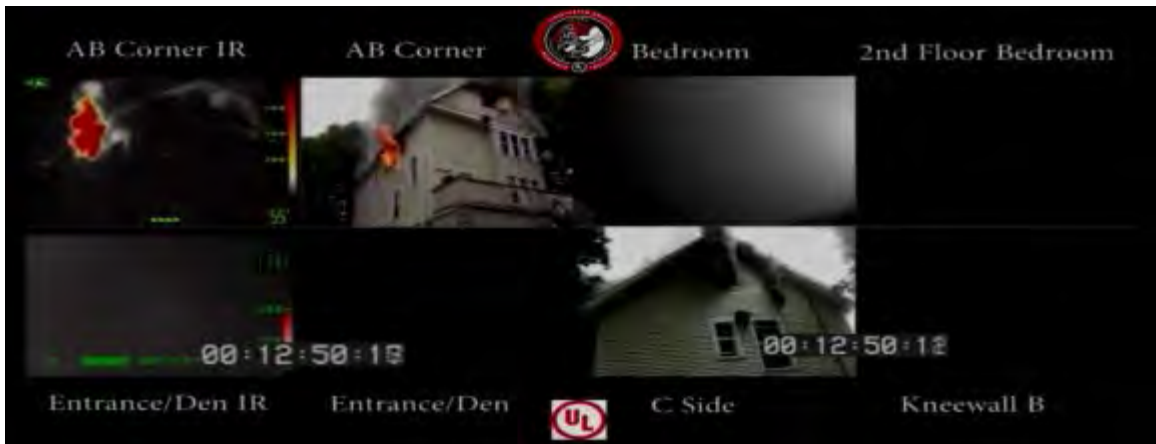
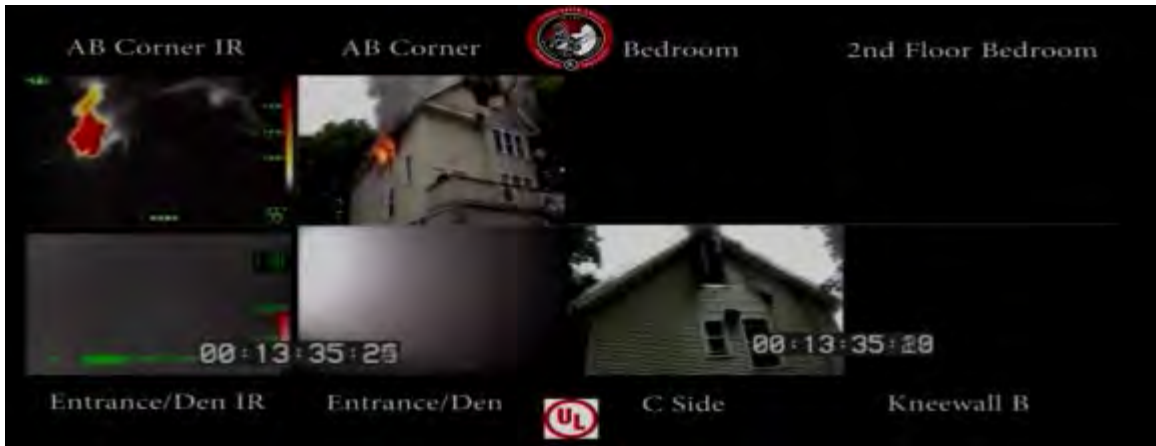
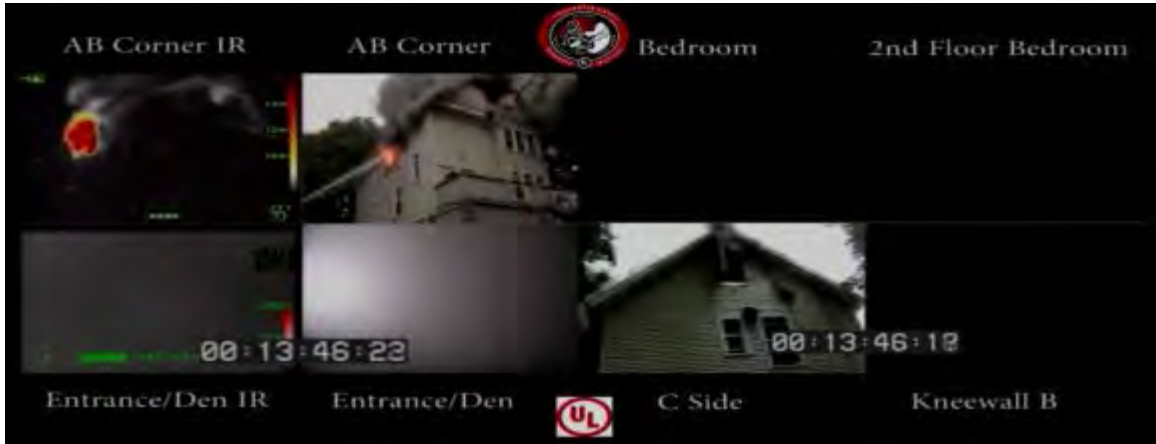
Table 9. 3: Field Experiment 2 Chronological Images

Ignition occurs at time 00:00 (mm:ss). The fire is then allowed to grow for several minutes and reach flashover in the second story bedroom. At 09:02, water was supplied into the ignition room from an exterior ground attack. Immediately following at 09:25 an eave attack

is performed from the 'AB' corner to the 'BC' corner. The fire is allowed to grow again, and at 12:00 the attic door is opened followed at 12:30 by the 'A' side and 'C' side attic windows simultaneously. At 12:50 the knee wall B access hatch is removed. Conditions are monitored for one minute followed by an exterior attack into the second story bedroom window at 13:50. At 14:06, fire growing on the exterior siding of the B side of the structure is suppressed. The B side eaves are pulled, moving in the direction of the C side, at 17:25. A ground attack into the second story bedroom window begins at 18:45. The attack continues and moves to the fire on the exterior siding before eventually targeting the eave line on the B side. At 19:00 the experiment is brought to an end and the fire is turned over to the Milwaukee Fire Department for complete suppression. Table 9. 4 lists all actions and when they occurred. Table 9. 3 provides a snapshot of all 8 camera views for each action in the Table 9. 4.

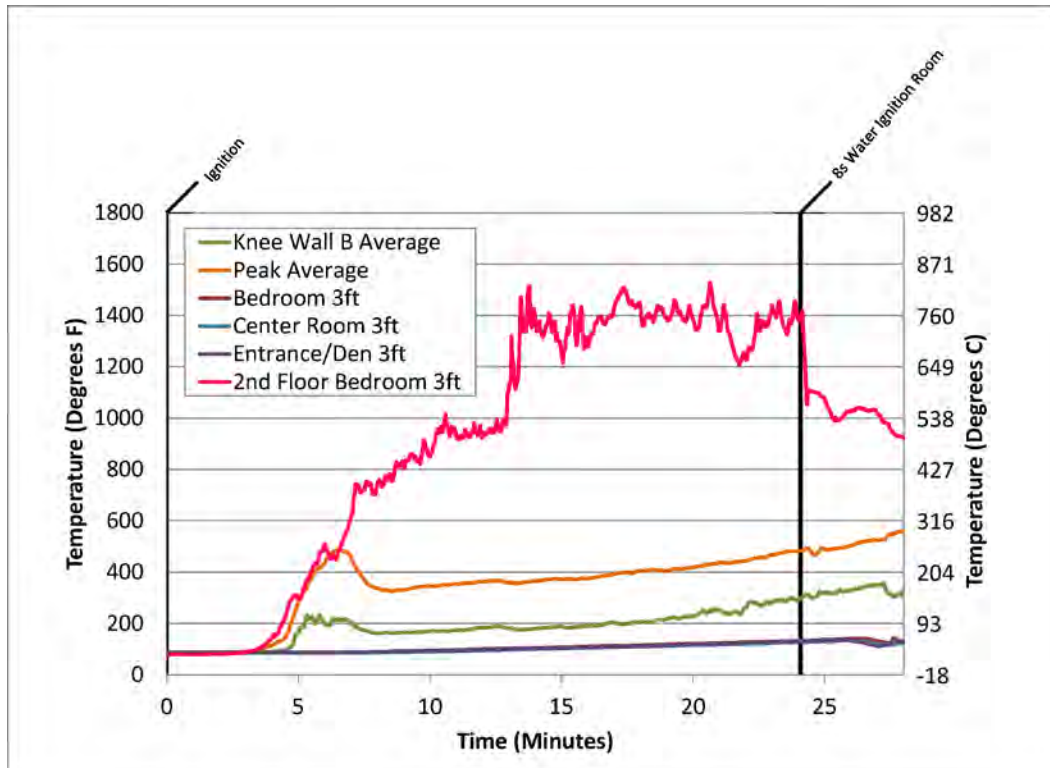
Figure 9. 27: Experiment 1 Transitional Attack Effect

The first fire service intervention was performed at 24 minutes and 5 seconds into the experiment by directing an exterior stream flowing 150gpm into the 2nd floor bedroom window off the ceiling for 8 seconds. Temperatures within the second floor bedroom were reduced and there was a very small effect on the, knee wall and peak. The living spaces on the half attic floor showed no change and remained at levels prior to water application around between 135°F and 129°F (See Figure 9. 27).
