Study of Residential Attic Fire Mitigation Tactics and Exterior Fire Spread Hazards on Fire Fighter Safety

UL Firefighter Safety Research Institute

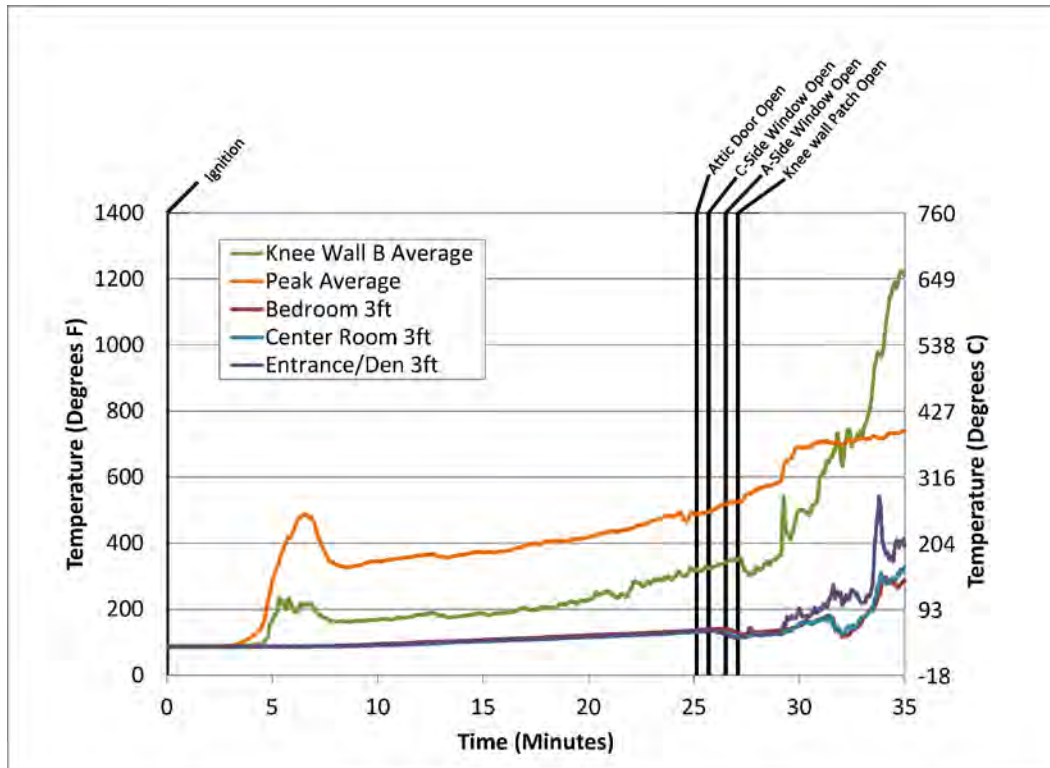
Figure 9. 28: Experiment 1 – Ventilation Operations.

After the application of water from the exterior ventilation was provided to simulate an interior attack crew entering the attic space from the second floor. The attic door was opened followed approximately 30 seconds later by opening the ‘C’ Side window as the crew passed it. It was estimated it would take the crew 30 seconds to reach the ‘A’ Side of the attic at which time the window was opened. Assuming the crew found no fire or heat, the knee wall was opened near the stairs to simulate a crew behind the original crew entering and searching for fire. The effects can be seen in Figure 9. 28. Fire growth before the knee wall patch was opened remained steady in the knee wall and peak, after opening the knee wall patch fire growth was accelerated to flashover temperatures in the knee wall and over 350°F in the living spaces. The peak, being above the neutral plane of any ventilation with a finite exhaust area, maintained the slow temperature increase until it became steady as the knee wall reached flashover temperatures.

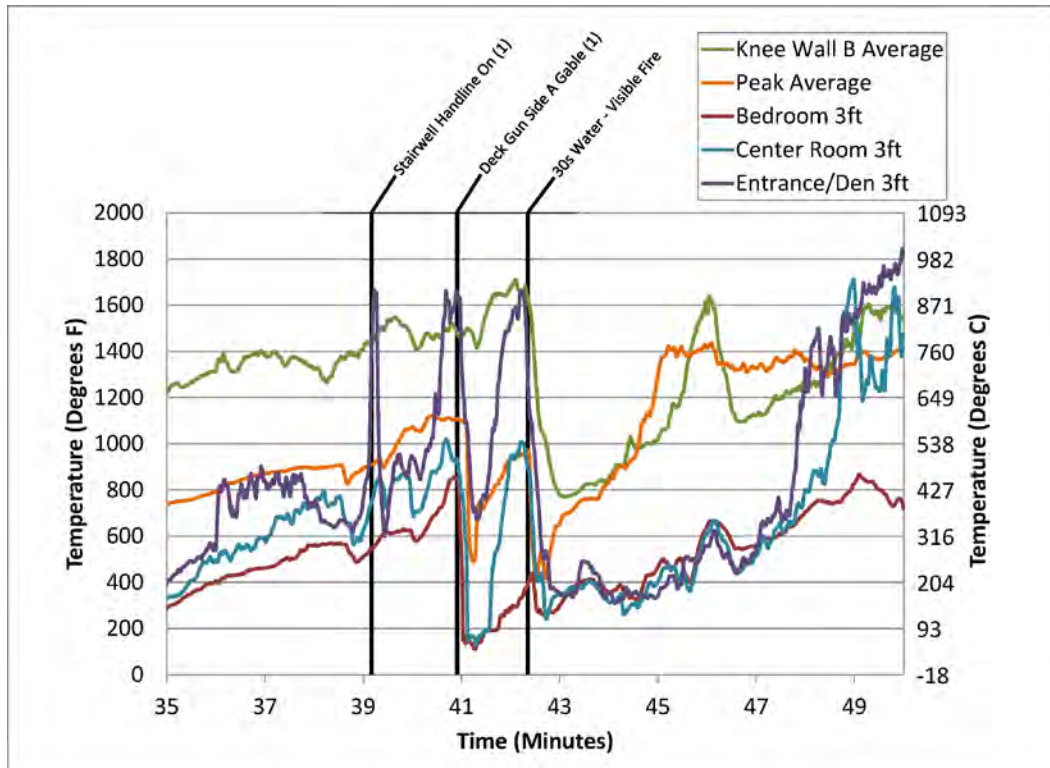
Figure 9. 29: Experiment 1 – Water Suppression Effectiveness

Suppression operations were simulated in the stairwell via a remotely activated automatic nozzle flowing 150gpm for 10 seconds. This had no suppression effect on temperatures throughout living space and knee wall. This is most likely due to the source of the fire not being controlled and providing energy which is not reduced by cooling from surface cooling/extinguishment. The hand line was followed 1 minute and 30 seconds later with a 10 second 1000gpm burst from a smooth bore apparatus mounted master stream on side ‘A’ through the side ‘A’ gable. Temperatures reduced in the front two rooms of the living space to below 200°F, but with limited water reaching the Entrance/Den temperature were only reduced to below 800°F. No water reached the knee wall and thus temperatures remained steady. Temperatures in the center room and entrance/den rebounded within 1 minute and 30 seconds of application. In the same time period the front bedroom climbed to 400°F. The master stream application was followed by suppressing all visible fire on the ‘B’ side of the structure. This took temperature in the knee wall space from 1600°F to 800°F the peak from 1000°F to 450°F and the living spaces all to below 400°F. Temperatures remained below 600°F for two minutes before beginning to increase again in the living spaces. The peak and knee wall increased to pre water application temperatures in the same period of time. The effectiveness of each tactic can be seen in Figure 9. 29.

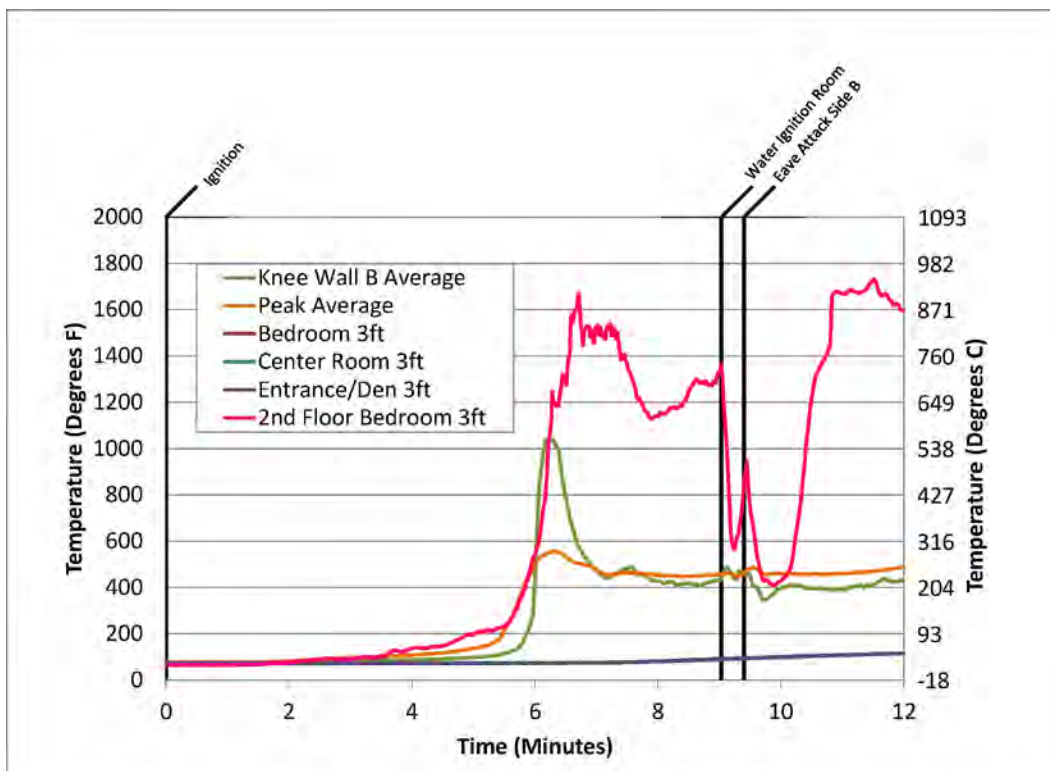
Figure 9. 30: Experiment 2 - Transitional Attack & Eave Attack

The first fire service intervention was performed at 9 minutes into the experiment where an exterior transitional attack using a 150gpm automatic nozzle from the ground level through the second floor bedroom window. The nozzle set to straight stream was directed off the ceiling for 10 seconds. Temperatures in the 2nd floor bedroom reduced from over 1300°F to below 600°F however regrew rapidly to over 900°F as the eave attack was performed. The hose line was then directed across the side 'B' eaves starting at side 'A' and walking toward side 'C'. The eave attack further reduced the temperatures in the 2nd Floor Bedroom from above 900°F to just above 400°F for 30 seconds before regrowth occurred. The eave attack had an effect on the bedroom due to the penetrations from the bedroom into the knee wall. The side 'B' yard was located 2 ½ stories below the eave line, this vertical distance along with the presence of the vinyl soffit coverings caused limited water to flow into the eaves. With little water penetration the eave attack only had a minor effect on the temperatures within the knee wall and had no effect on the temperature is the peak. Much of the vinyl soffit stayed in place after the eave attack with the exception of the area near the fire compartment where the soffit melted and fell away. Figure 9. 30 shows the initial growth and effect of the exterior suppression on the rooms within the structure. Within 2 minutes of the water application temperatures returned to at or above pre water application temperatures.

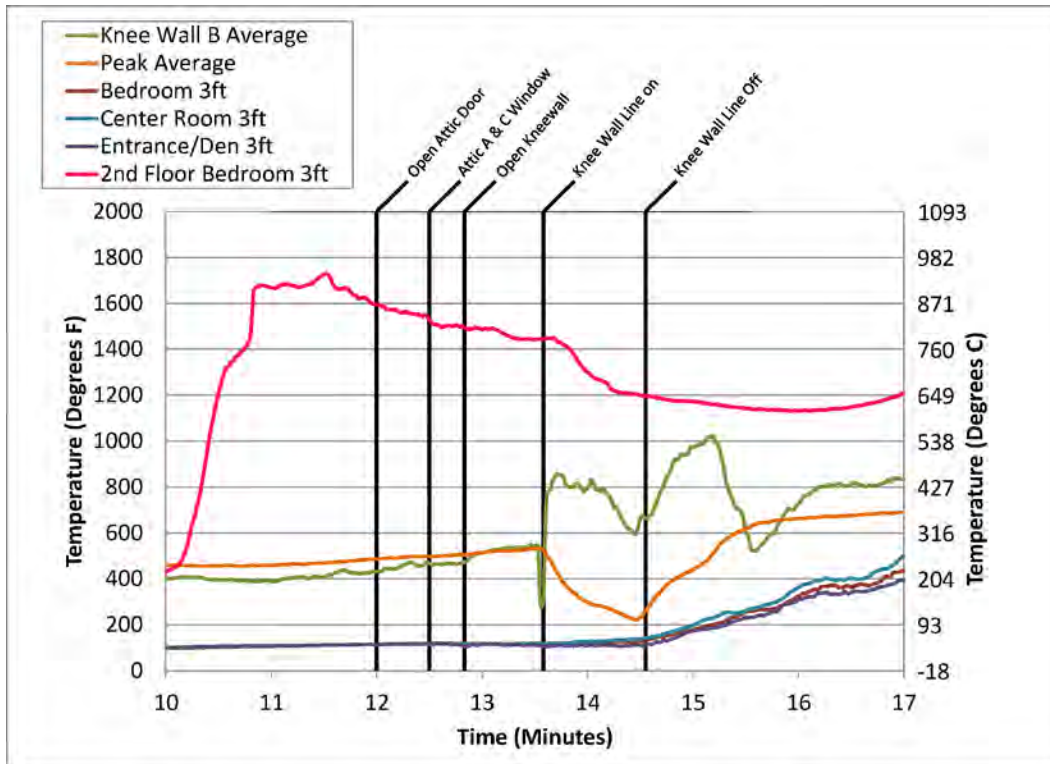
Figure 9. 31: Experiment 2 – Interior Fire Service Interventions

Water was then applied via a 150gpm automatic nozzle set to straight stream, located in the knee wall installed to simulate applying water horizontally down the center of the knee wall. Turning on the knee wall nozzle caused the average temperature in the knee wall to increase (Figure 9. 31). When individual thermocouples are reviewed the water had an impact on temperatures at the far side of the attic by reducing them below 200°F at end of the knee wall remote from the nozzle as seen in Figure 9. 32, TC's 15-18. TC – 20 at the center of the knee wall has temperatures reduced from over 900°F to below 500°F. Moving toward the nozzle located at TC-23 the temperatures increase from approximately 700°F to approximately 2000°F. The knee wall line flowed for 58 seconds, after 32 seconds the water begins to have an impact on the average knee wall temperature. The temperature is reduced until the line is turned off at which time temperatures rebound for approximately 1 minute then become ventilation-limited. After the knee wall becomes ventilation-limited, temperatures dropped until they reach approximately 600°F. As the fire slowly burns larger openings allowing more oxygen in the temperatures slowly grow to the temperature pre water application at 1 minute and 30 seconds after the line was turned off.

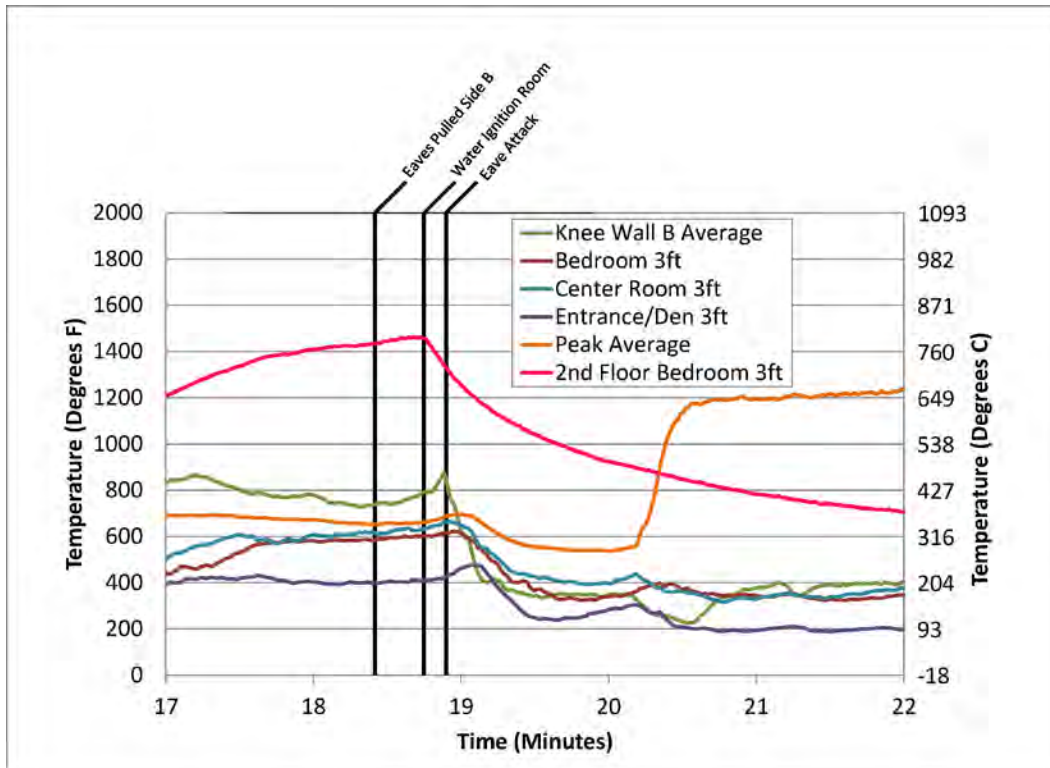
Figure 9. 34: Experiment 2 – Eave Attack Effectiveness (Soffit Removed)

After interior Suppression was completed an additional attempt at the eave attack was conducted. Instead of using the nozzle to attempt to remove the vinyl soffit a pike pole and extension ladder were used to remove the entire soffit line. As seen in Figure 9. 34, removing the eaves allowed more air into the knee wall and peak, increasing the burning rate and temperatures in both spaces. Water was applied via a transitional attack into the 2nd floor bedroom followed closely by a sweep of the eve line. The temperatures responded quickly throughout the knee wall with reductions from over 800°F to under 400°F. The living space temperatures dropped to the same level. Indicating the attack had a significant impact on conditions in these spaces (See Figure 9. 34).

Although water was able to penetrate the knee wall, limited impact was achieved on the peak space. Temperatures dropped because the space feeding the peak dropped however this also allowed an increase in airflow to the peak space which increased temperatures to an average of 1200°F within a minute and 30 seconds of applying water to the eave, an increase of 500°F from prior to water application.

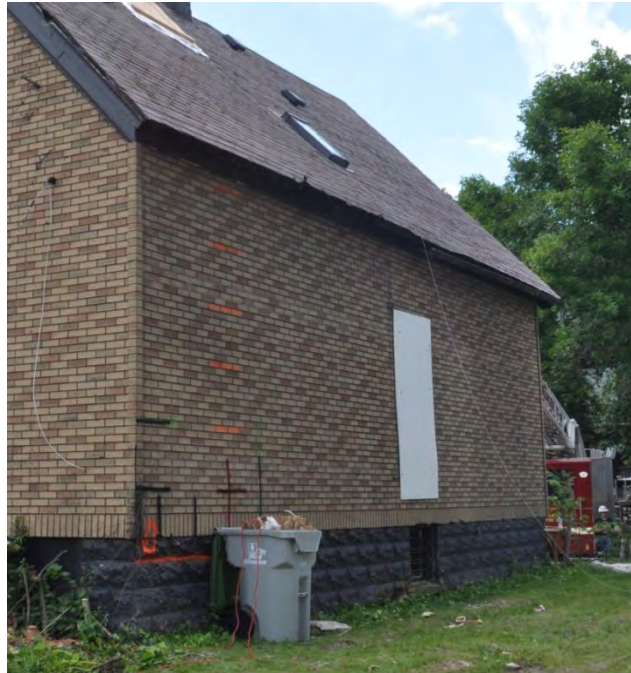
Figure 9. 35: Experiment 3 – North 25th Street Exterior Ignition Source

A standard size city trash can, 65 gallons, was utilized as the ignition source loaded with construction debris such as wood, paper and plastic refuse. The can was placed up against the structure and ignition was provided via an electric match (See Figure 9. 35). The fire grew up the exterior of the house and into the open eave space. The change in temperatures monitored can be seen in Figure 9. 36.

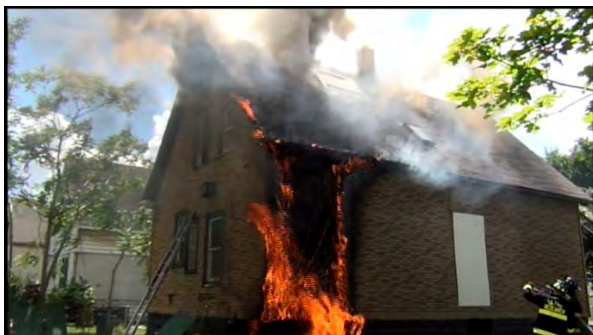
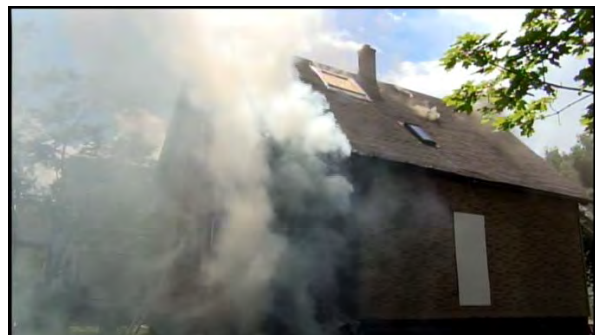
Figure 9. 36: Experiment 3 - Eave Attack Effectiveness

(a) 10s Before Water Application

(b) 10s After Water Application

Initial fire service intervention by a single crew was performed on the exterior side ‘B’ of the structure. Suppression with an automatic nozzle flowing 150gpm set to straight stream was performed along the eaves where the fire had penetrated into the joist bays. Figure 9. 37 indicates temperatures prior to the application of water in the joist bay averaged over 1200°F and in the peak averaged over 550°F. After the 14 seconds of water through the eaves the temperatures reduced to below 200°F in both the peak and joist areas, while no increases occurred in any of the attic living spaces. Water also indirectly effected the flames in the trash can as seen in the series of images in Figure 9. 36 and the bulk of the visible fire was extinguished.

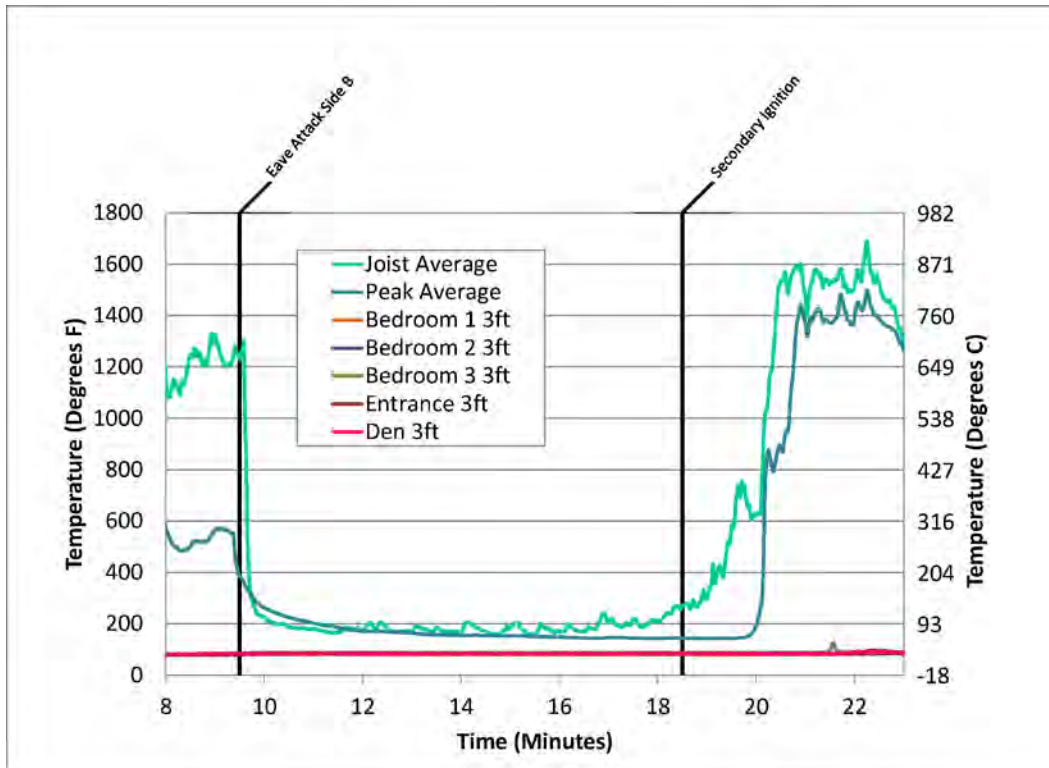
Figure 9. 38: Experiment 3 – Regrowth

After suppression the temperatures remained below 200°F for the next 8 minutes as seen in Figure 9. 38. The eave attack appeared to have controlled the growth and suppressed the bulk of the fire, wetting the surfaces and preventing re-growth. To gain more insight into the growth of exterior fires a second trash can was placed along the house and the remnants of the first can were raked over adjacent to the can, igniting the can. Depicted in Figure 9. 39a-d prior to the extension from the second trash can to the structure the attic space reached temperatures indicating flash over and the side ‘C’ gable vented flames.

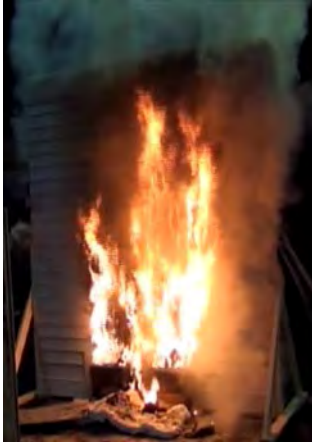
Figure 10. 5. Exp. 3 – Vinyl Siding over plywood

Legacy construction practices using cement based stucco and solid wood wall sidings provided a form of fire resistance to the structure, preventing or slowing even large outdoor and rubbish fires from extending into a structure. **Modern homes now commonly utilize plastic siding as the outer layer. This evolution in building materials has led to an increased ignition potential from exposure to outside fires such as mulch and grass fires, as well as fires extending from garbage and rubbish bins kept next to the structure.** The wall system experiments show that stucco, fiber cement, and wood siding would not sustain burning even after 10 minutes of exposure from a 100kW heat source. By comparison, the plastic wall sidings ignited in one minute or less and grew rapidly. A 100 kW source is equivalent to a small fire measuring approximately 2 ft wide by 2 ft deep with flames 2 feet high. This could be a mulch, grill, small trash can or plastic potted plant fire. These images show 6 different wall types after 2 minutes of exposure to the 100kW burner.

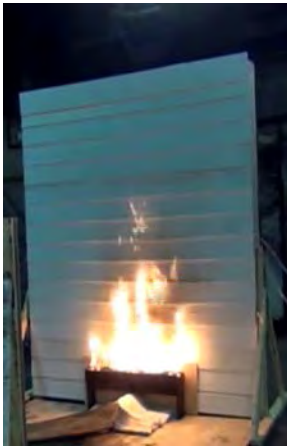
Figure 10. 8. Exp. 19 – Fiber Cement Siding

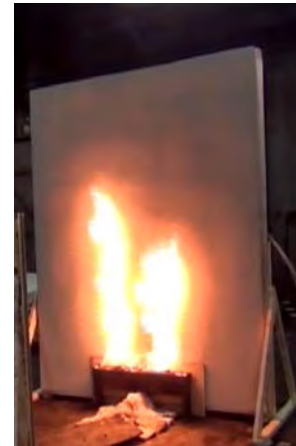
Figure 10. 10. Exp. 26 - Stucco Siding

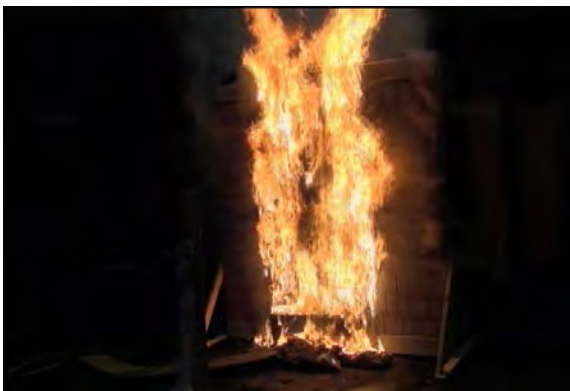
Figure 10. 11. Flame spread 2 minutes after ignition of a polypropylene shingle sided wall over polystyrene sheathing

Ignition and flame spread experiments indicate that the use of plywood as a sheathing material prevented rapid fire growth when compared to rigid foam board. Even when the plastic siding ignited and burned rapidly, the underlying plywood sheathing resisted sustained ignition for up to 20 minutes. When rigid foam board replaced the plywood

sheathing, the foam ignited almost immediately and spread up a two story structure in under two minutes. The high heat release rate quickly drove fire into the attic space.

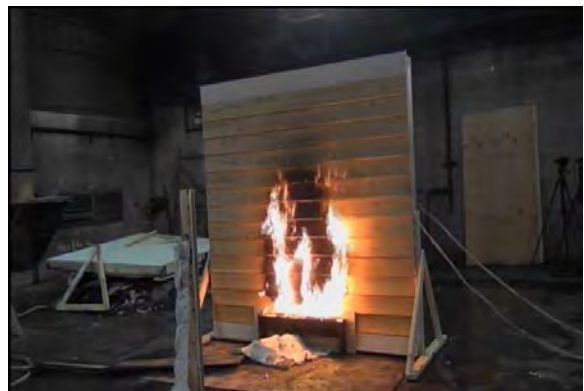
Figure 10. 12. Flame spread 2 minutes after ignition of a wood lap sided wall over polystyrene sheathing

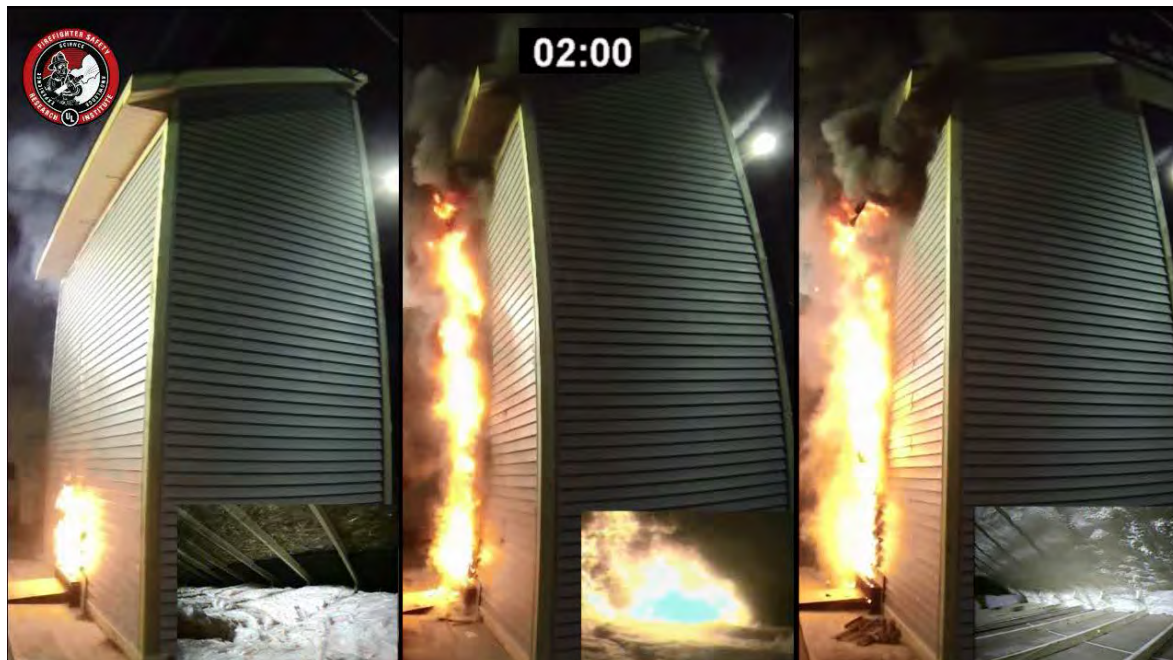
Figure 10. 13. Wall and Eave experiment as Vinyl Siding/Polystyrene Sheathing/Fiberglass Insulation system transitions to an attic fire (2 minutes after ignition)

Modern attic construction is designed to produce natural ventilation that reduces moisture and heat buildup in the attic space. Solid wood eave and soffit construction has largely been replaced by vinyl soffits with built in ventilation openings to allow circulation of air. These openings provide the opportunity for direct flame spread from an exterior fire into the attic space. This process accelerates as the plastic soffits melt and fall away. Other eave construction practices, such as aluminum or solid wood with smaller air vents, also allow for fire penetration, though at a slower rate. If air can pass through, so can fire gases. This direct flame spread potential, along with the rapid ignition and flame spread found to occur within modern wall construction, combine to increase the exterior fire hazard. **Fires adjacent to modern exterior wall construction have the potential to transition to structure fires within two minutes of ignition.** This is well before most fire department intervention times. Heat sources larger than 100 kW such as fires involving vehicles, decks,

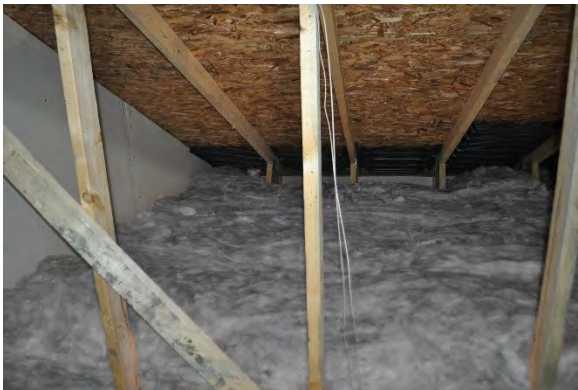
Figure 10. 18. View of vented attic from the attic

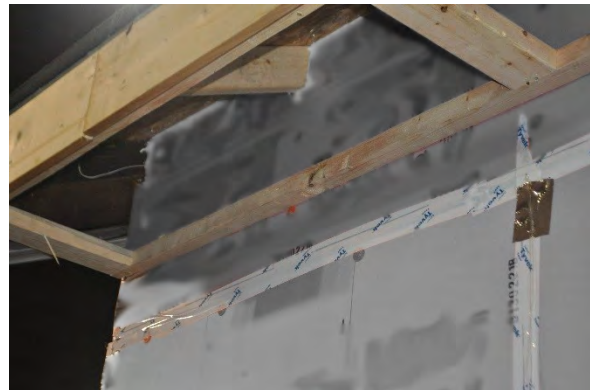
Figure 10. 19. View of unvented attic construction eaves

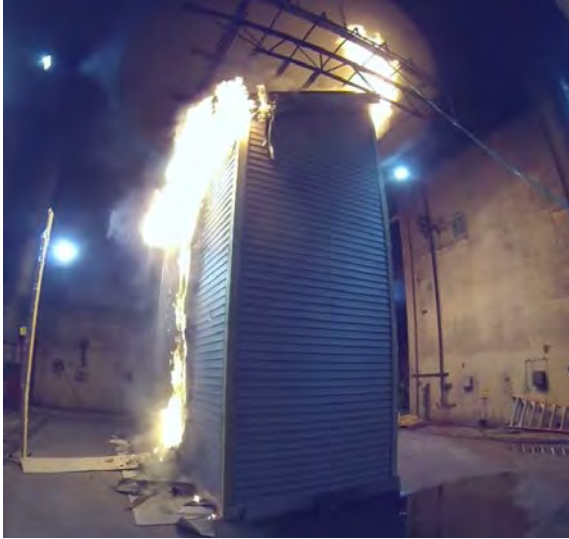
Figure 10. 20. Burning at eave line with vented attic (Experiment 1)

With the two story wall configuration used in the tests, fire exposure to a surface opposite the test wall was minimal during the fire's spread up the wall. However, when the fire reached the eave line, exposing the attic and involving the eaves and soffits, heat flux measurements of radiant energy at the wall opposite indicated a significant increase in exposure fire potential. **Therefore, the projection of the flames out of the eaves and the additional fuel load at the eave/soffit line combine to increase the radiant energy directed at any adjacent structures, increasing the exposure threat.** In scenarios where the wall and roof voids are filled with spray foam insulation, this effect is even more pronounced since there is more fuel available than with other insulation and sheathing combinations such as plywood over fiberglass batts or even foam board over fiberglass batts.

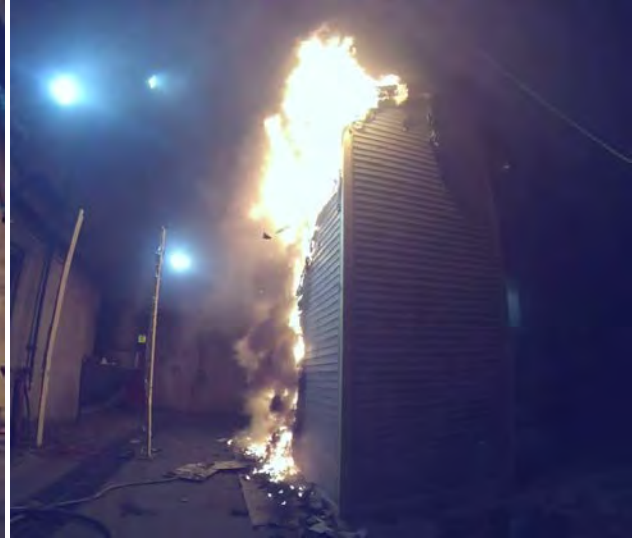
Figure 10. 21. Burning at eave line with the unvented attic (Experiment 3)

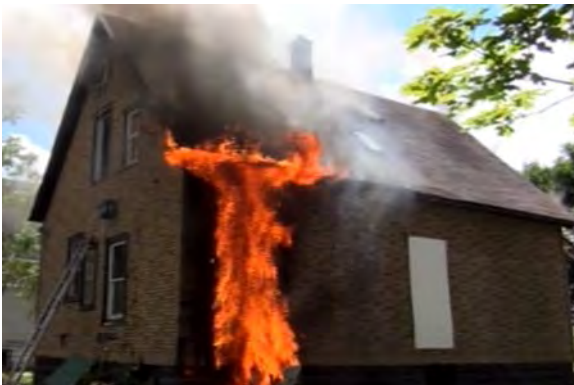
Figure 10. 22. Fire extending from a trash can into the eaves during a field experiment in Milwaukee, WI.

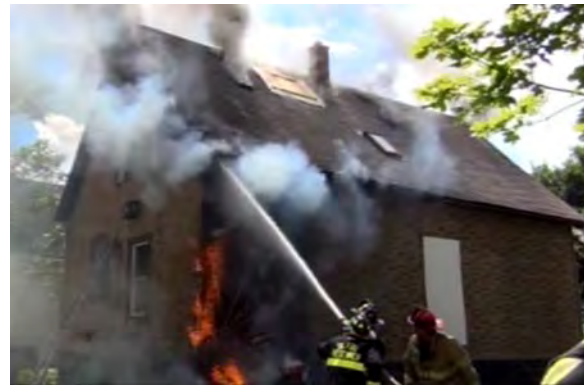
Figure 10. 23. Water applied to extinguish the exterior fire and flow into the eaves before interior operations were commenced.

Tactics applied during these experiments demonstrate that an additional line can be deployed or the same line used to knock down the exterior fire can often be redirected to achieve a similar knock down of fire that has extended into the building. For instance, water may easily be flowed up through the eaves and onto the burning underside of the roof decking. This exterior and interior knock down permits firefighters to more quickly, effectively and safely advance on the interior fire. This could be the original hose crew with the same line repositioned, the same hose crew with a new hoseline, or an additional crew or crews.

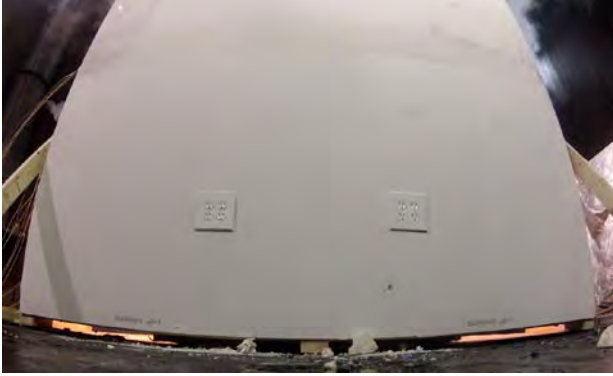
Figure 10. 24. Wall Experiment 13 before receptacle burn through

In all experiments where the gypsum wall board contained no penetrations, there were limited heat increases noted on the occupant side of the wall, and only slight discoloration of the drywall as an indication of thermal damage to that part of the system. Once electrical receptacles were included in the wall system, flames were noted on the interior side of the wall at the receptacle locations. This hazard is amplified when plastic receptacle boxes are used as they tend to melt away, providing a larger unrestricted opening for the fire to spread into the interior.

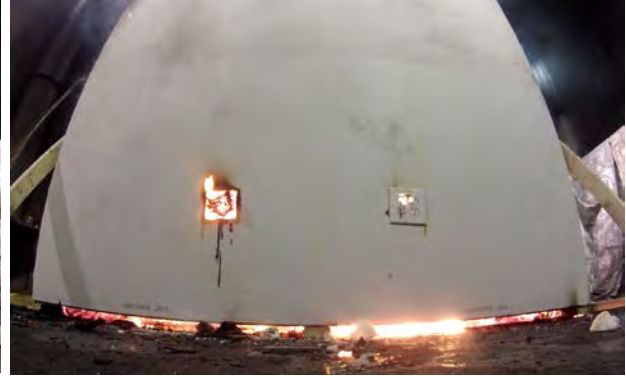
Figure 10. 25. Wall Experiment 13 after fire penetrates the receptacles

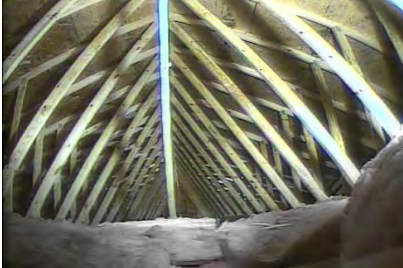
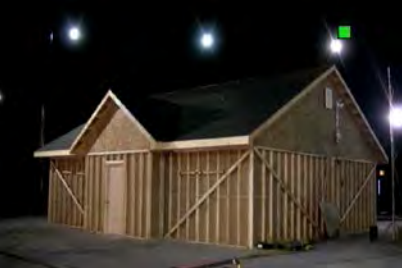
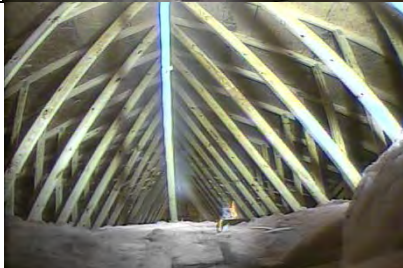
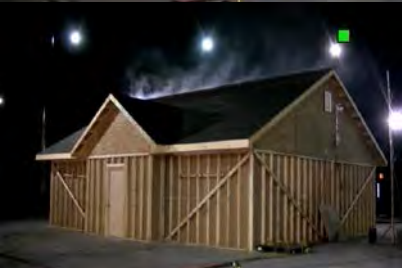
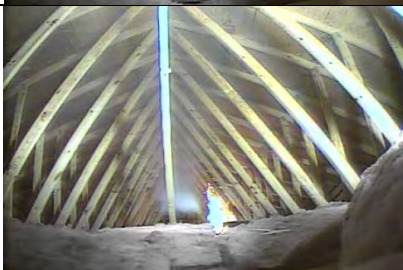
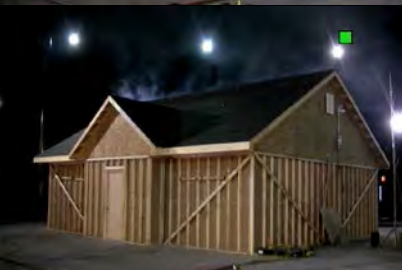
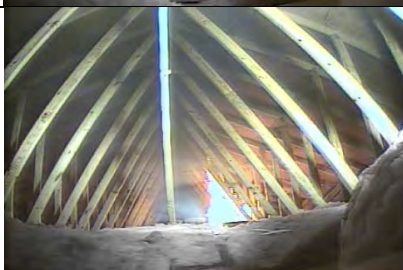
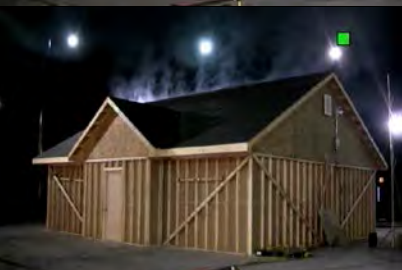
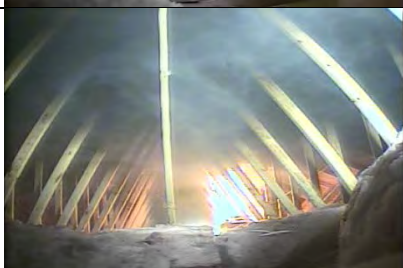
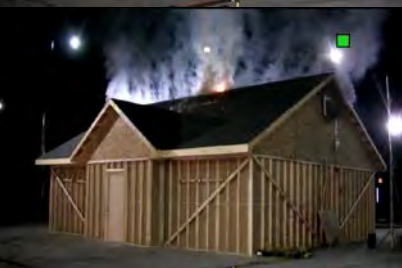
Table 1. Attic fire growth to ventilation-limited in 5 minutes. Views from inside attic and front of structure.

limited fire within the attic. **The openings provided for natural ventilation are not sufficient to maintain steady state burning and fuel limited fire behavior. The size of the fire is limited by the available oxygen and will nearly always become ventilation-limited.**

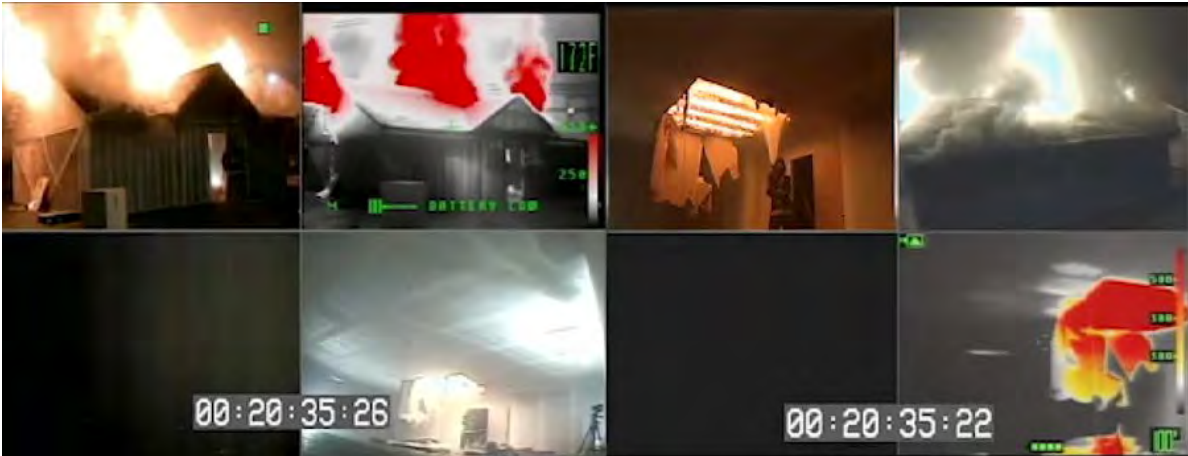
Figure 10. 26. Burning at interior ventilation opening in the ceiling during Attic Fire Experiment 2B

A small opening in the ceiling will supply some air to the attic fire, but without an outlet like open gables or a large hole in the roof, there is not a flow path through the attic sufficient enough to lead to rapid fire growth. There will be local mixing of fuel and air at the opening that will produce flaming, but this will only be able to exist at that opening and not throughout the attic because there is no increase in airflow throughout the attic (Figure 10. 26).

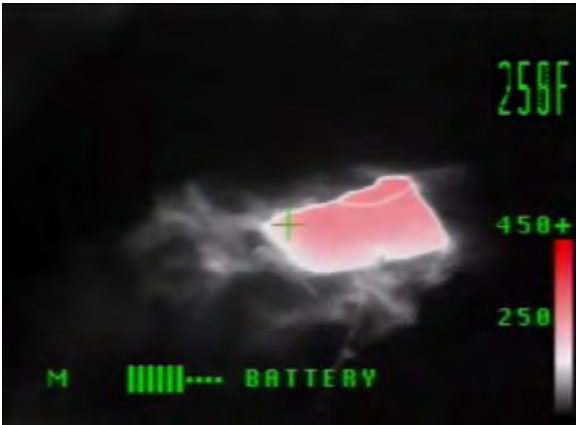
Figure 10. 27. Thermal imaging view of ceiling vent in Field Experiment 3 shortly after opening

However, when several openings or a very large opening is made through the ceiling below, more mixing will occur and the fire may begin to grow rapidly, overwhelming any natural or firefighter made openings in the roof. This creates the potential for the fire to burn downward or for a pulse of hot, unburned gases that mix with air below and ignite (Figure 10. 27 and Figure 10. 28).

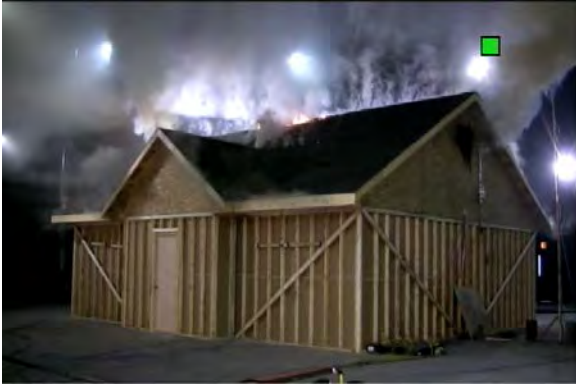
Figure 10. 29. Attic Fire Experiment 3 during peak temperatures in the attic with gable vents opened.

In every experiment, the fire growth and development was controlled by the size of the exhaust vents or a vertical ventilation opening. As the fire increased in size, the plastic gable vents commonly failed by melting away. The resulting six square feet of exhaust openings along with the replacement air supplied by the soffit vents was NOT enough to keep the fire from reaching a ventilation-limited state. In each of these cases, any of the suppression methods chosen for the experiment series (i.e. a large hole in the ceiling and water from below, water introduced into the attic through the gable ends, and water applied to the underside of the roof by way of the eaves) was successful at knocking down and limiting the size of the fire, making final suppression and overhaul relatively easy.

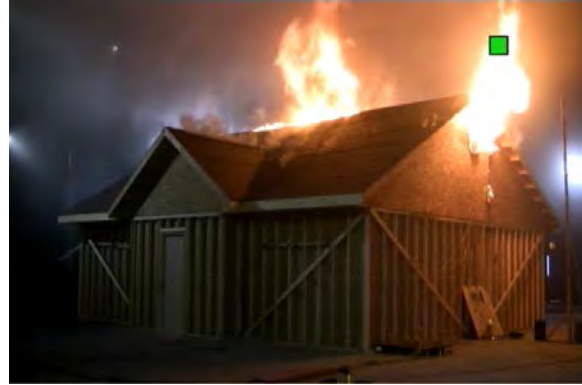
Figure 10. 30. Attic Fire Experiment 3 during peak temperatures in the attic with gable vents and roof vent opened.

The fire dynamics changed significantly when a hole in the roof was created. In some of the experiments a 4 ft. by 4 ft. hole was opened over the center of the attic. This simulated a vertical vent performed by the fire service, burn through of the sheathing by the fire, or failure of a skylight. Once the hole was opened, the products of combustion exited efficiently and a large volume of replacement air entered the attic through the eaves, gable vents, a hole in the ceiling, or combinations of all three of these. This affected the ventilation-limited fire, rapidly increasing the heat release rate. This in turn produced more energy than could be let out by the available ventilation openings. At this point, most of the burning was taking place at the vent locations in the roof, the gable ends, the eaves, and the openings created in the ceiling for suppression efforts. The fire grew at an increased rate, rapidly involving more surfaces such as trusses and the underside of the roof deck. **This relatively well vented attic fire was more difficult to control with the indirect methods applied to the unvented attic test.** This appeared to be the result of two phenomena. First, much of the steam produced by conversion followed the fire gas convection path out of the attic before the indirect attack process had full effect. Second, there were many surfaces burning at and around the ventilation openings that had to be wetted and thus cooled with direct water application in order to stop the combustion process. **This, “open up above and then attack it from below” tactic can and has been successfully used at attic fires. However, it can create a large amount of property damage and puts both civilians and firefighters at high risk during the initial stages of the operation if not timed properly.** This is due to the potential for uncontrollable fire growth, fire blow back into the occupied space, and even smoke explosions.

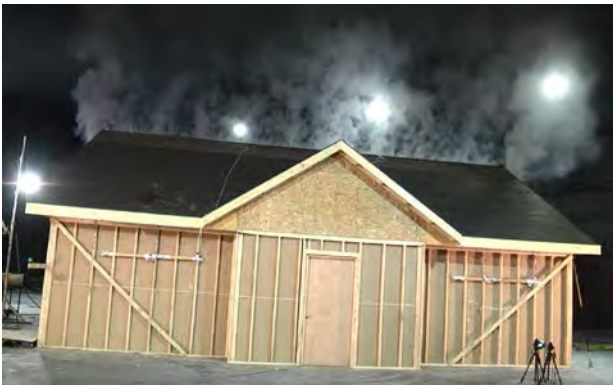
Figure 10.31. Smoke coming from the ridge vent.

Two common attic vents are mushroom vents and continuous ridge vents. Mushroom vents are commonly made of metal and allow fire gases to exit for the duration of the fire. They are installed on the slope of a peaked roof and the material, whether metal or plastic, flows away from the opening if the mushroom cap melts. Continuous ridge vents are nearly always made of plastic and allow fire gases to vent until they heat up. **As the vents heat, the plastic melts and collapses on the opening at the peak, creating a very effective seal.** The sealed opening (the equivalent of 10 ft² in these experiments) restricts air flow out of the attic, leading to a ventilation-limited fire. Thus, the true nature of the fire may be hidden during your size up. **Once the ridge vent seals, the eaves will act as both the source of air as well as the exhaust and you may notice a pulsing of smoke out of the eaves.** This is a sign that you have a ventilation-limited fire in the attic.

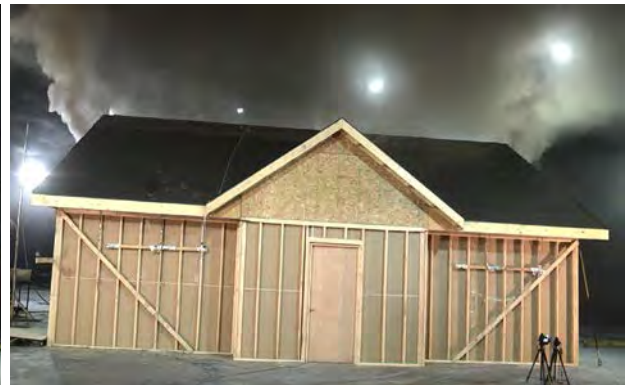
Figure 10.32. Ridge vent after sealing.

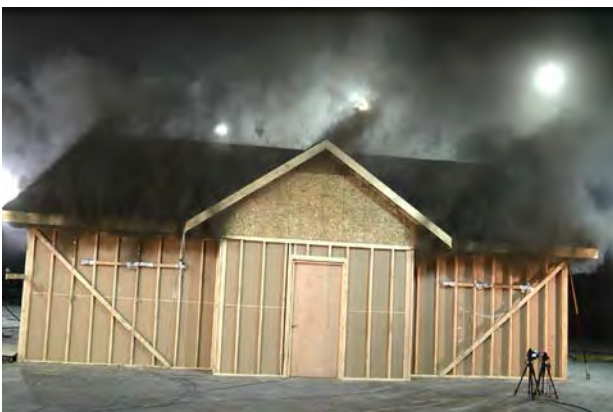
Figure 10.33. Smoke pulsing from eaves after ridge vent sealed.

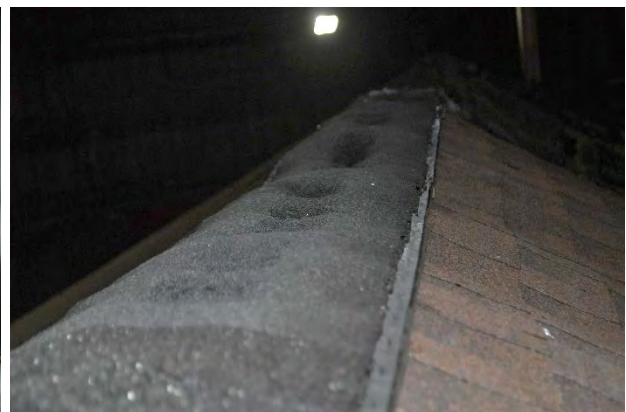
Figure 10.34. Ridge vent after experiment.

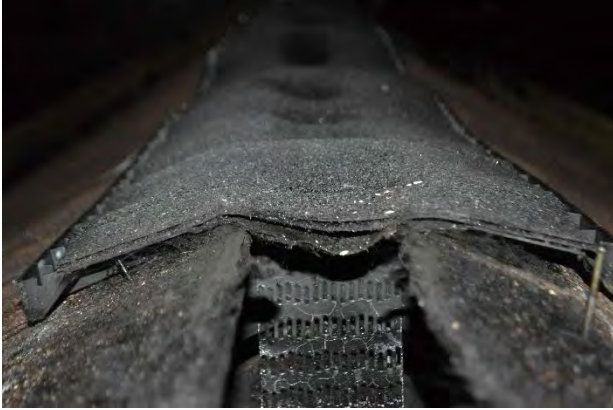
Figure 10. 35. Section cut away after experiment to see ridge vent seal.

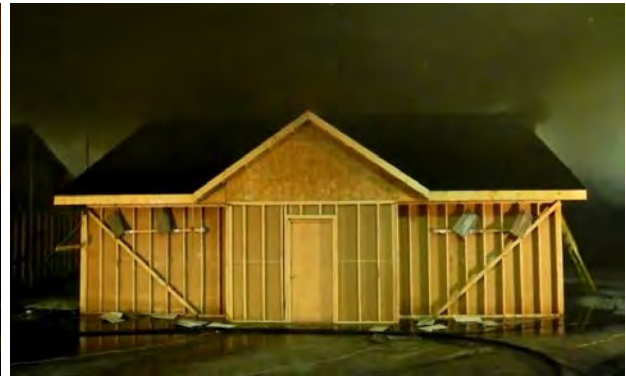
Figure 10. 37. Conditions at the end of eave attack during Attic Experiment 4

Removing the soffit and flowing water along the eave line of these structures was the most effective way to gain the upper hand on a fire that was venting through the roof. After the fire ventilates through the roof, increased air is entrained through the eaves and burning is increased. An eave attack puts water on these burning surfaces by flowing it up one side of the attic to the peak, and then running down the other side. As water wets the sheathing, it also rains down on the burning gases and other burning contents in the attic, extinguishing even more fire. In these experiments, a 1 ¾ in. handline flowing approximately 150 gpm easily had enough penetration to wet a 30 ft. by 36 ft. attic space under a 6/12 pitch roof system. Larger attics may require larger flows with more penetrating ability. Additionally, if bird blocking or other obstructions such as solid wood eaves are in place, they may need to be removed for this tactic to be effective. Careful preplanning, site visits and the ability to profile buildings in your response area will assist in the decision to make use of this tactic on the fire ground.

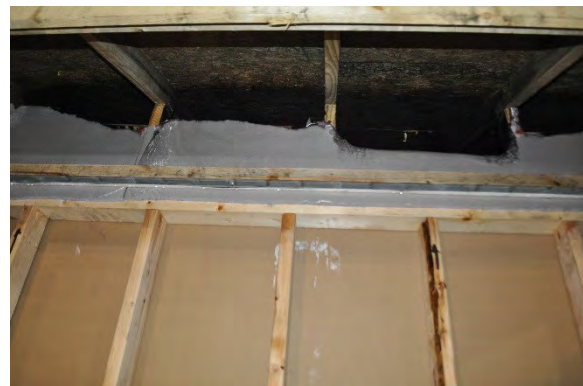
Figure 10. 39. View into the eaves after Attic Fire Experiment 4

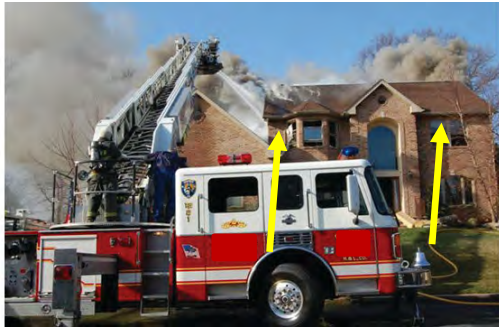
Figure 10. 41. Master stream flowing down into attic fire and not into eaves.

When a fire grows in the attic space and burns through the sheathing or out of the gable ends, crews may be called out and transitioned to a defensive operation. This has commonly included putting up an aerial device and flowing water into the holes in the roof or gable ends with fire coming out of them. This tactic typically fails to put much water on the underside of the roof deck or onto any burning material or contents that are not directly beneath or in the immediate vicinity of the hole. Large portions of the roof must burn away before angles of attack are created that allow water to reach the burning materials. As an alternative, **consider using an aerial device or portable ladders and hand lines to open up the eaves and flow water into the attic** as was described in earlier tactical considerations. **This approach could result in controlling the fire enough to permit firefighting crews to transition back inside the structure to complete searches, suppression, and overhaul.**

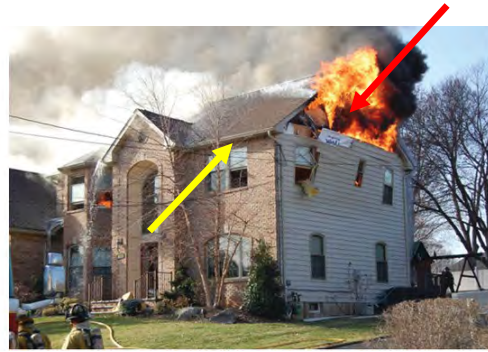
Figure 10. 42. Potential to flow water where fire is coming from instead of where fire is.

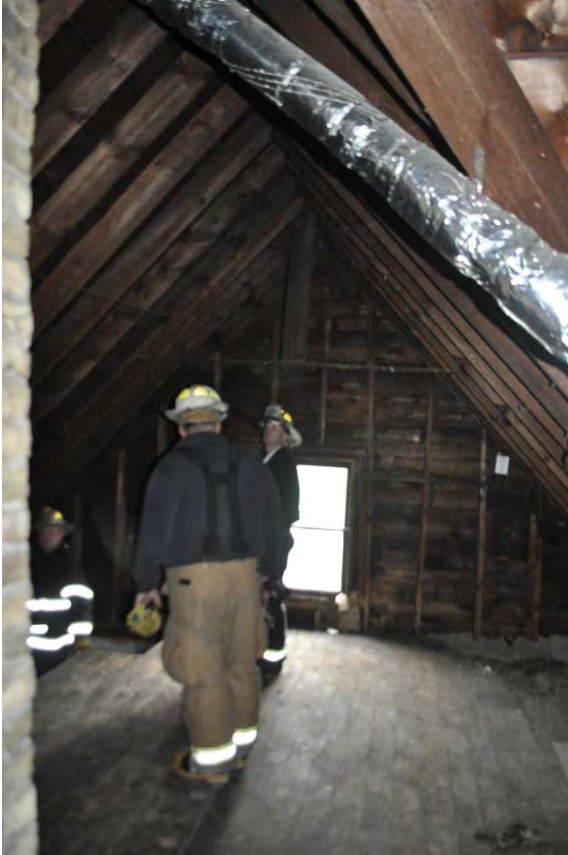
Figure 10. 43: North 9th St attic prior to finishing

Utilizing the upper ½ story of a structure for living space creates unique compartmentation not found on lower levels of the building (Figure 10. 43 through Figure 10. 46). The interior living space is surrounded on three sides by void spaces separated only by drywall and possibly insulation (Figure 10. 47). **During a structure fire, it is possible for fire to enter void spaces and surround crews conducting interior operations** before they notice a rise in temperatures or see any signs of fire. Any penetration into the void space from the interior creates a flow path, allowing fire to spread into the interior and exposing the crews. This fire spread may not occur immediately following the opening of the wall or ceiling, as the void space fire is likely ventilation-limited. Thus, firefighters may breach a separation and then continue further into the structure. **Even though there is a delay between making the breach and the change in conditions, once initiated, the transition to untenable conditions in the area of operation occurs in seconds.** In Figure 10. 48 the temperatures at 3 feet in the attic increased 300 degrees in 5 seconds. When things go bad, they go bad fast.

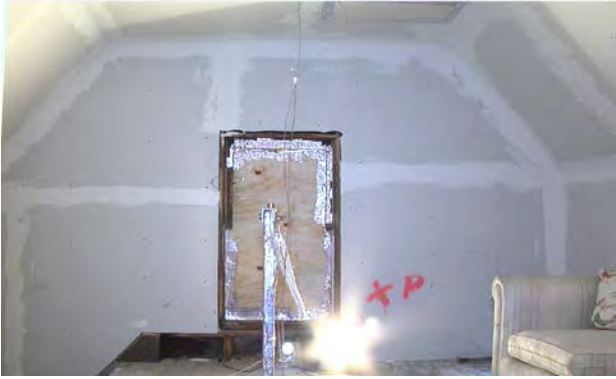
Figure 10. 44: North 9th St attic after finishing

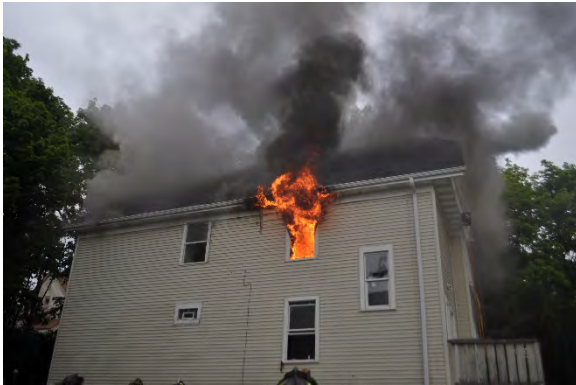
Figure 10. 50. Fire on second floor with extension into the knee wall. Water should be flowed to extinguish the room (from inside or outside) and then flow into the eaves (from inside or outside) before accessing the attic.

Applying water utilizing the same path the fire took to enter the void space may be the most effective method at slowing fire growth. If the fire starts on the outside of the structure, enters the knee wall due to auto exposure through a window, or enters the knee wall through interior wall cavities (balloon flame construction as an example) controlling the source is imperative to a successful fire attack. After controlling the source fire direct water to the potential path of extension into the knee wall. This will be the eaves from an exterior fire or exposure out of the window from a room fire or the interior wall or ceiling cavities from a room fire. **Water application to the knee wall will not be effective until the source below it is controlled with direct water application to the source.** Once the source fire is controlled, crews can more readily and safely gain access to the void spaces, extinguishing any active fire in the void and wetting all exposed surfaces. This will prevent regrowth of the fire. Attempting to initiate fire control only through a breach into the knee wall, or before the source fire is effectively controlled, can place the attack crew in the flow path of a fire. If they cannot

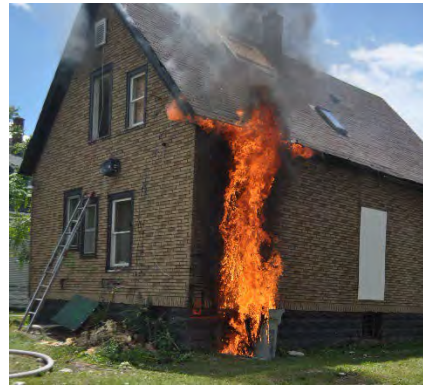
Figure 10. 51. Fire on outside with extension into the attic. Water should be flowed to extinguish the exterior fire and then flow into the eaves before accessing the attic.
