Study of Residential Attic Fire Mitigation Tactics and Exterior Fire Spread Hazards on Fire Fighter Safety

UL Firefighter Safety Research Institute

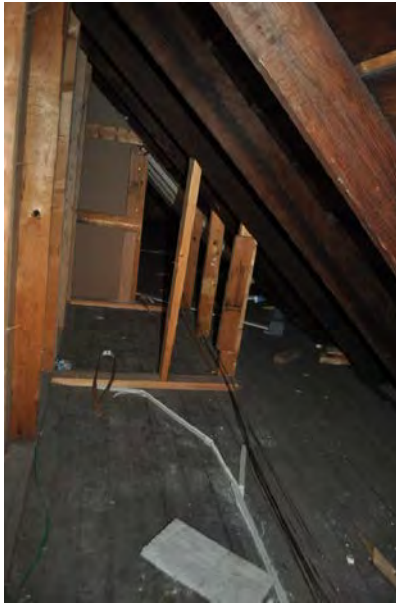
Figure 10. 52. Knee wall access showing difficulty of flowing water past the rafters.

Knee wall construction creates interconnected void spaces where the wooden structural members provide a relatively large surface area of exposed fuel along with air flow conducive to spreading fire (Figure 10. 52). The experiments demonstrated that getting effective stream reach and penetration inside a knee wall and other attic voids is hindered in much the same way as are streams applied into open attics through gable ends or from the floor below (Figure 10. 53). In both cases, structural members effectively broke up the stream before it could successfully penetrate the fire area. The experiments also demonstrated that water should initially be applied into the knee walls at multiple locations through small holes, in order to suppress the burning gases, before large sections of the knee wall are opened for complete extinguishment. This tactic will maximize the benefit of energy absorption through steam conversion while minimizing the spread of fire along the flow path created by the openings made for the nozzle. Once the gases are suppressed or cooled, focus on getting water into the rafter bays where air moving from the eave line to the peak will sustain and accelerate the remaining fire. This is similar to the concept that makes the eave attack successful; the sheathing is where the air and fuel come together most effectively, so this is where suppression efforts should be focused. Don't wait to see fire in a knee wall before you apply water to the void space or the surfaces. **Tests have demonstrated that the most effective way to get a handle on knee wall fires is to control the source fire, cool the gasses prior to making large breaches in the barrier, and then aggressively open the knee walls to complete extinguishment, focusing on wetting the underside of the roof decking.**

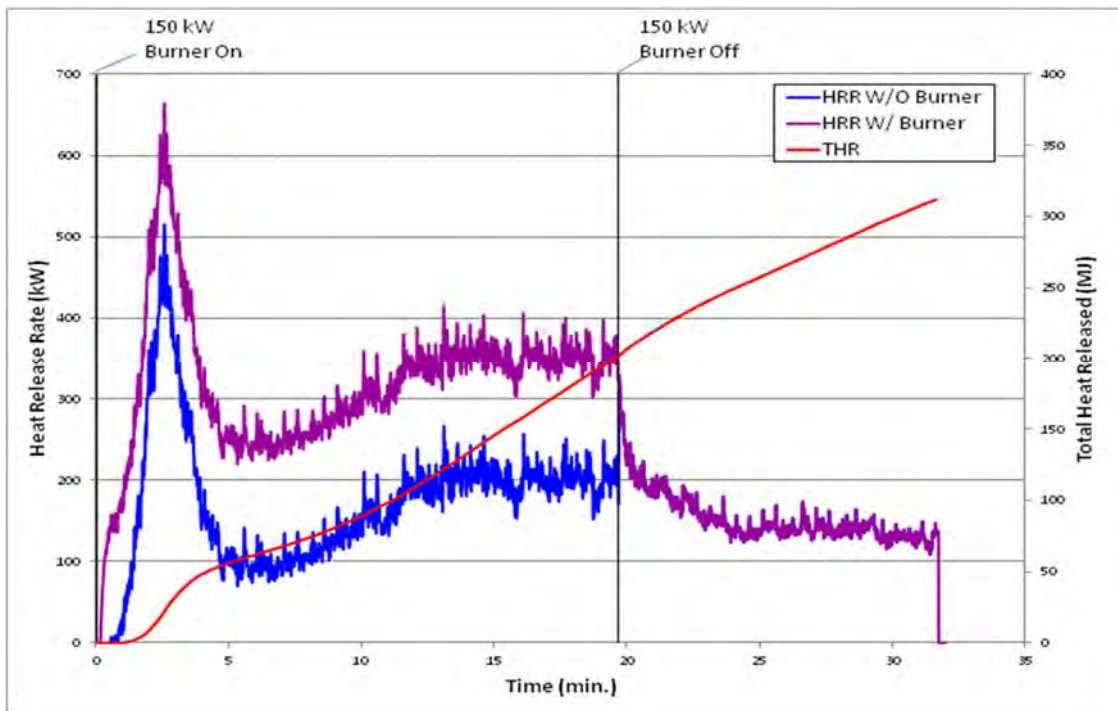
Figure G. 2: Wall Experiment 1 Heat Release Rate and Total Heat Released

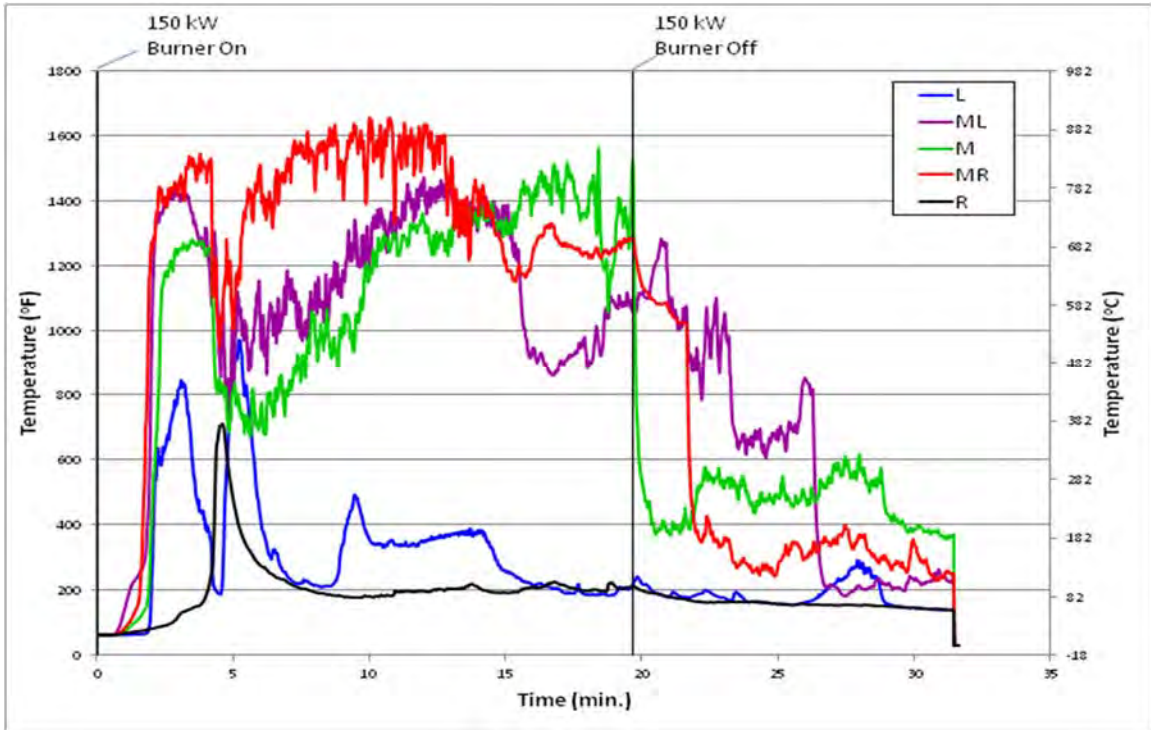
Figure G. 3: Wall Experiment 1 under Siding Horizontal Temperatures

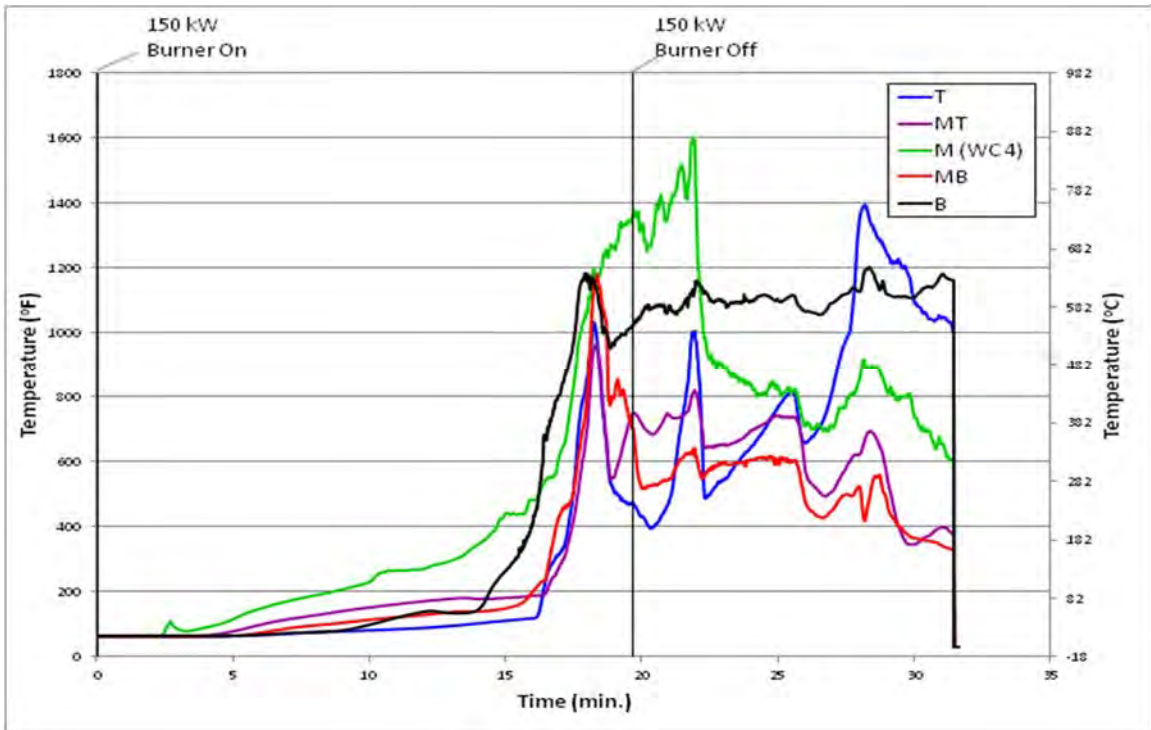
Figure G. 6: Wall Experiment 1 Wall Cavity Vertical Temperatures

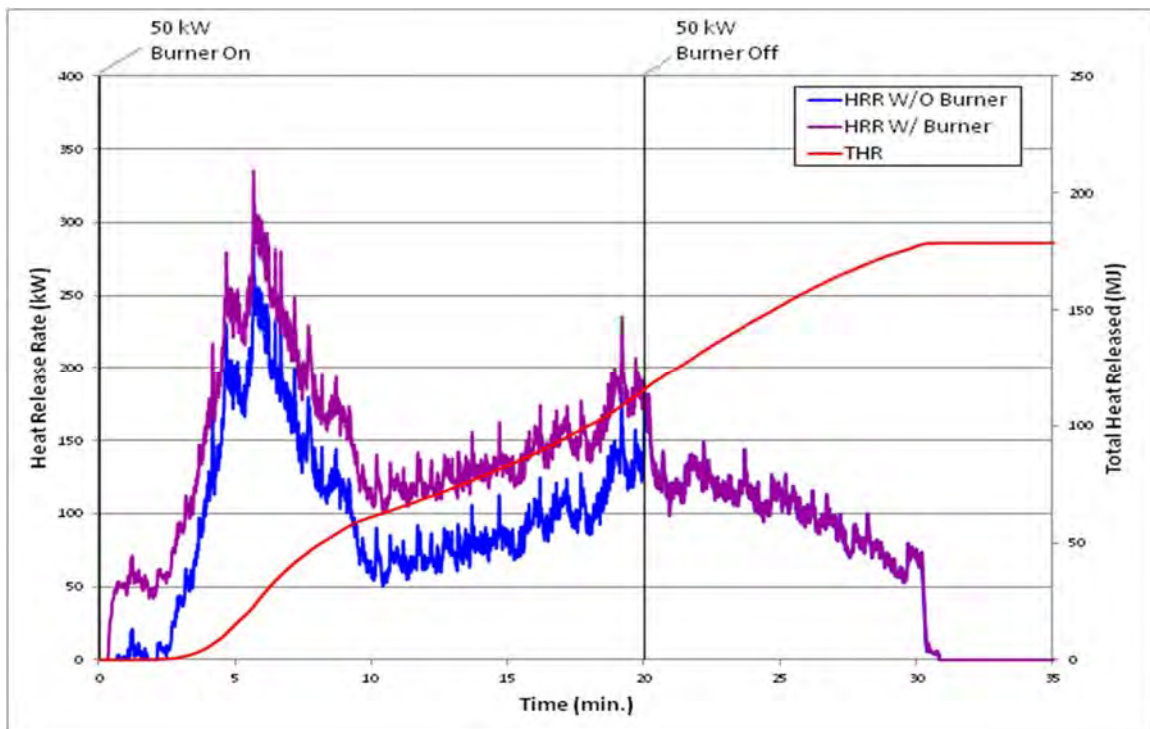
Figure G. 8: Wall Experiment 2 Heat Release Rate and Total Heat Released

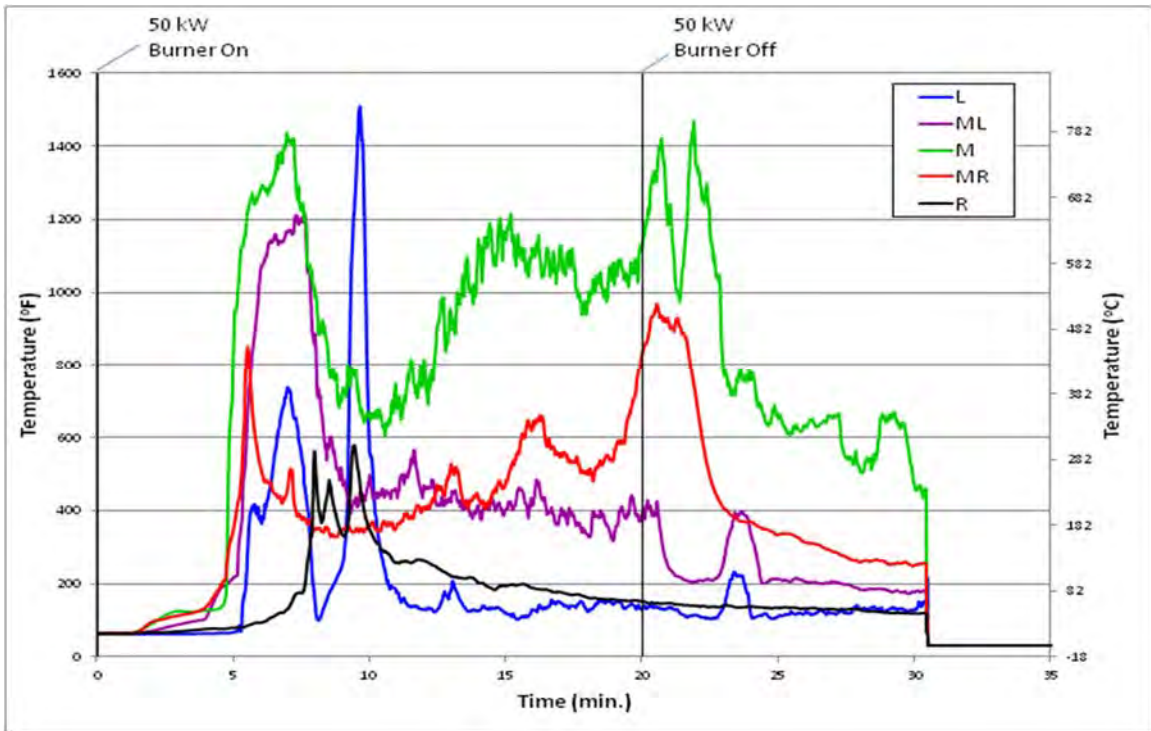
Figure G. 9: Wall Experiment 2 under Siding Horizontal Temperatures

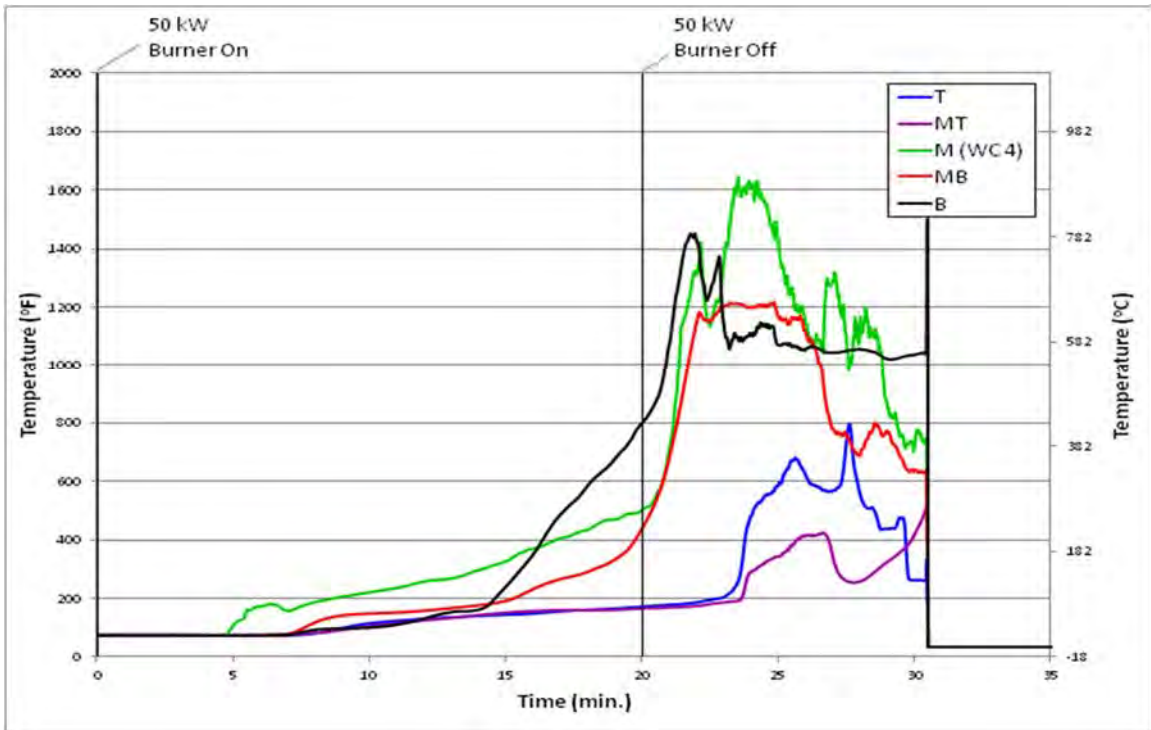
Figure G. 12: Wall Experiment 2 Wall Cavity Vertical Temperatures

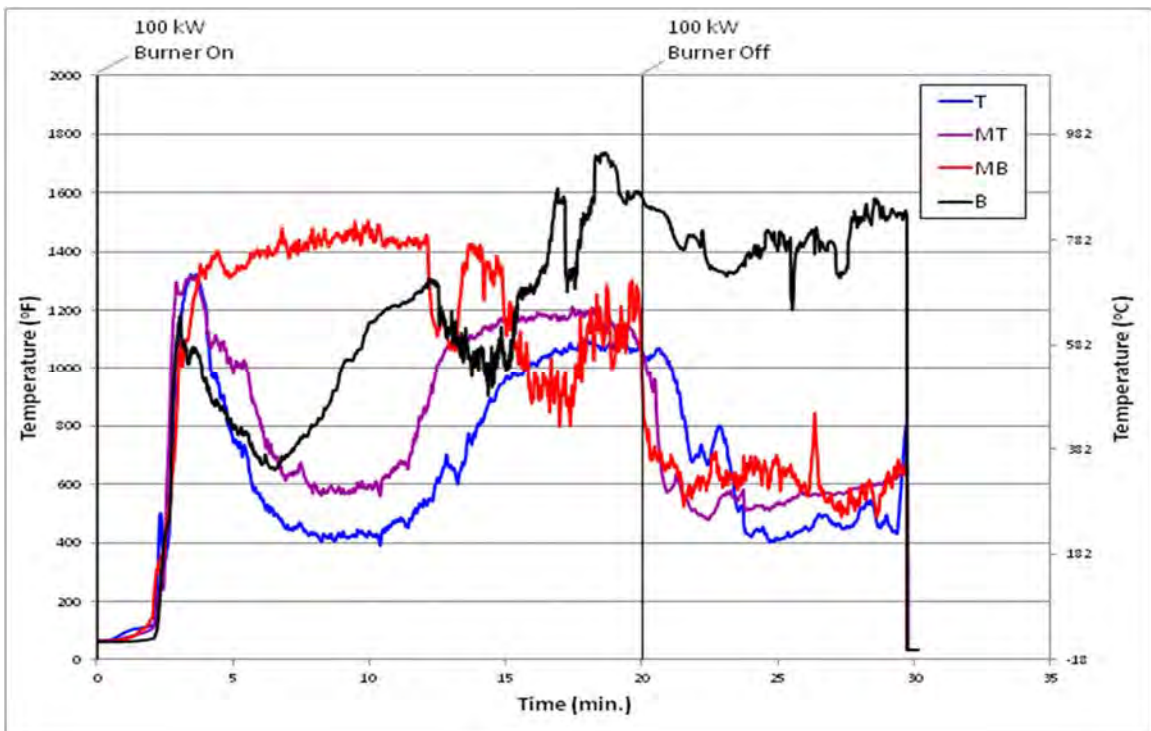
Figure G. 16: Wall Experiment 3 under Siding Vertical Temperatures

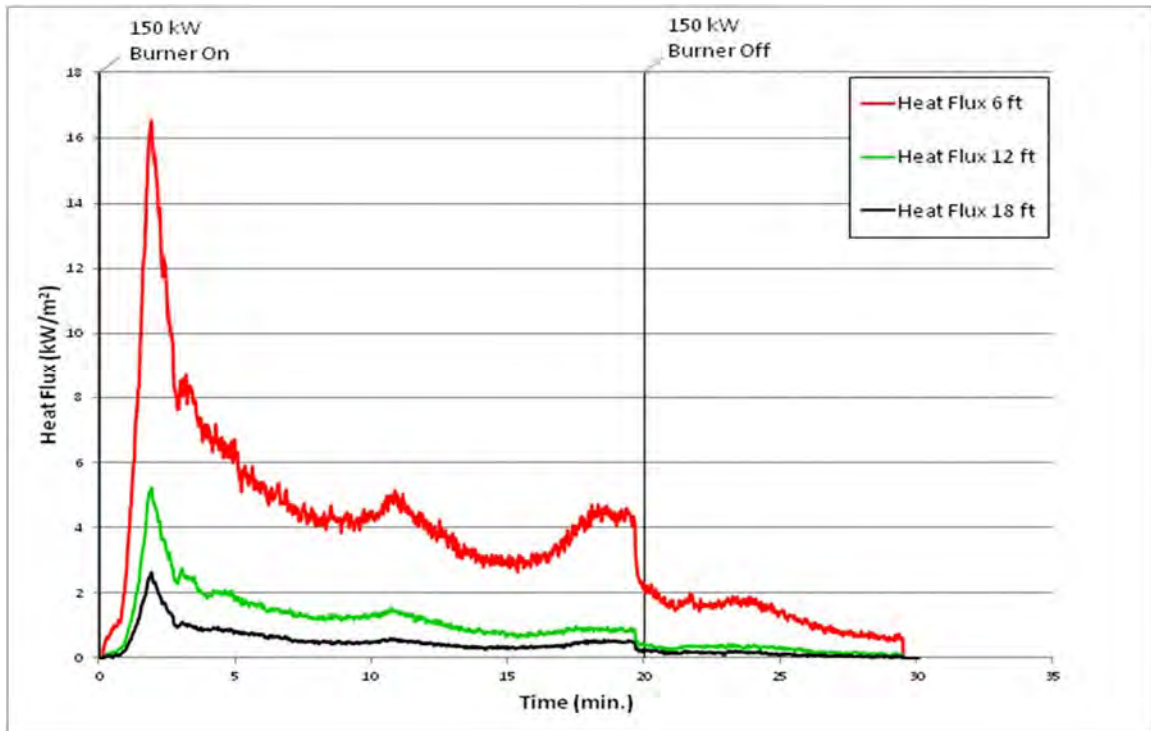
Figure G. 19: Wall Experiment 4 Heat Flux

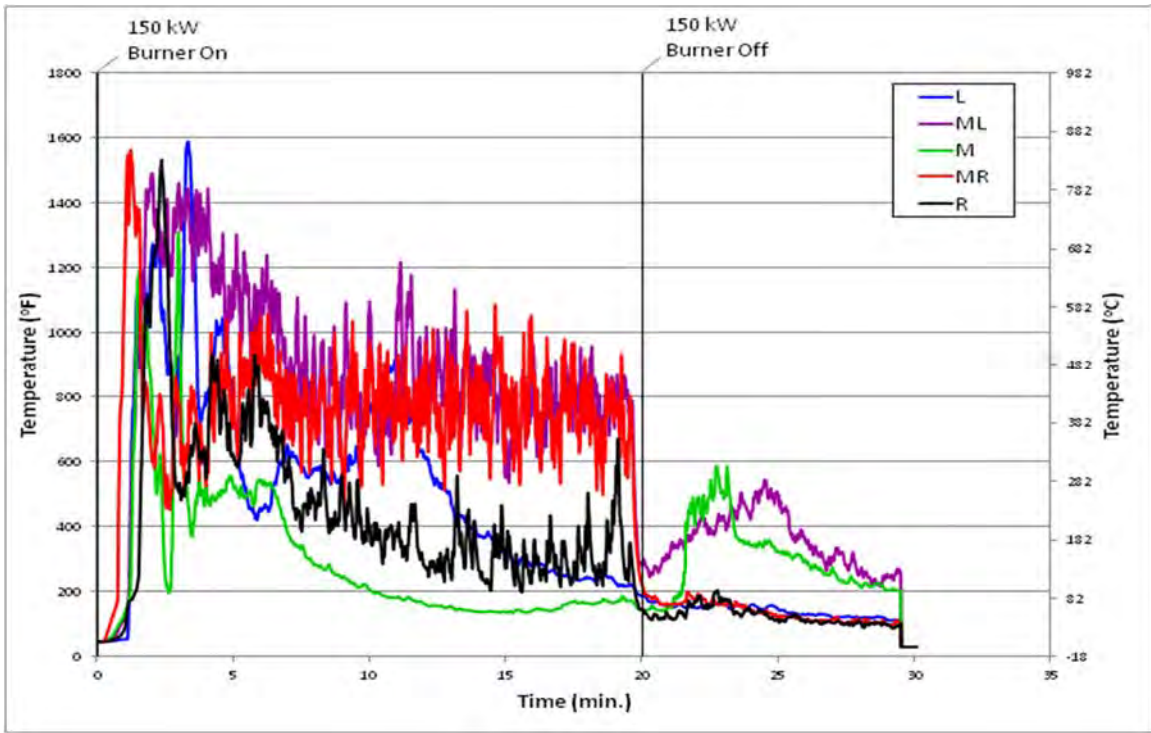
Figure G. 21: Wall Experiment 4 under Siding Horizontal Temperatures

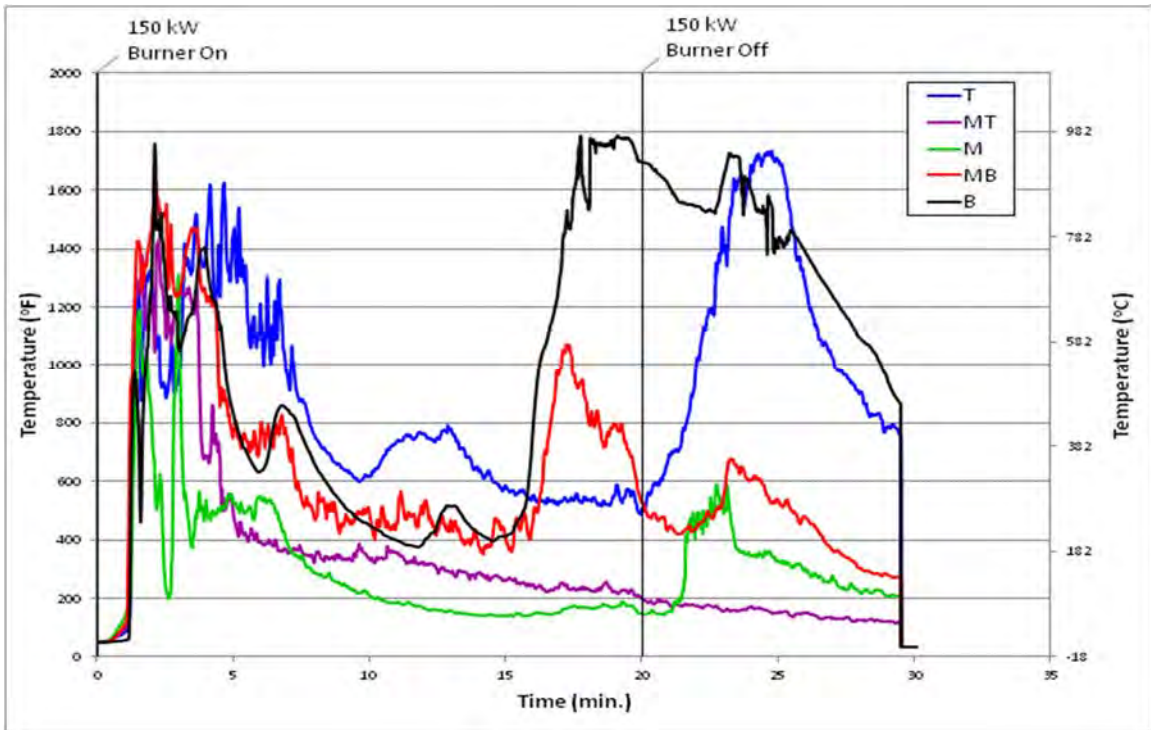
Figure G. 22: Wall Experiment 4 under Siding Vertical Temperatures

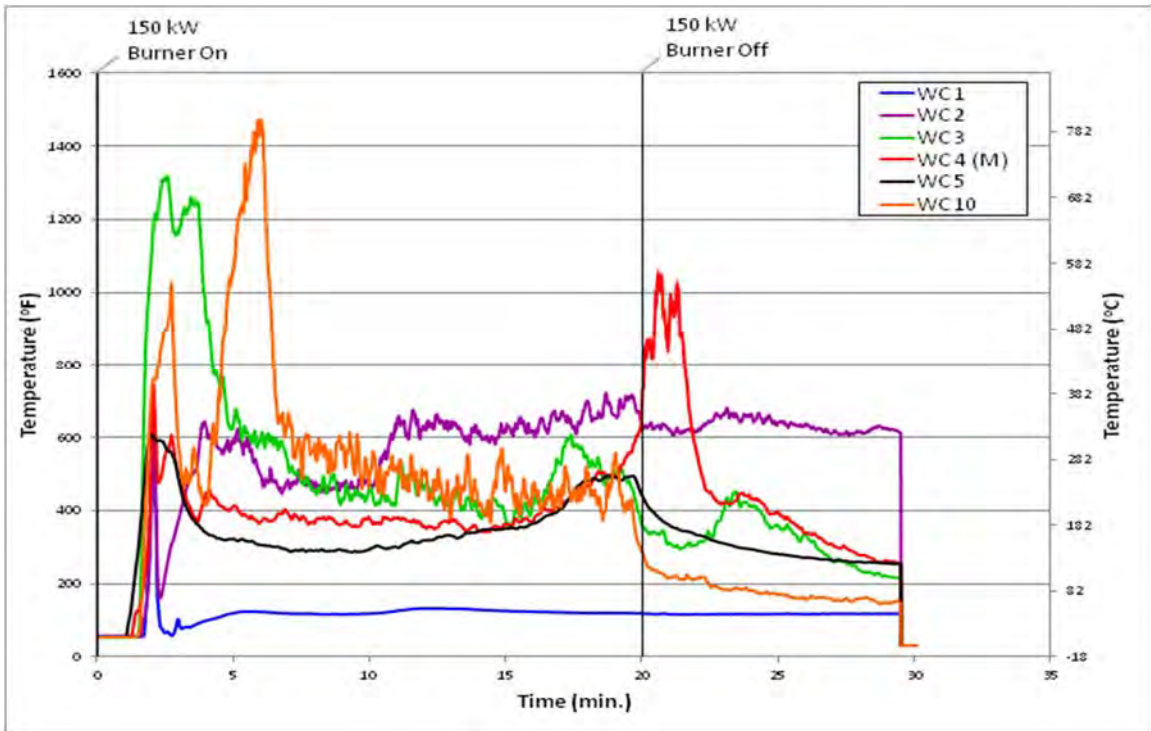
Figure G. 23: Wall Experiment 4 Wall Cavity Horizontal Temperatures

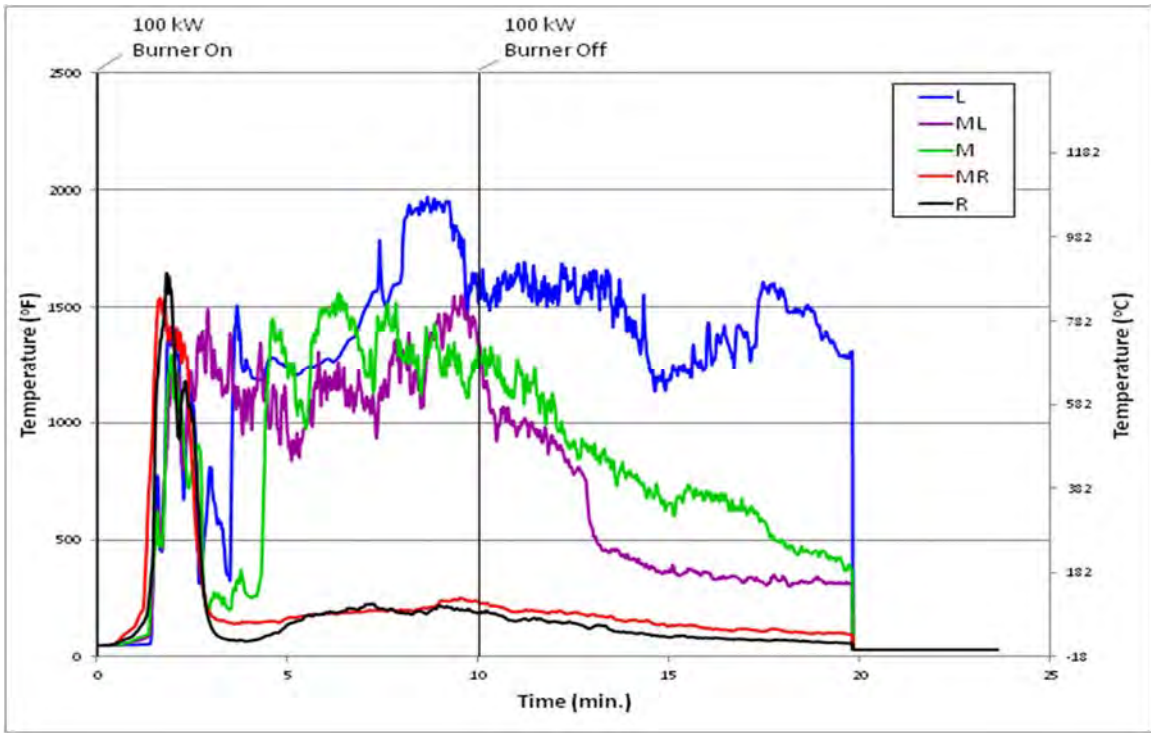
Figure G. 27: Wall Experiment 5 under Siding Horizontal Temperatures

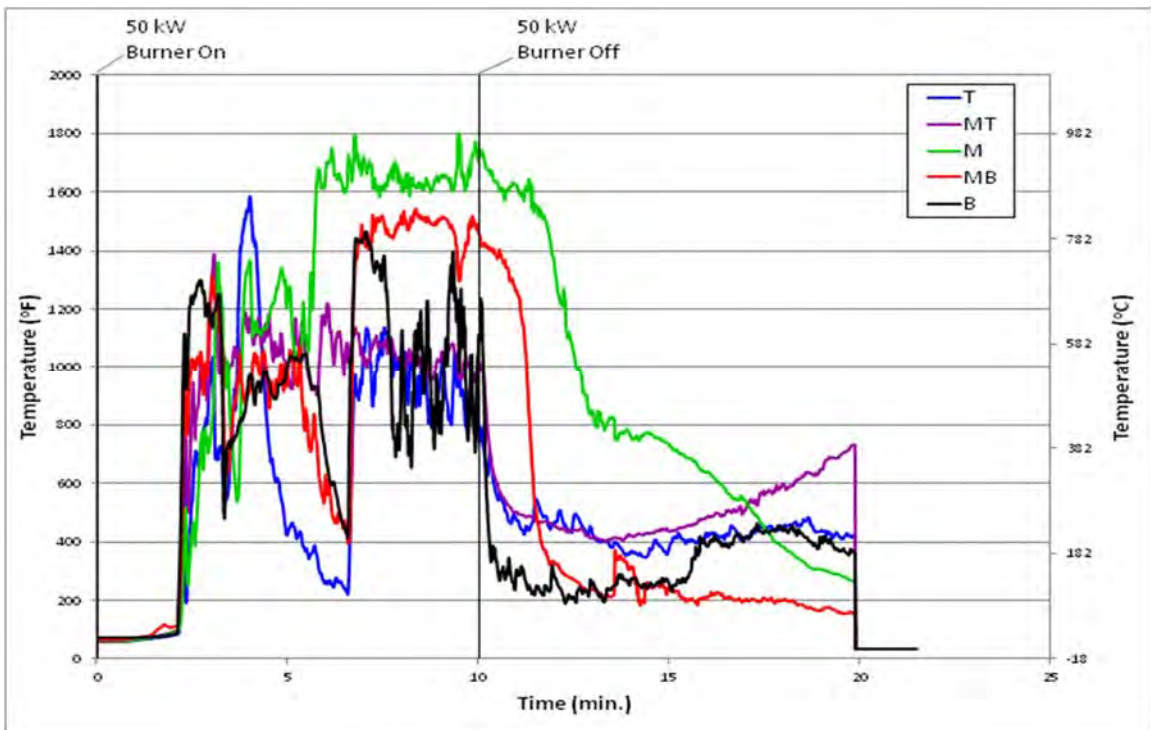
Figure G. 34: Wall Experiment 6 under Siding Vertical Temperatures

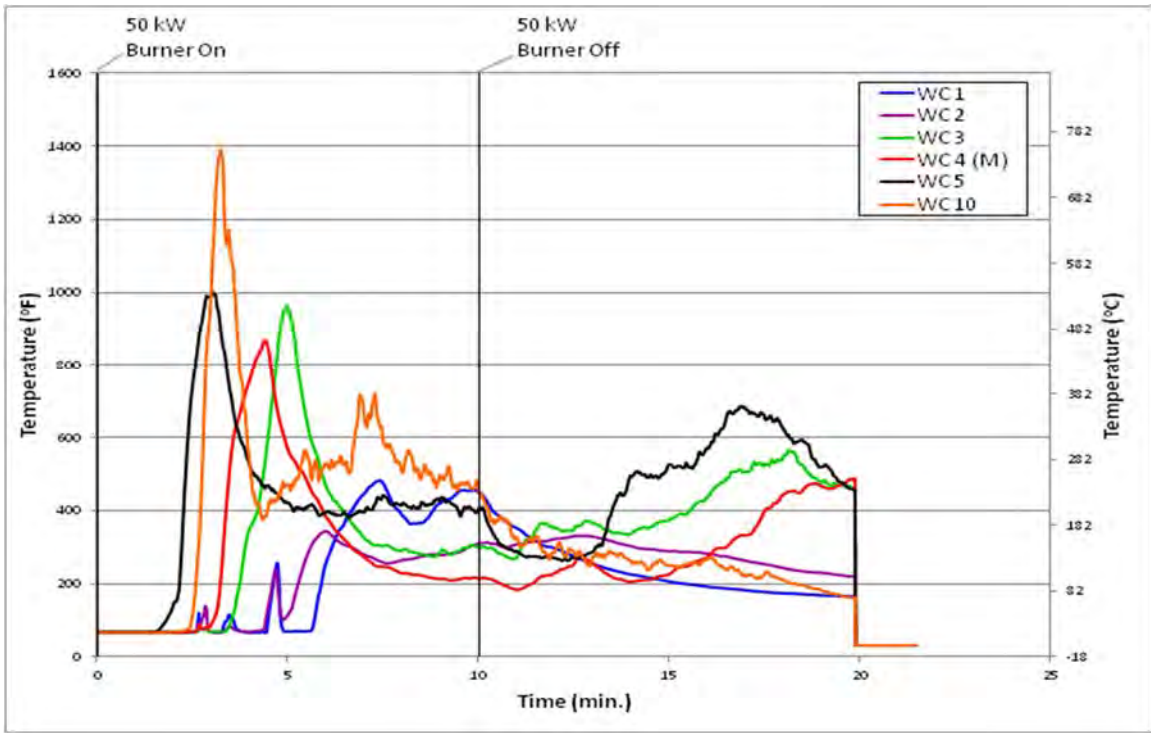
Figure G. 35: Wall Experiment 6 Wall Cavity Horizontal Temperatures

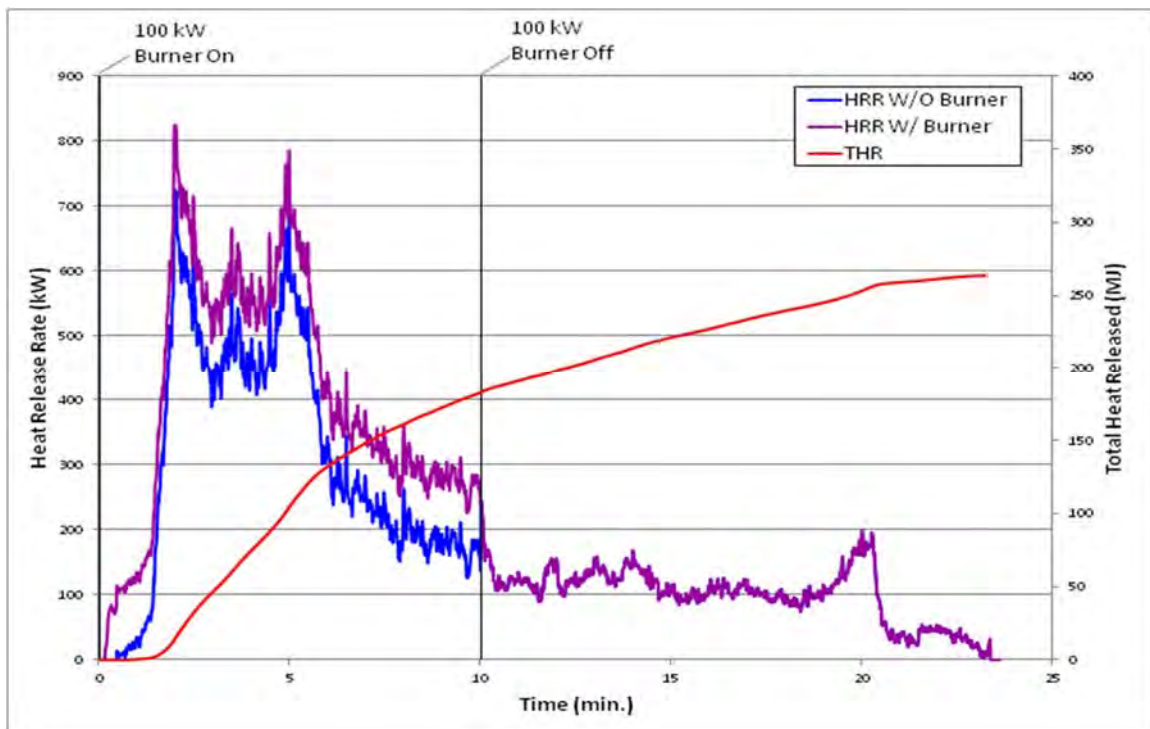
Figure G. 38: Wall Experiment 7 Heat Release Rate and Total Heat Released

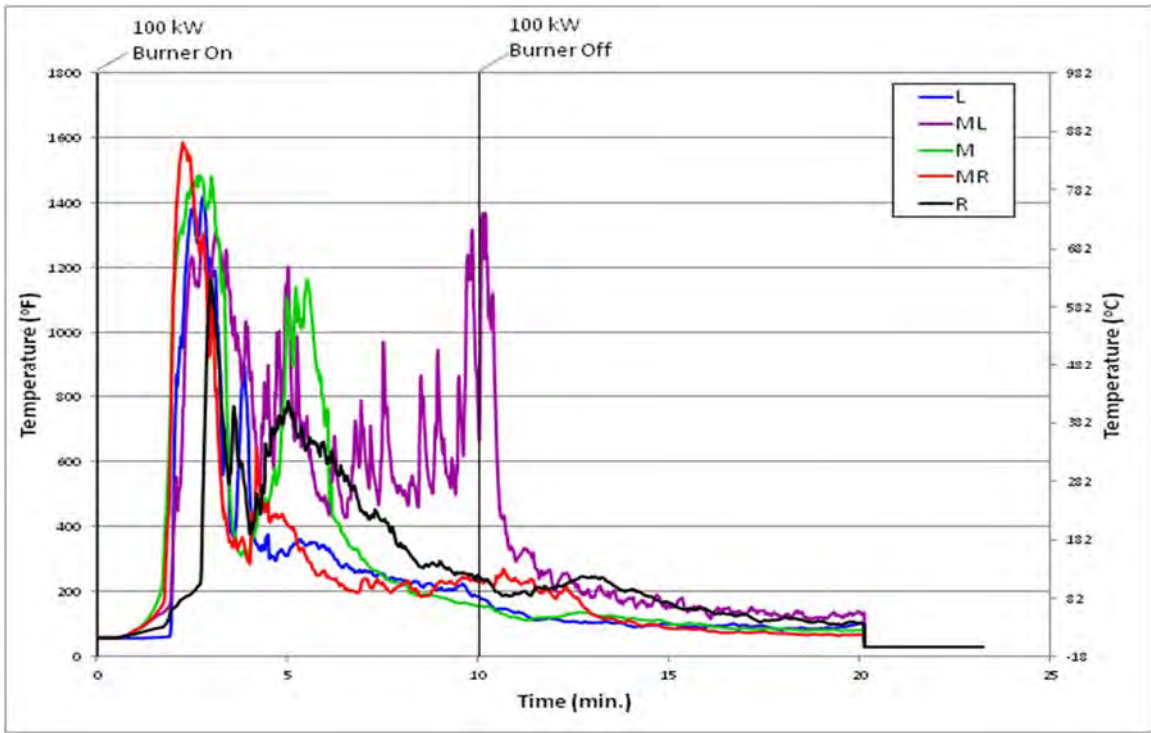
Figure G. 39: Wall Experiment 7 under Siding Horizontal Temperatures

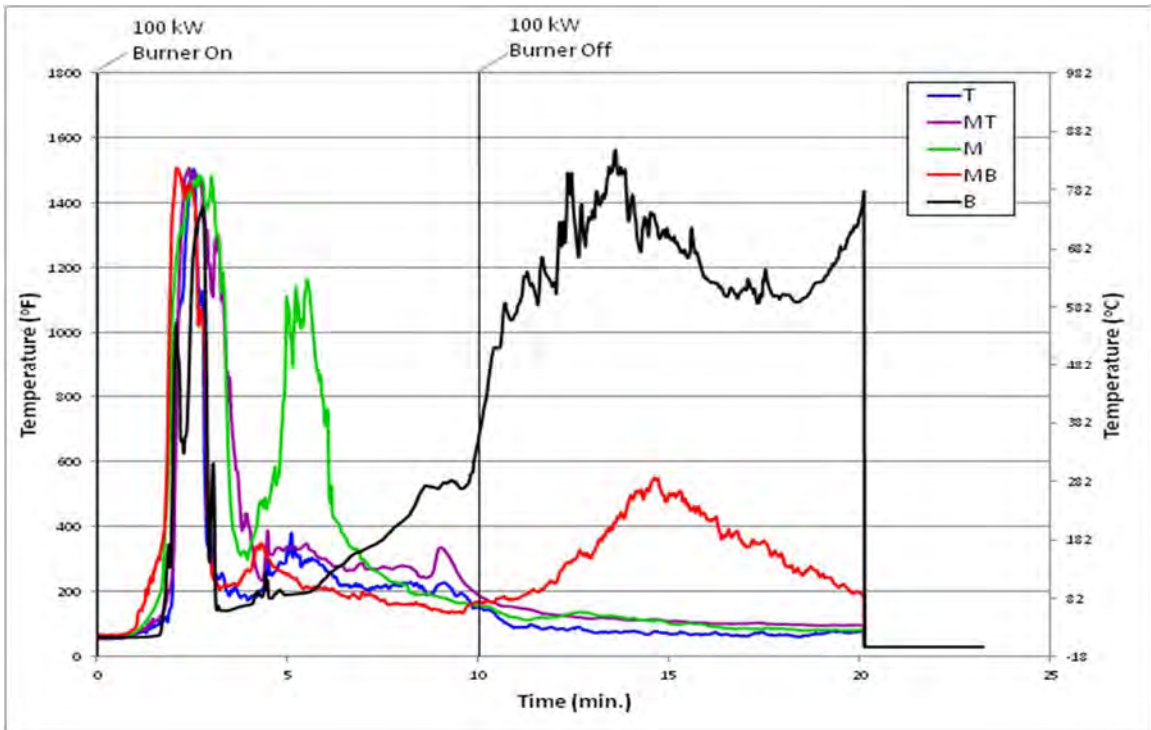
Figure G. 40: Wall Experiment 7 under Siding Vertical Temperatures

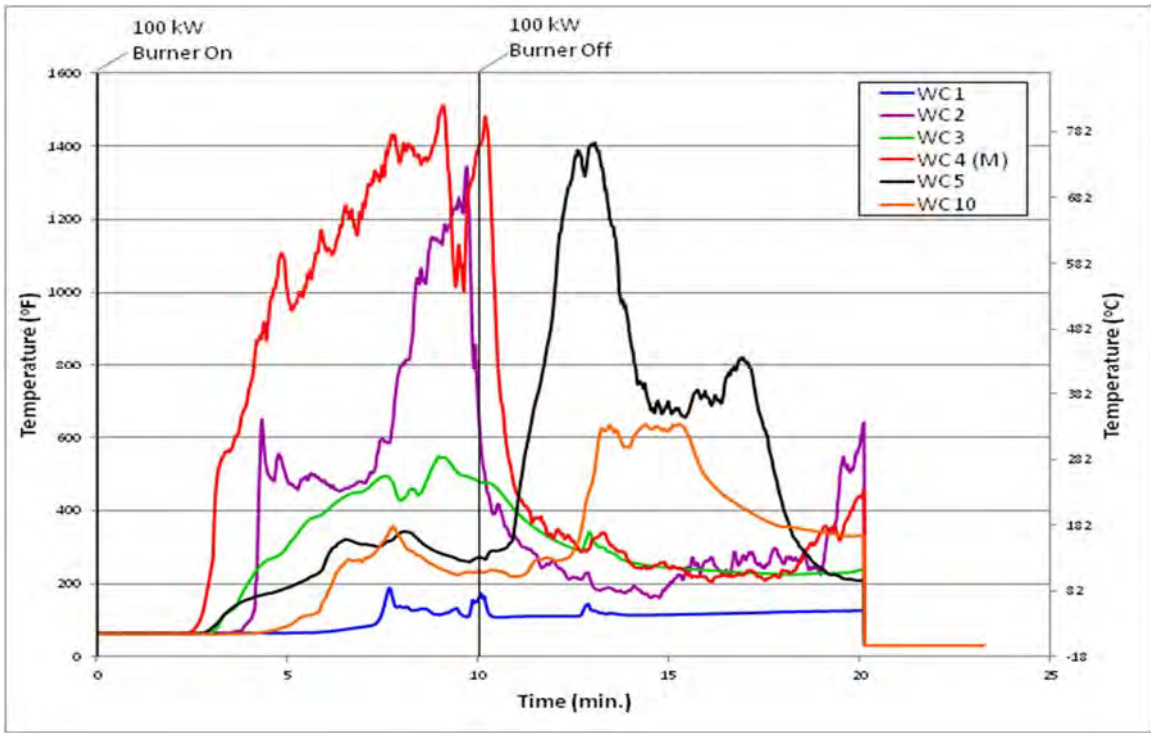
Figure G. 41: Wall Experiment 7 Wall Cavity Horizontal Temperatures

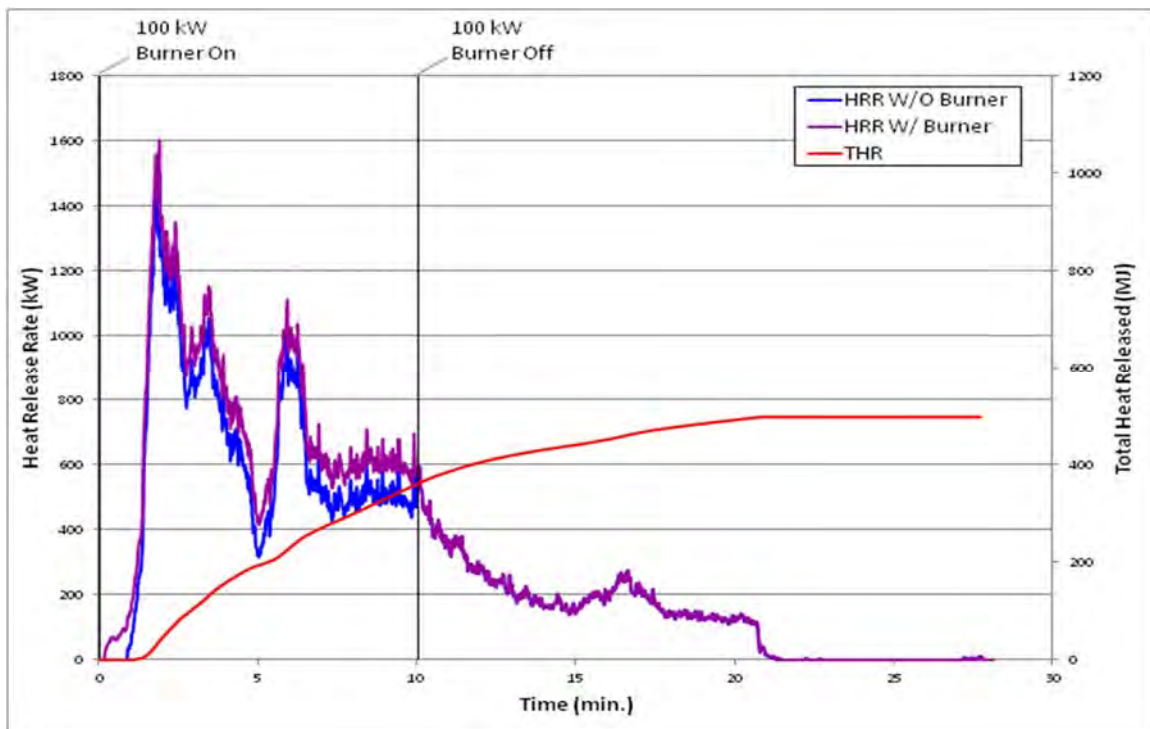
Figure G. 44: Wall Experiment 8 Heat Release Rate and Total Heat Released

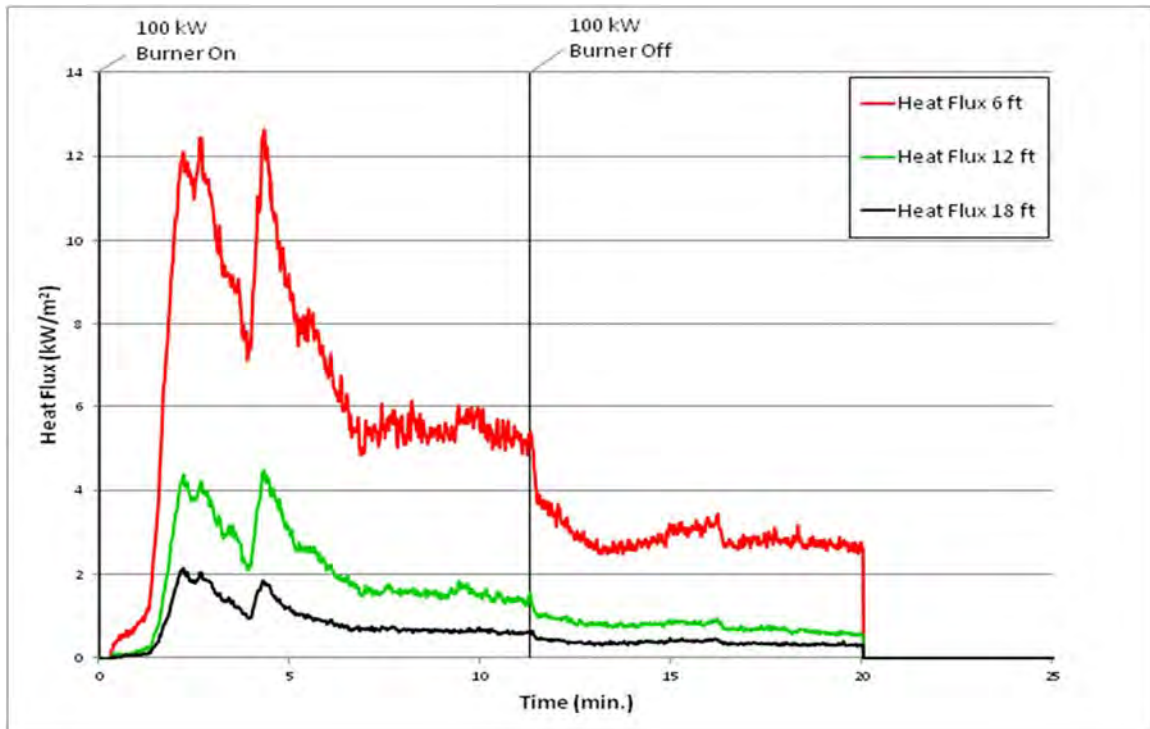
Figure G. 49: Wall Experiment 9 Heat Flux

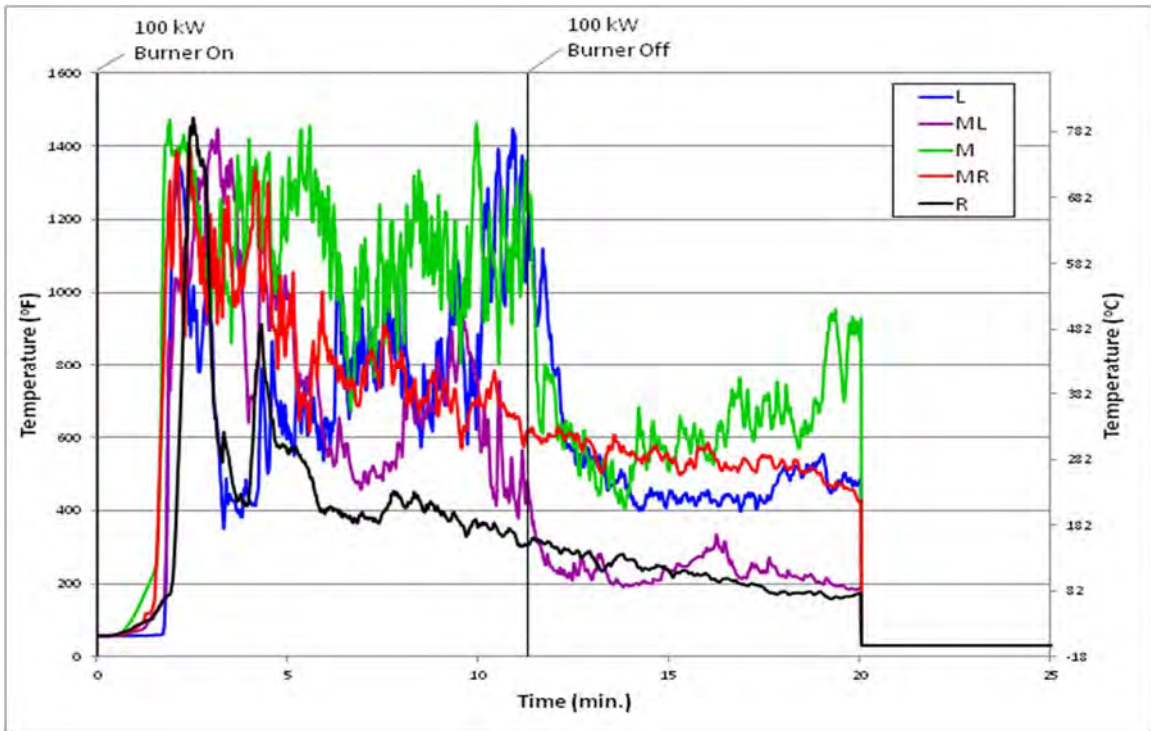
Figure G. 51: Wall Experiment 9 under Siding Horizontal Temperatures

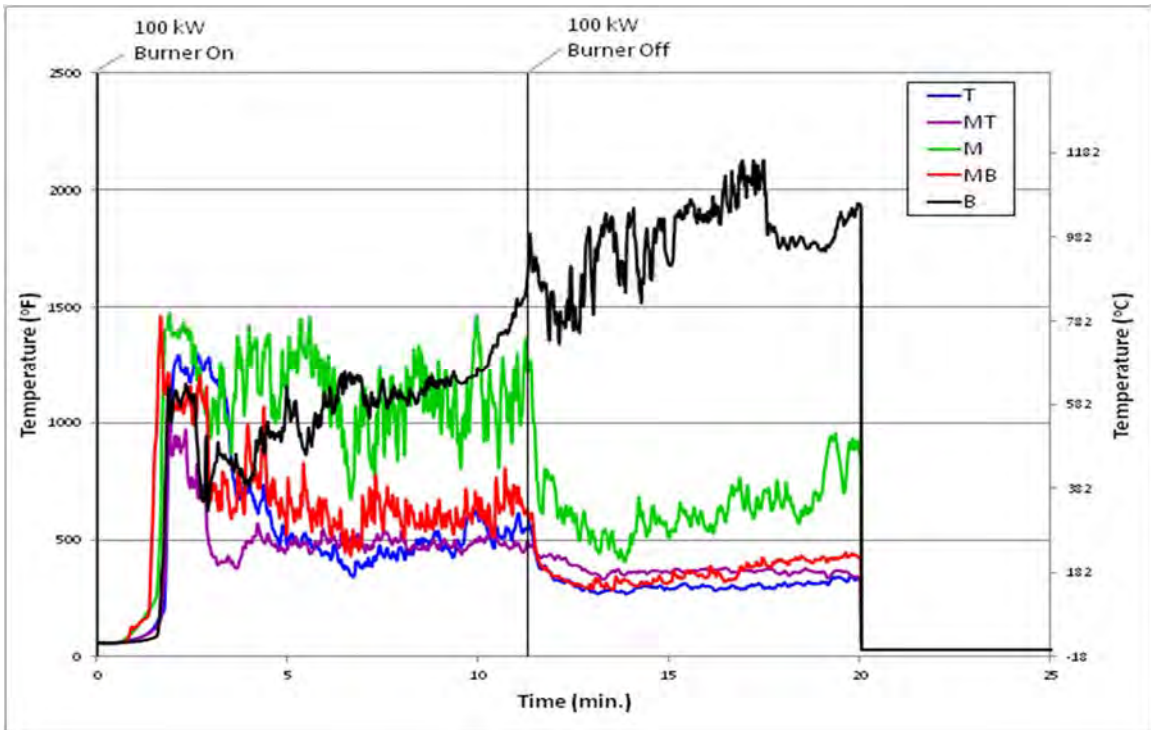
Figure G. 52: Wall Experiment 9 under Siding Vertical Temperatures

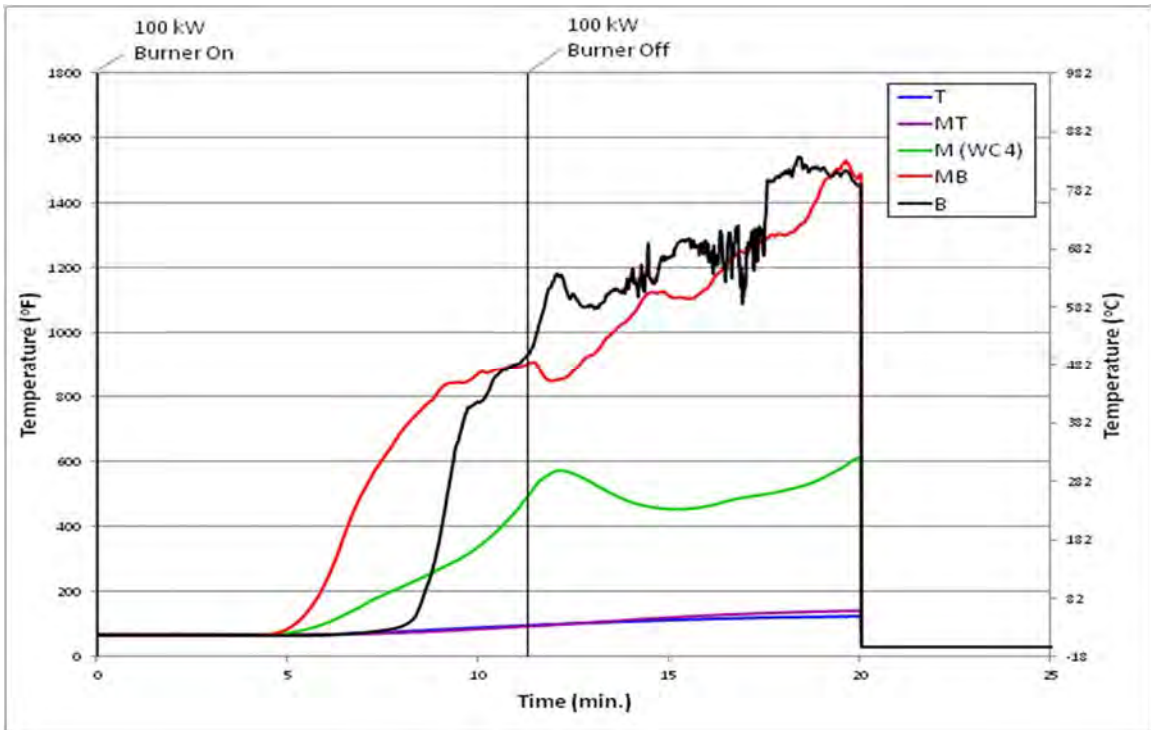
Figure G. 54: Wall Experiment 9 Wall Cavity Vertical Temperatures

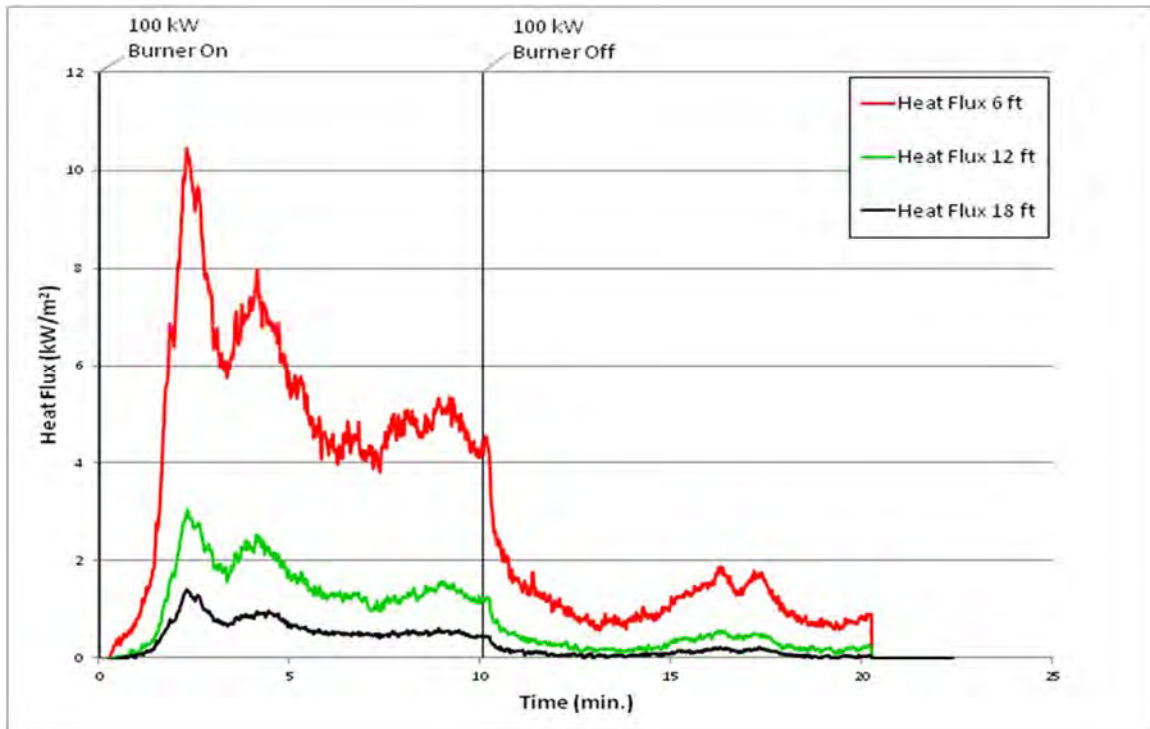
Figure G. 55: Wall Experiment 10 Heat Flux

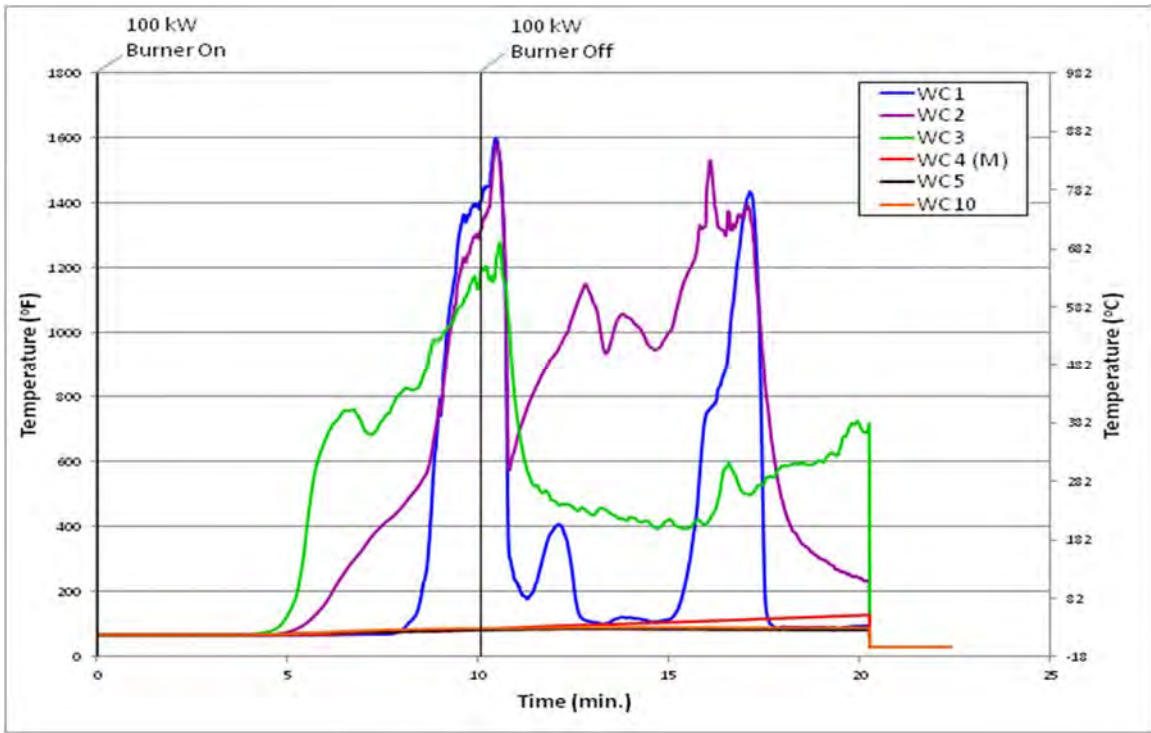
Figure G. 59: Wall Experiment 10 Wall Cavity Horizontal Temperatures

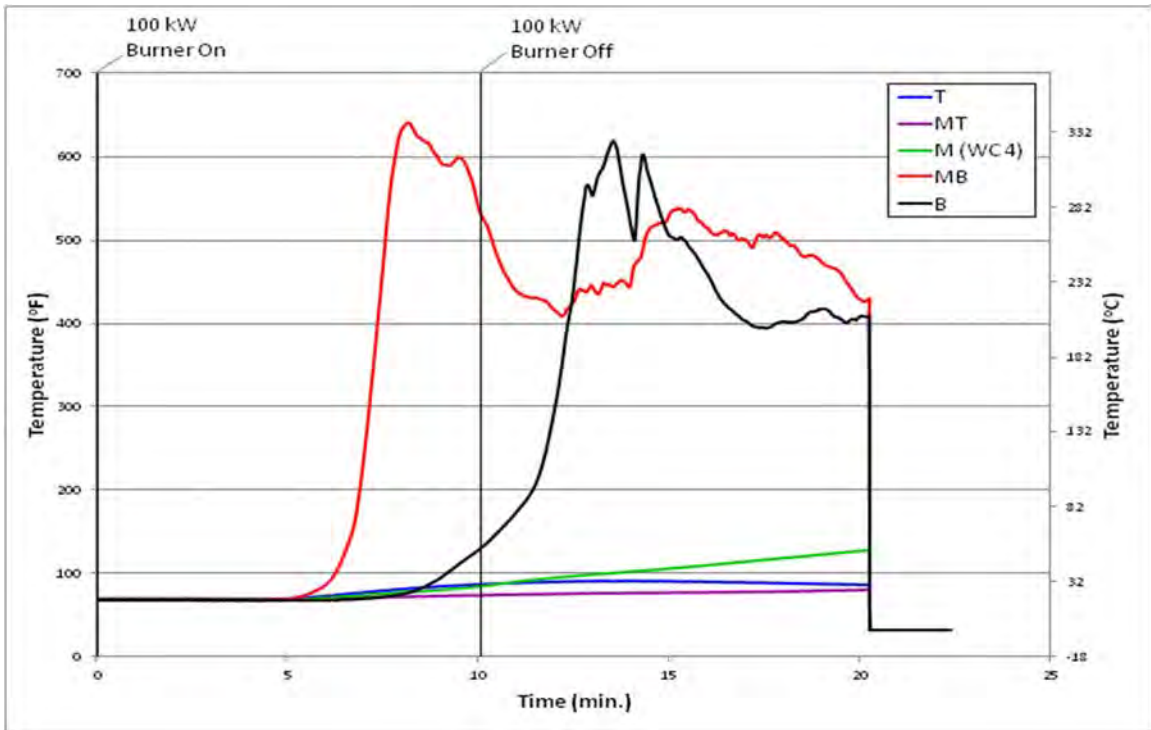
Figure G. 60: Wall Experiment 10 Wall Cavity Vertical Temperatures
