Study of Residential Attic Fire Mitigation Tactics and Exterior Fire Spread Hazards on Fire Fighter Safety

UL Firefighter Safety Research Institute

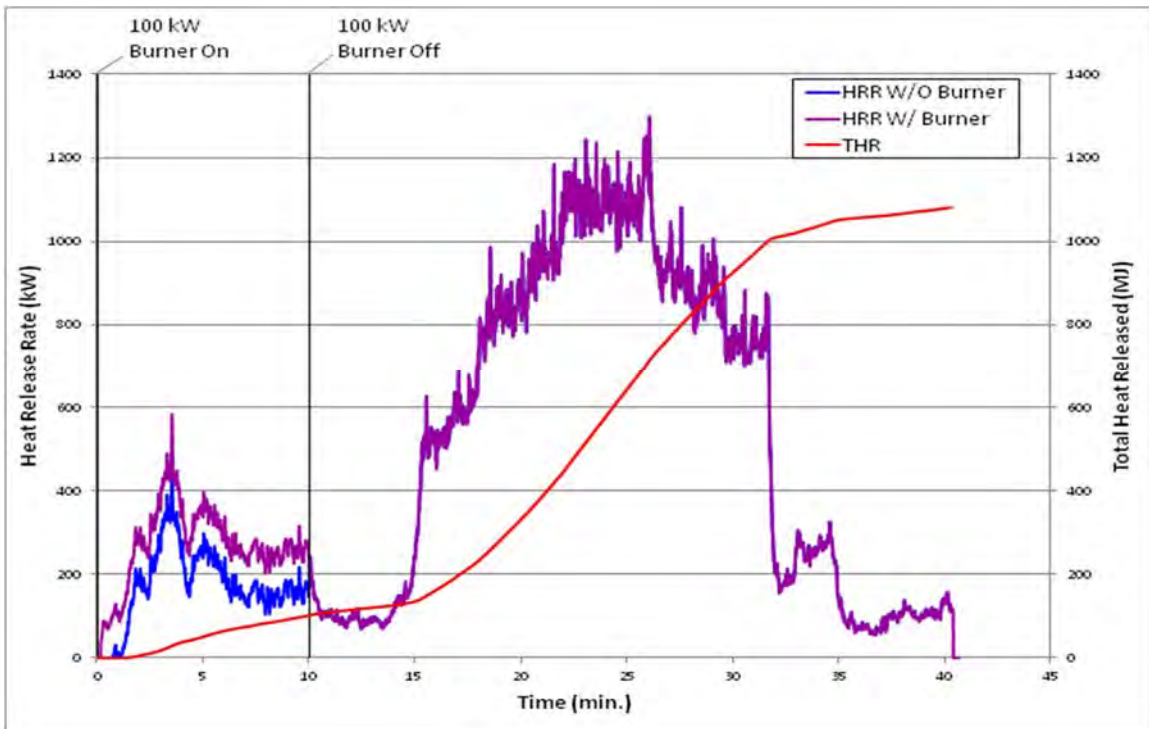
Figure G. 62: Wall Experiment 11 Heat Release Rate and Total Heat Released

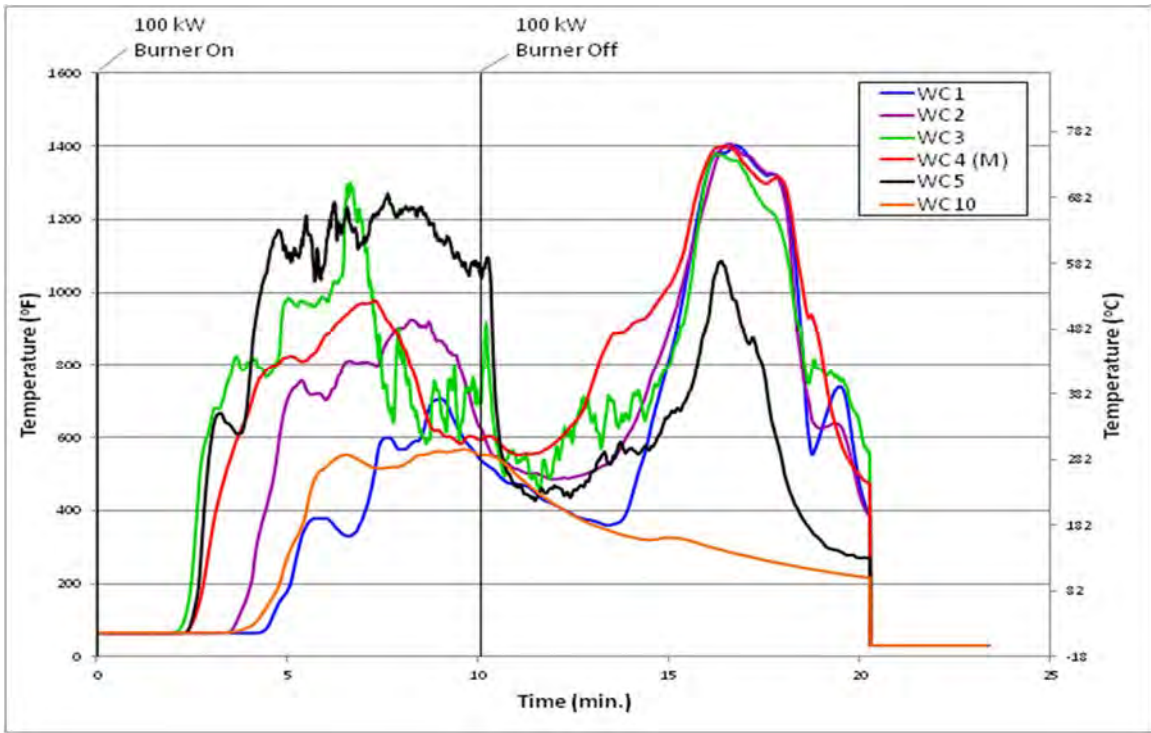
Figure G. 71: Wall Experiment 12 Wall Cavity Horizontal Temperatures

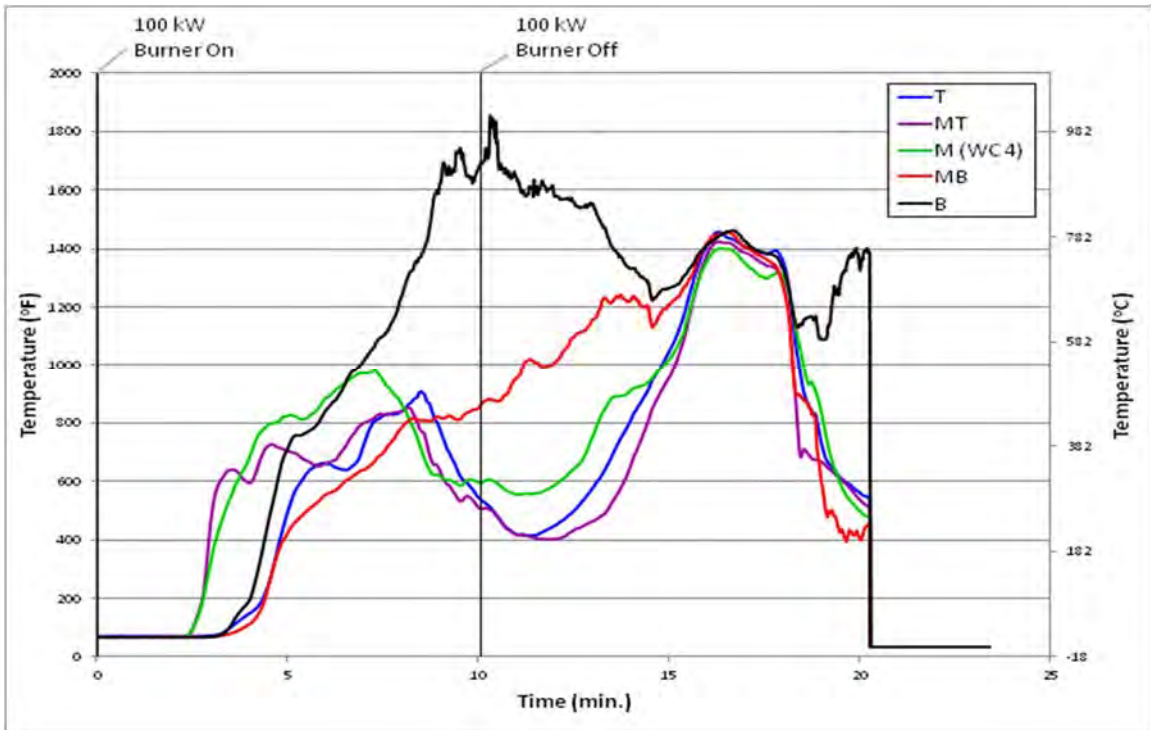
Figure G. 72: Wall Experiment 12 Wall Cavity Vertical Temperatures

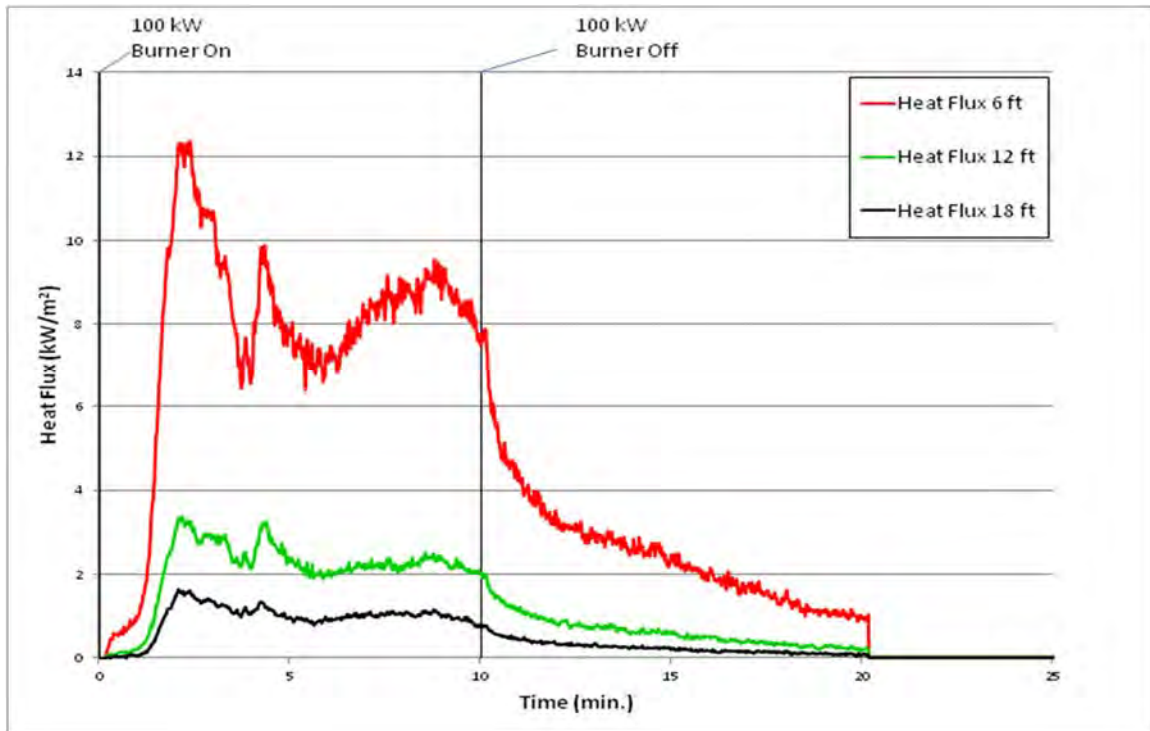
Figure G. 73: Wall Experiment 13 Heat Flux

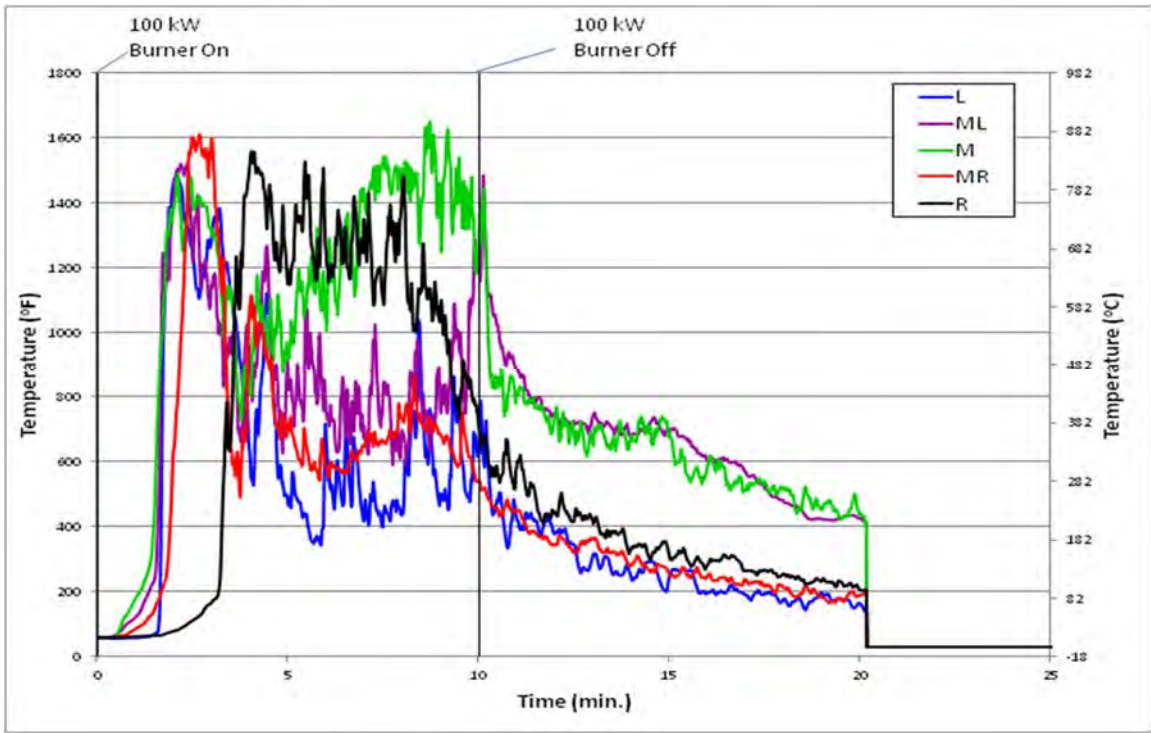
Figure G. 75: Wall Experiment 13 under Siding Horizontal Temperatures

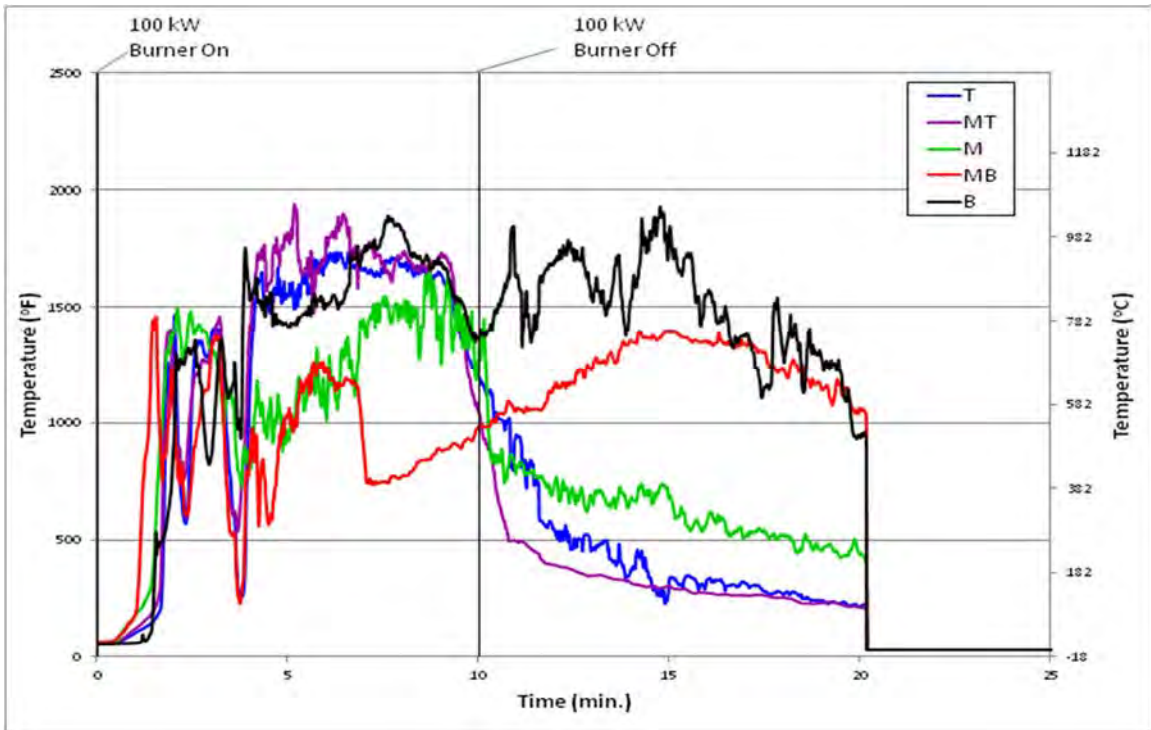
Figure G. 76: Wall Experiment 13 under Siding Vertical Temperatures

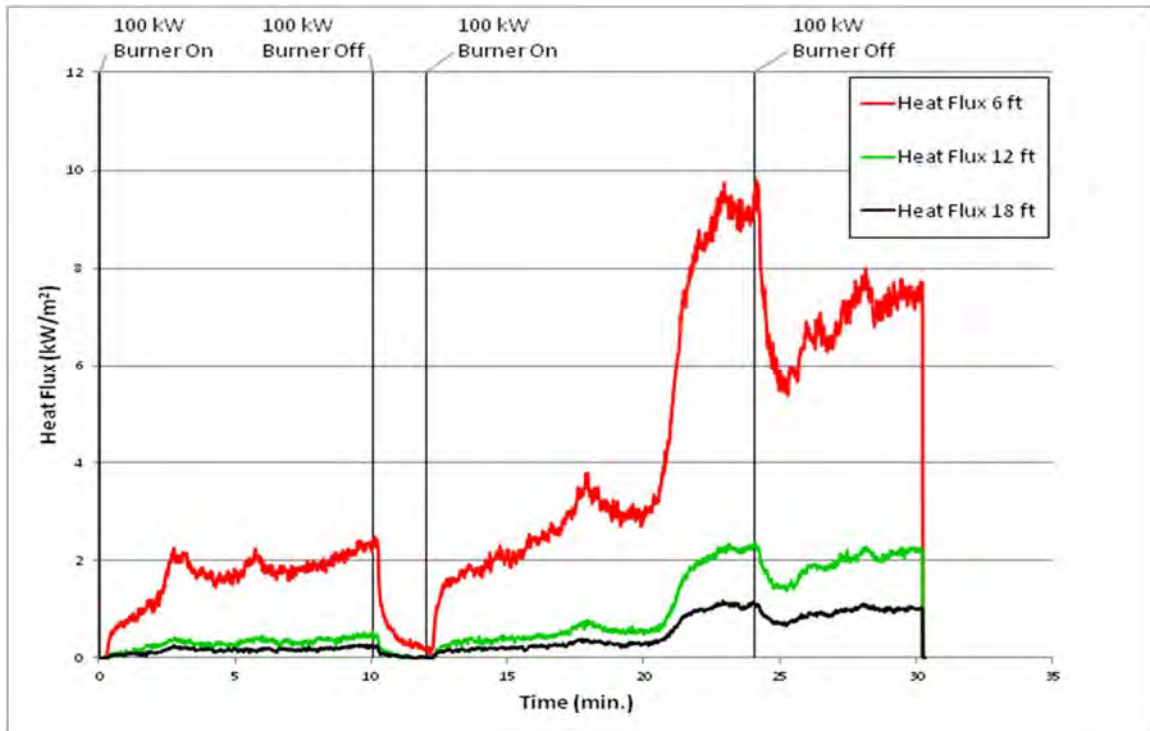
Figure G. 79: Wall Experiment 14 Heat Flux

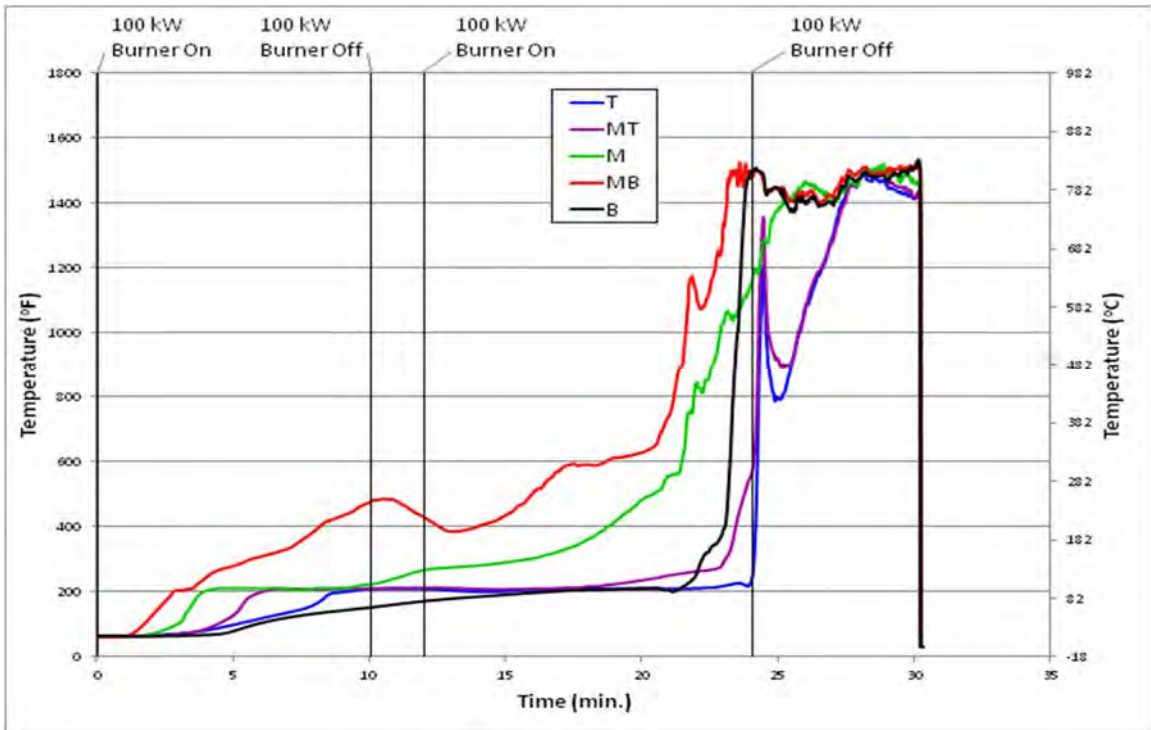
Figure G. 82: Wall Experiment 14 under Siding Vertical Temperatures

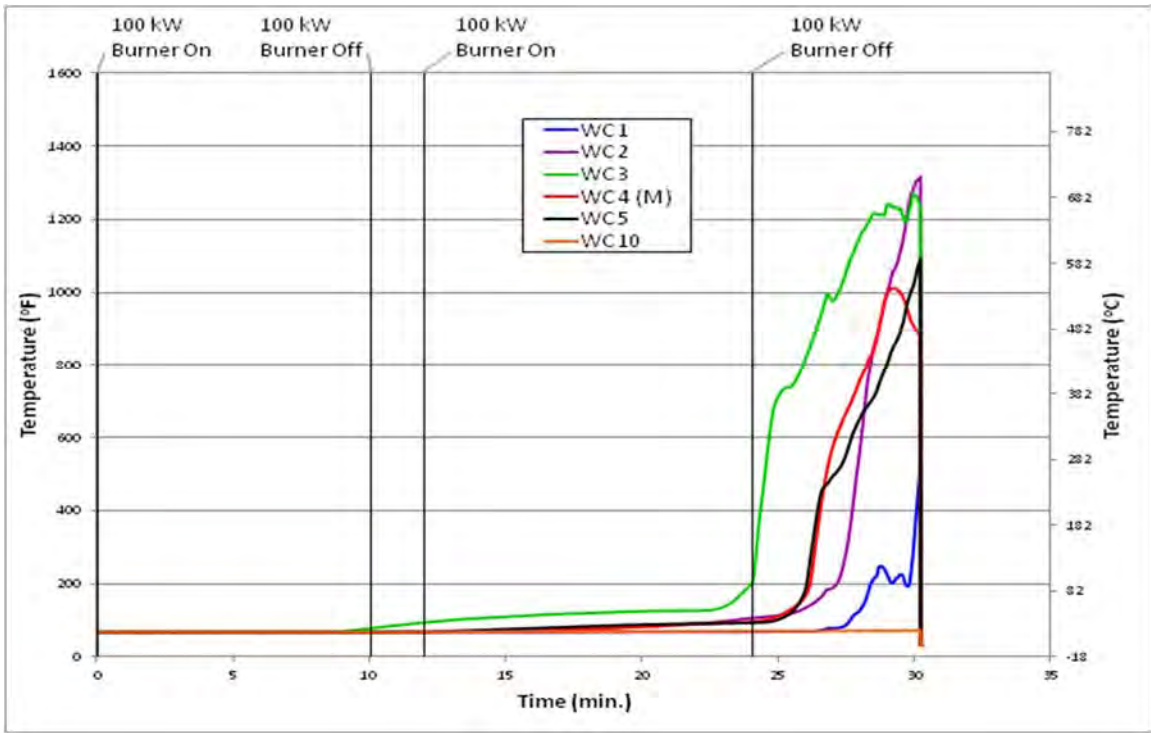
Figure G. 83: Wall Experiment 14 Wall Cavity Horizontal Temperatures

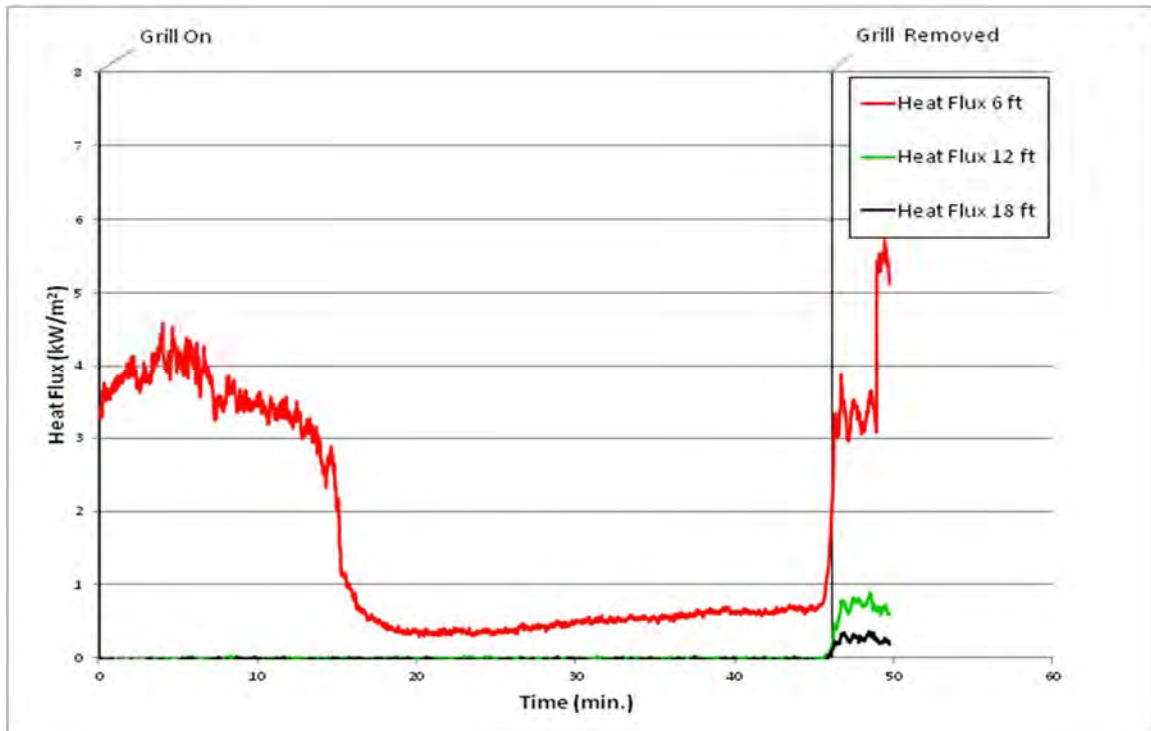
Figure G. 85: Wall Experiment 15 Heat Flux

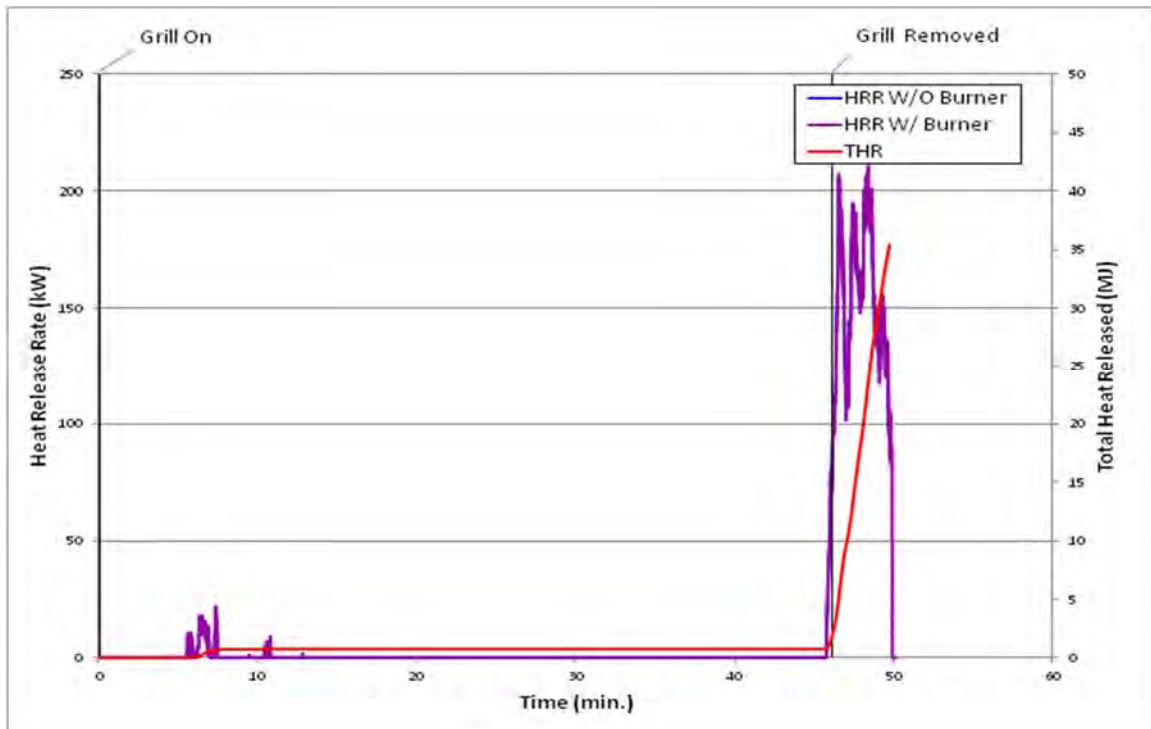
Figure G. 86: Wall Experiment 15 Heat Release Rate and Total Heat Released

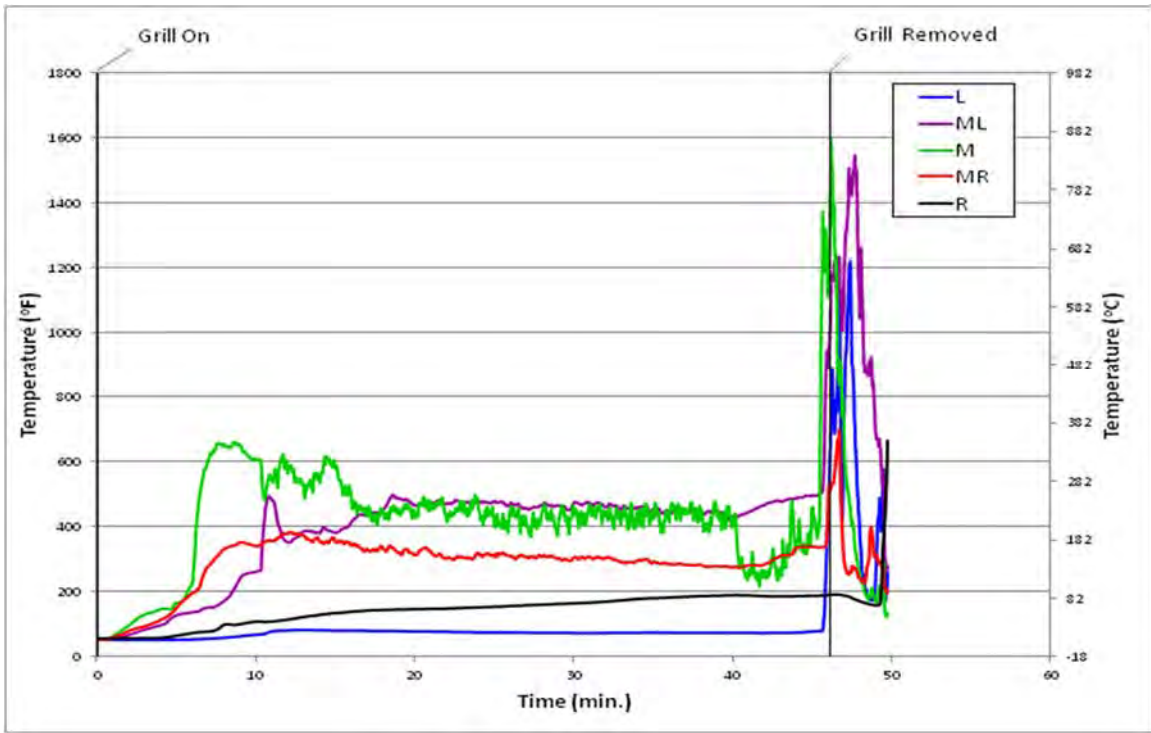
Figure G. 87: Wall Experiment 15 under Siding Horizontal Temperatures

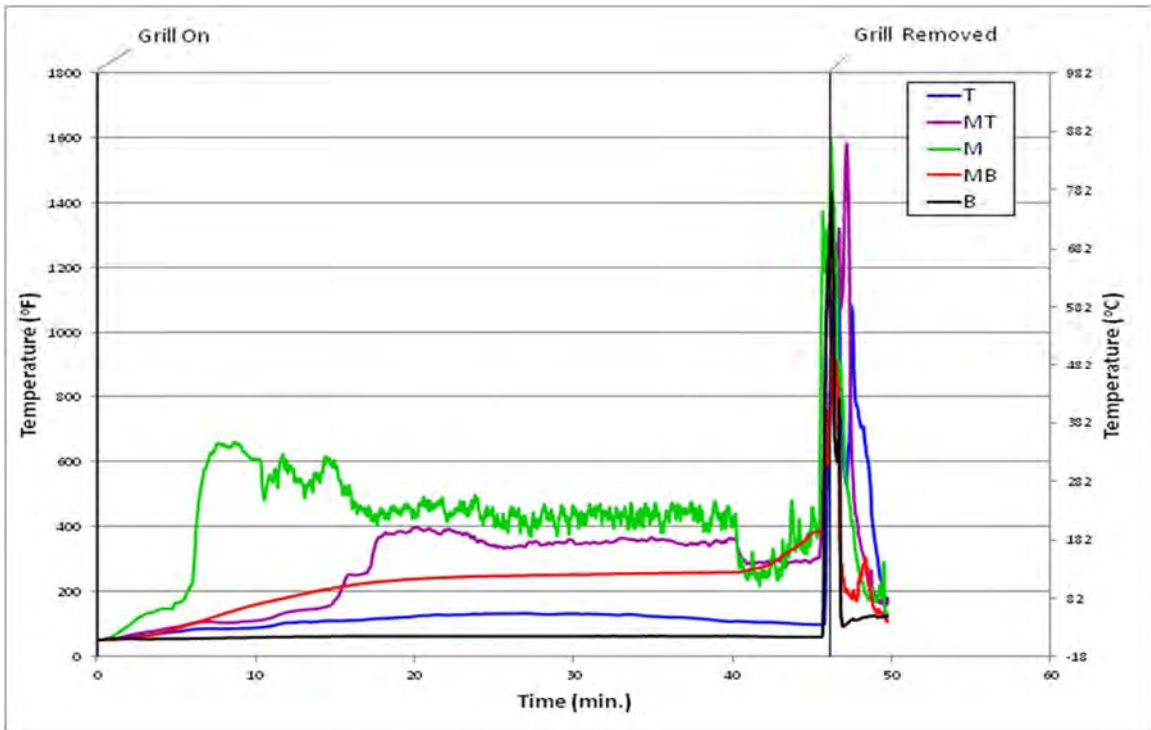
Figure G. 88: Wall Experiment 15 under Siding Vertical Temperatures

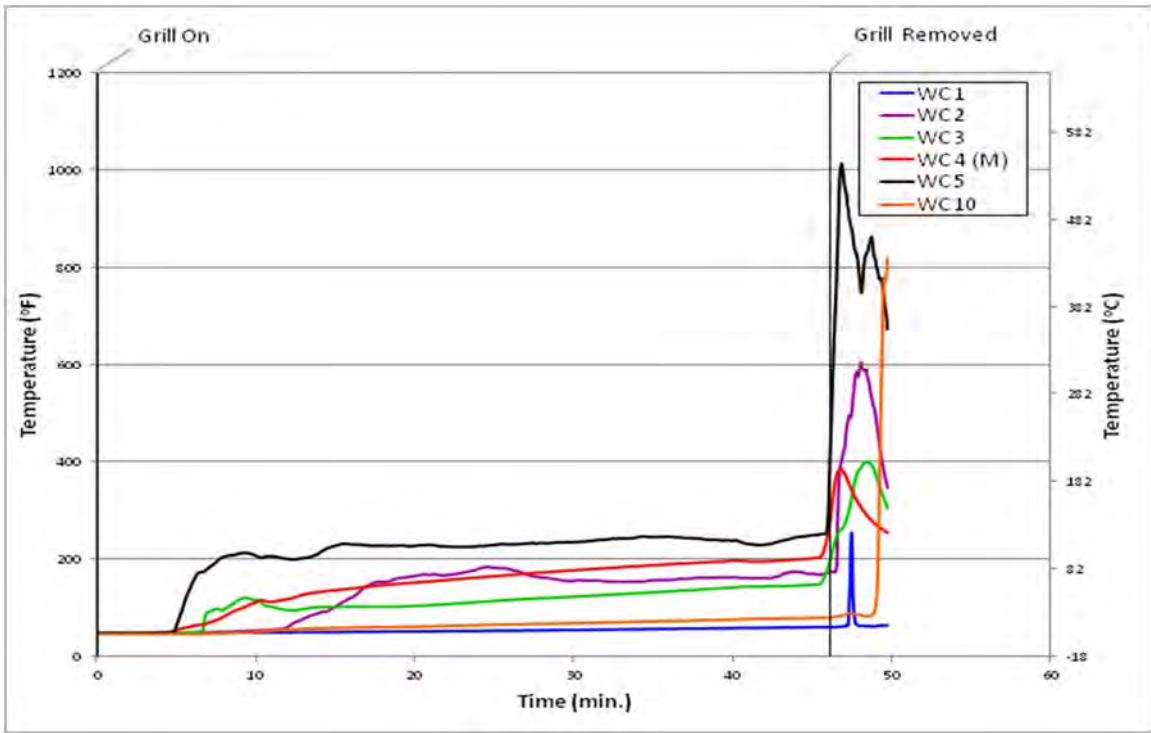
Figure G. 89: Wall Experiment 15 Wall Cavity Horizontal Temperatures

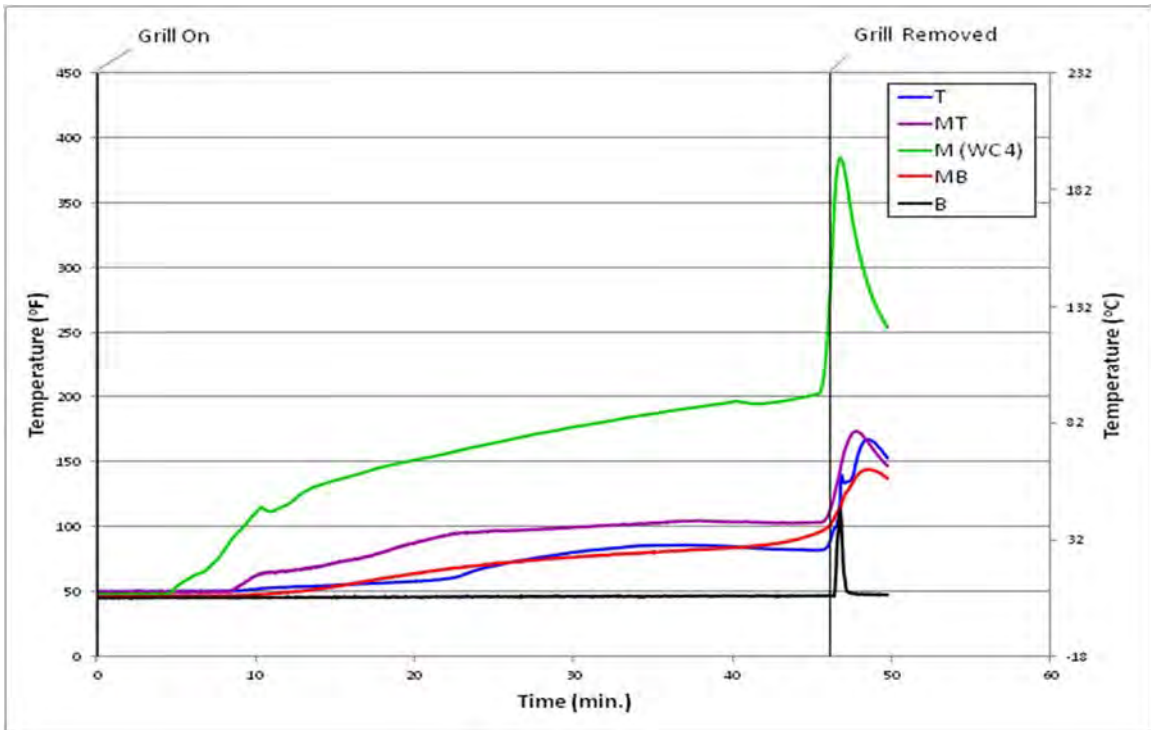
Figure G. 90: Wall Experiment 15 Wall Cavity Vertical Temperatures

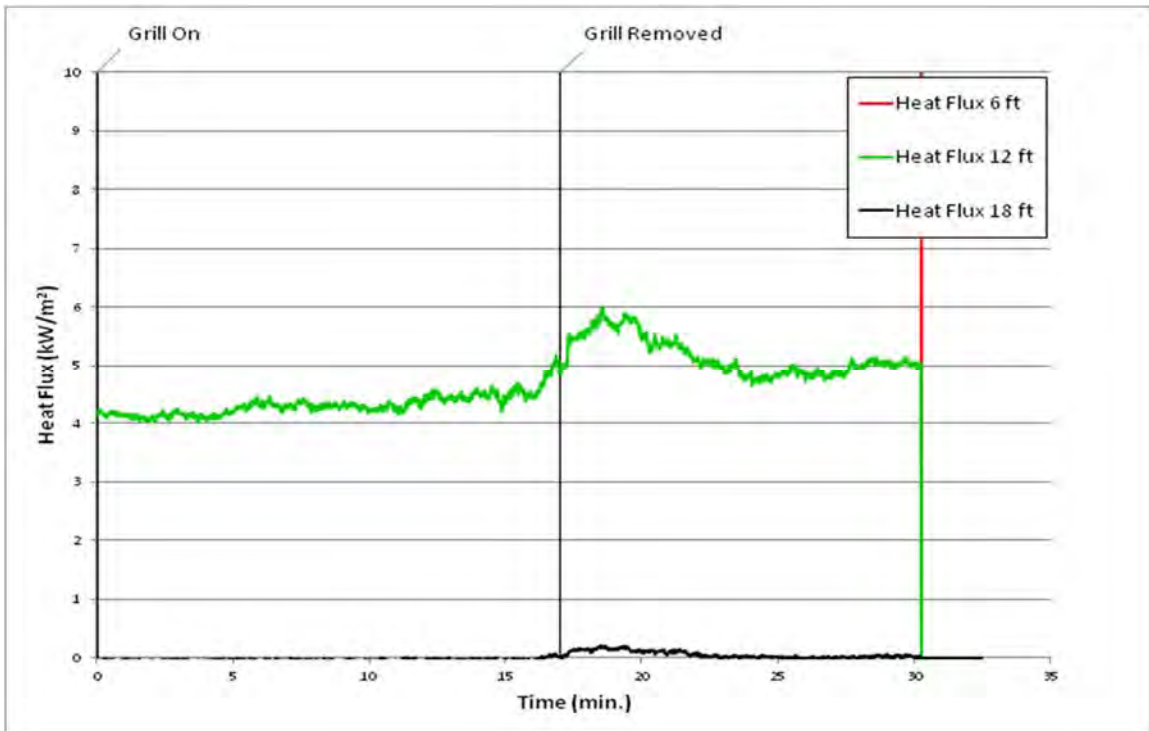
Figure G. 91: Wall Experiment 16 Heat Flux

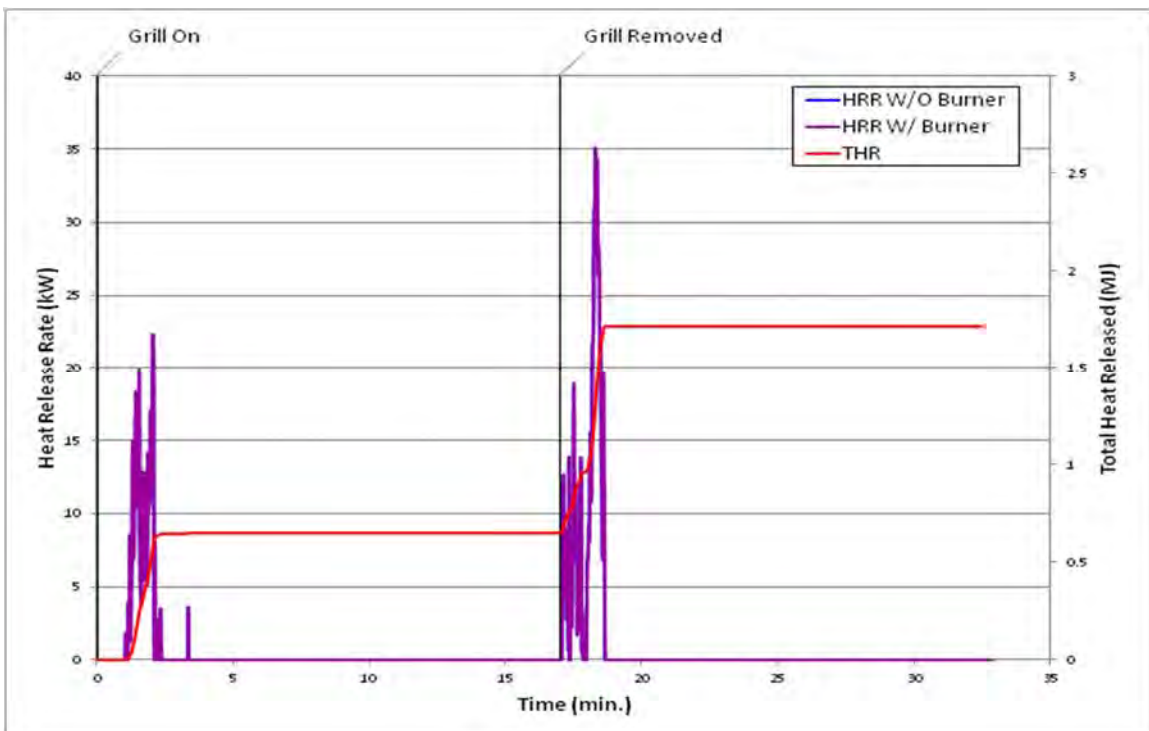
Figure G. 92: Wall Experiment 16 Heat Release Rate and Total Heat Released

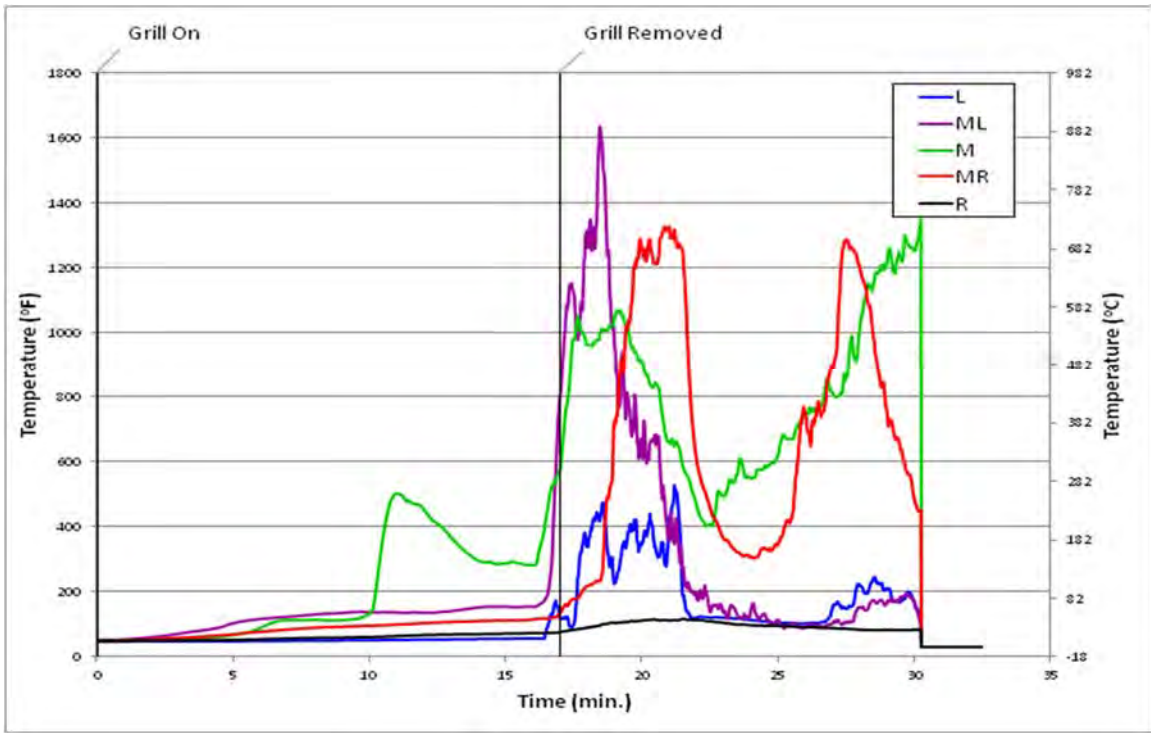
Figure G. 93: Wall Experiment 16 under Siding Horizontal Temperatures

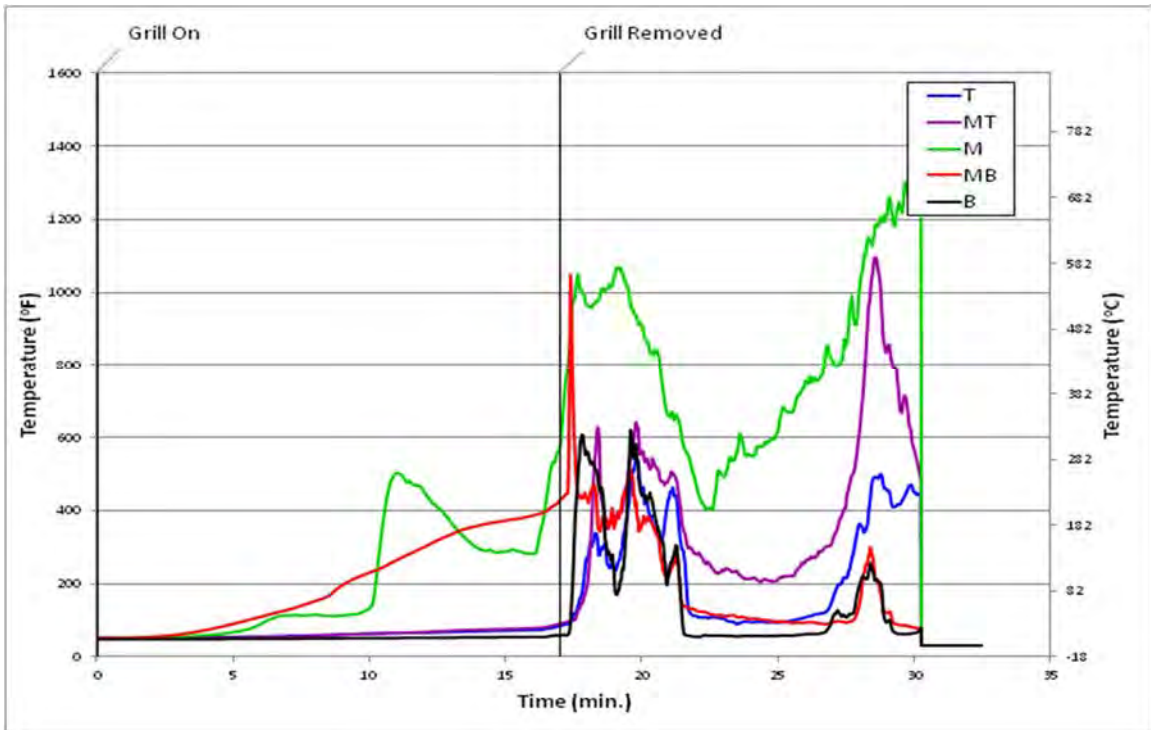
Figure G. 94: Wall Experiment 16 under Siding Vertical Temperatures

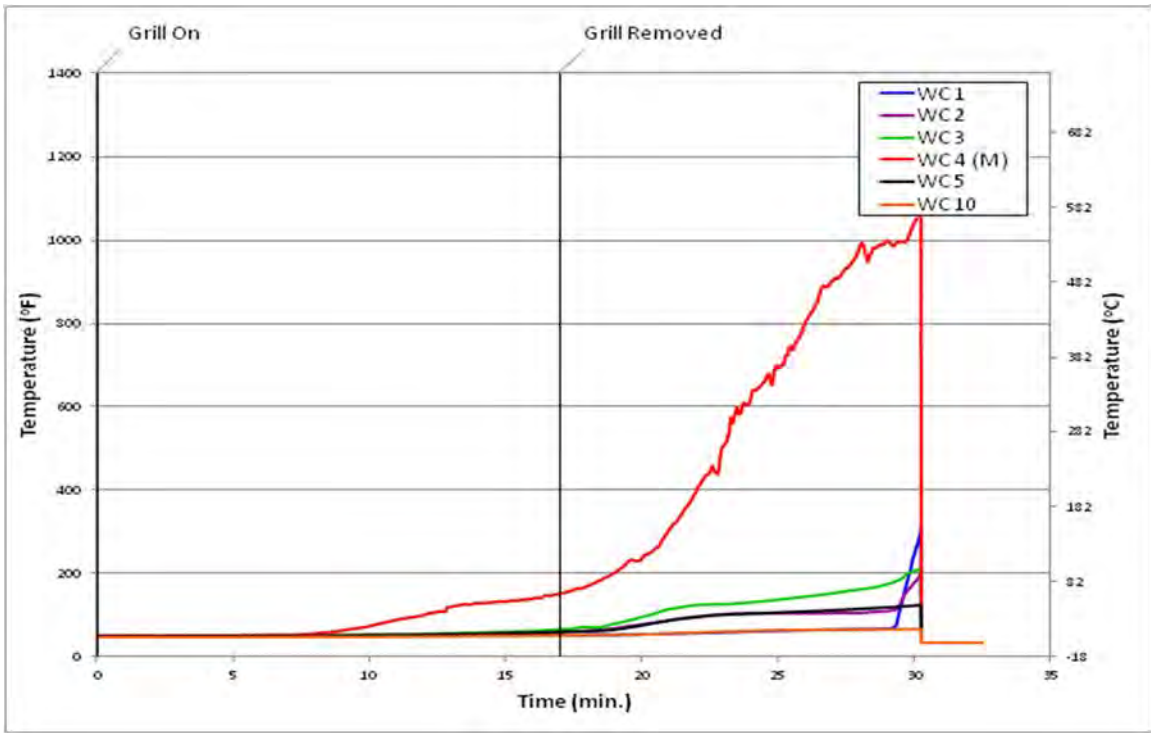
Figure G. 95: Wall Experiment 16 Wall Cavity Horizontal Temperatures

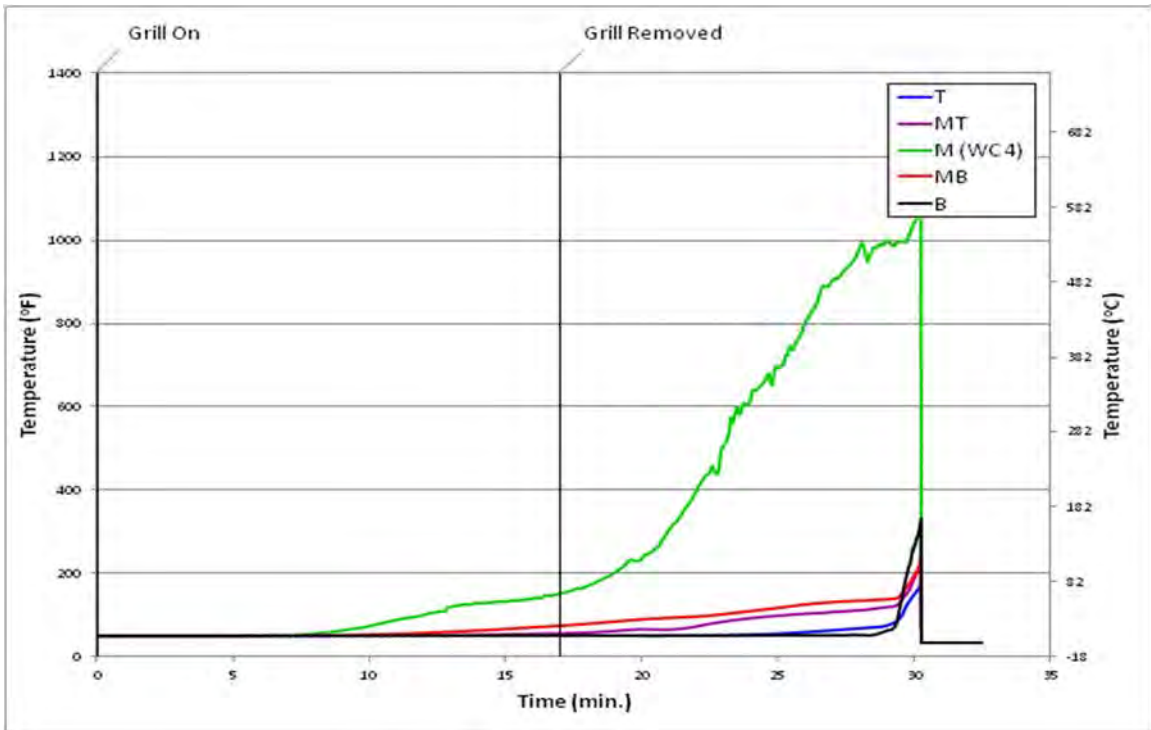
Figure G. 96: Wall Experiment 16 Wall Cavity Vertical Temperatures

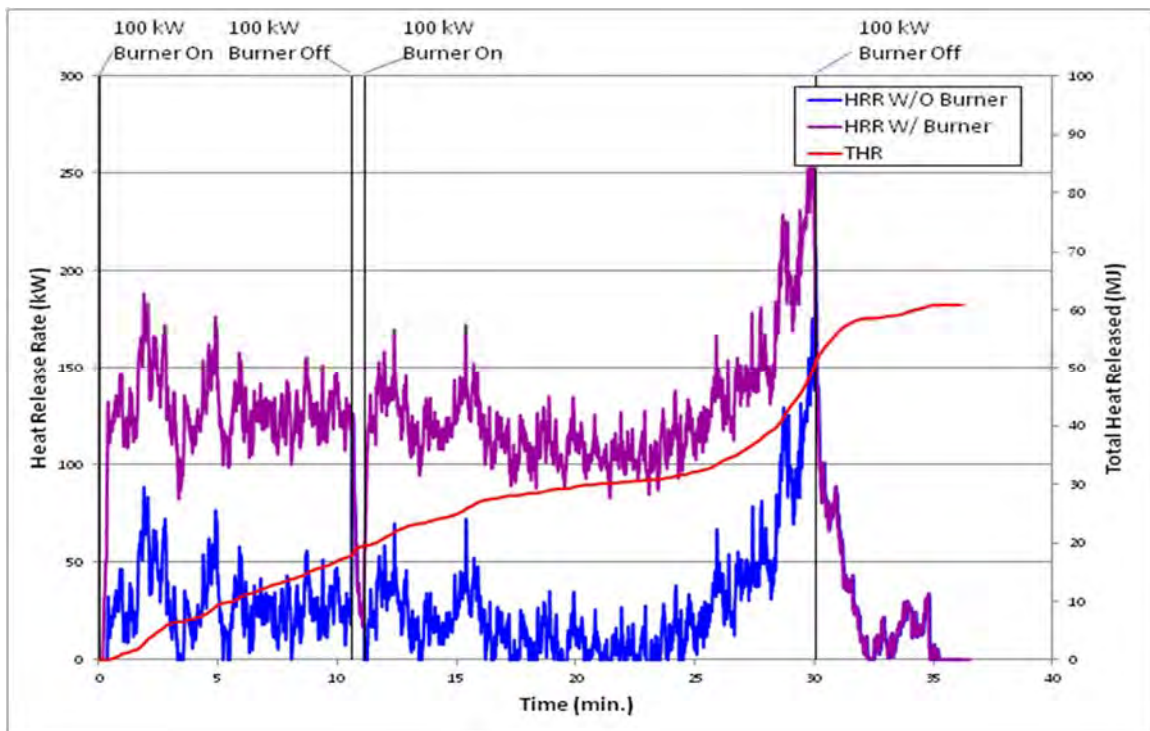
Figure G. 98: Wall Experiment 17 Heat Release Rate and Total Heat Released

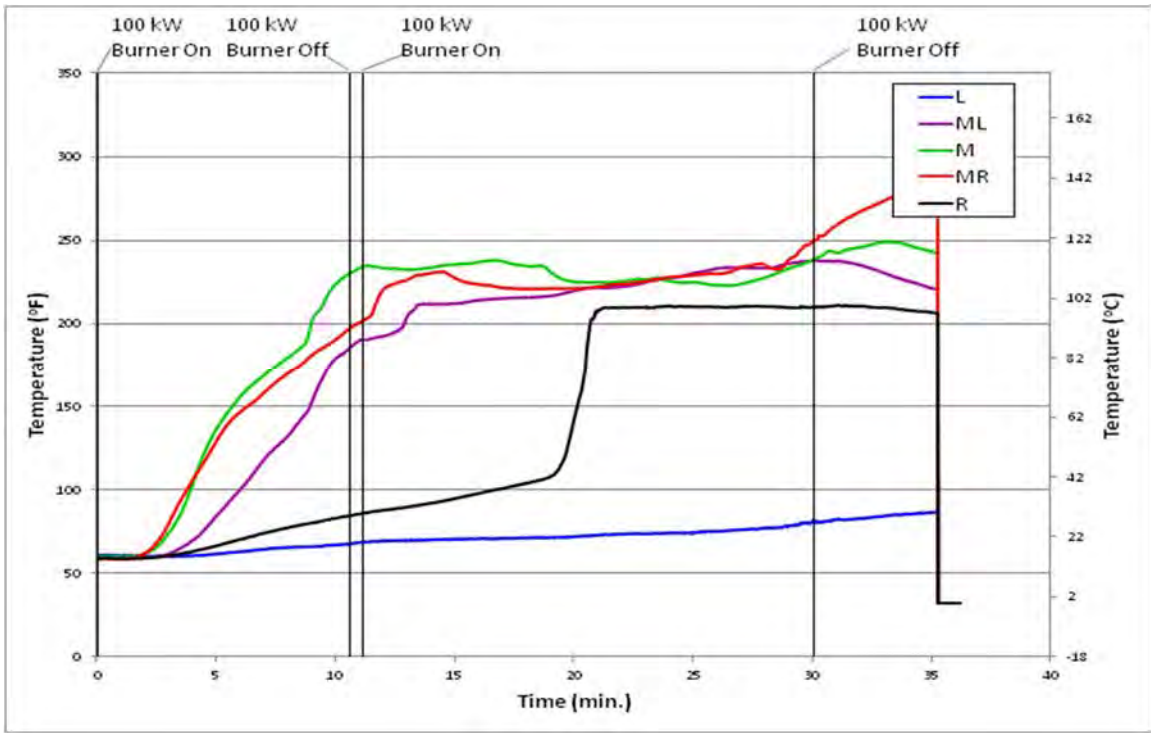
Figure G. 99: Wall Experiment 17 under Siding Horizontal Temperatures

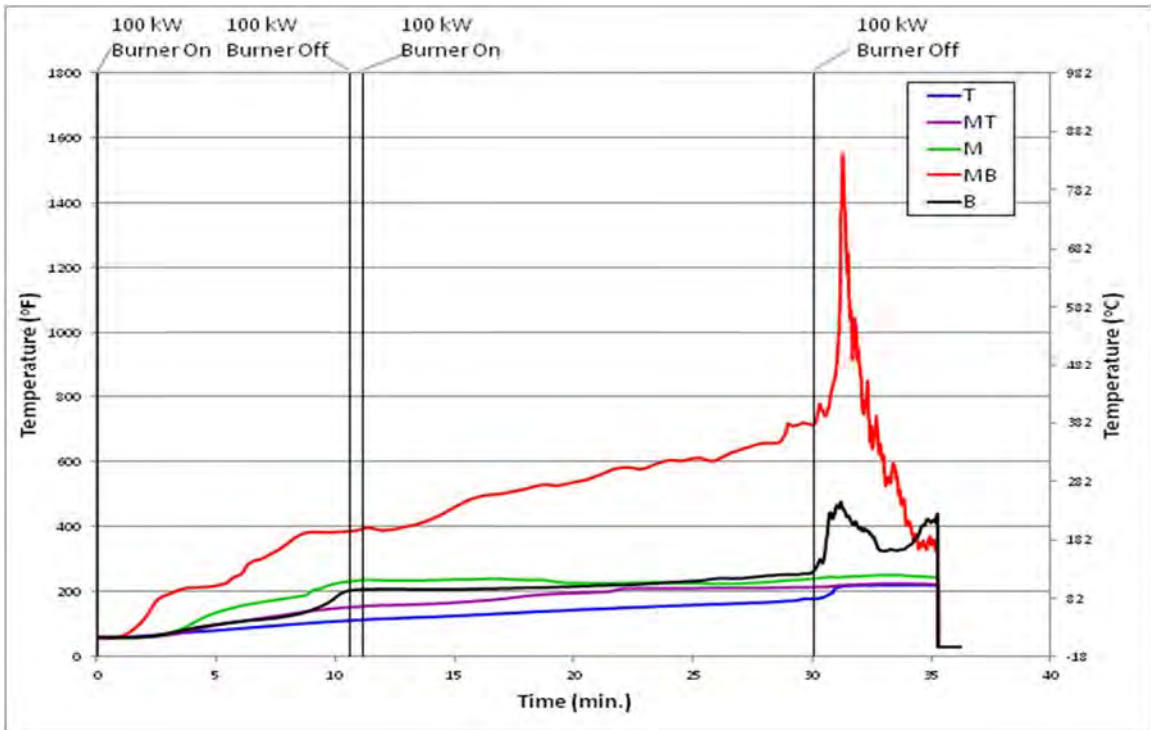
Figure G. 100: Wall Experiment 17 under Siding Vertical Temperatures

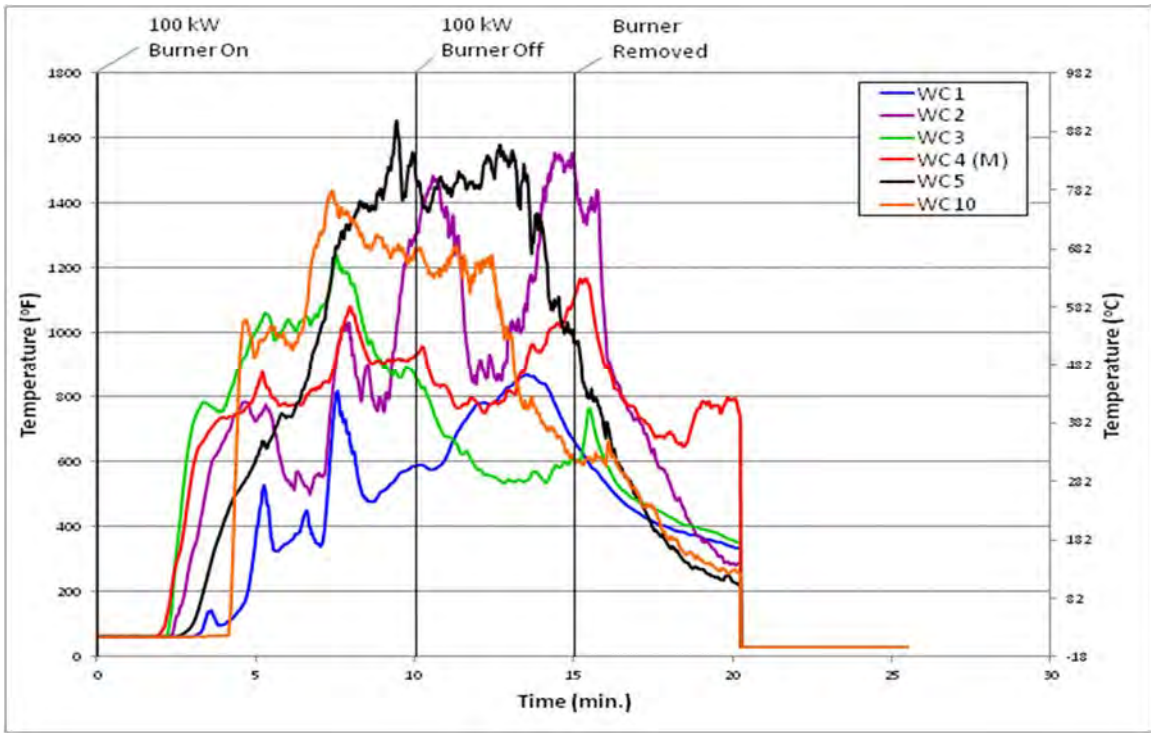
Figure G. 107: Wall Experiment 18 Wall Cavity Horizontal Temperatures

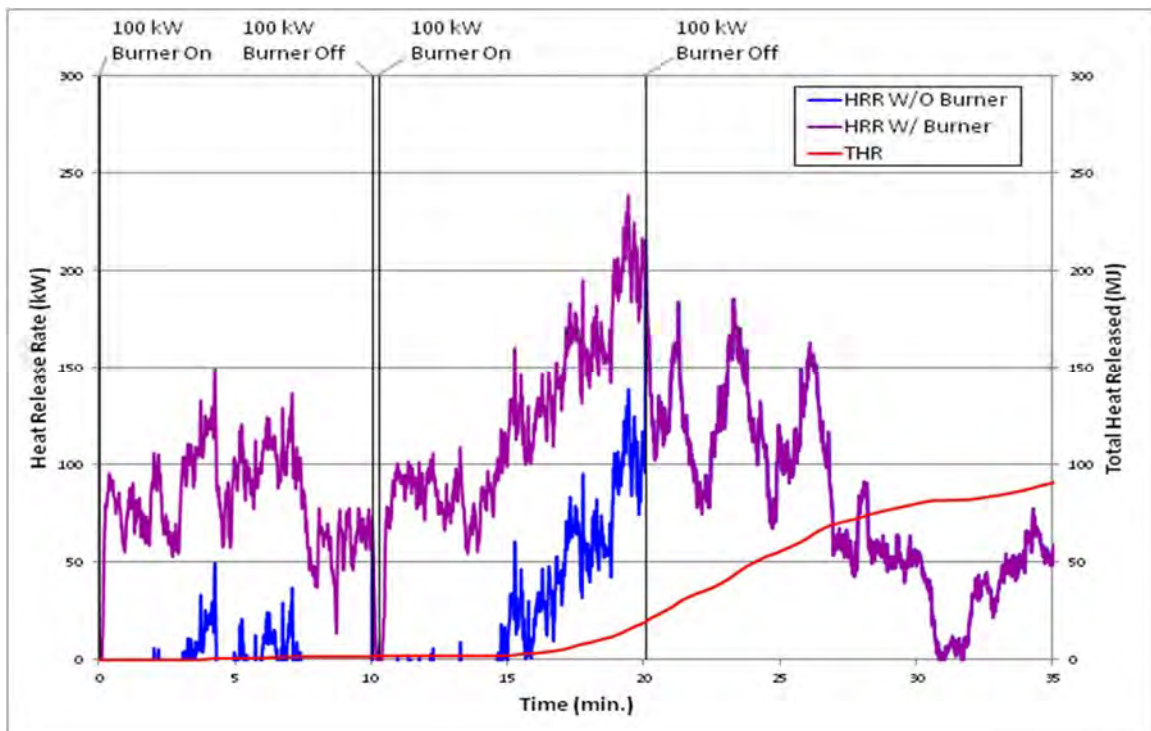
Figure G. 110: Wall Experiment 19 Heat Release Rate and Total Heat Released

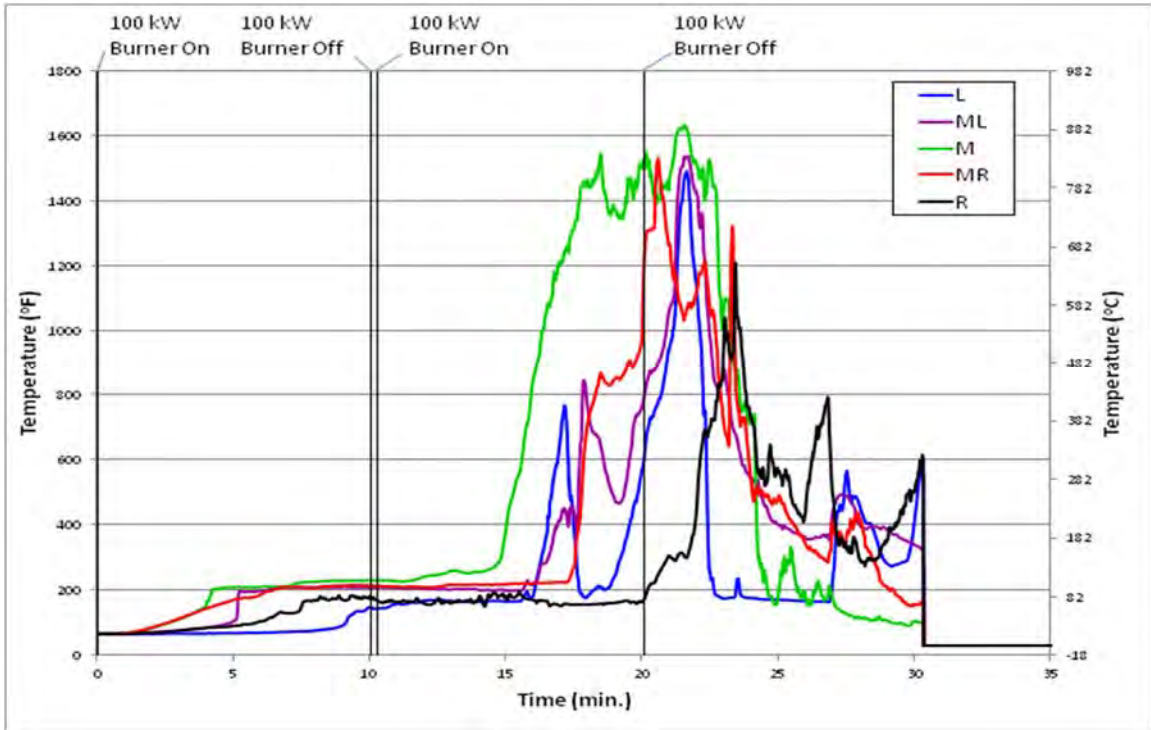
Figure G. 111: Wall Experiment 19 under Siding Horizontal Temperatures
