Study of Residential Attic Fire Mitigation Tactics and Exterior Fire Spread Hazards on Fire Fighter Safety

UL Firefighter Safety Research Institute

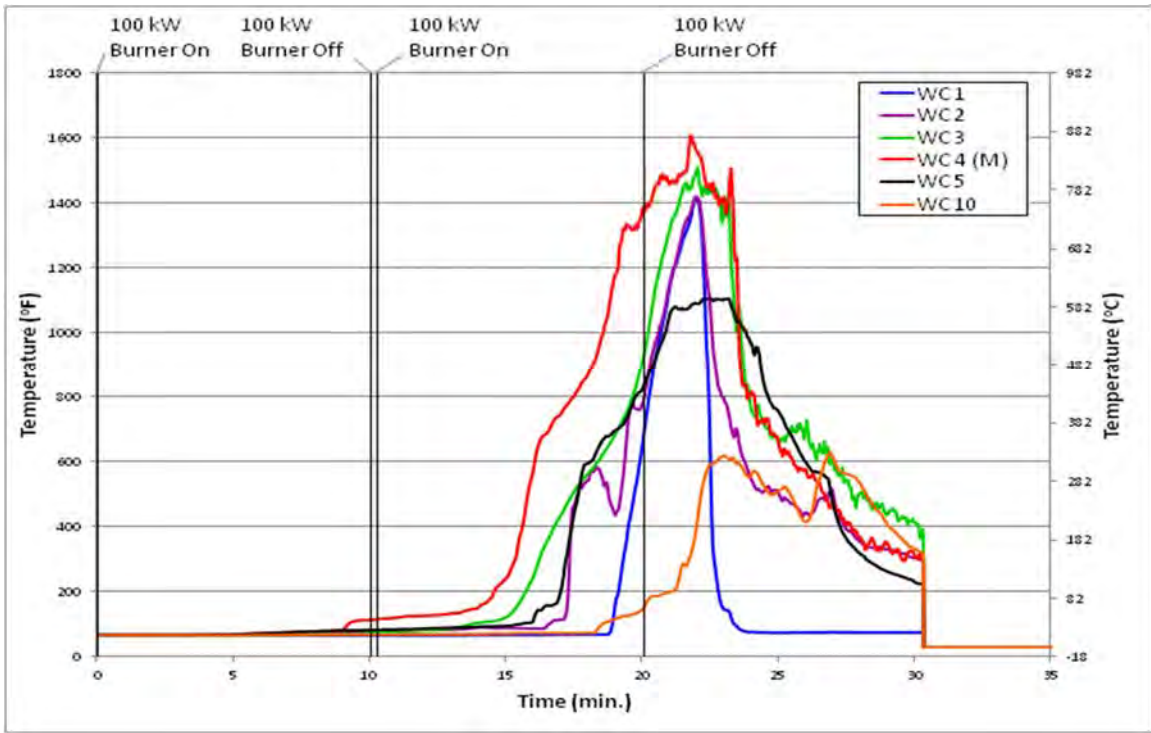
Figure G. 113: Wall Experiment 19 Wall Cavity Horizontal Temperatures

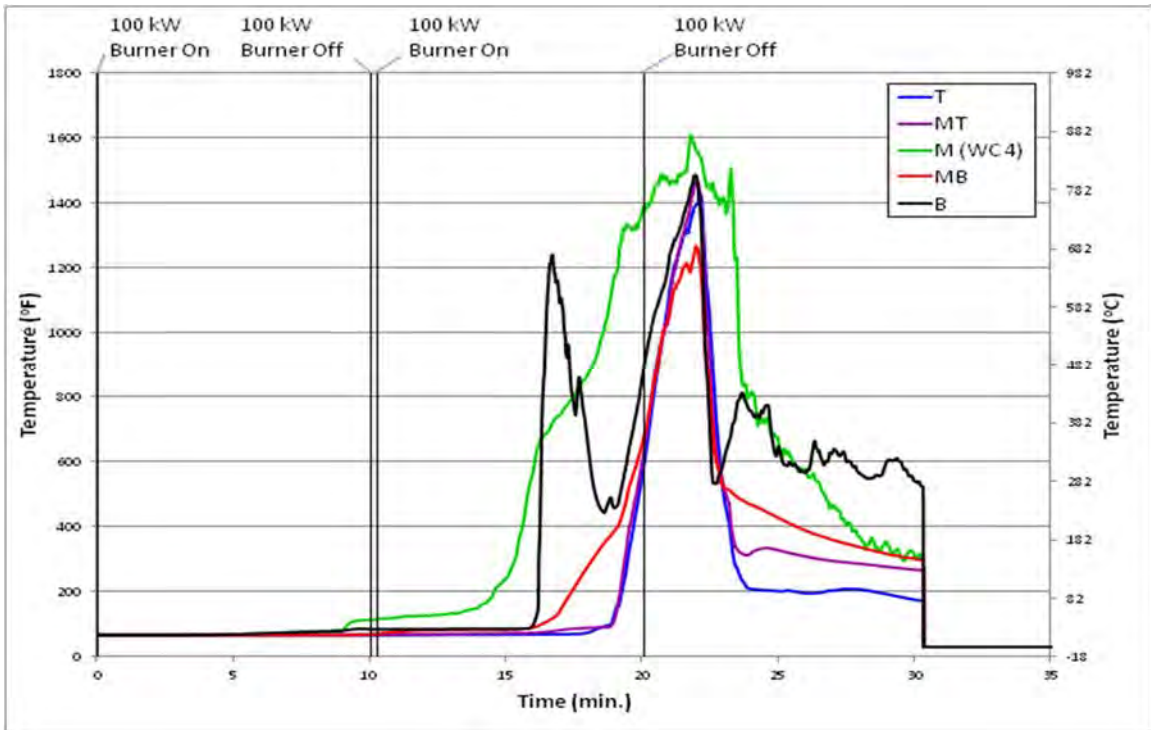
Figure G. 114: Wall Experiment 19 Wall Cavity Vertical Temperatures

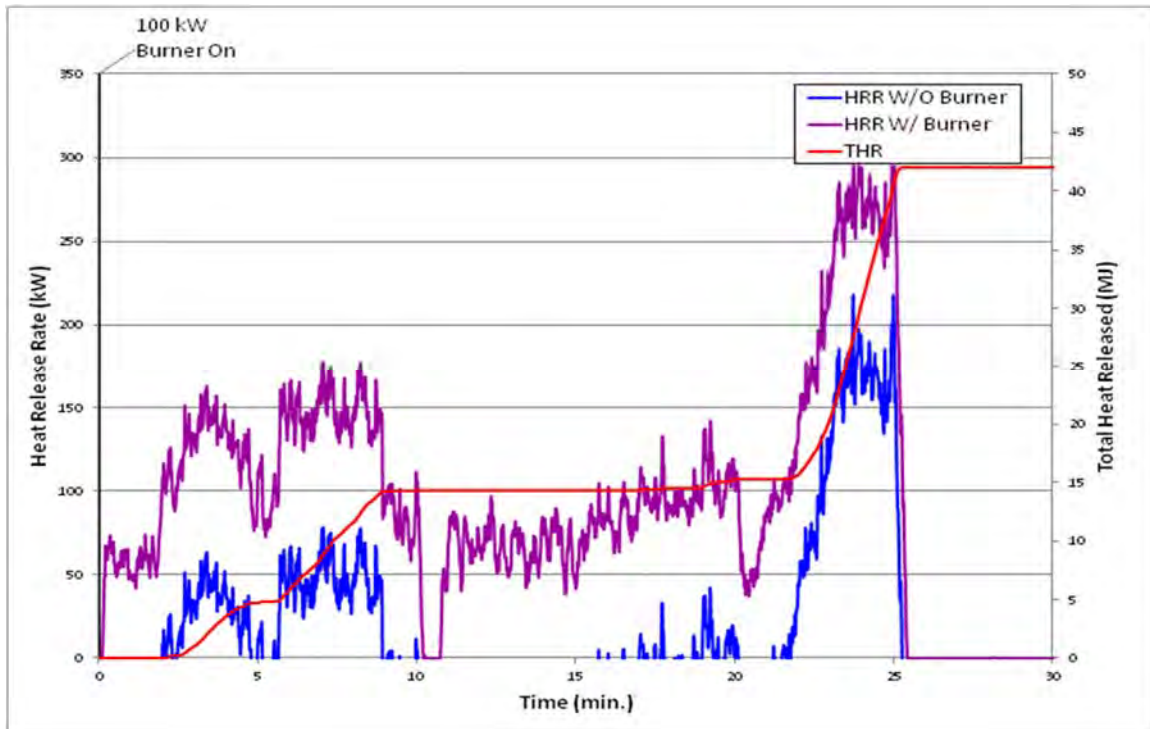
Figure G. 123: Wall Experiment 22 Heat Release Rate and Total Heat Released

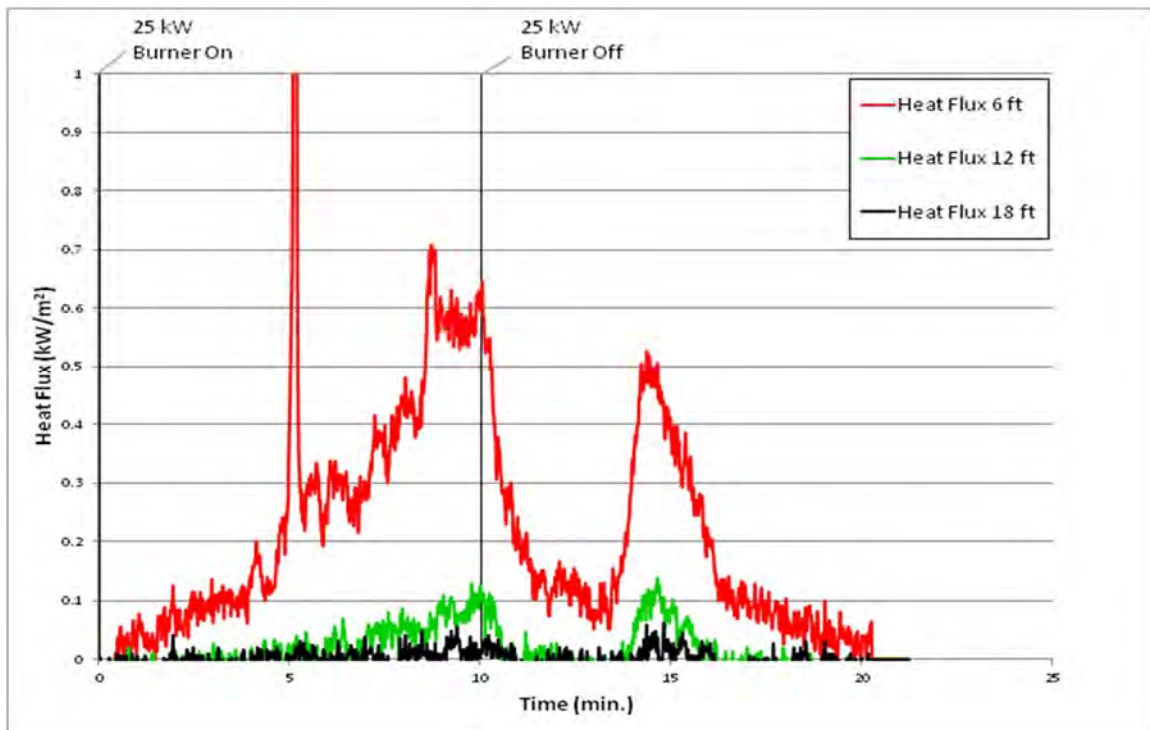
Figure G. 124: Wall Experiment 23 Heat Flux

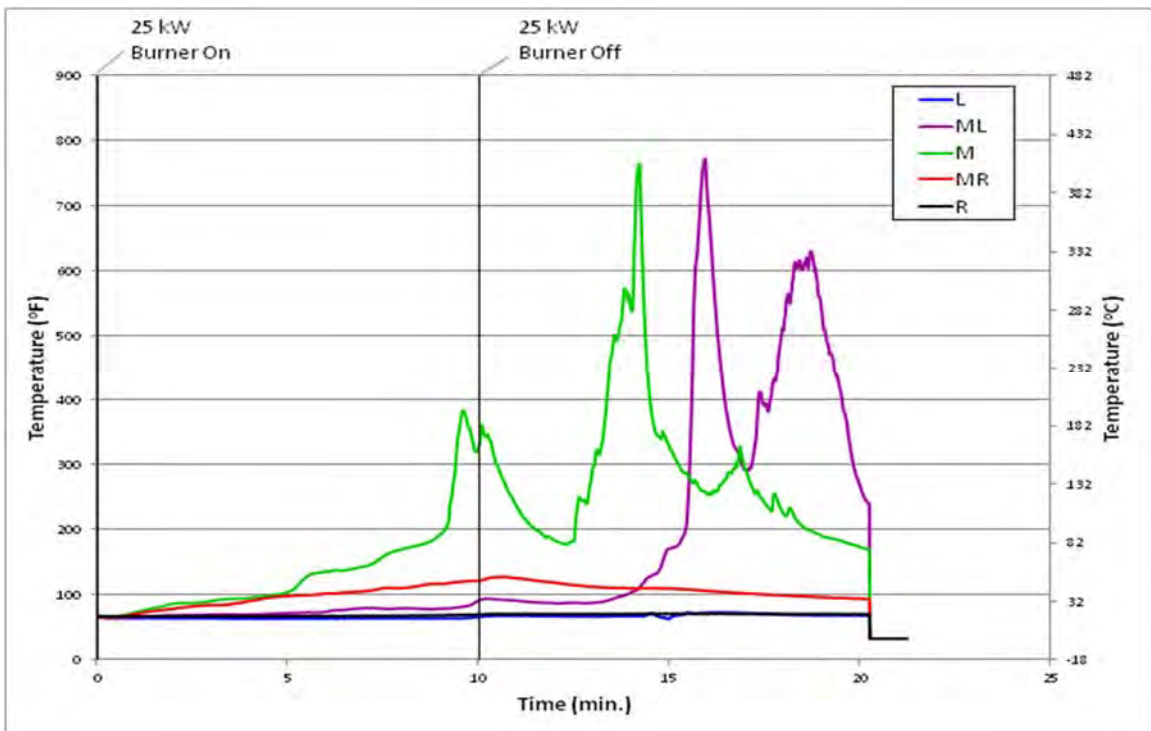
Figure G. 126: Wall Experiment 23 under Siding Horizontal Temperatures

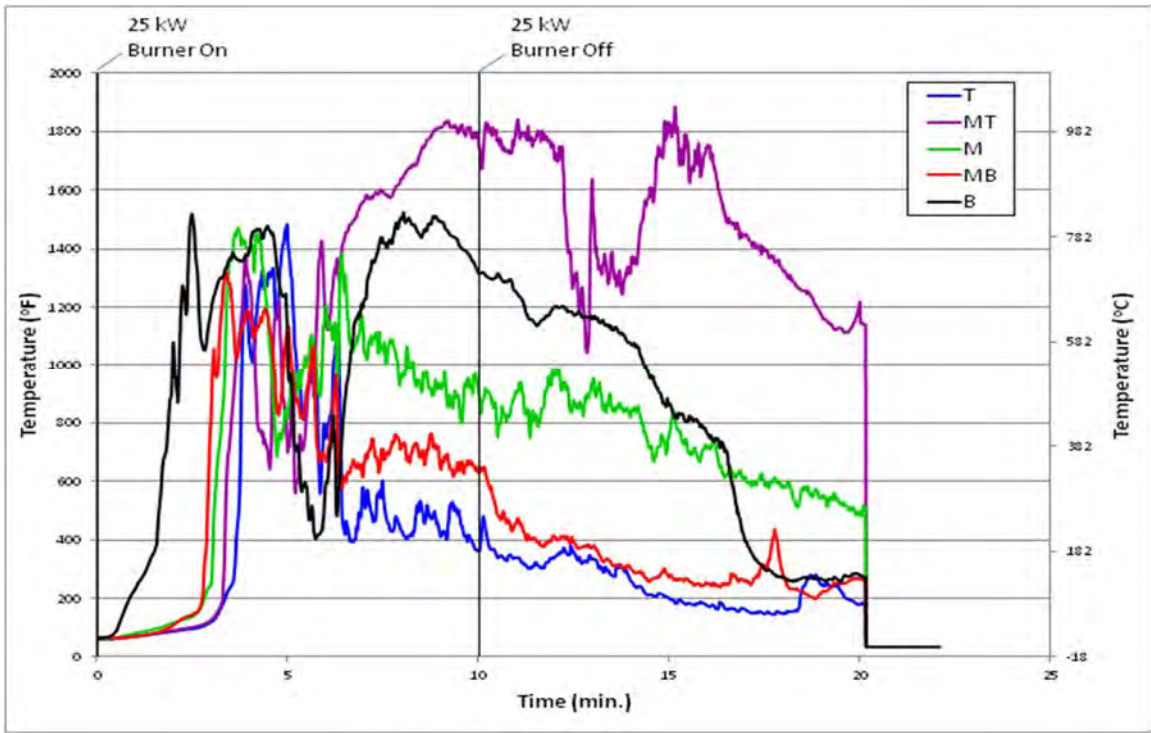
Figure G. 133: Wall Experiment 24 under Siding Vertical Temperatures

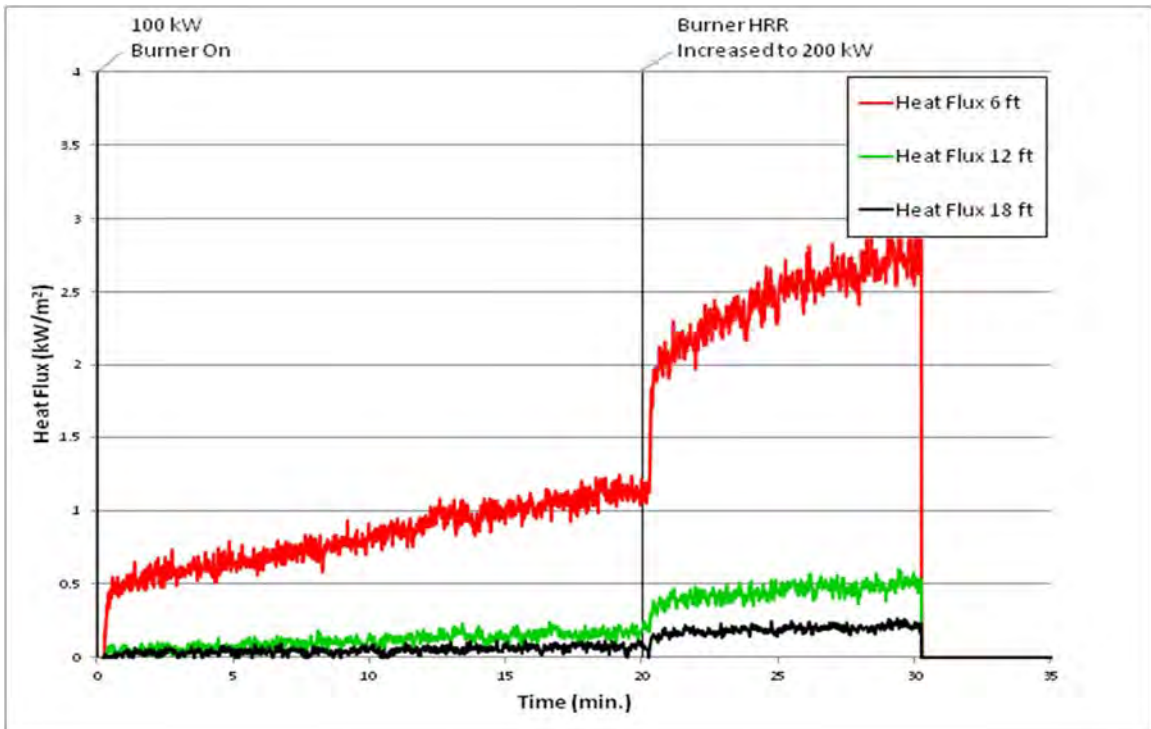
Figure G. 136: Wall Experiment 25 Heat Flux

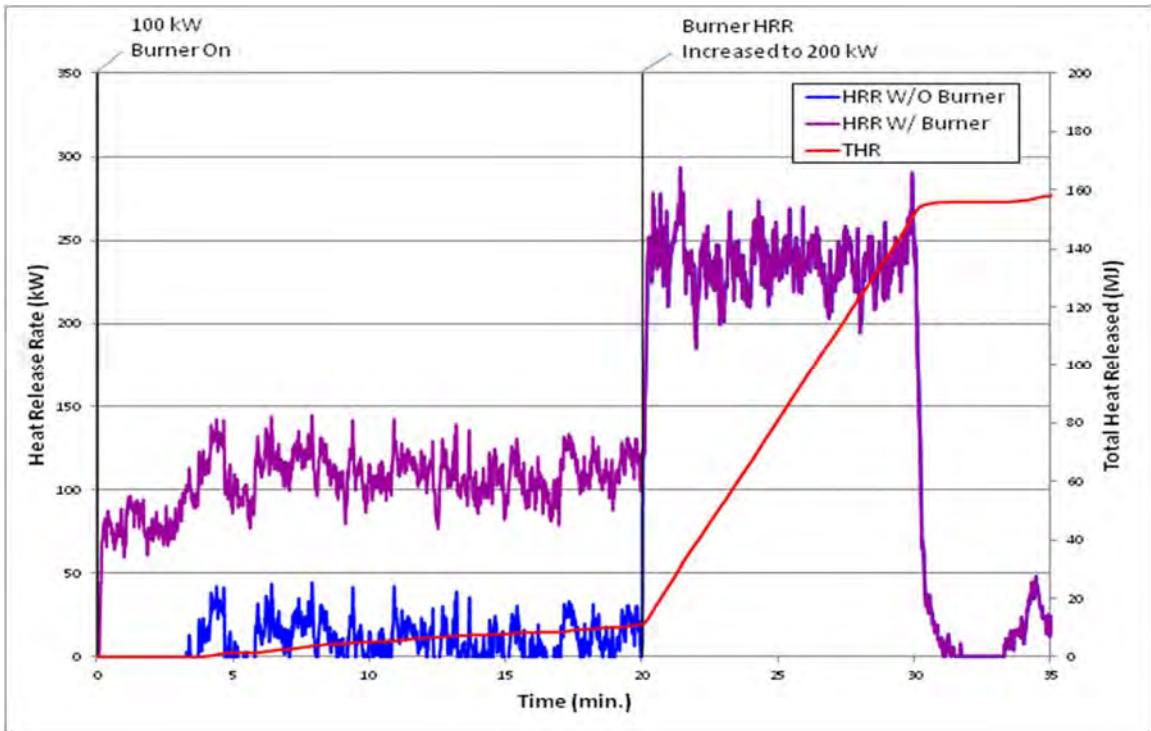
Figure G. 137: Wall Experiment 25 Heat Release Rate and Total Heat Released

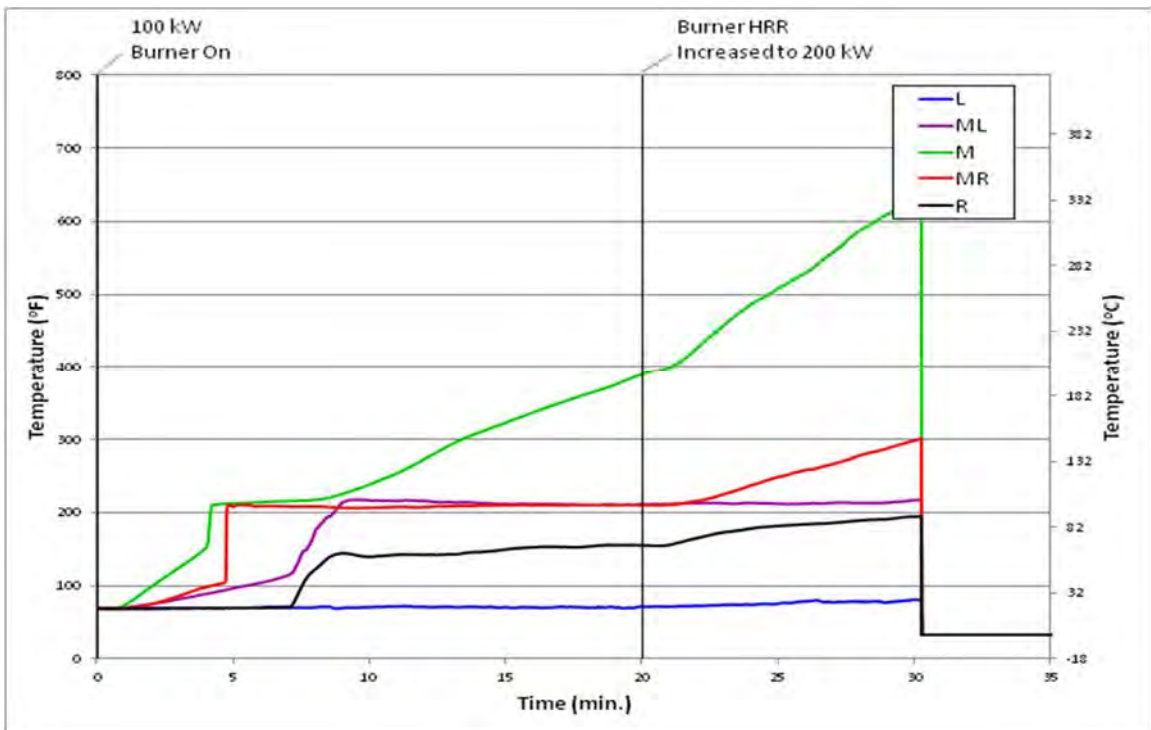
Figure G. 138: Wall Experiment 25 under Siding Horizontal Temperatures

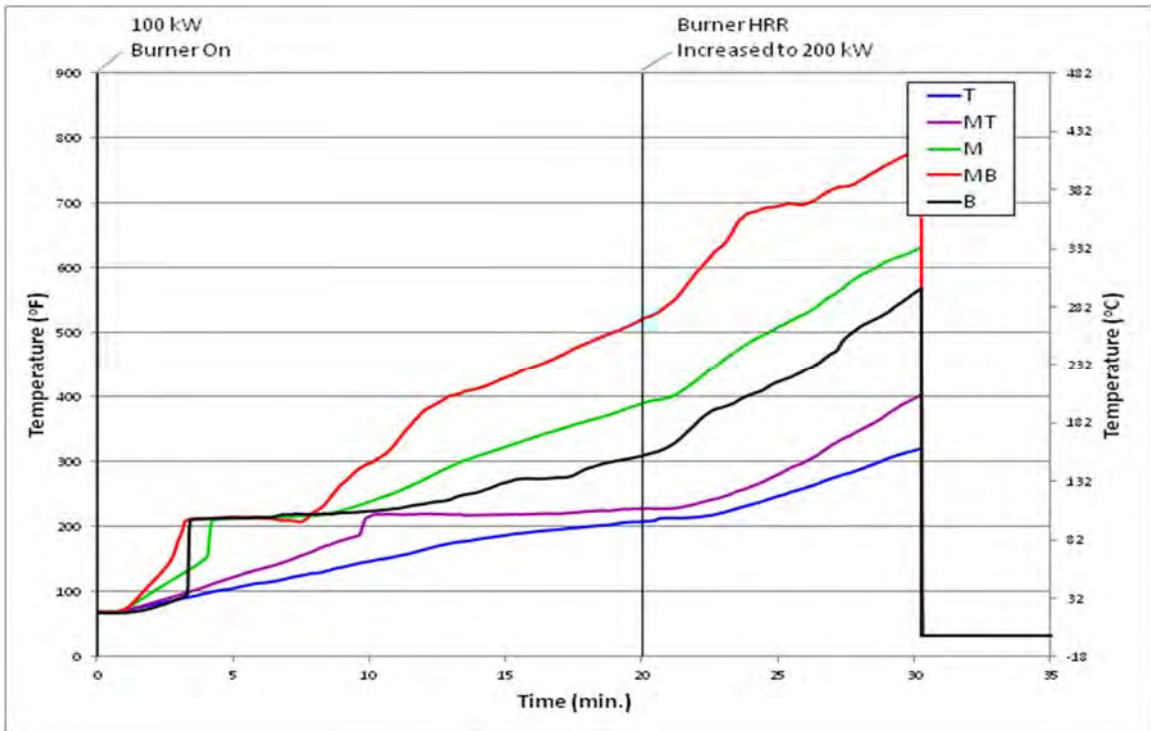
Figure G. 139: Wall Experiment 25 under Siding Vertical Temperatures

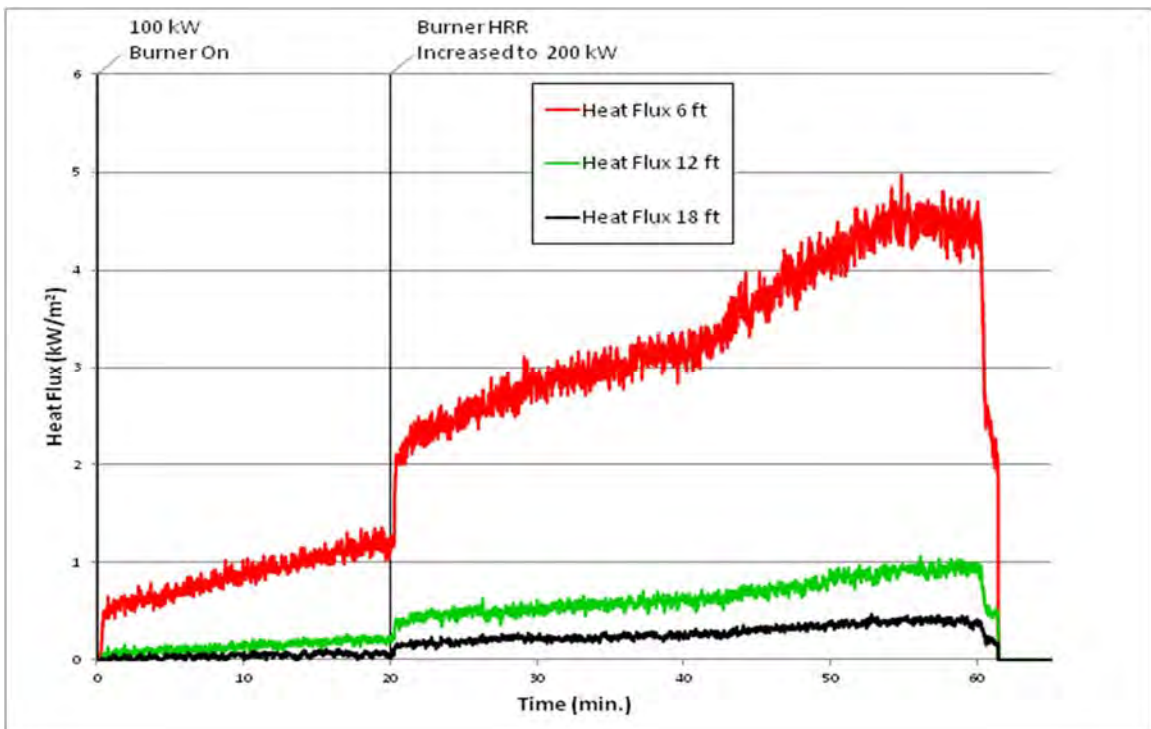
Figure G. 142: Wall Experiment 26 Heat Flux

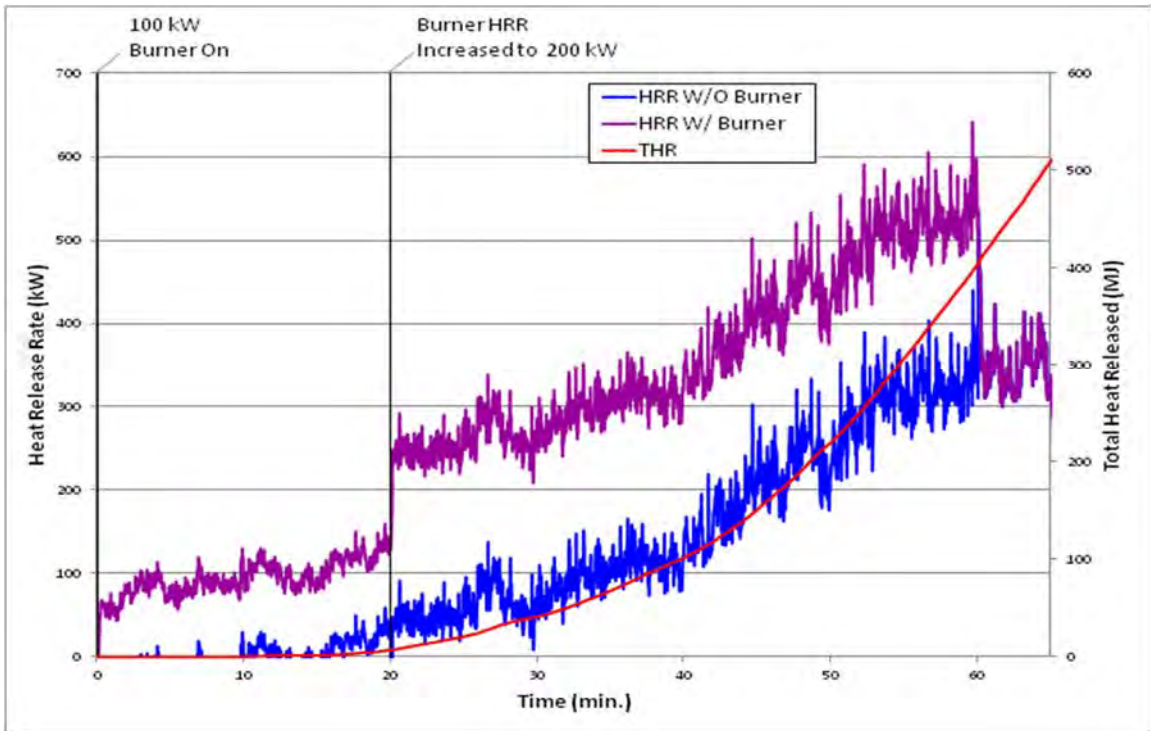
Figure G. 143: Wall Experiment 26 Heat Release Rate and Total Heat Released

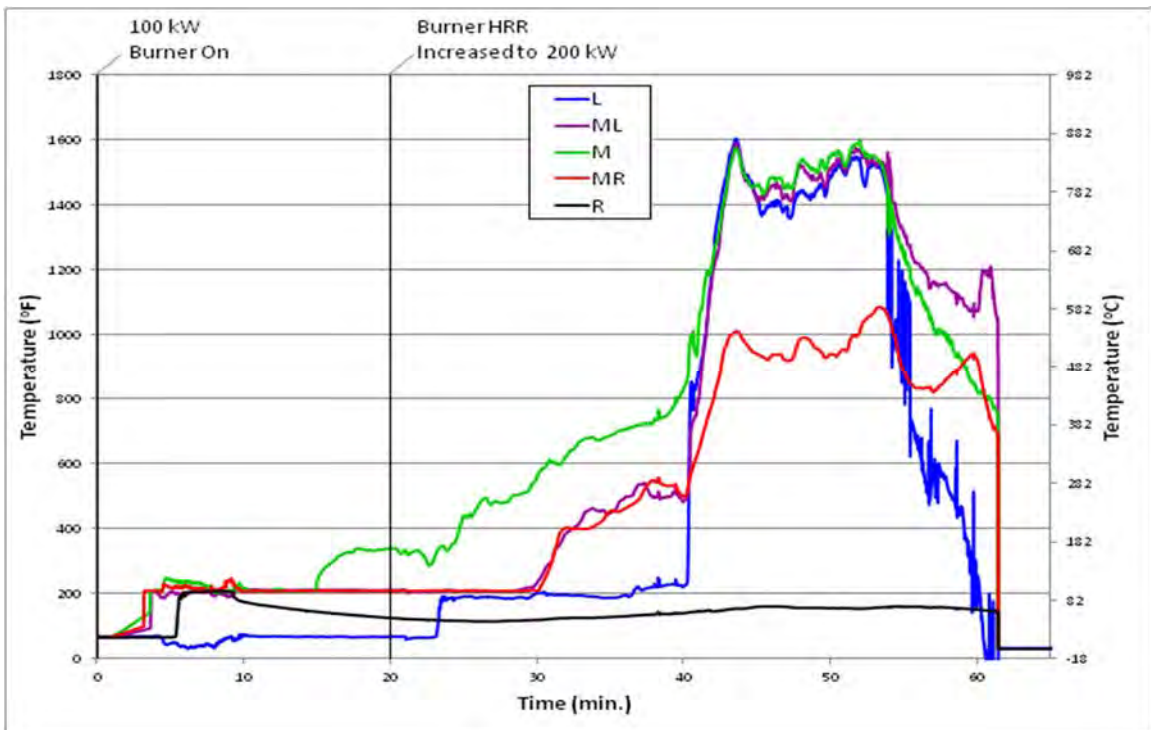
Figure G. 144: Wall Experiment 26 under Siding Horizontal Temperatures

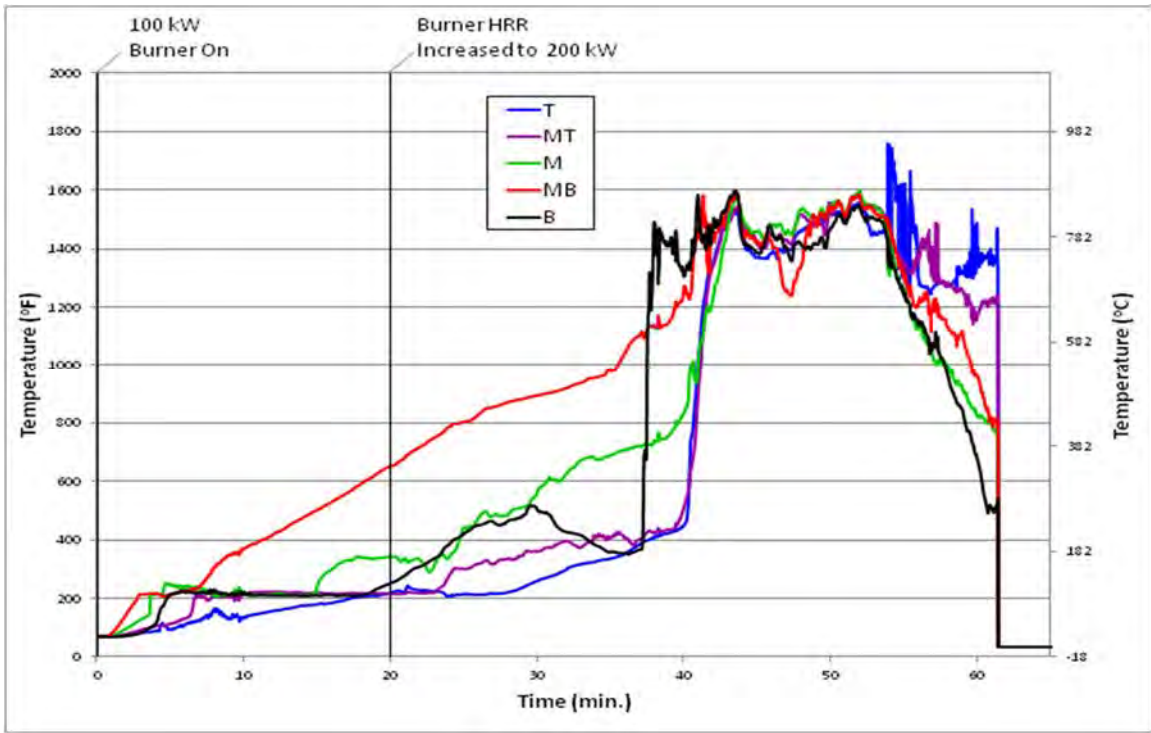
Figure G. 145: Wall Experiment 26 under Siding Vertical Temperatures

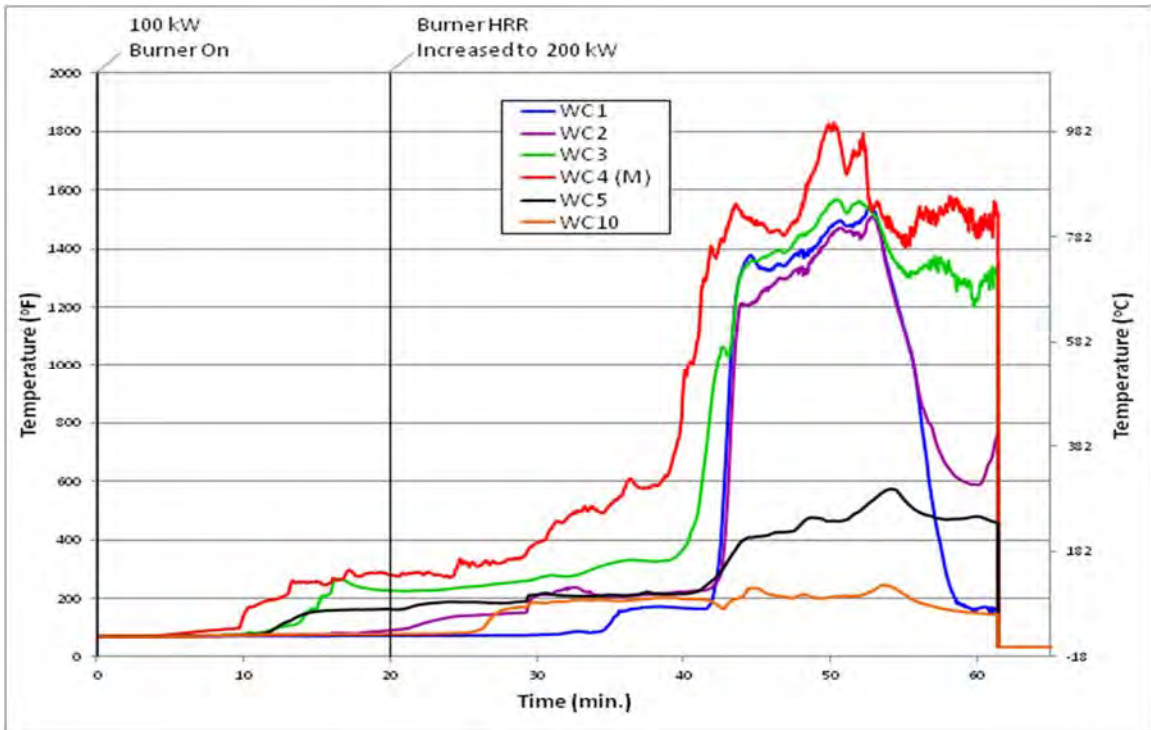
Figure G. 146: Wall Experiment 26 Wall Cavity Horizontal Temperatures

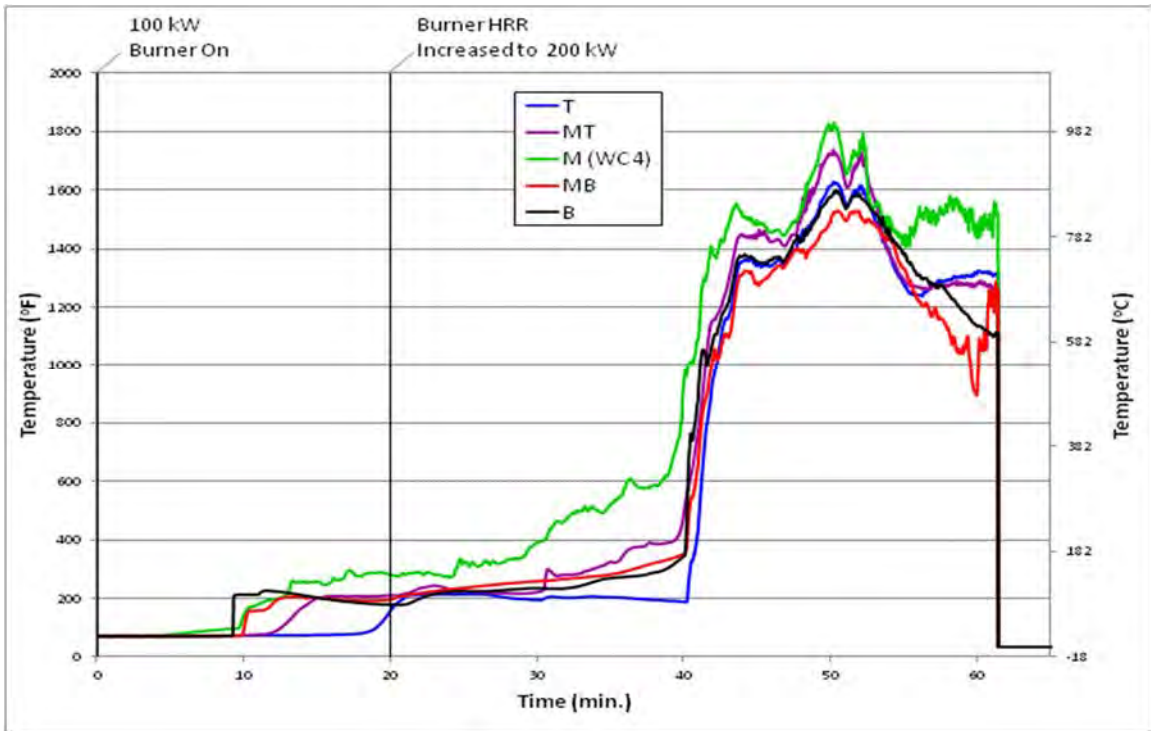
Figure G. 147: Wall Experiment 26 Wall Cavity Vertical Temperatures

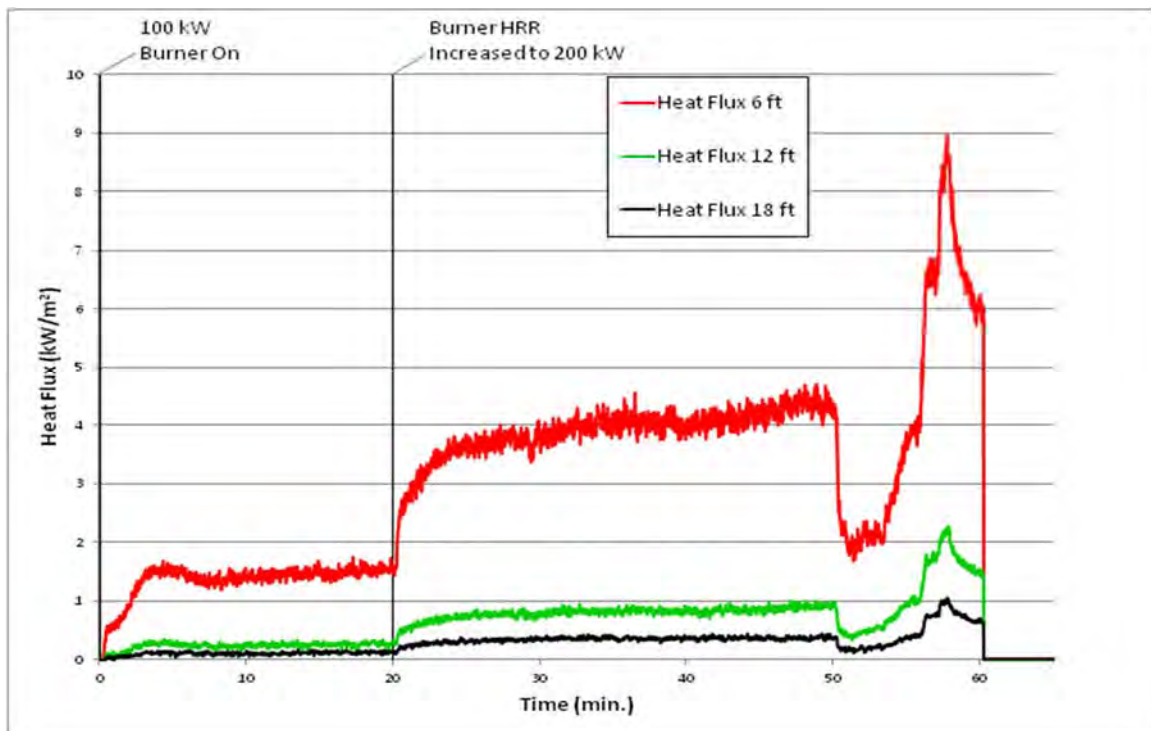
Figure G. 148: Wall Experiment 27 Heat Flux

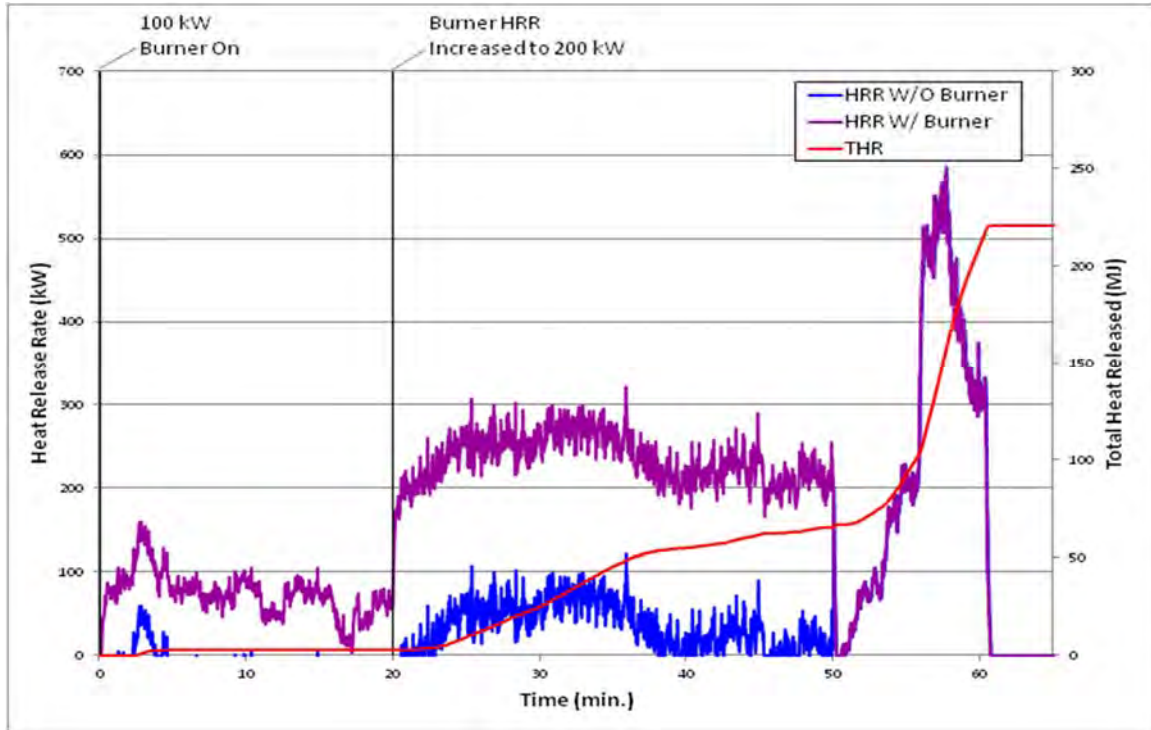
Figure G. 149: Wall Experiment 27 Heat Release Rate and Total Heat Released

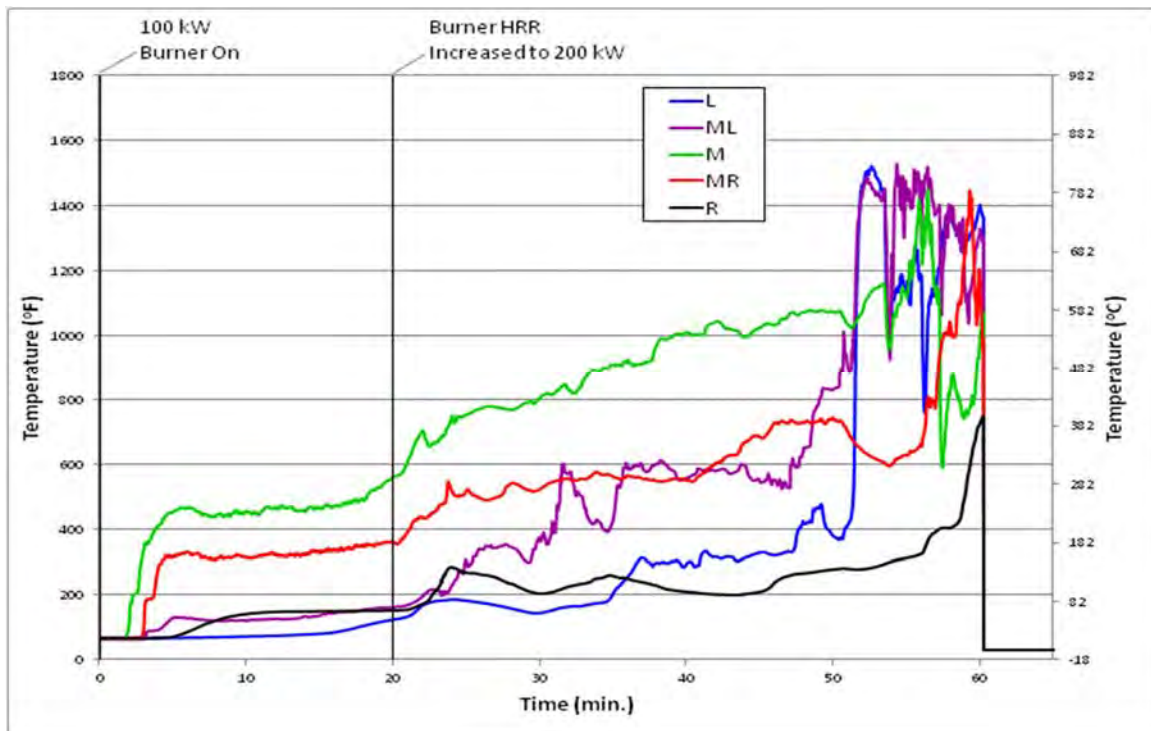
Figure G. 150: Wall Experiment 27 Under Siding Horizontal Temperatures

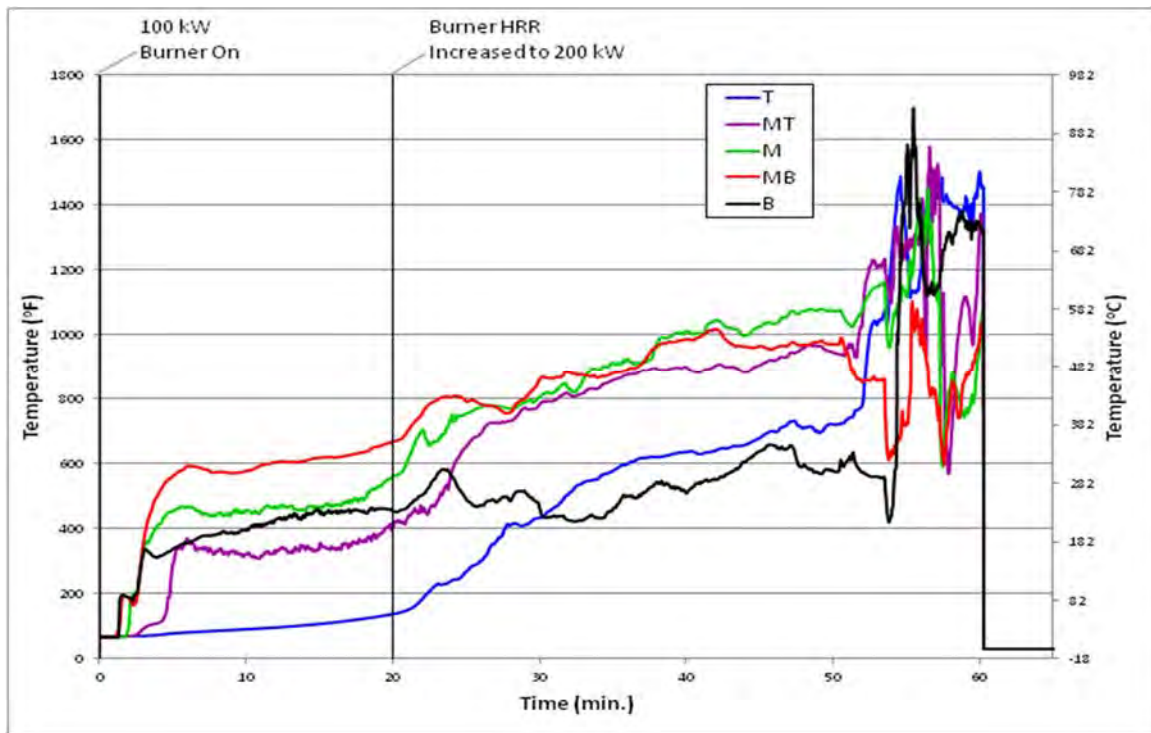
Figure G. 151: Wall Experiment 27 Under Siding Vertical Temperatures

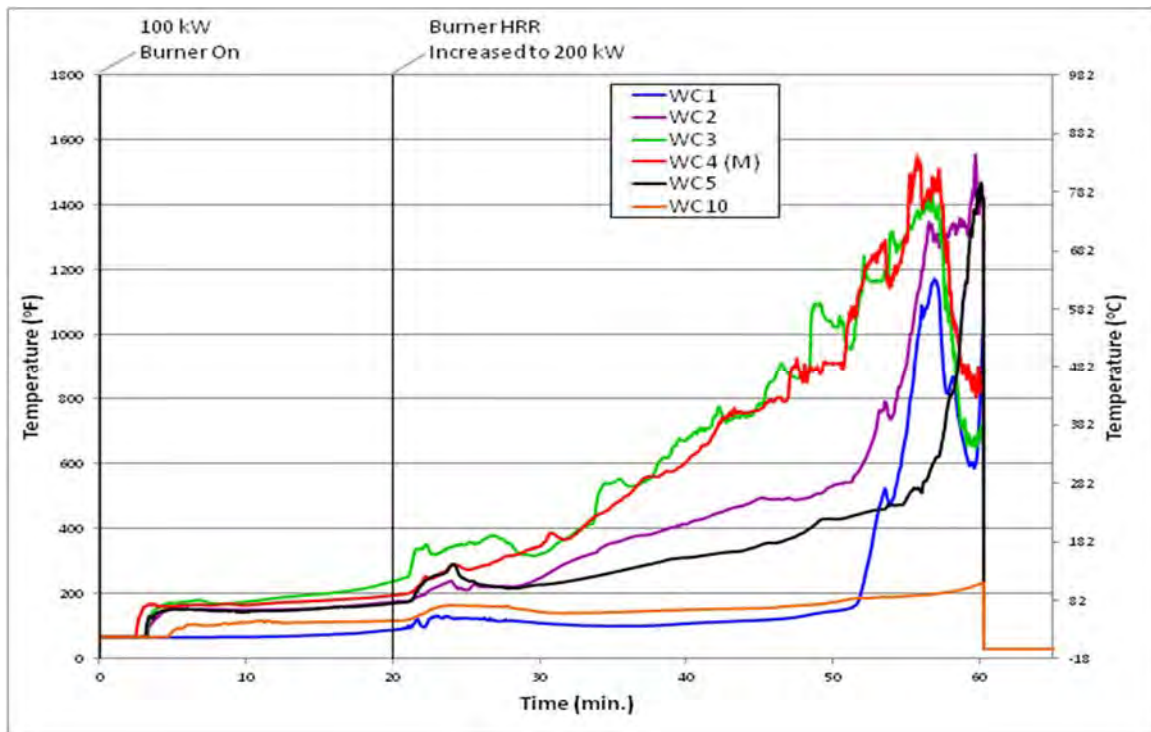
Figure G. 152: Wall Experiment 27 Wall Cavity Horizontal Temperatures

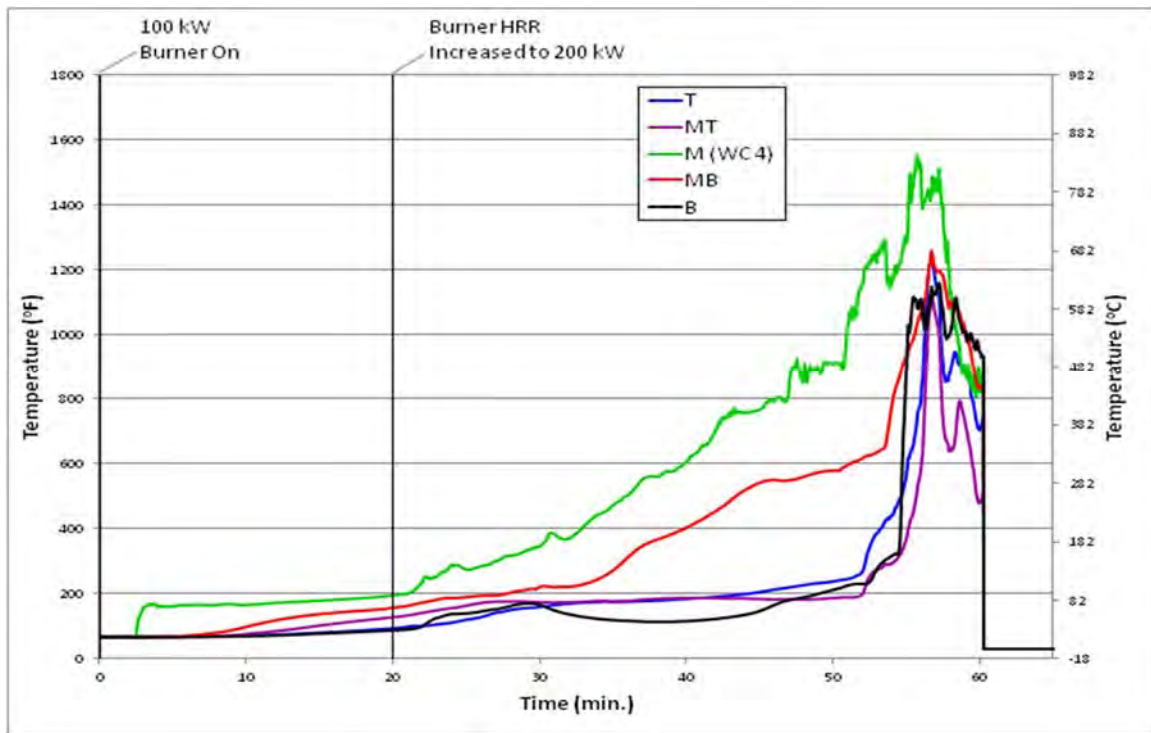
Figure G. 153: Experiment 27 Wall Cavity Vertical Temperatures

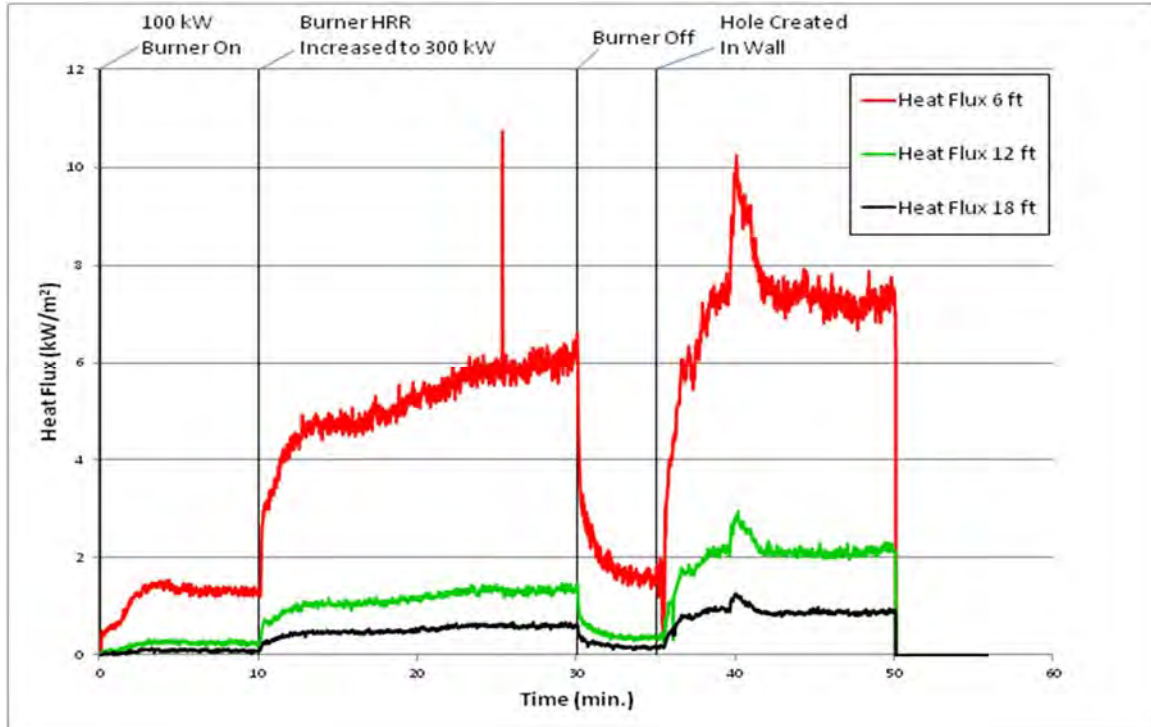
Figure G. 154: Experiment 28 Heat Flux

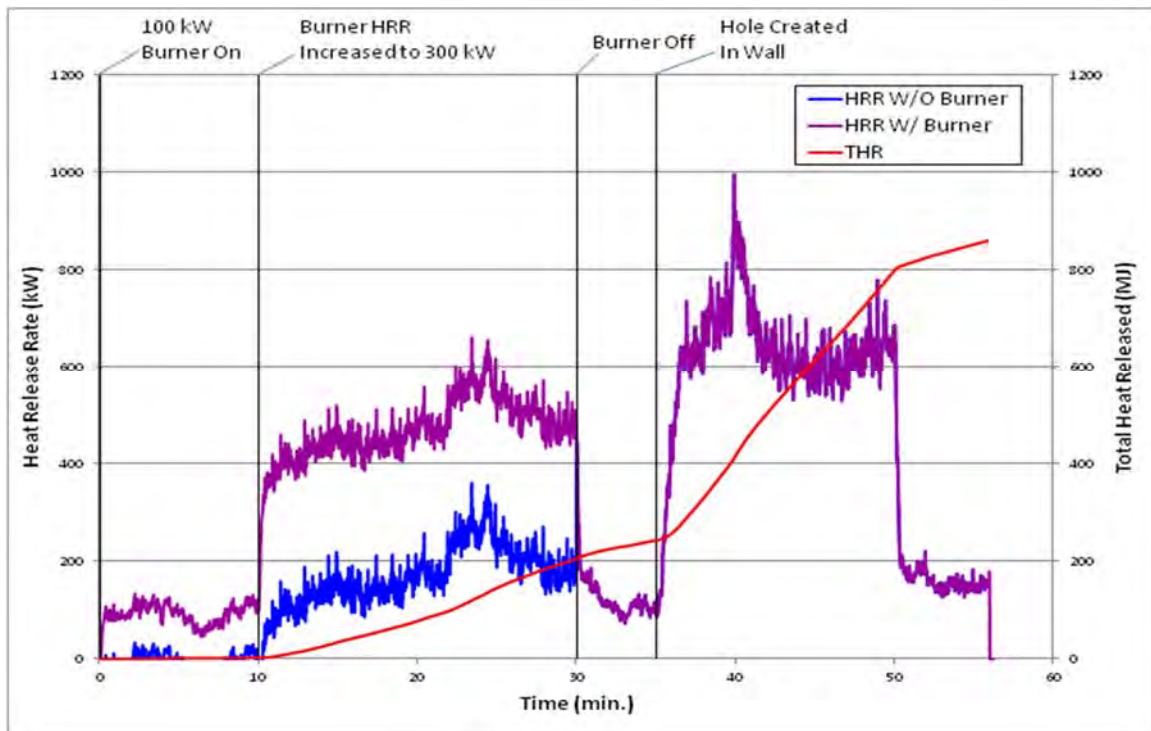
Figure G. 155: Experiment 28 Heat Release Rate and Total Heat Released

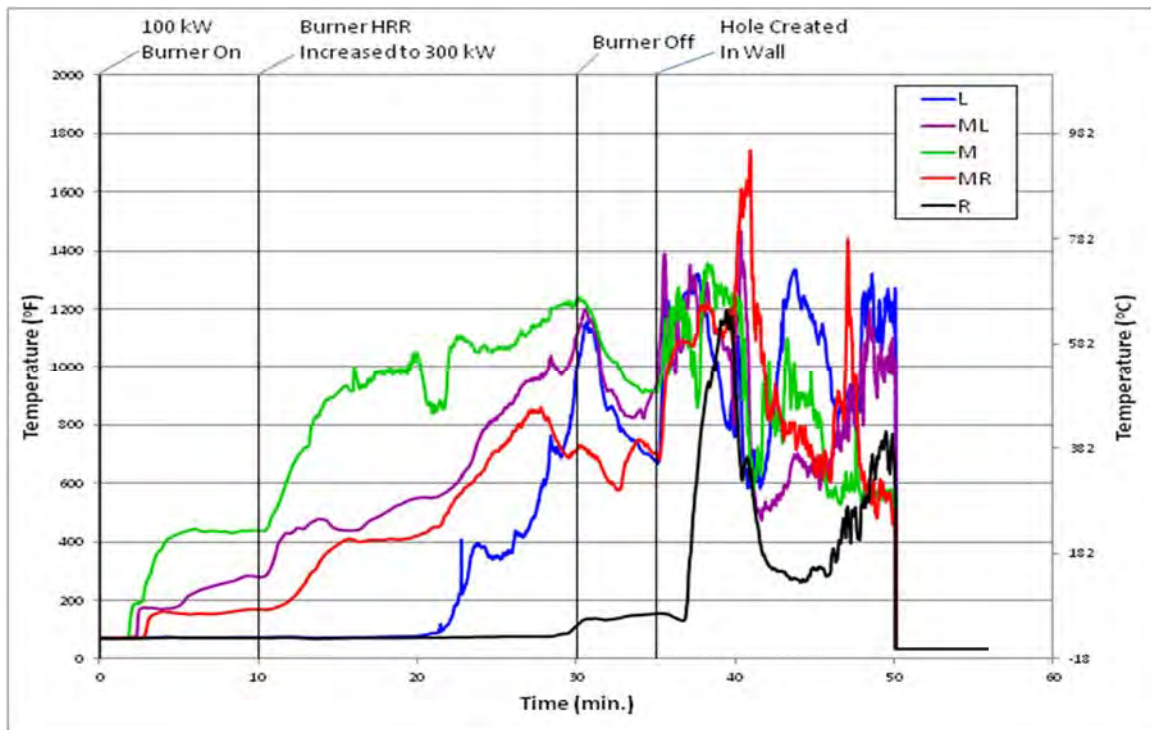
Figure G. 156: Experiment 28 Under Siding Horizontal Temperatures

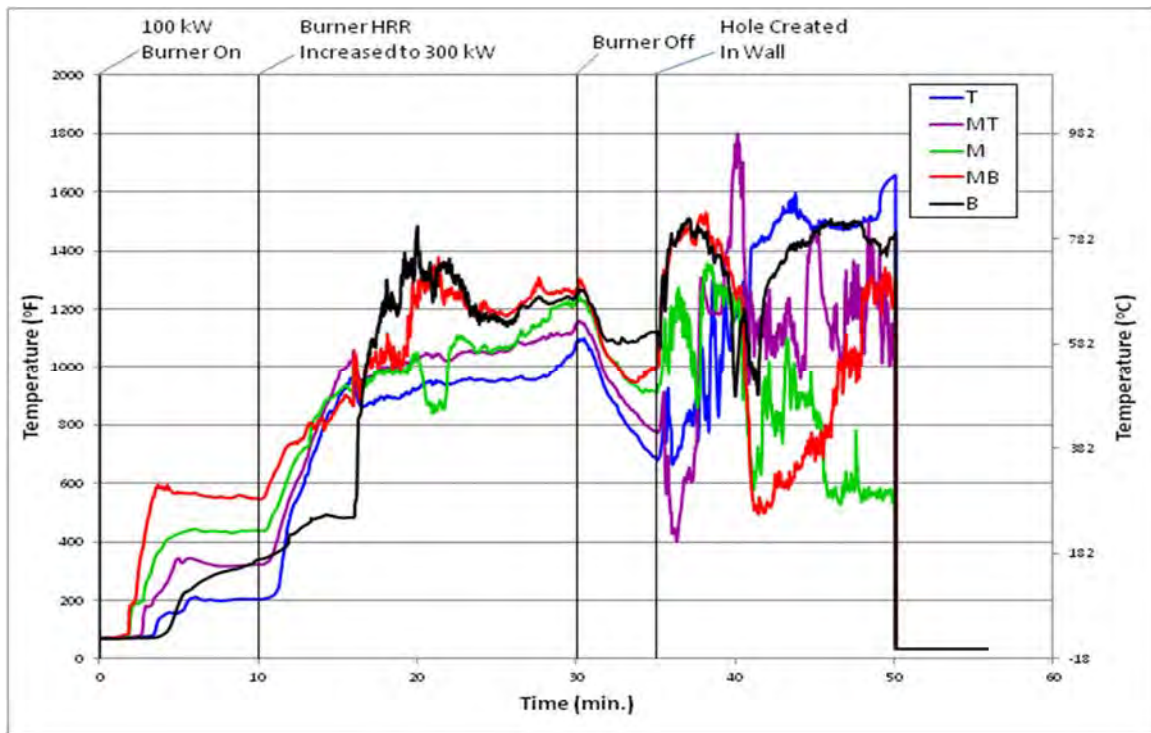
Figure G. 157: Experiment 28 Under Siding Vertical Temperatures

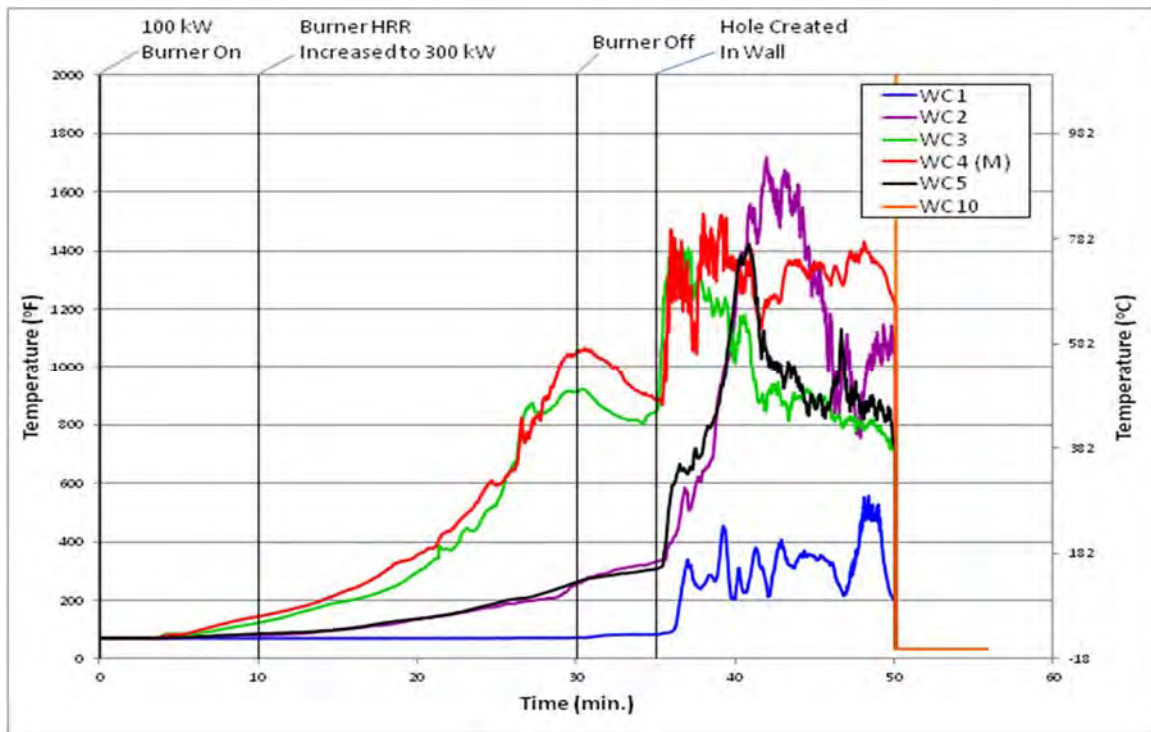
Figure G. 158: Experiment 28 Wall Cavity Horizontal Temperatures
