Study of Residential Attic Fire Mitigation Tactics and Exterior Fire Spread Hazards on Fire Fighter Safety

UL Firefighter Safety Research Institute

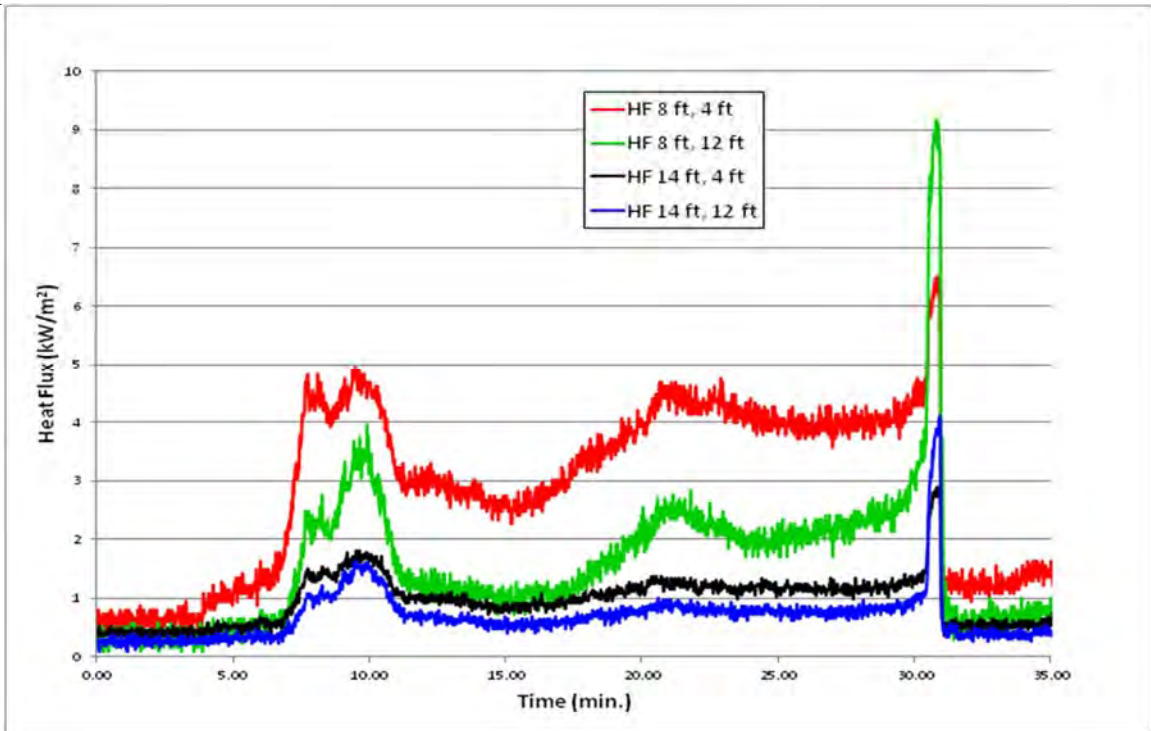
Figure H. 1: Eave Experiment 1 Heat Flux

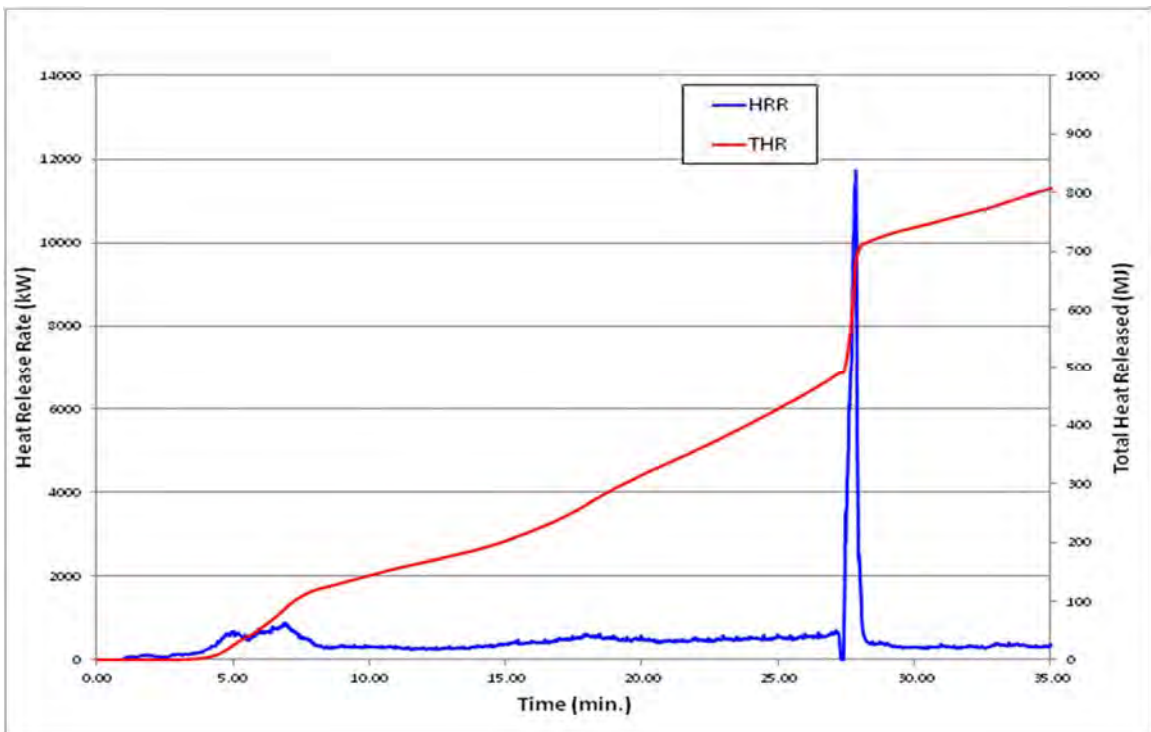
Figure H. 2: Eave Experiment 1 Heat Release Rate and Total Heat Released

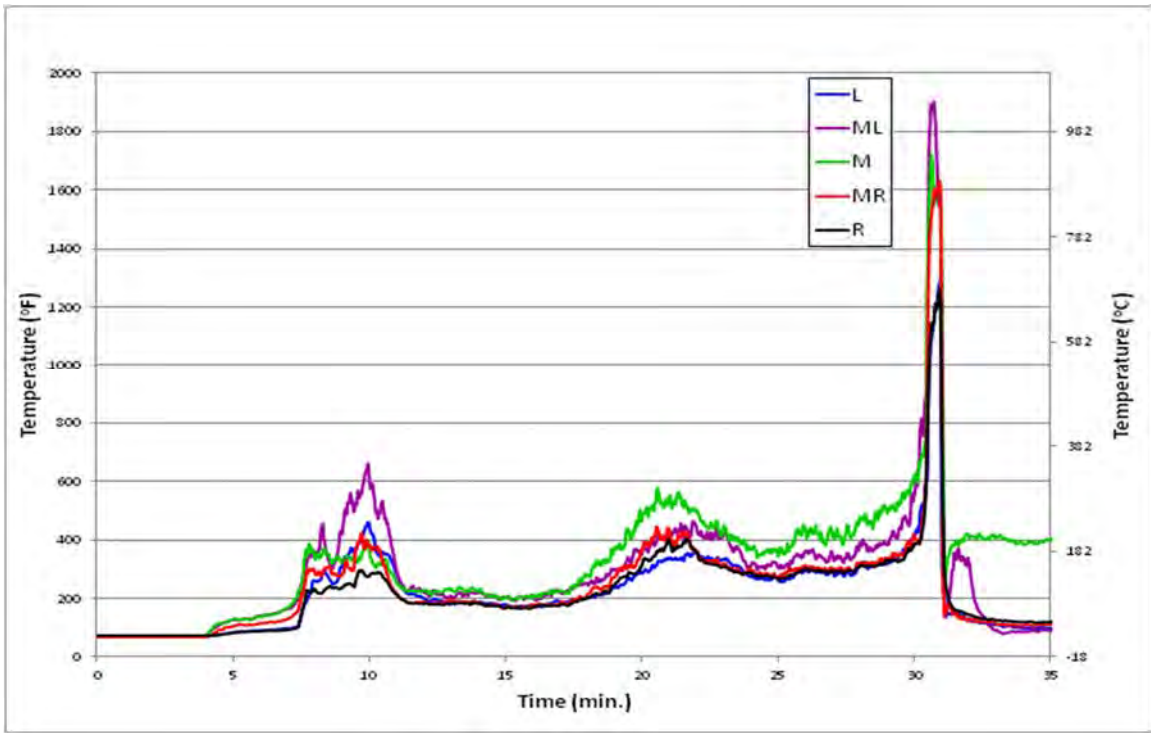
Figure H. 11: Eave Experiment 1 Eave Attic Temperatures

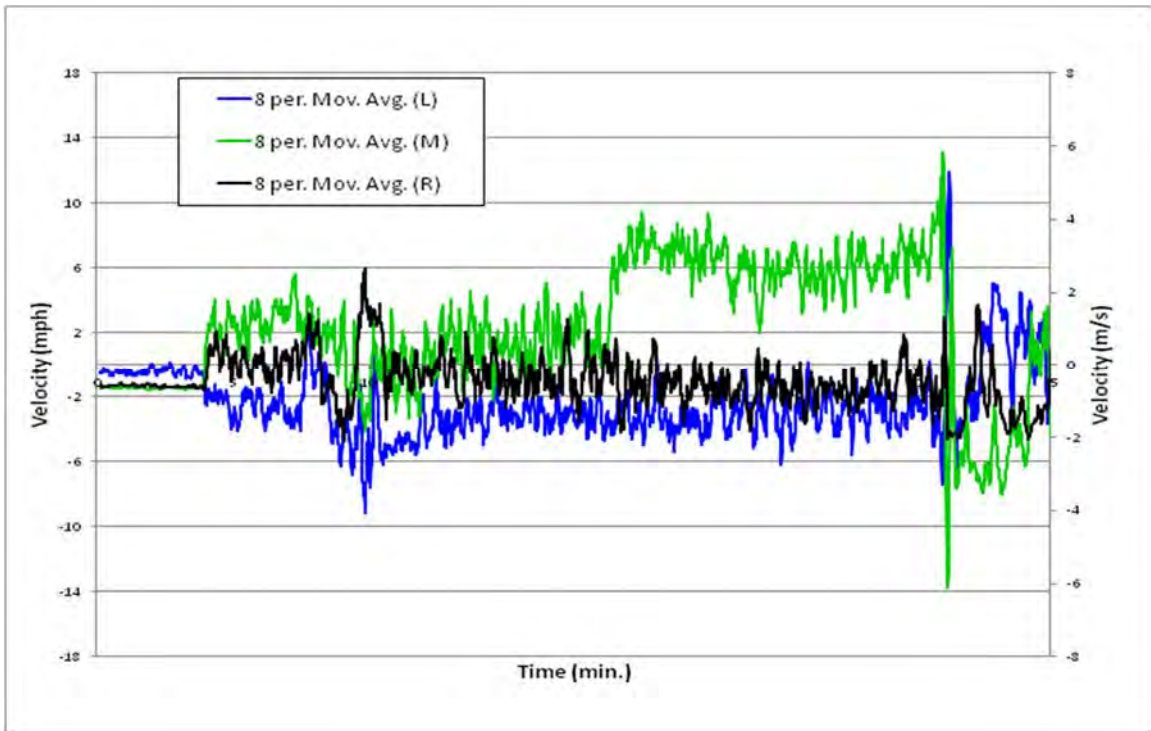
Figure H. 13: Eave Experiment 1 Eave Flow Velocity

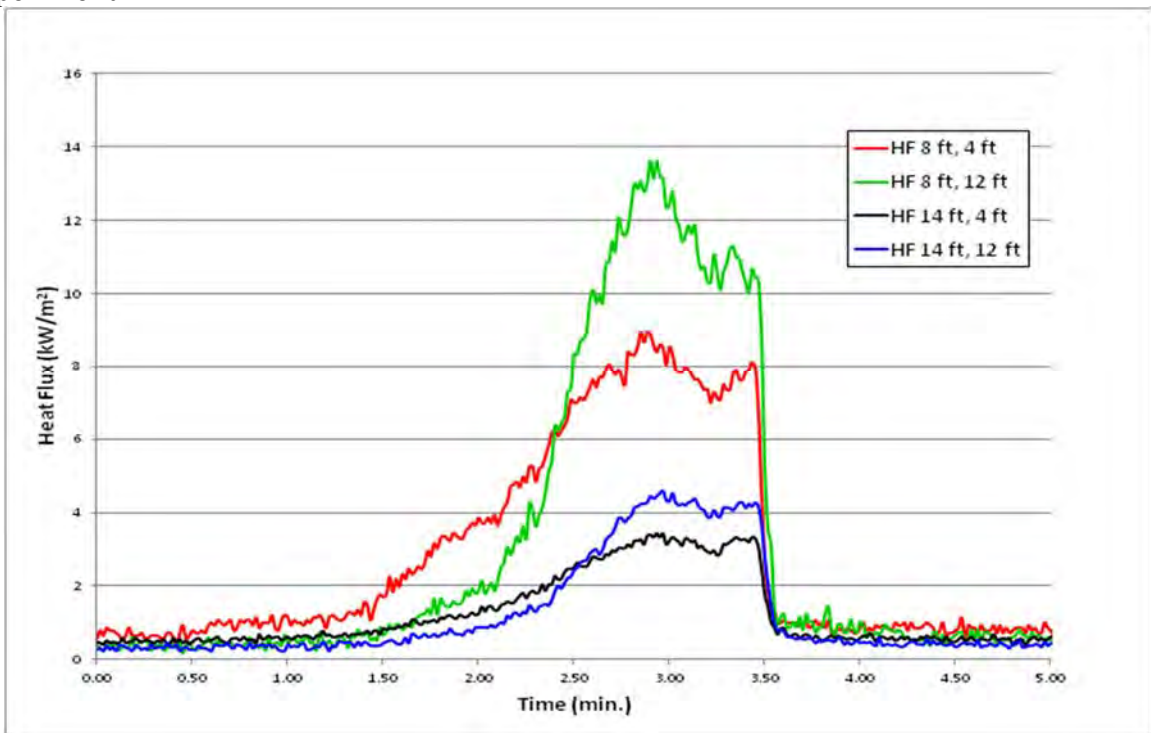
Figure H. 14: Eave Experiment 2 Heat Flux

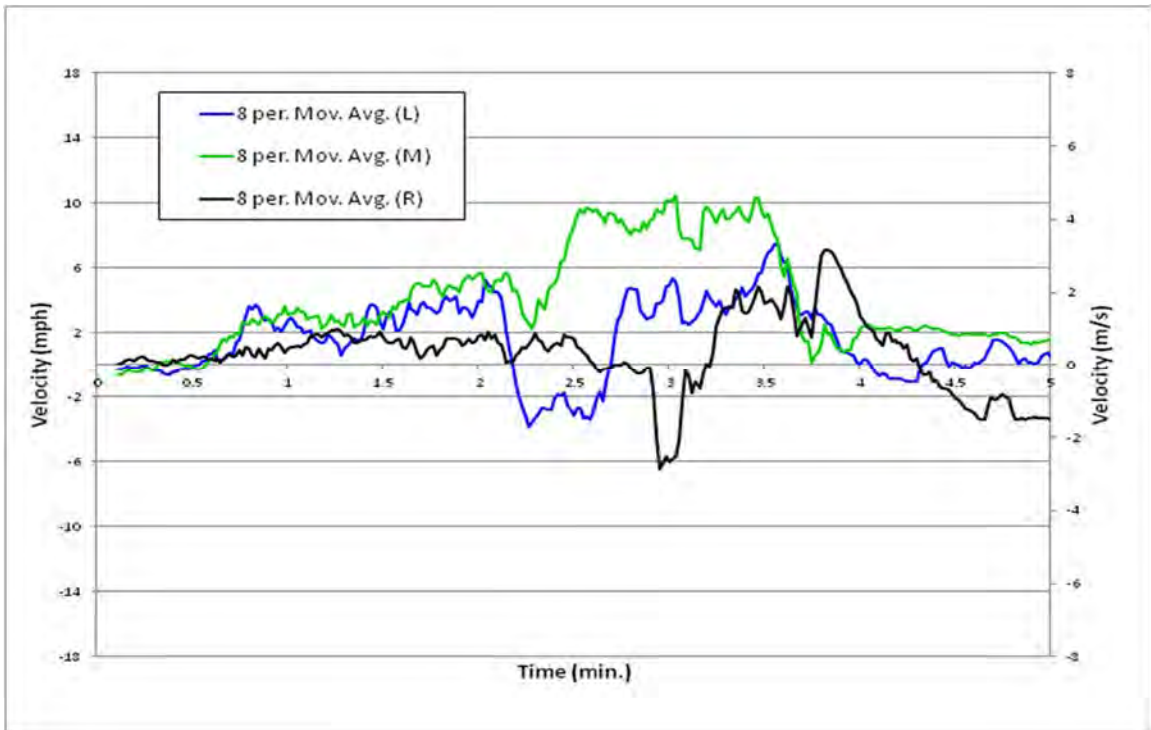
Figure H. 26: Eave Experiment 2 Eave Flow Velocity

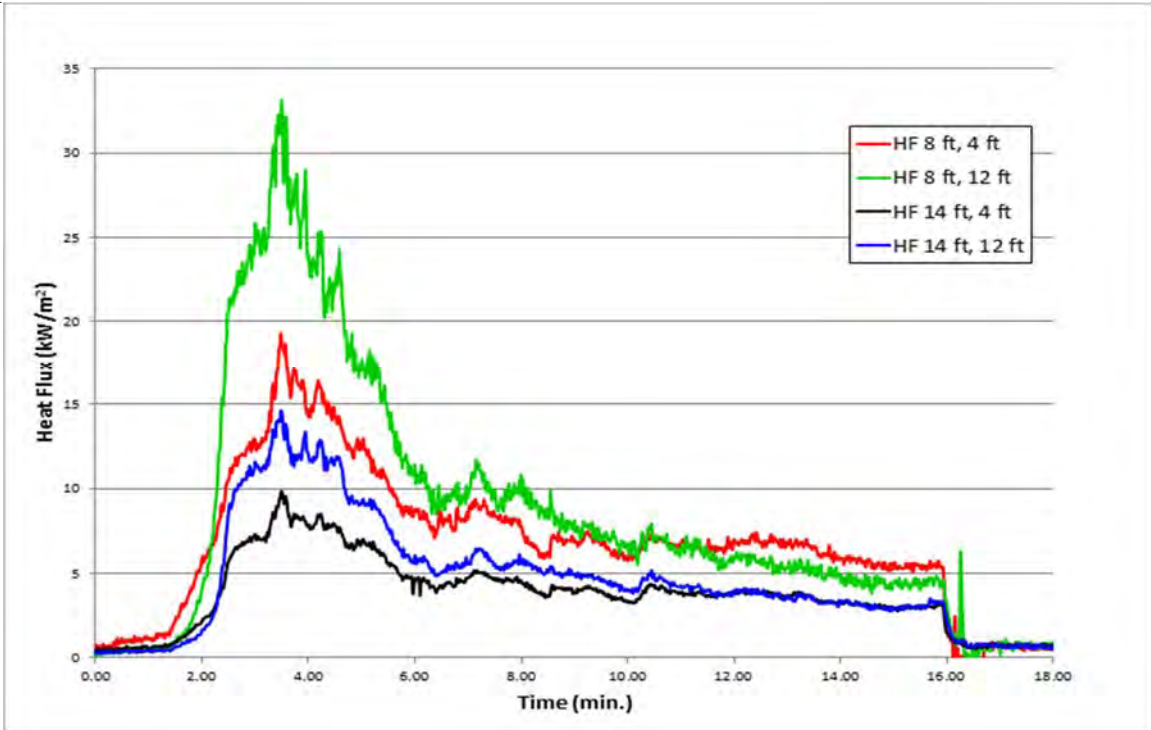
Figure H. 27: Eave Experiment 3 Heat Flux

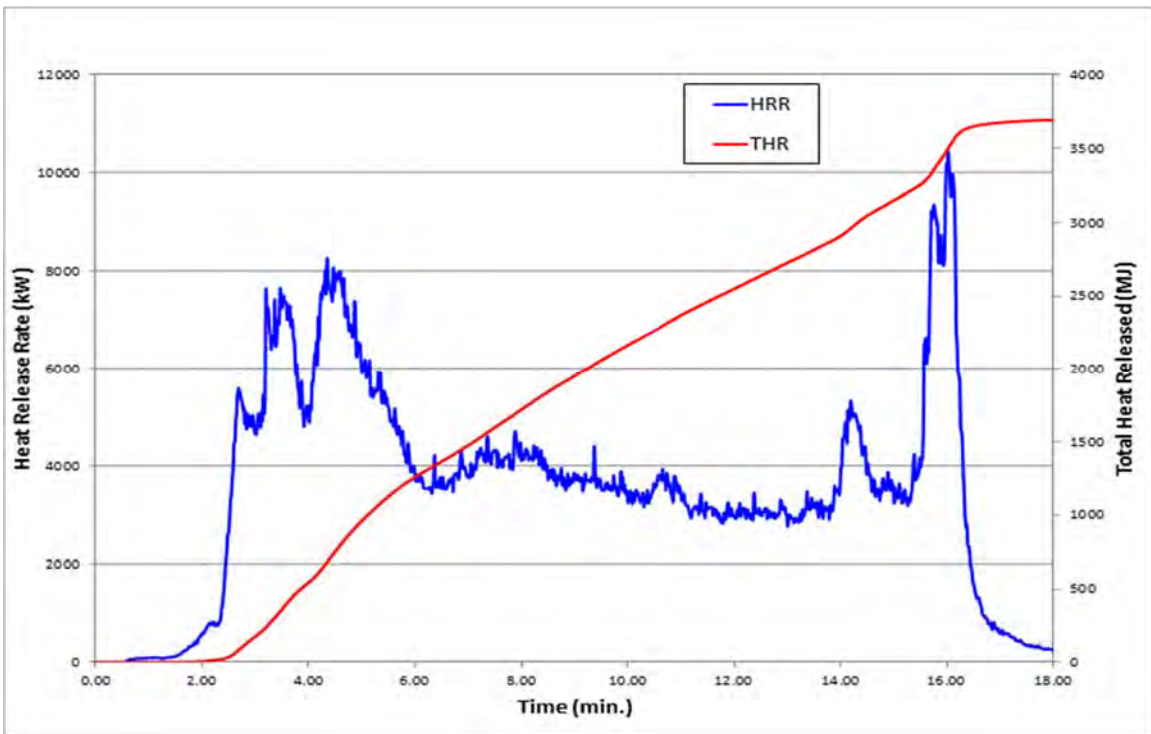
Figure H. 28: Eave Experiment 3 Heat Release Rate and Total Heat Released

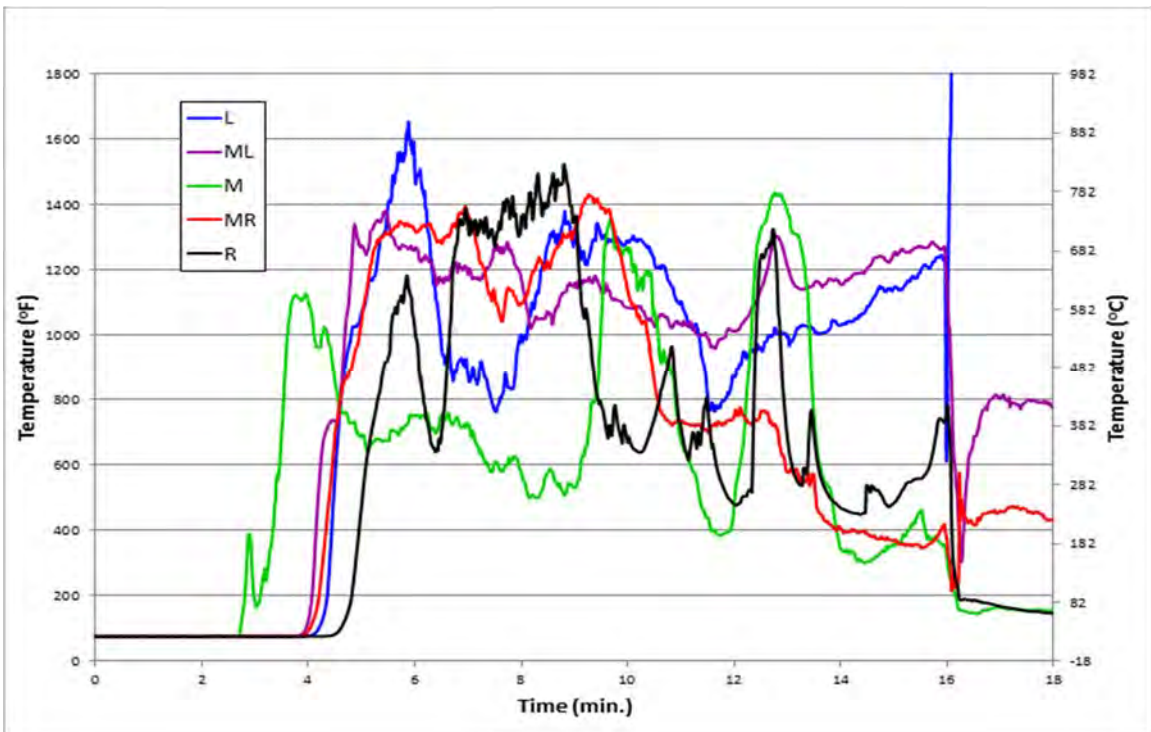
Figure H. 36: Eave Experiment 3 Top Wall Cavity Temperatures

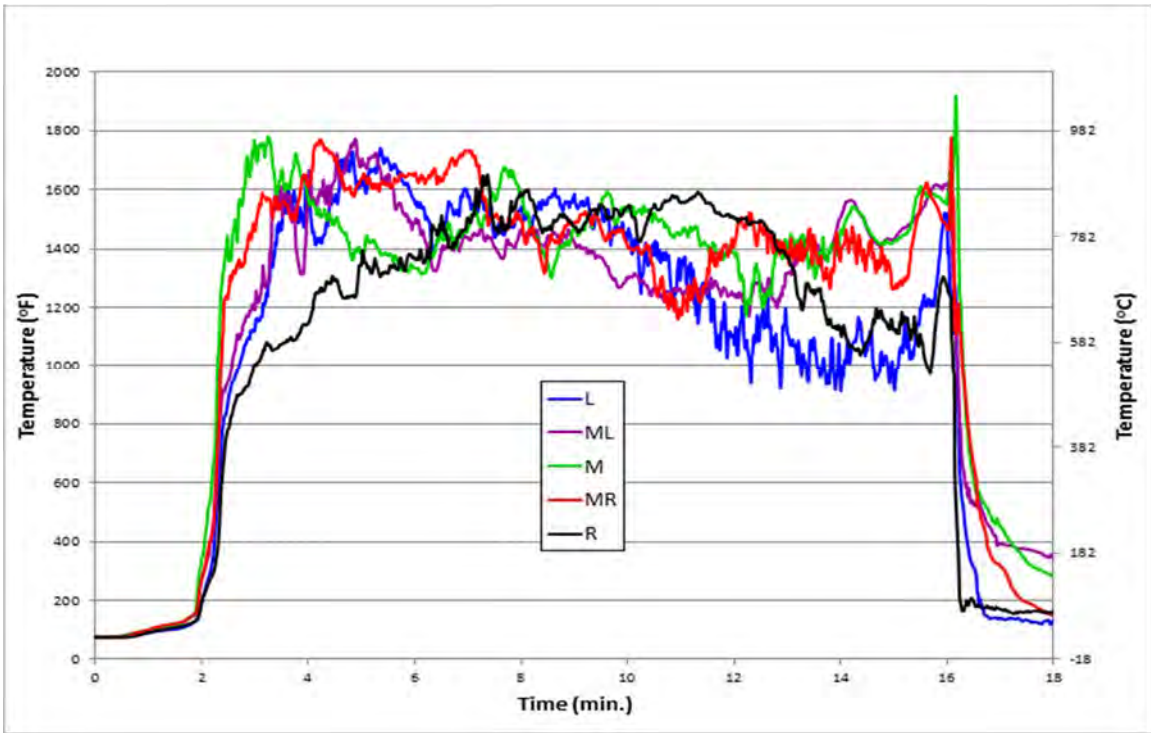
Figure H. 37: Eave Experiment 3 Eave Attic Temperatures

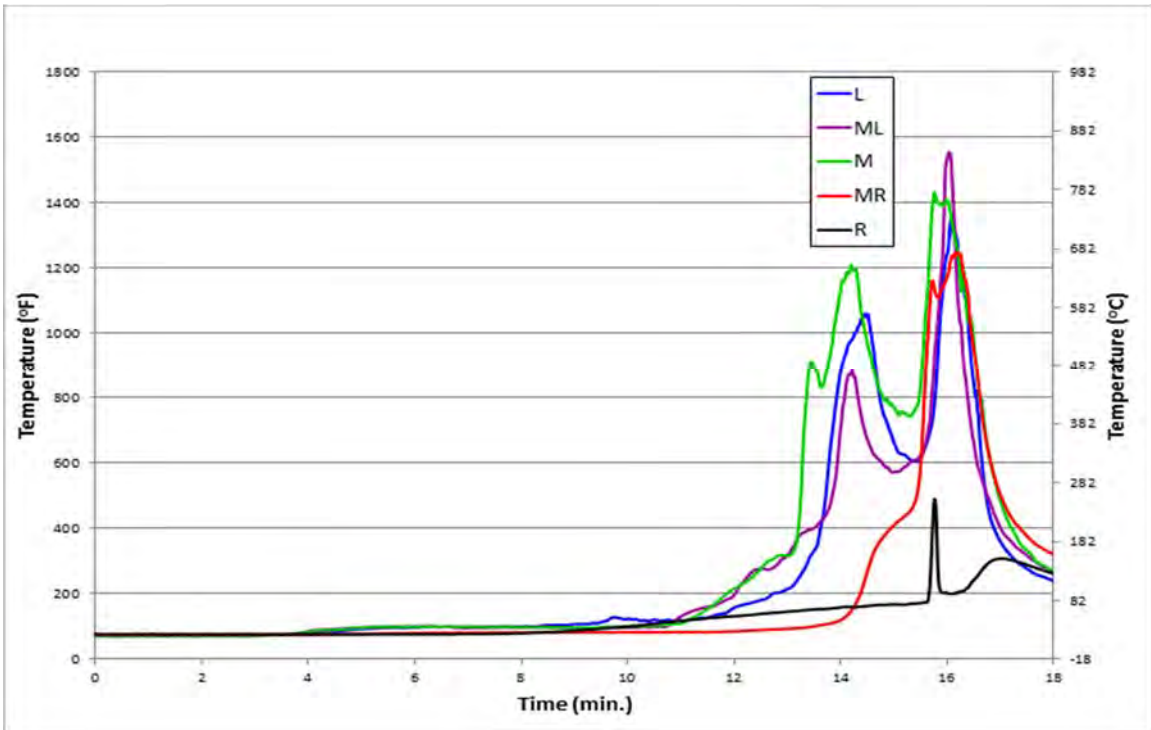
Figure H. 38: Eave Experiment 3 Back Attic Temperatures

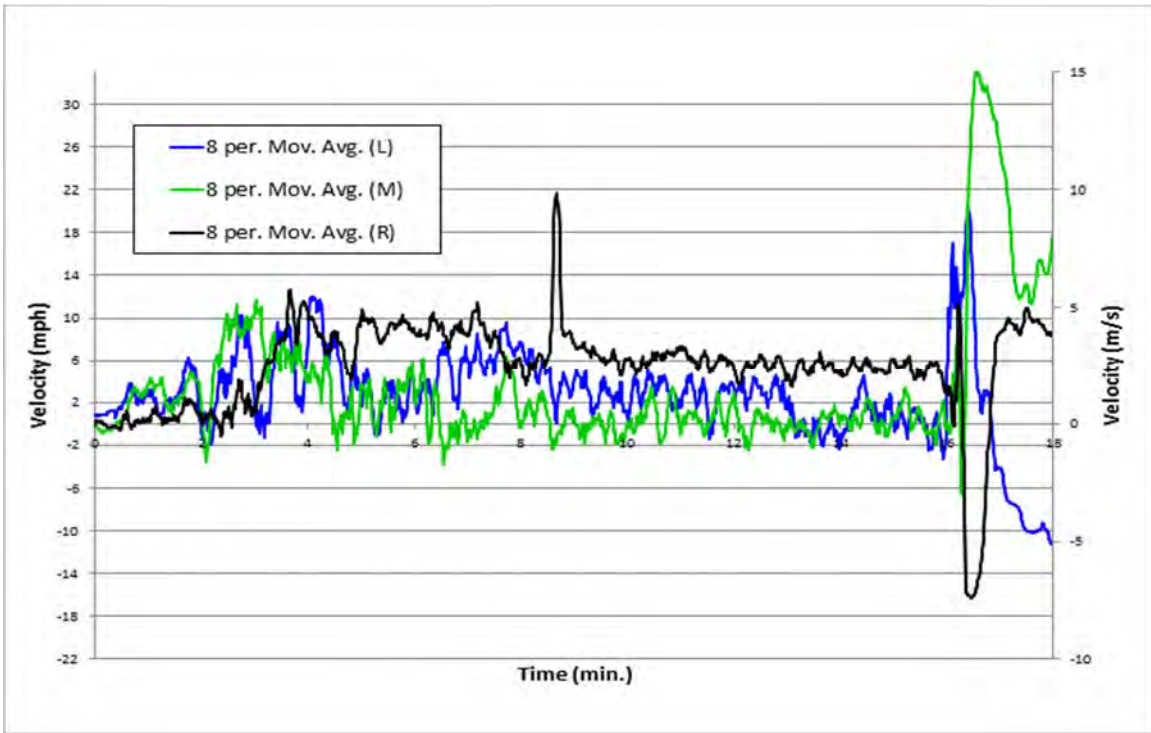
Figure H. 39: Eave Experiment 3 Eave Flow Velocity

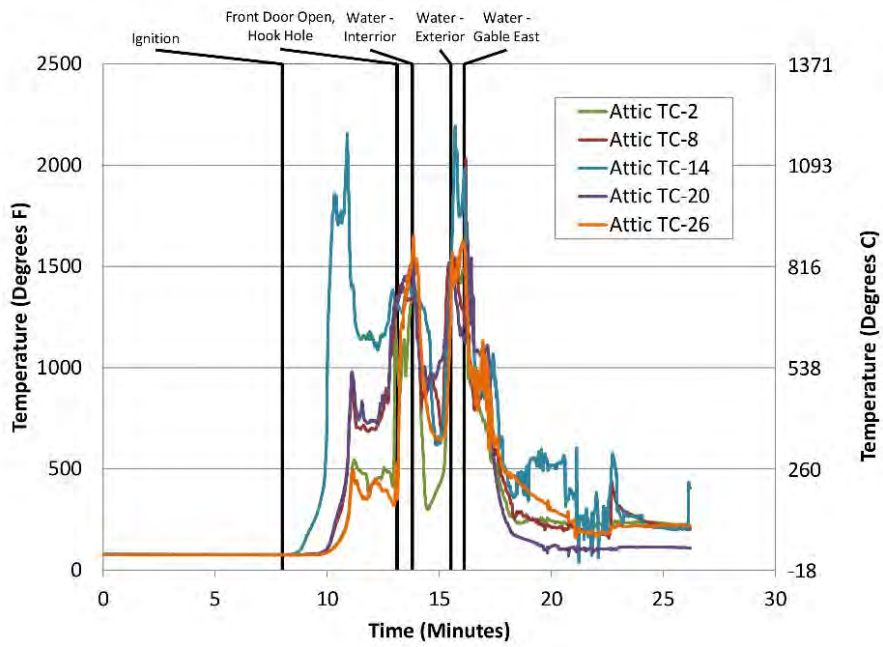
Attic Temperature Slice 2 Test 1 Fog Nozzle Below

Figure I. 2: Attic Experiment 1 Attic Temperature Slice 2

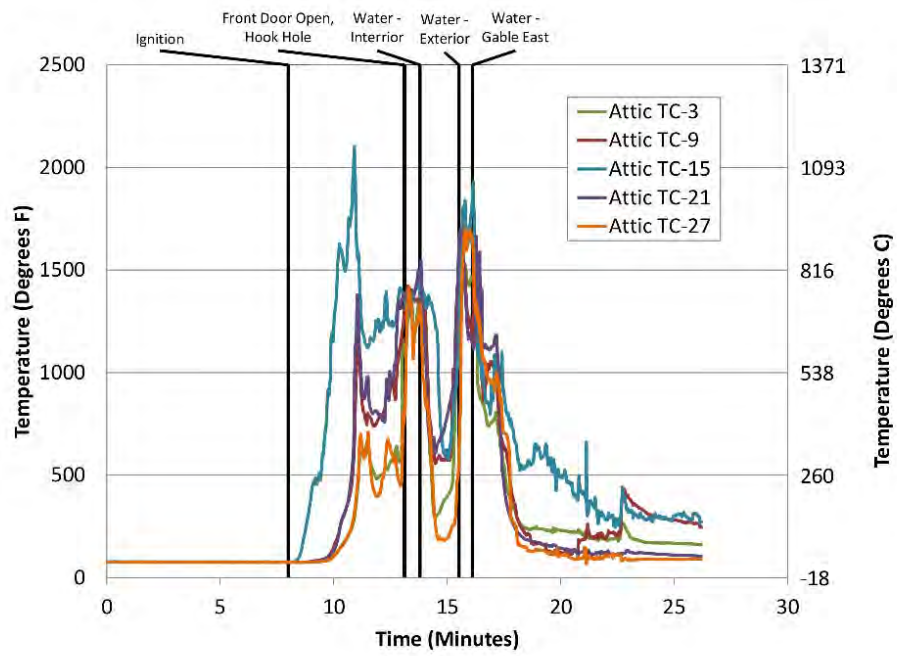
Attic Temperature Slice 3 Test 1 Fog Nozzle Below

Figure I. 3: Attic Experiment 1 Attic Temperature Slice 3

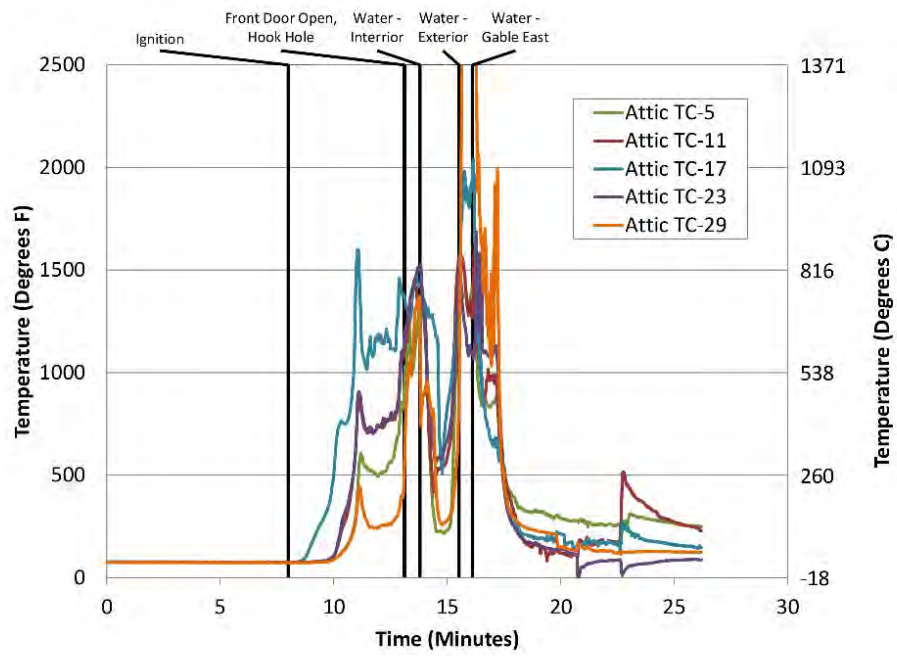
Attic Temperature Slice 5 Test 1 Fog Nozzle Below

Figure I. 5: Attic Experiment 1 Attic Temperature Slice 5

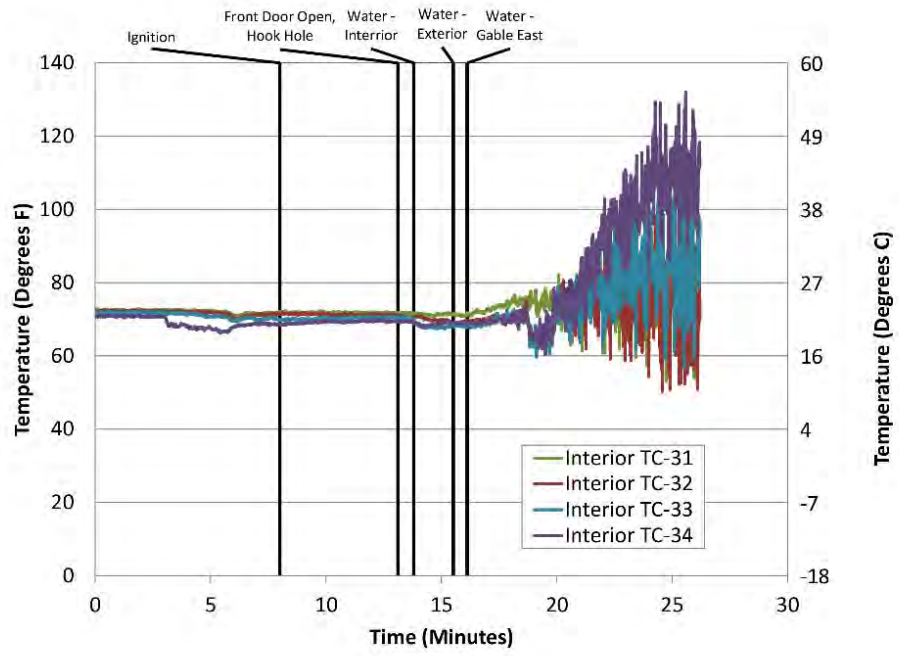
Figure I. 6: Attic Experiment 1 Attic Temperature Slice 6

Attic Temperature Slice 6 Test 1 Fog Nozzle Below

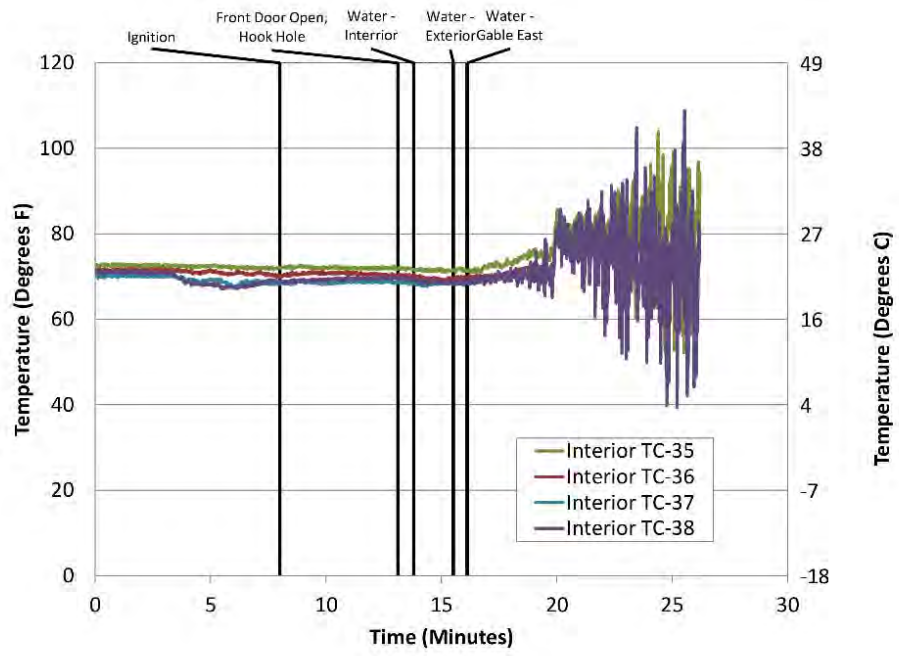
Figure I. 7: Attic Experiment 1 Attic Interior Array AB

Interior Array AB Test 1 Fog Nozzle Below

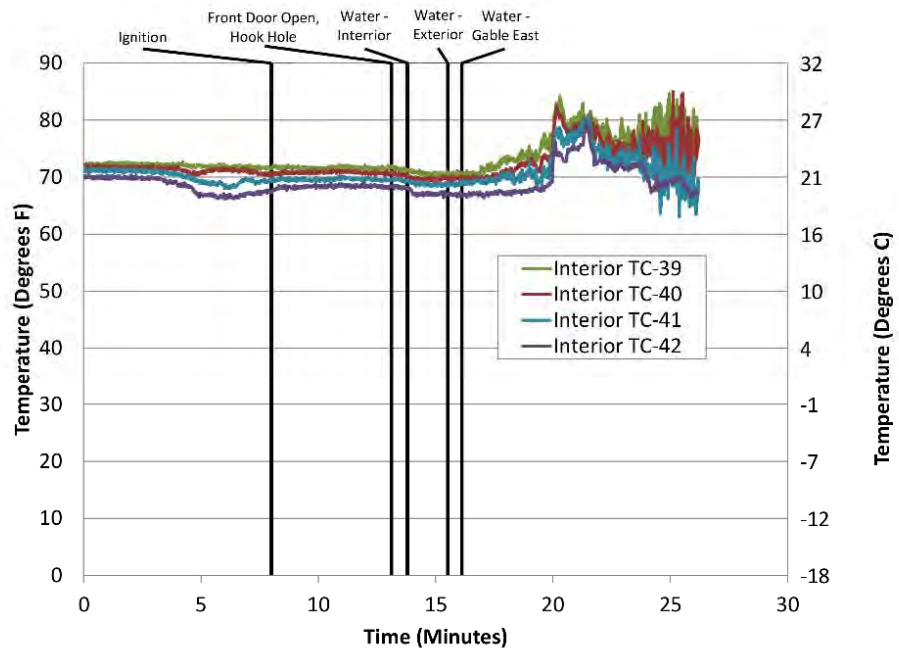
Figure I. 8: Attic Experiment 1 Attic Interior Array AB

Interior Array BC
 Test 1 Fog Nozzle Below

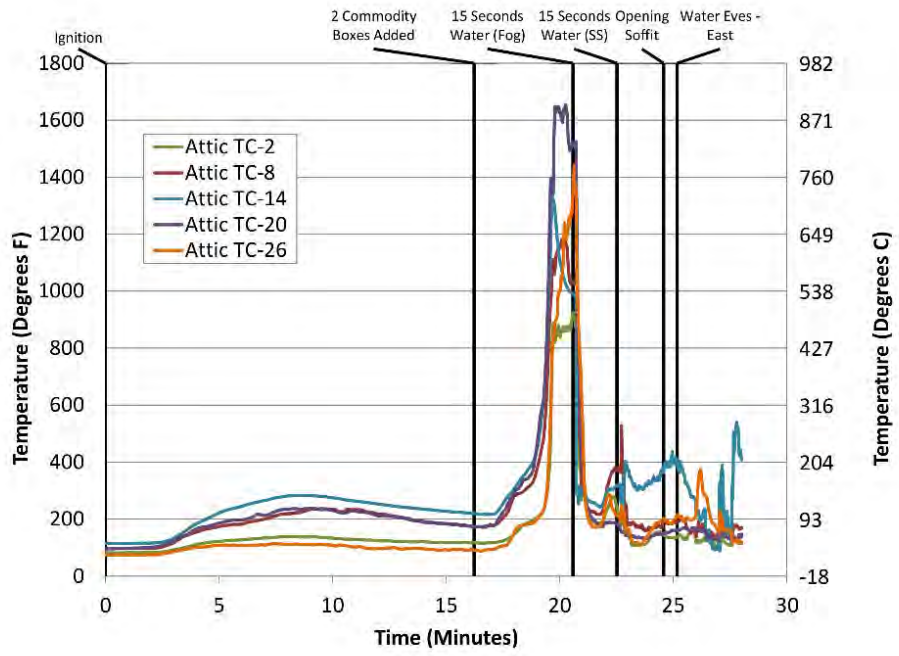
Attic Temperature Slice 1
 Test 2B - Large Hole Below Vented

Figure I. 27: Attic Experiment 2B Attic Temperature Slice 1

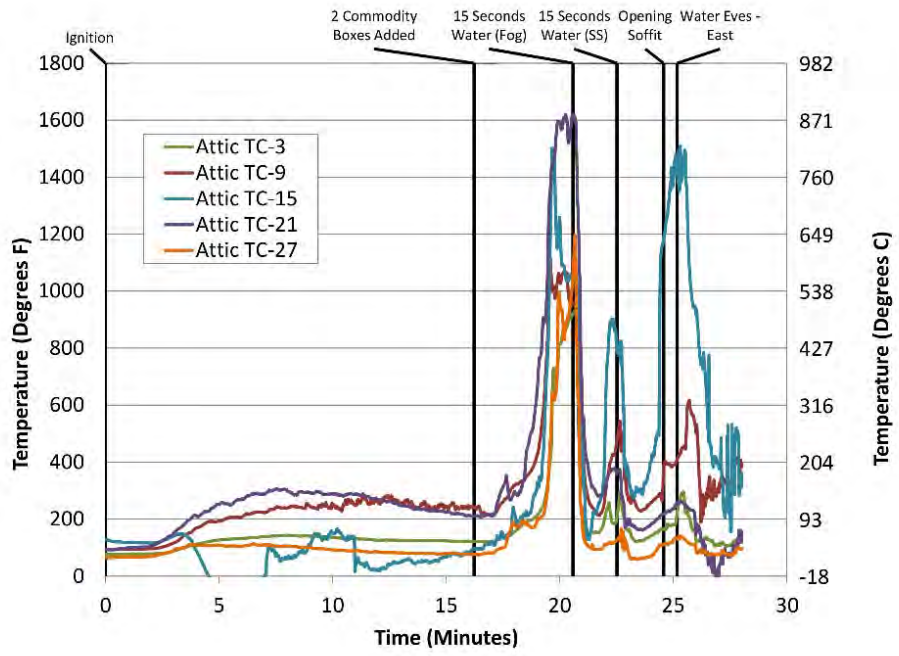
Attic Temperature Slice 2 Test 2B - Large Hole Below Vented

Figure I. 28: Attic Experiment 2B Attic Temperature Slice 2

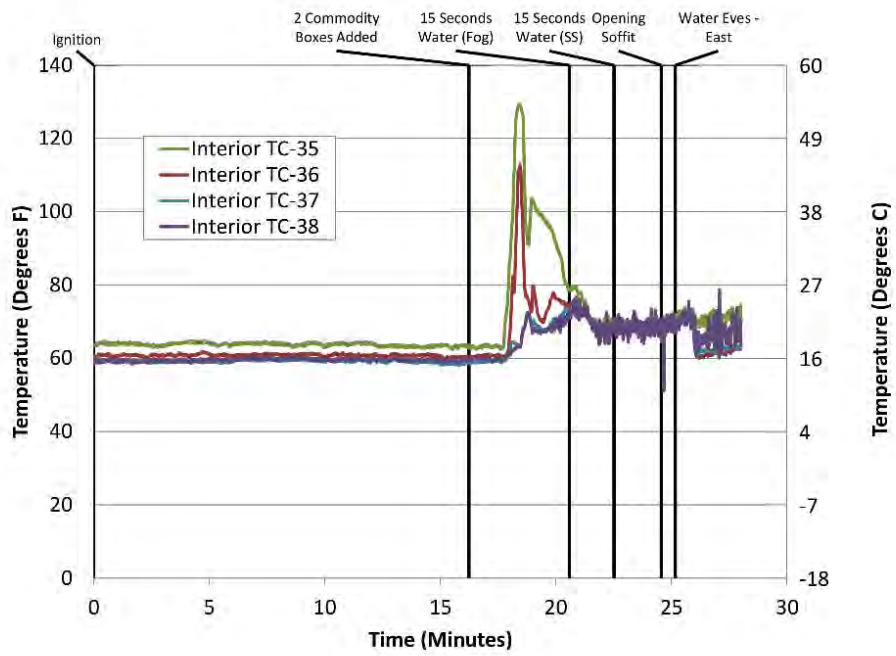
Interior Array AB Test 2B - Large Hole Below Vented

Figure I. 33: Attic Experiment 2B Interior TC Array AB

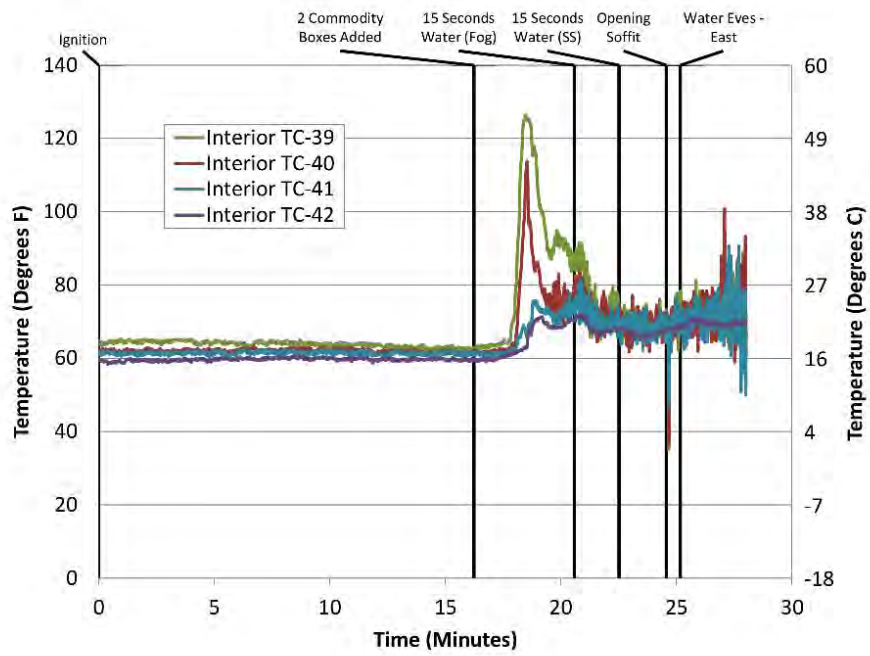
Interior Array BC Test 2B - Large Hole Below Vented

Figure I. 34: Attic Experiment 2B Interior TC Array BC

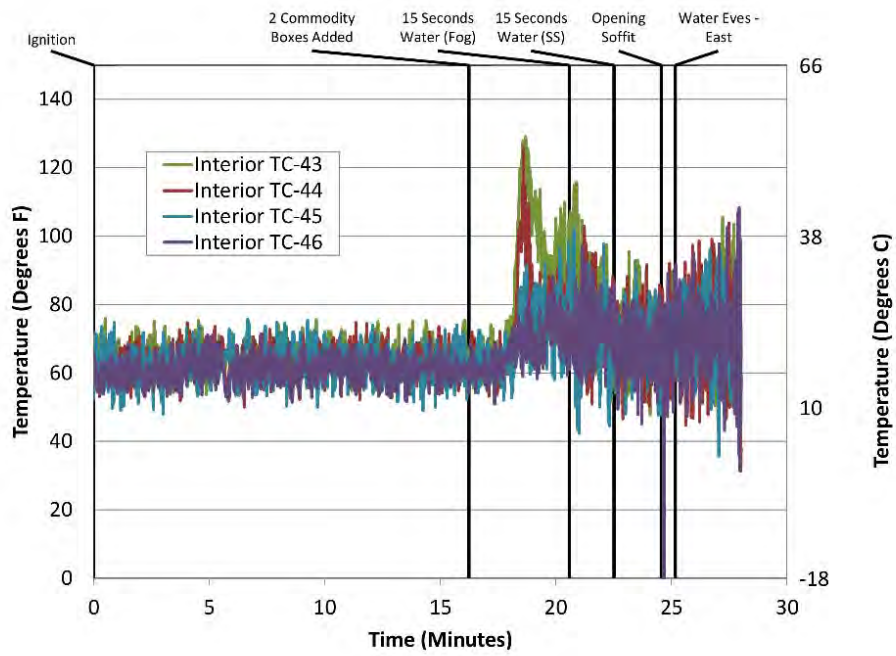
Interior Array CD Test 2B - Large Hole Below Vented

Figure I. 35: Attic Experiment 2B Interior TC Array CD

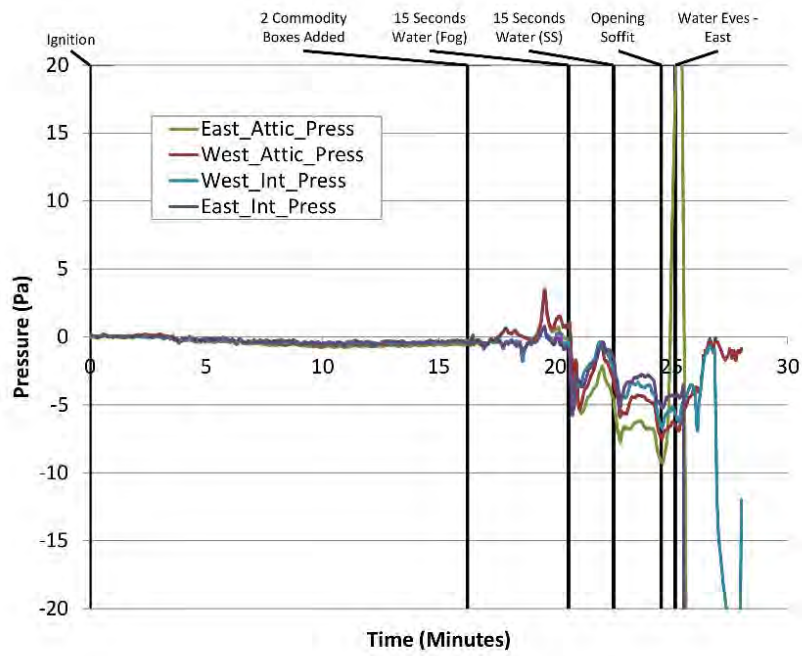
Attic Pressure Test 2B - Large Hole Below Vented

Figure I. 40: Attic Experiment 2B Attic Pressure

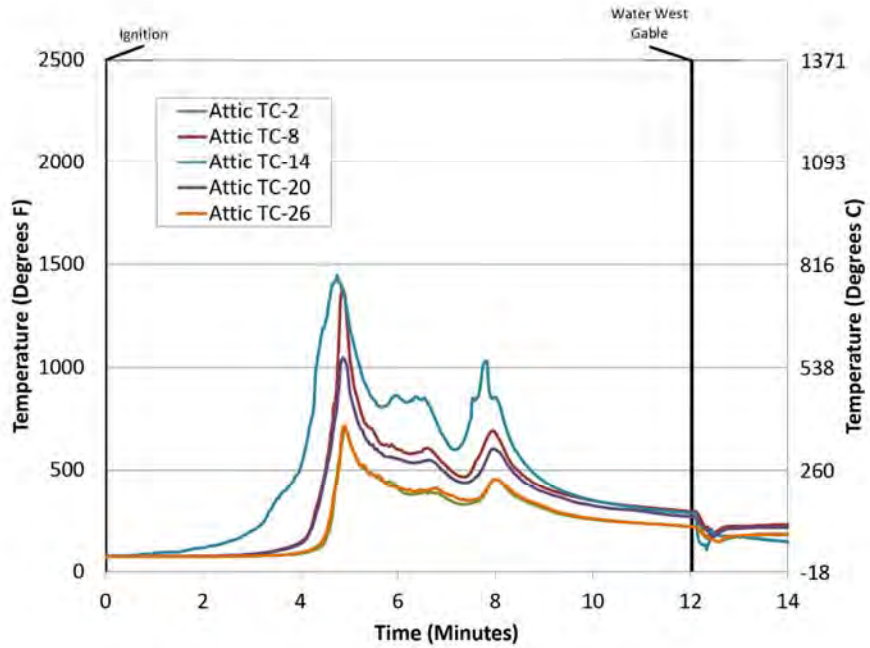
Attic Temperature Slice 1
Test 3A - Gable Attack Unvented

Figure I. 42: Attic Experiment 3A Attic Temperature Slice 1

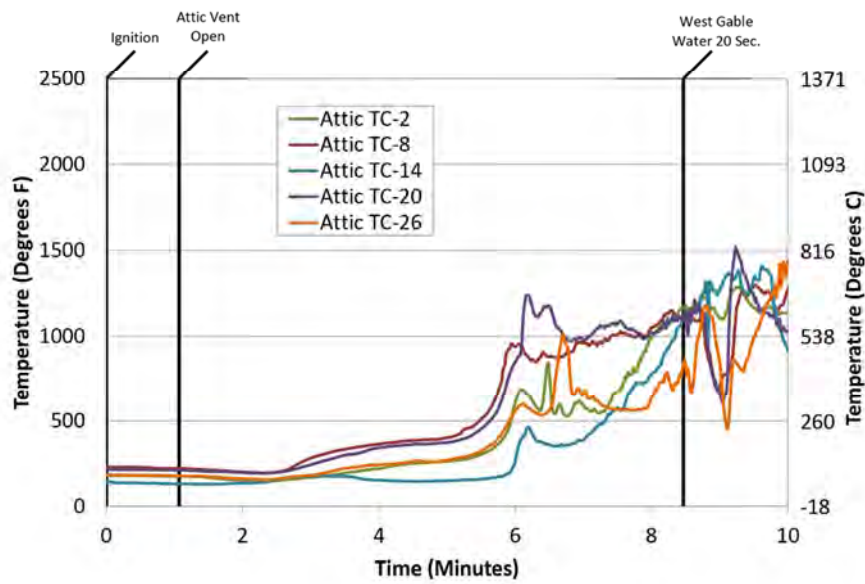
Attic Temperature Slice 1
Test - 3B Gable Attack Vented

Figure I. 57: Attic Experiment 3B Attic Temperature Slice 1

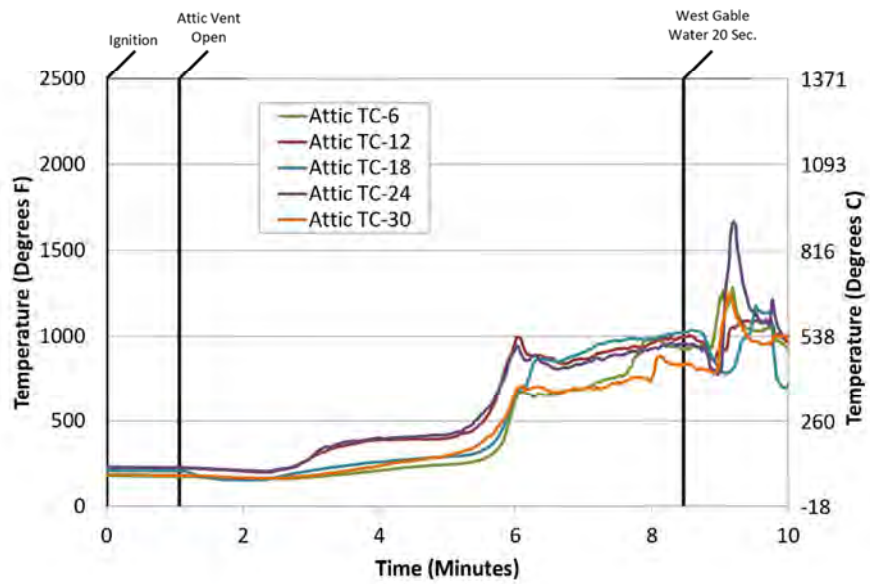
Attic Temperature Slice 5 Test - 3B Gable Attack Vented

Figure I. 61: Attic Experiment 3B Attic Temperature Slice 5

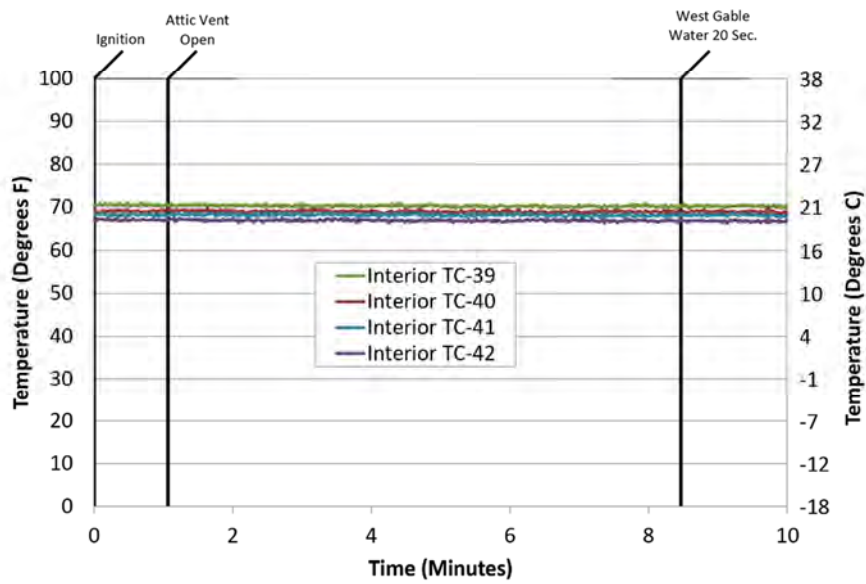
Interior Array BC Test - 3B Gable Attack Vented

Figure I. 64: Attic Experiment 3B Interior TC Array BC

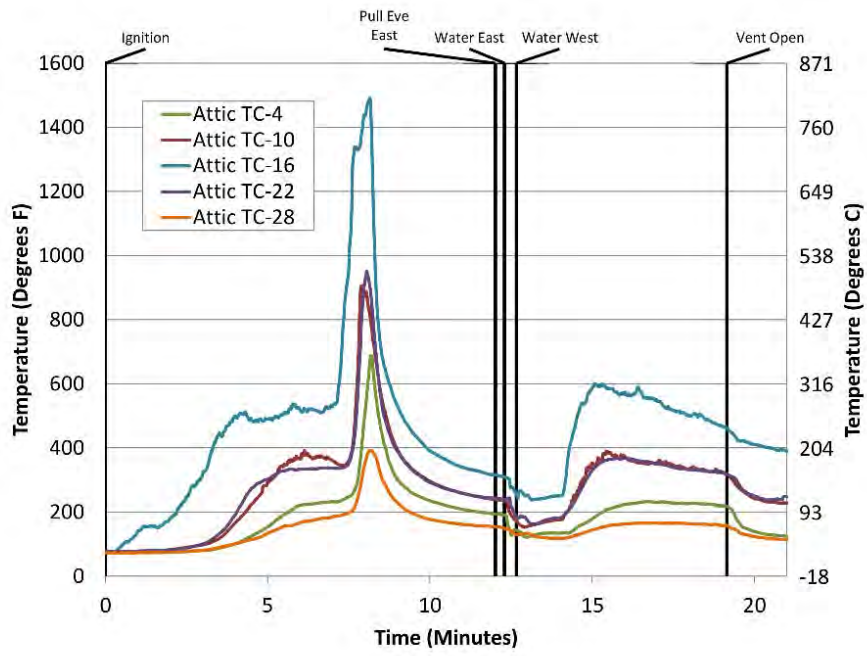
Attic Temperature Slice 4
 Test 4A - Eave Attack Unvented

Figure I. 74: Attic Experiment 4A Attic Temperature Slice 4

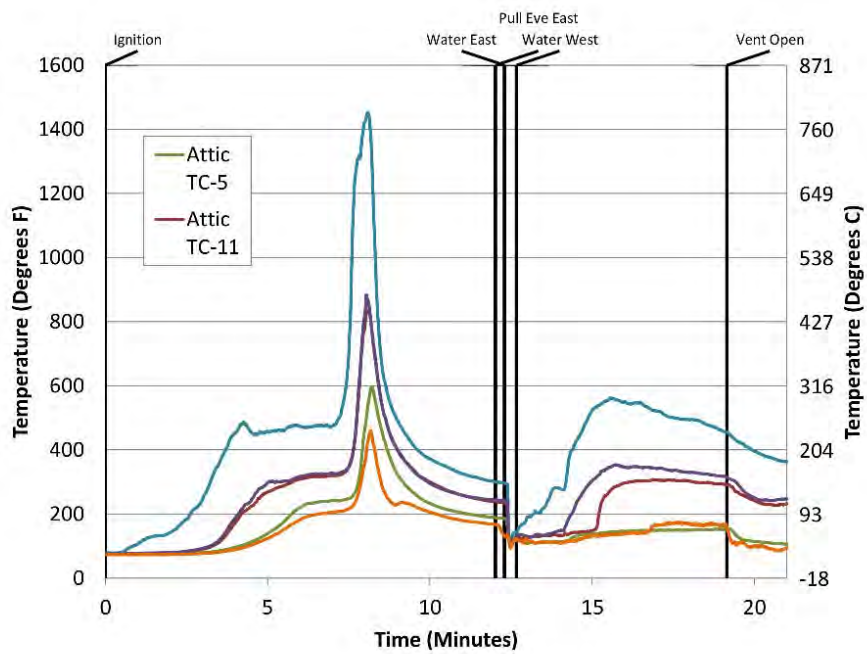
Attic Temperature Slice 5 Test 4A - Eave Attack Unvented

Figure I. 75: Attic Experiment 4A Attic Temperature Slice 5

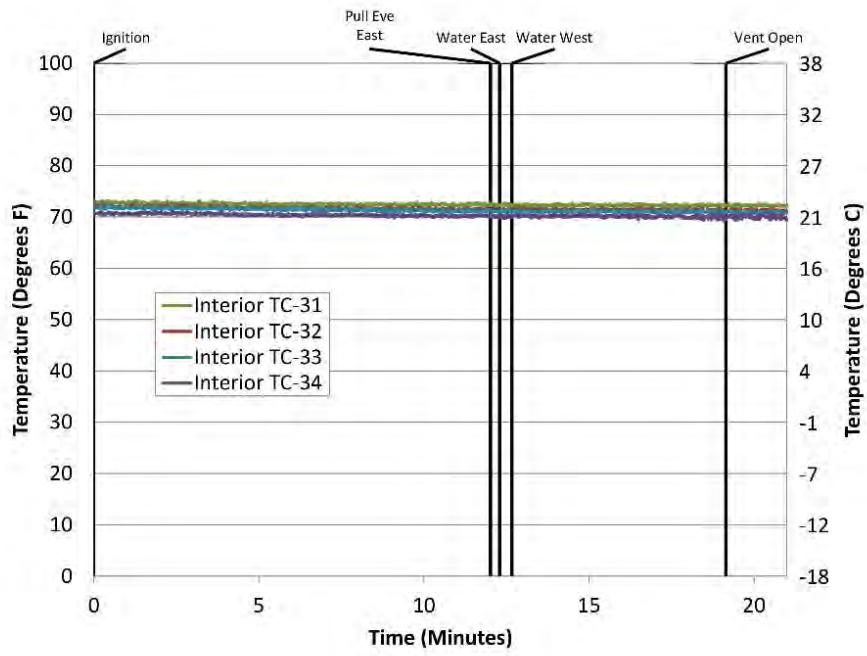
Interior Array AB
 Test 4A - Eave Attack Unvented

Figure I. 77: Attic Experiment 4A Interior TC Array AB

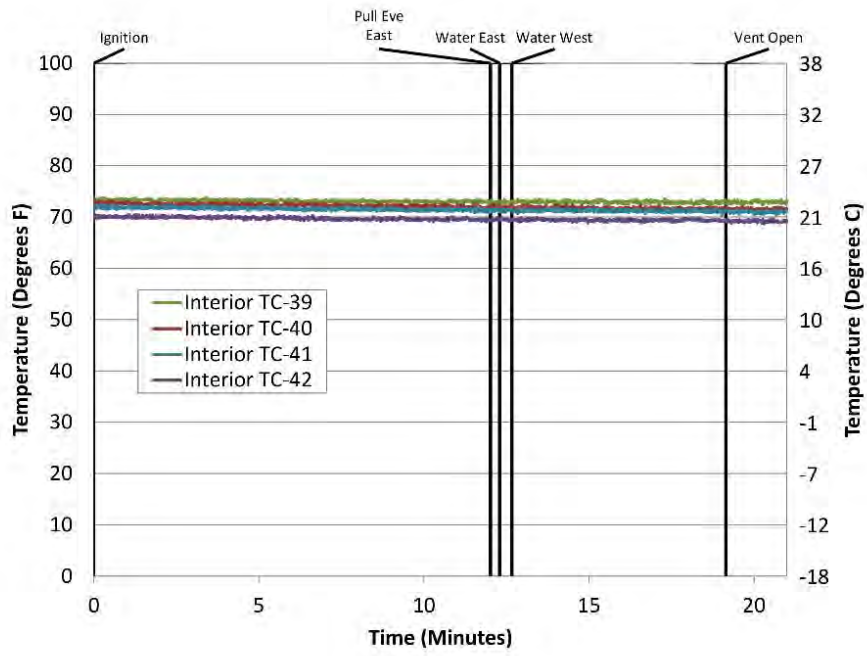
Interior Array CD
 Test 4A - Eave Attack Unvented

Figure I. 79: Attic Experiment 4A Interior TC Array CD

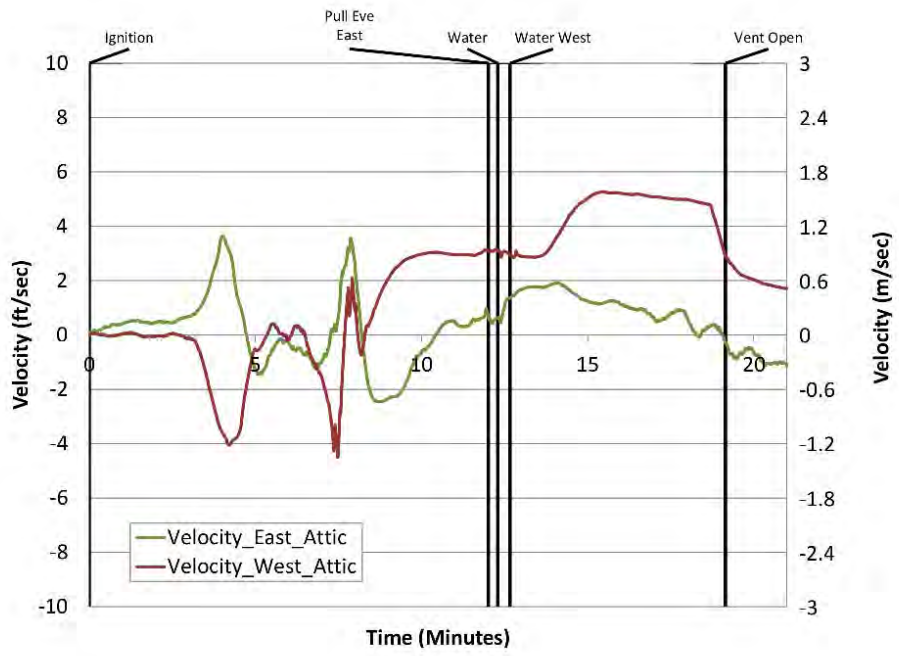
Figure I. 82: Attic Experiment 4A Gable Vent Velocity

Gable Vent Velocity Test 4A - Eave Attack Unvented
