Study of Residential Attic Fire Mitigation Tactics and Exterior Fire Spread Hazards on Fire Fighter Safety

UL Firefighter Safety Research Institute

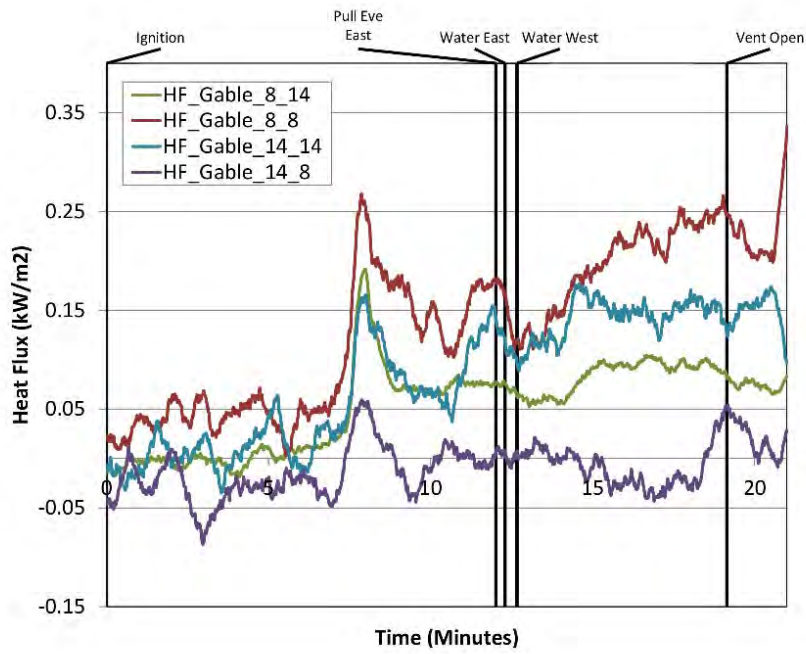
Figure I. 83: Attic Experiment 4A Gable End Heat Flux

Heat Flux Gable End Test 4A - Eave Attack Unvented

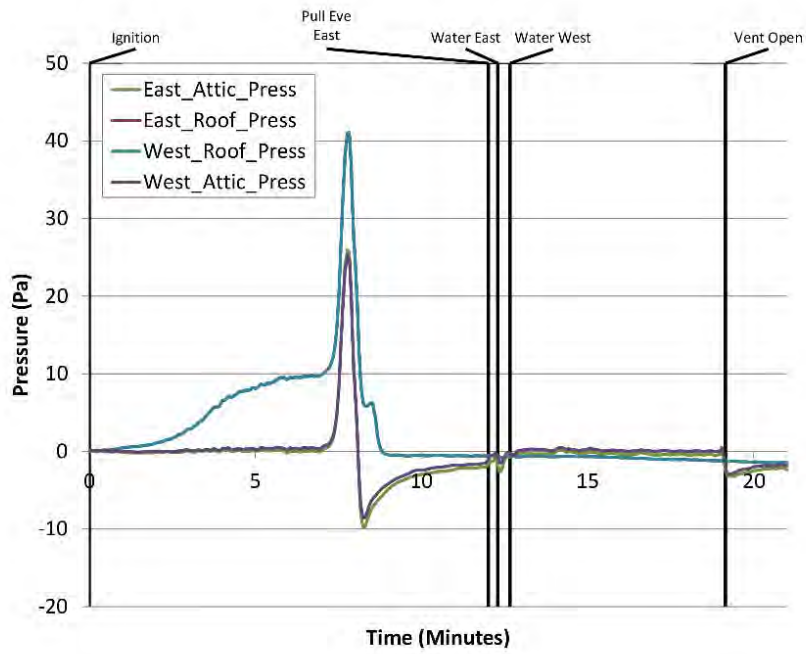
Figure I. 84: Attic Experiment 4A Attic Pressure

Attic Pressure Test 4A - Eave Attack Unvented

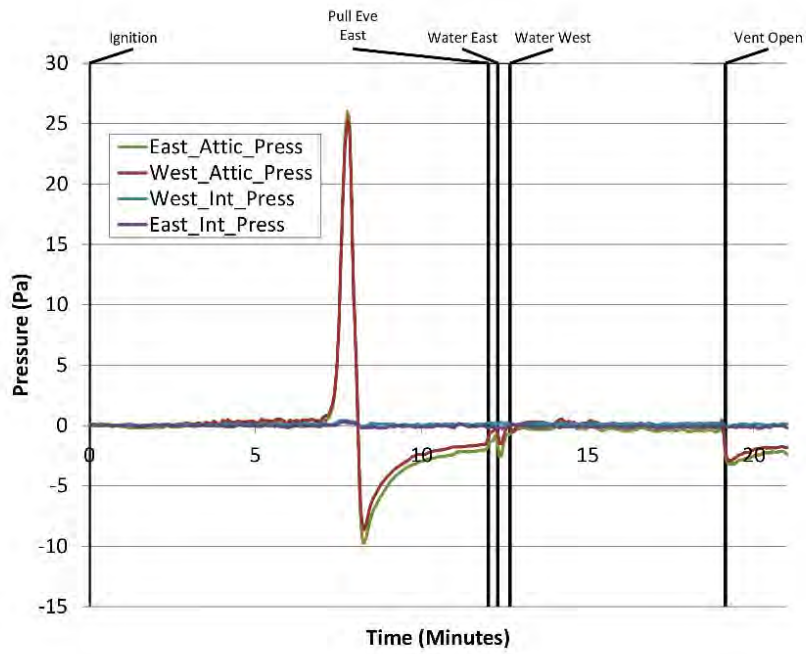
Figure I. 85: Attic Experiment 4A Attic Vs. Interior Pressure

Interior Pressure & Attic Pressure Test 4A - Eave Attack Unvented

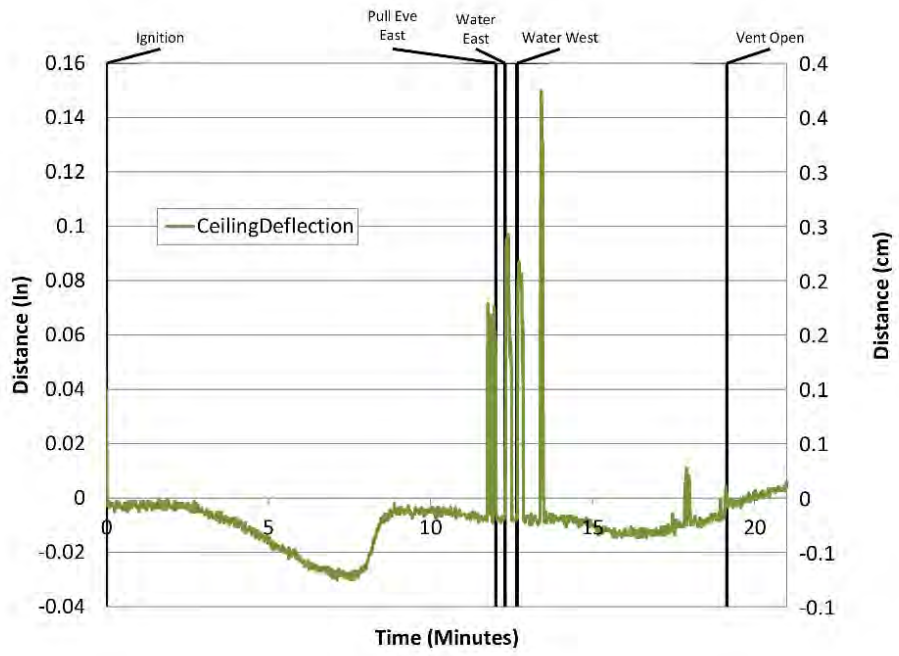
Figure I. 86: Attic Experiment 4A Ceiling Deflection

Ceiling Deflection Test 4A - Eave Attack Unvented

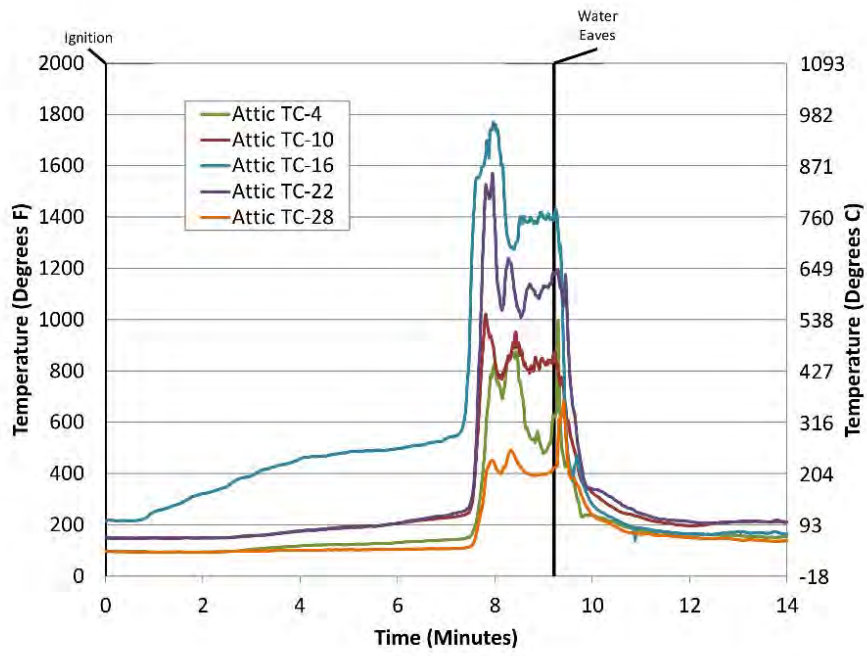
Figure I. 90: Attic Experiment 4B Attic Temperature Slice 4

Attic Temperature Slice 4
 Test 4B - Eave Attack Vented

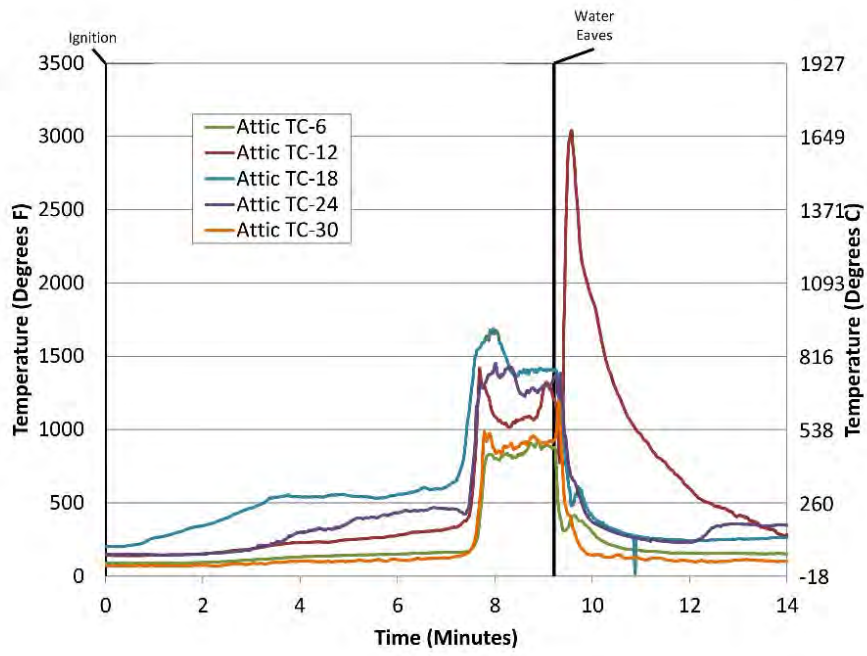
Figure I. 92: Attic Experiment 4B Attic Temperature Slice 6

Attic Temperature Slice 6
 Test 4B - Eave Attack Vented

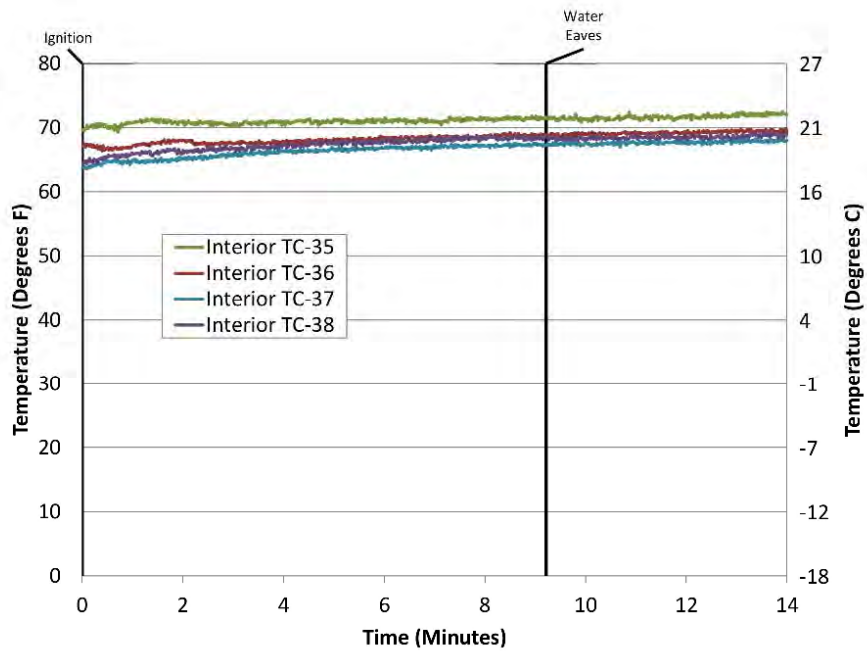
Figure I. 94: Attic Experiment 4B Interior Array BC

Interior Array BC Test 4B - Eave Attack Vented

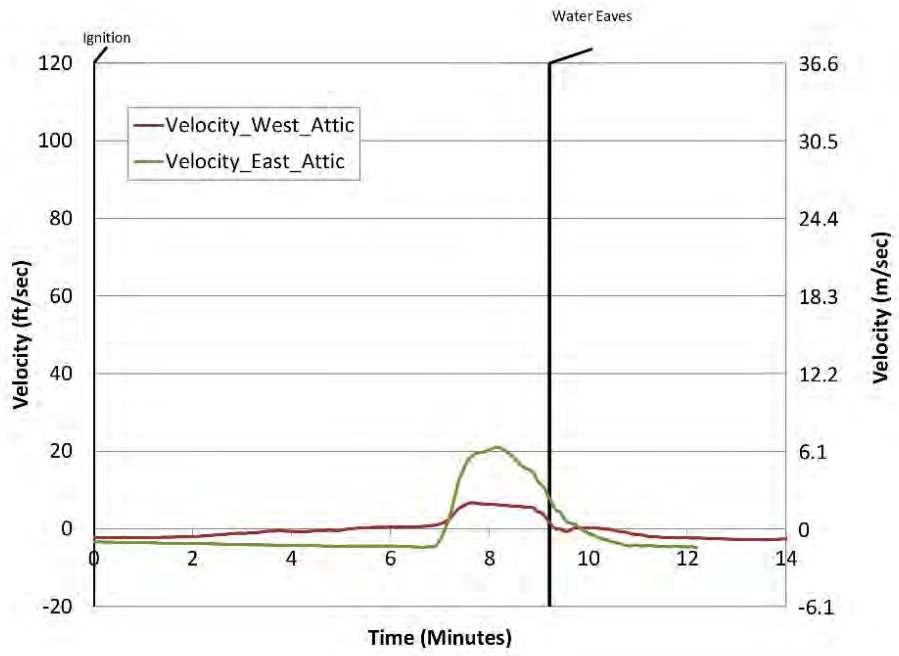
Figure I. 97: Attic Experiment 4B Gable Vent Velocity

Gable Vent Velocity Test 4B - Eave Attack Vented

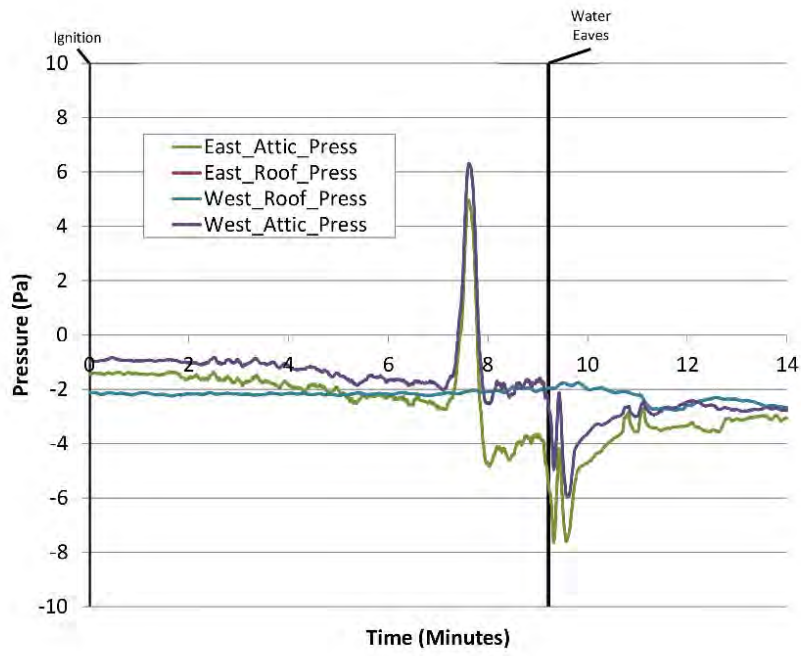
Figure I. 99: Attic Experiment 4B Attic Pressure

Attic Pressure Test 4B - Eave Attack Vented

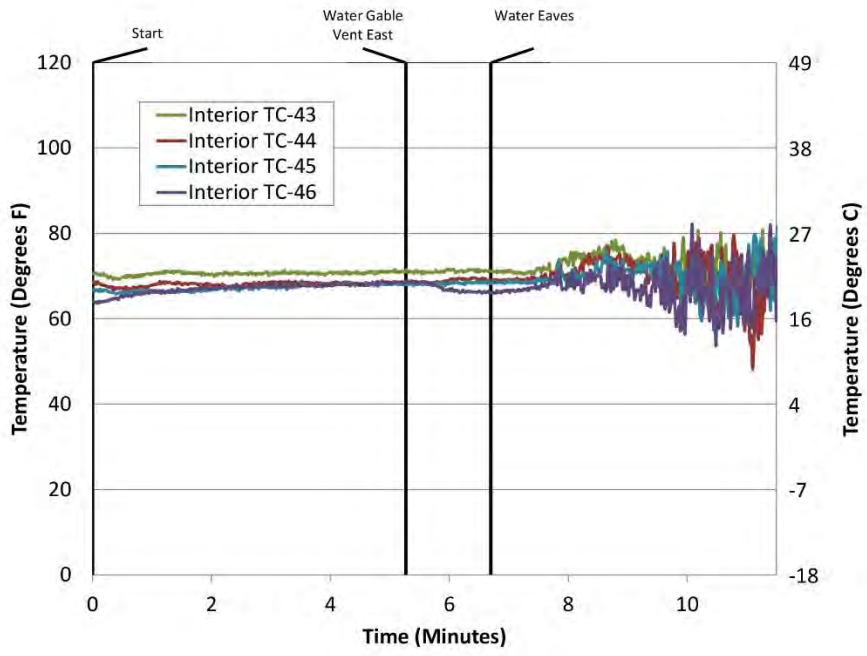
Figure I. 110: Attic Experiment 4C Interior Array CD

Interior Array CD Test 4C - Gable End & Eave Attack

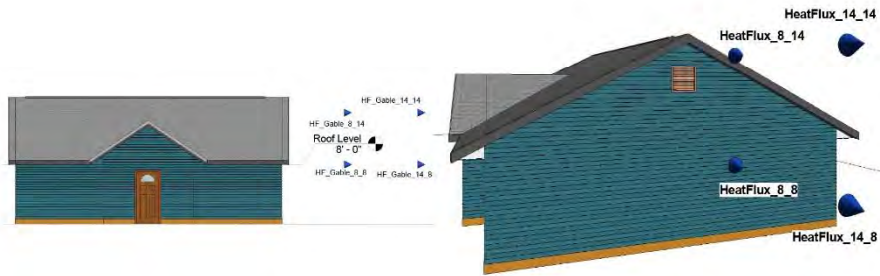
Figure I. 111: Attic Experiment 4C Interior Array AD

Interior Array AD Test 4C - Gable End & Eave Attack

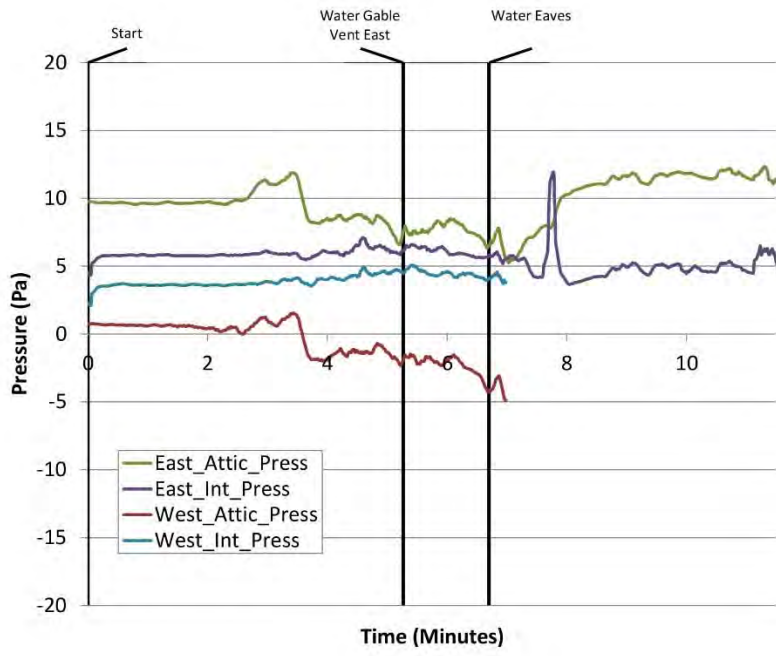
Figure I. 113: Attic Experiment 4C Attic Pressure

Attic Pressure Test 4C - Gable End & Eave Attack

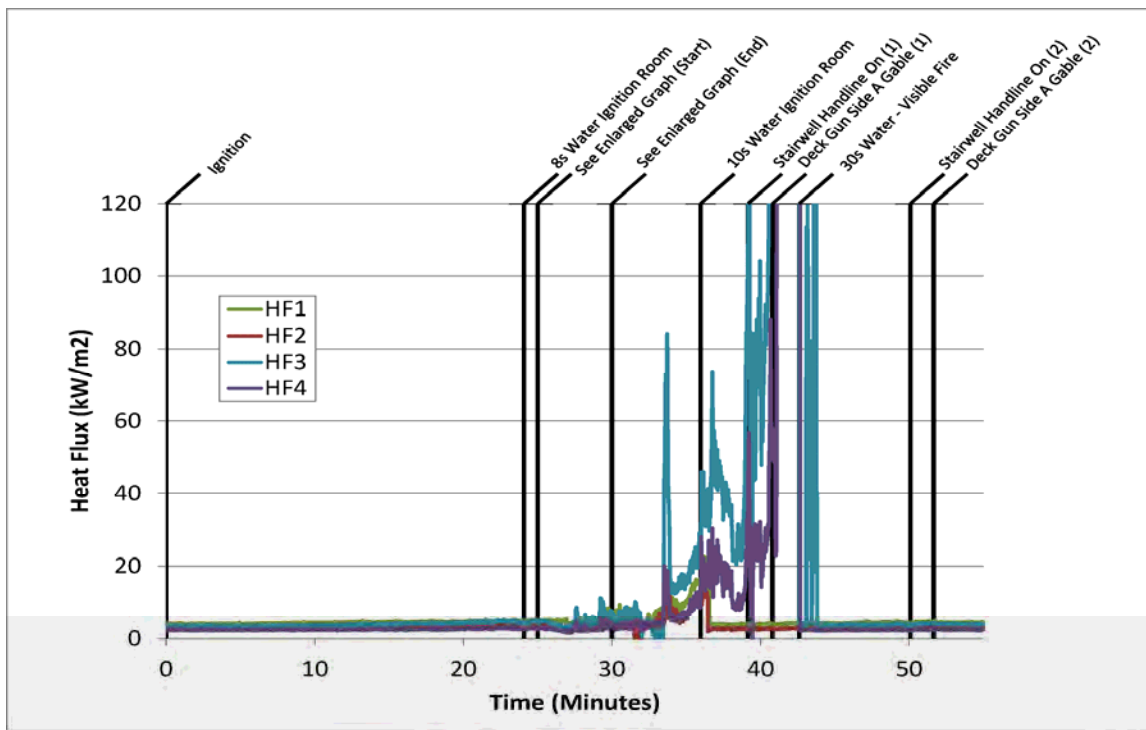
Figure J. 1: Knee Wall Experiment 1 Heat Flux Measurements

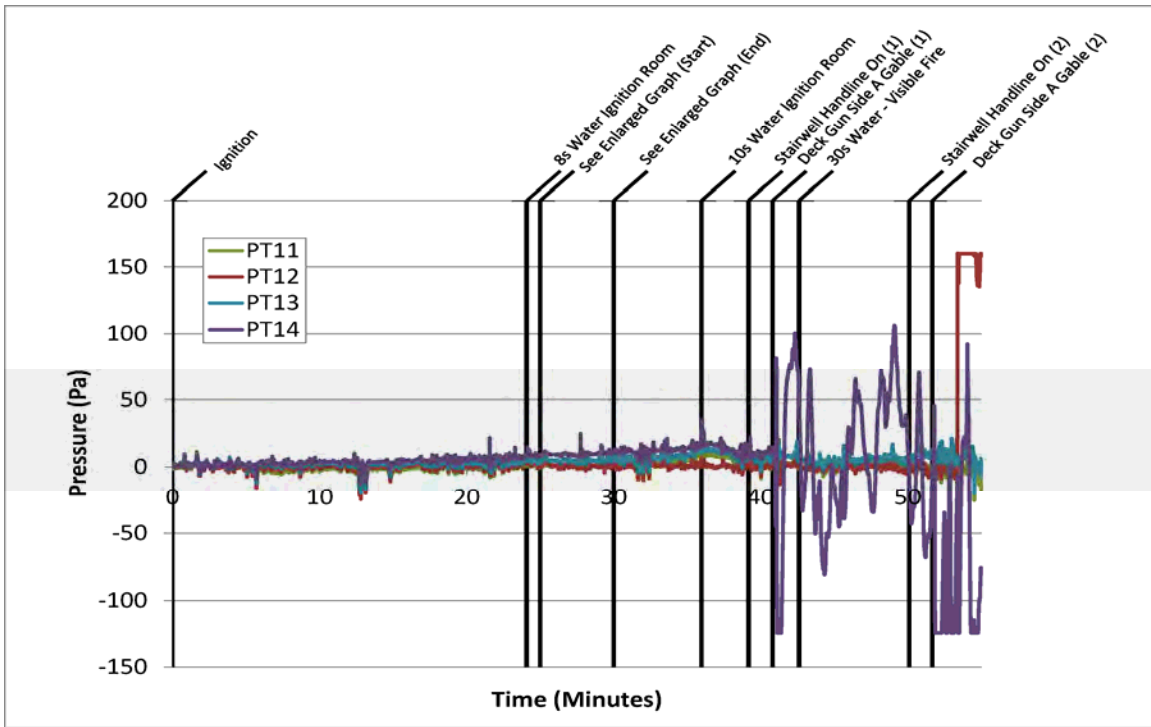
Figure J. 5: Pressure Measurements Side A

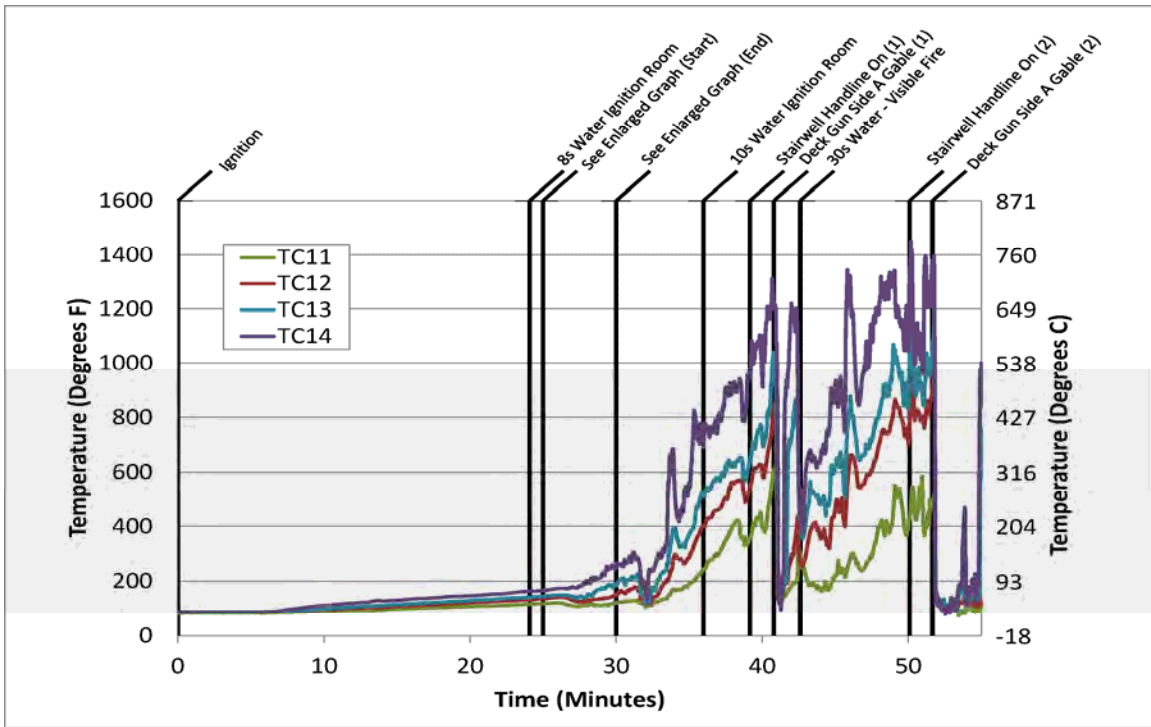
Figure J. 15: Attic Bedroom Temperatures

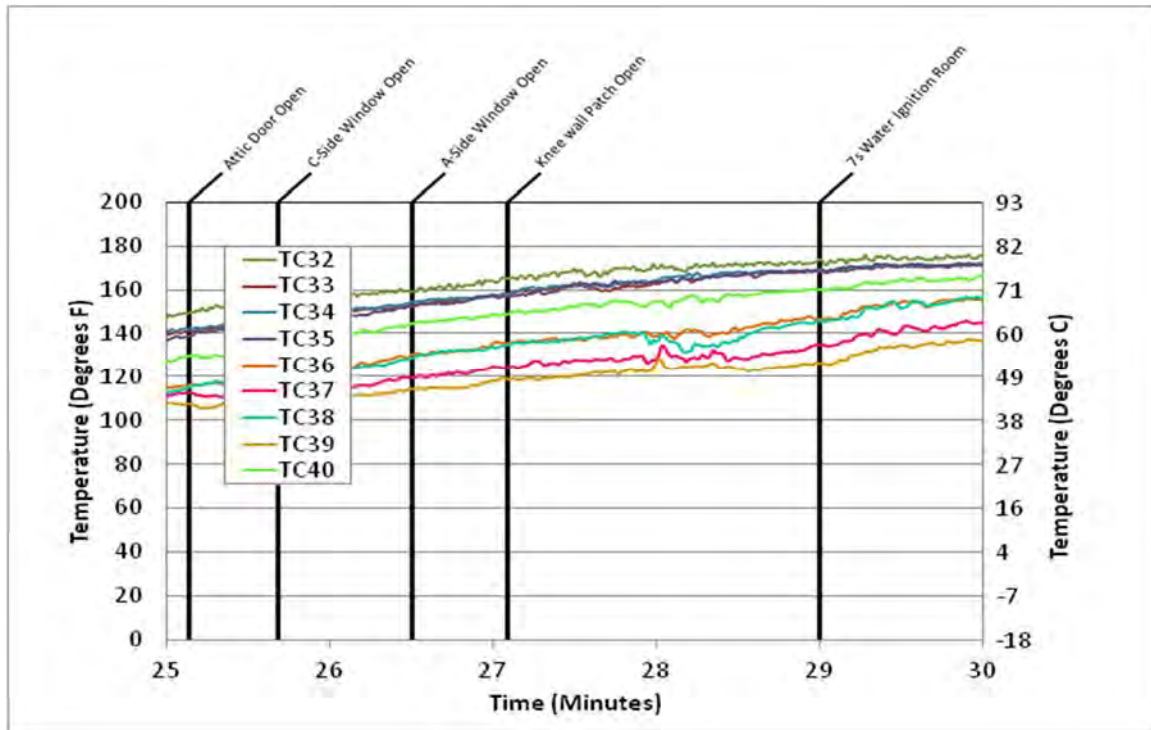
Figure J. 18: Knee Wall D Temperatures (from 25 to 30 min)

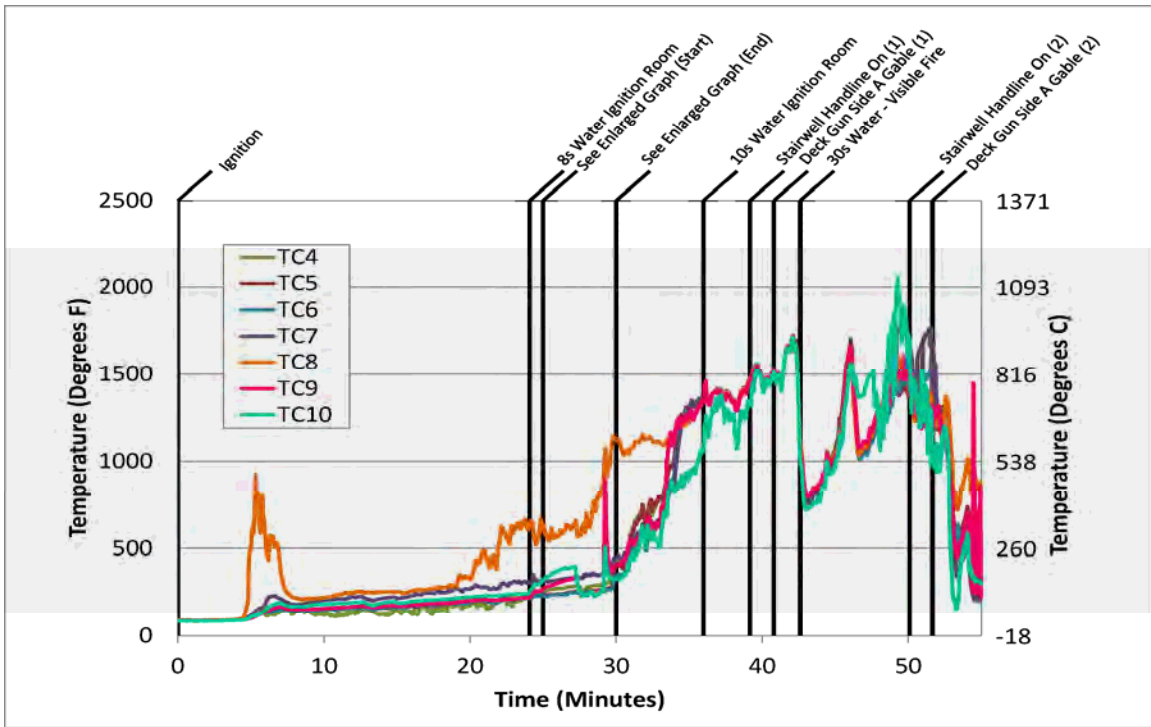
Figure J. 21: Knee Wall B Temperatures

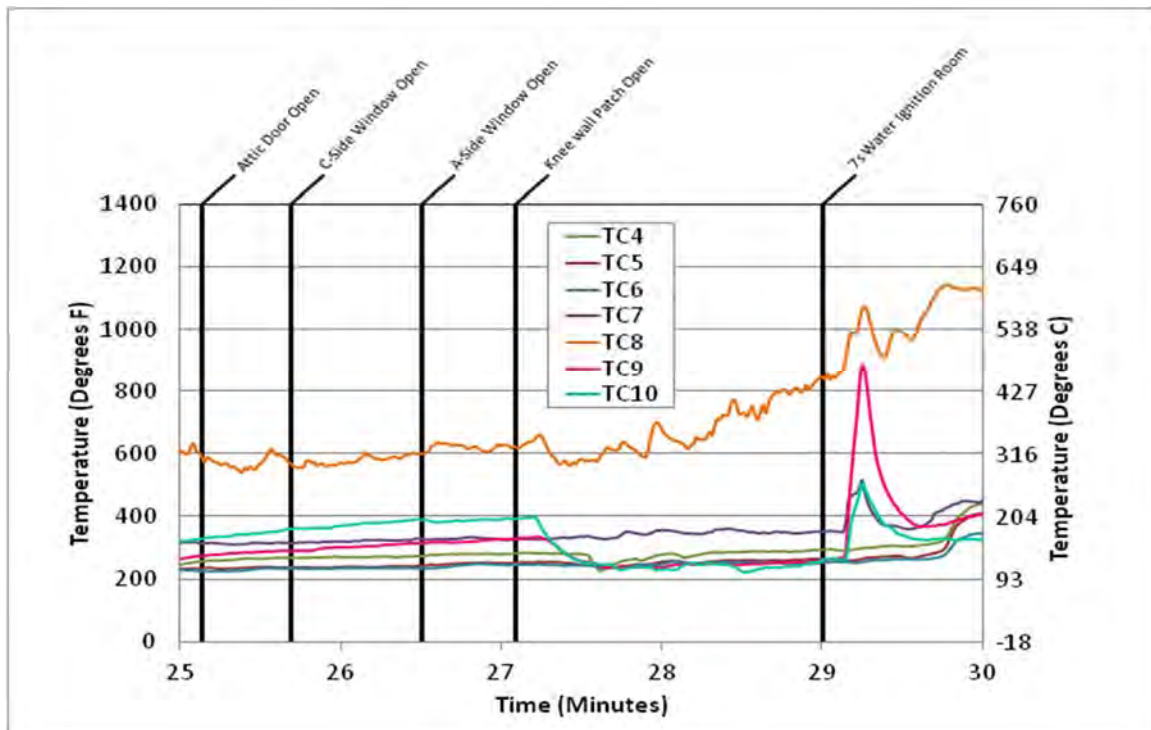
Figure J. 22: Knee Wall B Temperatures (from 25 to 30 min)

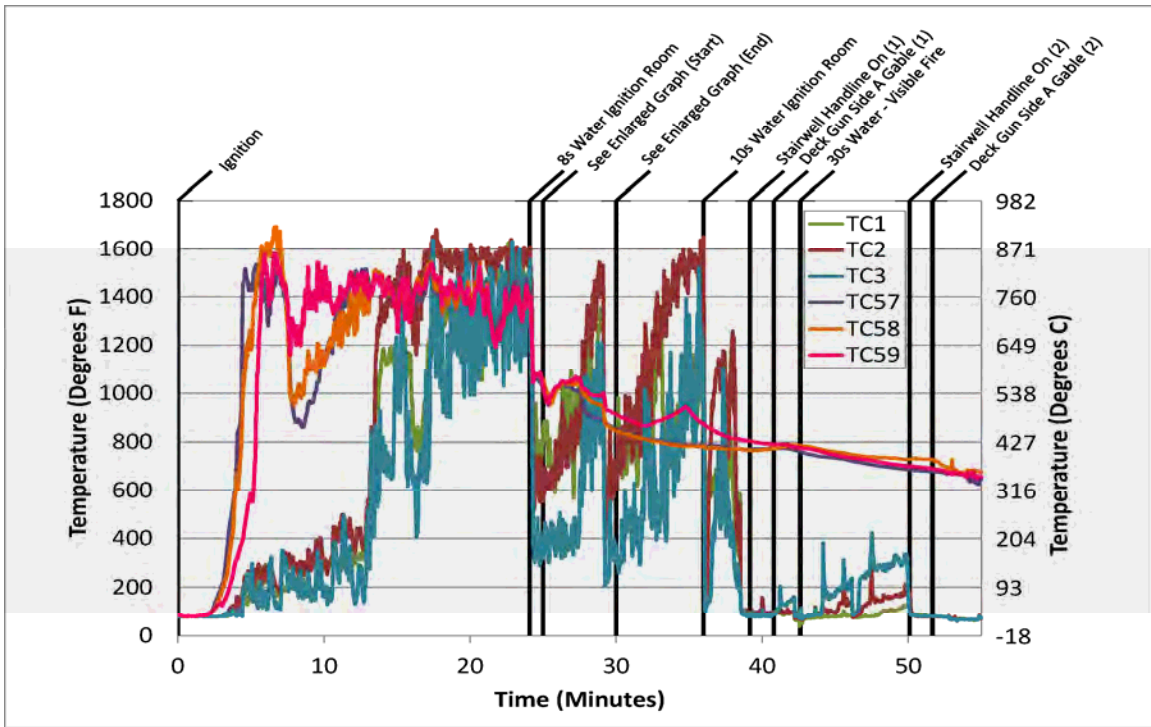
Figure J. 23: Exterior and Interior Temperatures in the Eave

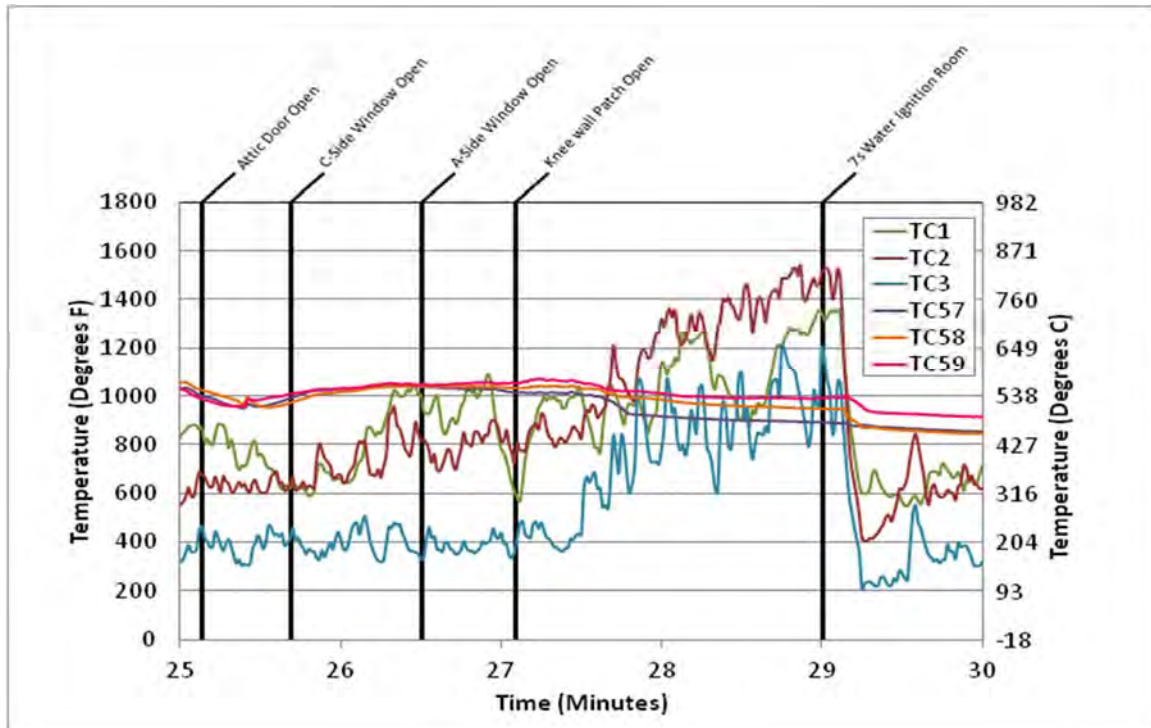
Figure J. 24: Exterior and Interior Temperatures in the Eave (from 25 to 30 min)

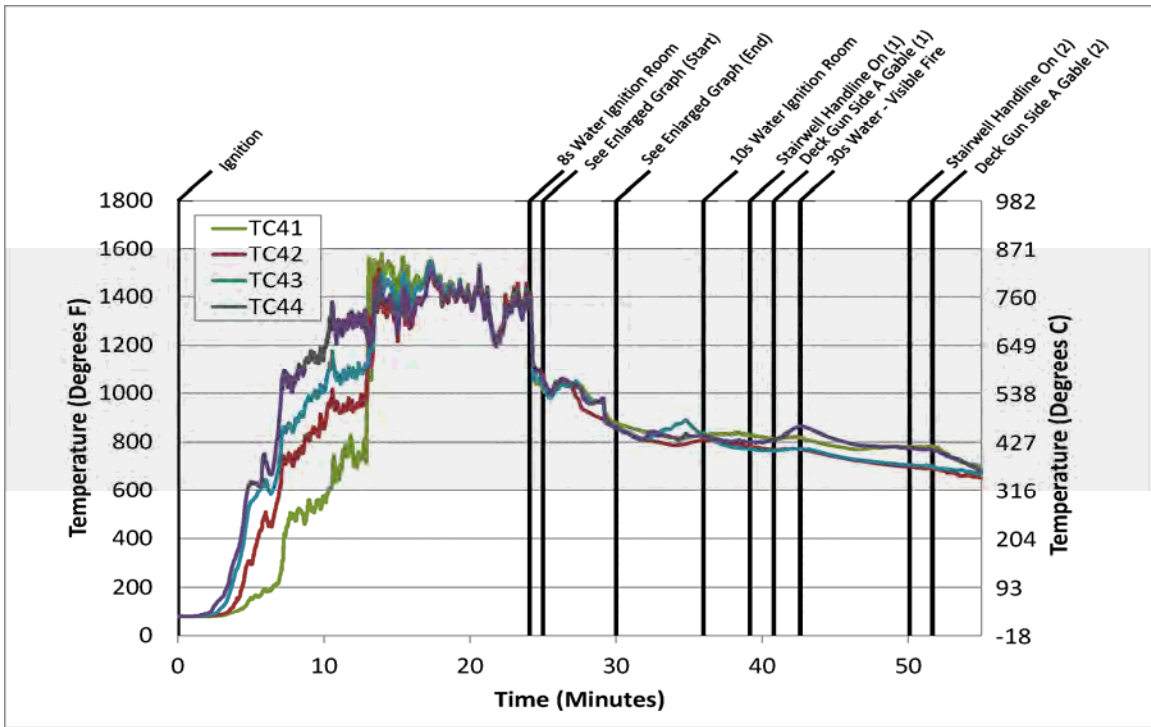
Figure J. 25: Second Floor Bedroom Temperatures

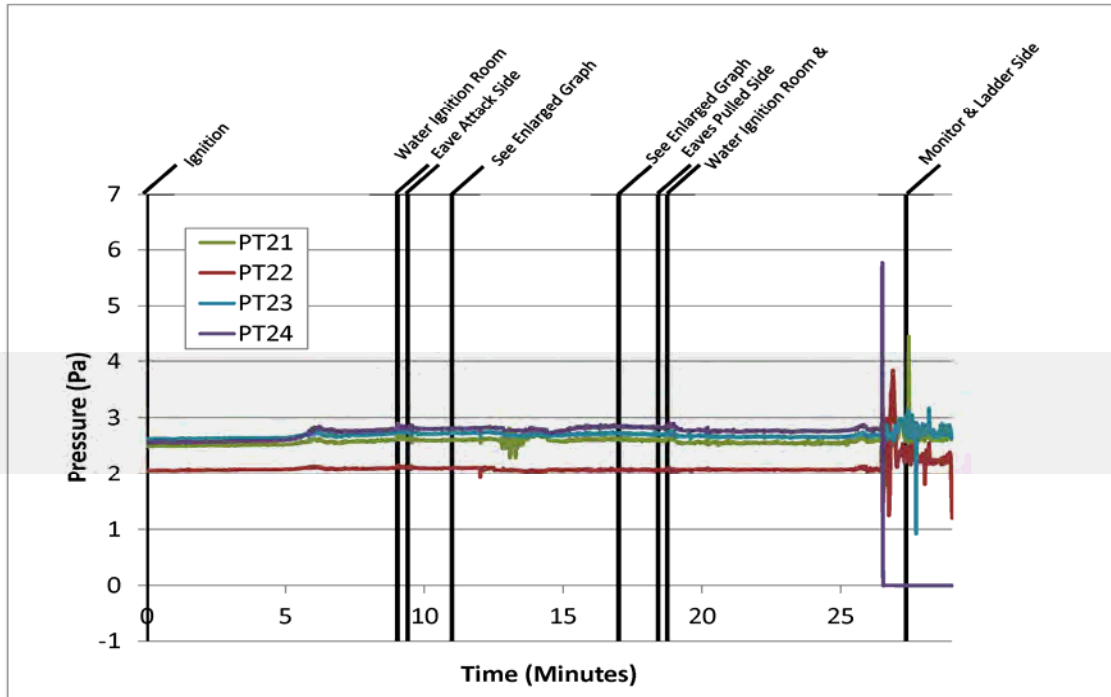
Figure J. 27: Pressure Measurements Side C

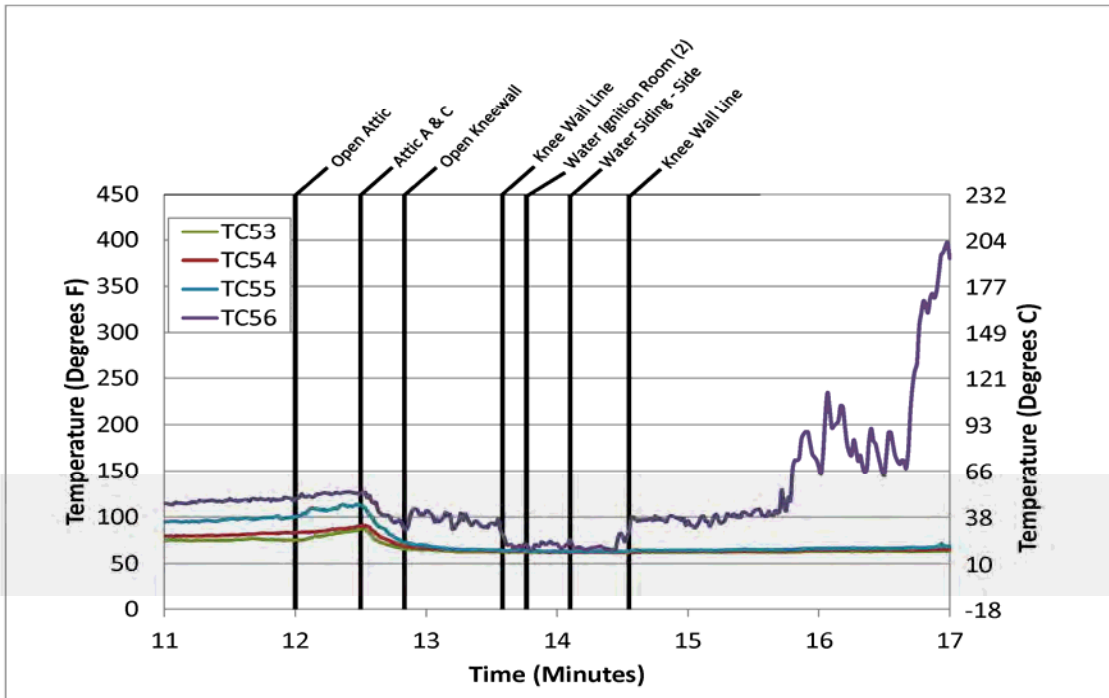
Figure J. 32: Stairwell Temperatures (from 11 to 17 min)

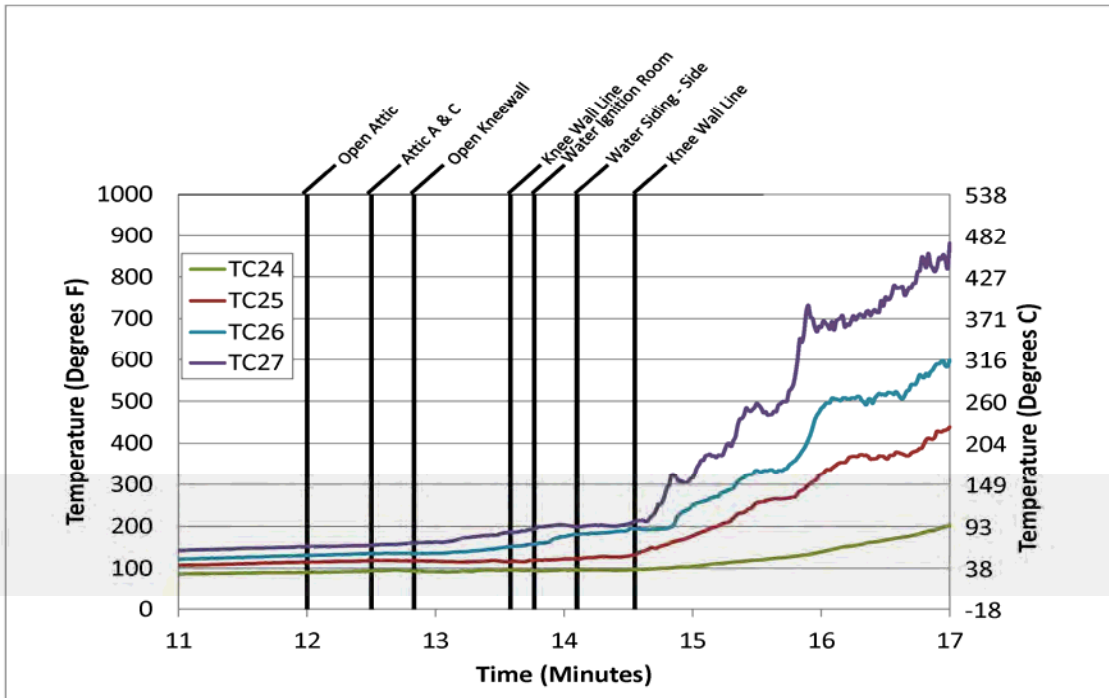
Figure J. 38: Attic Bedroom Temperatures (from 11 to 17 min)

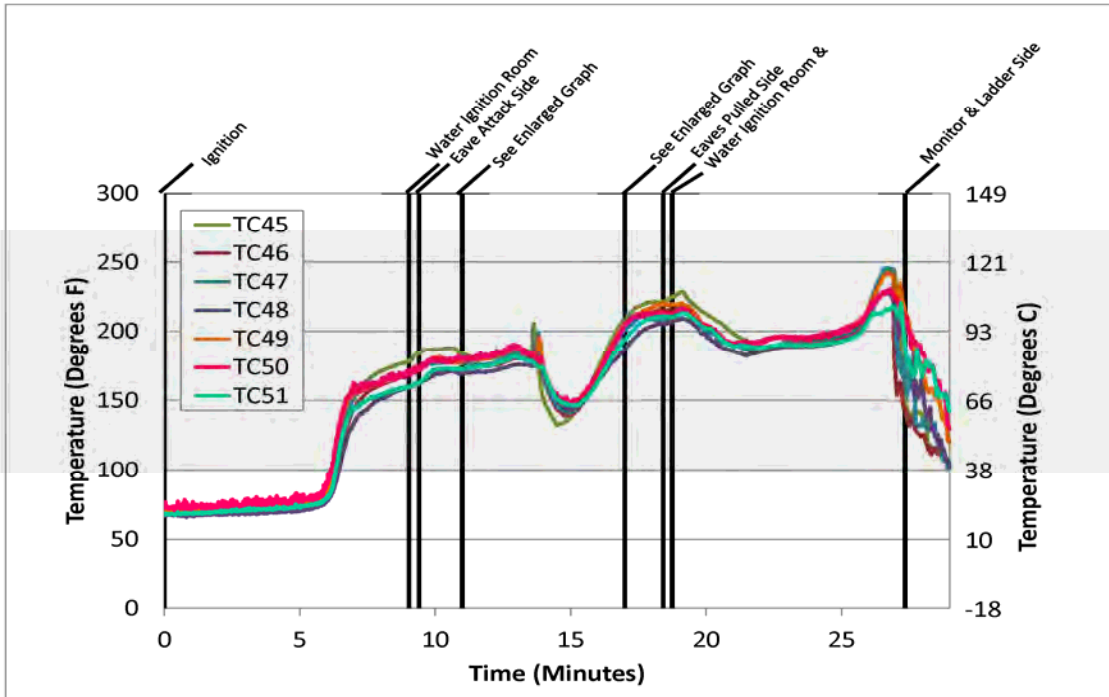
Figure J. 39: Knee Wall D Temperatures

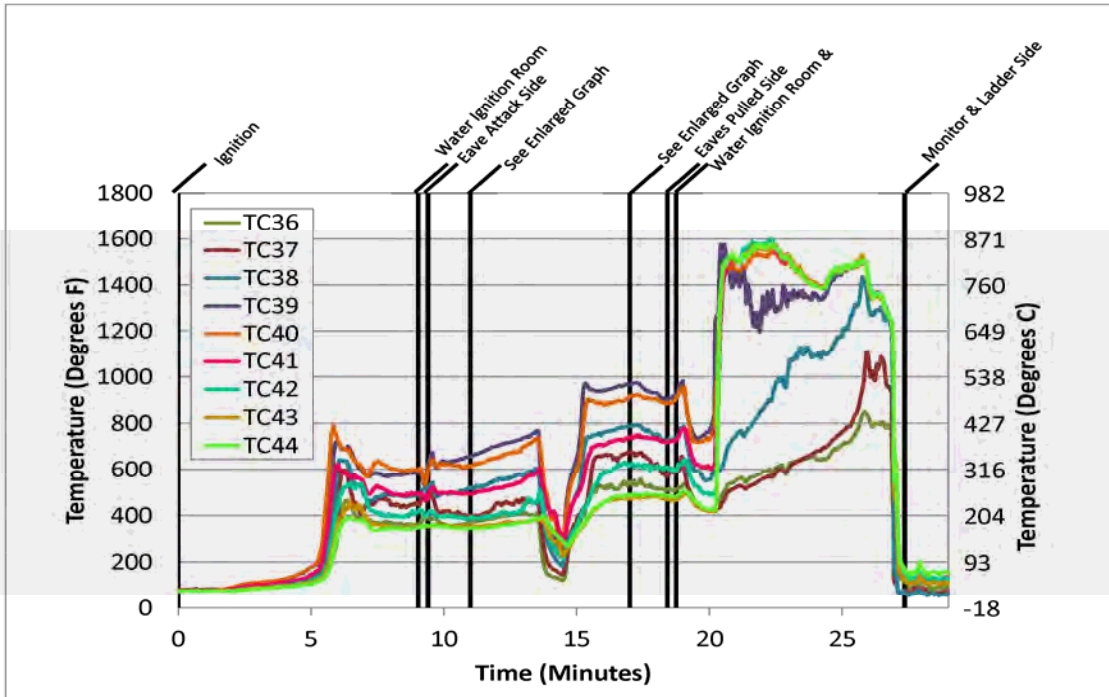
Figure J. 41: Temperatures in the Peak of the Attic

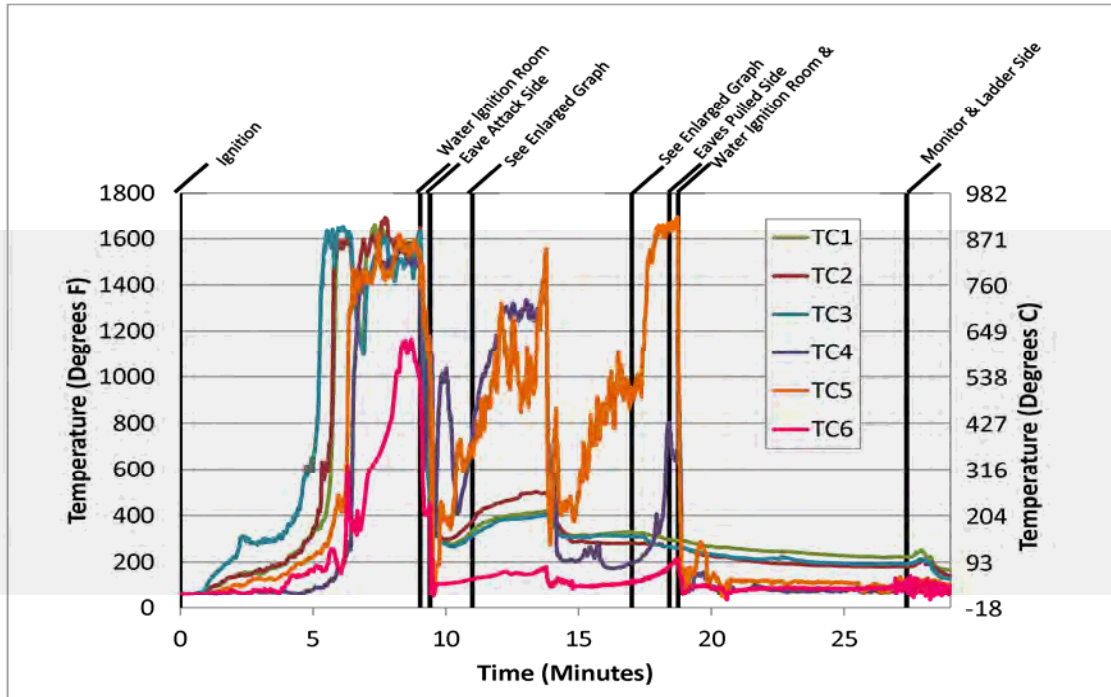
Figure J. 47: Exterior and Interior Temperatures in the Eave

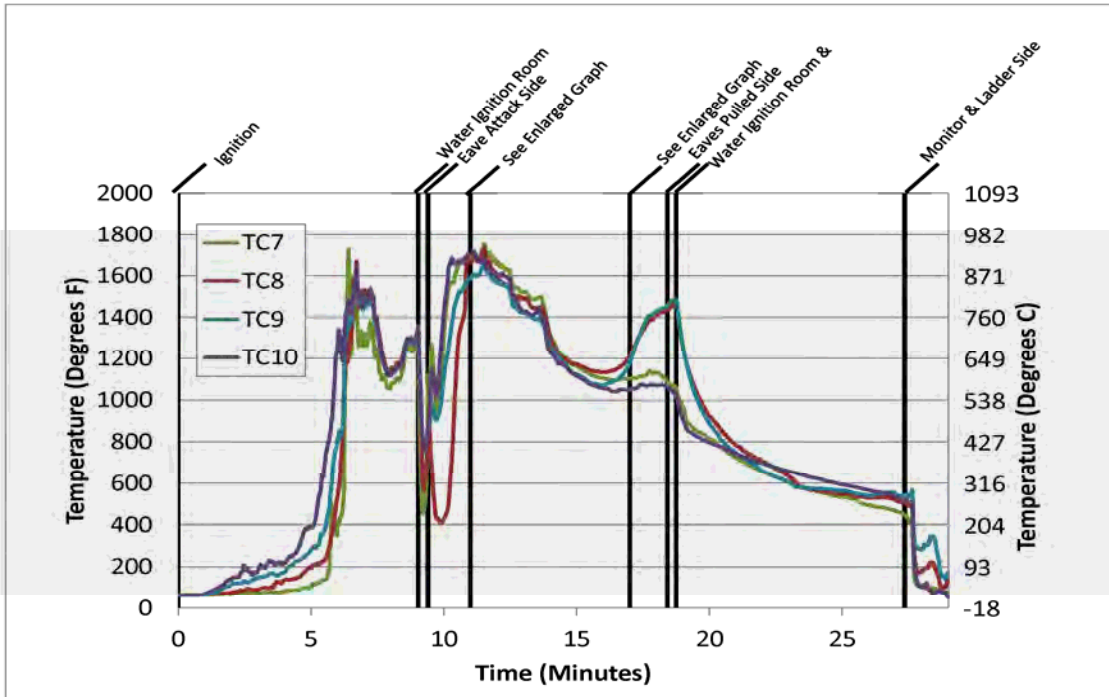
Figure J. 49: Second Floor Bedroom Temperatures

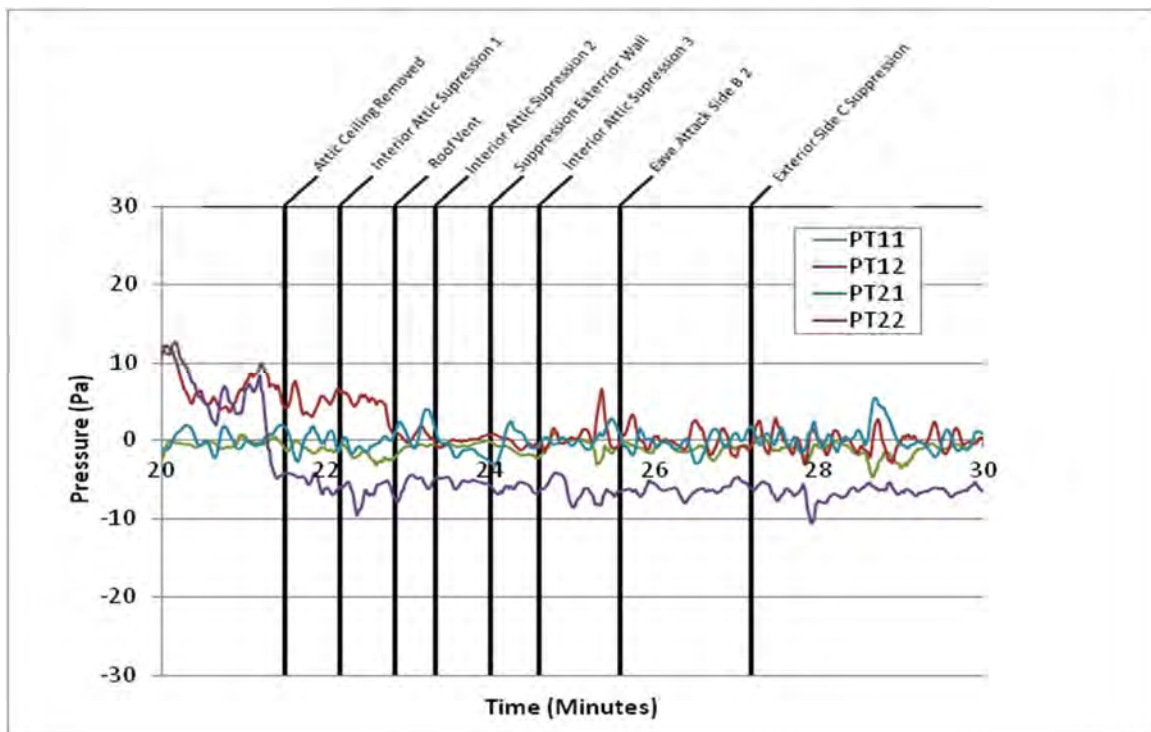
Figure J. 52: Pressure Measurements (from 20 to 30 min)

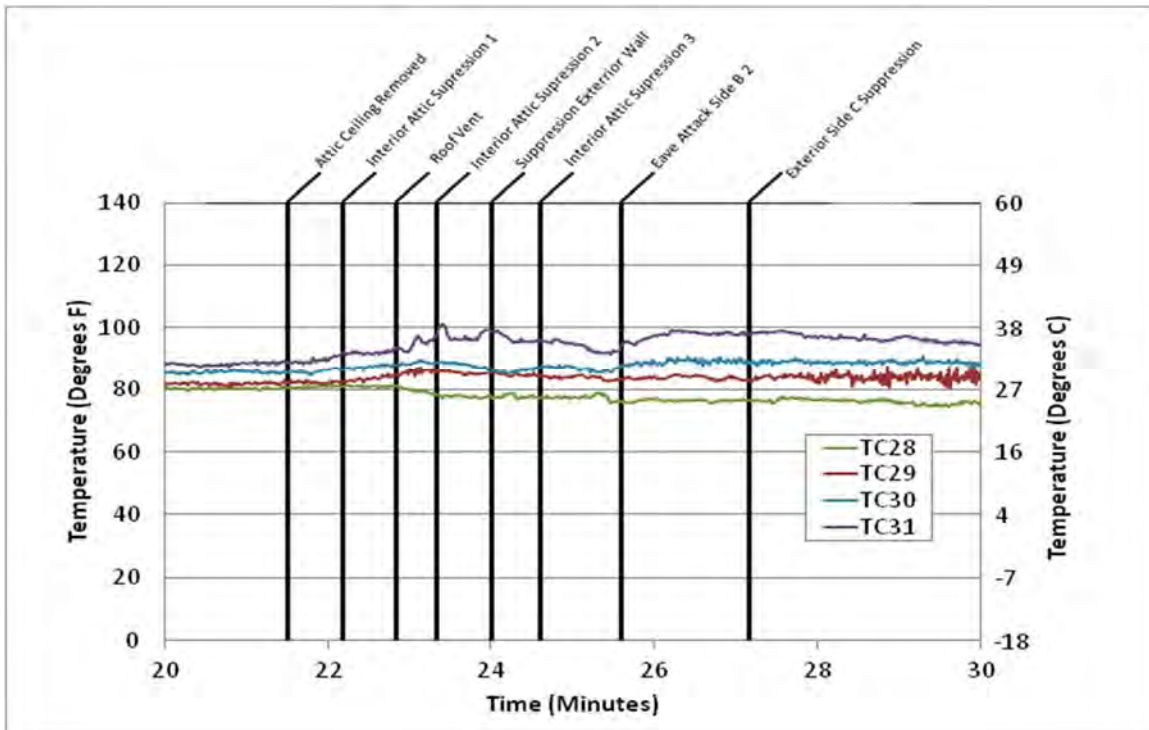
Figure J. 62: Bedroom 2 Temperatures (from 20 to 30 min)

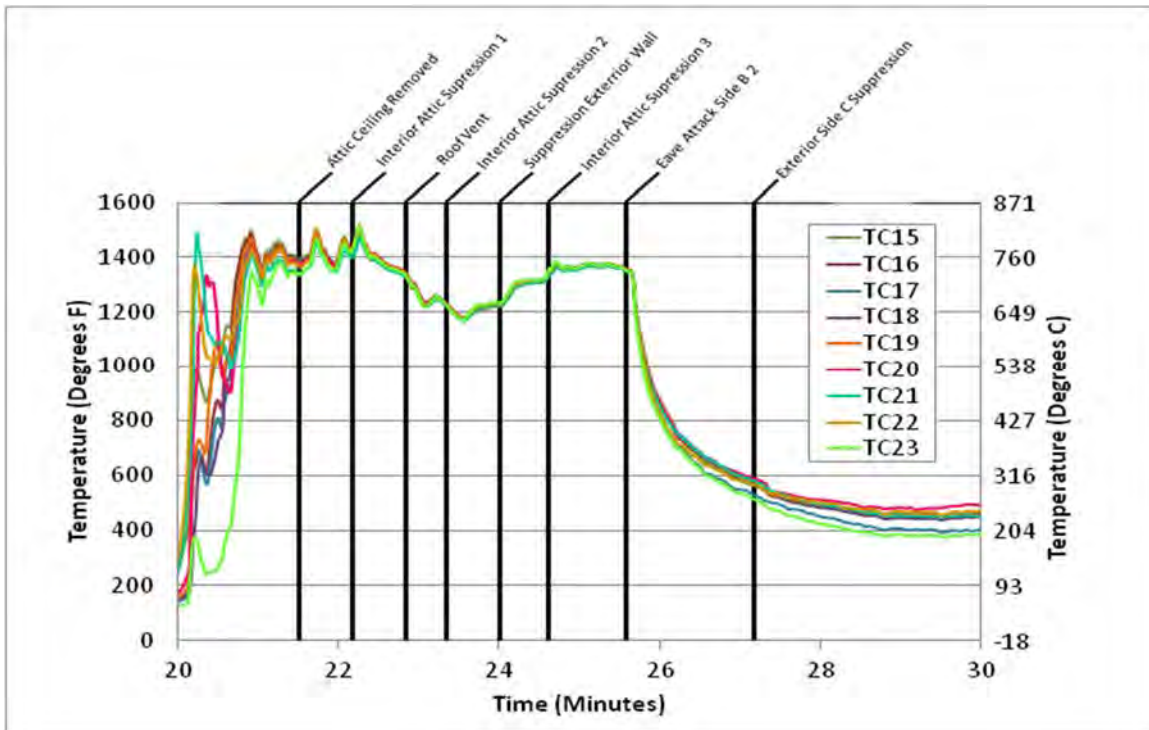
Figure J. 68: Attic Space Temperatures 1 Ft. above second story ceiling (from 20 to 30 min)

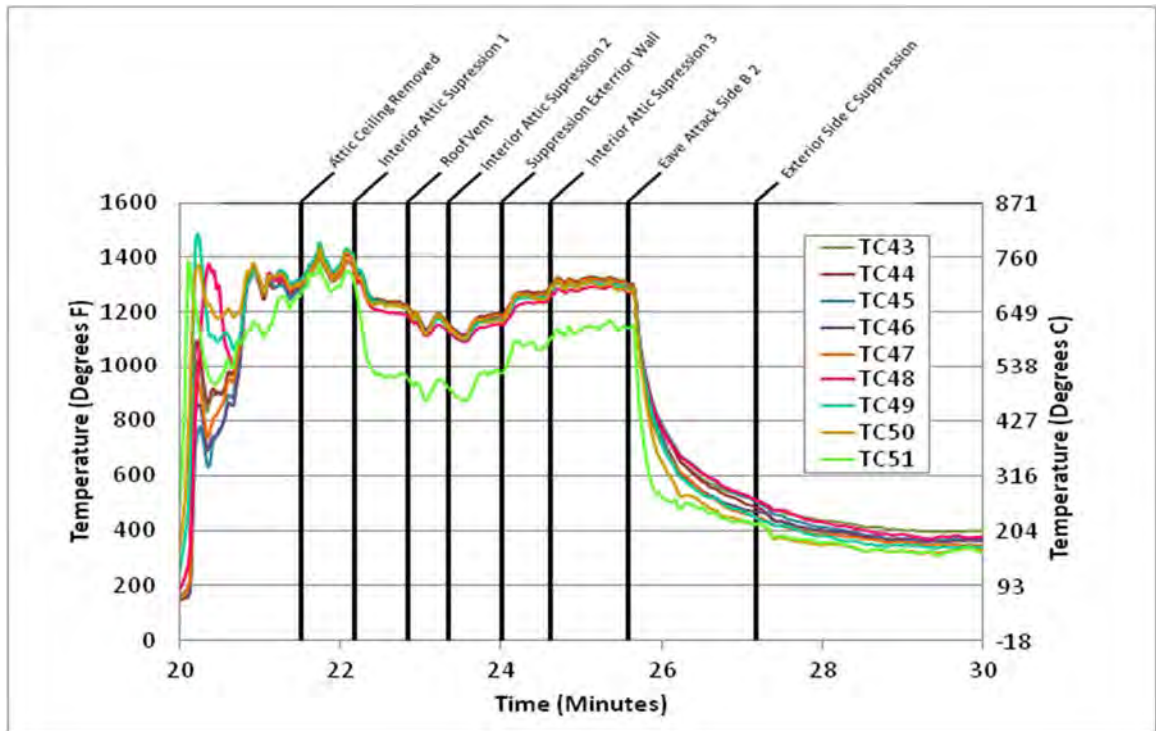
Figure J. 70: Attic Space Temperatures 1 Ft. below roof (from 20 to 30 min)
