Study of Residential Attic Fire Mitigation Tactics and Exterior Fire Spread Hazards on Fire Fighter Safety

UL Firefighter Safety Research Institute

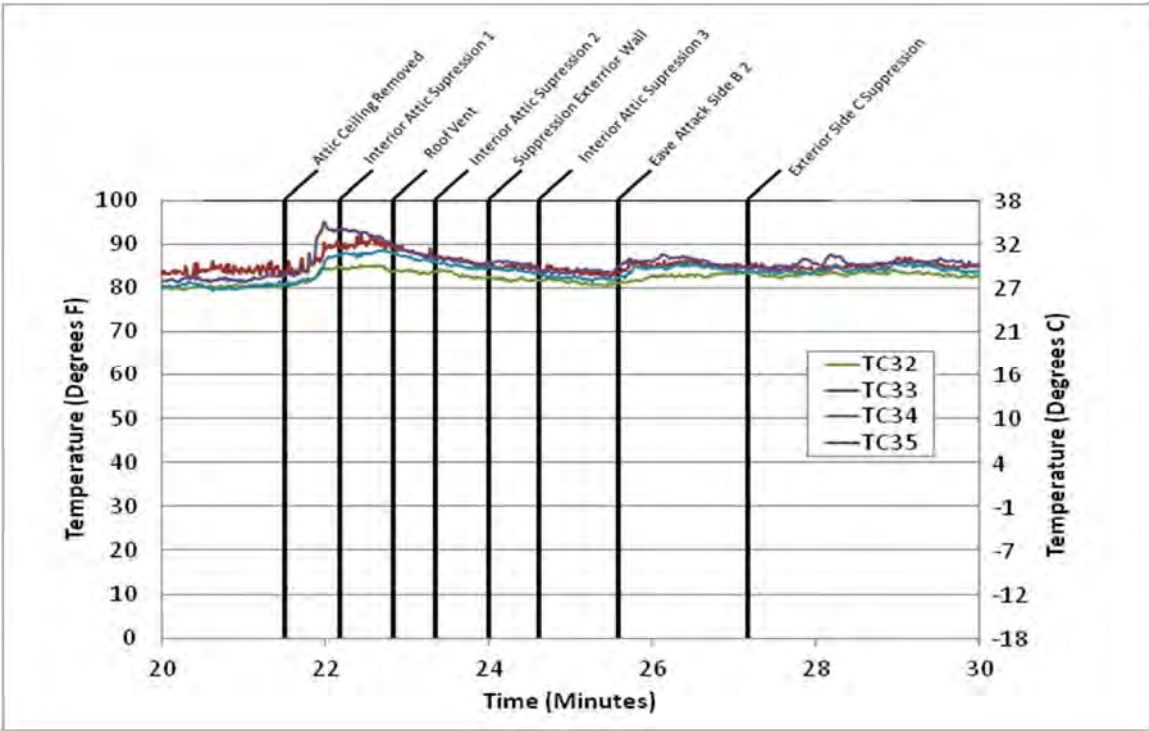
Figure J. 73: Den Temperatures (from 20 to 30 min)
