**Report
on
Structural Stability of Engineered Lumber in Fire Conditions**

**Project Number: 07CA42520
File Number: NC9140**

**Underwriters Laboratories Inc.
333 Pfingsten Road, Northbrook, IL 60062**

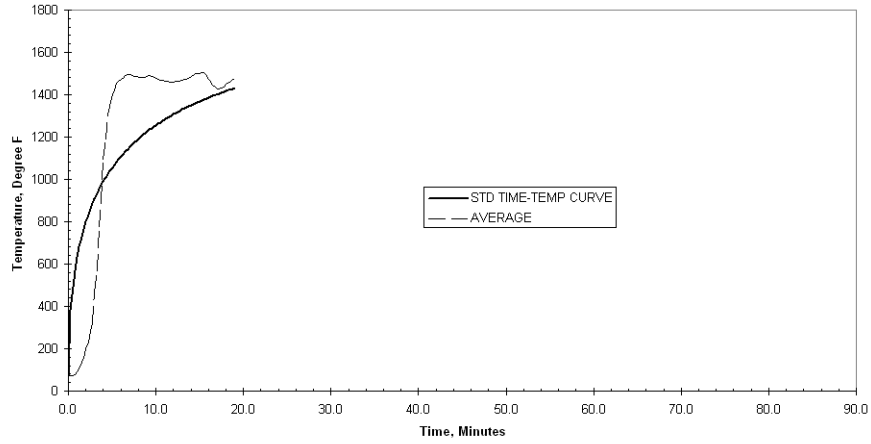
Character and Distribution of the Furnace Fire - The furnace fire was luminous and well distributed throughout the test. A plot of the furnace temperature can be seen on Figure 1.

Figure 1 - UL263 Standard Time Temperature Curve and Average Furnace Temperature vs. Time for Assembly No. 1

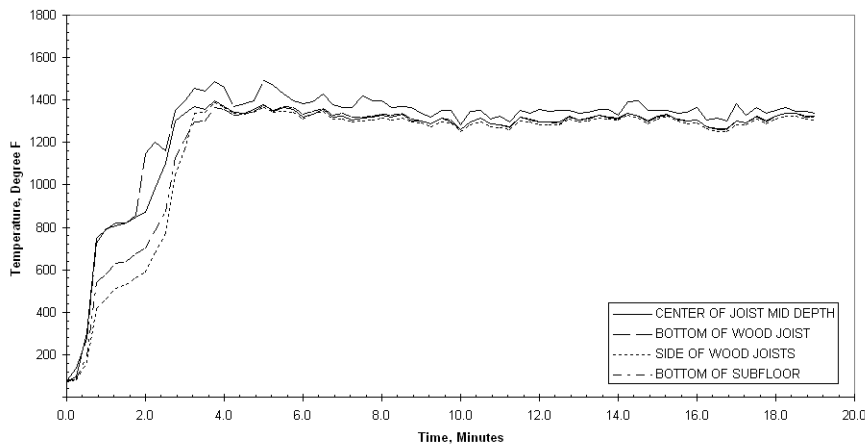
Temperatures of the Sub Floor Between Wood Joists – The average and maximum temperatures of the sub floor between the wood joists just before the moment of collapse (18 min 45 sec) were 1122°F and 1161°F respectively. The maximum individual temperature was recorded by thermocouple number 46. The average temperature was plotted on Figure 2.

Figure 2 - Plot of Temperatures Below Subfloor vs. Time for Assembly No. 1

Temperatures of the Mid Depth Between Wood Joists – The average and maximum temperatures of the mid depth between the wood joists just before the moment of collapse (18 min 45 sec) were 1114°F and 1147°F respectively. The maximum individual temperature was recorded by thermocouple number 38. The average temperature was plotted on Figure 1.2.

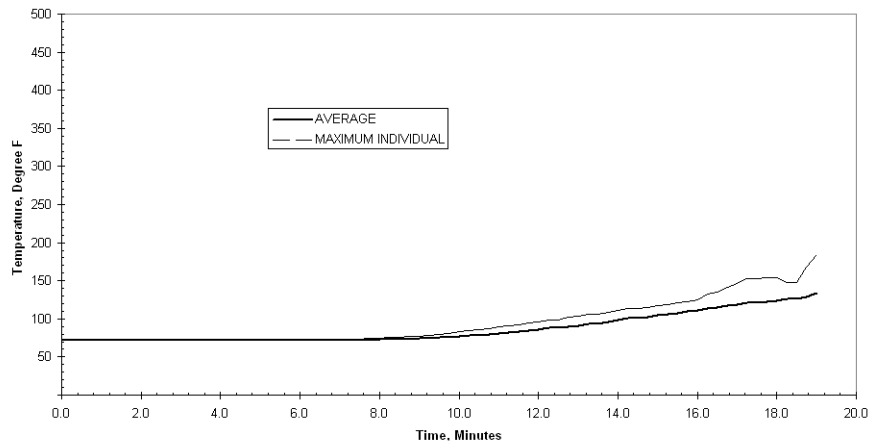
Temperatures of the Unexposed Surface – The average and maximum temperatures of the unexposed surface just before the moment of collapse (18 min 45 sec) were 122°F and 616°F respectively. The maximum individual temperature was recorded by thermocouple number 61. The average temperature and maximum temperatures were plotted on Figure 4.

Figure 4 - Plot of the Unexposed Surface Temperatures vs. Time for Assembly No. 1

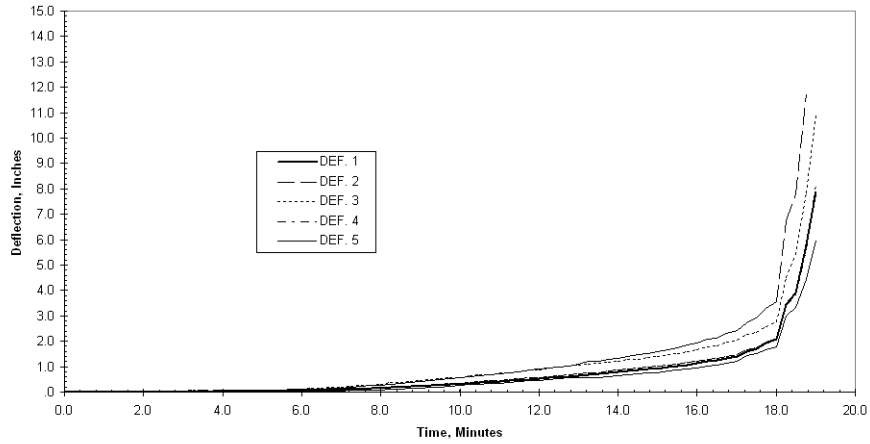
Deflection of the Assembly - The deflection of the floor-ceiling assembly during the fire test is shown on Figure 5. The location of each deflection transducer can be seen in Appendix A under Test Assembly 1.

Figure 5 - Plot of Deflections vs. Time for Assembly No. 1

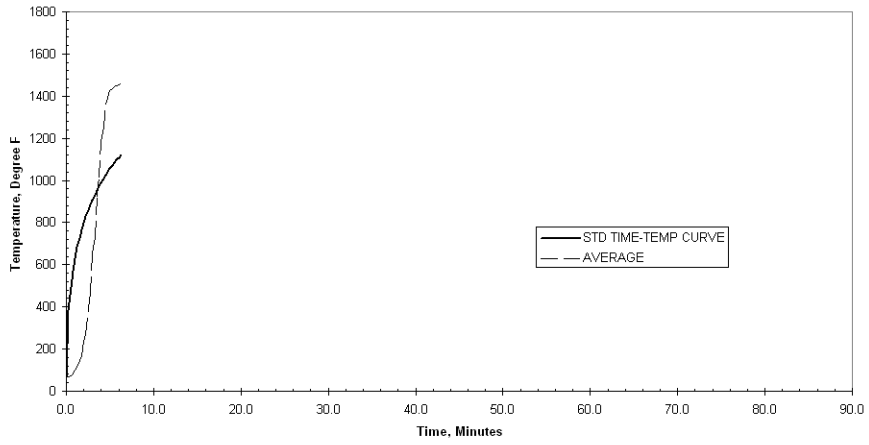
Character and Distribution of the Furnace Fire - The furnace fire was luminous and well distributed throughout the test. A plot of the furnace temperature can be seen on Figure 6.

Figure 6 – UL263 Standard Time Temperature Curve and Average Furnace Temperature vs. Time for Assembly No. 2

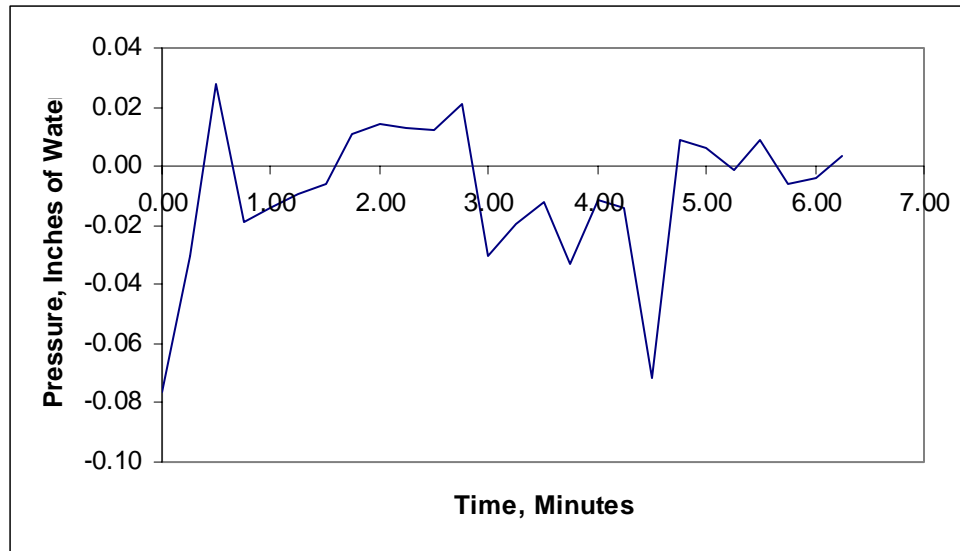
The furnace pressure and oxygen concentration measured in the furnace are presented in Figure 7 and Figure 8.

Figure 7 - Furnace Pressure vs. Time for Assembly No. 2

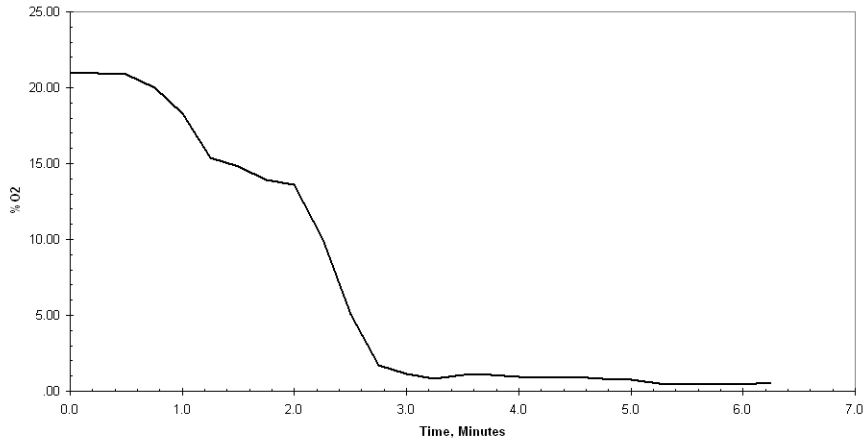
Figure 8 - Oxygen Content vs. Time Oxygen Content vs. Time for Assembly No. 2

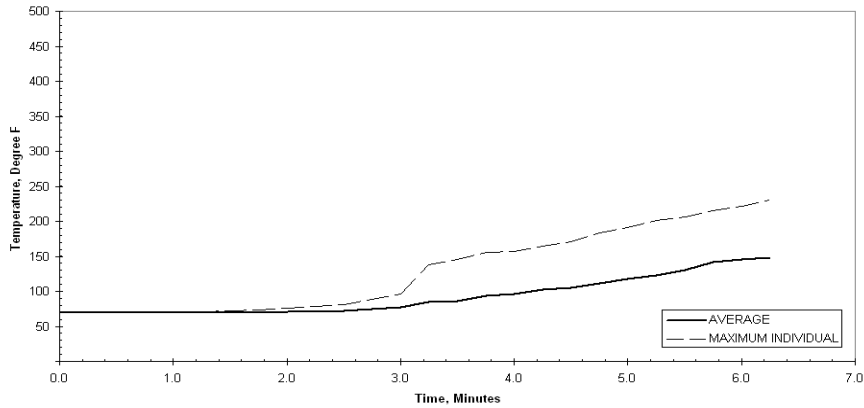
Temperatures of Between the Sub Floor and Carpet Padding – The average and maximum temperatures between the sub floor and finish floor just before the moment of collapse (6 min 3 sec) were 228°F and 1371°F respectively. The individual temperature

was recorded by thermocouple number 3. A plot of these temperatures can be seen on Figure 10.

Figure 10 - Plot of the Subfloor Temperatures vs. Time for Assembly No. 2

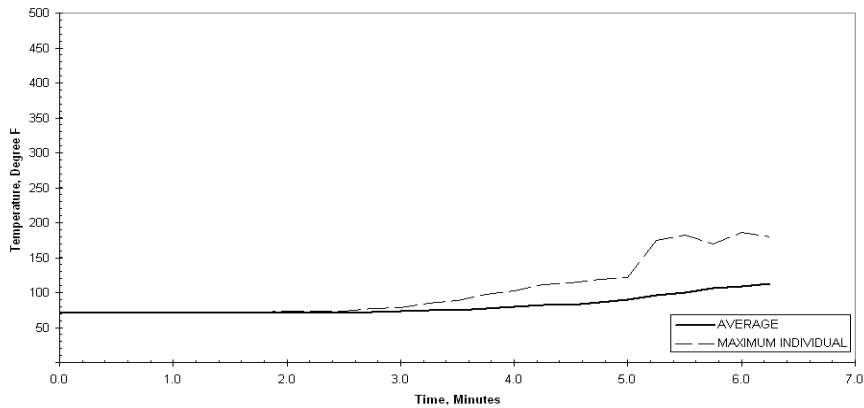
Temperatures of Between the Carpet Padding and Carpet – The average and maximum temperatures between the carpet padding and carpet just before the moment of collapse (6 min 3 sec) were 109°F and 187°F respectively. The individual temperature was recorded by thermocouple number 29. A plot of these temperatures can be seen on Figure 11.

Figure 11 - Plot of Temperature of the Carpet Padding vs. Time for Assembly No. 2

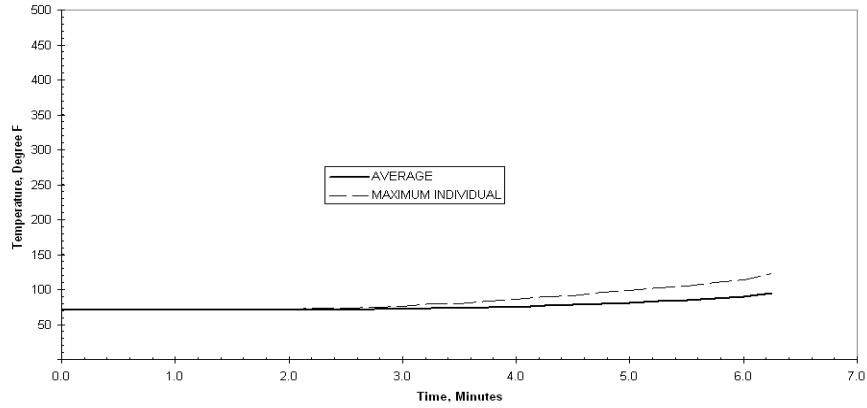
Temperatures of the Unexposed Surface – The average and maximum temperatures of the unexposed surface just before the moment of collapse (6 min 3 sec) were 90°F and

114°F respectively. The individual temperature was recorded by thermocouple number 83. A plot of these temperatures can be seen on Figure 12.

Figure 12 - Plot of Unexposed Surface Temperatures vs. Time for Assembly No. 2

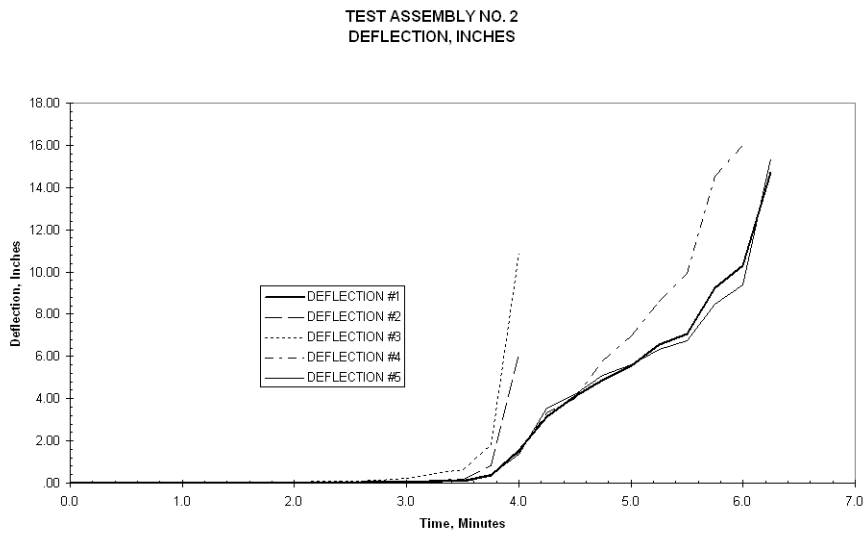
Deflection of the Assembly - The deflection of the floor-ceiling assembly during the fire test is shown on Figure 13. The location of each deflection transducer can be seen in Appendix A under Test Assembly 2.

Figure 13 - Plot of Deflections vs. Time for Assembly No. 2

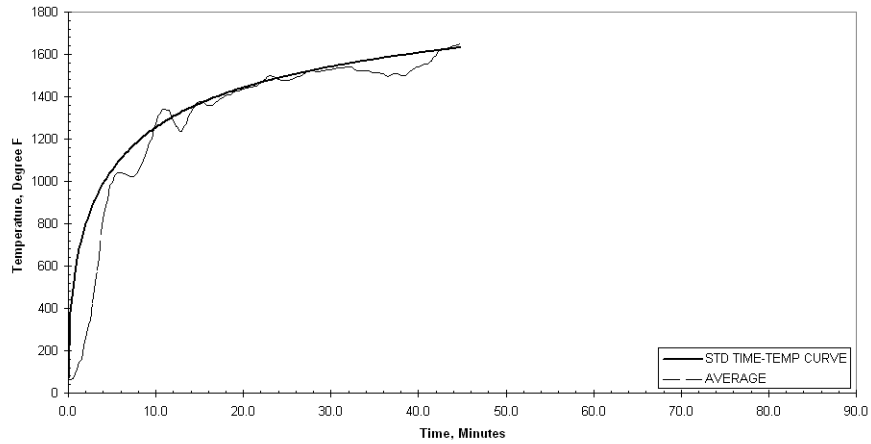
Character and Distribution of the Furnace Fire - The furnace fire was luminous and well distributed throughout the test. A plot of the furnace temperature can be seen on Figure 14.

Figure 14 - UL263 Standard Time Temperature Curve and Average Furnace Temperature vs. Time for Test Assembly No. 3

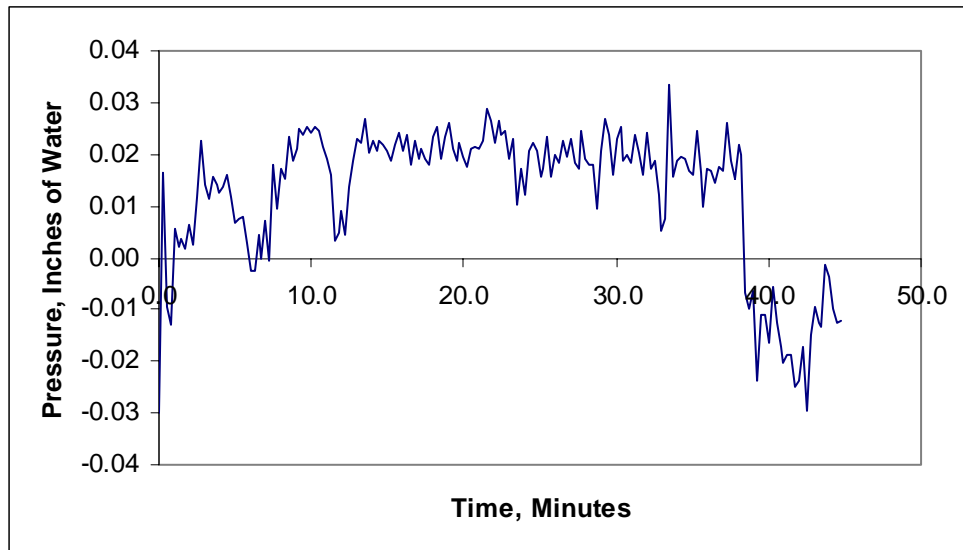
The furnace pressure and oxygen concentration during the test are presented in Figure 15 and Figure 16.

Figure 15 - Furnace Pressure vs. Time for Test Assembly No. 3

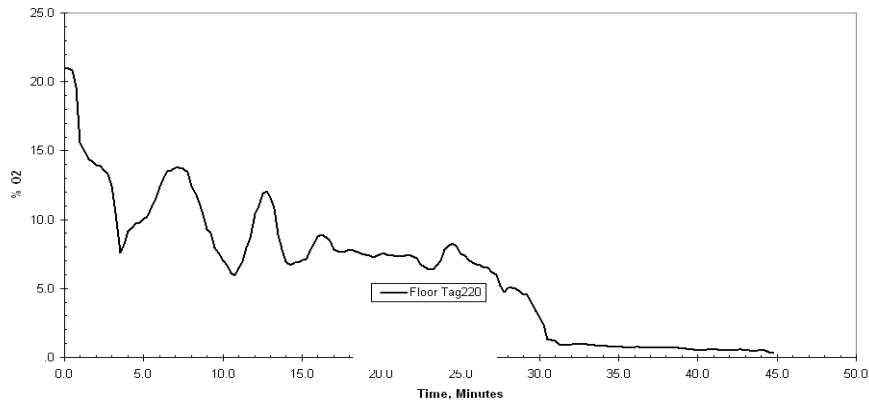
Figure 16 - Oxygen Content vs. Time for Test Assembly No. 3

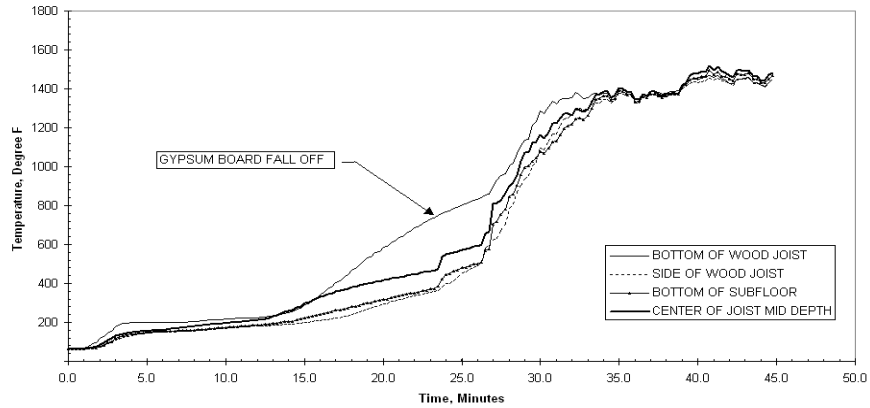
Temperatures of the Side of Mid Depth of Wood Joists – The average and maximum temperatures of the sides of the wood joists just before the moment of collapse (44 min 45 sec) were 1450°F and 1550°F respectively. The individual temperature was recorded by thermocouple number 33. A plot of these temperatures can be seen on Figure 17.

Temperatures of the Mid Depth Between Wood Joists – The average and maximum temperatures of the mid depth between the wood joists just before the moment of collapse (44 min 45 sec) were 1482°F and 1566°F respectively. The individual temperature was recorded by thermocouple number 52. A plot of these temperatures can be seen on Figure 17.

Temperatures of the Sub Floor Between Wood Joists – The average and maximum temperatures of the sub floor between the wood joists just before the moment of collapse (44 min 45 sec) were 1467°F and 1528°F respectively. The individual temperature was recorded by thermocouple number 62. A plot of these temperatures can be seen on Figure 17.

Figure 17 - Plot of Temperature Below Subfloor vs. Time for Assembly No. 3

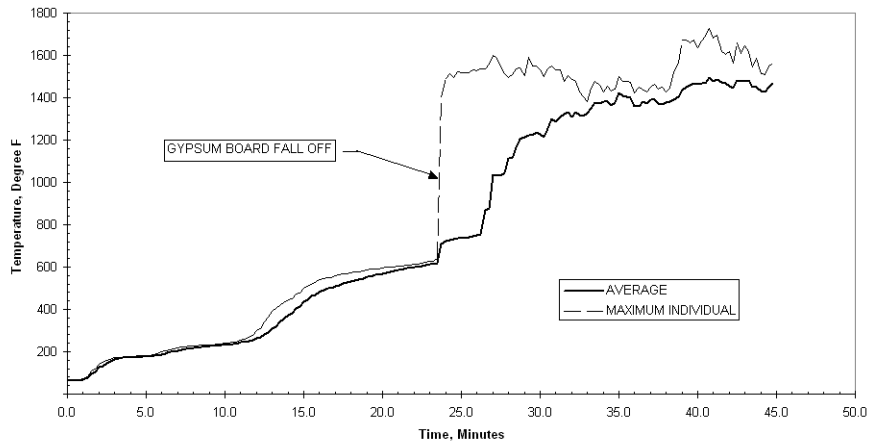
Temperatures of the Unexposed Side of Gypsum Board - The average and maximum temperatures of the unexposed surface just before the moment of gypsum board fall off (23 min 30 sec) were 605°F and 617°F respectively. The individual temperature was recorded by thermocouple number 41. A plot of these temperatures can be seen on Figure 18.

Figure 18 - Plot of Temperature of the Unexposed Surface of Gypsum Board vs. Time for Assembly No. 3

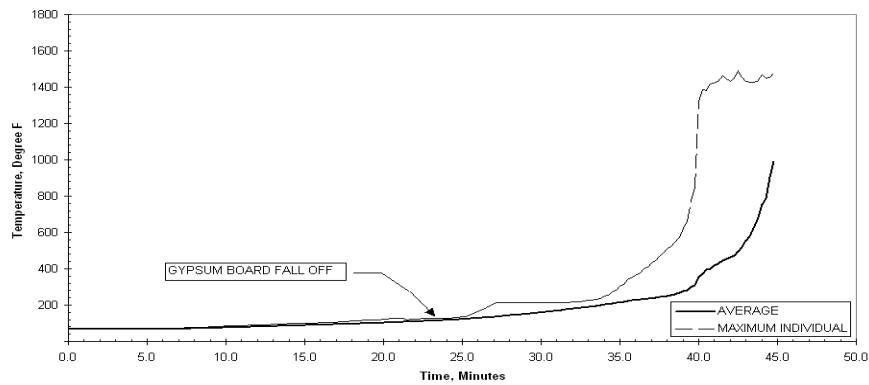
Temperatures of Between the Sub Floor and Finish Floor – The average and maximum temperatures between the sub floor and finish floor just before the moment of collapse (44 min 45 sec) were 993°F and 1479°F respectively. The individual temperature was recorded by thermocouple number 6. A plot of these temperatures can be seen on Figure 19.

Figure 19 - Plot of Temperature of the Subfloor Temperatures vs. Time for Assembly No. 3

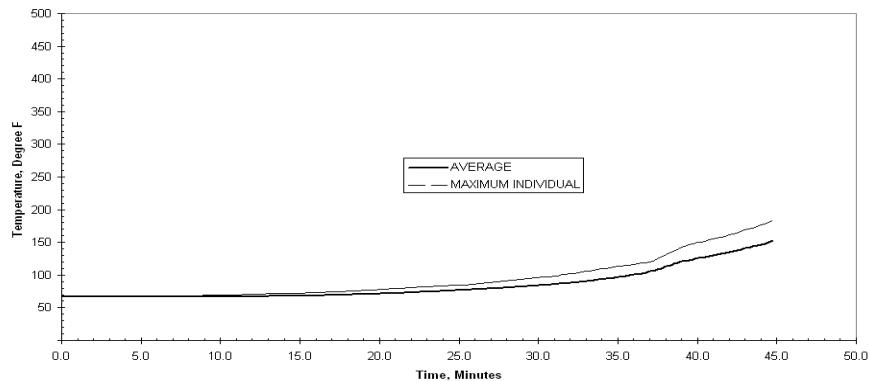
Temperatures of the Unexposed Surface – The average and maximum temperatures of the unexposed surface just before the moment of collapse (44 min 45 sec) were 152°F and 183°F respectively. The individual temperature was recorded by thermocouple number 77. A plot of these temperatures can be seen on Figure 20.

Figure 20 - Plot of Temperatures of the Unexposed Surface vs. Time for Assembly No. 3

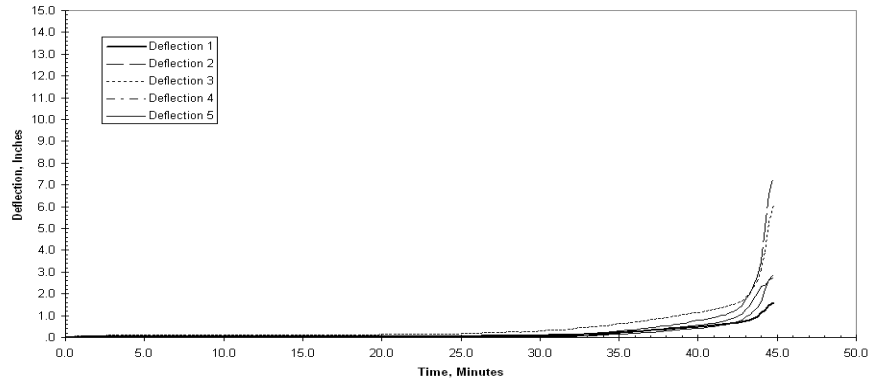
Deflection of the Assembly - The deflection of the floor-ceiling assembly during the fire test is shown on Figure 21. The location of each deflection transducer can be seen in Appendix A under Test Assembly 3.

**Figure 21 - Plot of Deflections vs. Time for Assembly No. 3**

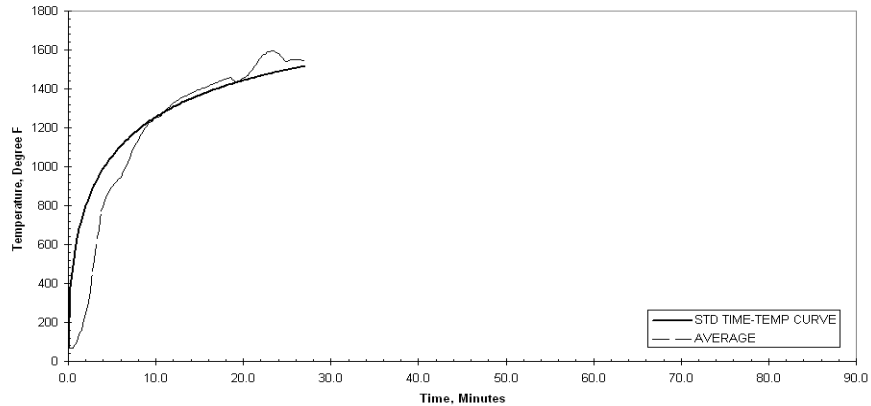
Character and Distribution of the Furnace Fire - The furnace fire was luminous and well distributed throughout the test. A plot of the furnace temperature can be seen on Figure 22.

Figure 22 - UL263 Standard Time Temperature Curve and Average Furnace Temperature vs. Time for Assembly No. 4

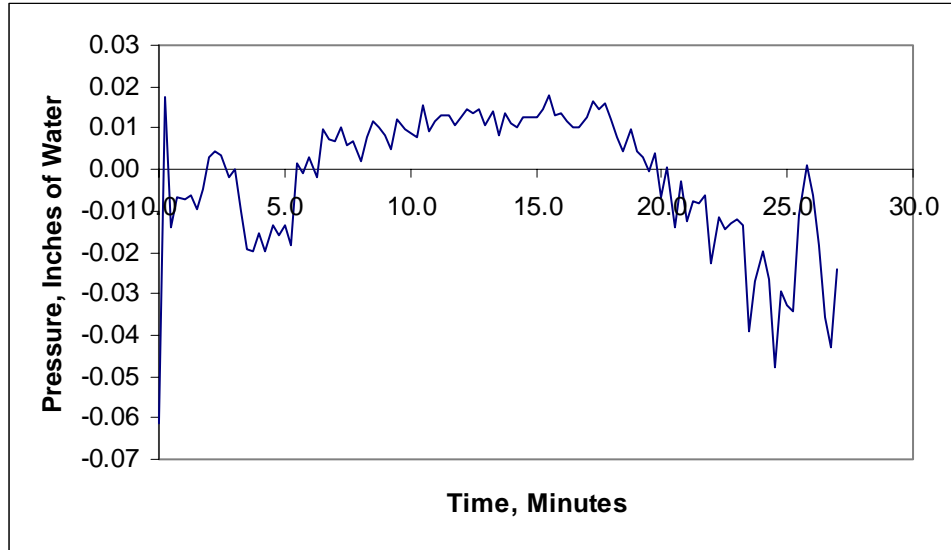
The furnace pressure and oxygen concentration during the test are shown in Figure 23 and Figure 24.

Figure 23 – Furnace Pressure vs. Time for Assembly No. 4

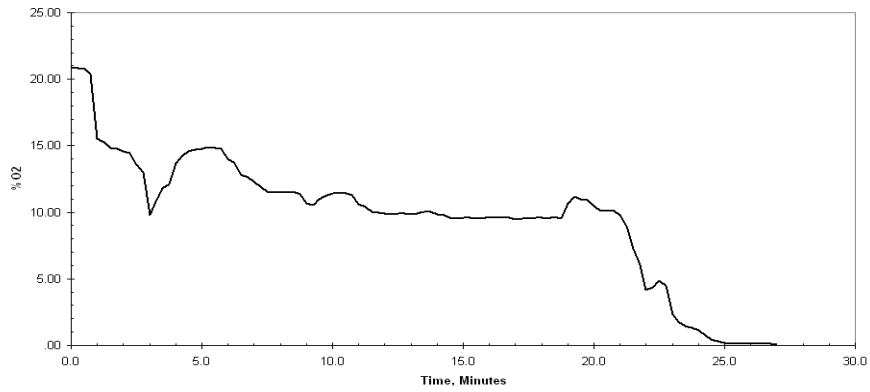
Figure 24 - Oxygen Content vs. Time for Assembly No. 4

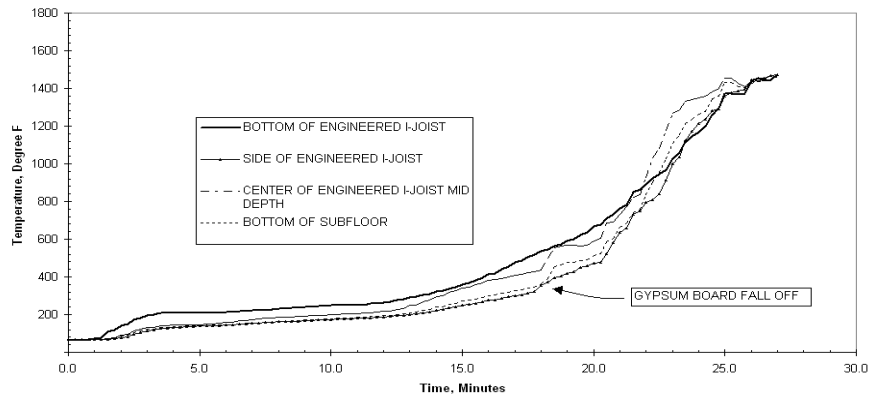
Temperatures of the Side of Mid Depth of Wood Joists – The average and maximum temperatures of the sides of the wood joists just before the moment of collapse (26 min 45 sec) were 1467°F and 1597°F respectively. The individual temperature was recorded by thermocouple number 48. A plot of these temperatures can be seen on Figure 25.

Temperatures of the Mid Depth Between Wood Joists – The average and maximum temperatures of the mid depth between the wood joists just before the moment of collapse (26 min 45 sec) were 1475°F and 1547°F respectively. The individual temperature was recorded by thermocouple number 70. A plot of these temperatures can be seen on Figure 25.

Temperatures of the Bottom of the Sub Floor Between Wood Joists – The average and maximum temperatures of the sub floor between the wood joists just before the moment of collapse (26 min 45 sec) were 1467°F and 1549°F respectively. The individual temperature was recorded by thermocouple number 80. A plot of these temperatures can be seen on Figure 25.

Figure 25 - Plot of Temperatures Below Subfloor vs. Time for Assembly No. 4

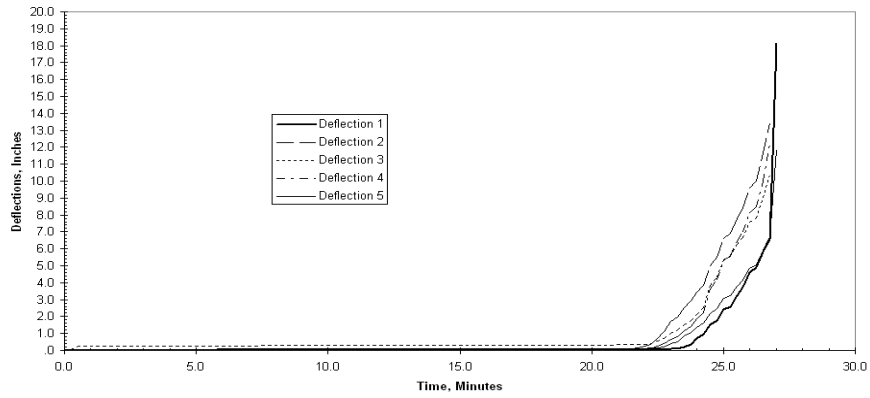
Deflection of the Assembly - The deflection of the floor-ceiling assembly during the fire test is shown on Figure 30. The location of each deflection transducer can be seen in Appendix A under Test Assembly 4.

Figure 30 - Plot of Deflections vs. Time for Assembly No. 4

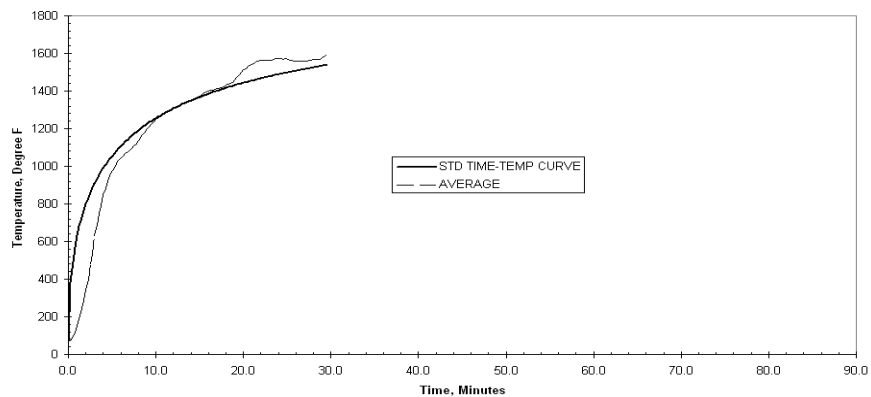
Character and Distribution of the Furnace Fire - The furnace fire was luminous and well distributed throughout the test. A plot of the furnace temperature can be seen on Figure 31.

Figure 31 - UL263 Standard Time Temperature Curve and Average Furnace Temperature vs. Time for Assembly No. 5

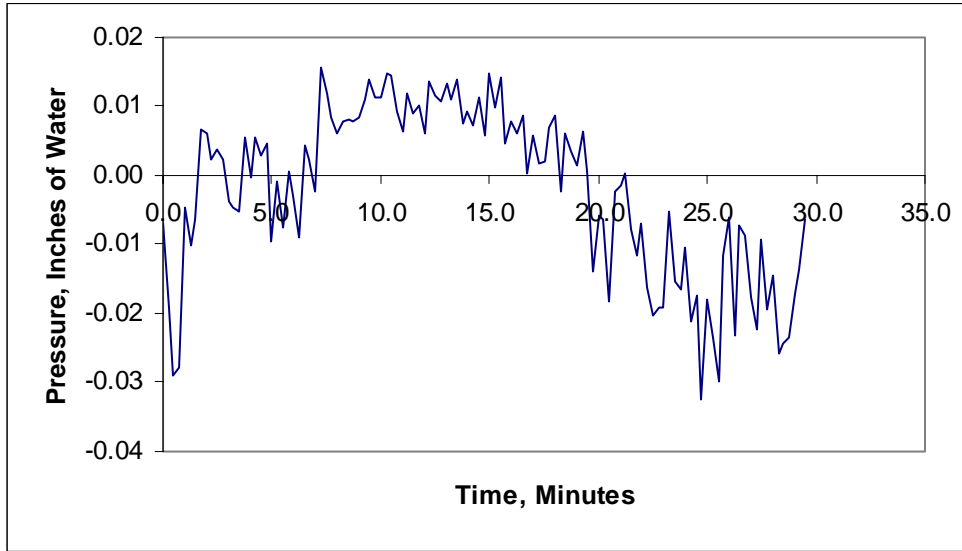
Figure 32 - Furnace Pressure vs. Time for Assembly No. 5

The furnace pressure and oxygen concentration during the test are presented in Figure 32 and Figure 33.

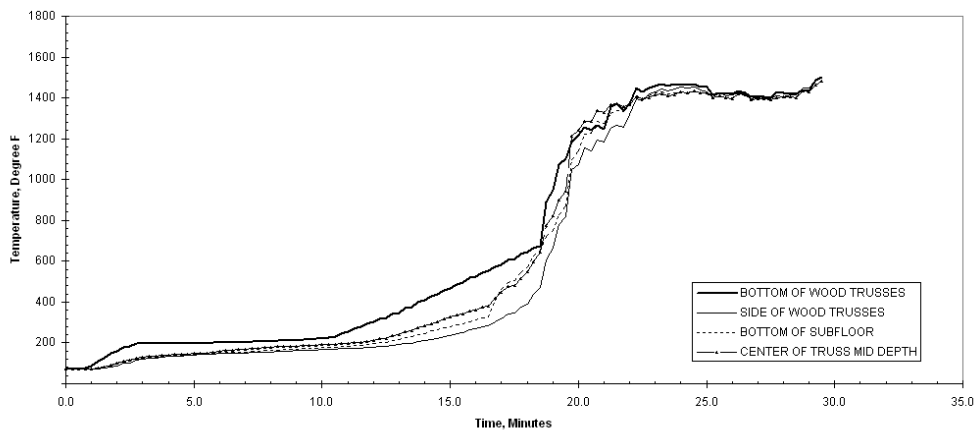
Figure 34 - Plot of Temperature of the Average Interstitial Space vs. Time for Assembly No. 5

Temperatures at Mid Depth on the Side the Wood Trusses – The average and maximum temperatures of the sides of the wood trusses just before the moment of collapse (29 min 15 sec) were 1488°F and 1561°F respectively. The individual temperature was recorded by thermocouple number 41. A plot of these temperatures can be seen Figure 34.

Temperatures of the Mid Depth Between Wood Trusses – The average and maximum temperatures of the mid depth between the wood trusses just before the moment of collapse (29 min 15 sec) were 1464°F and 1534°F respectively. The individual temperature was recorded by thermocouple number 63. A plot of these temperatures can be seen on Figure 34.

Temperatures of the Sub Floor Between Wood Trusses – The average and maximum temperatures of the sub floor between the wood trusses just before the moment of collapse (29 min 15 sec) were 1464°F and 1538°F respectively. The individual temperature was recorded by thermocouple number 71. A plot of these temperatures can be seen on Figure 34.

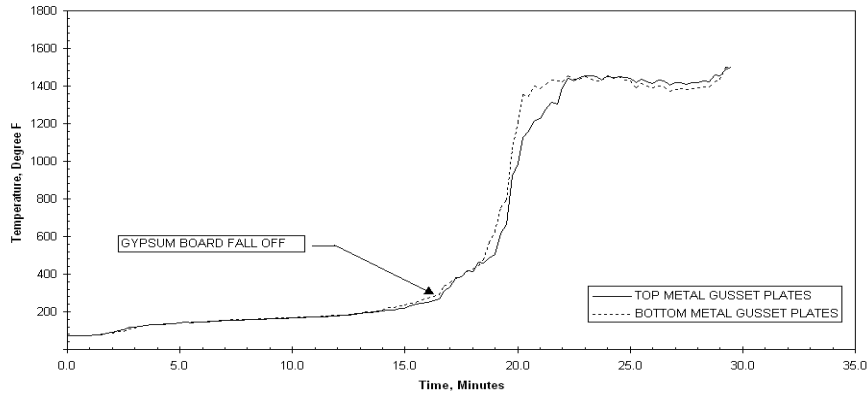
Figure 35 - Plot of Temperature of the Top and Bottom Metal Gusset Plates vs. Time for Assembly No. 5

Temperatures of the Metal Gusset Plates – The average and maximum temperatures of the top metal gusset plates just before the moment of collapse (29 min 15 sec) were 1487°F and 1537°F respectively. The individual temperature was recorded by thermocouple number 81. The average and maximum temperatures of the bottom metal gusset plate just before the moment of collapse (29 min 15 sec) were 1502°F and 1581°F respectively. The individual temperature was recorded by thermocouple number 86. A plot of the metal gusset temperatures can be seen on Figure 5.5.

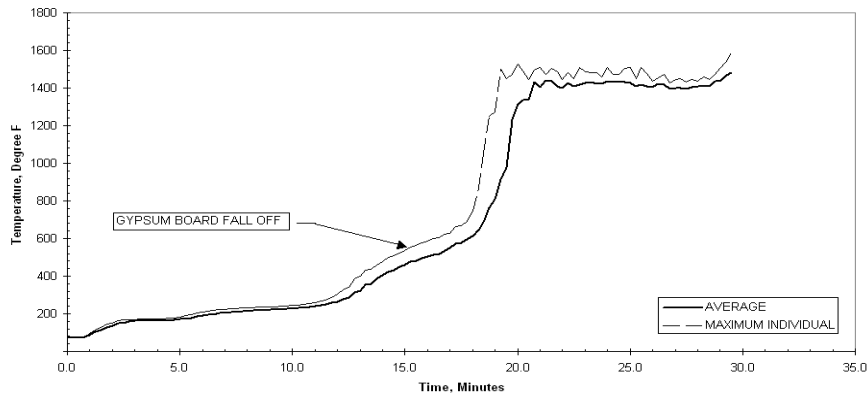
Figure 36 - Plot of Temperature of the Unexposed Surface of Gypsum Board vs. Time for Assembly No. 5

Temperatures of the Unexposed Side of Gypsum Board – The average and maximum temperatures of the unexposed surface just before the gypsum board fall off (16 min 30 sec) were 519°F and 606°F respectively. The individual temperature was recorded by thermocouple number 54. A plot of these temperatures can be seen on Figure 36.

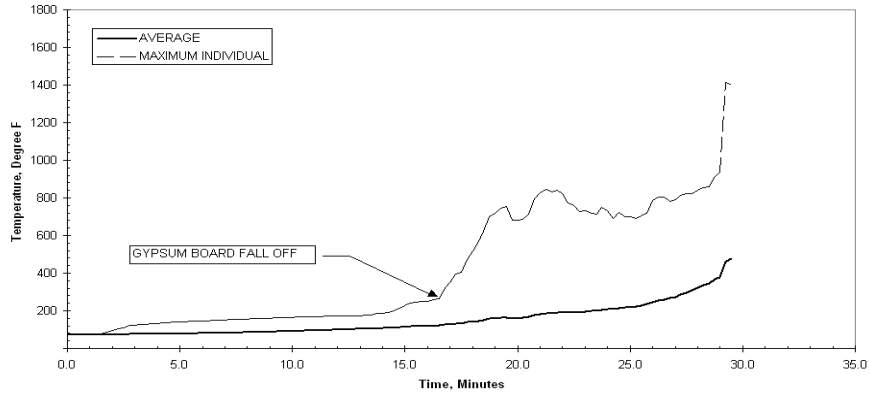
Figure 37 - Plot of Temperature of the Subfloor Temperatures vs. Time for Assembly No. 5

Temperatures Between the Sub Floor and Carpet Padding – The average and maximum temperatures between the sub floor and finish floor just before the moment of collapse (29 min 15 sec) were 459°F and 1416°F respectively. The individual temperature was recorded by thermocouple number 9. A plot of these temperatures can be seen on Figure 37.

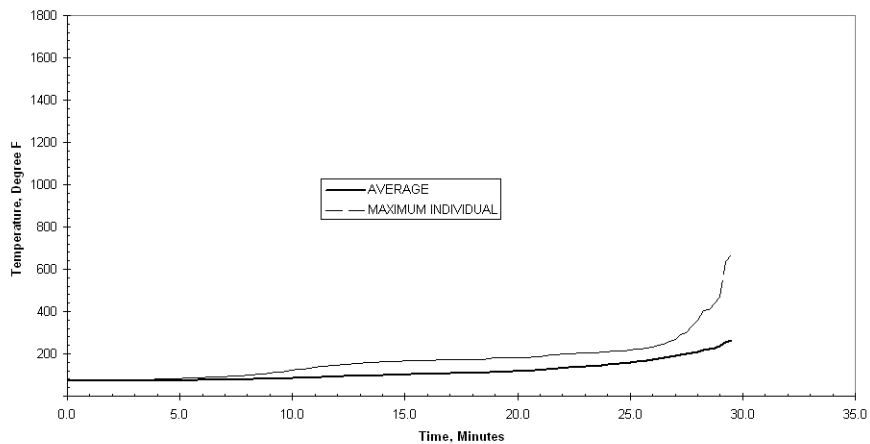
Figure 38 - Plot of Temperature of the Carpet Padding vs. Time for Assembly No. 5

Temperatures Between the Carpet Padding and Carpet – The average and maximum temperatures between the sub floor and finish floor just before the moment of collapse (29 min 15 sec) were 256°F and 636°F respectively. The individual temperature was recorded by thermocouple number 24. A plot of these temperatures can be seen on Figure 38.

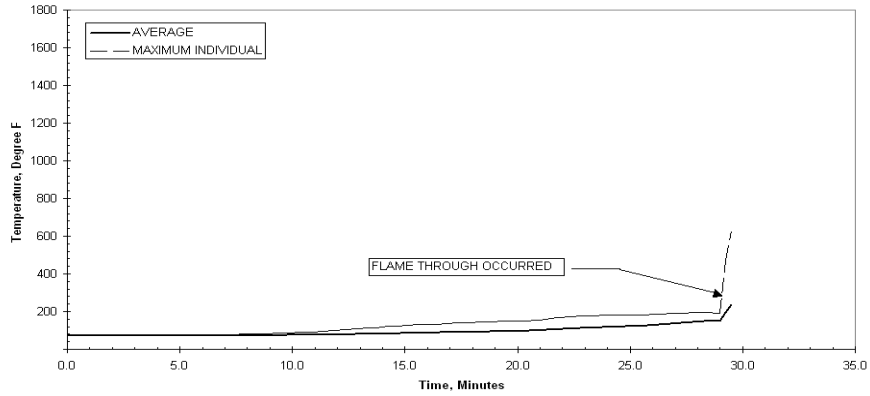
Figure 39 - Plot of Temperatures of the Unexposed Surface vs. Time for Assembly No. 5

Temperatures of the Unexposed Surface – The average and maximum temperatures of the unexposed surface just before the moment of collapse (29 min 15 sec) were 194°F

and 474°F respectively. The individual temperature was recorded by thermocouple number 96. A plot of these temperatures can be seen on Figure 5.9.

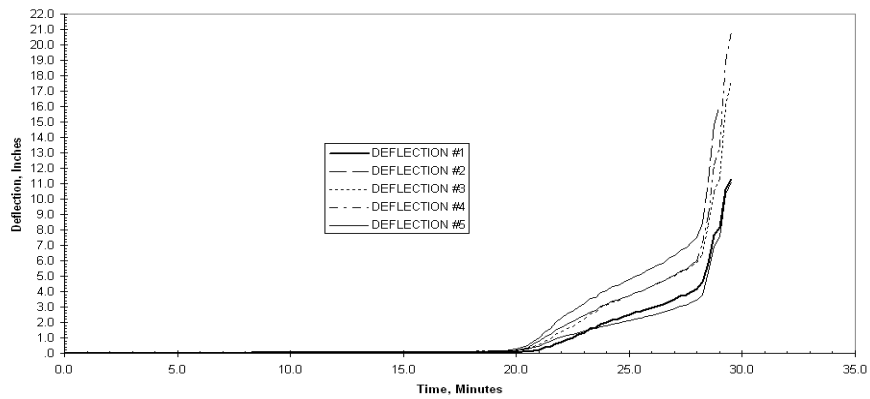
Figure 40 - Plot of Deflections vs. Time for Assembly No. 5

Deflection of the Assembly - The deflection of the floor-ceiling assembly during the fire test is shown on Figure 40. The location of each deflection transducer can be seen in Appendix A under Test Assembly 5.

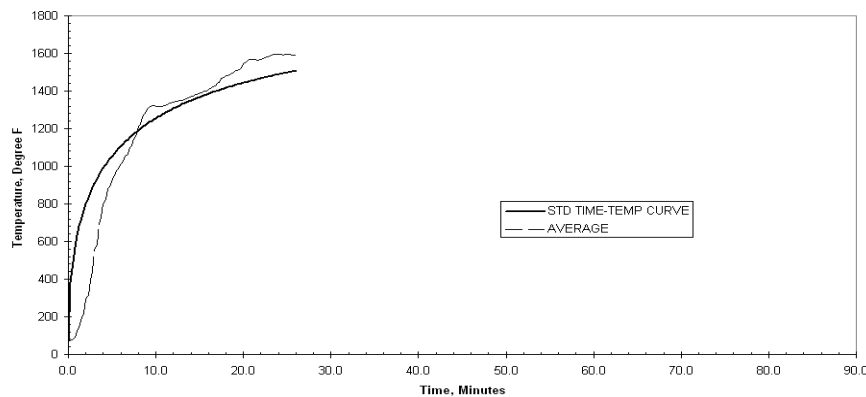
Figure 41 - UL263 Standard Time Temperature Curve and Average Furnace Temperature vs. Time for Assembly No. 6

Character and Distribution of the Furnace Fire - The furnace fire was luminous and well distributed throughout the test. A plot of the furnace temperature can be seen on Figure 41.

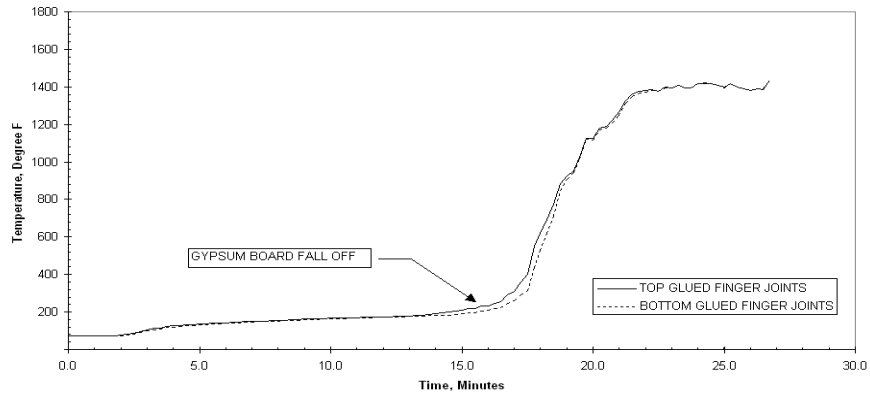
Figure 45 - Plot of Temperature of the Top and Bottom Glued Finger Joints vs. Time for Assembly No. 6

Temperatures of the Glued Finger Joints – The average and maximum temperatures of the top glued finger joints just before the moment of collapse (29 min 45 sec) were 1435°F and 1477°F respectively. The individual temperature was recorded by thermocouple number 84. The average and maximum temperatures of the bottom glued finger joints just before the moment of collapse (29 min 45 sec) were 1434°F and 1474°F respectively. The individual temperature was recorded by thermocouple number 81. A plot of the glued finger joint temperatures can be seen on Figure 6.5.

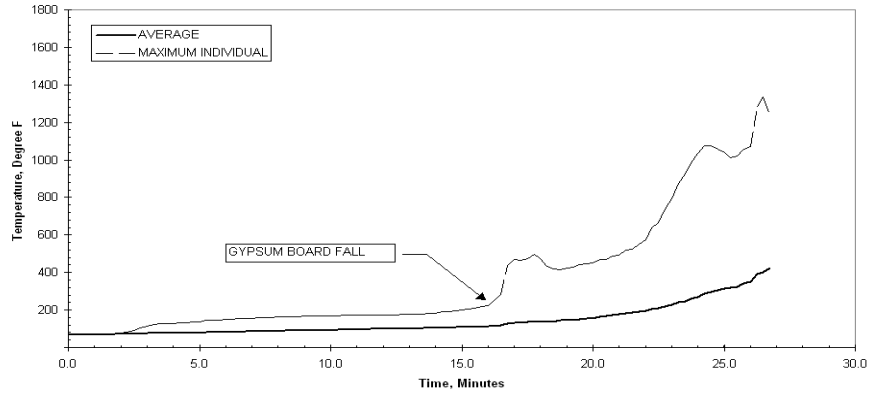
Figure 47 - Plot of Temperature of the Subfloor Temperatures vs. Time for Test Assembly No. 6

Temperatures Between the Sub Floor and Carpet Padding – The average and maximum temperatures between the sub floor and finish floor just before the moment of collapse (29 min 45 sec) were 424°F and 1240°F respectively. The individual temperature was recorded by thermocouple number 9. A plot of these temperatures can be seen on Figure 47.

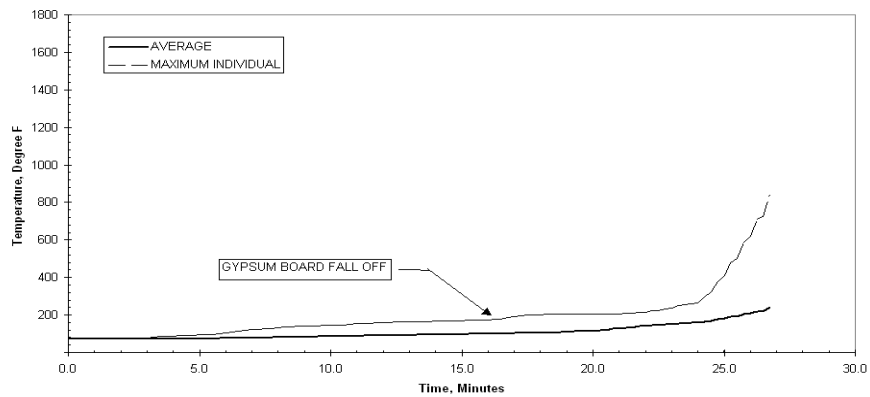
Figure 48 - Plot of Temperature of the Carpet Padding vs. Time for Test Assembly No. 6

Temperatures Between the Carpet Padding and Carpet – The average and maximum temperatures between the sub floor and finish floor just before the moment of collapse (29 min 45 sec) were 241°F and 843°F respectively. The individual temperature was recorded by thermocouple number 24. A plot of these temperatures can be seen on Figure 48.

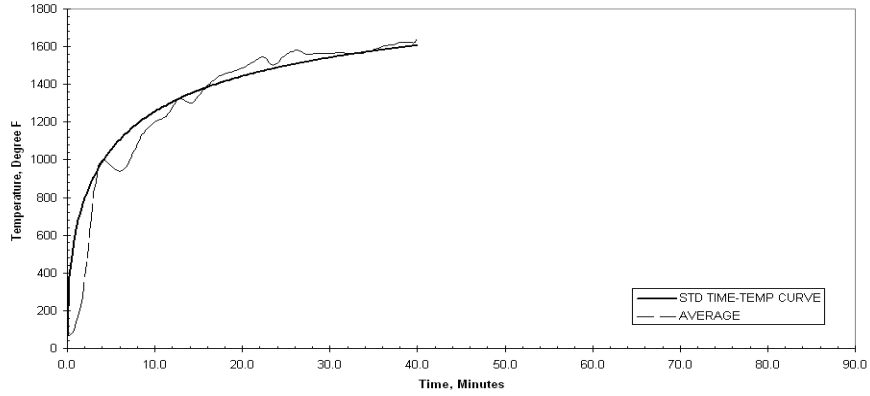
Figure 51 – UL263 Standard Time Temperature Curve and Average Furnace Temperature vs. Time for Assembly No. 7

Character and Distribution of the Furnace Fire - The furnace fire was luminous and well distributed throughout the test. A plot of the furnace temperature can be seen on Figure 51.

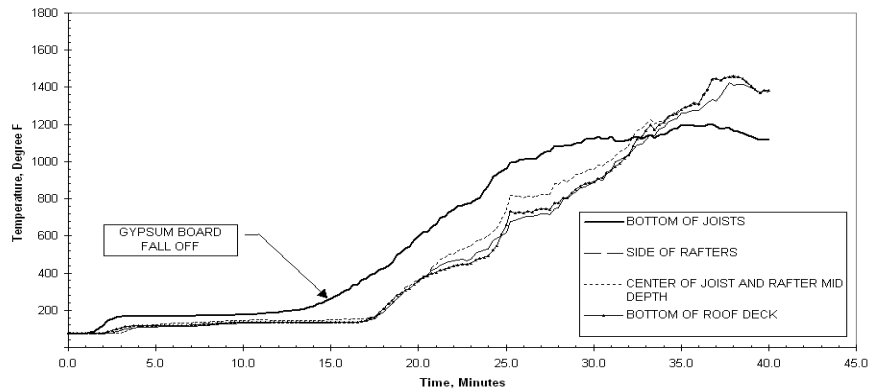
Figure 54 – Plot of Temperatures Below Subfloor vs. Time for Test Assembly No. 7

Temperatures of the Mid Depth Between Wood Joists and Rafters – The average and maximum temperatures of the mid depth between the wood trusses just before the moment of collapse (40 min 00 sec) were 1376°F and 1482°F respectively. The individual temperature was recorded by thermocouple number 63. A plot of these temperatures can be seen on Figure 54.

Temperatures on the Bottom of the Roof Deck Between Wood Joists – The average and maximum temperatures of the sub floor between the wood joists just before the moment of collapse (40 min 00 sec) were 1383°F and 1487°F respectively. The individual temperature was recorded by thermocouple number 72. A plot of these temperatures can be seen on Figure 54

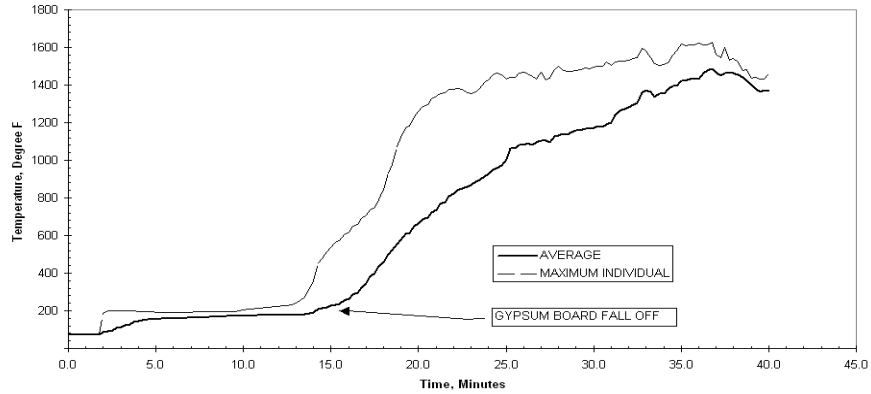
Figure 55 – Plot of Temperature of the Unexposed Surface of Gypsum Board vs. Time for Test Assembly No. 7

Temperatures of the Unexposed Side of Gypsum Board – The average and maximum temperatures of the unexposed surface just before the gypsum board fall off (15 min 45 sec) were 253°F and 606°F respectively. The individual temperature was recorded by thermocouple number 58. A plot of these temperatures can be seen on Figure 55

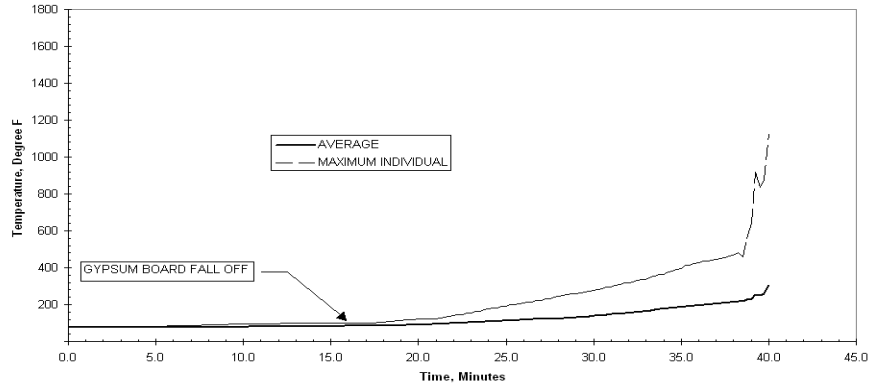
Figure 57 – Plot of Temperature of the Roofing Felt vs. Time for Test Assembly No. 7

Temperatures on the Roofing Felt – The average and maximum temperatures between the sub floor and finish floor just before the moment of collapse (40 min 00 sec) were 303°F and 1129°F respectively. The individual temperature was recorded by thermocouple number 19. A plot of these temperatures can be seen on Figure 57.

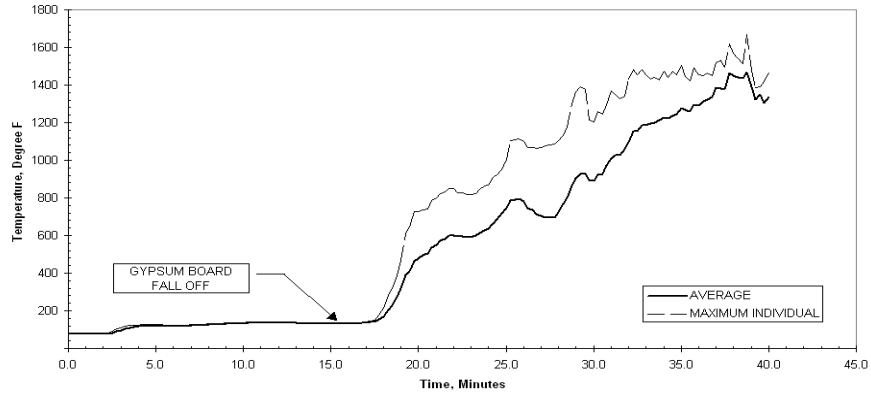
Figure 59 – Plot of Temperatures of the Unexposed Surface of the Mushroom Vent vs. Time for Test Assembly No. 7

Temperatures of the Unexposed Surface of the Mushroom Vents – The average and maximum temperatures of the unexposed surface just before the moment of collapse (40 min 00 sec) were 1338°F and 1470°F respectively. The individual temperature was recorded by thermocouple number 94. A plot of these temperatures can be seen on Figure 59.

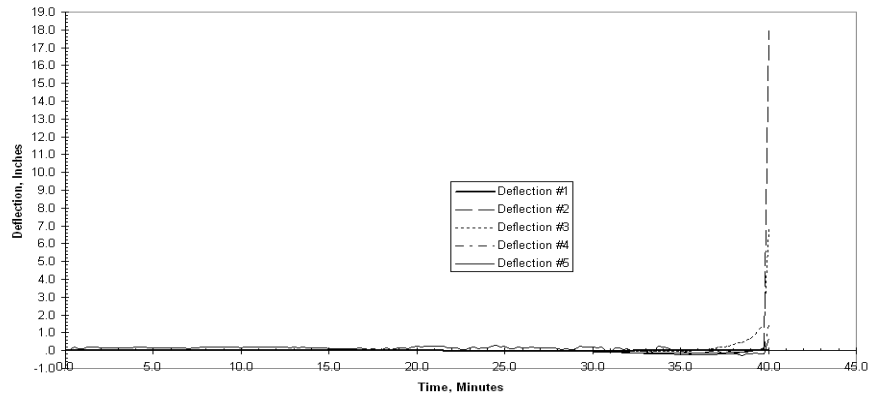
Figure 60 – Plot of Deflections vs. Time for Test Assembly No. 7

Deflection of the Assembly - The deflection of the floor-ceiling assembly during the fire test is shown on Figure 60. The location of each deflection transducer can be seen in Appendix A under Test Assembly 7.

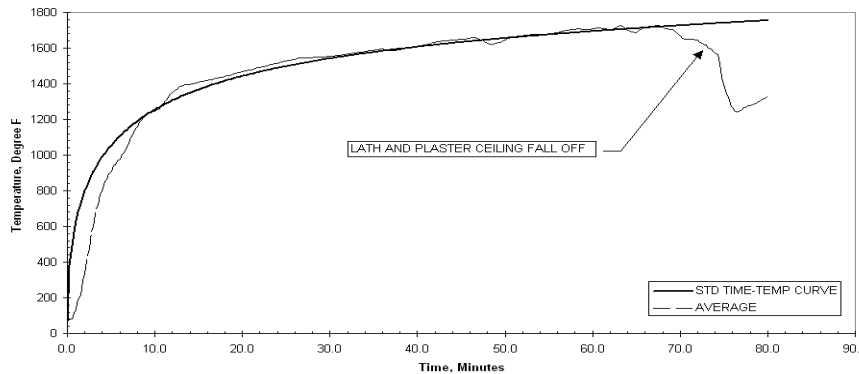
Figure 61 – UL263 Standard Time Temperature Curve and Average Furnace Temperature vs. Time for Test Assembly No. 8

Character and Distribution of the Furnace Fire - The furnace fire was luminous and well distributed throughout the test. A plot of the furnace temperature can be seen on Figure 61

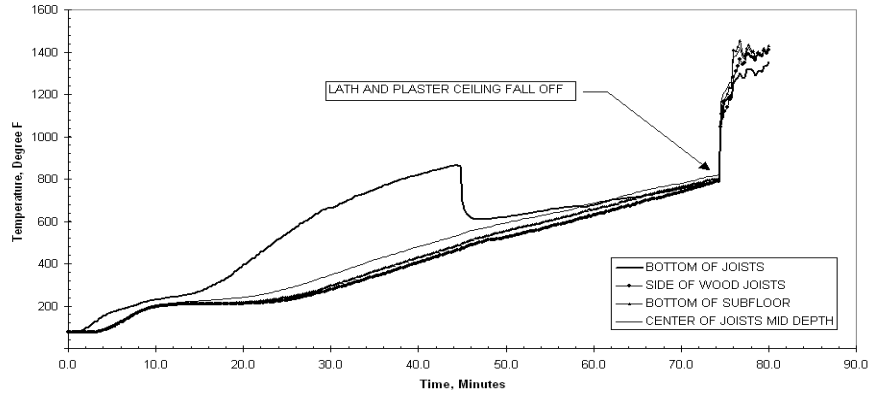
Figure 64 – Plot of Temperatures Below Subfloor vs. Time for Test Assembly No. 8

Temperatures of the Side of Mid Depth of Wood Joists – The average and maximum temperatures of the sides of the wood joists just before the moment of collapse (79 min 45 sec) were 1395°F and 1483°F respectively. The individual temperature was recorded by thermocouple number 27. The average temperatures were plotted on Figure 64.

Temperatures of the Mid Depth Between Wood Joists – The average and maximum temperatures of the mid depth between the wood joists just before the moment of collapse (79 min 45 sec) were 1403°F and 1466°F respectively. The individual temperature was recorded by thermocouple number 46. The average temperatures were plotted on Figure 64.

Temperatures of the Sub Floor Between Wood Joists – The average and maximum temperatures of the sub floor between the wood joists just before the moment of collapse (79 min 45 sec) were 1402°F and 1464°F respectively. The individual temperature was recorded by thermocouple number 55. The average temperatures were plotted on Figure 64.

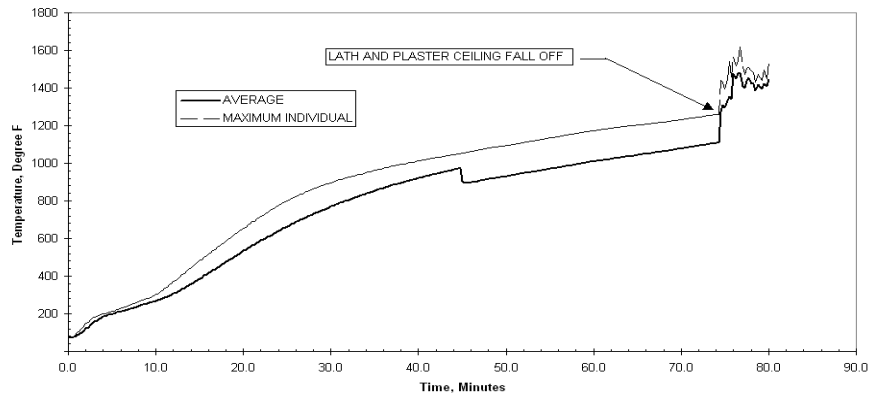
Figure 65 – Plot of Temperature of the Back of the Metal Lath vs. Time for Test Assembly No. 8

Temperatures on the Back of the Metal Lath – The average and maximum temperatures on the back of the metal lath just before the lath and plaster ceiling fall off (74 min) were 1109°F and 1259°F respectively. The individual temperature was recorded by thermocouple number 38. The average temperatures were plotted on Figure 65.
