**Report
on
Structural Stability of Engineered Lumber in Fire Conditions**

**Project Number: 07CA42520
File Number: NC9140**

**Underwriters Laboratories Inc.
333 Pfingsten Road, Northbrook, IL 60062**

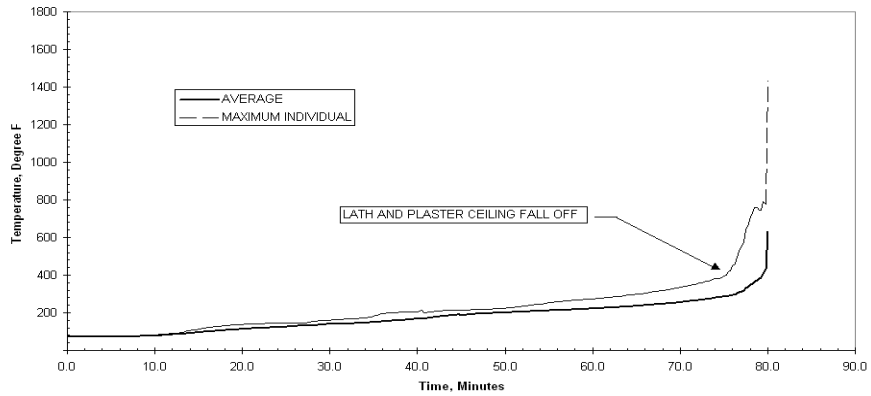
Figure 66 – Plot of Temperature of the Subfloor Temperatures vs. Time for Test Assembly No. 8

Temperatures of Between the Sub Floor and Finish Floor – The average and maximum temperatures between the sub floor and finish floor just before the moment of collapse (79 min 45 sec) were 430°F and 777°F respectively. The individual temperature was recorded by thermocouple number 4. The average temperatures were plotted on Figure 66.

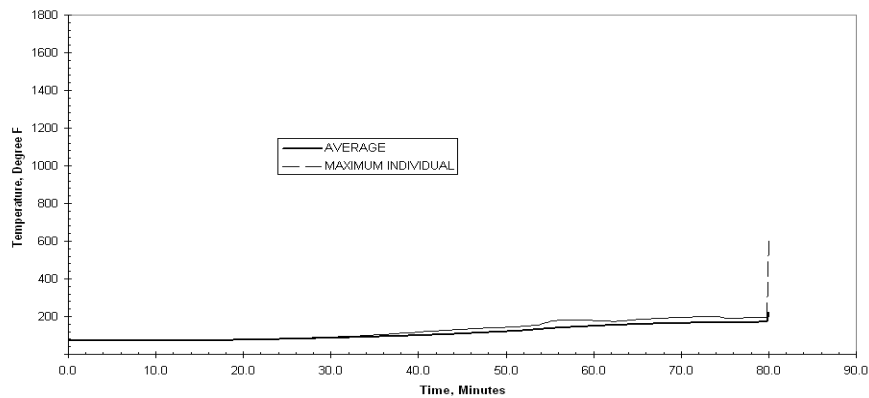
Figure 67 – Plot of Temperatures of the Unexposed Surface vs. Time for Test Assembly No. 8

Temperatures of the Unexposed Surface – The average and maximum temperatures of the unexposed surface just before the moment of collapse (79 min 45 sec) were 174°F and 197°F respectively. The individual temperature was recorded by thermocouple number 65. The average temperatures were plotted on Figure 67.

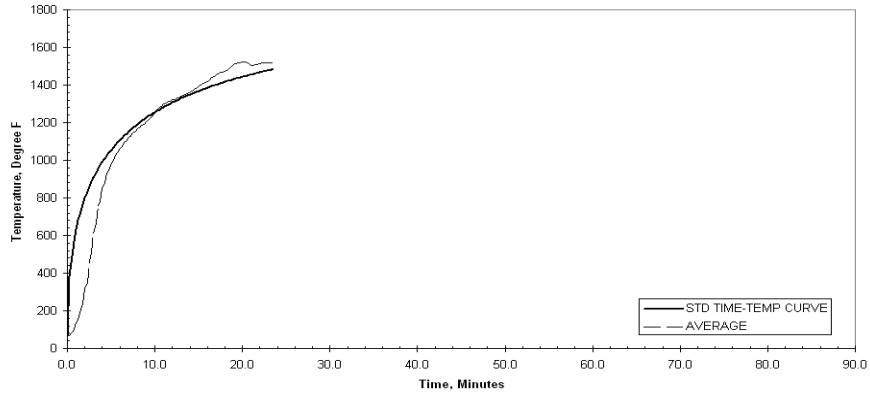
Figure 69 – UL263 Standard Time Temperature Curve and Average Furnace Temperature vs. Time for Test Assembly No. 9

Character and Distribution of the Furnace Fire - The furnace fire was luminous and well distributed throughout the test. A plot of the furnace temperature can be seen on Figure 69.

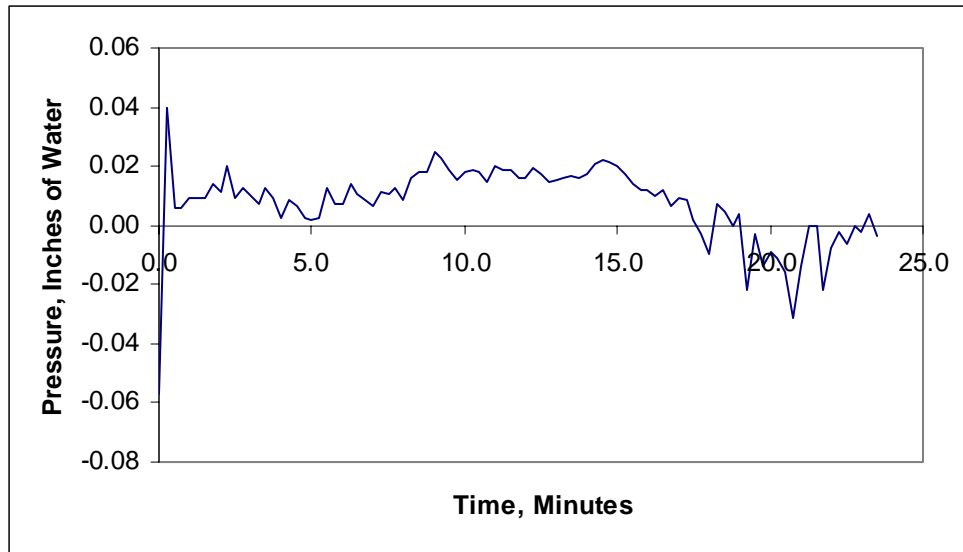
Figure 70 – Furnace Pressure vs. Time for Test Assembly No. 9

The furnace pressure and oxygen concentration are presented in Figure 70 and Figure 71.

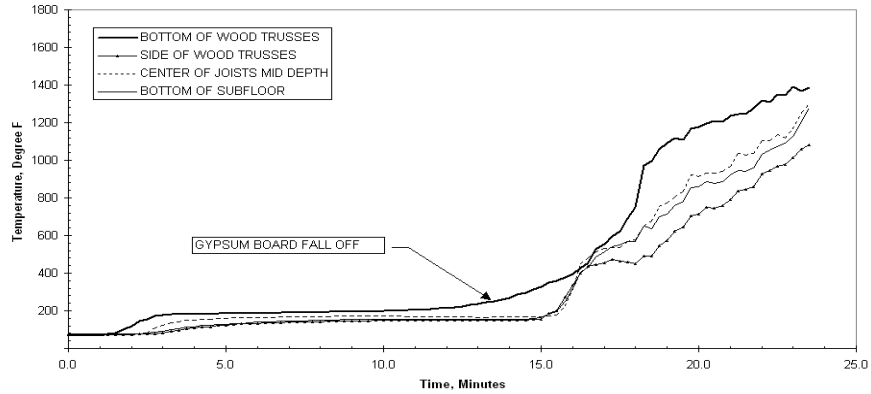
Figure 72 – Plot of Temperature Below Subfloor vs. Time

Temperatures at Mid Depth on the Side the Trusses – The average and maximum temperatures of the sides of the wood trusses just before the moment of collapse (23 min 15 sec) were 1061°F and 1432°F respectively. The individual temperature was recorded by thermocouple number 46. A plot of these temperatures can be seen on Figure 72.

Temperatures of the Mid Depth Between Wood Trusses – The average and maximum temperatures of the mid depth between the wood trusses just before the moment of collapse (23 min 15 sec) were 1255°F and 1500°F respectively. The individual temperature was recorded by thermocouple number 64. A plot of these temperatures can be seen on Figure 72.

Temperatures on the Bottom of the Roof Deck Between Wood Trusses – The average and maximum temperatures of the sub floor between the wood joists just before the moment of collapse (23 min 15 sec) were 1206°F and 1499°F respectively. The individual temperature was recorded by thermocouple number 74. A plot of these temperatures can be seen on Figure 72.

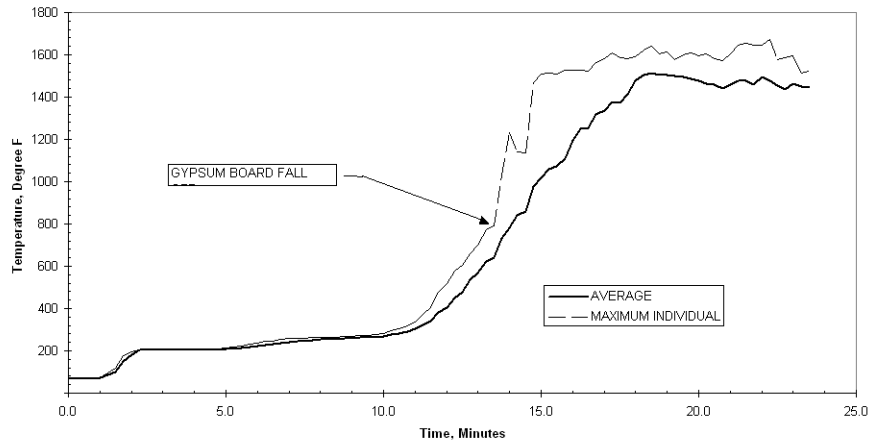
Figure 73 – Plot of Temperature of the Unexposed Surface of Gypsum Board vs. Time

Temperatures of the Unexposed Side of Gypsum Board – The average and maximum temperatures of the unexposed surface just before the gypsum board fall off (13 min 45 sec) were 731°F and 1033°F respectively. The individual temperature was recorded by thermocouple number 56. A plot of these temperatures can be seen on Figure 73

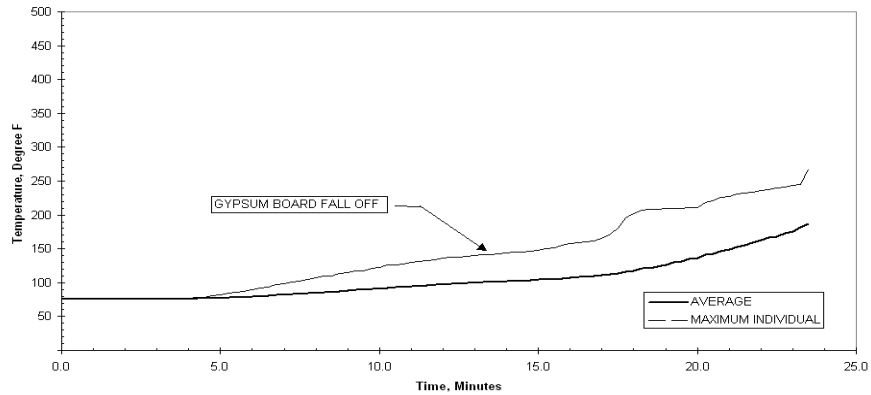
Figure 74 – Plot of Temperature of the Roofing Felt vs. Time

Temperatures on the Roofing Felt – The average and maximum temperatures between the sub floor and finish floor just before the moment of collapse (23 min 15 sec) were 182°F and 245°F respectively. The individual temperature was recorded by thermocouple number 23. A plot of these temperatures can be seen on Figure 9.7.

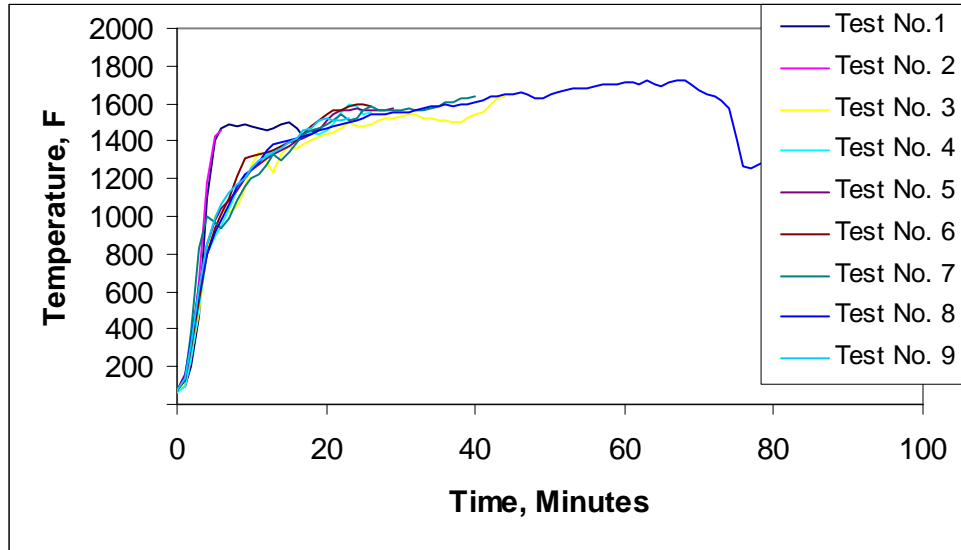
Figure 77 - Furnace Temperature

The average temperature within the furnace, the pressure within the furnace and the percent oxygen content in the furnace exhaust duct were plotted in Figure 77, Figure 78 and Figure 79, respectively.

The furnace temperature during the initial portion of Test Nos. 1 and 2 were significantly higher than recorded during Test Nos. 3 through 9 because the combustible supports and sub-floors for both of these assemblies were exposed to the furnace fire at the start of the test. The relatively low furnace temperatures recorded during the later stages of Test No. 8 reflect the collapse of the plaster ceiling upon the thermocouples in the furnace.

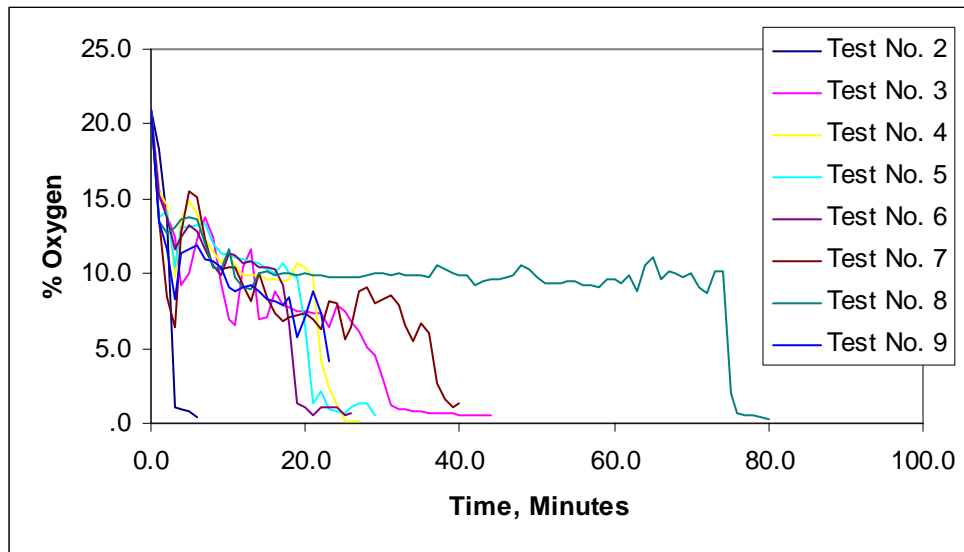
Figure 79 - Percent Oxygen in Furnace

The percent oxygen content at the beginning of the tests was approximately 19 to 20 percent and was reduced to approximately 6 to 8 percent during the tests when the ceilings were in place. The percent oxygen content dropped to near zero after the ceilings fell and the combustible supports and sub-floor were exposed to the furnace flames.

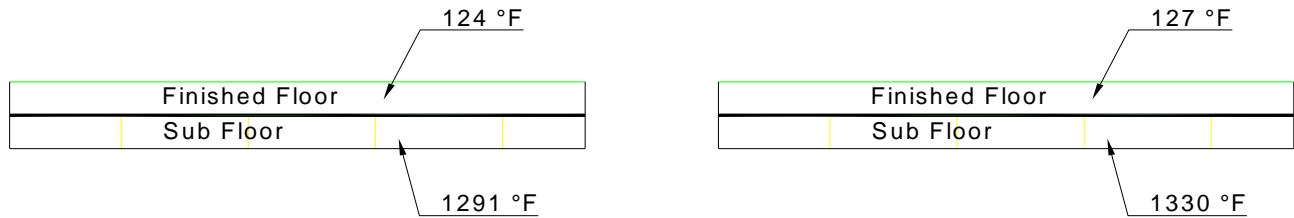
Figure 80 -Test Assembly No. 1

60 seconds before collapse

30 seconds before collapse

Collapse at 18 min.: 45 sec.

The use of thermal imaging cameras by firefighters continues to grow and has many current and potential life safety applications. The temperature on the surfaces of the floor and roof were measured at several locations during each fire test. The temperatures of these surfaces at 60 seconds and at 30 seconds before collapse are shown in Figure 80 to Figure 88.

Table 15 provides a summary of the temperature data in the previous Figure 80 through Figure 88.

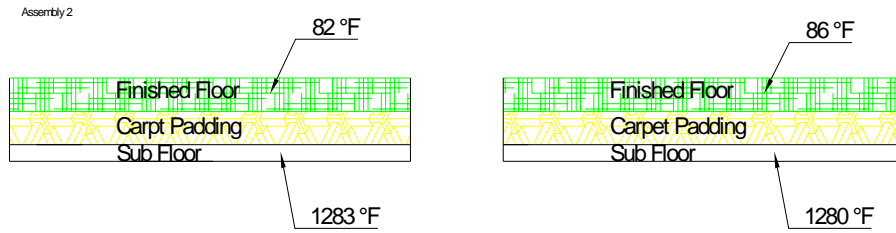
Figure 81- Test Assembly No. 2

60 seconds before collapse

30 seconds before collapse

Collapse at 6 min.: 3 sec.

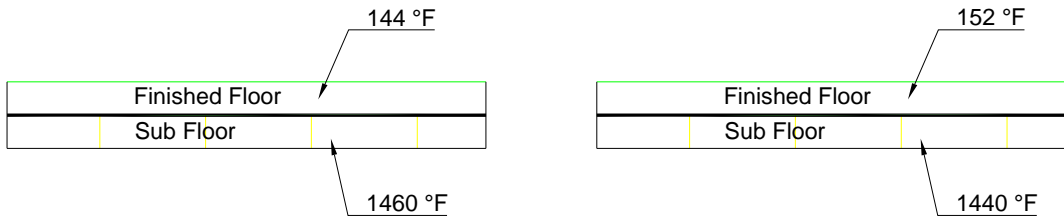
Figure 82 - Test Assembly No. 3

60 seconds before collapse

30 seconds before collapse

Collapse at 44 min.: 45 sec.

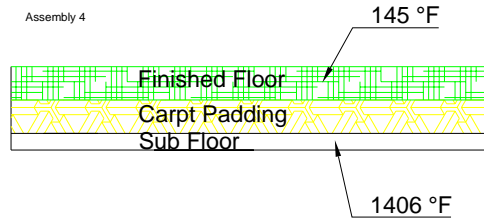
Figure 83 - Test Assembly No. 4

60 seconds before collapse

30 seconds before collapse

Collapse at 26 min.: 45 sec.

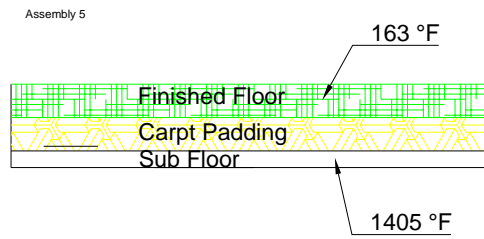
Figure 84 - Test Assembly No. 5

60 seconds before collapse

30 seconds before collapse

Collapse at 29 min.: 15 sec.

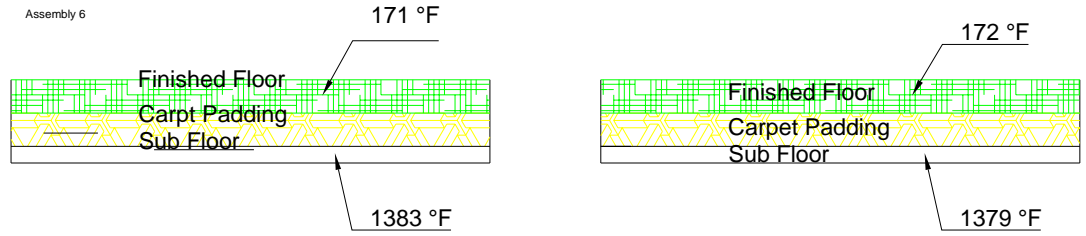
Figure 85 - Test Assembly No. 6

60 seconds before collapse

30 seconds before collapse

Collapse at 26 min.: 45 sec.

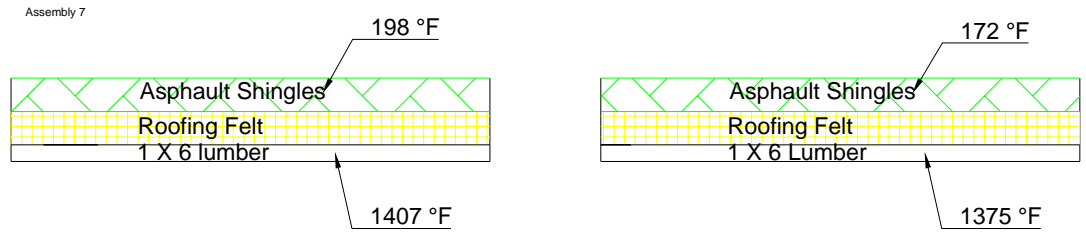
Figure 86 - Test Assembly No. 7

60 seconds before collapse

30 seconds before collapse

Collapse at 40 min.

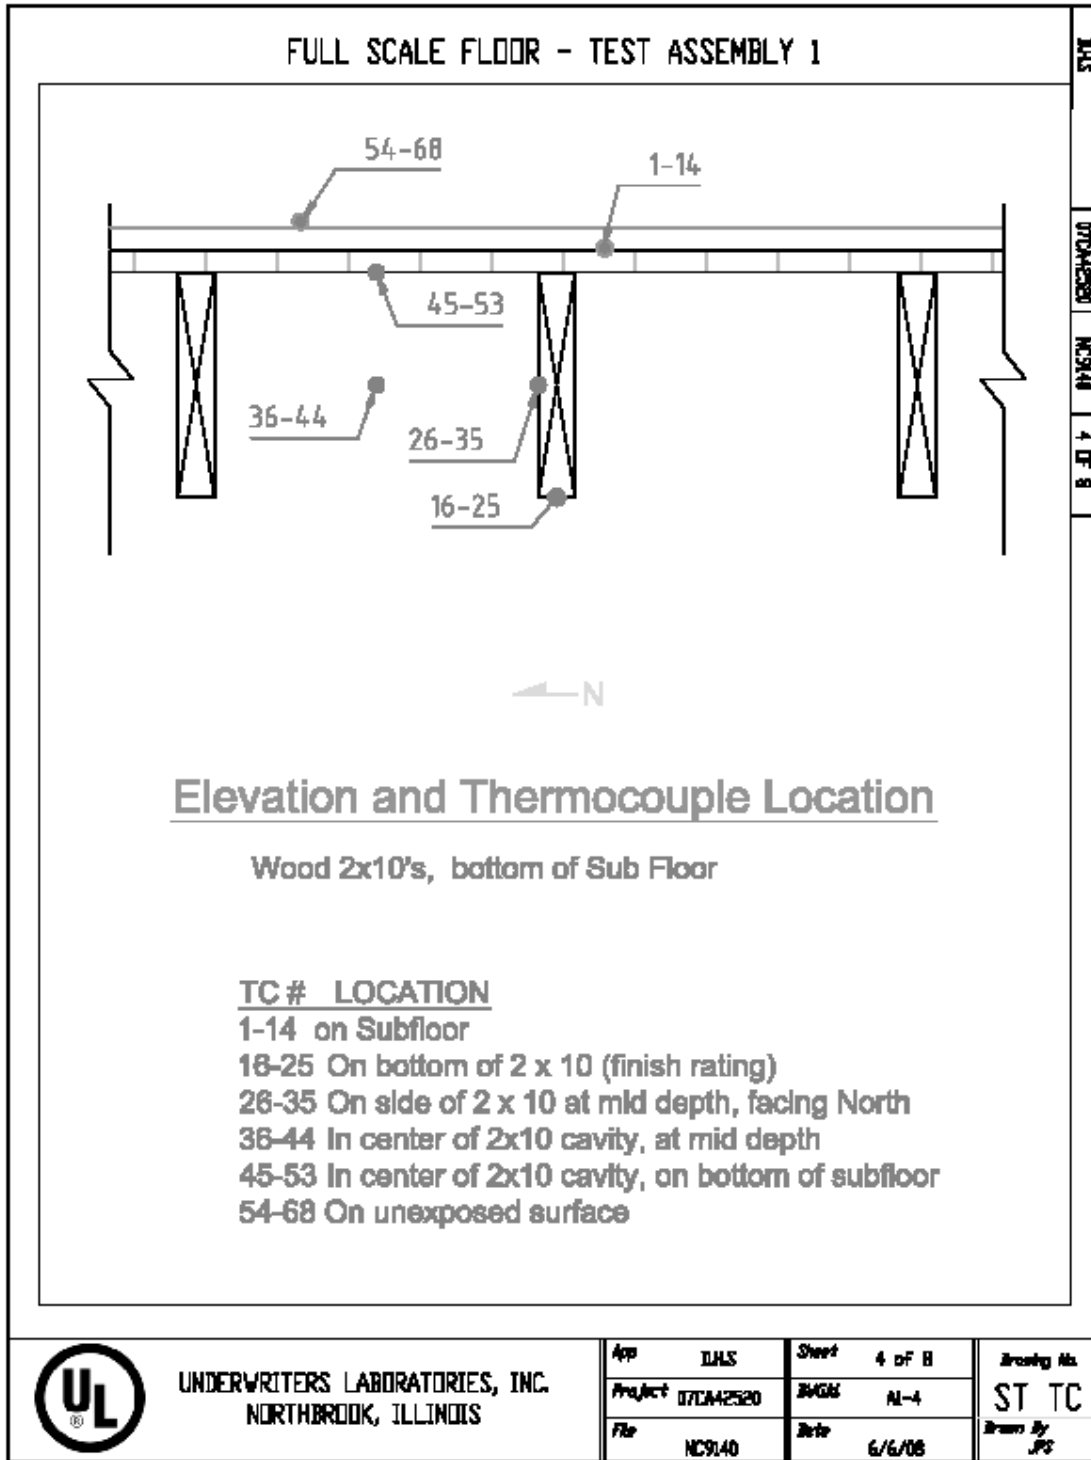
Figure A.1.3 – Thermocouple Locations - Elevation.

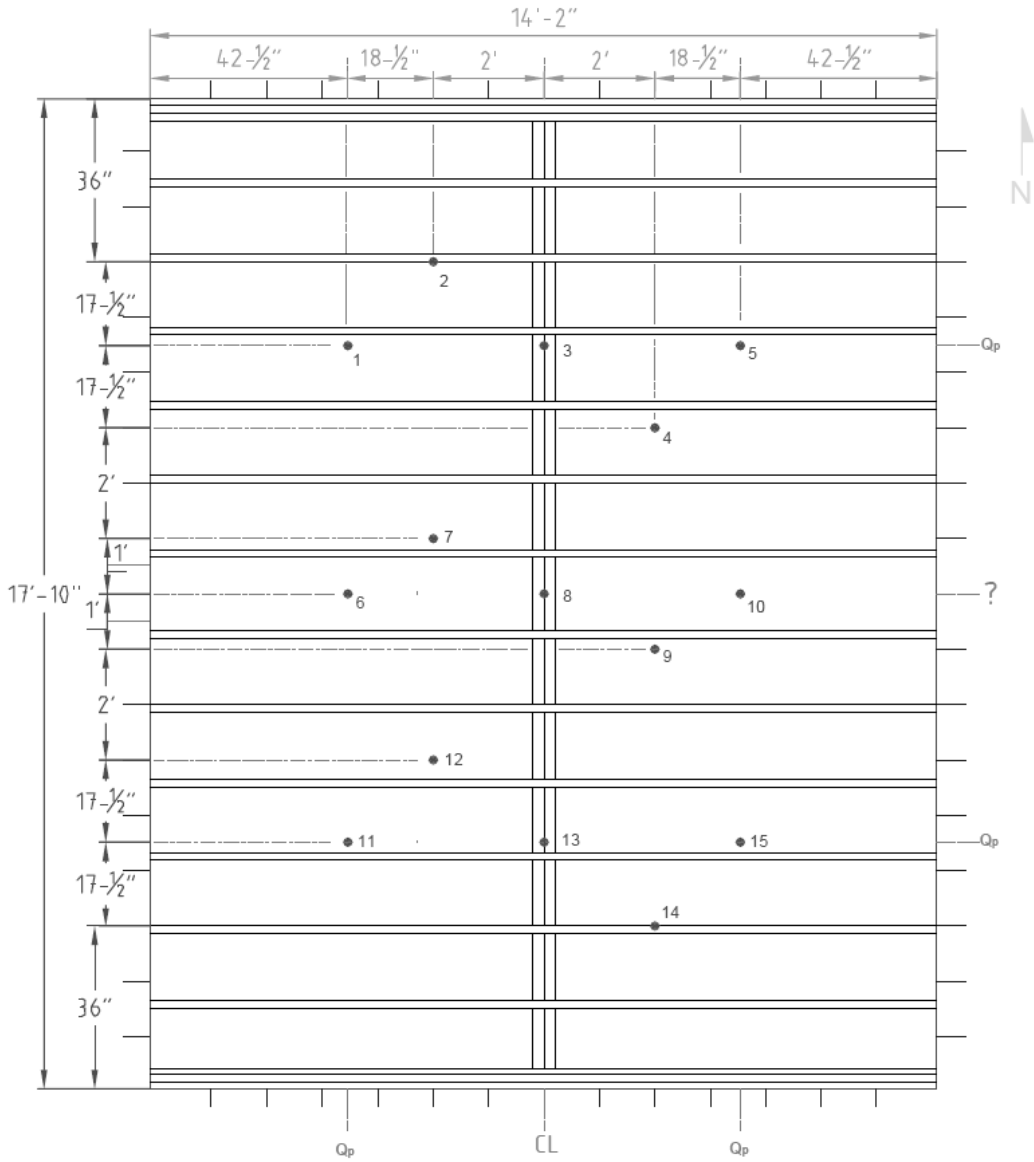
Figure A.1.5 – Thermocouple Locations on Subfloor.

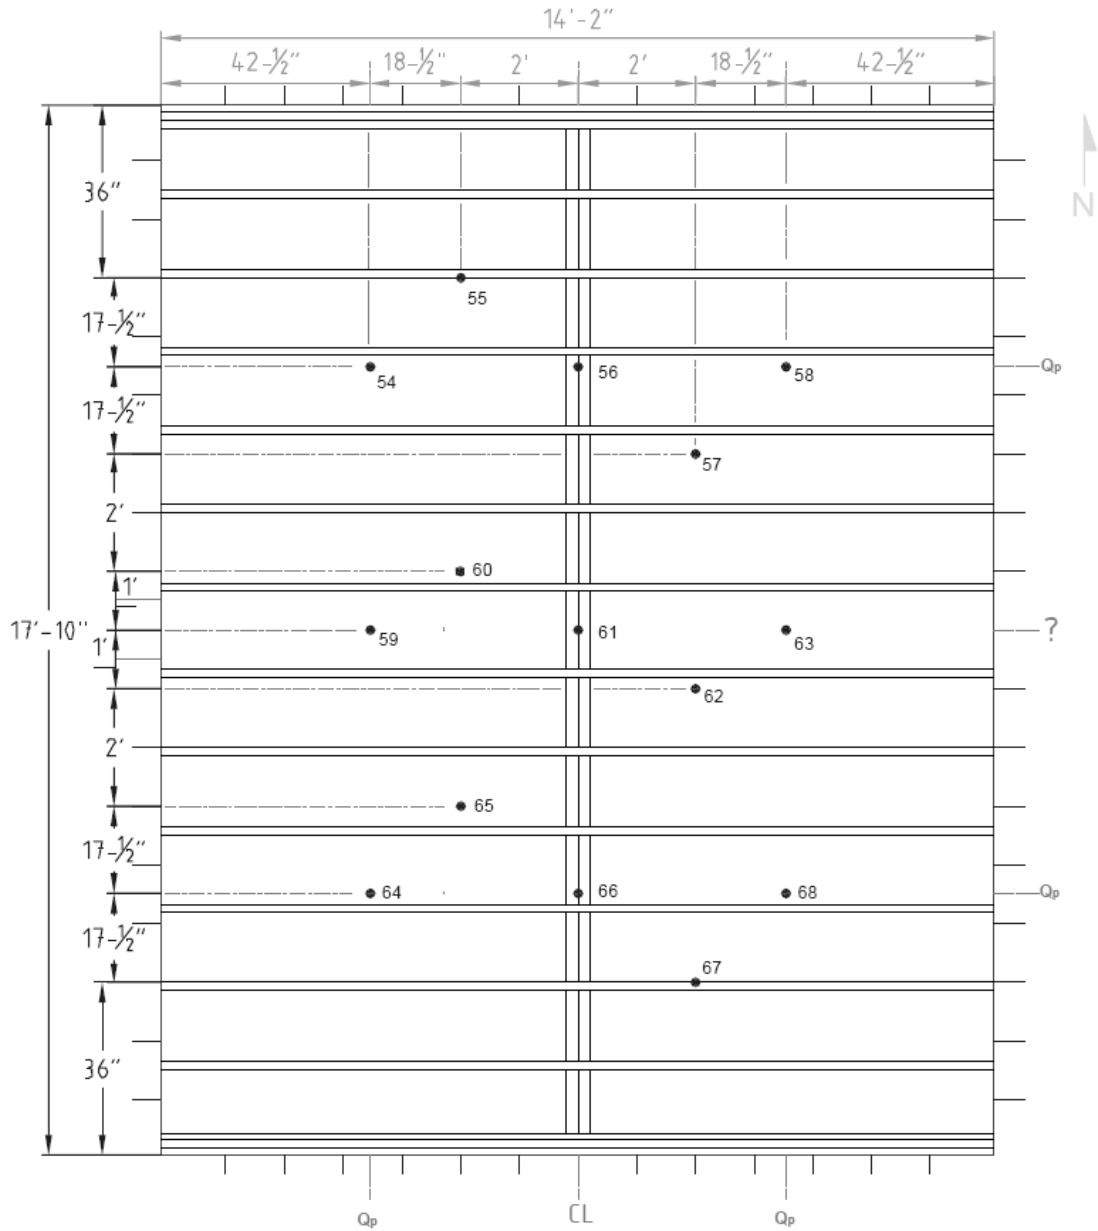
Figure A.1.6 – Thermocouple Locations on Unexposed Surface.

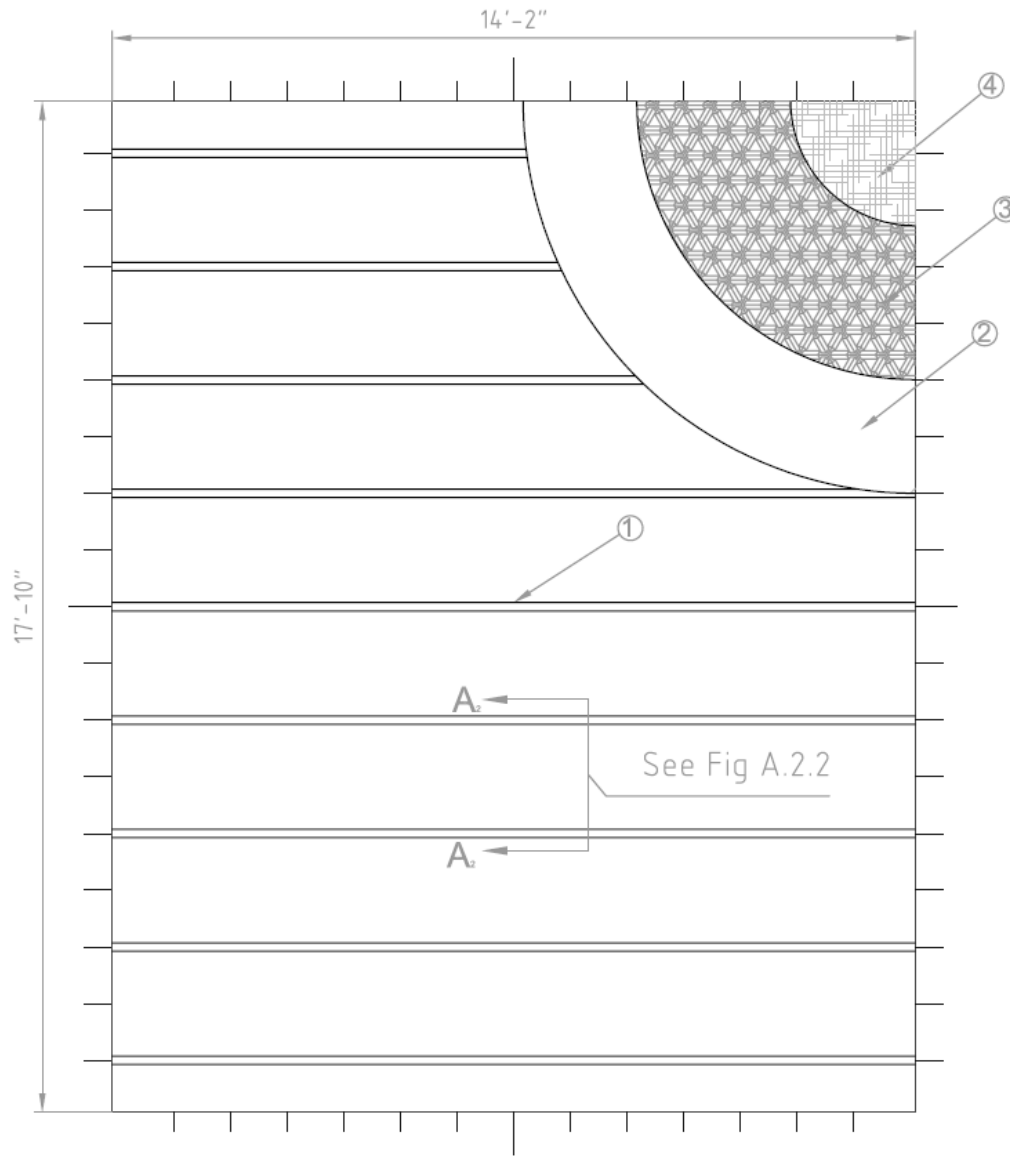
Figure A.2.1 – Construction Layout

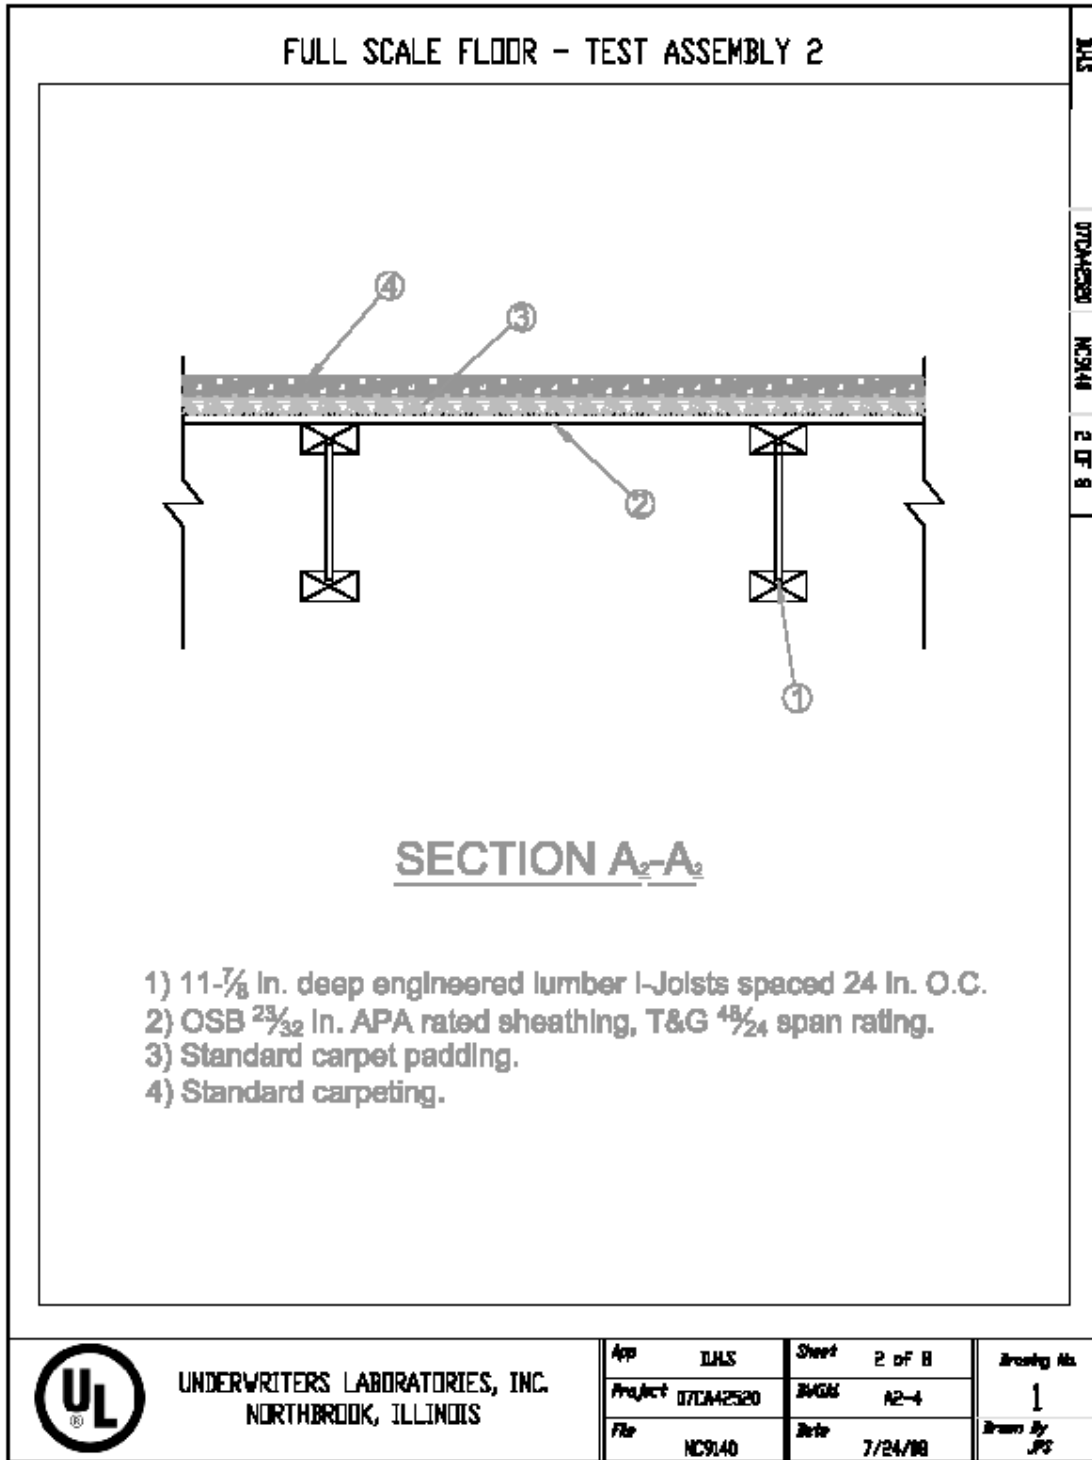
Figure A.2.2 – Construction Layout Section A₂-A₂.

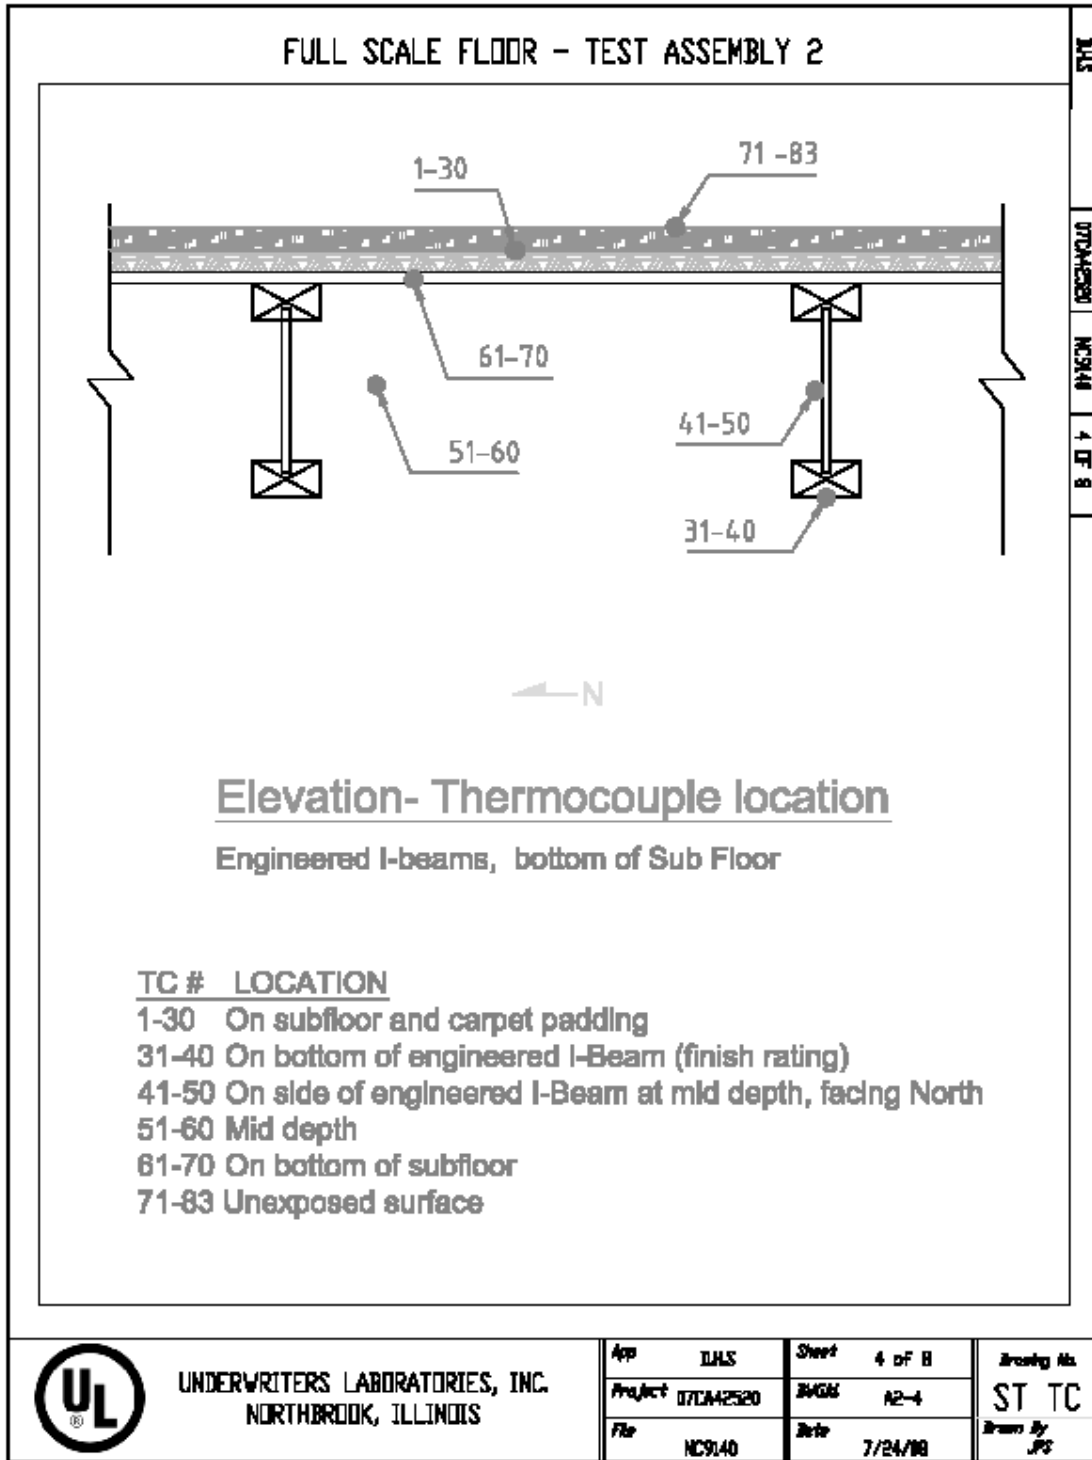
Figure A.2.3 – Thermocouple Locations - Elevation.

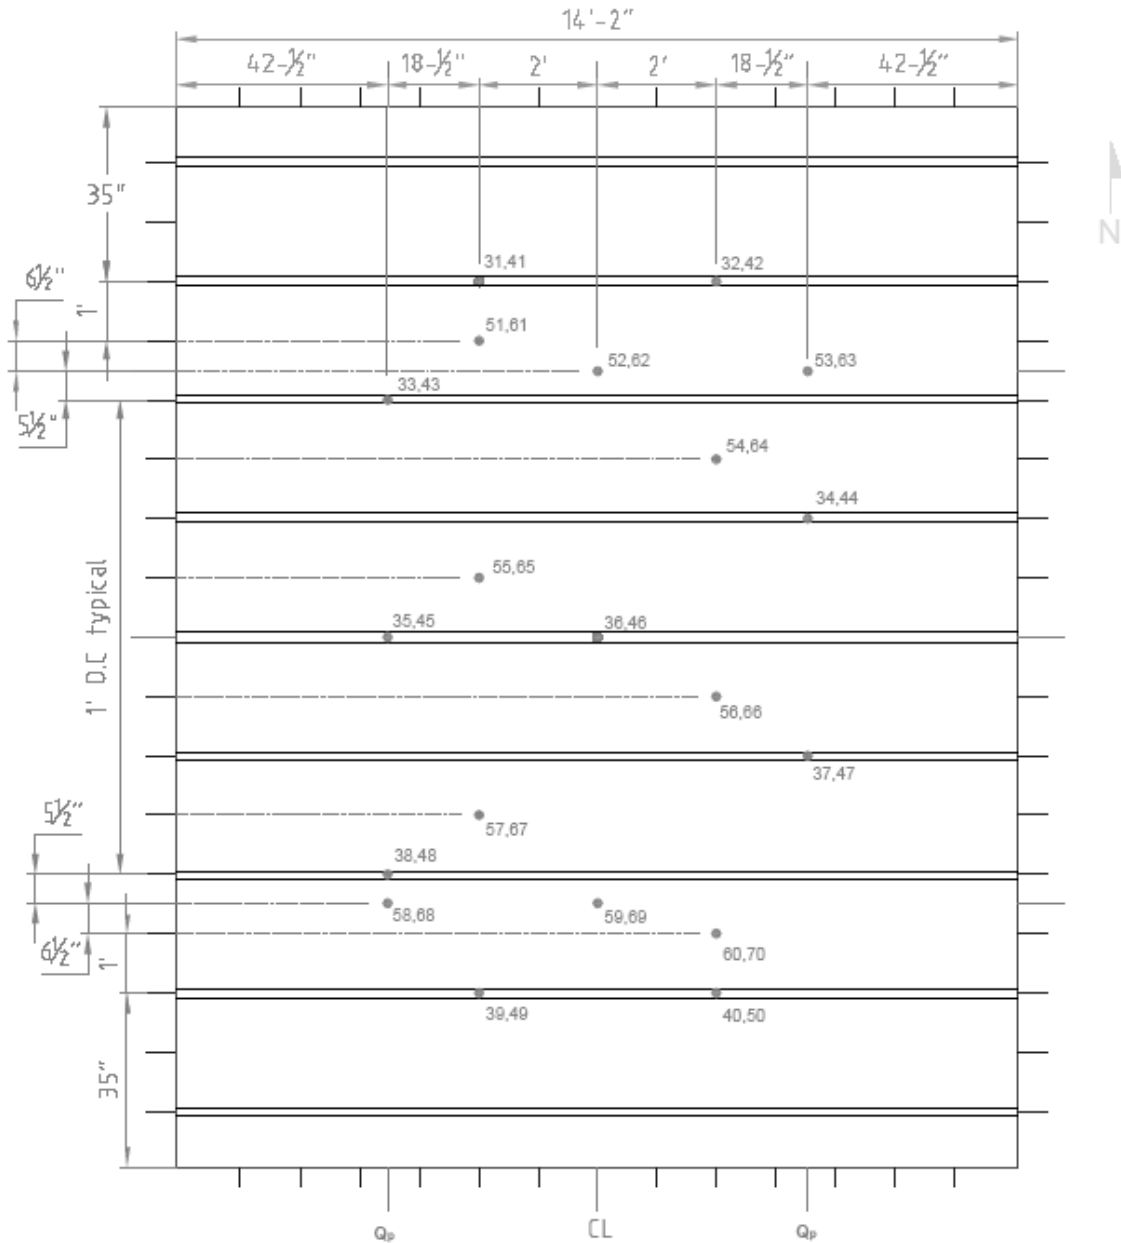
Figure A.2.4 – Thermocouple Locations on Wood Members.

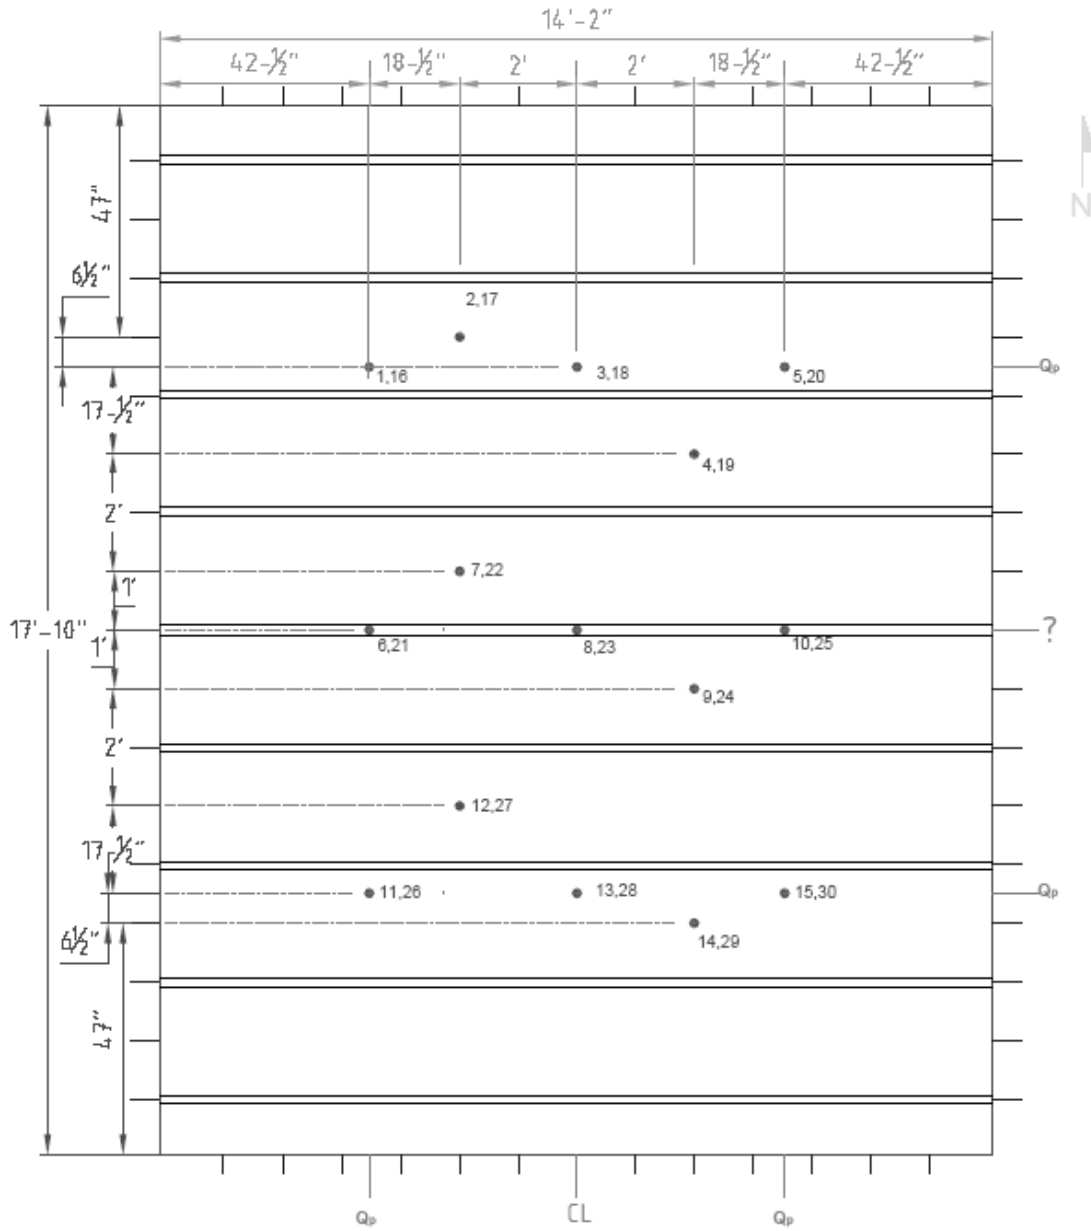
Figure A.2.5 – Thermocouple Locations on Subfloor and Carpet Padding.

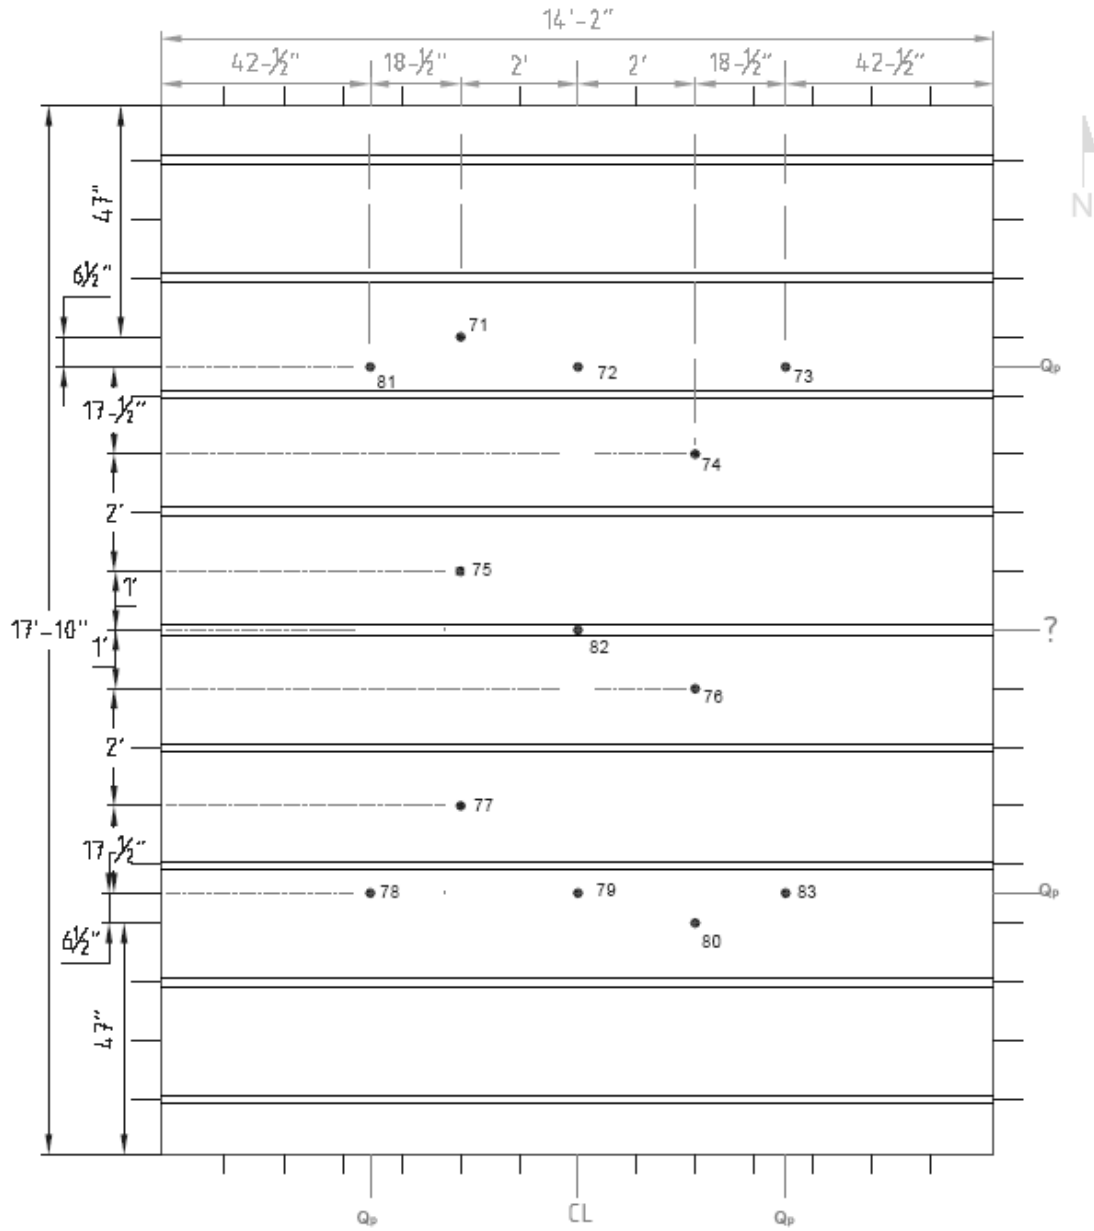
Figure A.2.6 – Thermocouple Locations on Unexposed Surface.

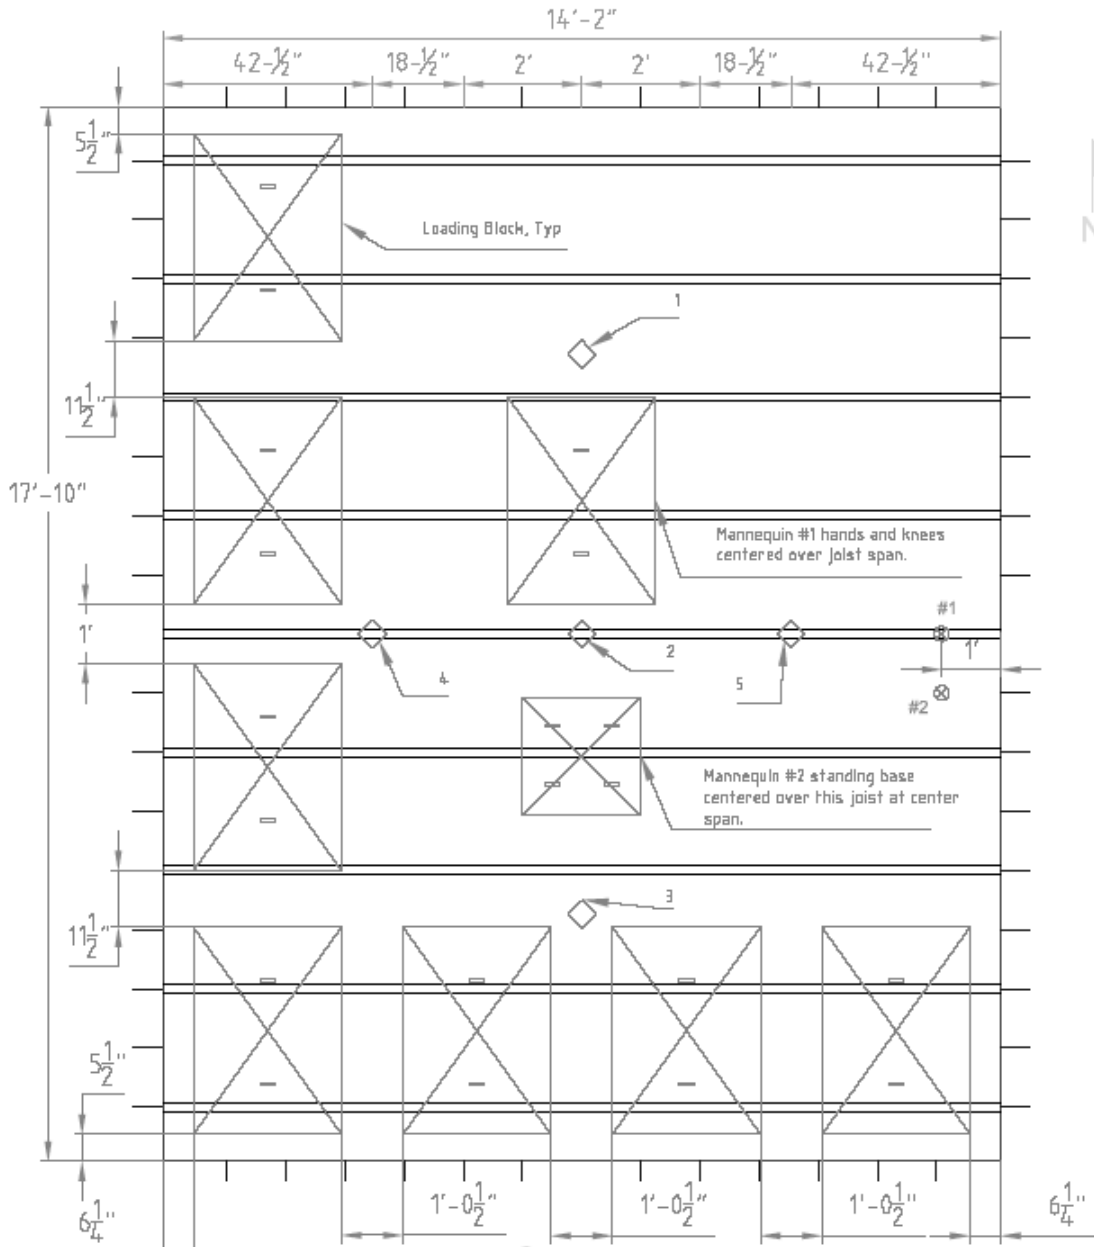
Figure A.2.7 – Loading and Instrumentation Layout (See Figure A.2.8).

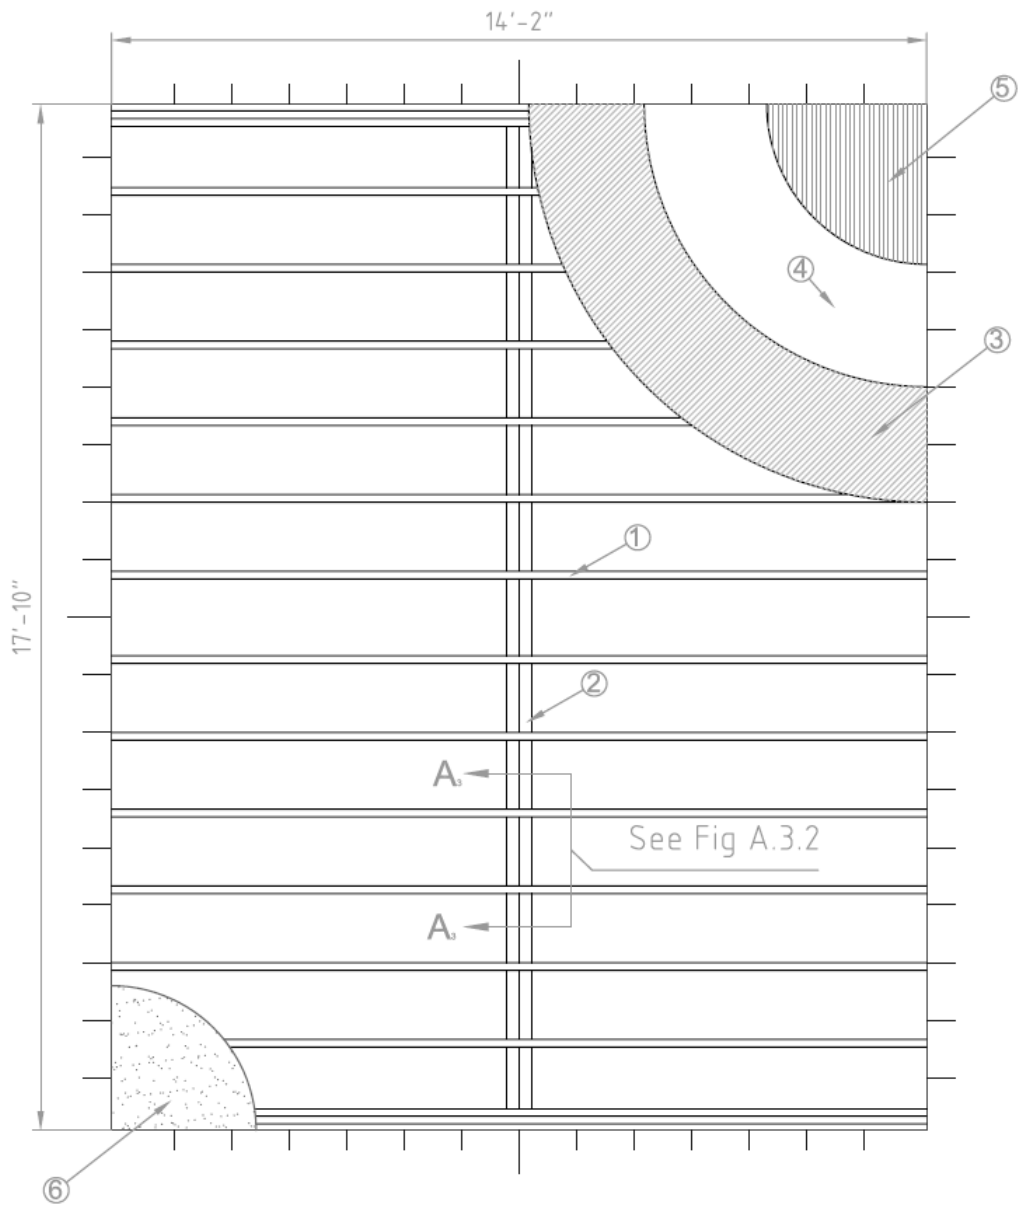
Figure A.3.1 – Construction Layout.
