**Report
on
Structural Stability of Engineered Lumber in Fire Conditions**

**Project Number: 07CA42520
File Number: NC9140**

**Underwriters Laboratories Inc.
333 Pfingsten Road, Northbrook, IL 60062**

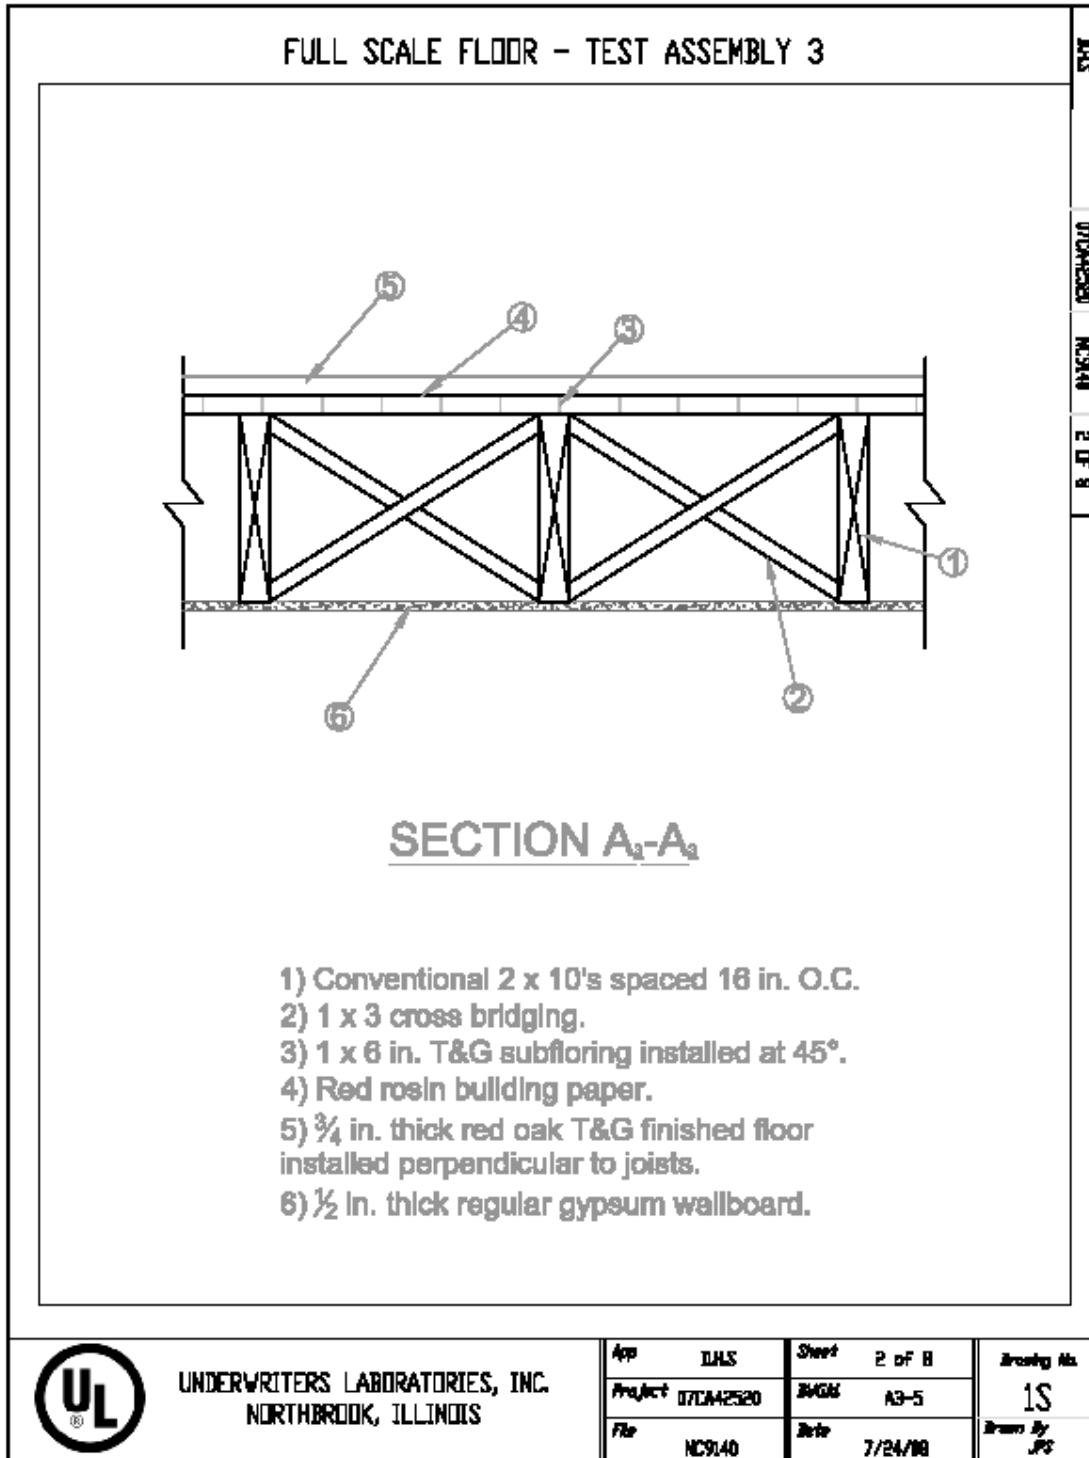
Figure A.3.2 – Construction Layout Section A₃-A₃.

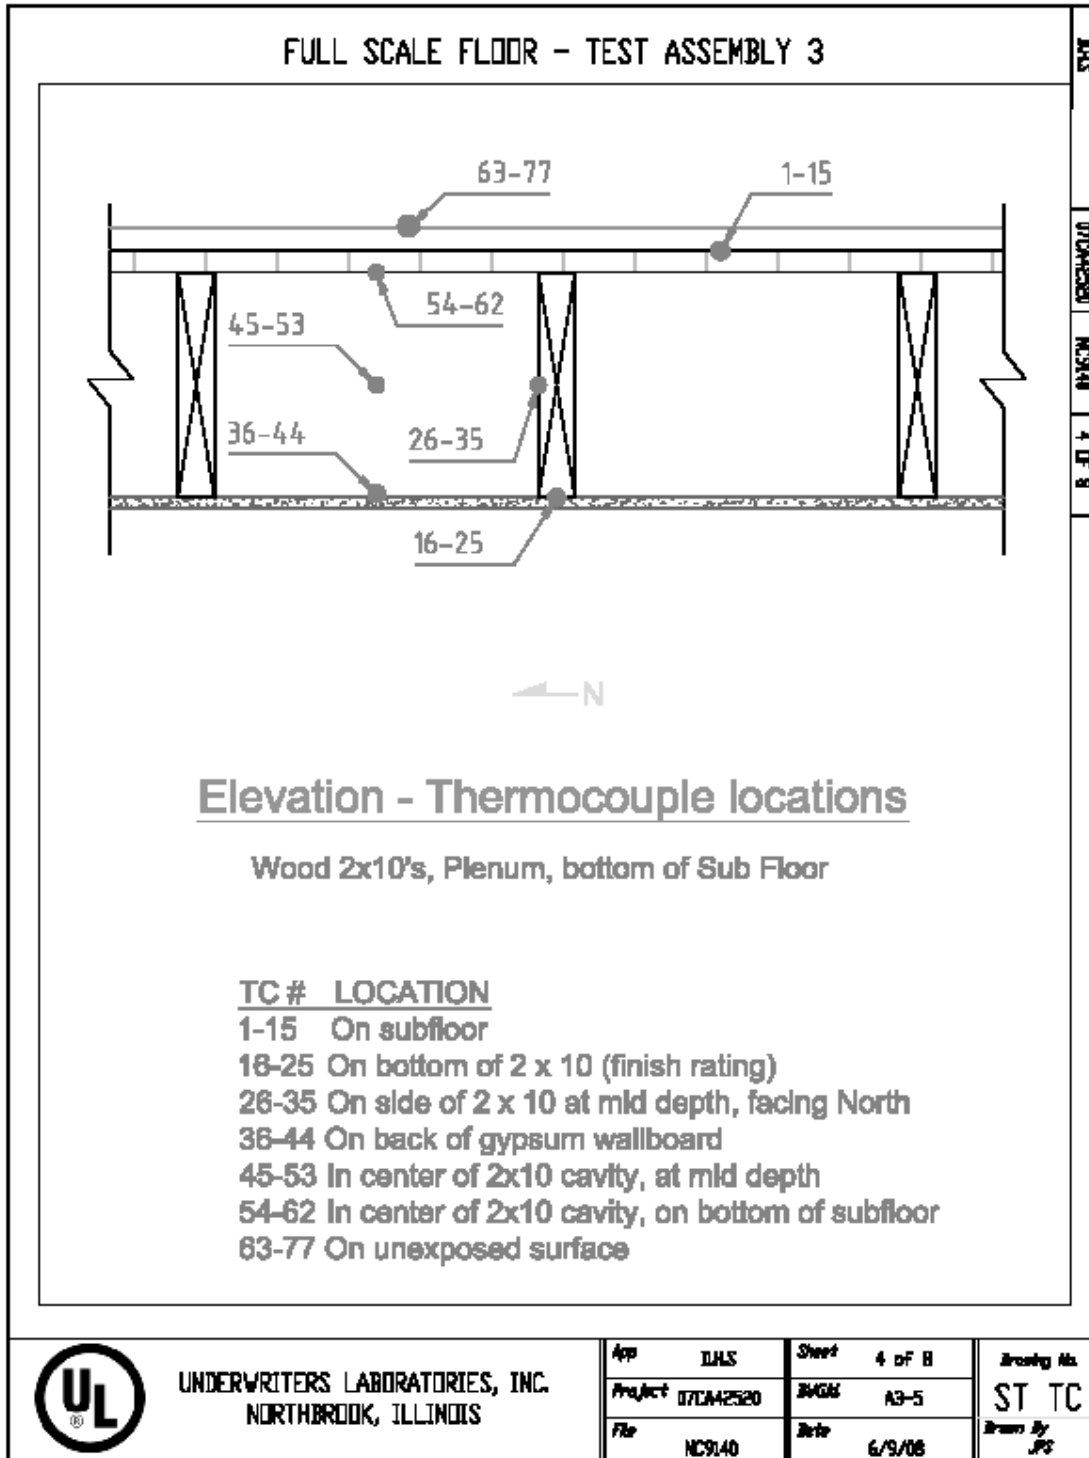
Figure A.3.3 – Thermocouple Locations - Elevation.

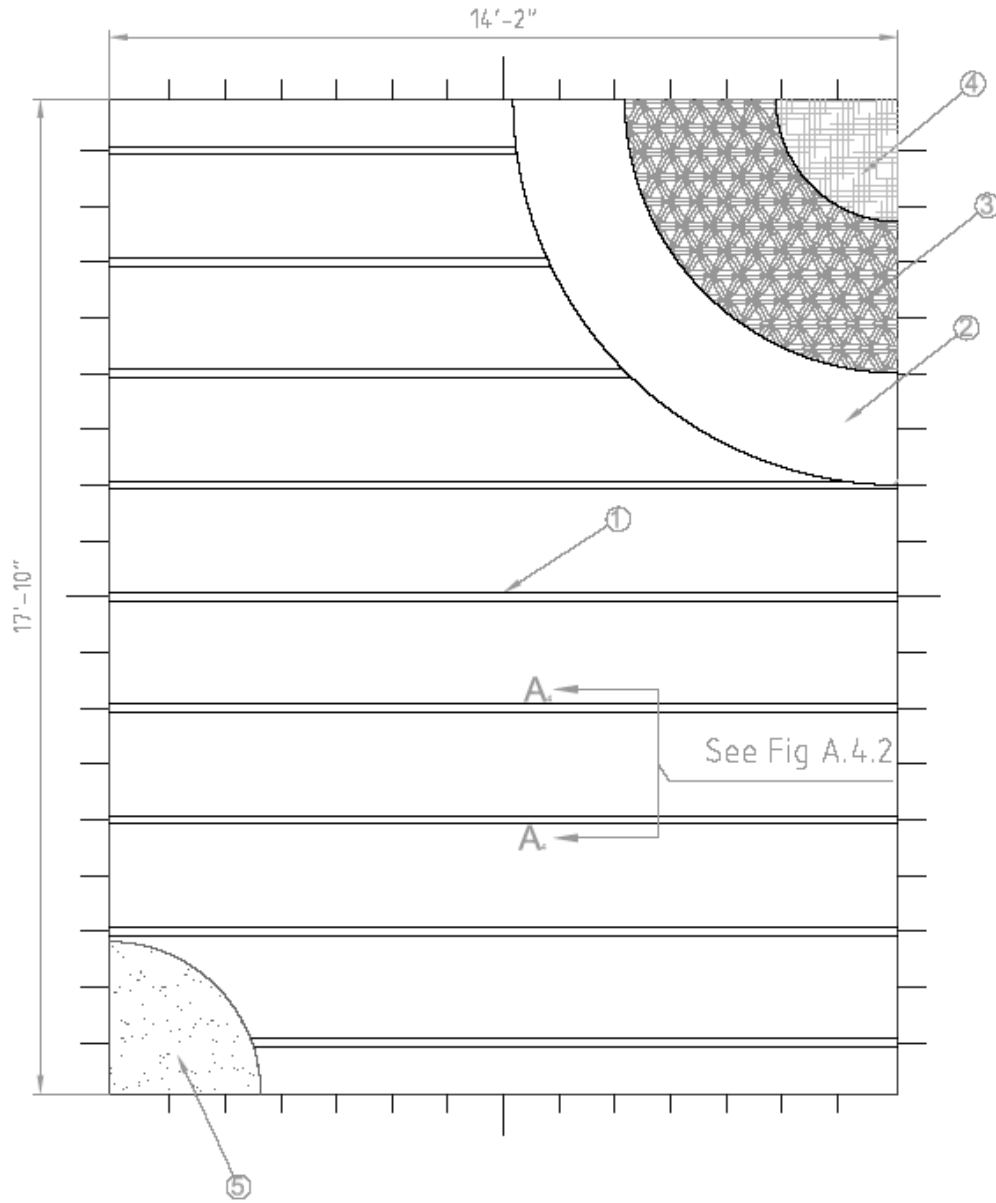
Figure A.4.1 – Construction Layout

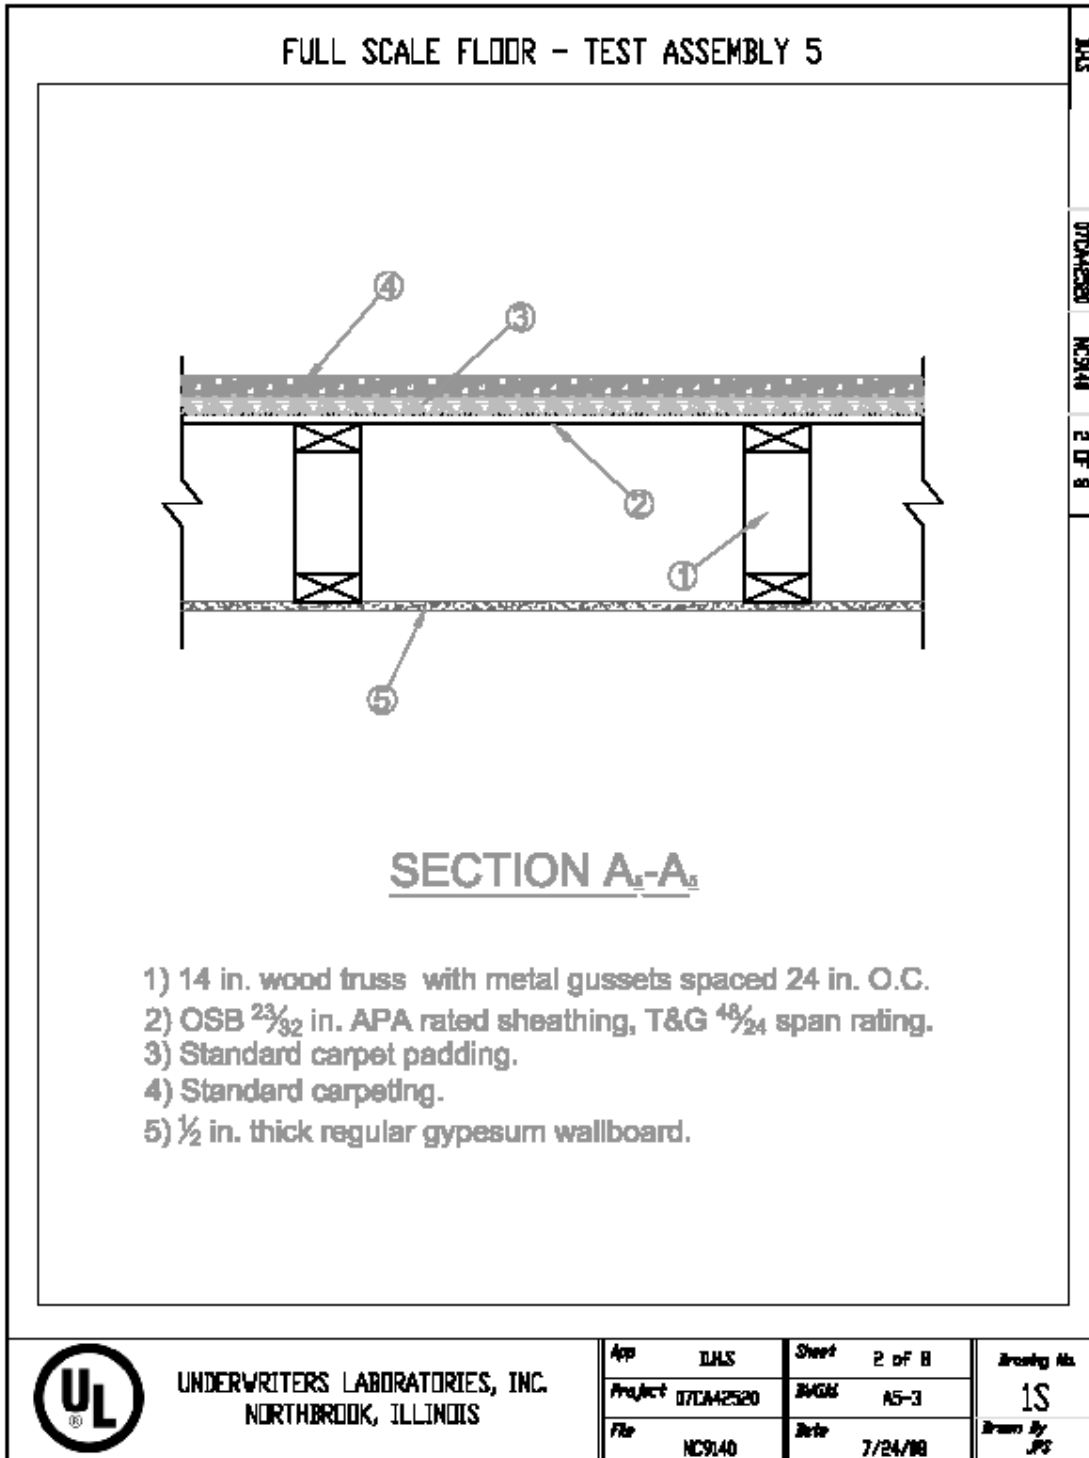
Figure A.5.2 – Construction Layout Section A₅-A₅.

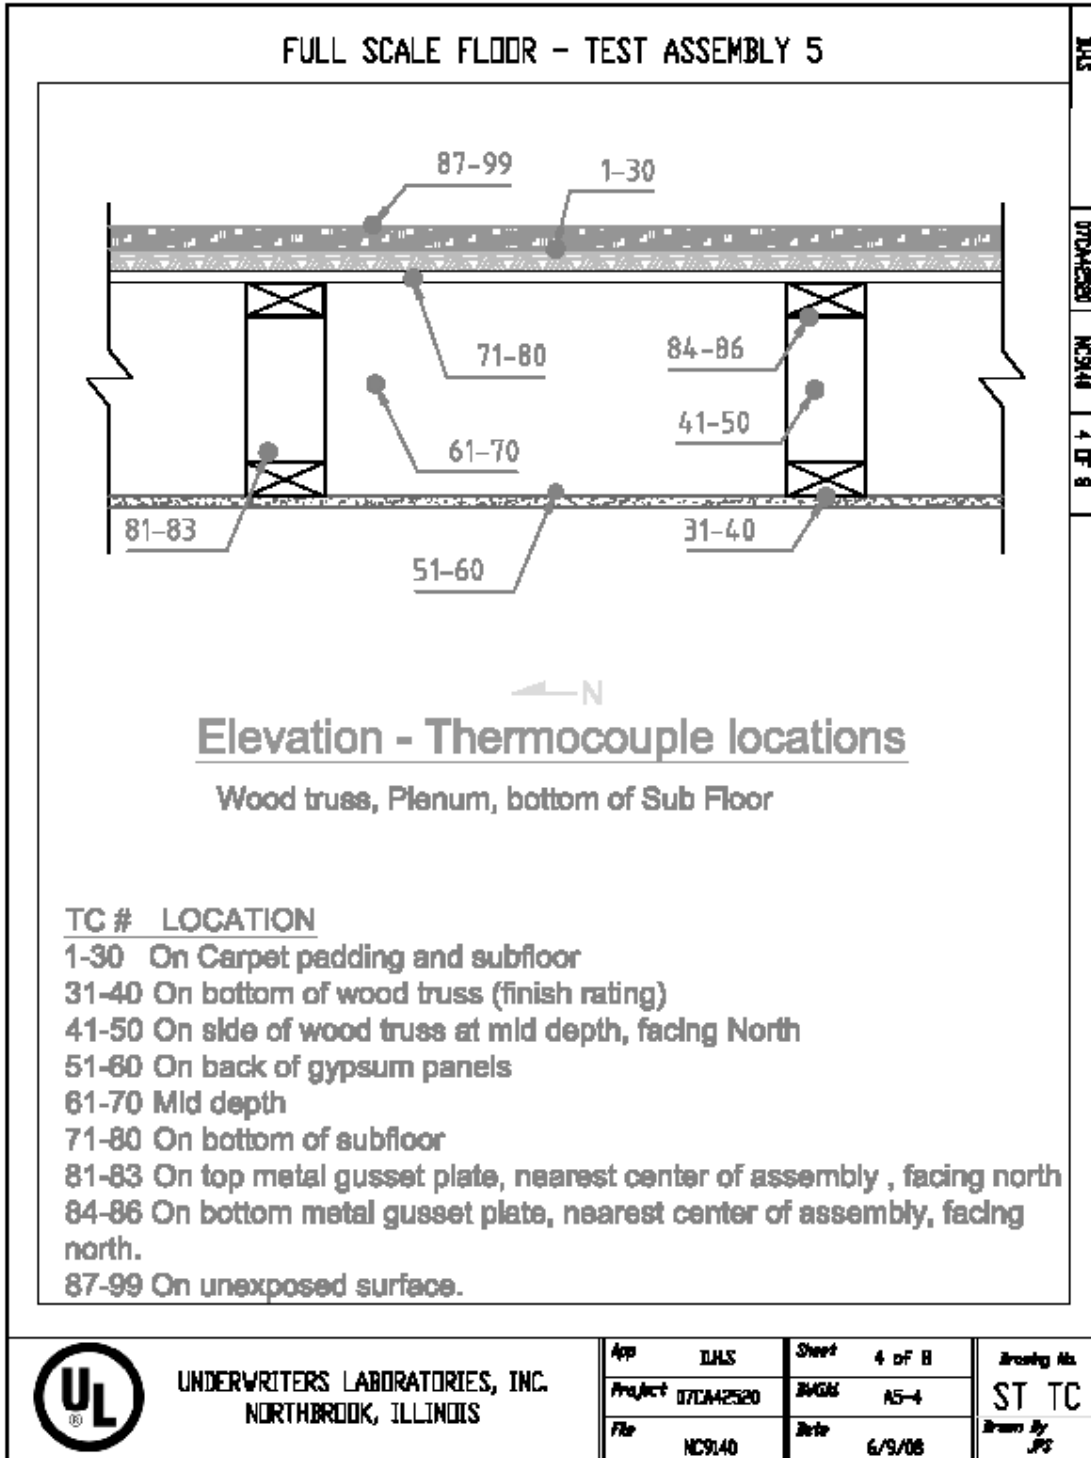
Figure A.5.3 – Thermocouple Locations - Elevation.

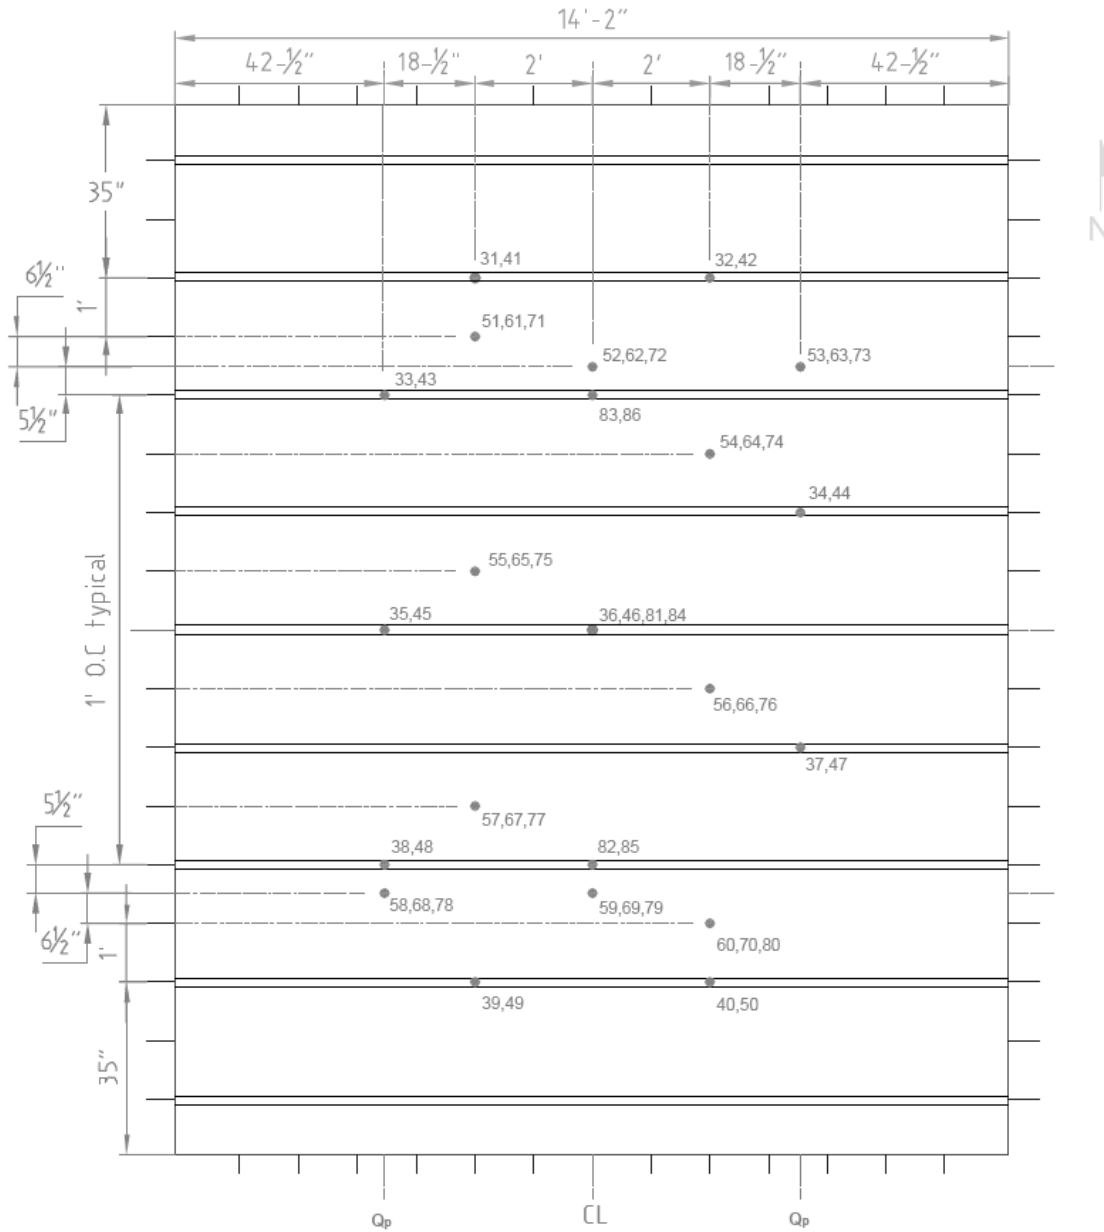
Figure A.5.4 – Thermocouple Locations on Wood Members.

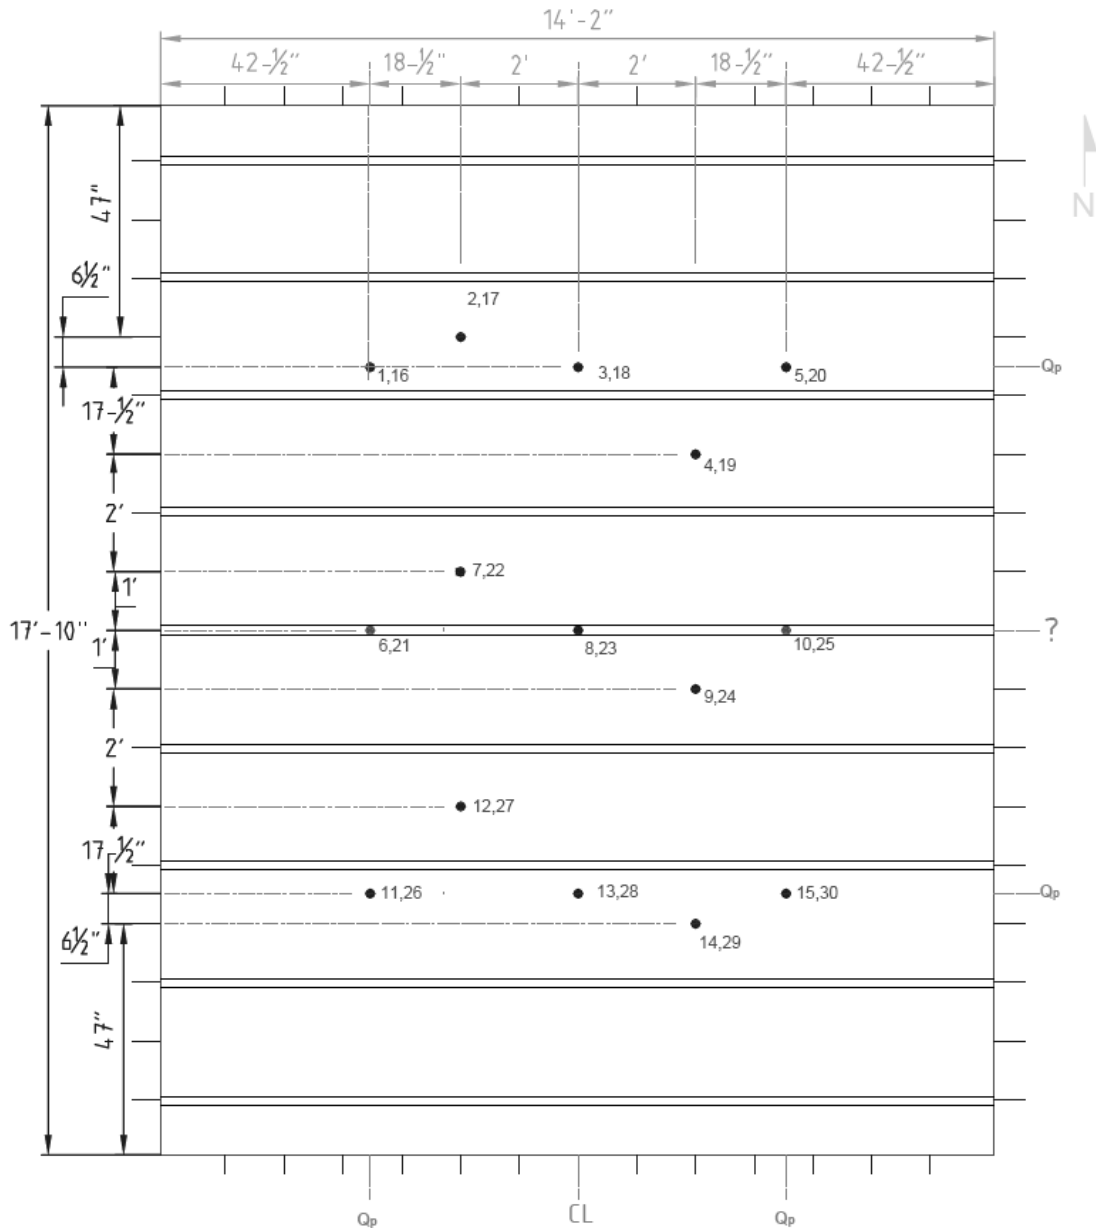
Figure A.5.5 – Thermocouple Locations on Subfloor and Carpet Padding.

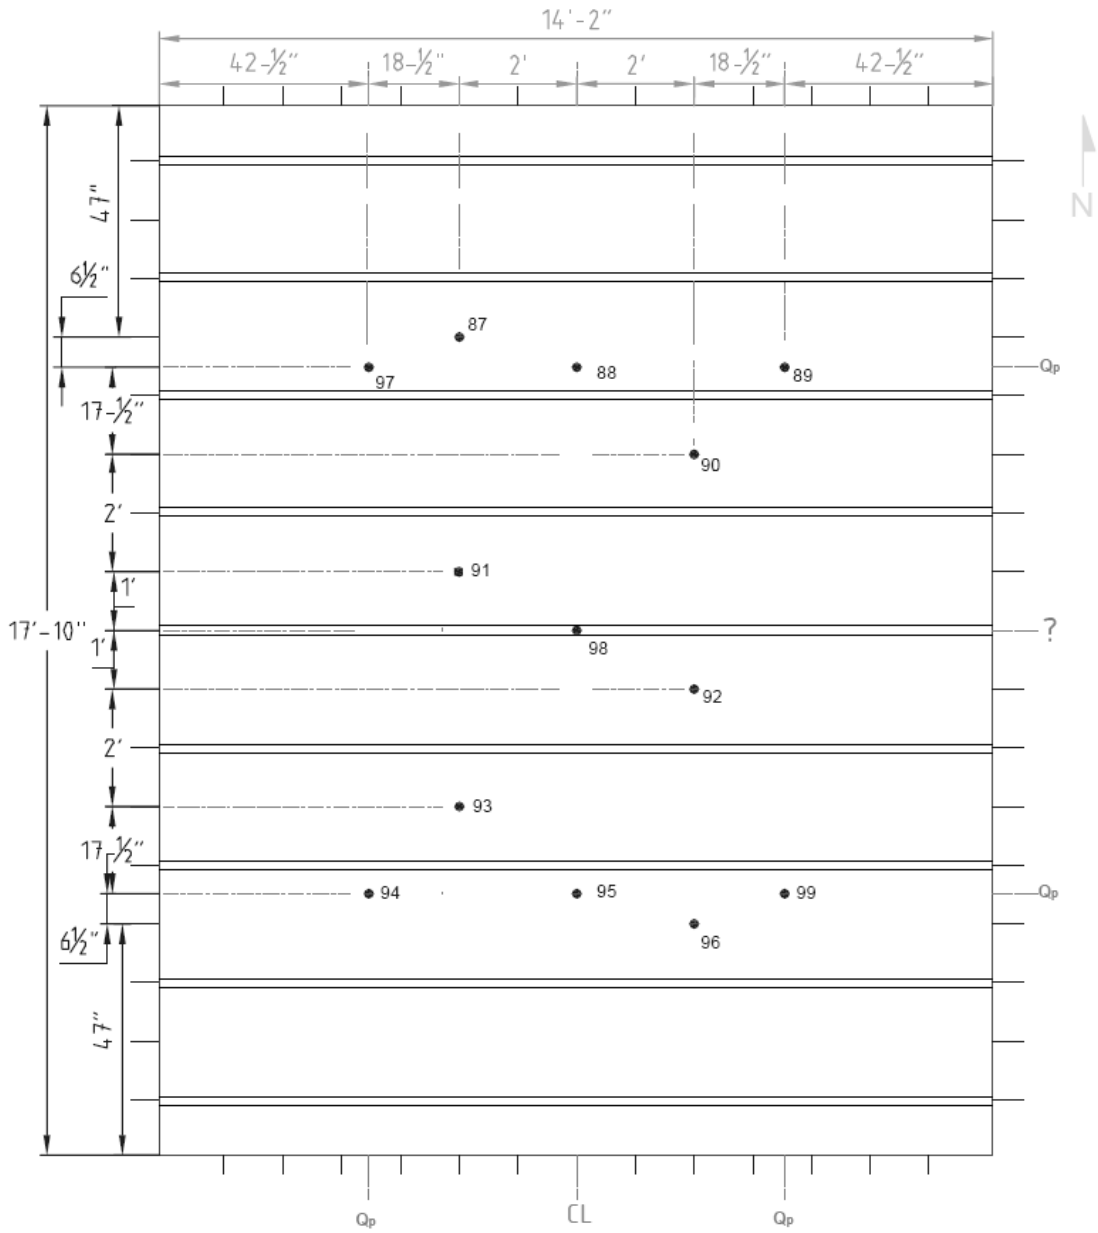
Figure A.5.6 – Thermocouple Locations on Unexposed Surface.

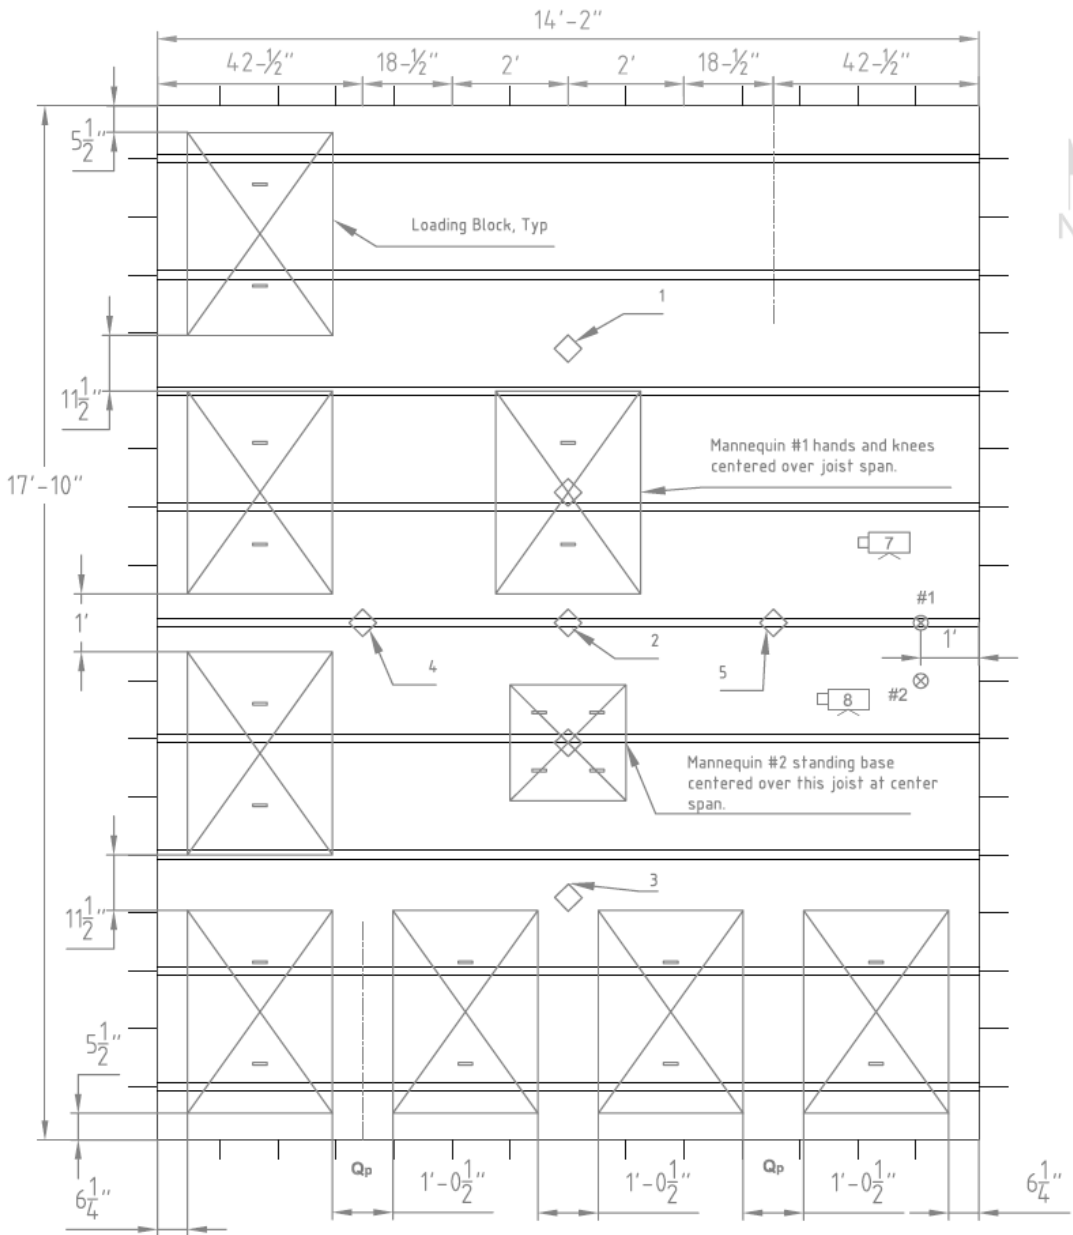
Figure A.5.7 – Loading and Instrumentation Layout (See Figure A.5.8).

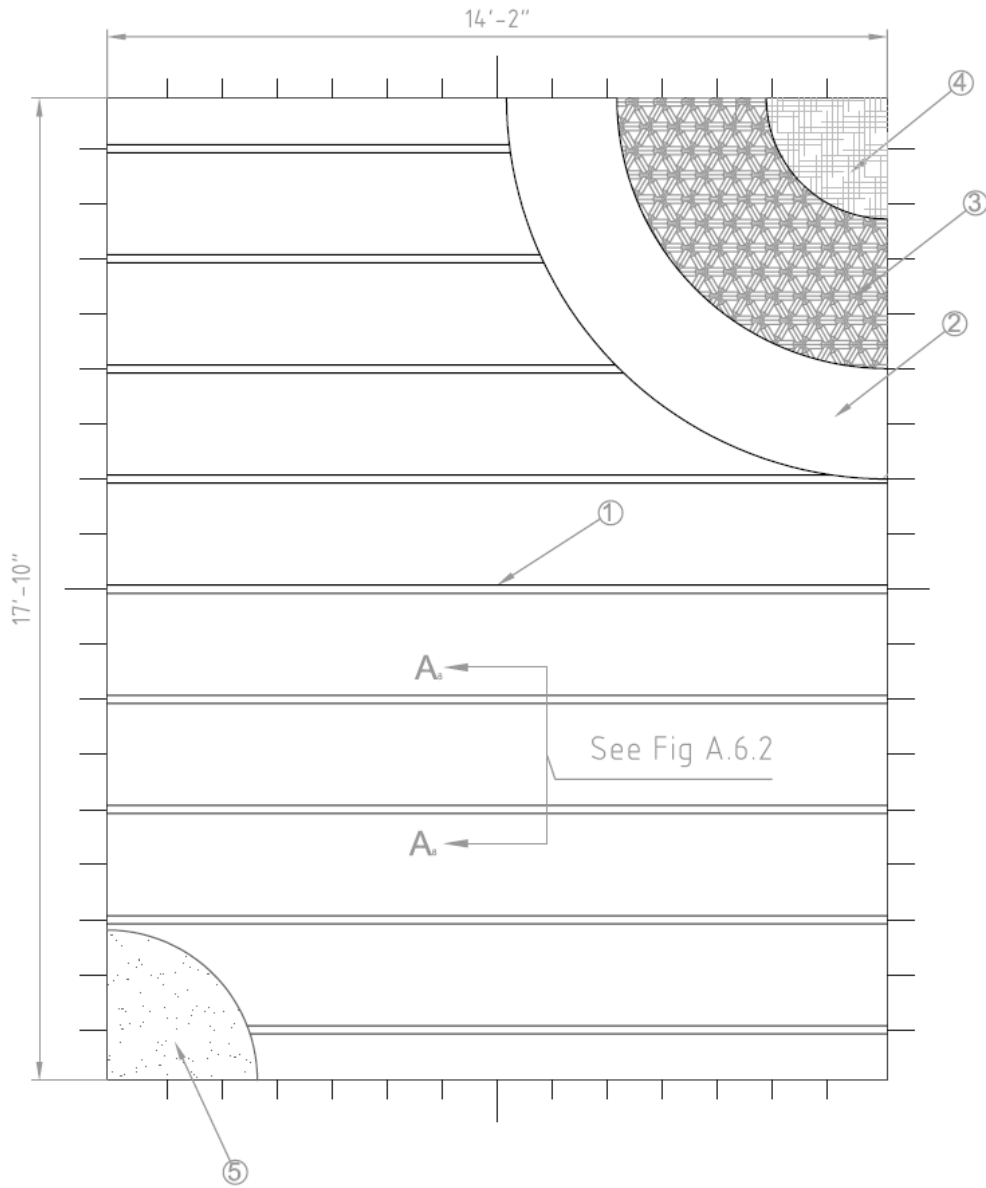
Figure A.6.1 – Construction Layout

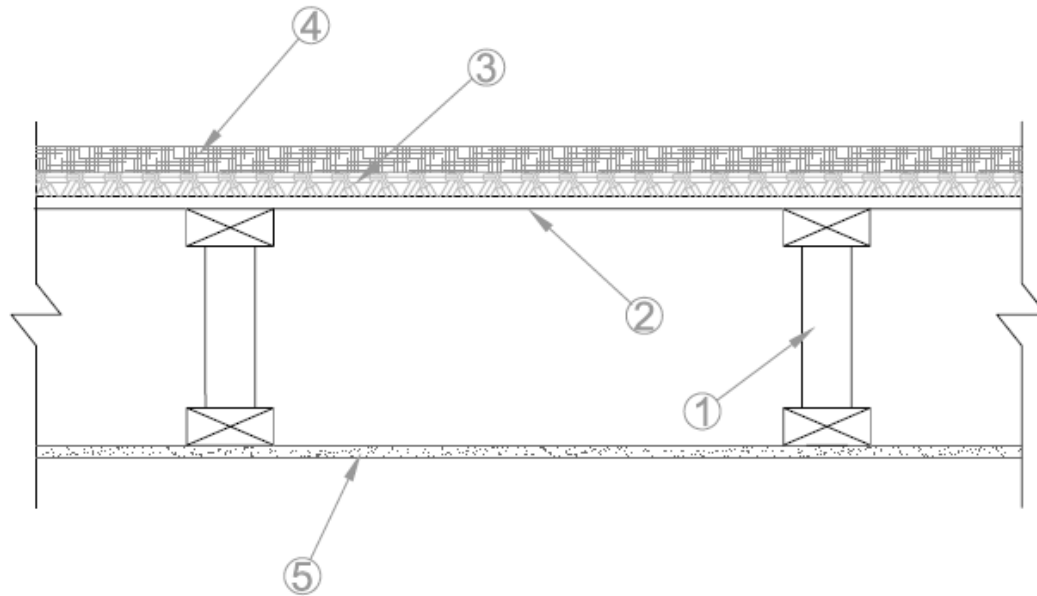
SECTION A₆-A₆

- 1) 14 in. Deep wood truss with glued finger joints spaced 24 in. O.C.
- 2) OSB $\frac{23}{32}$ in. APA rated sheathing, T&G $\frac{48}{24}$ span rating.
- 3) Standard carpet padding.
- 4) Standard carpeting.
- 5) $\frac{1}{2}$ in. thick regular gypsum wallboard.

Figure A.6.2 – Construction Layout Section A₆-A₆.

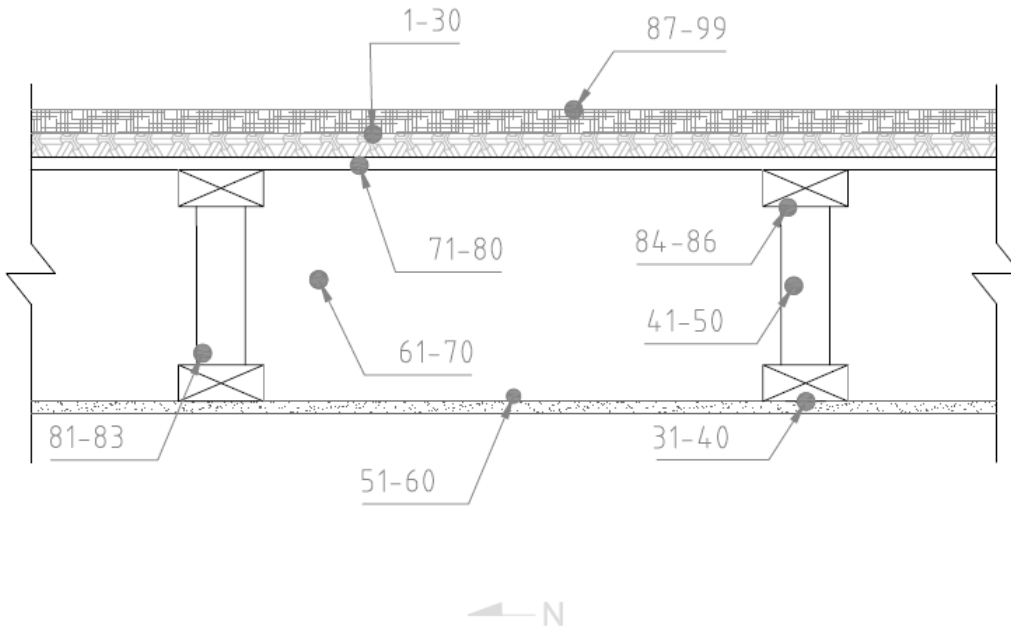
Elevation - Thermocouple Locations

Wood truss, Plenum, bottom of Sub Floor

Figure A.6.3 – Thermocouple Locations - Elevation.

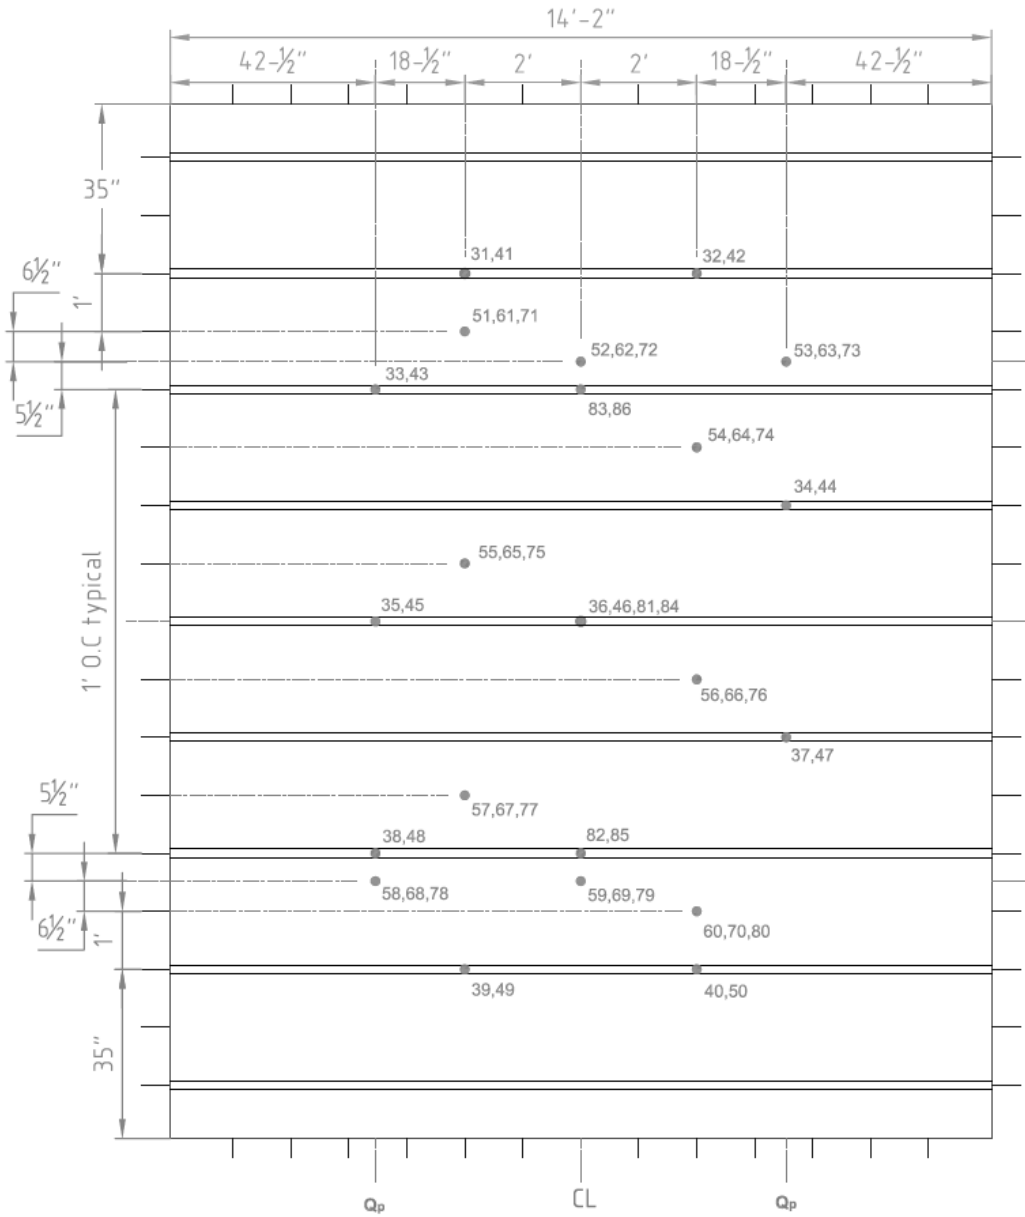
Figure A.6.4 – Thermocouple Locations on Wood Members.

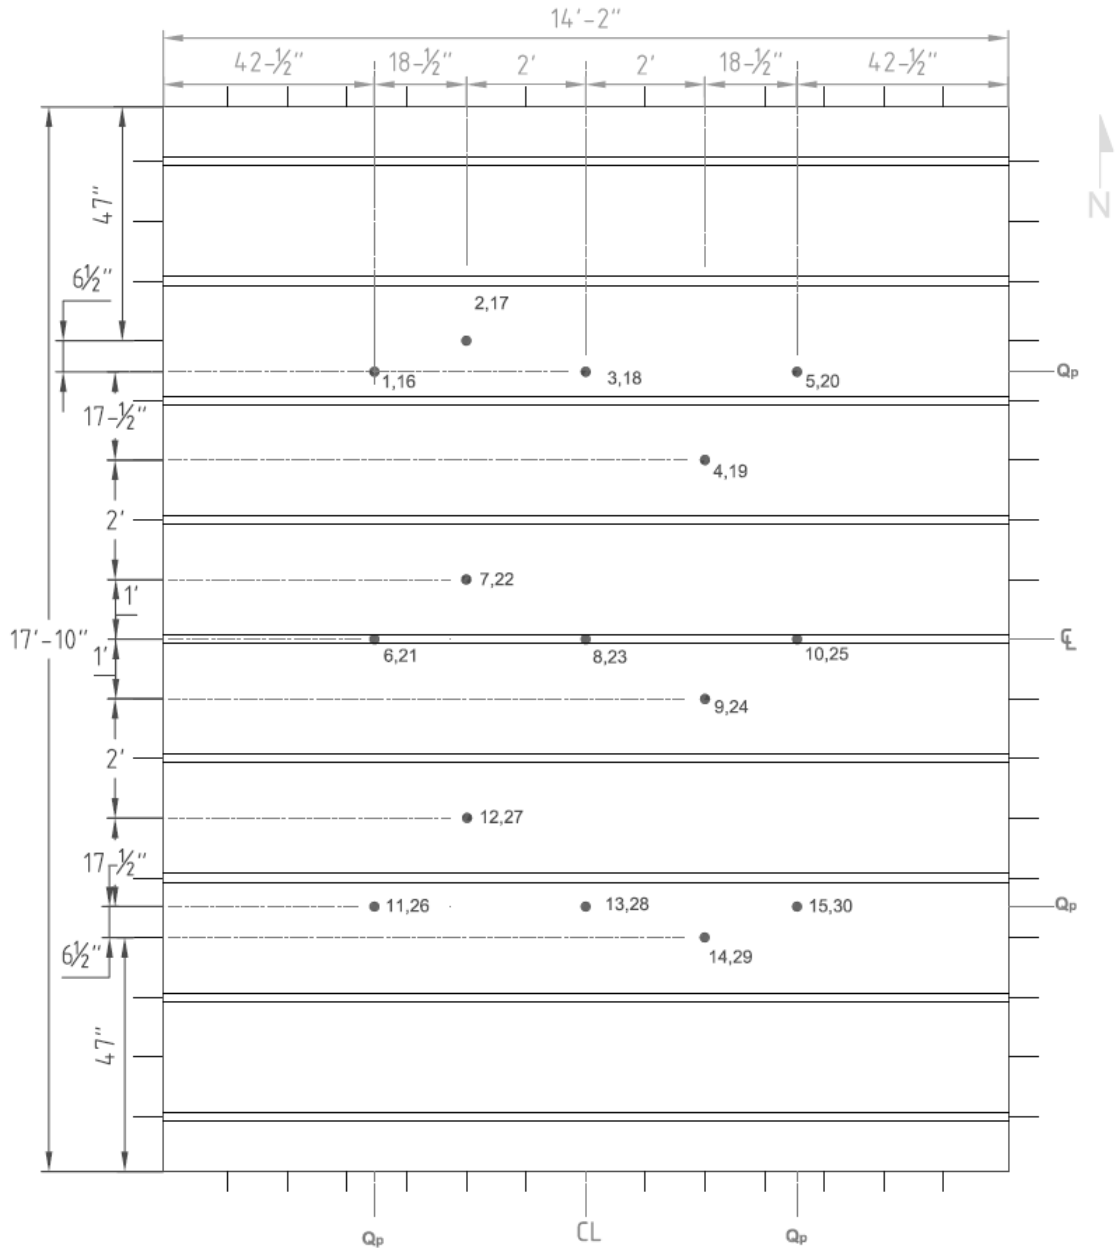
Figure A.6.5 – Thermocouple Locations on Subfloor and Carpet Padding.

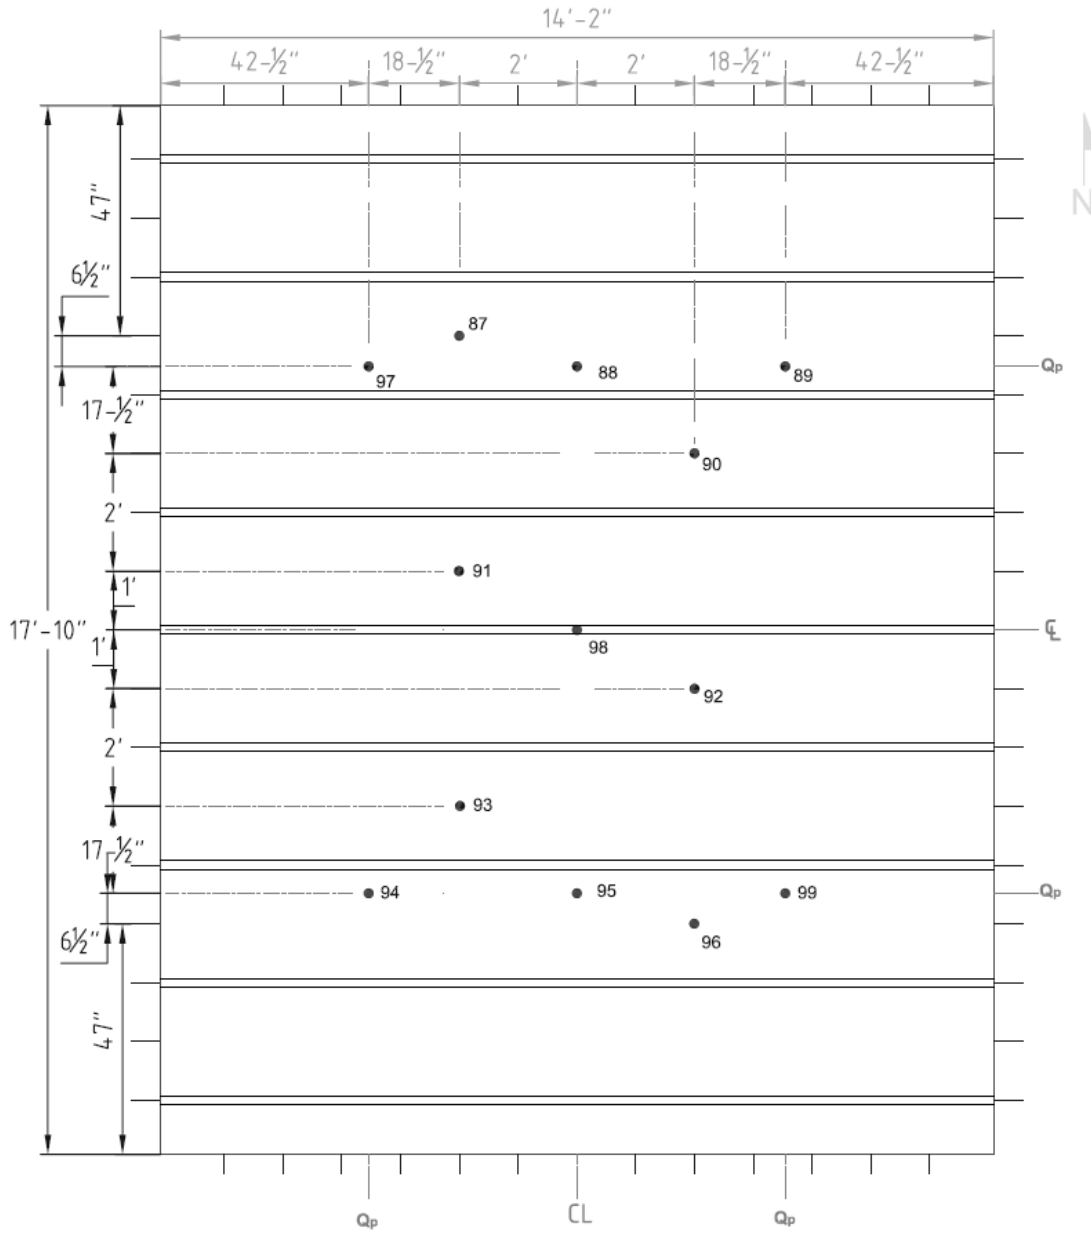
Figure A.6.6 – Thermocouple Locations on Unexposed Surface.

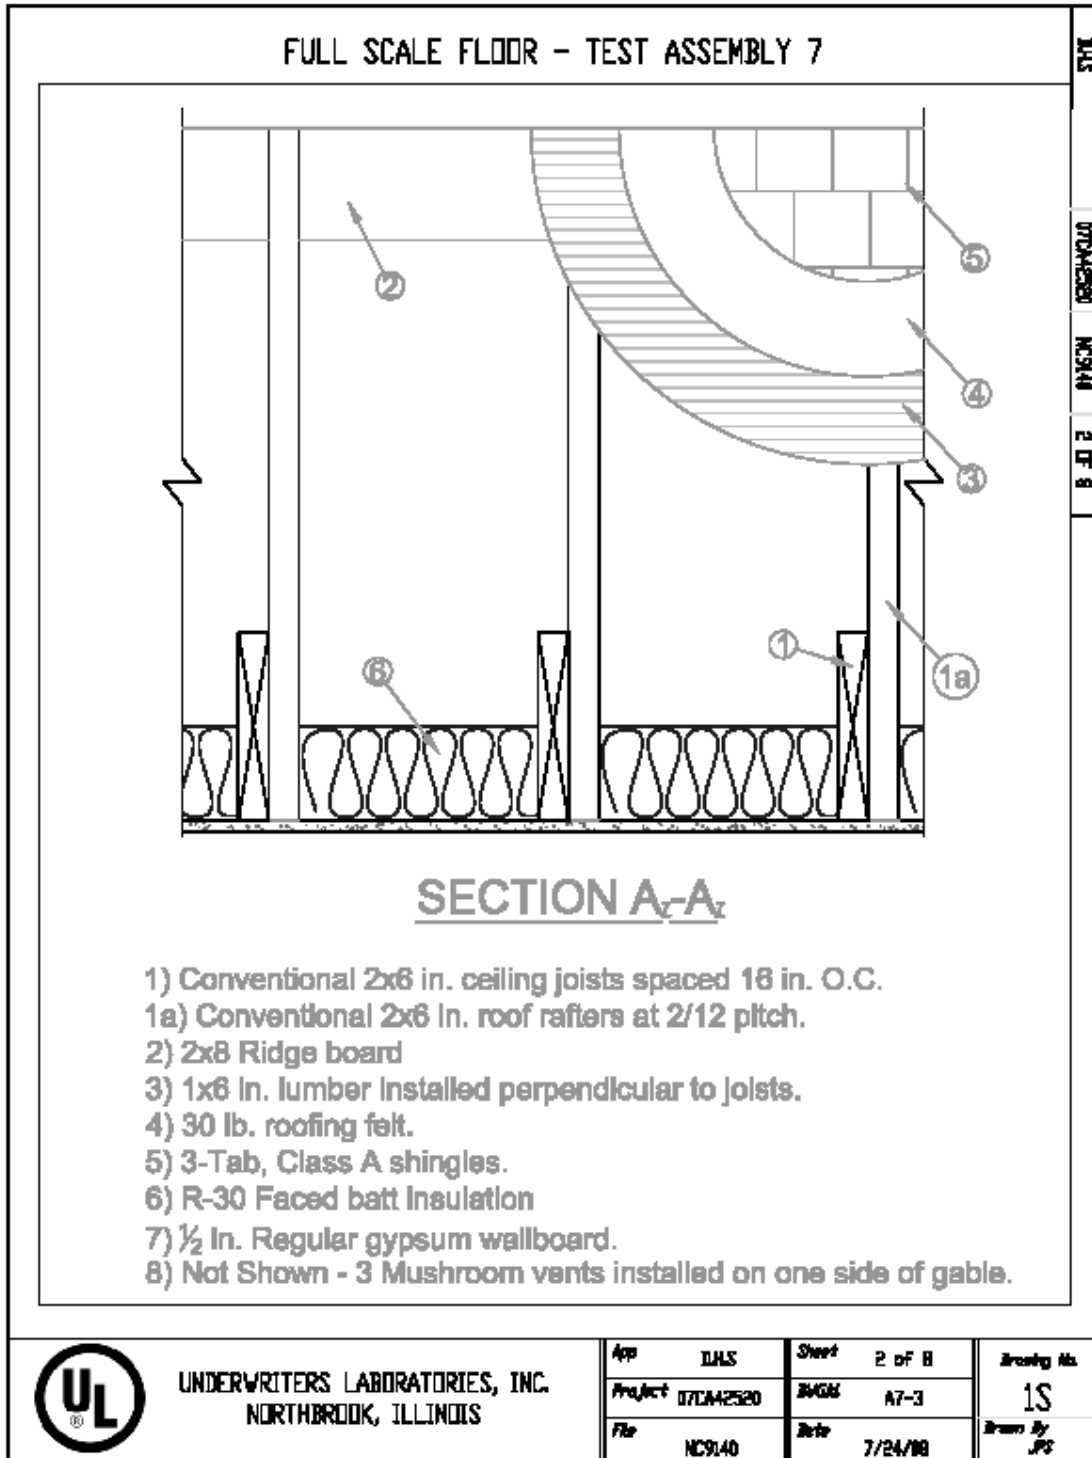
Figure A.7.2 – Construction Layout Section A₇-A₇.

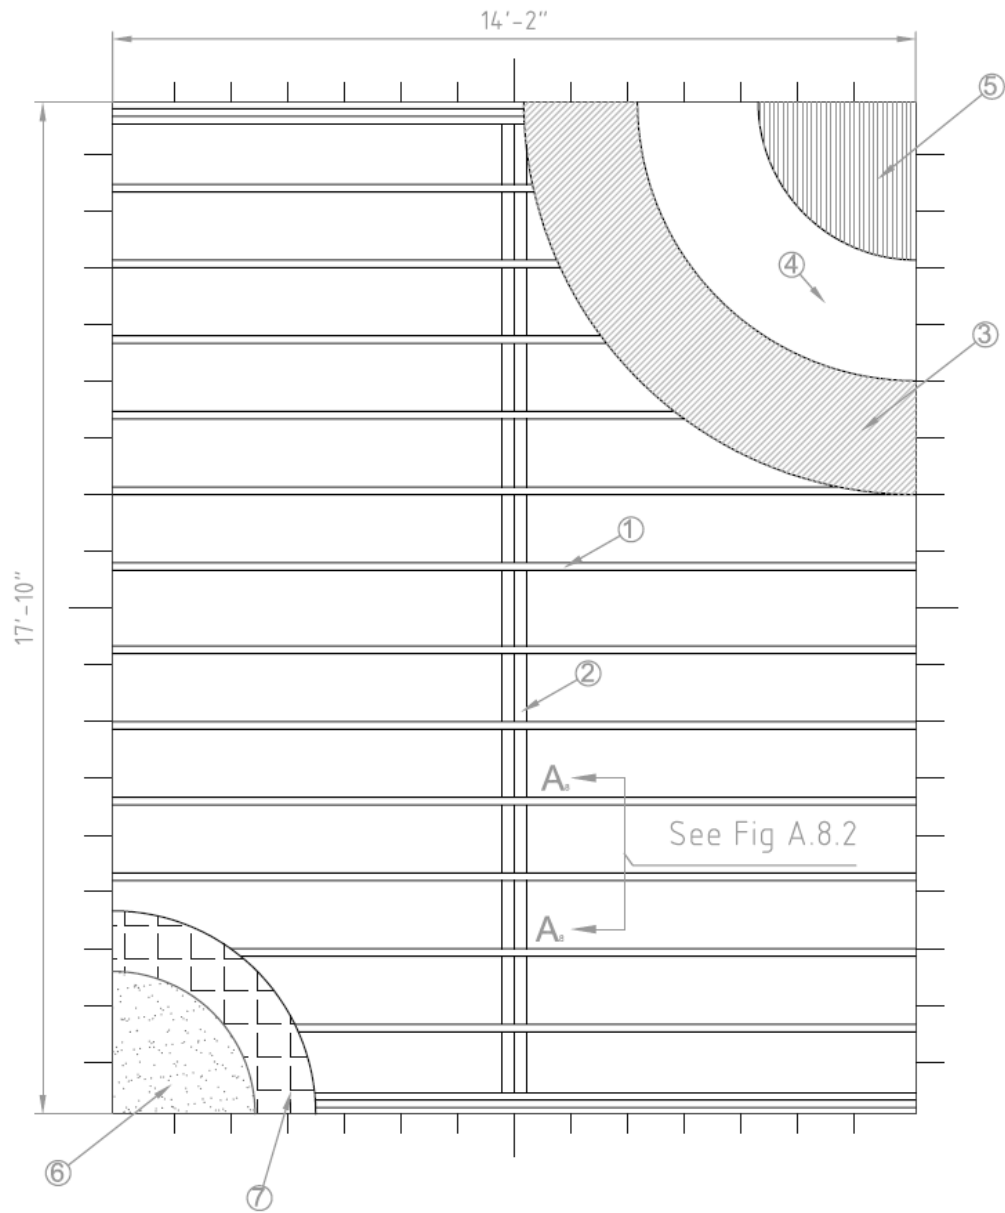
Figure A.8.1 – Construction Layout
