**Report
on
Structural Stability of Engineered Lumber in Fire Conditions**

**Project Number: 07CA42520
File Number: NC9140**

**Underwriters Laboratories Inc.
333 Pfingsten Road, Northbrook, IL 60062**

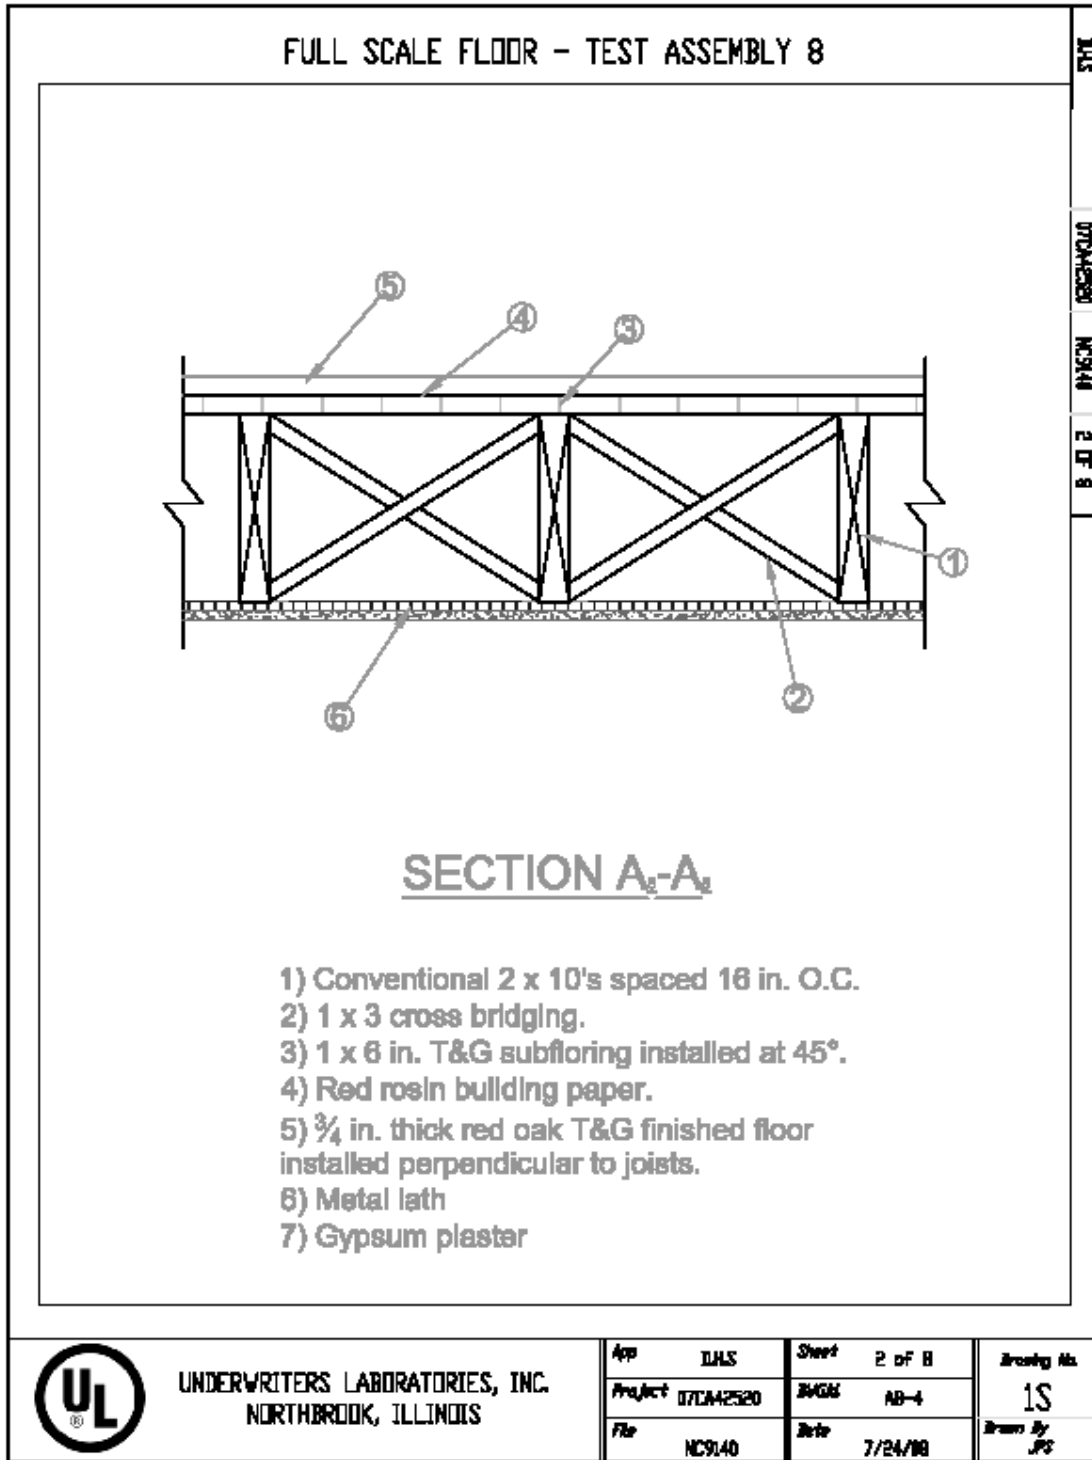
Figure A.8.2 – Construction Layout Section A₈-A₈.

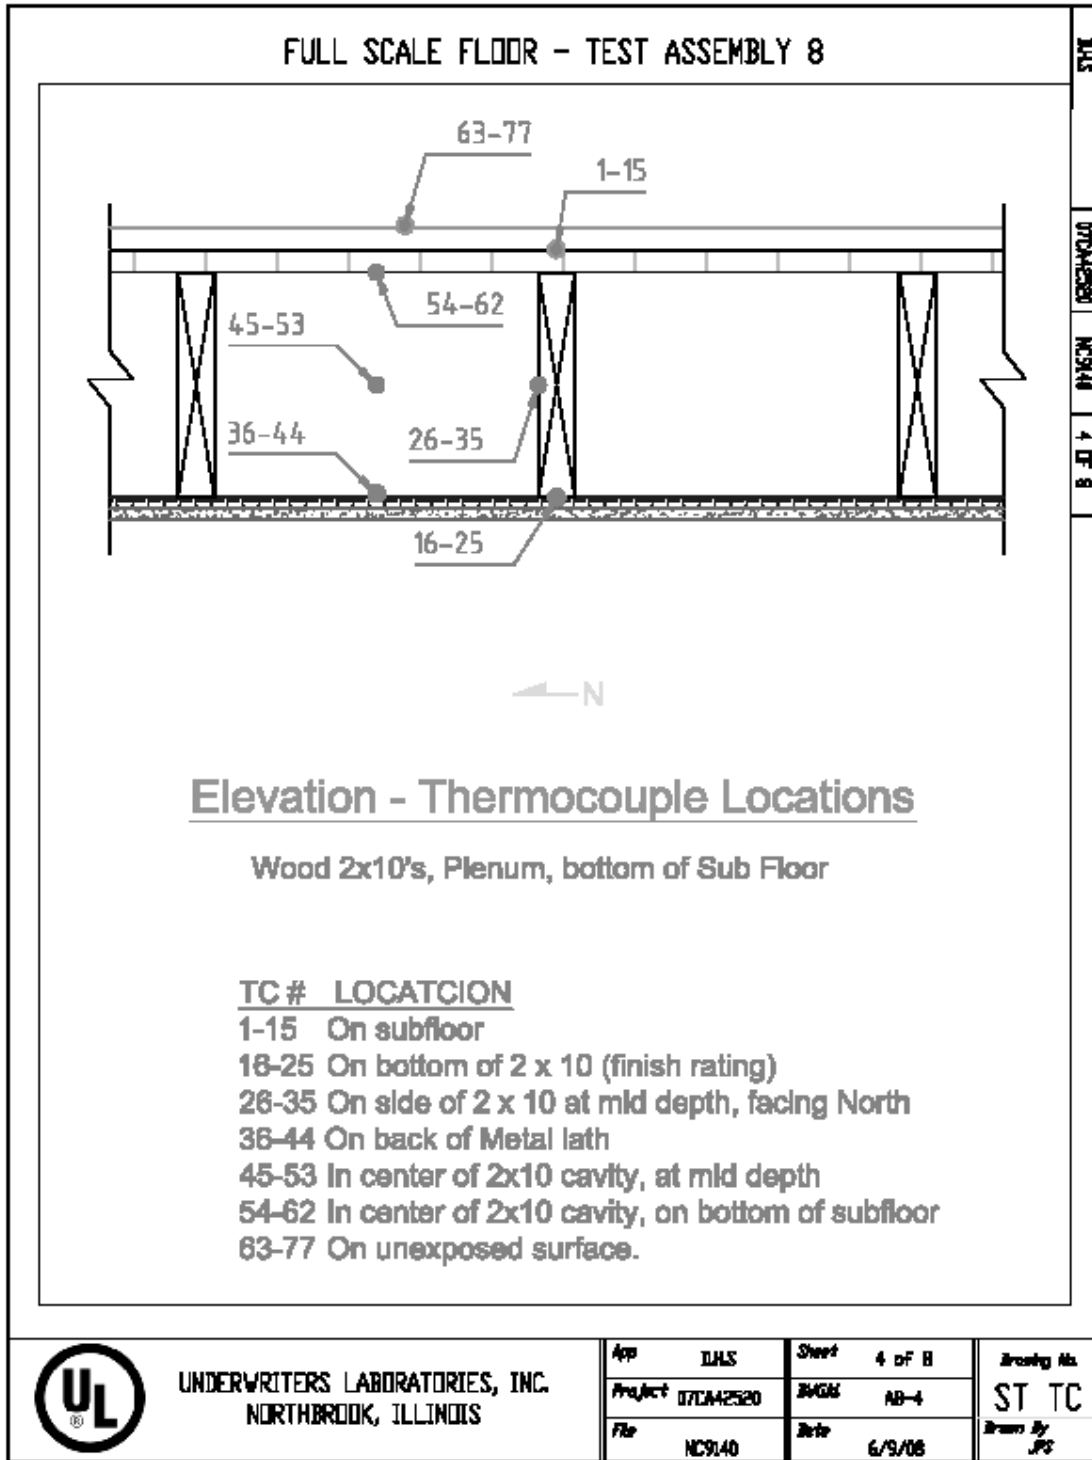
Figure A.8.3 – Thermocouple Locations - Elevation.

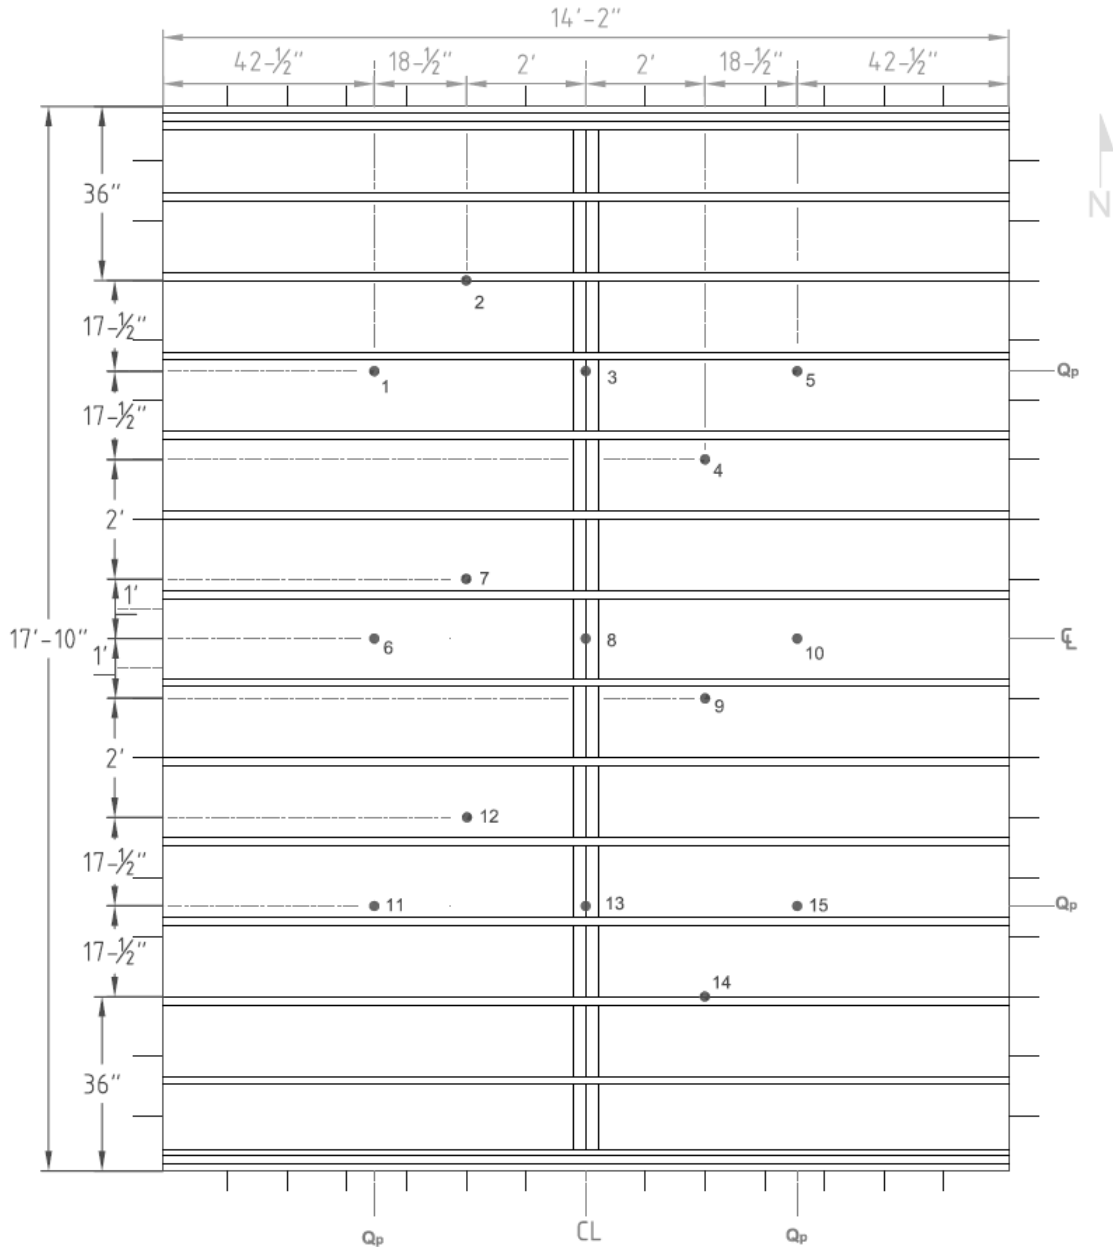
Figure A.8.5 – Thermocouple Locations on Subfloor.

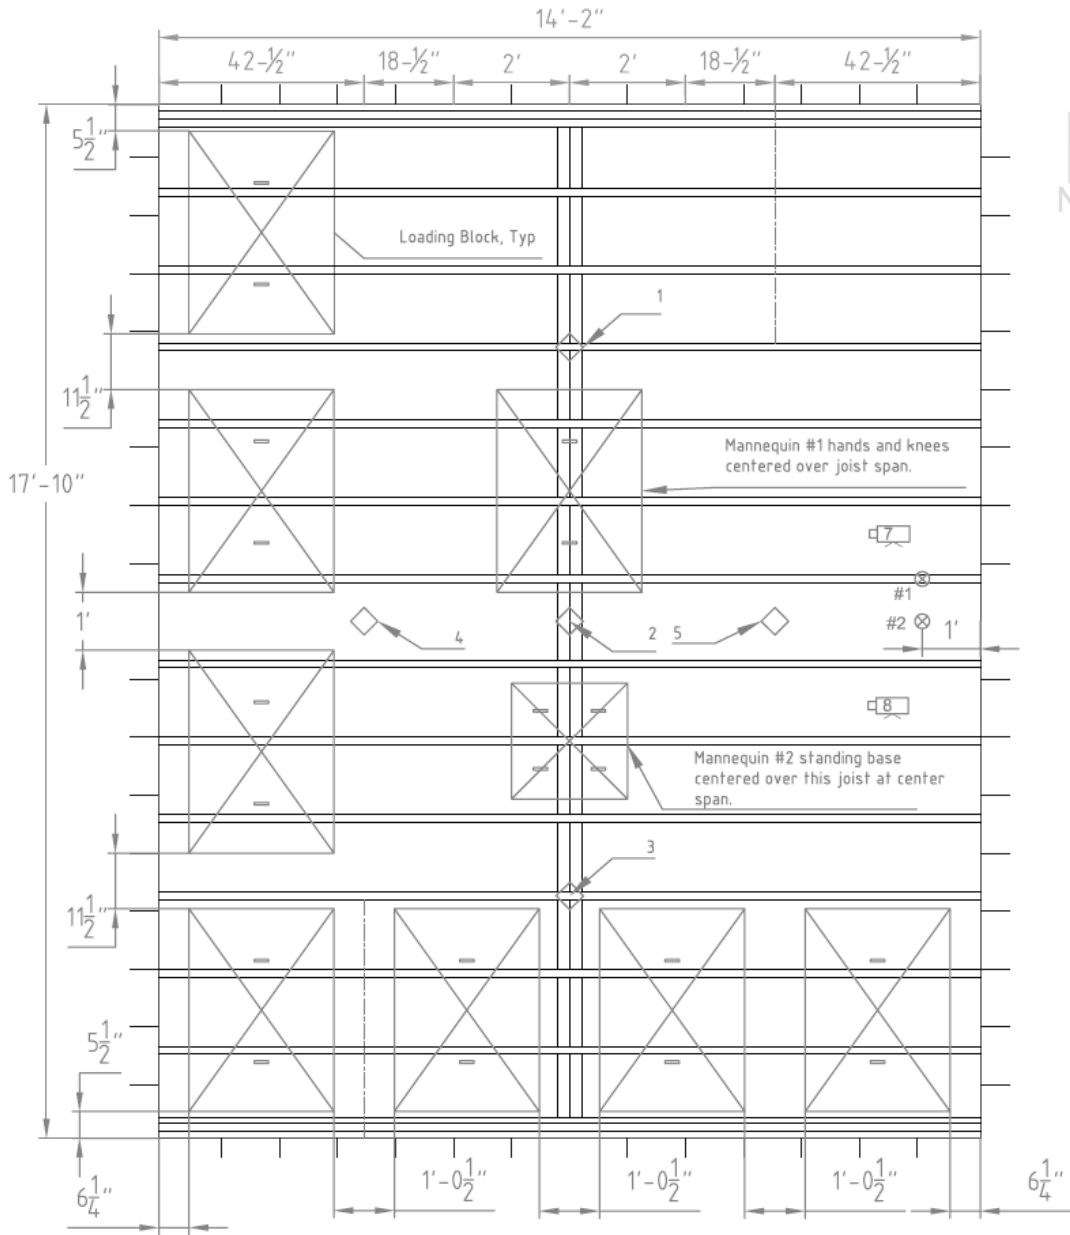
Figure A.8.7 – Loading and Instrumentation Layout (See Figure A.8.8).

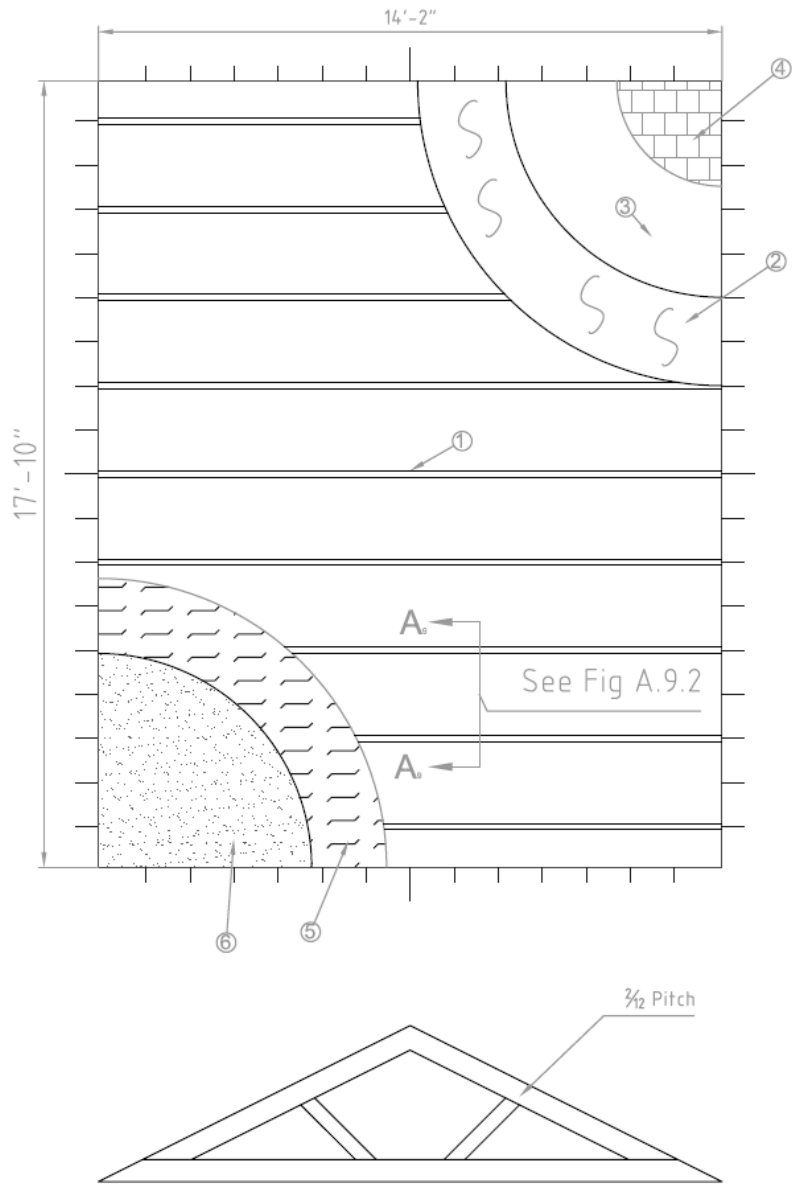
Figure A.9.1 – Construction Layout

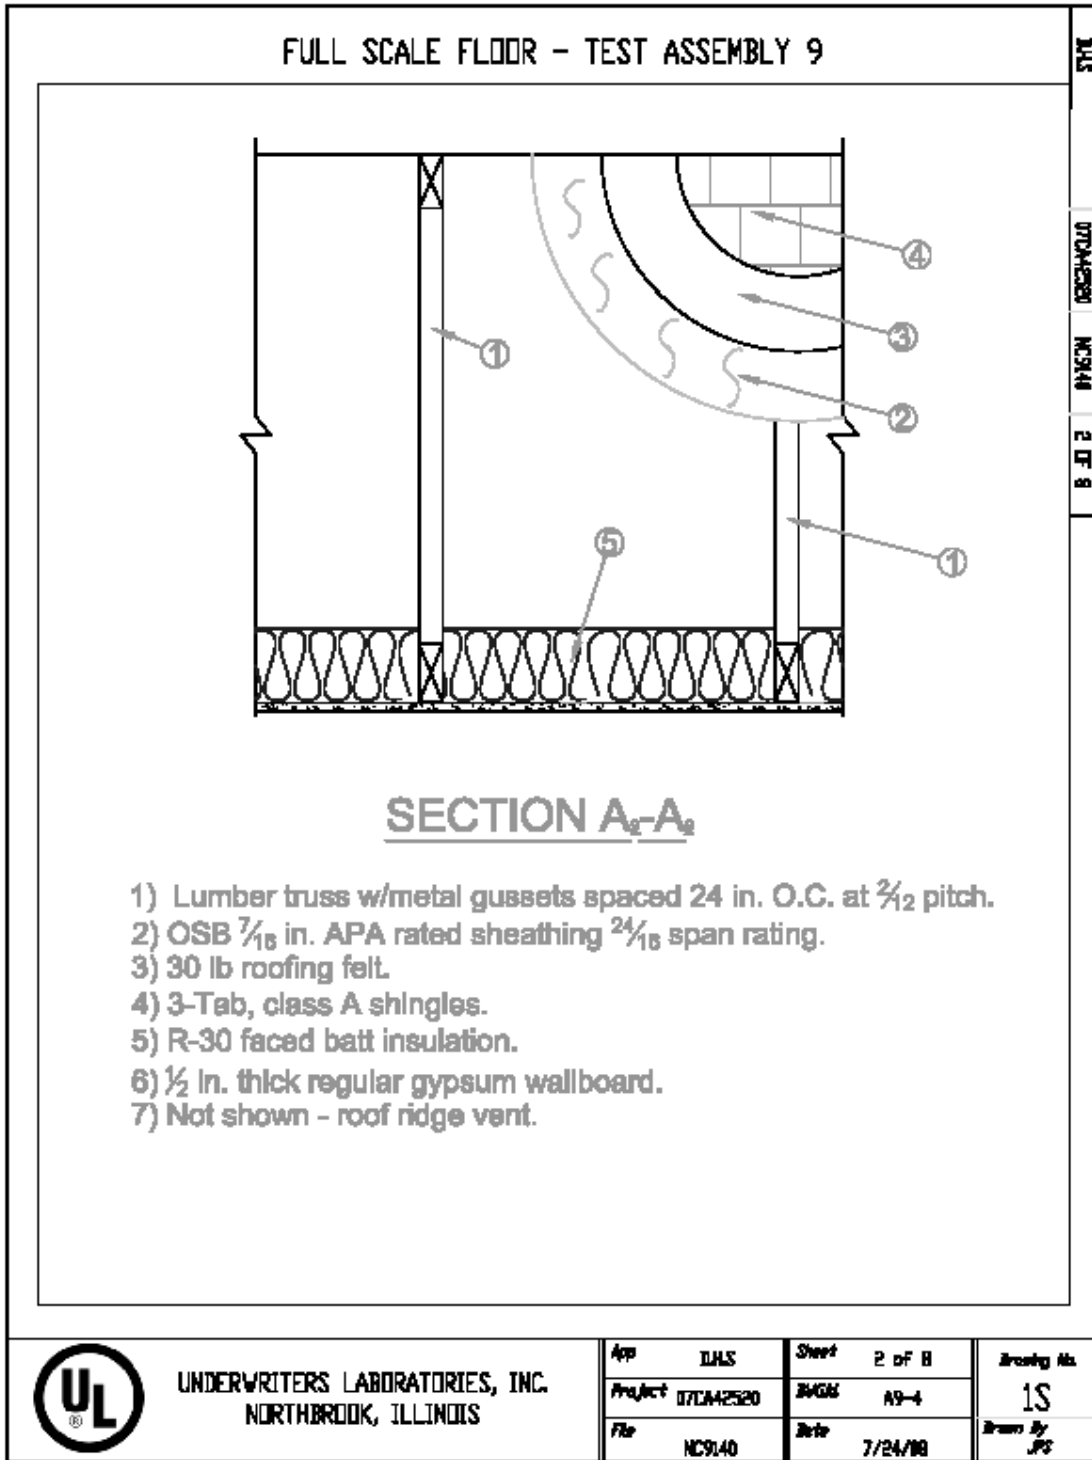
Figure A.9.2 – Construction Layout Section A₉-A₉.

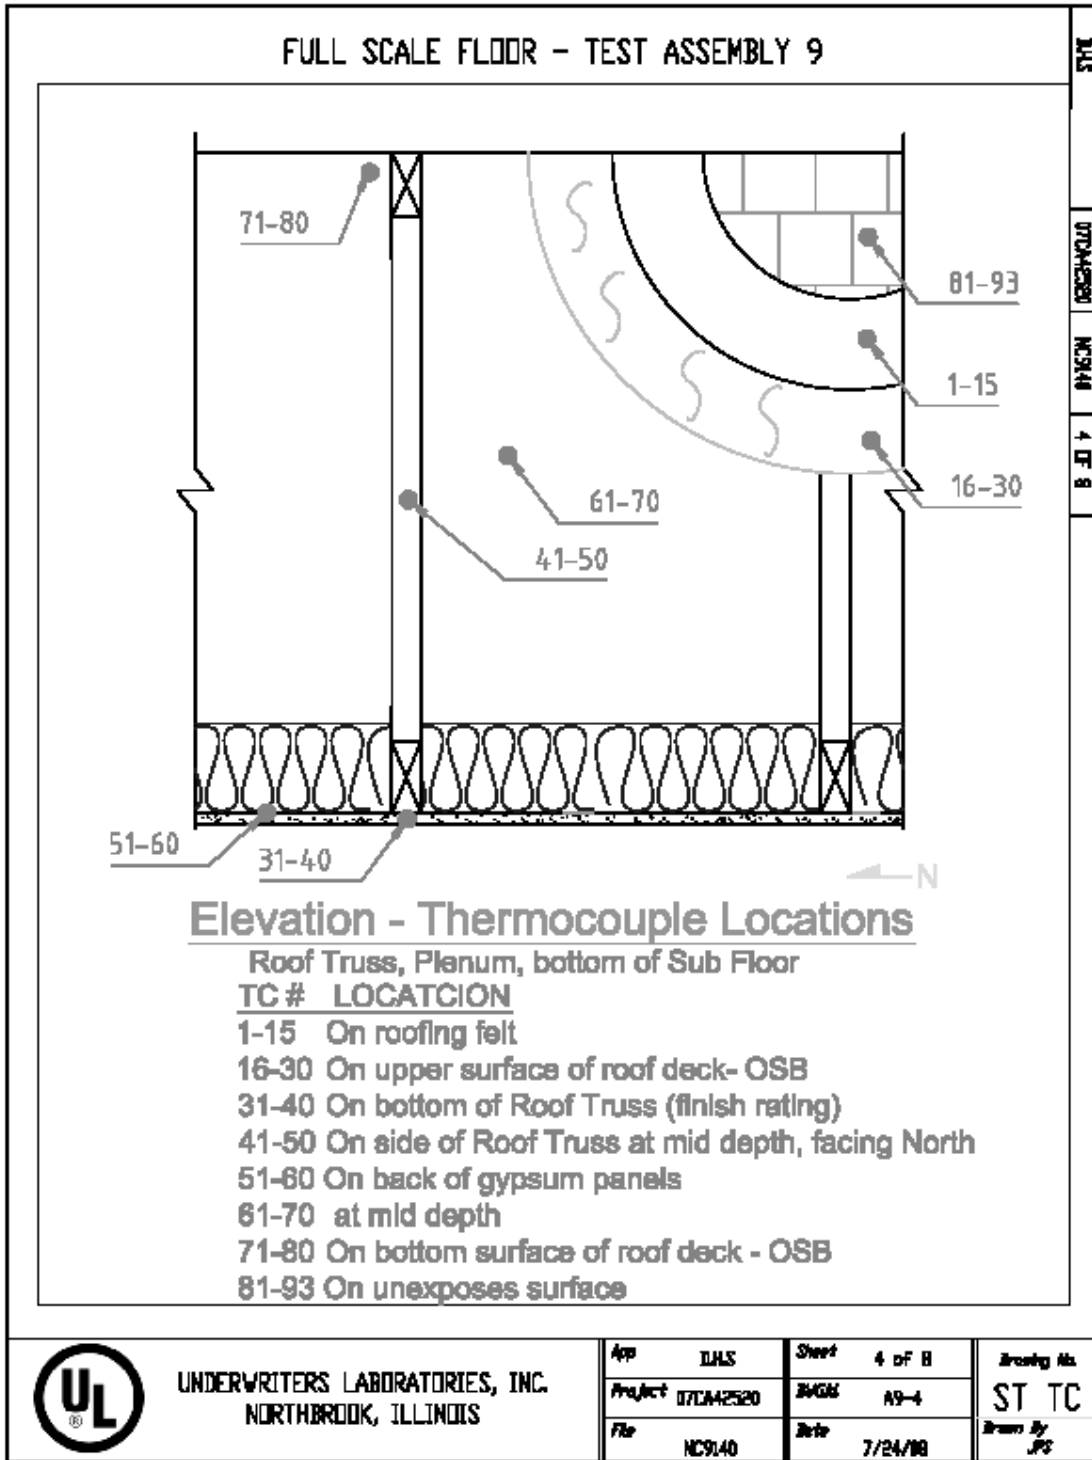
Figure A.9.3 – Thermocouple Locations - Elevation.

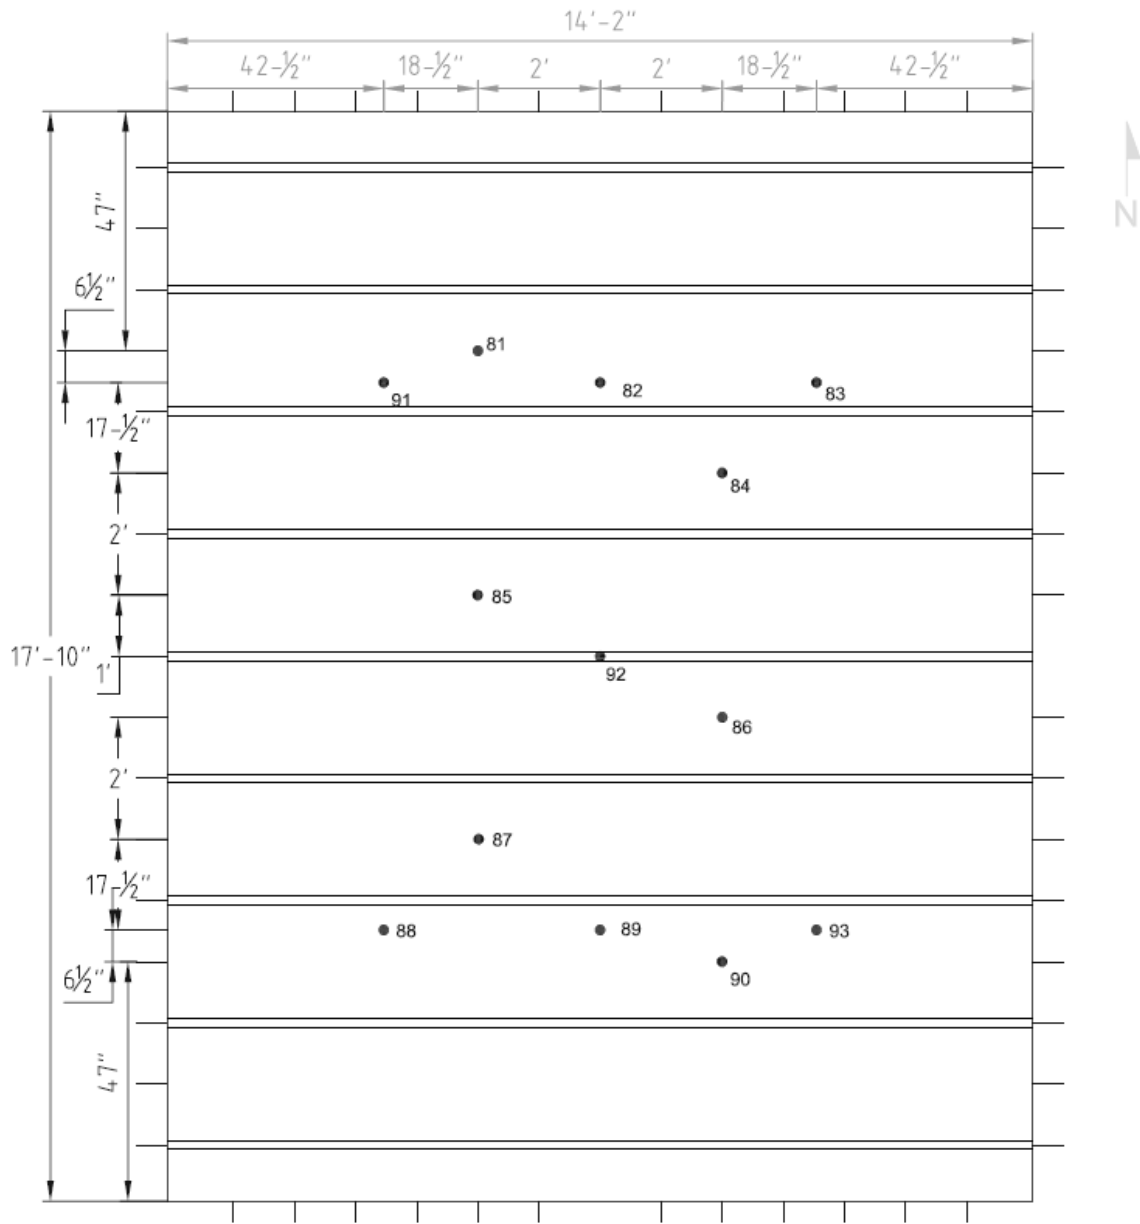
Figure A.9.6 – Thermocouple Locations on Unexposed Surface.
